Re: Replace Bridge 140-1.5 at Courthouse Creek and Avery Creek Culvert on FSR 477, Pisgah Ranger District, Pisgah National Forest, Transylvania County, ER 16-0506

**Historic Documentation and National Register of Historic Places Evaluation of the  
Courthouse Creek Bridge and Avery Creek Culvert, Pisgah Ranger District,  
Pisgah National Forest, Transylvania County, North Carolina**

Final Report

August 18, 2015

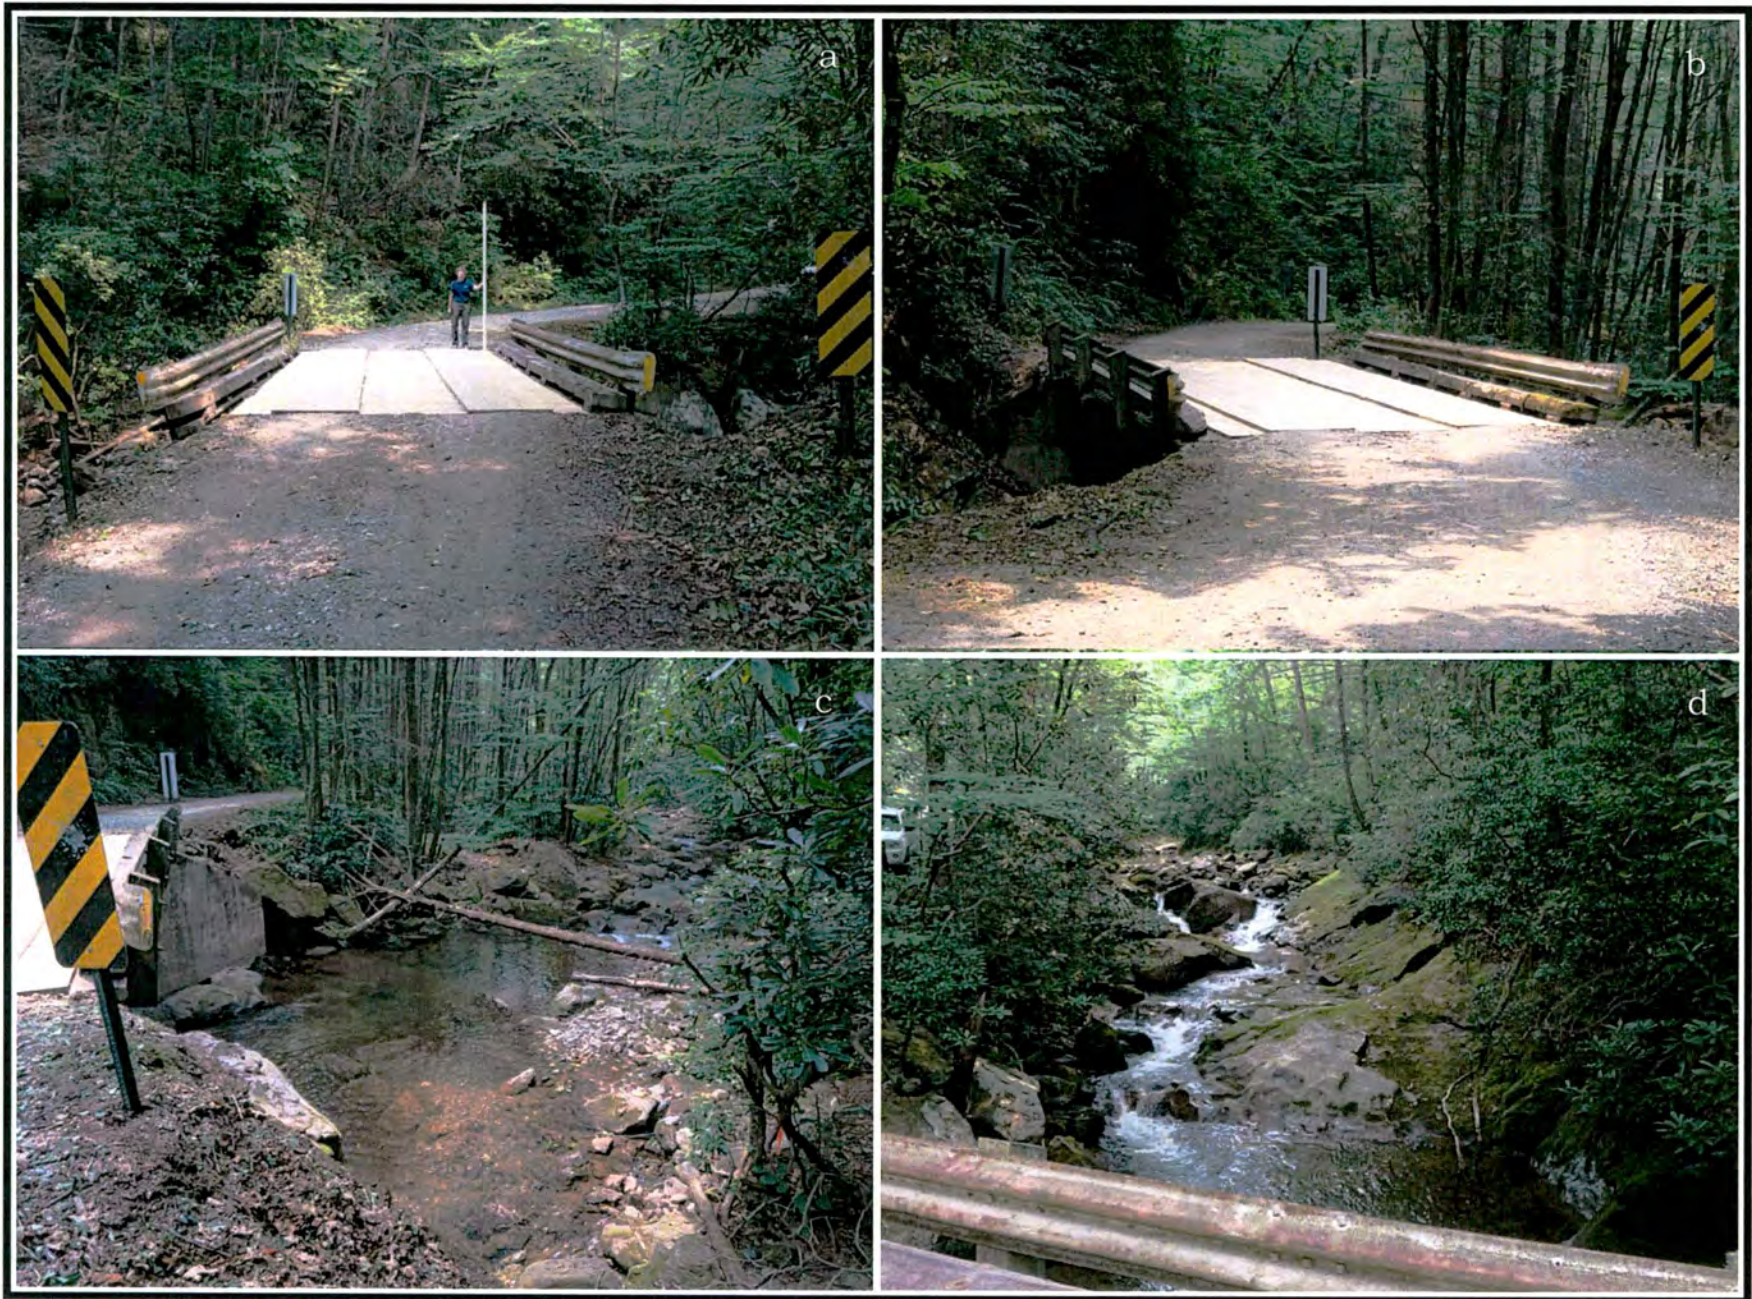
**Vegetation/Site Surface:** mixed hardwoods, conifers & rhododendron; rock ledges, boulders in stream channel  
**Structure Condition:** poor; decking has been breached (recently, temporarily patched); timber subflooring is crushed and splintered in places; one of two side rails is failing, the other slightly leaning; significant rust on most metal elements; erosion/undermining of base of concrete abutments at both ends of bridge

Figure 5. Overview photographs of Bridge 140-1.5 and Courthouse Creek: a) Bridge 140-1.5, view to northwest; b) Bridge 140-1.5, view to southeast; c) upstream portion of Courthouse Creek, view to southwest; d) upstream portion of Courthouse Creek; view to northeast.

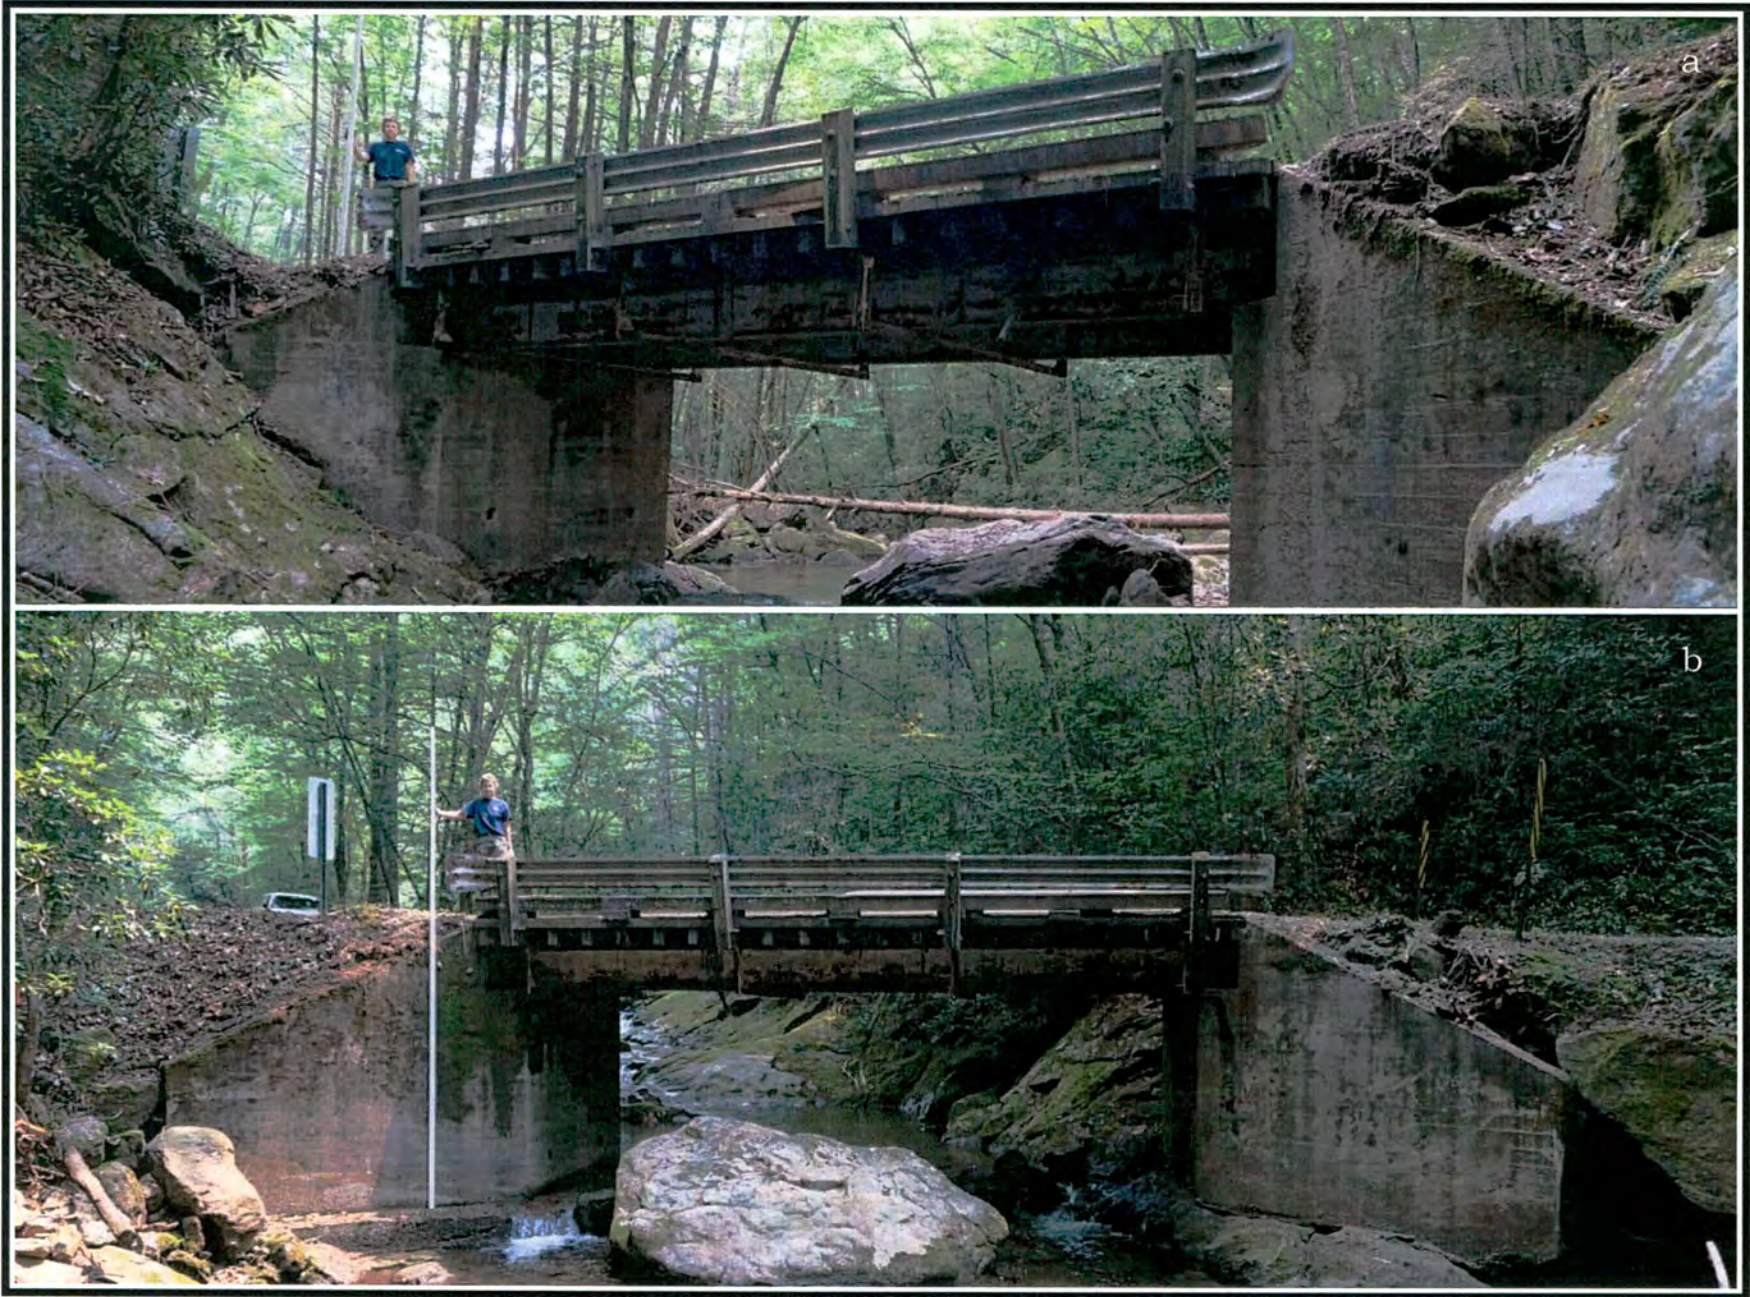
Figure 6. Overview photographs of Bridge 140-1.5 on Courthouse Creek: a) view to southwest; b) view to northeast.

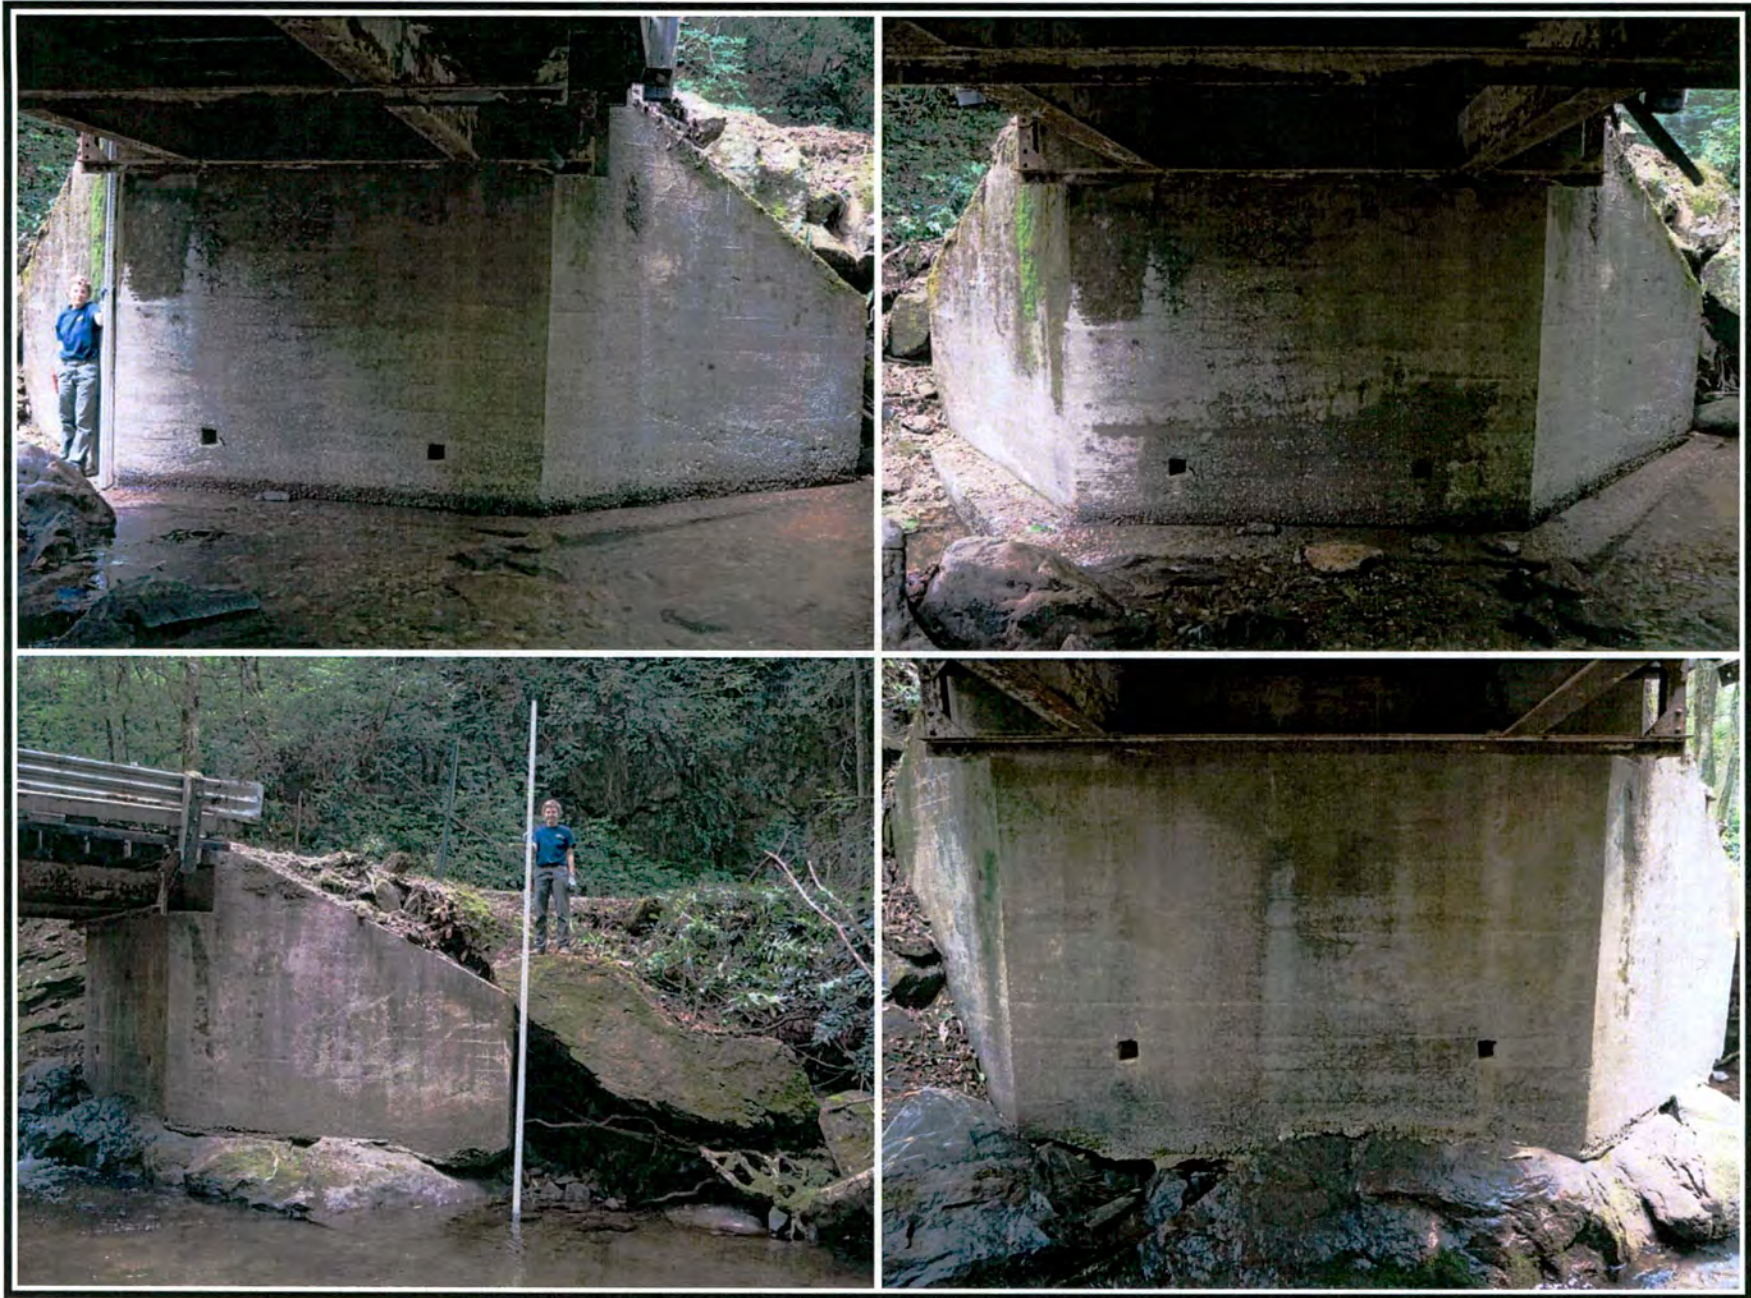
**Abutments:** The reinforced concrete abutments located at the north and south ends of the bridge appear to be structurally sound (see Figures 10 a-d). The bottommost six inches of both abutments exhibit greater wear and erosion of their concrete surfaces, but in no way could this be characterized as cracking or crumbling. At present there is no evidence of longitudinal or transverse fracture on either the breast walls or the wing walls of either abutment. However, the southwest corner of the southern wing wall is broken away, and there are noticeable voids between this wing wall and its adjoining breast wall and the boulder substrate on which they rest. In addition, there appears to be a considerable cavity behind the southwest end of the west wing wall of the southern abutment. The northern abutment rests

Figure 10. Overview and close-up photographs of the concrete abutments at Bridge 140-1.5: a-b) north abutment, view to northwest; c) south abutment, view to east; south abutment, view to southeast.

on a prepared concrete footer whose footprint measures approximately 1.4 feet wider than the outline of the vertical abutment. Although at present, the gravelly sand substrate in this part of Courthouse Creek appears to closely surround the footer of this abutment, earlier USFS inspections indicate that at various times the creek flow exposed a significant void beneath this abutment foundation. For example, a 1981 report documents the loss of as much as 30 inches of rock and soil from beneath the northeast wing wall and its adjoining breast wall (see Figure 11).

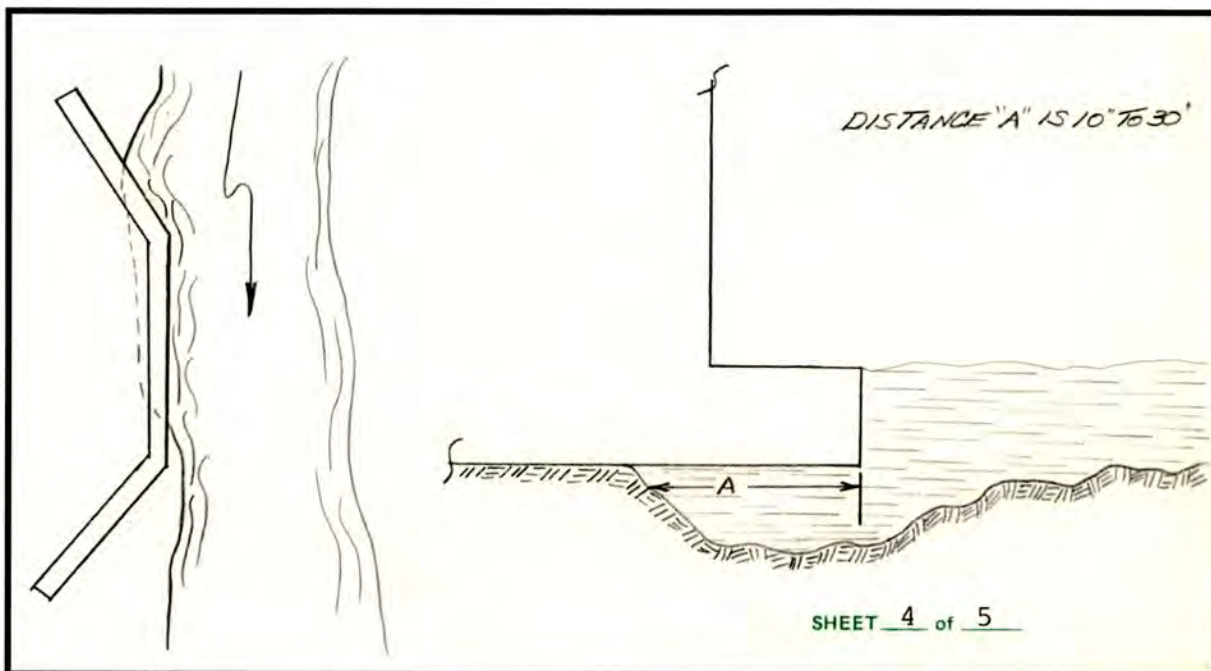
Figure 11. Plan view of the northern abutment on Courthouse Creek (left) and profile view (right) of base of same abutment illustrating the depth of void.

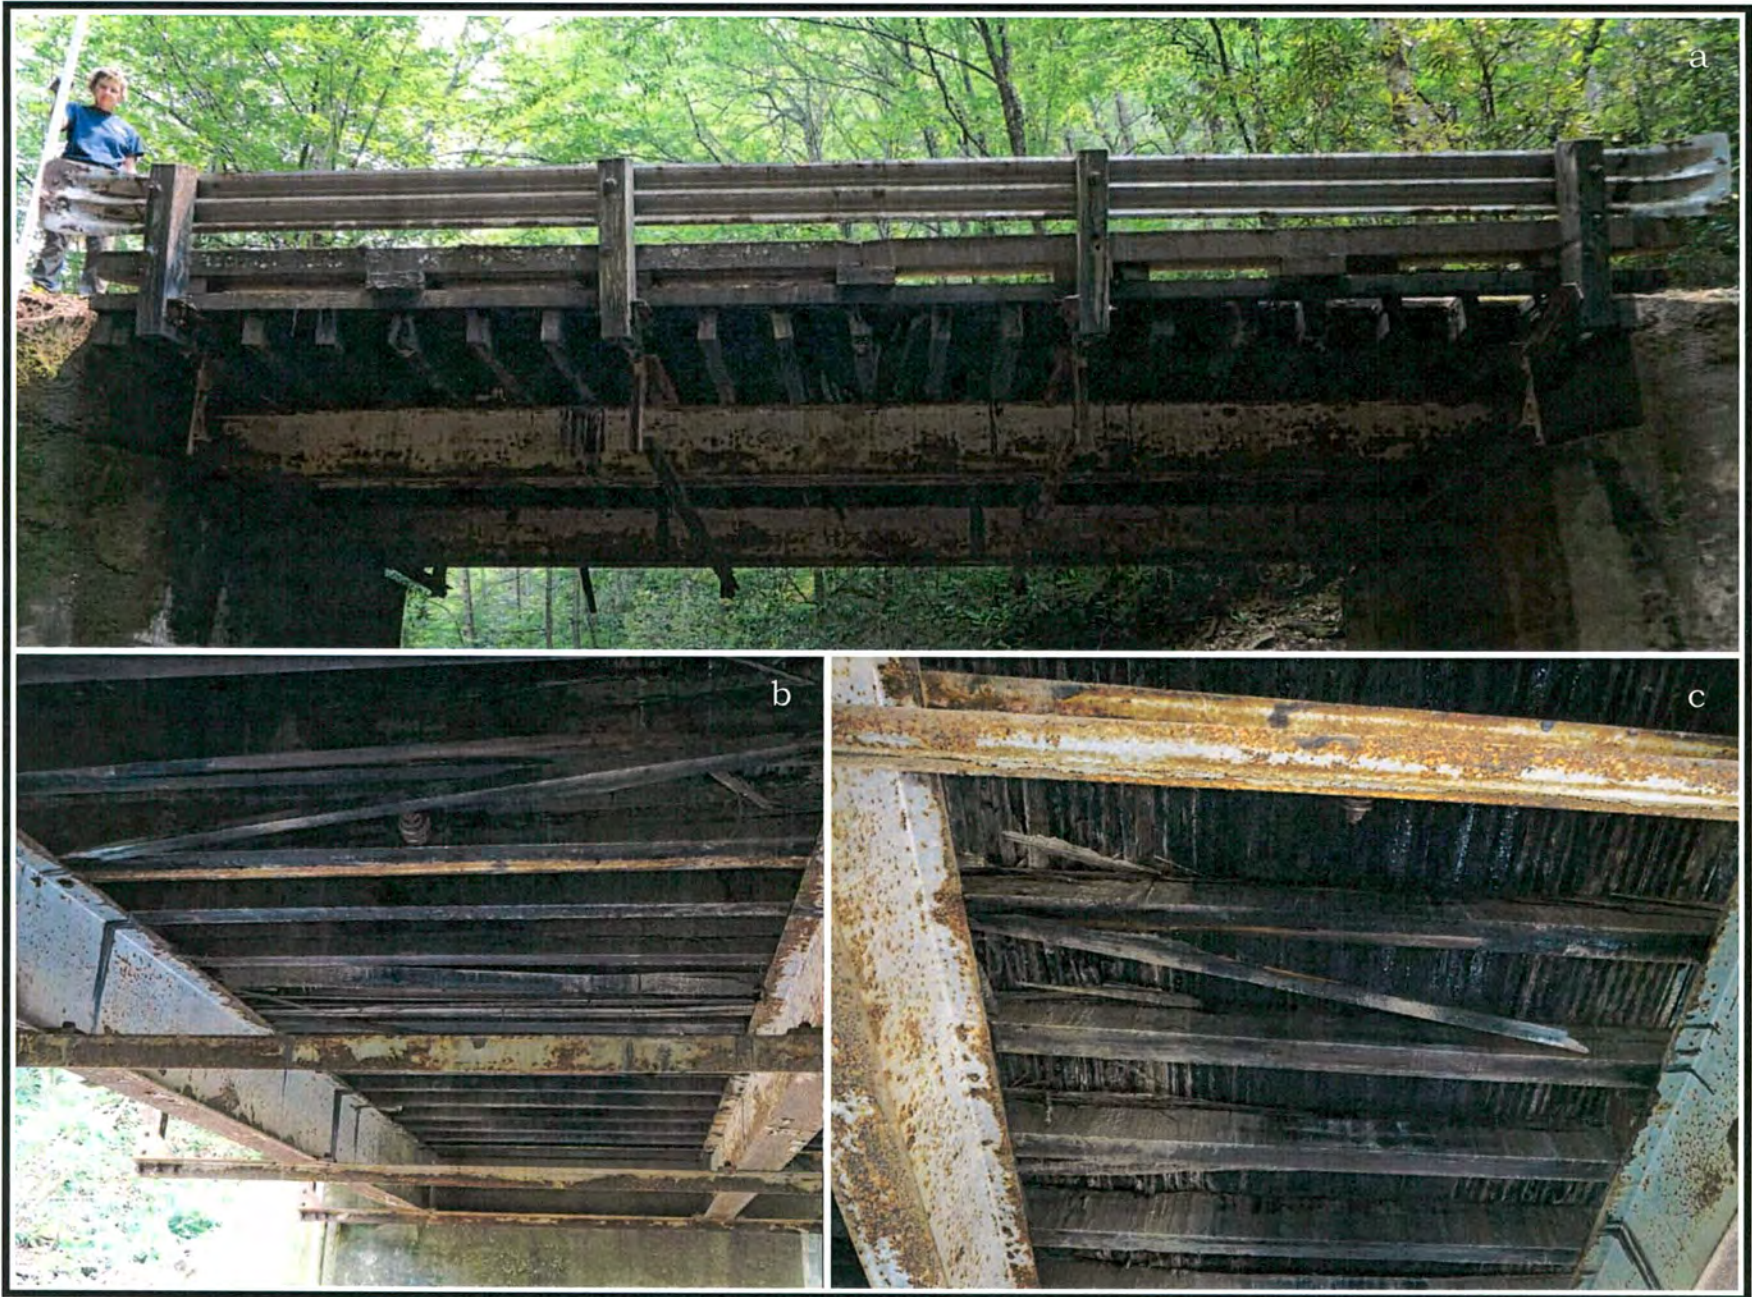
Superstructure: Rust, scaling, pitting, and peeling paint are readily apparent on the surfaces of both steel support girders (or I-beams) and on all flanges, bolts, nuts, brackets, and angle bars that constitute the metal web that ties these two beams together and to which the wooden deck above is attached. Estimates generated during the 2013 USFS inspection of Bridge 140-1.5 suggest that section loss due to rust and pitting ranges from 1/16" to 1/8" deep, while anchor bolts and nuts exhibit as much as 60% loss.

Deck: The laminated 2 x 4-inch bridge decking is significantly weathered, splintered, and in one section broken through. This recent break resulted in a temporary repair with the addition of layer of 2 x 10-inch planks laid down perpendicular to the long axis of the bridge. A second layer of 2 x 10 planks was then laid down above and perpendicular to the first (i.e. with the long axis of the bridge), but only as two parallel runs to correspond to the wheel-base of most vehicles. The upper surface of the original deck is now difficult to examine given the layer of new planking, but viewed from below, the damage and weathering is more apparent (Figures 12 a-d). Several of the original 4 x 8-inch transverse support timbers, on which the laminated 2 x 4-inch decking is laid, exhibit obvious fractures, splintering, and in at least one instance complete failure. The ends of many of these transverse support timbers are cracked and decayed. The failing south guard rail has resulted in the separation of several courses of the laminated 2 x 4-inch decking at that end of the bridge. The 4 x 12-inch wooden curbs or wheel guards are splintered and out of alignment at the base of the south end of the south guard rail. All curbing elements exhibit decay—especially in the north half of the south curb. Decay in the risers that lift the curbing timbers off the deck is even more advanced.

Since the 2013 inspection of Bridge 140-1.5, a number of structural elements have deteriorated further or in a few instances failed. For example, several of the transverse timbers located beneath the laminated decking have cracked—and one these is now nearly completely broken. The downstream guard

Figure 12. Overview photographs of the steel girders, steel angle brackets, wooden transverse joists, and laminated decking at Bridge 140-1.5: a) view to northeast; b) view to northwest; and c) view to southeast.

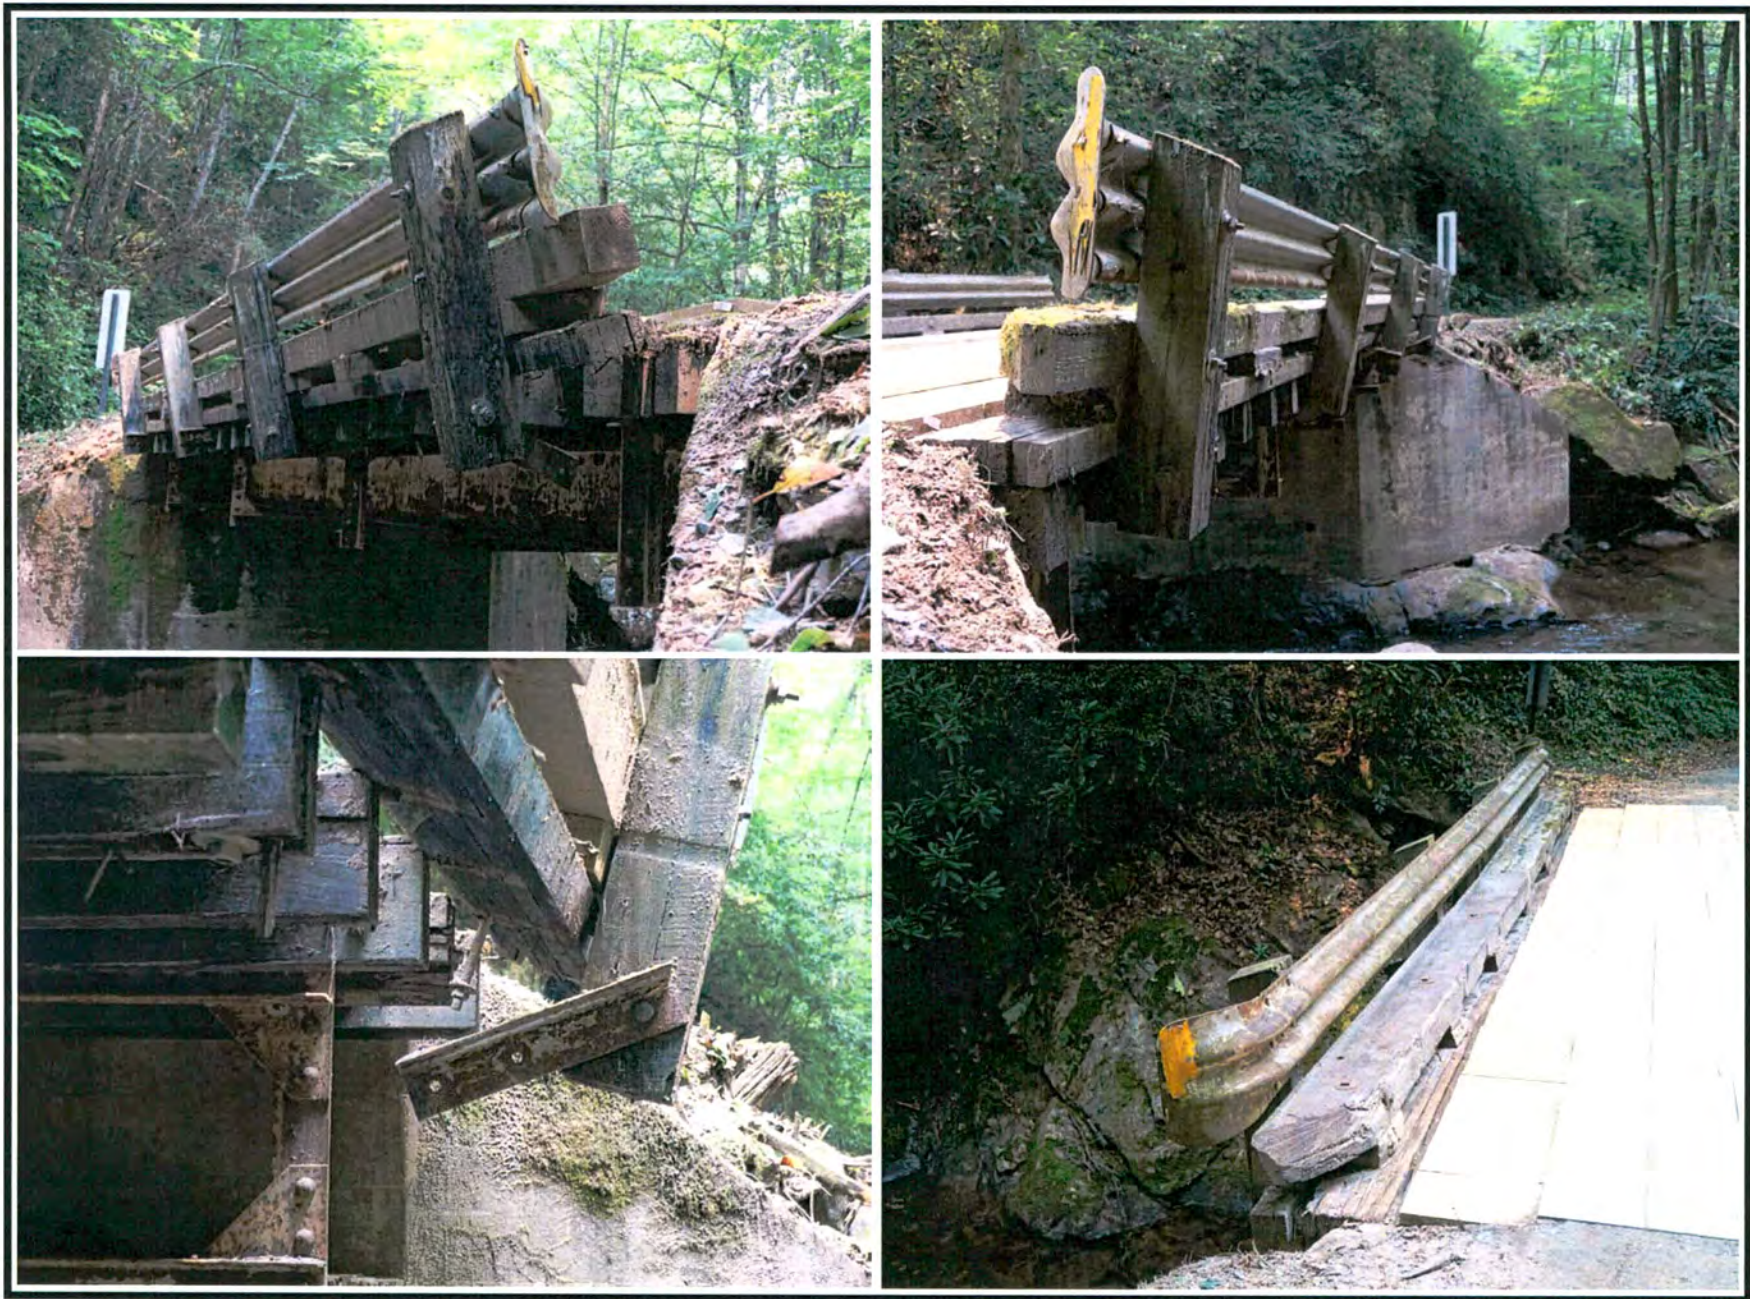
Railings: Bridge railing timbers are weathered, but for the most part functional (Figures 13a-d). Though not directly tested, the vertical guard rail posts appear to exhibit significant dry rot or decay. The horizontal W-beam steel portions of the guard rails exhibit significant rust on both interior and exterior surfaces. Reflective paint at the ends of the north and south railings is nearly gone in all cases. Vehicle impact to the south railing has resulted in a broken support bracket below deck and an increasingly angled side railing above, such that the latter now leans at its top as much as 1.4 feet out of alignment. The north end of the south railing and the north end of the northern railing are out of alignment by several inches.

Figure 13. Overview and close-up photographs of the wood and steel railings at Bridge 140-1.5: a) south railing, view to north; b) south railing, view to southeast; c) close-up of broken support bracket on south railing, view to southeast; and d) north railing, view to southeast.

rail continues to list increasingly downstream at its south end and one of its support brackets is now hanging by a thread. It may also be the case that these wooden post and W-profile steel guard rails represent a latter (circa 1950s or 1960s) addition to the 1939 bridge over Courthouse Creek. The voids noted beneath and behind the south abutment of the bridge are still obvious and cannot be thought to have improved with time. The void previously noted beneath the north abutment was not obvious at the time of the 2015 inspection, but then no attempt was made to probe the space beneath the footer. Finally, the recently added decking constitutes an emergency repair following an incident in which a vehicle nearly broke through the old decking (Scott Ashcraft, personal communication 2015). Although Bridge 140-1.5 was most likely constructed by the Civilian Conservation Corps, and for that reason is a structure of historical interest, it must be argued that the bridge is now in poor condition and has become a safety concern. Records maintained by the USFS indicate that Bridge 140-1.5 is one a dozen bridges located within the Pisgah, Nantahala, and Grandfather Ranger Districts constructed between the years 1930 and 1941. The same records indicate that most of these other bridges are in a better state of repair and in some instances offer better examples of CCC-construction techniques and style—for example, exhibiting stone instead of poured concrete abutments. For these several reasons, Bridge 140-1.5 is evaluated as ineligible for nomination to the National Register of Historic Places. We find no objection to the proposed replacement of this structure and recommend that its replacement proceed with all due haste.

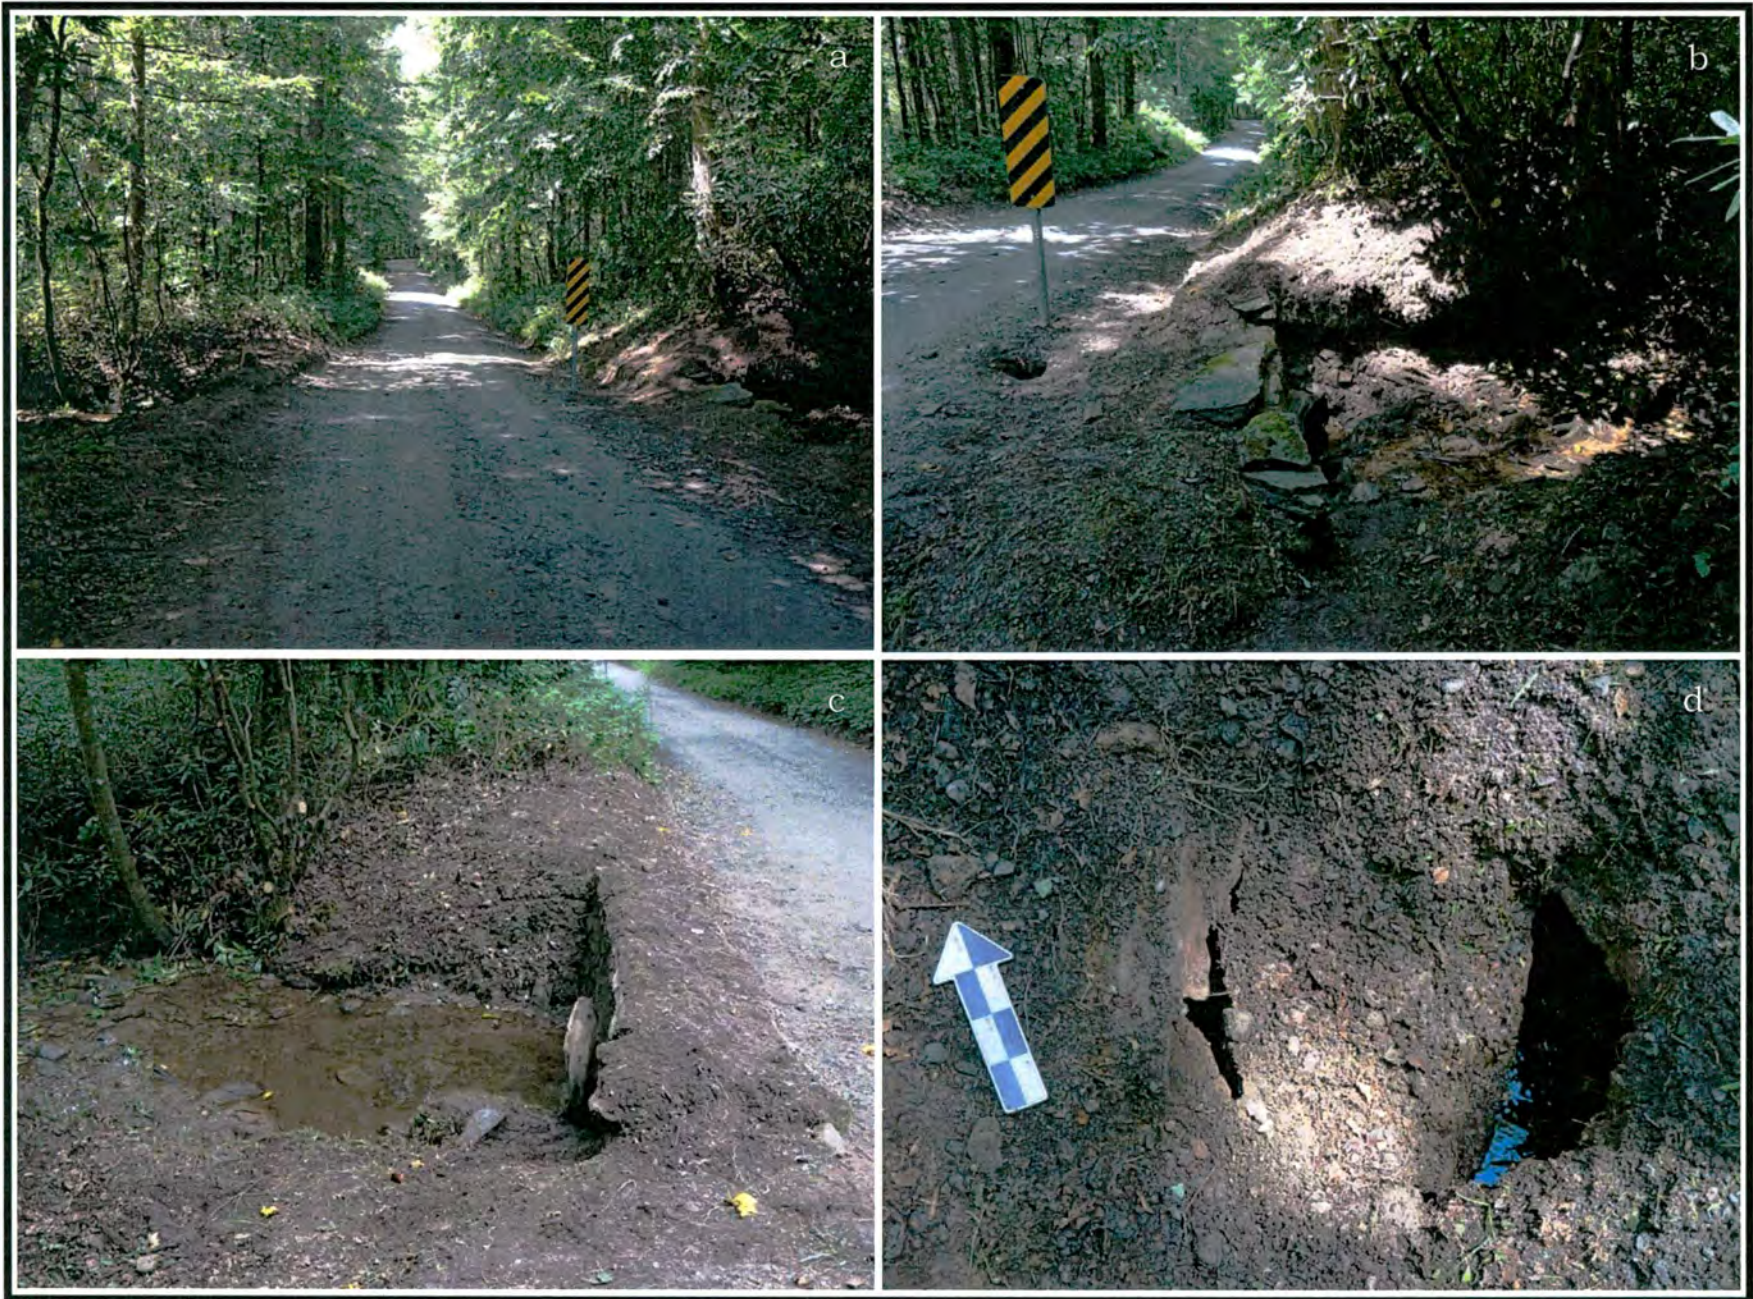
Figure 14. Overview photographs of the Avery Creek Road culvert on FSR 477: a) view to south/southwest; b) headwall & breach in culvert, view to south; c) outflow wall, view to southwest; close-up of breach in steel culvert/FSR 477, view to northeast.

As noted above, the mortar that binds the stones of both the headwall and the outflow wall is eroded in places, and this is especially the case near the base of both walls and in those areas immediately surrounding the steel culvert. The slap-dash and at times globular appearance of the mortar bond finish of the headwall contrasts with the smooth and more narrowly pointed bonds of the outflow wall. It is also clear that the mason of the outflow wall made a much more concerted effort to arrange stones in such a way that the end result was an exterior (east wall) surface that may be characterized as smooth and plumb, where the face of each stone was closely aligned with each of those beneath it and beside it. The same cannot be said of the western headwall. Despite the extra care and greater craftsmanship applied to the outflow wall, the stonework of this particular wall has suffered significant damage. The top four courses of stone in the north half of the wall are now pushed eastward by several inches and the northernmost and topmost several courses of stone have separated from the rest and settled downward by

several inches. The displacement of these stones is likely the result of impact with a heavy machinery or logging truck. Not surprisingly, the more poorly constructed west headwall has also suffered loss of integrity over time. Several of its uppermost stones are now displaced, while others appear to be missing. Stones at the north end of this wall may have been displaced by those who maintain the roadside ditches—one of which empties immediately adjacent to, if not onto the north end of the headwall. Most adversely impacted has been the corrugated steel pipe that passes beneath the Forest Road from headwall to outflow wall. Rust likely created a weak surface near its western end and the passage of some particularly heavy vehicle has recently created a breach in the top of the pipe and in the surface of the road (see Figures 14d and 15). The placement of a reflective caution sign on one side of this hole prevents others from driving over it, but its occurrence may indicate that the integrity of other portions of the steel pipe are also nearly as compromised.
