North Carolina Department of Natural and Cultural Resources
State Historic Preservation Office

Ramona M. Bartos, Administrator

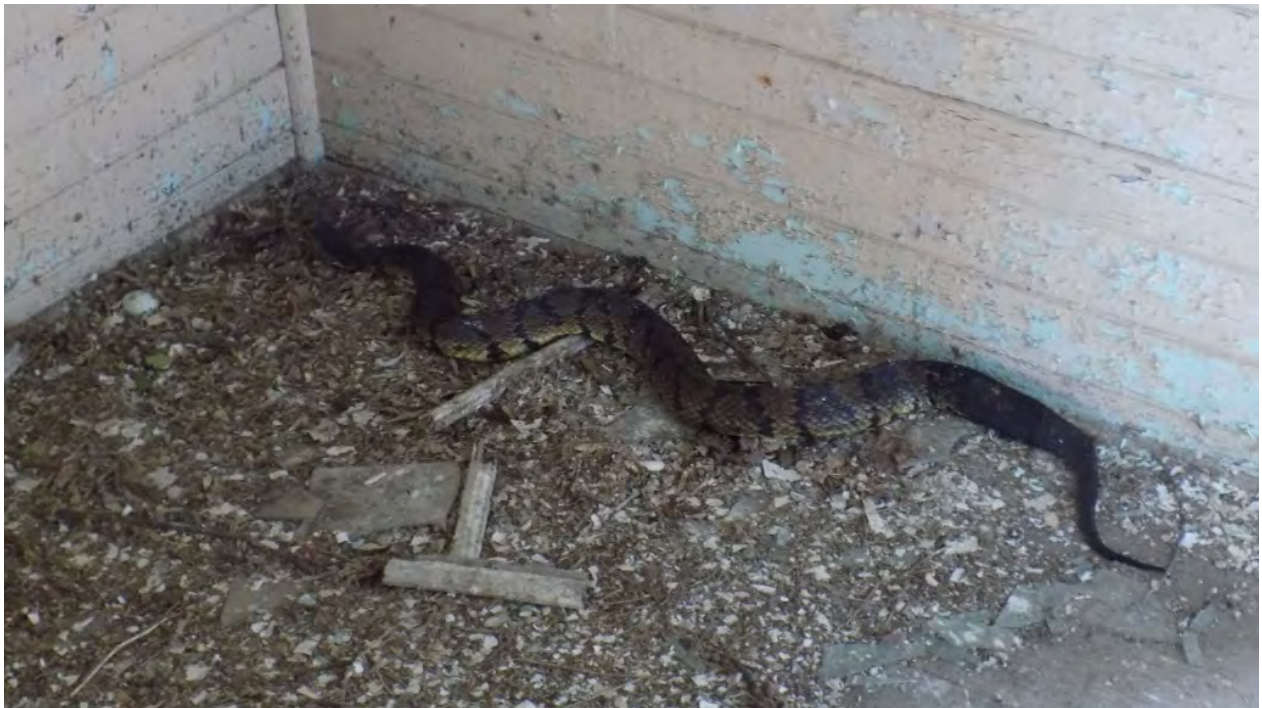
One of the numerous water moccasins (*Agkistrodon piscivorus*) that inhabit Monkey Island. [Source: Brant 2017].

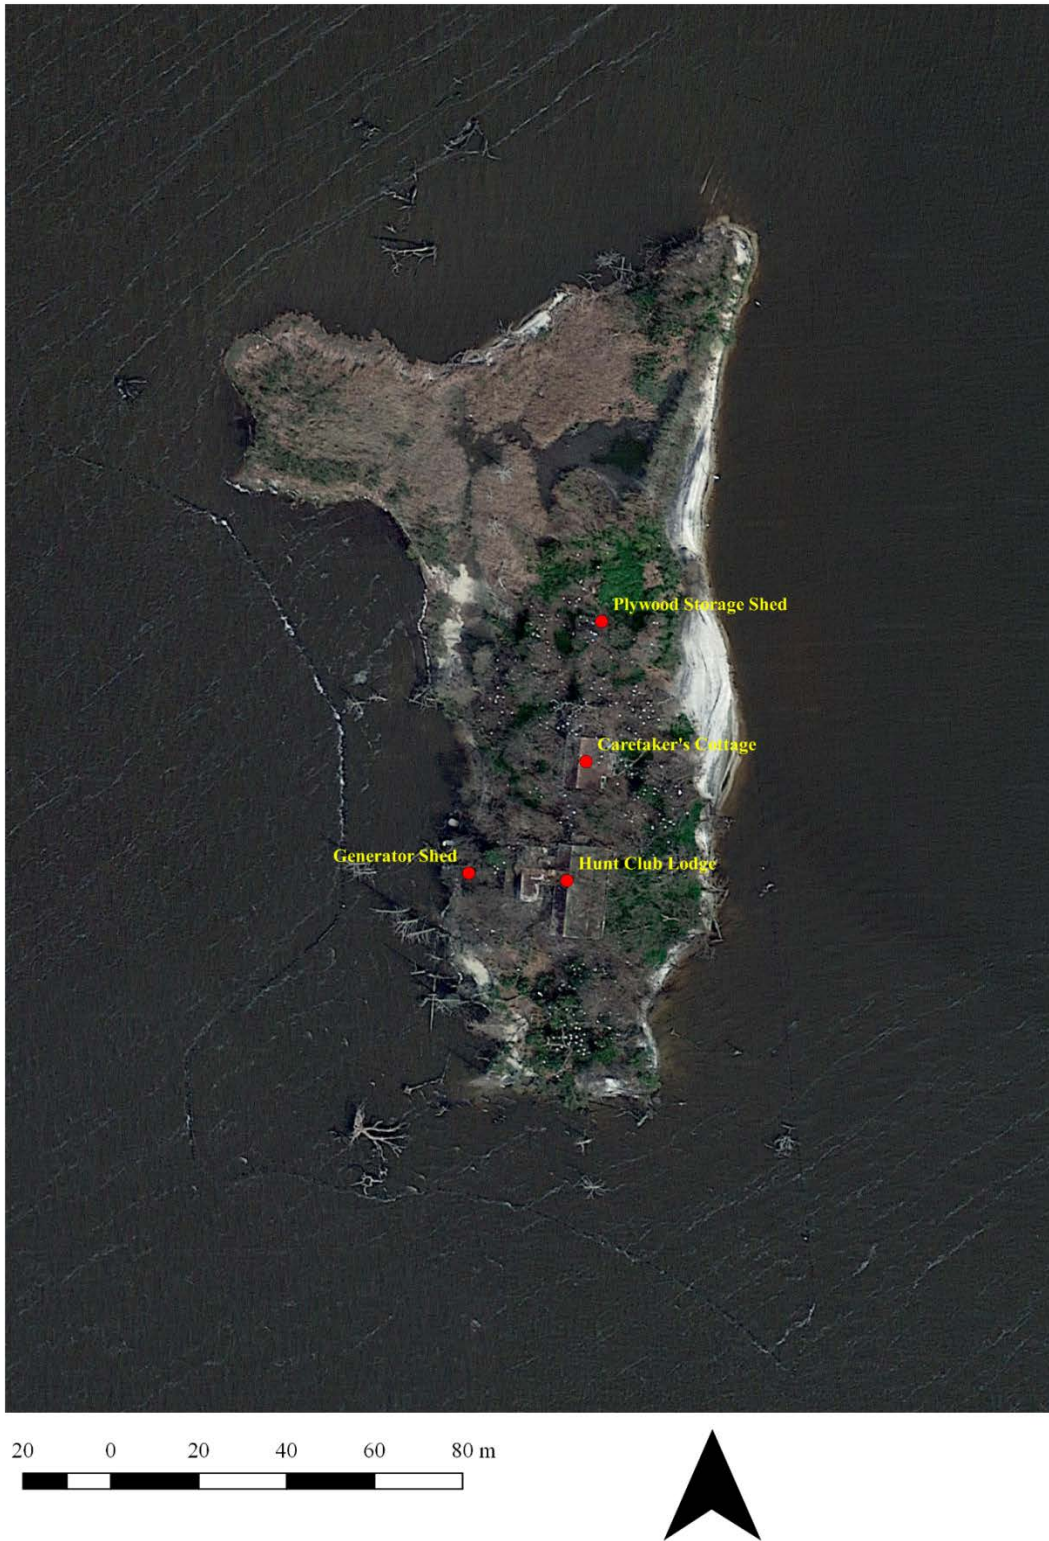
Figure 1. Aerial imagery of Monkey Island depicting the locations of the Caretaker's Cottage, the generator shed, the Hunt Club Lodge, and the plywood storage shed.

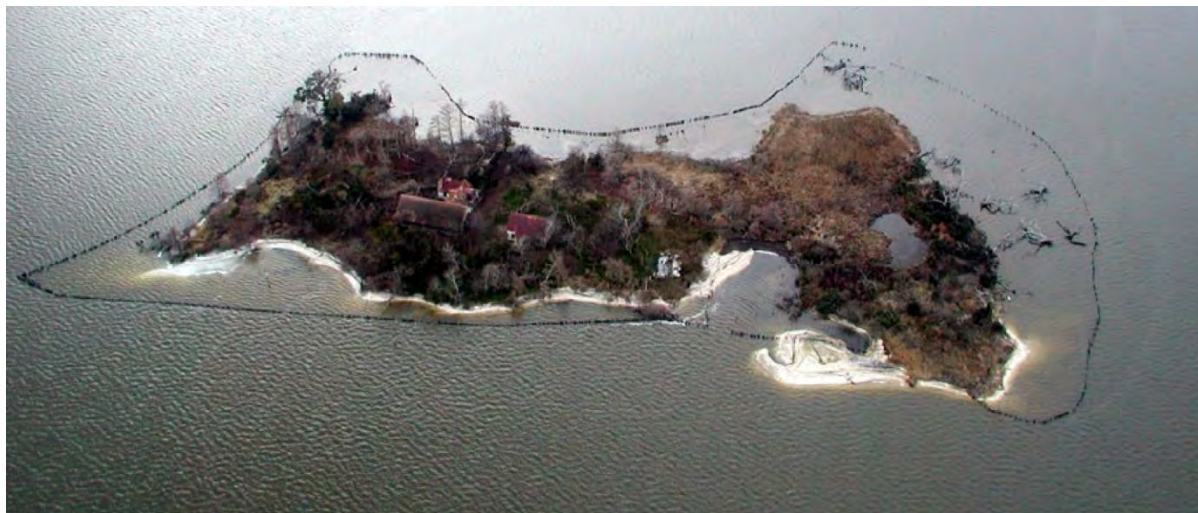
Figure 3. Aerial imagery of Monkey Island from 2005 depicting the location of the Caretaker's Cottage, Hunt Club Lodge, storage shed, boat basin, and retaining wall. Note the significant shoreline erosion due to the failure of the retaining wall (Source: Kanaski [2016]).

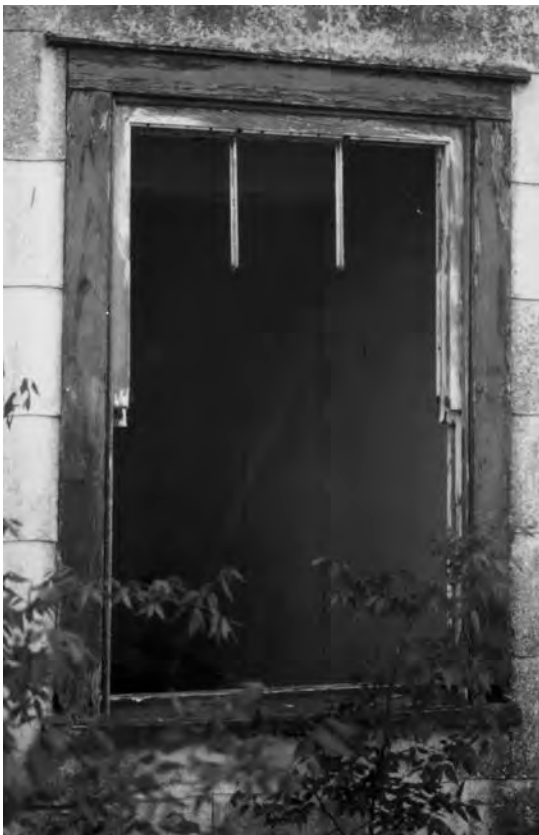
Figure 4a. Vandalized window on the lodge.

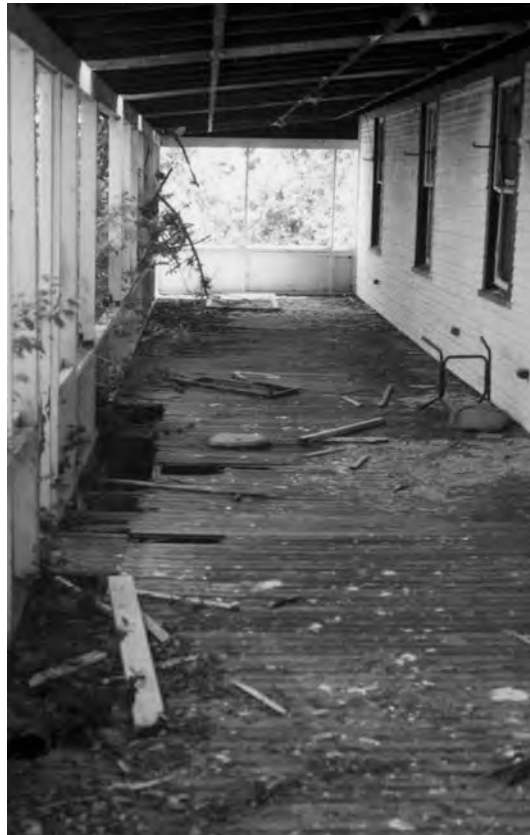
b. Damage to the lodge’s main porch [Source: Kanaski 2001].

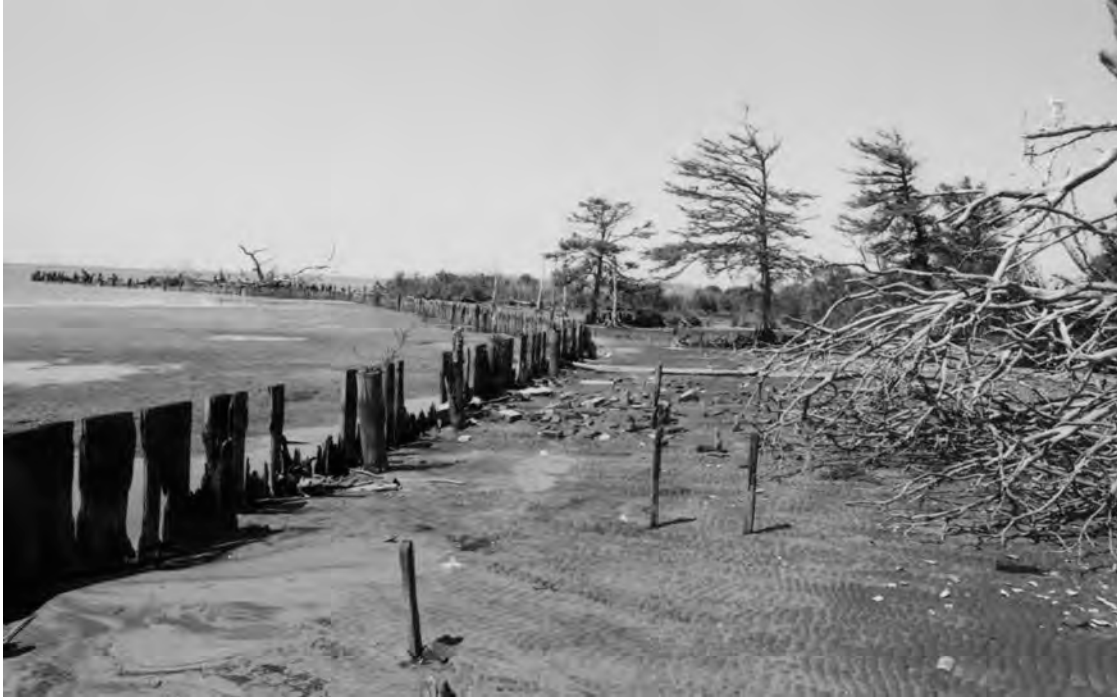
Figure 5. Failed wood bulkhead, west side of Monkey Island [Source: Kanaski 2001].

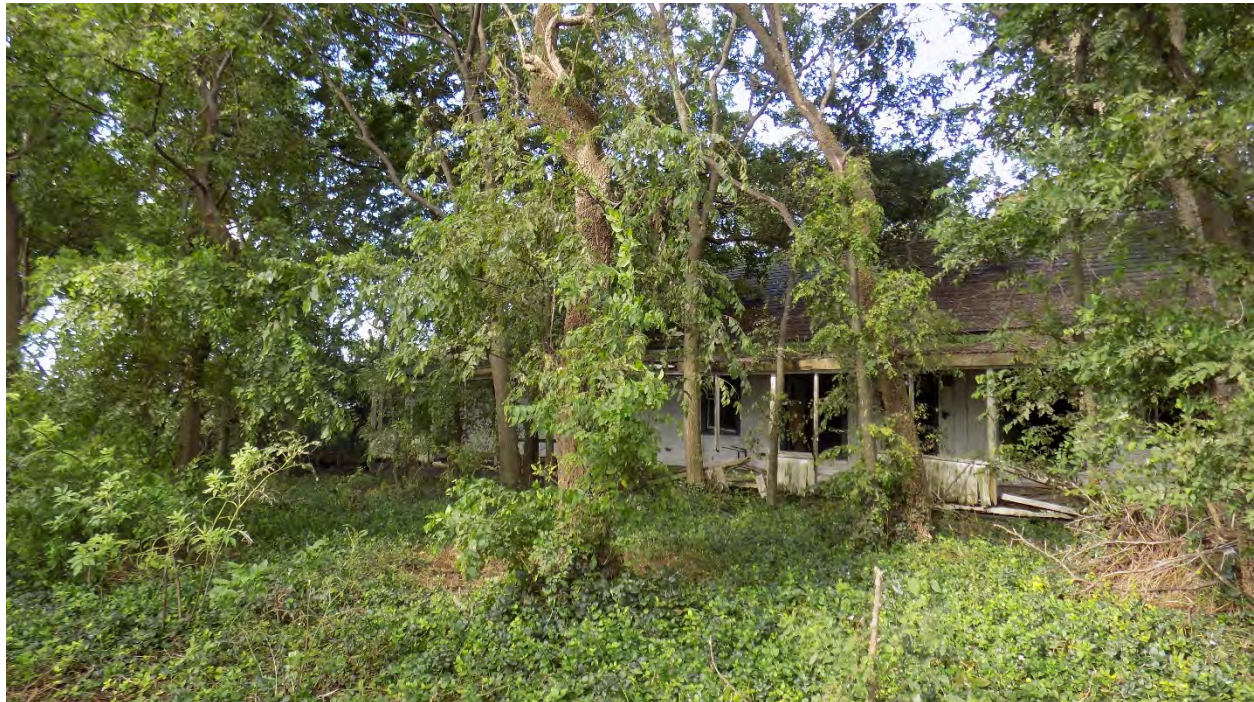
Figure 6. Hunt Club Lodge, eastern elevation. The front deck is in disrepair and foliage has encroached on the structure.

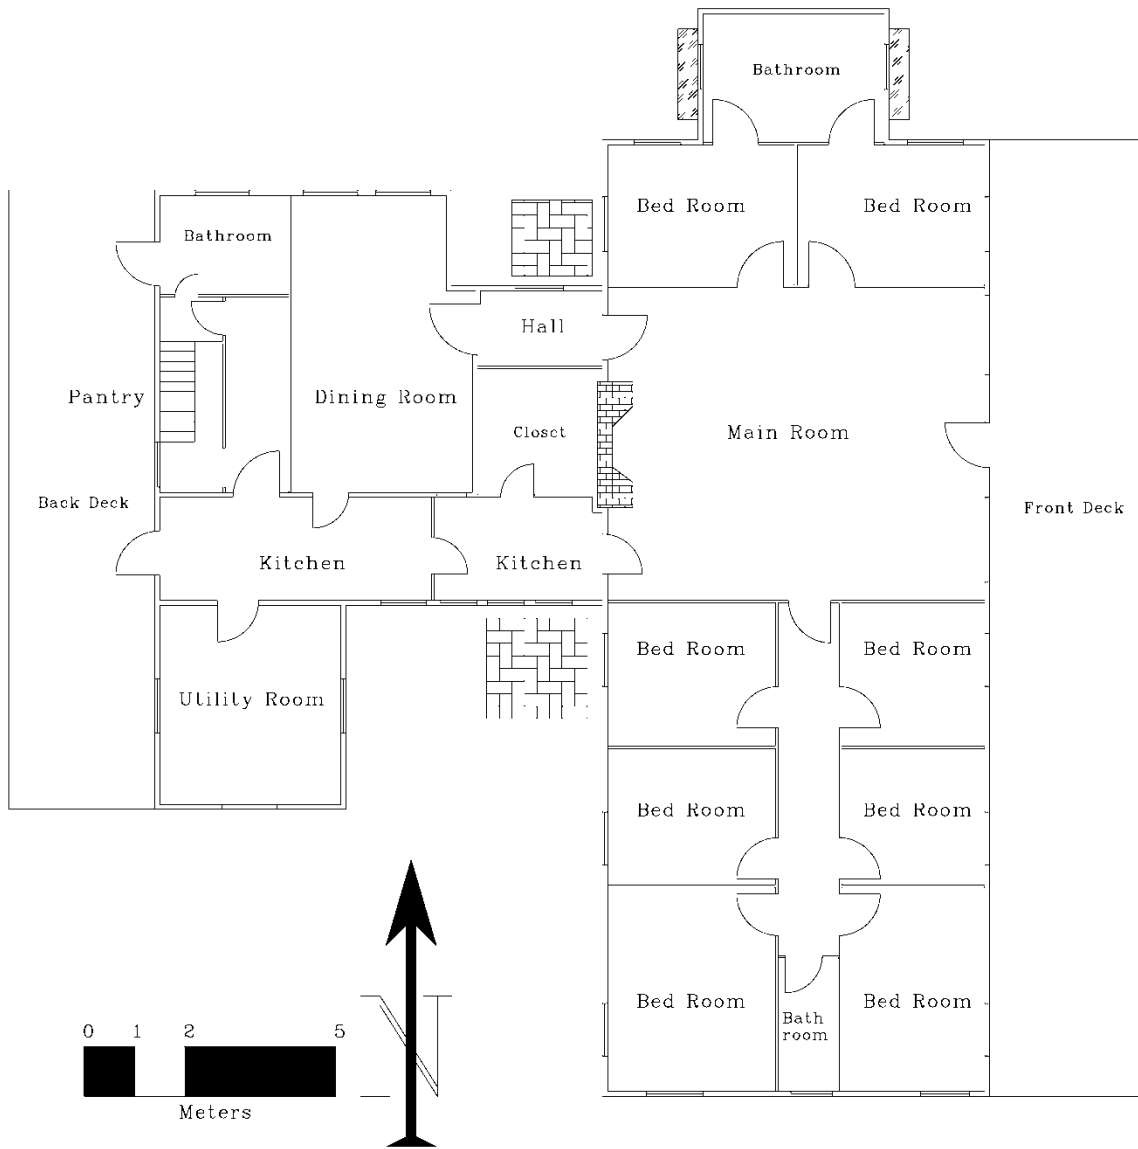
Figure 8. Floorplan of the Hunt Club Lodge. Herringbone rectangles denote brick cisterns. Hatched rectangles on either side of the northeastern bathroom represent a visible septic field likely corresponding to a previous cistern.

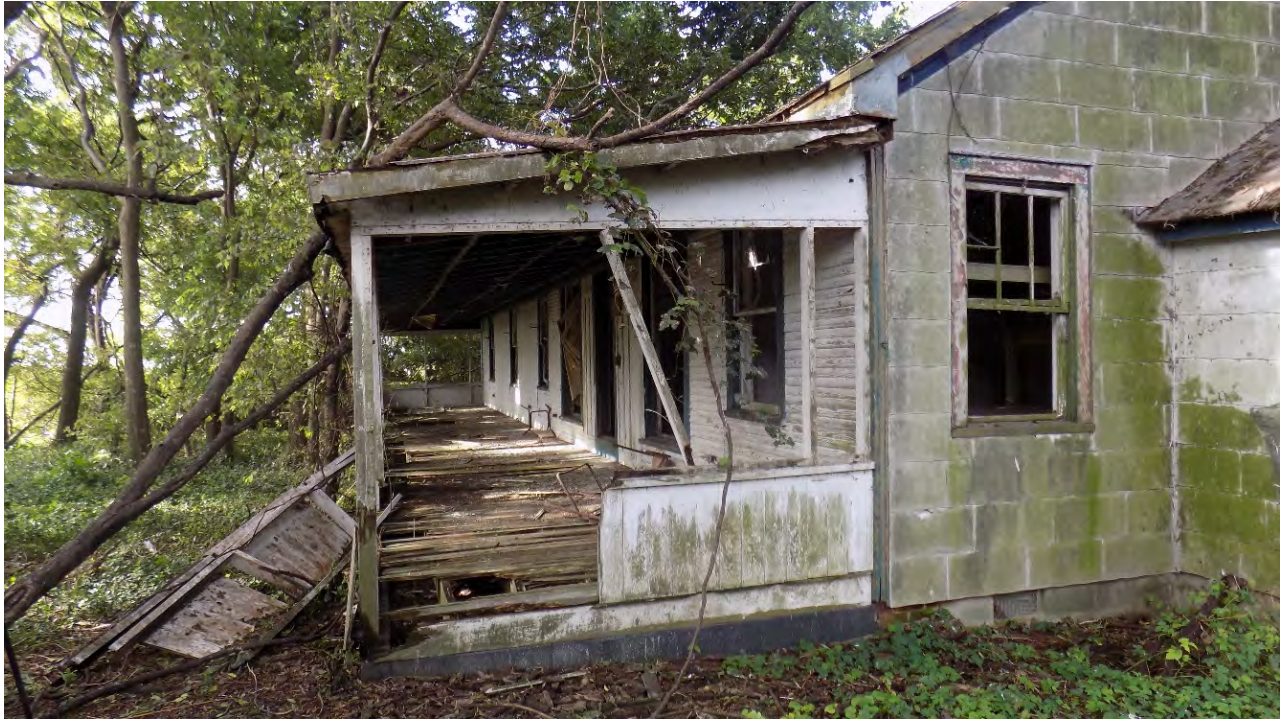
Figure 9. Hunt Club Lodge northeast corner. The eastern exterior, as well as the western and southern exteriors, are covered in white-painted clapboard. Only the northern exterior is covered in asbestos shingles.

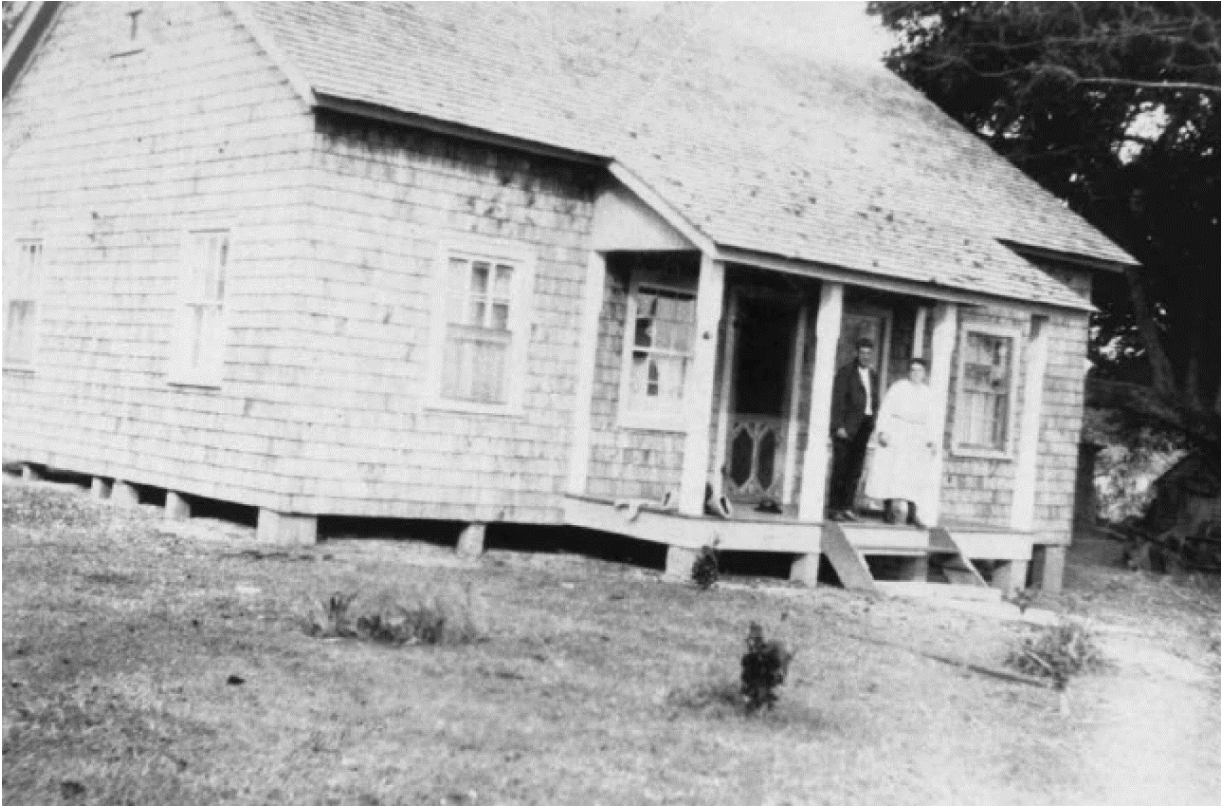
Figure 18. Undated photograph of the Caretaker's Cottage, northwest elevation. The people are likely former caretakers Earl and Mary Baum (Source: Kanaski [2016]).

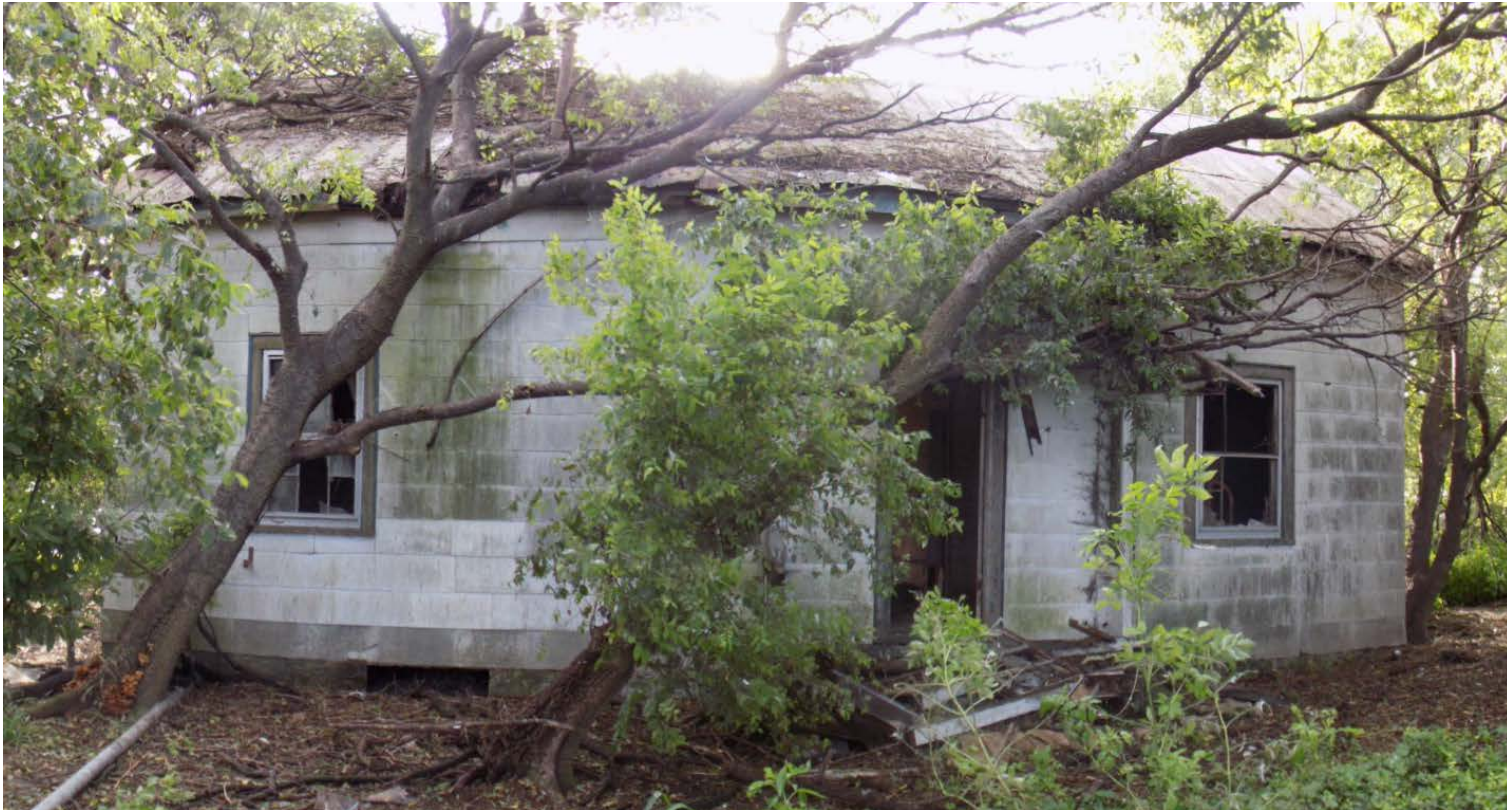
Figure 19. Caretaker's Cottage, western elevation. Many windows have been broken and the back porch overhang has collapsed. Fallen trees and limbs have damaged portions of the roof.

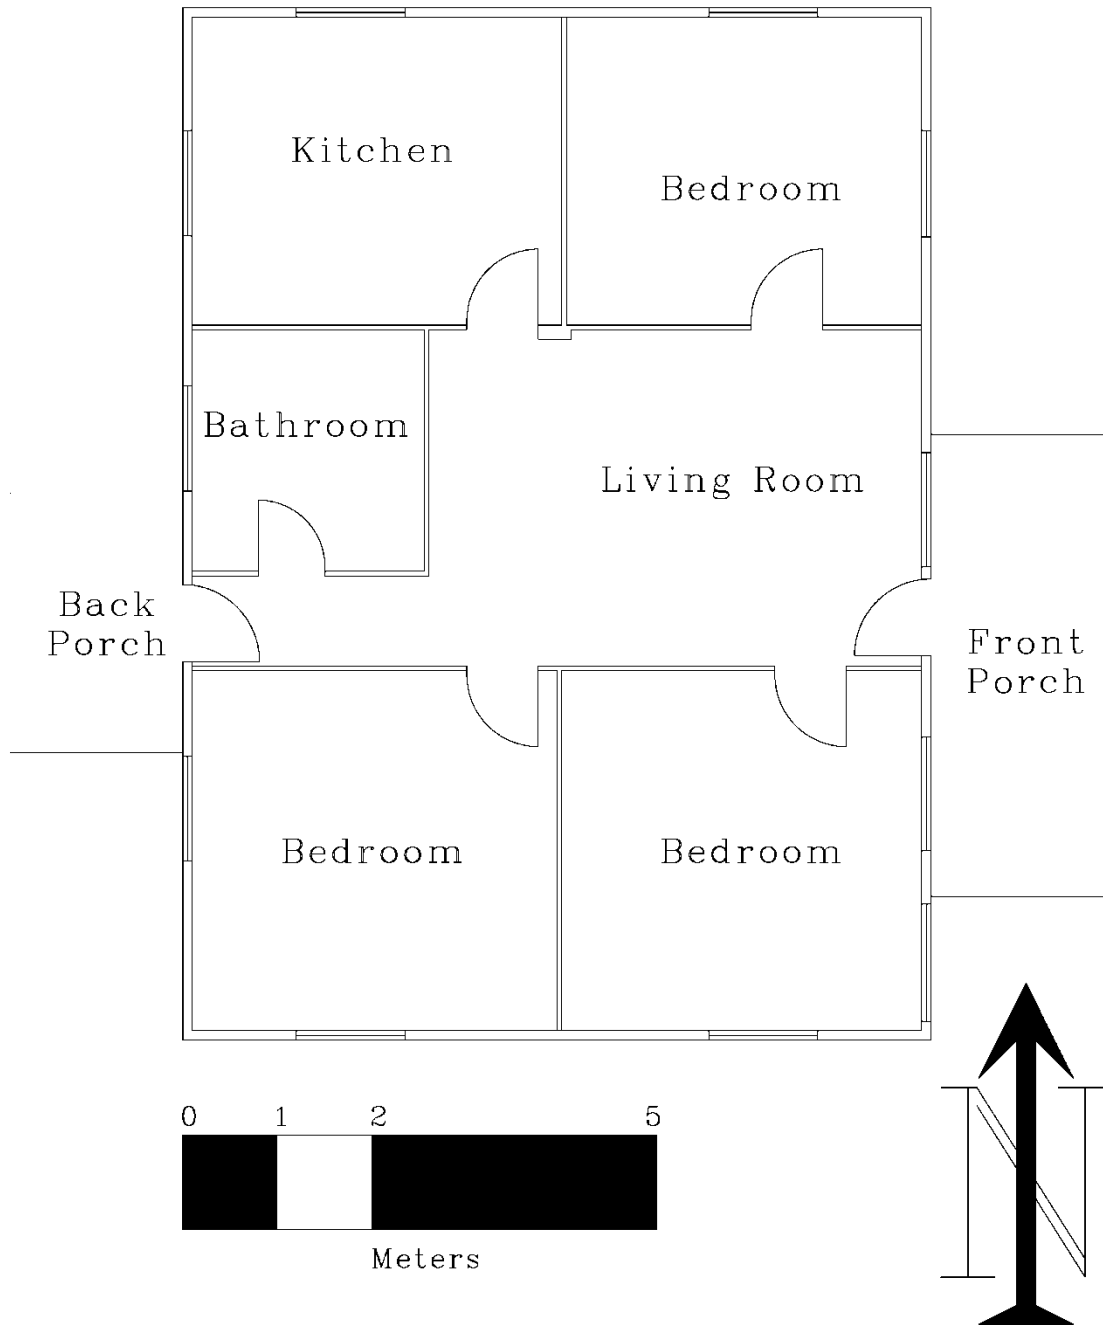
Figure 20. Floorplan for the Caretaker's Cottage. The base of the structure is a central-hall plan bungalow. The bathroom was not original to the house and was added at an unknown date.

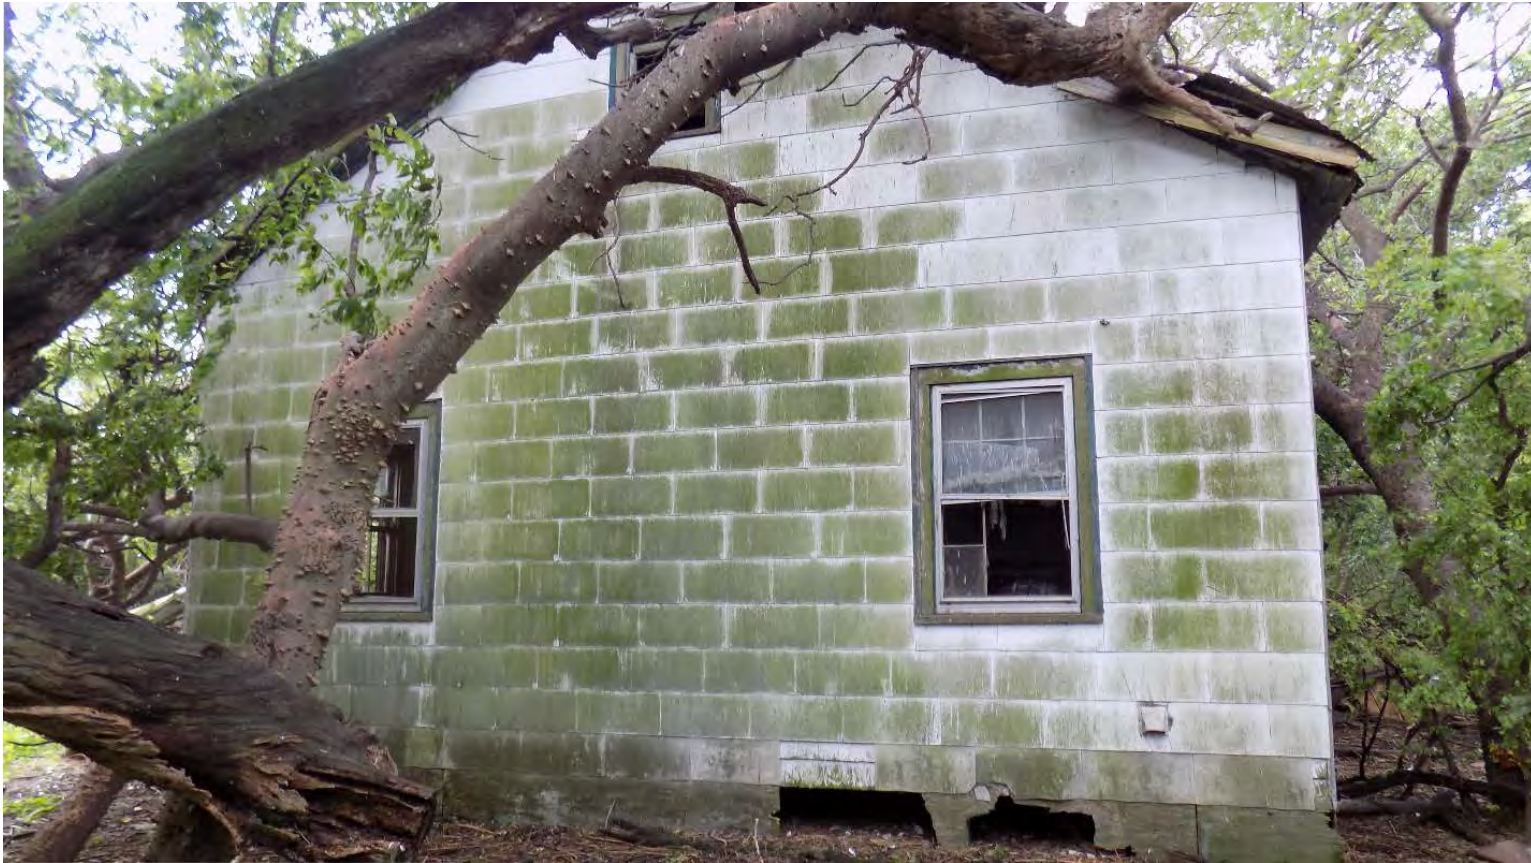
Figure 21. Caretaker's Cottage, north elevation. The building is gabled with boxed eaves and baseboards are used as underpinning. The exterior is covered in white-painted asbestos shingles over white-painted wood shingles.

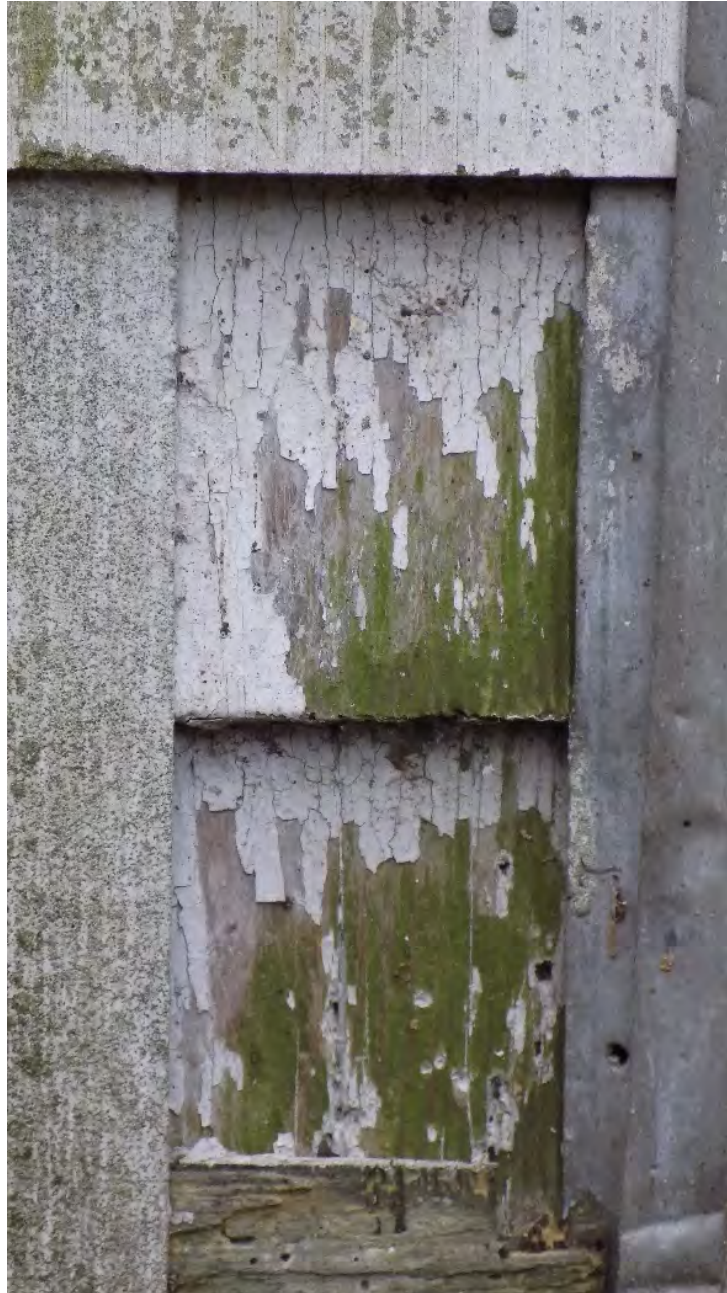
Figure 22. The wooden shingles underlying the asbestos shingles can be seen in portions along the building's northern elevation.

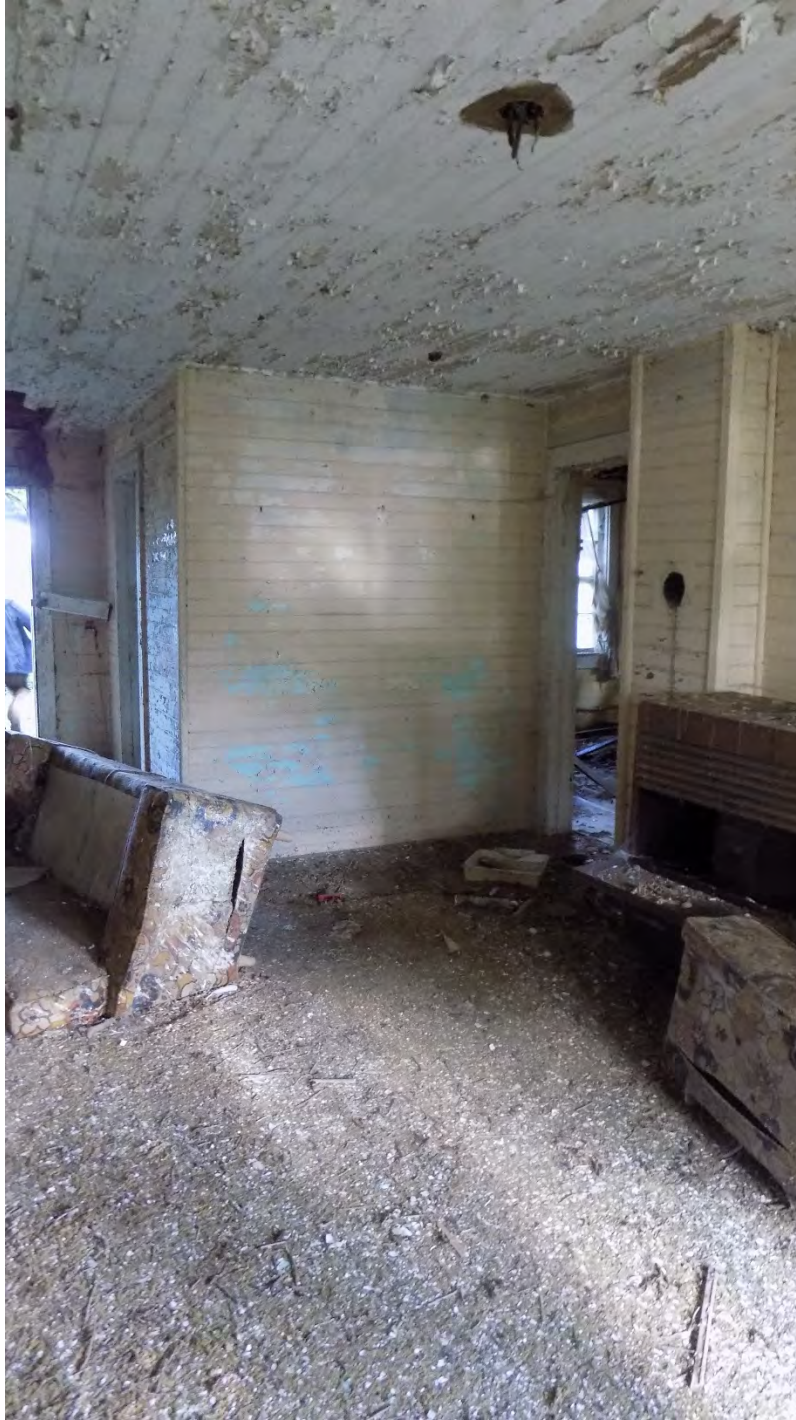
Figure 23. Living room of the Caretaker's Cottage, facing west-northwest. Ceilings and walls are covered in tongue and groove boards. The floor is covered with tongue and groove floor planks covered in yellow shag carpet.

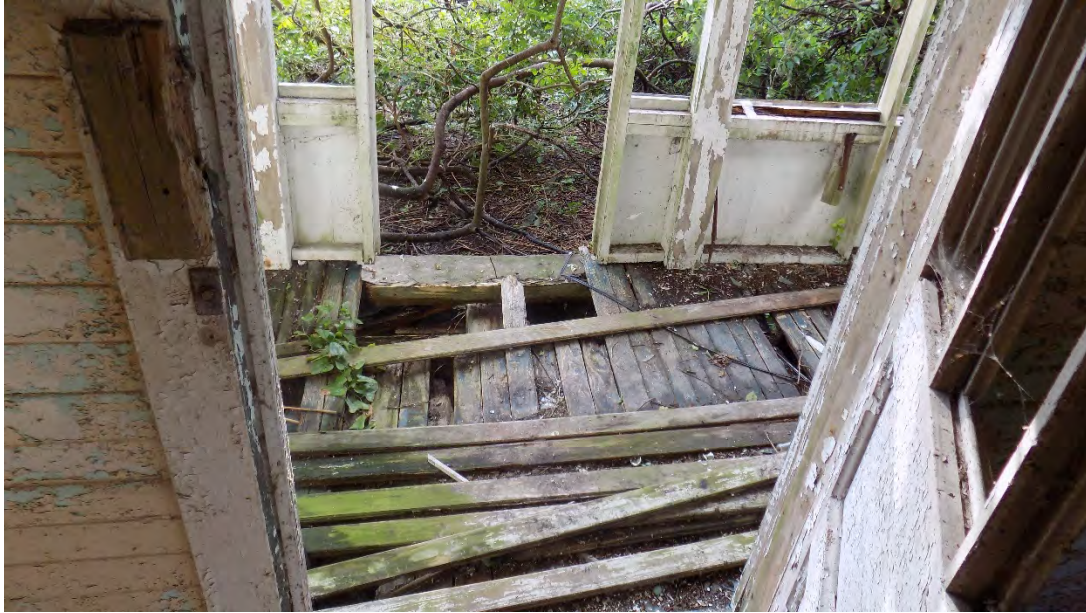
Figure 24. Caretaker's Cottage front porch, viewing east. The porch is in severe disrepair and unsafe to walk upon.

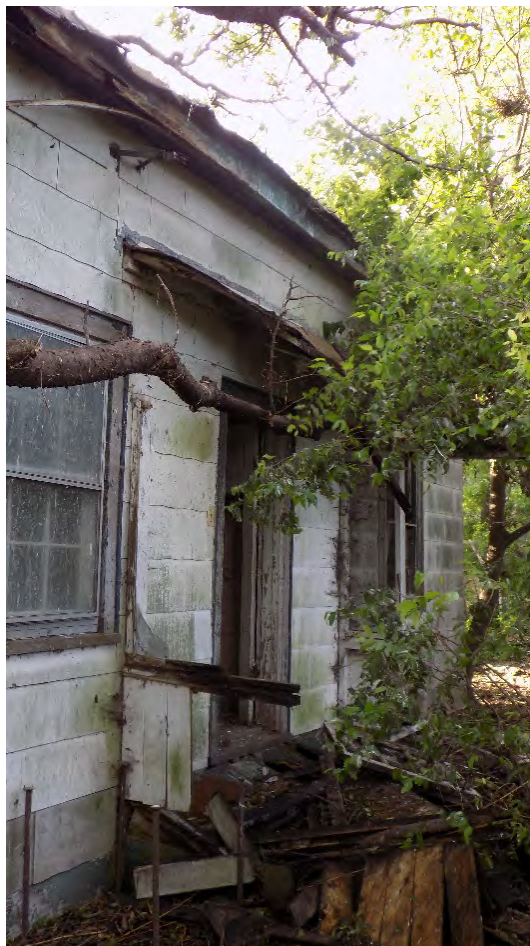
Figure 25. Caretaker's Cottage back porch, facing south-southeast. The overhang has almost completely collapsed. The threshold is covered in debris and rotting wood.

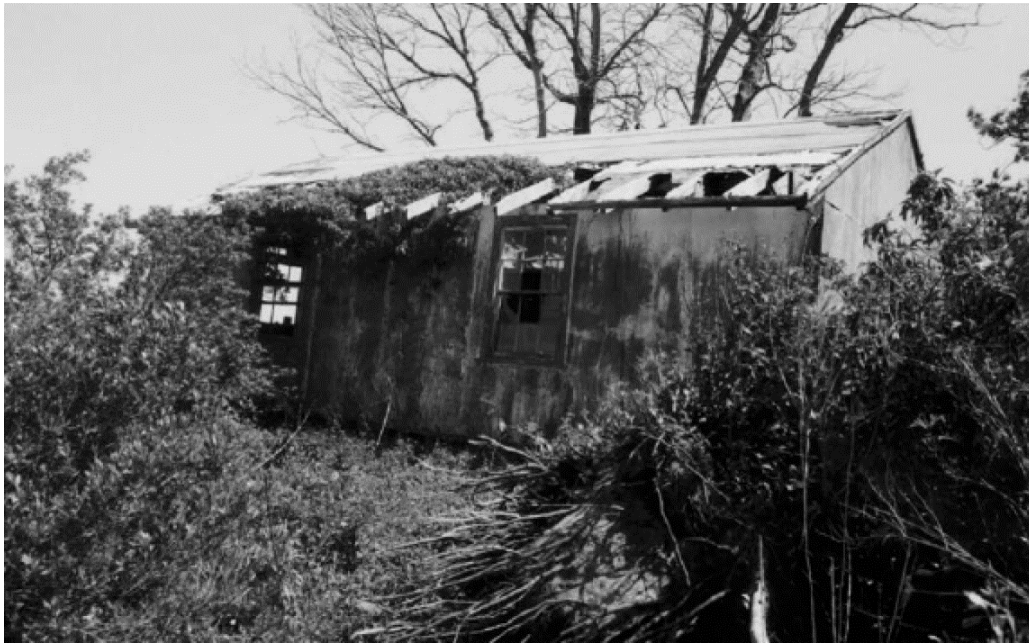
Figure 28. Plywood equipment shed, southwest corner, circa 2001 (Source: Kanaski [2016]).

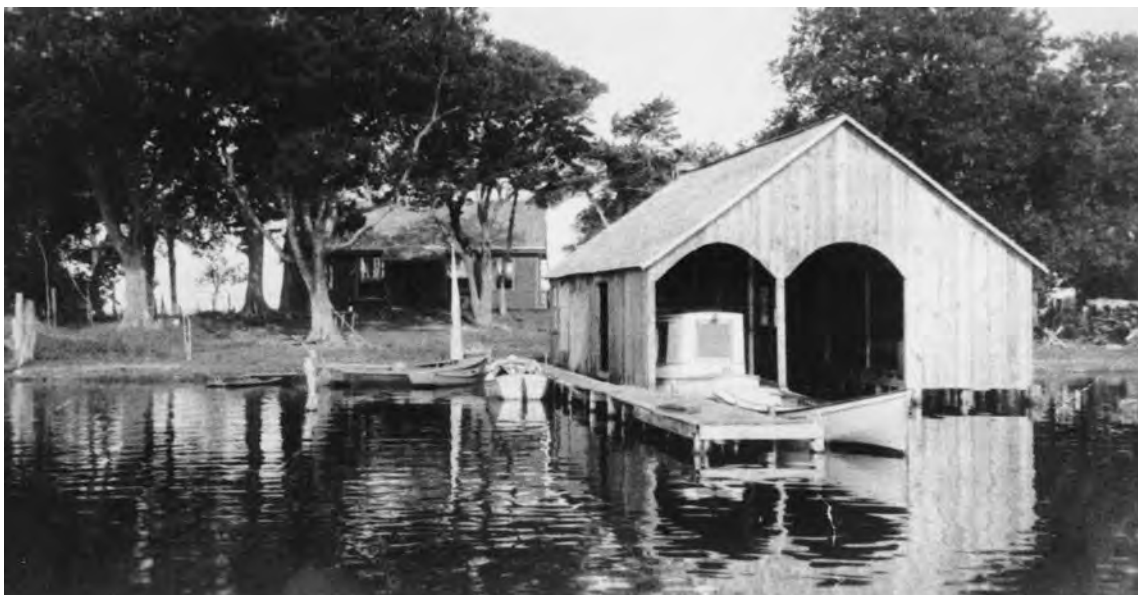
Figure 31. The club's boathouse and dock, ca. 1918. The Lodge can be seen in the background [Source: Currituck Archives].
