**SUBJECT:** Historic Structures Survey Report for the Replacement of Bridge 148 and I-95 Exit 19  
Improvements at SR 1528, PA 16-04-0028, Robeson County, ER 17-0881

**SUBJECT:** PA No. 16-04-0028, Replace Bridge No. 148 and I-95 Exit 19  
Improvements at SR 1528 (Carthage Road), Robeson County

**Replace Bridge No. 148 and I-95 Improvements to Exit 19  
on SR 1528 (Carthage Road),  
Robeson County, North Carolina**

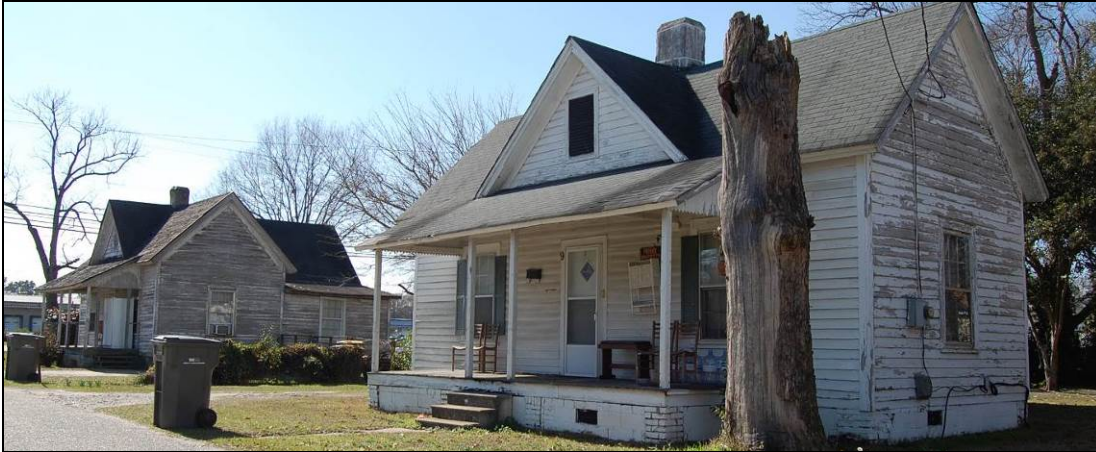
**Figure 13. Largely intact Type A houses at 7 Albion Street, at left, and 9 Albion, at right**

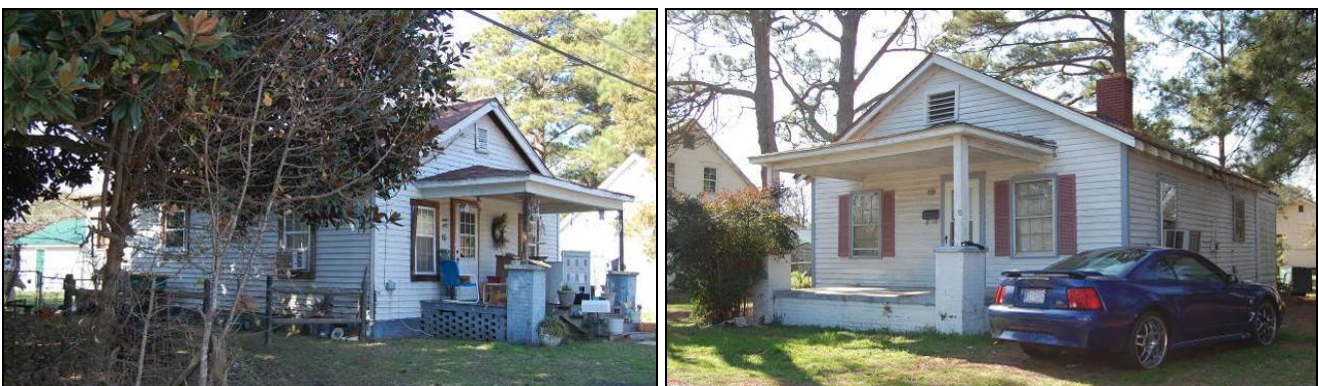
**Figure 14. Largely intact Type B houses at 65 Crescent Street, at left, and 69 Crescent, at right**

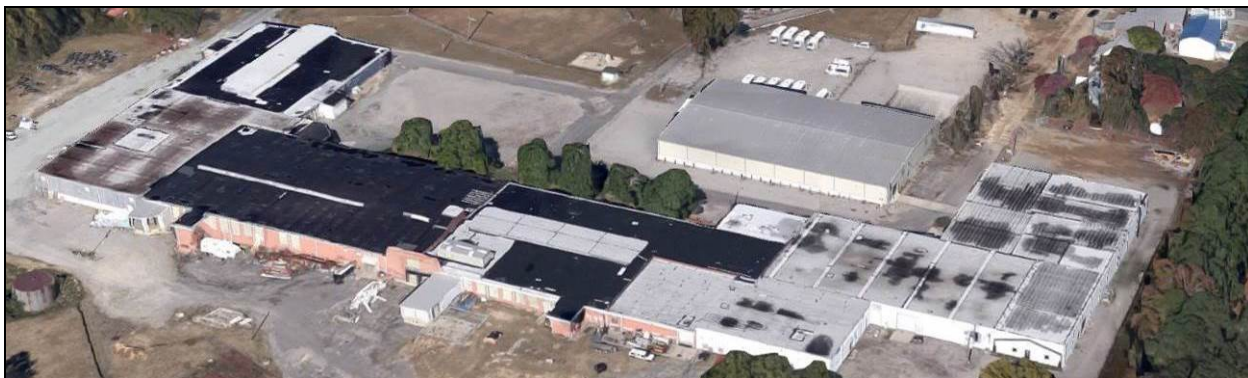
**Figure 81. Modern Google Earth image of south rear of mill depicting boxy addition at southwest (far left corner), large roughly L-shaped wing with stained gray roofs at southeast (right), and freestanding warehouse to north (center right); note post-1957, on-ground water tank at far lower left**

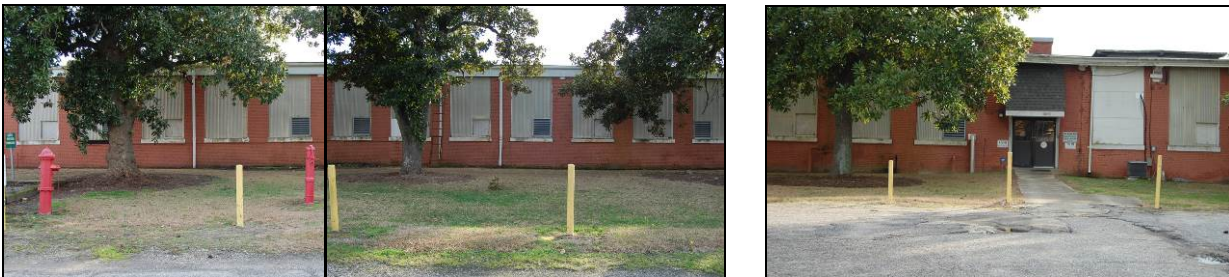
**Figure 83. Eastern section of north front elevation; note altered window bays and, at right, entry**

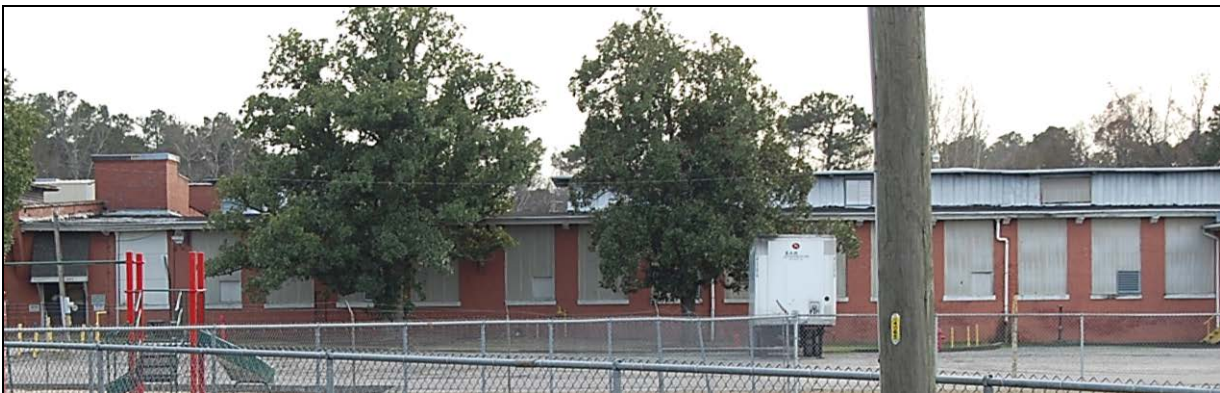
**Figure 84. Western section of north front elevation with entry at far left; note altered bays and sheet-metal-clad clerestory**

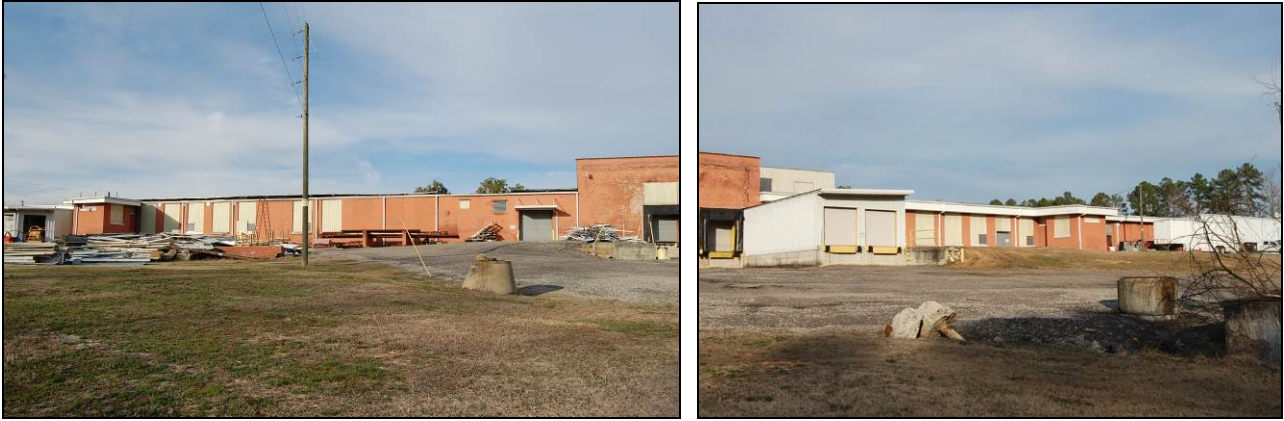
**Figure 88. South rear elevation of original mill building; windows enclosed by brick, concrete block, and fiberglass panels**
