North Carolina Department of Natural and Cultural Resources
State Historic Preservation Office

Ramona M. Bartos, Administrator

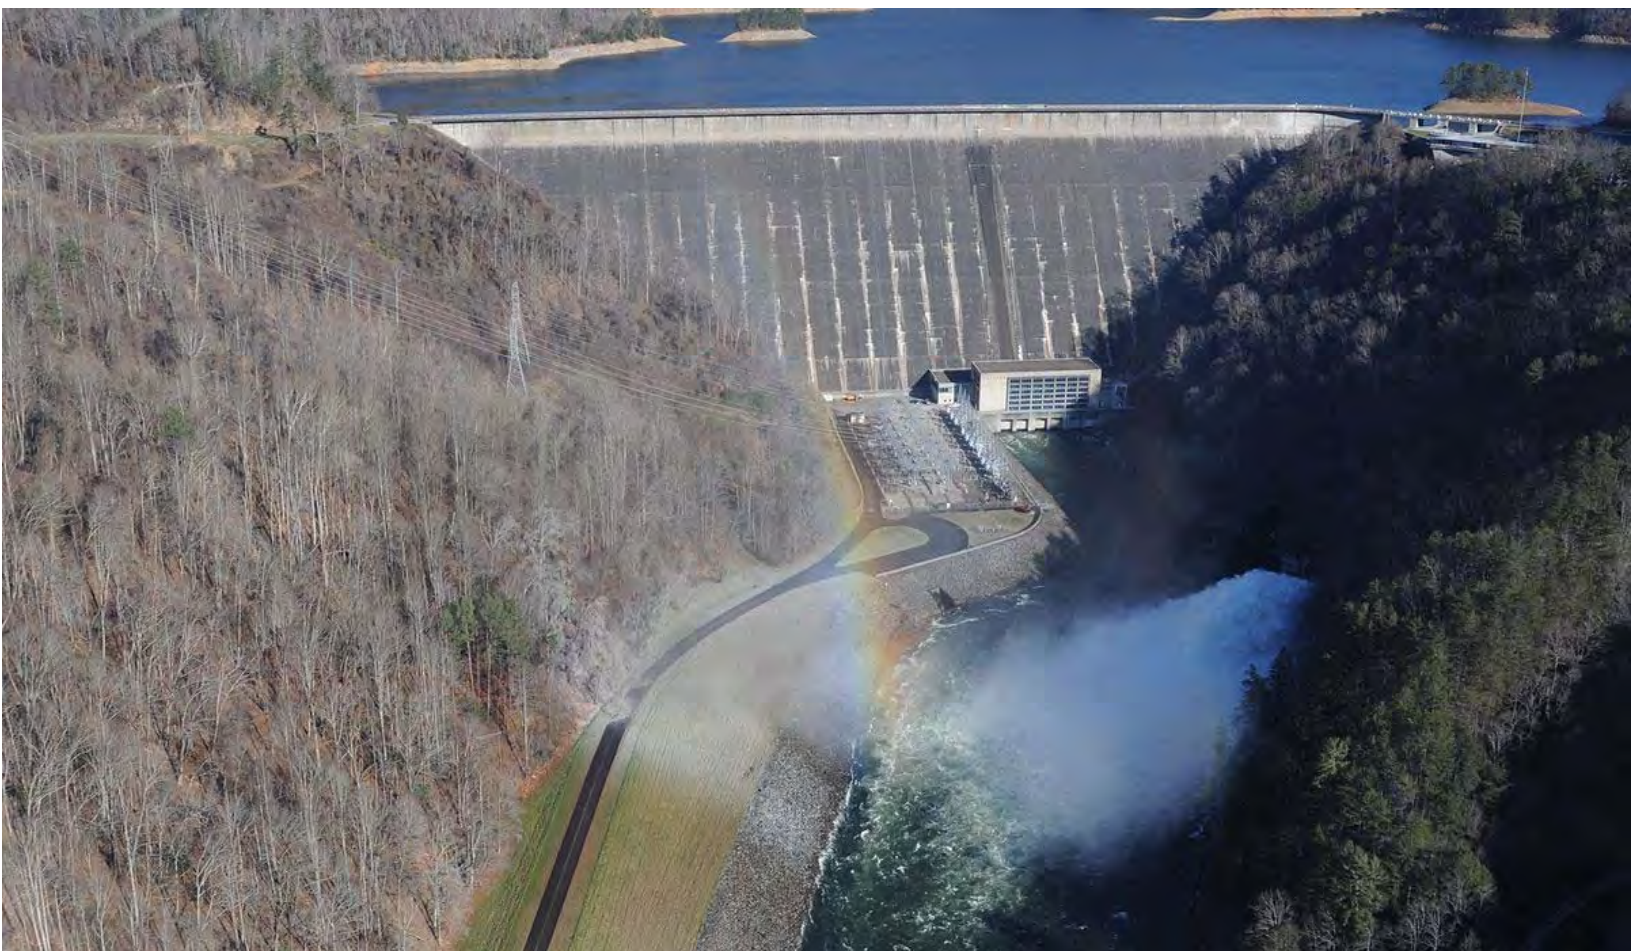
DOCUMENTATION OF EFFECT UNDER 36 CFR 800 EVALUATION

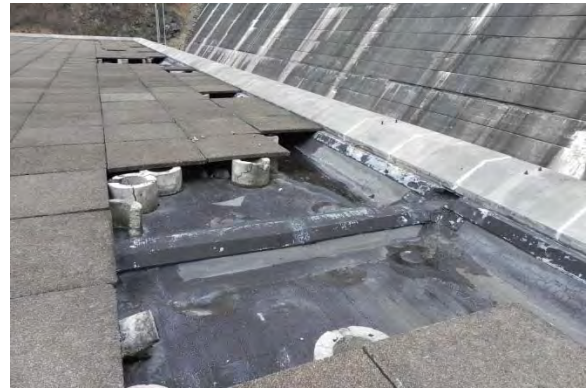
Perimeter coping, roof pavers, pedestals, and nailable concrete cants over construction joints. The roof membrane is visible where pavers are displaced.

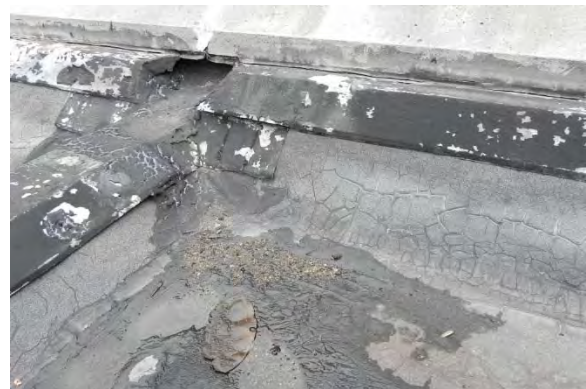
Base flashing and sheet metal flashing at construction joint and perimeter coping

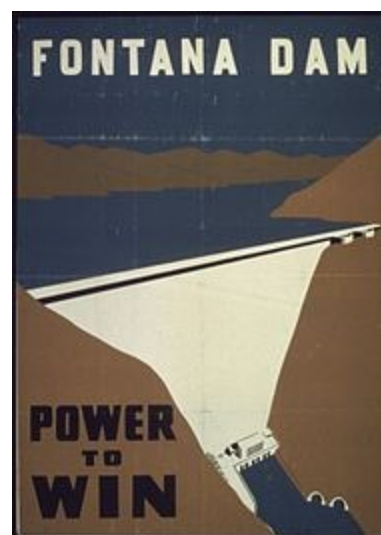
Project: Fontana Dam Power House Roof Assessment
No. 10697-00 pH 130

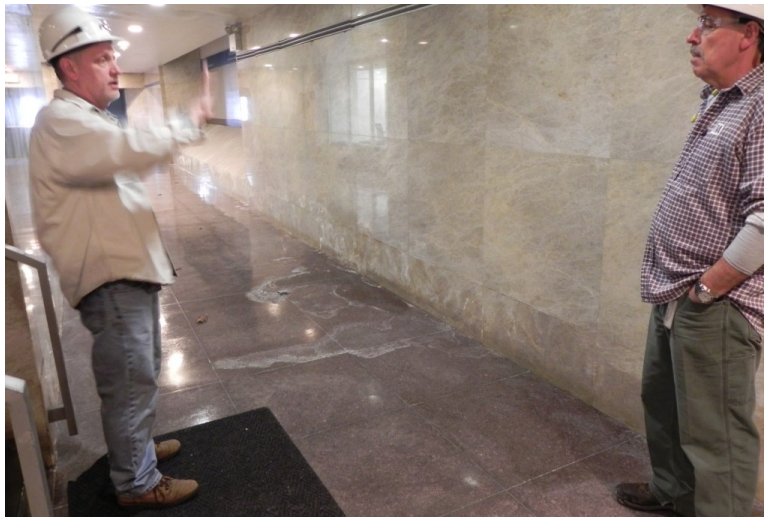
a display room or corridor behind the control room

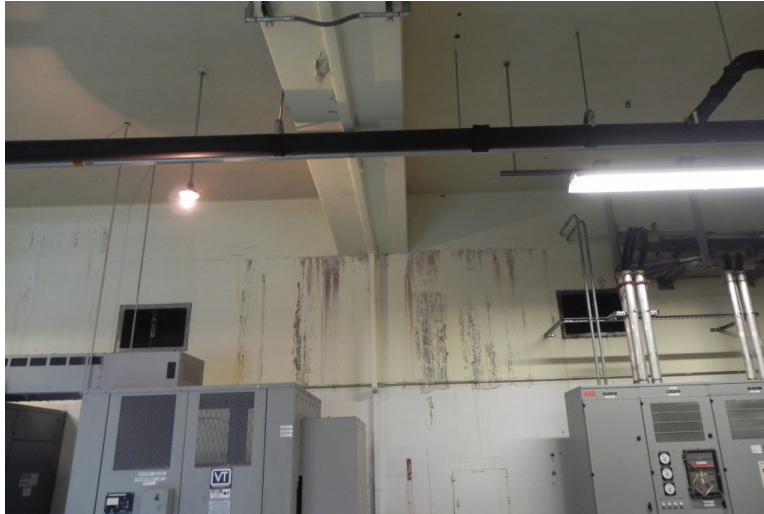
On the main generator room level, leaks were reported on the ceiling and north wall of the 480v room; a gutter had been installed along the ceiling directly underneath of a construction joint in the roof slab above.

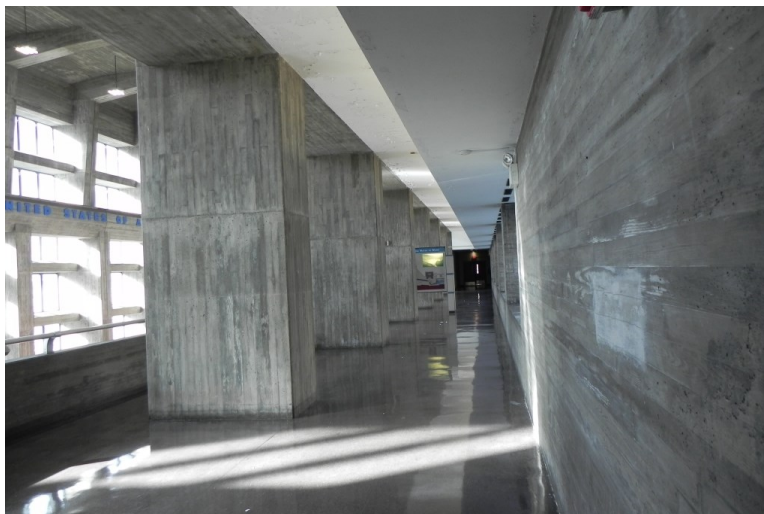
Peeling paint is visible on ceiling of visitor's gallery

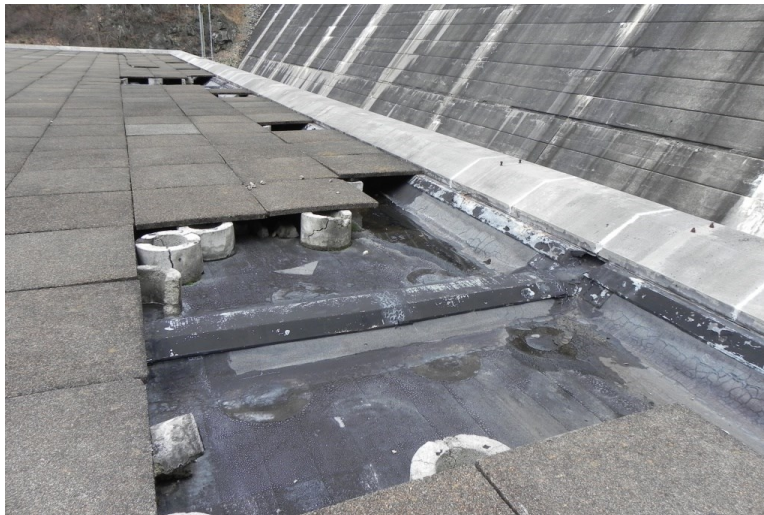
Perimeter coping, roof pavers, pedestals, and nailable concrete cants over construction joints.
The roof membrane is visible where pavers are displaced.

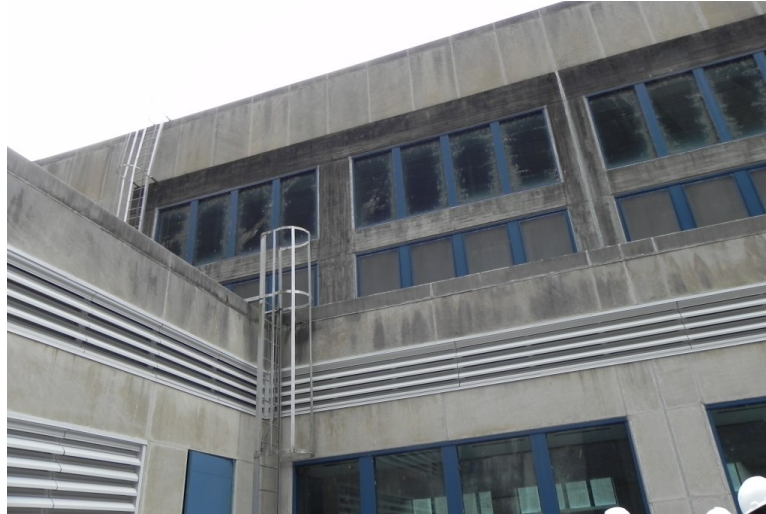
The façade comprises limestone masonry panels, exposed cast-in-place concrete structural elements, and large glazed portions. A barely cursory look at the joint work observed reasonably intact mortar joints, but some deterioration may be apparent if the façade were more closely observed.
