SUBJECT: Historic Structures Survey Report for Roundabout at US 264 and NC 32, W-5702I,
PA 18-04-0006, Beaufort County, ER 18-3385

Historic Structures Report
TIP No. W-5702I, WBS No. 44848.1.1, PA No. 18-04-0006
Construct Roundabout at US 264 and NC 32
Beaufort County, North Carolina
S&ME Project No. 4213-18-199

**Historic Structures Report
TIP No. W-5702I
Construct Roundabout at US 264 and NC 32
Beaufort County, North Carolina**

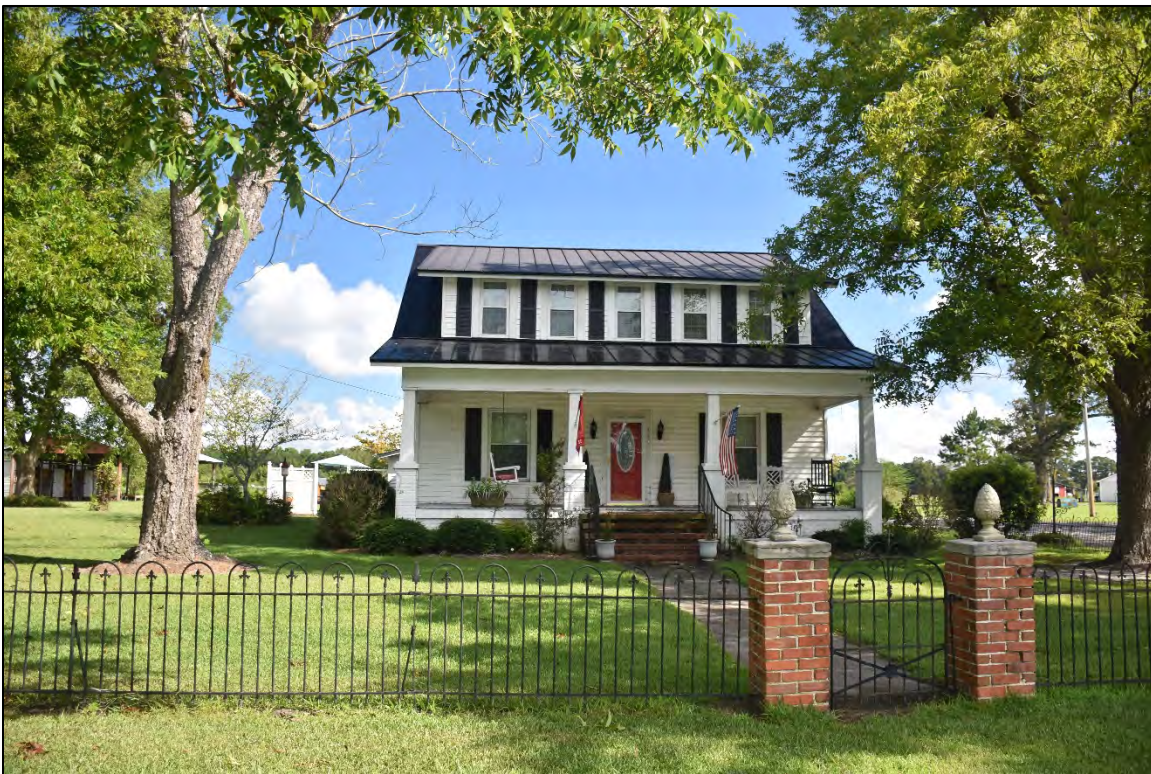
Figure 2.1.11. Douglas Farm (BF1400), house, facing north.

The Douglas Farm (BF1400) is located at 6371 US Highway 264, northwest of the intersection of US 264 and NC 32, approximately six miles east of the town center of Washington, in Beaufort County (Figures 1.1 and 1.2). The Douglas Farm was originally surveyed as part of the historic architecture survey of rural Beaufort County in 2010, but it was identified only as "Farm" with no historic association (Survey File 2010:BF1400). The house associated with the farm, which has a setback of approximately 60 feet from US 264, was built around 1919 and is a one and one-half story, Craftsman-style residence (Figure 2.1.11). The parcel on which the house sits, which is approximately 69 acres, also contains a circa-1920s well house, a circa-1920s shed, a late-twentieth century tobacco shed and bulk storage building, and a twenty-first century shed, chicken coop, and dog kennel; the parcel frontage along US 264 has a mid-twentieth century iron fence (Figure 2.1.12).

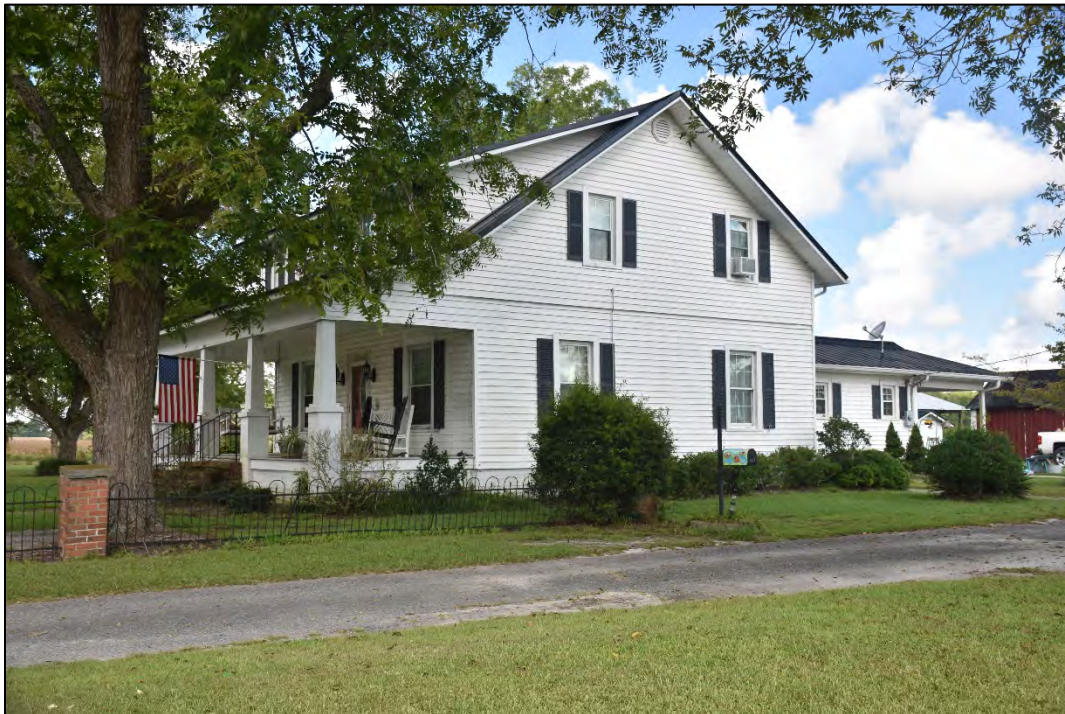
front elevation has a central entry door, located beneath a shed-roofed porch that is supported by four tapered square columns that rest on brick piers; infilled areas of plain trim suggest that the door is a replacement and is smaller than the original, which potentially had a transom, based on the space above the existing door. Flanking the door is a single six-over-six, double-hung, vinyl sash window on either side; these windows have wide vinyl frames to fill the larger openings of the original windows. A large shed-roofed dormer is centered in the front roofline and contains five evenly spaced windows; each of these windows is a six-over-six, double-hung, vinyl sash and they have the same wide frames as the first story windows, indicating that larger original windows were replaced.

Figure 2.1.13. Douglas Farm (BF1400), house, facing northwest.

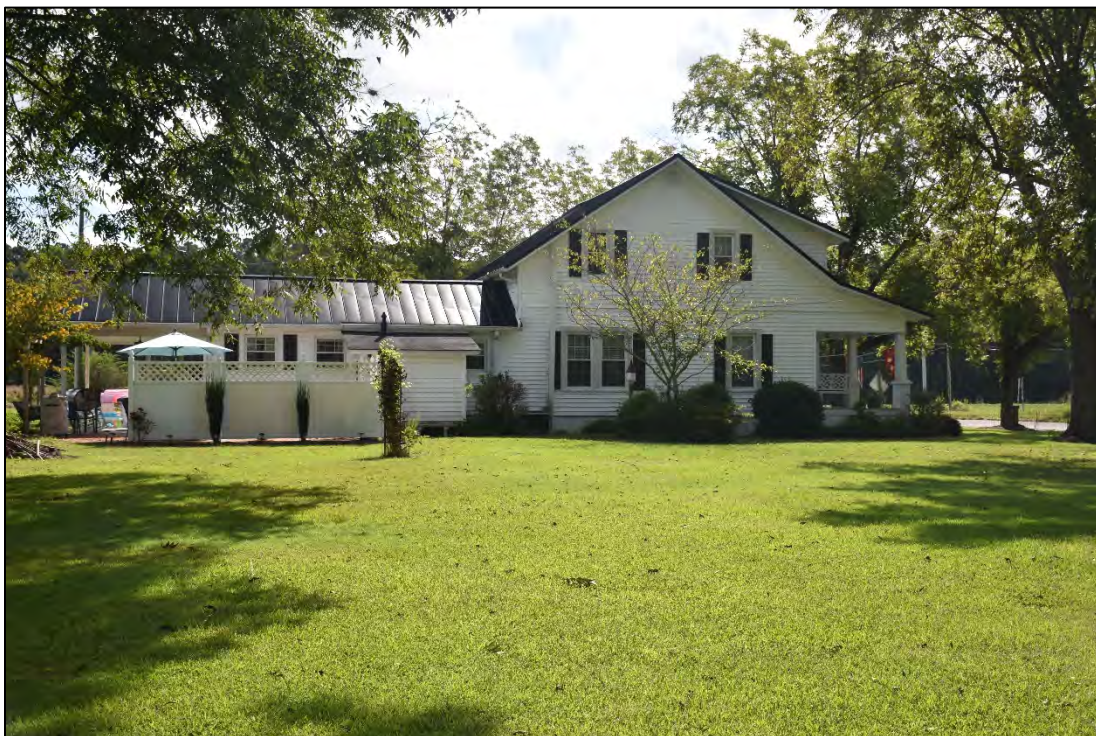
The house rests on a brick pier foundation that has been infilled with newer brick. The roof of the structure is standing-seam metal; there is a wide roof overhang on the main portion of the house that is covered with vinyl soffit. The siding on the house is vinyl, which covers both the main structure and the rear ell, as well as the trim above the porch supports. S&ME attempted to gain interior access to the structure but the request was denied.

Figure 2.1.15. Douglas Farm (BF1400), house, facing east.

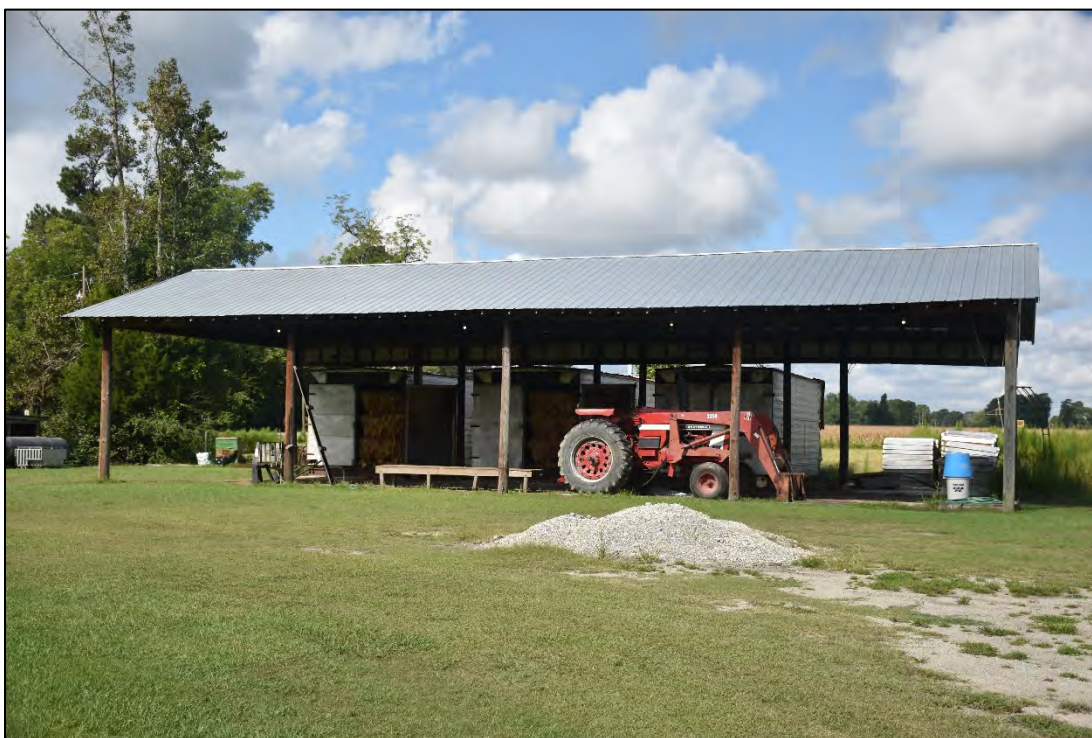
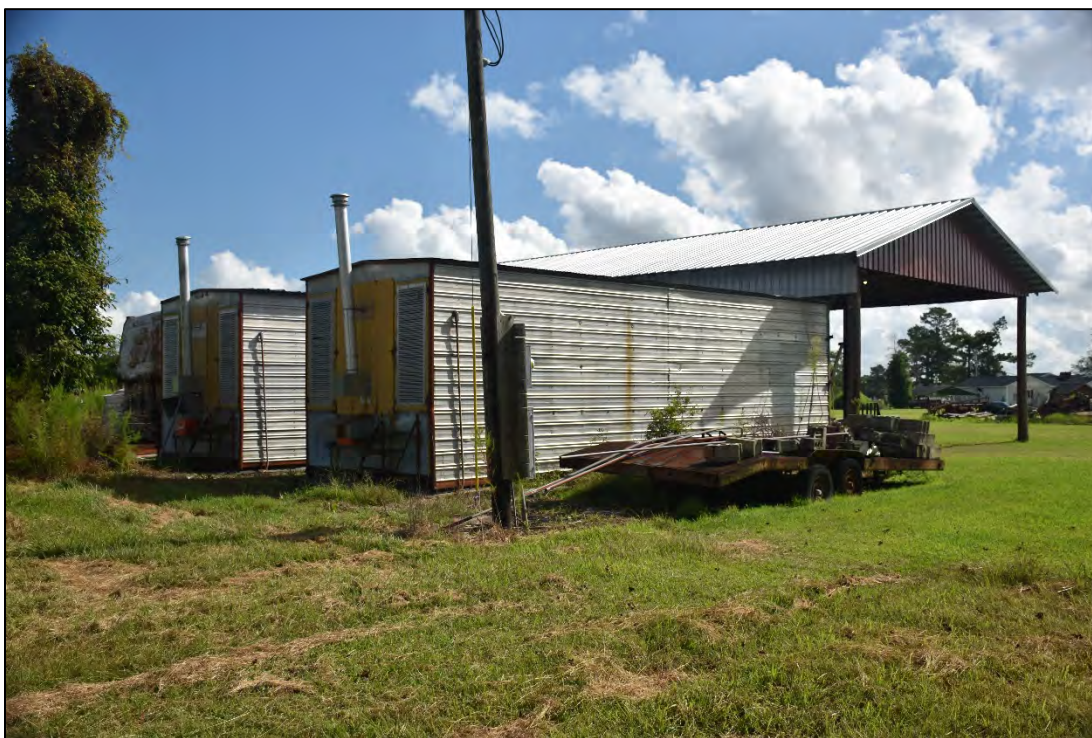
West of the circa-1920s shed is a late-twentieth century tobacco shed and bulk storage (Figures 2.1.21 and 2.1.22). The tobacco shed is an open-framed structure with a gabled roof that is supported by a mixture of square wooden posts and rough-hewn timbers. The gable ends of the shed are sheathed in vertical metal siding and the roof, which has visible rafter tails, is standing-seam metal. The bulk tobacco storage consists of three rectangular metal trailers with hinged doors. North of the tobacco shed and bulk storage is a modern wooden shed with a gambrel roof; the shed has vertical wooden panel siding and a standing-seam metal roof (Figure 2.1.23). West of the modern wooden shed is a modern chicken coop (Figure 2.1.24). The chicken coop is a small rectangular wooden structure, with a pent roof; it has a hinged entry door and is covered with vertical wooden siding and a standing-seam metal roof. The building is attached to an open structure that is wooden frame with chicken wire. South of the tobacco shed and bulk storage is a modern dog kennel (Figure 2.1.25). The kennel is an open frame building, with a pent roof, that has a rear wall and wire comprising the other three walls; it has four rooms, each with wire walls and an entry door. Adjacent to the main kennel is a smaller, raised frame structure with a flat roof that serves as a puppy hutch.

Figure 2.1.21. Douglas Farm (BF1400), tobacco shed and bulk storage, facing west.

Figure 2.1.22. Douglas Farm (BF1400), tobacco shed and bulk storage, facing northeast.

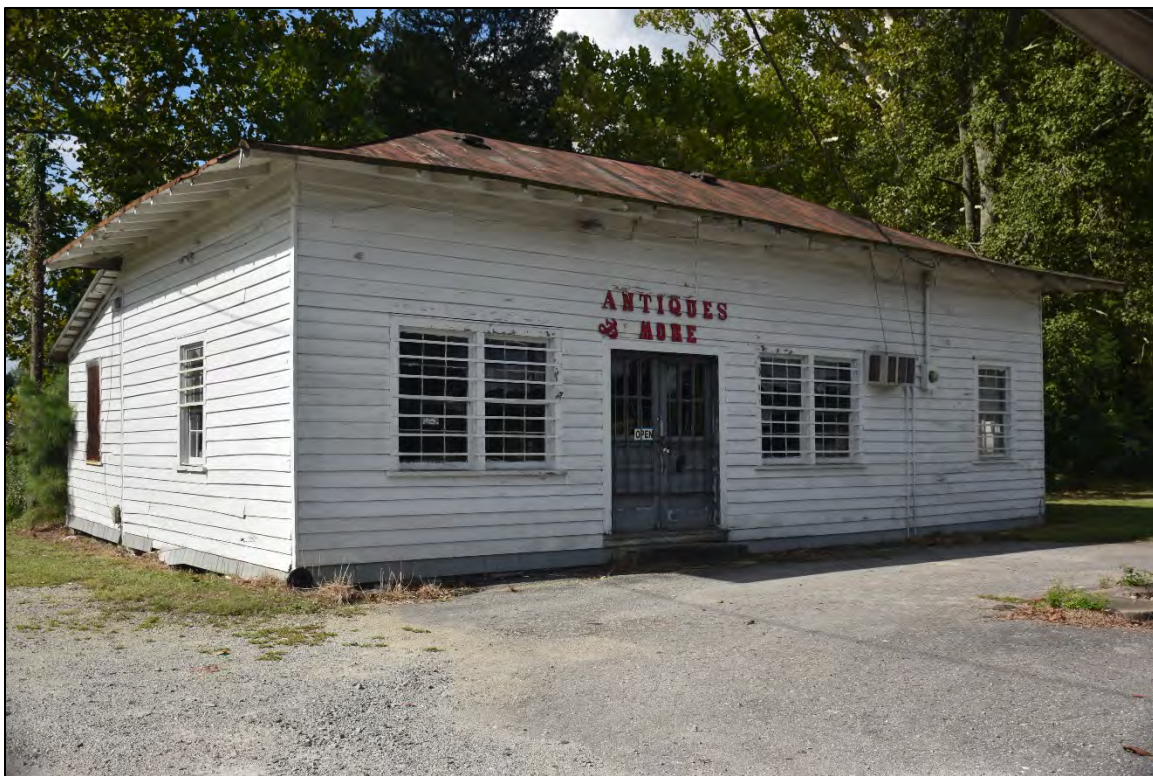
Figure 2.1.36. Douglas Crossroads Store (BF1404), facing southwest.

The Douglas Crossroads Store (BF1404) is located at 8275 Broad Creek Road, southwest of the intersection of US 264 and NC 32, approximately six miles east of the town center of Washington, in Beaufort County (Figures 1.1 and 1.2). The Douglas Crossroads Store was originally surveyed as part of the historic architecture survey of rural Beaufort County in 2010, but it was identified only as “Store” with no historic association (Survey File 2010:BF1404); although it is located on the same tax parcel as the Jack Douglas House (BF1412) it was given a separate survey number. The structure, which oriented toward US 264, is situated close to the right-of-way; it was built around 1919 and is a single story, rectangular plan commercial building with a bonnet-style roof (Figure 2.1.36). The store is four bays wide, with a set of double doors that are located east of center; the doors have three panels on the lower, wooden portion and six-pane glass on the upper portion (Figure 2.1.37). On either side of the doors are paired six-over-six, double-hung, wooden sash windows; the westernmost bay has a single six-over-six, double-hung, wooden sash window. The windows and doors on the store are covered with metal bars.

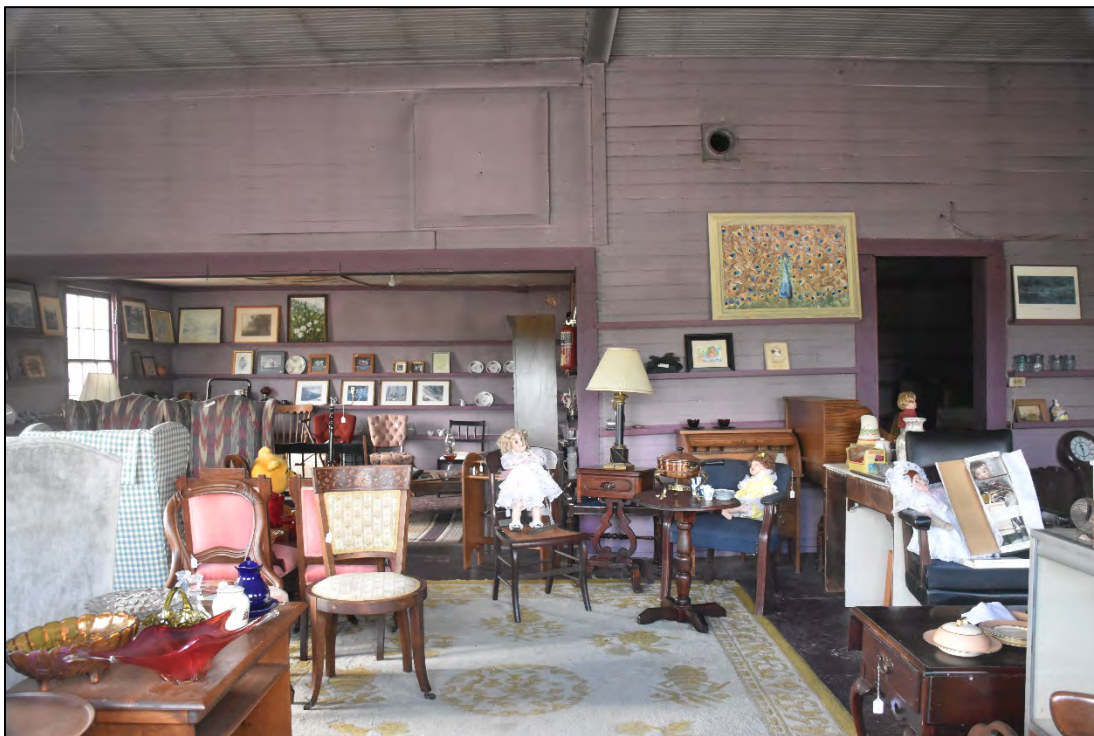
S&ME attempted to gain interior access to the structure but the request was denied. However, a portion of the interior of the store was visible from front windows (Figure 2.1.41). The interior of the store is a single, large room with horizontal wooden sheathing on the interior of the walls and bead board on the ceiling. The rear addition is accessed by two cased openings; one large cased opening on the eastern side of the room, which opens into another room with a shorter ceiling and display shelves, and a smaller, door-sized cased opening on the western side of the room. Last used as an antique store, the Douglas Crossroads Store has a variety of furnishings and decorative items remaining inside.

Figure 2.1.41. Douglas Crossroads Store (BF1404), interior.

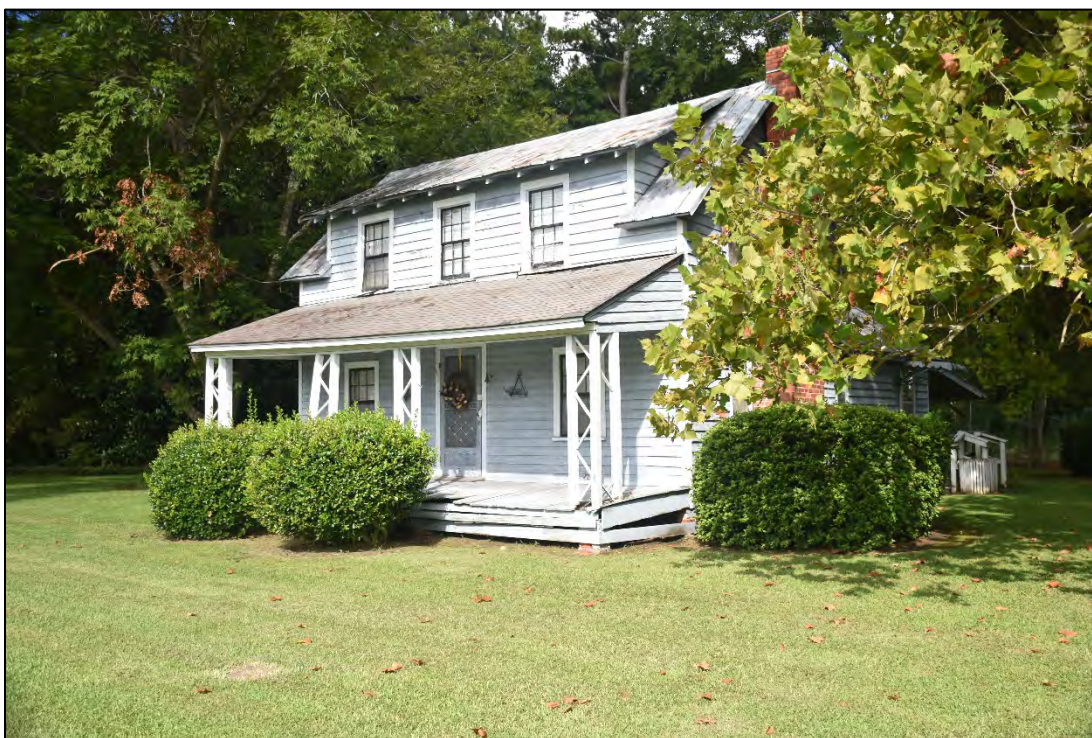
The house rests on a brick pier foundation that has been infilled with newer brick (Figure 2.1.57). The roof of the structure is standing-seam metal; there is a wide roof overhang on the main portion of the house that has visible rafter tails. The siding on the house is horizontal wooden weatherboard, which covers both the main structure and the rear ell. S&ME attempted to gain interior access to the structure but the request was denied.

Figure 2.1.57. Jack Douglas House (BF1412), facing southwest.

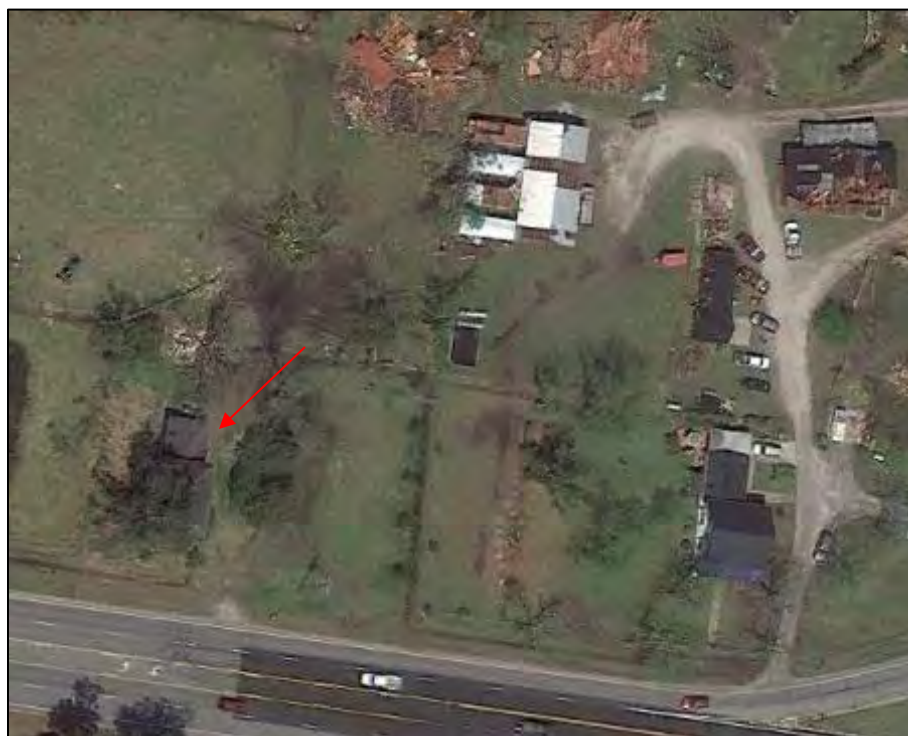
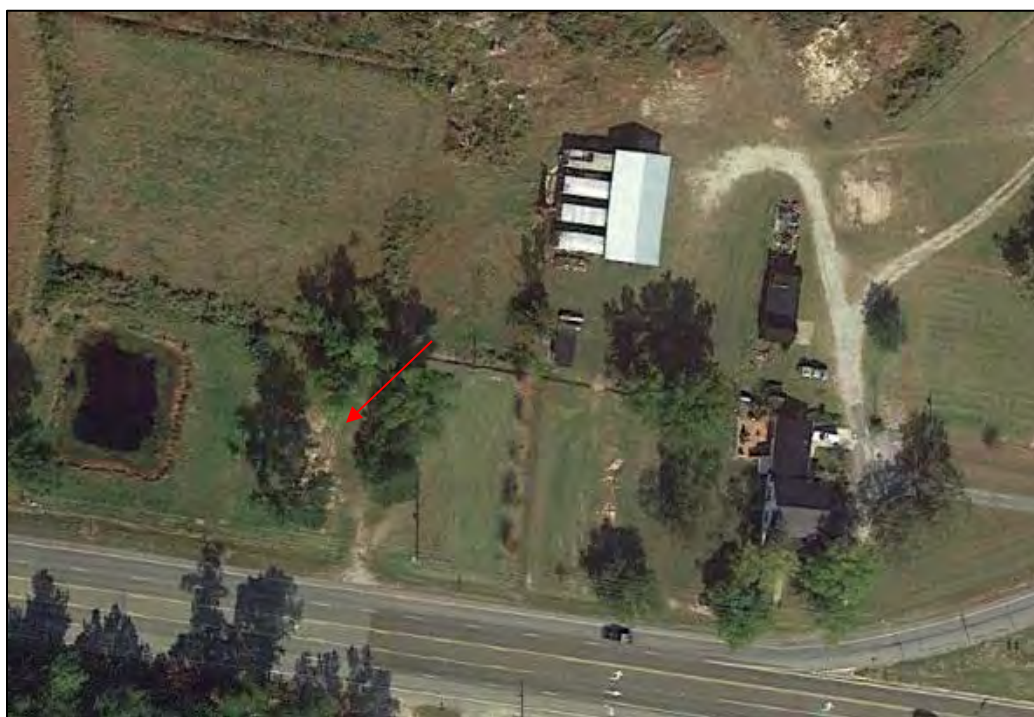
The Grady Douglas House (BF1437) was originally surveyed as part of the historic architecture survey of rural Beaufort County in 2010; it was identified as “House” with no historic association listed (Survey File 2010:BF1437). The house was located approximately 500 feet west of the intersection of US 264 and NC 32. The survey information indicates that it was a circa-1910 Foursquare house with a hipped roof and Colonial Revival details. Six outbuildings were associated with the house and located on the property. The Grady Douglas House was located on a portion of the James C. Douglas Farm that James Douglas sold to his son, Grady P. Douglas and his wife, Callie, in 1939 as he divided his property among his six children; Grady Douglas’s portion of the property contained approximately 60 acres but there was no mention of a structure in the deed. In 2012, the 60 acre parcel was sold to Douglas Crossroads, LLC. A field visit to the location of the Grady Douglas House indicates that the structure is no longer extant (Figure 2.1.70). Aerial photographs show that the house was demolished between 2014 and 2015 (Figures 2.1.71 and 2.1.72).

Figure 2.1.71. Aerial photograph (2014), showing the Grady Douglas House (BF1437).

Figure 2.1.72. Aerial photograph (2015), showing the Grady Douglas House (BF1437) no longer extant.
