**HISTORIC ARCHITECTURE  
ELIGIBILITY EVALUATION REPORT:  
WOODEN BRIDGES AND FOOTPATHS/ROADWAY  
WITHIN PEA ISLAND NATIONAL WILDLIFE REFUGE**

**Phase IIa for the Replacement of the Herbert C. Bonner Bridge  
(Bridge No. 11) on NC 12 over the Oregon Inlet  
and Improvements to NC 12, Dare County**

**TIP# B-2500  
WBS# 32635  
FA# BRS-2358(15)**

**November 2016**

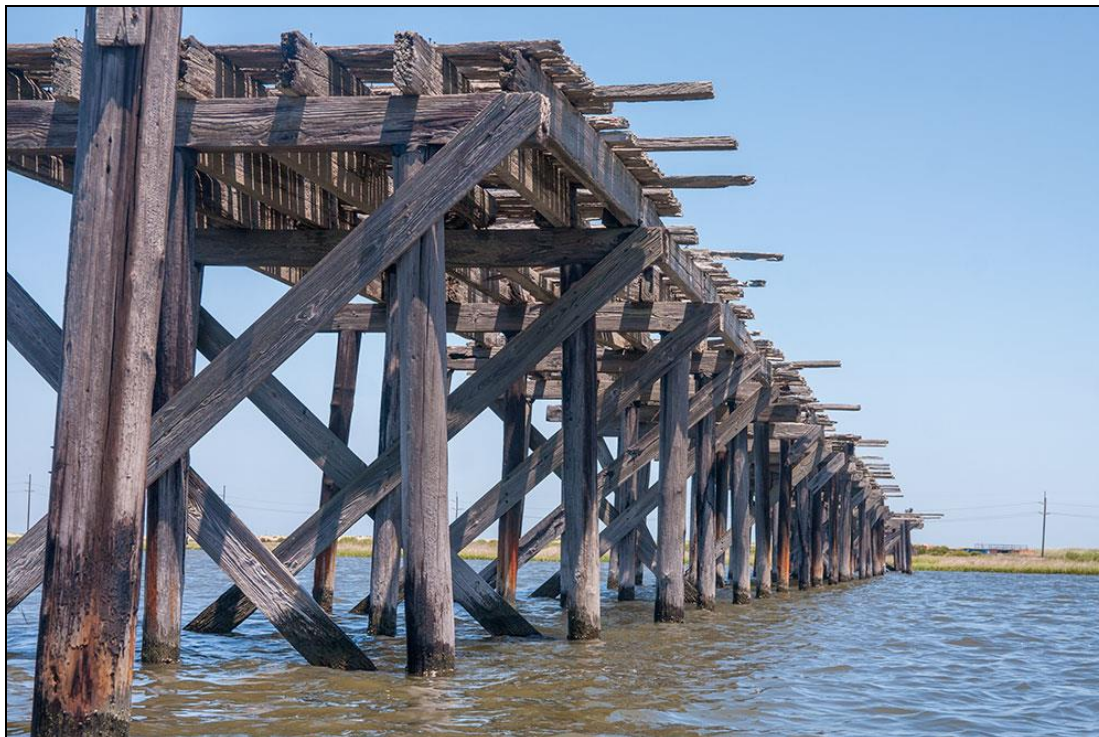
**Figure 26. Pile bents of North Channel Bridge from Pamlico Sound (photographer: Michael Henderson, January 30, 2016)**

The bridge, which has not been maintained for at least 65 years, has lost its integrity of design, materials, and workmanship. Its barrier rails are gone, as is almost all of its deck. Heavily deteriorated wooden caps and stringers survive in part atop and across most of the bents of its largest southern section. Its northern

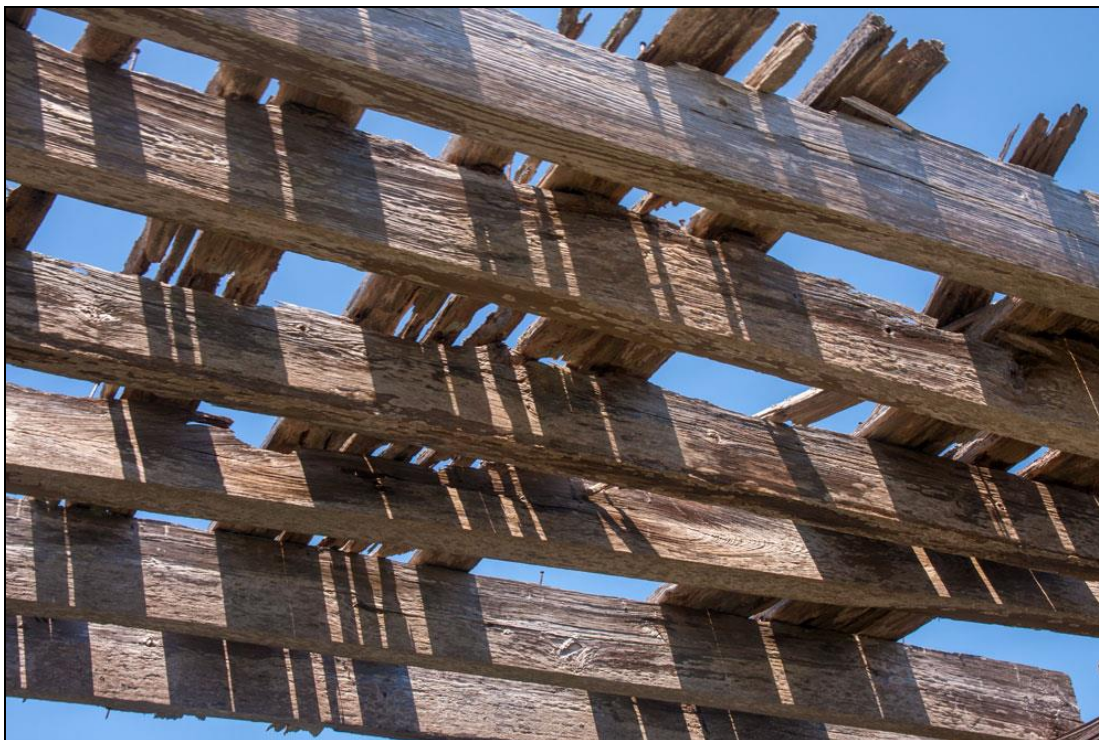
**Figure 27. Stringers and deck of North Channel Bridge from Pamlico Sound (photographer: Michael Henderson, January 30, 2016)**

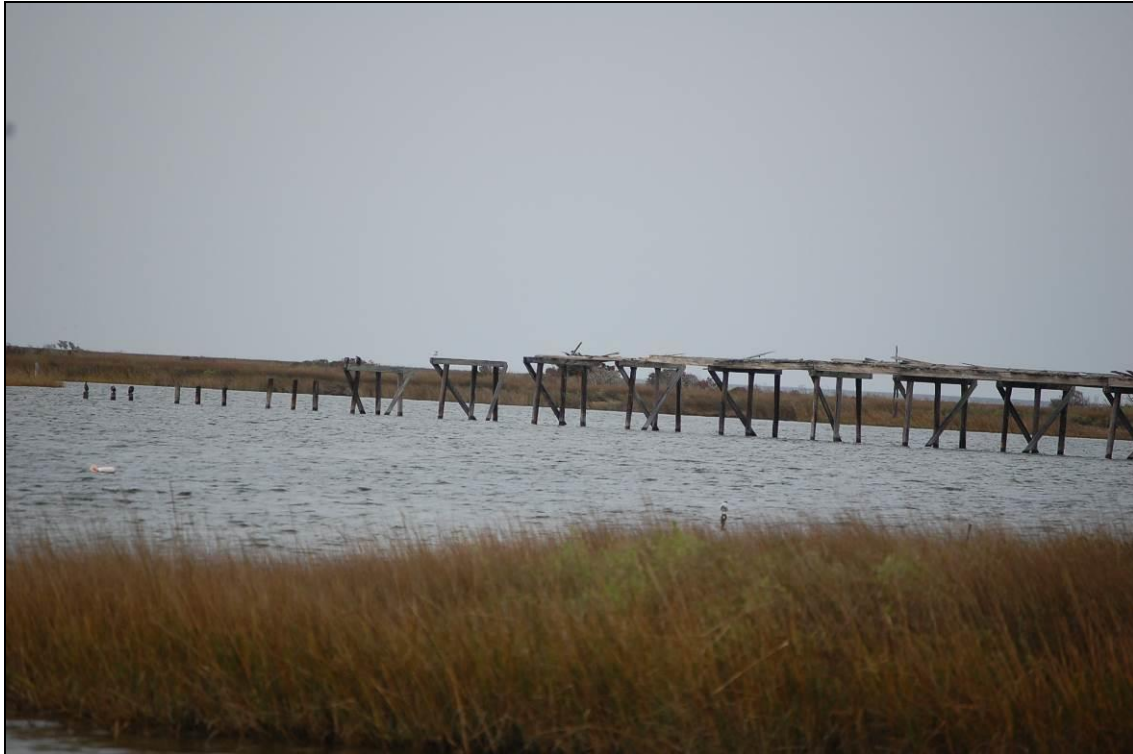
**Figure 28. Southern end of North Channel Bridge from NC 12 (photographer: Marvin Brown, November 9, 2016)**

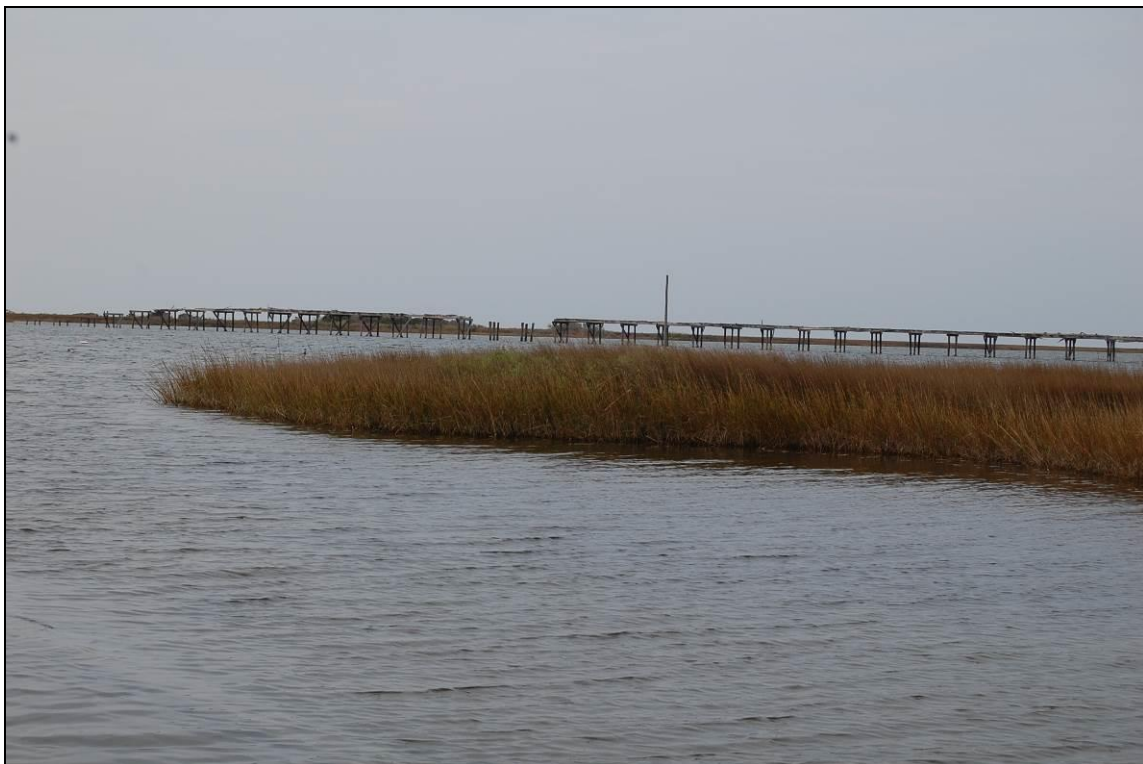
**Figure 29. Southern and central sections of North Channel Bridge from NC 12 (photographer: Marvin Brown, November 9, 2016)**

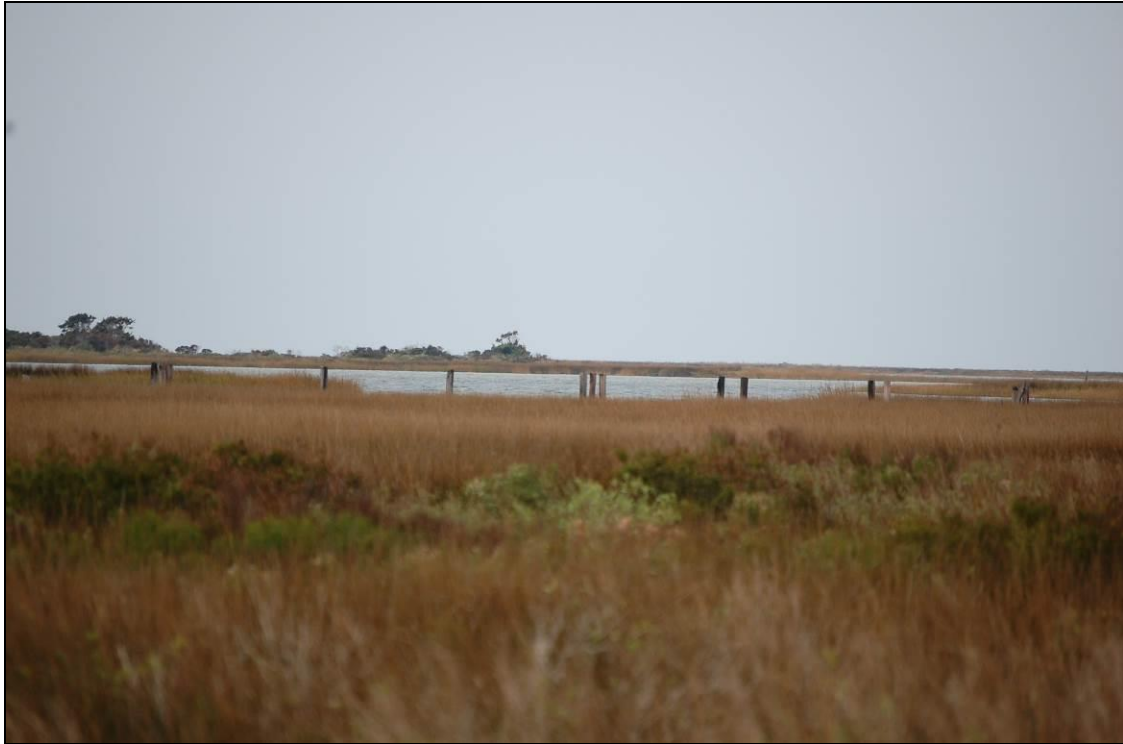
**Figure 30. Northern section of North Channel Bridge from NC 12 (photographer: Marvin Brown, November 9, 2016)**

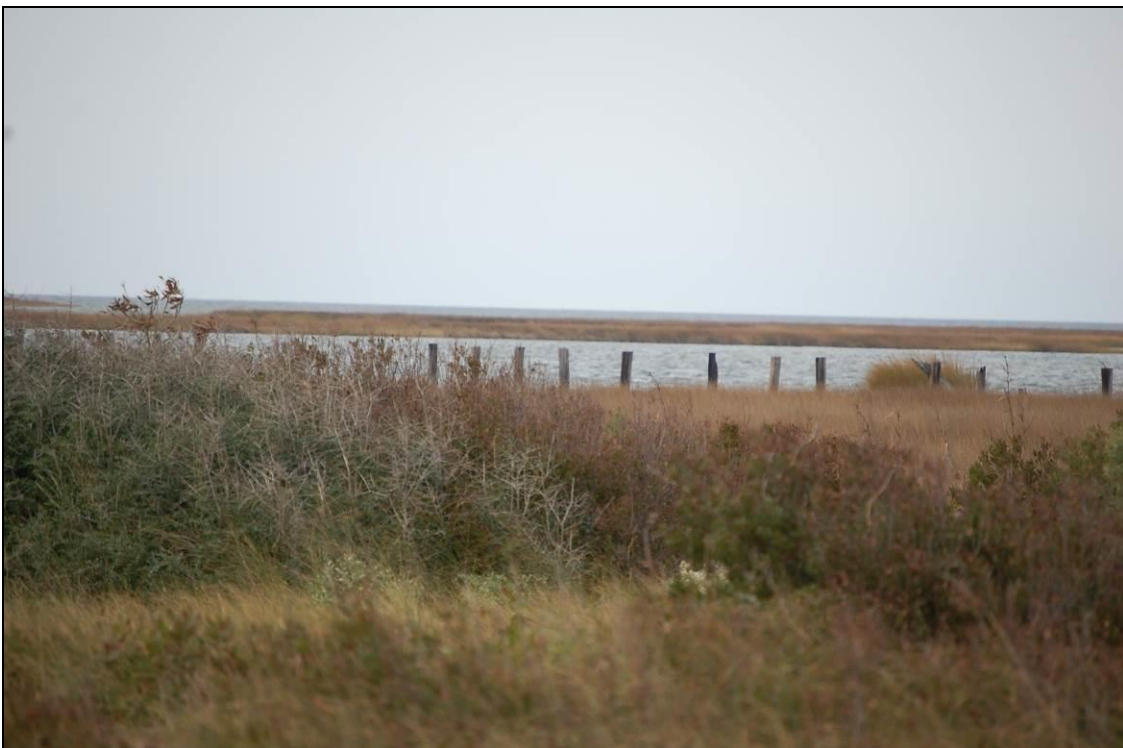
**Figure 31. Northern section of North Channel Bridge from NC 12 (photographer: Marvin Brown, November 9, 2016)**

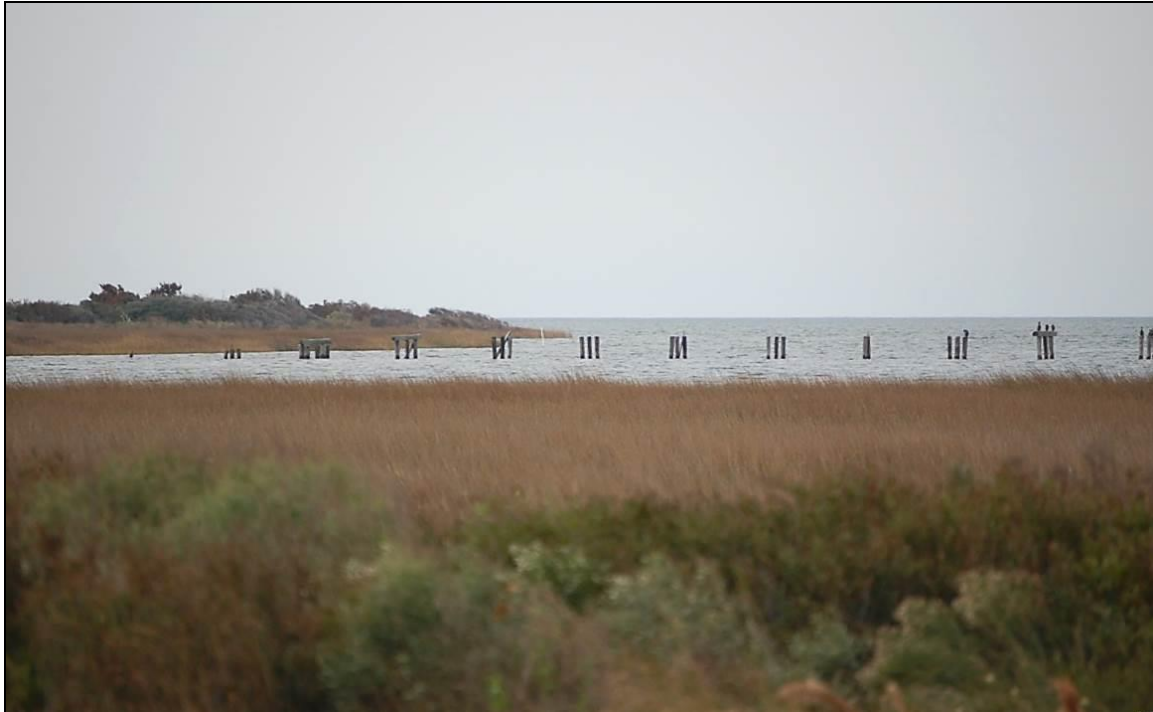
**Figure 34. South Channel Bridge from NC 12 (photographer: Marvin Brown, November 9, 2016)**

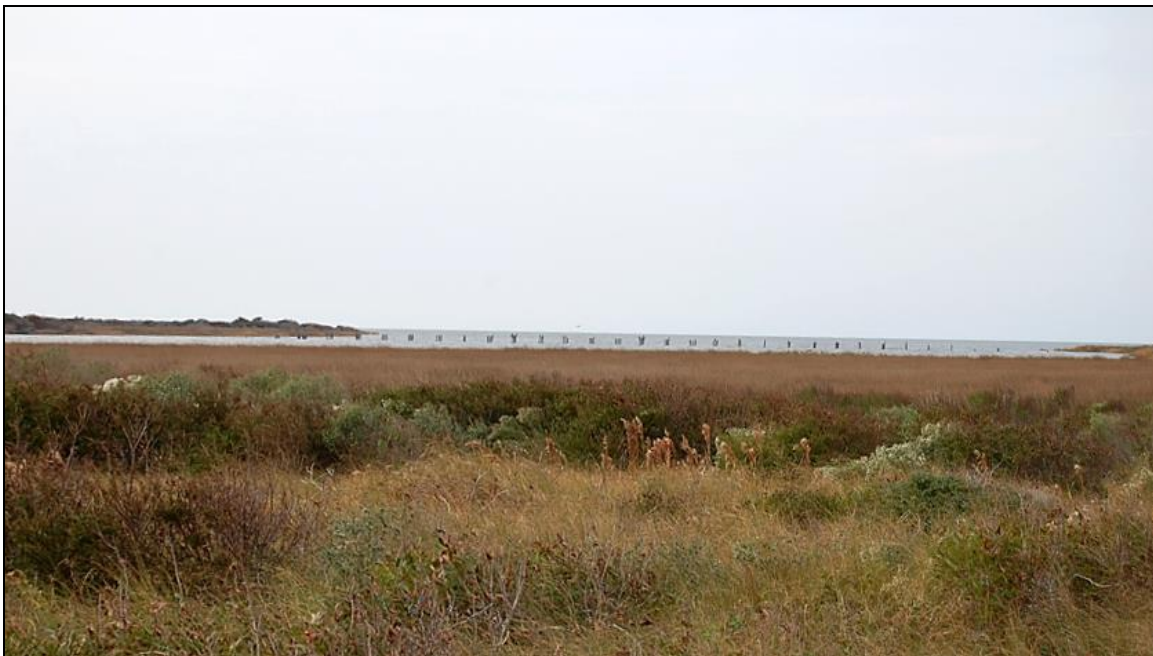
**Figure 35. South Channel Bridge from NC 12 (photographer: Marvin Brown, November 9, 2016)**

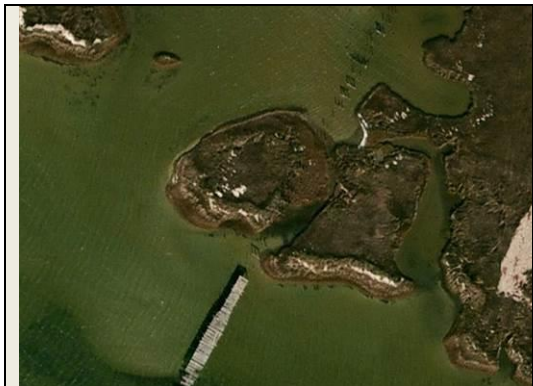
<b>North Channel Bridge</b>
	Within NRHP-eligible Pea Island National Wildlife Refuge (DR0607)
	Surviving pile bents and some superstructure elements of bridge in Pamlico Sound in PINWR, west of NC 12 between Oregon Inlet and Rodanthe, Dare County
	Center point of bridge within channel at Latitude 35.675390, Longitude 75.484543 (within Parcel 028727990, PIN 074200340875)
	Ca.1935
	Recommended not eligible for National Register listing due to loss of all seven NRHP elements of integrity

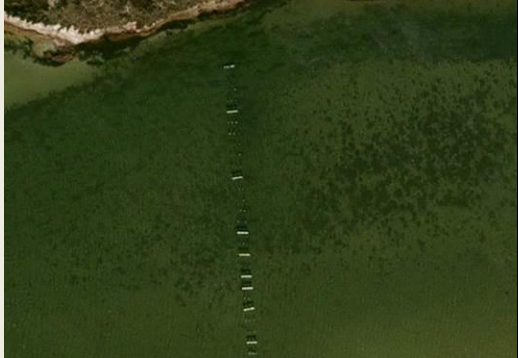
<b>South Channel Bridge</b>
	Within NRHP-eligible Pea Island National Wildlife Refuge (DR0607)
	Surviving pile bents of bridge in Pamlico Sound in PINWR, west of NC 12 between Oregon Inlet and Rodanthe, Dare County
	Center point of bridge within channel at Latitude 35.670468, Longitude 75.484977 (within Parcel 028727990, PIN 074200340875)
	Ca.1935
	Recommended not eligible for National Register listing due to loss of all seven NRHP elements of integrity

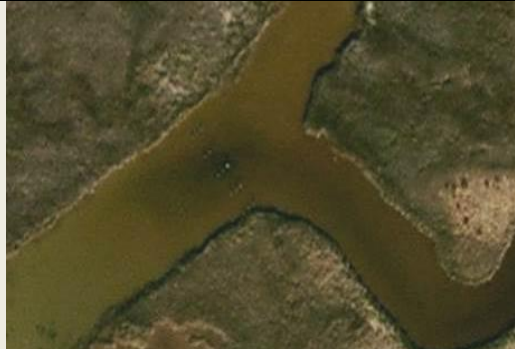
<b>South Slew Bridge</b>
	Within NRHP-eligible Pea Island National Wildlife Refuge (DR0607)
	Some surviving pile bents of bridge in Pamlico Sound in PINWR, west of NC 12 between Oregon Inlet and Rodanthe, Dare County
	Center point of bridge within channel at Latitude 35.663854, Longitude 75.481641 (within Parcel 028727990, PIN: 074200340875)
	Ca.1935
	Recommended not eligible for National Register listing due to loss of all seven NRHP elements of integrity

Association	Low	Heavily diminished through loss of all barrier rails, decking, stringers, and caps, and many of its bents, as well as loss of intact associated bridges and roadway.

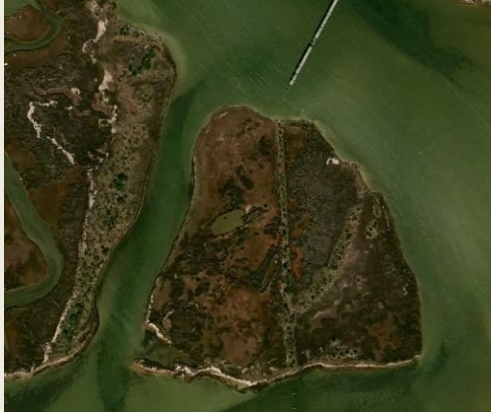
<p><b>New Inlet Bridges Roadway</b></p>
	<p>Within NRHP-eligible Pea Island National Wildlife Refuge (DR0607)</p>
	<p>Surviving path of roadway connecting North Channel, South Channel, and South Slew bridges with NC 12 in Pamlico Sound in PINWR, west of NC 12 between Oregon Inlet and Rodanthe, Dare County</p>
	<p>Runs between three bridges and NC 12 at north (at Longitude 35.680787, Latitude 75.482635) and NC 12 at south (at Longitude 35.661251, Latitude 75.478857) (within Parcel 028727990, PIN 074200340875)</p>
	<p>Ca.1935</p>
<p>Recommended not eligible for National Register listing due to loss of integrity</p>
