**North Carolina Department of Natural and Cultural Resources**  
**State Historic Preservation Office**

July 22, 2019

Re: Draft Addendum Historic Structures Survey Report, MVP Southgate Pipeline Project,  
Multi County, ER 18-1041

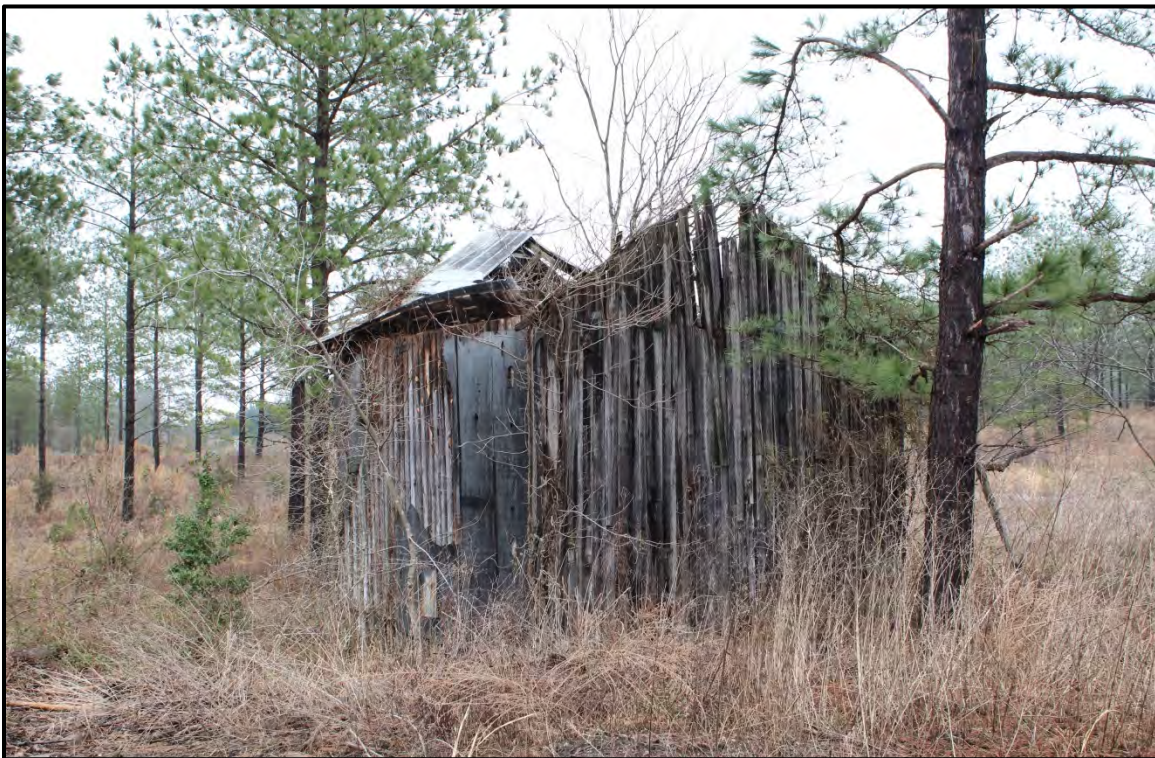
NRHP Assessment. Architectural resource RK1086 does not exhibit a distinctive architectural style or workmanship. Although the structure is likely associated with mid-twentieth century tobacco cultivation on Willow Oaks Farm, the resource is in poor condition due to neglect, which has resulted in the partial collapse of the roof and some exterior siding. Due to the poor integrity of the resource, it is the opinion of TRC that architectural resource RK1086 is not eligible for the NRHP.

Figure 2.4. Architectural resource RK1086; view is southeast featuring the north (primary) and west elevations.

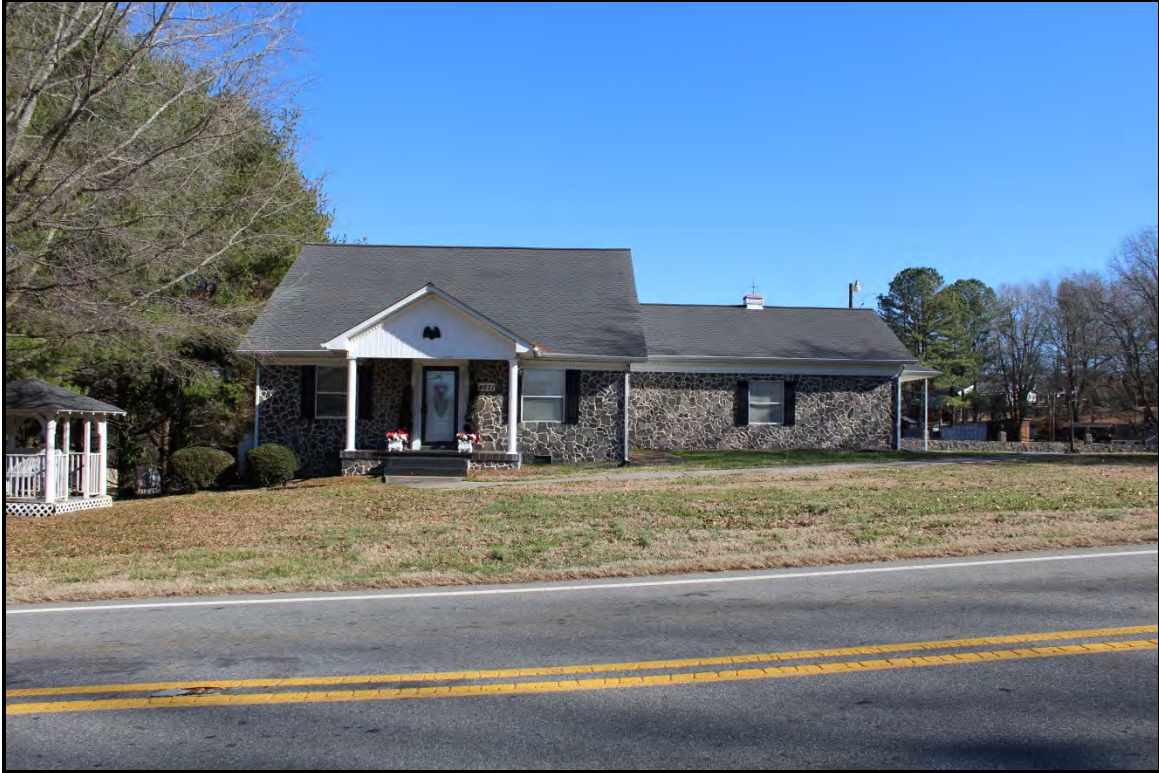
**NRHP Assessment.** Architectural resource RK1790 does not exhibit a distinctive architectural style or workmanship. In addition, the house has been altered through the installation of vinyl sashes, the construction of the south elevation garage wing, the reconstruction of the façade porch, and the application of modern stone veneer siding. Based on the lack of architectural merit, as well as the inability to associate the house and/or its original owner(s) with an important historical event or series of events, it is TRC's opinion that architectural resource RK1790 is not eligible for the NRHP.

Figure 2.25. Architectural resource RK1790; view is east featuring the façade.

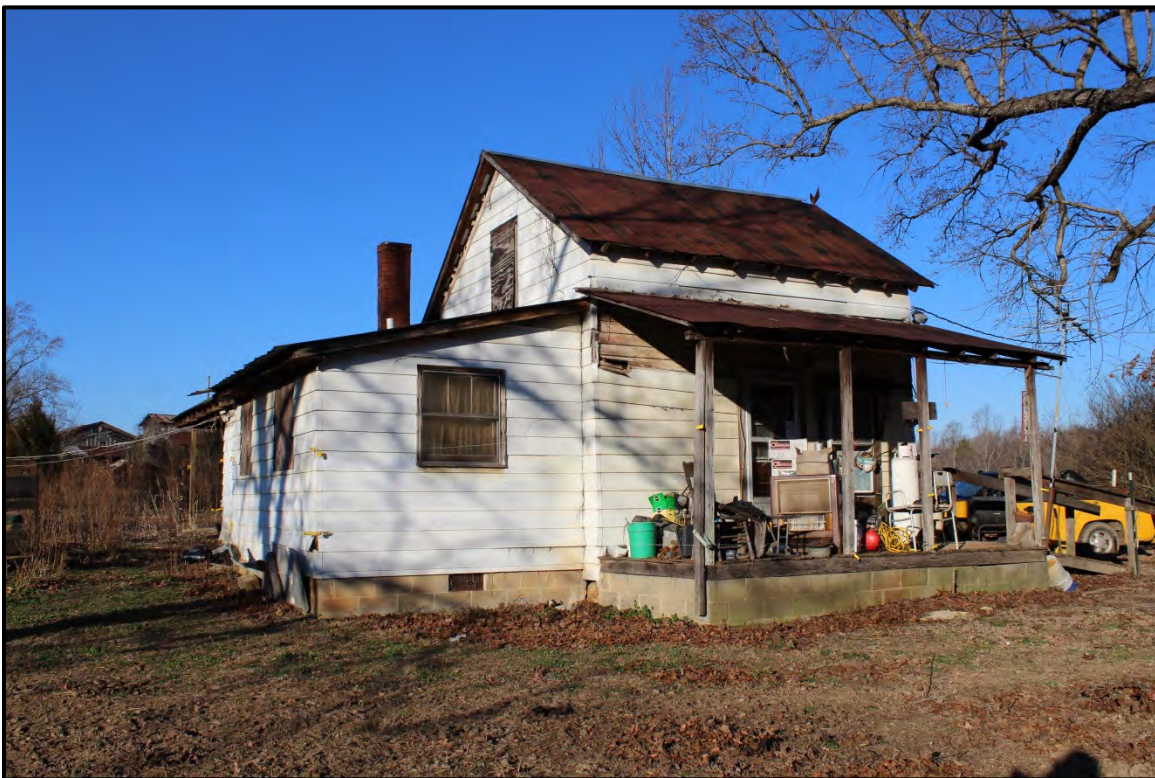
NRHP Assessment. Architectural resource RK1792 is an active farmstead anchored by a side-gabled house that does not exhibit distinctive characteristics of architectural style or workmanship. In addition, the building has been altered through the reconstruction of the façade porch, the application of aluminum siding, and the construction of the rear addition. The historic setting of the property has been compromised with the construction of modern agricultural buildings on the property. For these reasons, the farm no longer conveys its early twentieth century appearance, thereby rendering the property ineligible for its agricultural associations. For these reasons it is the opinion of TRC that architectural resource RK1792 is not eligible for the NRHP.

Figure 2.32. Architectural resource RK1792 farmhouse; view is northwest featuring the façade and south elevation.

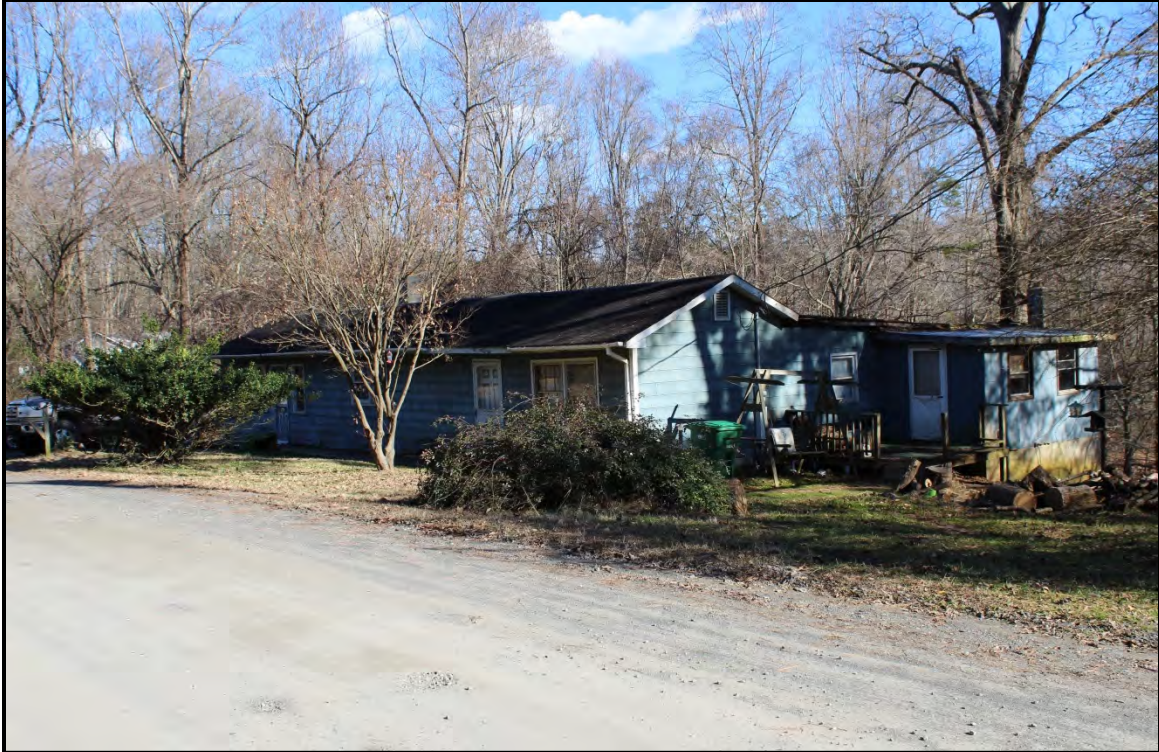
NRHP Assessment. Architectural resource RK1793 does not exhibit a distinctive architectural style or workmanship. In addition, the house has been altered through the application of aluminum siding, the installation of vinyl sashes, and the installation of a modern door and windows on the façade. Based on the lack of architectural merit, as well as the inability to associate the house and/or its original owner(s) with an important historical event or series of events, it is TRC's opinion that architectural resource RK1793 is not eligible for the NRHP.

Figure 2.46. Architectural resource RK1793; view is northeast featuring the façade and southwest elevation.

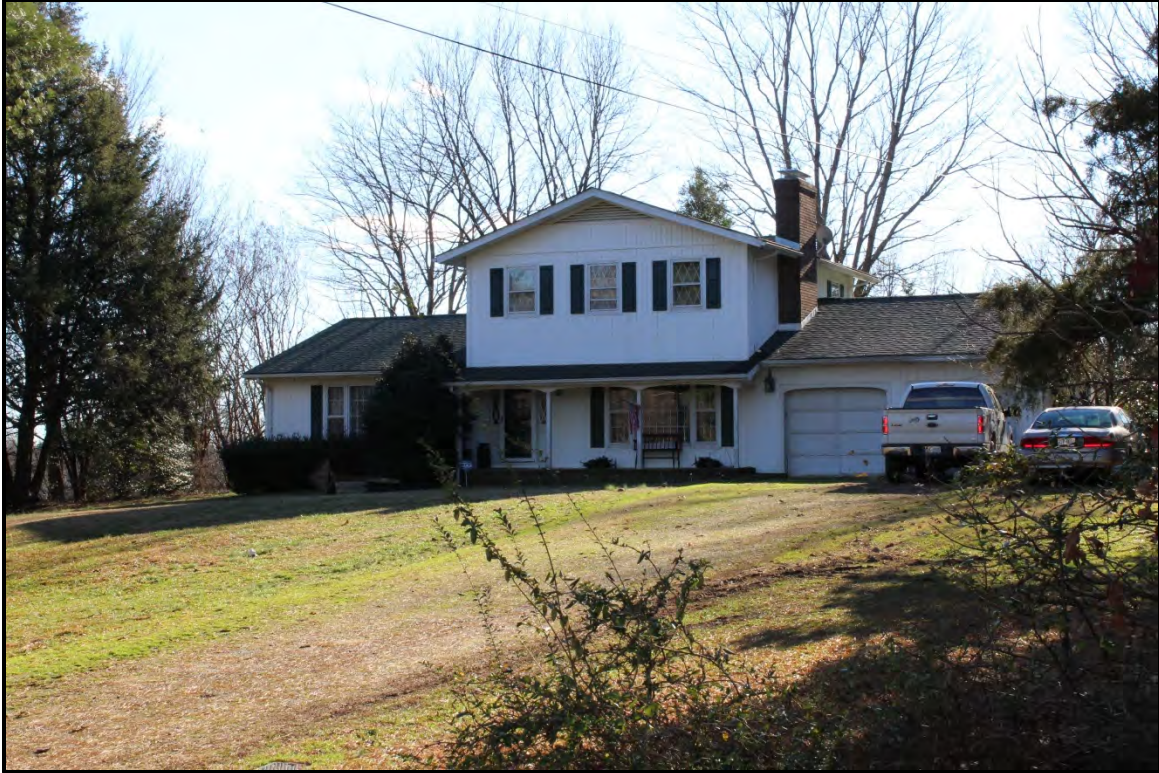
NRHP Assessment. Architectural resource RK1795 does not exhibit a distinctive architectural style or workmanship. In addition, the house has been altered through the installation of vinyl sash windows. Based on the lack of architectural merit, as well as the inability to associate the house and/or its original owner(s) with an important historical event or series of events, it is TRC's opinion that architectural resource RK1795 is not eligible for the NRHP.

Figure 2.55. Architectural resource RK1795; view is southwest featuring the façade and east elevation garage wing.

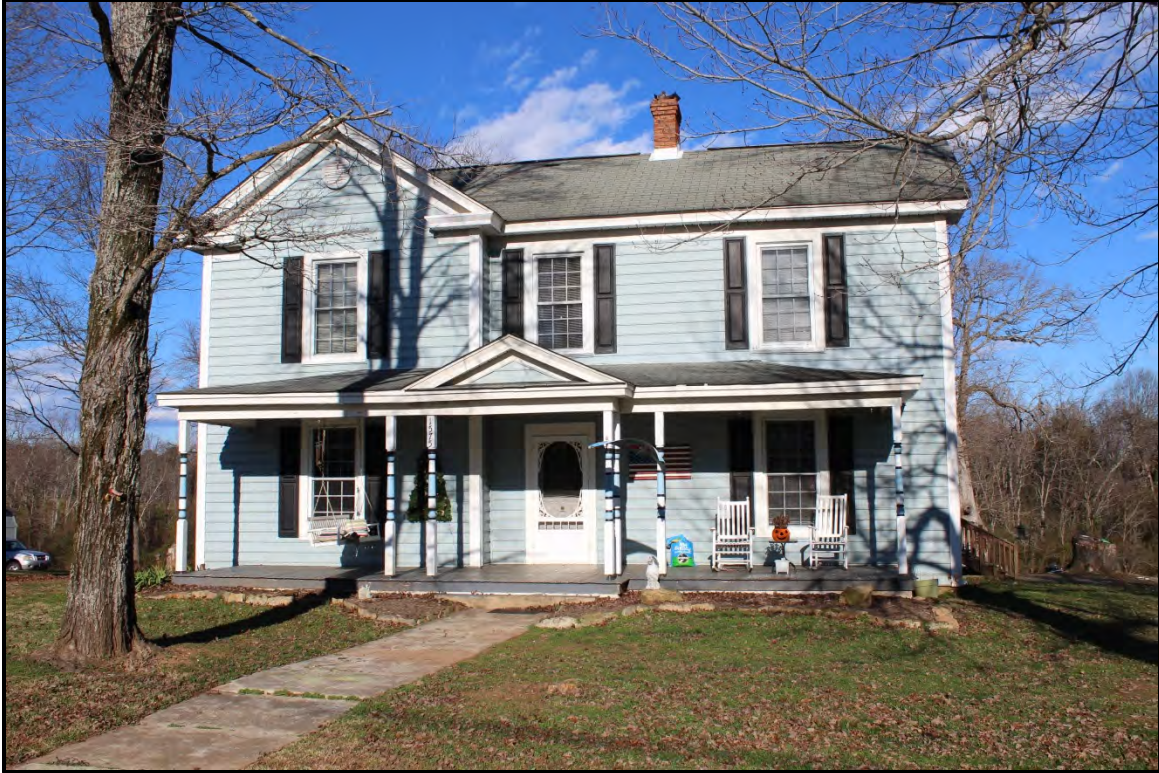
NRHP Assessment. Architectural resource RK1796 does not exhibit a distinctive architectural style or workmanship. In addition, the house has been altered through the installation of vinyl sash windows and the application of aluminum siding. Based on the lack of architectural merit, as well as the inability to associate the house and/or its original owner(s) with an important historical event or series of events, it is TRC's opinion that architectural resource RK1796 is not eligible for the NRHP.

Figure 2.56. Architectural resource RK1796; view is northeast featuring the façade.

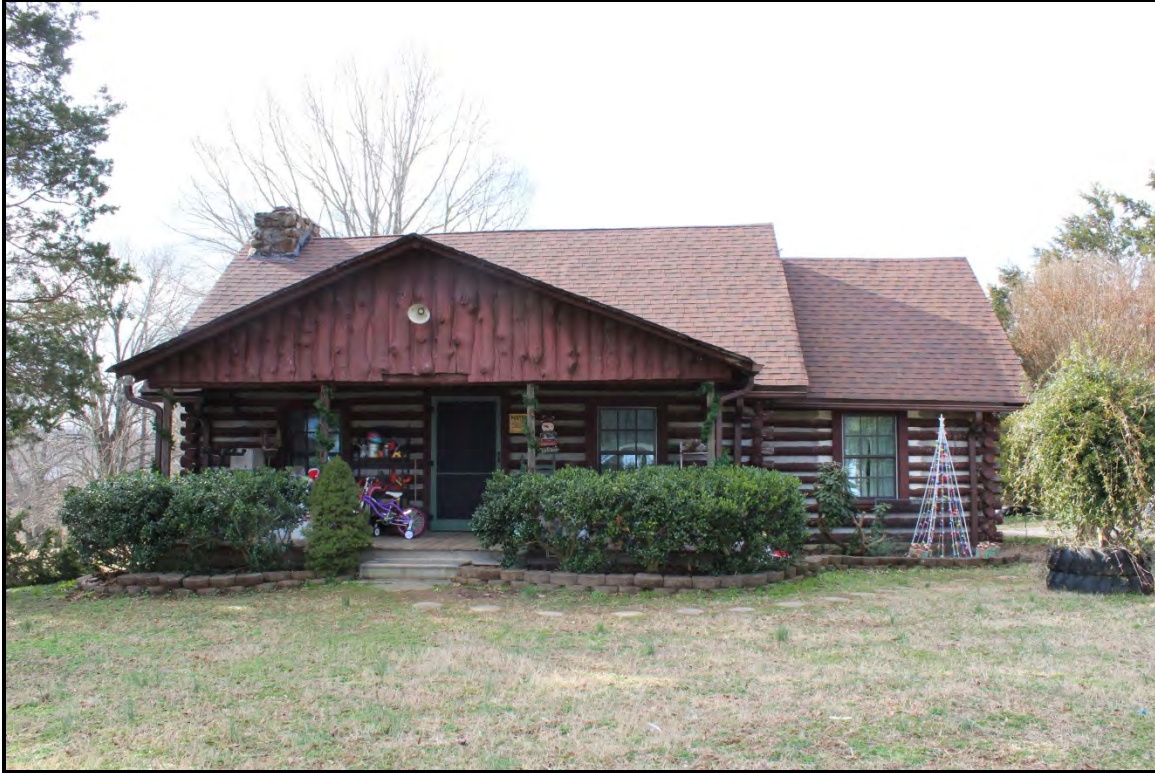
NRHP Assessment. Architectural resource RK1820 does not exhibit a distinctive architectural style or workmanship. In addition, the house has been altered through the installation of vinyl sash windows. Based on the lack of architectural merit, as well as the inability to associate the house and/or its original owner(s) with an important historical event or series of events, it is TRC’s opinion that architectural resource RK1820 is not eligible for the NRHP.

Figure 2.59. Architectural resource RK1820; view is east and features the façade.

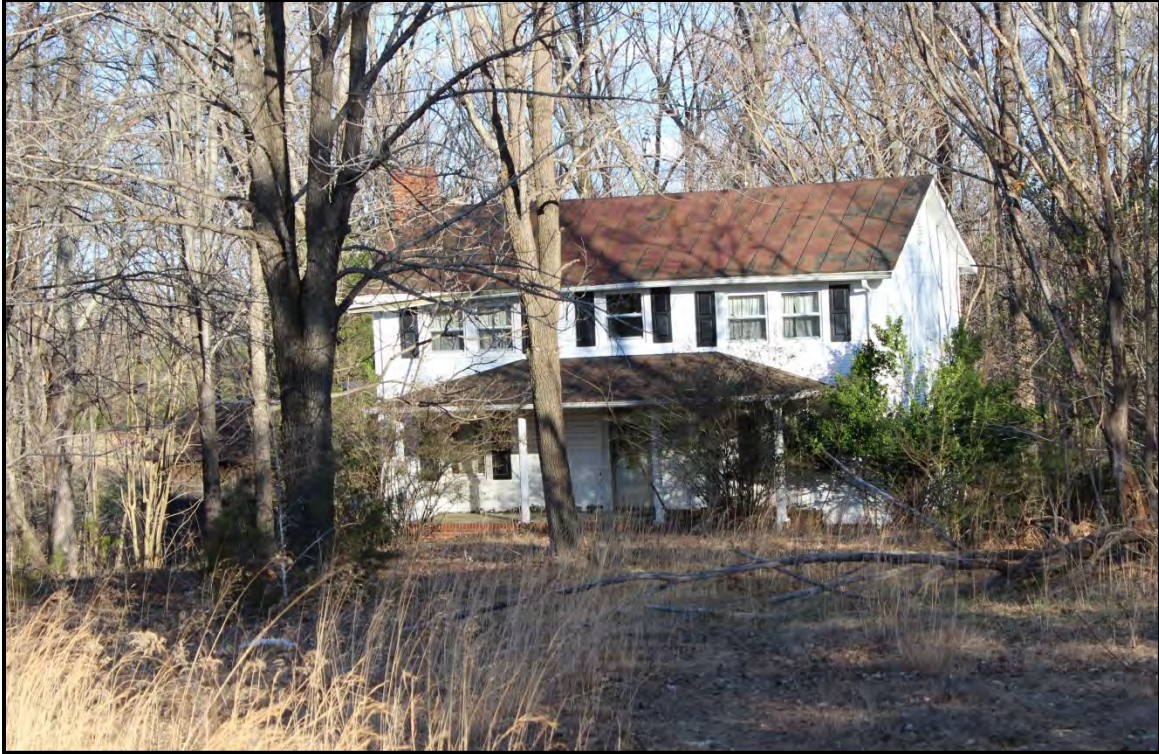
NRHP Assessment. Architectural resource RK1798 does not exhibit a distinctive architectural style or workmanship. In addition, the house has been altered through the installation of a vinyl sash window, the application of vinyl siding, and the reconstruction of the façade porch. Based on the lack of architectural merit, as well as the inability to associate the house and/or its original owner(s) with an important historical event or series of events, it is TRC's opinion that architectural resource RK1798 is not eligible for the NRHP.

Figure 2.67. Architectural resource RK1798; view is northeast featuring the façade and south elevation.

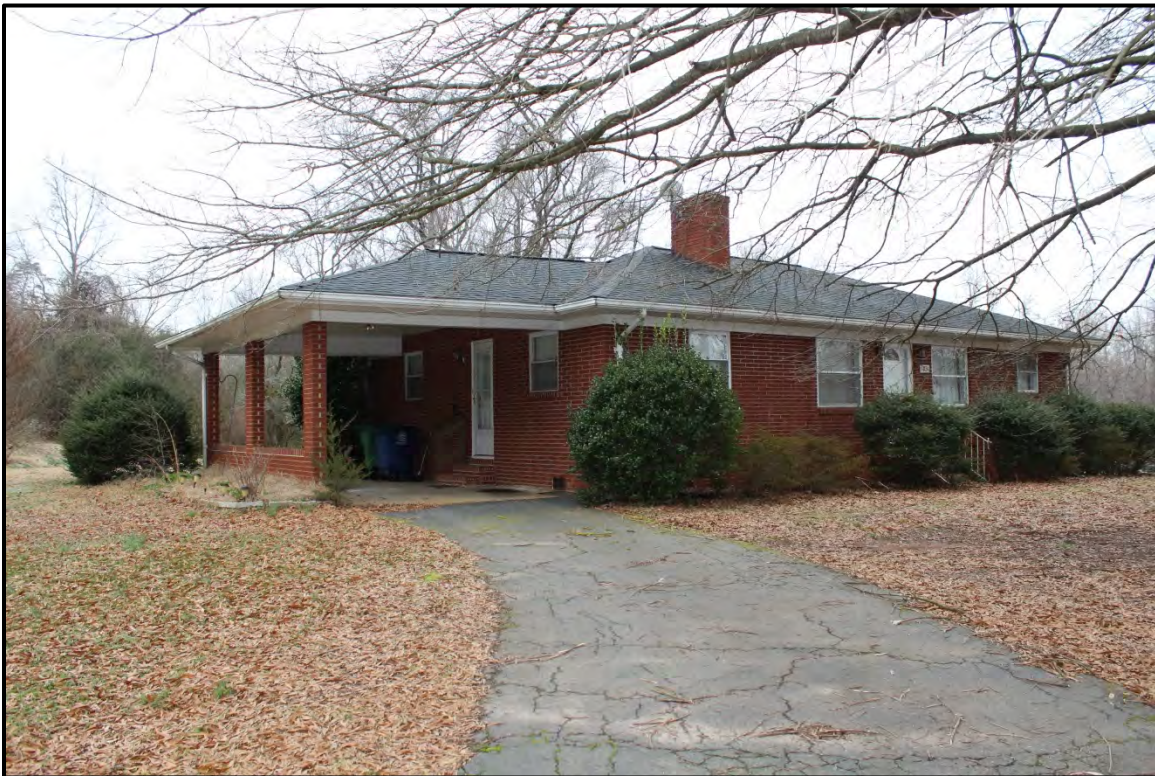
NRHP Assessment. Architectural resource RK1818 is an active farmstead anchored by a Ranch-style house that does not exhibit distinctive characteristics of architectural style or workmanship. In addition, the building has been altered through the replacement of the original window sashes. The historic setting of the property has been compromised with the construction of modern agricultural buildings on the property. For these reasons, the farm no longer conveys its early twentieth century appearance, thereby rendering the property ineligible for its agricultural associations. For these reasons it is the opinion of TRC that architectural resource RK1818 is not eligible for the NRHP.

Figure 2.74. Architectural resource RK1818 farmhouse; view is northeast featuring the façade and west elevation.

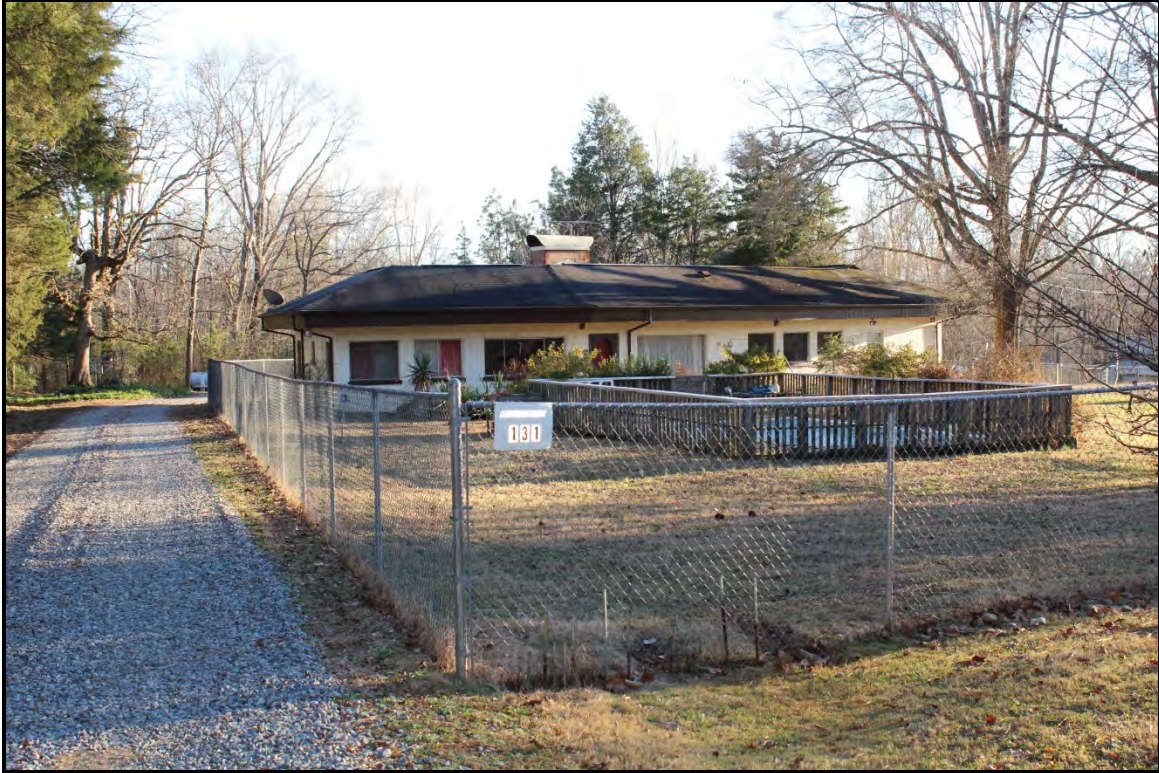
NRHP Assessment. Architectural resource RK1801 does not exhibit a distinctive architectural style or workmanship. Based on the lack of architectural merit, as well as the inability to associate the house and/or its original owner(s) with an important historical event or series of events, it is TRC's opinion that architectural resource RK1801 is not eligible for the NRHP.

Figure 2.99. Architectural resource RK1801; view is southwest featuring the north (rear) and east elevations. Note in-ground pool in the foreground.

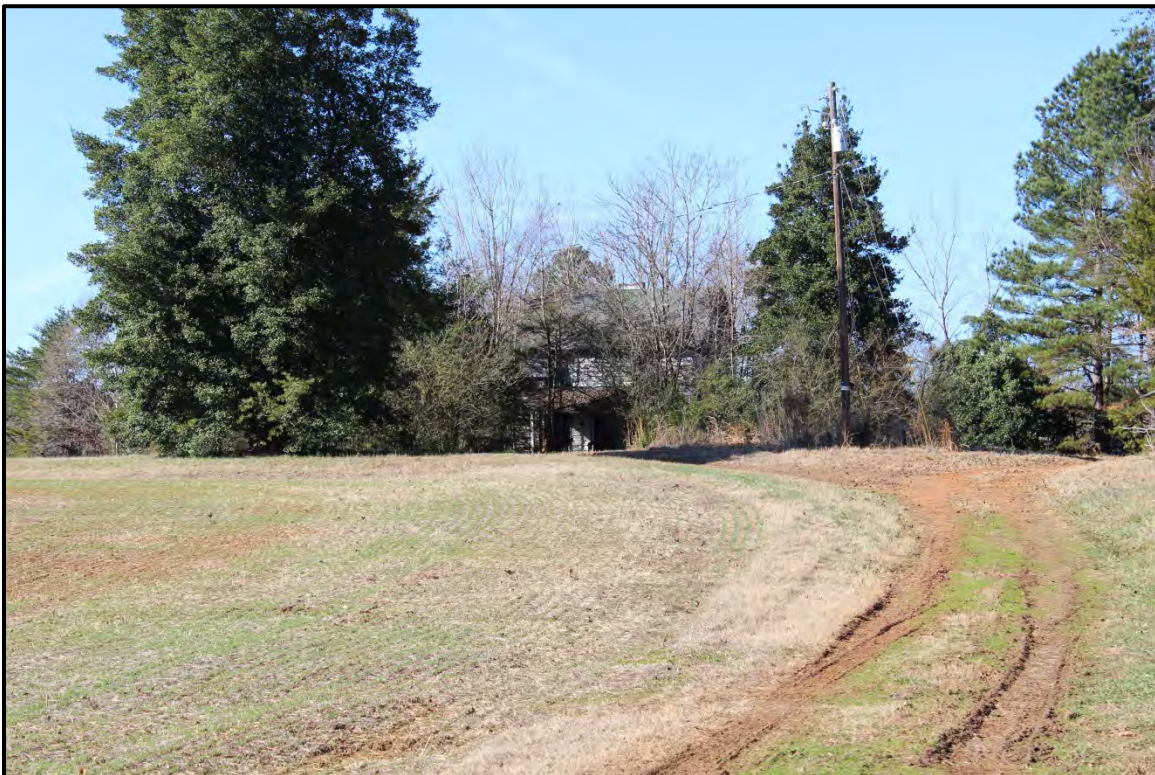
We also acknowledge that RK1822 remains unevaluated due to lack of access. However, the house appears to be substantially deteriorated, overgrown, and not likely eligible for listing.

NRHP Assessment. Architectural resource RK1822 is overgrown with vegetation and not visible from the public right-of-way along High Rock Road, which prevented TRC from evaluating its NRHP eligibility. Additional field work and research would be necessary to complete assessment of this property.

Figure 2.106. Architectural resource RK1822; view is west and features the façade.

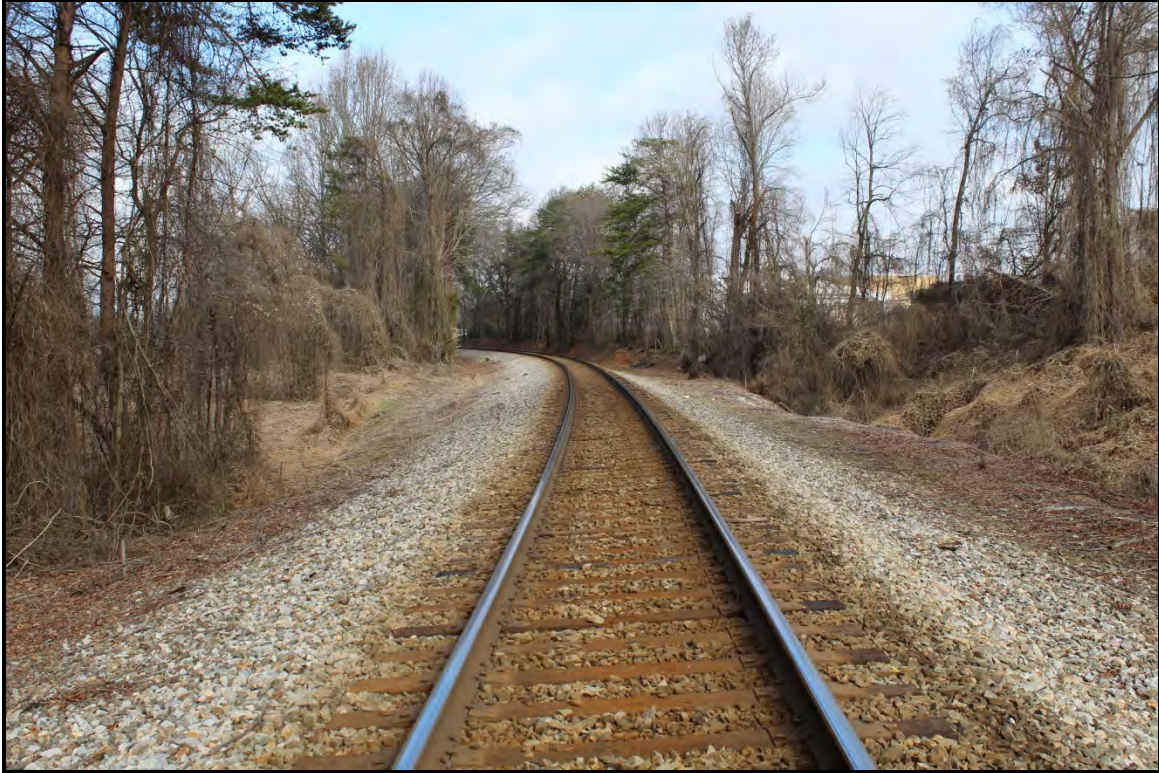
NRHP Evaluation. Architectural resource RK1802 consists of a railroad track segment that is located within a late nineteenth century railroad corridor. Since the completion of the railroad corridor, the track has been continuously altered through routine maintenance for more than a century. As an actively managed rail line, the railroad bed has received regular repairs that have resulted in the replacement of the original tracks, cross-ties, and ballast. As such, no materials associated with the original construction of the railroad remain. For these reasons, it is the opinion of TRC that architectural resource RK1802 is not eligible for the NRHP.

Figure 2.107. Architectural resource RK1802 along the western border of CY-08; view is north.

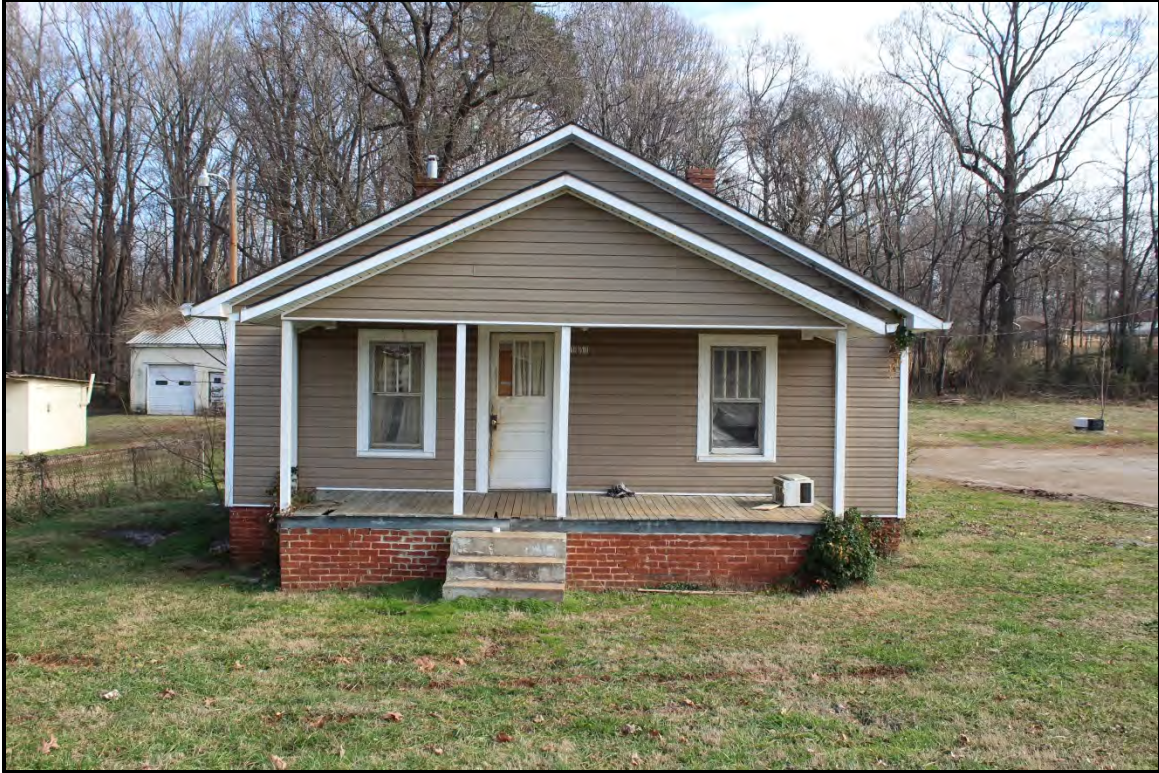
NRHP Assessment. Architectural resource RK1805 does not exhibit a distinctive architectural style or workmanship. In addition, the house has been altered through the application of vinyl siding. Based on the lack of architectural merit, as well as the inability to associate the house and/or its original owner(s) with an important historical event or series of events, it is TRC's opinion that architectural resource RK1805 is not eligible for the NRHP.

Figure 2.118. Architectural resource RK1805; view is east and features the façade.

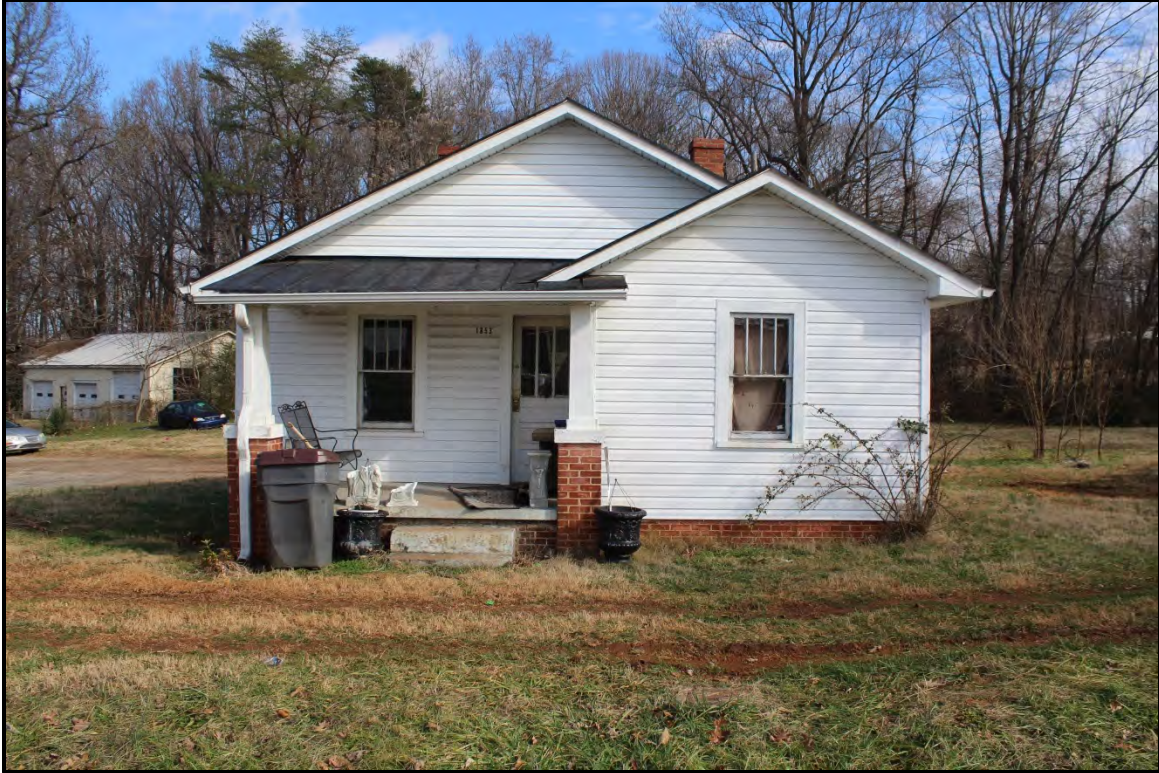
NRHP Assessment. Architectural resource RK1806 does not exhibit a distinctive architectural style or workmanship. In addition, the house has been altered through the application of vinyl siding. Based on the lack of architectural merit, as well as the inability to associate the house and/or its original owner(s) with an important historical event or series of events, it is TRC's opinion that architectural resource RK1806 is not eligible for the NRHP.

Figure 2.121. Architectural resource RK1806; view is east and features the façade.

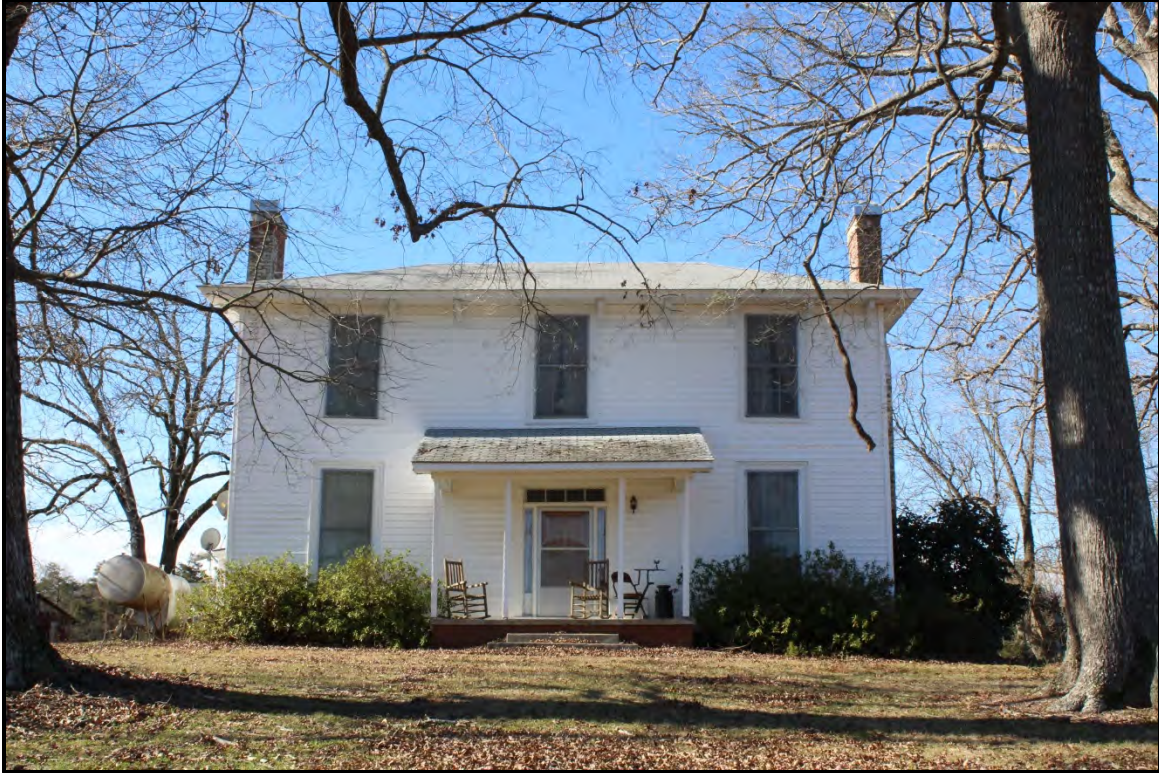
We do not concur that AM2635 is potentially eligible for listing under Criterion C due to lack of integrity to the resource's presumed period of significance. Instead, we find that AM2635 is not eligible for listing in the National Register of Historic Places under Criterion C.

Figure 4.106. Architectural resource AM2635 farmhouse; view is west featuring the façade.
