North Carolina Department of Natural and Cultural Resources
State Historic Preservation Office

Ramona M. Bartos, Administrator

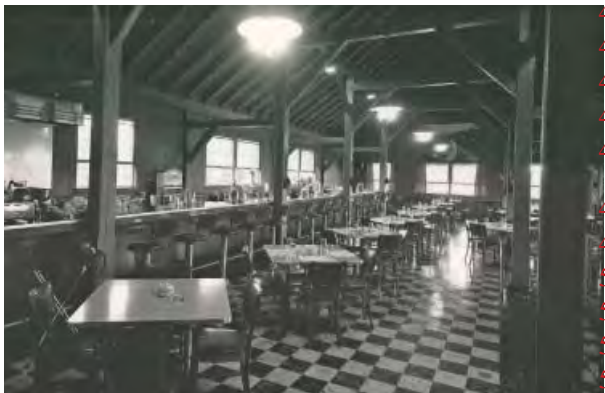
Figure M4. Dining room of Bluffs Coffee Shop in 1952. (BLRI Coll.)

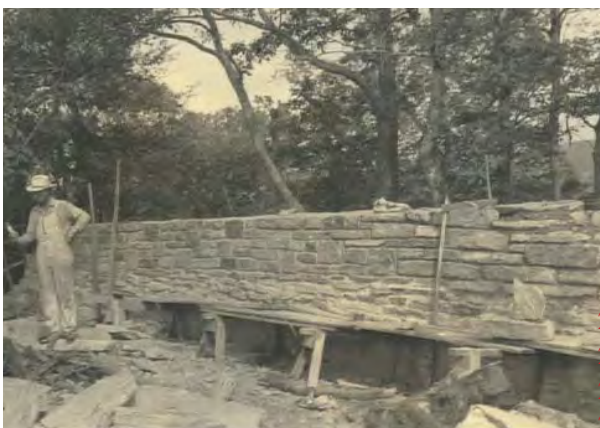
Figure A7. Construction of stone retaining wall of parking area for the Woods Picnic Area, east of future coffee shop site, July 1938. (BLRI Coll.)

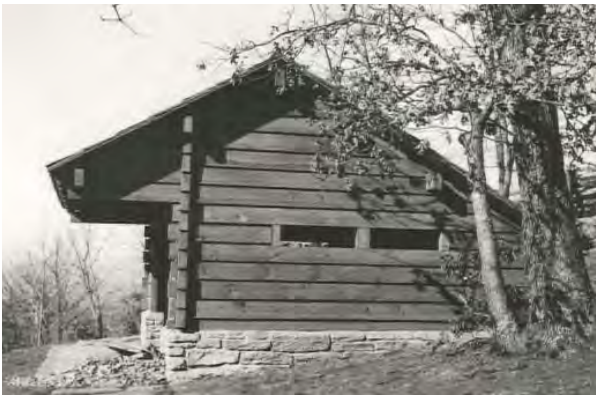
Figure A8. Trail shelter at Doughton Park in the 1940s. Note that structure is partially-embeded in the slope, also note squared log construction and stone foundation walls. (BLRI Coll.)

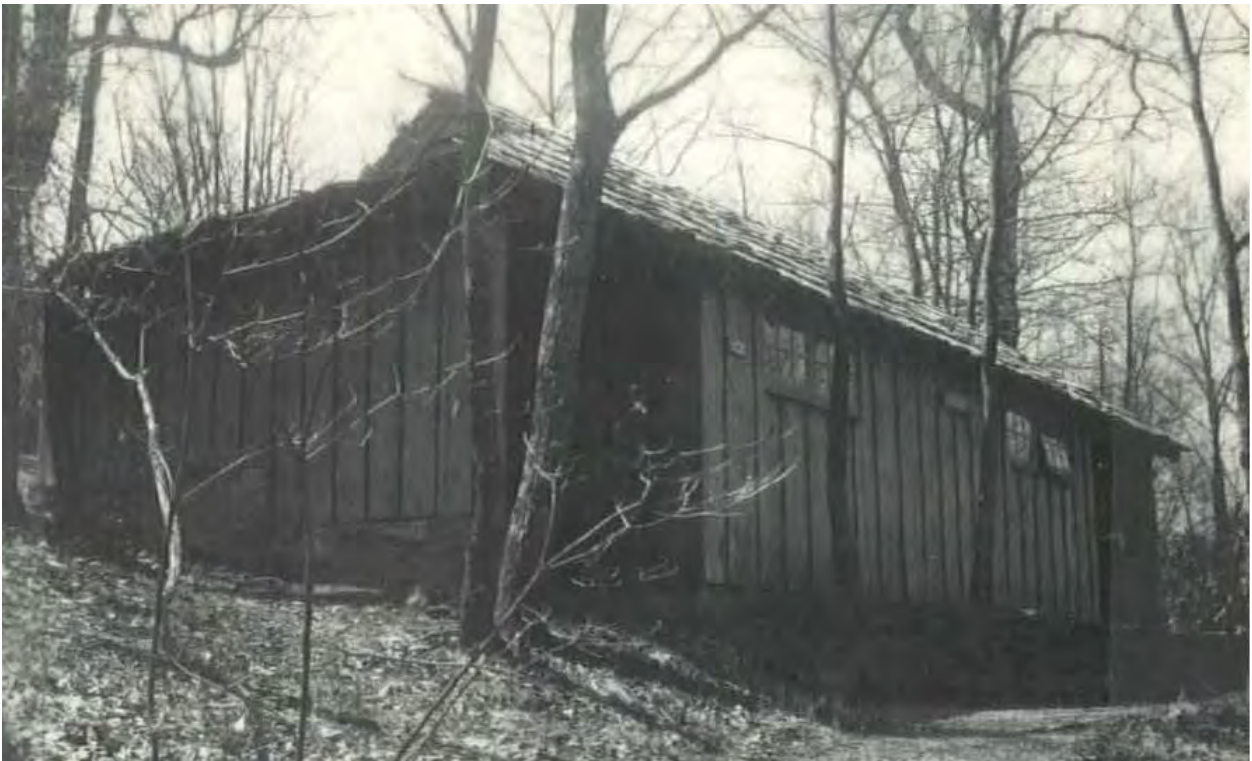
Figure A9. Rustic comfort station at the Woods Picnic Area, northeast of the coffee shop site. Note board-and-batten siding and stone foundation walls. (BLRI Coll.)

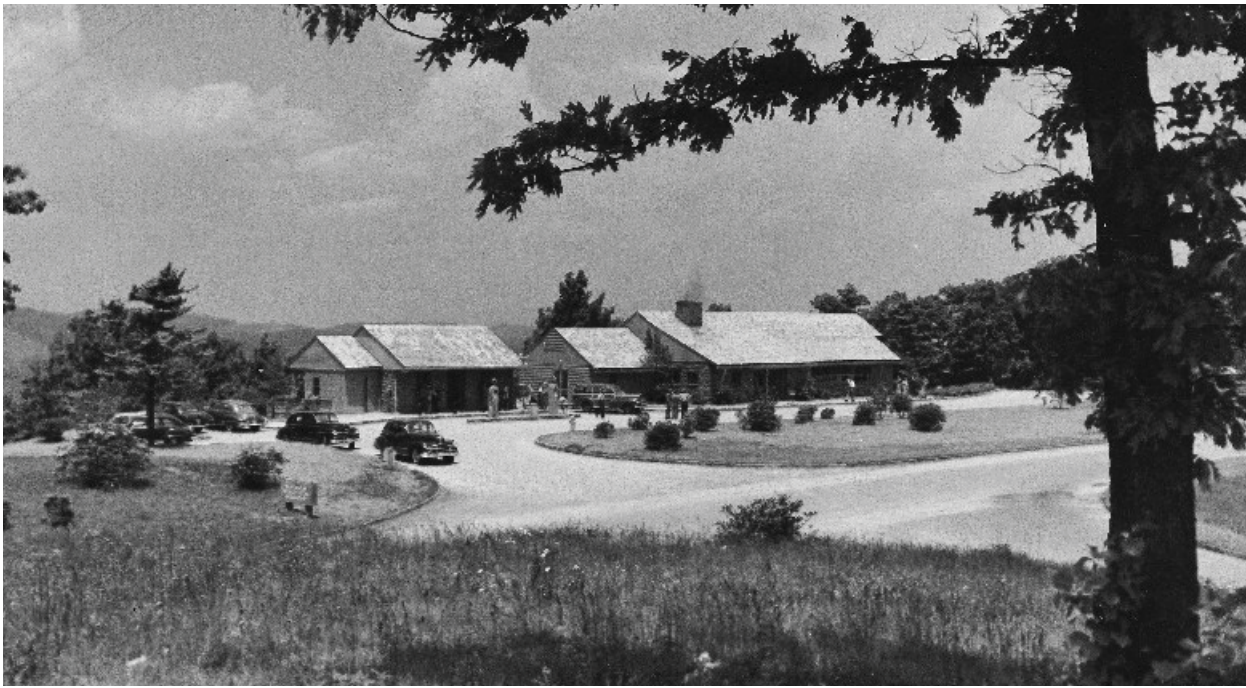
Figure A10. View of Bluffs Coffee Shop from south of the parkway before 1953. (BLRI Coll.)

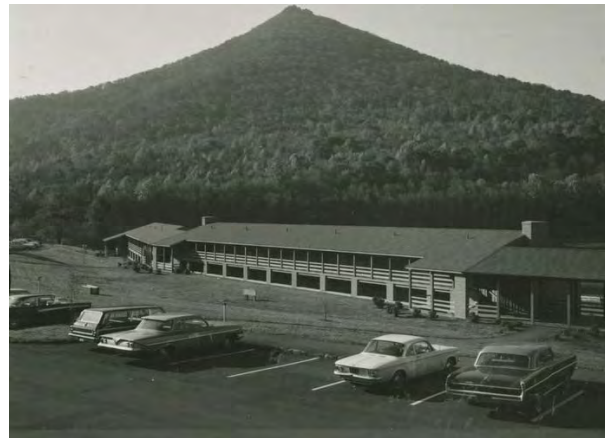
Figure A11. Peaks of Otter Lodge embodies the same hybrid rustic style seen at Bluffs Coffee Shop and Bluffs Lodge. Photo taken October 1964. (BLRI Coll.)

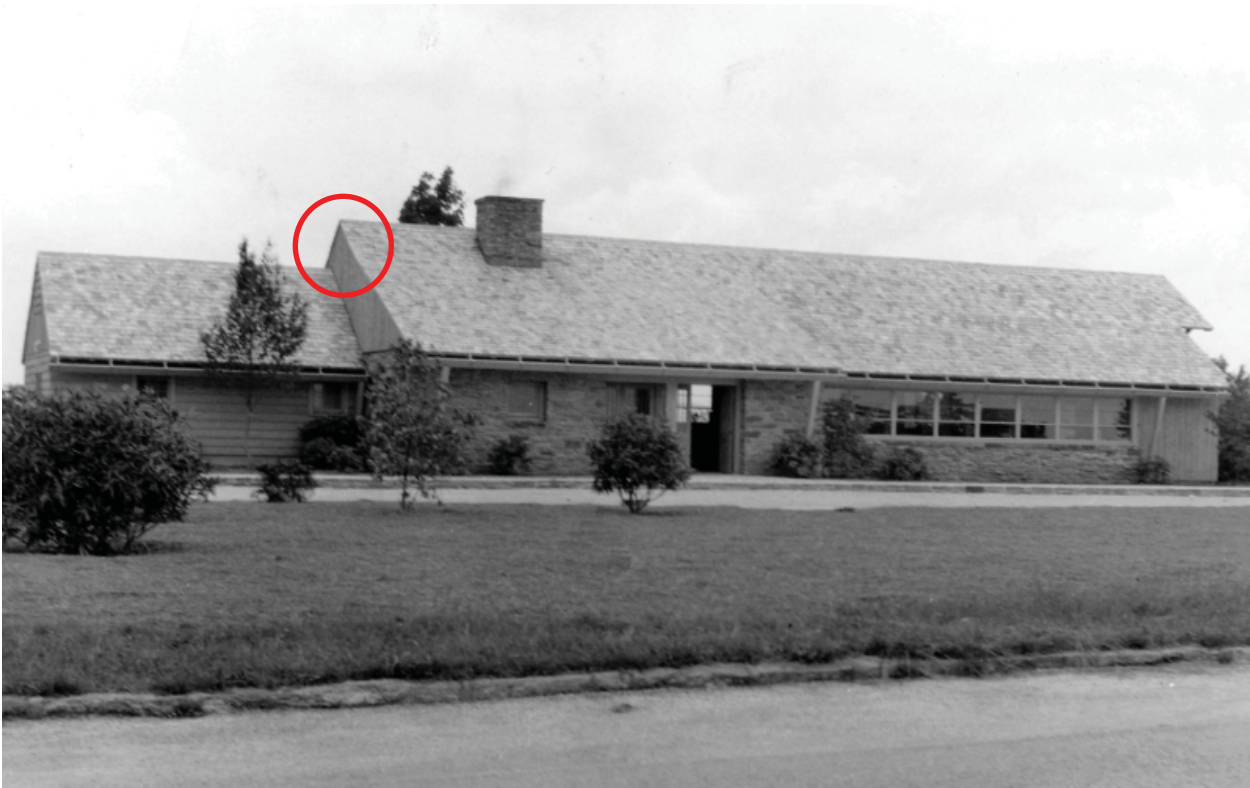
Figure B8. Undated photo taken before September 1953 showing south and partial west elevations. Similar conditions suggest that this picture was taken at or near the same time as the photo above. Note lack of vent on west gable. Also note doors propped open within the exterior vestibule. (BLRI Coll.)

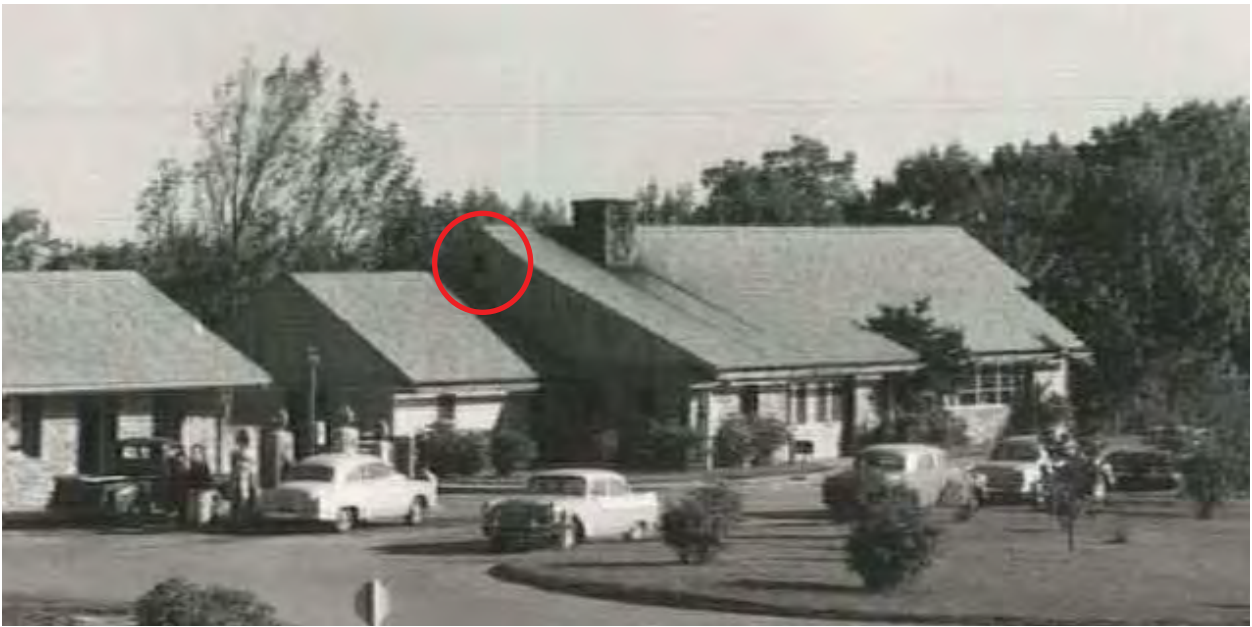
Figure B9. September 1953 photograph taken from the southwest. Attic vent, exterior screen doors, and redesigned downspouts are visible. (BLRI Coll.)

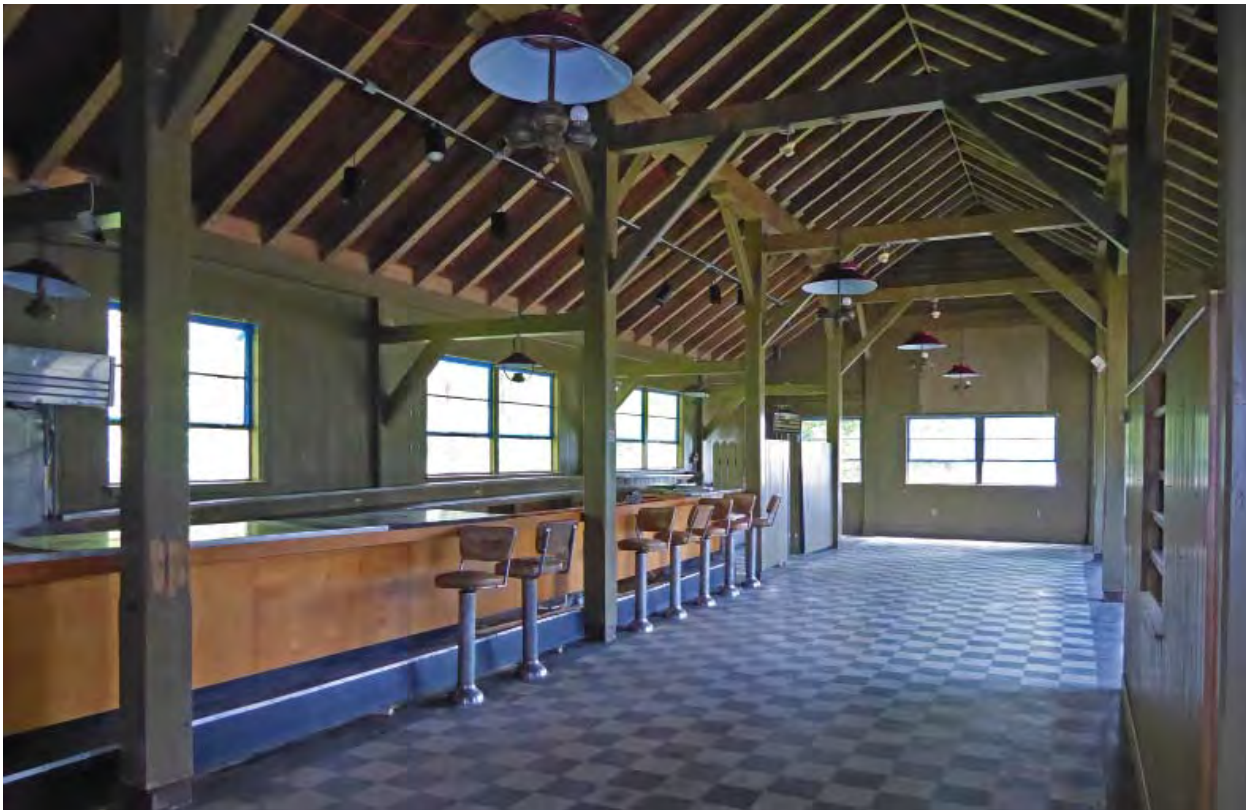
Figure B12. The view above in 2018. Note many remaining original fixtures and finishes, including flooring, central light fixtures, counter, and bar stools. The original hood at right, though repositioned, is also present. Changes include the removal of the far east bay of the counter and stools and addition of screening partition, as well as the installation of modern gift shop cabinets at right. Early rustic-design fixtures have been added to the underside of the beams on the north and south structural bays. Modern track lighting over counter replaces flood fixtures. (JKOA)

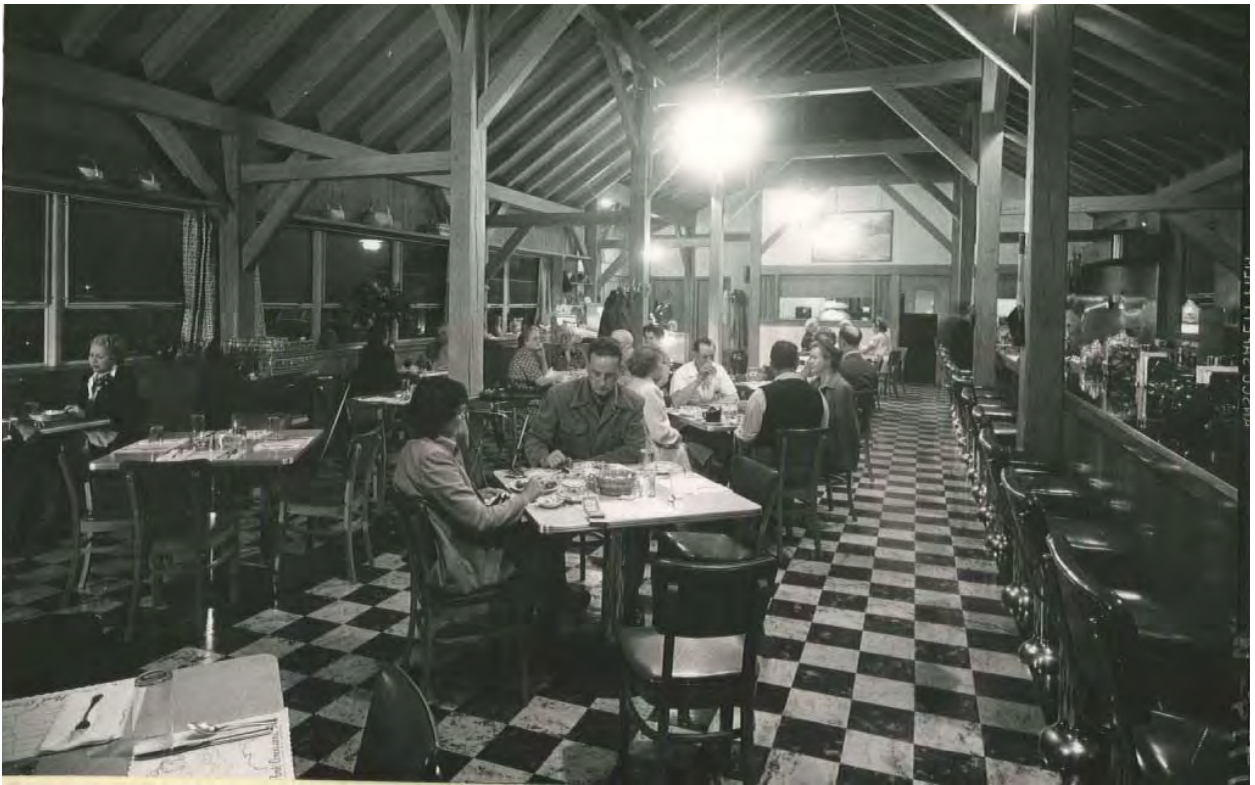
Figure B13. View of the dining room in May 1952. Note original length of counter at right. The east side of the original gift shop is visible in the background at left. A low gate, seemingly matching that shown on original drawings, provides employee access behind the counter. (BLRI Coll.)

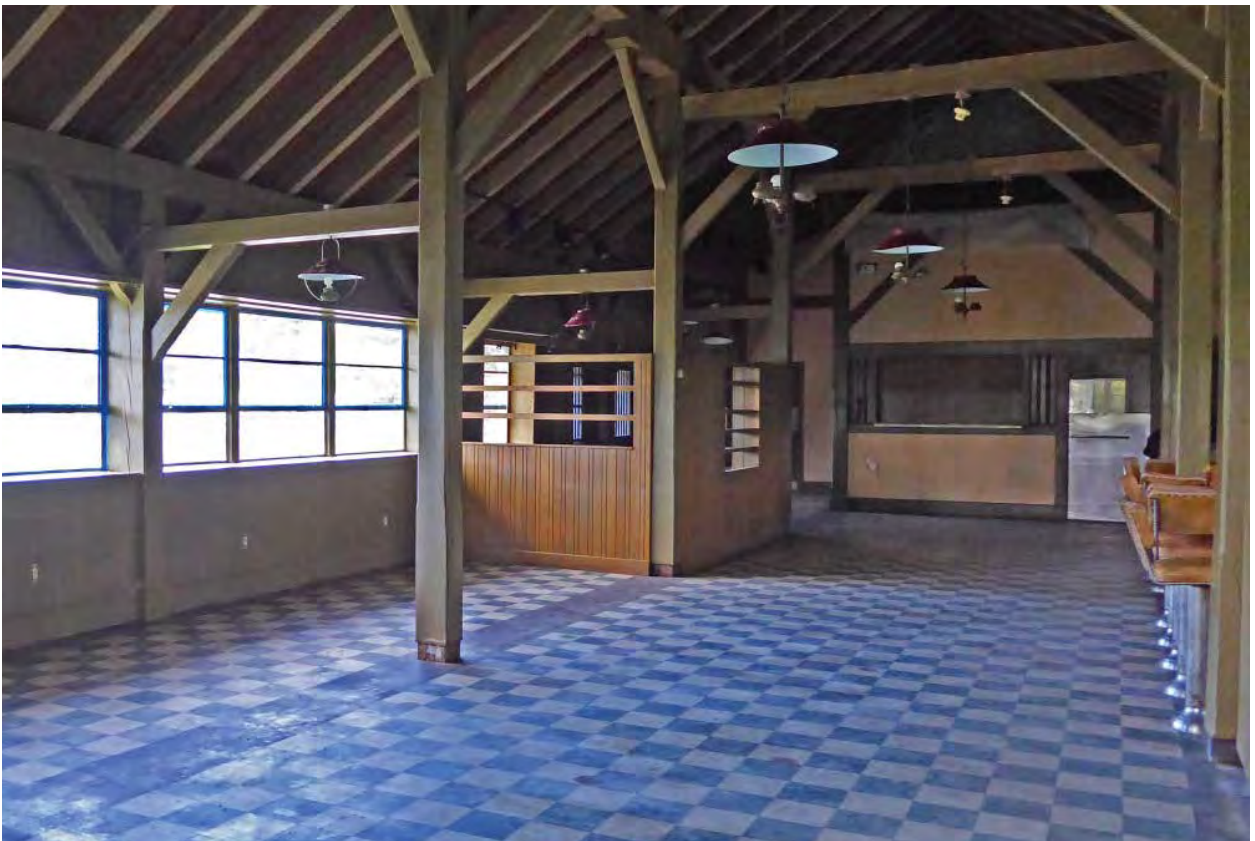
Figure B14. The view above in 2018. The reduction of the counter is evident at right. Modern casework has replaced the original gift shop design. The far west wall and its openings remain unchanged. (JKOA)

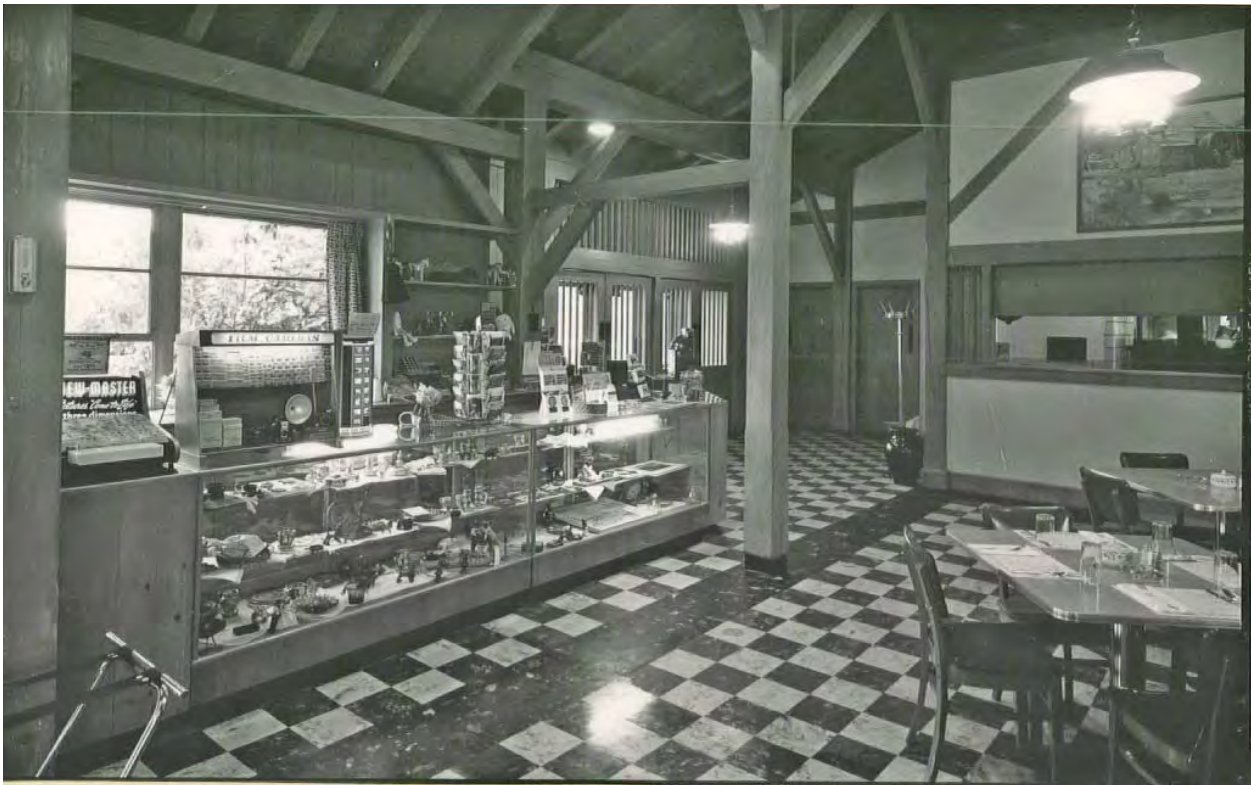
Figure B15. Gift Shop area photographed in 1952. Note low glass showcases with wood cabinets on the outside corners. The gift shop appears to wrap around the corner and into the entryway as outlined in the original drawings, included in *Appendix A*. (BLRI Coll.)

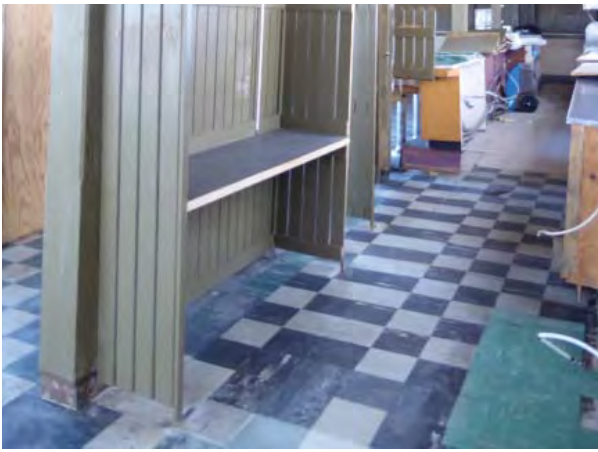
Figure B17. Asphalt tile patch where original section of counter was removed (JKOA, 2018)

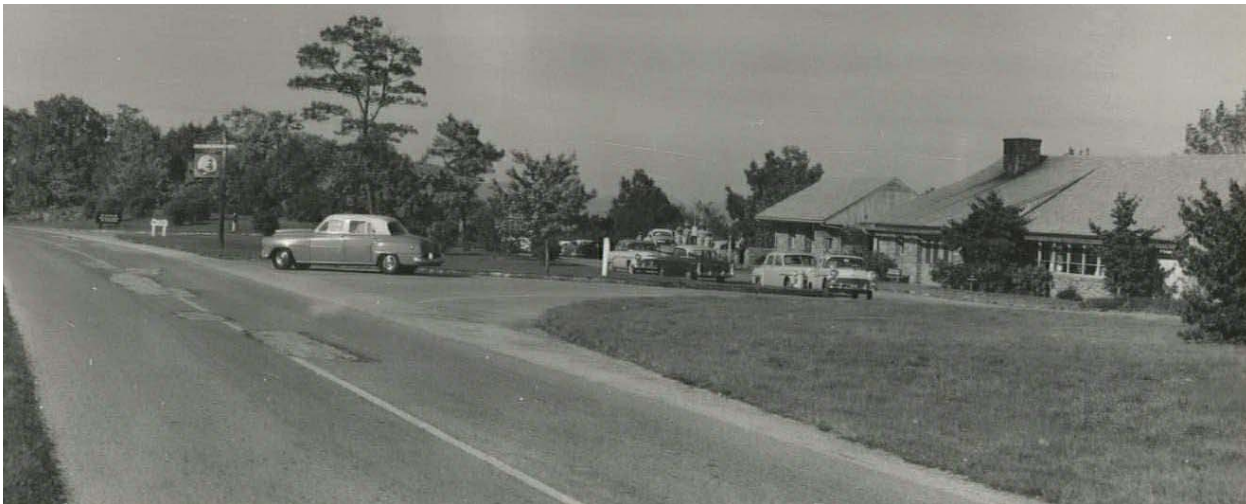
Figure B21. View of coffee shop from the parkway looking northeast. (BLRI Coll.)

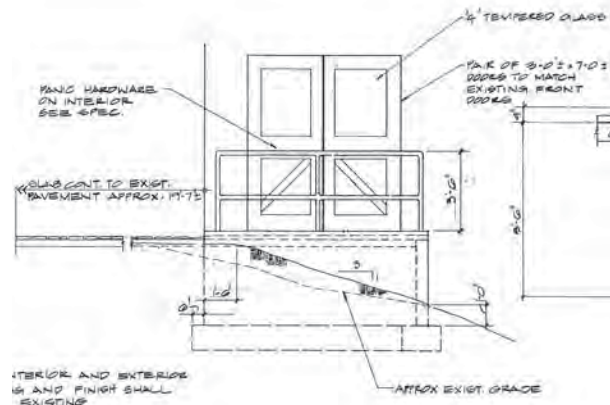
Figure B24. Drawing showing design added east doorway. Note single light-over-single panel design matching that of original doors. No photographic record of these doors has been found; however, the doors currently in place are replacements, as determined by visual inspection of the frame. (BLRI Coll., Drawing No. 106-80002, ETIC)

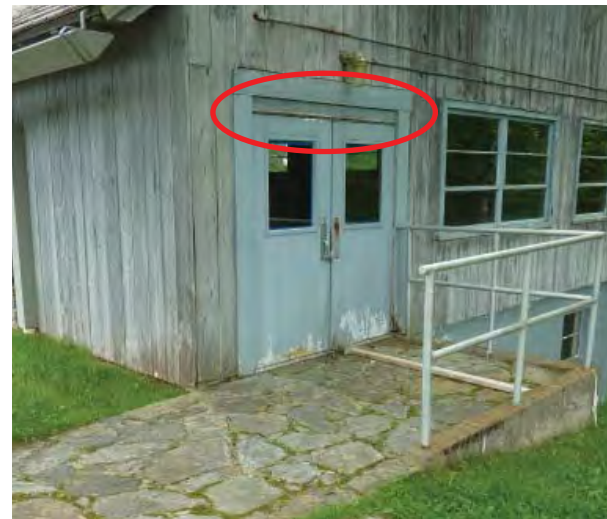
Figure B25. Current flagstone-paved ramp, railing, and replacement steel doors. Blocking at the top of the doorway suggests the height of the original doors. (JKOA, 2018)

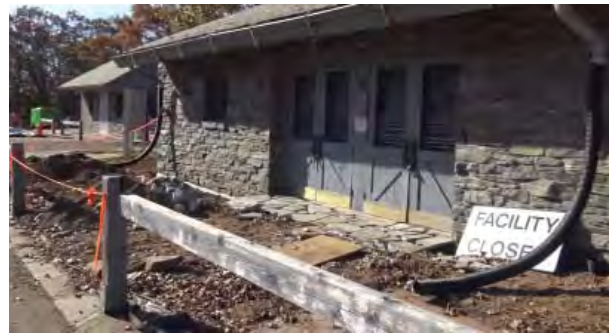
Figure B29. Drainage work in progress in November 2016. Note excavated foundation wall left of the doors. (<https://goo.gl/images/UbnngBb>)

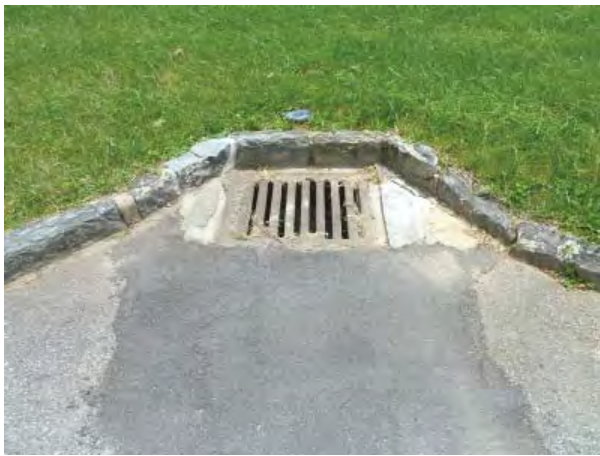
Figure C5. Storm water collection basin, note asphalt patch from recent drainage repair.

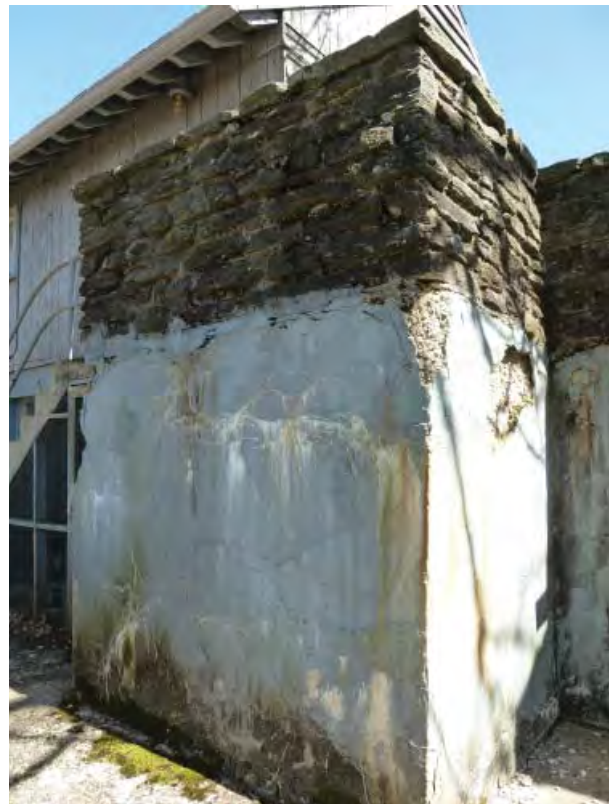
Figure C8. Concrete retaining wall and stone railing. Note heavy deterioration of concrete due to moisture.

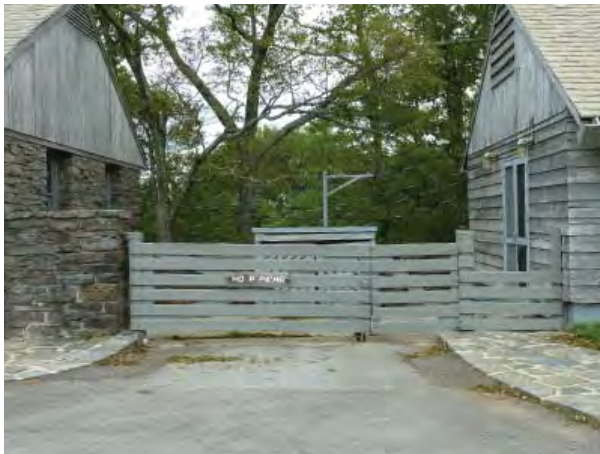
Figure C6. Service area viewed from the south. Coffee shop at right, service station at left.

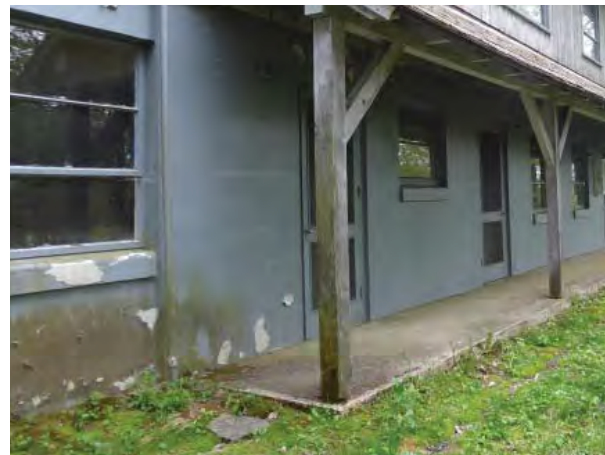
Figure C16. Typical concrete foundation walls.

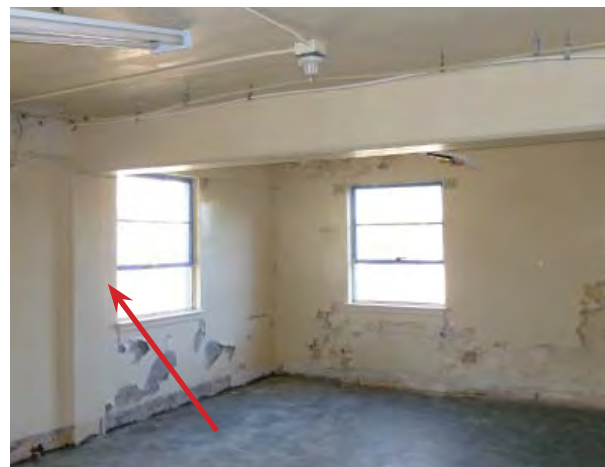
Figure C17. Engaged concrete column (left) and concrete beam in Room 001.

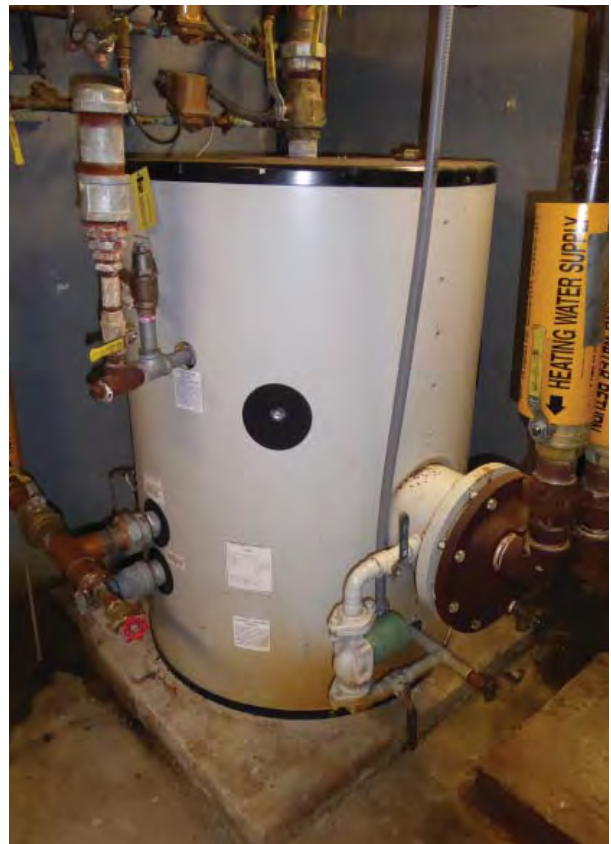
Figure C46. Indirect hot water heater connected to boiler in Room 006.

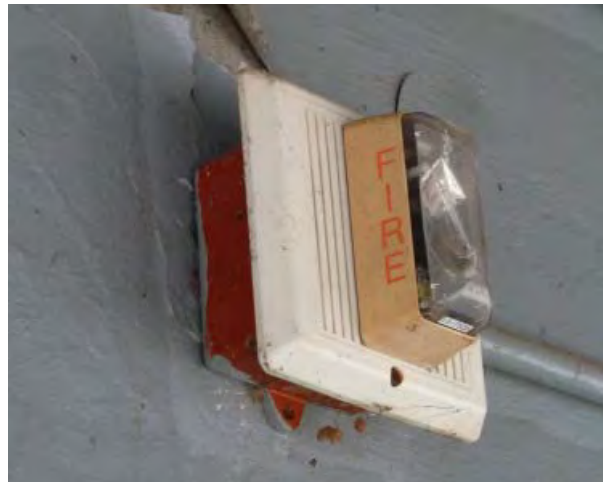
Figure C48. Fire alarm beacon, in this case on the north elevation beneath the porch.

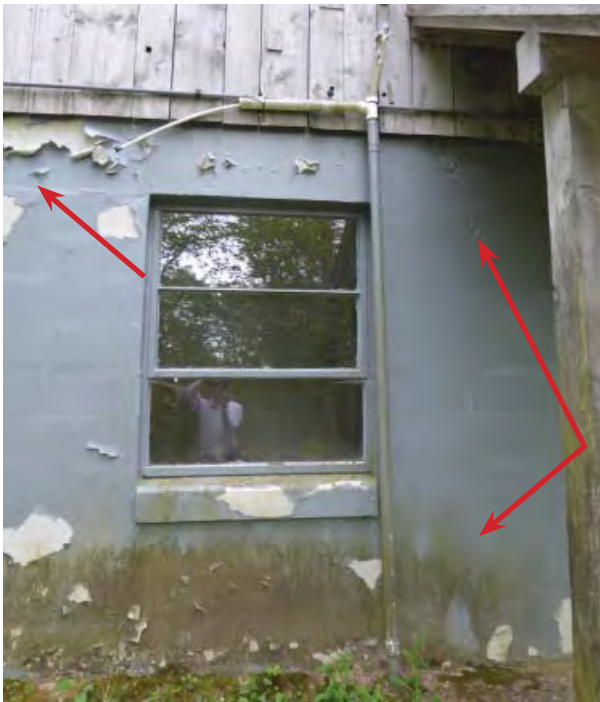
Figure C55. Foundation wall on north elevation. Note seam for concrete header and floor slab (left), and seam for concrete column (right).

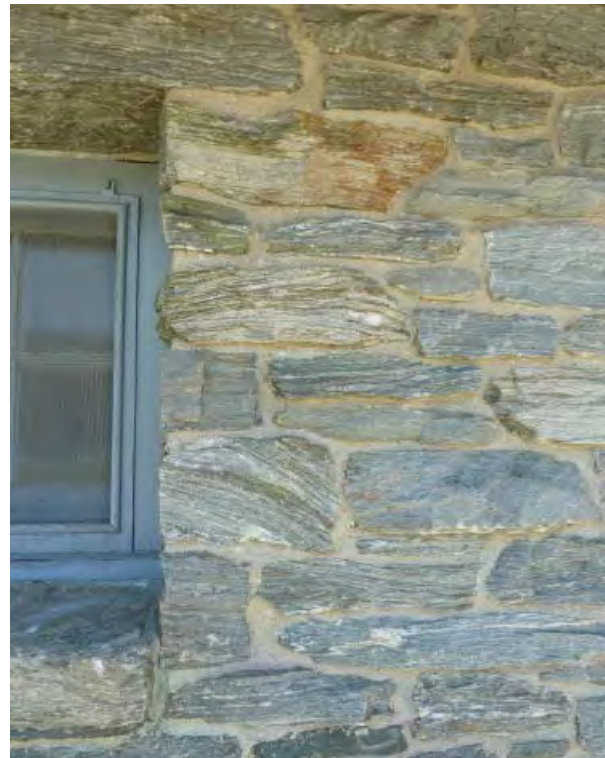
Figure C56. Coloration and pattern of stone exterior walls.

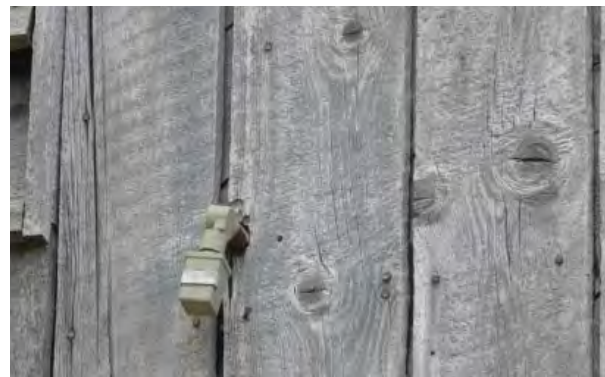
Figure C58. Typical shrinkage cracks, note diagonal sheathing visible between boards.

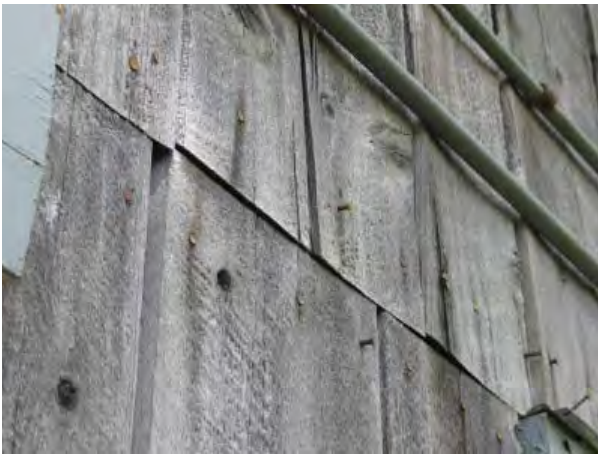
Figure C59. Detail of siding at top of window and door openings on east elevation. Note popped nails.

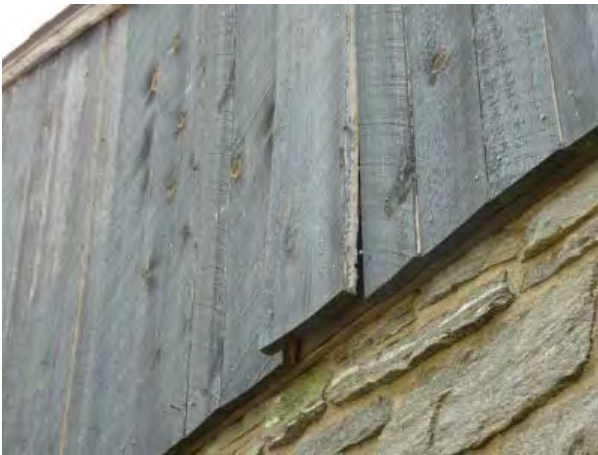
Figure C60. Recently-replaced siding on west gable end of main body. Note warped board; also note popped nails.

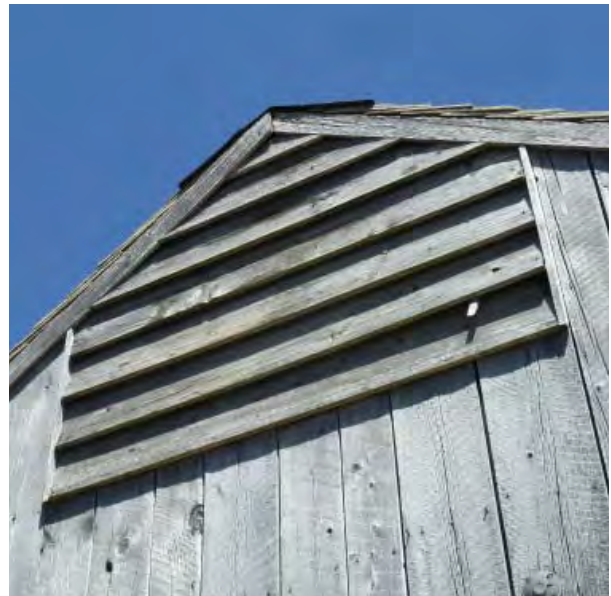
Figure C63. Louvered vent on west gable end of wing.

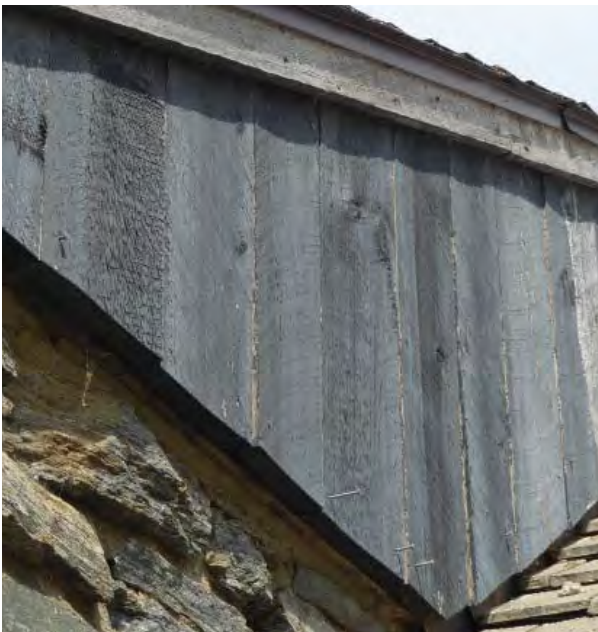
Figure C61. Recently-replaced siding on east wall of projecting south bay. Note popped nails.

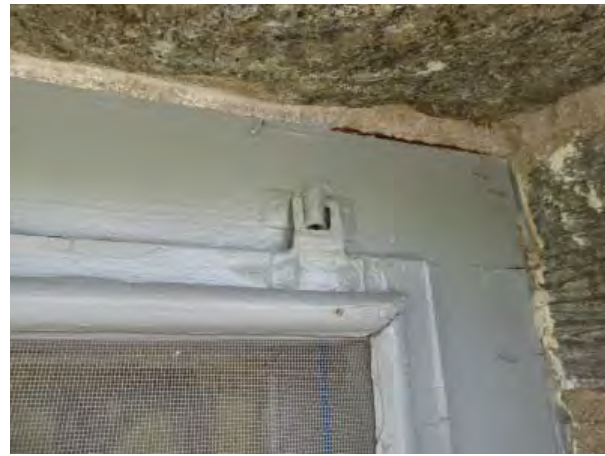
Figure C75. Typical screen and casing detail. Note rusted lintel at top right.

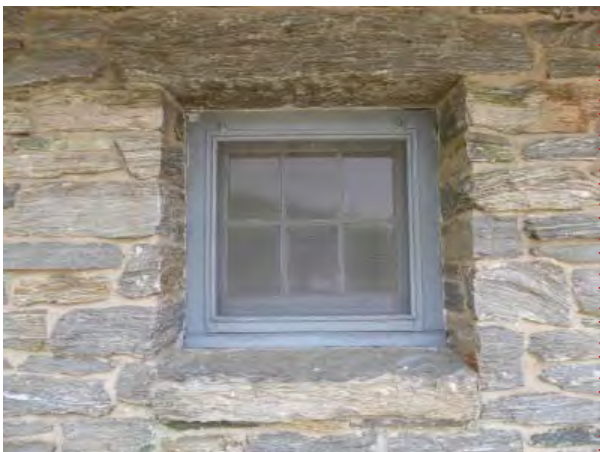
Figure C74. Typical six-light hopper-sash window.

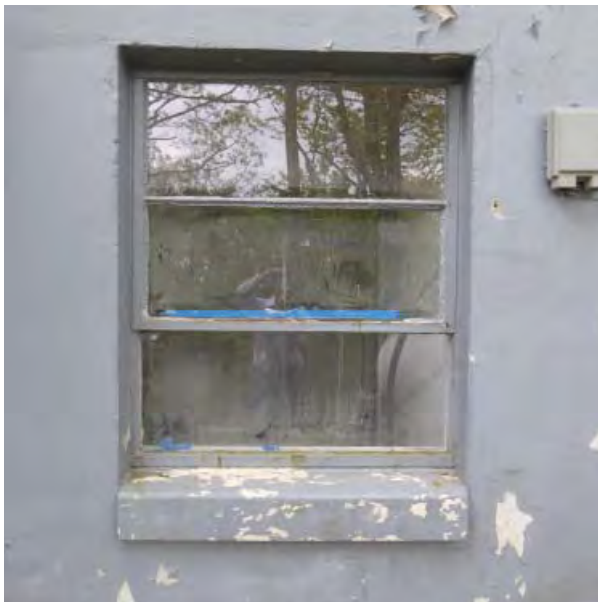
Figure C77. Typical two-over-one light awning-sash basement window.

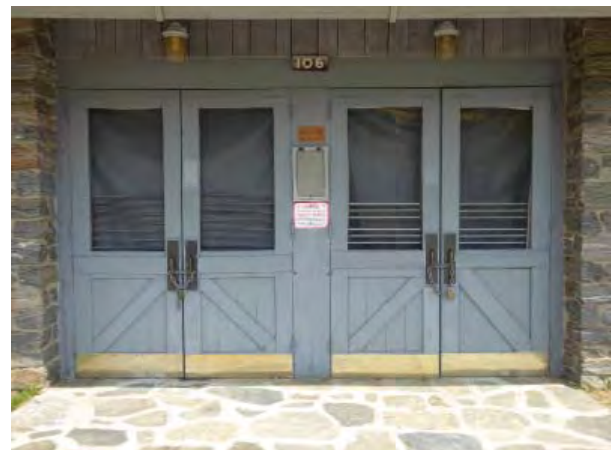
Figure C79. Overview of main entrance doorways. Note inconsistent size of lower panel at far right.

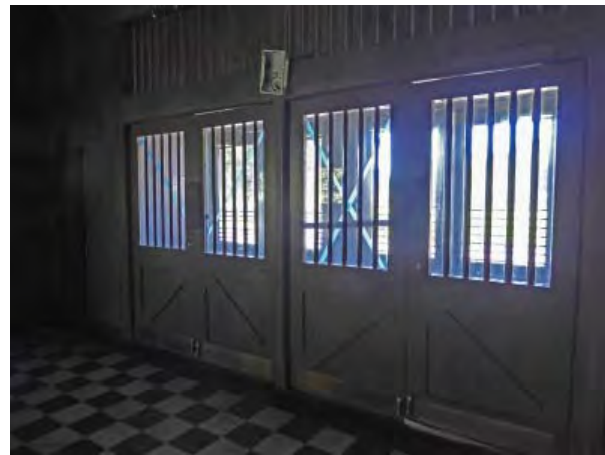
Figure C83. Inner set of paired doors, viewed from interior.

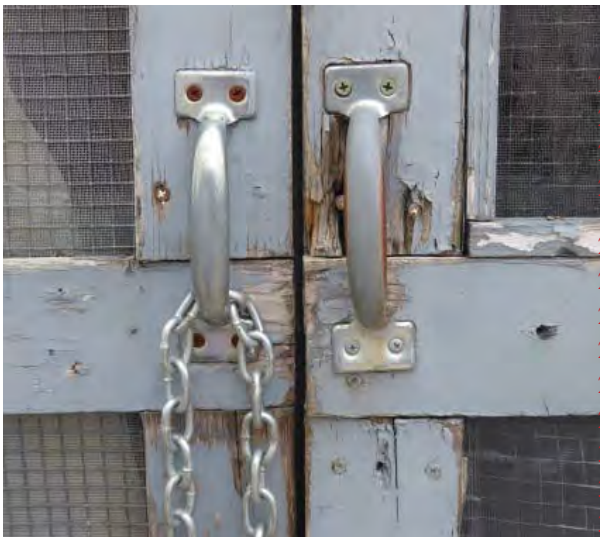
Figure C88. Exterior pull handles on screen doors. Note overall deterioration of doors and inferior construction.

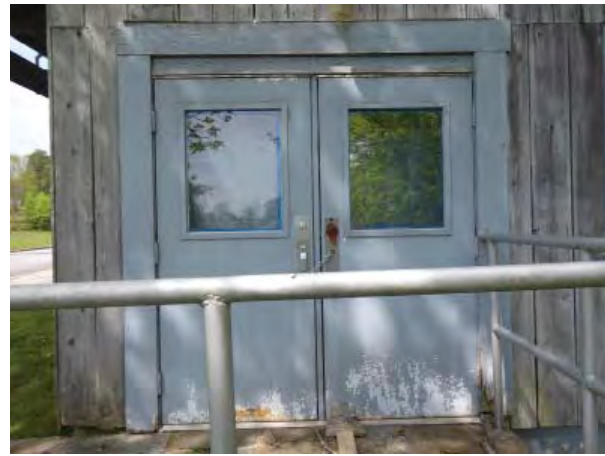
Figure C89. Replacement steel doors in added doorway on east elevation.

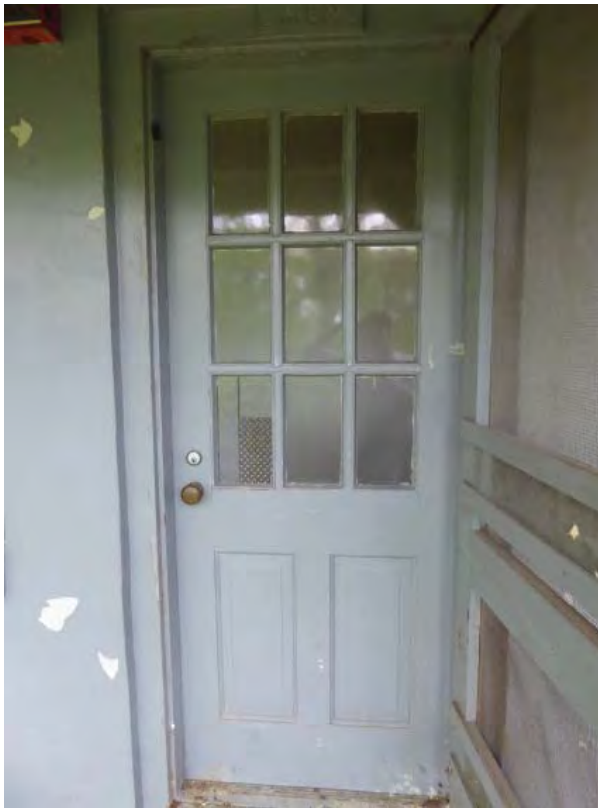
Figure C90. Typical exterior door at basement level.

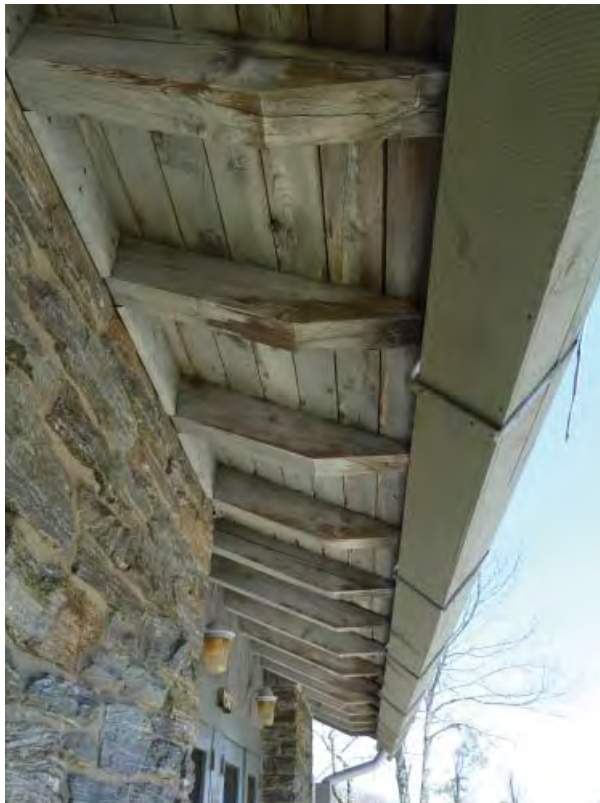
Figure C102. Exposed rafter tails and decking on south elevation.

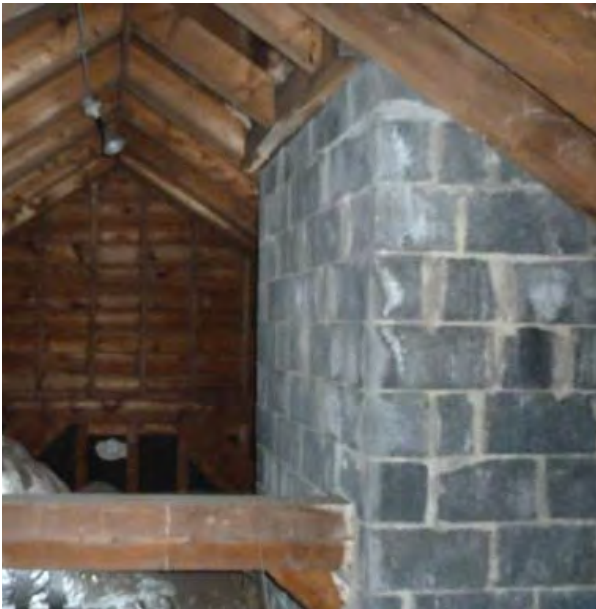
Figure C105. View of chimney in the attic. Note water damage left of the chimney, and signs of moisture on CMU.

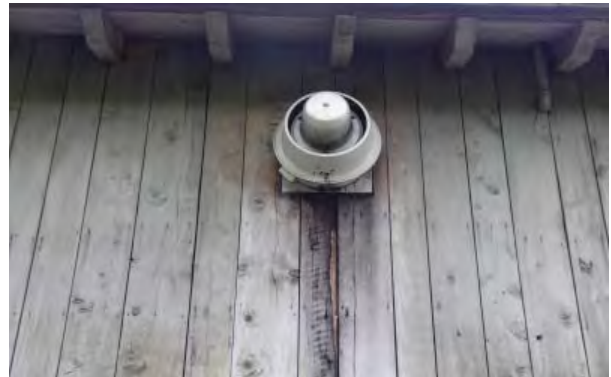
Figure C108. Wall vent on north elevation. Note discoloration of siding beneath.

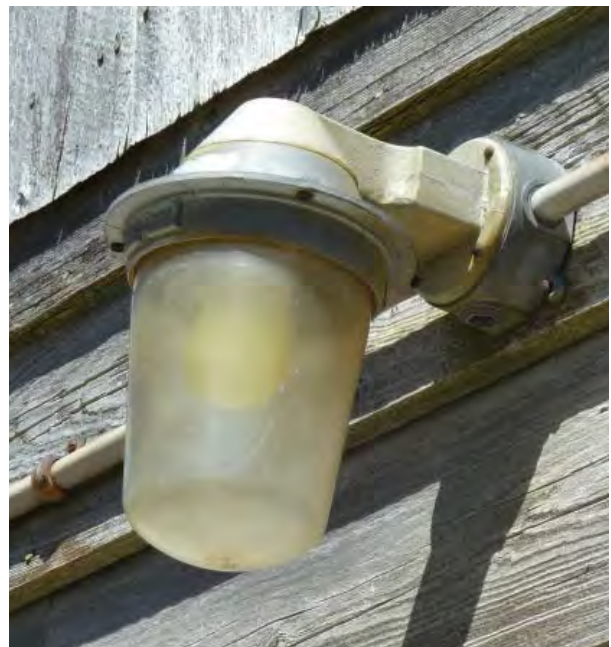
Figure C117. Typical wall-mounted replacement light fixture.

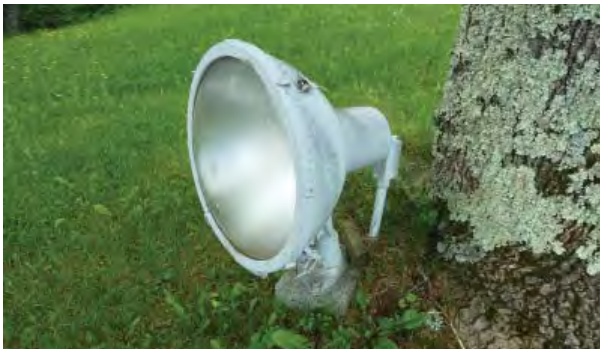
Figure C118. Exterior floodlight.

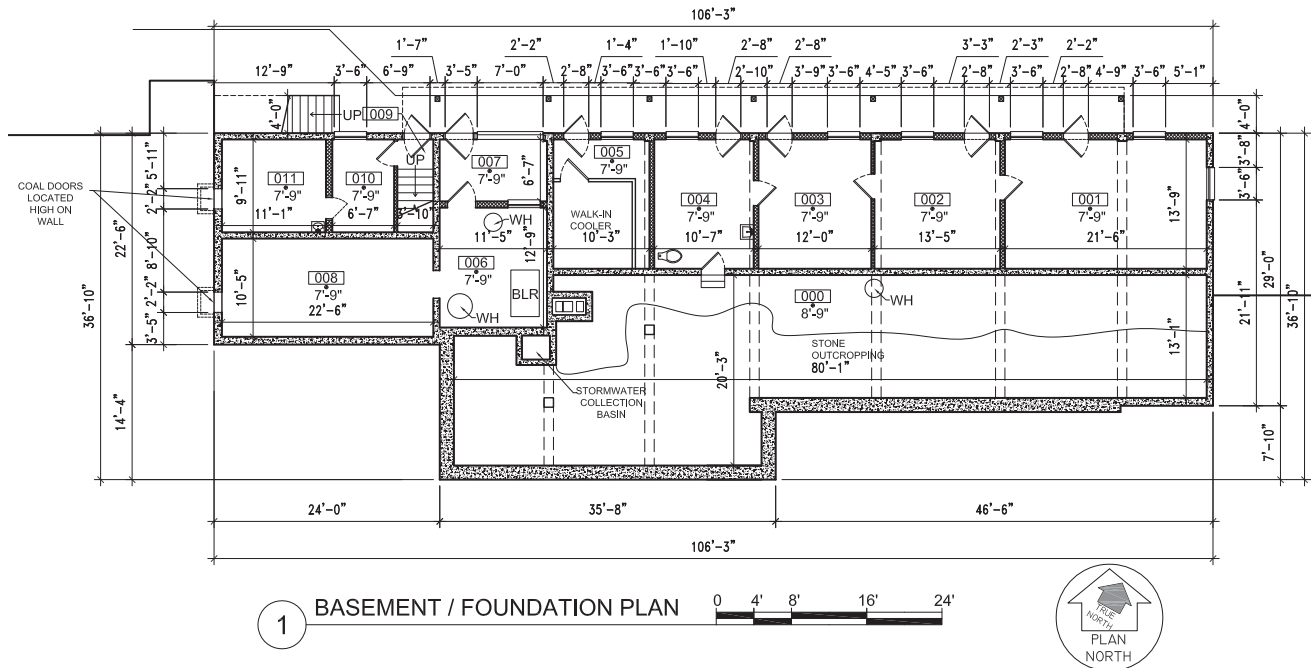
Figure C128. Basement level plan. A larger version of this plan can be found in *Appendix B*.

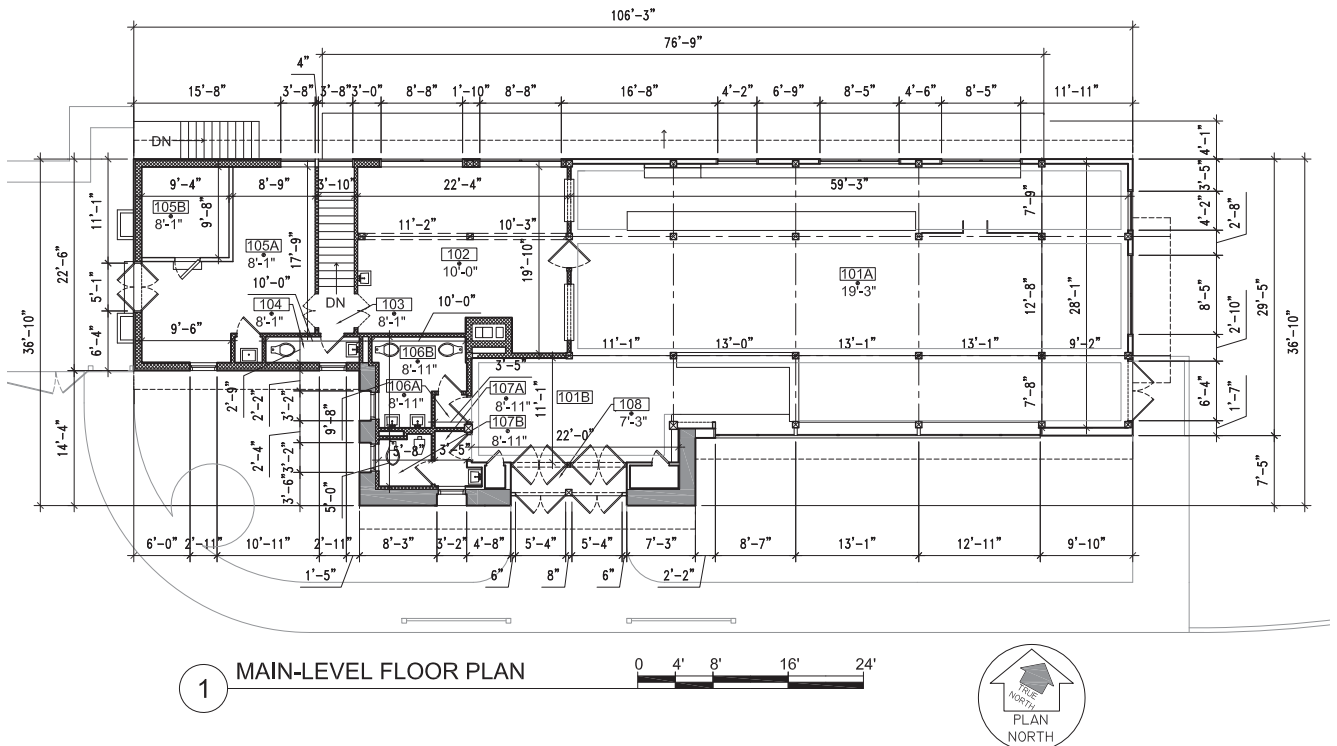
Figure C129. Main-floor plan. A larger version of this plan can be found in *Appendix B*.
