North Carolina Department of Natural and Cultural Resources
State Historic Preservation Office

Ramona M. Bartos, Administrator

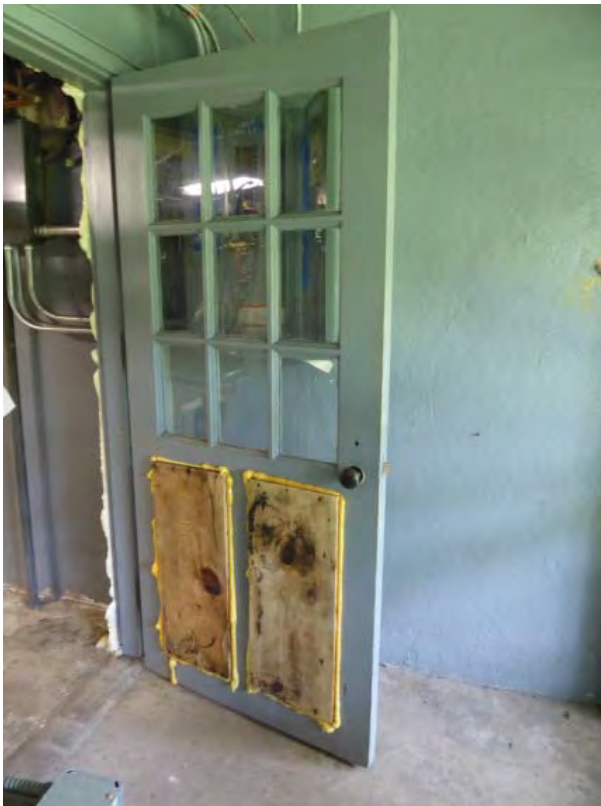
Figure C155. Nine-light sash door on north wall of Room 006.

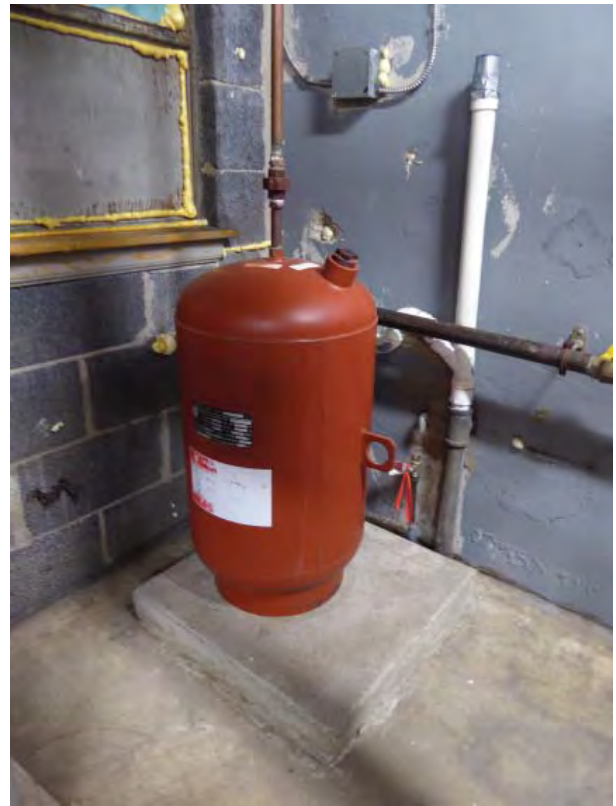
Figure C159. Pressurized tank in northeast corner.

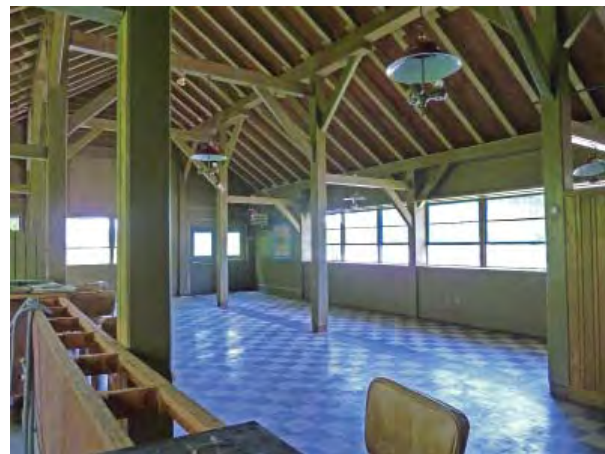
Figure C180. Room 101A - Oblique view looking southeast.

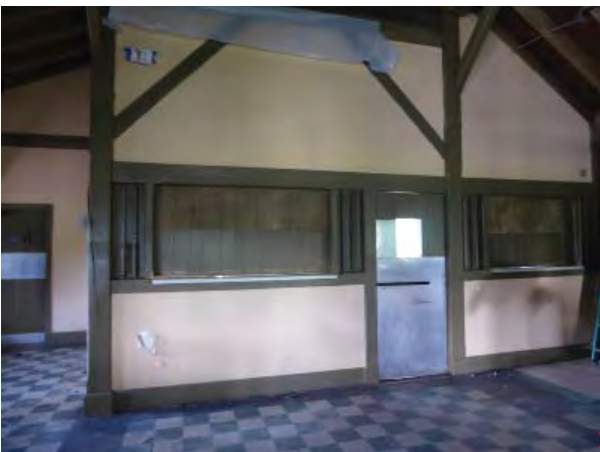
Figure C186. Plaster finish on west wall.

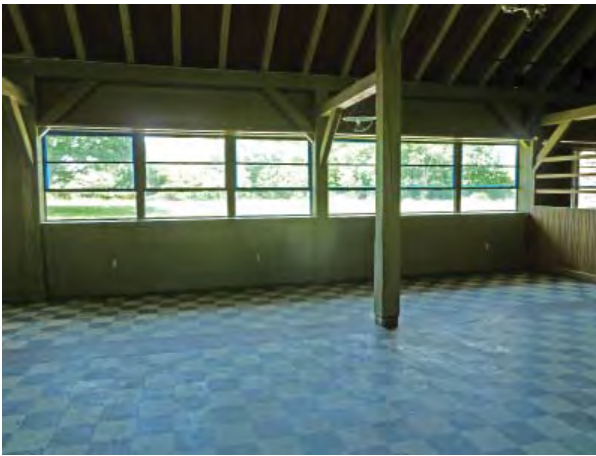
Figure C190. South ribbon windows viewed from interior.

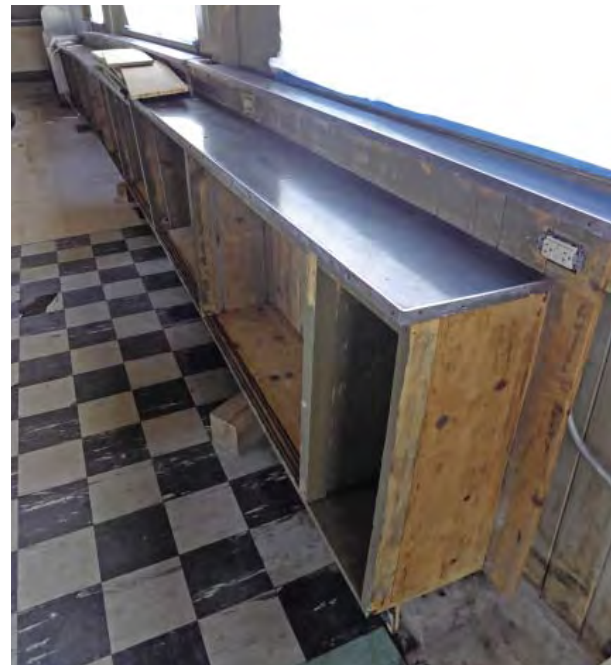
Figure C192. Rear counter. Note replacement tile.

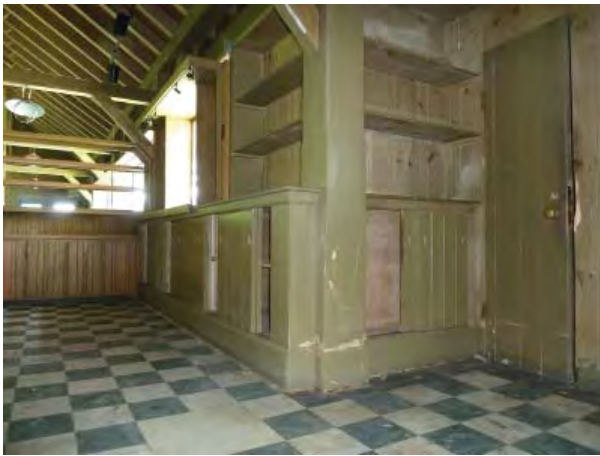
Figure C193. Original casework on south wall in gift shop area.

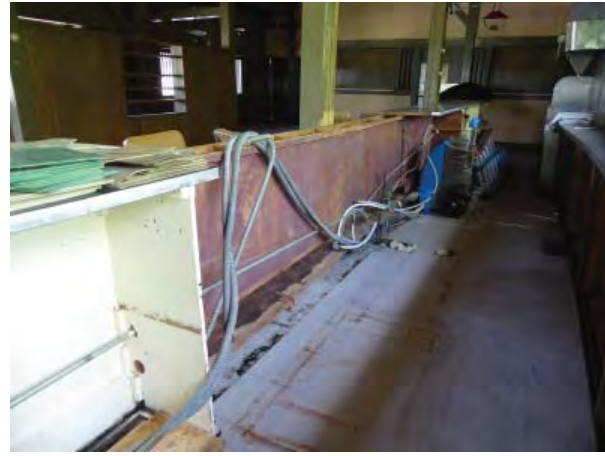
Figure C195. Back of serving counter showing general condition. Note replacement tile.

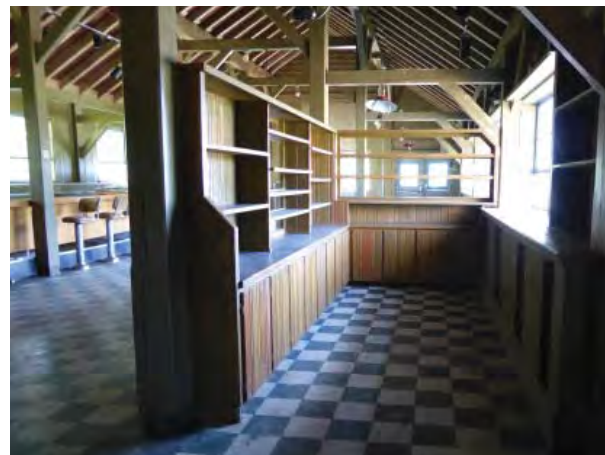
Figure C196. Modern cabinets forming gift shop area.

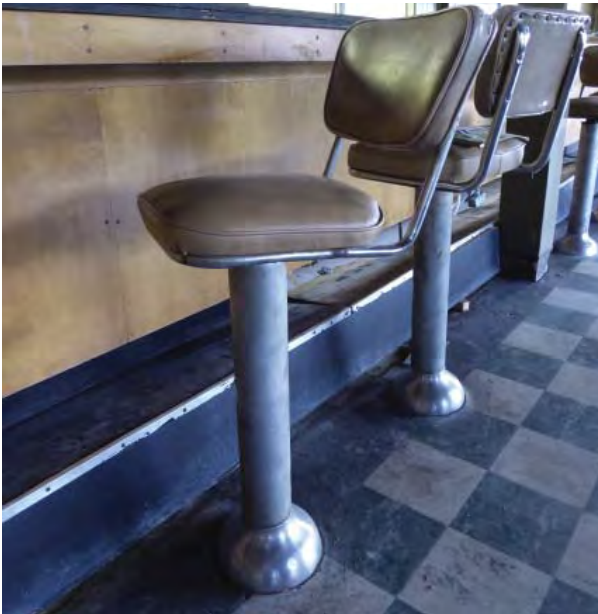
Figure C197. Typical original bar stool.

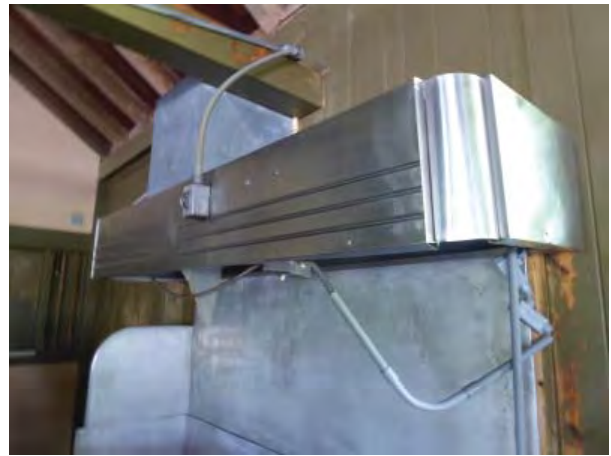
Figure C198. Original stainless steel hood on north wall.

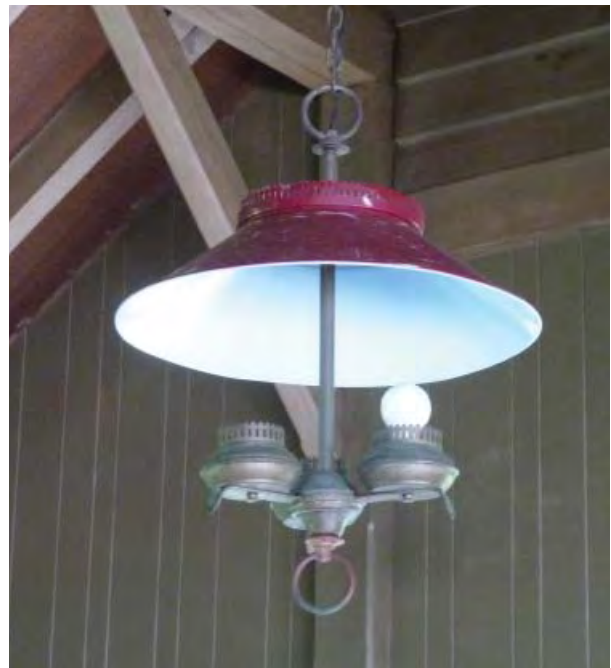
Figure C199. Typical original three-lamp fixture.

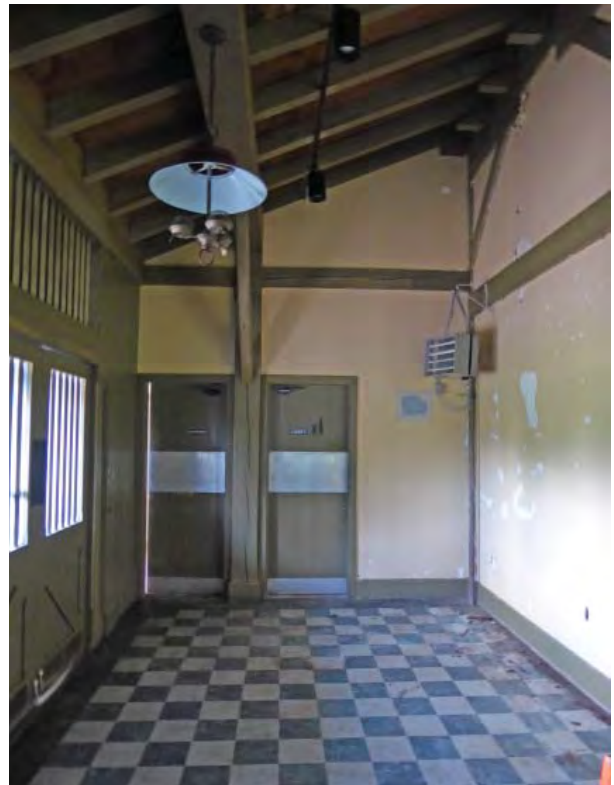
Figure C205. Room 101B - View looking west.

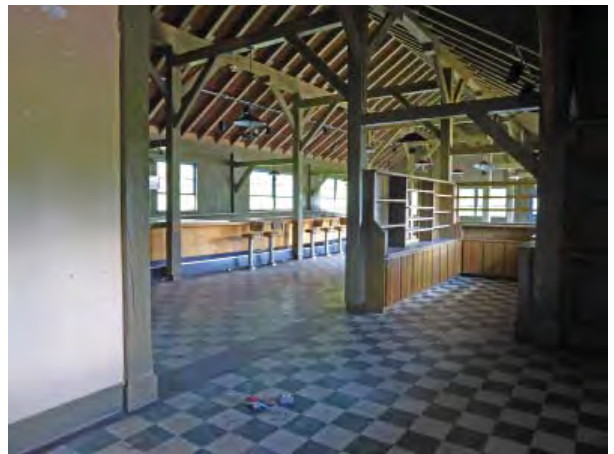
Figure C206. Room 101B - Oblique view looking northeast.

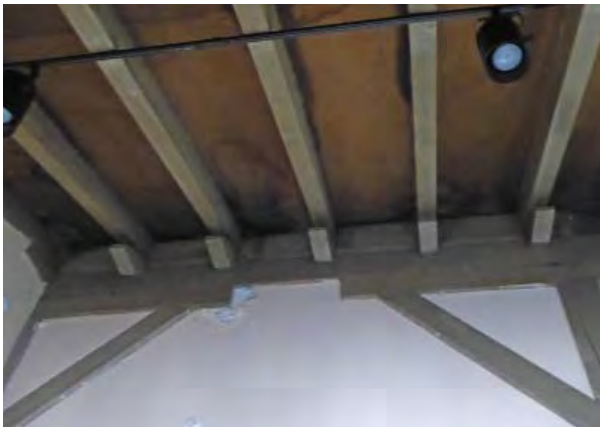
Figure C207. Water damage along north wall in Room 101B.

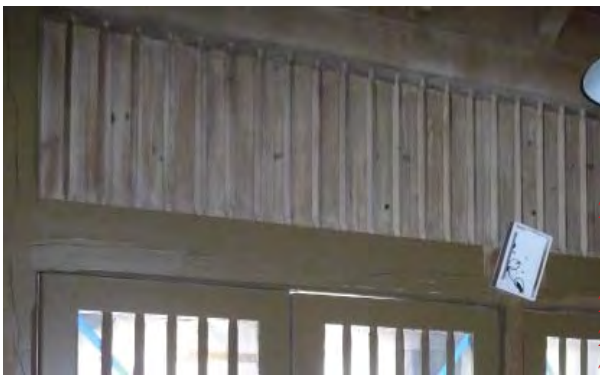
Figure C208. Spindle detail above south doorways.

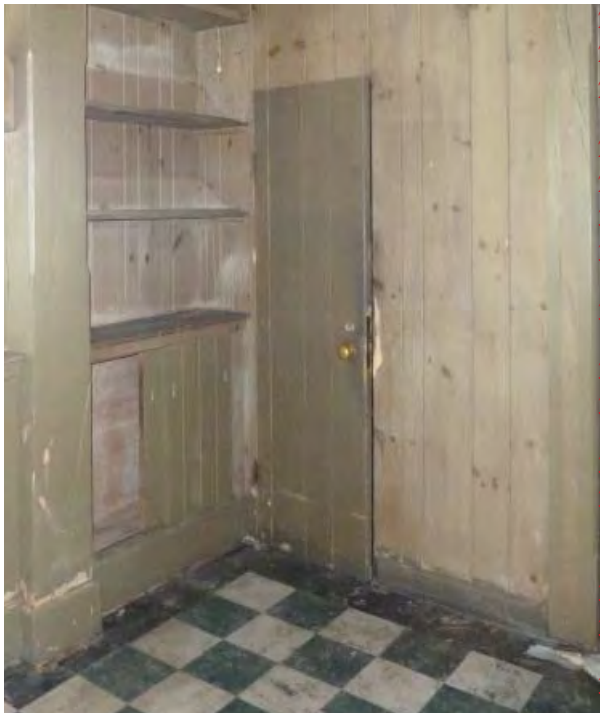
Figure C209. Concealed closet door in southeast corner. Note damage to right jamb.

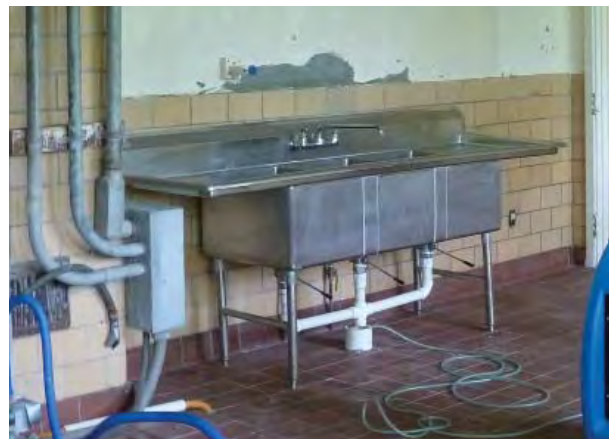
Figure C218. Stainless steel sink on south wall.

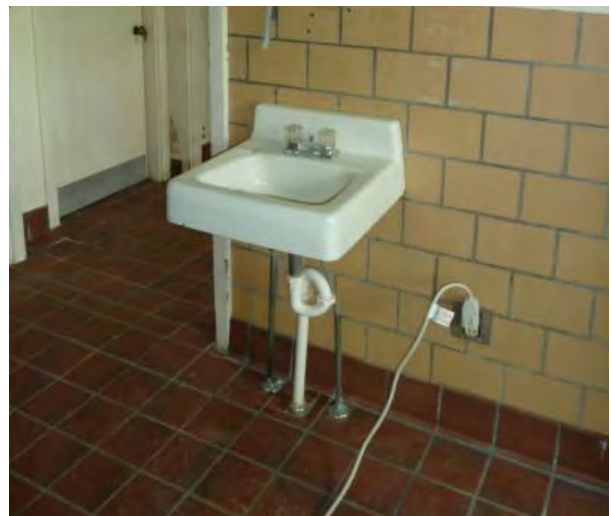
Figure C219. Lavatory on west wall.

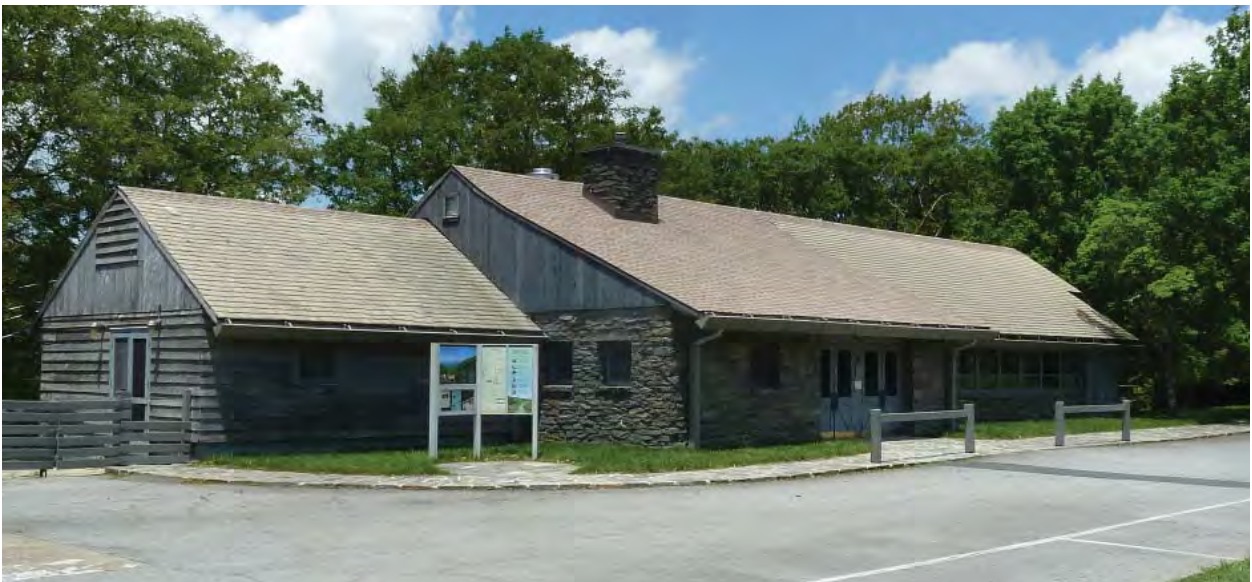
Figure II.1. Bluffs Coffee Shop as viewed from the median of the loop road, looking northeast. (JKOA, 2018)

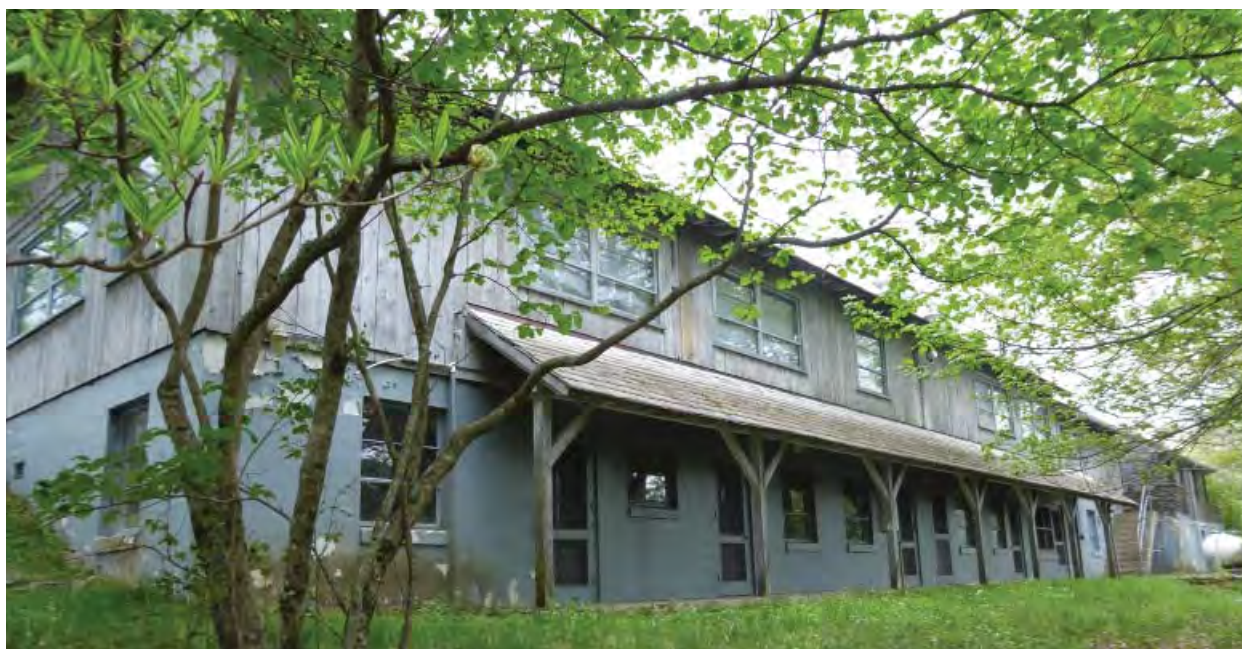
Figure 11-3. Rear of coffee shop looking southwest. (JKOA 2018)

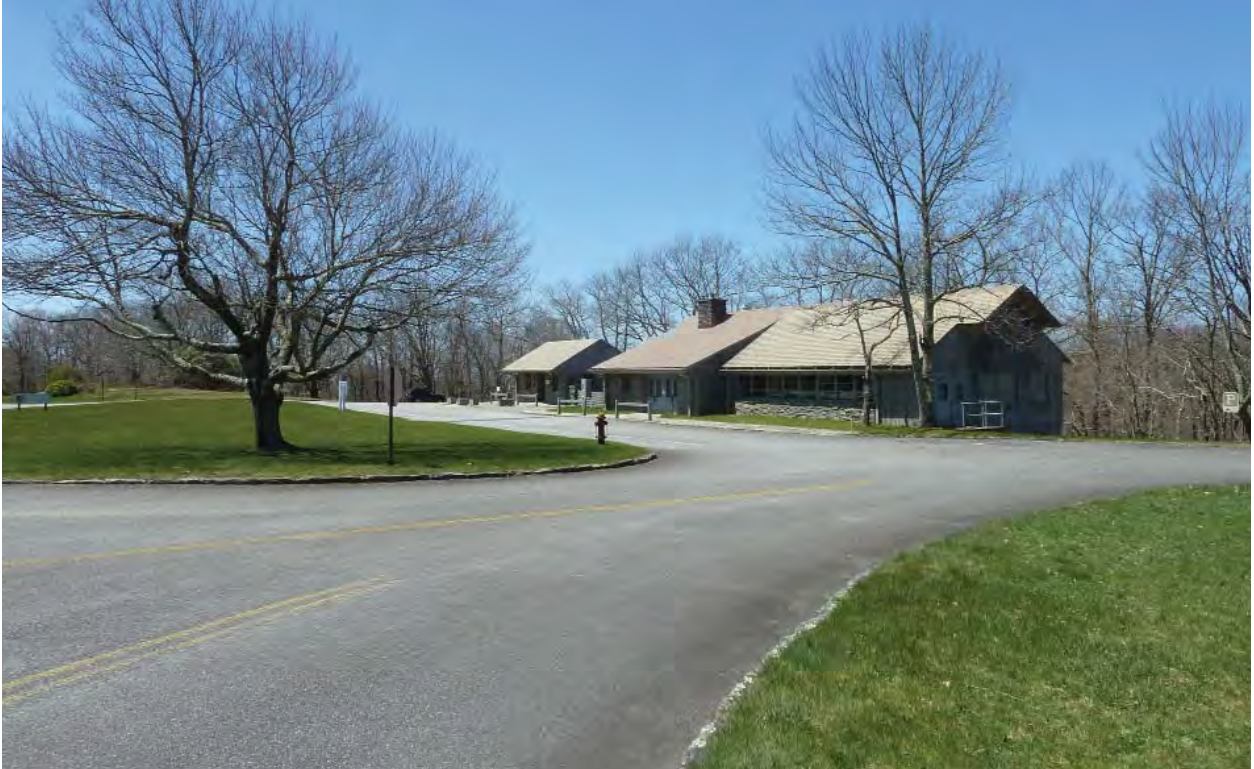
Figure II-6. Bluffs Coffee Shop and service station viewed from the edge of the Parkway, looking northwest. All photos in this section were taken by JKOA in 2018.

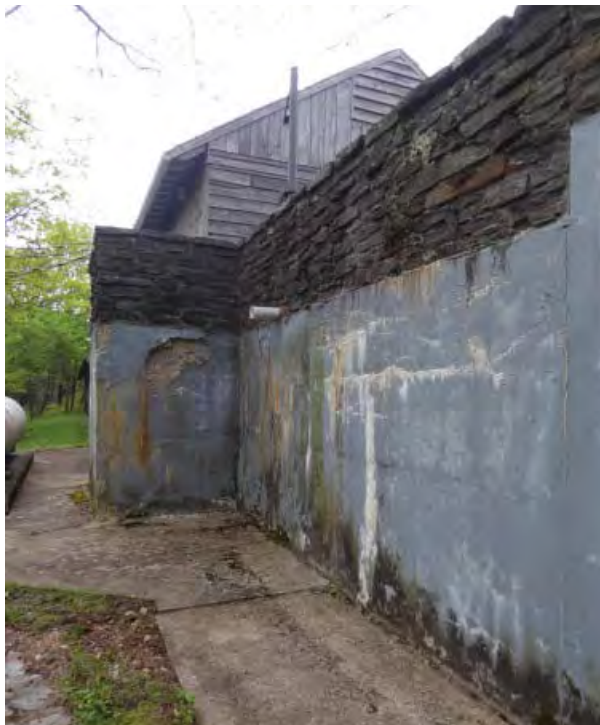
Figure II-7. Concrete retaining wall between coffee shop and service station. Note extensive deterioration.

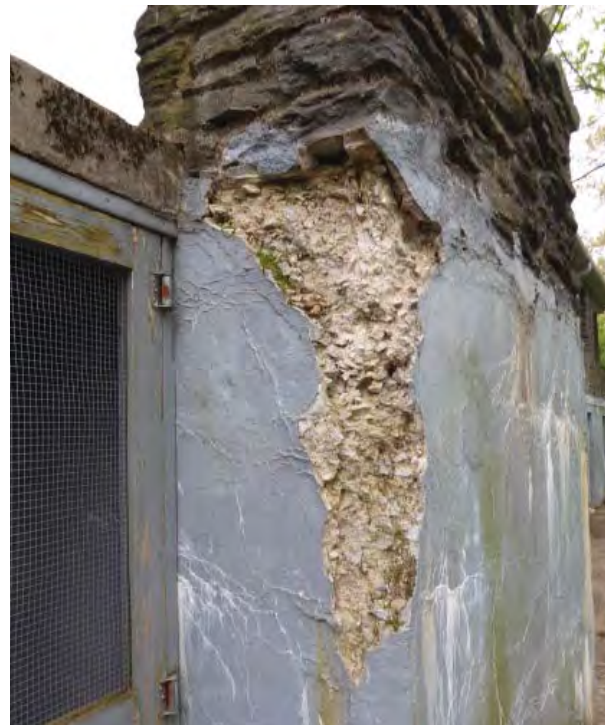
Figure II-8. Example of severe spalling at far east end of retaining wall, adjacent to exterior staircase.

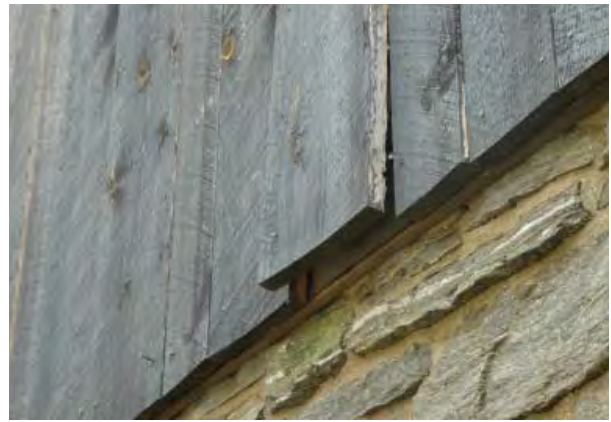
Figure II-9. Example popped fasteners and warped board on west wall of south bay.

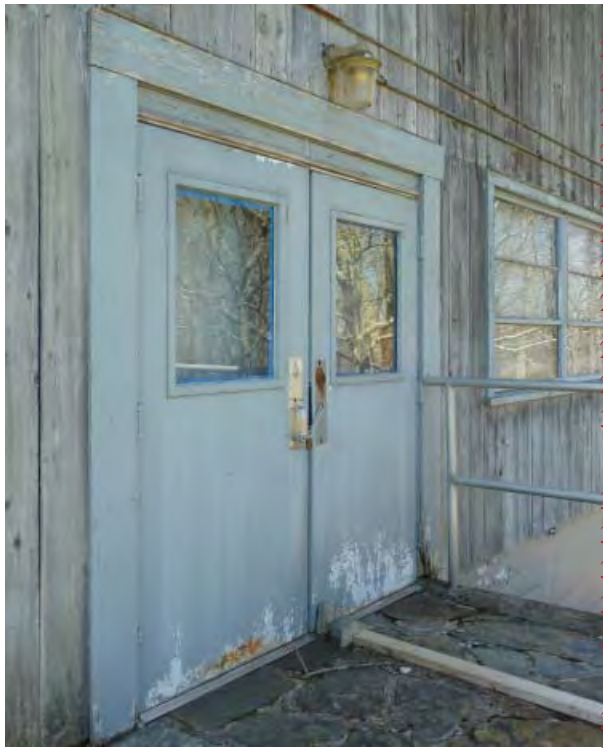
Figure II-10. Deteriorated, poorly-detailed replacement doors in east doorway.

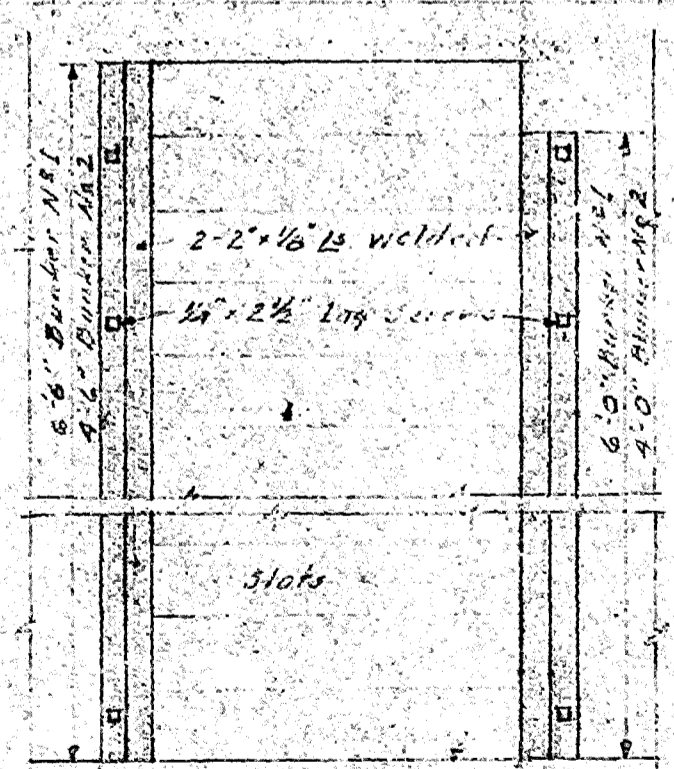
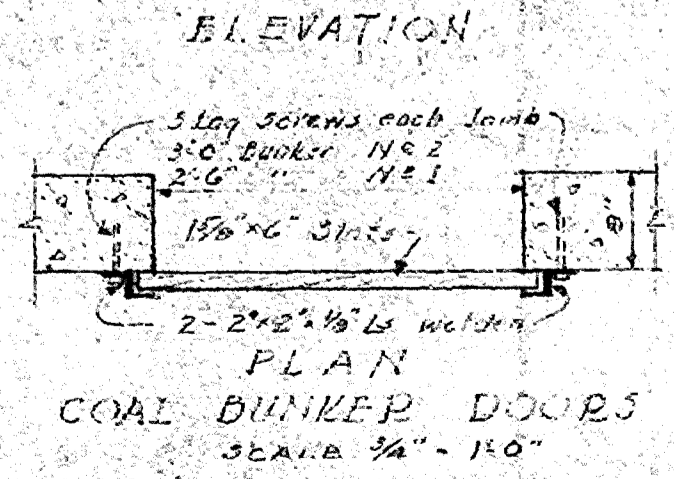
ROOM & SPACE	SUB-FLOOR	FIN FLOOR	BASE	WALLS	CEILING	REMARKS
Living Quarters No 1	Concrete	Asphalt Tile	Asphalt Tile	Cement Plumb	Cement Wash	
" " No 2	"	"	"	"	"	
" " No 3	"	"	"	"	"	
Womens Locker Room	"	Concrete	Concrete	"	"	
Mens "	"	"	"	"	"	
Refuse Room	"	"	"	"	"	
Boiler "	"	"	None	None	None	
Stairs	"	"	Concrete	Cement Plumb	Cement Point	
Compressor Room	"	"	None	None	None	
Coal Bunker No 1	"	"	"	"	"	
" " No 2	"	"	"	"	"	
Storage	"	"	"	"	"	
Porch	"	"	"	Cement Point	Stained

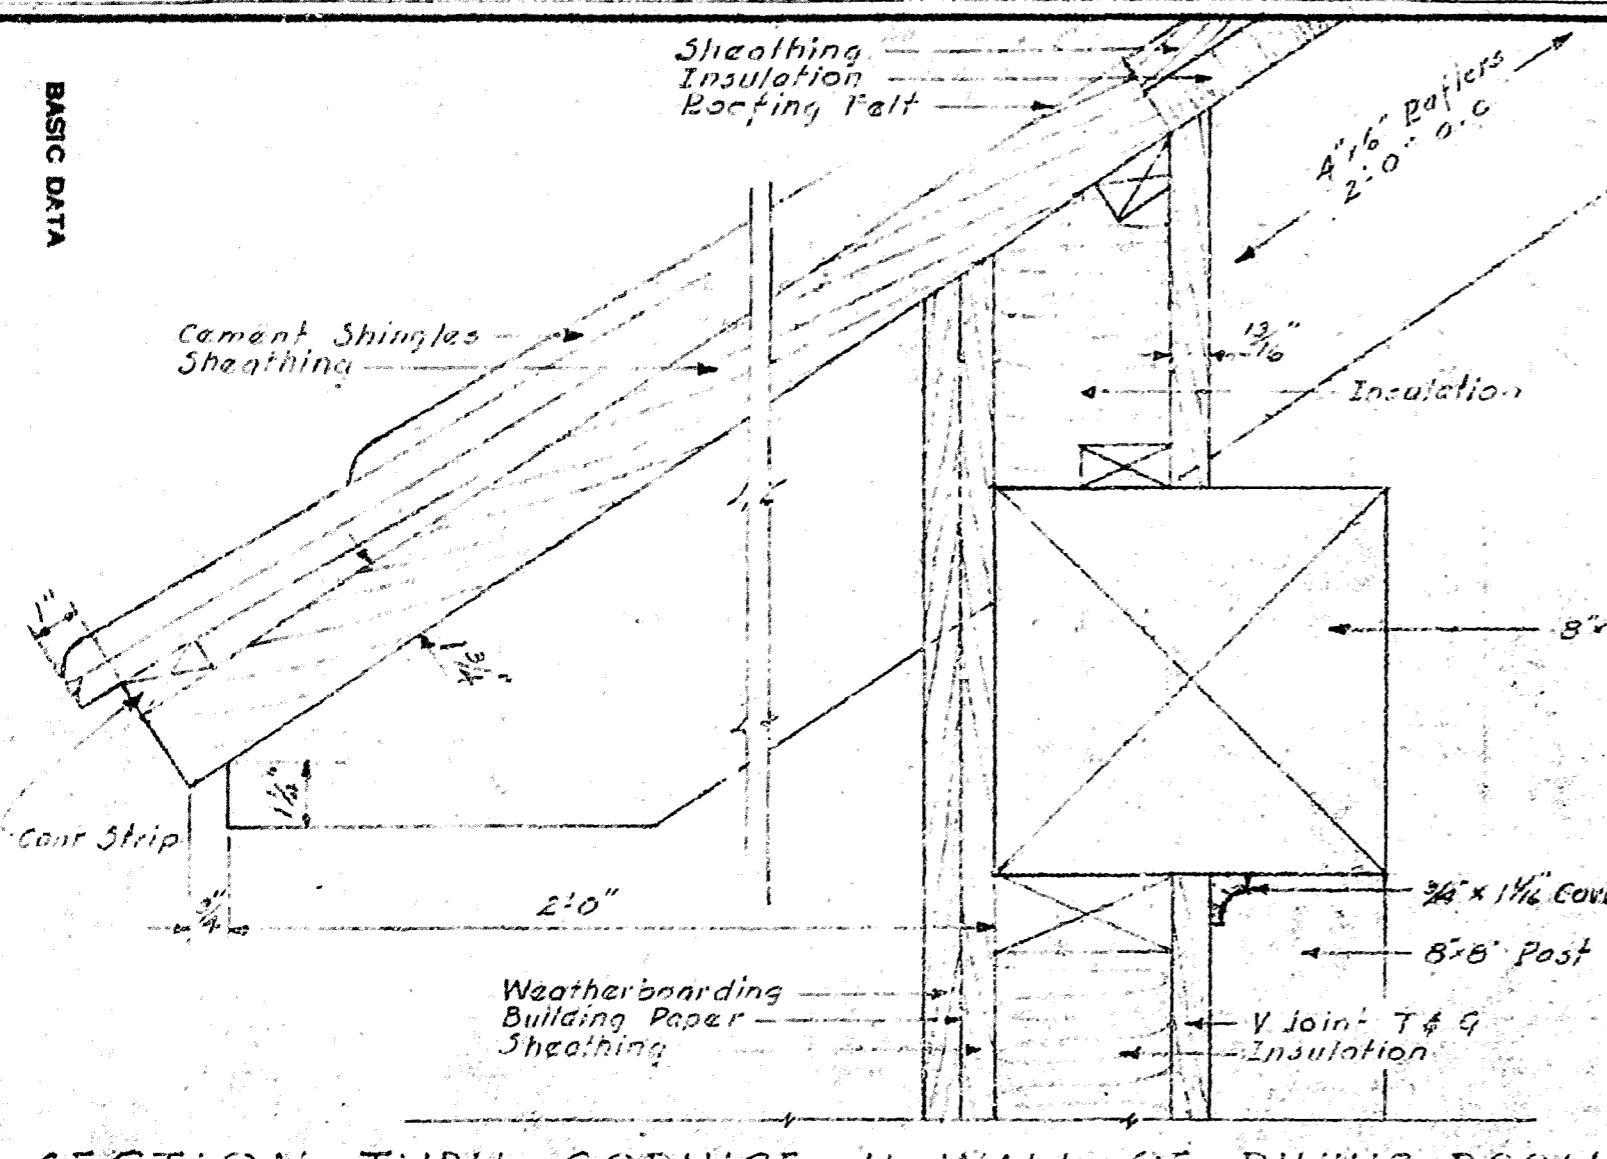
SECTION THRU CORNICE - N. WALL OF DINING ROOM

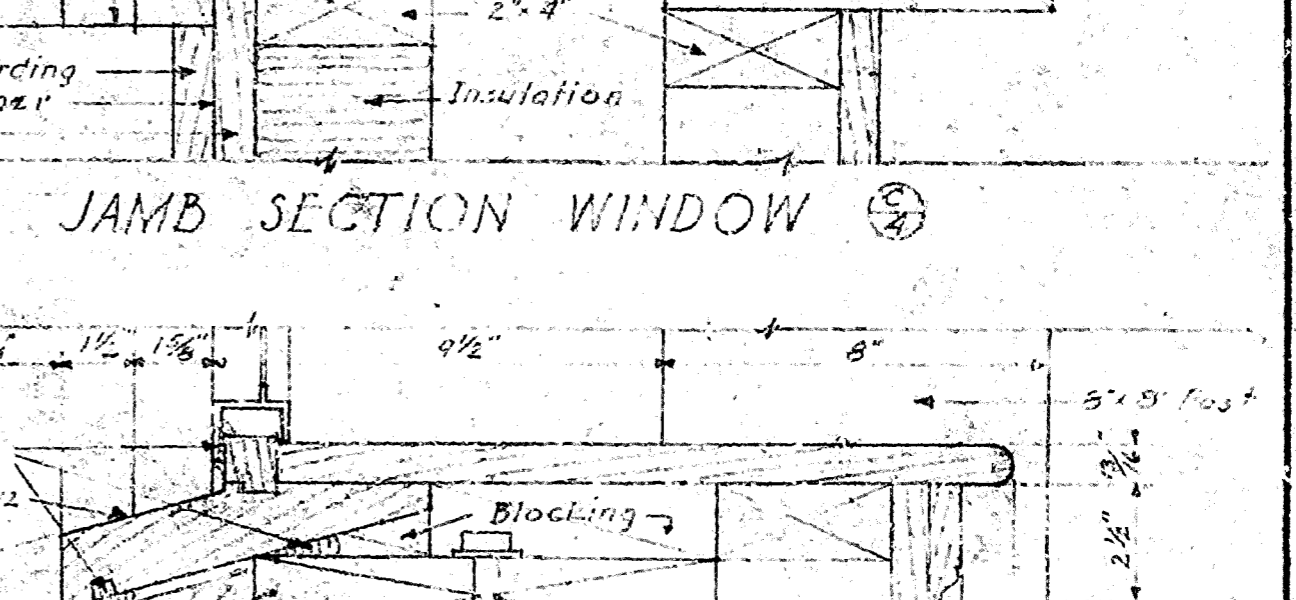
SECTION AT FLOOR WINDOWS
