North Carolina Department of Natural and Cultural Resources
State Historic Preservation Office

Ramona M. Bartos, Administrator

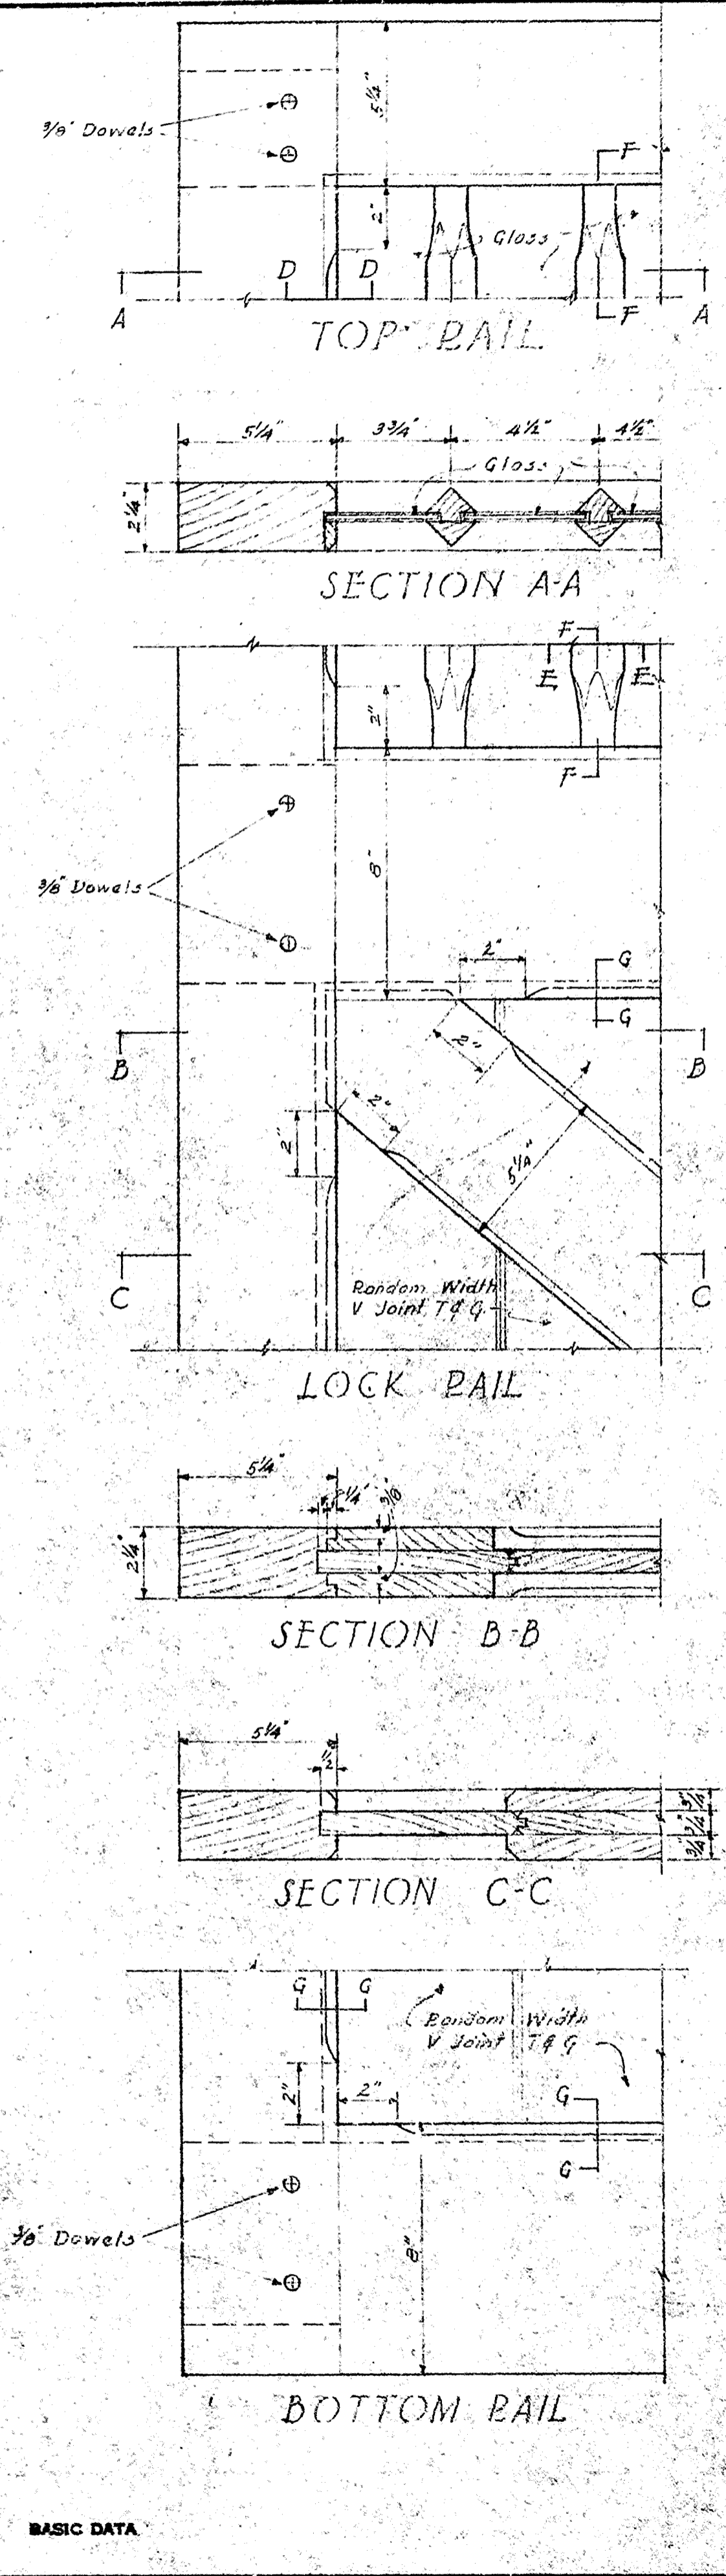
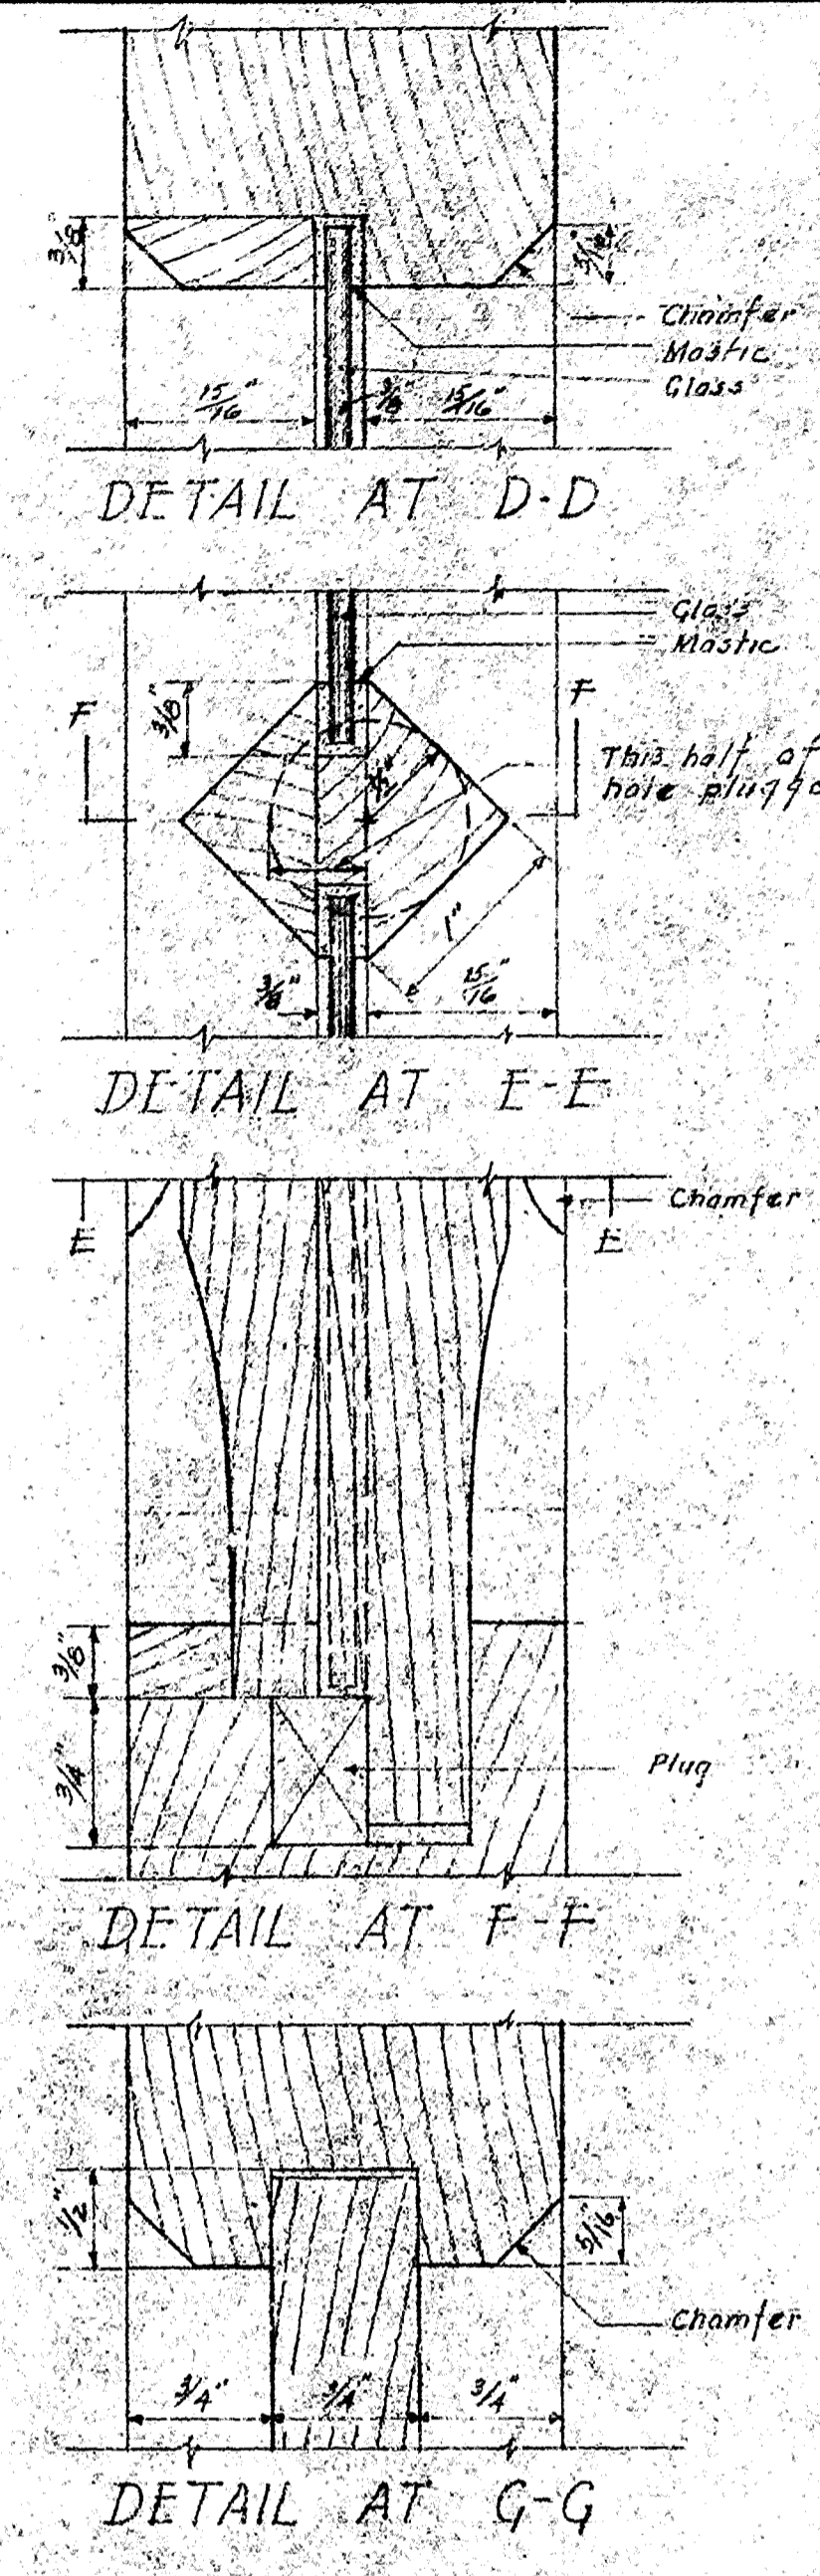
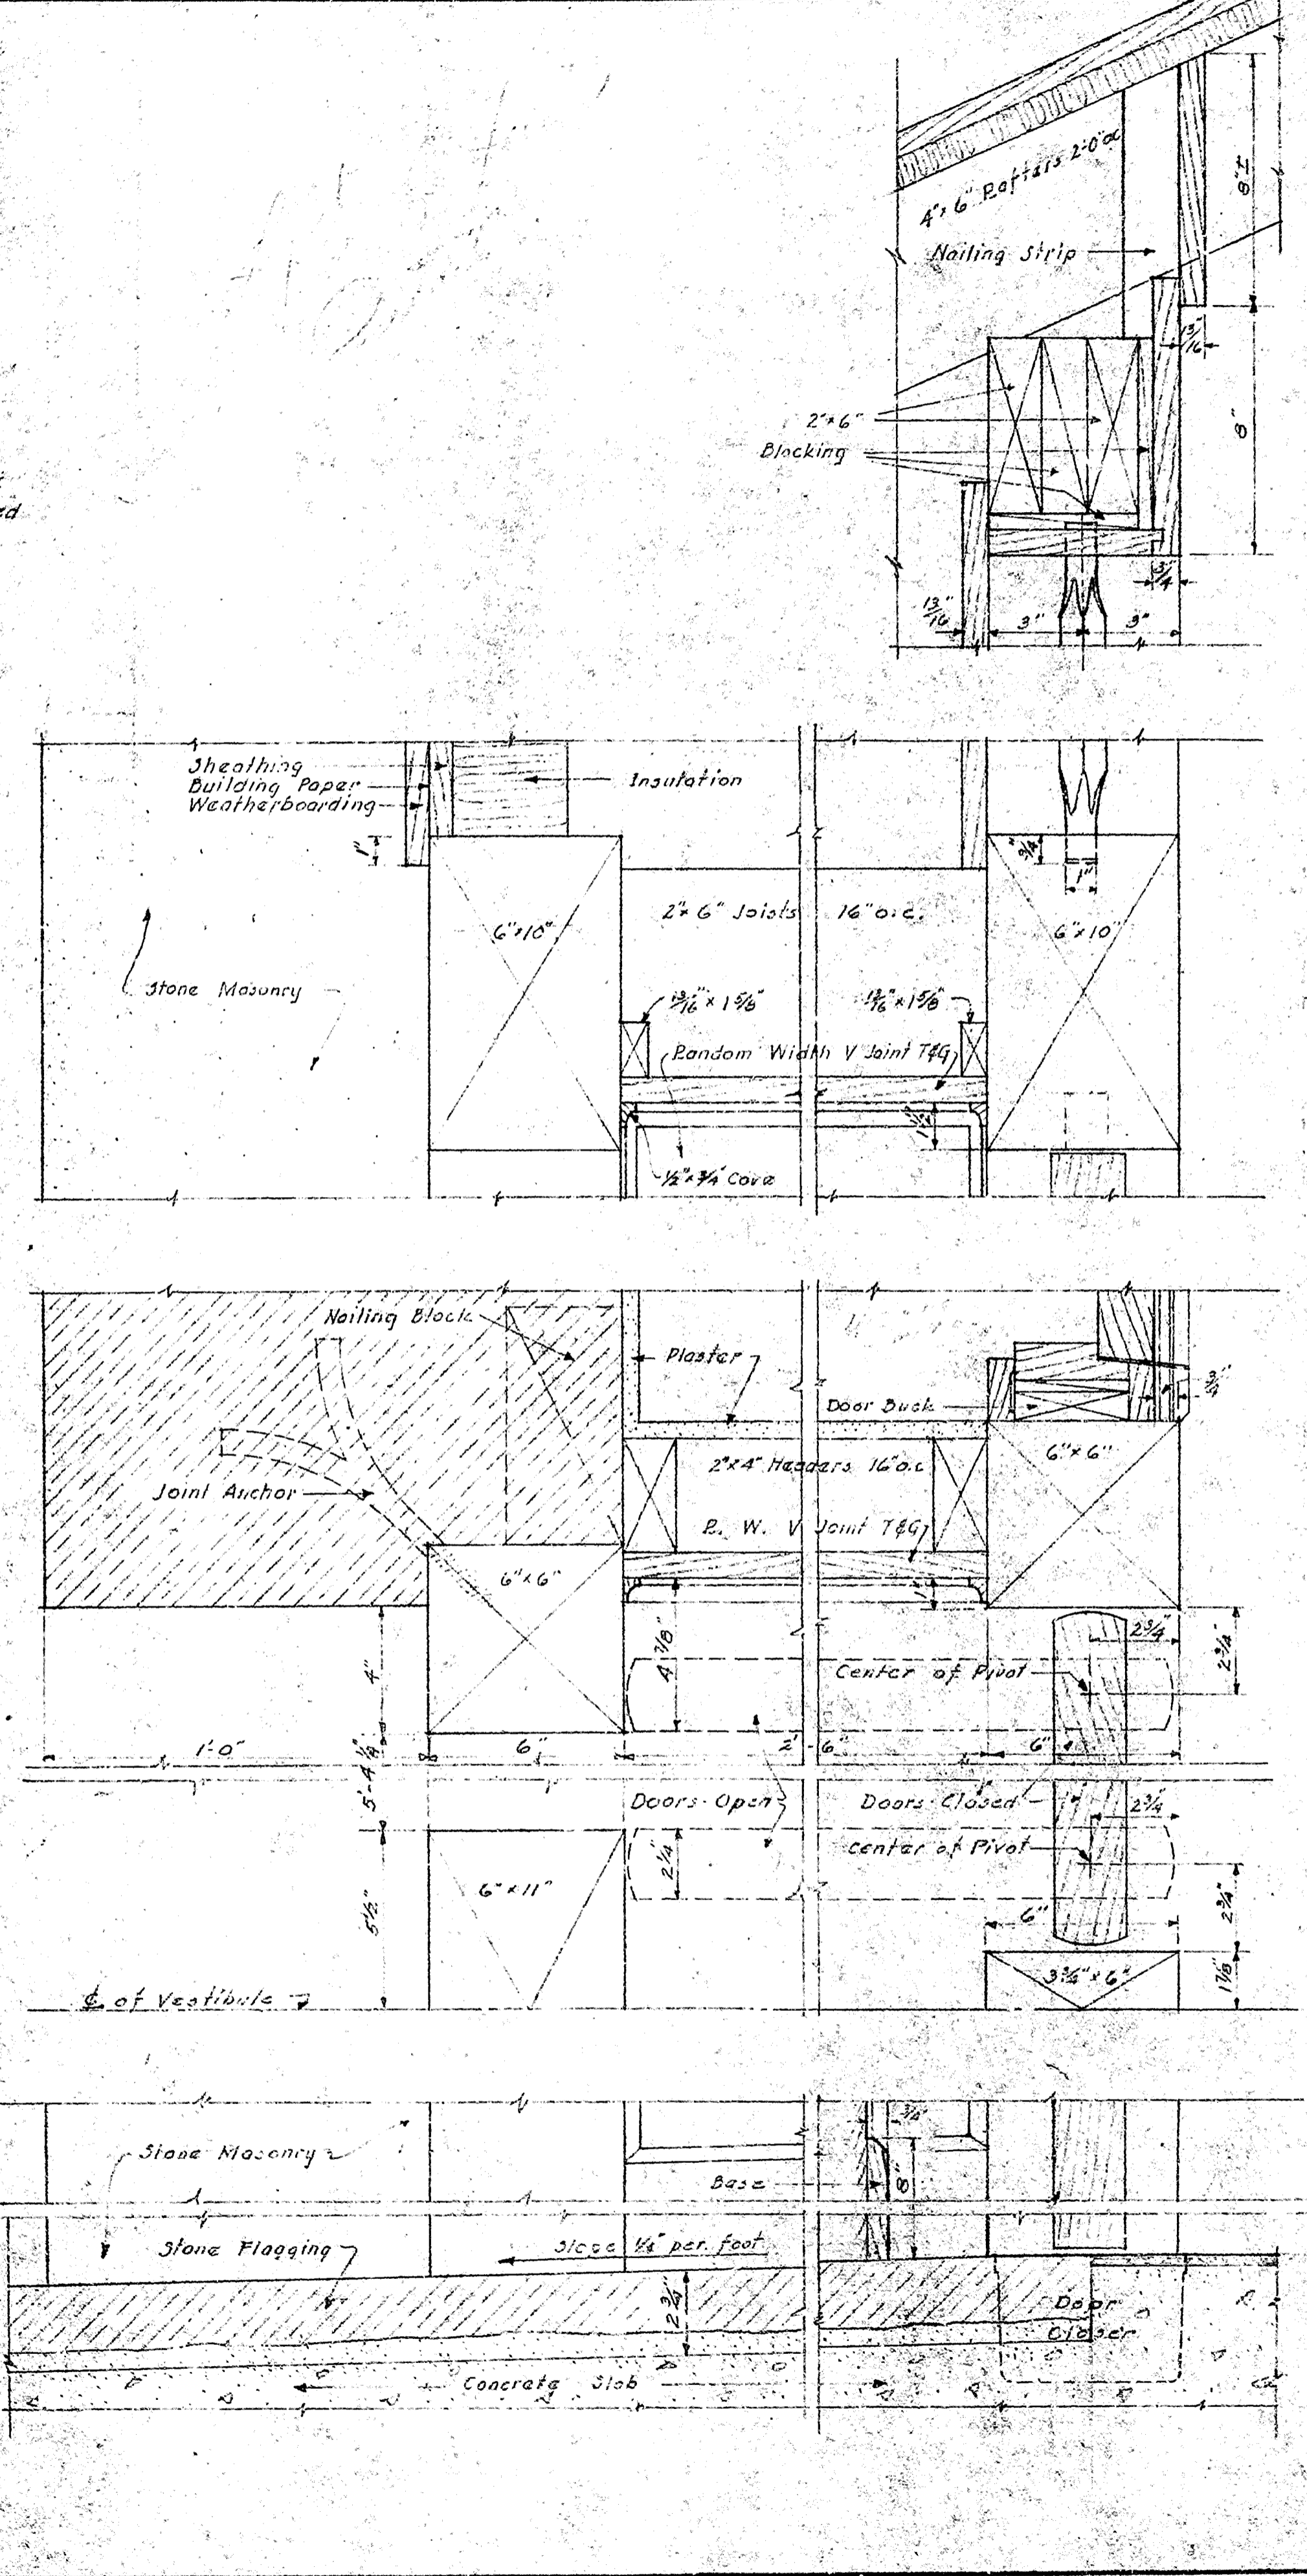
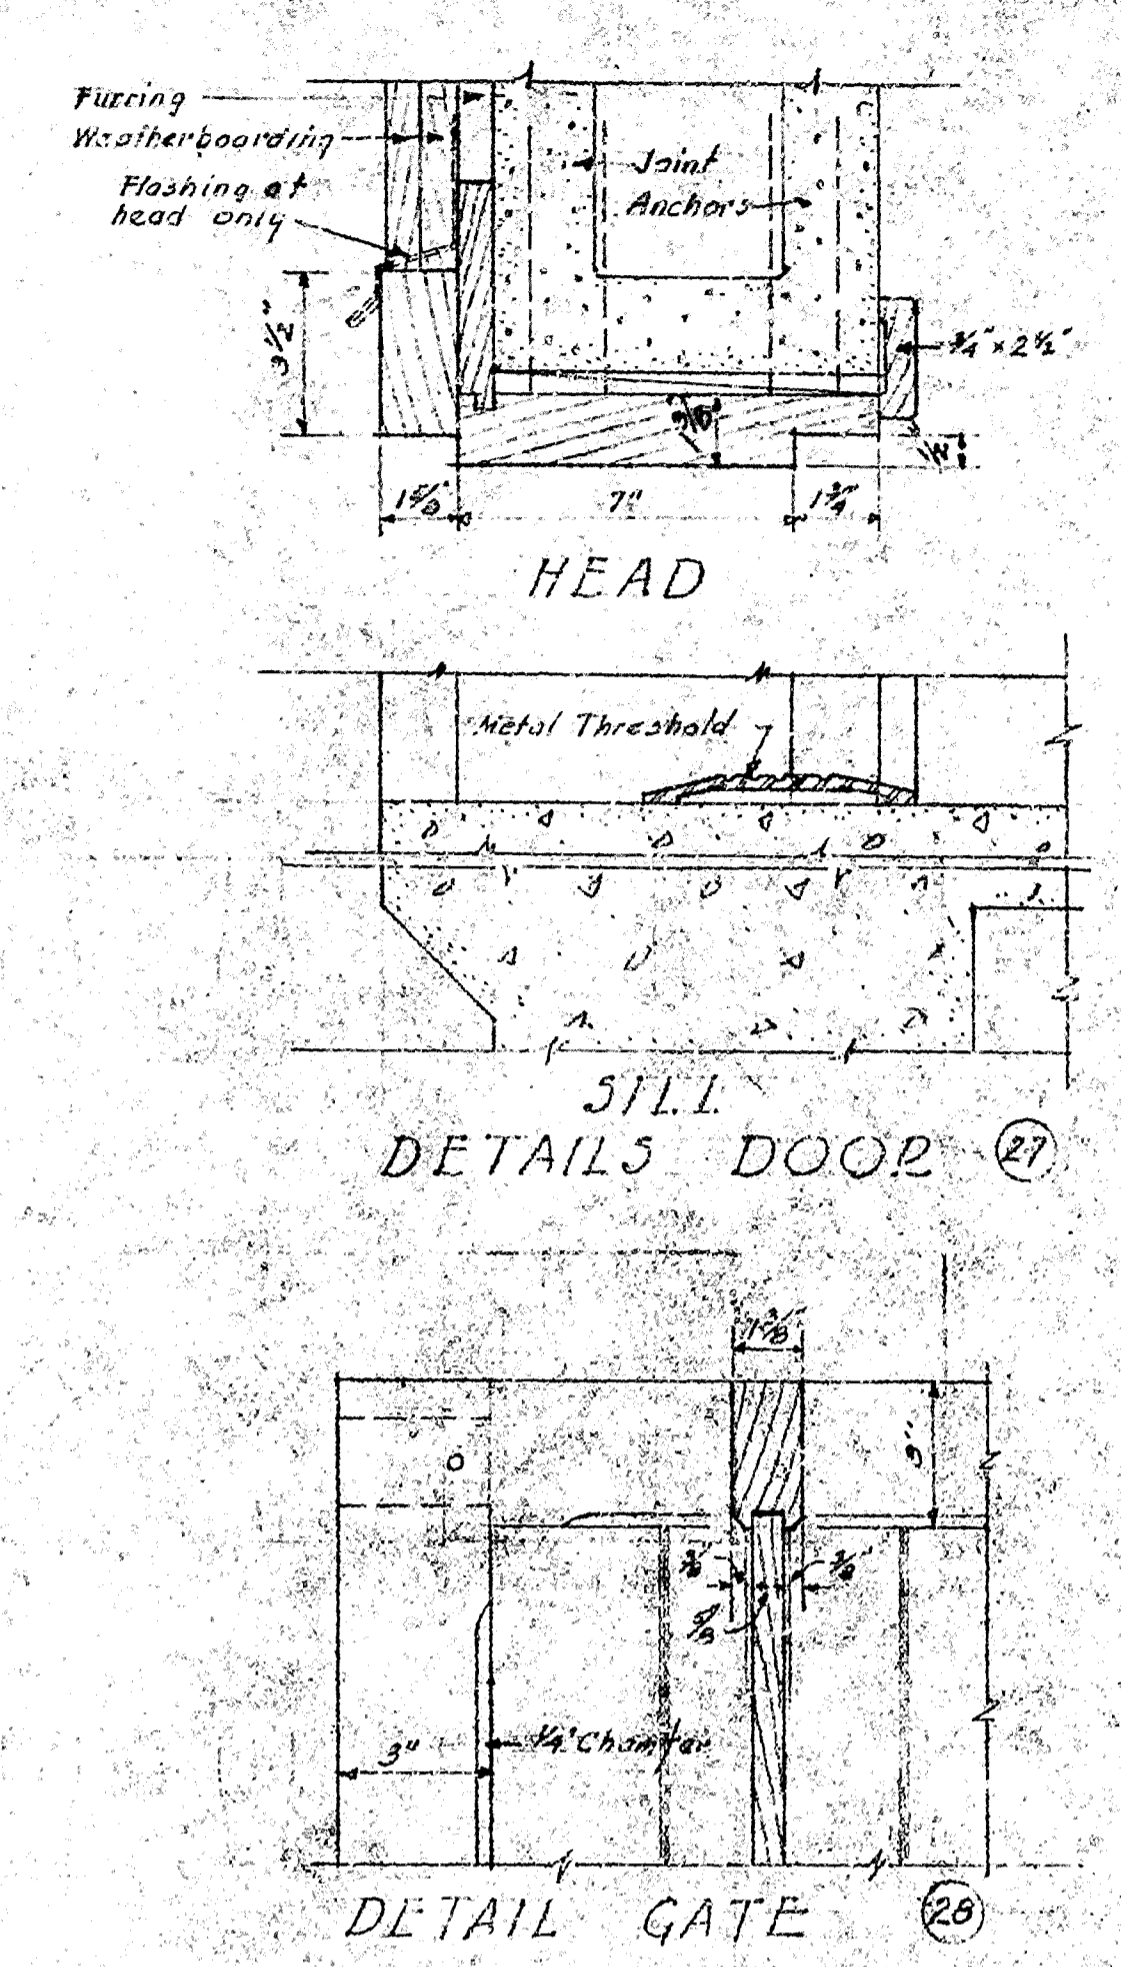
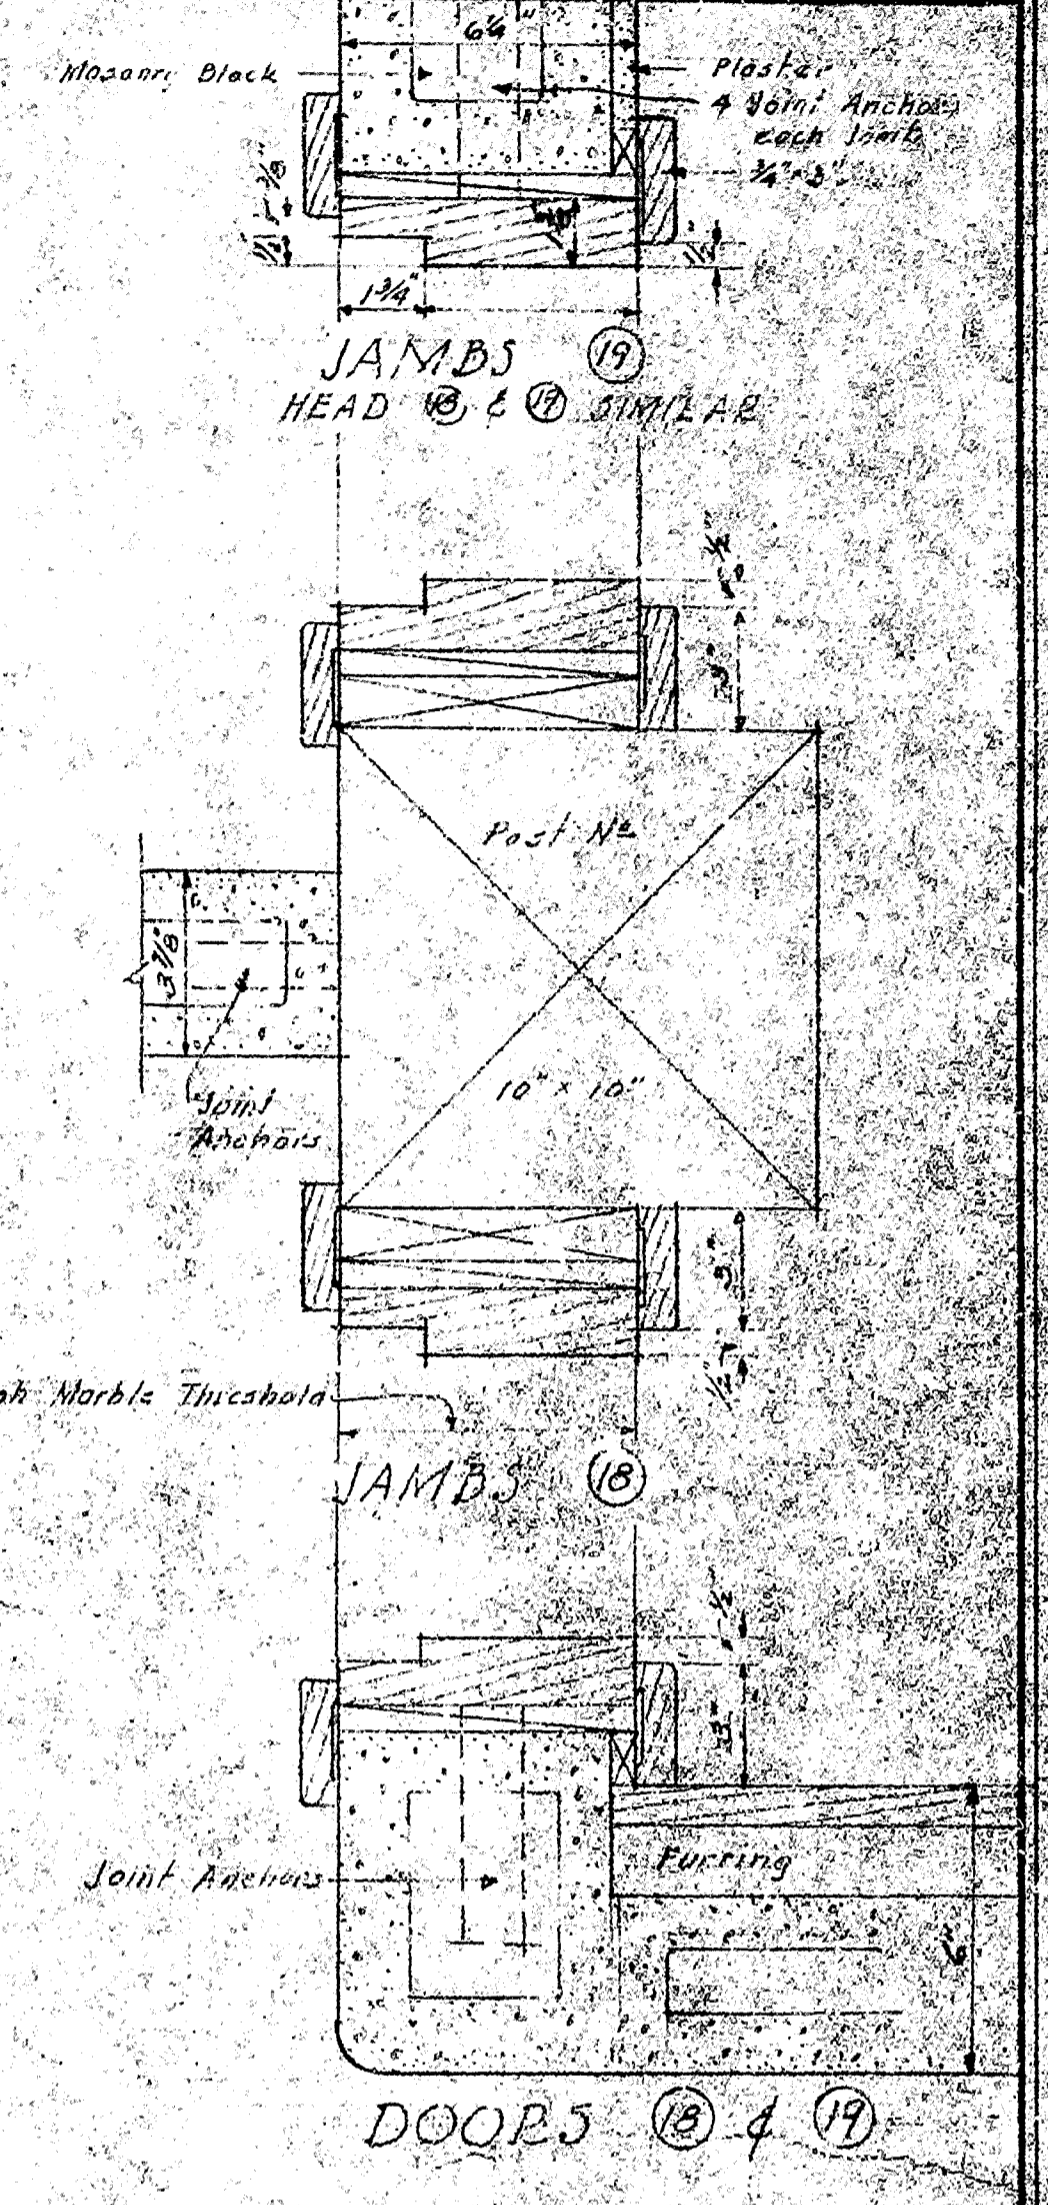
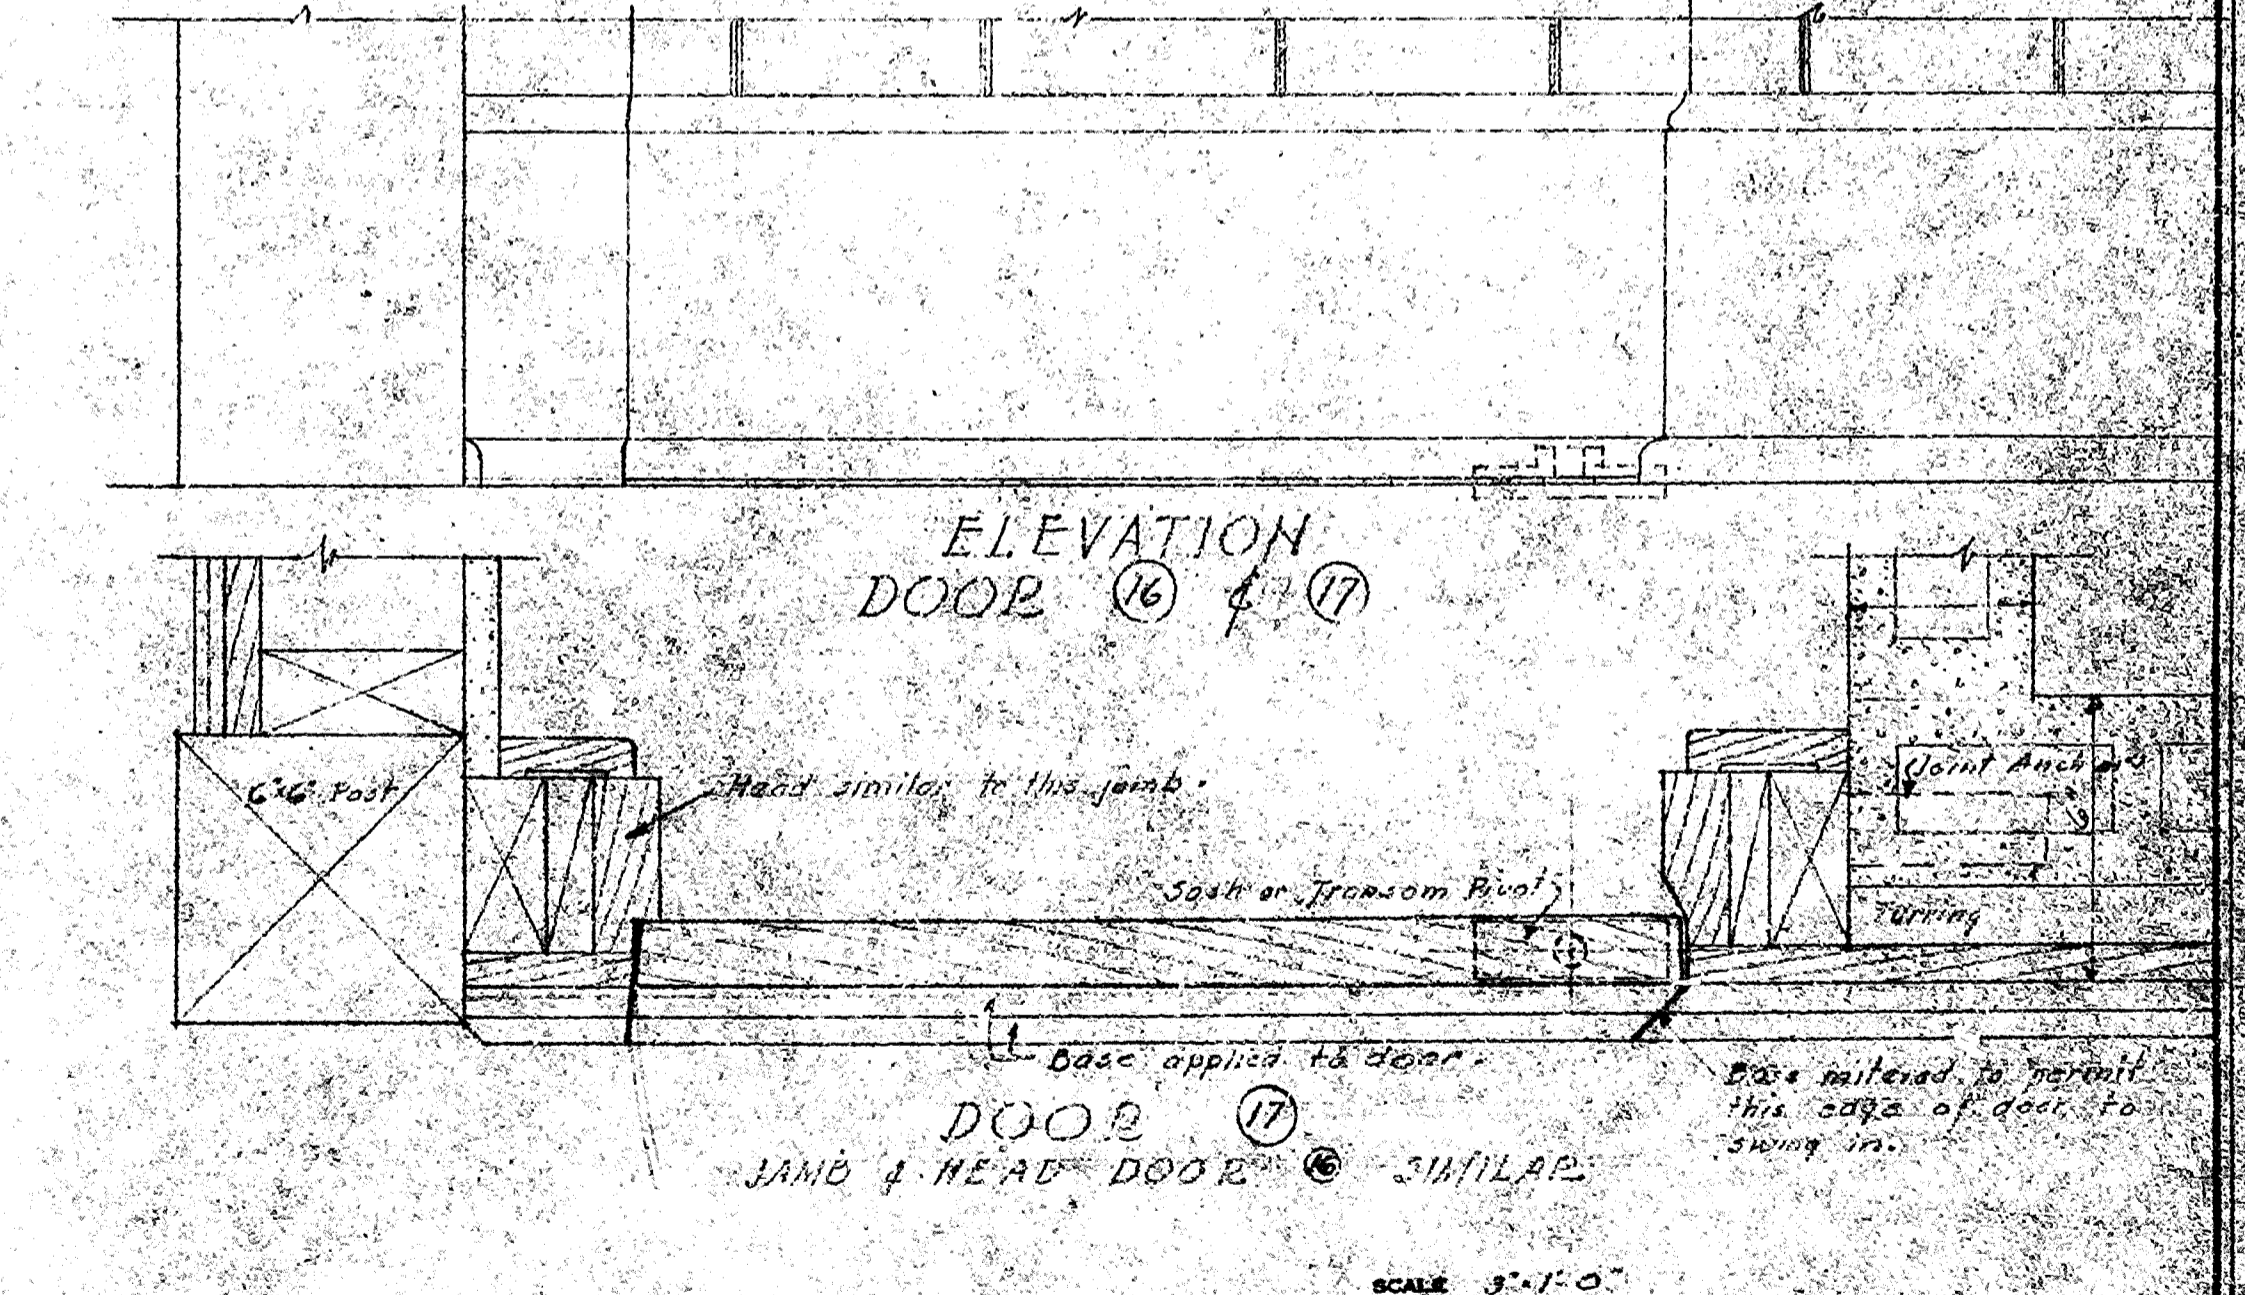
RECOMMENDED _____ DATE _____	DATE _____	UNITED STATES DEPARTMENT OF THE INTERIOR NATIONAL PARK SERVICE PLANS AND DESIGN DIVISION PREPARED BY GEORGE J. SHAW COFFEE SHOP - BLDG. NO. 106 THE BLUFFS BLUE RIDGE PARKWAY STATE OF MISSOURI	REGION ONE SHEET 12 OF 14 DRAWING NO. BI-2047-B DATE 4-21-34
CONCURRED _____ DATE _____	DATE _____		
APPROVED _____ DATE _____	DATE _____

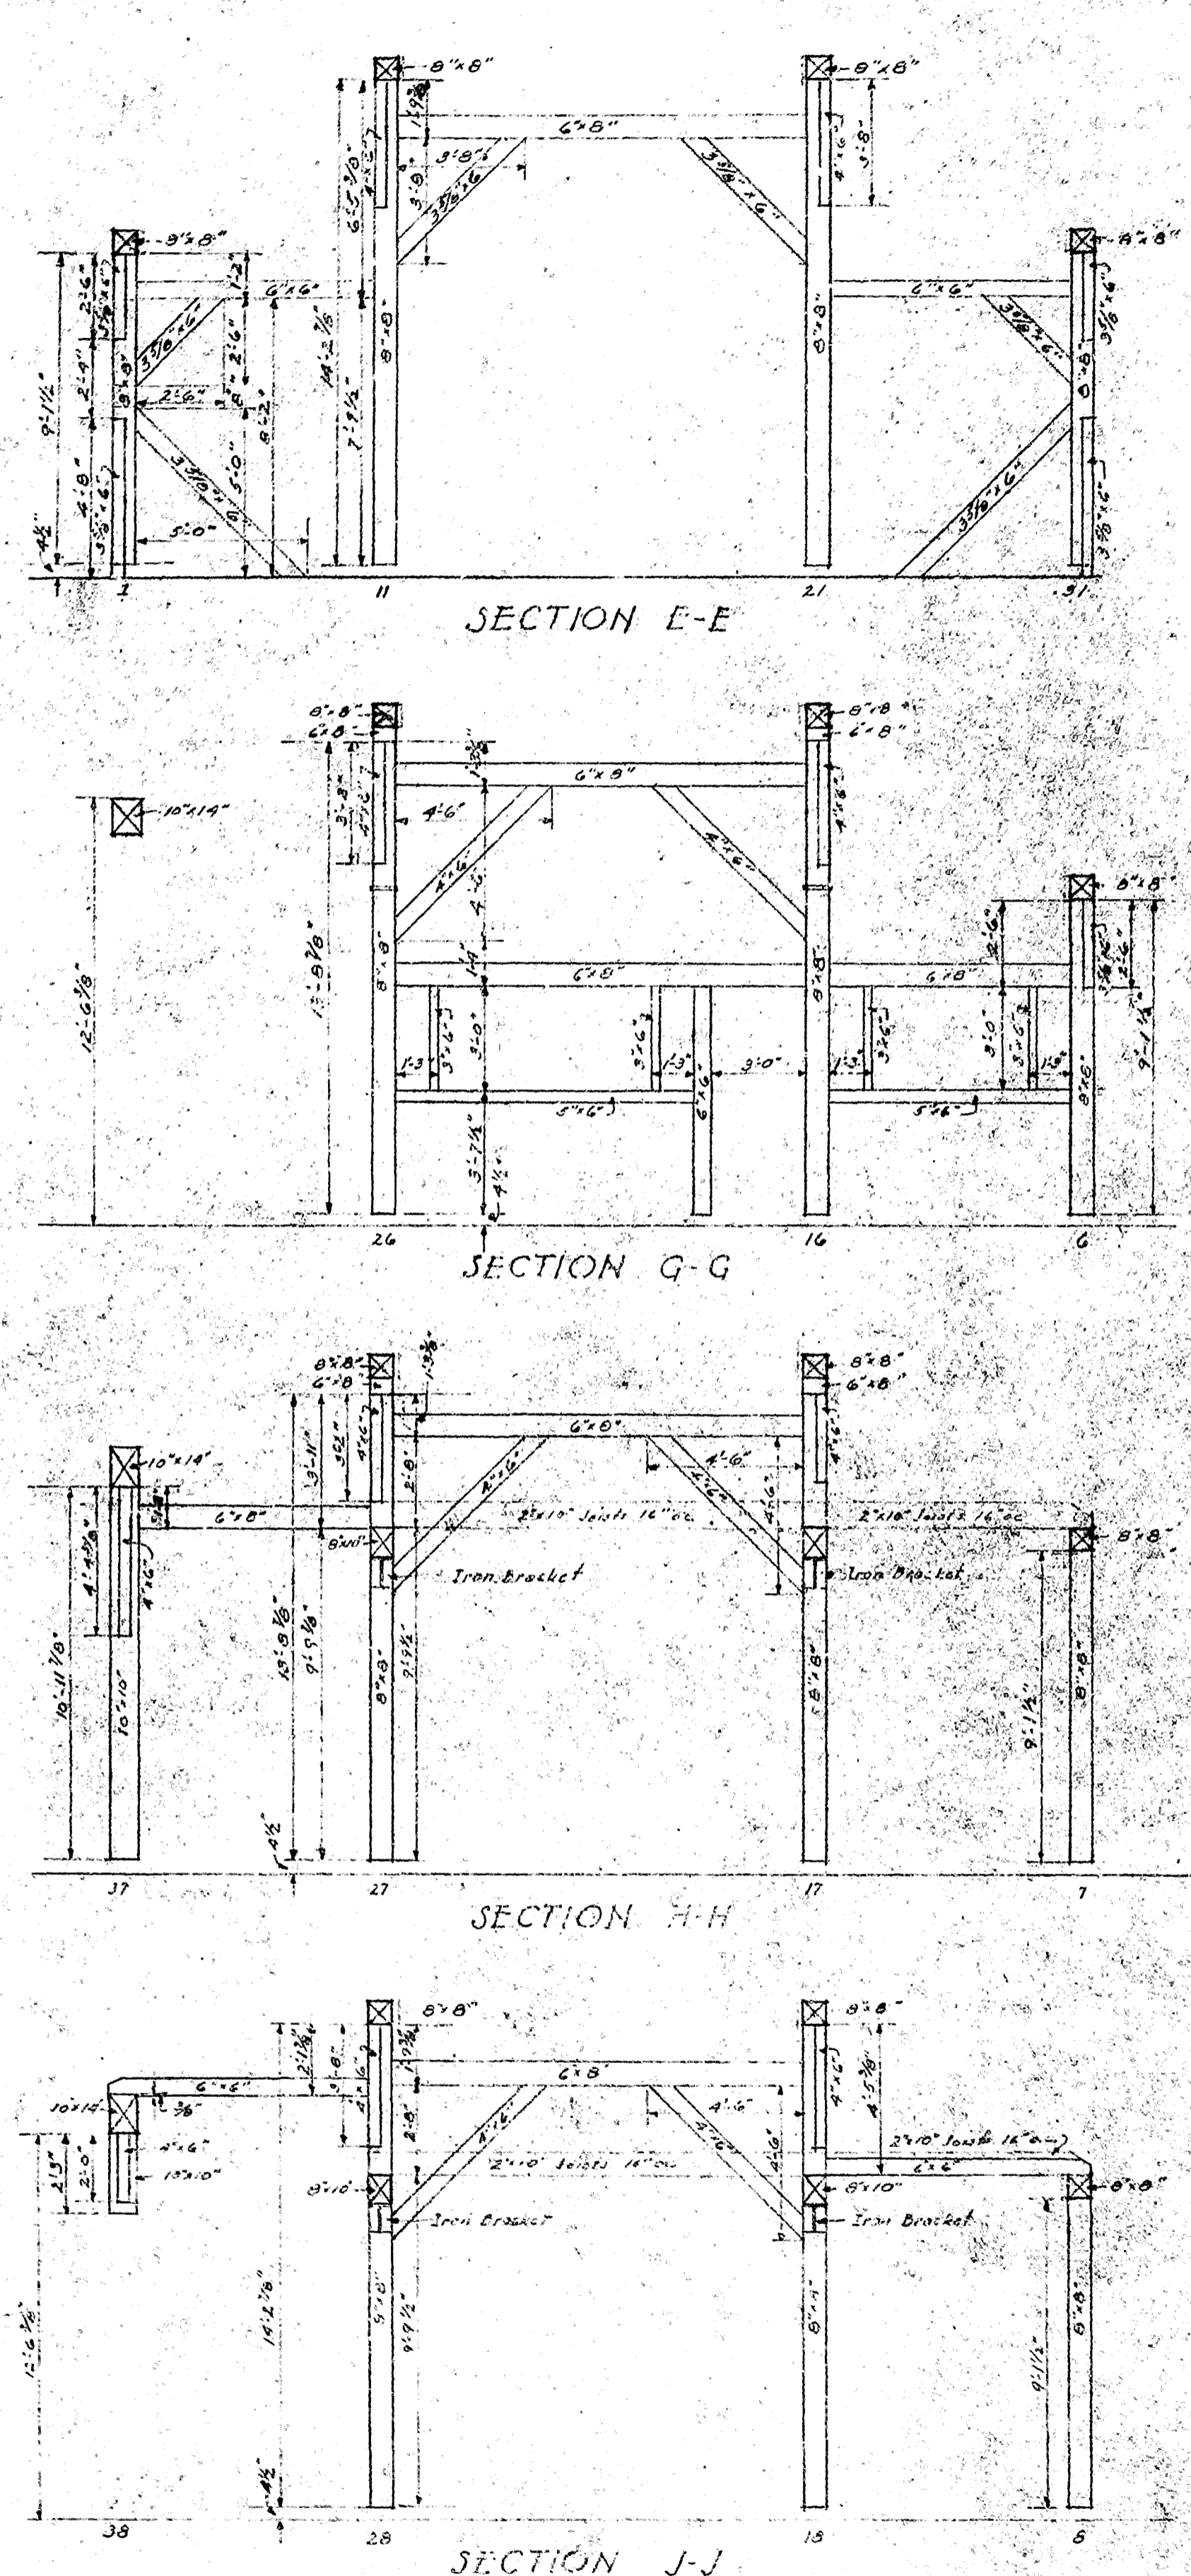
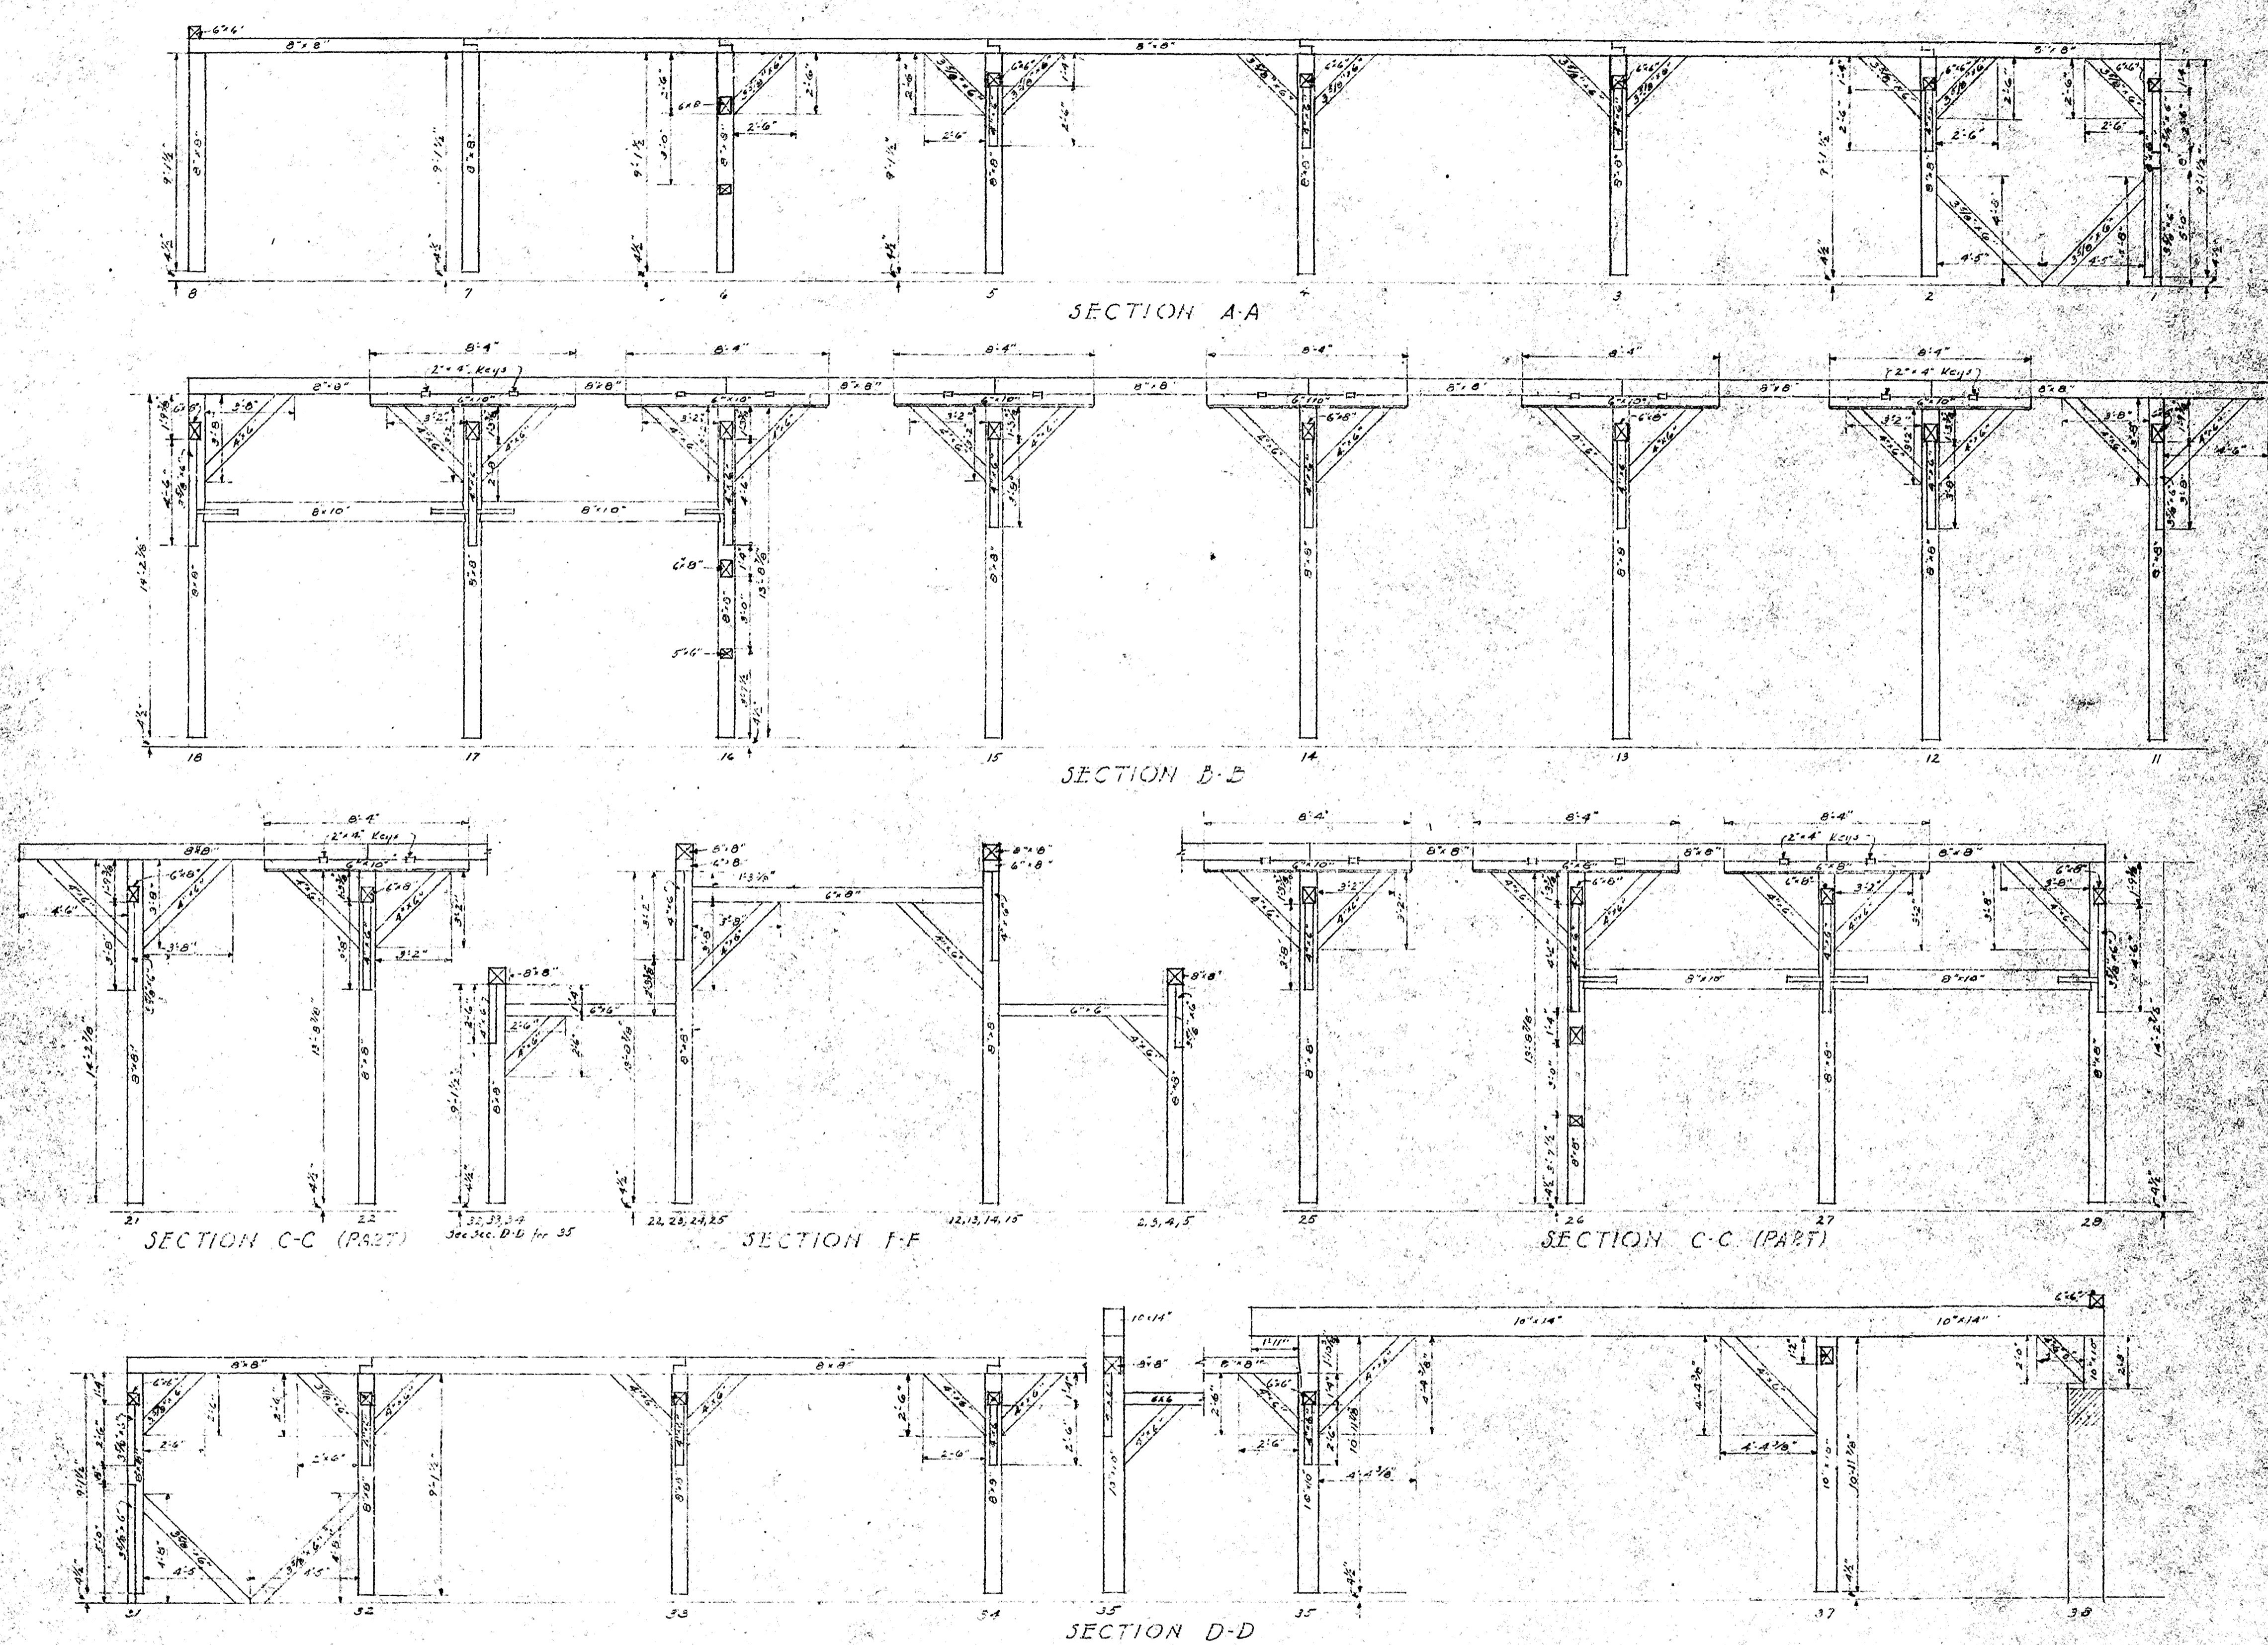
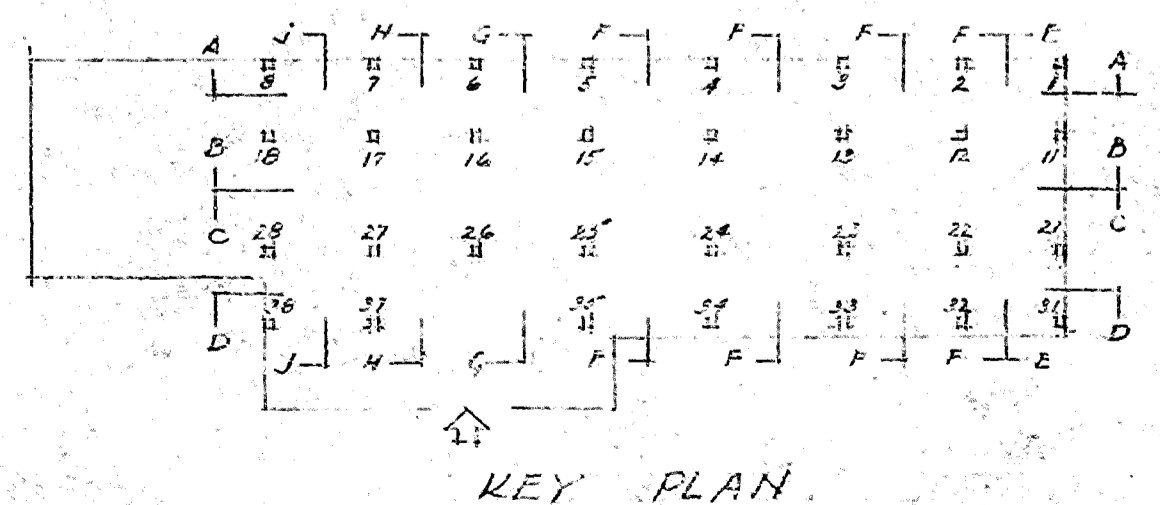
DESIGNED BY: G. C. ...
 CHECKED BY: ...
 DRAWING NO.: ...
 DATE: ...
 REGION: ONE
 SHEET # OF 14
 DRAWING NO.: PLY-BP
 DATE: 4-24-58
