North Carolina Department of Natural and Cultural Resources
State Historic Preservation Office

Ramona M. Bartos, Administrator

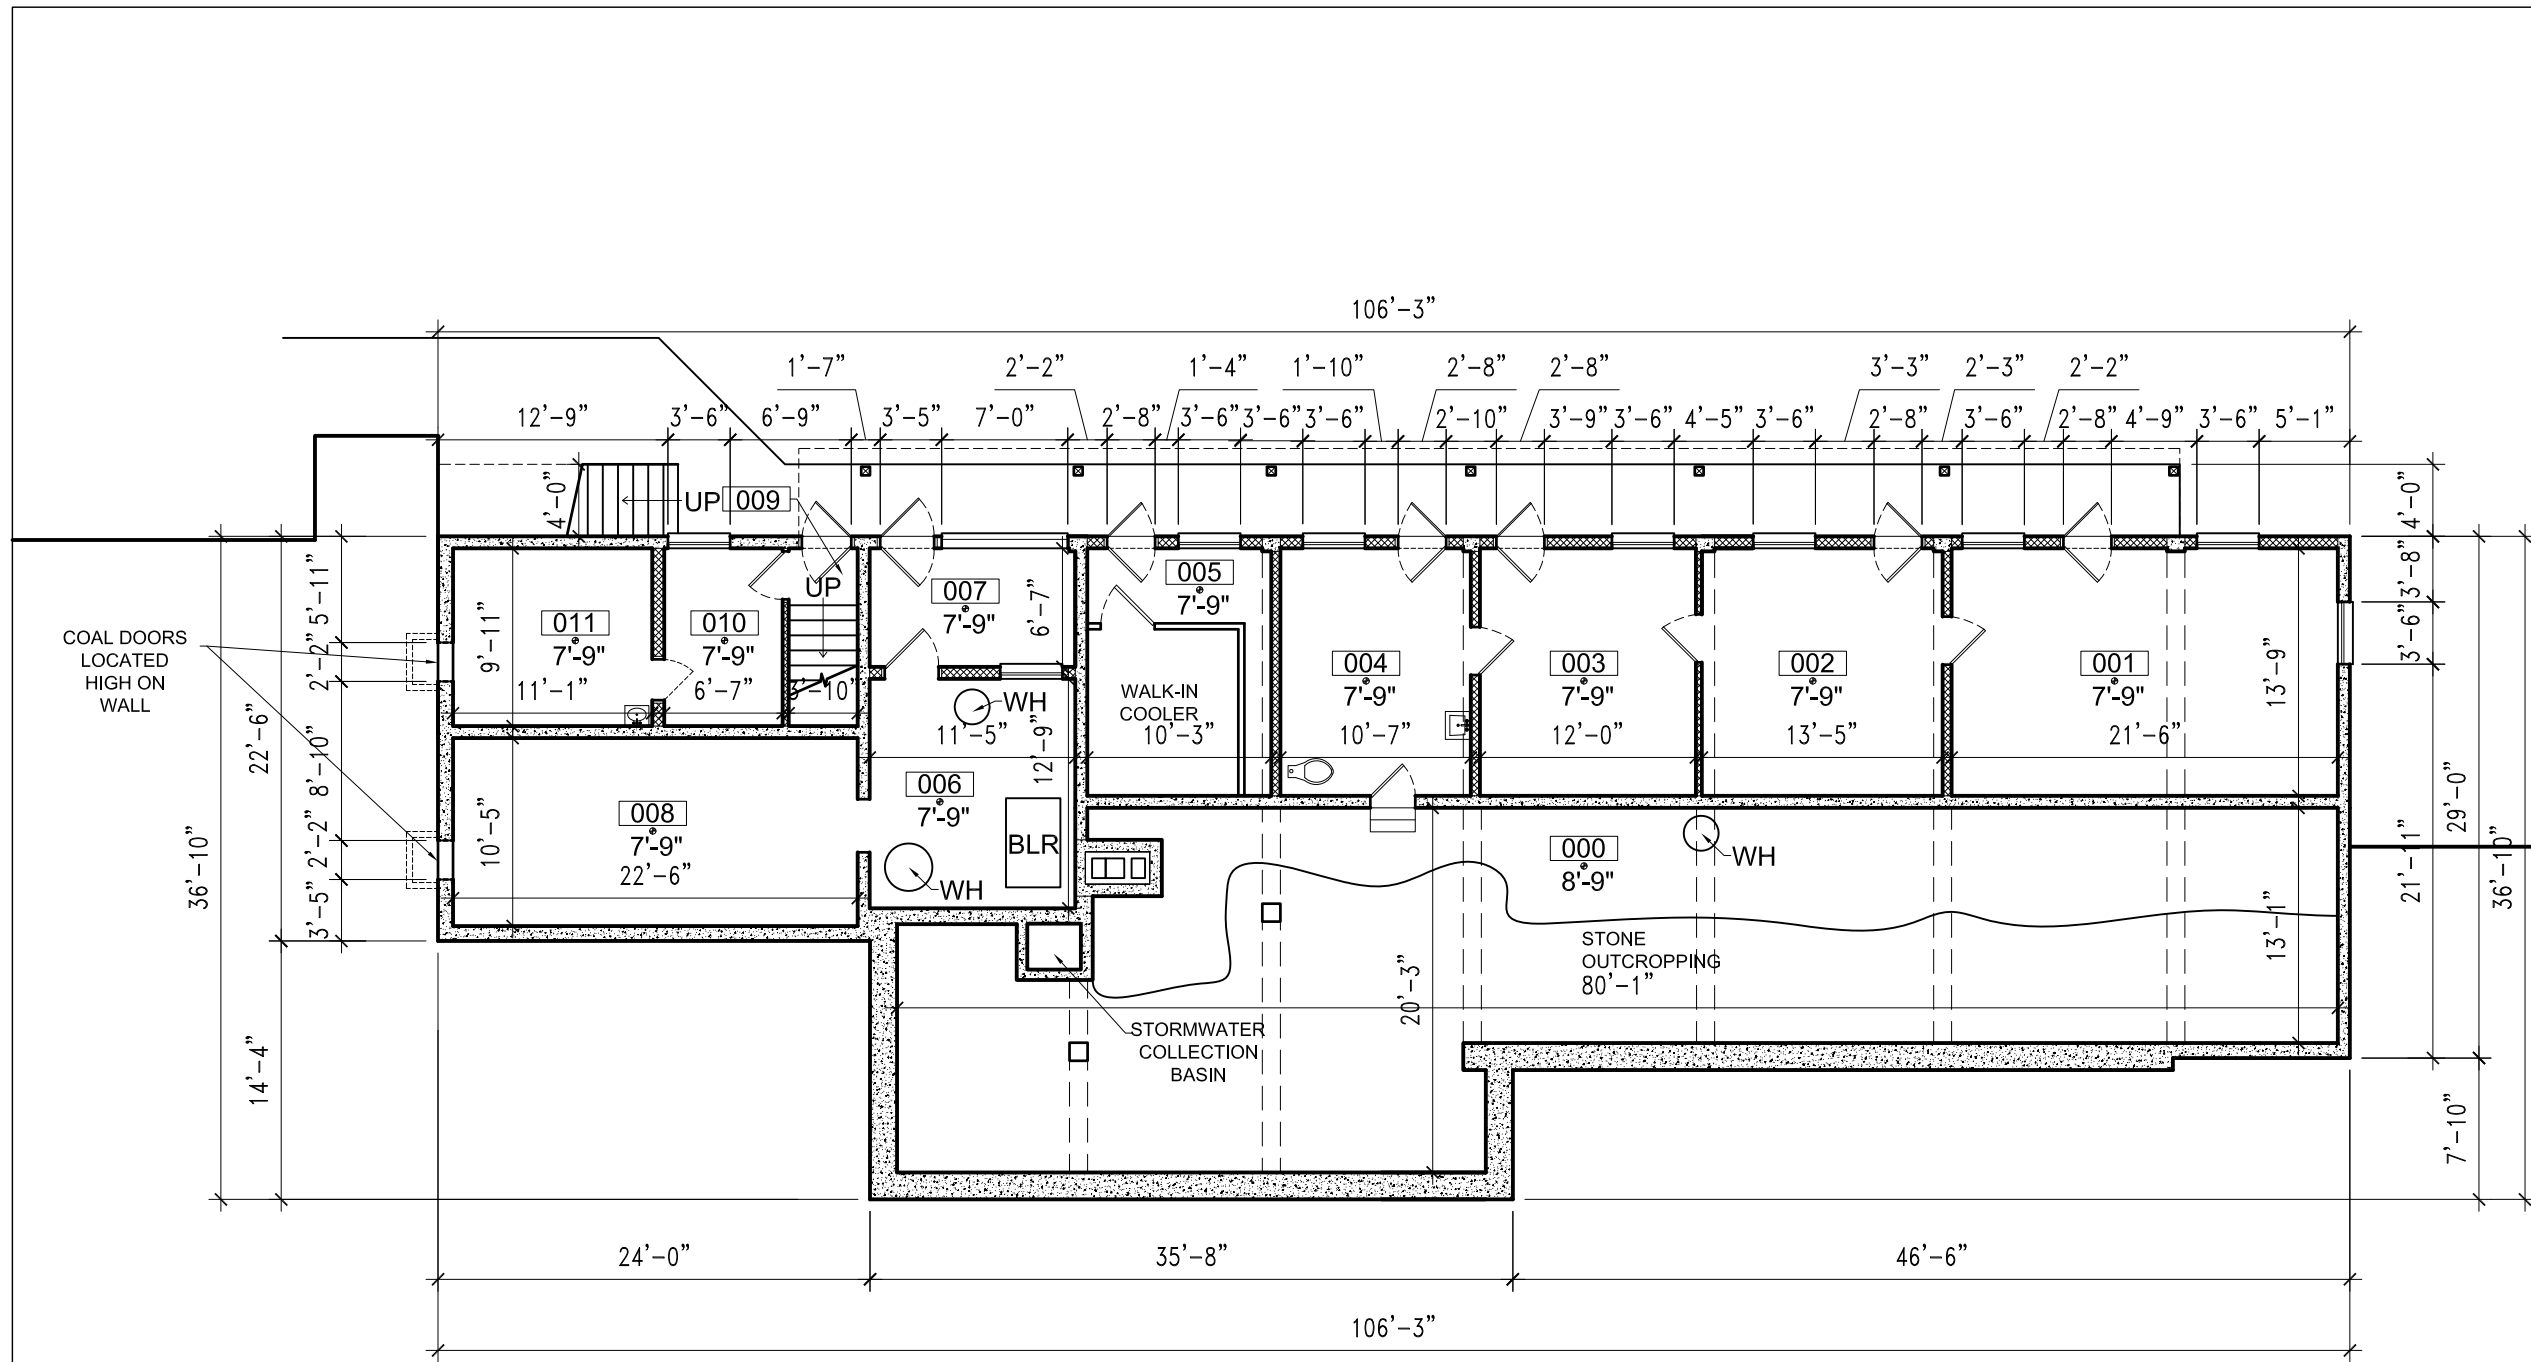
1 BASEMENT / FOUNDATION PLAN
SCALE: 3/32" = 1'-0"
