SUBJECT: Historic Structures Survey Report, Left Turn Lane Construction, SR 1650 and SR 1538,
W-5710AC, Stanly County, ER 19-2324

**Historic Structures Survey Report
Left Turn Lane Construction at SR 1650 (NE Connector) and
SR 1538 (Moss Springs Road)
Stanly County, North Carolina**

TIP No. W-5710AC
WBS No. 44856.1.29
PA No. 18-10-0054

July 17, 2019– Final Report

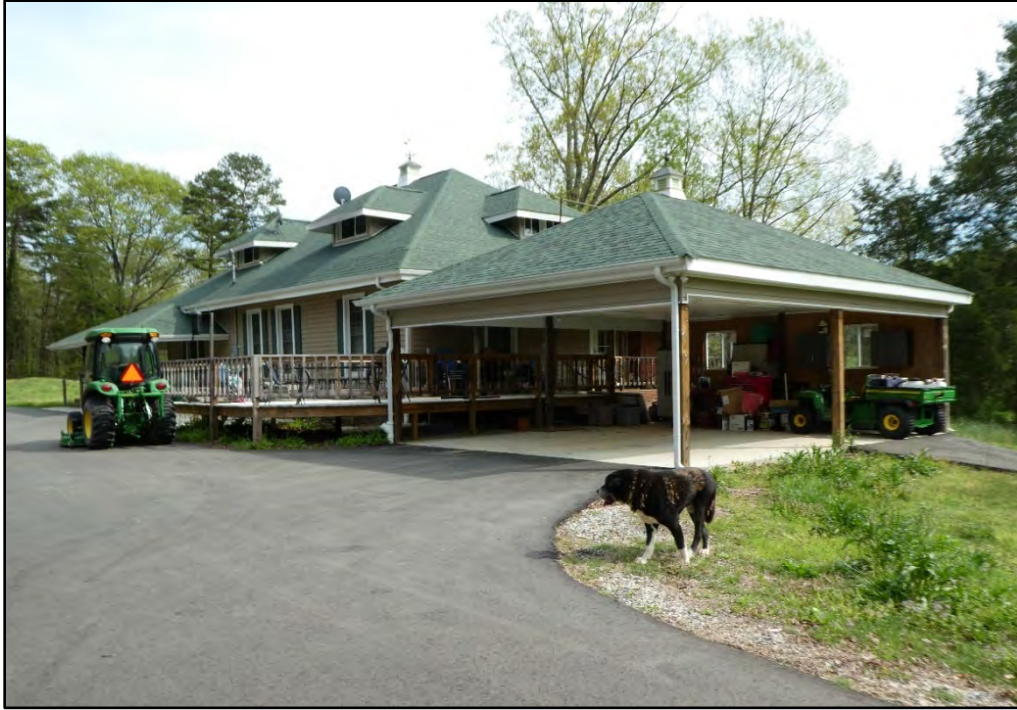
- Installation of modern brickwork and alteration of window and door openings at the foundation level;
- Construction of a new partially wrap-around deck in place of the screen porch, using composite decking and classically ornamented balusters;
- Addition of a carport with shallow-pitch, hip roof;
- Installation of mock ventilators with weather vanes on ridge of house and carport; and
- Significant alteration to the immediate landscape around the house, including the removal of trees and installation of an extensive, hardscaped driveway.

Figure 13. North and west elevations of the farmhouse today, showing new deck, carport, and hardscaping, taken facing southeast.

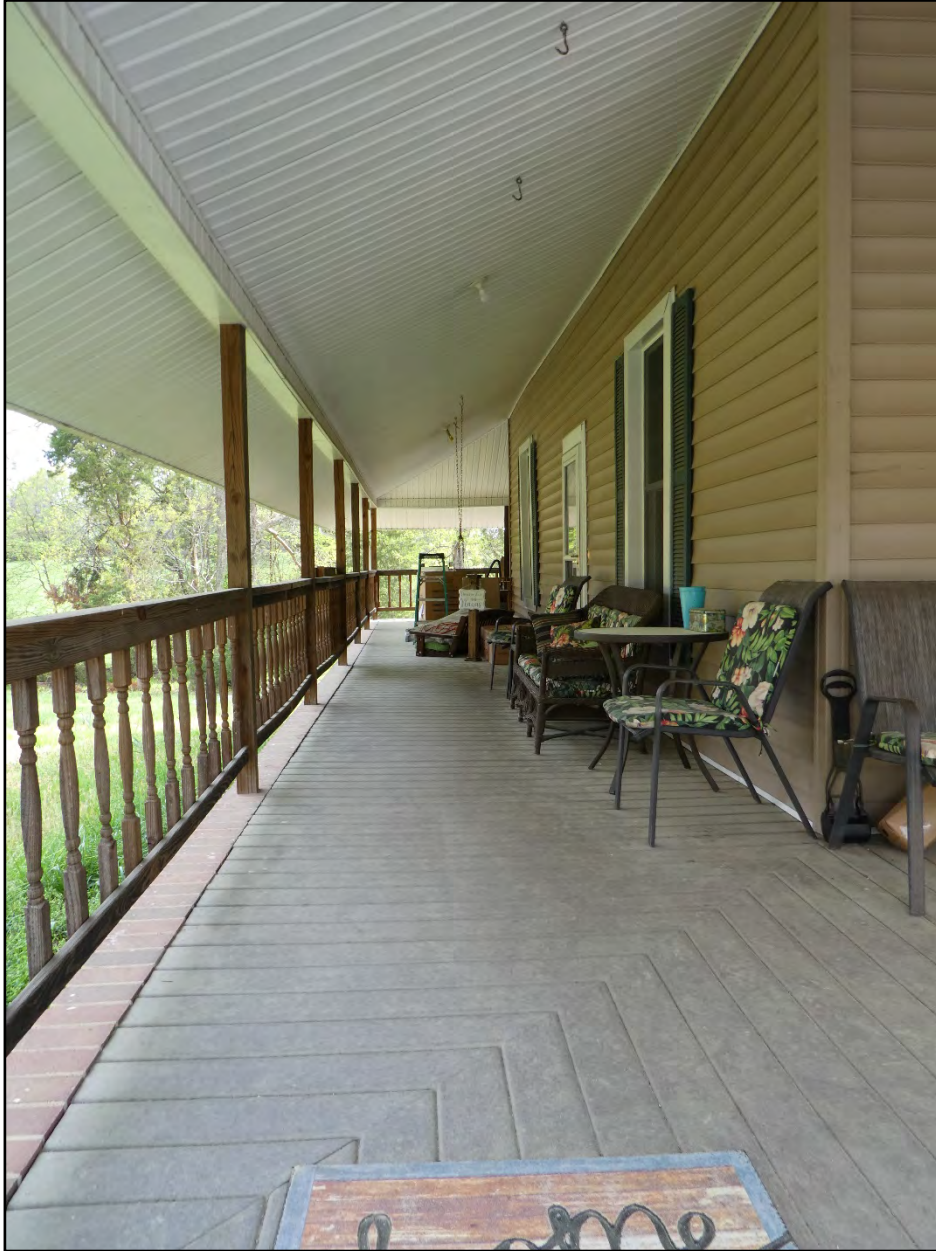
Figure 15. Detail of wraparound porch as seen in 2019, illustrating new framing, ballusters, composite decking, vinyl siding, vinyl windows, and applied vinyl shutters, taken facing west.

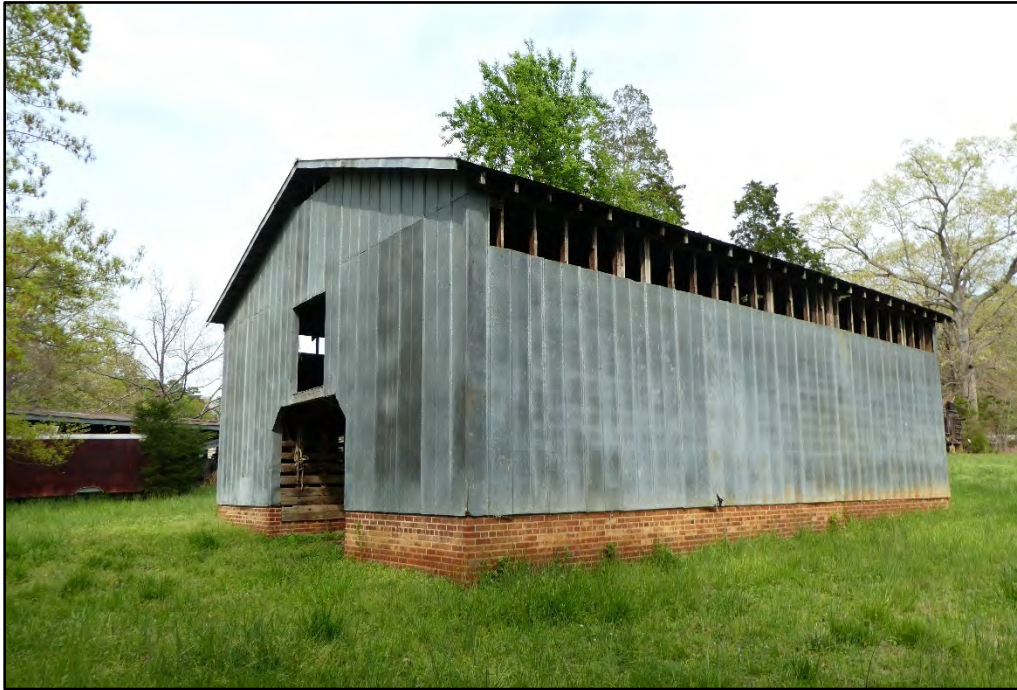
3. **Transverse-Crib Barn** (see Figure 16 and Figure 18): Oriented on an east-west axis, this ca. 1912 lofted barn with central passageway is set on a brick stem wall in five-course American bond with earthen floor. Exterior walls are clad in 5V-crimp metal sheets and are open just below the eaves, resulting in clerestory ventilation in the loft area. Additional ventilation is provided by square openings above the machinery doors at each end of the barn. Neither the openings nor the doors have fenestration units. The gable roof is clad in rusted, 5V-crimp metal sheets.

Figure 18. West and south elevations of the Transverse-Crib Barn (Site Plan # 3), taken facing northeast. A trailer parked next to Machine Shed B (Site Plan # 15) is just visible on the left.

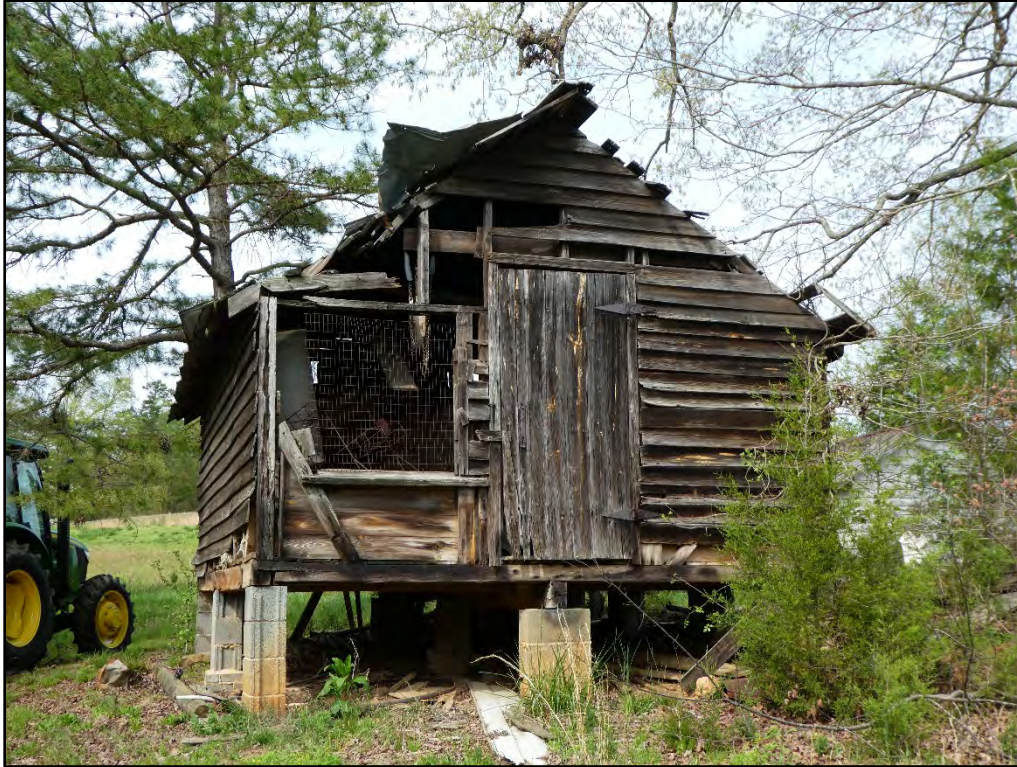
5. **Coop A** (Figure 21, Figure 22, and Figure 23): This partially collapsed, wood-frame structure with a gable roof was built ca. 1912. Exterior walls are clad in unpainted clapboard, which is missing in places. The roof is partially covered in rusted, 5V-crimp metal sheets. The only openings are on the south end of the building: a pedestrian door of vertical planks and an unglazed, square, ventilation window treated with chicken wire. The building is set on concrete-block piers.

Figure 23. South elevation of Coop A (Site Plan #5), taken facing north.

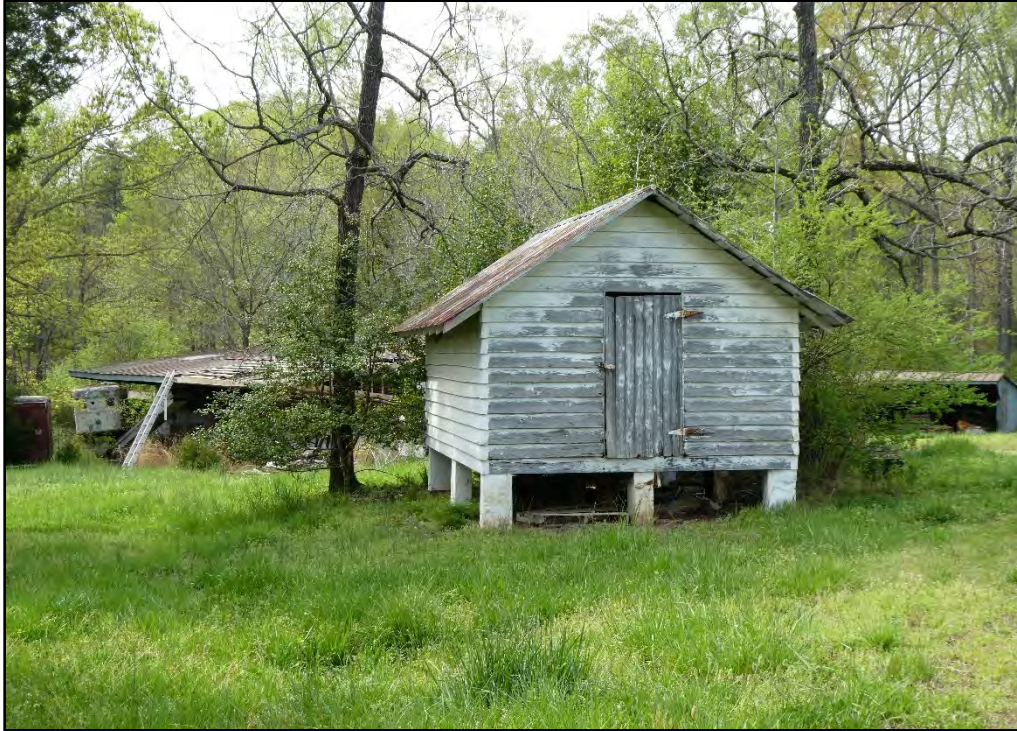
9. **Granary A** (Figure 27, Figure 29, Figure 30, and Figure 32): Clad with weatherboard, this wood-frame rectangular granary was built ca. 1912. This small, one-story structure faces east and rests on a parged, brick pier foundation. The gable roof is surfaced with 5V-crimp sheet metal and features exposed rafter ends in the eaves on the north and south elevations. A vertical plank wood door is centrally located on the east elevation. The interior was not accessible.

Figure 29. Granary A (Site Plan # 9), east elevation, taken facing west-northwest.

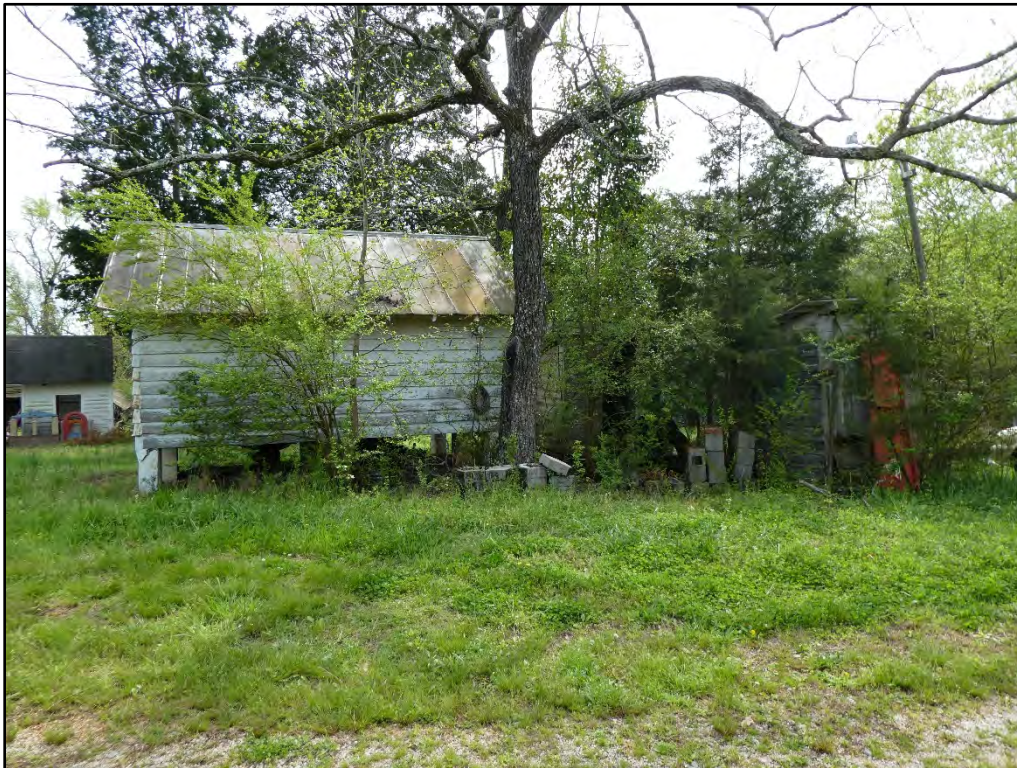
13. **Privy A** (Figure 30 and Figure 32): Privy A is situated immediately west of Granary A. Both Privy A and Privy B are overgrown with vegetation. Estimated to have been built ca. 1912, it may be somewhat younger than Privy B due to its different design. It is clad with weatherboard with corner boards. Its opening is on the north elevation, but the door is missing and a portion of the sheet metal covering the shed roof has fallen. The building appears to rest on loose bricks so is likely to have been moved to this location.

14. **Privy B** (Figure 30 and Figure 32): Privy B is located immediately northwest of Granary A and has paired vertical plank doors facing north. Built ca. 1912, the outbuilding is clad with weatherboard and vertical plank siding topped by a shed roof surfaced with sheet metal. Exposed rafter ends are evident in the eaves on the north and south elevations. Based on photographic evidence, the structure appears to have been moved since the 1990 survey; a foundation was not visible during the current survey.

Figure 30. North elevations of Granary A and Privies A & B (Site Plan # 9, 13, and 14), taken facing south-southwest.

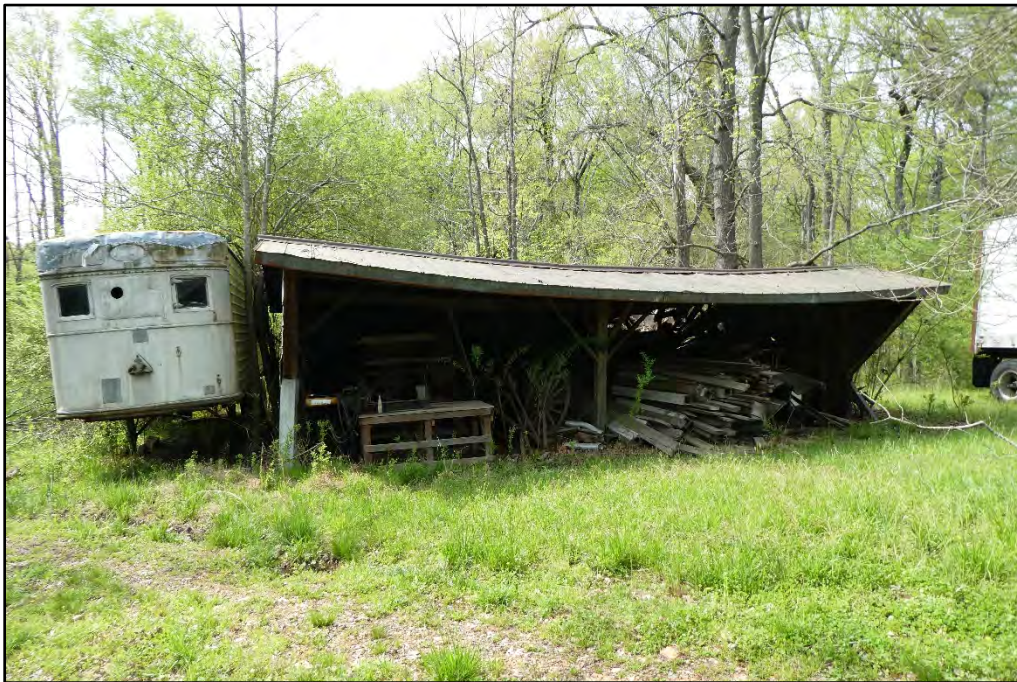
16. **Machine Shed C** (Figure 33 and Figure 36): Built ca. 1940, Machine Shed C is the smallest of the machine sheds, incorporating only two bays. The wood-frame structure is clad with 5V-crimp and standing seam sheet metal. The shed roof features a pent roof along the open, northeast elevation and is surfaced with 5V-crimp sheet metal. In poor condition, the roof has bowed and the structure appears in danger of collapse.

Figure 36. Machine Shed C (Site Plan # 16), southeast elevation, taken facing west.

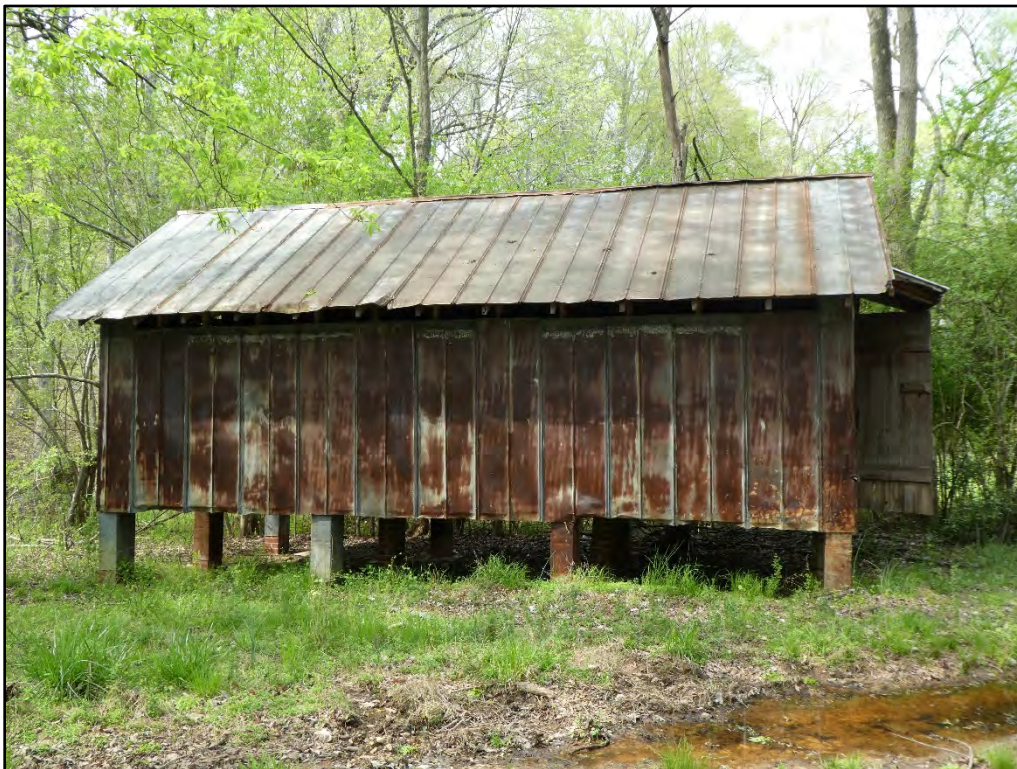
17. **Granary B** (Figure 37 and Figure 38): Facing northeast, the ca. 1912 Granary B is a one-story, wood-frame rectangular structure clad with rusting standing seam sheet metal. The gable roof is surfaced with 5V-crimp sheet metal and features exposed rafter ends. Open areas at the top of the wall under the eaves provided the ventilation necessary for the granary. Both entrances, located in the gable ends, are shaded by a shed roof, or pentice, surfaced with 5V-crimp. The openings have vertical plank wood doors. A brick pier foundation supports the structure, but most of the piers are partially encased in sheet metal at the top of the pier.

Figure 38. Granary B (Site Plan # 17), south elevation, taken facing north.

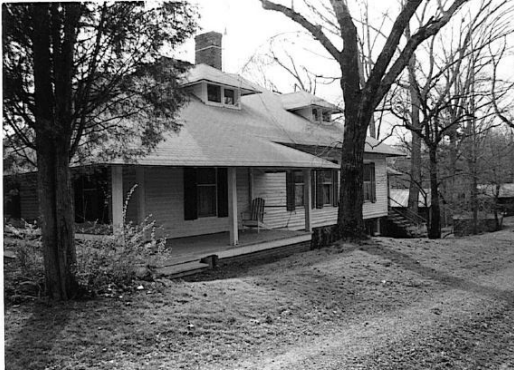
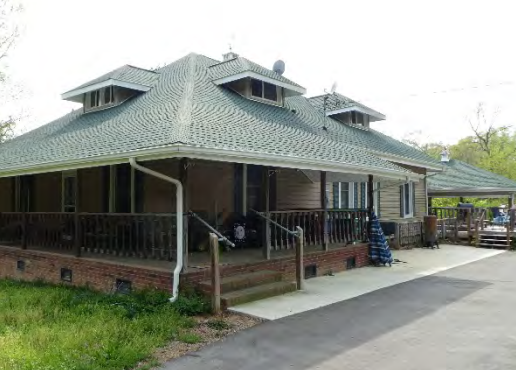
<p>From driveway near northwest corner of dwelling, taken facing west-northwest. NOTE: Loss of building in foreground, hardscaping & loss of trees</p>	 	 
<p>At intersection of driveway & back road, taken facing southeast towards house. NOTE: Overgrowth of road & loss of landscape buffer between domestic & working parts of farm</p>
