SUBJECT: Historic Structures Survey Report, R-5777C, US 70 Improvements from SR 1116 (Thurman Road) to the Havelock Bypass, Craven County, ER 20-0790

# Historic Structures Survey Report

US 70 Improvements from SR 1116 (Thurman Road)  
to the Havelock Bypass

TIP No. R-5777C  
WBS No. 44648.1.1  
PA. No. 19-03-0022

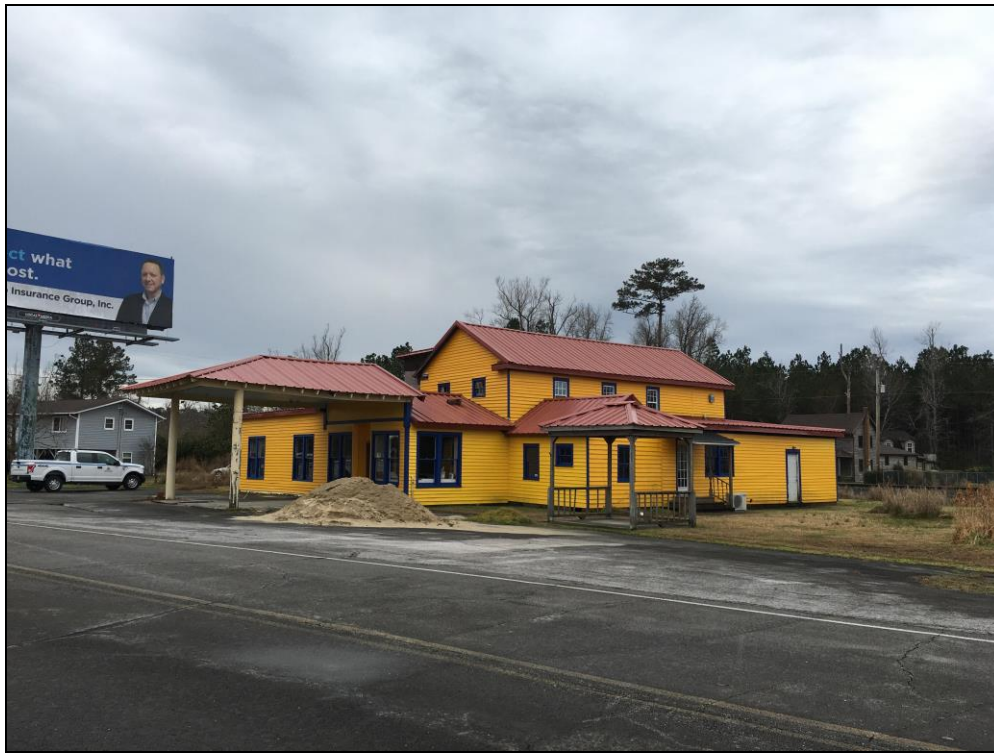
**Figure 7:** Tom Haywood Store (CV1044), looking southwest.

The Tom Haywood Store retains a low level of integrity. The overall form of the original building and its historic additions remain, however most of the interior has been removed, new framing for walls has been added, and some windows and doors have been replaced throughout the building diminishing design, materials, and workmanship. In addition, both the original Self Kicking machine and its replica are no longer on the property, neither is the original unhewn log gazebo, lost sometime after 1981. The outdoor bathroom structure, once used by those visiting the store and roadside attraction, are no longer extant nor are the camping grounds mentioned in Tom Haywood's stationary. It has therefore lost integrity of setting, and more importantly association and feeling with the loss of the Self Kicking Machine roadside attraction so closely associated with the store.

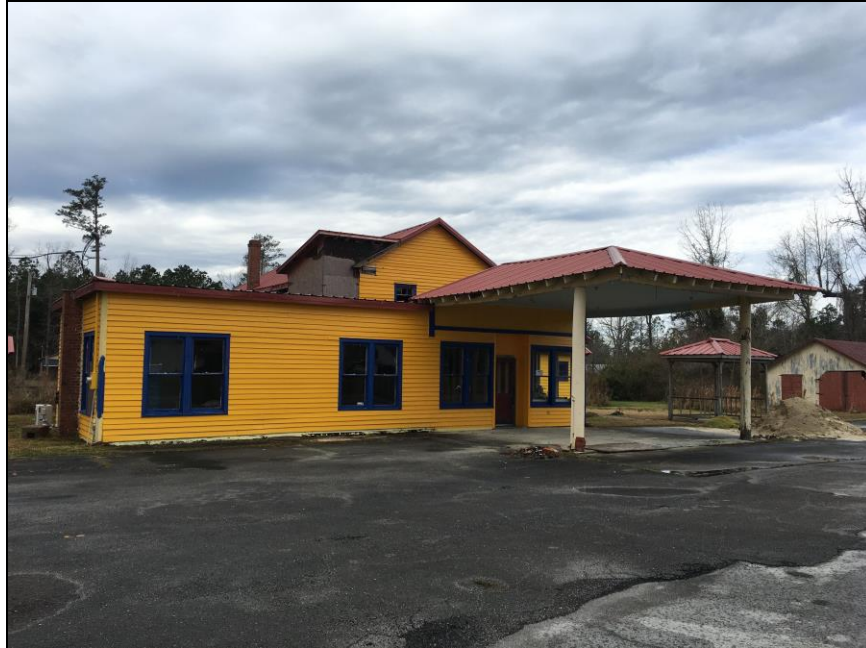
The Tom Haywood Store consists of an original two-story frame structure on a continuous brick foundation and clad in weatherboard. The front gable roof of the original portion is clad in standing-seam metal and features cornice returns. An exterior brick chimney is located on the south elevation of this original portion of the store. Multiple one-story additions extend off the north, west, south, and east elevations and are clad in the same materials as the original structure. The one-story addition on the east elevation, constructed to accommodate a restaurant, reorients the building east towards US 70 and features a flat roof with an exterior brick chimney on the south elevation that terminates at the roofline. From that addition extends a slightly taller hip-roofed canopy with exposed end brackets, which is clad in standing-seam metal and supported by round metal posts. The canopy once covered gas pumps that are no longer extant.

**Figure 10:** East elevation of Tom Haywood Store, looking northwest.

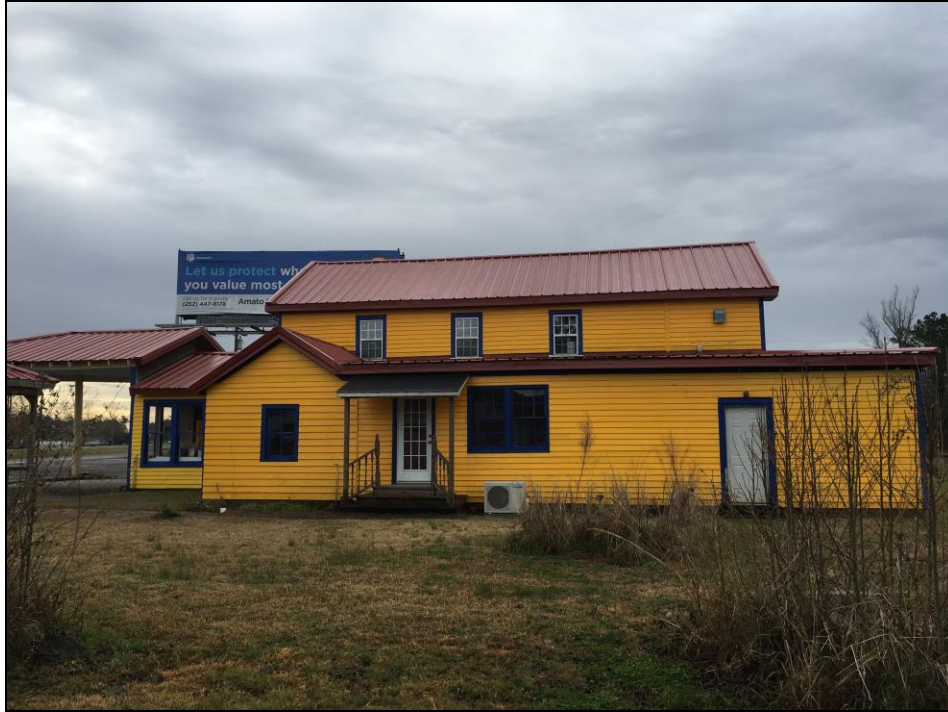
Windows on the first floor of the east elevation are paired one-over-one wood sash windows, two of which flank the recessed one-light, two-panel wood entry door. On the second story are two three-over-three wood sash windows. Six-over-six wood sash windows are present on the other three elevations of both the original store and its additions, however three of the six-over-six windows on the second story of the north elevation are vinyl sash replacements. Entry doors on the north elevation are replacements.

**Figure 12:** Tom Haywood Store, north elevation.

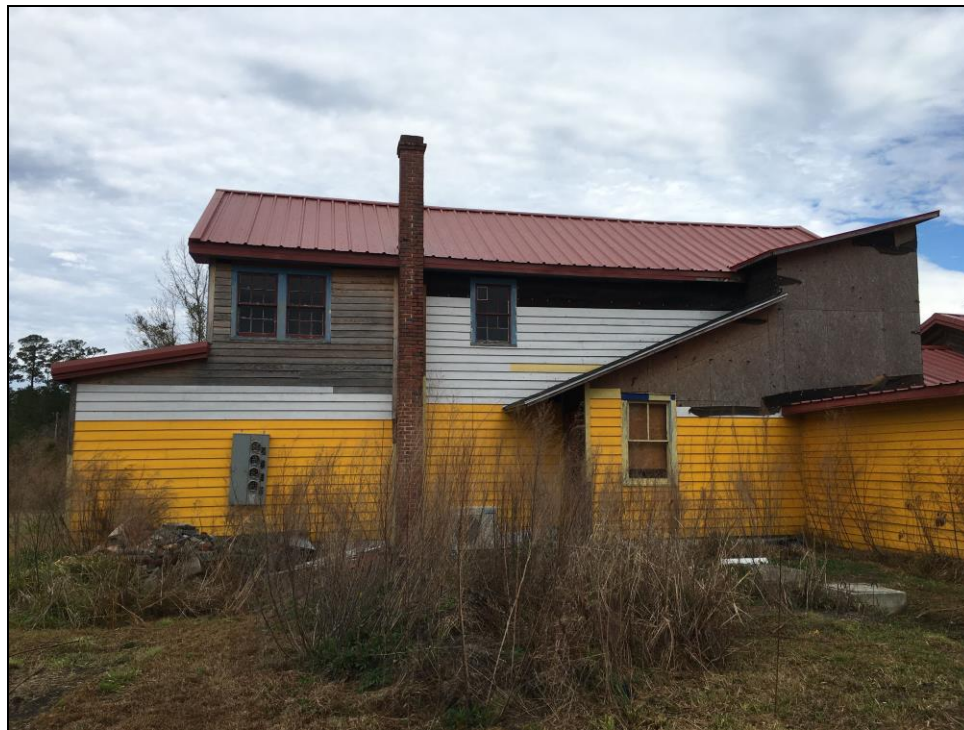
An exterior covered stairwell providing access to the second story is located on the south elevation, behind the restaurant addition, and contains one two-over-one wood sash window. It was most likely constructed when the second floor was converted to a residence. The door is no longer extant, and plywood covers the entrance.

**Figure 14:** Tom Haywood Store, south elevation.

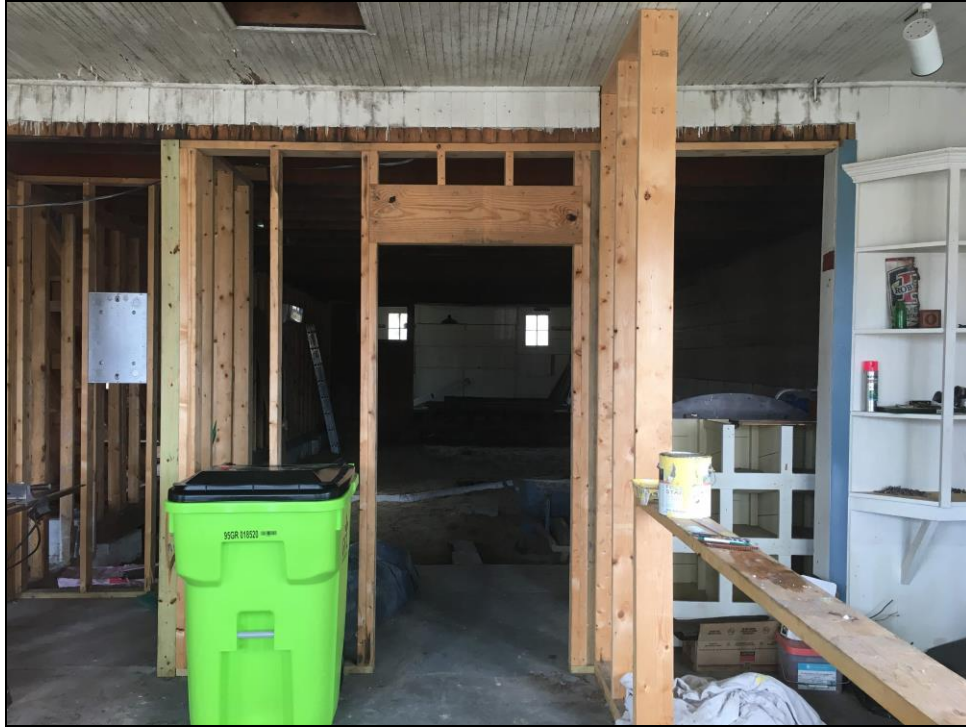
On the interior, the store appears to be undergoing renovation and is stripped of most of the flooring, some of the ceiling finishes, and other fixtures. New framing for interior walls has been added, and the floors within the original store and its additions have been removed and are exposed to dirt. Built in shelving and novelty board on the ceiling of the restaurant addition is still present, as are hanging light fixtures. Photographs from the 1981 survey documenting the interior prior to this ongoing renovation can be found in the History section of this report on page 21. The second floor was not accessible.

**Figure 15:** Interior looking west from the one-story restaurant addition into the original portion of the store.

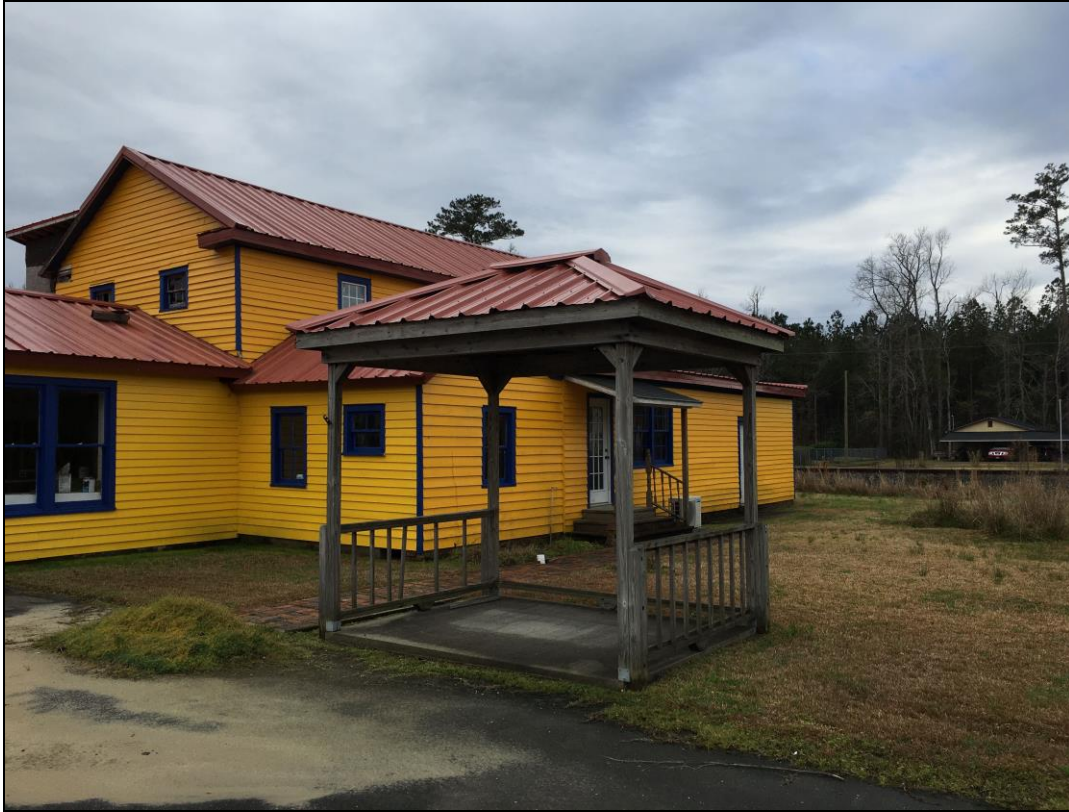
A wood frame gazebo with a hipped roof clad in standing-seam metal is located directly north of the store. This gazebo appears to be a replacement of the original gazebo, which featured unhewn logs as posts and railings, that once sheltered a “Self Kicking Machine.” The Self Kicking Machine is now located in the North Carolina Museum of History in Raleigh; it was replaced with a replica and it is unknown where the replica of the machine is located.

**Figure 22:** Replica gazebo which once housed the Self Kicking Machine, looking southwest.

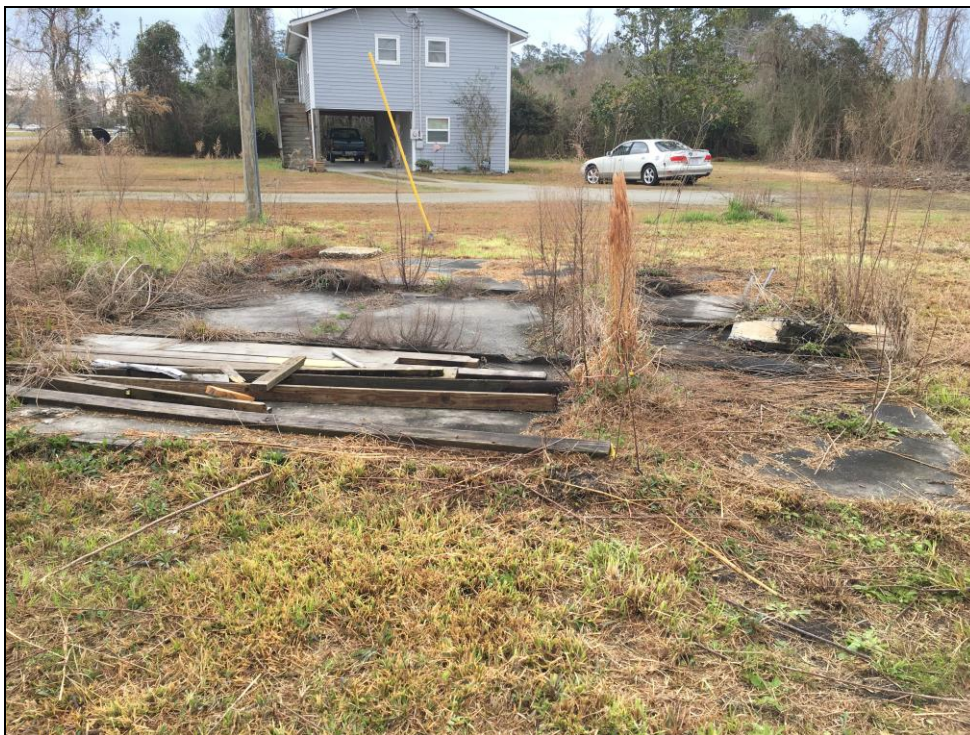
**Figure 26:** Concrete pad which was former location of restrooms, looking south.

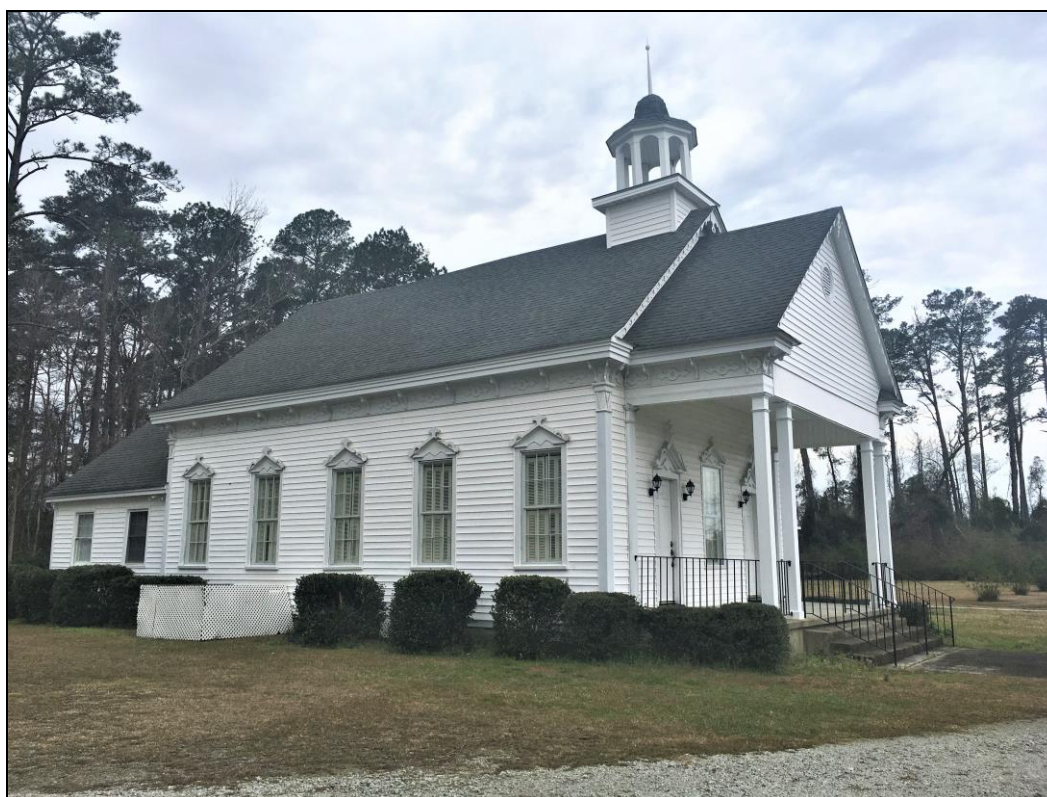
**Figure 40:** Croatan Presbyterian Church (CV1385) looking west.

The Croatan Presbyterian Church retains a low to moderate level of integrity. Although road projects have led to its relocation twice, it remains in its general original location. The overall form and style of the church and its historic additions remain, it therefore retains integrity of location, setting, and association. Integrity of workmanship and materials is diminished due to hurricane damage of 2011 with the replacement of the roof and most of the interior, and the addition of aluminum siding. A portion of the aluminum siding was examined, and it appears that the original weatherboard siding is no longer extant underneath. With the addition of the brick veneered Sunday school and fellowship hall, and the creation of the opening between the two buildings in what was originally a continuation of the window band, the church has lost integrity of design and feeling.

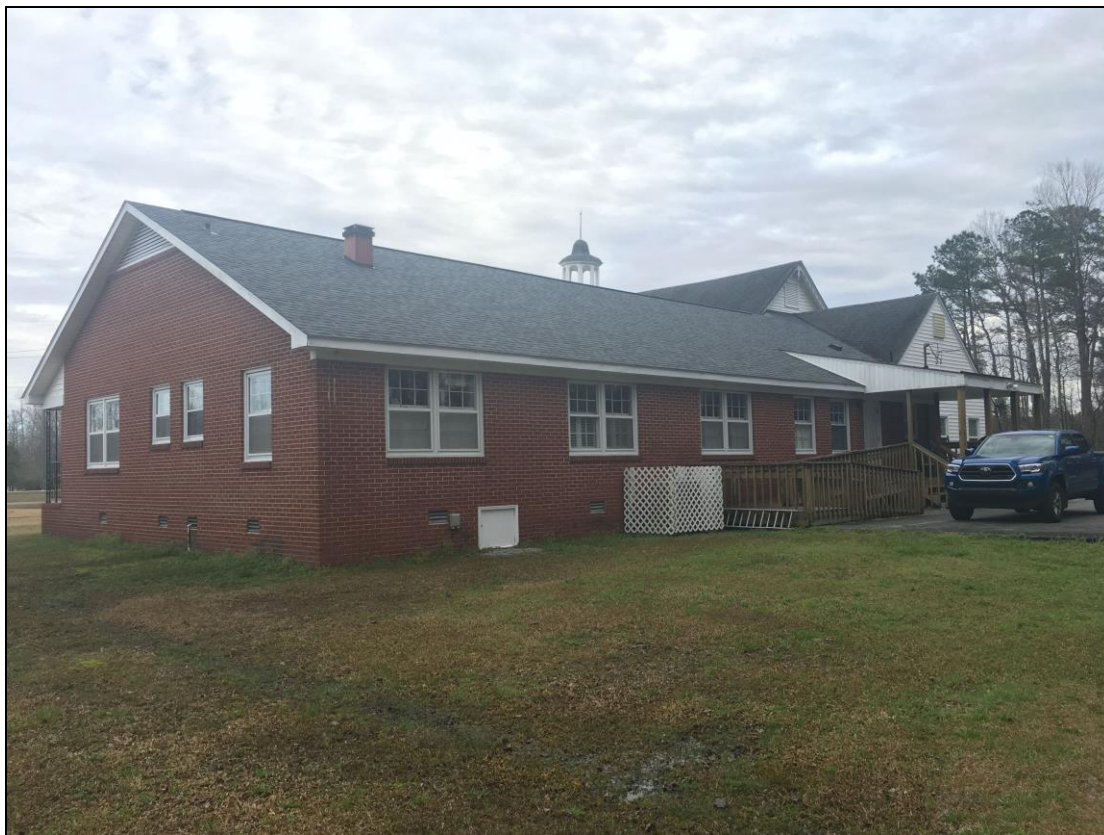
**Figure 48:** Sunday school and fellowship hall addition, looking east.

In the spring of 2011 a tornado, and then in the fall of 2011 a hurricane, heavily damaged the church. The tornado damaged its foundation and structure, and cracks within the walls of the fellowship hall are still present. Dr. Richard C. Boyd, pastor, noted that foundation repair is ongoing but is not complete.<sup>13</sup> Much of the roofing was torn off during the hurricane. This resulted in the collapse of the sanctuary ceiling and interior water damage. Almost all the interior of the sanctuary was replaced at this time. When the new pews were installed, the old pews were purchased by church members as mementos. A new handicapped bathroom and back porch were added in 2015.<sup>14</sup>
