North Carolina Department of Natural and Cultural Resources
State Historic Preservation Office

MEMORANDUM

SUBJECT: Historic Structures Survey Report, Upgrade US 276 (Jonathan Creek Road) from US 19 to I-40 R-5921, Haywood County, ER 21-1422

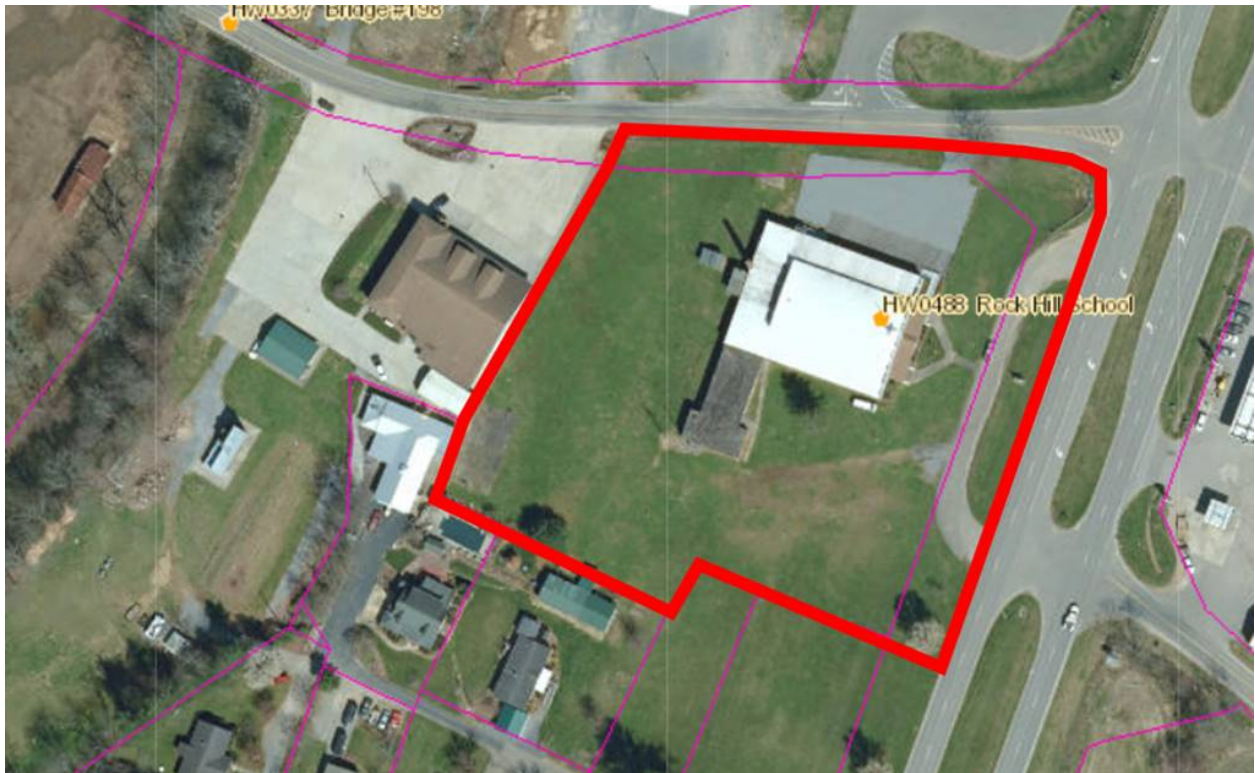
HW0488 (Rock Hill School) - We do not concur with the consultant's assessment that the Rock Hill School (HW0488) is ineligible for listing in the National Register of Historic Places. While the property does not appear to be significant under Criteria B and D and does not retain sufficient material integrity to be eligible under Criterion C, the property is eligible for listing under Criterion A in the area of Education. Though the windows have been replaced and the steeple added after a likely Period of Significance of 1935 (construction date) to 1971 (50 years) or 1973 (accreditation). Considering that the name "Rock Hill School" appears on the enclosed porch in the 1983 survey photos, it is clear that this alteration was done in service to the building's historic use. Possibly completed after 1973, the alteration perpetuated the property's historic associations and is less impactful than it might be, if undertaken for the change of use. The interior photos shot through windows suggest that the interior retains its overall configuration and historic finishes, which are important in conveying historic significance of

education. That the windows have been replaced does not necessarily preclude eligibility, since other schools with similar alterations have been listed in the western region. An appropriate boundary for the eligible resource is shown below.

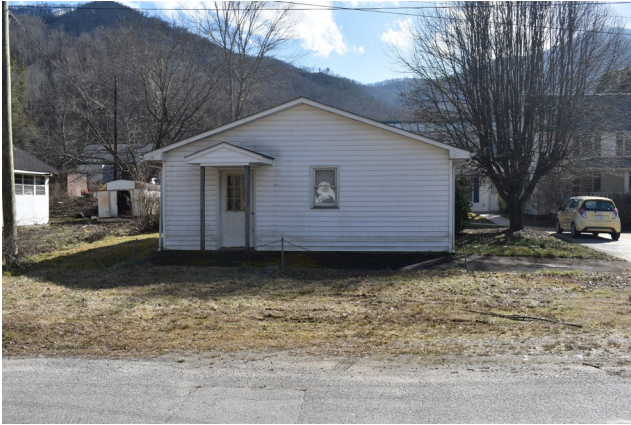
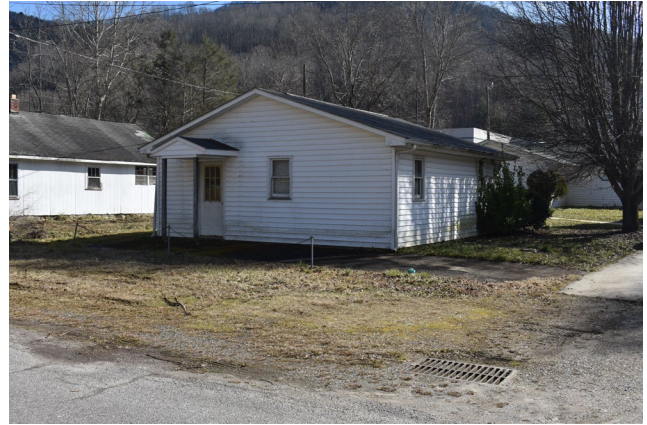
The simple front-gabled, frame residence is one of two buildings located at 132 Teague Loop. It sits at the northeast corner of its parcel and is accompanied by the sprawling Dellwood Baptist Parsonage (see Resource D below). The single-story residence is rectangular in plan and clad with vinyl siding. Its roof is topped with asphalt shingles. The residence is accessed via an off-centered, fiberglass door at its façade. This entrance rests beneath a simple pedimented portico supported by wooden posts. One-over-one wood-sash windows are found at the façade and secondary elevations and suggest a mid-twentieth century construction date, as does historic map evidence (Figure 31). The building presents no notable design or stylistic features.

Figure 15: Left, north elevation of Resource C at 132 Teague Loop, looking south; right, oblique of Resource C at 132 Teague Loop, north and west elevations, looking southeast.

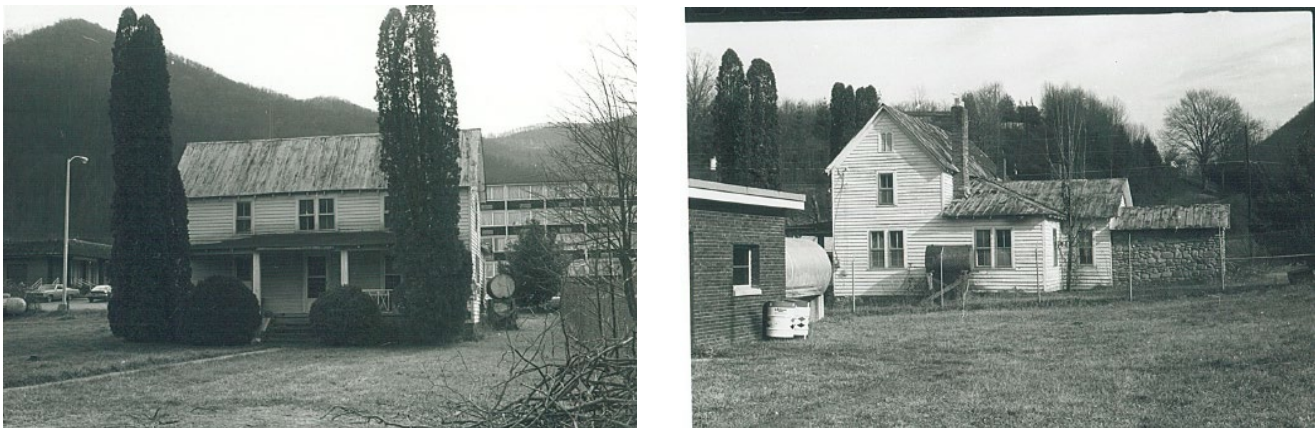
Figure 17: Photographs of former Dellwood Baptist Parsonage (HWO374)/Resource D ca. 1982 from Cotton survey (photo credits: J. Randall Cotton, HWO374 Survey File, NCHPO).

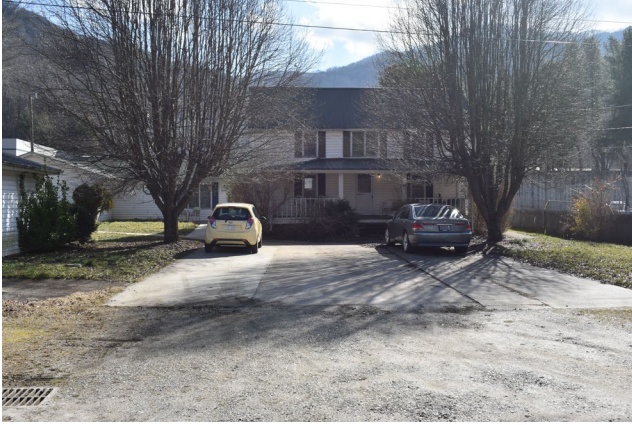
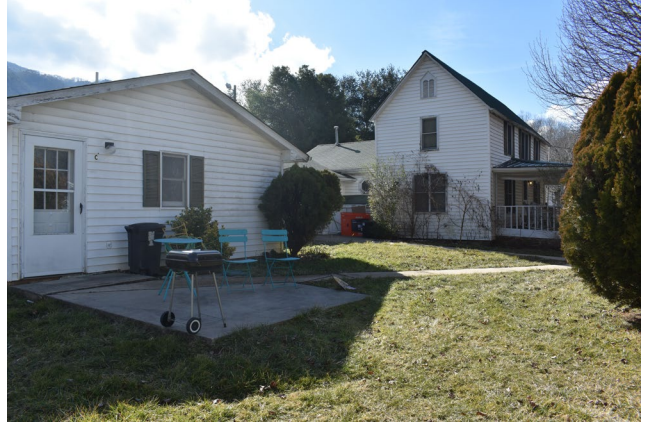
In the almost four decades since Cotton's survey, the building has been significantly altered and lost an extensive amount of original material. The biggest alteration to the residence is the increase in its building footprint through the addition of a large single-story, frame L-wing which extends from its western elevation (Figure 16). According to historic aerial images, this addition was added sometime between 1982 and 1998. Material changes to the original I-house block include the removal or covering of original weatherboards with vinyl; the replacement of the original two-over-two sash windows with one-over-one vinyl units; the replacement of the hipped-roof porch in its entirety; and the application of a new roof and removal of exposed rafter tails. Limited views of the building's interior as seen at Zillow.com suggest the interior retains very little, if any, of the original material observed by Cotton in 1982 (Figure 18-Figure 20).

Figure 18: Left, north elevation of Resource D (former Dellwood Baptist Parsonage (HWO374)) at 132 Teague Loop, looking south; right, oblique of Resource D at 132 Teague Loop, north and east elevations at 132 Teague Loop, looking southwest.

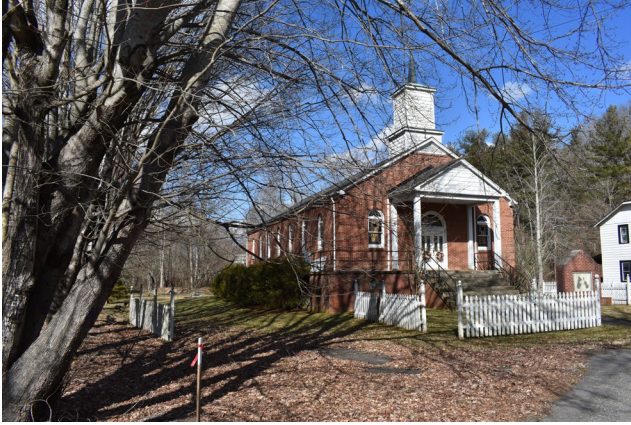
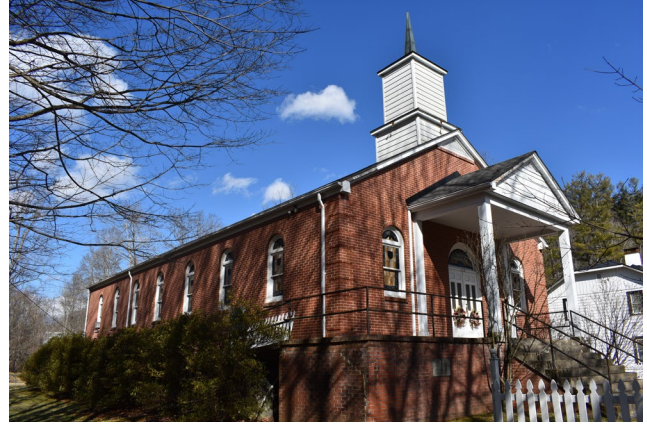
The former church stands on the north side of Teague Loop and is oriented to the south. Featuring a simple, rectangular plan, the building is clad in brick with brick quoins at its corners. The church's front-gabled roof is asphalt-shingled and topped with a steeple comprised of a vinyl tower and metal spire. A vinyl-clad, pedimented portico supported by wooden posts embraces the façade and rests on a raised brick foundation. The portico covers the building's centrally placed arched doorway, which holds an original set of paired, wood-paneled doors, each with two rectangular lights. The doorway is topped by an arched stained-glass transom. Flanking either side of the doorway are arched window openings holding one-over-one stained-glass, double-hung, wood sash. Like the door, they are topped with arched stained-glass transoms. The windows rest on simple brick sills and are set in deep, stepped, wood casings. Seven windows of the same style punctuate both the building's eastern and western elevations. The building appears to retain its original footprint and displays little evidence of alterations to its exterior. A brief interview with a Dellwood residence suggests that the building's interior has been heavily altered to serve a residential function.

Figure 23: Left, west and south elevations of Resource F at 115 Teague Loop looking north; right, oblique of Resource F at 115 Teague Loop, west and south elevations, looking northeast.

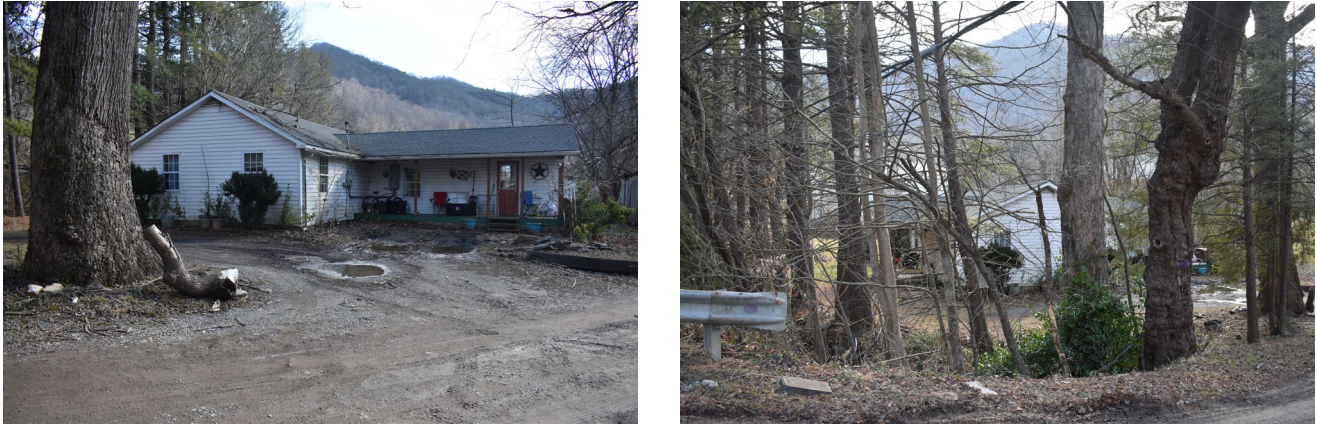
The small single-story residence stands directly north of Resource E. It is bounded to the east by the NCDOT right-of-way buffer for Jonathan Creek Road/US 276. According to Haywood County tax data, the building dates to ca. 1942. Situated near the northern edge of its roughly half-acre parcel, it retains a low degree of material integrity. It has a T-shaped plan with an original side-gabled front block and rear ell. Its original siding has been removed or replaced with vinyl, as have its original windows and doors. A pedimented porch supported by replacement posts is centered on the building's façade, which faces east toward Jonathan Creek Road/US 276. An engaged porch at its rear (southwest) is also supported by replacement posts.

Figure 28: Left, west elevation of Resource K at o Jonathan Creek, looking northeast; right, oblique of Resource K at o Jonathan Creek, north and east elevations, looking southwest.

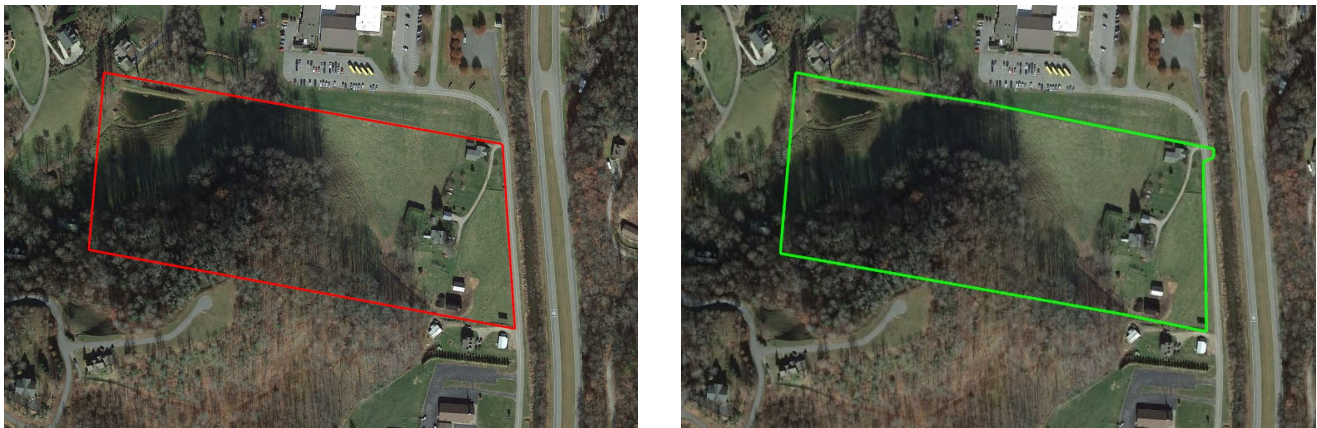
The recommended boundary of the Campbell-Hall House property is the entirety of its 19.31-acre parcel (PIN 8607-02-7085), which is historically associated with the house, excepting a small hook that extends into Hall Drive. This boundary contains the house, its contributing gambrel-roof barn, small livestock barn, concrete silo, frame run-in shed, and stone wall, in addition to its non-contributing garage, modern paddock barn and mid-twentieth-century house. The proposed boundary is believed to provide the Campbell-Hall House with sufficient historic context to support its significance. At its east, the boundary extends to the edge of pavement, into the NCDOT right-of-way along Hall Drive, as this area contains pasture historically associated with the resource's farming operations. The small hook of land atop Hall Drive is paved and has lost its integrity. It is therefore excluded from the proposed boundary (Figure 66).

Figure 66: Left, proposed NRHP boundary for the Campbell-Hall House (outlined in red); right, current parcel boundary for comparative purposes (outlined in green).

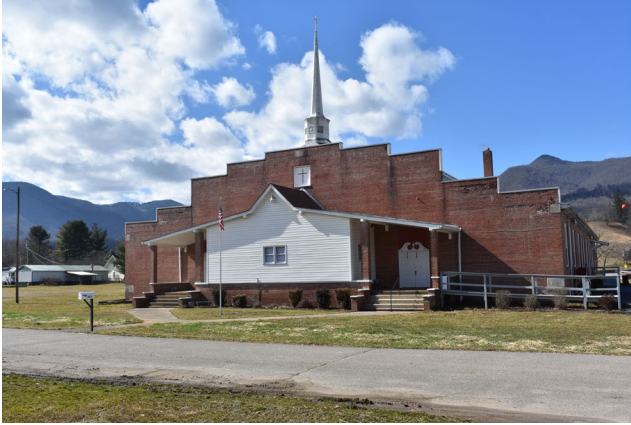
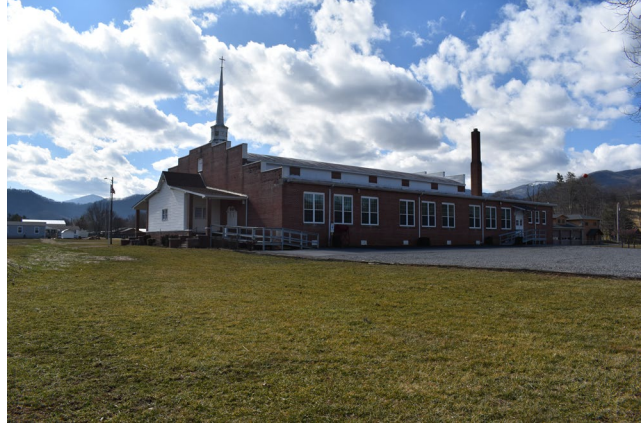
A front-gabled, double-entry front porch embraces the façade but was enclosed with T1-11 siding as of the 1982 Cotton survey. This siding was subsequently replaced with vinyl, although the paired windows centrally placed in the enclosed block appear to be earlier one-

over-one, double-hung, wood sash. The roof of the porch, which features a center gable with two shed-roof wings extending from either side, is supported original brick columns. The porch shelters two doorways, one under each shed-roof wing (Figure 68). The original paneled wood doors with multi-fixed panes have been removed and replaced with paired fiberglass units, and the original large, multi-paned transom windows have been replaced with prefabricated scrolled pediments. The original doors remained in place as of the 1982 Cotton survey (Figure 79).

Figure 68: Left, front (east) elevation of Rock Hill School, looking west; right, oblique view of east and north elevations, looking southwest.

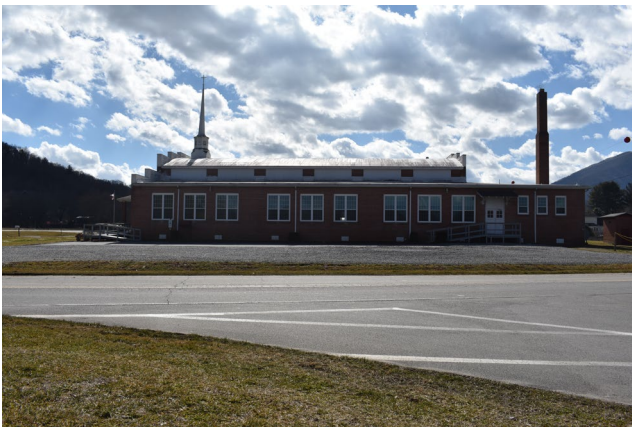
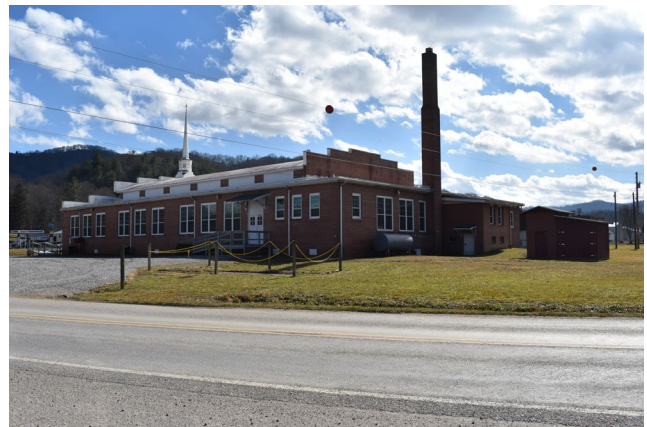
Three groupings of paired twelve-over-twelve replacement vinyl windows march along the north and south elevations of the one-story level, indicating three classrooms at either side wing. The replacement windows rest on original concrete sills and are framed at the top and bottom by a row of header bricks. Accompanying these windows on the building's eastern and western elevations is a set of original wood-paneled double doors which lead into the building's rear hall. The hall door at the building's southwestern corner is comprised of four recessed panels with four fixed lights above and a multi-pane transom light which has been covered over. A shed-roof awning with exposed rafter tails and wooden brackets shelters the entryway which is accessed by a modern wood ADA-compliant ramp. Three replacement nine-over-six vinyl windows are found to the right (west) of the exterior hall door and signify the location of offices. In turn, the hall door at the building's north elevation/northwestern corner is comprised of four recessed panels and six fixed lights above. The door is accessed by a raised, poured concrete ramp. No office windows are found to the rear (west) of this door. Limited views through the windows of both exterior doors revealed the retention of the building's original rear hall configuration. A raised stairway is visible at the hallway's center in addition to multiple doorways suggesting the retention of at least some of the building's original room divisions (Figure 71).

Figure 70: Left, view of north elevation, looking south; right, oblique view of north and west elevations, looking southeast.
