North Carolina Department of Cultural Resources
State Historic Preservation Office

Ramona M. Bartos, Administrator

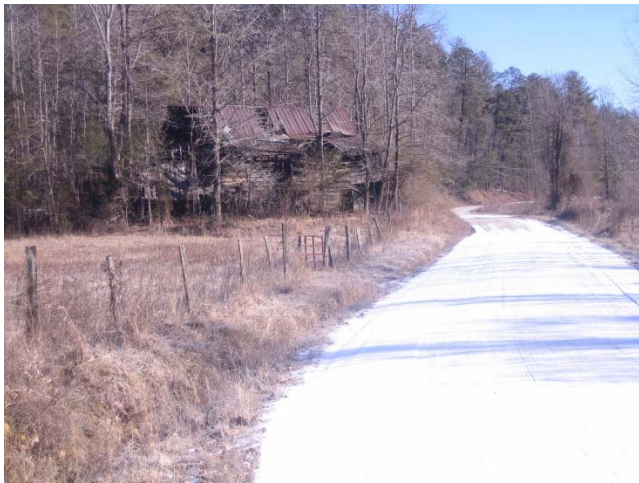
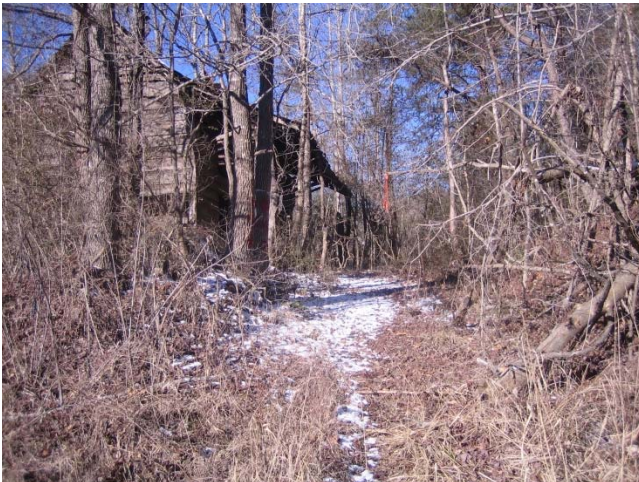
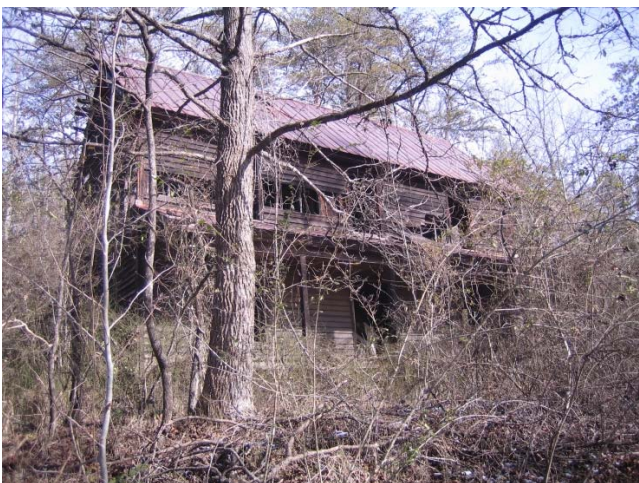
Thank you for your cooperation and consideration. If you have questions concerning the above comment, contact Renee Gledhill-Earley, environmental review coordinator, at 919-807-6579 or renee.gledhill-earley@ncdcr.gov. In all future communication concerning this project, please cite the above referenced tracking number.

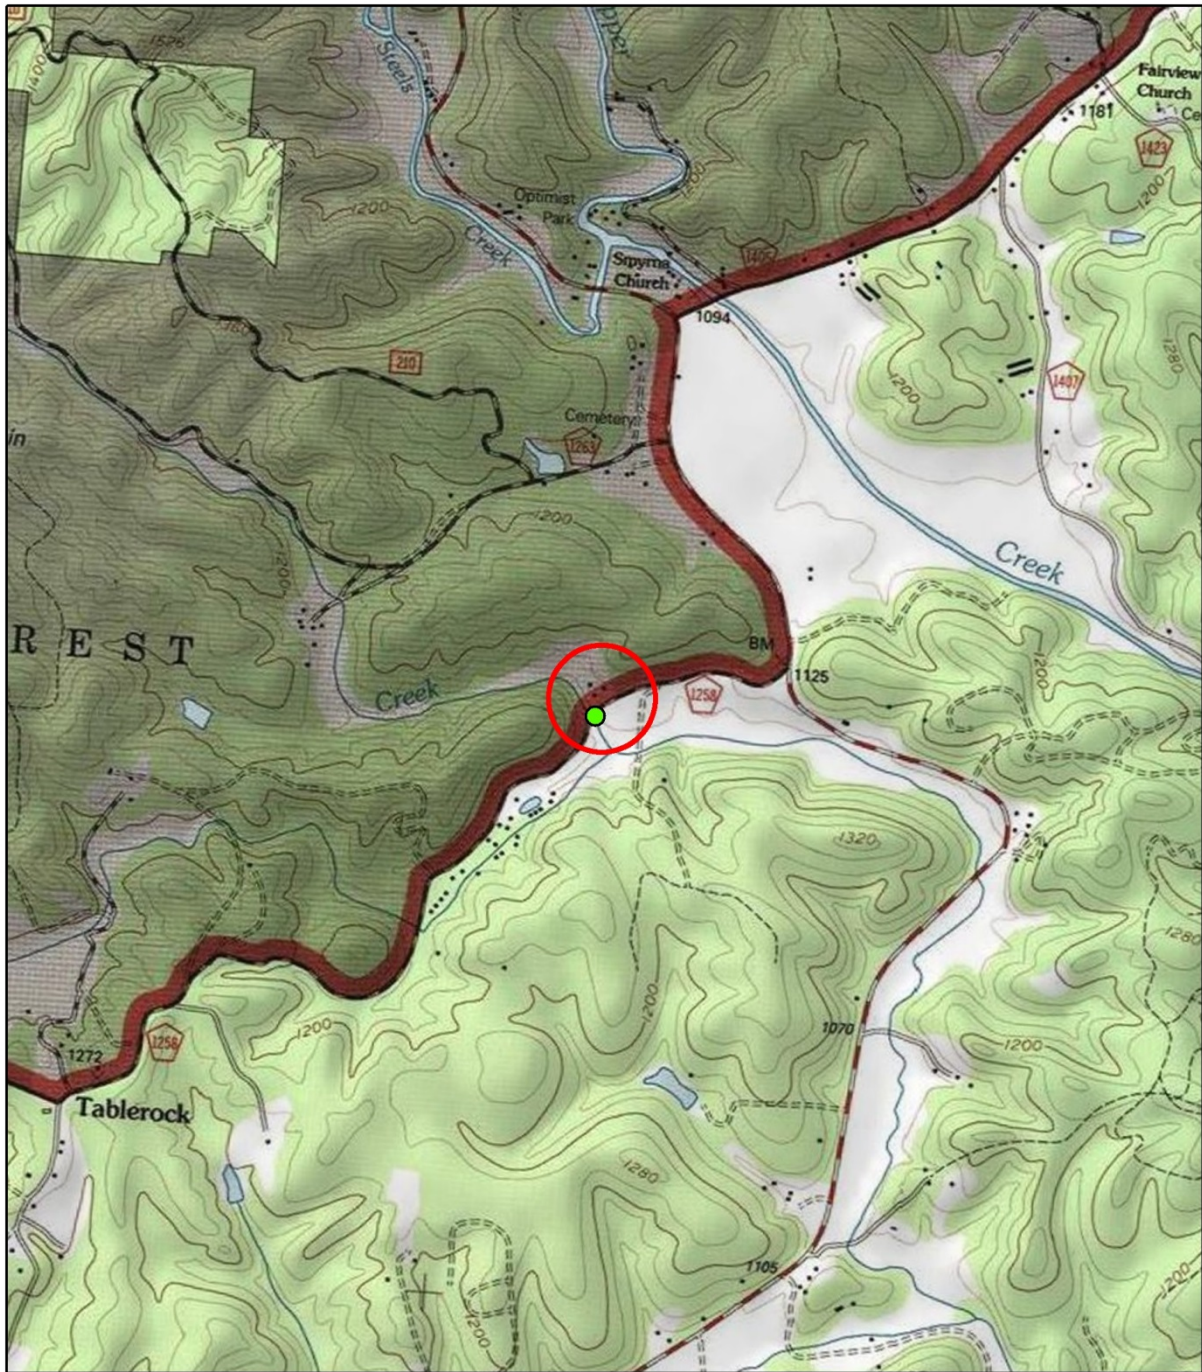
Figure 1. Cox-Simpson Creek Farm Location Map

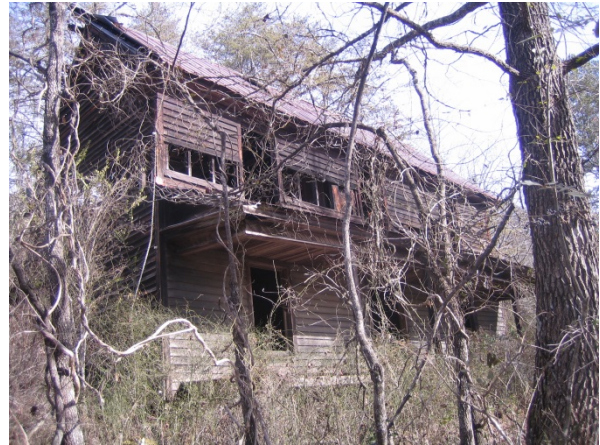
The Cox-Simpson Creek Farm is located on the north side of SR 1258 (Rose Creek Road), north of Simpson Creek and west of Rose Creek, at the edge of the Pisgah National Forest (the property is within the National Forest Boundary according to USGS maps, but is privately owned.) Most of the terrain is hilly and wooded, with the exception of level land in the floodplain of Simpson Creek (**Photo 1**). Much of the property in the vicinity of the buildings is overgrown, though some former circulation routes are discernable among the trees (**Photos 2 and 3**). The level land in the creek floodplain appears recently cultivated and is bordered along the roadside by a wood post and barbed wire fence, which dates no earlier than the road's realignment in the 1910s or 1920s. An abrupt rise in terrain, together with evergreen and deciduous trees, marks the northeastern edge of the cultivated area.

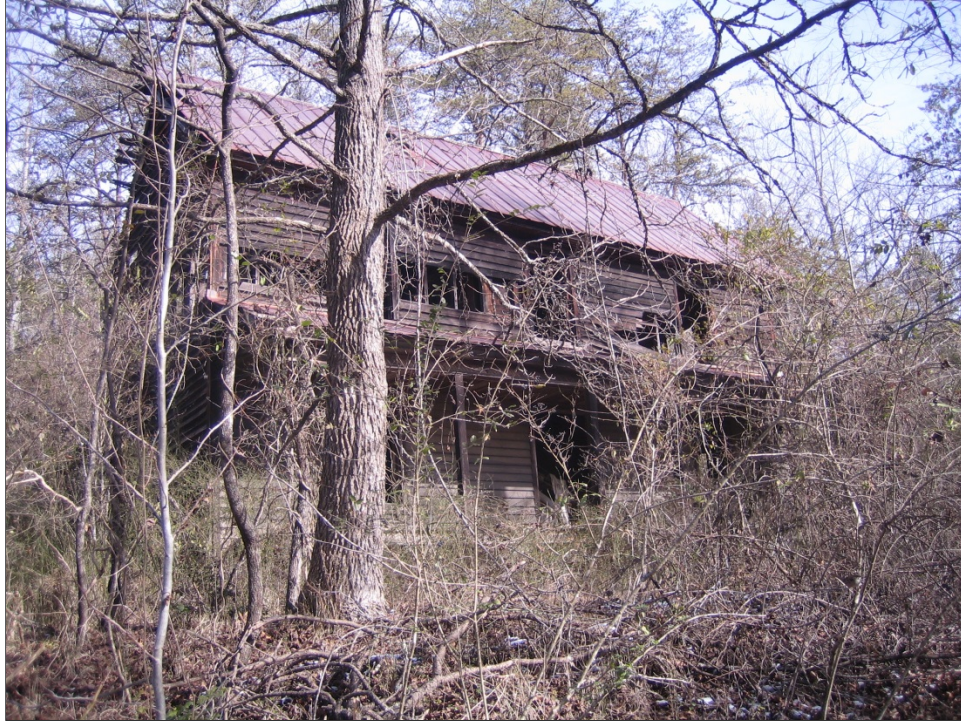
Photo 4. House, view northeast. Note the missing weatherboard at the second story, and missing door and window muntins.

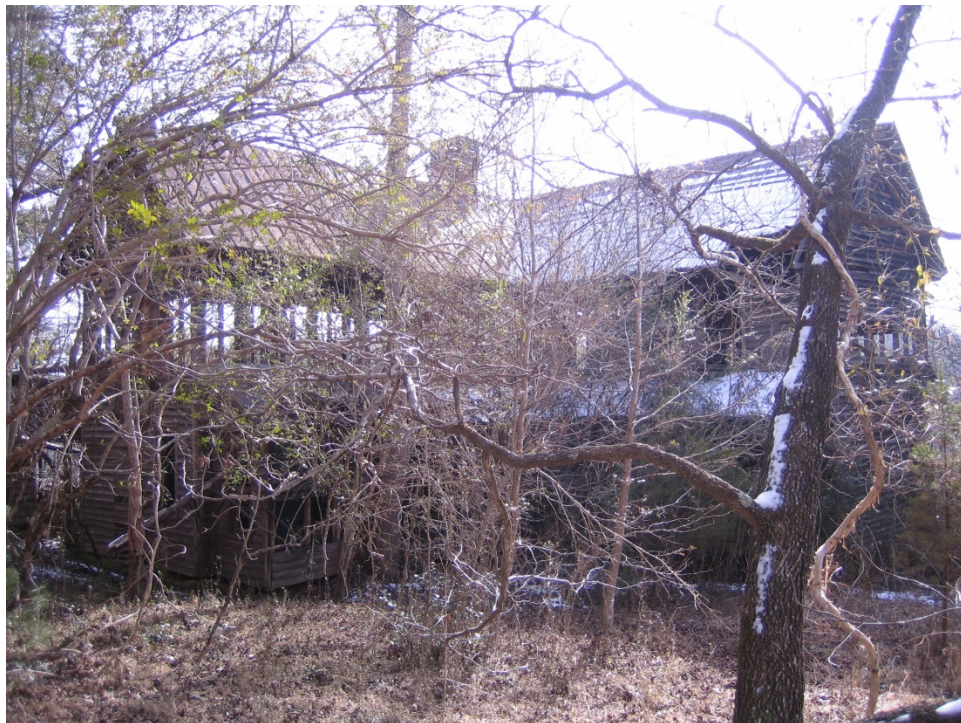
Photo 5. House, rear ell and rear of main block, view southeast. Note the missing weatherboard at the second story. Much of the weatherboard is missing at the second story of the rear ell.

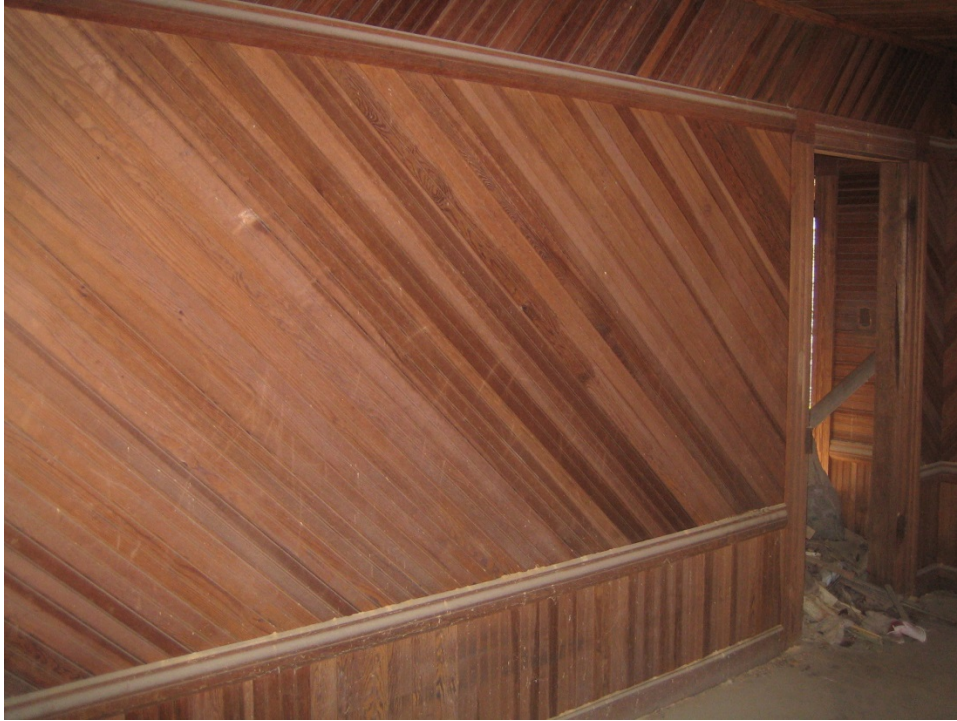
Photo 6. House, west room of main block, view southeast. The doorway accesses the center hall; the door frame of the main entrance is just visible through the doorway.

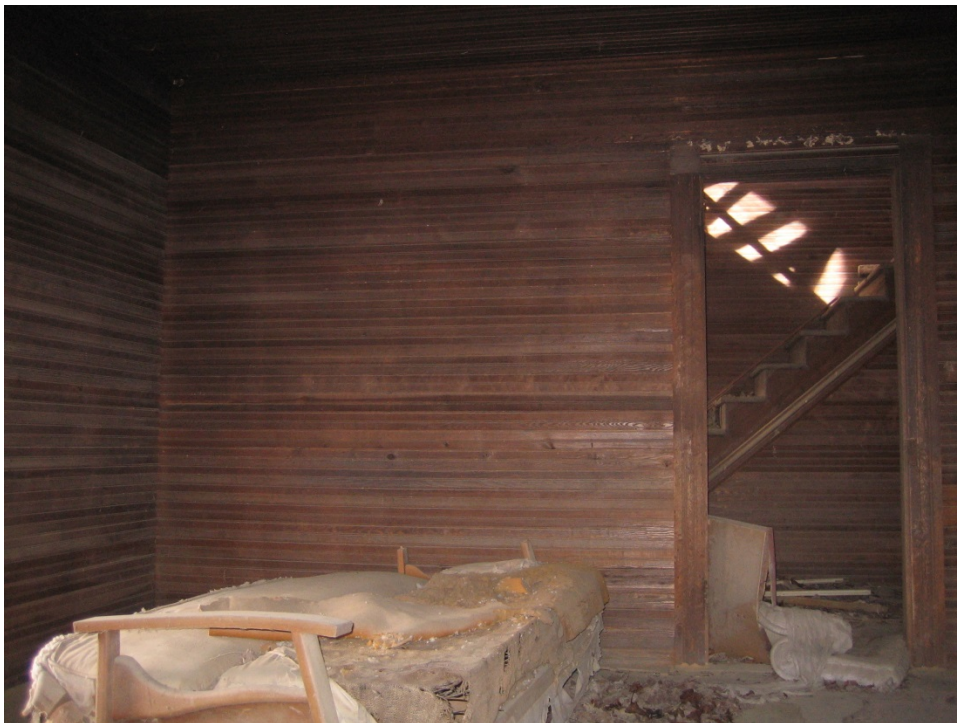
Photo 7. House, east room of main block, view west. The doorway accesses the center hall; the stair to the second floor is visible through the doorway. Similar matchstick finish is found throughout the house.

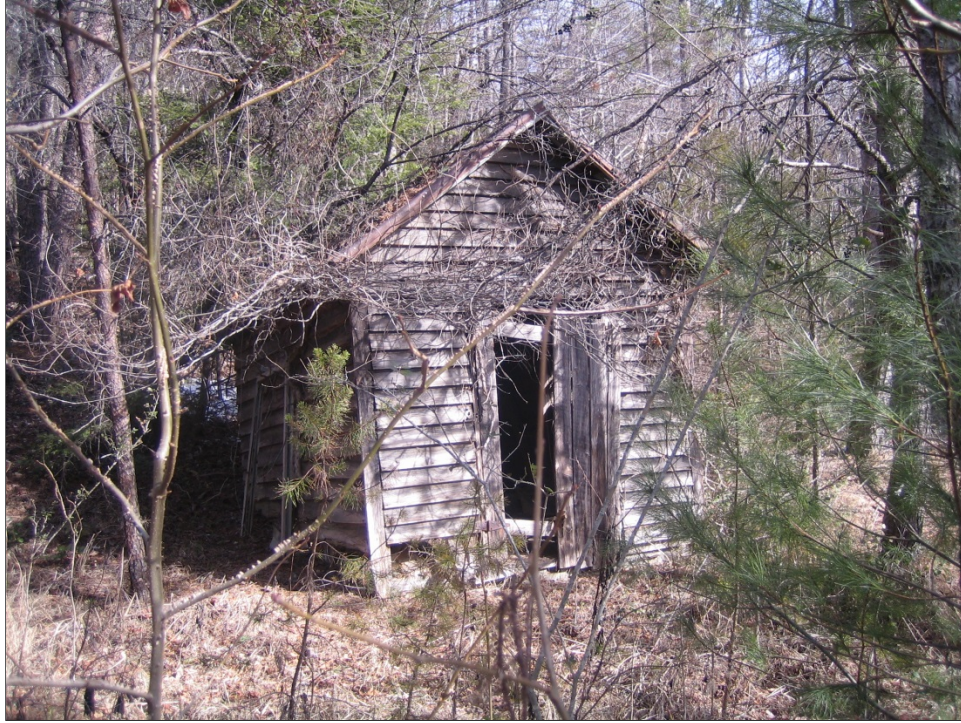
Photo 9. Shed A, view northeast.

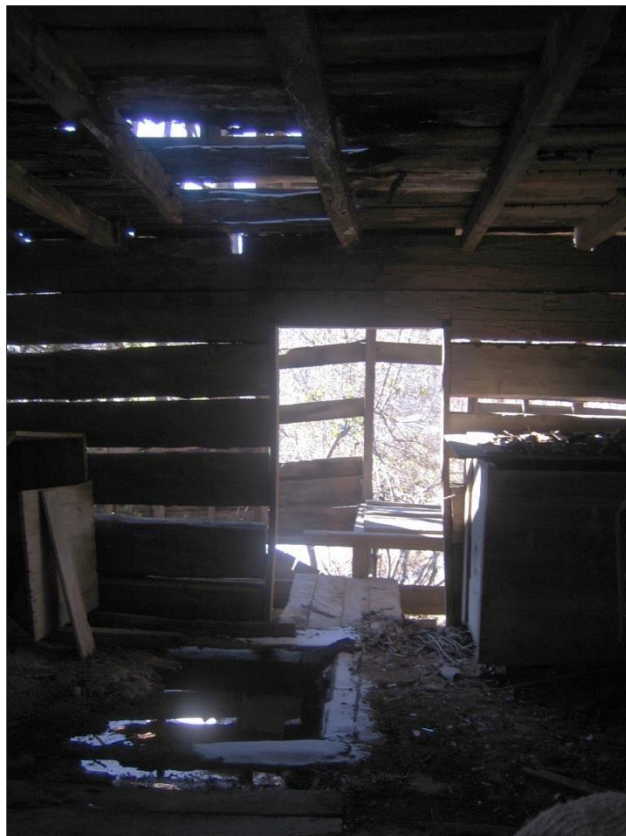
Photo 17. Barn, interior, view south. This view through the log building from the north entry shows deteriorated flooring at each level, and the south doorway to plank covering over a stall in the frame addition.

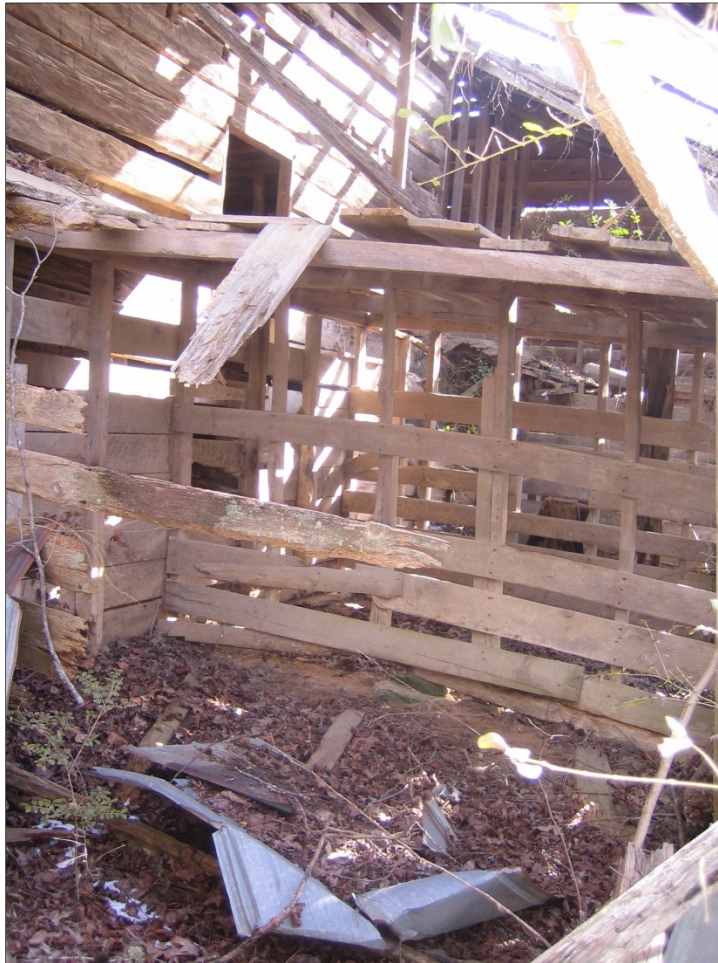
Photo 18. Barn, interior south side, view east. This area appears to have functioned as animal pens. Planks have been laid over the central pen, which is accessible from the doorway in the log section at left.

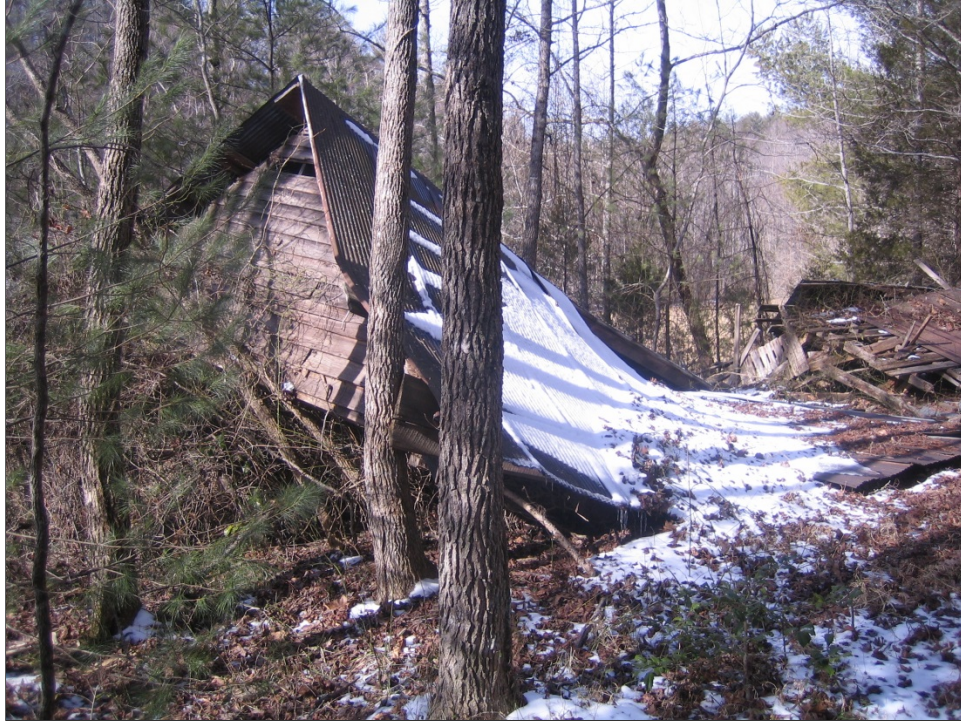
Photo 19. Former latched crib, now collapsed, view southwest.
