North Carolina Department of Natural and Cultural Resources  
State Historic Preservation Office

MEMORANDUM

Re: Improve NC 73 from NC 16 Business to Northcross Avenue (SR 2316), PA 16-04-0034, R-5710/R-5721/U-5765, Lincoln and Mecklenburg Counties, ER 17-1165

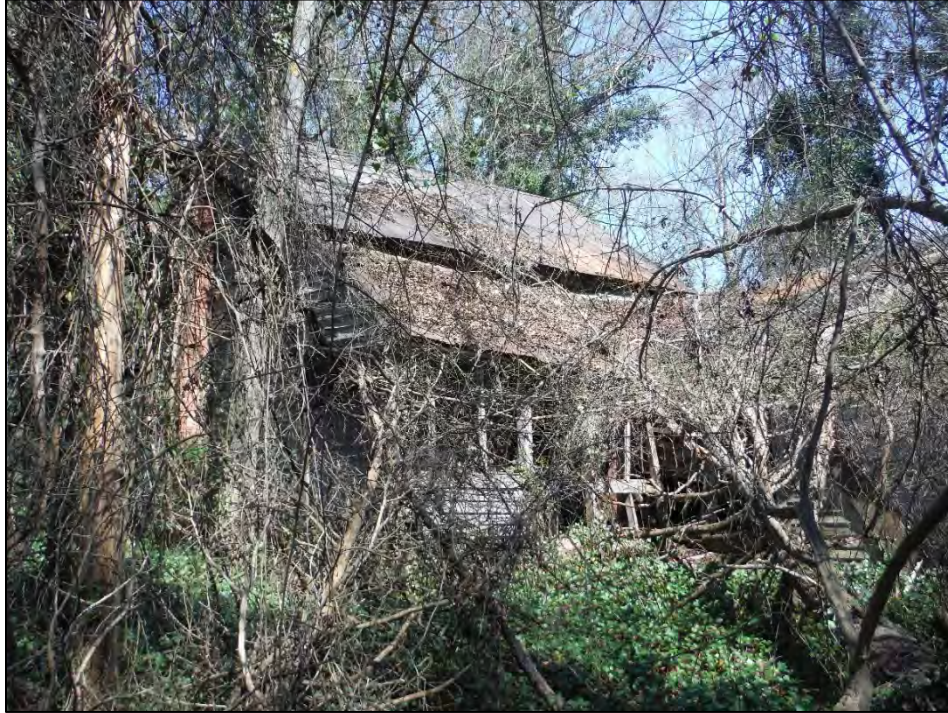
**Figure 2.2.4. View of the Carl Beard House, facing northeast.**

house has a central exterior brick chimney, which is flanked by a single rectangular window opening on either side on the first story and a single, square window opening on the upper, loft story; none of these window openings has extant window components (Figure 2.2.3). The rear elevation of the original structure has a shed-roofed porch spanning its width, which is partially supported by wooden posts; this porch is in poor condition and has begun to collapse (Figure 2.2.4).

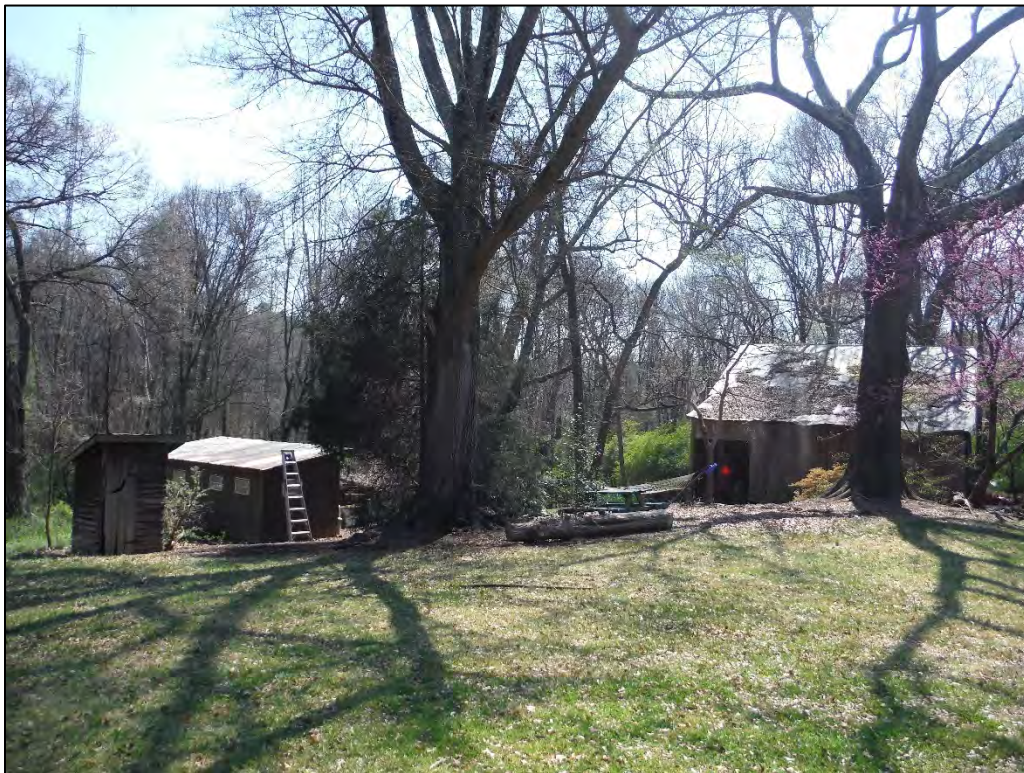
**Figure 2.3.12. View of privy, chicken house, and barn, Lynn Beard House, facing southeast.**

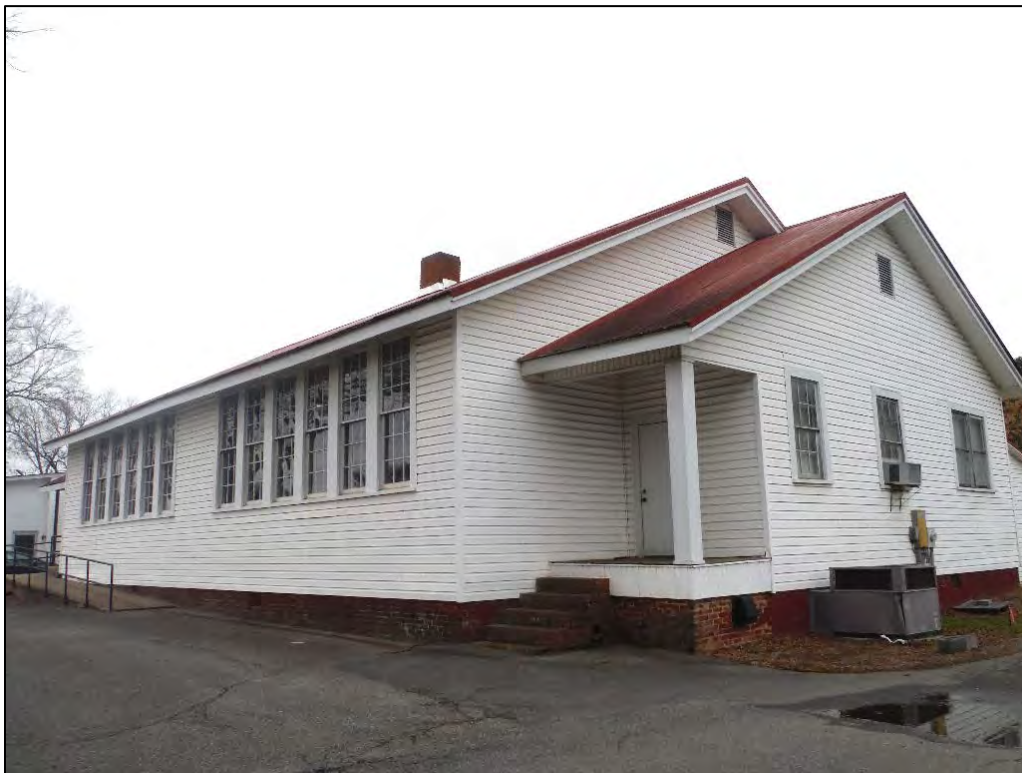
The school building is a wooden framed structure that sits on a brick foundation, with a side-gabled roofline and a small, side-gabled entry portico on the eastern side of the structure (Figure 2.5.3). The south elevation

Figure 2.5.3. Caldwell Rosenwald School, facing west.

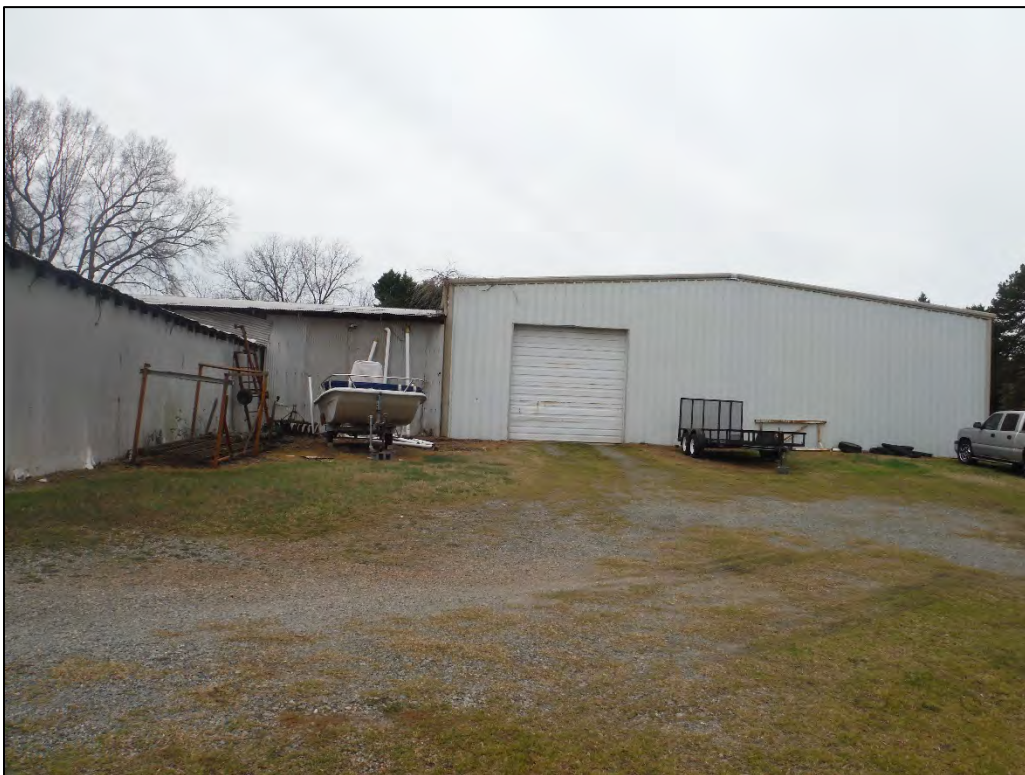
A shed-roofed metal addition, with two garage door bays, has been attached to the northern elevation of the school building (Figure 2.5.5). Two metal-framed, flat-roofed warehouse buildings, with brick veneer exterior and concrete interior, have been attached to the western elevation of the school via a frame hyphen section that connects to the mid-twentieth-century western porch structure (Figure 2.5.6). The eastern warehouse structure has a large, glassed opening that is divided into five large panes surrounding a double, glass entry door. To the west of this portion of the structure, the warehouse extends forward, in a structure with one entry door on both the eastern and western walls, and three tall, single-pane, casement windows along the south elevation (Figure 2.5.7). The western warehouse structure has a single garage-style door, a single main entry door, and a single-pane casement window on its south elevation, while it has two, small, single-pane casement windows on its western elevation. An interior brick chimney structure is visible above the roof (Figure 2.5.8). Attached to the north elevation of the metal/concrete/brick veneer warehouse structures is a large, metal warehouse structure with a low-pitched gable roof, corrugated metal sheathing, and a loading dock area on both the eastern and western elevations (Figures 2.5.9 and 2.5.10).

**Figure 2.5.10. Caldwell Rosenwald School, rear warehouse addition, facing west.**
