**NATIONAL REGISTER OF HISTORIC PLACES**

**Cicero Pennington Farm**

Sturgills vicinity, Ashe County, AH0153, Listed 09/11/2018

Nomination by Eric Plaag, PhD, Carolina Historical Consulting, LLC

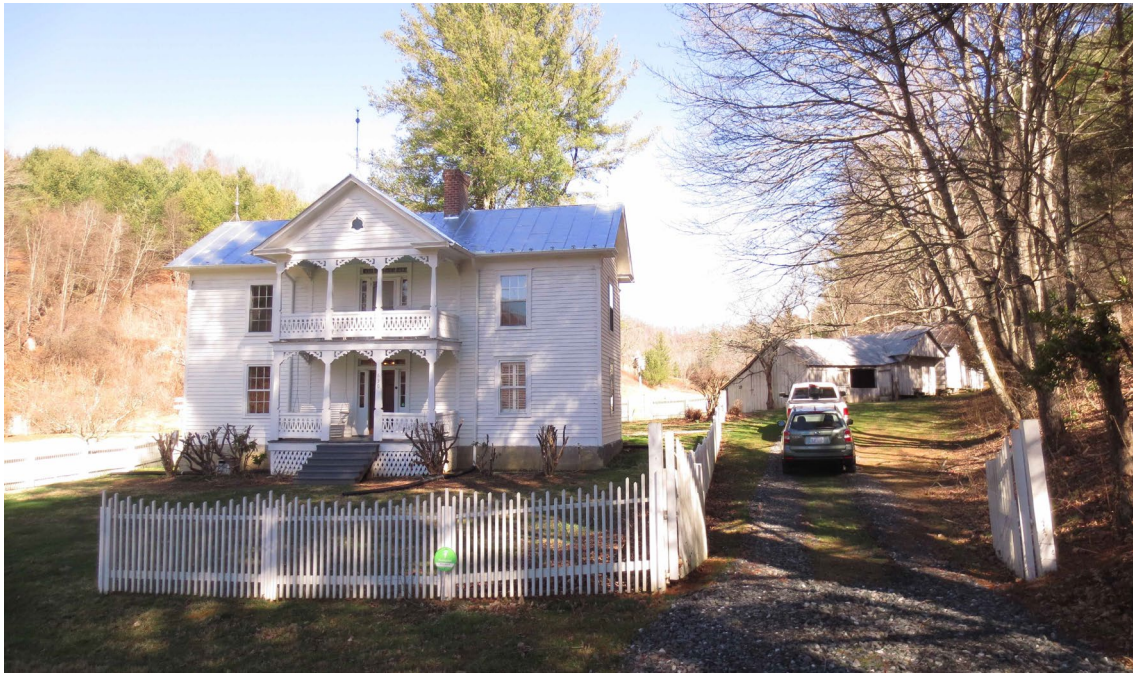
Front (south) elevation of main house, looking north

The south (front) elevation of the house presents an unusually ornate appearance for an I-house of this era in Ashe County. Three bays wide, the south elevation is dominated by a single-bay, centrally placed, double-tier porch, both levels of which feature silhouette posts that are sawn into curvilinear shapes with stout bases and capitals to divide the three sections of the porch. Decoratively sawn brackets fill the spaces between the capitals. The balustrades feature alternating, jigsaw-cut, curvilinear designs and attach to the house along twin pilaster-like features that interrupt the weatherboard and frieze board of the main block of the house. This double-tier porch is capped with a front-facing gable with a prominent pediment and cornice return. The gable end is clad in weatherboard, while an unusual, bell-shaped attic window (sometimes inaccurately described as a “circle-over-triangle design”) punctuates the center of the gable end. The floor of both porches is wood plank, while the ceiling of both porches is clad in beaded slats that do not dovetail into the adjacent boards, creating a slight gap presumably designed to help the second floor porch drain rainwater and the attic space breathe. A set of six wood steps descends to the yard from the first floor porch, while the area under the porch is obscured by a modern application of latticework.

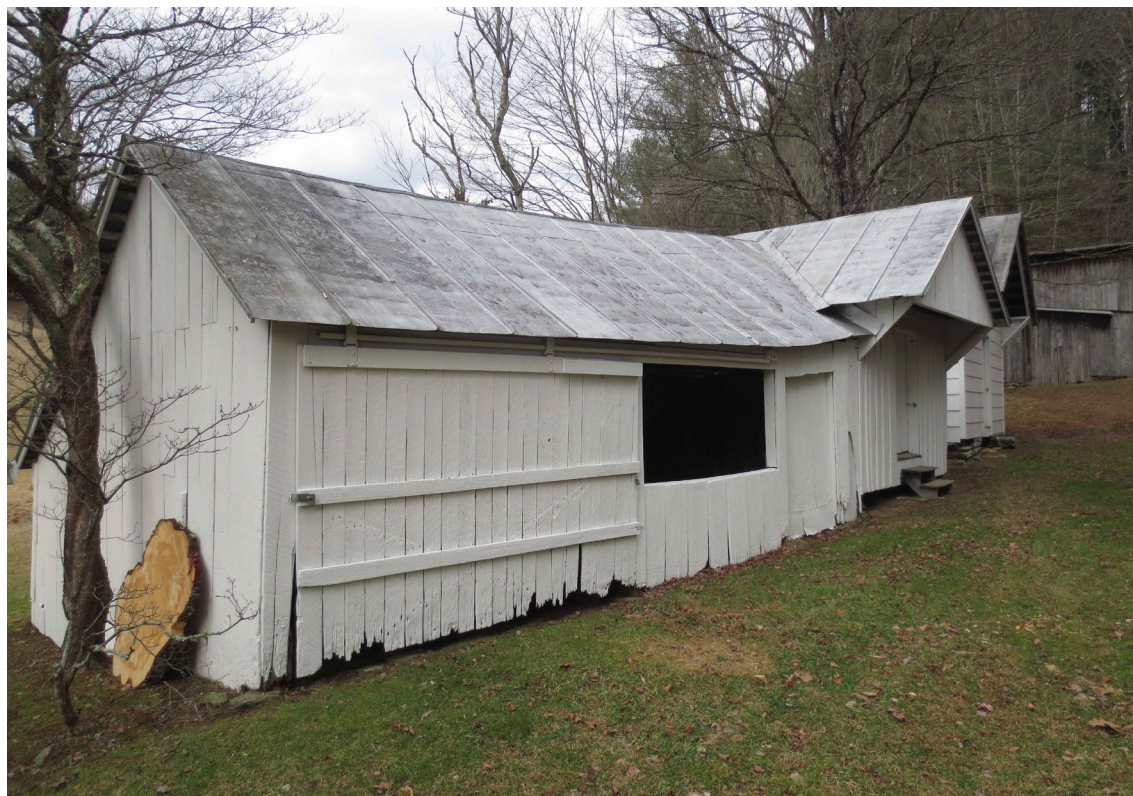
South and east elevations of carriage house/wood shop complex, looking north

a front-gabled wood shop attachment at the north end of this building. The rear, west gable of the wood shop and the lower portion of the west elevation are clad in vertical board and batten, with the entire wood shop resting on a banked, stone foundation. A single, horizontal, rectangular, six-light wood sash is visible at the upper part of the center of the wood shop main floor, while a wood, vertical board door with a strap-hinged, wood surround provides access through the stone foundation into a root cellar with early wood shelving.<sup>16</sup> The north elevation of the wood shop annex is featureless vertical board and batten resting on the stone foundation. Open rafter tails are visible at the roofline of the north elevation of the wood shop.
