RE: Historic Structure Documentation and Assessment of the Houston Dam,  
Nantahala Ranger District, Nantahala National Forest, Macon County, CH 14-0031

Enclosed for your review and comment is the report *Historic Structure Documentation and Assessment of the Houston Dam, Nantahala Ranger District, Nantahala National Forest, Macon County, North Carolina.*

**Historic Structure Documentation and Assessment of the Houston Dam  
Nantahala Ranger District, Nantahala National Forest,  
Macon County, North Carolina**

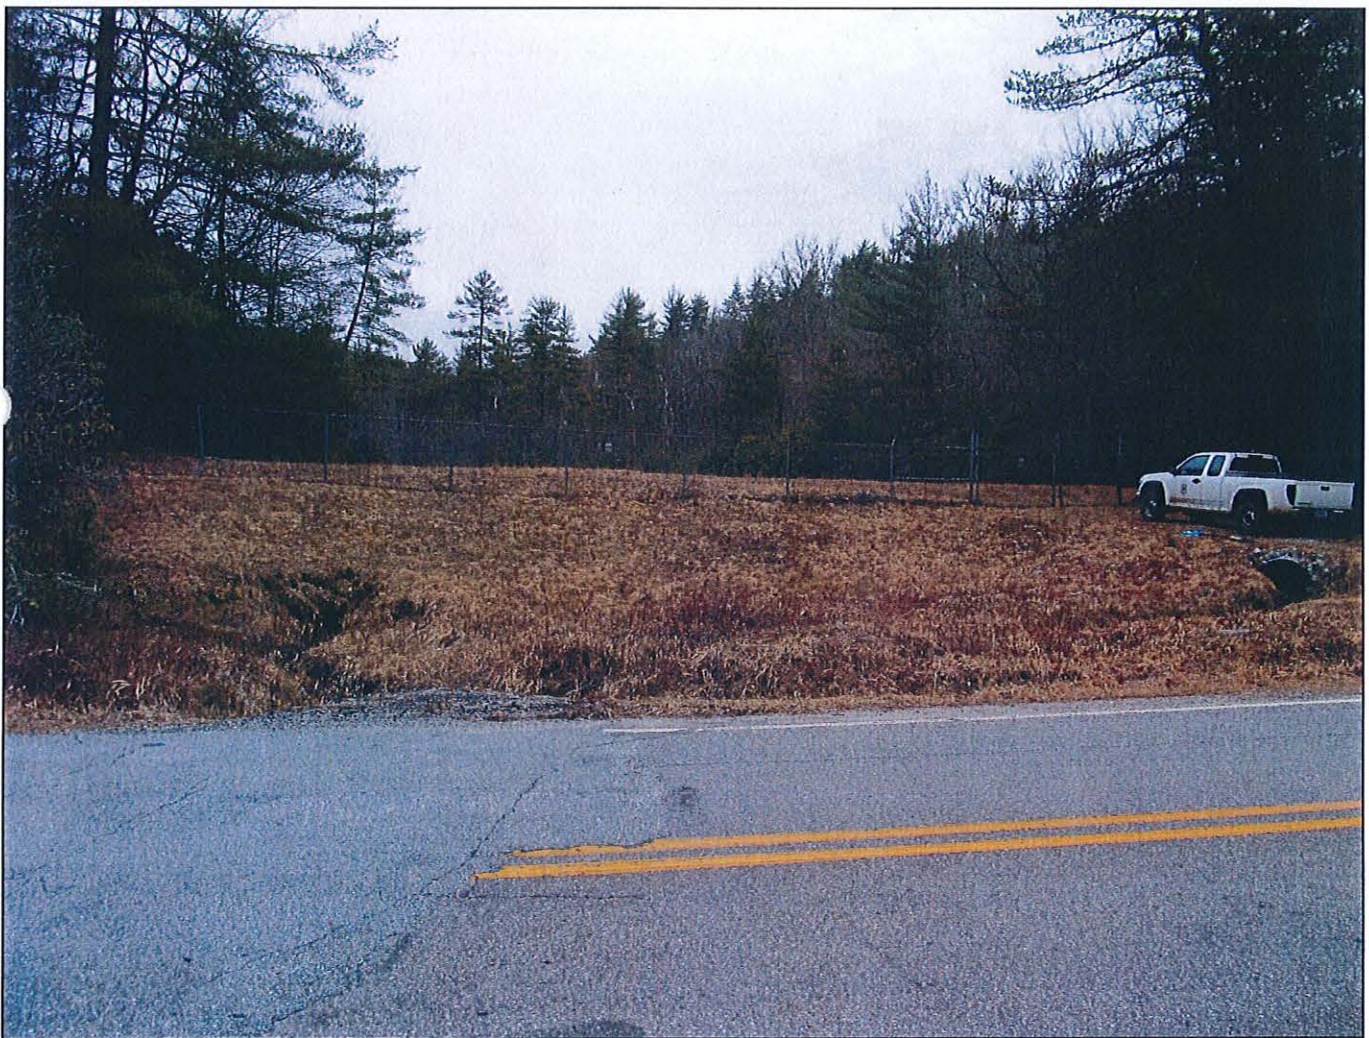
Plate 1. View north, showing the 12-foot tall earthen Houston Dam at Highlands Reservoir. North Carolina State Highway 1538 is in the foreground. Note eroding face of the dam in left foreground.

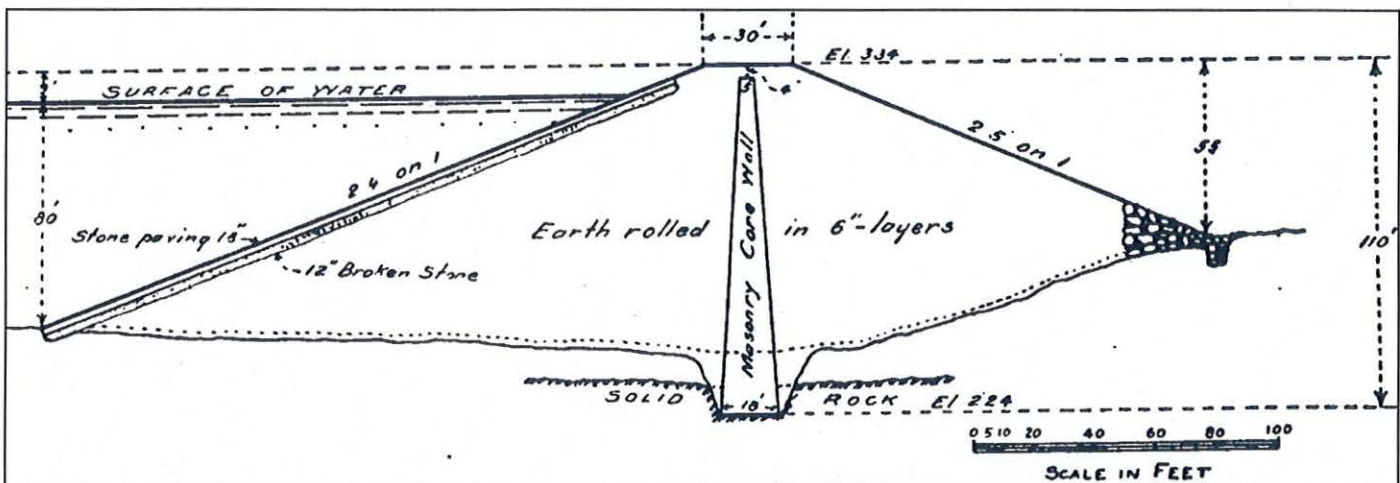
Figure 4. A cross-section diagram showing the construction of a typical earthen dam. The description of this dam states, "In the center is built a wall of rubble masonry, generally founded upon solid rock, and intended to stop the free seepage of water, but not heavy enough to act alone as a retaining wall for either water or earth." Copied from page 40, Bassel, 1904.

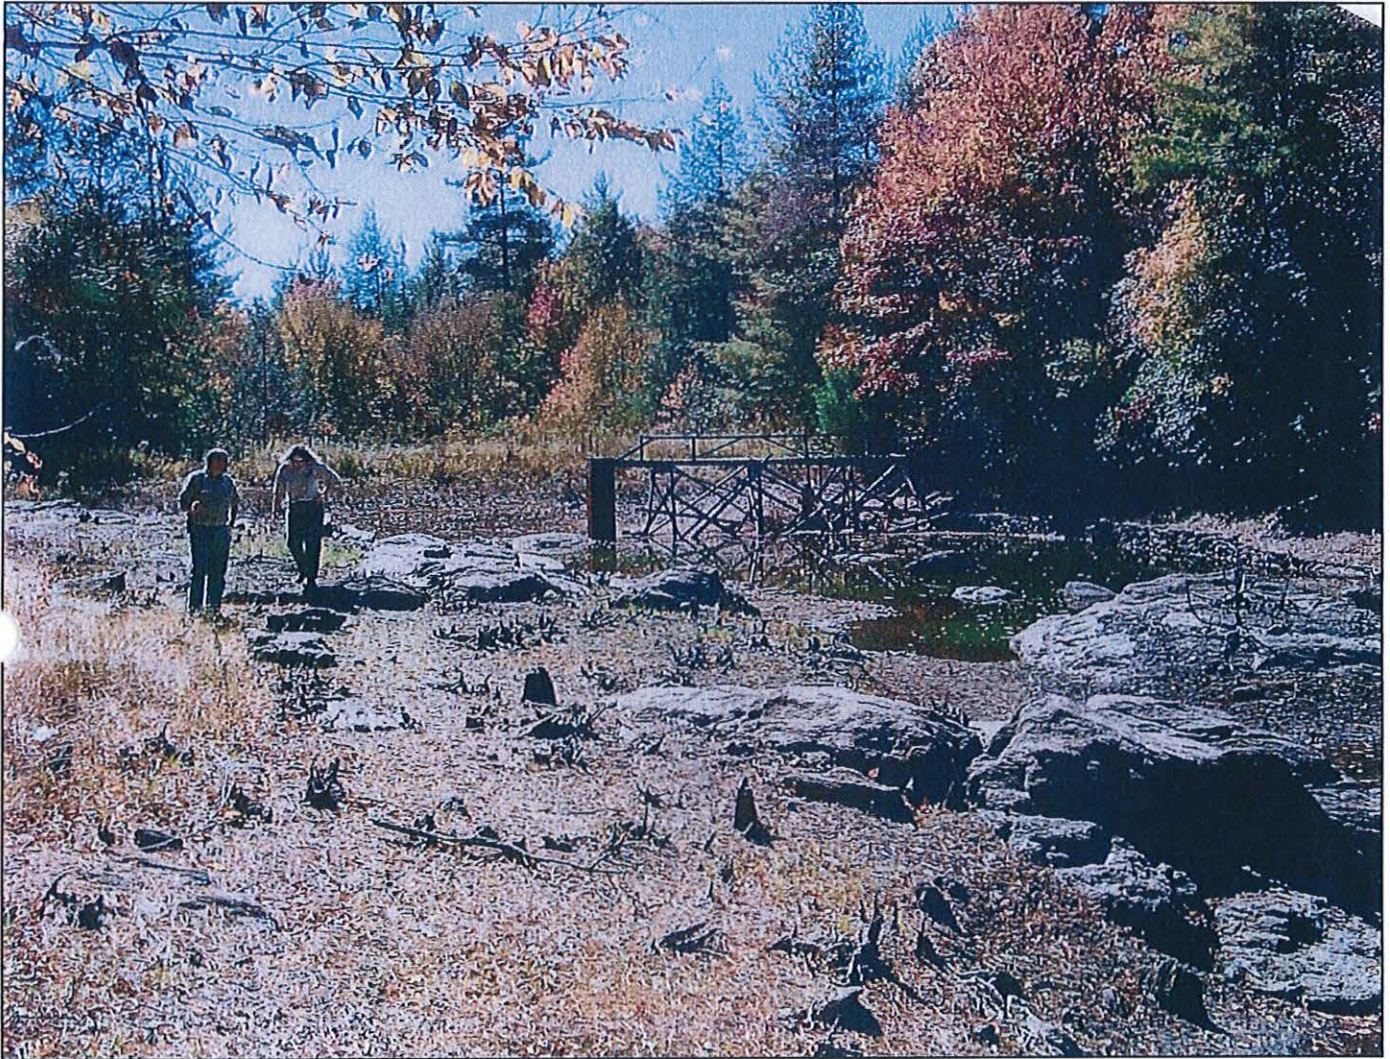
Plate 2. View south, showing the earthen dam in the background and the bedrock floor of the drained reservoir. Picture was taken about 3 - 5 years ago.

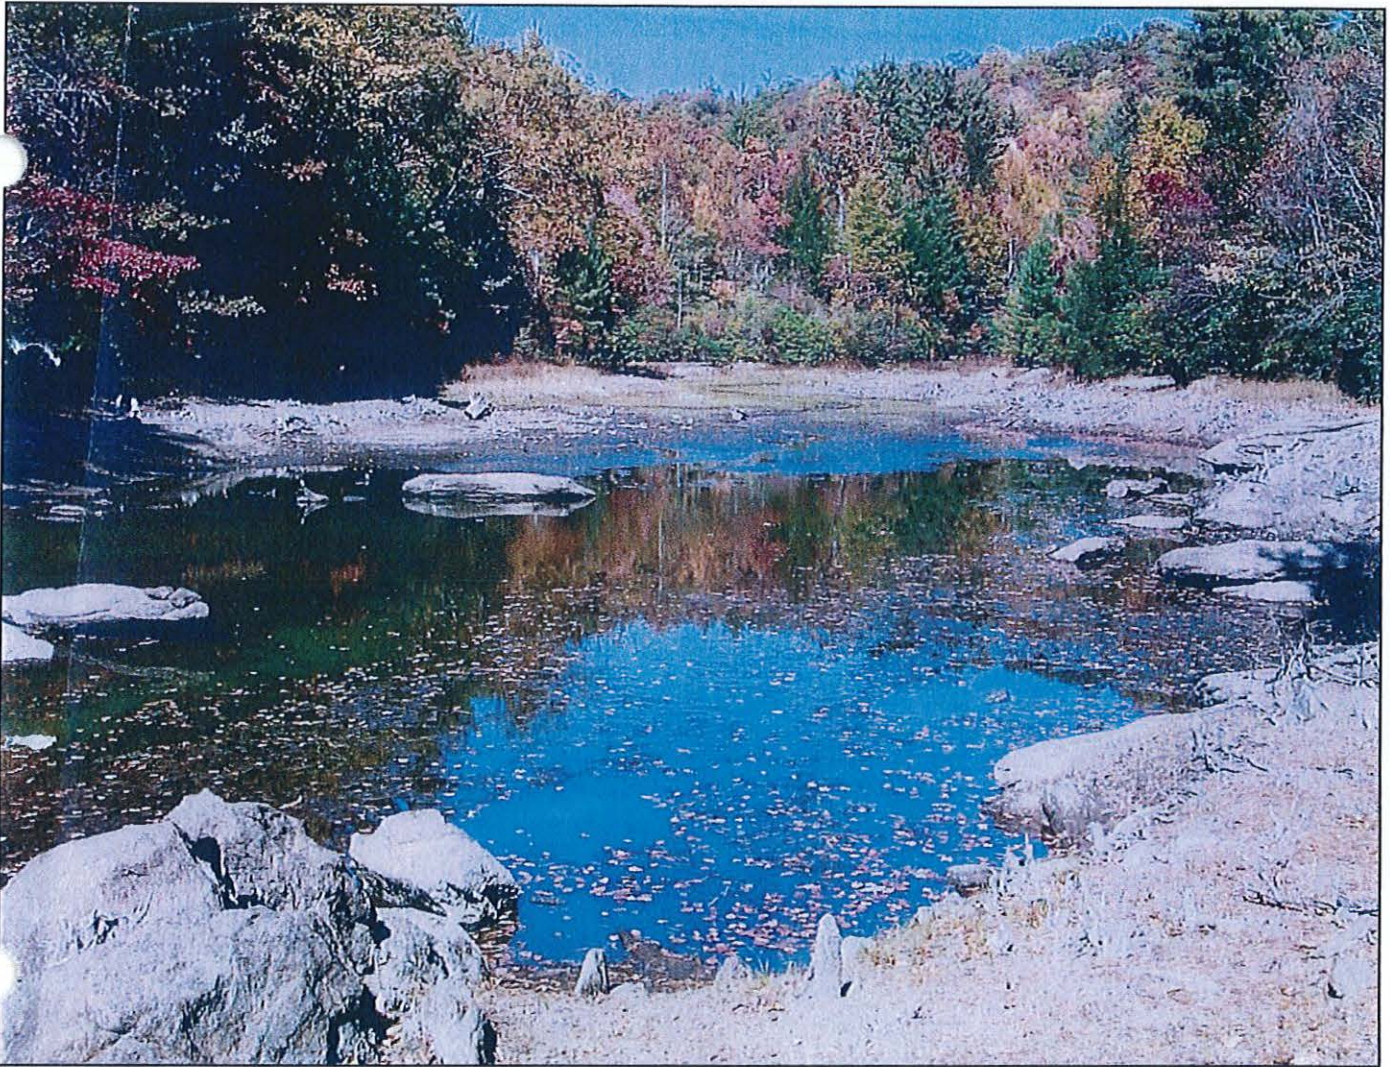
Plate 3. View north, showing the bedrock floor of the drained reservoir. Picture taken at the same time as the previous picture.
