May 4, 2005

MEMORANDUM

SUBJECT: Historic Architecture Survey Report, Windsor Bypass Improvement and Extension, R-2404,
Bertie County, CH90-0883

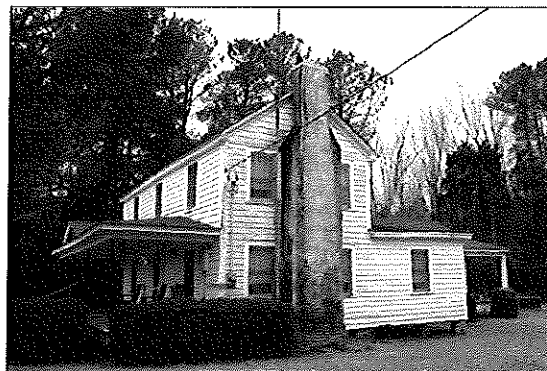
Figure 6. Speller House (BR 192)

The basic side-gabled form (with and without the centered front gable at the roof) persisted into the early years of the twentieth century throughout Bertie County and elsewhere. The Speller House (BR 192), a two-story example located east of Todd's Crossroads on the north side of SR 1301 just west of its junction with SR 1351, appears to be an early-twentieth-century house. It features a hip-roofed front porch, a weatherboarded exterior, and four-over-one, double-hung sash windows. BR 192 also features a single-story, gabled rear ell with engaged porch that predates the front section. The I-house interior features a center-hall plan, beadboarded walls and ceilings, and a boxed stair in the hall.

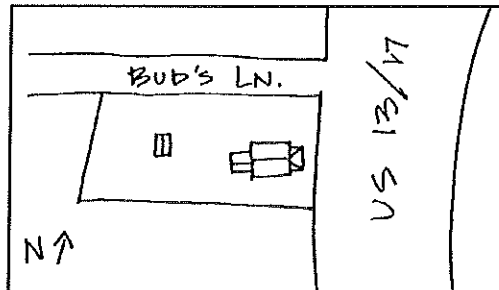
Figure 10. Site plan for G.D. Mizell Homeplace (not to scale)

Description: This two story, front-gabled, weatherboarded house features gable-end returns; two-over-two, double-hung sash; interior brick stack; and a screened, hip-roofed front porch. A single-story, gabled addition with metal roof and two-over-two, double-hung sash extends from the rear of the house. The house is in poor repair and has a large hole on the south slope of the roof of the two-story section. A single-story, front-gabled, weatherboarded outbuilding (11a) has two-over-two, double-hung sash and a metal roof.

Evaluation: The building lacks any distinctive architectural features that would qualify it for the National Register under Criterion C. Other two-story, early twentieth-century houses exist in the county, including a hip-roofed example on Broad Street in Windsor. Background research revealed no significant historic events or persons associated with the property that would qualify it for the National Register under Criteria A or B. The property is not recommended as eligible under Criterion D because it is unlikely to yield information about our past not otherwise accessible from other extant resources and written records.

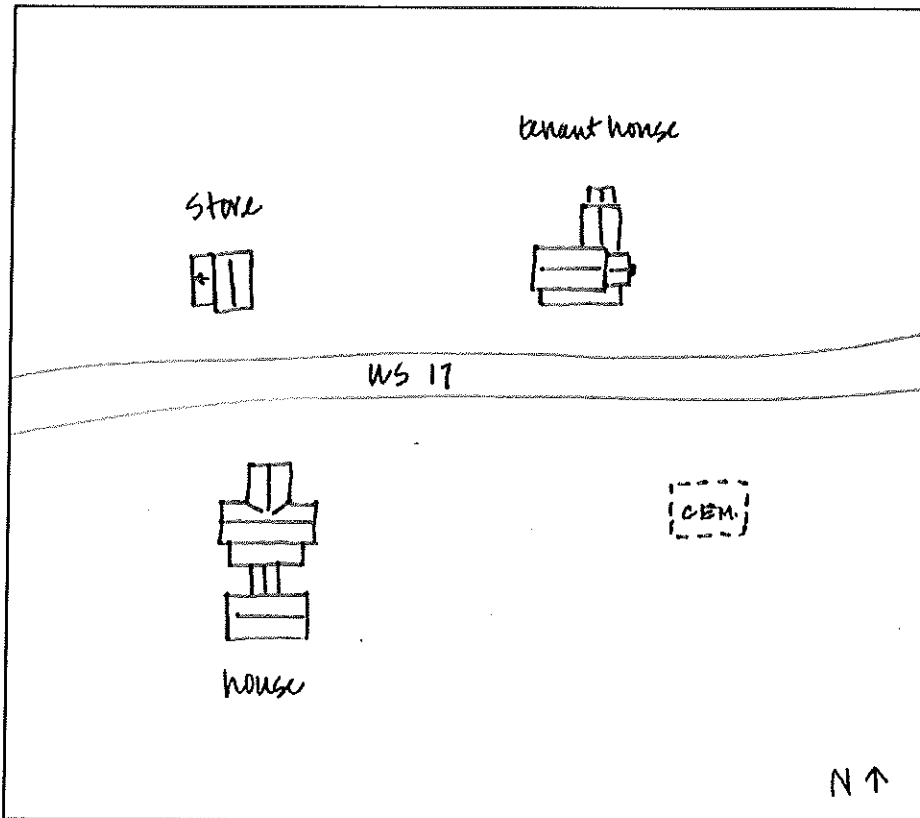
Figure 23. Levi Harden Farmstead site plan (not to scale)

House (#63b, also deteriorated); a thirty-six-acre field stretched north behind the buildings. These domestic and agricultural outbuildings and the commercial building formed a significant concentration of structures that once clearly indicated varied activity and social interaction at this place. The now-demolished mill and the severely deteriorated Harden Store (#63a) illustrated the farm's commercial and social roles, now underrepresented in the remaining fabric. Had a tobacco barn survived, it would have provided information about crops and production, while the stable that once stood south of Highway 17 could have demonstrated the role of animal power and livestock. The loss of these defining buildings leaves the extant structures to present an incomplete and inaccurate record of the farm. The store and tenant house, the two surviving late-nineteenth-century buildings on the north side of the road, are not being maintained and could be lost at any time.

Additionally, the alterations to both the John Sam Harden House (#61) and the Levi Harden House (#62) have introduced late twentieth-century forms (the large attached garage at the rear of the Levi Harden House) and materials (vinyl siding and replacement windows) that have obscured historic details and construction. Together, the changes to the dwellings and the extensive loss of historic fabric and of significant and varied structures have adversely affected the integrity of design, feeling, and association of the overall landscape, making the area ineligible for the National Register of Historic Places under Criteria A or C as a rural agricultural historic district. The area is not eligible as a rural historic district under Criterion B (regardless of integrity) because it lacks an association with significant persons. A 2002 study completed by Environmental Services, Inc., of Raleigh found some archaeologically intact deposits associated with the Levi Harden Farm; their report concluded that some of the land associated with the farm was eligible for the National Register under Criterion D (see the individual evaluation of the Levi Harden Farm above for more specific information).

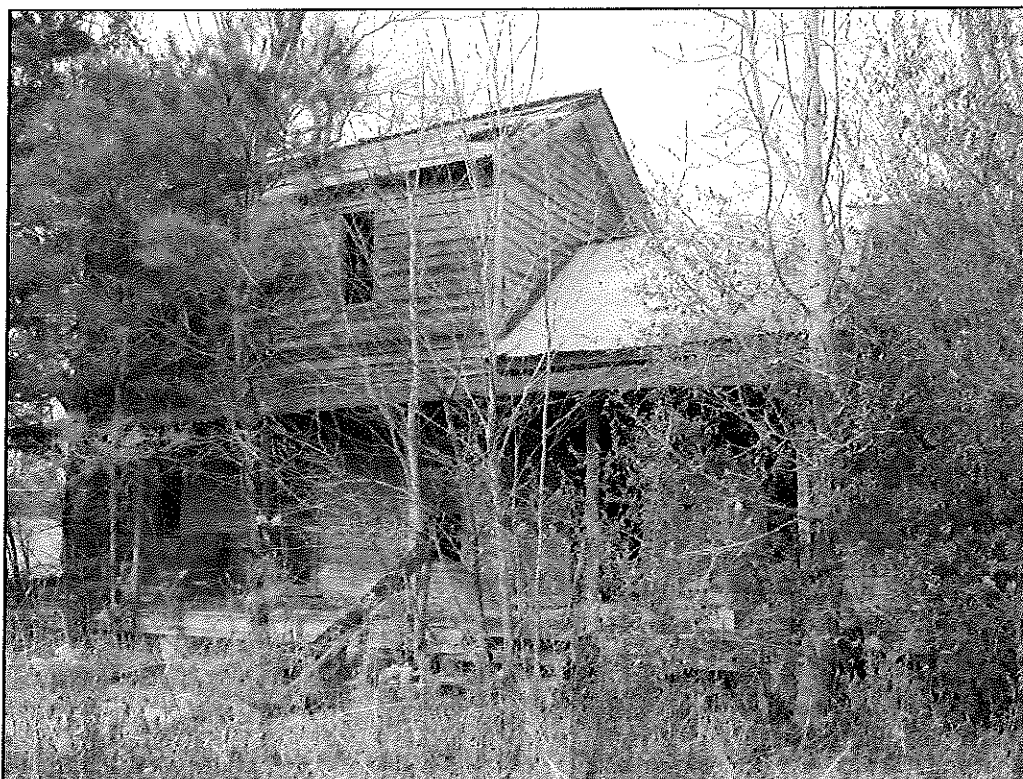
Figure 31. Harden Tenant House, façade

The **Harden Tenant House (63b)** stands east of the Harden Store on the north side of US 17. The house consists of a three-bay, double-pile, two-story, gable-roofed block added to an earlier single-story, two-bay, double-pile, gable-roofed block at the east side. A shed-roofed porch stretches across both façades, and the two sections stand on concrete-block foundation piers. A deteriorating, single-shouldered brick exterior chimney with tumble courses rises on the east side of the single-story block. A single-story gable-end addition extends from the rear of the two-story section, and a very small gabled section extends from its rear gable wall. The rear wing stands on a brick pier foundation. Weatherboard sheathes the entire house and metal covers the various gable roofs. Most windows are missing; a few window openings are boarded. Family tradition dates the building to about 1890.

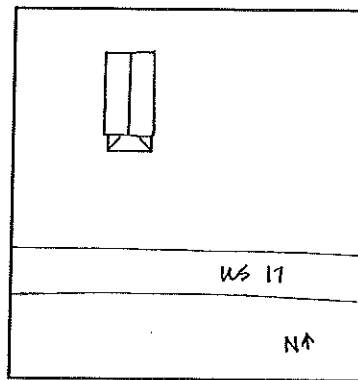
Figure 33. Site plan, 1123 US 17N (not to scale)

Evaluation: The house is typical of its type, scores of which are seen scattered on rural highways all over Bertie County and the state, and is therefore not eligible for the National Register under Criterion C. Background research revealed no significant historic events or persons associated with the property that would qualify it for the National Register under Criteria A or B. The property is not recommended as eligible under Criterion D because it is unlikely to yield information about our past not otherwise accessible from other extant resources and written records.

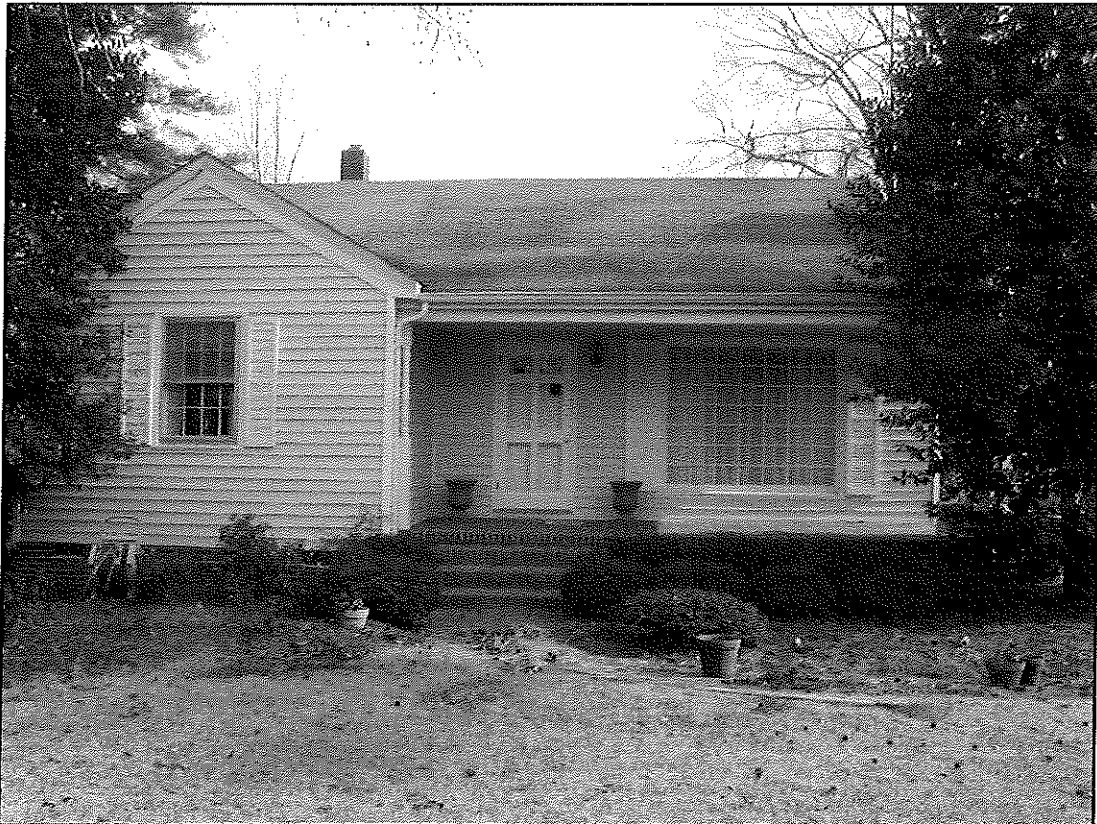
Figure 36. Robert and Shirley Spivey House

Description: The one-and-one-half-story, side-gabled house features a projecting gabled bay at the north end of the façade and front porch recesses across the balance of the façade. The front door is centered on the overall façade, in the recessed porch. A large, multi-light, fixed-sash window fills much of the remaining façade wall to the right of the door. Elsewhere, windows are eight-over-eight double-hung sash. Vinyl siding has been added to the house, covering the asphalt shingles that originally sheathed the walls. The concrete porch floor has been replaced with brick.²⁷

Evaluation: The building lacks any distinctive architectural features that would qualify it for the National Register under Criterion C. Background research revealed no significant historic events or persons associated with the property that would qualify it for the National Register under Criterion A or B. The property is not recommended as eligible under Criterion D because it is unlikely to yield information about our past not otherwise accessible from other extant resources and written records.

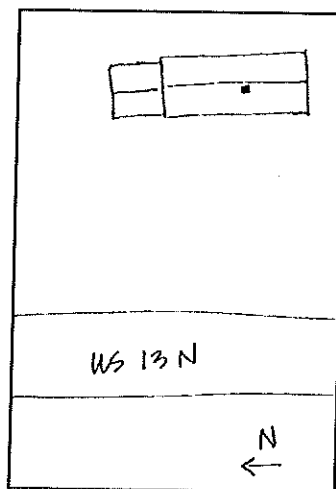
Figure 37. White house site plan (not to scale)

Evaluation: The building lacks any distinctive architectural features that would qualify it for the National Register under Criterion C. Background research revealed no significant historic events or persons associated with the property that would qualify it for the National Register under Criterion A or B. The property is not recommended as eligible under Criterion D because it is unlikely to yield information about our past not otherwise accessible from other extant resources and written records.

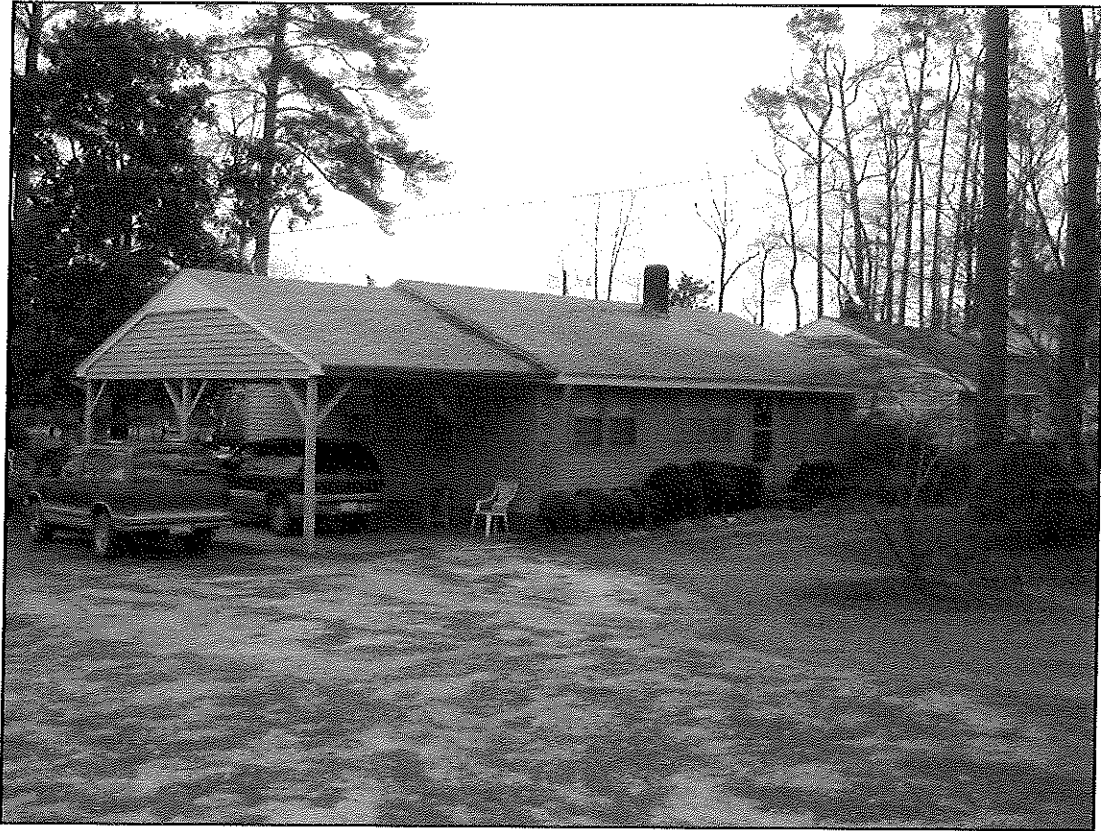
Figure 38. Webster and Elsie White House

Historical Background: Webster and Elsie White owned this parcel in 1954, when the house was built. He sold the house to Dalton and Evie White in 1956. The Dalton White family built rear additions to the house in the 1970s, enclosed back porch, and applied vinyl siding over the original weatherboard.²⁹

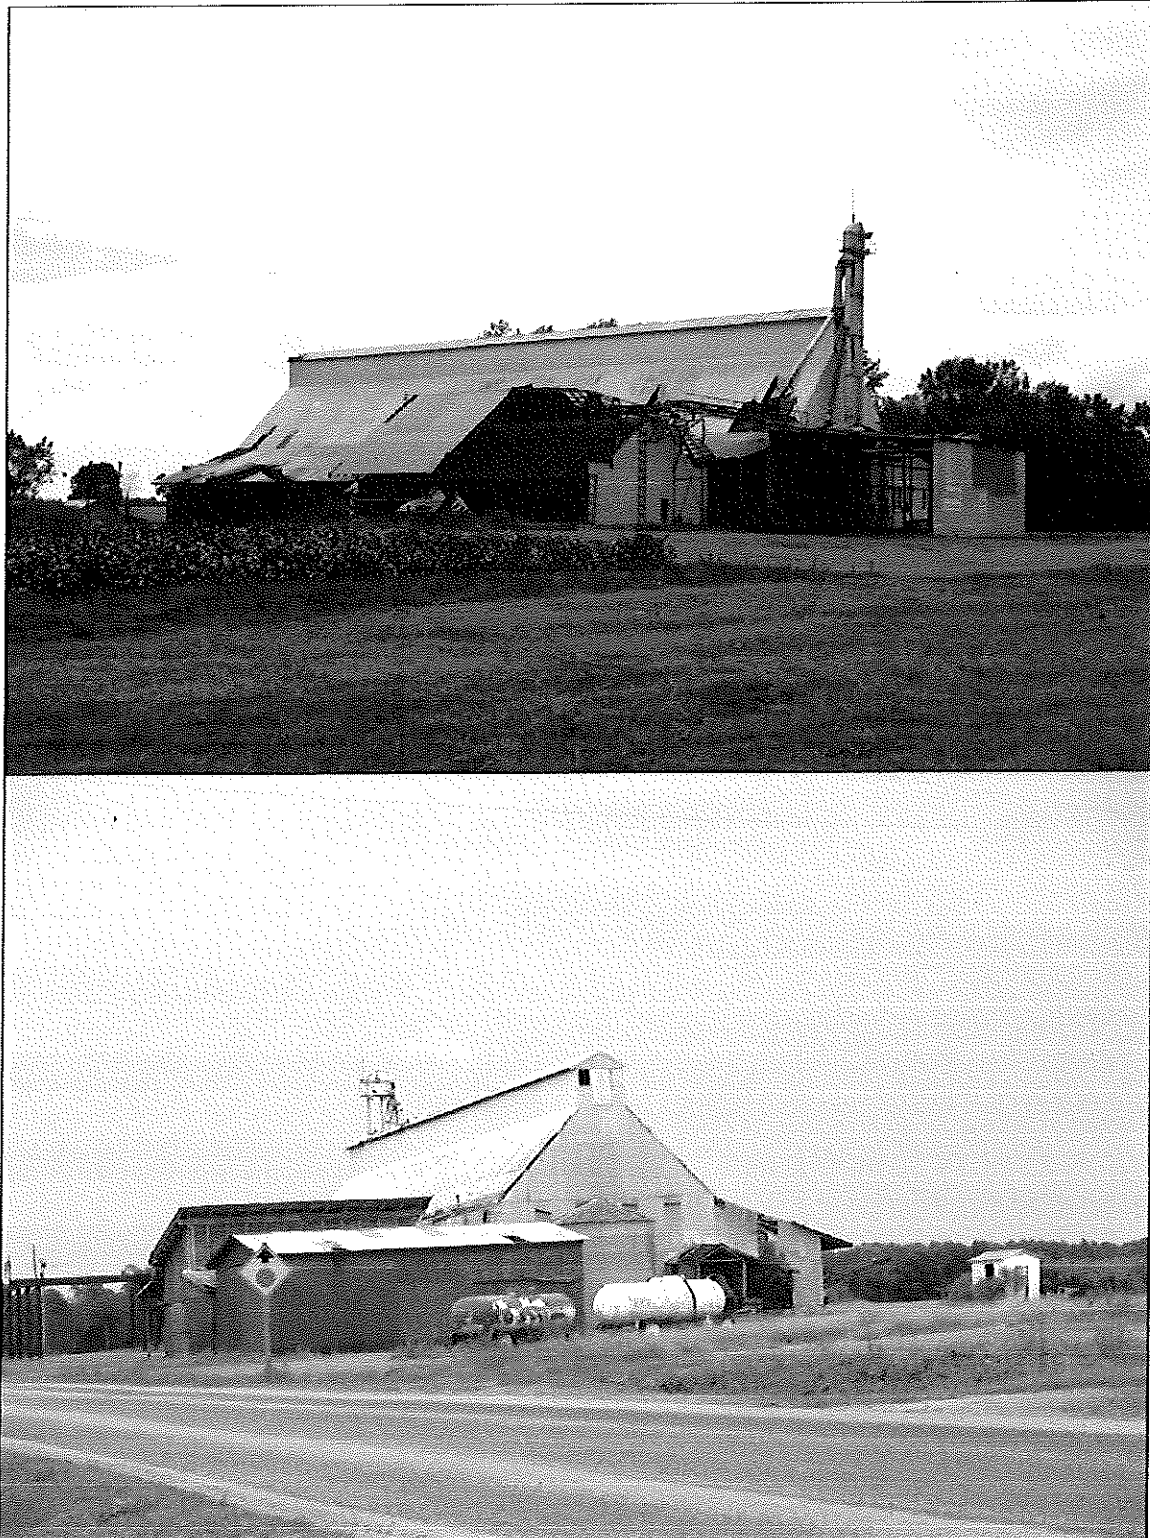
**16. Bell Brothers Inc. Peanut Plant Complex, SW corner US 13 and SR 1100
(top shows view of southeast corner of complex from US 13; bottom shows view of
northwest corner of complex from SR 1100)**

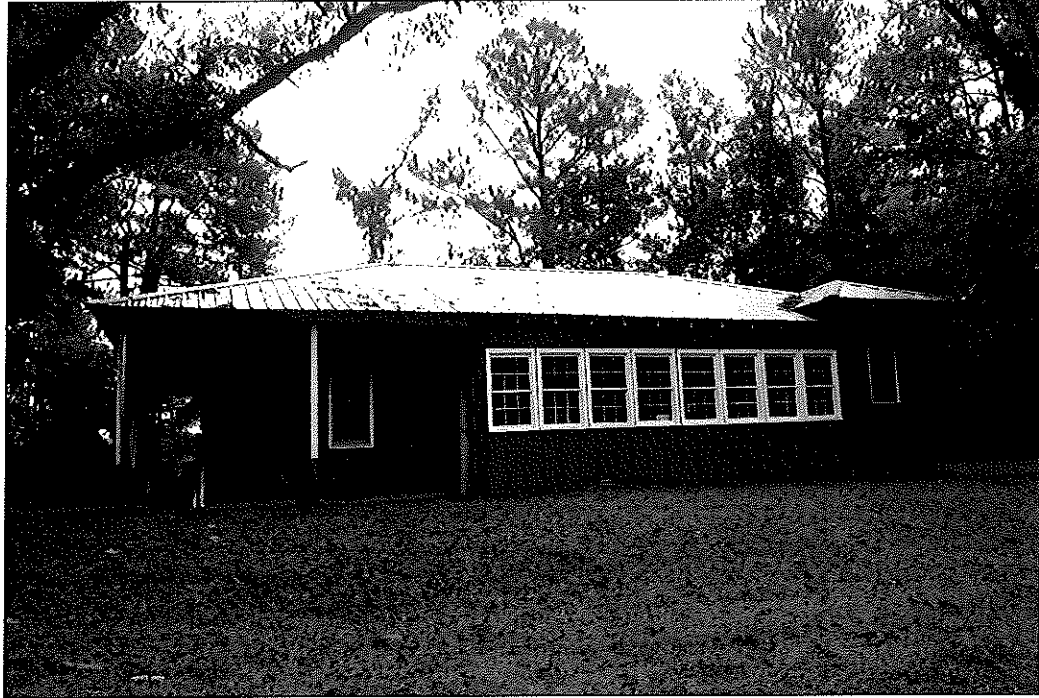
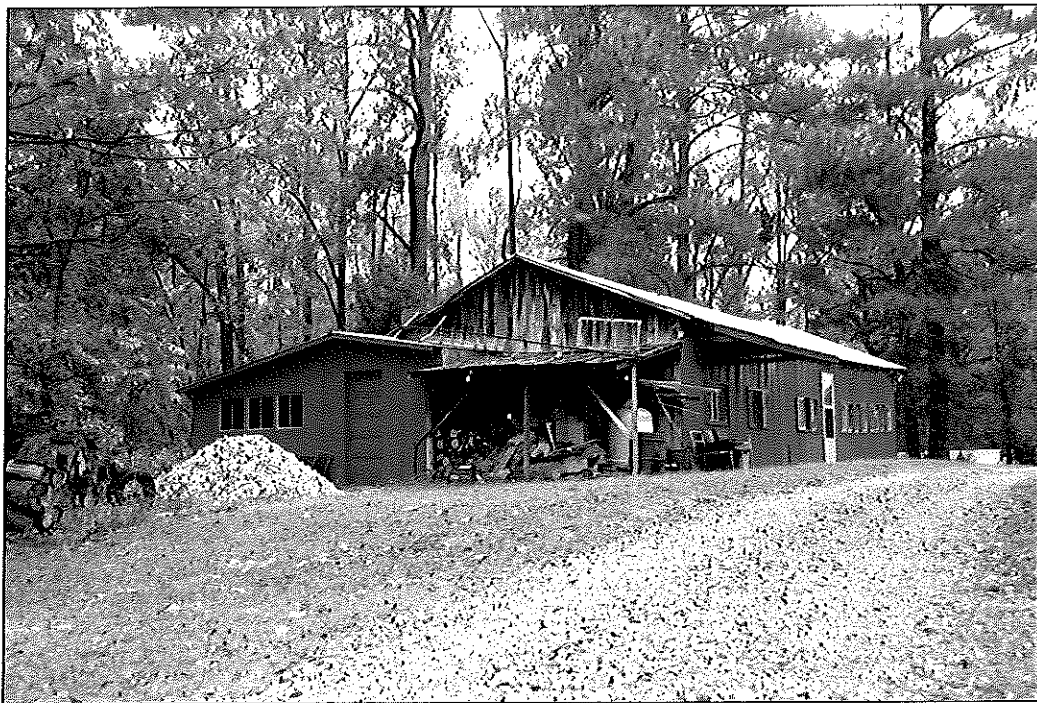
One-story, side gable roof, plank siding, replacement windows, small gabled addition and wood shed at southwest end. Originally a mule and equipment shed, the building was converted into an oyster bar in 1950.

**39. Thompson's Club House, location, S side Greens Cross Road (SR 1300)
club house at top; oyster shack at bottom**
