Historic Structures Survey Report for US 74 Shelby Bypass, Cleveland County, R-2707, Federal Aid Project NHF-74(14), State Project 8.1801001, ER 97-8452

# Properties Considered Eligible for the National Register

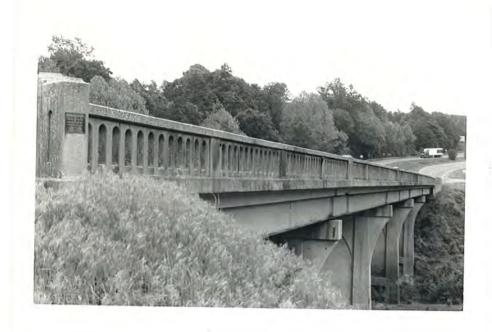
Plate 1. Cleveland County Bridge No. 79, Looking East.

Cleveland County Bridge No. 79 carries two lanes of eastbound traffic along U.S. 74 at the western city limits of Shelby. The surrounding area is rural and primarily agricultural although post-World War II commercial construction is found along U.S. 74.

This bridge was constructed in 1938-1939 from designs prepared by the State Highway and Public Works Commission. Wannamaker and Wells, Inc., an Orangeburg, South Carolina engineering firm, constructed this span, which replaced an earlier truss bridge.

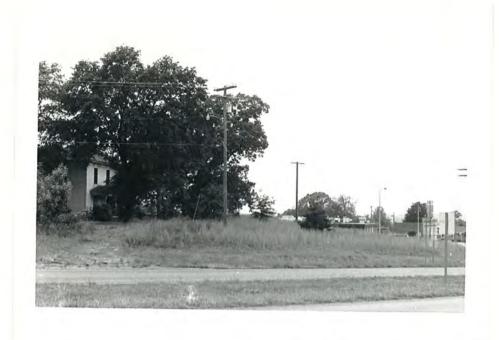
Plate 5. Hamrick House, Setting, and U.S. 74 Right-of-Way, Looking Southwest.

The proposed boundary along U.S. 74 follows the highway's southern right-ofway limit, which extend seventy-five feet from the center line in the direction of the house. Because this portion of the Hamrick tract is now entirely mowed open space, this boundary delineation excludes no historic landscape features.

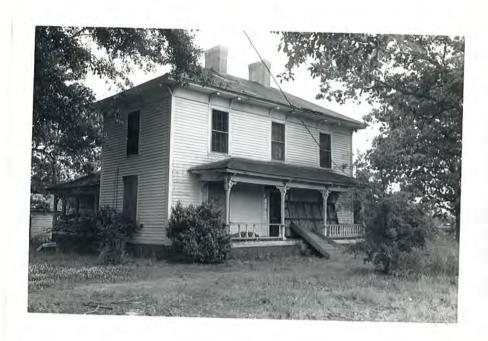
Plate 7. Hamrick House, Facade, Looking South.

Integrity (Plates 5-14) Although now vacant, this weatherboard I-house survives in stable condition with its original architectural elements substantially intact. Reflecting the influence of the Italianate style, the main block of the Hamrick House includes a low hip roof with deep eaves, a wide frieze, and a bracketed cornice. A bracketed hip-roofed front porch with chamfered posts extends across the three-bay facade. The wooden porch flooring is in disrepair and some of the balusters are missing. The dwelling's large six-over-six windows with simple molded surrounds and corner blocks remain mostly intact, though some windows have been boarded over. The center entrance has original double doors, sidelights, and a transom. A pair of interior, stuccoed brick chimneys pierce the roof. The house rests on a stone pier foundation with brick infill. The interior of the main block retains its original center-hall plan, plaster walls, wooden floors and ceilings, and two-panel and four-panel doors. As with the exterior, the door and window surrounds have simple square corner blocks. The center hall features a notable winding stairway, with curvilinear sawnwork in the stair ends and a slender rail with stick balusters. The east front room has a simple post-and-lintel mantel with a slightly curved mantel shelf. There is no evidence that fireplaces ever existed in the other rooms, which were heated with stoves connected to the chimney flues.

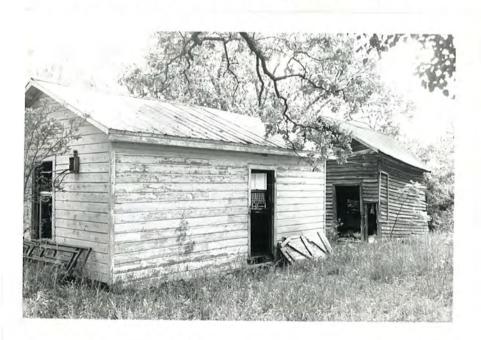
Plate 14. Hamrick House, Outbuildings, Looking South.

A frame, early-twentieth-century cotton shed and a frame, nineteenth-century smokehouse stand behind the house. Both are abandoned, and the smokehouse is in ruinous condition. The original agricultural tract has been subdivided over the years for commercial and residential real estate, and currently only 2.78 acres of the original Hamrick tract remains.

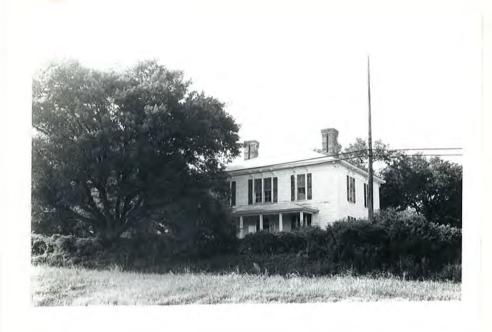
Plate 17. Burwell Blanton House, Looking North.

The Burwell Blanton House survives basically intact, although most of the surrounding outbuildings are in ruinous condition. Constructed ca. 1875, the house reflects vernacular Italianate design in its decorative elements. The two-story, weatherboard double-pile dwelling has a low hip roof with deep eaves and a bracketed cornice. The roof is pierced by interior chimney stacks with handsome brick corbelling. Tall, narrow shuttered windows with original four-over-four sash survive throughout the main block. The hip-roofed front porch appears to have its original configuration, though the tapered wood posts and flooring are modern replacements. The double-door main entrance retains the original doors and three-pane transom.

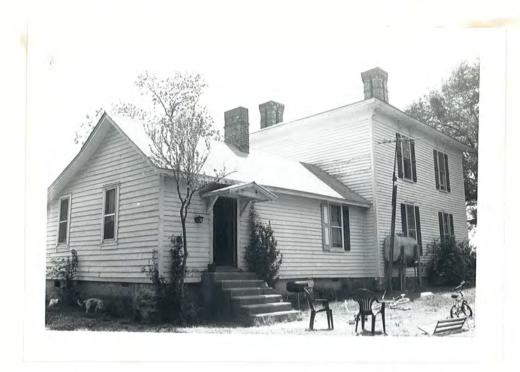
Plate 19. Burwell Blanton House, West Elevation, Looking Southeast.

The house rests on a foundation of stone piers with later brick and concrete block infill. A one-story, two-room gable-roofed ell with a foundation similar to the main block extends from the rear elevation. This ell consists of weatherboard siding, an engaged porch with an enclosed end bay on the south elevation, and both four-over-four and six-over-six sash windows. A later door with a gable-roofed canopy is located on the ell's north elevation.

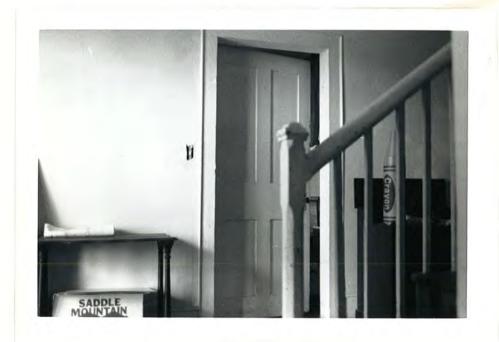
Plate 20. Burwell Blanton House, Stairhall.

The interior of the main block retains its original center-hall plan, with an open-string stairway in the center passage. Also intact are two-panel and four-panel doors with simple molded surrounds, wood flooring, and mantels with curvilinear frieze boards in the two south rooms and in three of the upstairs bedrooms. However, the mantels have been removed or altered in the two north rooms and in one of the upstairs bedrooms of the main block. The original plaster walls, which appear to be deteriorating, have been covered with sheet rock in most of the rooms. The rear ell contains an early-twentieth-century mantel with slender colonnettes in the kitchen.

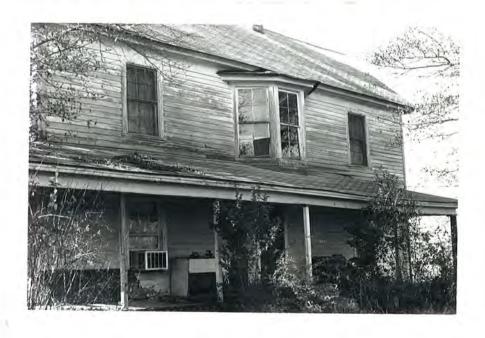
Plate 50. Dedmon House, Facade, Looking West.

Although now rental property and in disrepair, this weatherboard I-house survives in stable condition. It is a substantial gable-roofed dwelling consisting of a two-story, three-bay main block, a two-story, two-bay rear ell, and a one-story kitchen wing attached to this ell. The house also has original six-over-six windows with simple molded surrounds, brick interior chimneys with corbeled caps, and a distinctive second-story bay window on the center of the facade. The roofs are covered with asphalt shingles, and the chimney stack on the rear ell is deteriorating.

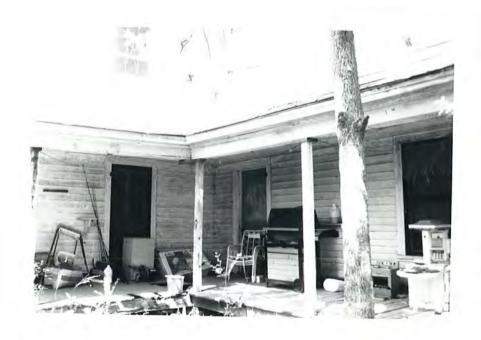
Plate 52. Dedmon House, Rear Porch, Looking North.

The principal alteration to the exterior has occurred on the wraparound porch, which lost its original turned posts and balustrade in the 1970s when the current square posts were probably installed (Harrell Cook Interview 1996). Some of these posts as well as major portions of the porch roof and flooring are deteriorated. Despite the principal investigator's numerous attempts to gain access to the interior, access was denied.
