Subject:  
Section 106 Review  
Proposed Cellular Tower Site  
**Connelly creek Site (HK4546.1)**  
Lenoir, North Carolina  
GAI Project No.: 00ATAMR01.A36

**Proposed Connelly Creek Cell Phone Tower Site  
Caldwell County, North Carolina**

**Agency:** American Tower Corporation  
**Site Name:** Connelly Creek  
**Site Location:** North of Highway 321A, North Main Street, Lenoir, North Carolina  
**Site Address:** 827 A North Main Street, Lenoir, North Carolina  
**County:** Caldwell  
**Map Reference:** Lenoir, North Carolina USGS, 1956  
**Project #:** HK4546-1  
**Tower Type:** 110 Foot Monopole

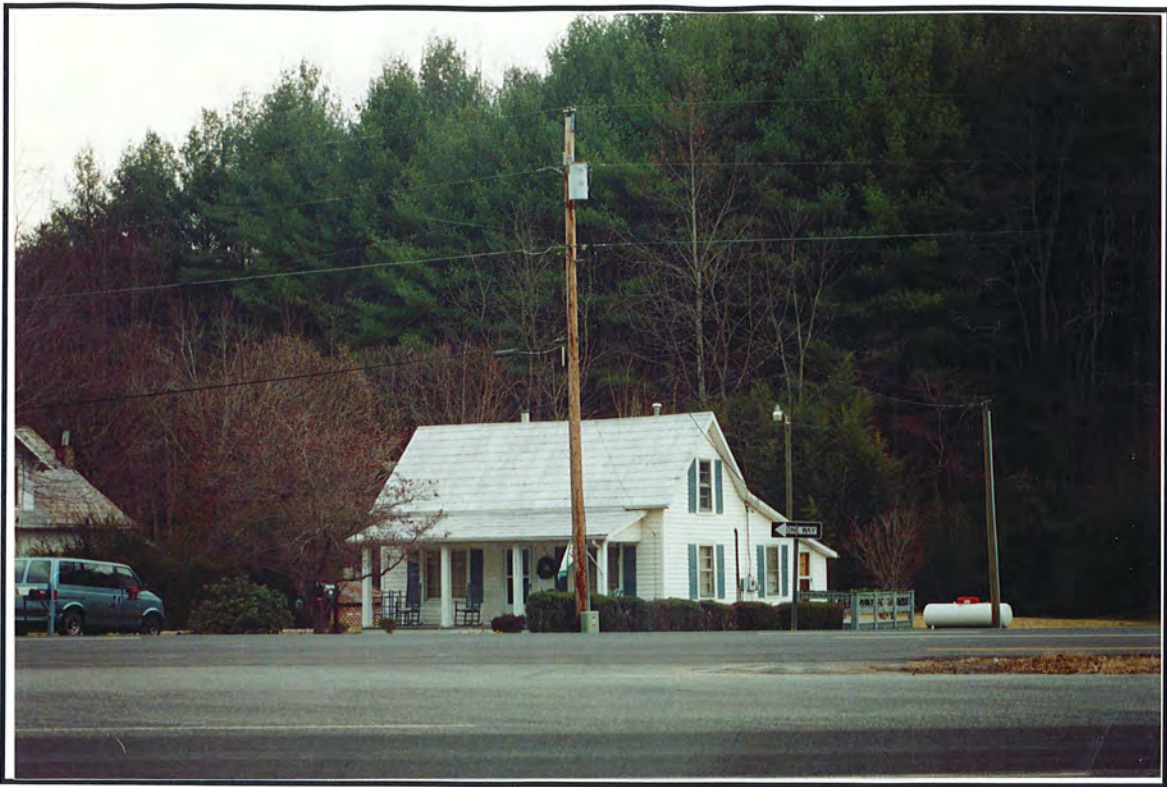
Photograph 13. View of Structure 5, facing east.

*Structure 5:* Structure 5 is a c.1900 1½ story structure with a central hallway, two rear additions, a pressed shingle roof, square wood supports, and no academic style (Photograph 13). It is recommended eligible for the NRHP. Structure 5 is located on Echo Drive, approximately 2,400 feet north-northwest of the proposed tower, which will not be visible due to intervening trees and moderate topography (Photograph 14). Because the proposed tower will not be visible from this structure, no effect is expected.

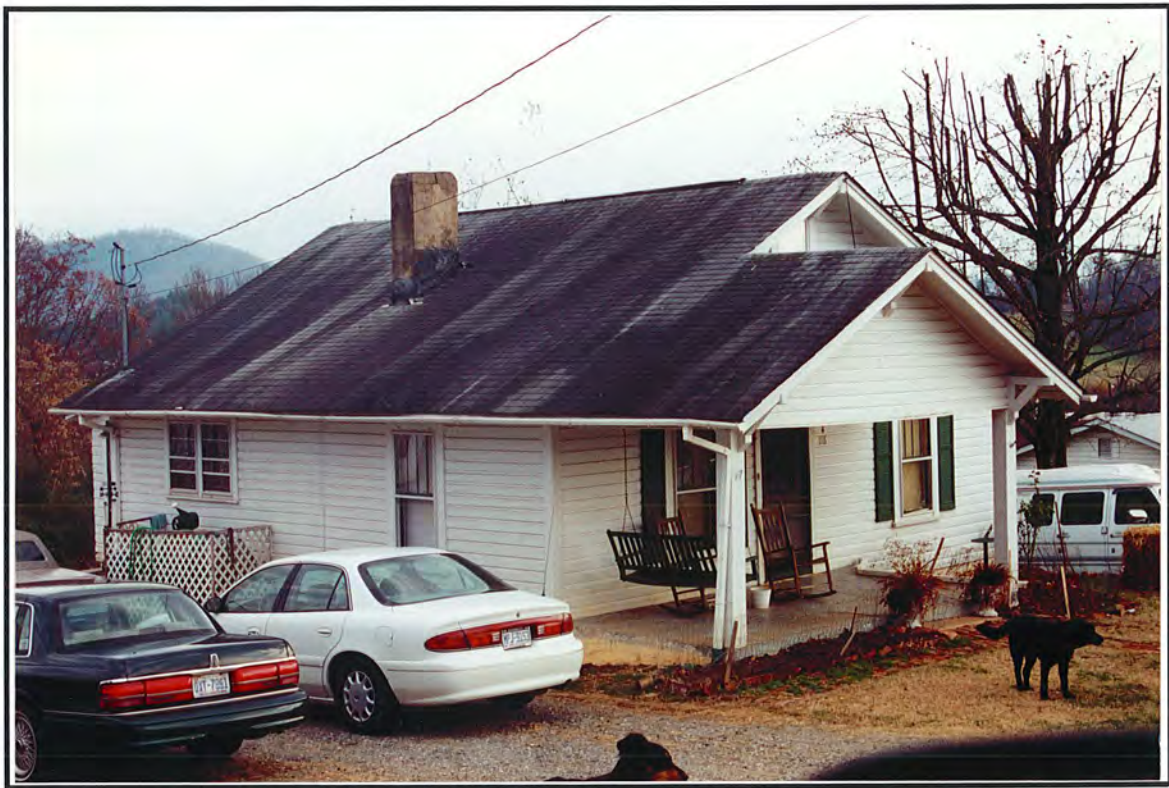
Photograph 34. View of Structure 16, representative of historic structures on Carolina Drive, facing east.

*Structure 16:* Structure 16 is a c.1930 front gabled bungalow with 4/1 windows, no academic style, and is representative of other historic structures on Carolina Drive (Photograph 34). It is considered ineligible for the NRHP. Structure 16 is located approximately 2,300 feet east-northeast of the proposed tower, which will possibly be partially visible above the tree line (Photograph 35). A water tower is visible from Structure 16, as shown in Photograph 36. Because the structure is recommended ineligible to the NRHP, no effect is expected.

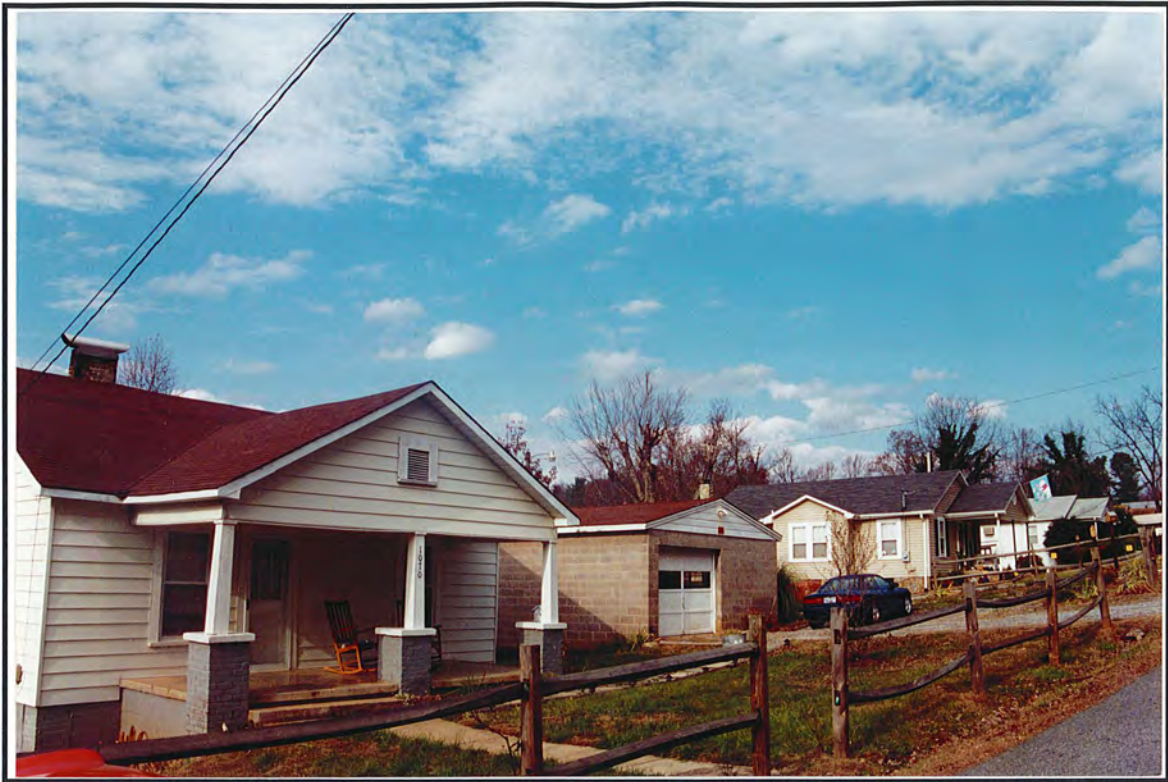
Photograph 37. View of Streetscape 17, representative of historic structures on Nuway Circle, facing north-northeast.

*Streetscape 17:* Streetscape 17 illustrates c.1930s and 1940s bungalows which are representative of other historic structures on Nuway Circle (Photograph 37). None is considered eligible for the NRHP. Streetscape 17 is located approximately 1,600 feet northeast of the proposed tower, which will possibly be visible above the treeline (Photograph 38). Because none of the structures is recommended eligible for the NRHP, no effect is expected.

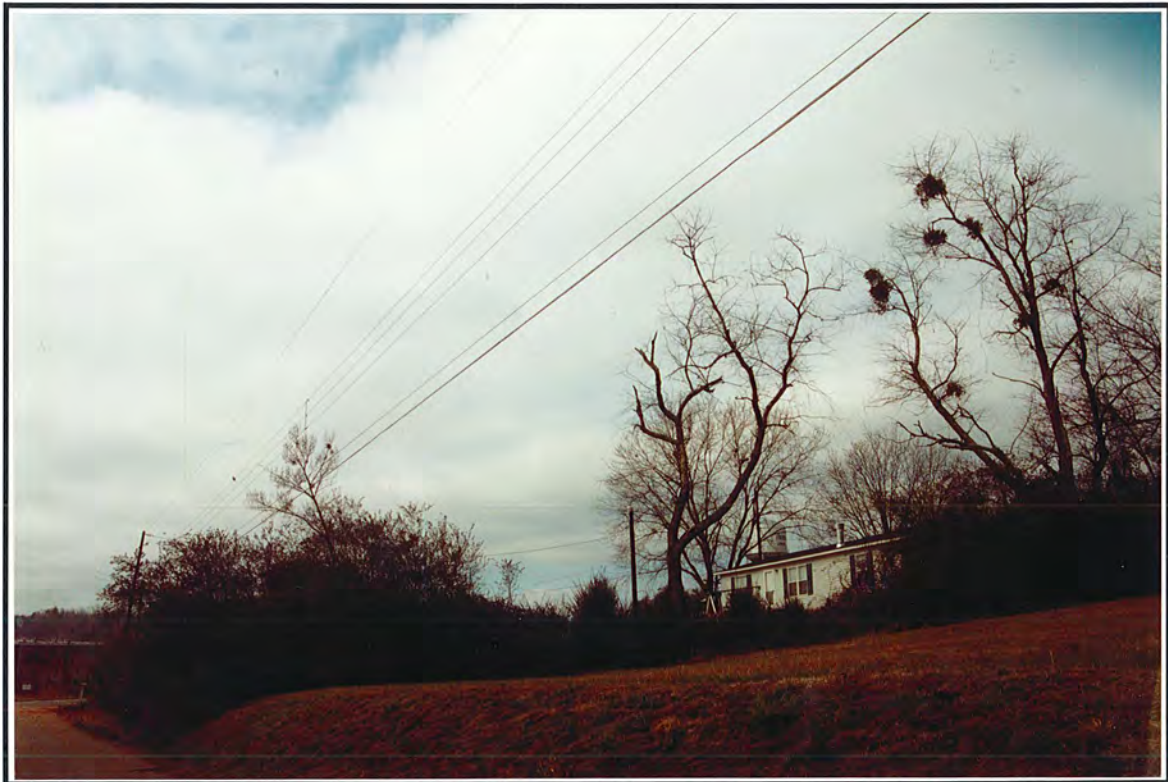
Photograph 44. View from Structure 20, towards proposed tower site, facing northwest.

*Structure 20:* Structure is a c.1920 hip bungalow with Craftsman elements and wood supports on brick piers, a brick foundation, and 4/4 windows (Photograph 43). It is representative of other historic structures on Sunset Street and is considered ineligible for the NRHP. Structure 20 is located approximately 2,800 feet southeast of the proposed tower, which should not be visible due to intervening trees and vegetation (Photograph 44). No effect is expected.

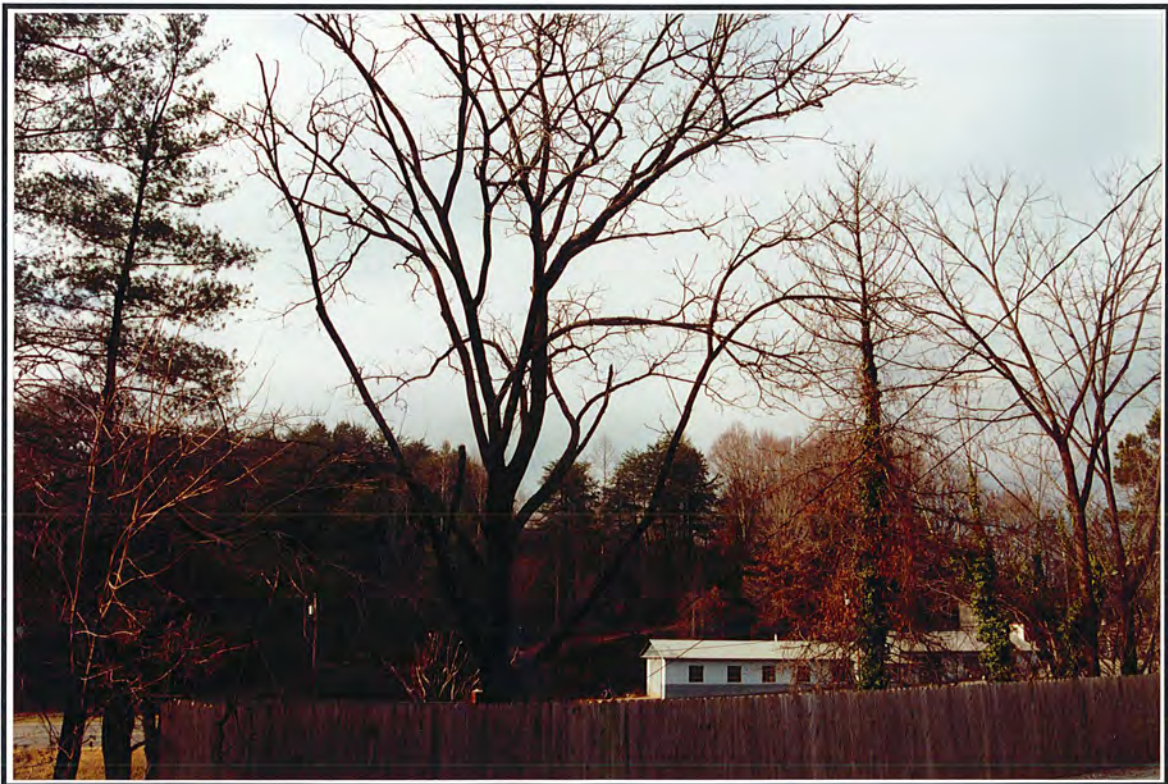
Photograph 50. View from Structure 23, towards proposed tower site, facing west-northwest.

*Structure 23:* Structure 23 is a c.1886 1½ story duplex with Victorian elements, clapboard siding, and a standing seam roof (Photograph 49). It is recommended as eligible for the NRHP. Structure 23 is located west of Elizabeth Street, approximately 500 feet east-southeast of the proposed tower, which will be partially visible above the tree line, due to proximity to the hill on which the proposed tower would be located (Photograph 50). In our opinion, tower construction may potentially cause an adverse affect to Structure 23.

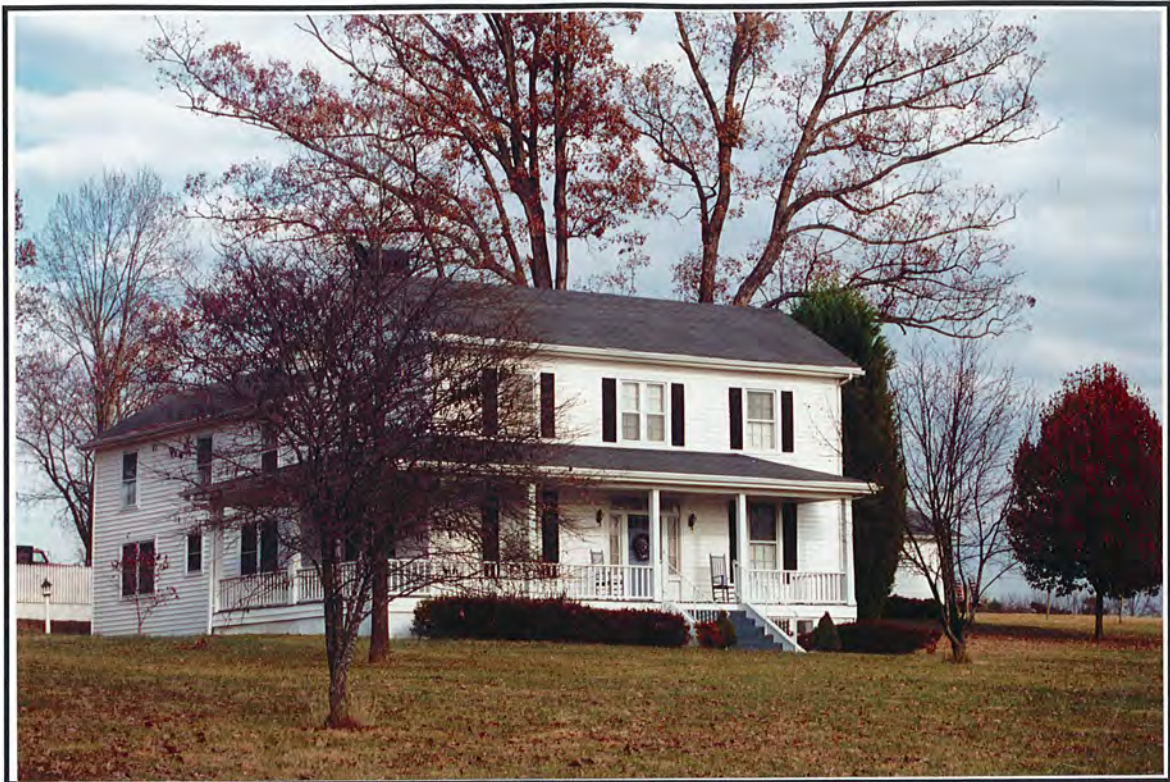
Photograph 51. View of Structure 24, facing east.

*Structure 24:* Structure 24 is a c.1920 (possibly older) two story structure with 6/6 and 4/4 windows, transom and side lights around the front door, and a rear addition (Photograph 51). It is recommended eligible for the NRHP. Structure 24 is located on the corner of Clark and Valmeade Streets, approximately 1,400 feet southeast of the proposed tower, which may be partially visible above trees (Photograph 52). A water tower and industrial complex,

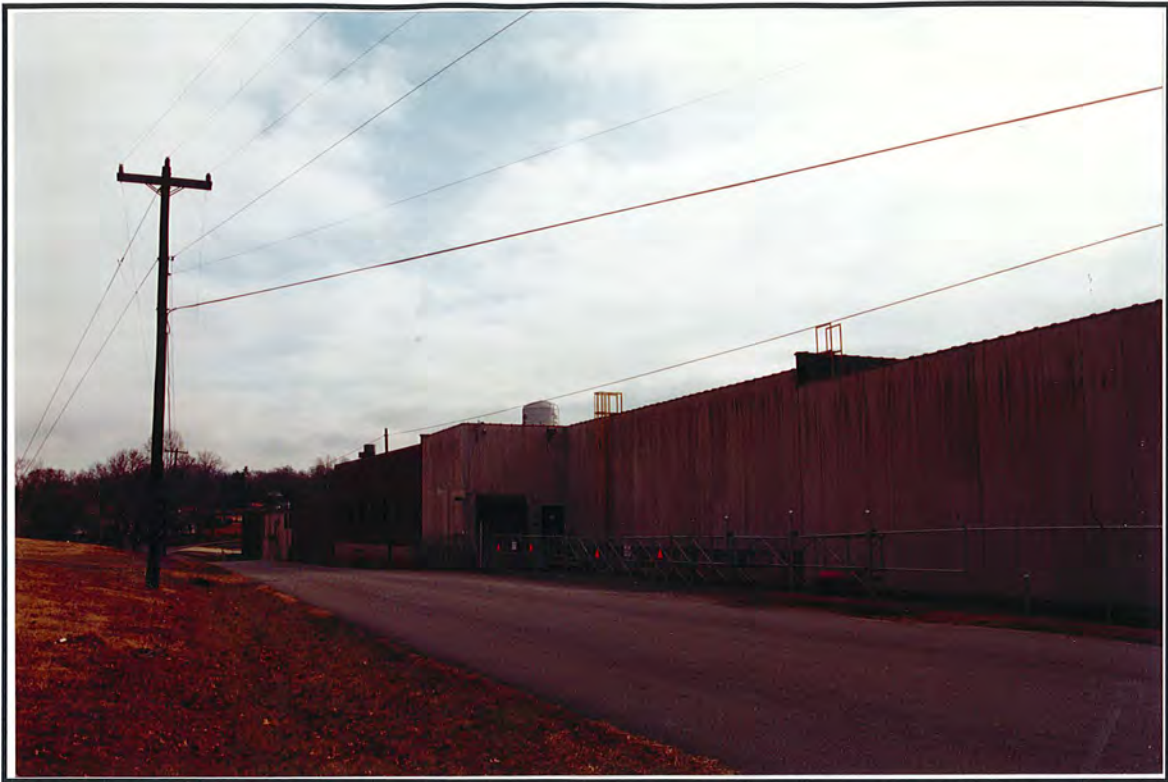
Photograph 53. View towards water tower, visible from Structure 24, facing southwest.

located across the street to the southeast, affect the viewshed of this structure (Photograph 53). In our opinion, the proposed tower would not cause additional adverse effects to Structure 24, considering the existing adverse effect of the water tower and industrial complex.

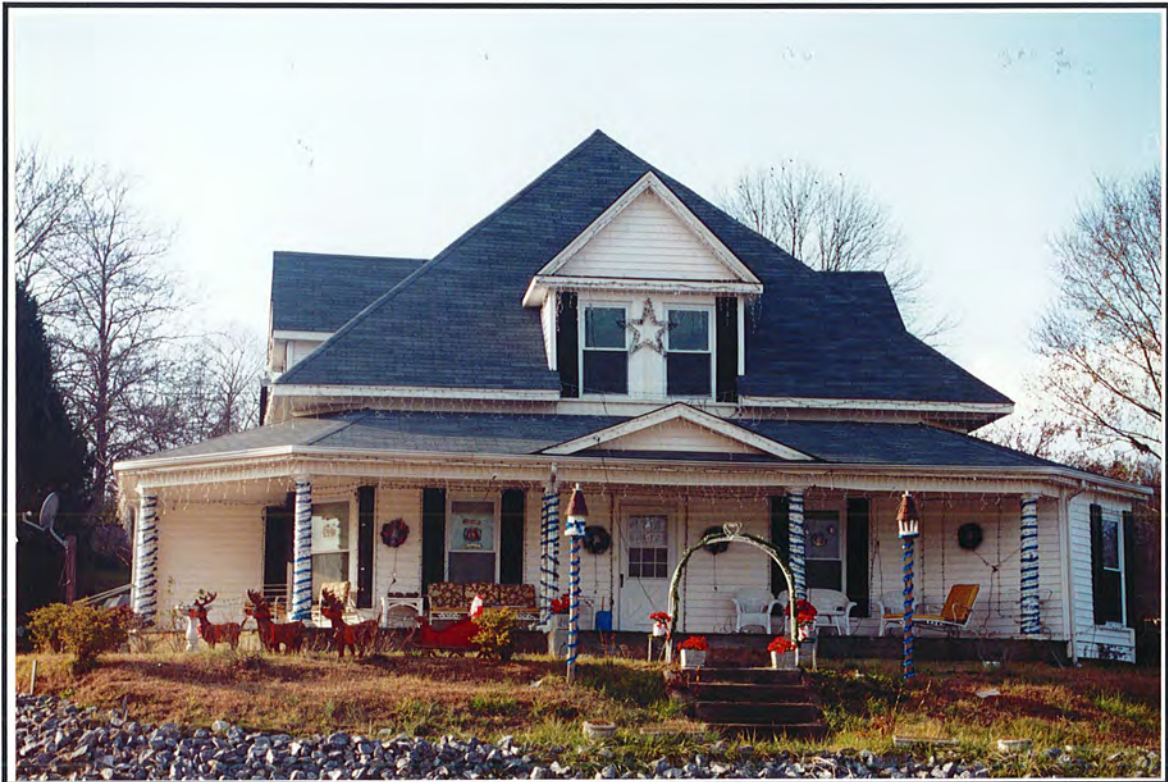
Photograph 54. View of Structure 25, facing west-northwest.

*Structure 25:* Structure 25 is a c.1890 1½ story structure with a front gabled dormer on a pyramidal roof, vinyl siding, altered windows, and no academic style (Photograph 54). It is recommended as eligible for the NRHP. Structure 25 is located on the corner of North Main Street and Laurel Place, approximately 2,500 feet south of the proposed tower, which will not be visible due to intervening trees and topography (Photograph 55). A transformer station (Photograph 56) is visible from this structure. Because the proposed tower will not be visible, no effect is expected.

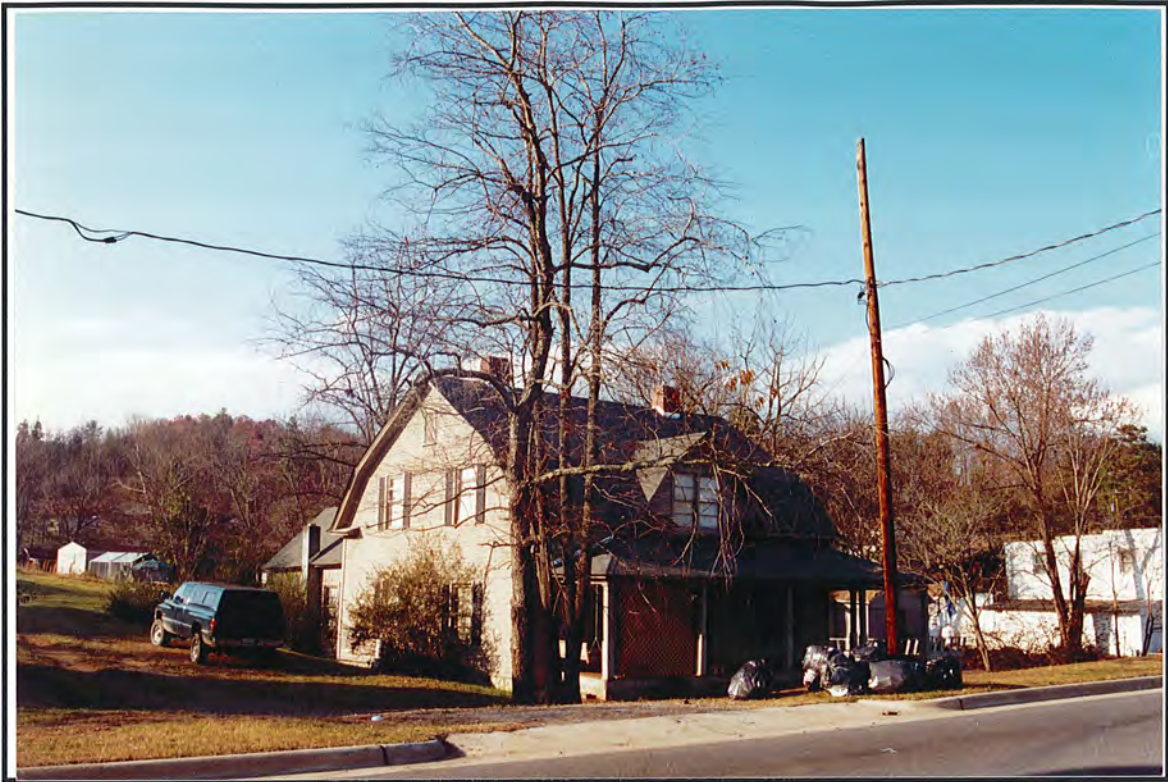
Photograph 59. View of Structure 28, facing north.

*Structure 28:* Structure 28 is a c.1890 two story structure with a gambrel roof, chamfered wood supports, weatherboard siding, and no academic style (Photograph 59). It appears to have been altered in the 1940s. It is recommended eligible for the NRHP. Structure 28 is located on North Main Street, approximately 2,400 feet south of the proposed tower, which will not be visible due to intervening trees and topography (Photograph 55). A transformer station (Photograph 56) is visible from this structure. Because the proposed tower will not be visible, no effect is expected.

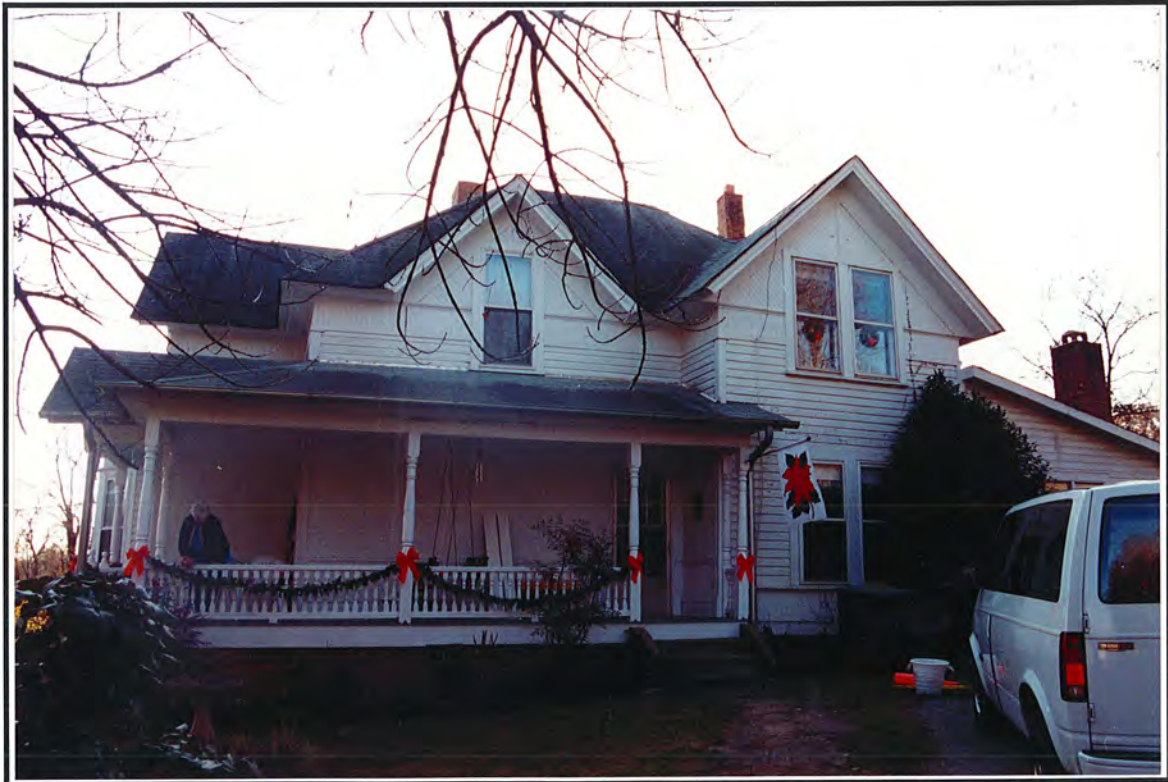
Photograph 64. View of Structure 31, facing southwest.

*Structure 31:* Structure 31 is a c.1890 1½ story structure with Folk Victorian elements, 1/1 windows, turned wood supports, and a brick foundation (Photograph 64). It is recommended eligible for the NRHP. Structure 31 is located on North Main Street, approximately 2,800 feet south of the proposed tower, which will not be visible due to intervening trees and topography (Photograph 65). A transformer station (Photograph 56) is visible from this structure. Because the proposed tower will not be visible, no effect is expected.

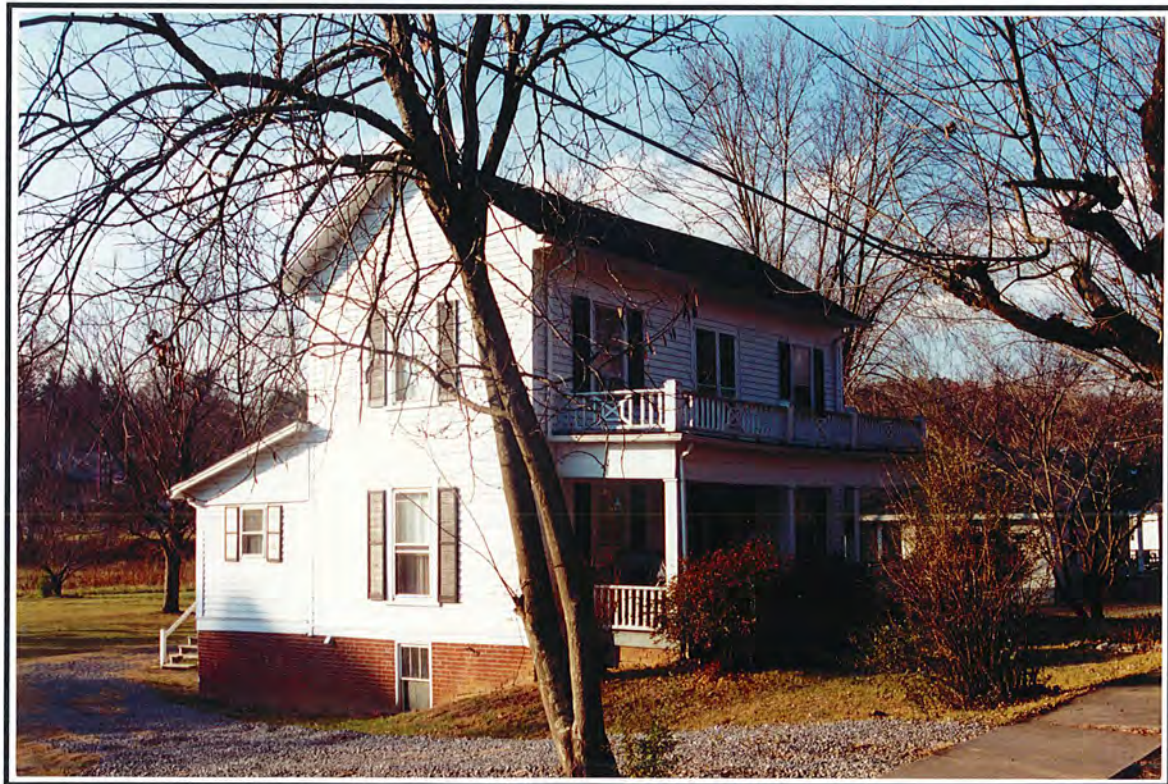
Photograph 66. View of Structure 32, facing northwest.

*Structure 32:* Structure 32 is a c.1920 two story plantation plain structure with a wooden balustrade, a brick foundation, and no academic style (Photograph 66). It is recommended eligible for the NRHP. Structure 32 is located on Old North Road, approximately 3,700 feet south of the proposed tower, which will not be visible due to intervening topography and trees (Photograph 67). Because the proposed tower will not be visible, no effect is expected.

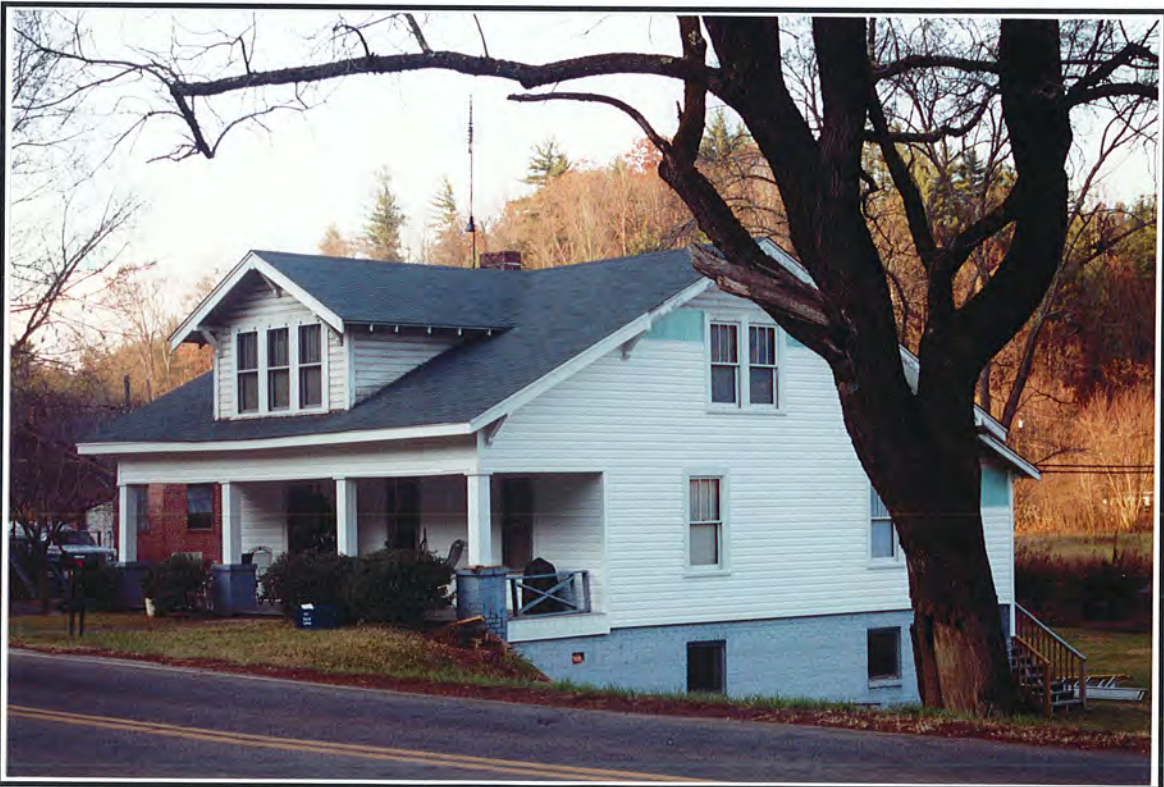
Photograph 80. View of Structure 41, representative of historic structures on Highway 90, facing north.

*Structure 41:* Structure 41 is a c.1920 side gabled bungalow with Craftsman elements, 3/1 windows, exposed eaves, square wood supports on brick piers, and brackets (Photograph 80). It is representative of other historic structures on Highway 90 (Valway Road). Structure 41 is considered ineligible for the NRHP. Structure 41 is located approximately 1,000 feet southwest of the proposed tower, which will be partially visible due to its proximity to the structure (Photograph 81). Because the structure is not recommended eligible for the NRHP, no effect is expected.

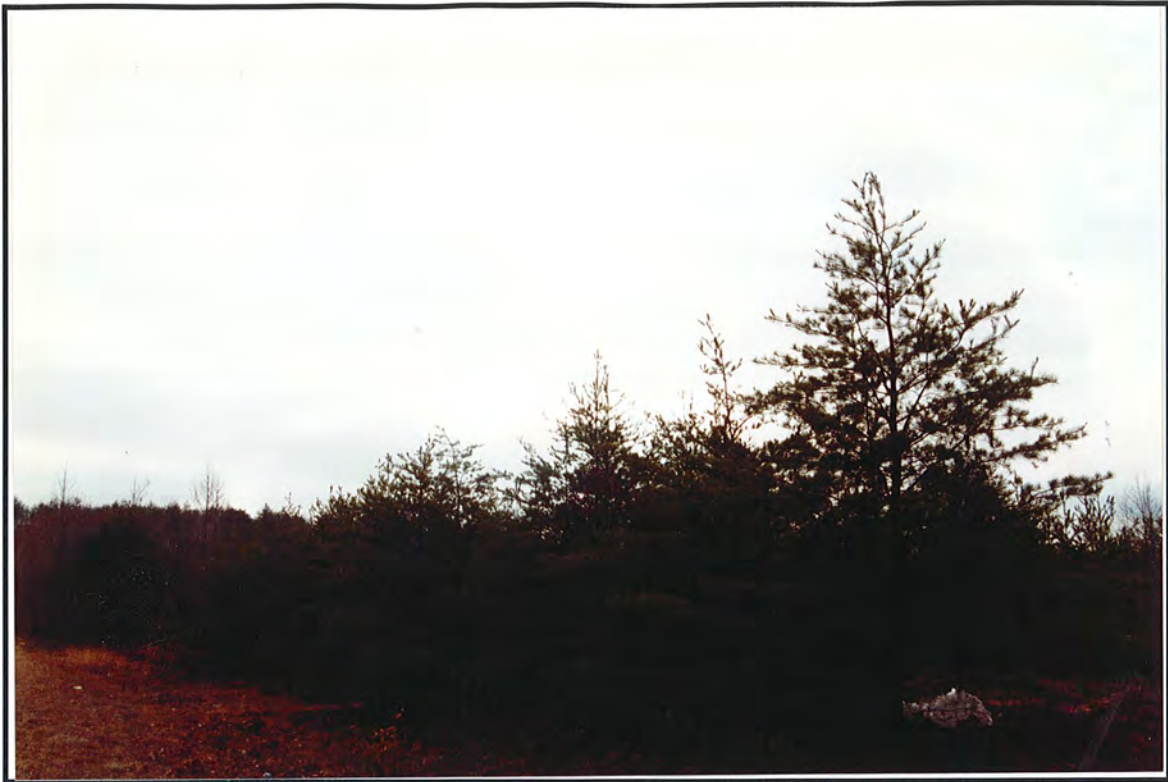
Photograph 95. View from Structure 50, towards proposed tower site, facing southwest.

due to distance, and intervening topography and trees (Photograph 95). No effect is expected.

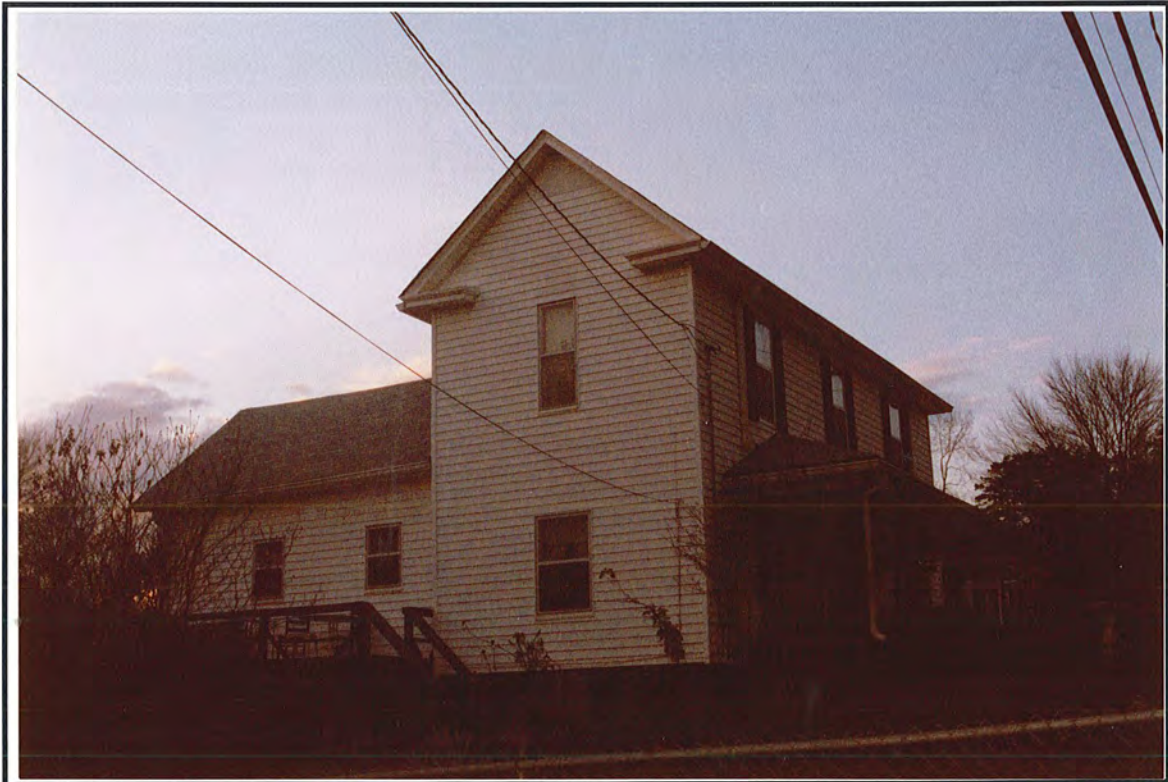
Photograph 96. View of Structure 51, facing northwest.

*Structure 51:* Structure 51 is a c.1890 plantation plain two-story structure with gabled returns, a rear ell, and no academic style (Photograph 96). It is recommended eligible for the NRHP. Structure 51 is located on Old North Road, approximately 2,800 feet southwest of the proposed tower, which will not be visible due to distance, intervening trees, and topography (Photograph 97). Because the proposed tower will not be visible from the structure, no effect is expected.

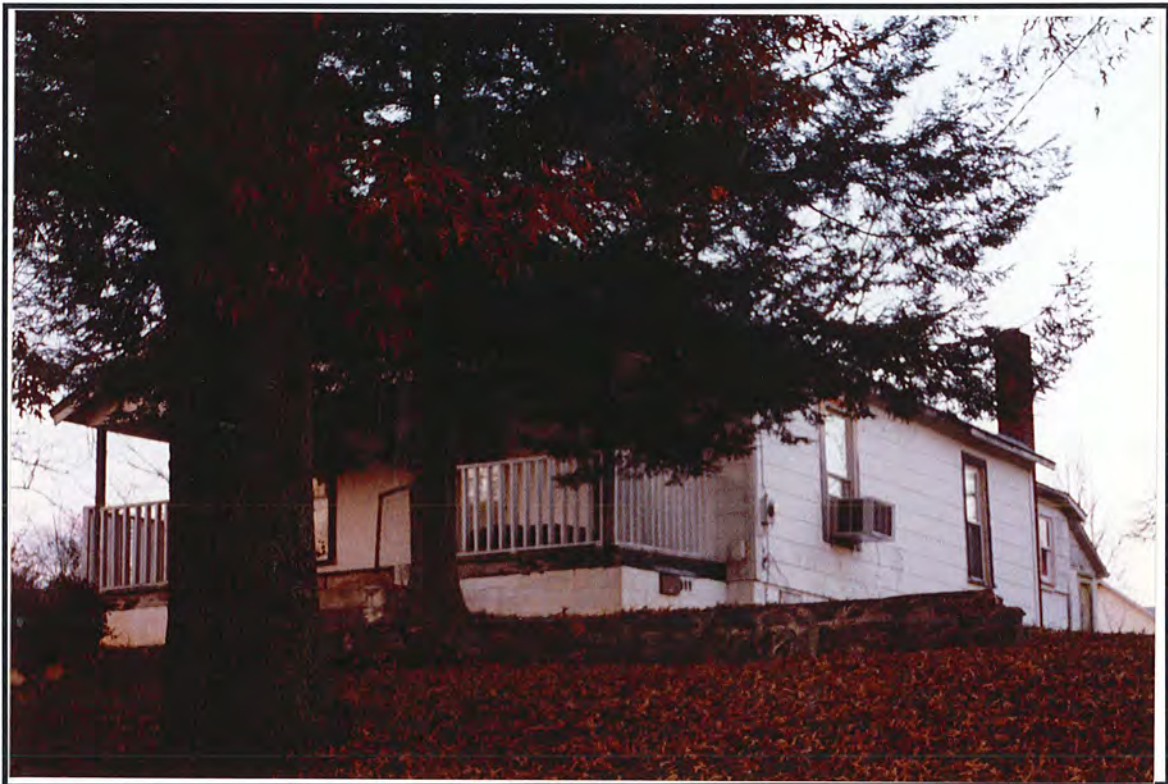
Photograph 98. View of Structure 52, facing northeast.

*Structure 52:* Structure 52 is a c.1930 front gabled bungalow with asbestos siding, 1/1 windows, a cinder block foundation, and no academic style (Photograph 98). It is considered ineligible for the NRHP. Structure 52 is located on Old North Road, approximately 2,700 feet southwest of the proposed tower, which will not be visible due to intervening trees and topography (Photograph 97). No effect is expected.

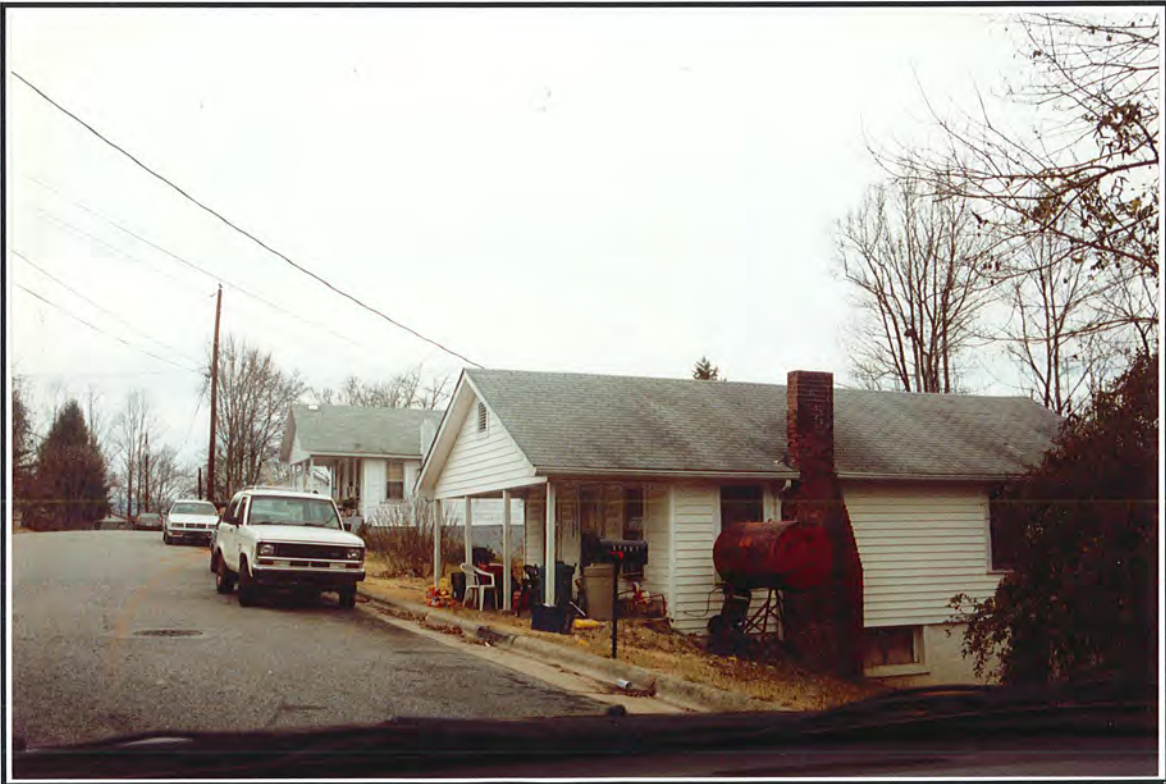
Photograph 112. View of Streetscape 61, representative of structures on Holloway Road, facing northeast.

*Streetscape 61:* Streetscape 61 illustrates late 1930s front gabled bungalows with cinder block foundations and no academic style (Photograph 112). It is representative of historic structures on Holloway Road, and none is considered eligible for the NRHP. Streetscape 61 is located approximately 4,000 feet southeast of the proposed tower, which will not be visible due to distance, intervening topography, and trees (Photograph 113). No effect is expected.

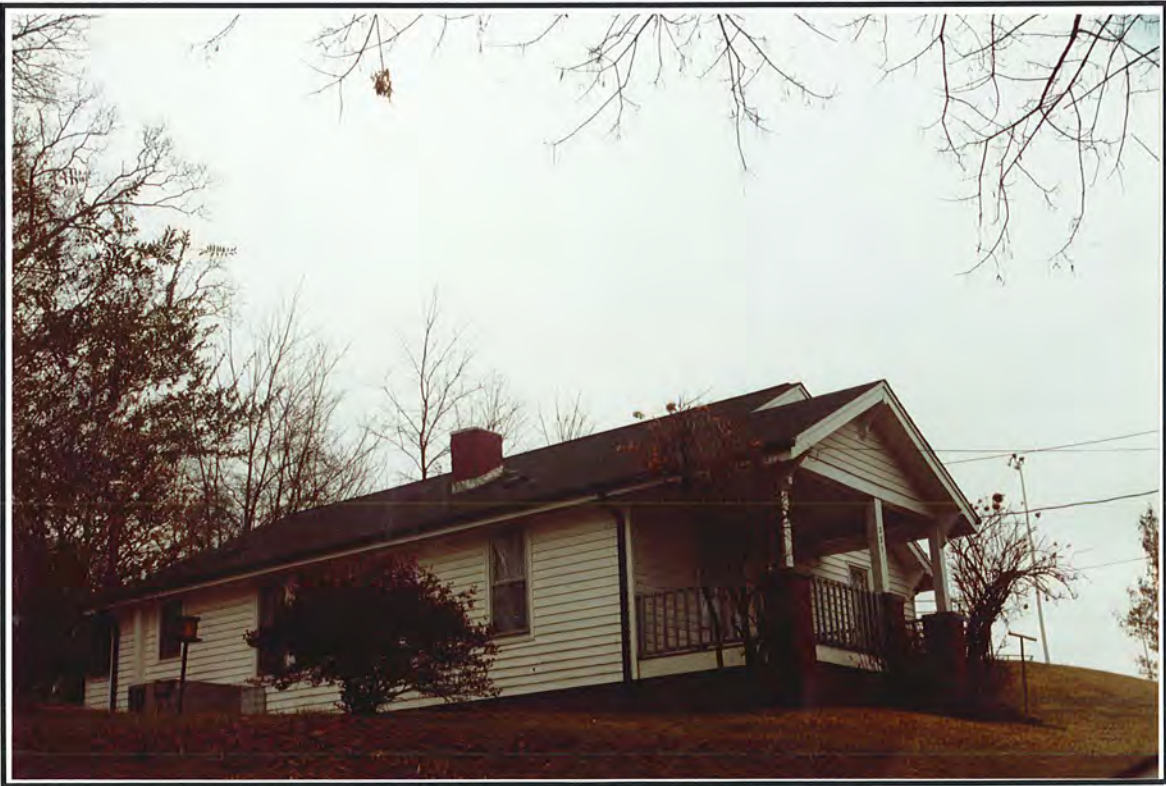
Photograph 116. View of Structure 63, representative of historic structures on Greenhaven Drive, facing southeast.

*Structure 63:* Structure 63 is a c.1930 front gabled bungalow with Craftsman elements, 3/1 windows, square wood supports on brick piers, a brick foundation, vinyl siding, and no academic style (Photograph 116). It is considered ineligible for the NRHP. Structure 63 is located on Greenhaven Drive, approximately 4,500 southeast of the proposed tower, which will not be visible due to distance, intervening trees and topography (Photograph 115). No effect is expected.
