NORTH CAROLINA STATE HISTORIC PRESERVATION OFFICE
Office of Archives and History
Department of Cultural Resources

Hampton-Ellis Farm

Bahama vicinity, Durham County, DH3310, Listed 12/22/2011

Nomination by Heather M. Wagner

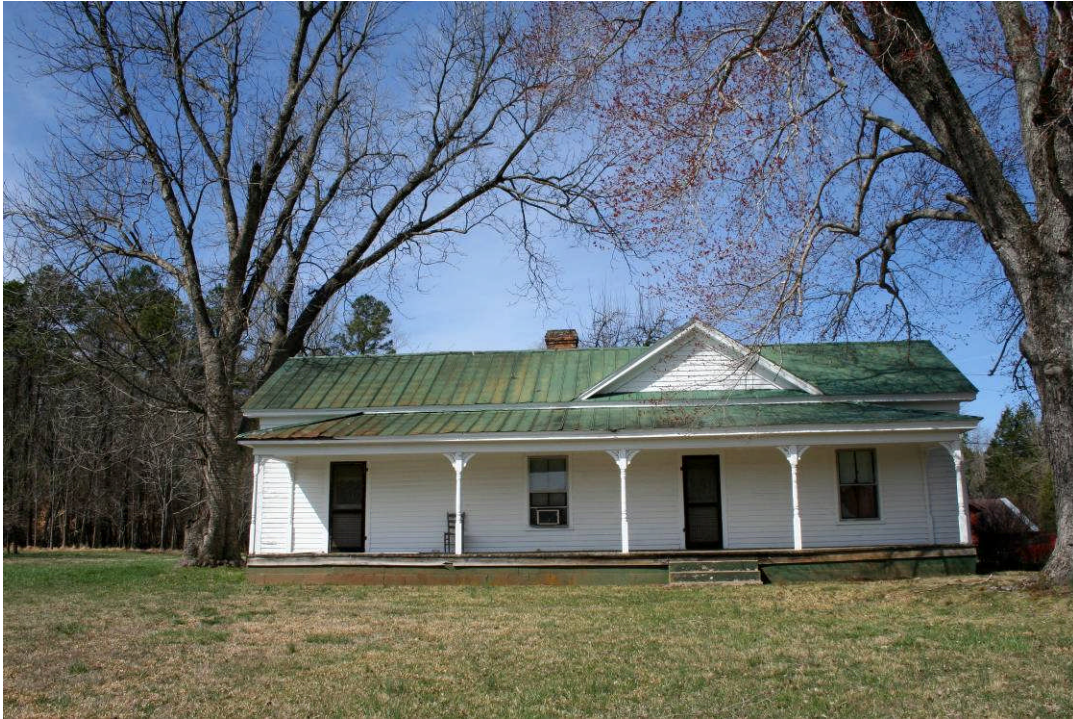
Façade view

The c. 1900 triple-A-roofed house is currently four bays wide and single-pile with a gabled rear kitchen ell. Originally a three-bay-wide, center-hall plan house, a third room was added to the left (south) end shortly after Jonah Ellis purchased the property in 1922. The house has a brick pier foundation with a concrete-block curtain wall and retains a 5V metal roof and painted wood weatherboards throughout, including in the decorative front gable. A corbelled brick chimney rises between the main block and the rear kitchen ell and a second, smaller brick chimney is located on the south slope of the roof near the west end of the kitchen ell. The house has simple wood cornerboards and boxed eaves with wood soffits, fascia, bedmold, and flared rakeboards in the gable ends. Two-over-two, double-hung, wood sash windows are trimmed with simple wood casings and have wood windowsills and dripcaps. The gabled kitchen ell is flanked by screened porches, both added around 1922, and has paired two-over-two, horizontal-pane, wood sash windows on the rear gable end and on the enclosed (bathroom) portion of the shed-roofed porch.

The one-story, hip-roofed front porch extends nearly the full width of the façade and is supported by turned wood posts with decorative sawn brackets. The porch has a replacement wood floor, but retains an original flush-wood ceiling with small crown molding. The porch is supported by a later, concrete-block foundation and has concrete steps in line with the main entrance. There are two entrances to the

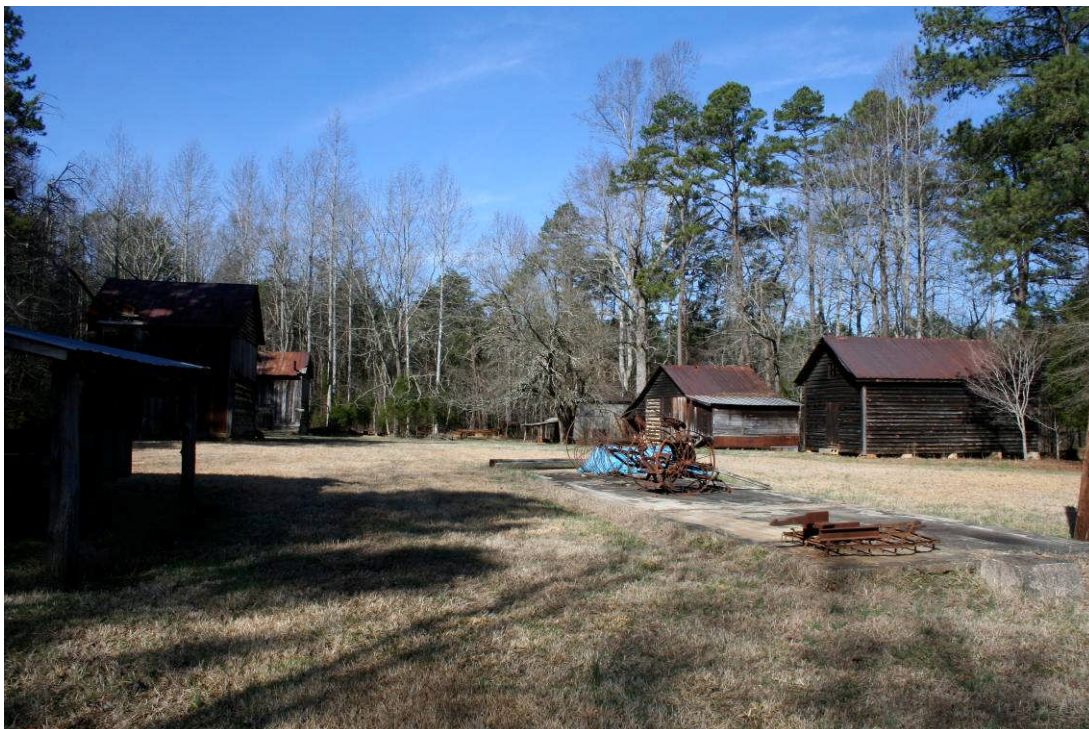
Farm outbuildings – general view
