SUBJECT: Architectural Survey Report for Improvements to the NC 42/I-40 Interchange, I-4739,
Johnston County, ER 06-3052

**ARCHITECTURAL SURVEY REPORT
IMPROVEMENTS TO
NC 42 INTERCHANGE WITH I-40
JOHNSTON COUNTY, NORTH CAROLINA**

**TIP No. I-4739
WBS # 36595**

**New South Associates Inc.
6150 Ponce De Leon Avenue
Stone Mountain, Georgia 30083**

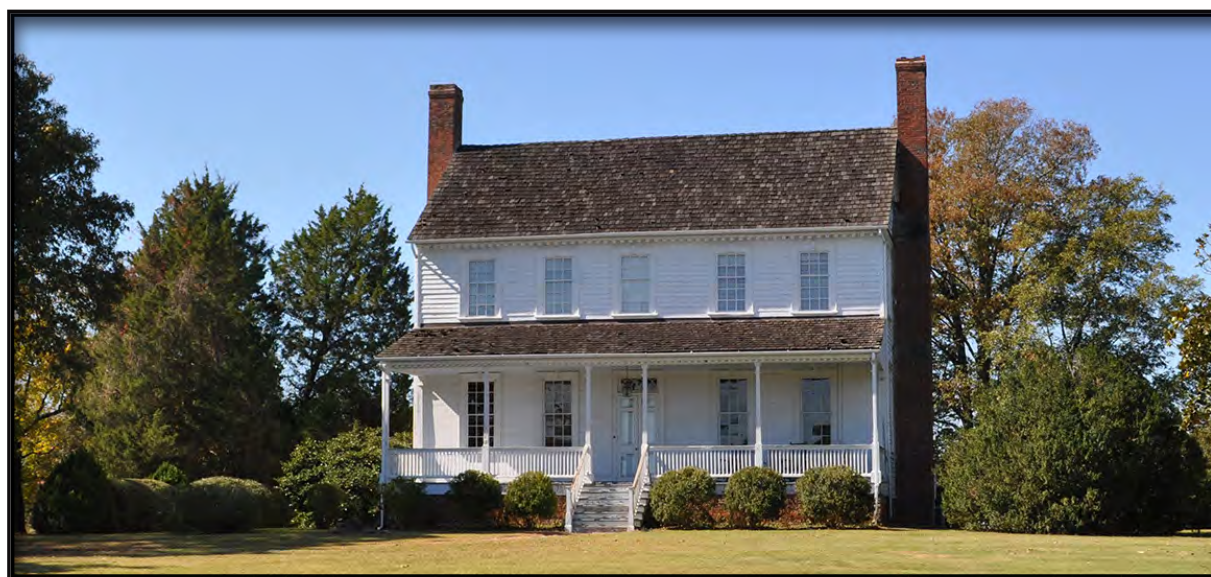
Figure 4. Façade (East Elevation) from Cornwallis Road

and 9/6 window sashes. Windows are set in robust molded surrounds surmounted by carved “keystones.” The keystone motif is repeated in the paired oculus windows in the pediments of the side elevations. On the side and rear elevations, the first-story windows are topped with triangular pediments above a delicate dentil molding with circular gouge work. The distinctive dentil is molding applied liberally on the exterior cornices of the porch and main block of the house, as well as under the porch handrail. The dentil molding is also seen on the second story windows beneath the horizontal molded hoods.

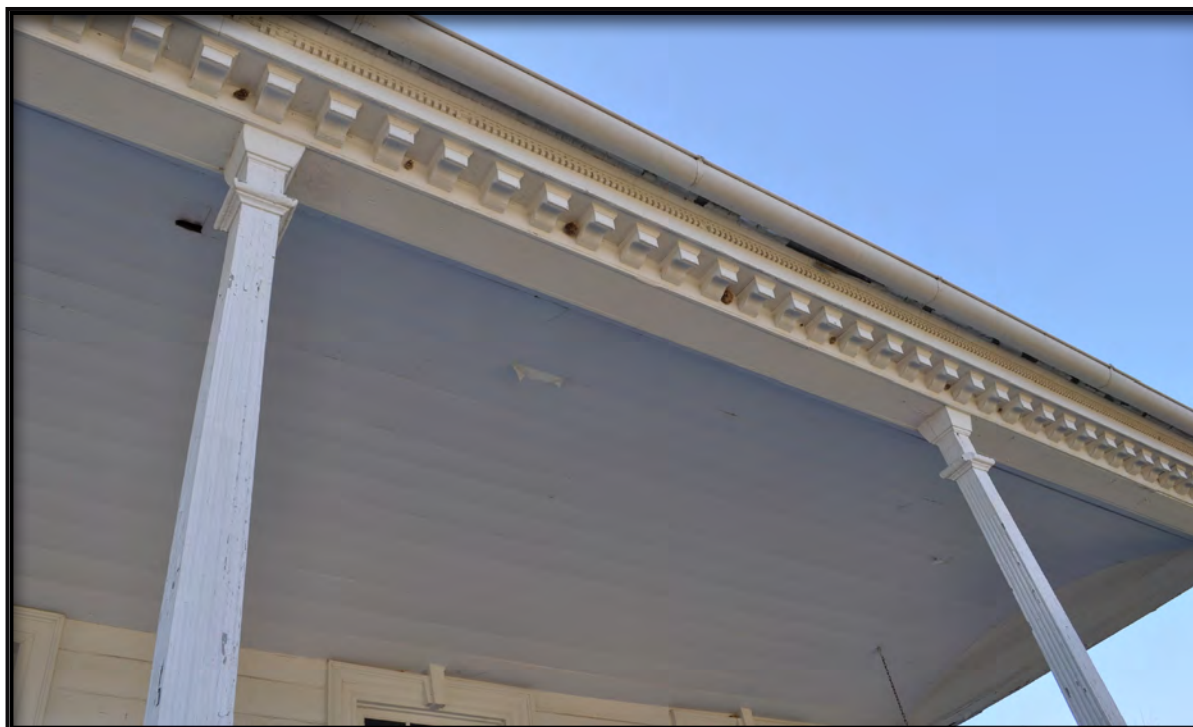
Figure 5. Porch Cornice Detail

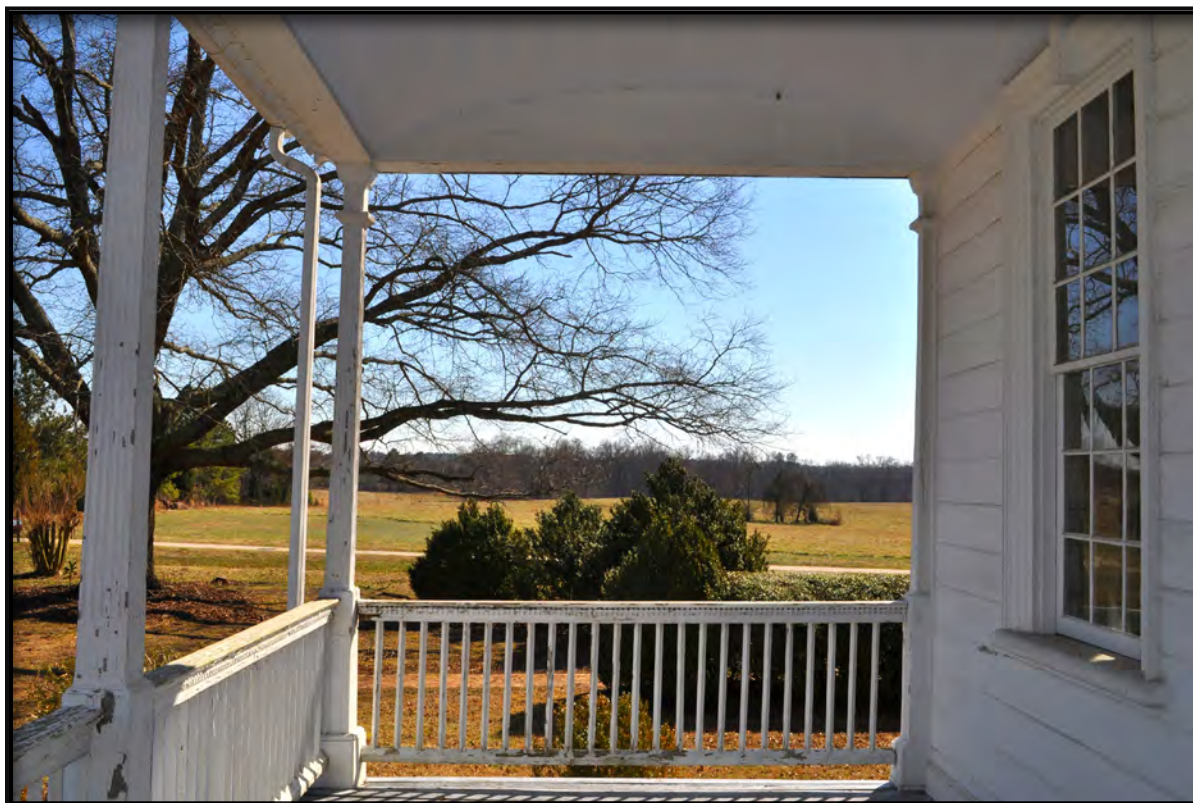
Figure 6. Porch Vaulted Ceiling, "Keystone" Window Surround, Fluted Columns and Balustrade with Dentilated Handrail, Looking South with Fields in Background

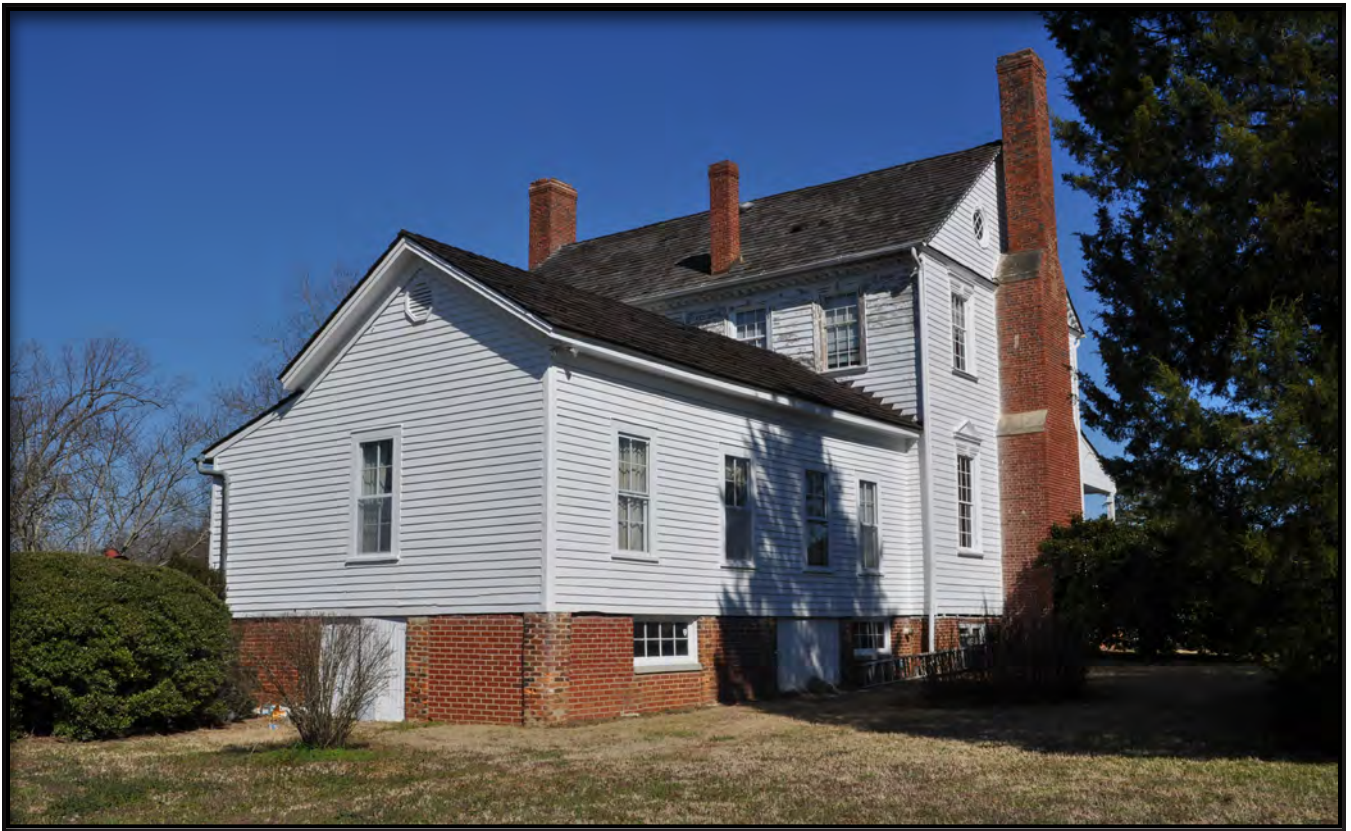
Figure 7. South and West Elevations

A mid-nineteenth-century one-story gabled ell projects from the rear elevation (Figures 7 and 8). In contrast with the main block, the addition is plainly finished with weatherboard siding, 4/4 windows, and plain surrounds and eaves. A.Y. Hairr added a shed addition to the ell’s north side in the 1950s. Current owner, Billy Troxler added the band of windows to the shed in the 1980s. Troxler also added the rear deck and brick patio.

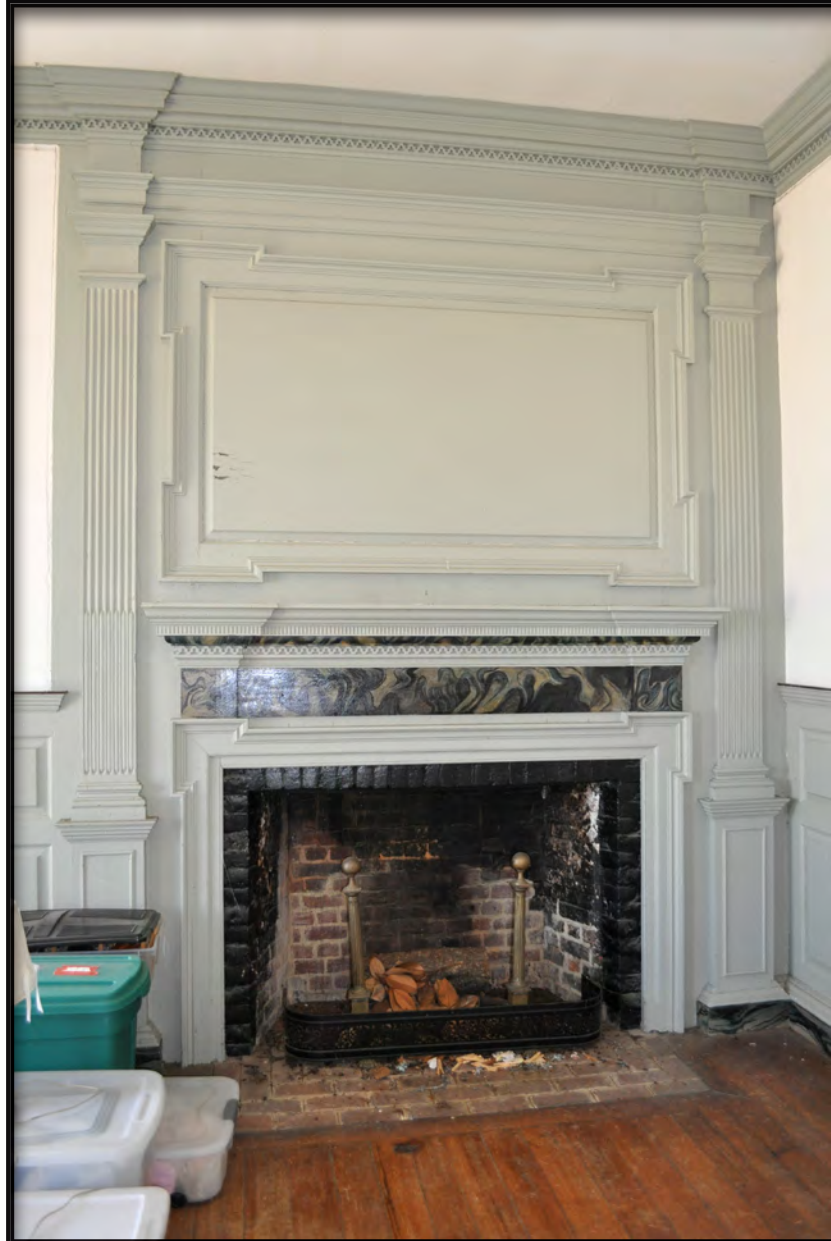
Figure 9. View of Hall Fireplace Showing Mantel and Overmantel with Original Marbled Paint

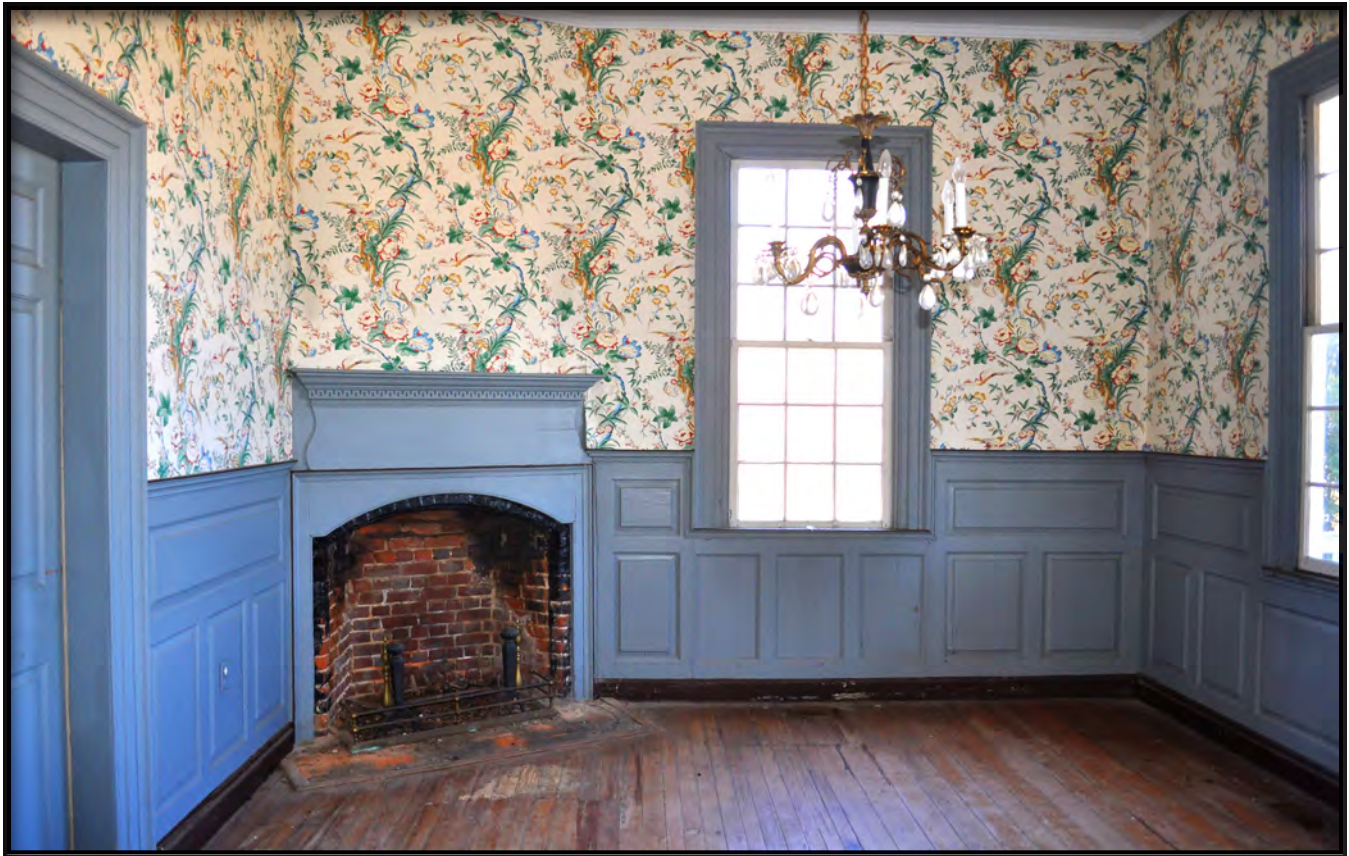
Figure 10. View of Parlor with Paneled Wainscot, Arched Firebox, and Georgian-Style Mantle

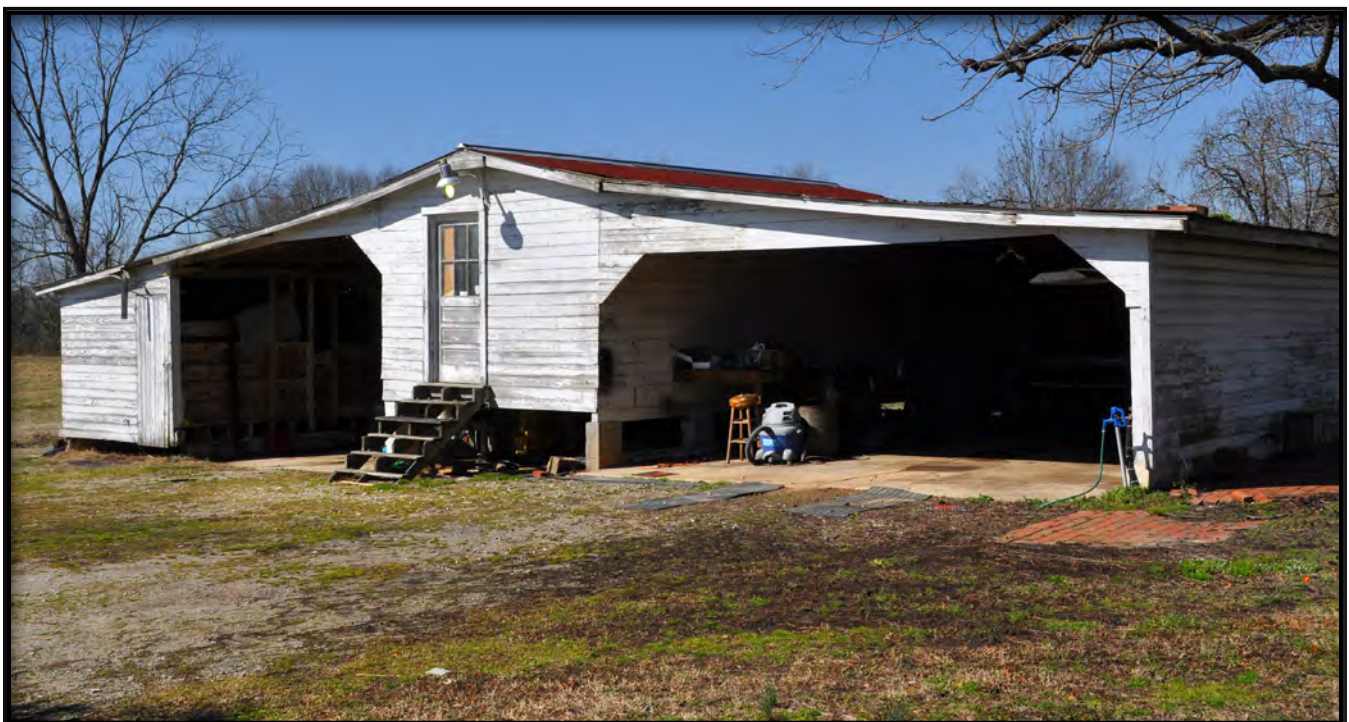
Figure 11. Tractor/Car Garage and Workshop, South Side

This elevated frame workshop has large, partially enclosed sheds on the east and west sides (Figure 11).

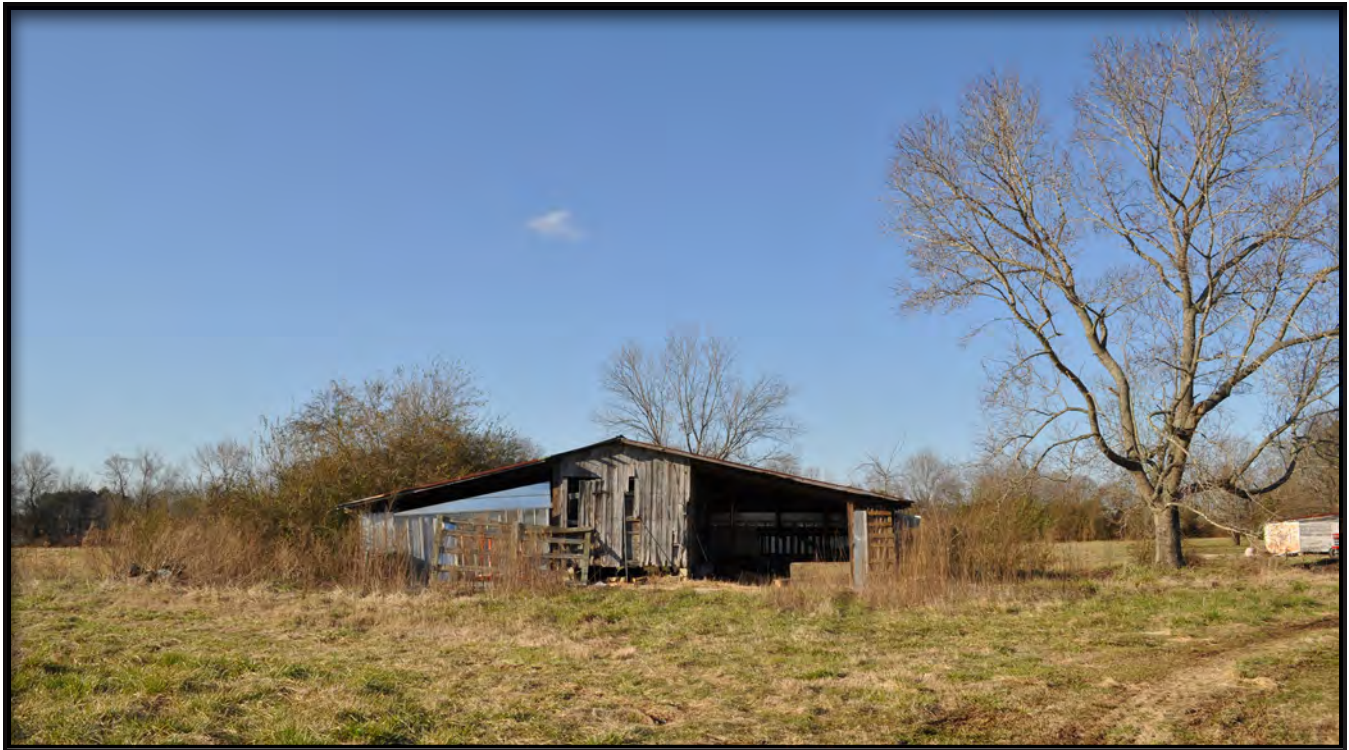
This deteriorating structure is similar in form to the Car/Tractor Barn and Workshop (Figure 12).

Figure 12. Barn 1, South Side

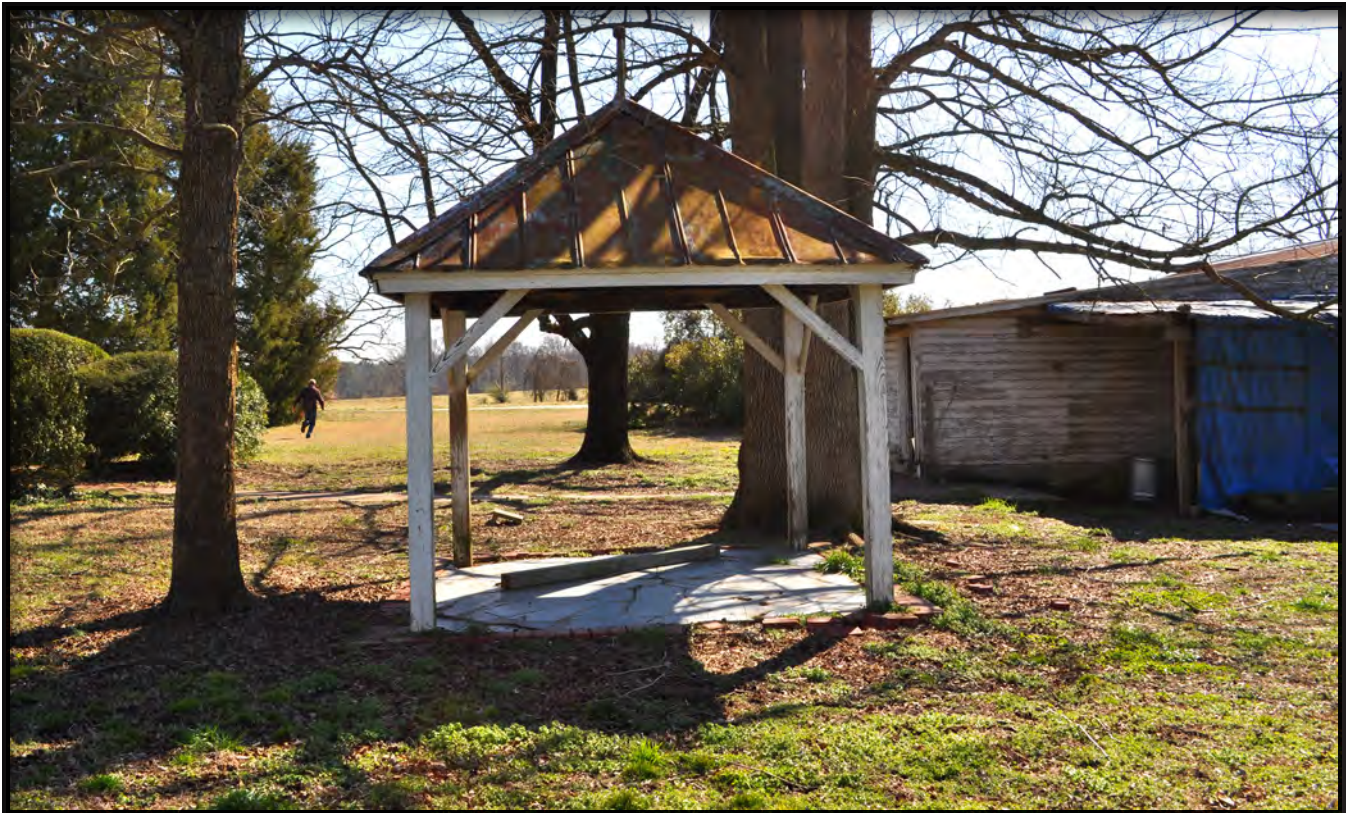
Figure 13. Well Cover

The pyramidal-roofed well cover on square posts shelters an early well, now sealed. The structure retains a decorative wood finial at the peak of the metal-covered roof (Figure 13).

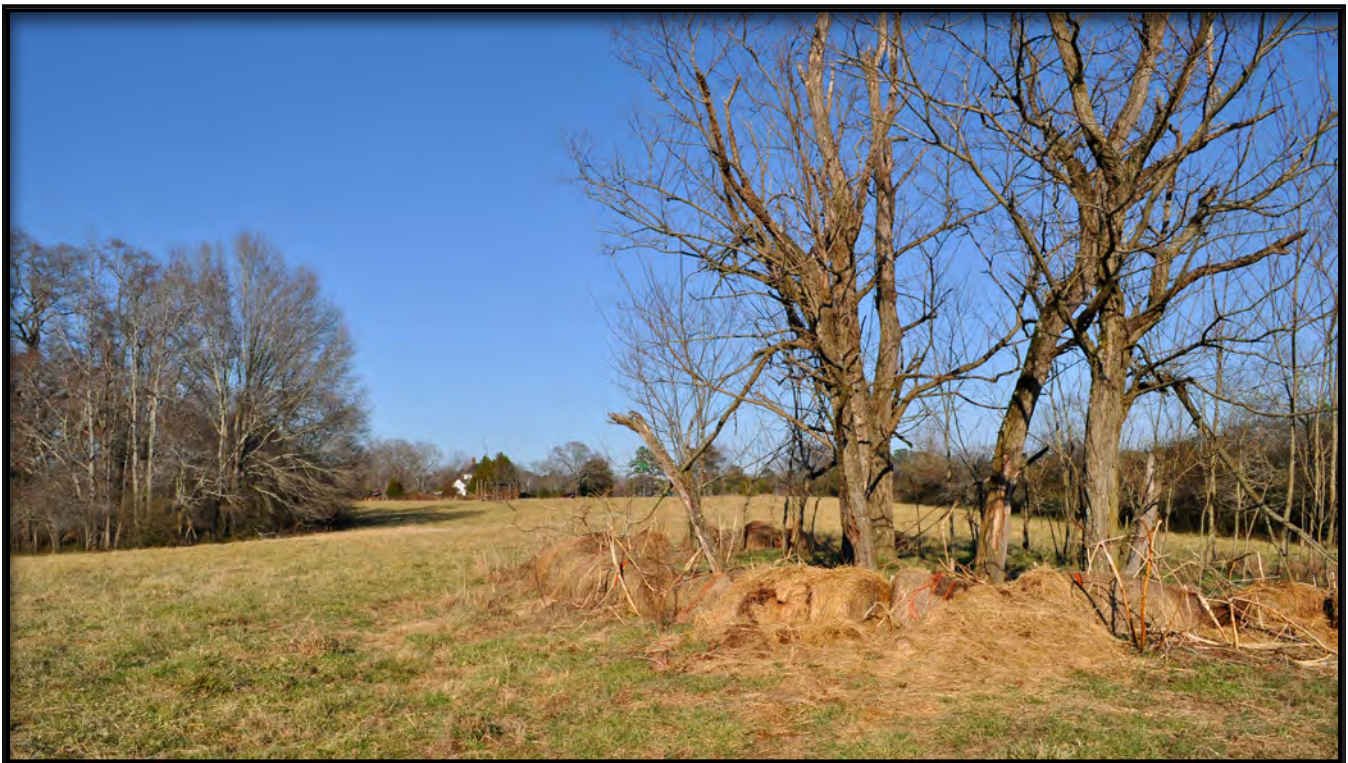
Figure 14. View from Gravesite Looking Northeast to House

On a rise approximately 1,200 feet southwest of the house is the burial site of Reubin Sanders and his second wife, Keren. In the mid-nineteenth/early twentieth century, descendants moved the headstones to a nearby cemetery (Personal communication, William “Billy” Troxler, February 25, 2013). The stone bases and burials remain. The site is protected from grazing livestock by large hay bales but otherwise not maintained (Figure 14).

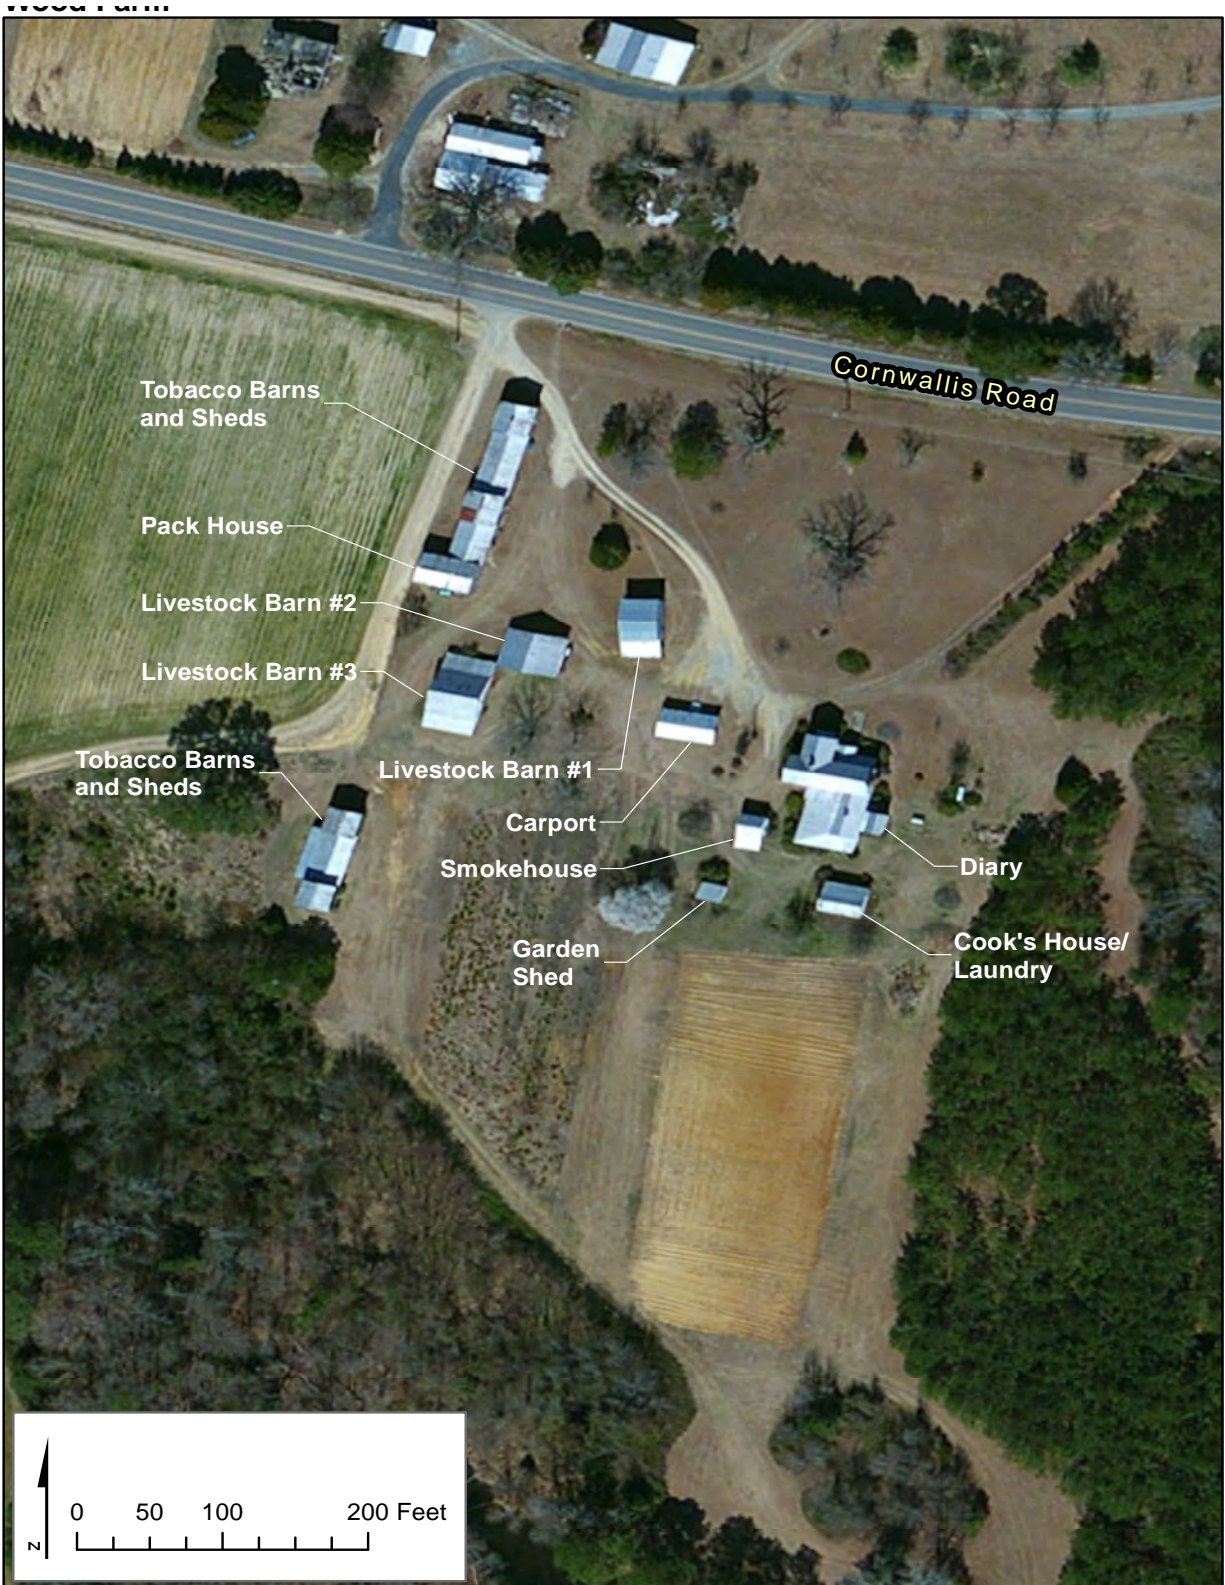
The Wood Farm is located on the south side of Cornwallis Road (Figure 16). The two-story house that anchors the farmstead sits at the top of a knoll, approximately 300-feet from the road (Figure 17). Domestic (detached kitchen, dairy and smokehouse) and agricultural outbuildings (livestock and tobacco barns) are clustered south and west of the house. South of the house is a large 0.75-acre vegetable garden and a farm pond, dammed at the southwest end, on an unnamed intermittent tributary of Middle Creek. The surrounding setting is primarily rural, although a residential subdivision has been built northwest of the farm. Cultivated fields and open pastures remain north, south and west of the house and outbuildings. Evergreen trees grow on the west side of the parcel.

Figure 16. Wood Farm Site Plan

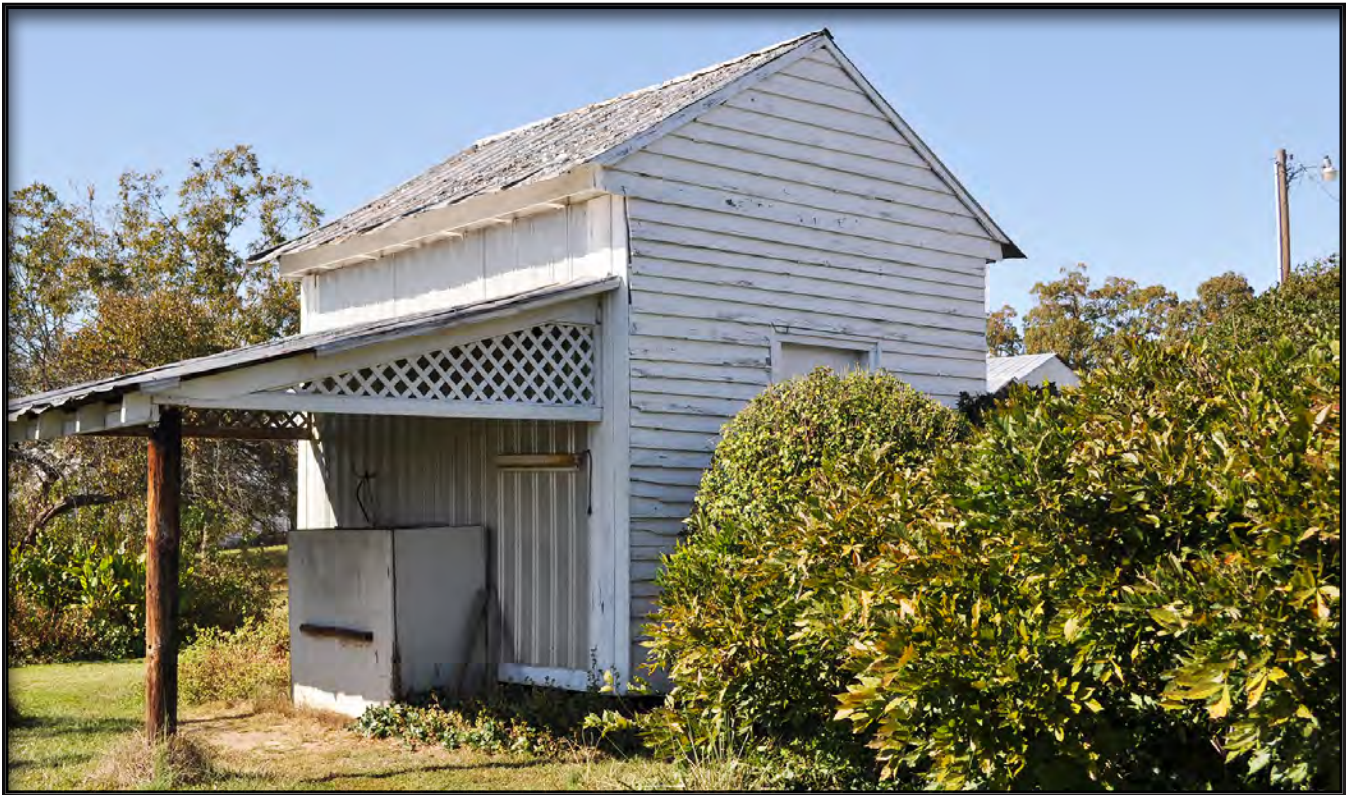
This frame smokehouse has flush gable ends and boxed eaves suggestive of a mid-nineteenth-century date of construction. It is covered with weatherboard siding and has a batten door. An open shed has been built off the south elevation (Figure 20).

Figure 20. East and South Elevations of Smokehouse

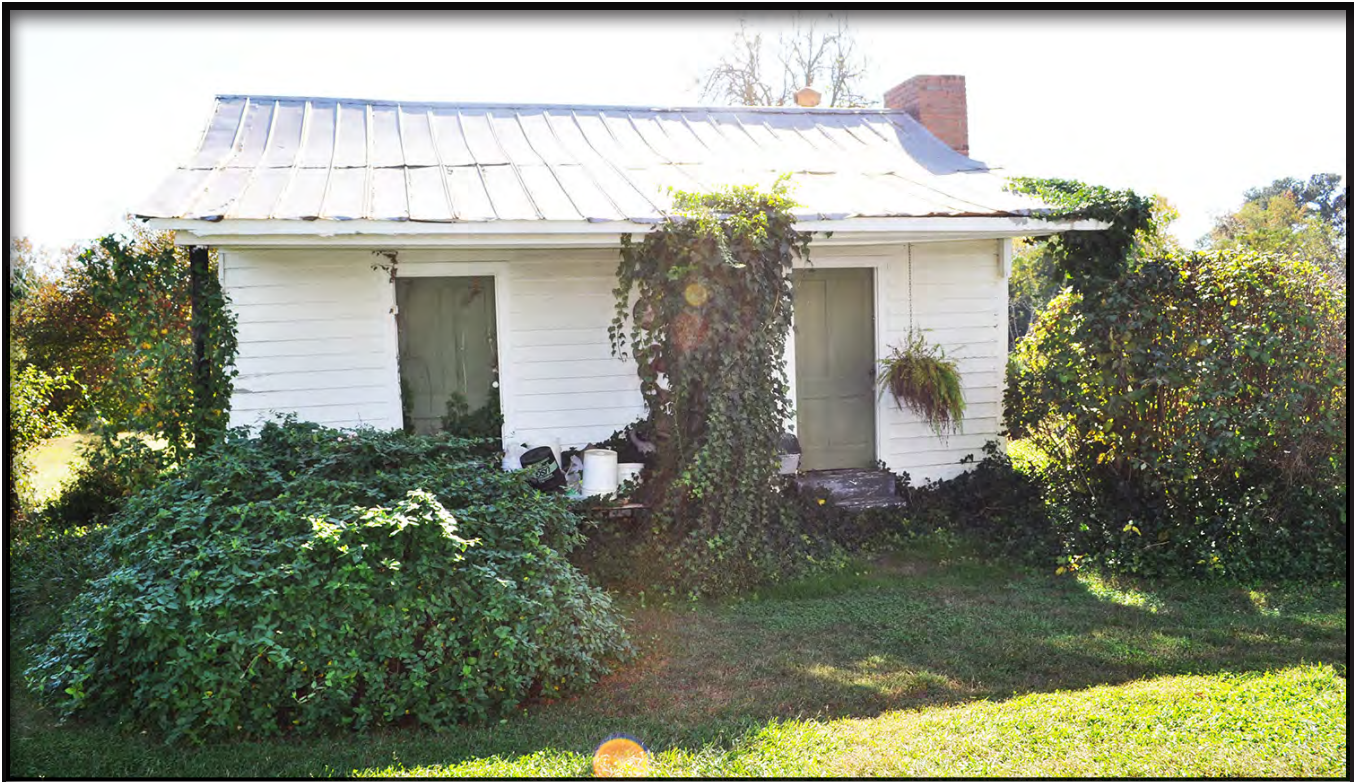
Figure 21. North Elevation of Laundry/Kitchen

This frame, one-story, side-gabled dependency has an engaged shed porch roof across the north elevation facing the rear of the main dwelling (Figures 21 and 22). There is no porch floor; only a post at the east end supports the porch roof. Under the porch roof are two entries, each with a five-panel door. The small, square window openings on the east, south and west sides have fixed, two-pane sashes. The building is covered in weatherboard siding and has boxed eaves on the south side. It rests on brick and stone piers and has a metal covered roof.

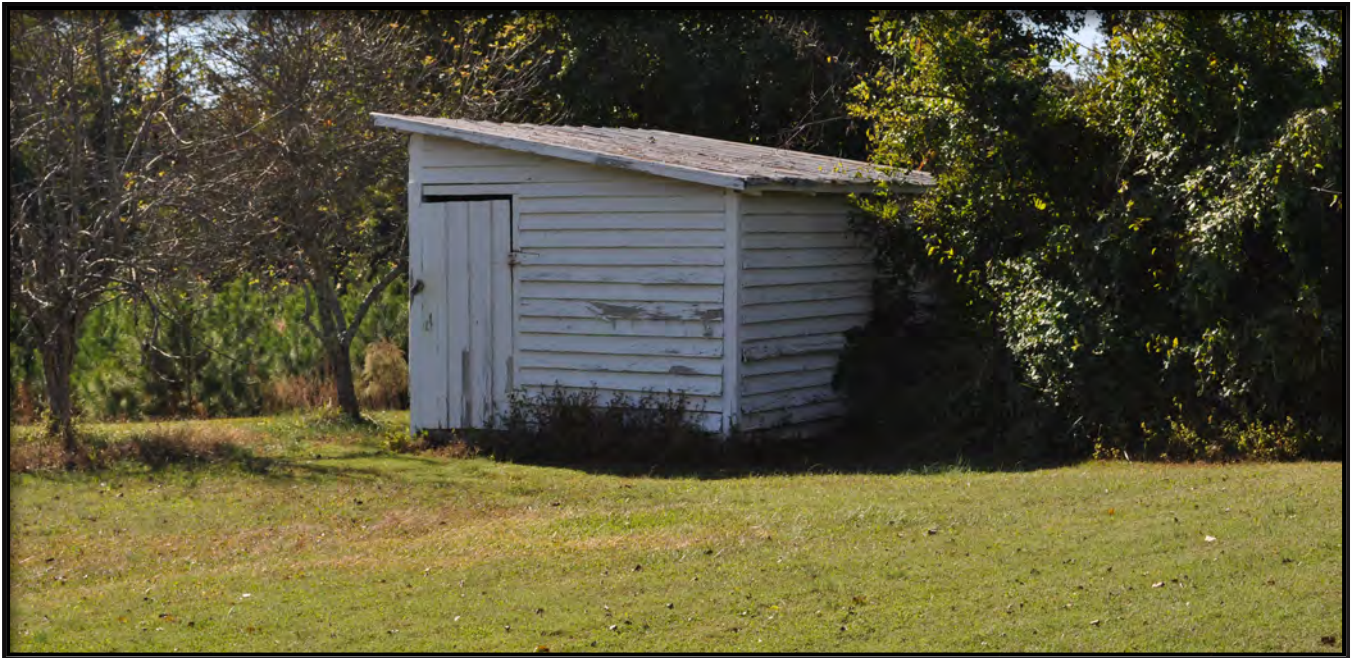
South of the house and north of the vegetable garden is a small, frame, shed-roofed building (Figure 23). It is covered with weatherboard siding and has a metal-covered roof with exposed rafter ends. A board-and-batten door is on the east side. This building may be the chicken house referenced in the 1982 survey file; today it is used as a garden shed (Butchko 1982a).

Figure 23. East Elevation of Garden Shed

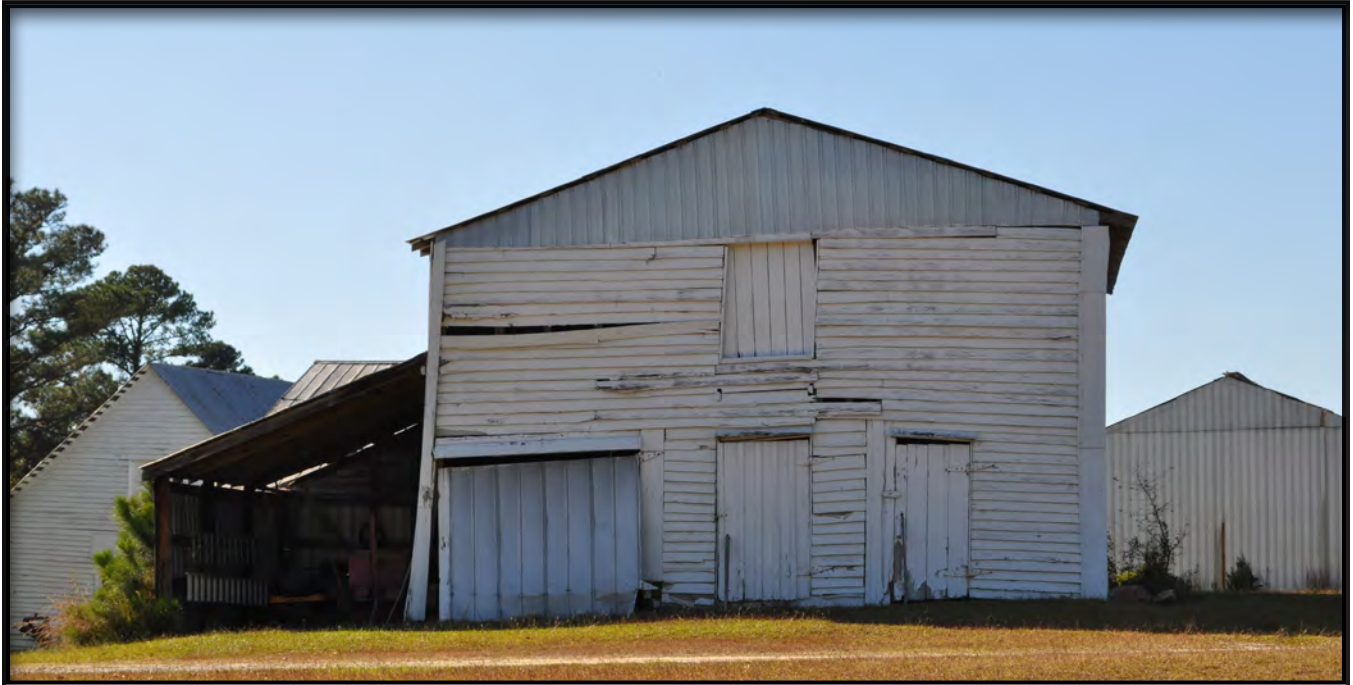
One of three intact frame livestock barns on the property, Livestock Barn #1 is the only one that is two full stories in height (Figure 24). The barn has a gabled roofline with exposed rafter ends and a partially enclosed shed on the south side. There are two board-and-batten doors and a large bay covered with metal on the front (east) elevation. The weatherboard siding remains in tact, except in the east gable end where it has been replaced or covered with sheet metal. The roof is also metal.

Figure 24. Livestock Barn #1, East Elevation

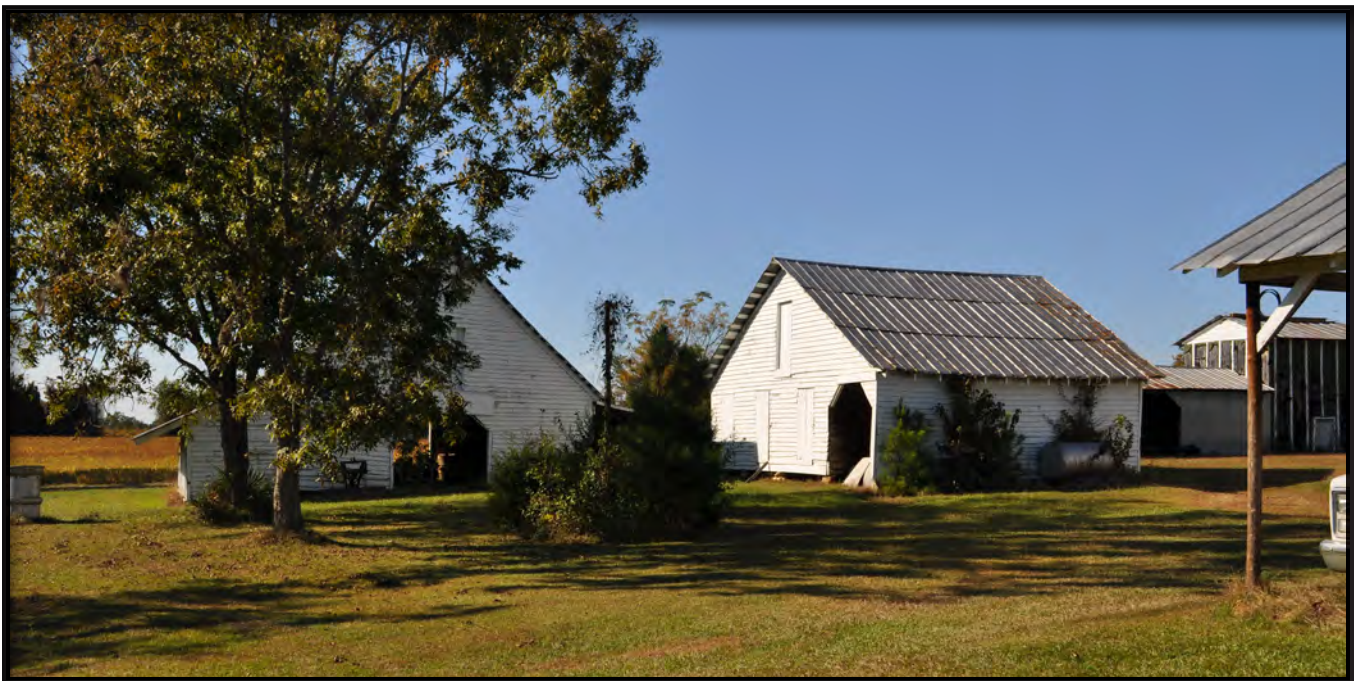
Figure 25. Livestock Barns #2 and #3, Taken from Carport Looking Northwest

This 1.5-story weatherboard barn rests on low stone piers and has a metal-covered roof with exposed skip sheathing in the gable ends and exposed rafter ends on the long sides (Figure 25). It faces south and has four board-and batten doors, three across on the first level and once accessing the loft. There is an open bay at the east end.

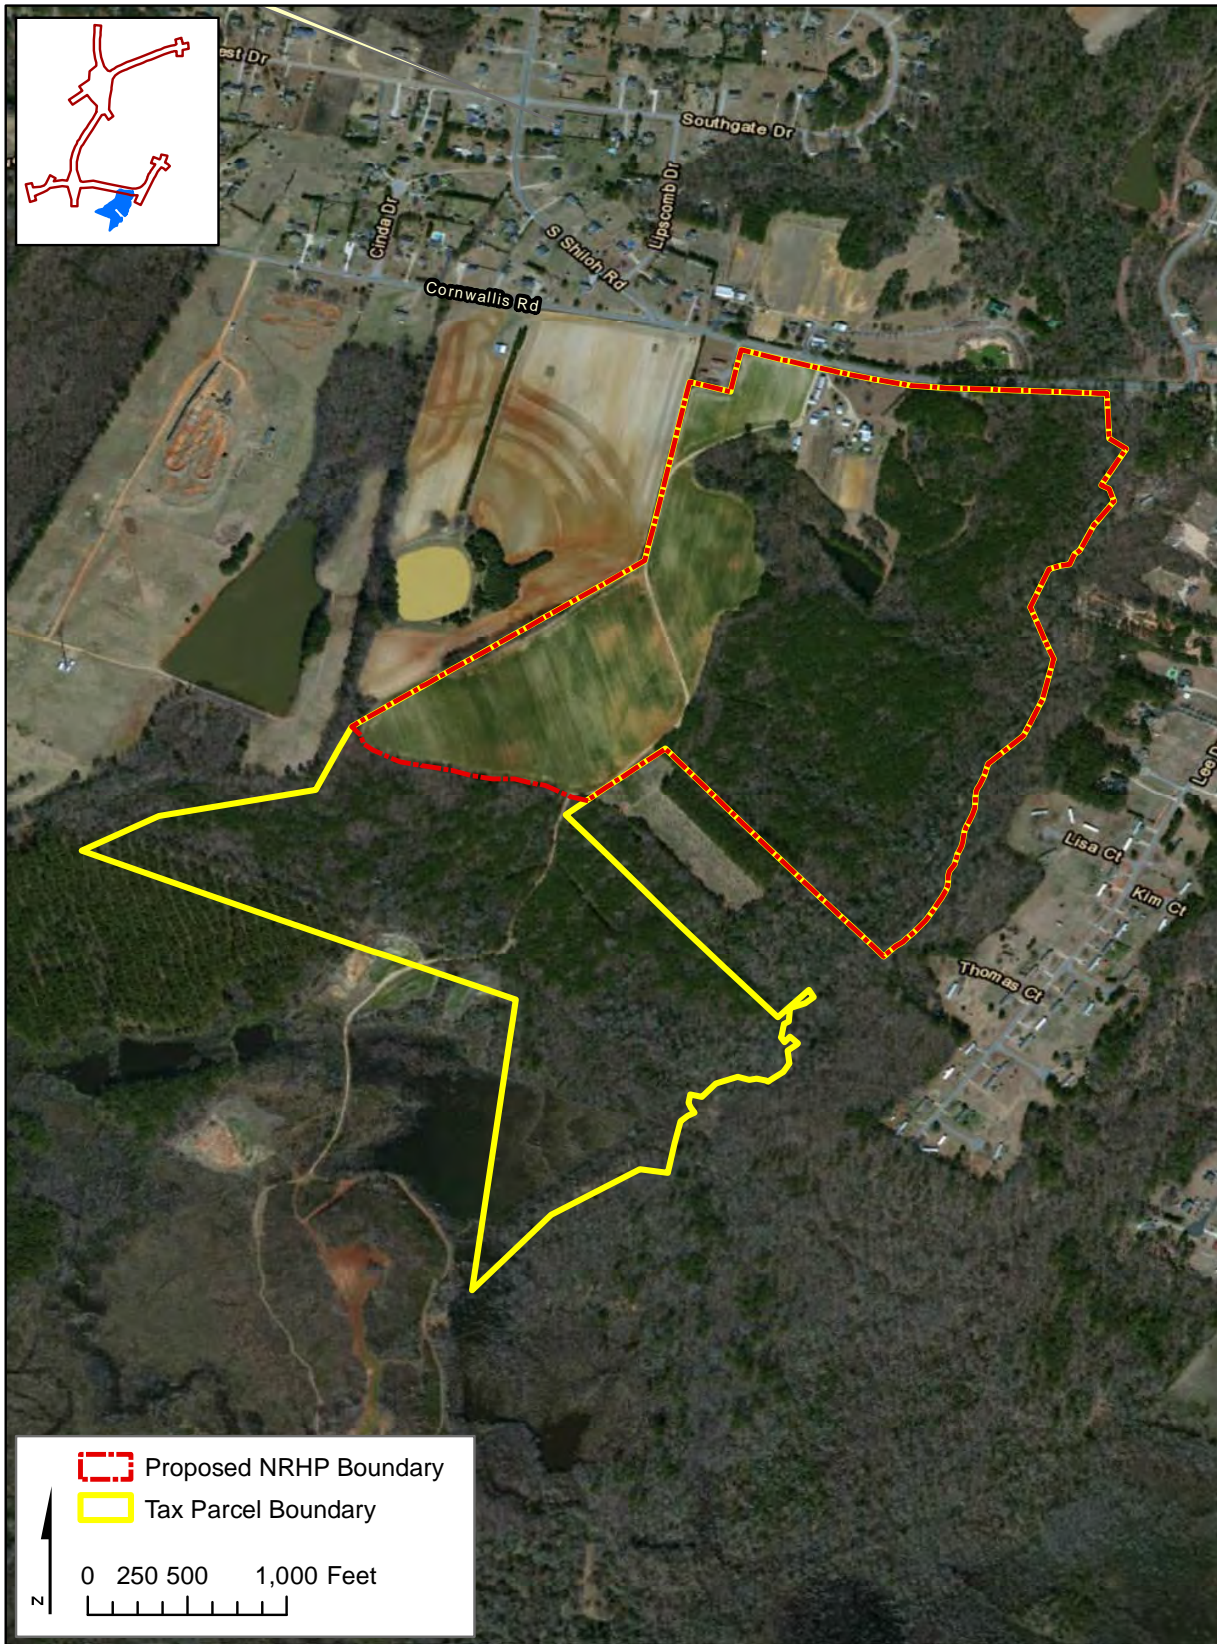
The recommended NRHP boundary includes 50 acres that correspond with the legal parcel, but omits roughly 10 acres of Middle Creek bottom land south of the crop fields (Figure 29). This land is excluded from the recommended boundary because of the character of the landscape in this area. It contains a dense wood of deciduous and evergreen trees and is not visibly associated with the historic agricultural context. The boundary encompasses the complex of domestic and agricultural structures at the parcel's north end and the cultivated fields connected by unpaved farm roads and paths south and west of the complex. The south boundary is the tree line along the south crop field. The east boundary follows the path of an intermittent stream that flows into Middle Creek to the south. The stream is the most readily distinguishable feature, either natural or manmade, on the farm's east side and was therefore determined to be an appropriate boundary.

Figure 29. Wood Farm Tax Parcel and Recommended NRHP Boundary

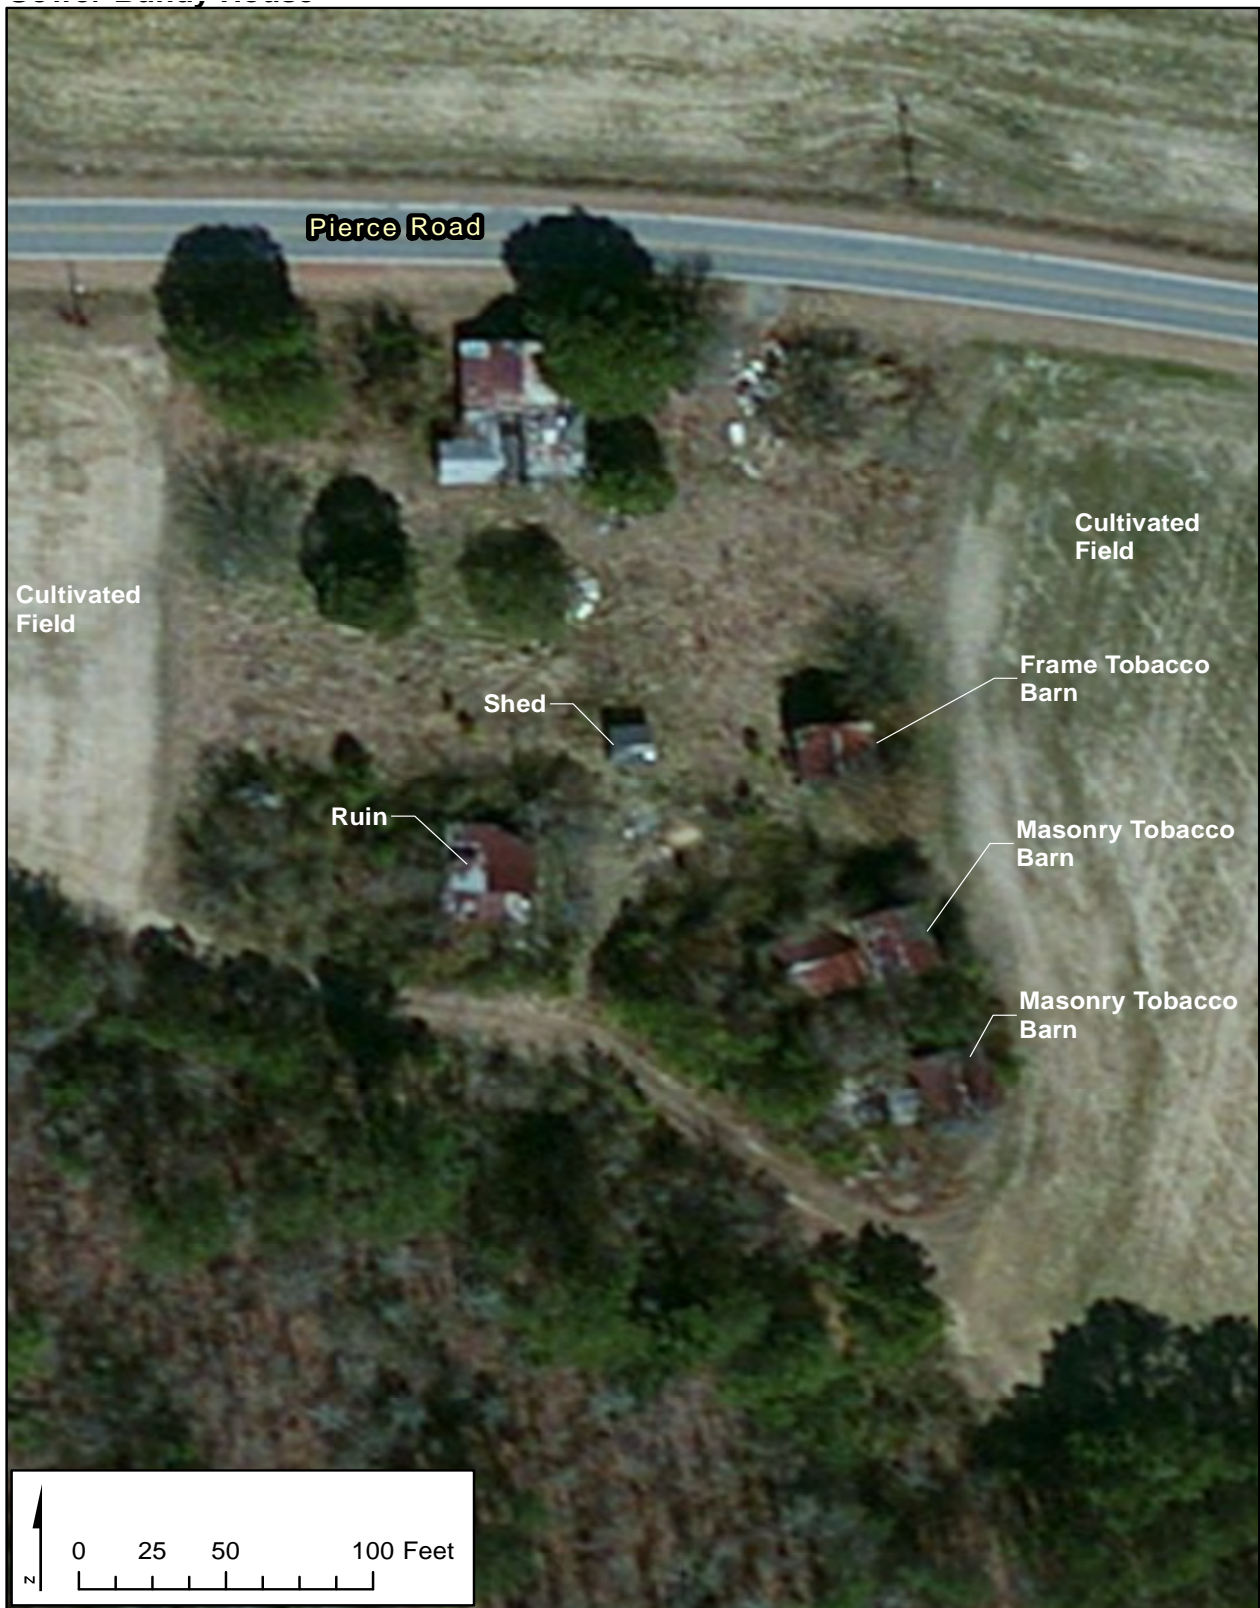
Source: ESRI Resource Data, Imagery Layer
Figure 30. Gower-Bundy House Site Plan

Situated close to the south side of Pierce Road, the circa 1830- Gower-Bundy House is an elongated, two-part, one-story structure (Figures 30 and 31). The earliest part is the two-room section at the south end measuring 16x24 feet. This section has a vernacular coastal cottage form; however, a close examination of the roof rafters and siding covering the south elevation indicate that the inset porch--the defining characteristic of the coastal cottage form--was a later addition, and that the structure was erected with a side-gable roofline.
