SUBJECT: Architectural Survey Report for Improvements to the NC 42/I-40 Interchange, I-4739,
Johnston County, ER 06-3052

**ARCHITECTURAL SURVEY REPORT
IMPROVEMENTS TO
NC 42 INTERCHANGE WITH I-40
JOHNSTON COUNTY, NORTH CAROLINA**

**TIP No. I-4739
WBS # 36595**

**New South Associates Inc.
6150 Ponce De Leon Avenue
Stone Mountain, Georgia 30083**

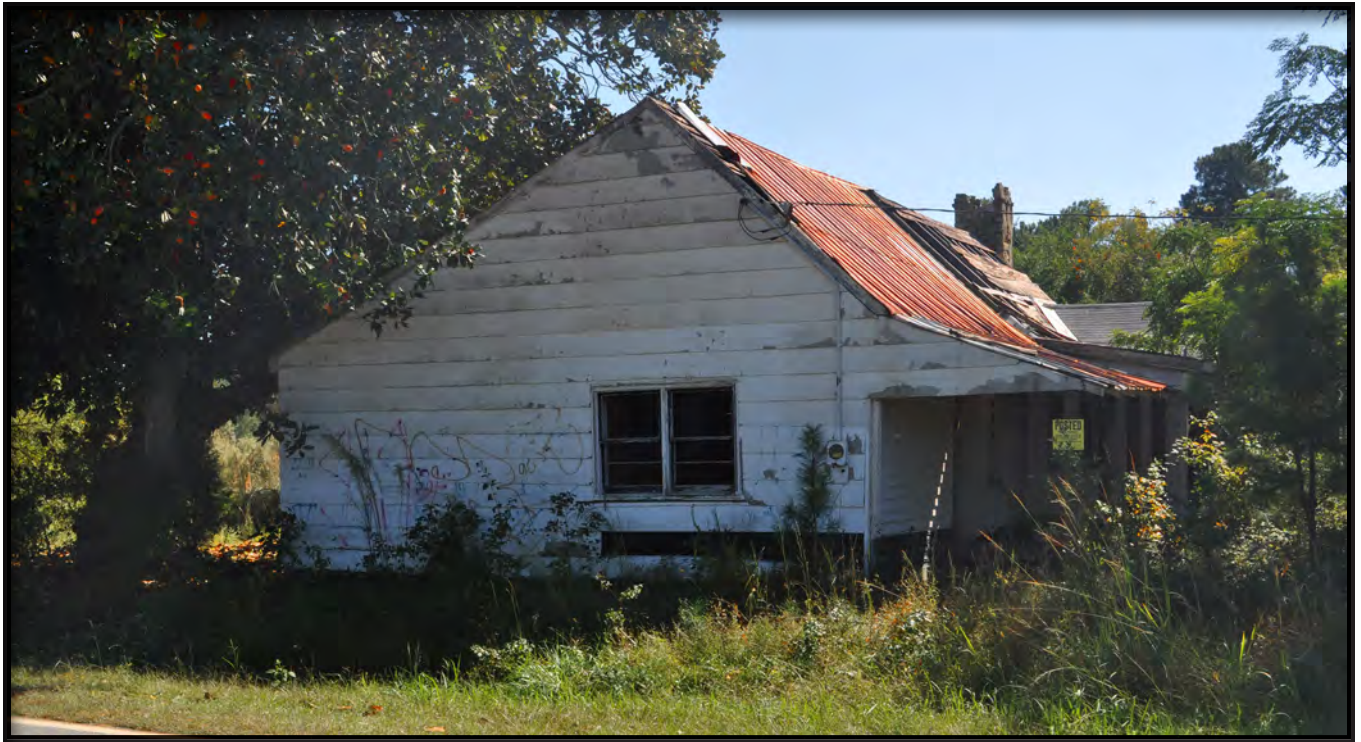
Figure 32. East Elevation, Looking Southwest from Pierce Road

The house was expanded with a side-gabled addition on the north side (Figure 32) The north section possesses a similar coastal cottage form and gabled roofline as the earlier, south section; however, the two sections are clearly distinguishable by the uneven heights of the two roof ridges. The roof framing of the north section displays circular sawn rafters and skip sheathing. The joinery, nails, and saw patterns of the roof structure indicate this section post-dates the south section. Together the “old” and “new” sections result in the house’s present elongated form, tied together by the inset porch across the east side. At the south end, the porch has a beaded ceiling supported by square posts. Two enclosed porch rooms flank a central entry in the north addition (Figures 33 and 34).

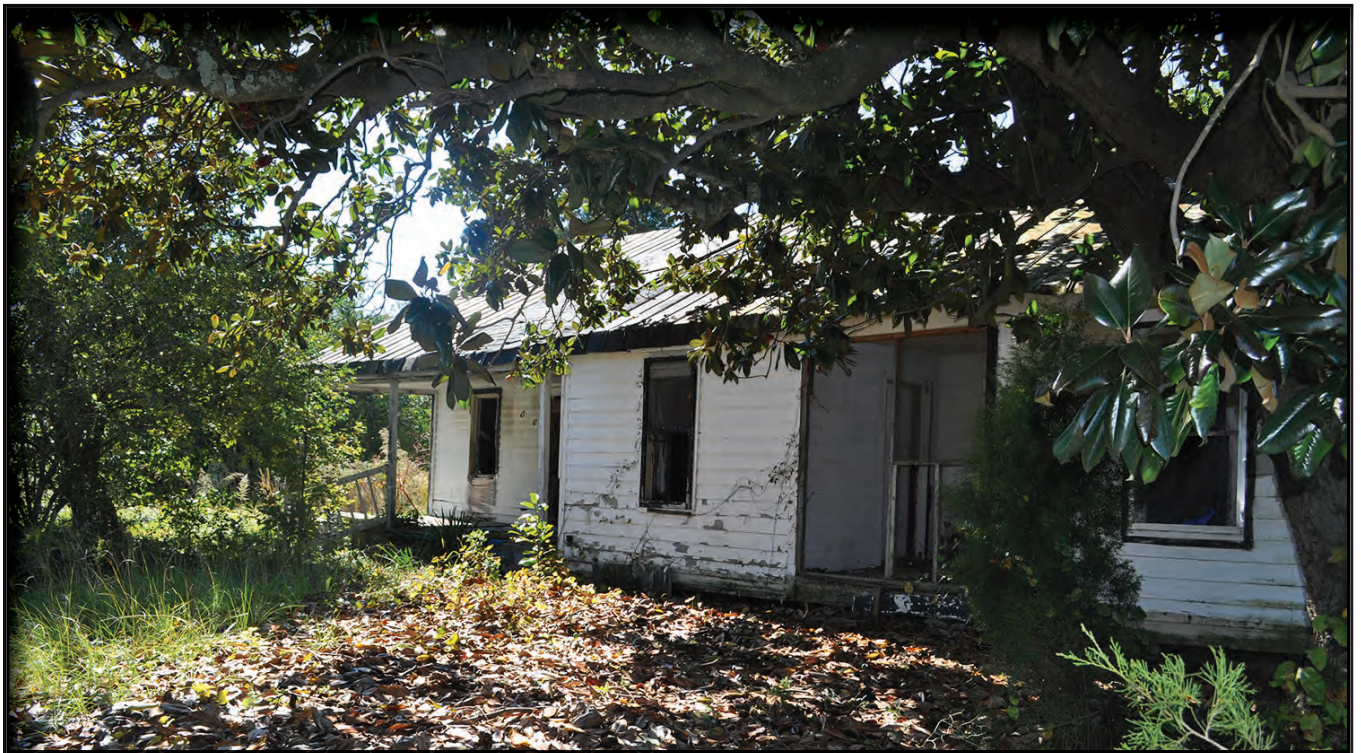
Figure 33. North Elevation Showing circa 1830s Section

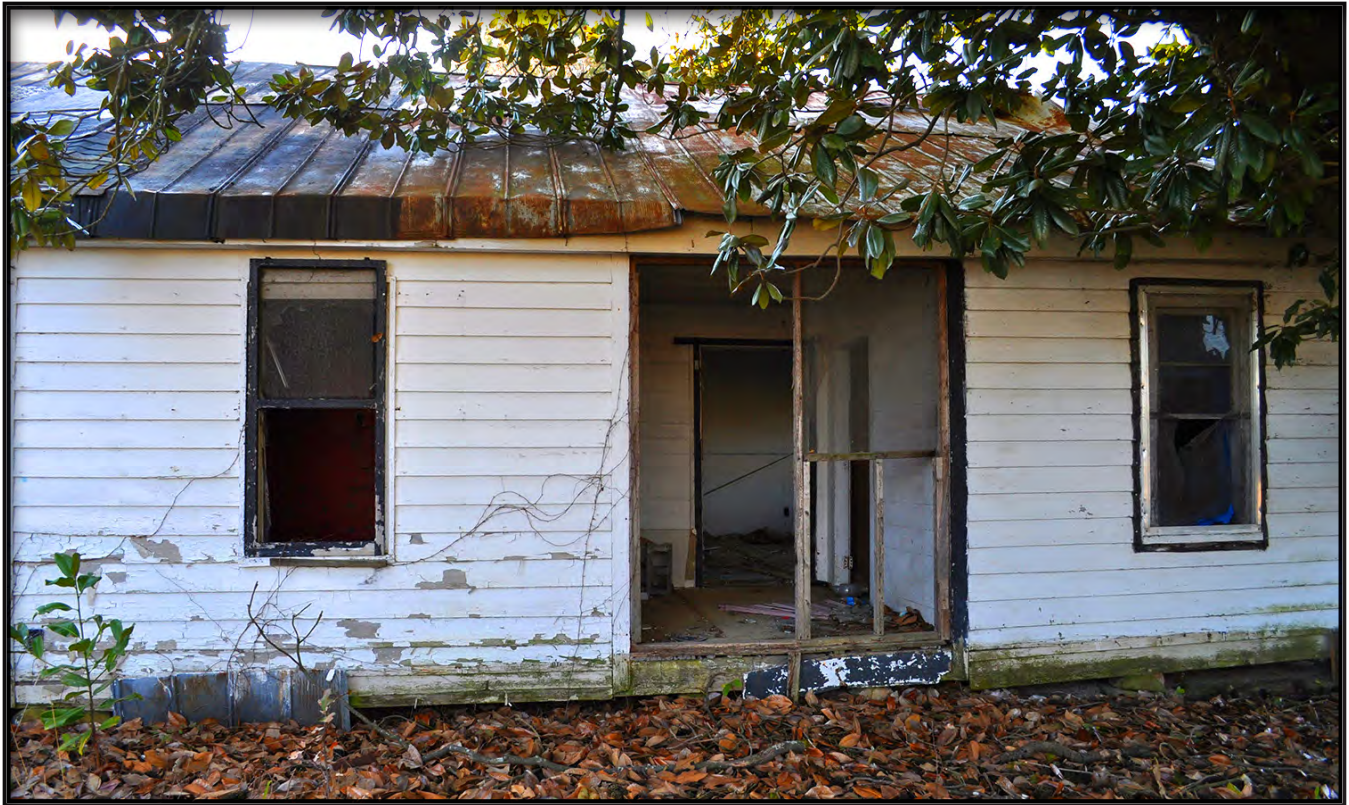
Figure 34. East Elevation Showing Mid-Nineteenth-Century Addition with Shed Rooms

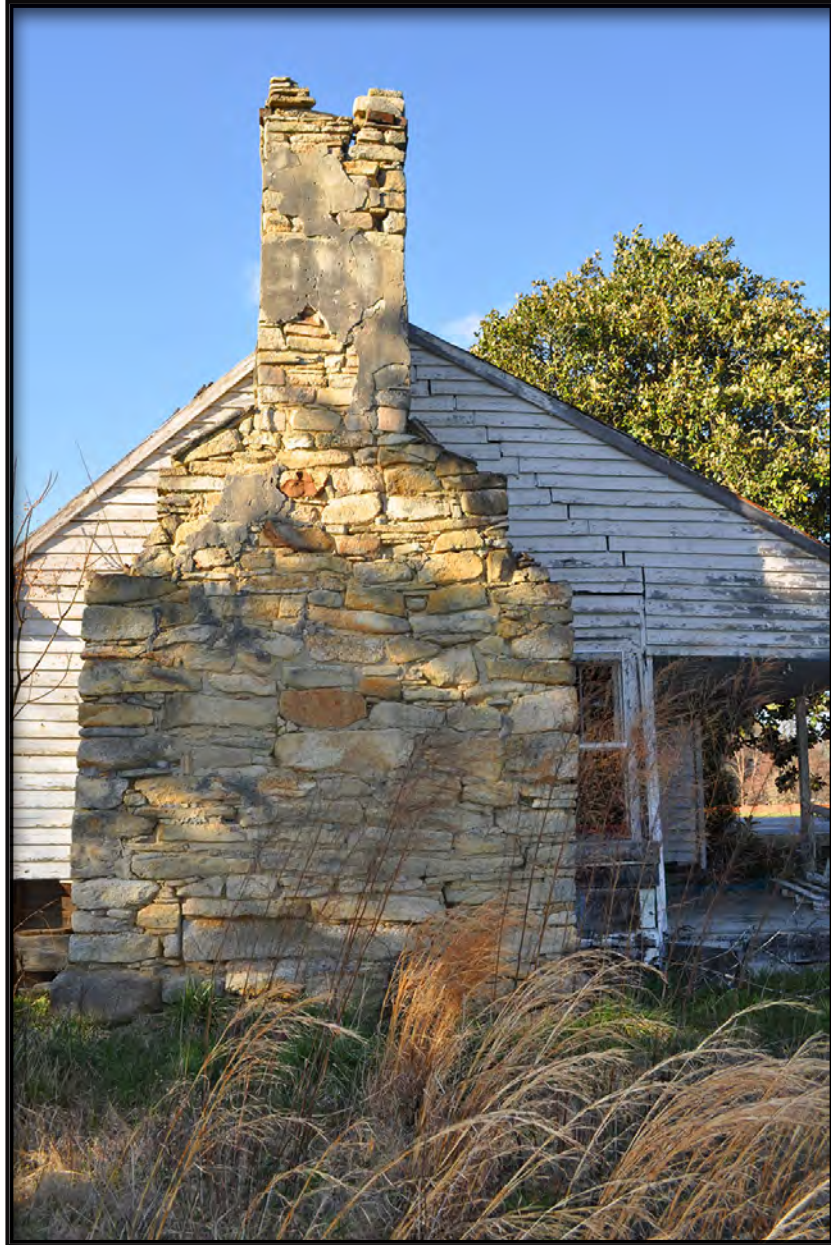
On the south elevation is a massive, double-shouldered chimney constructed of uncut fieldstones (Figure 35). The base of the chimney measures 10x5 feet. The shoulders are paved with flat stones, and the dry stack chimney appears to have been mortared with mud and then covered with a smooth finish of stucco (Figure 36). The HPO survey site file, prepared in 1982, identifies the chimney as “the most substantial stone chimney in a county where stone saw prevalent use in nineteenth-century chimney and foundation construction” (Tom Butchko 1982b).

Figure 36. Stone Chimney on South Elevation, Note the Separation of Weatherboards Where Shed Porch has been Added

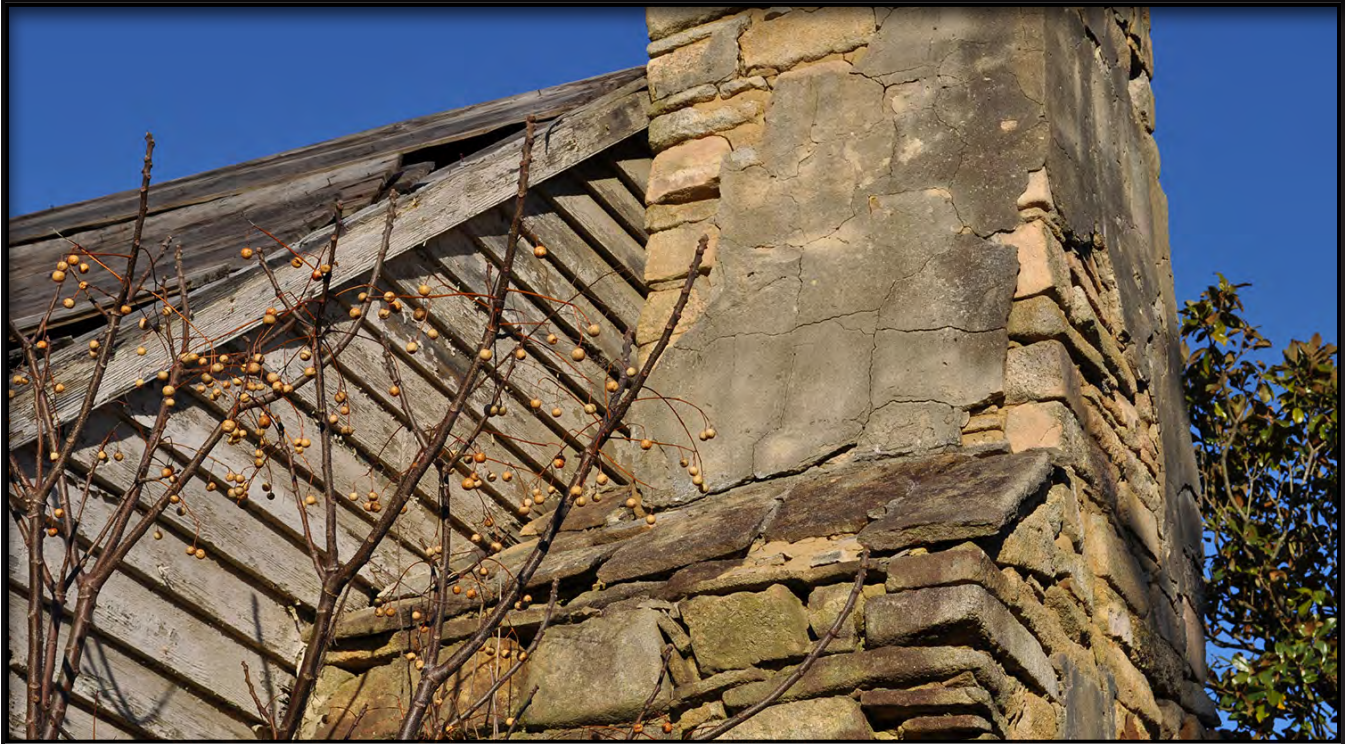
Figure 37. Detail of West Side of Chimney Showing Stone Shoulder Pavers and Remnants of Stucco

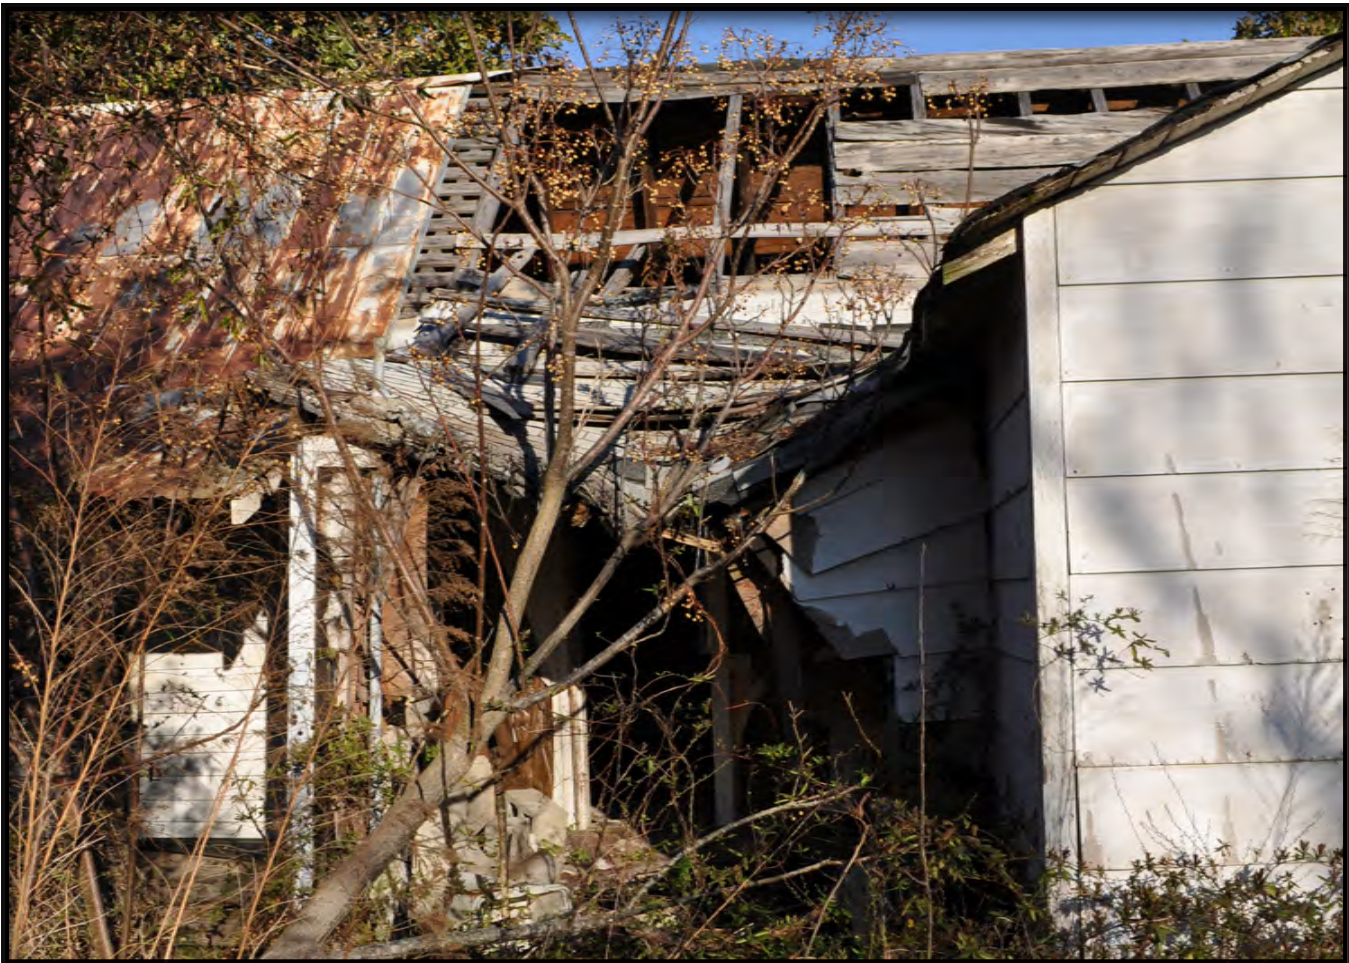
A modern, gabled addition sheathed in Masonite siding projects from west elevation at the south end of the circa 1830 section. The west side porch north of the addition has partially collapsed (Figure 37 and 38). The porch’s engaged roofline remains at the north end. It is supported on unfinished posts and has exposed rafter ends. Weatherboard siding remains on the house; however, it has been replaced or covered on the north side facing the road.

Figure 38. Close-up of West Elevation Showing Porch Collapse

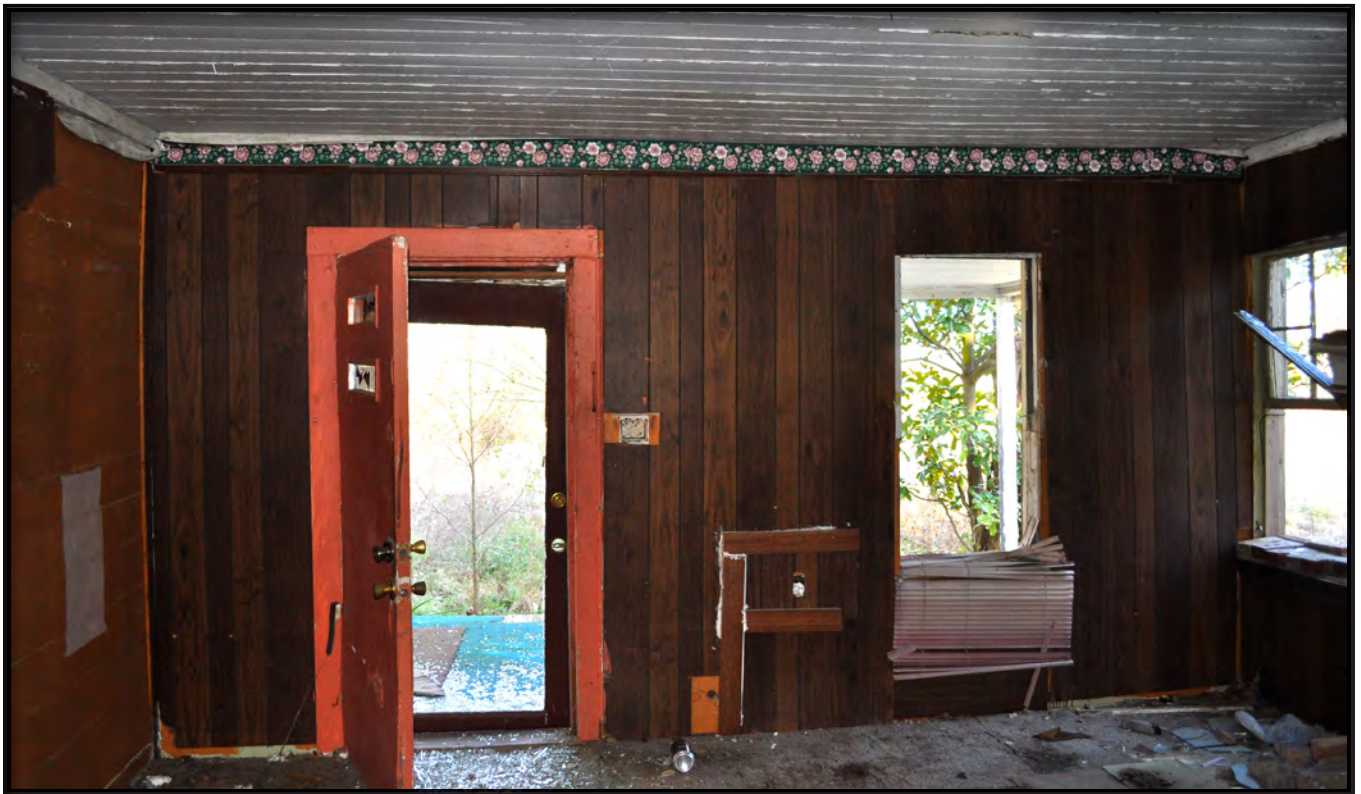
Figure 39. View from South Room Looking East

The interior of the house has been altered with modern materials (Figure 39 and 40). Since the property was first recorded in 1982, the failure of the roof has led to structural deterioration and interior damage (Figures 41 and 42). Many of the original wall, floor, and trim treatments have been removed or covered over with modern materials such as fake wood paneling and drywall. No period doors or windows remain. Replacement 2/2 sashes are present on the north and east elevations. The house has been heavily vandalized.

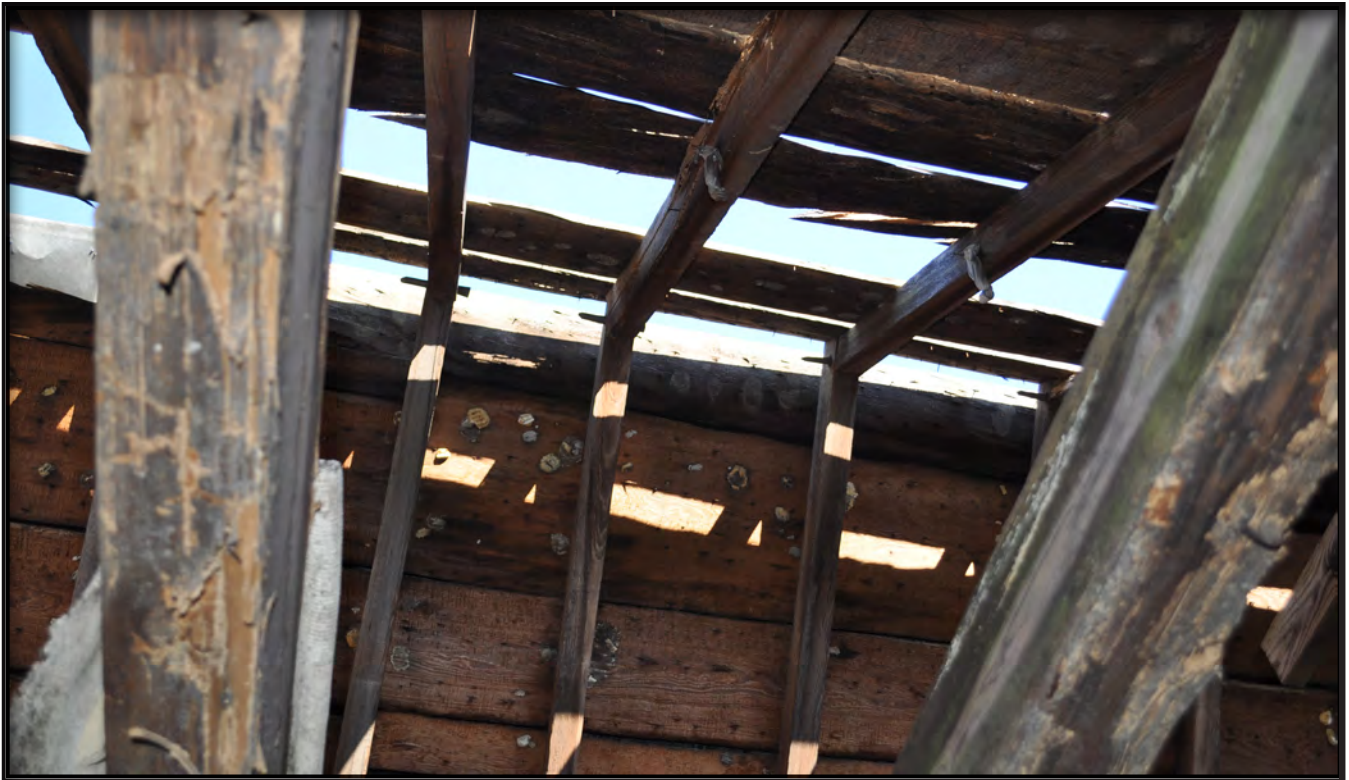
Figure 41. View of Rafter, Pegged Ridge, and Butt Jointed Sheathing in circa 1830s Section

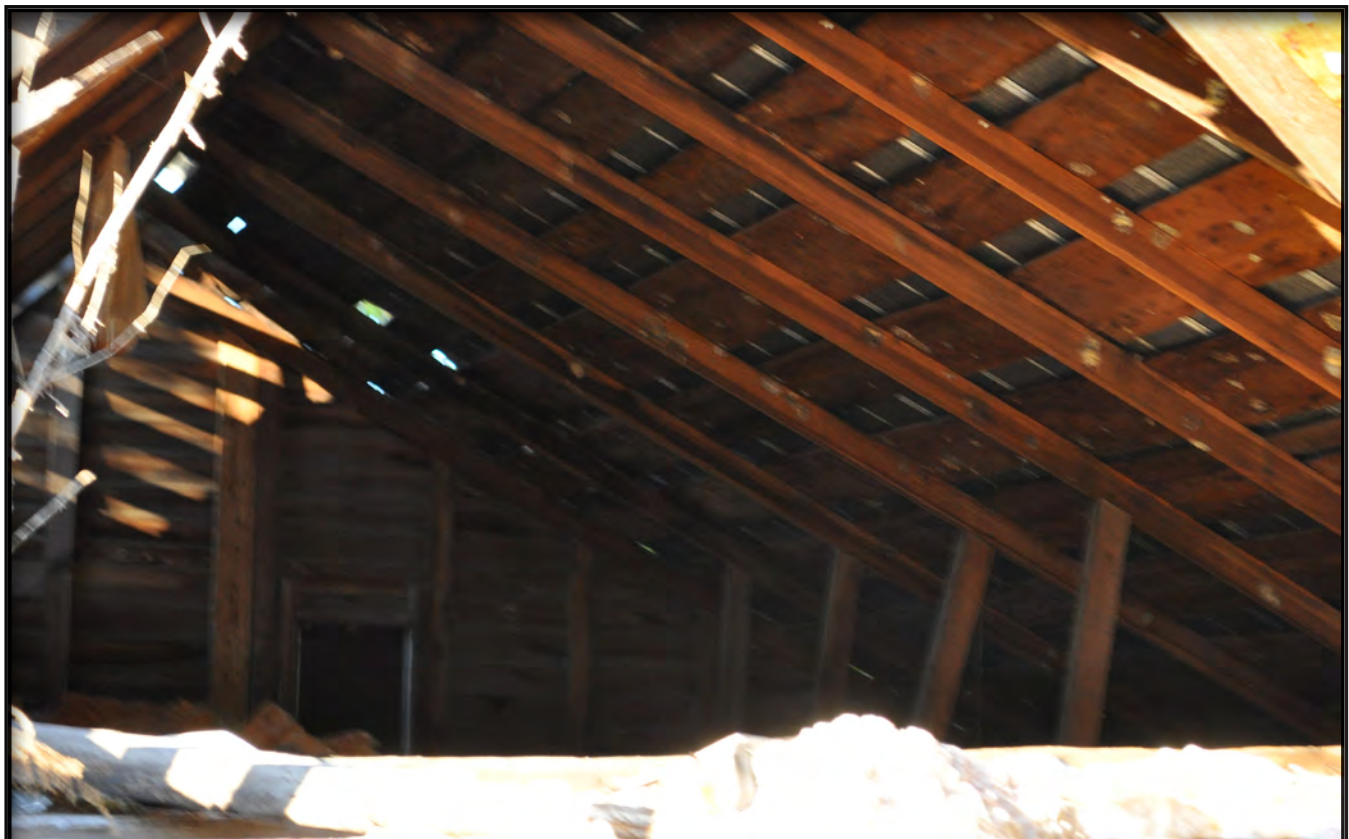
Figure 42. View of Rafters and Skip Sheathing in of Mid-Nineteenth-Century Addition

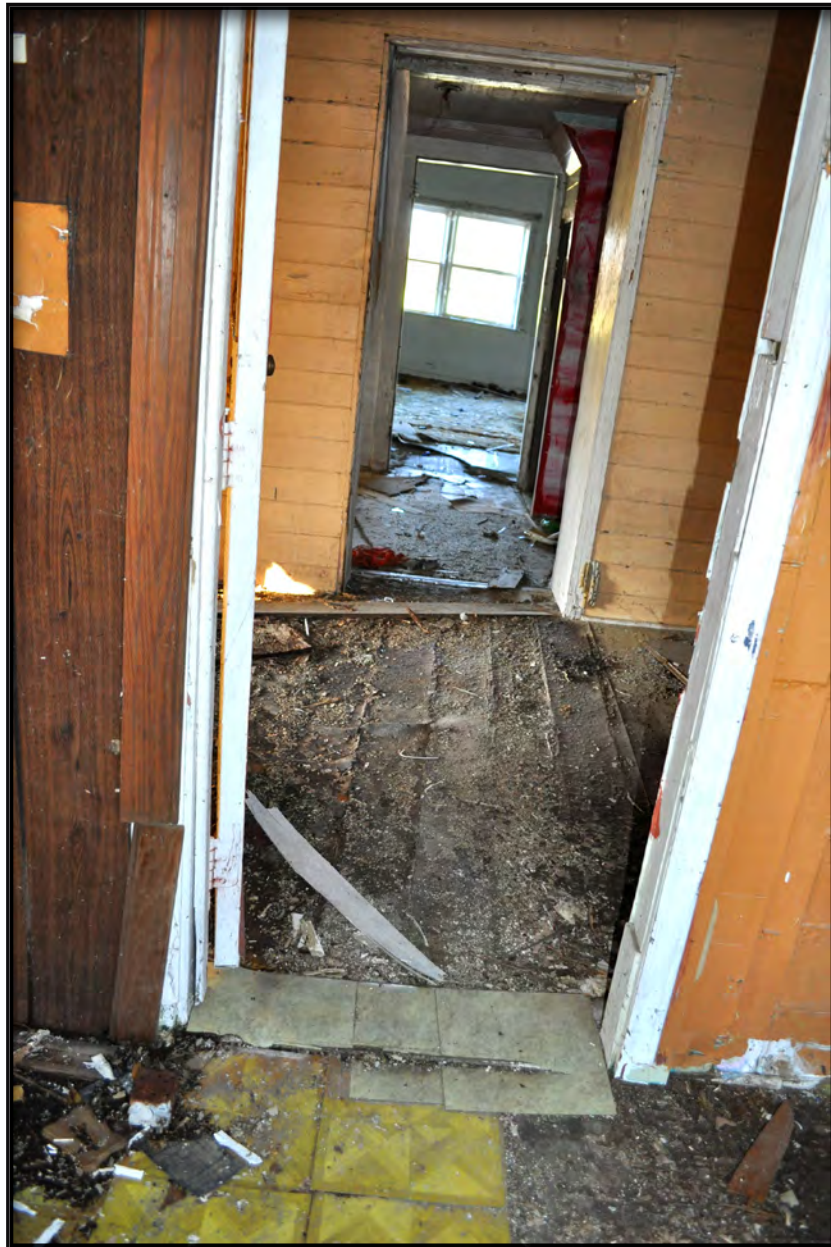
Figure 43. View from South Room Looking North

The interior floor plan is a series of four connected rooms running north-south (Figure 43). A large open room with a four-foot high, arched stone firebox is located at the south end of the 1830s section (Figure 44). The firebox opening measures over six-feet in length. A simple mantel consisting of plain square pilasters on plinths and a plain mantel shelf remains, although partially intact (Figure 45).

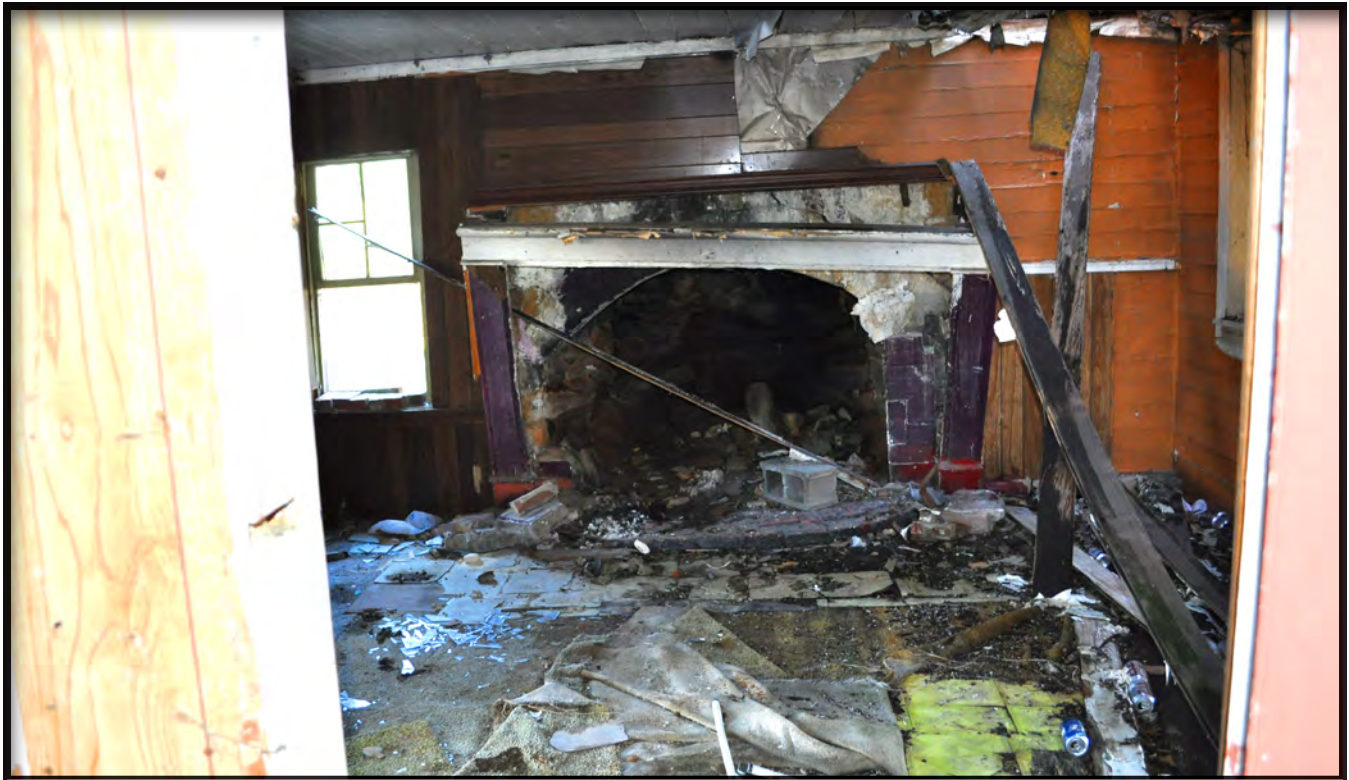
Figure 44. View from South Room Looking South to Firebox and Mantel

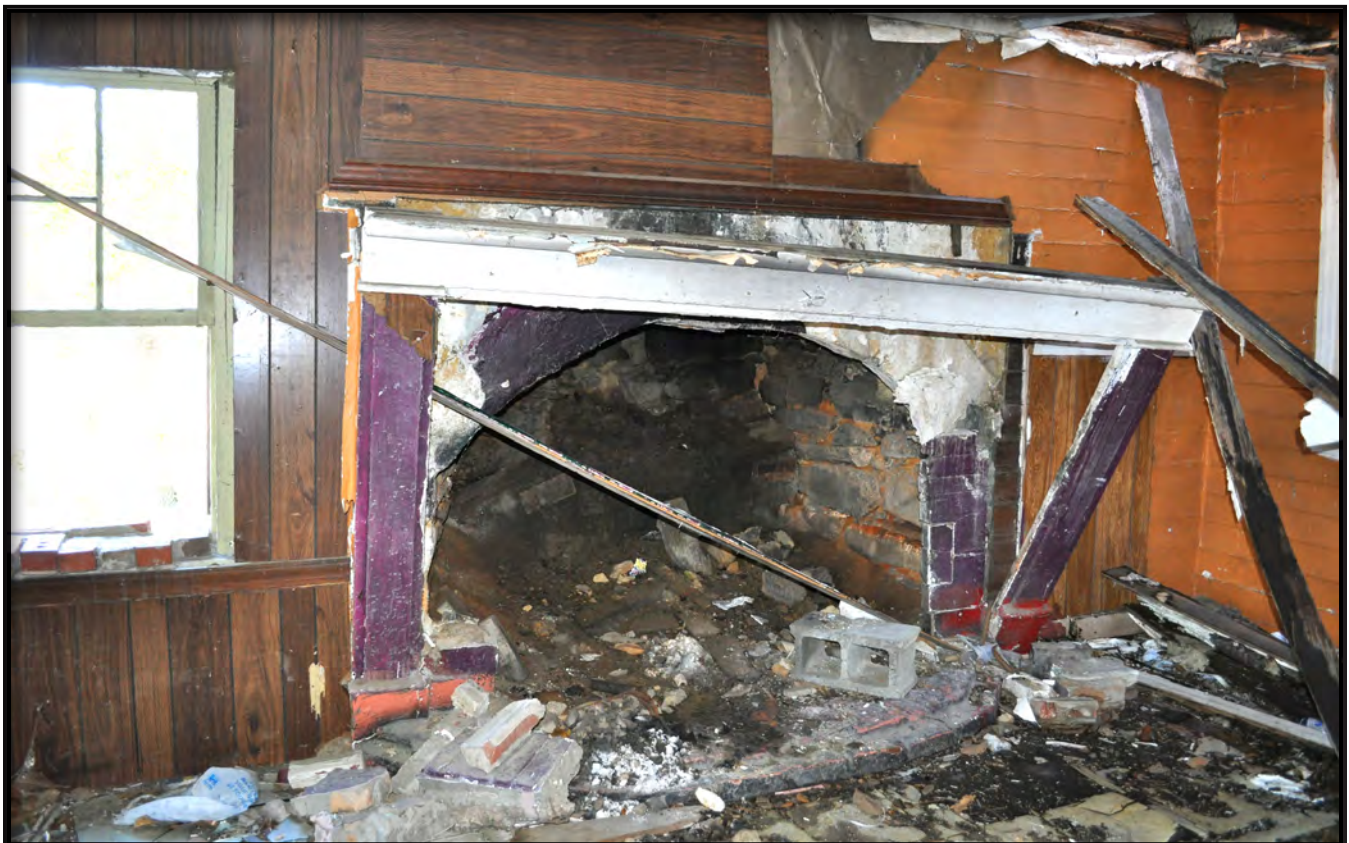
Figure 45. Mantel

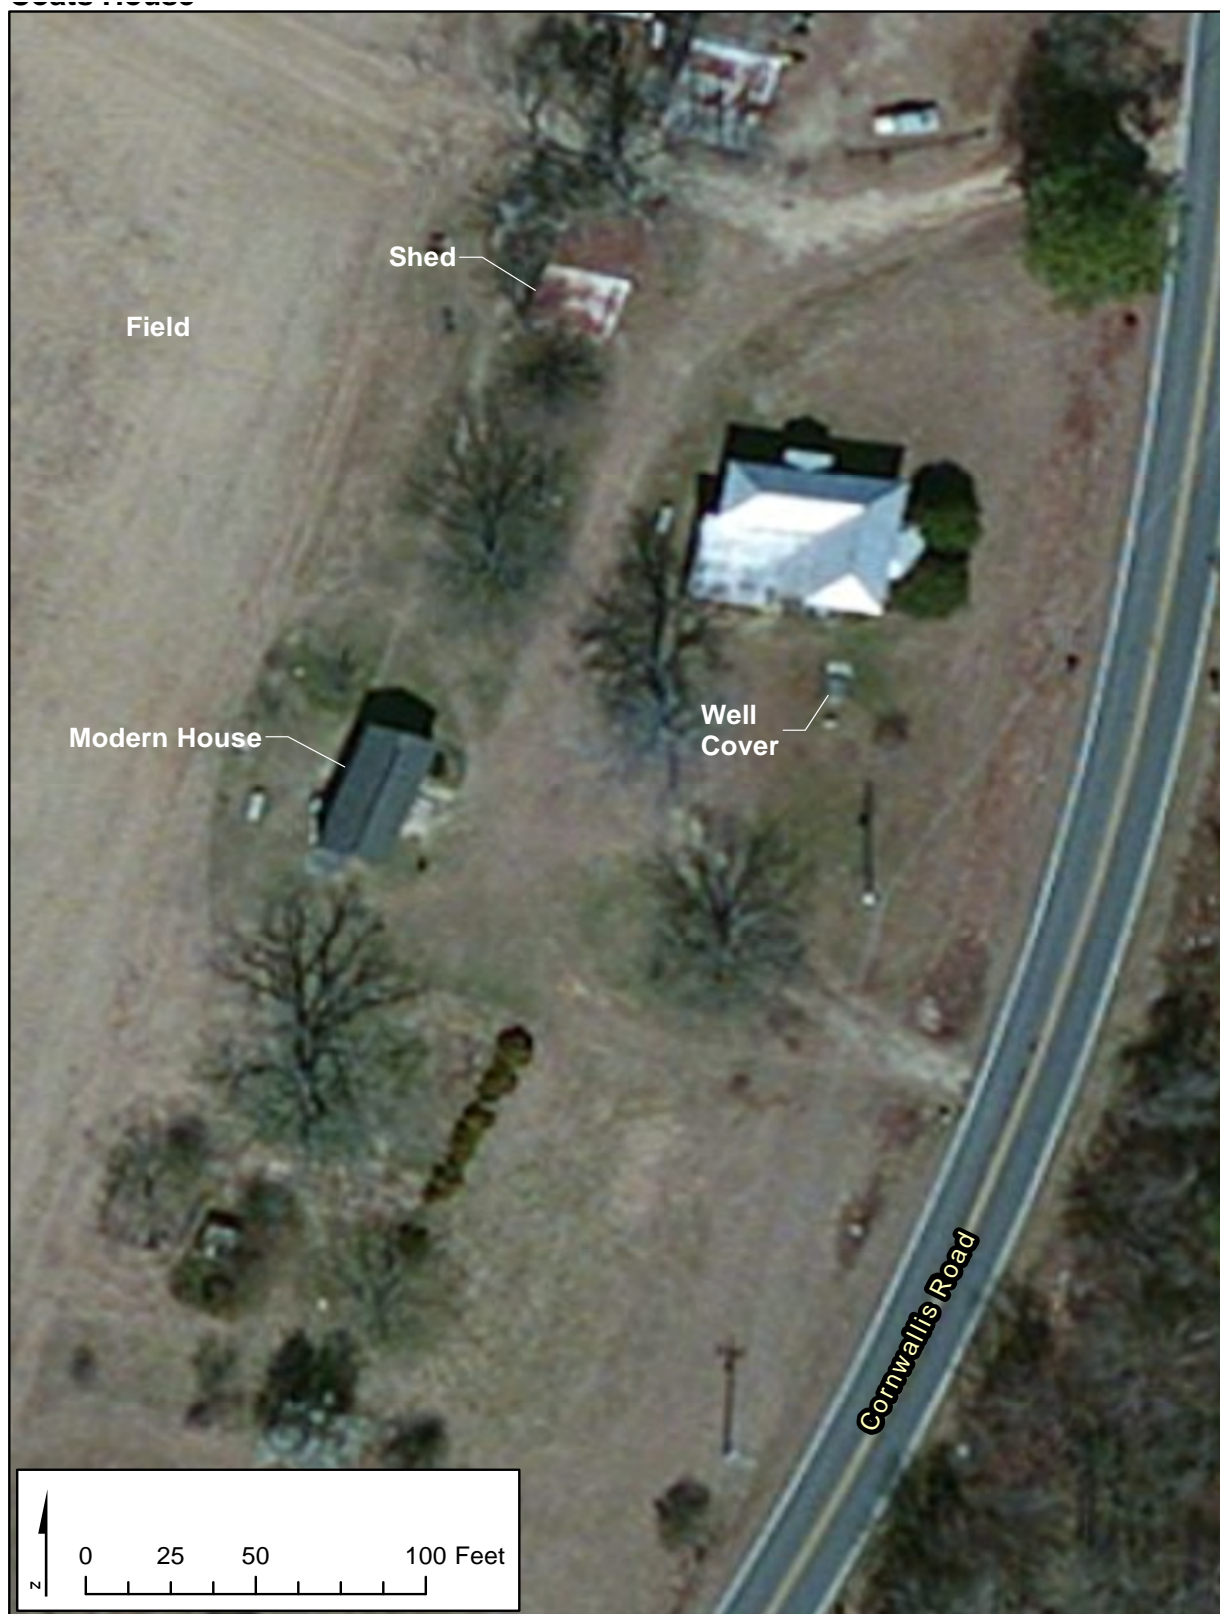
Figure 47. Coates House Site Plan

The dwelling sits on the west side of Cornwallis Road at the southeast quadrant of a 51-acre parcel (Figures 47 and 48). It is presently unoccupied. Most of the acreage west of the house is cleared with the exception of a dense buffer of deciduous trees growing along the north, west and south property lines. Near the center of the parcel northwest of the house are two ponds within an open field. A dilapidated frame, metal-covered, gabled storage shed with deep sheds on the north and south sides is situated in the house's north yard. In the south yard is a low, gabled well cover constructed of concrete masonry units. An unpaved driveway accesses the parcel north of the dwelling. Approximately 80 feet southwest of the subject dwelling is a second house of recent construction (Figure 49). The small one-story side-gable dwelling has vinyl siding and 1/1 windows.

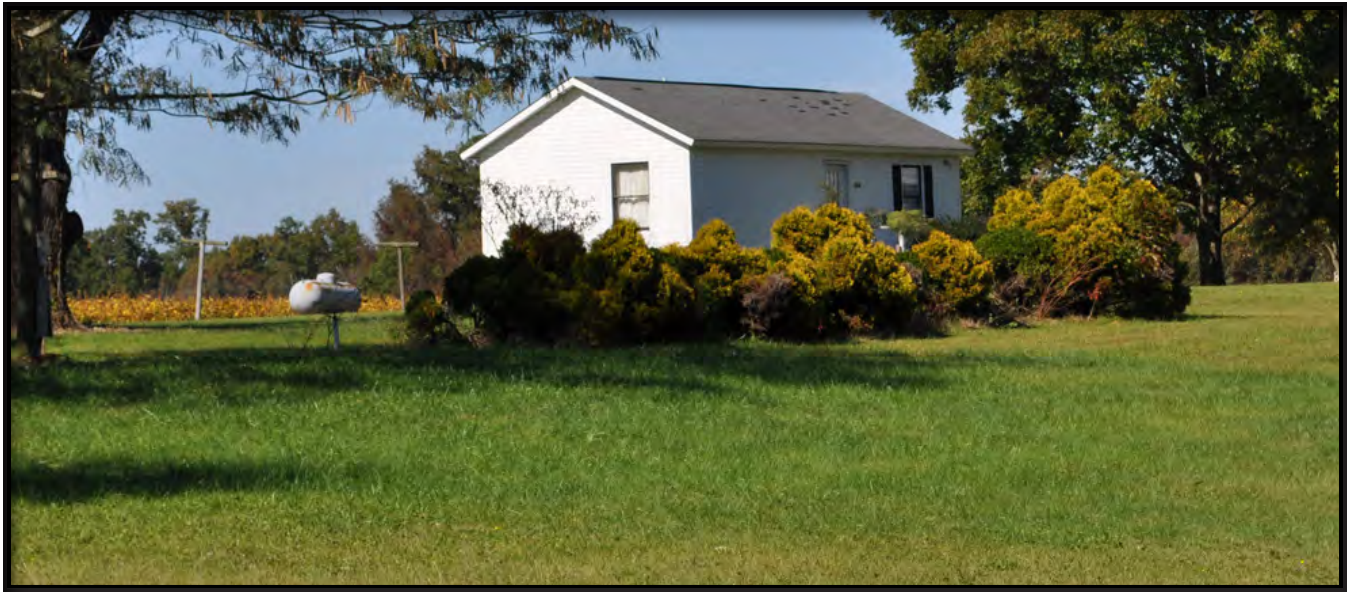
Figure 49. Front (East) Elevation of Modern Dwelling South of House

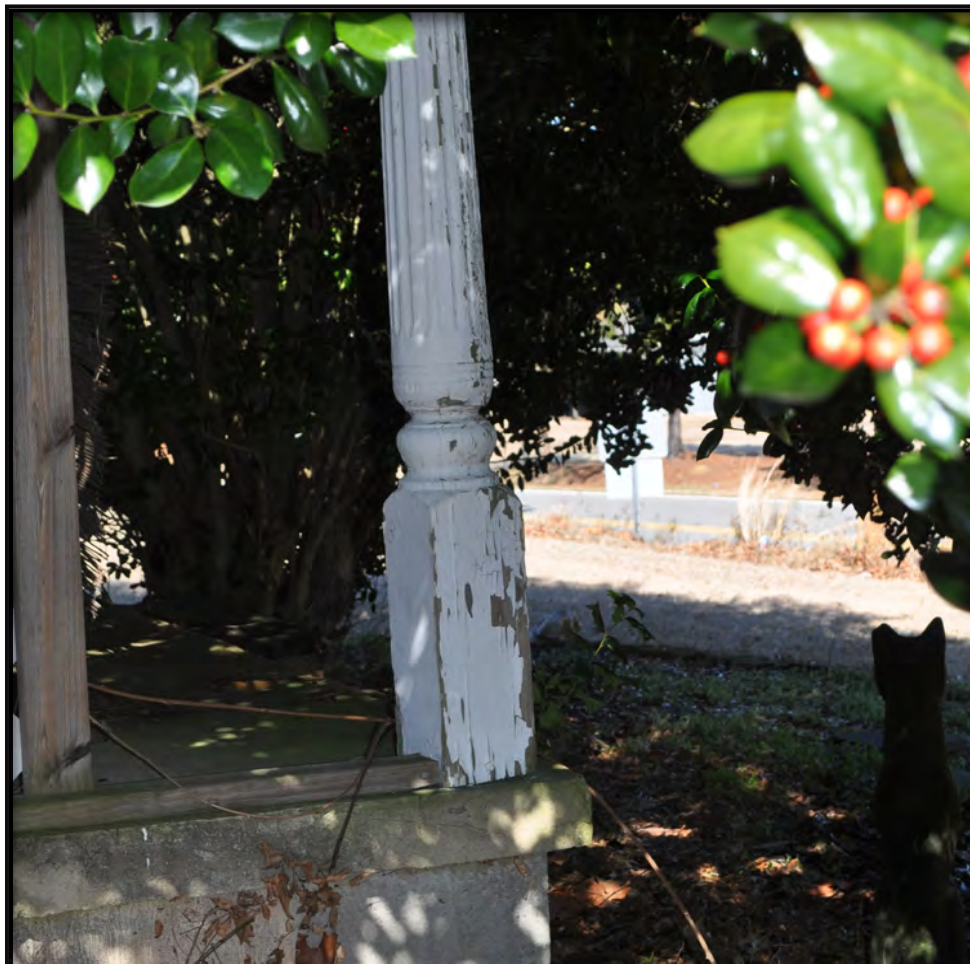
Figure 51. Detail of Porch Post on Front (East) Porch

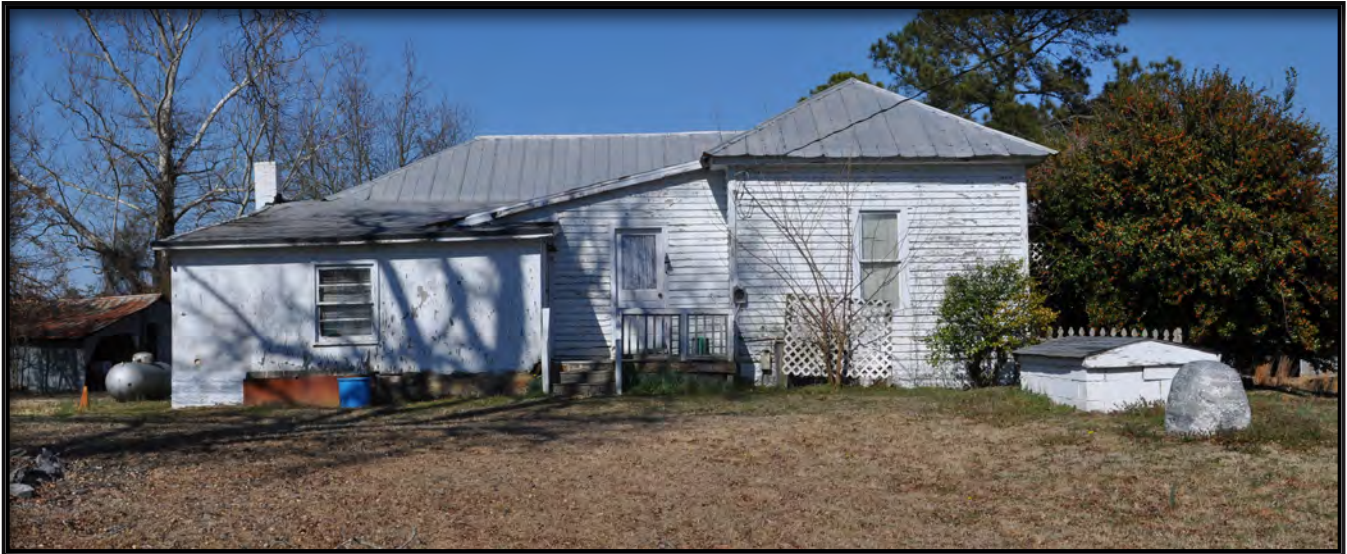
This massing of this circa 1900 frame house is that of a one-story, L-plan building composed of two equally sized wings that intersect at a right angle at the northeast corner of the structure. The overall form is not typical and its arrangement, with entries and matching fenestration patterns on each wing suggest the house may have been built to accommodate two families. Both wings have a metal-covered, high-hipped roof with an overhanging boxed eave. Two overgrown holly bushes extend above the roofline and obscure the façade (Figure 50). The front elevation has a central entry flanked by narrow window openings. A one-bay shed-roofed porch on turned posts shelters the east entry (Figure 51). The fenestration of the north elevation is arranged like that of the east side, with an entry and windows on either side (Figure 52). A second, single-bay entry porch is supported by the same turned posts as on the front porch; however, the north porch roof is front gabled. The north and east wings are covered with weatherboard siding. There are narrow corner boards at each corner. The window openings are uncharacteristically narrow and are set in plain surrounds. The windows are replacement 2/2 vertical sashes. No chimneys or stove flues were observed. The house sits on a contagious foundation of stone and concrete. A later one-story, metal-roofed shed addition spans the rear (west) elevation of the front (east) wing (Figure 53 and 54). However, the west elevation of the shed is now covered by a more recent, rectangular flat-roofed addition (Figure 55). The addition is sided with plywood.

Figure 55. South Elevation Showing Rear Shed Addition, Modern Addition, and Well Cover
