North Carolina Department of Natural and Cultural Resources
State Historic Preservation Office

MEMORANDUM

SUBJECT: Historic Structures Survey Report for Grade Separation at I-40/SR 1228 and Realignment of SR 1228, I-4759, Buncombe County, ER 08-0959

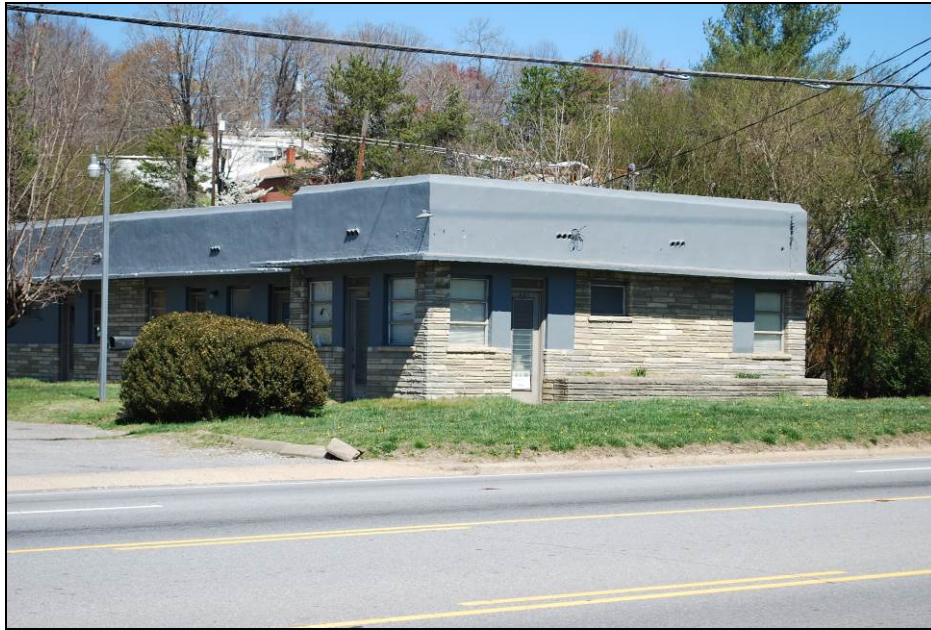
Photograph 3. Miami Motel Building No. 1, 1952

The first building located on the property was completed in 1952. The low and narrow building features a flat roof with a low parapet wall on the south and west elevations. Projecting bays at the south end of the east and west elevations create its T-shaped form. The mid-20th century motel features restrained Spanish Colonial Revival-stylistic influences. The exterior is covered in a coursed, ashlar stone veneer from the top of the window and door openings to ground-level. Above the bay openings, the exterior is a smooth stucco. Multiple sets of three round pipes are located along the upper, stuccoed portion of the building. It is plausible that these elements were intended to reflect earlier Spanish Colonial Revival precedents when flat roof construction required rainspouts. A flat concrete awning extends above the windows and doors the full width of the façade and west elevations. This element further enhances an emphasis on the horizontal, typical of the Spanish Colonial Revival style. Primary windows on the building are three-light metal awnings, and all entry doors feature glass jalousies.

The south elevation of the building faces toward Smokey Park Highway. It contains four bays (W, D, W, W), with a single pane fixed window occupying bay three of the south elevation. The entry door features glass jalousies. On either side of the door, sharing the length of the windows, the exterior wall is stucco. Many of the windows and doors throughout the building feature similar decorative stuccoing. To the right of the entry door is a raised garden bed, constructed of ashlar stone. The T-shaped massing at the south end of the building is occupied by the former registration

office and a small kitchen, with the motel suites occupying the long perpendicular massing to the north.

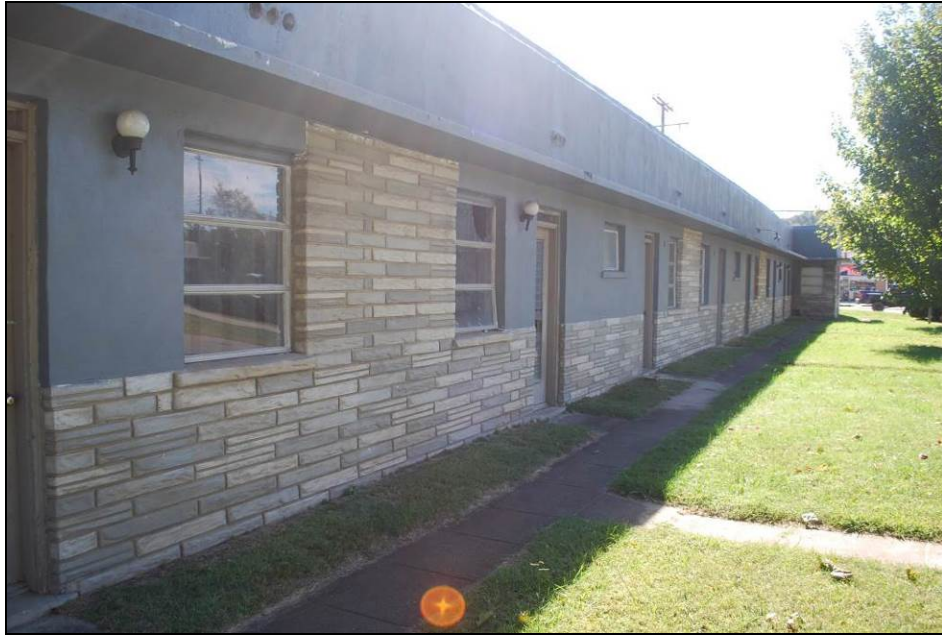
Photograph 4. Façade (west elevation) of Building No. 1, looking southeast

The façade (west elevation) is perpendicular to Smokey Park Highway. It is comprised of 14 suites, each with one entry door and one three-light awning window. In some instances, where the interior bathroom is on the west side of the building, the bathroom window is single pane with textured glass and positioned high on the exterior wall. The three northernmost suites were added in 1954, conforming to the original design of the building (Photograph 6). The rainspouts observed on the south elevation are continued along the façade.

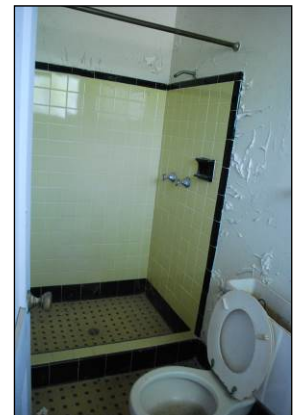
Photograph 7. Bathroom Tiling, Building No. 1

All of the interior suites within Building No. 1 are relatively the same. Each unit is comprised of a single room with a small closet and bathroom to the north of the room. The majority of the rooms exhibit original decorative tile flooring and stuccoed walls. Bathrooms feature tiled floors and shower, reminiscent of mid-20th century finishes. While access to all rooms was not permitted, evidence of original turquoise or teal wall paint survives beneath the current white paint. Each room features one, three-light awning window on its east (rear) wall.

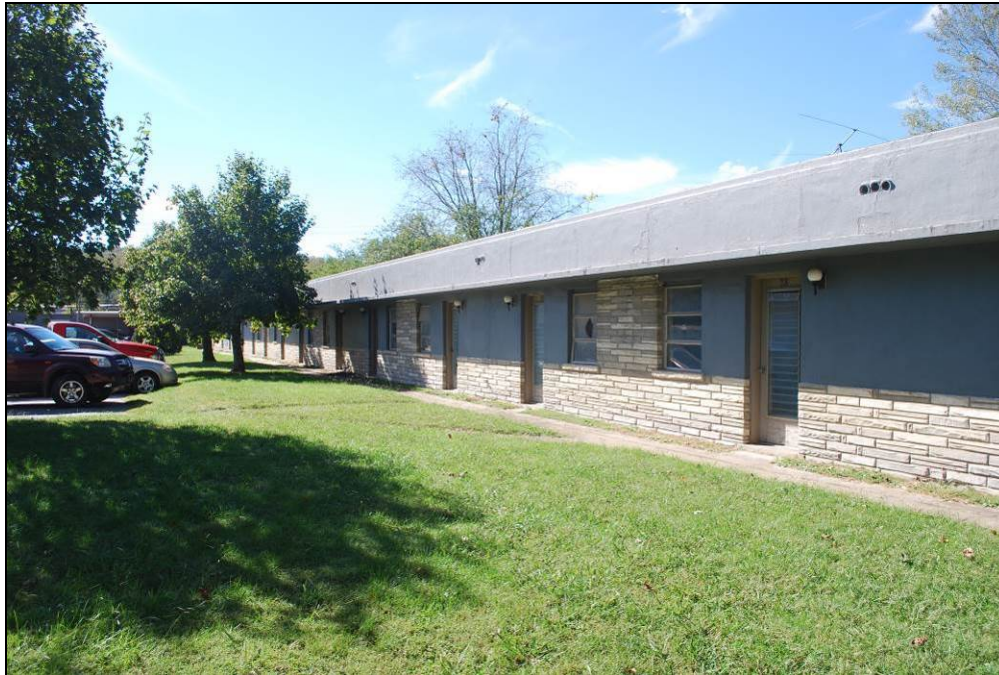
Photograph 10. Building No. 2, east elevation, looking southwest

Completed in 1954, Miami Motel Building No. 2 is located along the western property boundary and is similar in style and form as Building No.1. Like its predecessor, it reflects restrained Spanish Colonial Revival influences combined with modest mid-20th century embellishments. Unlike the former building, however, Building No.2 lacks the projecting office bays on the south elevation. The low, one-story motel is long and narrow, rectangular in shape, and constructed of concrete block. The building is 238 feet in length and 16 feet wide. The roof is flat and features a flat stuccoed parapet on the south and east elevations. The exterior of the building is smooth stucco. A decorative coursed ashlar stone buttress projects from the south end of the façade (east elevation) and tapers upwards. Topping the buttress is a unique curvilinear decorative element, also stuccoed to match the exterior (Photograph 11).

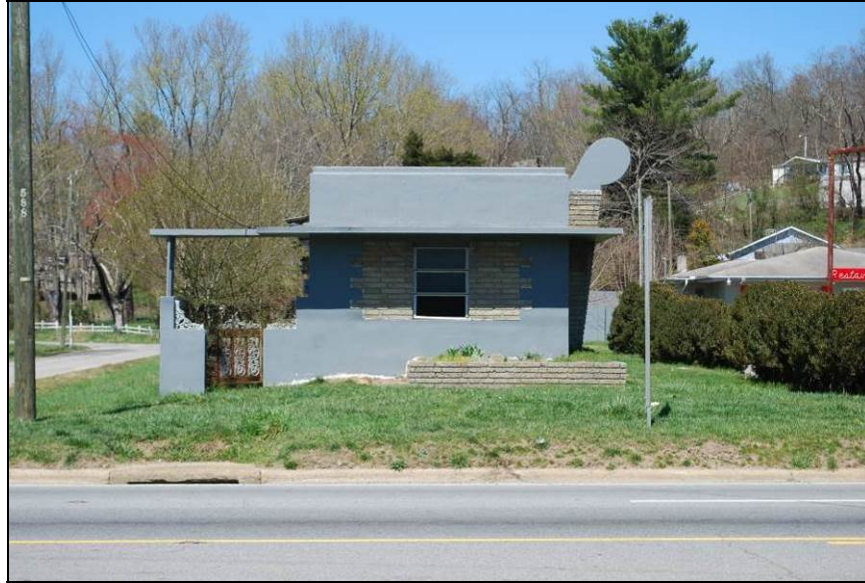
Photograph 12. South Elevation, Building No.2

The south elevation of the building features a three-light metal awning window surrounded by decorative stone ashlar. A low stuccoed wall, flush with the wall of the south elevation, projects to the west and contains a faux vine metal gate. A flat roof extends from the building above a knee wall and gate. A raised garden bed constructed of ashlar stone is along the south elevation, wrapping around the east corner of the building to the buttress.

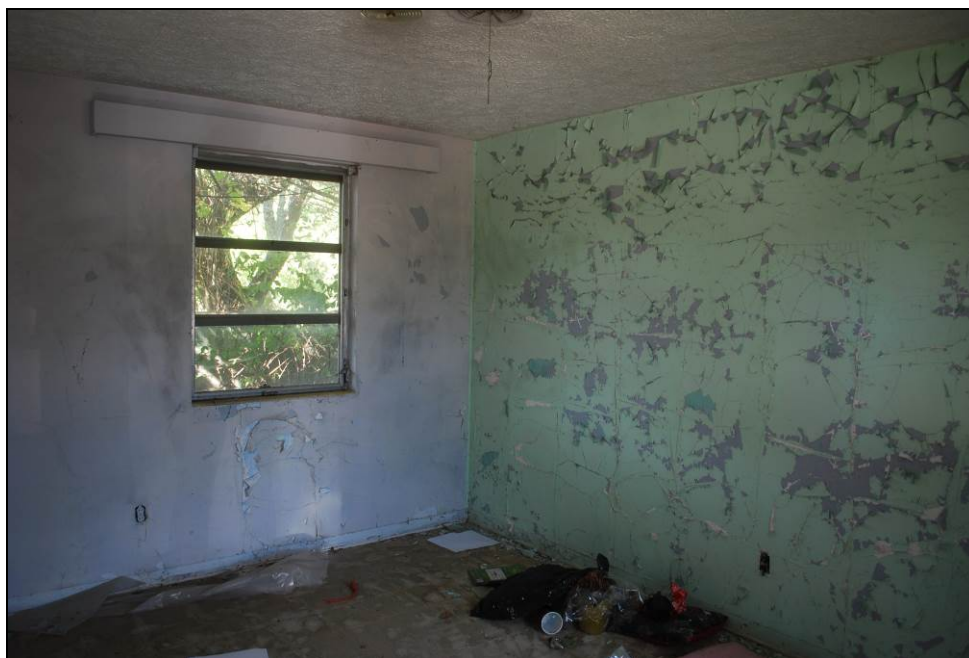
Photograph 14. Interior of a Unit and Teal Wall Coloring, Building No. 2

The interior of the 1954 building is nearly identical to the earlier building; however, the closet and bathrooms are oriented at the southern end of each unit. The rooms feature teal or white painted walls and original floor tiling. The bathroom tiling is also similar to the former building. Although the tile colors are slightly different than the 1952 building, they are indicative of mid-20th century bathroom finishes.

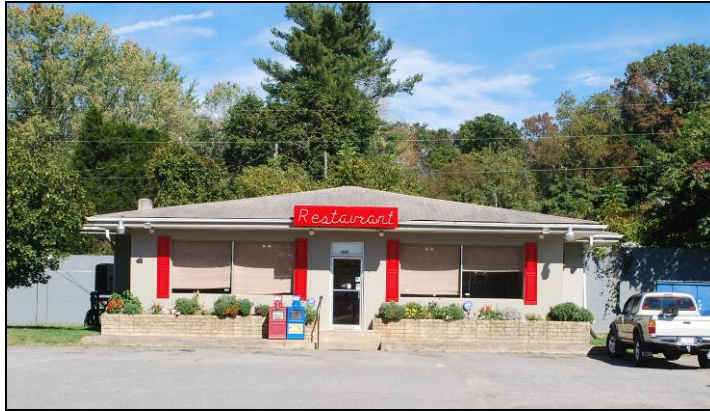
Photograph 15. Miami Restaurant, looking north

The Miami Restaurant, presently a diner, was completed in 1964 at the north end of the parking lot. It is rectangular in shape, with a low-pitched pyramidal roof clad in asphalt shingles. Lower hipped bays project from the east and west elevations. The roof features wide overhanging boxed eaves. The building is constructed of concrete block and the exterior is stucco. The façade (south elevation) is three bays (2W, D, 2W) with a centered glazed entry door. A transom above the door is boarded over. The windows are large, fixed panes set in a metal frame and flanked by wood-paneled shutters. A raised garden bed constructed of ashlar stone runs the width of the façade and concrete steps lead to the entry door.

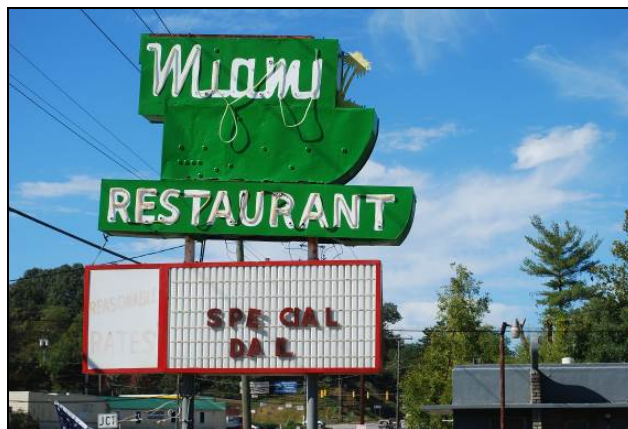
Photograph 16. Neon Signage

The original neon sign advertising vacancy, specials, and the restaurant survives within the grassed median. Extravagant neon signage is characteristic of motels and businesses during the mid-20th century, luring the rise of automobile owners.

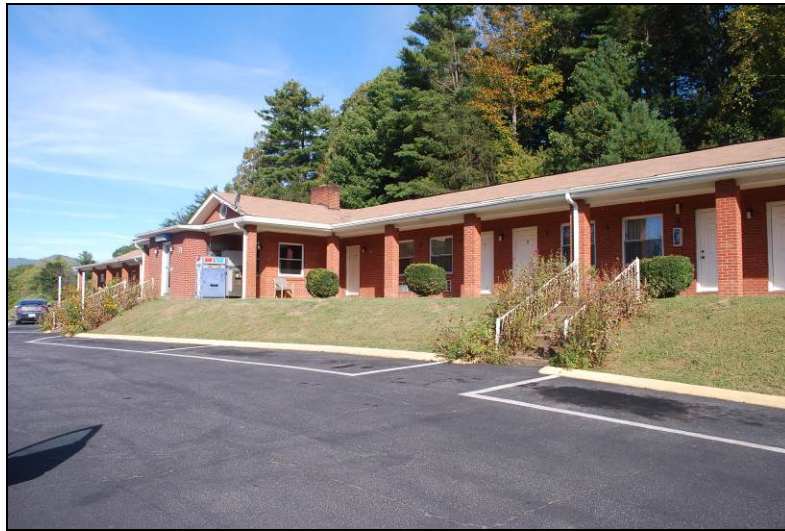
Photograph 23. Nakon Motel, 2016

Constructed during the early 1950s, the Nakon Motel is located less than ½-mile east of the Miami Motel. It sits on a hilltop fronting Smokey Park Highway. The brick building is rectangular in shape, long and low with a side gabled roof. The registration office is centered on the building and projects from the façade. The office features a front gable roof. A concrete walkway is beneath the roof eaves supported by square brick columns. The Nakon Motel lacks stylistic elements, and features a plain exterior. Windows and doors are modern replacements. While it is a good example of a mid-20th century single building court motel, it is unexceptional compared with the Miami

Motel and Mountaineer Inn. Further, the Nakon Motel does not include a restaurant, pool, or other amenities common among roadside motels throughout the mid-20th century.

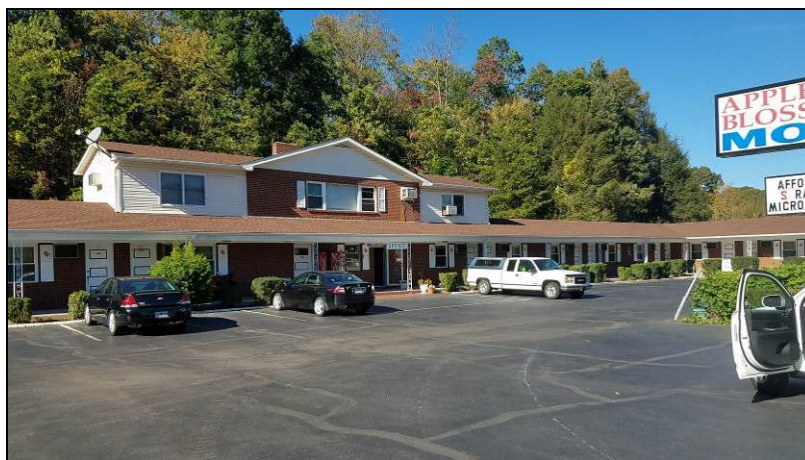
Photograph 24. Apple Blossom Motel, 2016

Constructed in 1958, the Apple Blossom Motel is located east of Asheville near Black Mountain. It is a transitional court motel including both single-story and two-story massings. The brick veneer motel is u-shaped with an interior paved parking lot. The motel is long and low with a low-pitched gable roof. At the center of the building is the two-story massing featuring both brick veneer and vinyl siding. A concrete path beneath the single-story roof surrounds the façade. Faux vine metal posts support the eave of the roof. Entry doors are contemporaneous with the construction of the building and feature three horizontal raised panels. While the Apple Blossom Motel is indicative of mid-20th century roadside court motels, it is transitional in form and lacks stylistic elements.

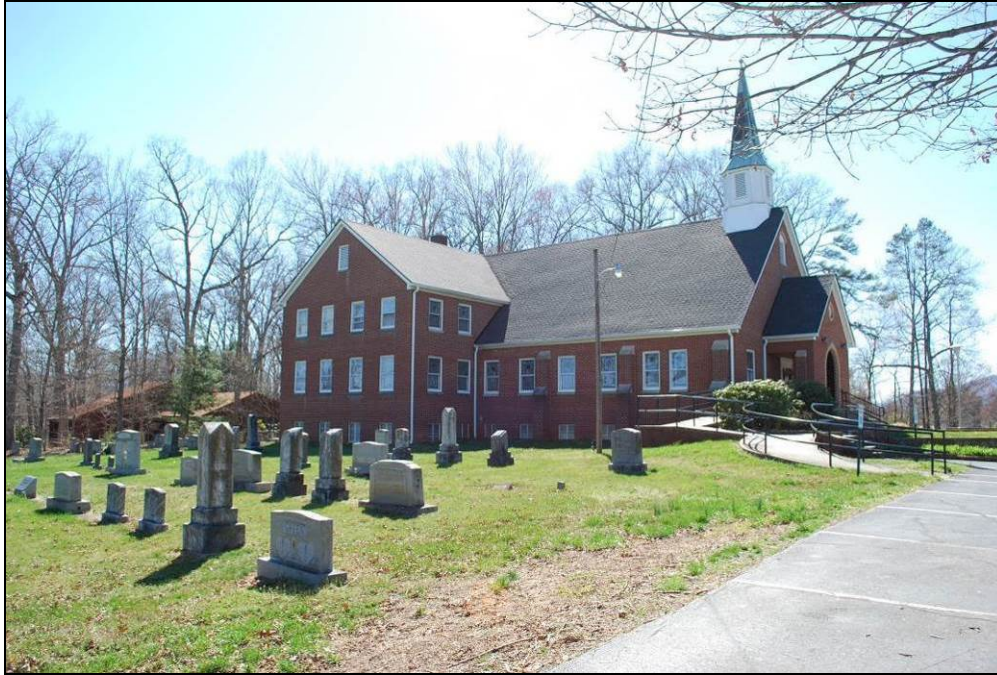
Photograph 27. Liberty Baptist Church

Liberty Baptist Church is a brick, T-shaped, one- and two-story building with a raised basement. According to a plaque on the façade (north elevation), the building was erected in 1954. It is comprised of a front-gabled, single-story sanctuary with two-story wings projecting from the rear of the side elevations creating the present T-shape. The projecting wings are gabled and do not exceed the height of the sanctuary. The roof of the sanctuary is steeply-pitched, while the wings are moderately-pitched. The roof is clad in asphalt shingles, recently replacing asbestos shingle roofing. The overhanging eaves are boxed with vinyl siding. Gable ends are open, with brick extending into the peaks. Windows on the sanctuary, as well as those on the north elevations of the projecting wings are stained glass with exterior metal storm windows. The side and rear elevations of the wings are one-over-one, double-hung wood sash. Basement level windows are metal casements. An octagonal cupola straddles the front of the roof ridgeline. It is vinyl-sided and features a wood-louvered vent and is topped by a copper steeple. A brick chimney is centered on the rear roof slope.

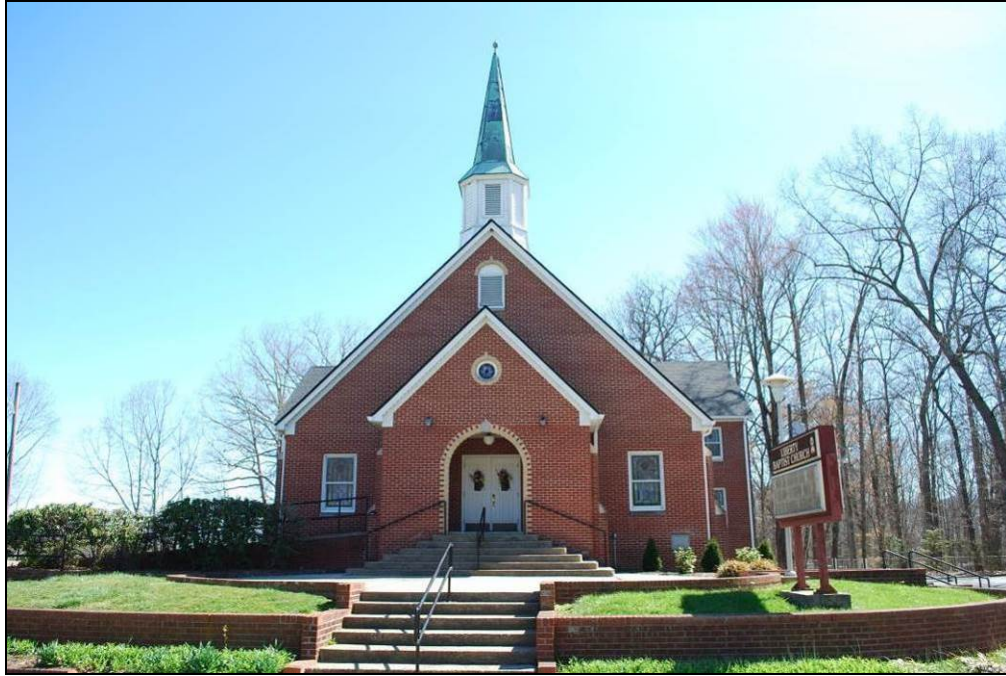
Photograph 29. Liberty Baptist Church, facade

The façade (north elevation) of the sanctuary is symmetrical with three bays (W, D, W). The two-leaf entry door is paneled. A wood-louvered vent is in the gable peak and features a concrete arched head. A cornerstone engraved with “LIBERTY BAPTIST CHURCH 1895-1954” is located at the northwest corner. A prominent lower, front-gabled entry vestibule is centered on the façade. It features brick walls and a round-arched opening with stone keystone. The opening is surrounded by cream-colored bricks contrasting with the dark red brick of the building. A round, stained glass window is above the opening. Within the entry vestibule, the ceiling is vinyl-sided. Its west end is walled, whereas the east end is open and leads to a concrete handicap ramp. A square brick buttress adorns the side elevations of the entry vestibule. The entry is accessed by concrete steps with a metal railing. The north elevation of each of the rear wings features two windows on both the first and second floors, as well as two basement-level windows.

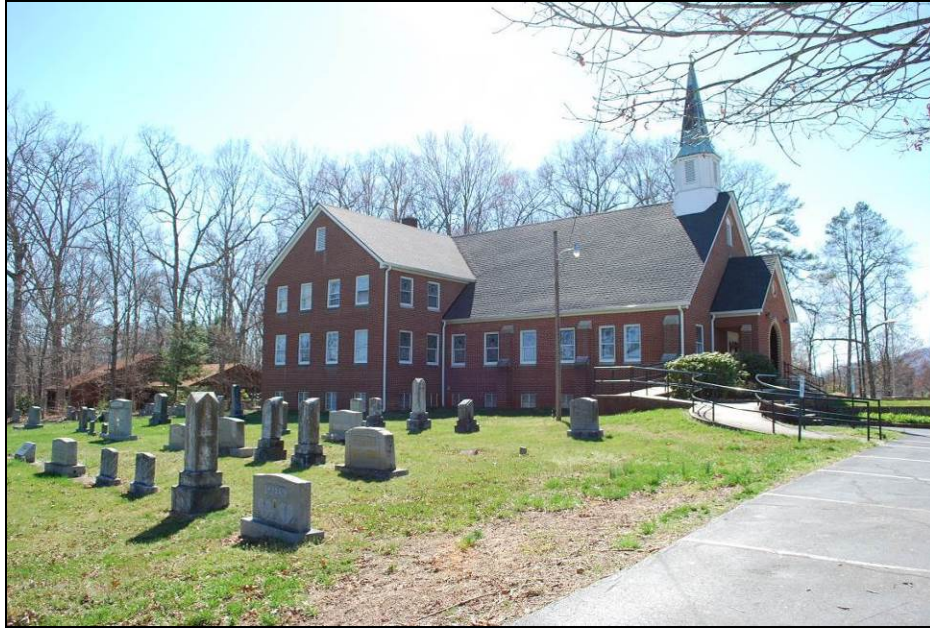
Photograph 31. Northeast Oblique

The east elevation of the Liberty Baptist Church is ten bays comprised of all windows. The first four bays (from left to right) occupy the rear wing, while the remaining are on the sanctuary. Three buttresses with concrete caps are located between bays six (6) and seven (7), eight (8) and nine (9), and after the final bay of the sanctuary. The projecting wing features an additional four windows on the second floor. Basement-level windows are aligned with the ten bays on the east elevation. A wood-louvered vent is in the gable end of the rear wing. The west elevation mirrors the east.

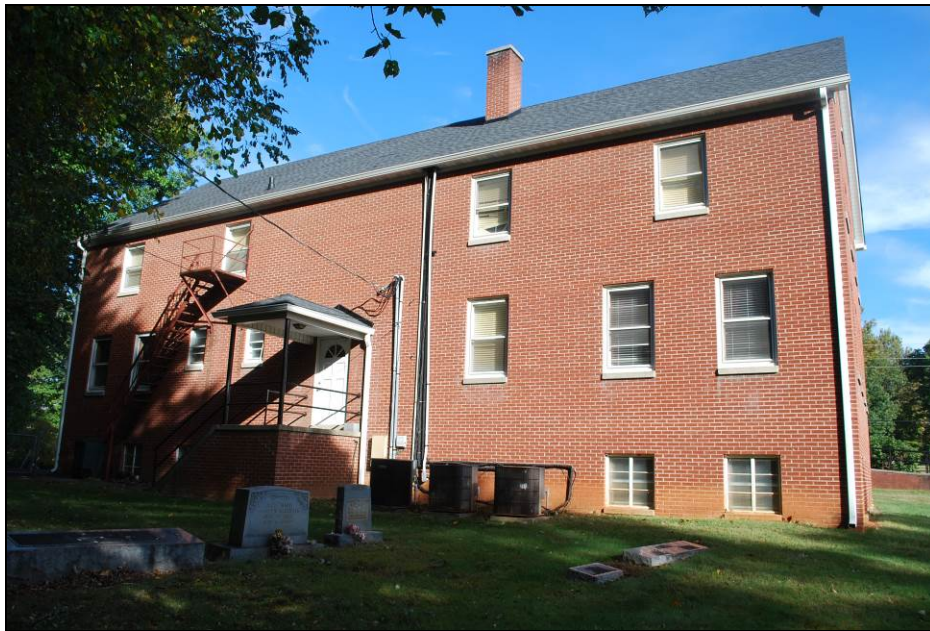
Photograph 32. Rear Elevation

The rear elevation of the Liberty Baptist Church includes an entry stoop with a hipped roof supported by round metal posts. A set of stairs with metal railing lead to the entry stoop. The rear includes five basement-level casement windows. There are seven windows on the first floor and four on the second. An exterior metal fire escape leads from the second window on the second floor.

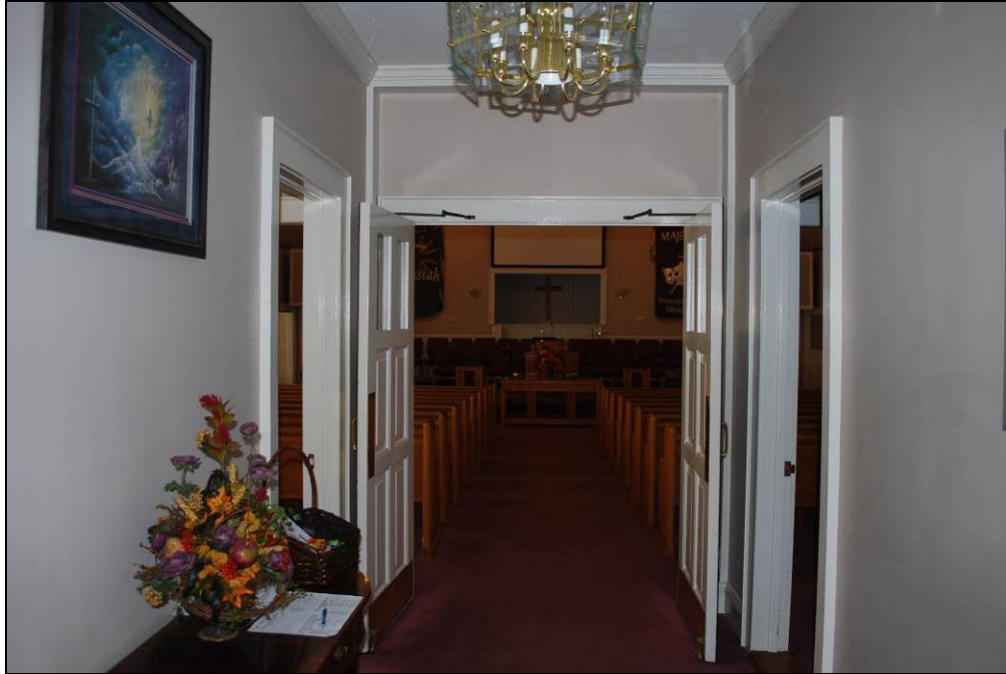
Photograph 33. Entry Hall, looking south

Access to the interior of the Liberty Baptist Church was limited to the first floor, including the sanctuary. Upon entry into the church, a central hall leads into the sanctuary. Flanking either side of the central hall is the rear of the sanctuary with rows of pews. Pews are arranged along the side of the sanctuary facing south towards the pulpit and choir. Two doors along the south wall of the sanctuary lead into the perpendicular wings. Rooms within the wing include a lounge, nursery and changing room, bathroom, library, and a rear lobby near the exit door. A baptismal room is opposite the rear wall of the sanctuary. A large, single pane window separates the sanctuary from the baptismal room. Figure 10 is an approximate floorplan of the first floor. Photographs 33 and 34 show the central hall and sanctuary of the church.

The central hall and church sanctuary feature carpeted floors and a ceiling covered in unique fiberboard tiles. The original lighting fixtures hang from the ceiling. Within the sanctuary, the wooden truss is exposed and is stained to match the pews. Walls are plastered, and the window and

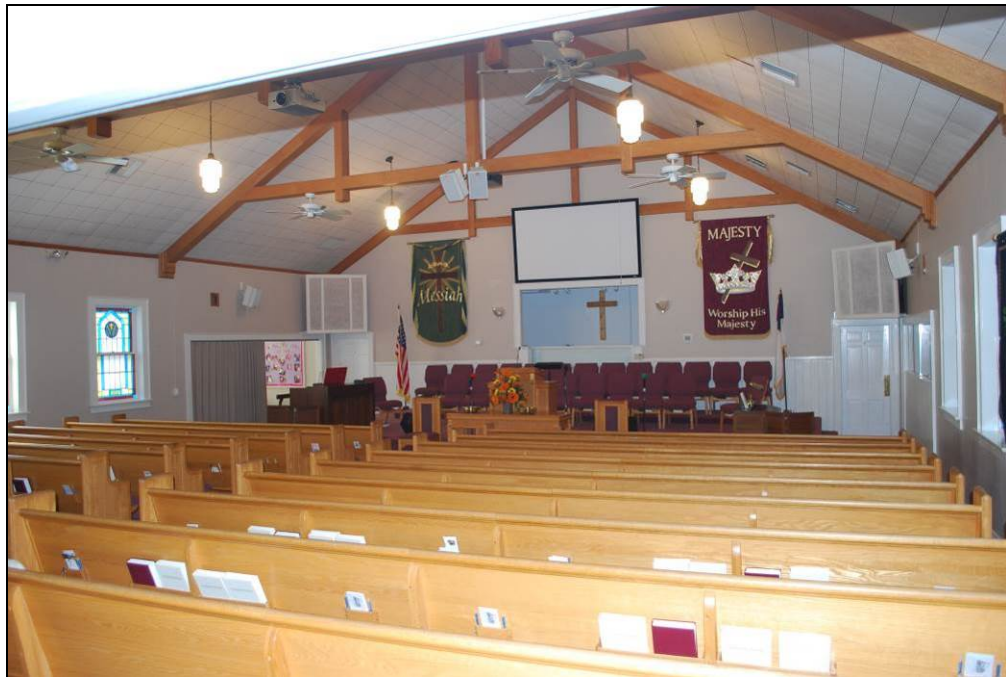
Photograph 34. Sanctuary, looking southwest

door surrounds are wood with modest molding. The central hall includes a molded trim. Within the interior of the sanctuary, each stained glass window features “In Memory of...” a deceased church member, their date of birth, and year of death. The rear wing features matching carpeting as the sanctuary. Some rooms within the rear wing include the same ceiling tiles as the sanctuary, while others feature a synthetic dropped ceiling.

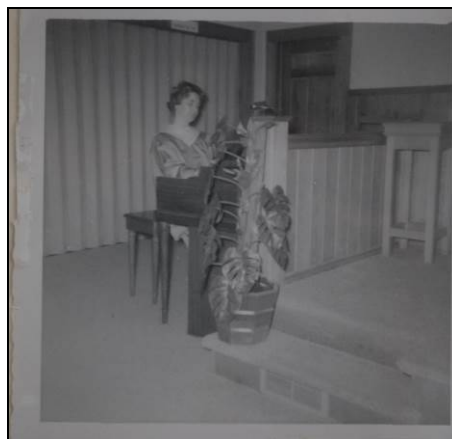
Photograph 37. Interior Photograph of the Sanctuary, nd

Historical photographs of the interior of the church confirm additional alterations. Photograph 37 indicates that the choral area was originally enclosed with a short wall of vertical boards. The same photograph also suggests that the present doors are modern replacements, where the original doors were stained wood with raised panels.

Modern alterations have compromised the historic **materials** of the church, particularly the application of vinyl siding to the exterior eaves and steeple, and the replacement of the original entry doors and interior doors at the rear of the sanctuary. Further, the original wall enclosing the choir is no longer extant.

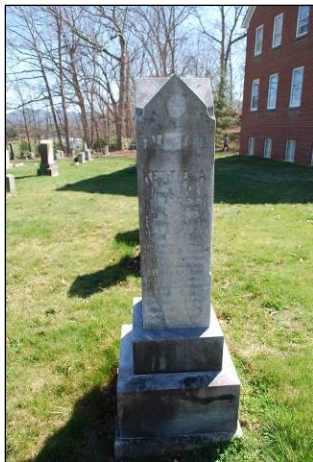
Photograph 39. Obelisk

The Liberty Baptist Church Cemetery dates to the late-19th century, with the earliest burial occurring in 1899. The most recent interment dates to 2012 with the burial of Annie Mae Jones Robinson. Approximately 170 burials within the churchyard are aligned in rows, with graves oriented to the east. Many of the burials feature both a headstone and simple footstone. The majority of the headstones are simple granite or marble markers with rectangular bases. There are a few examples of relatively short obelisks. The top of two obelisks is shaped similar to a cross gable roof. Two markers within the churchyard are taller in height than the traditional headstones and are carved to resemble a shroud.

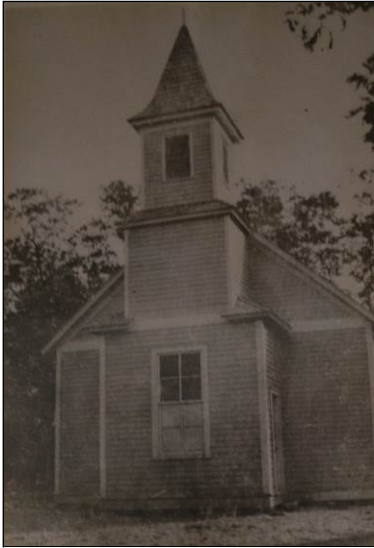
Photograph 42. Original Church Building, c.1905

Shortly following the formation of the church, local farmer, Dewey Poore, donated land for the site of a church and cemetery. The first church was completed in 1905. It was a frame building with central tower. Headstones within the churchyard shed light on families associated with the church from its early beginnings to present day. Among those families with multiple burials include the Young family, with burials dating between 1908 to 2012. Lowery William Young was among the early Deacons of the church. He remained an active member of the church until his death in 1959. His brother, Vernon Lemuel Young, and his family were also members of the church. V.L. Young served as Deacon during the 1930s. Another prominent family of the Liberty Baptist Church throughout its history is the Robinson family. J.C. Robinson (b.1862-d.1930) served as trustee of the church in 1916. Churchyard burials of the Robinson family span 1913 to 2012.

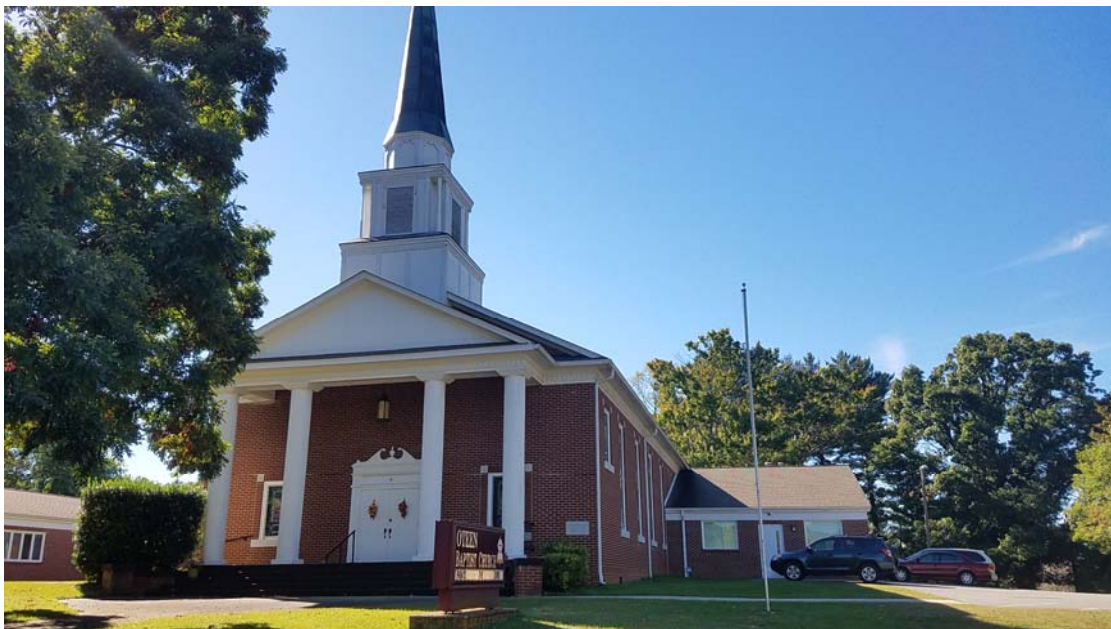
Photograph 43. Oteen Baptist Church

Completed in 1957, the Oteen Baptist Church is T-shaped in its original form, with a front gable roof and cupola with steeple. Like the Liberty Baptist Church, the Oteen Church is brick veneered. This representation of a mid-20th century church, however, is enhanced by a Colonial Revival-style entry door with broken pediment and a prominent entry portico with Ionic columns. The sanctuary features original stained glass windows. The original T-shape of the church is altered with a large scale addition on the south elevation. Although the building is a good example of a Colonial Revival-style church constructed during the 1950s, its large addition compromises the historic integrity of the original building. The Liberty Baptist Church is a better representation of a Post-World War II-era church in rural Buncombe County.

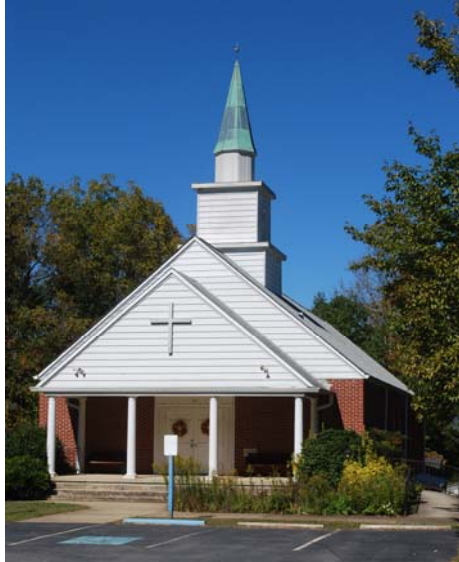
Photograph 44. Brown's View Methodist Church

The Brown's View Methodist Church was completed in 1950 on the site of the earlier church building. Like the Liberty Baptist Church, Brown's View Methodist Church includes an adjacent cemetery dating to the late-19th century. The church shares a brick veneer exterior, front gable roof, and steeple. Both lack an overall architectural style. Smaller in scale, the Brown's View Methodist Church is rectangular in shape with a prominent entry portico with fluted columns. Its two-leaf entry door is further enhanced by a decorative wood surround. Siding in the gable ends and on the cupola is aluminum. While this church is a good example of a traditional Post-World War II Era facility constructed within a rural setting, it does not appear to possess architectural significance.

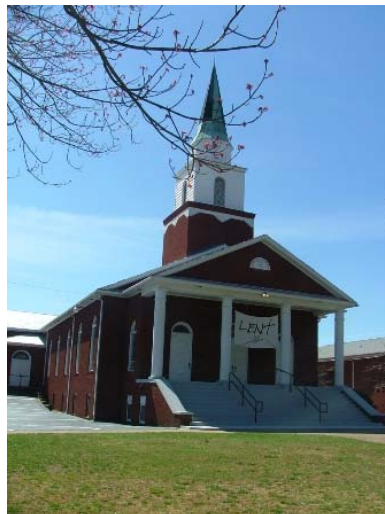
Photograph 45. Hominy Baptist Church

Hominy Baptist Church, located approximately 2 miles southwest of Liberty Baptist Church, was organized in 1812. The third, and present, church sanctuary was erected in 1949 in the Classical-style. It is T-shaped with a brick veneer exterior and front gable roof. It features entry doors with arched transoms, cupola, and steeple. A pedimented portico with round columns projects from the façade, and sanctuary windows are stained glass with arched transoms.

The church complex includes the second sanctuary building, constructed in 1923, which is now known as the Bennett Building. Its 1923 and 1949 sanctuaries are more distinguishable in terms of architecture than the Liberty Baptist Church. However, the church complex includes numerous large-scale additions compromising its historic integrity.

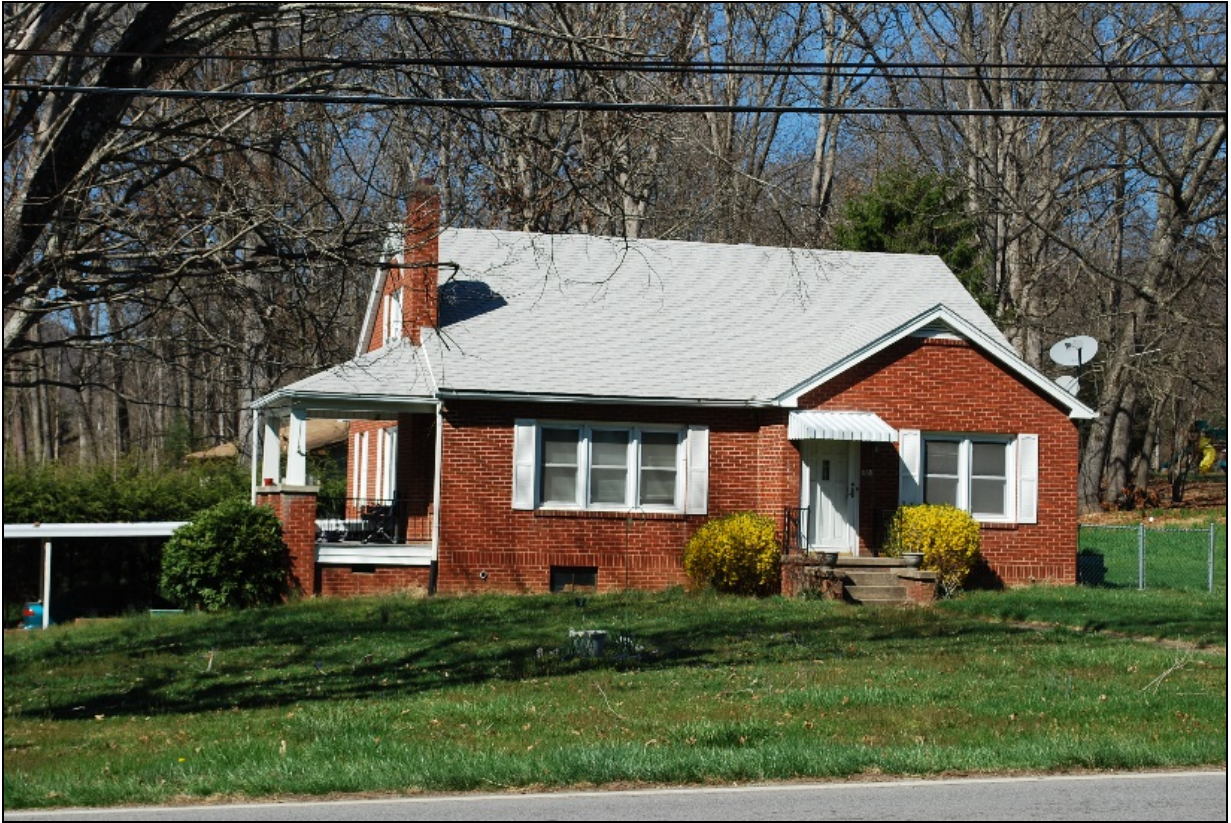
Photograph 48. Liberty Baptist Church Parsonage

Completed in 1952, the Liberty Baptist Church Parsonage (BN6289) is a one-and-one-half-story, Minimal Traditional house with a brick veneer exterior. The house has a medium-pitched, side-gabled roof covered with asphalt shingles and features slightly overhanging boxed eaves. Primary windows throughout the building are one-over-one, double-hung wood sash with exterior metal storm windows. The house is rectangular in shape with a lower gable bay projection located on the façade (south elevation). An exterior brick chimney is on the west elevation and within a side porch. The house rests on a continuous brick foundation topped by a water table of vertical brick stretchers.

Photographs of the parsonage when first completed confirm that all of the windows on the building were historically two (horizontal)-over-two (horizontal), double-hung wood sash. All were replaced with the present one-over-one windows.

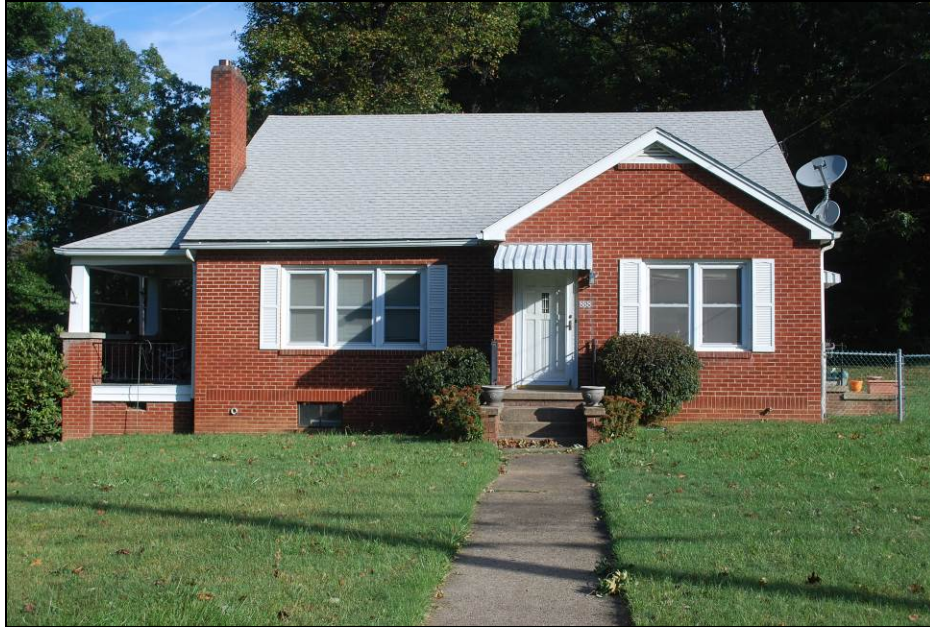
Photograph 49. Liberty Baptist Church Parsonage, Façade

The façade is asymmetrical with three bays (3W, D, 2W). Bays two and three occupy the lower gabled projection located on the east of the facade. The entry door is paneled with a small rectangular light and an aluminum awning. A concrete stoop with metal railings extends from the entry.

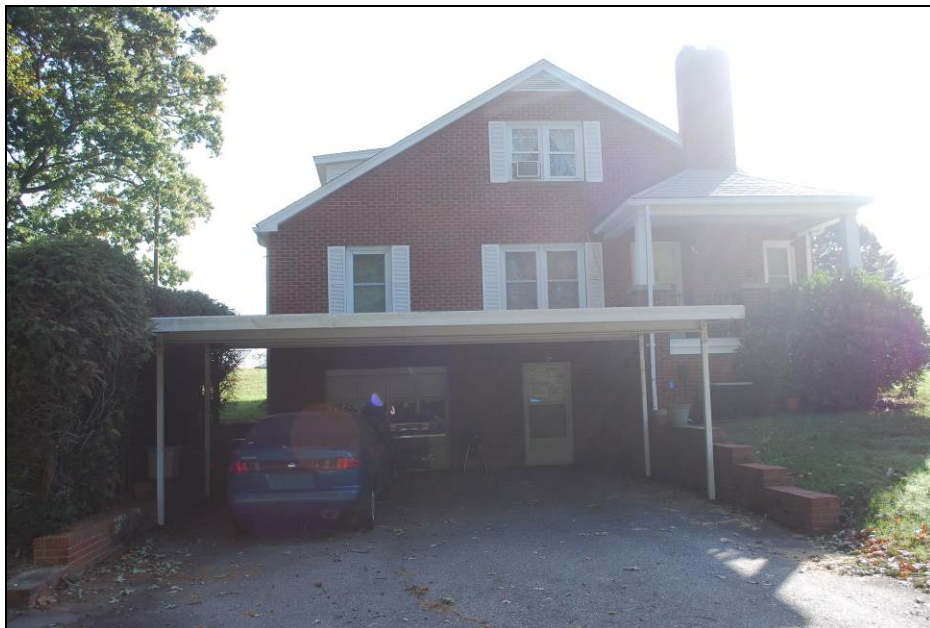
Photograph 50. West Elevation

The west elevation of the Liberty Baptist Church Parsonage features a partial-width hipped porch with battered wood posts on brick piers and a metal balustrade. The porch sits on a continuous brick foundation and features concrete flooring. Paired windows are located in the gable field. Above the windows, within the peak of the gable, is a triangular wood-louvered vent. An above-ground garage is located at basement level and features one garage bay door and one entry door. An open metal

carport with flat roof extends from the garage above the driveway, which is partially lined by a brick retaining wall.

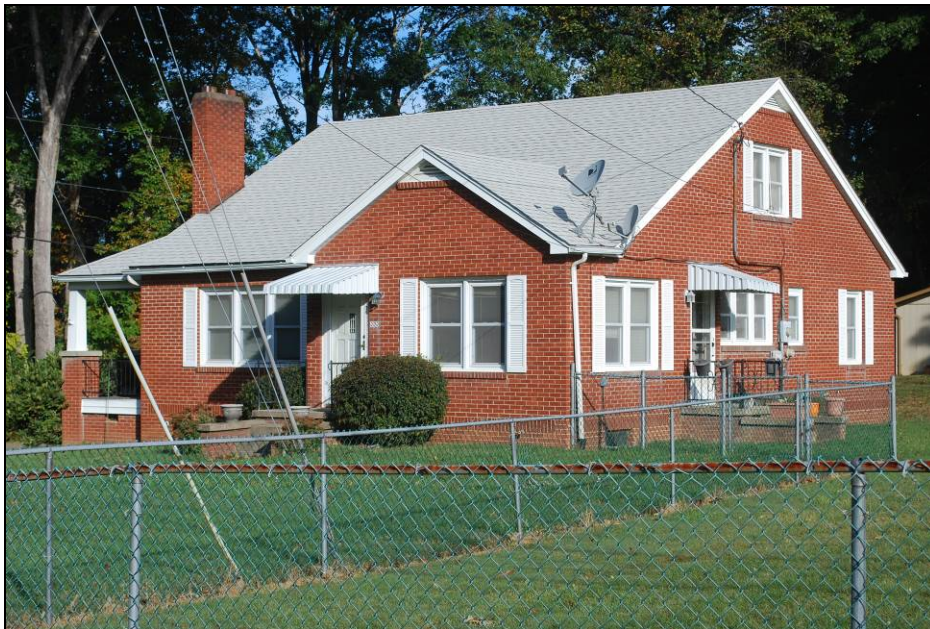
Photograph 52. Southeast Oblique

The east elevation features matching paired windows and triangular vent in the gable end as the west elevation. It features a combination of single, paired, and triple windows as well as a secondary entry door with aluminum awning. A small concrete stoop with metal railing extends from the entry door.

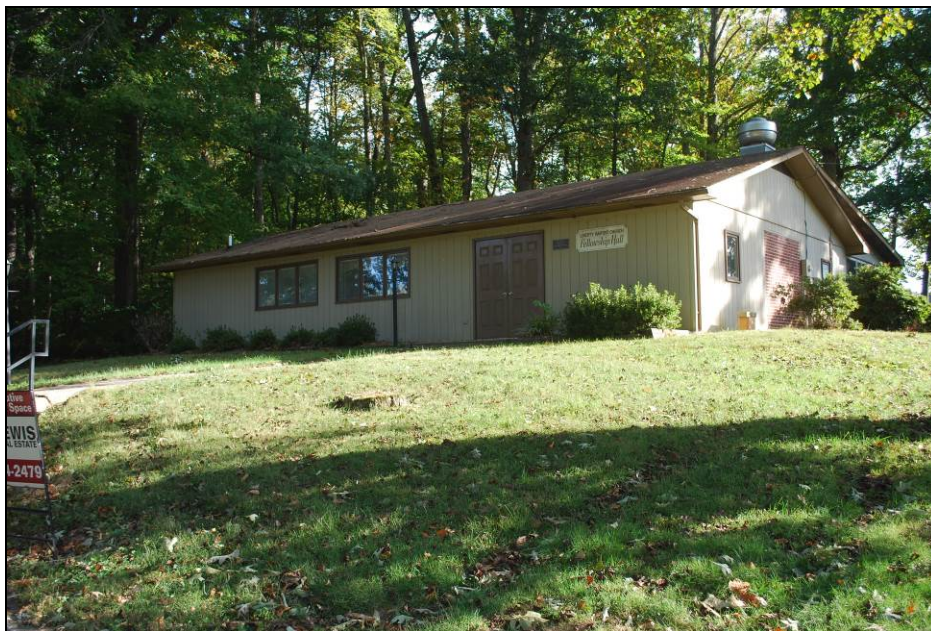
Photograph 54. Southwest Oblique, Fellowship Hall

The Liberty Baptist Church Fellowship Hall was completed in 1987 northeast of the parsonage. It is a rectangular building with a low-pitched, side-gabled roof clad in asphalt shingles. The roof features overhanging boxed eaves. The exterior of the building is vertical flush panels. The façade (west elevations) is three bays (3W, 3W, D) with a two-leaf paneled entry door. The windows on the façade are large fixed panes. Evidence of a brick chimney is on the south elevation.

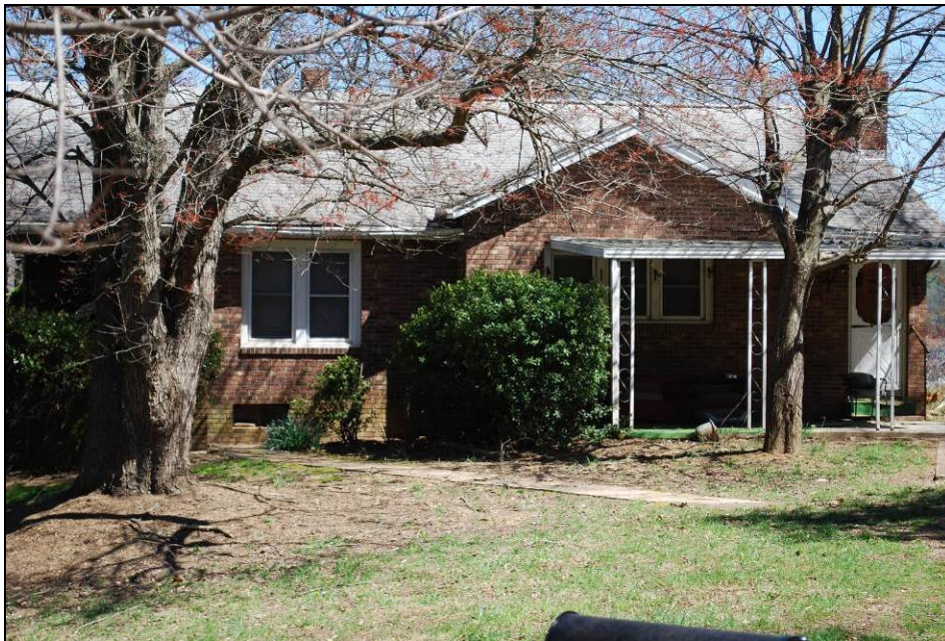
Photograph 55. 19 Westmont Road

Constructed c.1945, the residence located at 19 Westmont Road is approximately 1.5 miles south of the Liberty Baptist Church Parsonage. Similar to the parsonage, this residence features a projecting front gable bay and a side porch. It appears to retain its original design and materials.

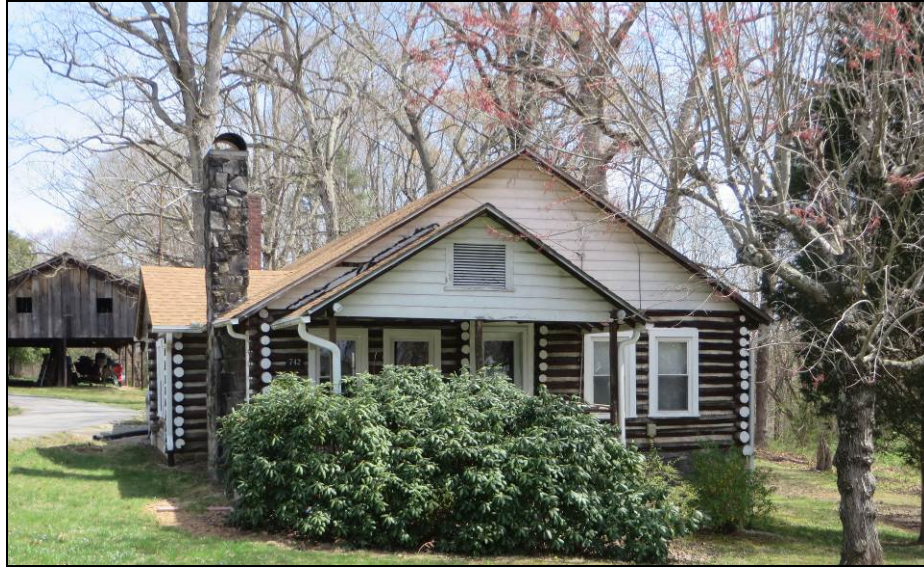
Photograph 58. Log House

Built in 1936, the single-story log house is a Rustic Revival-style dwelling featuring round logs, saddle notching, and a stone foundation. The front gable roof is clad in asphalt shingles and the exterior is characterized by its exposed log construction. Gable ends are clad in clapboard siding. The house is rectangular in shape with an original gabled bay projecting slightly from the north elevation. A prominent stone chimney is on the north elevation, and an interior brick chimney on the rear of the north roof slope. Windows are replacement one-over-one, double-hung vinyl sash with double glazing.

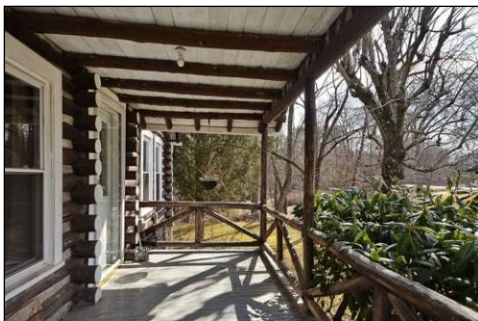
Photograph 59. Entry Porch

The façade (west) is three bays (2W, D, 2W) with an off-centered, replacement entry door and paired windows. A partial-width gabled entry porch with stone foundation projects from the façade. Round log posts support the roof and a log balustrade surrounds the porch. The ceiling of the roof includes exposed rafters and flush board.

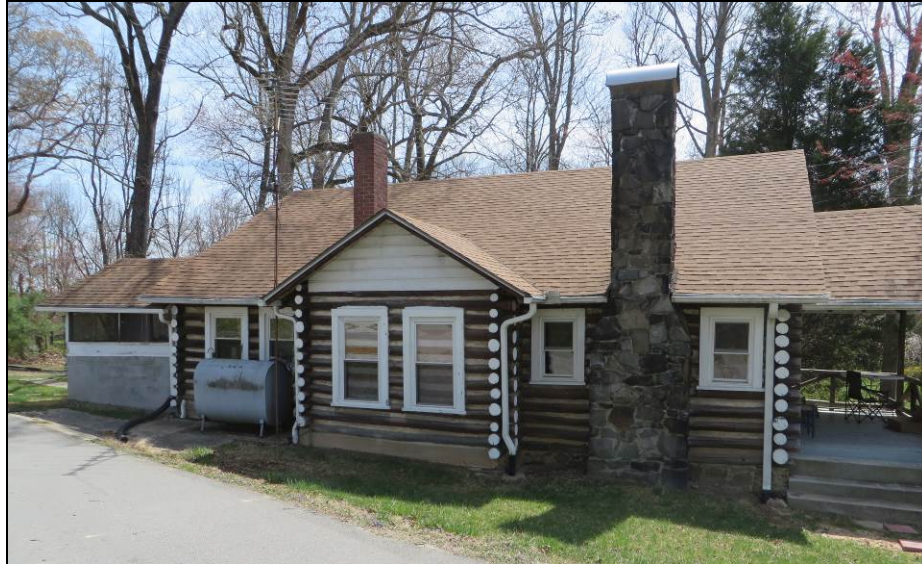
Photograph 60. North Elevation

The north elevation of the dwelling features six (6) windows, the centered projecting bay, and the exterior stone chimney between windows five (5) and six (6). A partial-width, screened porch addition extends from the east elevation. It features a lower gabled roof, and a concrete foundation.

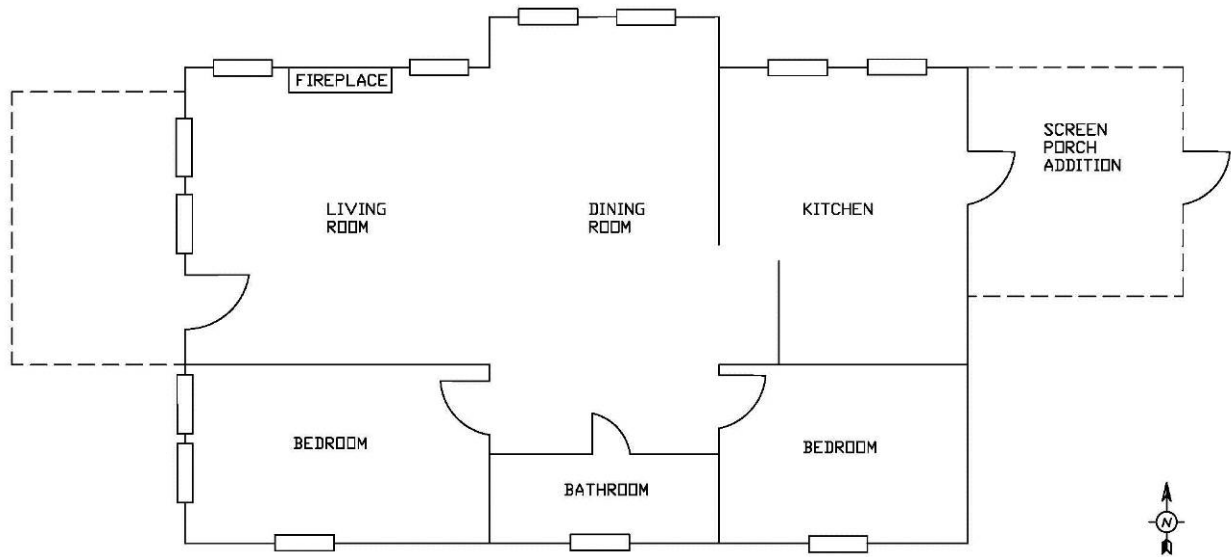
Figure 15. Anticipated Floor Plan of Sluder Log House

Upon entry into the house from the front porch is a large, open living and dining room. Ghost marks suggest that a wall once separated the two spaces. The rooms feature original hardwood floors and stained vertical flush board walls. The dropped ceiling is synthetic panels. A prominent stone fireplace with a log mantel occupies the north wall.

Non-historic alterations include the replacement of the original windows and exterior doors, the addition of the rear porch, the application of the dropped ceiling, the carpeting of the bedroom floors, and the removal of an interior wall. Collectively, these alterations have considerably compromised the dwelling's historic **design, materials, and workmanship.** It no longer retains its historic **association** with the Sluder family who resided on the property for more 60 years. The barns suggest that a portion of the property was used for small-scale farming, which no longer occurs on either of the two parcels.

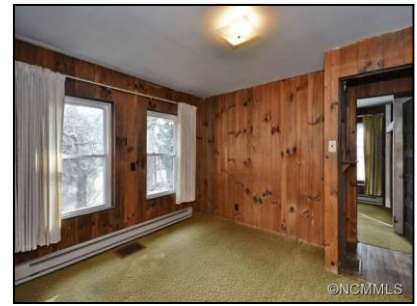
Photograph 64. Bedroom
Source: Trulia.com

The bedrooms are accessed from a narrow hallway extending from the south end of the living room. One bedroom features a plastered ceiling, and both are carpeted. Bedroom walls match those in the living room. Doors leading to each bedroom are original with horizontal wood panels. A bathroom is located at the end of the hall between the two bedrooms.
