North Carolina Department of Natural and Cultural Resources
State Historic Preservation Office

MEMORANDUM

SUBJECT: Historic Structures Survey Report for Grade Separation at I-40/SR 1228 and Realignment of SR 1228, I-4759, Buncombe County, ER 08-0959

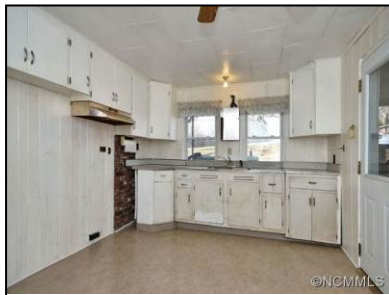
Photograph 63. Kitchen

The kitchen features white-painted walls and linoleum flooring. Cabinetry appears to be original. Evidence of a former oven and stove is on the west wall of the kitchen. A non-historic door leads from the east wall into to the screened porch addition.

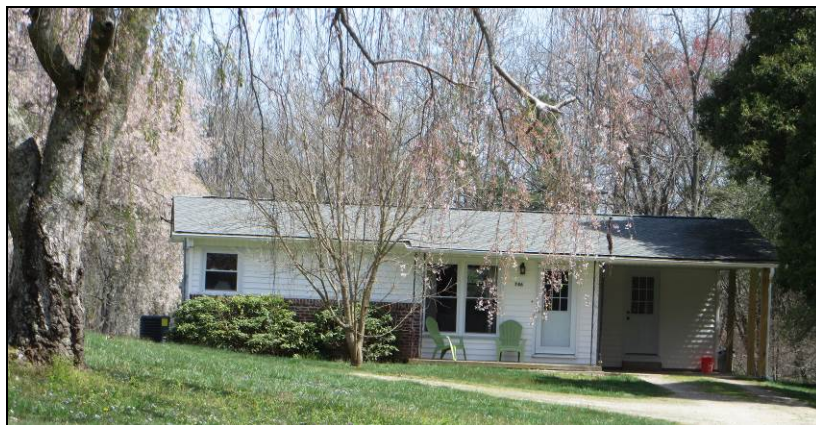
Photograph 65. Ranch House

Completed in 1962, the Ranch house is rectangular in shape with a low-pitched side-gabled roof featuring asphalt shingle. The exterior is vinyl-sided. The façade (west) is four bays (W, 2W, D, G) with an off-centered entry door and one-over-one double-hung, vinyl sash windows. At the south end of the façade is an integral carport, recessed beneath the principal roof. A secondary entry door leads from the east wall of the carport/garage into the house.

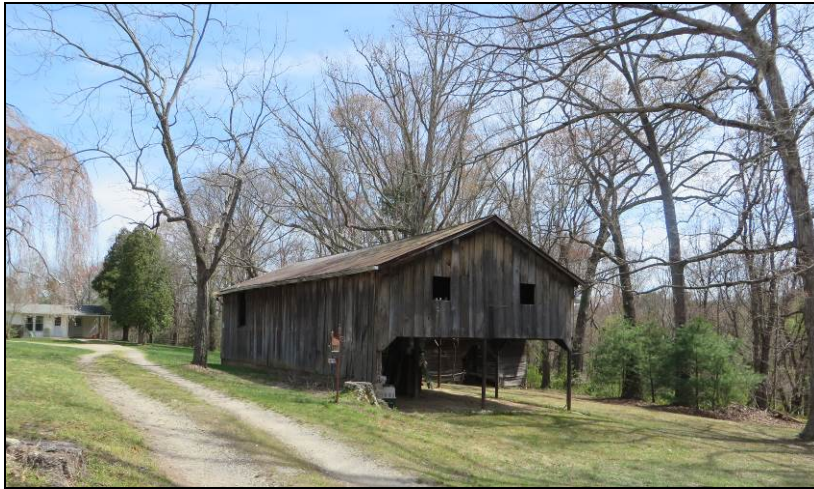
Photograph 66. Pole Barn with Loft

Constructed shortly following the completion of the log house, the front-gabled garage resembles a pole barn with an enclosed loft above. The roof is metal and the foundation is continuous concrete block. Only the north elevation is fully enclosed with exterior vertical board siding. Metal poles support the loft space in the upper-half story. There are two square window openings on the façade (west). A third opening is on the north elevation.

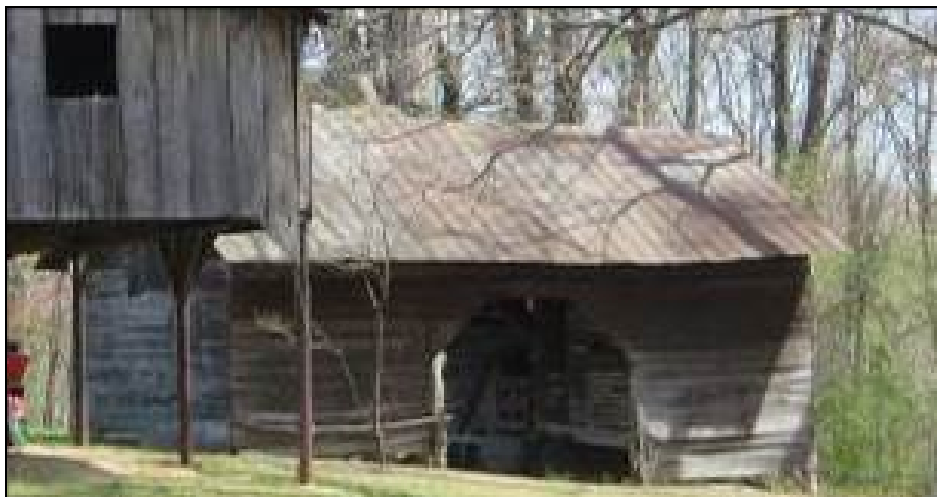
Photograph 67. Double Crib Barn

The double crib barn was constructed shortly following the completion of the log house. It is a frame structure with a side gable metal roof. The exterior is weatherboard siding. The double crib barn is characterized by two enclosed interior spaces, or cribs, divided by a central runway.

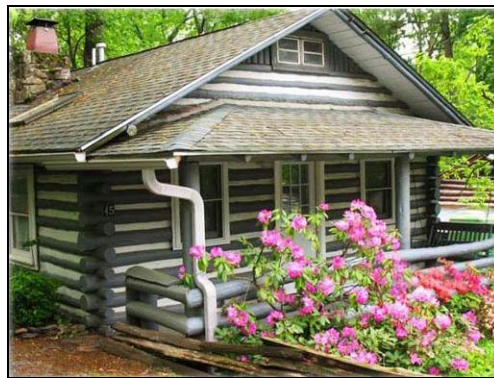
Photograph 68. Homeland Park Cabin

The Homeland Park neighborhood (c.1930) was initially built as a 45-acre resort outside of Asheville and included 50 small log cabins. As the city expanded, the cabins were sold as private residences during the 1950s. Homeland Park was listed on the National Register in 1999 as a historic district containing an impressive collection of Rustic Revival-style log dwellings. The cabins feature front and side gable roofs and saddle notching with chinking. Front porches are common, as well as stone chimneys.

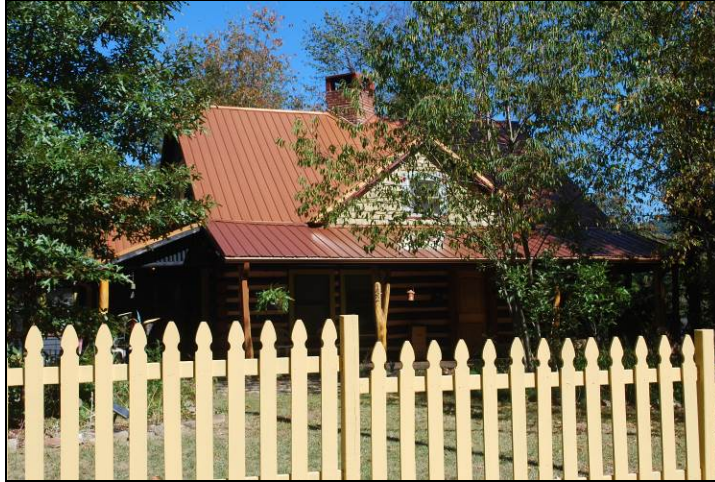
Photograph 69. 132 Spears Avenue (BN4569)

An impressive example of a Rustic Revival log house is located at 132 Spears Avenue (BN4569) in a residential neighborhood in Asheville. Constructed c.1935, the house features a steeply-pitched side gable roof with interior brick chimney and a front facing wall gable on the façade. Windows and doors appear original. A full-width shed porch is along the façade and features rough timber logs supporting the roof.

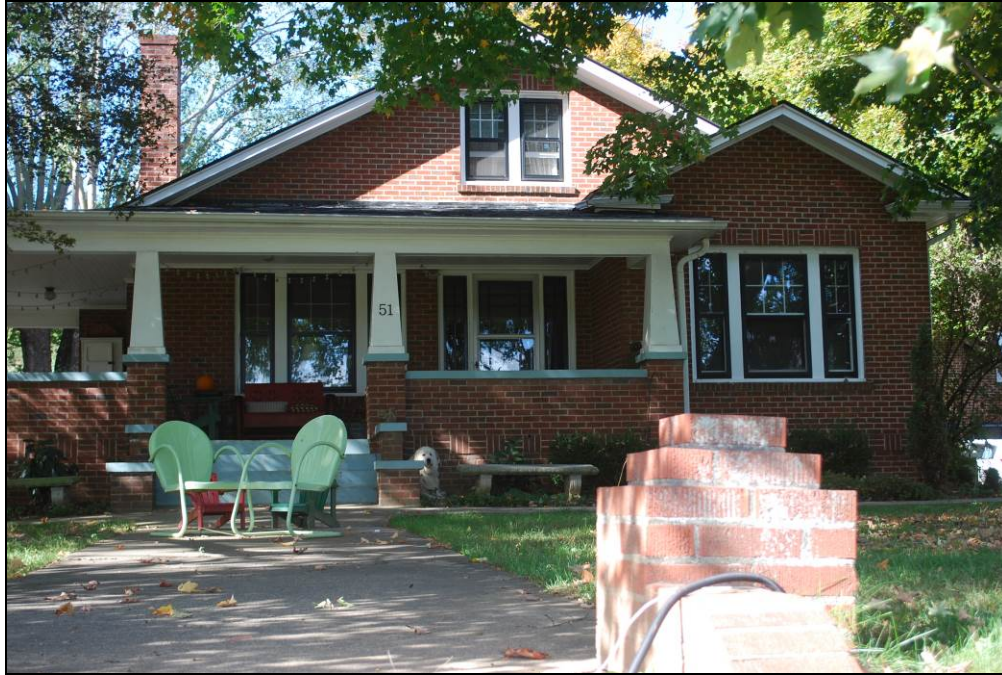
Photograph 77. Roberson Bungalow, façade (east elevation)

Completed in 1935, the one-and-one-half-story residence is an excellent representation of a Craftsman bungalow. The residence features a front-gabled roof with overhanging boxed eaves, a brick exterior, and a continuous brick foundation. A brick water table surrounds the house and is laid in a basket weave pattern. Primary windows are original six-over-one, double-hung wood sash and feature a brick basket weave header and brick sill. An interior brick chimney is located on both side roof slopes. The façade (east elevation) is asymmetrical and features a set of paired windows in the front gable. A lower gabled bay projects from the north end of the façade. The façade is three bays (3W, D, 3W) featuring a Craftsman-style entry door with numerous lights of varying sizes. Flanking either side of the door are multi-light sidelights. The window fenestration on the façade is comprised of a central, six-over-one window flanked by narrow four-over-one windows. An entry porch with shed roof wraps around the south elevation. The porch features heavy battered wood posts on brick piers and a brick balustrade.

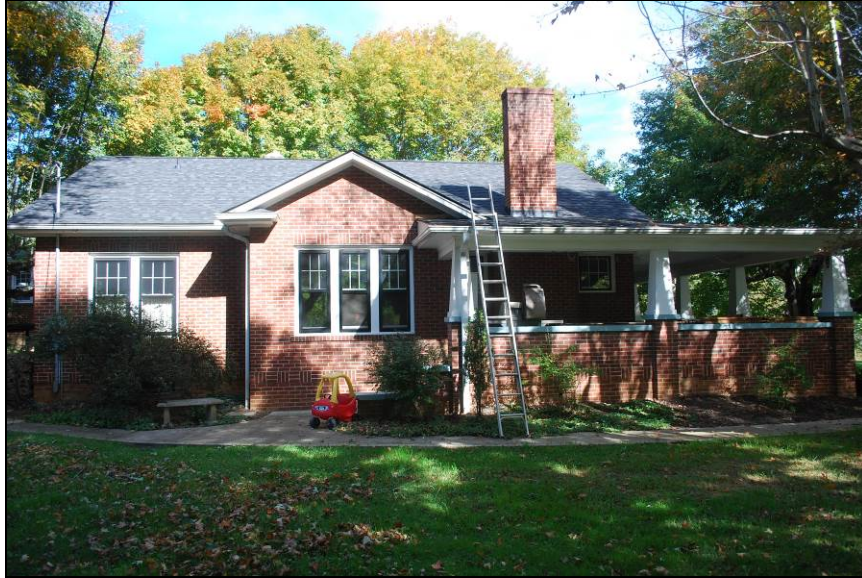
Photograph 79. Roberson House, south elevation

The south elevation of the bungalow includes paired and triple windows, as well as a projecting gable bay. The rear of the residence features partial gable returns. Paired windows are located within the gable end. The rear elevation is three bays with a single window located between two sets of

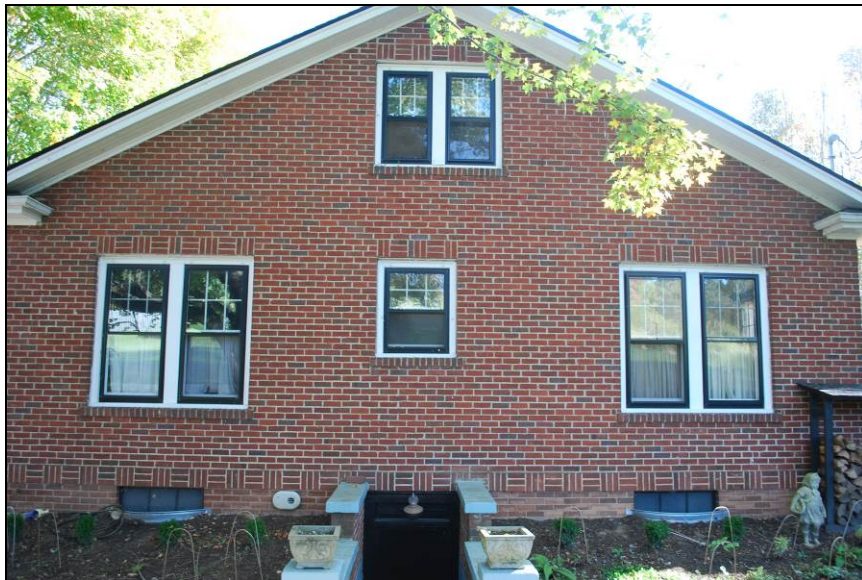
Photograph 80. Roberson Bungalow, rear elevation

paired windows. Two textured glass windows beneath the water table provide light into a basement. Brick steps lead to a paneled wood door accessing the basement. The north elevation also features a projecting gable bay. A glazed and paneled entry door leads into the projecting bay. Flanking either side of the door are two, rectangular fixed lights.

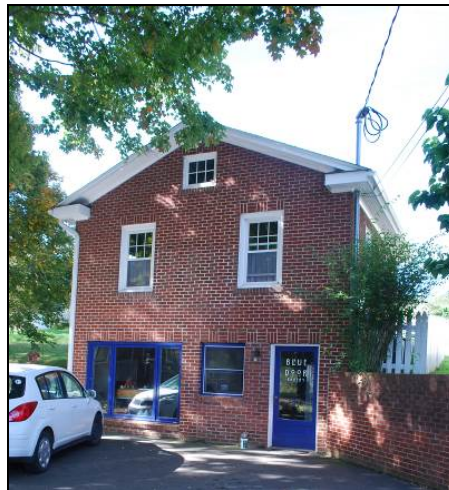
Photograph 82. Garage Apartment, façade (east elevation)

Completed in 1936, the brick apartment garage features a front gable roof with partial eave returns and a six-light fixed window in the front gable end. The garage faces east toward the paved driveway. Historically, the building featured two garage openings on the façade (east). Both were enclosed by the present property owners in c.2010, who converted the space into a bakery. Windows

are replacement six-over-one vinyl sash. The south elevation features two windows above the garage.

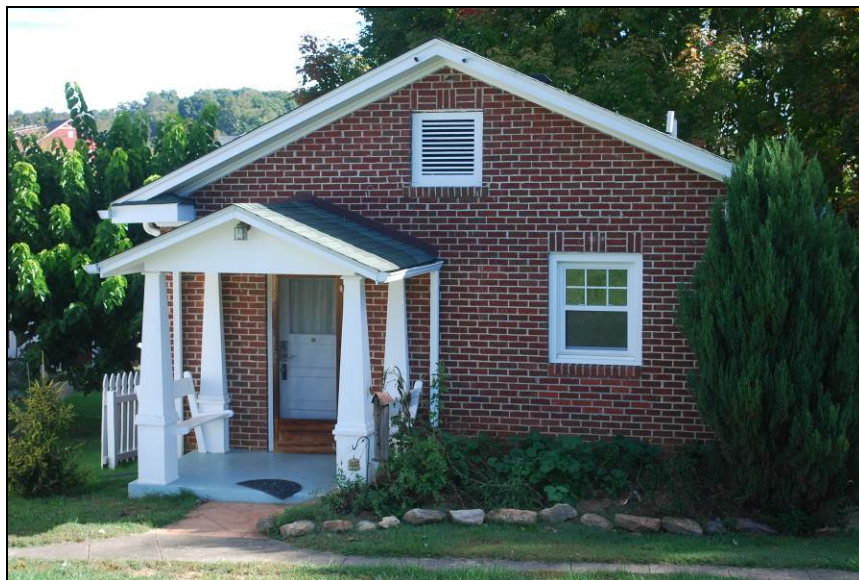
Photograph 84. Garage Apartment, west elevation

The west elevation is the “front” of the apartment at ground level. Due to the topography and landscaping, the garage is not above-ground at this elevation. The apartment is two bays with a glazed and paneled entry door. A gabled entry stoop with battered square posts extends from the door. Despite modern alterations, this building is contemporaneous with the main house, reflecting similar stylistic enhancements. It is considered a **contributing** resource to the farmstead.

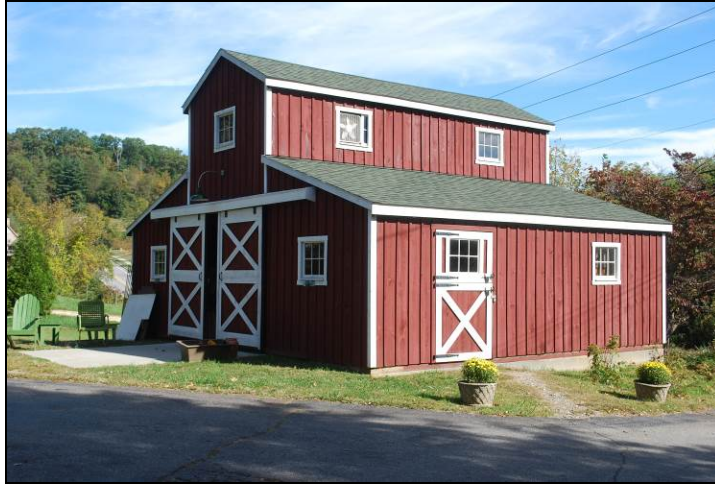
Photograph 85. Prefabricated Storage Shed

The prefabricated storage shed was erected on the property in 2010 by the current property owners. The building resembles a single pen barn with lower flanking lean-tos. The building features an exterior of board -and-batten siding, and an asphalt shingled roof. Two sliding doors are on the façade (west elevation). Windows are light fixed sash. Due to its age, this building does **not contribute** to the farmstead.

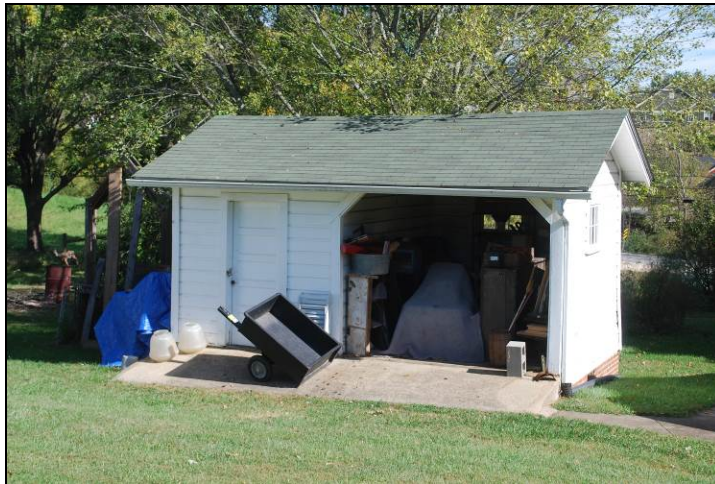
Photograph 86. Equipment Garage and Shed, c.1920

Completed c.1920, the frame garage and shed features flush board siding and a side gable roof clad in asphalt shingles. The foundation is continuous brick. The façade (southwest) includes a wide garage bay opening and an entry door with horizontal panels. A six-light fixed window is on the south elevation. This is a considered a **contributing** element to the Roberson Farmstead.

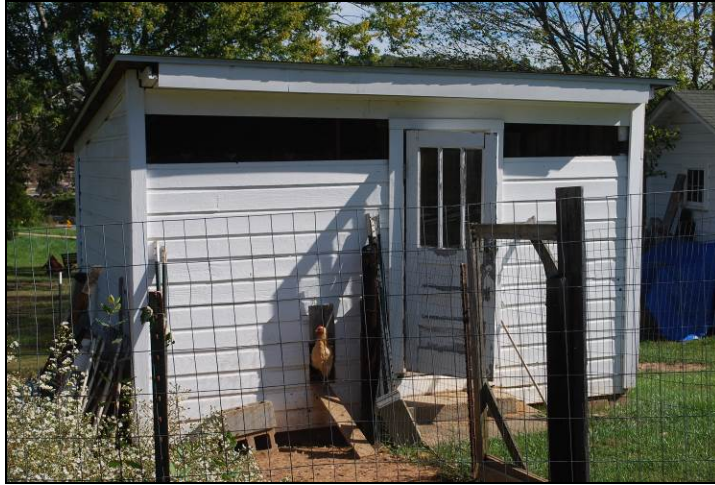
Photograph 87. Chicken Coop, c.1920

The chicken coop features flush board siding, a shed roof, and a continuous concrete block foundation. The building faces west and features a glazed and paneled entry door. Exterior boards at the top of the wall are removed, providing light into the interior of the coop.

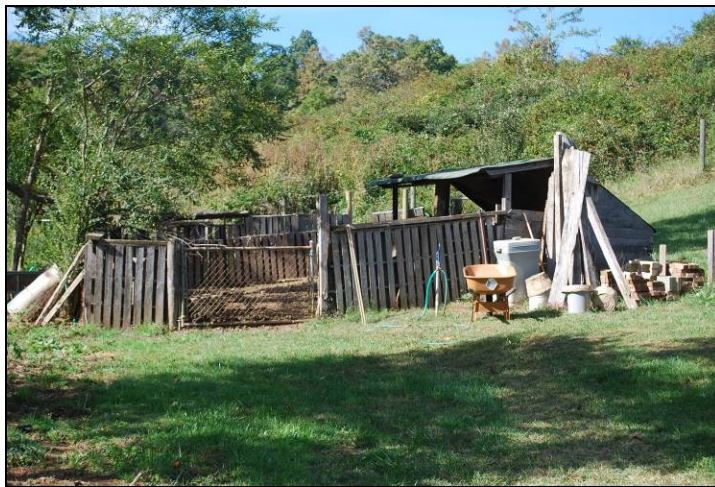
Photograph 88. Hog Pen, c.2010

The hog pen was constructed c.2010 by the present property owners. It features a fence of vertical wood boards. A lean-to/run-in is located at the north end of the pen. It features a metal roof and flush board siding. Due to its age, this resource does **not contribute** to the farmstead.

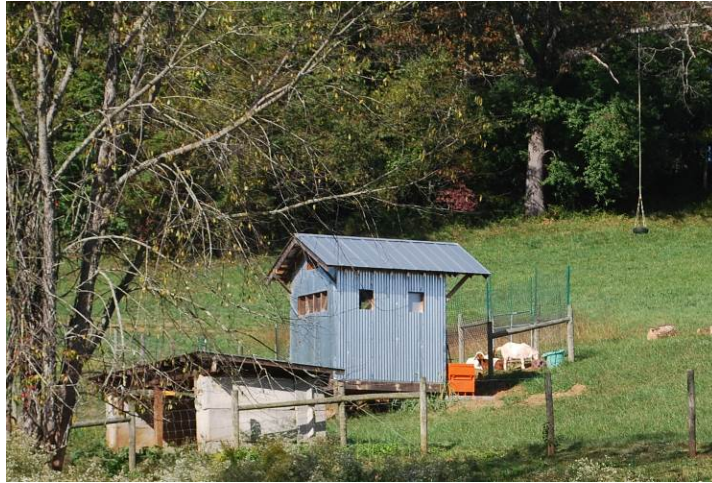
Photograph 89. Shed within Livestock Pen

The shed within the livestock keep is a small building with a gabled roof and corrugated metal exterior. It sits on a wood post foundation. Window openings are set high on the walls and are square. Due to its age, this structure does **not contribute** to the farmstead.

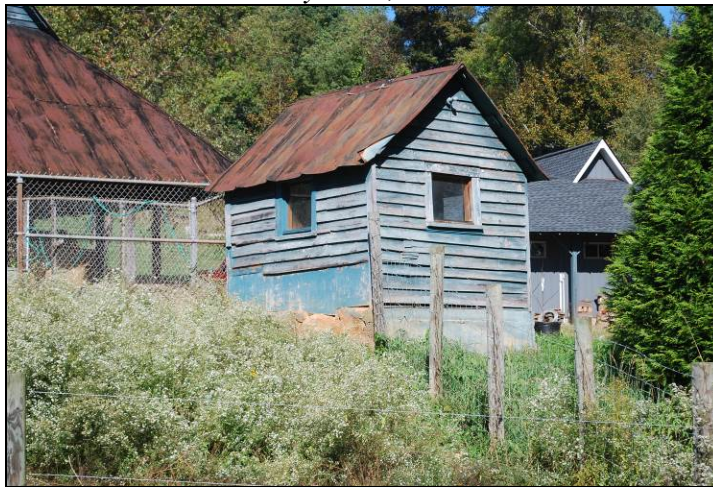
The utility shed located on the agricultural tract is a small, frame structure with a metal gable roof field stone foundation. The exterior is clad in weatherboard siding. Window openings are square fixed lights. This structure is a **contributing** element to the Roberson Farmstead.

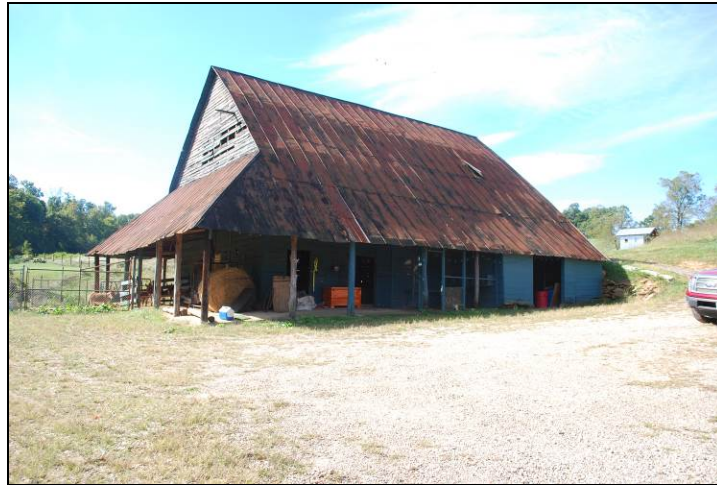
Photograph 90. Dairy Barn, looking southeast

The dairy barn is the most prominent among the agricultural buildings on the farmstead. It features a steeply pitched front gable roof, clad in corrugated metal, with wide overhanging eaves. The gable ends are sided in weatherboard. The dairy barn is clad in flush board siding and rests on a continuous foundation of field stone. The east elevation features a covered patio with steeply-pitched shed roof supported by round log posts. The covered patio wraps around the north and south elevations beneath the principal roof. Exterior observations of the barn reveal a separation of interior spaces. The livestock stalls occupy the southern section, which does not feature exterior walls. Whereas a portion of the north side is enclosed for office space. The dairy barn is a **contributing** element to the Roberson Farmstead.

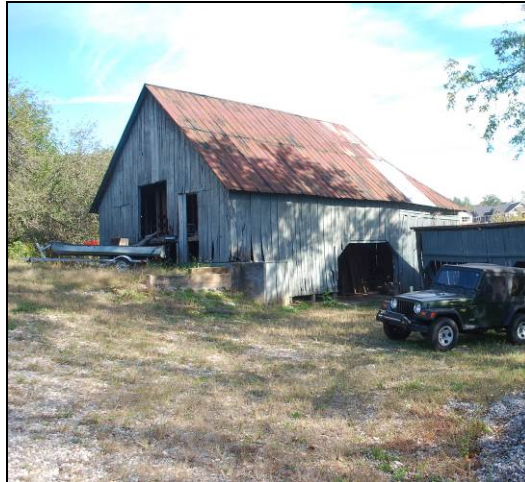
Photograph 92. Frame Barn, southwest oblique

The frame barn features a front gable roof covered in tin. The building faces west. It is clad in vertical flush board siding and the foundation is concrete slab. There is a large bay for heavy equipment on the west elevation, and another on the south. There appears to have been a rear lean-to with hipped roof along the rear. The siding suggests that the lean-to was once open and later enclosed with vertical board siding. The barn is a **contributing** resource to the Roberson Farmstead.

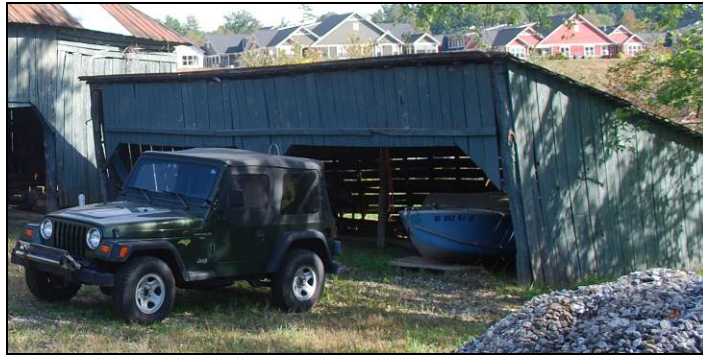
Photograph 94. Equipment Garage

The equipment garage resembles a lean-to with a shed roof covered in metal. It is clad in vertical board siding. Two, wide garage bays are on the west elevation. This is a **contributing** resource to the Roberson Farmstead.

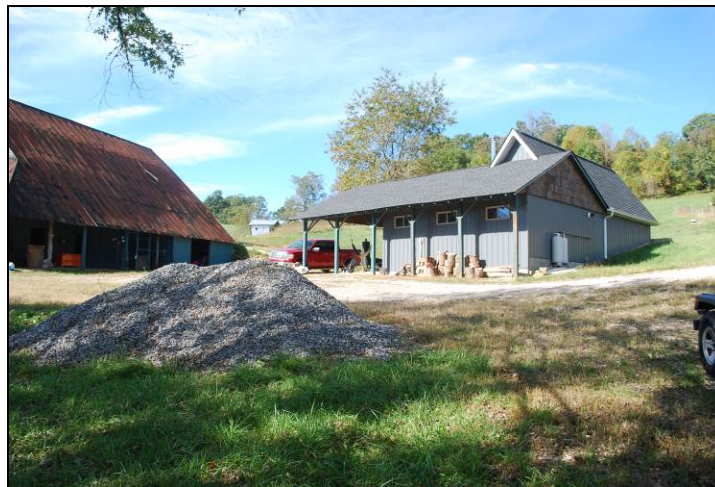
Constructed c.2015 by present owners, the one-story residence is L-shaped with a cross-gabled roof. The roof features asphalt shingles and exposed rafter ends. The house is clad in vertical metal siding resembling board-and-batten. The main roof extends from the house to the west, above a concrete patio that wraps around the southeast elevation. The extended roof is supported by square wood posts with braces. Due to its age, this resource does **not contribute** to the Roberson Farmstead.

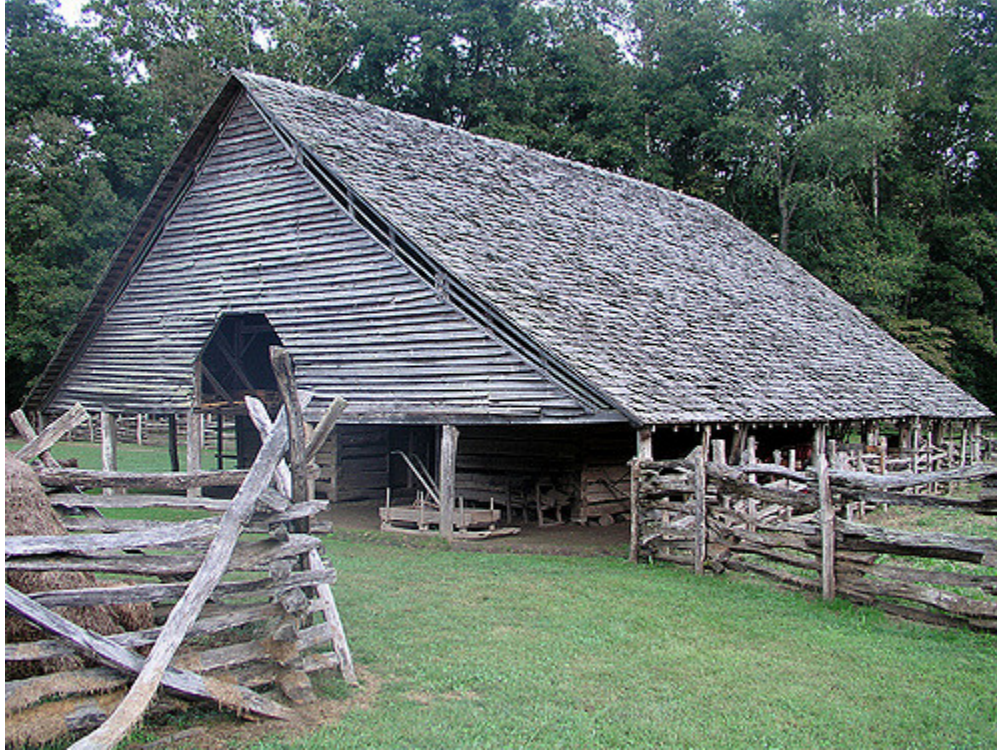
Photograph 97. Enloe Barn, Mountain Farm Museum, Great Smokey Mountains National Park

The Enloe Barn, constructed during the 1880s, is located in Cherokee at the Mountain Farm Museum in the Great Smokey Mountains National Park. The Enloe Barn is a pristine interpretation of a traditional livestock barn with a steeply-pitched roof with wide overhanging eaves supported by rough logs. The pole barn includes small enclosed rooms of log construction within the interior. The Roberson dairy barn is comparable to the Enloe Barn, though a later interpretation. The Roberson barn includes more enclosed interior space, sided with weatherboard rather than log construction, and features the patio roof projecting from the façade, creating additional covered space.
