SUBJECT: Intensive-Level Historic Architectural Analysis, Replace Bridges 227 and 213 on US 70 (Capital Boulevard) over Peace Street and Wade Avenue, B-5121 and B-5317, Raleigh, Wake County, ER 08-2607 and ER 11-0310

**INTENSIVE-LEVEL HISTORIC ARCHITECTURAL ANALYSIS
B-5121: REPLACE BRIDGE NO. 227 ON US 70 (CAPITAL
BOULEVARD) OVER PEACE STREET IN RALEIGH, WAKE
COUNTY, WBS# 42263, FEDERAL AID # BRNHS-0070(119)**

**B-5317: REPLACE BRIDGE NO. 213 ON WADE AVENUE OVER US
70 (CAPITAL BOULEVARD) IN RALEIGH, WAKE COUNTY,
WBS# 46031, FEDERAL AID # BRNHS-0070(149)**

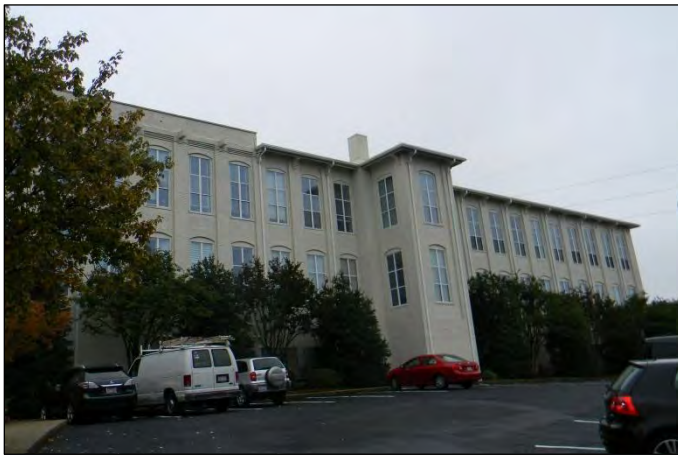
WA 3919: Raleigh Cotton Mill

614 Capital Boulevard
Raleigh, North Carolina
PIN: 1704622417

Today, the building continues to function as a multi-family residential complex. Though its historic windows have been replaced, the contemporary units were an attempt to match some of the original configuration and to preserve much of the historic fenestration pattern (Photo 1, p. 9). The building's massing and footprint has not changed since the mid-twentieth century when the mill was used as a warehouse for several different companies.

During the current survey, it was found that the Raleigh Cotton Mill retains the same architectural features and historical significance detailed in the 1999 and 2005 investigations of the property. Though a period of significance has not been previously prescribed, it is believed that the time from the mill's construction in 1890 until its sale in 1932 would encompass the significant architectural features and historic events detailed in earlier investigations where the resource was determined eligible for the NRHP. Based on the extant historic fabric from this time period, the building continues to display a high level of historic integrity in its location, workmanship, feeling and association, and a relatively moderate level in its setting, design, and materials.

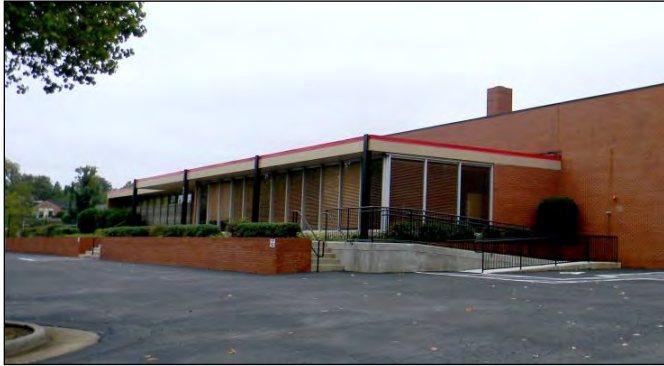
WA 7126: Noland Plumbing Company Building

1117 Capital Boulevard
Raleigh, North Carolina
PIN: 1704655538

During the current survey, it was found that the Noland Plumbing Company retains the same architectural features and historical significance detailed in the 2006 and 2009 investigations of the property. Though a period of significance has not been previously prescribed, it is believed that the time from the building's construction in 1960 until its sale, sometime after 2009, encompasses the significant architectural features and important historic events detailed in earlier investigations where the resource was determined eligible for the NRHP. Based on the extant historic fabric from this period, the building continues to display a high

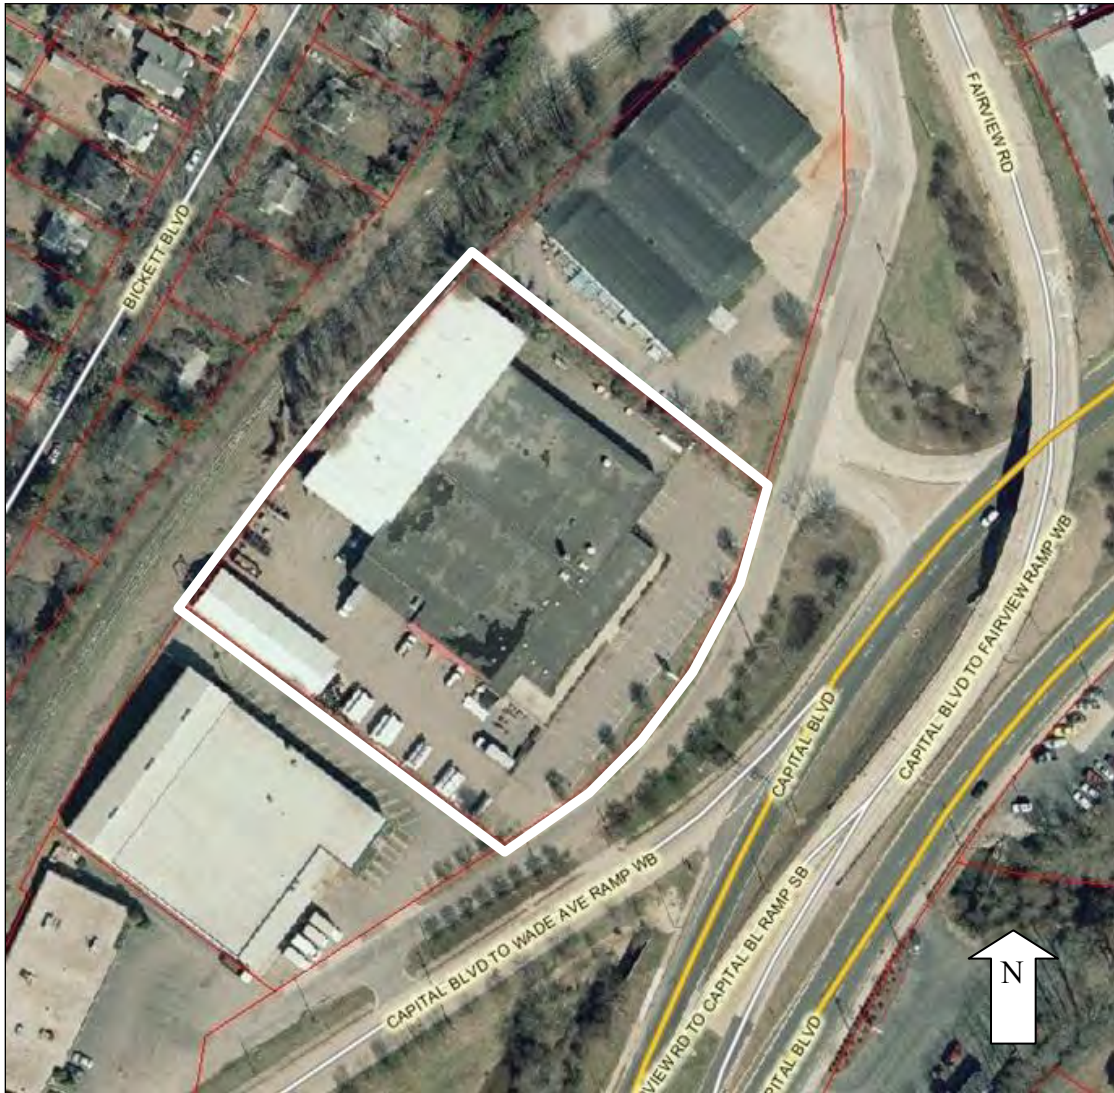
Figure 6: Map of Noland Plumbing Company (WA 7126) NHRP Boundaries and Current Tax Parcel, Highlighted in White (City of Raleigh and Wake County imaps 2012).

intension than the Noland Plumbing Company building, and therefore, it is recommended that this resource remains eligible for the NRHP under Criteria A and C. The NRHP boundaries established for the Noland Plumbing Company building during previous investigations conform to the existing tax parcel, and include the 2.5 acres that presently surround the property (Figure 6). These boundaries extend roughly from the railroad right of way on the west to the Capital Boulevard service road on the east, and from the property line with 1125 Capital Boulevard on the north to that of the parcel at 1113 Capital Boulevard on the south.

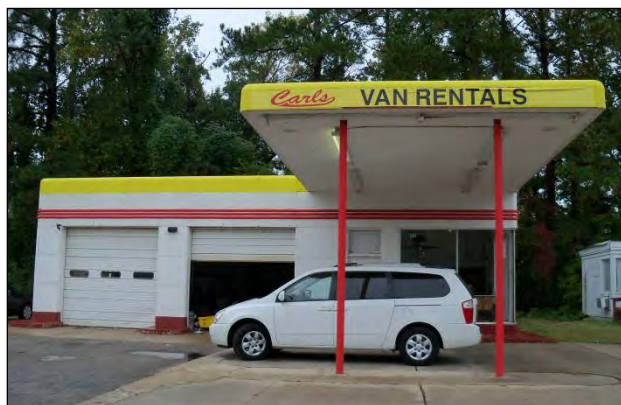
WA 7363: Gulf Gas Station

915 Capital Boulevard
Raleigh, North Carolina
PIN: 1704641482

The one-story, three-bay, International station building rests on a poured, concrete-slab foundation, and has a masonry structural system composed primarily of concrete block. It is covered by a low-pitched shed roof that slopes gently to the west, towards the rear elevation, and which is surrounded by a parapet wall. The primary elevations are the north and east sides of the building that face on-coming traffic headed south along Capital Boulevard. These

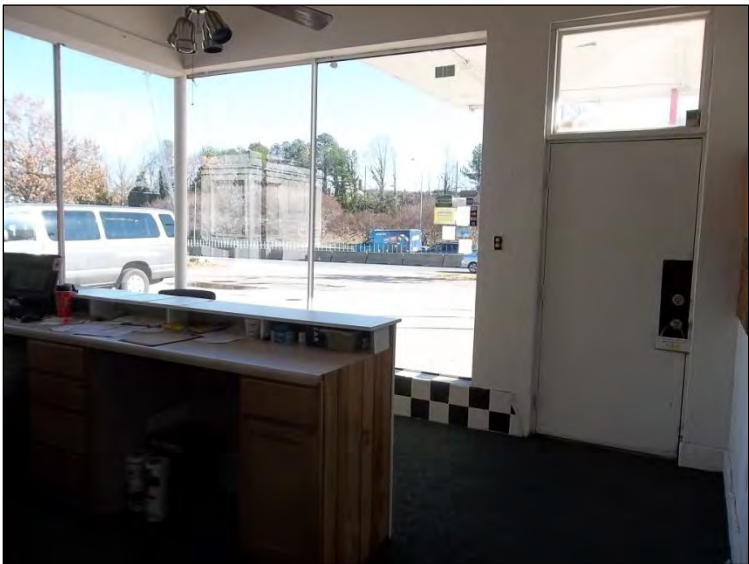
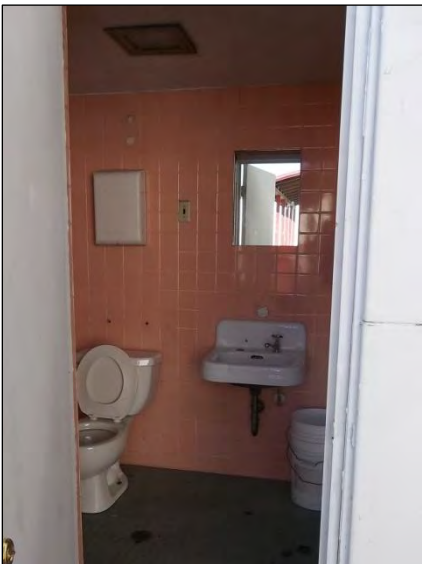
Photo 5: At Left, Interior View of Sales Area, Looking East Towards Capital Boulevard; at Right, Interior View of Bathroom, Gulf Gas Station (WA 7363).

The most visible space within the station is the sales area, where large display windows showcase the products and personnel inside. Interior walls within the sales room are clad in stucco with tiled skirting. Original display windows come together as “glass meets glass”—a typical architectural feature of the International style (Photo 5, p. 20). The indoor/outdoor carpeting in the sales room covers asbestos tiles, while the counter appears to be of a recent vintage. The main entry door and transom window are replacements. Only one of the restrooms is in working order, but both facilities retain mid-century fixtures and ornamentation. Bathroom walls are tiled from the floor to the dropped ceiling.

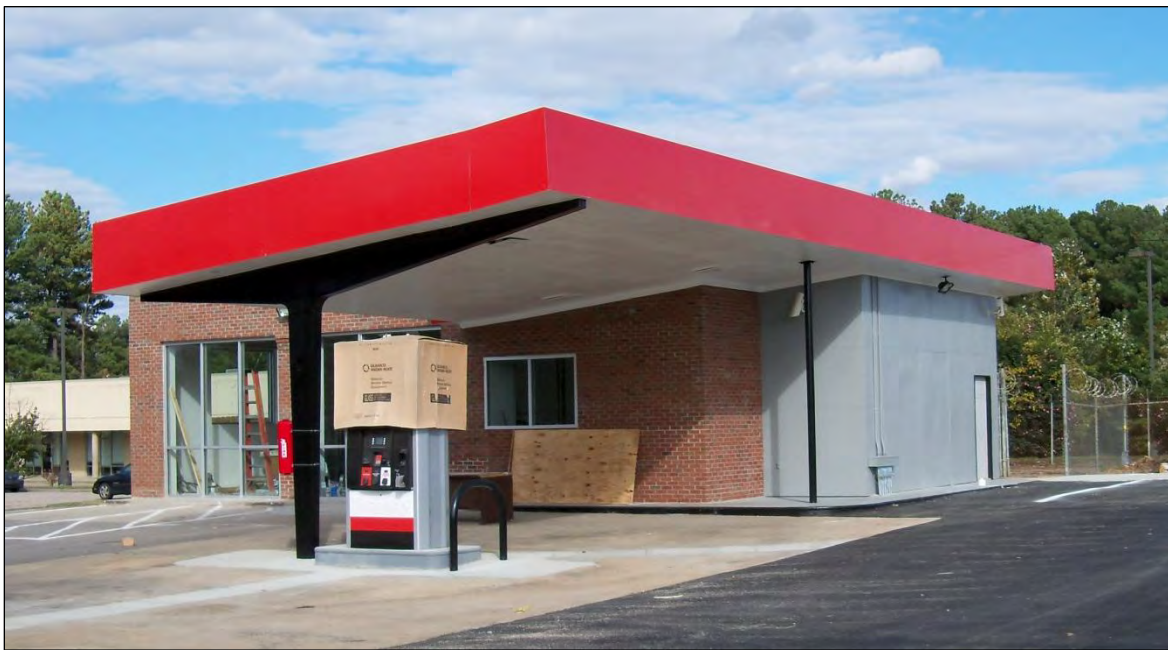
Photo 6: Northeast Oblique of Gas Station at 2121 Garner Road (October 2011).

Gas stations were noted as an “important suburban building type” in Little’s 2006 Modernist context for the City of Raleigh, although just one example was surveyed in association with the study. This resource, an Esso station at 2121 Garner Road, was prized for its “flat-roofed box with white enameled steel sheathing...” among other Modern architectural features (Little 2006:33). A reconnaissance survey of this building revealed that it has since been remodeled and its metal paneling removed (Photo 6).

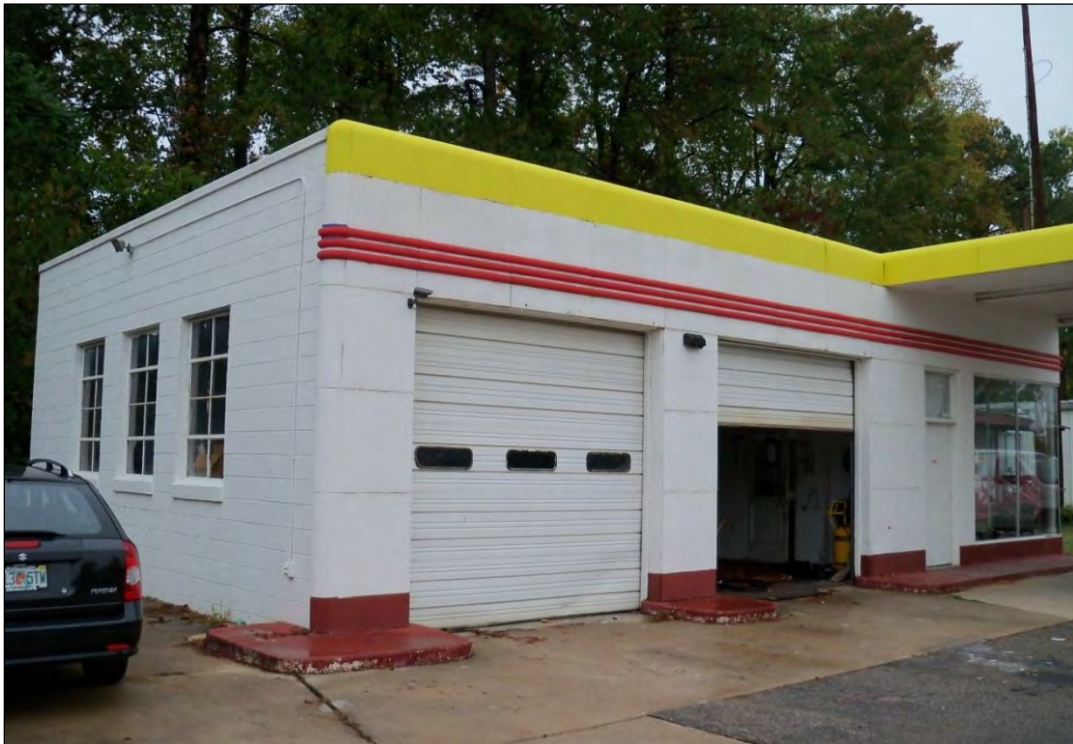
In your letter, you also suggest that the Gulf Gas Station is eligible under Criterion A for roadside commerce and branding. The Gulf does retain the three “Gulf bands” (now repainted) above the garage and storefront, but the station does not appear to have any other distinctive branding elements. The identifying features of 1940-70 Gulf stations noted by Jones, including a flat roof, display windows, multi-light garage doors, and porcelain enamel panels, are common to many stations of this era.²

Photo 7: Southeast Oblique, Gulf Gas Station (WA 7363), With View of Distinctive “Gulf” Bands. Note the touch of the company’s trademark blue visible under the red paint.

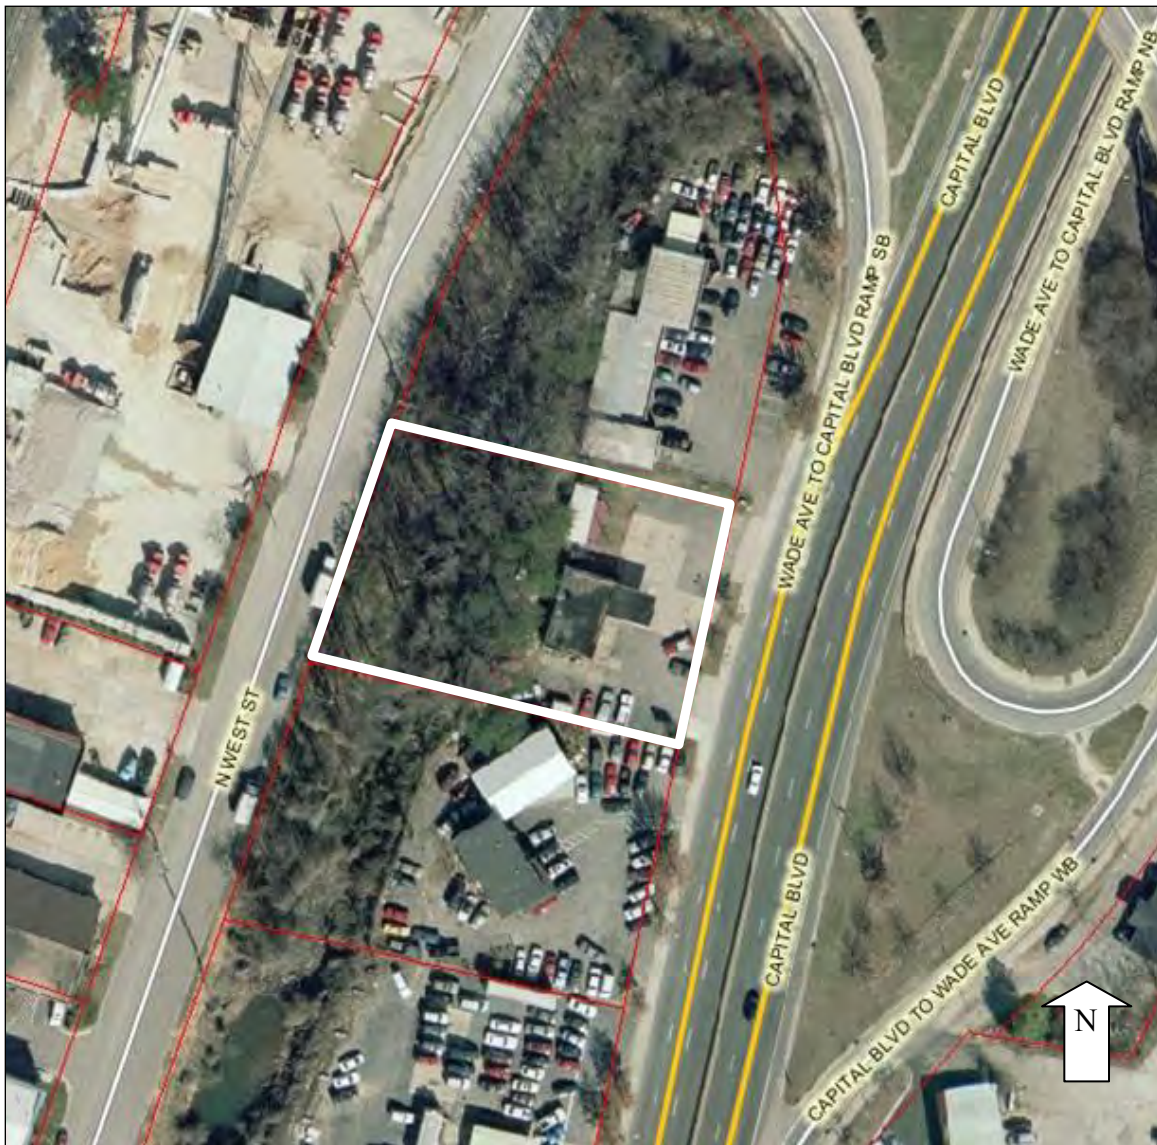
Figure 9: Map of Gulf Gas Station (WA 7363) NHRP Boundaries and Current Tax Parcel, Highlighted in White (City of Raleigh and Wake County imaps 2012).

business establishment, subsurface deposits throughout this area were greatly disturbed through the installation of subsurface gas tanks and other utilities and installation of signage. Moreover, the commonality of mid-century concrete block construction precludes the potential for below-ground remains associated with this resource to provide notable data on commercial structural technology in this area. As such, it is recommended that the resource is Not Eligible under Criterion D. Suggested NRHP boundaries conform to the existing tax parcel, and include the 0.65 acres that presently surround the building (Figure 9). These boundaries extend roughly from the right of way along N. West Street on the west to that of Capital Boulevard on the east, and from the property line with 919 Capital Boulevard on the north to that of the parcel at 909 Capital Boulevard on the south.

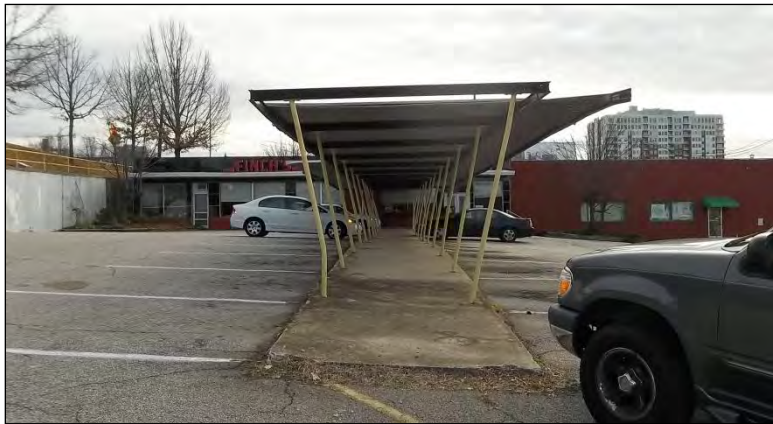
WA 4607: Finch's Restaurant

401 West Peace Street
Raleigh, North Carolina
PIN: 1704517934

The one-story, five-bay, mid-century, Modern commercial building located at 401 W. Peace Street was constructed in 1948. It rests on a poured, concrete-slab foundation and has a cinder-block structural system. The flat roof is surrounded by a parapet wall with terra-cotta tile coping. The primary façade, or north elevation, is clad in a mixture of stretcher-bonded brick and black Carrera glass (Photo 10, p. 28). The storefront is sheltered by a continuous, flat, metal awning that stretches across the façade. The name "Finch's" is spelled in metal letters that are painted red, and appear to have originally contained neon lighting (Photo 11, p. 28).

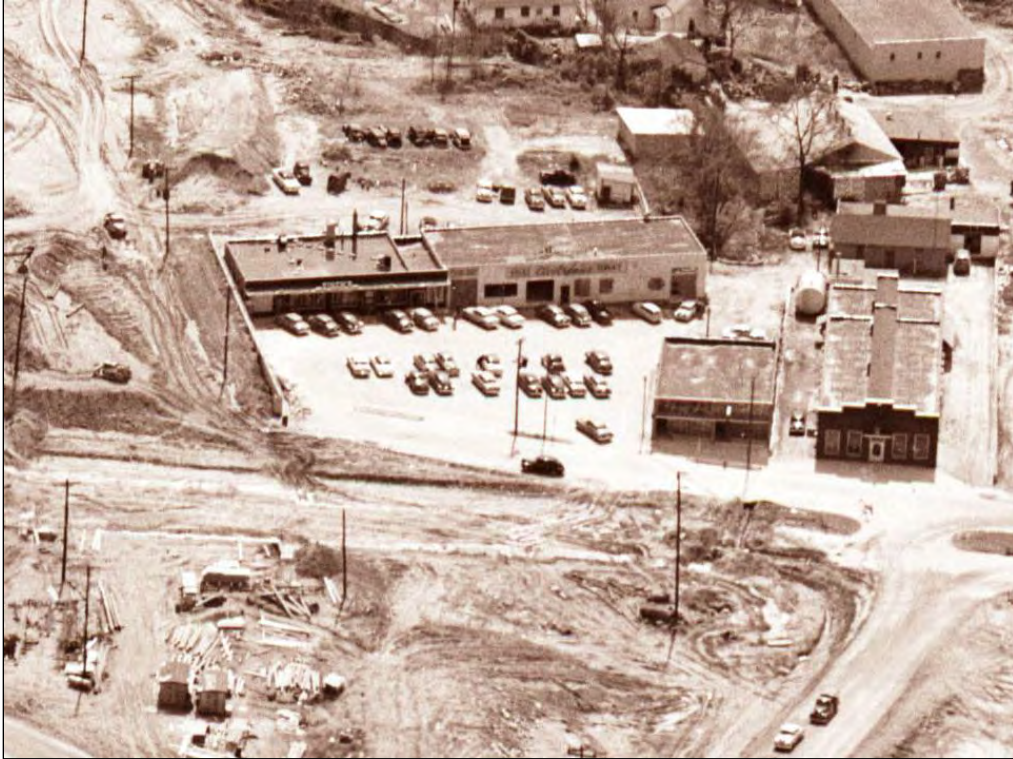
Photo 12: Detail of Finch's, *News and Observer* Aerial (on file, North Carolina State Archives). Certain elements suggest a date of 1953 or 1954.

Aerial photographs taken during the construction of Downtown Boulevard in the early-1950s indicate that the one-bay, west-side addition connecting Finch’s to the Heating and Electric Company building was an early alteration to the resource (Photo 12, p. 30). Based on communication with the current owner, this west-side addition was reportedly constructed to better facilitate the fast pace of curb-side service, provided by a double-leaf entrance and sizable “order up” window. Other modifications to the building include a concrete-block, lean-to addition on the south elevation, with another frame addition extending this later addition further west along the rear of the property (Photo 13, p. 30).

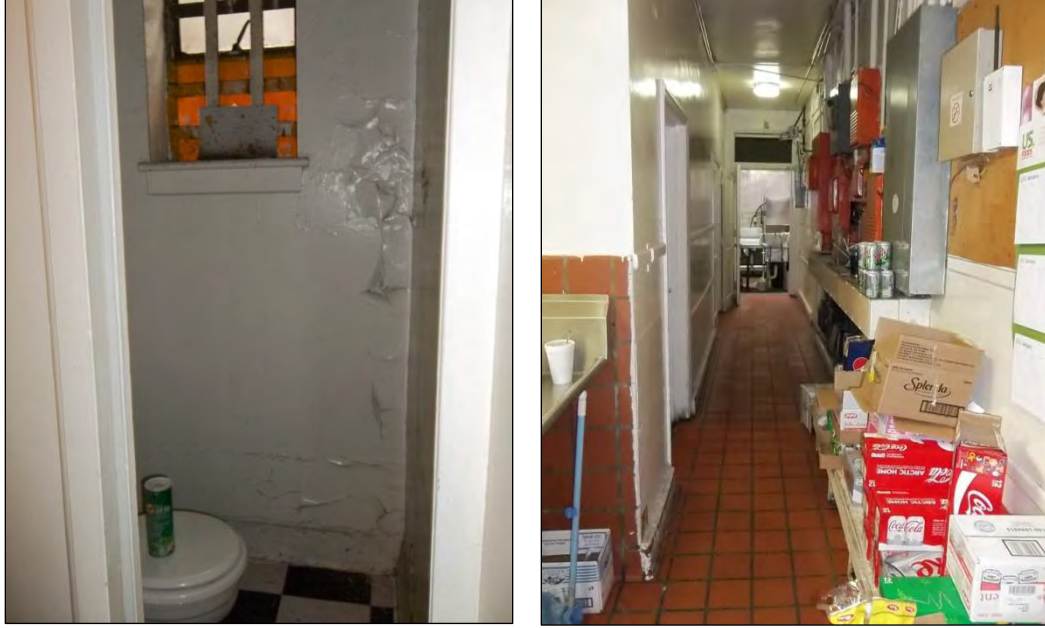
Photo 16: At Left, View of Staff Restroom, and at Right, View of Hallway Leading from Kitchen to Storage Spaces and Terminating at West-Side Kitchen Addition.

Modifications in the private service spaces of the building include the kitchen floor and some walls that have been covered by terra-cotta-colored tile. Some kitchen equipment appears to be of recent vintage, and the staff restrooms are in fair to poor physical condition (Photo 16, p. 33). Taken on the whole, work areas within the original footprint of the building remain relatively intact. The lean-to addition to the rear of the building has been modified over time to suit contemporary refrigeration and food storage regulations.

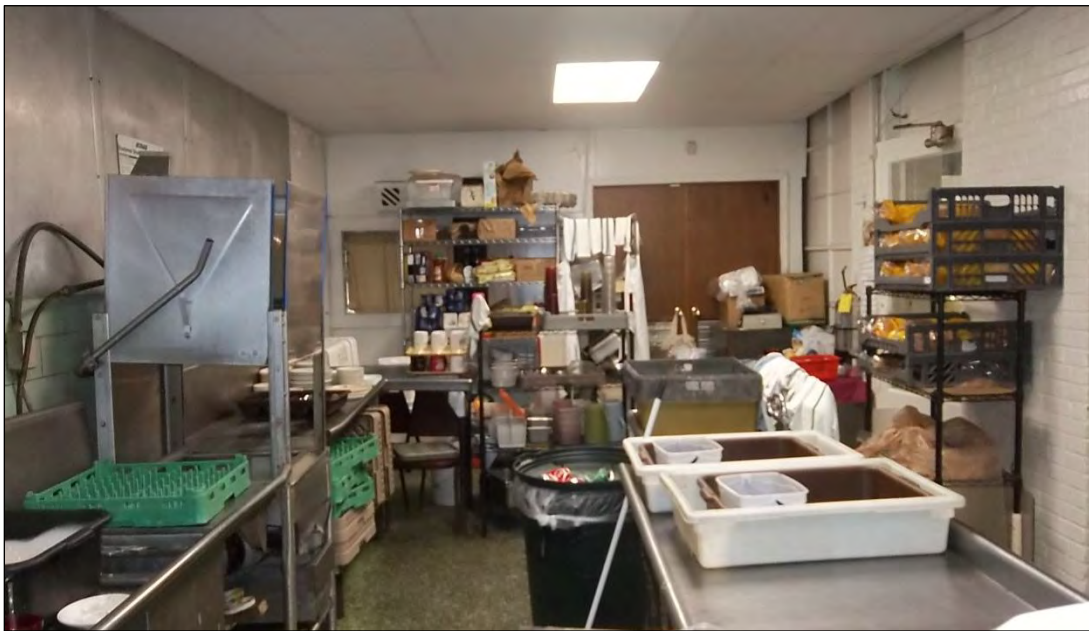
Photo 17: Interior View of Added Kitchen Space, Looking North.

The additional kitchen space added on to the west side of the building in the early 1950s appears to have been intended for improving curb-side service. A single-leaf doorway allowed the person at the grill behind the counter in the main dining area to cross over into the added kitchen area, while a large “order up” window (now covered by curtains in the small, west-side dining room) and double-leaf doors permitted a quick form of egress, giving wait-staff easy access to both the food and patrons (Photo 17 and Photo 18, p. 34).

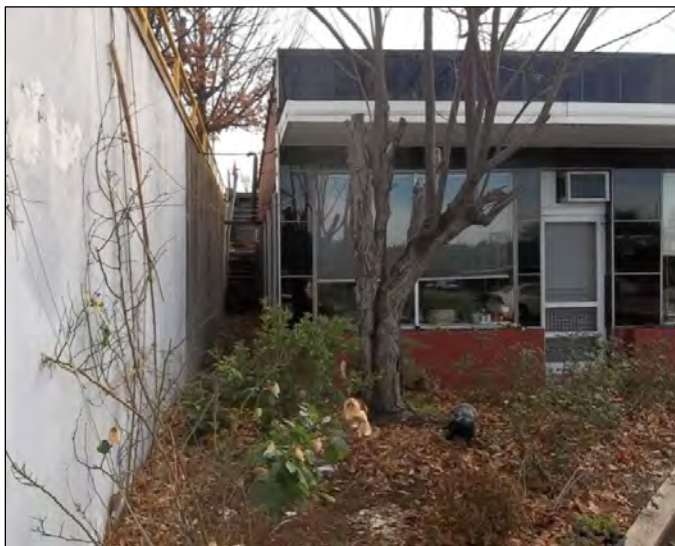
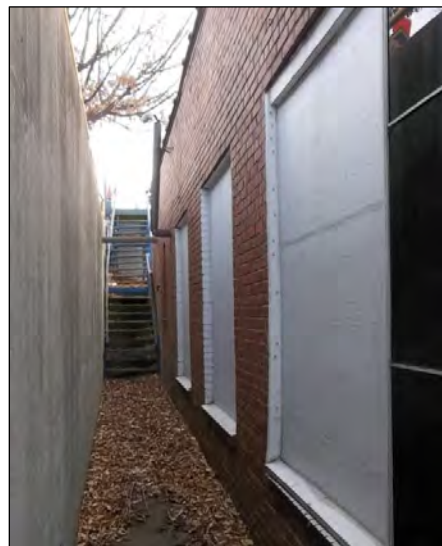
Photo 19: Views of Retaining Wall and Stairway to Capital Boulevard, Looking South.

Perhaps more so than the building, the setting surrounding Finch's restaurant has changed dramatically since 1948. Construction of Capital (Downtown) Boulevard required the demolition of numerous dwellings along what used to be N. Dawson Street and altered the layout of neighboring streets. The realignment of the intersection between W. Peace and N. Dawson Street cost Finch's the enhanced visibility provided by the corner lot, and substantially restricted the passage of automobiles through the parcel. The new roadway also necessitated the construction of a large retaining wall along the east side of Finch's lot, as well as the installation of metal stairs at the southeast corner of the property to provide pedestrian access from the new elevated sidewalk (Photo 19).

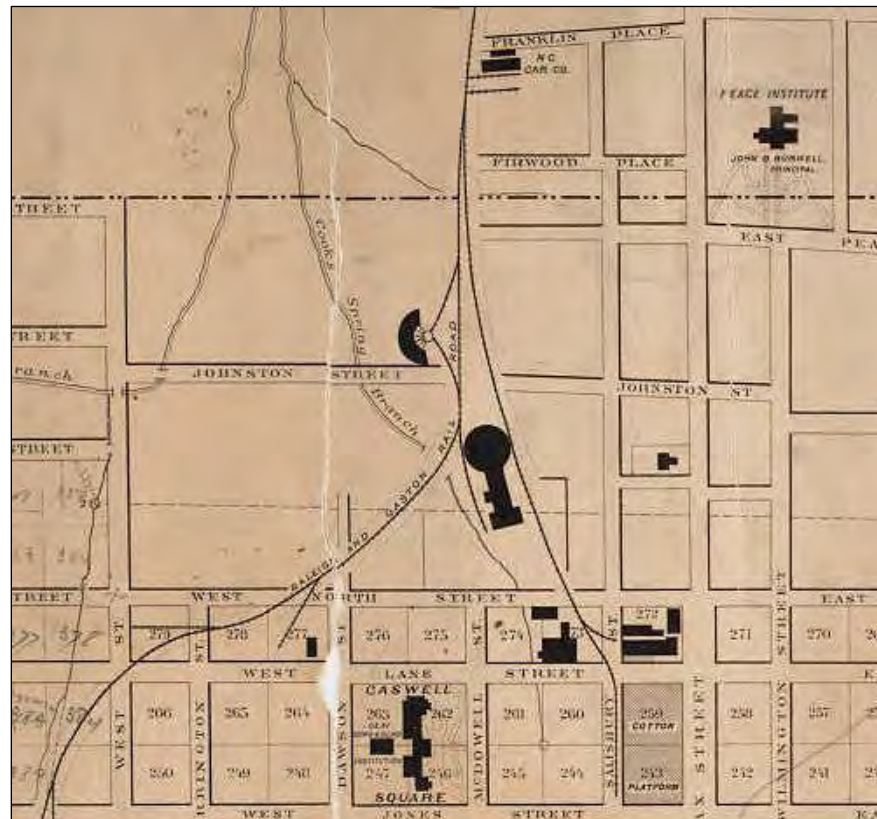
Figure 13: Detail of RGRR Roundhouses from “Shaffer’s Outline Map of the City of Raleigh, N. C.” (Shaffer 1888).

The first RGRR roundhouse and machine shops were constructed in the early 1860s, but not finished until 1870 (CRG 1990:2). Shortly after this complex was completed, the company outgrew it. The circa-1870 roundhouse became too small for the latest engines, so the RGRR company began construction on a second engine house in 1886 (CRG 1990:15). This second model was also referred to as a “roundhouse,” but was actually half of a roundhouse, functioning more like an open shed than the original, enclosed building. The new building, located on the west side of the racks just north of Johnson Street, contained 18 engine stalls, and was “...constructed with an iron and wood front, brick rear wall, iron rafters, [and] slate roof...” (CRG 1990:15). Both roundhouses are detailed in Shaffer’s 1888 map of Raleigh (Figure 13). Each building also appears on the Sanborn maps of 1888 and 1914, but by 1950, only the half-roundhouse remained standing.

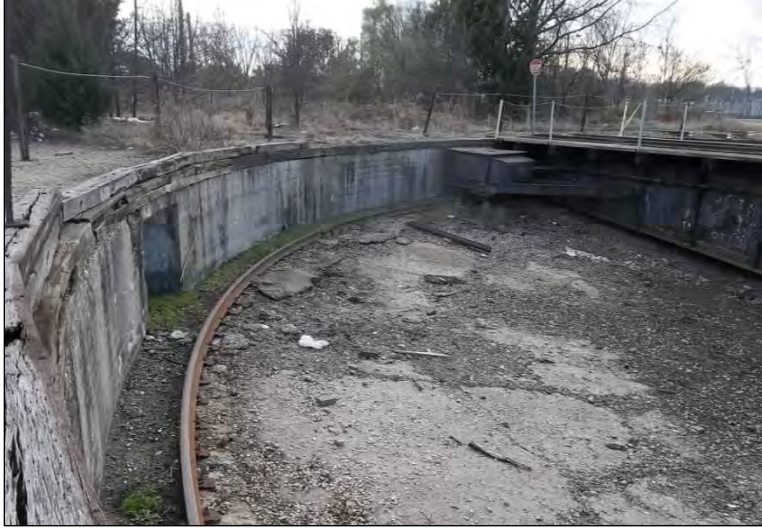
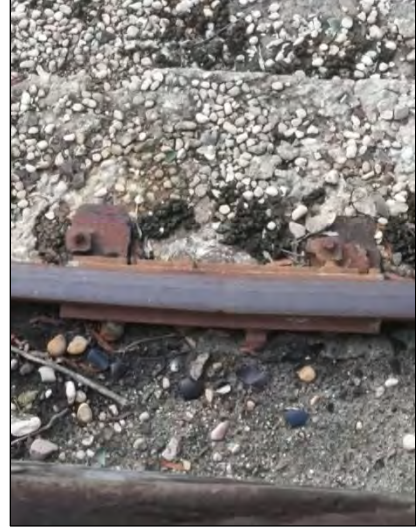
Photo 24: At Left, Turntable Pit and Track, Looking Southwest; At Right, Detail of Track.

Composed primarily of riveted steel, the turntable is roughly 100-feet long and about 10-feet wide (Photo 23). The circular pit around it is constructed of poured concrete. Wood-form marks are visible on the side walls and suggest that they are an original feature. The concrete floor of the pit is sloped towards the center and may have been modified over time. Around the edge of the pit floor is a single steel track that guides the table as it turns (Photo 24, p. 44). At the time of its construction, the turntable was moved by an electrified rack and pinion system, but is today operated by a gas-power engine that is controlled from the small, gable-roofed, metal motor house (Photo 25, p. 44). Old electrical cables remain visible at the top of the structure. The wooden deck of the table is in good condition, and is likely a replacement. Steel elements of the structure are showing signs of deterioration though it remains in use.

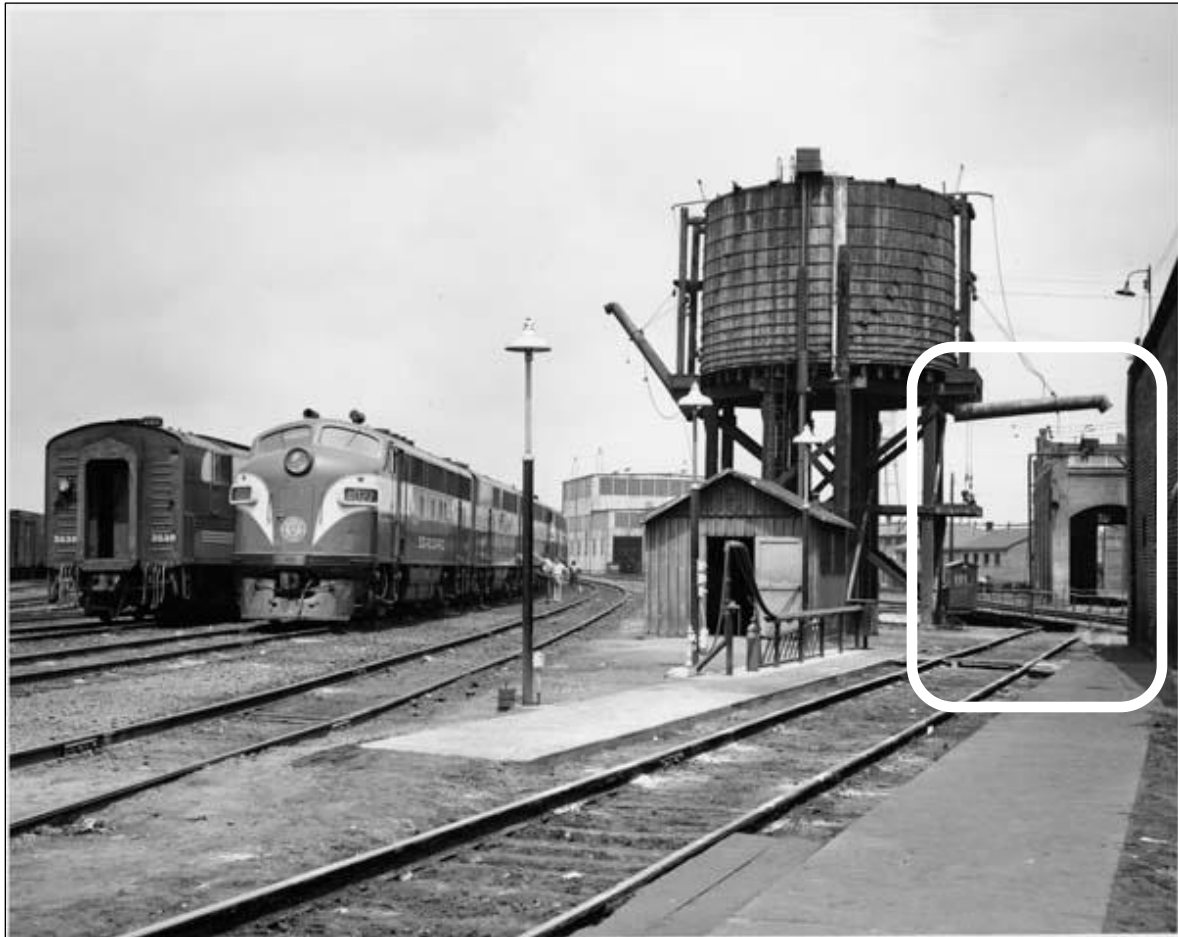
Photo 25: “In railroad yard, water tower in foreground; shop building in background...” (Lewis P. Watson Collection, Olivia Raney Local History Library). The east end of the roundhouse, the turntable, and its motor house are visible in this circa-1940s image.

The colored Sanborn map of 1914 illustrates the architecture of the second, circa-1886 roundhouse at its largest and includes a turntable that measures approximately 80 feet in length (Figure 14, p. 42). An archaeological investigation into the original roundhouse reports that both structures were routinely damaged by fire. However, the half-roundhouse appears to have survived the longest, and is visible in aerial photographs as late as 1959 (Photo 22, p. 42).

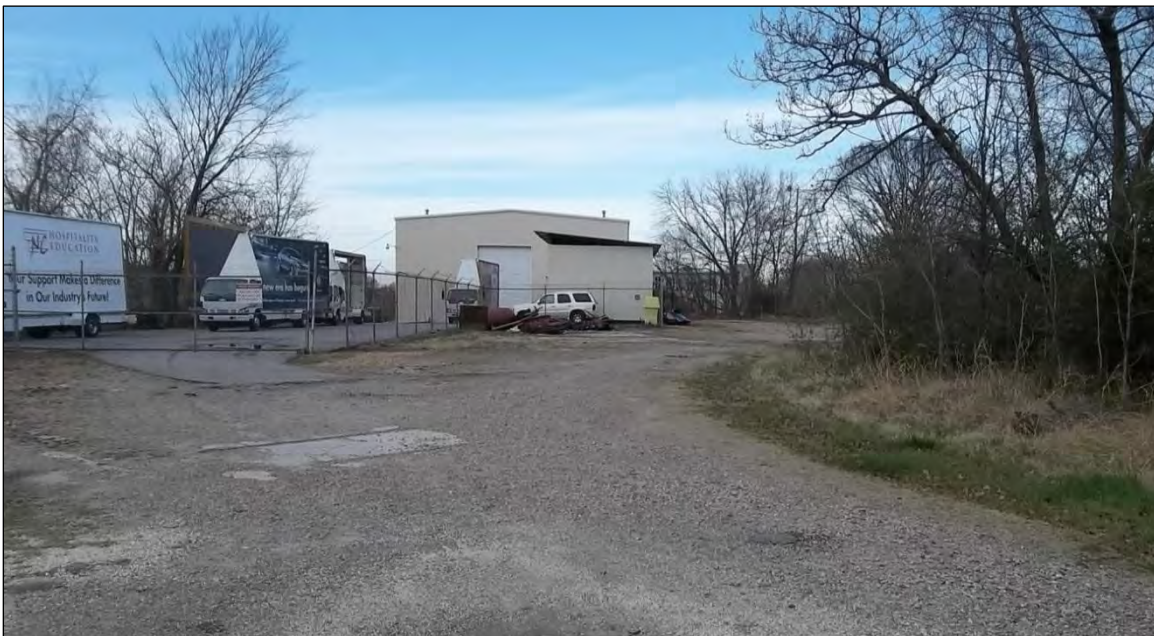
Photo 27: View of Late-Twentieth Century Storage Buildings and Fence, Looking North from a Point Near the Southwest Corner of the Property. Note semi-circular shape of vegetation that appears to conform to the old roundhouse foundation.

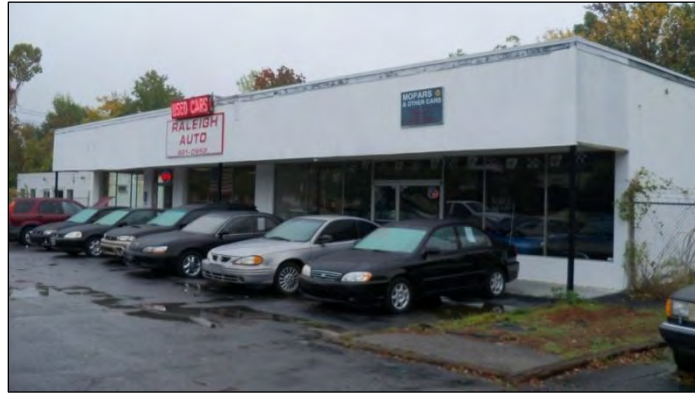
The resource at 1302–1304 Capital Boulevard is a circa-1962, one-story, two-bay, vernacular commercial building. It appears to have been originally designed as an automobile showroom. At 1302, a stretcher-bonded brick veneer adds interest to the façade, or west elevation. The entire building is covered by a flat roof surrounded by a parapet wall with metal coping. Constructed in the mid-twentieth century, the resource remains in fair condition, but it does not exhibit high artistic value as the work of a master, nor is it an outstanding example of this particular architectural style. Moderate modifications over time have diminished its historic integrity of design, materials, workmanship, feeling and association. It was determined to be not eligible for individual listing on the NRHP under Criteria A–C. It has not been evaluated under Criterion D.

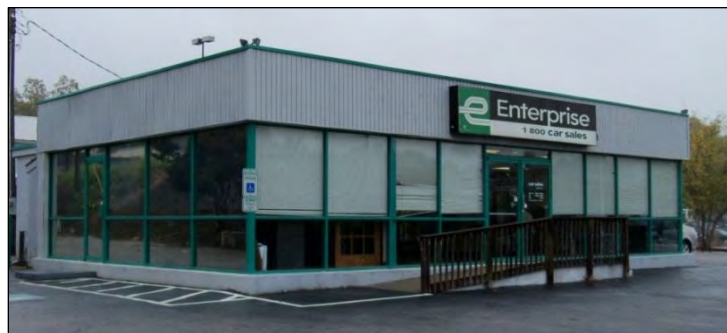
The resource at 1301 Capital Boulevard is a circa-1957, one-story, one-bay, commercial building with International and vernacular styling. The north, east, and south elevations are marked by a ribbon of fixed, metal-framed, display windows which appear to be recent replacements. A flat roof surrounded by a parapet wall with metal coping covers much of the building. At the rear, or west elevation, a large, concrete-block addition is flanked by small, lean-to, frame additions clad in T1-11 siding. A covered walkway leads from the rear to a side-gabled garage and workshop, situated west of the main building.

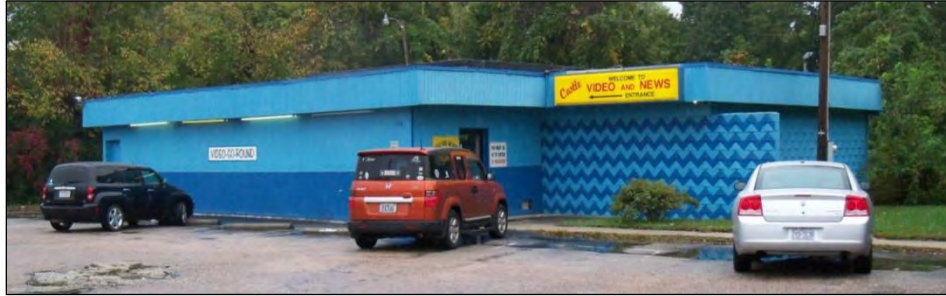
The resource at 1210 Capital Boulevard is a circa-1959, one-story, flat-roof, commercial building with Modern styling. It is primarily clad in a decorative concrete block, but a large part of the façade is covered by T1-11 siding, obscuring most fenestration. Alterations to the façade appear to be a recent modification. The resource was previously occupied by a drive-in restaurant, but is currently occupied by "Castle Video and News." Though it remains in fair condition, the building does not exhibit high artistic value as the work of a master, nor is it an outstanding example of this particular architectural style. Substantial modifications have diminished its historic integrity of design, materials, workmanship, feeling and association. It was determined to be not eligible for individual listing on the NRHP under Criteria A–C. It has not been evaluated under Criterion D.

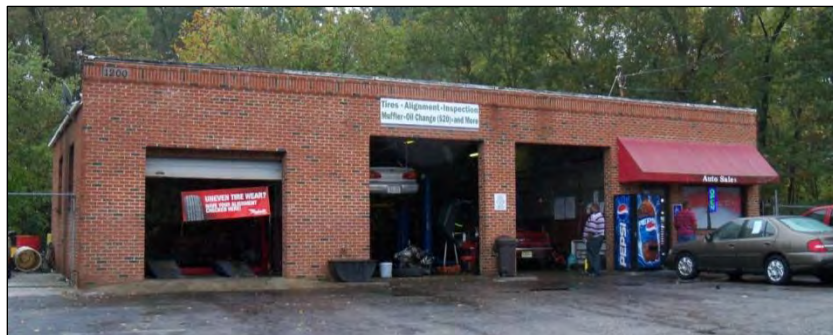
The resource at 1200 Capital Boulevard is a circa-1958, one-story, four-bay, vernacular commercial building that was designed as a gas and service station. Although the gas pumps have been removed, the property presently functions as a service station and sales lot, operated by a company called Global Autos. The station may have originally contained three bays, as the northernmost bay appears to be a later addition. The brick veneer may have been applied to the

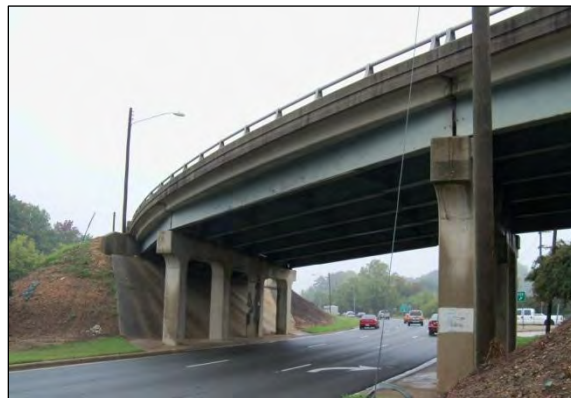
The Fairview Road bridge over Capital Boulevard is a continuous, steel-stringer bridge that carries two lanes of traffic. The structure was erected in the late-1950s during the construction of Capital Boulevard. Although it remains in fair condition, this bridge is not known to be an outstanding example of this particular type of bridge, nor is it directly associated with an important event or individual. It was determined to be not eligible for the NRHP under Criteria A–C as an individual resource. It has not been evaluated under Criterion D.

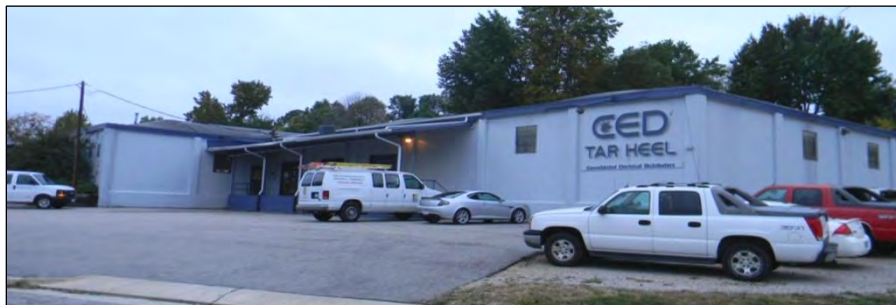
The resource at 1125 Capital Boulevard is a circa-1946, one-story, 12-bay, industrial warehouse. During the current survey it was found that this resource retains the same architectural features and historical significance detailed in previous investigations. This resource was built in the mid-

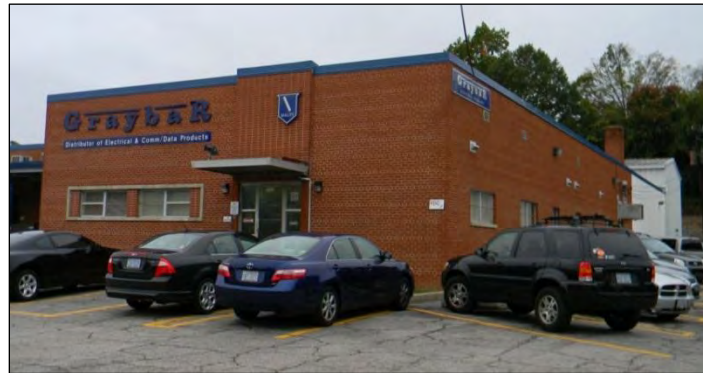
The Graybar Company Building at 1113 Capital Boulevard is a circa-1959, one-story, brick, Modernist warehouse and office building. During the current survey it was found that this resource retains the same architectural features and historical significance detailed in previous investigations. The resource was previously determined not eligible as a result of “Phase I Architectural Resources Survey on the N-S Line Alternative, Southeast High Speed Rail, Raleigh, Wake County, ER03-1507” (MAA 2009a) (HPO response dated May 7, 2009), and remains not eligible for the NRHP.

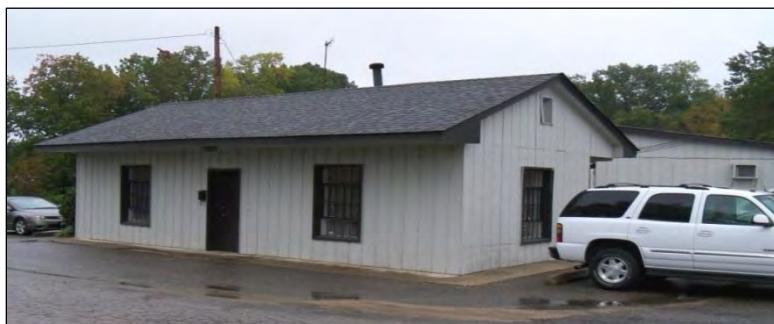
The resource at 110 Old Williamson Road is a circa-1950, office and warehouse complex. The primary resource is a one-story, three-bay, side-gabled office building, and is associated with a warehouse and other storage buildings. A covered walkway connects this addition with a long, shed-roof storage building that is also clad in T1-11 siding. This shed appears to have been constructed shortly after the primary resource. Additional non-historic storage buildings are situated on the property, and do not appear to function in relation to this resource.

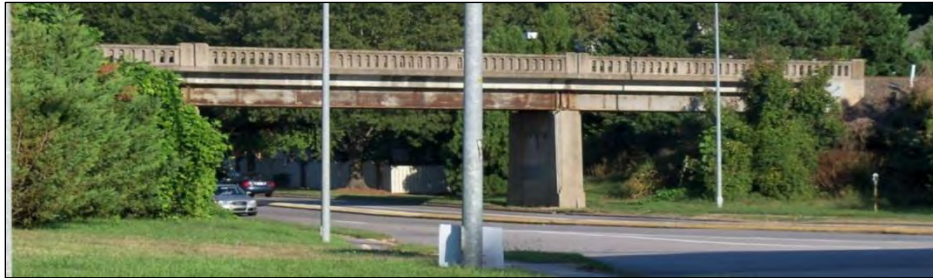
The railroad bridge over Wade Avenue, built in the mid-1950s, is one of several similar structures associated with the Norfolk Southern line in the City of Raleigh. During the current survey, it was found that this bridge retains the same architectural features and historical significance documented in previous investigations. This resource was determined not eligible as part of the Norfolk Southern Railway Bridges examined in "Phase II Architectural Resources Survey Report for Norfolk-Southern Line in Raleigh & Areas Outside the Original Petersburg/Raleigh APE, SEHSR, P-3819, Multi-County, ER 03-1507" (MAA 2009b) (HPO response dated September 8, 2009) , and remains not eligible for the NRHP.

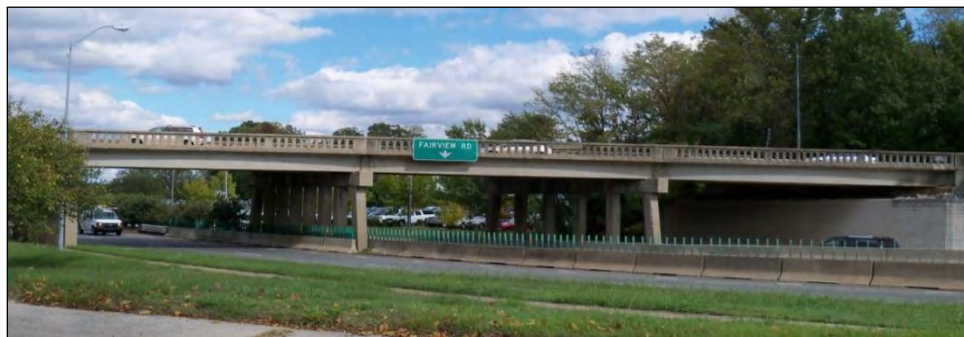
The Wade Avenue bridge is a circa-1954, tee-beam, reinforced-concrete bridge which carries two lanes of traffic over Capital Boulevard in the City of Raleigh (NCDOT Historic Bridge Inventory No. 910213). It was built in the mid-twentieth century during the construction of Capital Boulevard and remains in fair condition. In 2003, the bridge was surveyed during the North Carolina Historic Bridge Inventory, and recommended not eligible for the NRHP at that time. The resource is not known to be an outstanding example of this particular type of bridge, nor is it

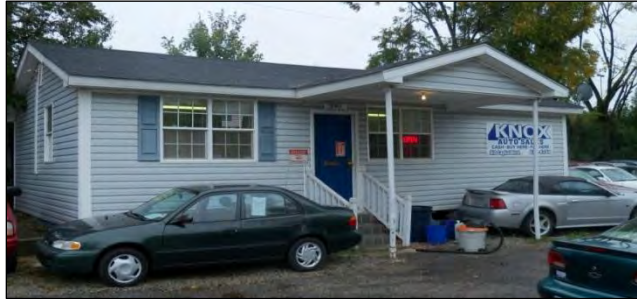
The resource at 910 Capital Boulevard is a circa-1958, one-story, three-bay, commercial building with vernacular styling. The building has a continuous, concrete-block foundation and a frame structural system that is currently clad in vinyl siding. It is covered by a side-gabled roof with a front-gabled porch, supported by slender metal posts, projecting from the center of the façade, or west elevation.

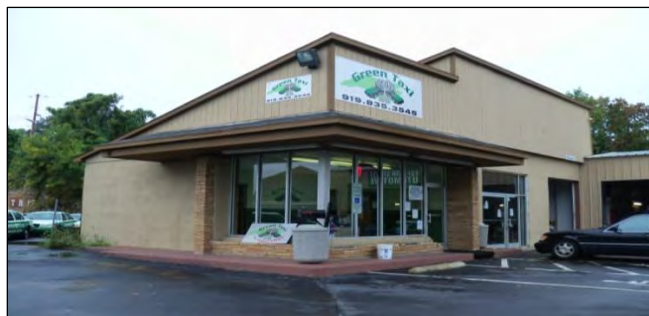
The resource at 909 Capital Boulevard is a circa-1955, one-story, three-bay, automobile service station with vernacular styling. Although the gas pumps have been removed, the property presently functions as a service station and sales lot, operated by the Green Taxi company. Historically covered by a flat roof, the building is presently topped by a shed roof sheathed in asphalt shingles. A one-story, three-bay, side-gabled addition was recently made to the northwest corner of the building, providing additional service space.

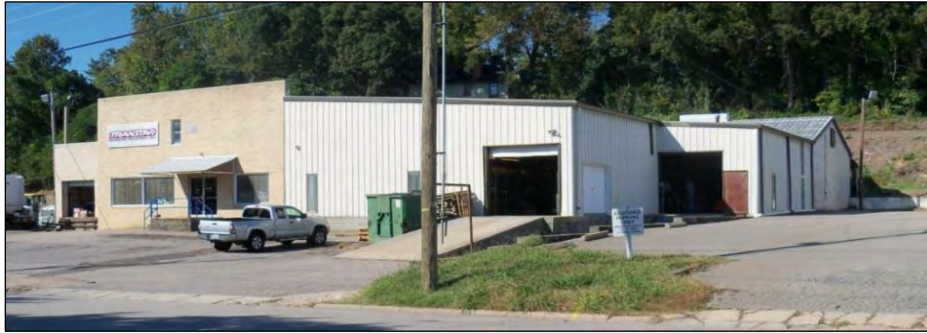
The resource at 1029 N. West Street is a circa-1962, one-and-a-half-story, three-bay, vernacular commercial building with several shed additions. A brick parapet facade covers a front-gabled roof, sheathed in standing-seam metal, along the east elevation. Constructed in the mid-twentieth century, the resource is in fair condition, but does not exhibit high artistic value as the work of a master, nor is it an outstanding example of a particular architectural style. Modifications over time have diminished its historic integrity. It was determined to be not eligible for individual listing on the NRHP under Criteria A–C. It has not been evaluated under Criterion D.

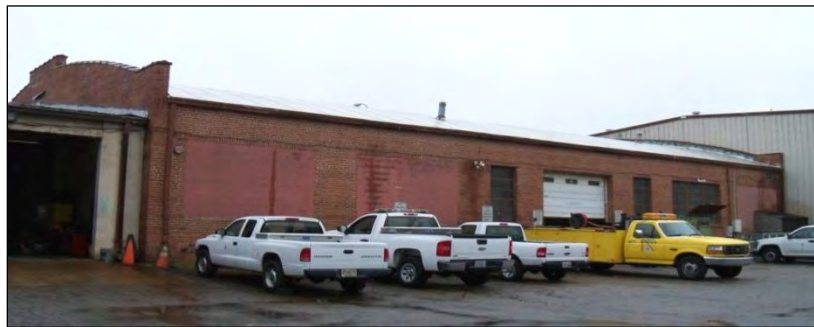
The resource at 1014 N. West Street is a warehouse complex that appears to date from the early 1940s. The oldest section of the complex is a one-story, five-bay, vernacular warehouse, with later additions dating as late as the 1980s. The main office building is located at 1027 N. West Street. On the whole, the complex is in fair condition, but it does not exhibit high artistic value as the work of a master, nor is it an outstanding example of any particular architectural style. Substantial modifications to each of the buildings over time have diminished the historic integrity of this property. It was determined to be not eligible for individual listing on the NRHP under Criteria A–C. It has not been evaluated under Criterion D.

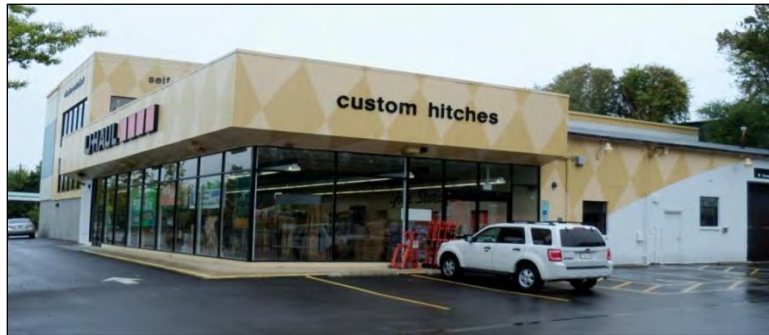
The resource at 720 Capital Boulevard is a circa-1961, one-story, two-bay, warehouse that is hidden behind with vernacular styling. Hidden behind a contemporary façade is a front-gabled masonry structure with multi-light, steel-framed windows. A three-bay, shed-roof addition extends from the southeast corner of the building. Originally constructed in the mid-twentieth century, the resource is in good condition, but does not exhibit high artistic value as the work of a master, nor is it an outstanding example of a particular architectural style. Substantial modifications to the façade and additions to the building over time have significantly diminished its historic integrity. It was determined to be not eligible for individual listing on the NRHP under Criteria A–C. It has not been evaluated under Criterion D.

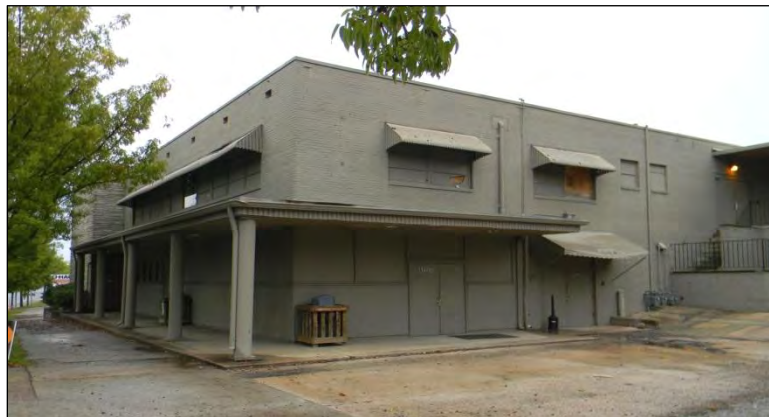
The resource at 622 Capital Boulevard is a circa-1955, two-story, three-bay, Modern-era commercial building and sprawling warehouse complex. The primary massing is primarily clad in brick and covered by a flat roof, with a projecting bay at the northwest corner that is clad in an ashlar stone veneer. This section of the building appears to be vacant. A long, one-story wing extends from the northeast corner, and its north end is also clad in an ashlar stone veneer. Several additions are visible at the rear. A long, flat-roof storage building is located east of the primary resource.
