SUBJECT: Intensive-Level Historic Architectural Analysis, Replace Bridges 227 and 213 on US 70 (Capital Boulevard) over Peace Street and Wade Avenue, B-5121 and B-5317, Raleigh, Wake County, ER 08-2607 and ER 11-0310

**INTENSIVE-LEVEL HISTORIC ARCHITECTURAL ANALYSIS
B-5121: REPLACE BRIDGE NO. 227 ON US 70 (CAPITAL
BOULEVARD) OVER PEACE STREET IN RALEIGH, WAKE
COUNTY, WBS# 42263, FEDERAL AID # BRNHS-0070(119)**

**B-5317: REPLACE BRIDGE NO. 213 ON WADE AVENUE OVER US
70 (CAPITAL BOULEVARD) IN RALEIGH, WAKE COUNTY,
WBS# 46031, FEDERAL AID # BRNHS-0070(149)**

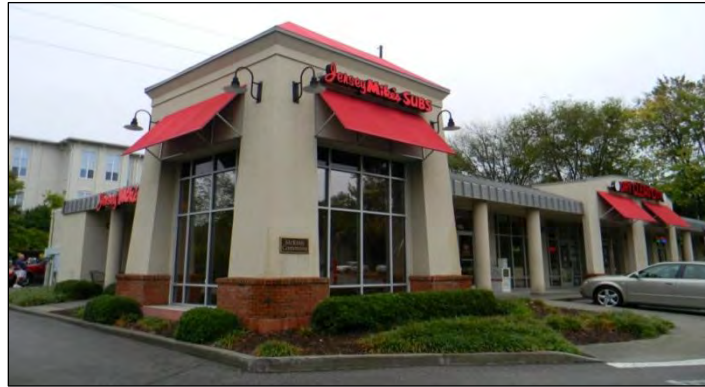
The resource at 200 W. Peace Street is a circa-1960, one-story, six-bay, commercial building with contemporary vernacular styling. Recent modifications to the façade hide a flat-roof, Modern-era masonry structure. Although the resource is in good condition, substantial alterations to the façade have significantly diminished its historic integrity. It was determined to be not eligible for individual listing on the NRHP under Criteria A–C. It has not been evaluated under Criterion D.

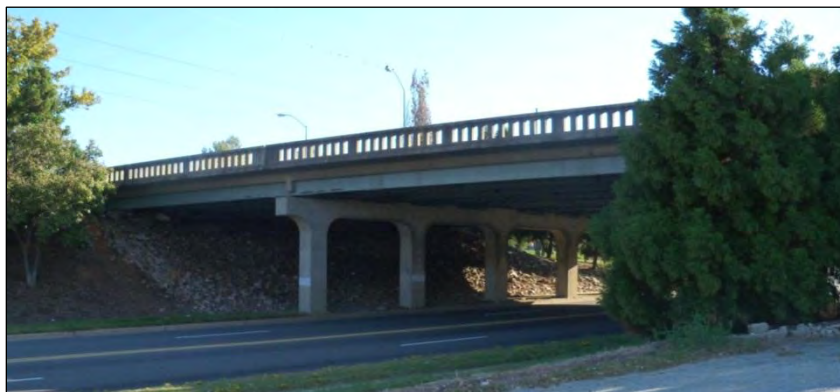
The Capital Boulevard Bridge over W. Peace Street is a continuous, steel-stringer bridge that carries four lanes of traffic. The structure was erected in 1953 during the construction of Capital Boulevard. This bridge was surveyed during the North Carolina Historic Bridge Inventory in 2003 and recommended not eligible for the NRHP at that time. As the resource is not known to be an outstanding example of this particular type of bridge, nor is it directly associated with an

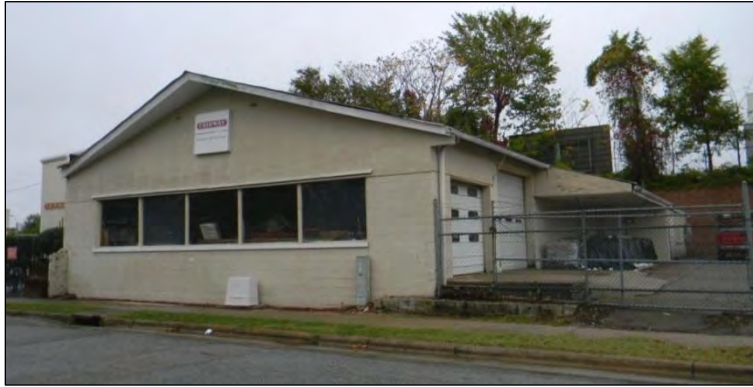
The resource at 506 Capital Boulevard is a circa-1959, one-story, one-bay, Modern-era commercial building. It is covered by a front-gabled roof sheathed in corrugated metal, and the façade, or west elevation, is marked by a row of fixed, display windows. Although, the resource is in fair condition, it does not exhibit high artistic value as the work of a master, nor is it an outstanding example of a particular architectural style. Modifications over time have diminished its historic integrity. It was determined to be not eligible for individual listing on the NRHP under Criteria A–C. It has not been evaluated under Criterion D.

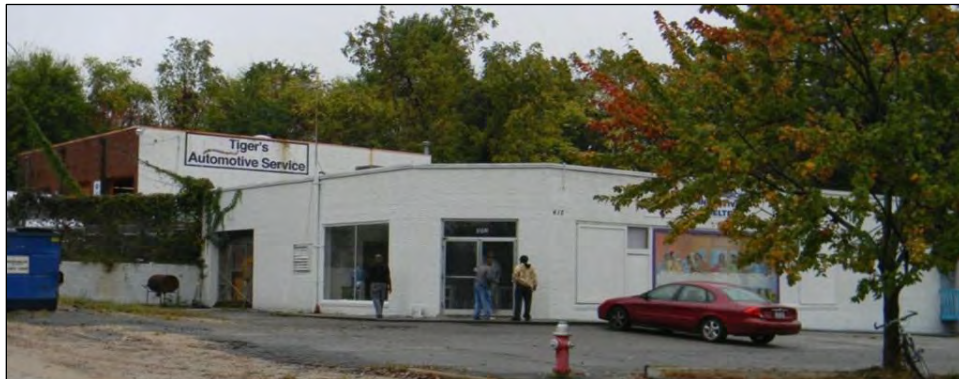
The resource at 412 Capital Boulevard is a circa-1955, one-story, three-bay, Modern-era commercial building with contemporary vernacular styling. It is covered by a flat roof with a double-leaf corner entry facing the intersection of W. Johnson Street and the Capital Boulevard service road. Fenestration along the west elevation has been heavily modified. Although the resource is in fair condition, it does not exhibit high artistic value as the work of a master, nor is it an outstanding example of a particular architectural style. Substantial modifications to the façade

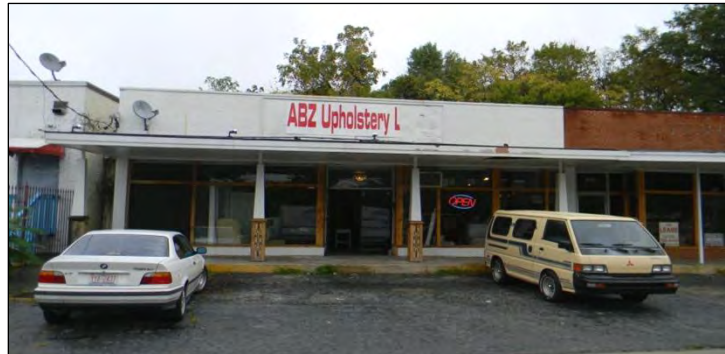
The resource at 406 Capital Boulevard is a circa-1960, one-story, three-bay, Modern-era commercial building with vernacular styling. The two northern storefronts have been recently replaced, while the southern bay is boarded over and appears to be vacant. The building is covered by a flat roof surrounded by a parapet wall with metal coping, and the façade is lined by a flat, metal awning supported by slender metal posts. The resource is in fair condition, but does not exhibit high artistic value as the work of a master, nor is it an outstanding example of a particular architectural style. Modifications to the façade have significantly diminished its historic integrity. It was determined to be not eligible for individual listing on the NRHP under Criteria A–C. It has not been evaluated under Criterion D.

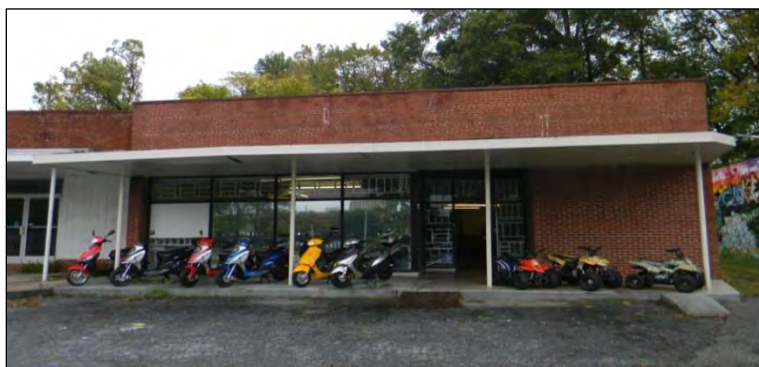
The resource at 404 Capital Boulevard is a circa-1957, one-story, one-bay, Modern-era commercial building with contemporary vernacular styling. The storefront appears to be a replacement and is filled with tinted windows. The building is covered by a flat roof surrounded by a parapet wall with metal coping, and the façade is lined by a flat, metal awning supported by slender metal posts. The resource is in fair condition, but does not exhibit high artistic value as the work of a master, nor is it an outstanding example of a particular architectural style.

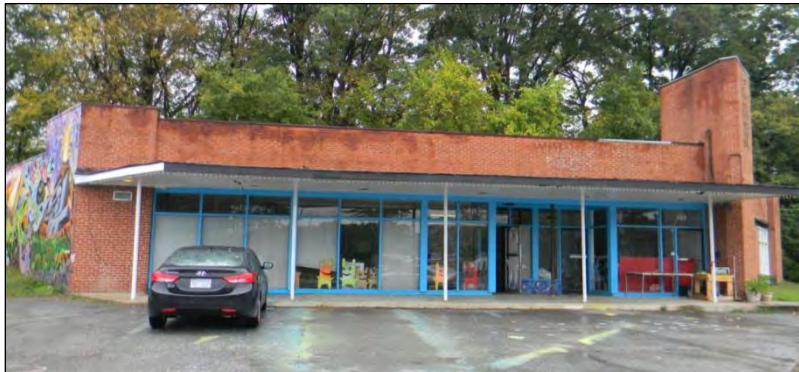
The resource at 400 Capital Boulevard is a circa-1958, one-story, two-bay, commercial building with elements of Modern styling. The façade is angled to face the Capital Boulevard service road and anchored by a large brick massing, projecting above the roofline, at the northwest corner. The storefront is likely a replacement and a porch or awning has been removed from the west elevation. The building is covered by a flat roof surrounded by a parapet wall, and the façade is lined by a flat, metal awning supported by slender metal posts. The resource is in fair condition, but does not exhibit high artistic value as the work of a master, nor is it an outstanding example of a particular architectural style. Modifications to the façade have significantly diminished its historic integrity. It was determined to be not eligible for individual listing on the NRHP under Criteria A–C. It has not been evaluated under Criterion D.

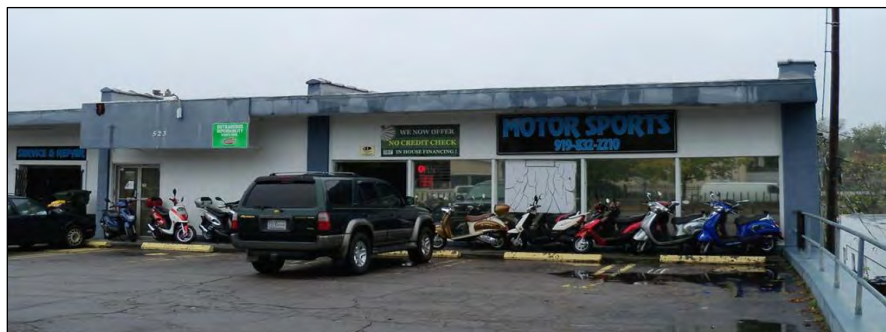
The resource at 523 Capital Boulevard is a circa-1955, two-story, three-bay, Modern-era commercial building with vernacular styling. The upper story opens onto street level with Capital Boulevard, while the lower story contains a separate business that faces west at the rear of the building. Substantial modifications have significantly diminished its historic integrity of this

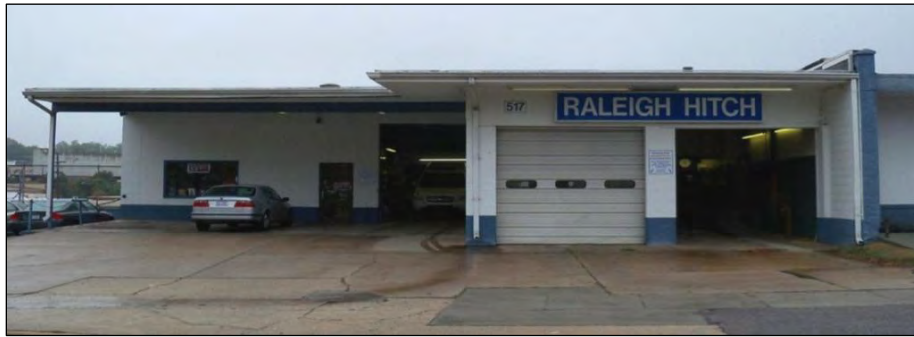
The resource at 517 Capital Boulevard is a circa-1956, two-story, four-bay, concrete-block commercial building with vernacular styling. It is covered by a low-pitched shed roof and directly abuts the resource at 523 Capital Boulevard. The upper story opens onto street level with Capital Boulevard, while the lower story faces west at the rear of the building. It is in fair condition, and does not exhibit high artistic value as the work of a master, nor is it an outstanding example of a particular architectural style. Substantial modifications have diminished its historic integrity. It was determined to be not eligible for individual listing on the NRHP under Criteria A–C. It has not been evaluated under Criterion D.

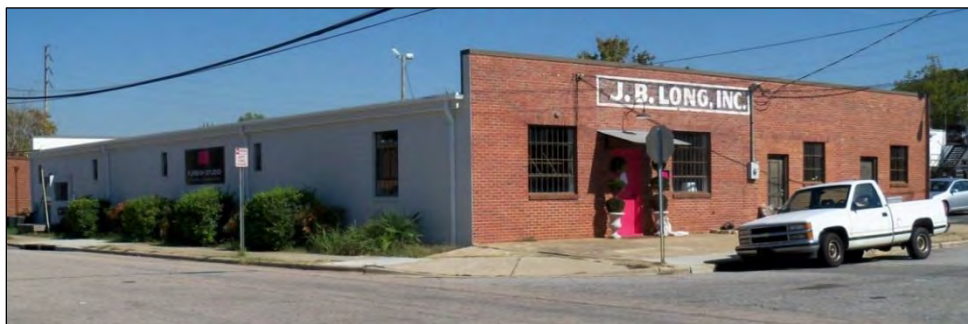
The resource at 312 W. Johnson Street is a circa-1951, one-story, three-bay, warehouse and commercial building with vernacular styling. It is located at the corner of W. Johnson and N. Harrington Street. The building is covered by a low-pitched roof with brick parapet walls at both the north and south elevations. It is in fair condition, but does not exhibit high artistic value as the work of a master, nor is it an outstanding example of a particular architectural style. Moderate modifications have diminished its historic integrity. It was determined to be not eligible for individual listing on the NRHP under Criteria A–C. It has not been evaluated under Criterion D.

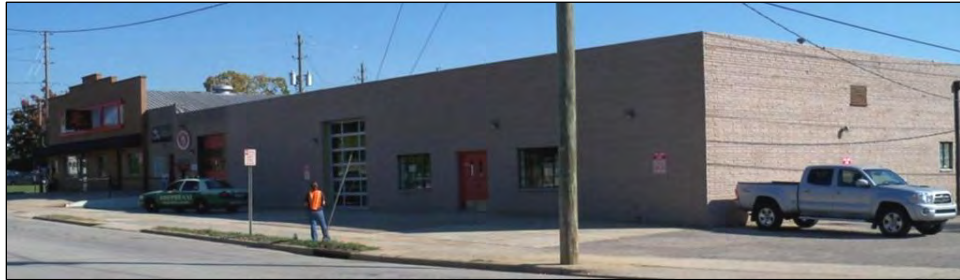
The commercial buildings at 600-620 N. West Street are located at the southeast corner of the intersection between N. West and N. Harrington Street. This group of buildings is surrounded by asphalt parking areas, driveways, and sidewalks. During the current survey, it was found that the majority of the commercial buildings on this block retain the same architectural features and historical significance documented in previous investigations (particularly 600 and 620 N. West Street). Local tax records date the property to 1957, but a portion of the building, addressed at 614 N. West Street and containing one-and-a-half stories, may be an earlier structure. The foundation at 614 is likely continuous concrete, with a concrete-block structural system that is clad in a stretcher-bonded brick veneer along the primary façade (west) and north elevations. Its front-gabled roof is sheathed in standing-seam metal with a stepped parapet wall at both the east and west elevations. Fenestration at the first floor of 614 is filled largely by contemporary, fixed, single-pane, metal-framed display windows and replacement, single-leaf metal doors. At the second floor, tripartite, multi-light, steel-framed casement windows are visible, though much of the fenestration is covered by corrugated metal. This section of the building is currently occupied by the "Southland Ballroom."

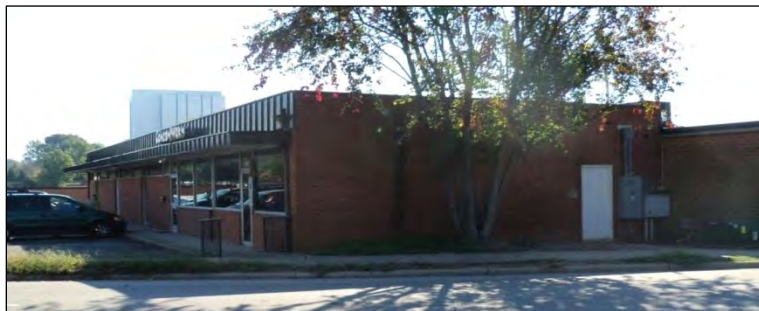
The resource at 435 W. Peace Street is a circa-1960, one-story, five-bay, commercial building with vernacular styling. It is located at the corner of W. Peace and N. West Street. The building is

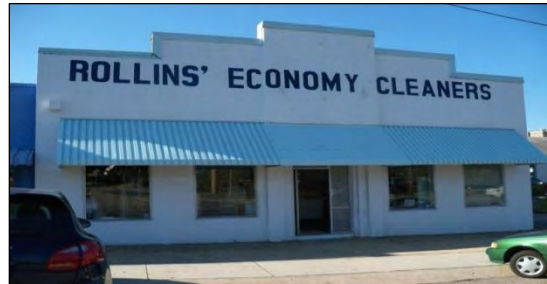
The resource at 407 W. Peace Street is a circa-1940, one-story, five-bay, Moderne-styled commercial building. A previous investigation noted that this resource was originally designed as a laundry, and it continues to serve this purpose today. Rising from the center of the roof is a front-gabled ridgeline that appears to have historically contained windows for ventilation. Today this area is enclosed and covered by vinyl siding. The remainder of the roof is flat and surrounded by a parapet wall with tile coping. The façade is marked by a stepped-parapet wall with metal coping. A metal awning extends across the five bays of the façade, and appears to be a later addition. A one-story outbuilding is associated with this resource. Rollins' Economy Cleaners remains in fair condition, but repeated modifications to the façade over time, particularly replacement windows, stucco cladding and awning additions, as well as the enclosure of the monitor roof, have diminished its historic integrity of design, materials, workmanship, and feeling. It was determined to be not eligible for individual listing on the NRHP under Criteria A–C. It has not been evaluated under Criterion D.

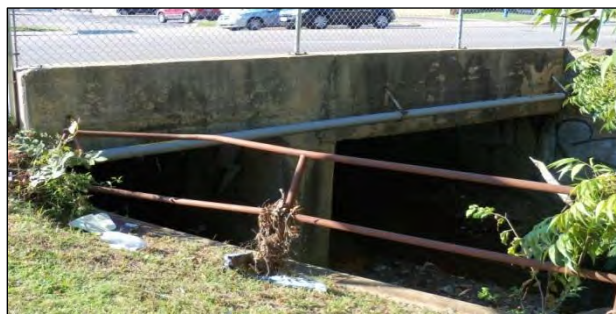
The reinforced, poured-concrete culvert located on the north side of W. Peace Street channels the waters of Pigeon House Branch (also labeled Wolf Branch on some maps) under the roadway.

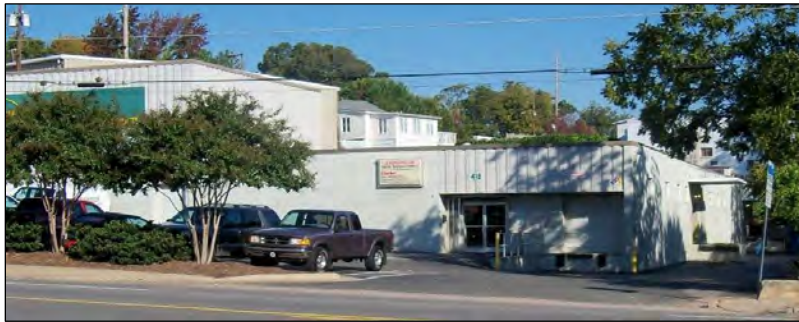
36. WA 7379: James H. Anderson Building;
418 W. Peace Street
PIN: 1704524340

The resource at 418 W. Peace Street is a circa-1947, one-story, two-bay, warehouse with vernacular styling. It is clad in a mixture of brick and corrugated metal. A large two-story addition was made to the west side of the building, and another one-story addition abuts the rear. The building is covered by a flat roof surrounded by a parapet wall with a metal coping. The resource is in fair condition, but does not exhibit high artistic value as the work of a master, nor is it an outstanding example of a particular architectural style. Modifications have diminished its historic integrity. It was determined to be not eligible for individual listing on the NRHP under Criteria A–C. It has not been evaluated under Criterion D.

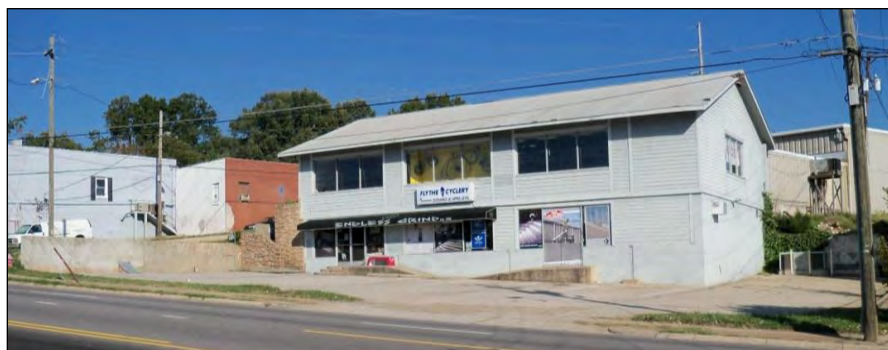
37. WA 7380: Commercial Building
424 W. Peace Street
PIN: 1704523204

The resource at 424 W. Peace Street is a circa-1950, two-story, three-bay, concrete-block commercial building with contemporary vernacular styling. It is located at the corner of W. Peace and N. West Street, with several additions at the rear, or north elevation. The building is covered by a side-gabled roof and predominantly clad in fiberboard siding. The resource is in good condition, but does not exhibit high artistic value as the work of a master, nor is it an outstanding example of a particular architectural style. Modifications to the building over time have

significantly diminished its historic integrity. It was determined to be not eligible for individual listing on the NRHP under Criteria A–C. It has not been evaluated under Criterion D.

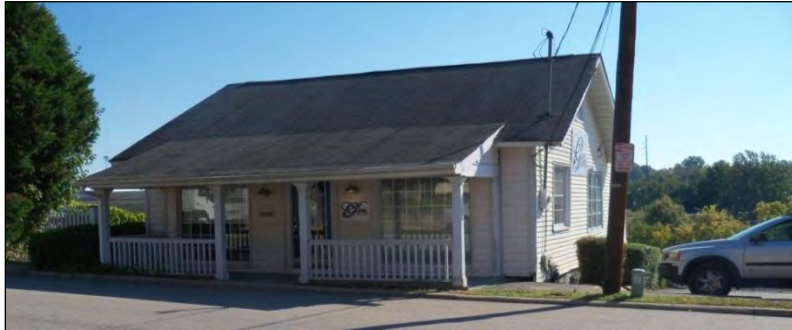
38. WA 7381: House; Glam Lounge
722 N. West Street
PIN: 1704523448

The resource at 722 N. West Street is a circa-1920, one-story, three-bay, residential dwelling that has been converted for commercial use. The frame dwelling is clad in vinyl siding and covered by a side-gable roof. A shed-roof porch, supported by square wood columns, extends across the façade, or west elevation. The resource is in fair condition, but does not exhibit high artistic value as the work of a master, nor is it an outstanding example of a particular architectural style. Modifications such as replacement windows and rear additions have diminished its historic integrity. It was determined to be not eligible for individual listing on the NRHP under Criteria A–C. It has not been evaluated under Criterion D.

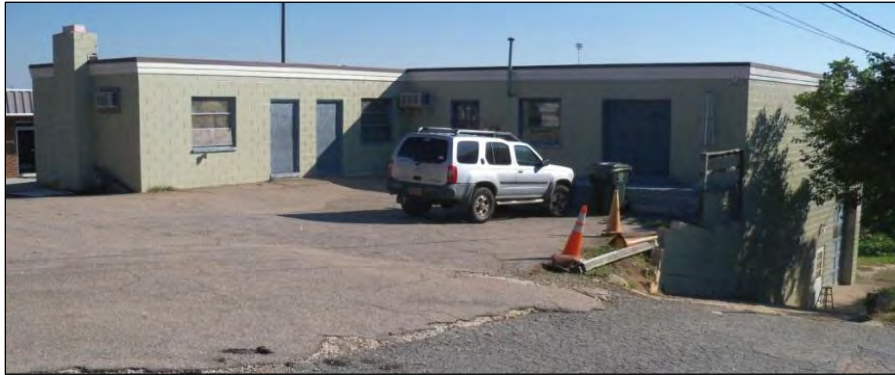
40. WA 7121: Warehouse
804 N. West Street
PIN: 1704524633

The warehouse at 804 N. West Street is a circa-1930, two-story, three-bay, vernacular warehouse. During the current survey, it was found to retain the same architectural features recorded in previous investigations. The property was previously determined not eligible as a result of "Phase I Architectural Resources Survey on the N-S Line Alternative, Southeast High Speed Rail, Raleigh, Wake County, ER03-1507" (MAA 2009a) (HPO response dated May 7, 2009), and remains not eligible for the NRHP.
