North Carolina Department of Natural and Cultural Resources  
State Historic Preservation Office

MEMORANDUM

Subject: Historic Architecture Eligibility Evaluation Report, US 70 Kinston Bypass, R-2553,  
Lenoir County, ER 09-1307

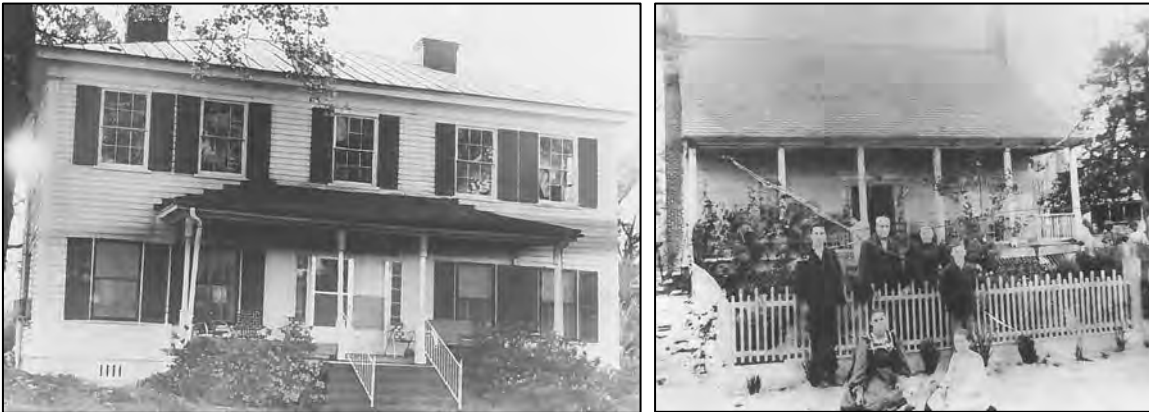
**Figure 4:** At left, ca. 1845 Greek Revival-style Moore-Heath House in 1969, demolished (photographer: Jim Shell); at right, ca. 1860 Greek Revival-style Jerry Sutton House in 1898 (NCDRC) (source of both: Little et al., *Coastal Plain and Fancy*).

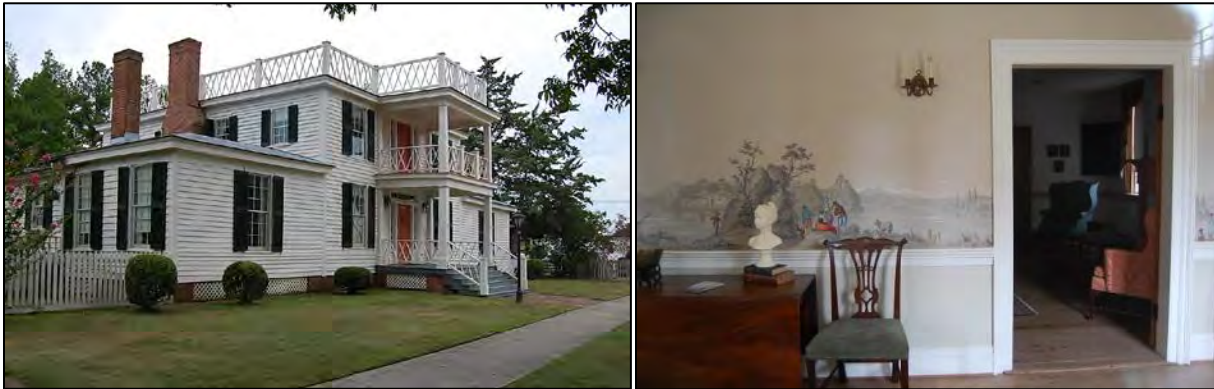
**Figure 5: Peebles House: east side and north front elevations, at left, and Federal-style finish at first floor, at right, 2017.**

The Peebles House (LR-0002), also known as Harmony Hall, was built about 1790 in Kinston with a two-story hall-parlor plan (Department of Archives and History 1971e) (Figure 5 and Figure 6). It was expanded in the late 1840s or 1850s into a center-hall-plan dwelling. Its Georgian and Federal-style features include original and early mantels, moldings, doors, and sash. Its original Flemish-bond chimneys also survive. Notable Greek Revival-style features from its expansion include post-and-lintel mantels, two-panel doors, cornerblocks, a trabeated entry, and a two-tier entrance porch retaining squared columns and X-shaped lattice railings. The

house's one-story wings and rear ell, and its unusual transverse front hall, likely date from this period as well. The Peebles House was listed in the NRHP in 1971.

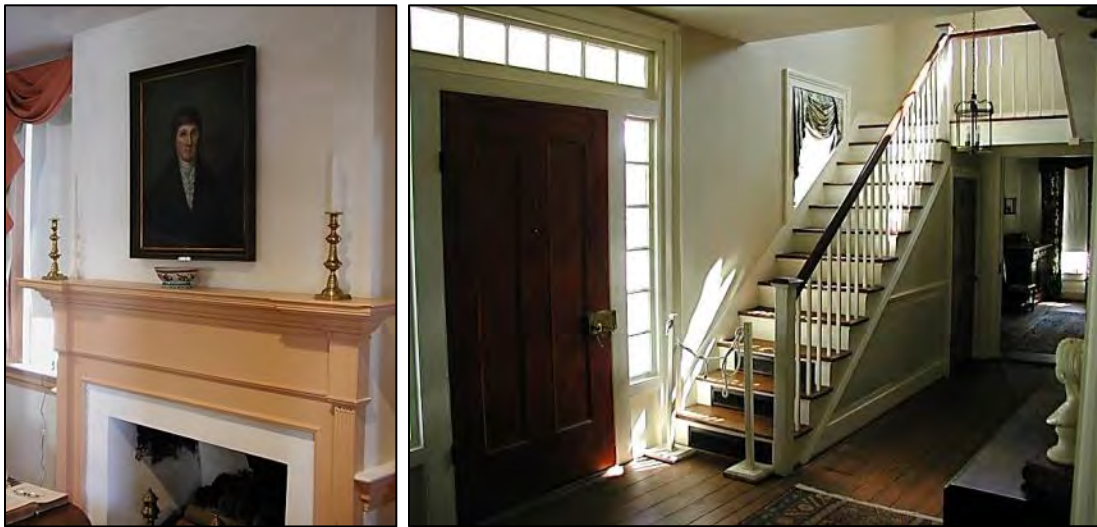
**Figure 6: Peebles House: Federal-style mantel, at left, and Greek Revival-style entry and hall, at right, in 2003 (source: NCDCCR).**

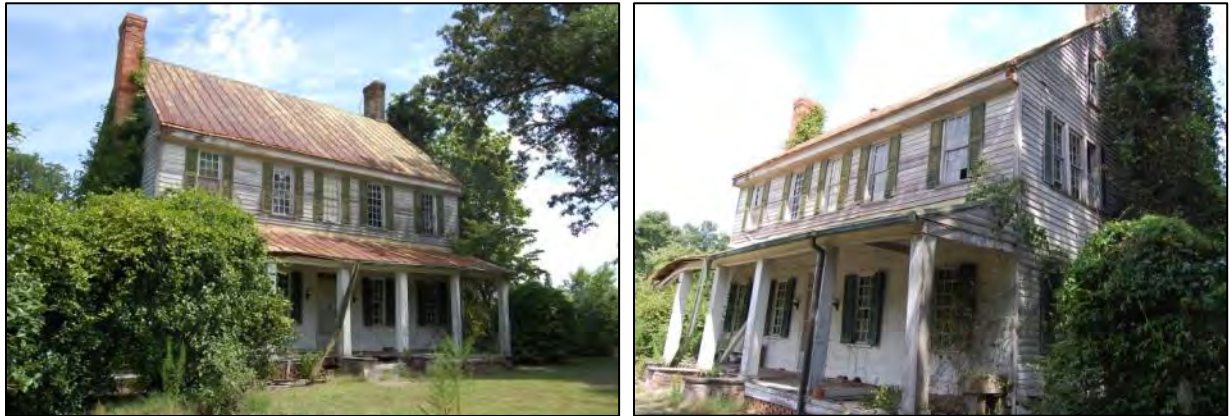
**Figure 7: Monticello: front and side elevations, 2017.**

The Whitfield-Carraway-Scarborough Farm or Monticello (LR-0830) near Wootens Crossroads is another house built in two periods with both Georgian and Federal-style adornment. It was determined eligible for NRHP listing in 1993. A two-story, center-hall-plan, double-pile residence, Monticello is thought to have been built in the late eighteenth century and added to and expanded around 1812. Its east dining room retains Georgian woodwork, which includes a mantel with flat-paneled frieze, a wide surround, and a built-in cupboard and closet door, both of which retain raised panels. Federal elements dating from the expansion are found throughout the house. They include the dining room's wainscoting, two tripartite mantels with molded shelves and dentil cornices, and doors with six flat panels. The house also retains plaster walls (but for the horizontal-sheathed walls in the hall), an open-string stair, nine-over-nine sash, flush-gable eaves, one Flemish bond chimney, and flush siding at the porch and beaded and non-beaded weatherboards elsewhere at the exterior. The porch is not original. The house has been sealed and untouched for decades (Scarborough 2017). It remains in family hands. A fine residence, it

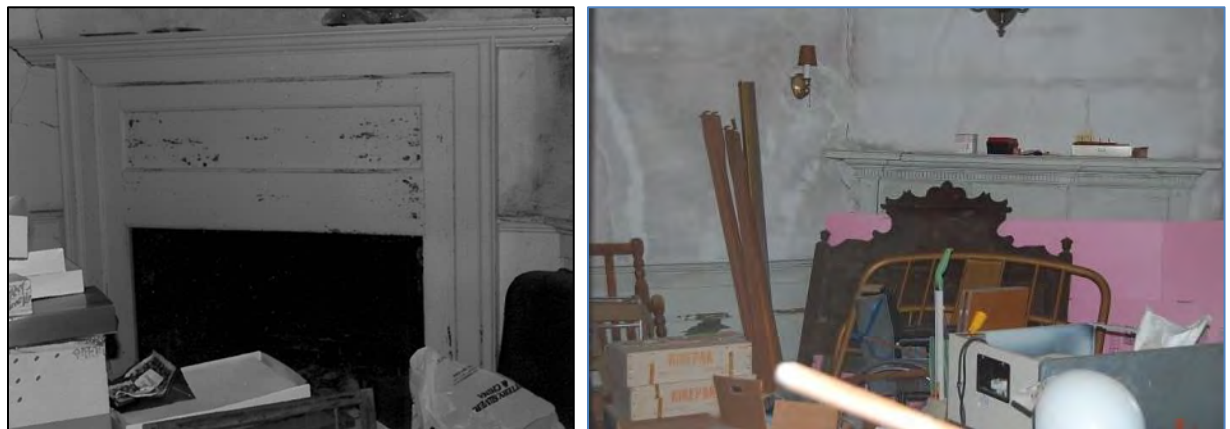
**Figure 8: Monticello: Georgian-style mantel in dining room, at left (photographer: Robbie Jones, 1994), and Federal-style mantel and wainscoting in downstairs front room, at right, 2017.**

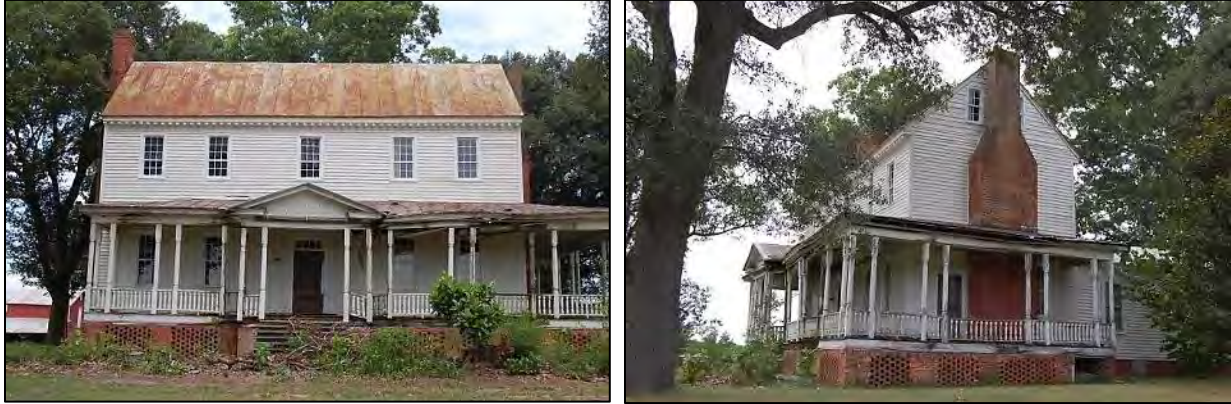
Listed in the NRHP in 1973 (Division of Archives and History 1973), the house appears to remain intact, although water has damaged its front porch.

**Figure 9: Herring House: south front and east side elevations, 2017.**

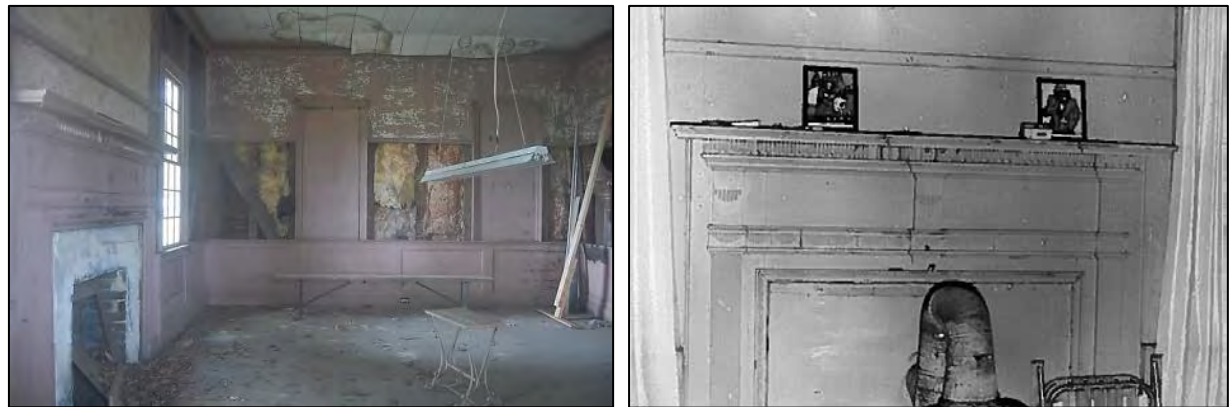
**Figure 10: Herring House: west parlor with reeded mantel, flush-paneled wainscoting, and three-part surrounds, 2017; detail of mantel in 1994 (photographer: Robbie Jones).**

*Coastal Plain and Fancy* (Little et al. 1998:45-46) described the Herring (or Needham Herring) House (LR-0004) near LaGrange in 1998 (Figure 9 and Figure 10):

The two-and-one-half-story Needham Herring House . . . probably exhibits the best-preserved elegant Federal finish in Lenoir County. The single-pile house has a later Victorian-style porch and rear additions. Its main block displays the craftsmanship of the early-nineteenth-century house carpenter and joiner in Lenoir County through the carefully executed decorative moldings, pegged doors, sash windows, paneling, and other features. The big frame house sits on a full Flemish bond foundation and has Flemish bond chimneys. One of the chimney bricks bears the date 1801. . . . But the mature Federal design and finish of the house suggest a construction date in the 1820s. . . . The Herring Family took advantage of the most up-to-date room arrangements, featuring a spacious center hallway displaying paneling more ornate than that of the rooms themselves. The hall contains the stairs to the second floor and affords privacy to the two downstairs parlors. Original woodwork, including dentiled cornices, tripartite

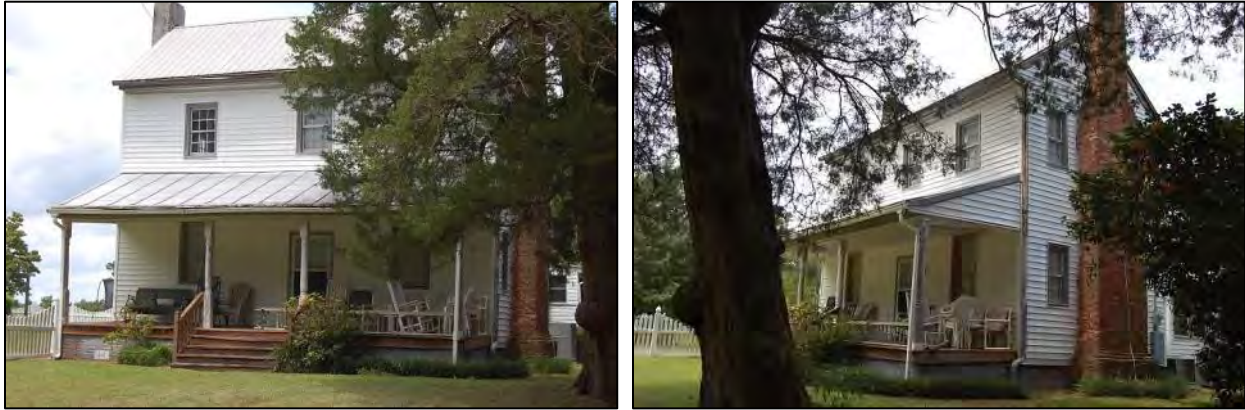
**Figure 11: Hill-Sutton House: south front and east side elevations, 2017.**

The ca. 1820 Hill-Sutton House (LR-0955) in the vicinity of LaGrange is also two stories tall with a Federal finish, although it utilizes a less fashionable hall-parlor plan and an asymmetrical placement of bays that reflect that plan. It retains original nine-over-six, six-over-six, and four-over-four sash, two-part surrounds, single-shoulder exterior-end chimneys, and a Federal-style cornice and beaded rakeboards. Its porch and large rear ell likely date from the early twentieth century. Vinyl covers its original cladding. The house's interior could not be viewed (Figure 11).

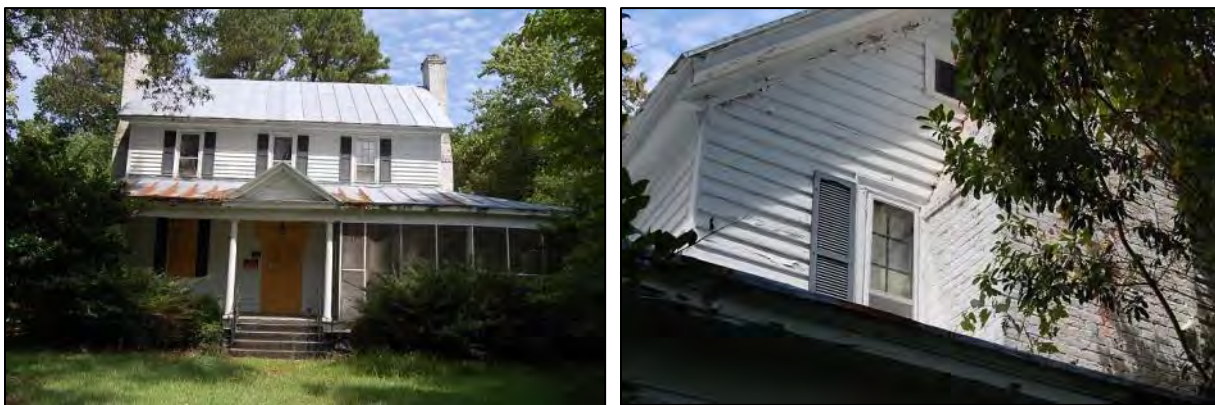
The house received a two-room shed addition to its rear in 1875 and a Colonial Revival-style porch, now partially screened-in, around the turn of the century. Most of its bays have been boarded over since 2010, possibly due to storm damage to the property, but a number of open ones retain their original sash. The beaded siding, cornices, and surrounds also remain in place. The house is currently inaccessible.

**Figure 12: Tull-Worth-Holland House: south front elevation and east side elevation detail depicting intact boxed cornice, beaded weatherboards, and surround, 2017.**

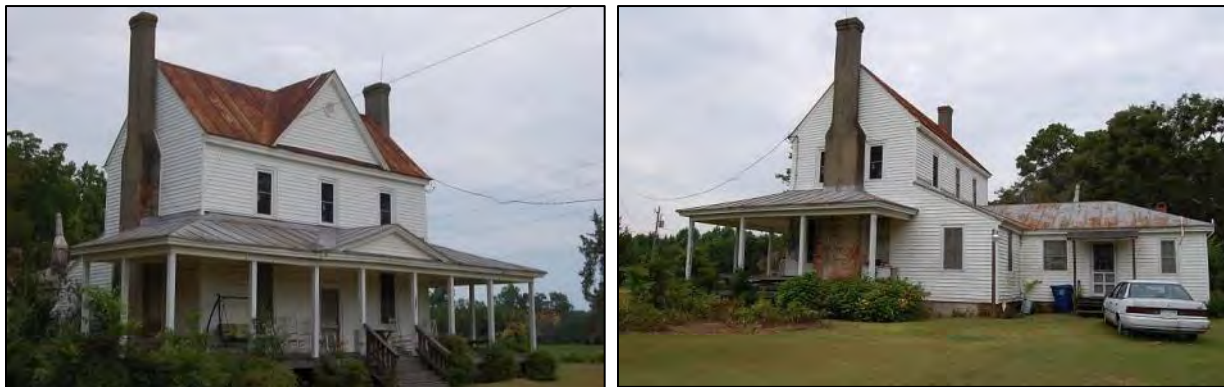
**Figure 13: Jericho: west side and south front elevations, at left, and east side and north rear elevations with original shed-roofed ell and turn-of-the-century hip-roofed addition, at right, 2017.**

The Walter Dunn, Jr. House or Jericho (LR-0816) near Kinston, the Dunn-Canady House or LaFayette (LR-0787) near Graingers, and the Grady-Harper House (LR-0003) near Woodington—all included on the state SL—also date from the 1820s or 1830s and retain Federal-style features. Jericho is a two-story single-pile residence, which likely began with a hall-parlor plan that evolved into a center-hall-plan L-shaped configuration (Figure 13 and

The house’s original sheathing is covered with modern siding and much of its later two-over-two sash has been supplanted by modern one-over-one windows.

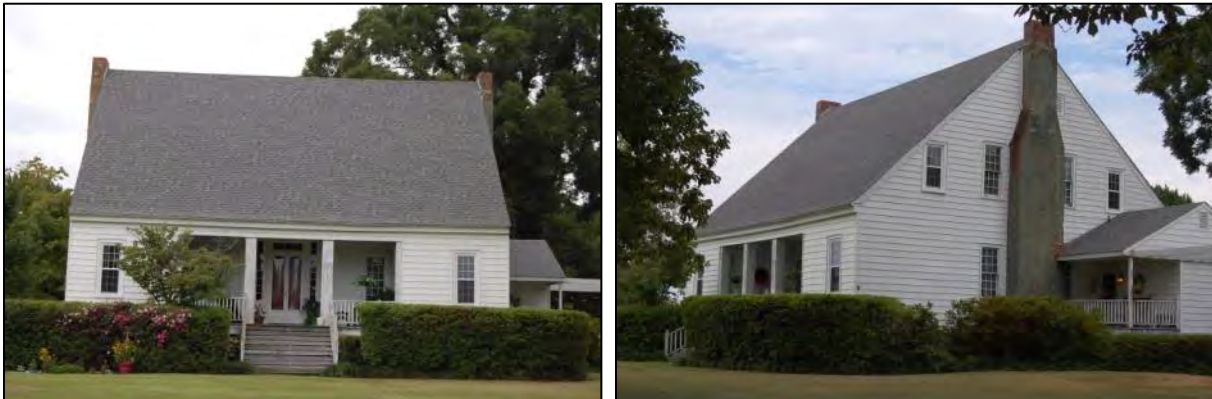
**Figure 15: LaFayette: south front and east side elevations, 2017.**

The coastal-cottage form of the five-bay-wide LaFayette is striking and unusual (Figure 15 and Figure 16). Its broad gable-end roof covers enclosed rooms at both sides of the front elevation—leaving what is effectively a recessed three-bay porch—and the original rear shed rooms as well. The house is covered with artificial siding, but outside retains many original nine-over-nine windows at its first story and the half-story above, and a trabeated entry. Inside, only one Federal-style mantel, adorned with dentil molding and reeded pilasters, survived in 1998. Other intact Federal details, however, included molded surrounds, horizontal-board-sheathed and flat-paneled wainscoting, and flat-paneled and battened doors. The house was renovated in 1979 after years as a tenant house and vandalism. Its carefully maintained appearance and the lack of exterior alteration since 1998 suggest that its interior, which could not be viewed, remains intact.

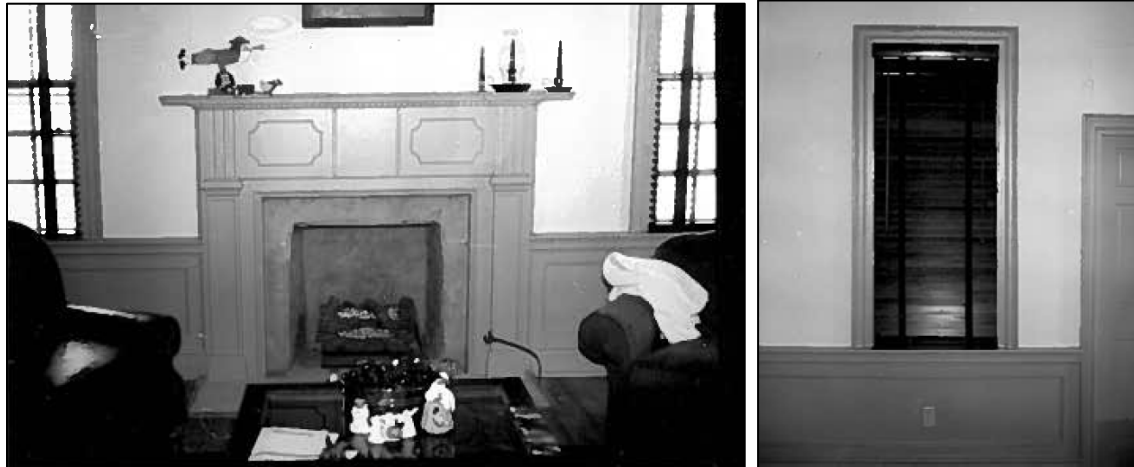
**Figure 16: LaFayette: Federal-style finish of downstairs parlors (photographer: Robbie Jones, 1994).**

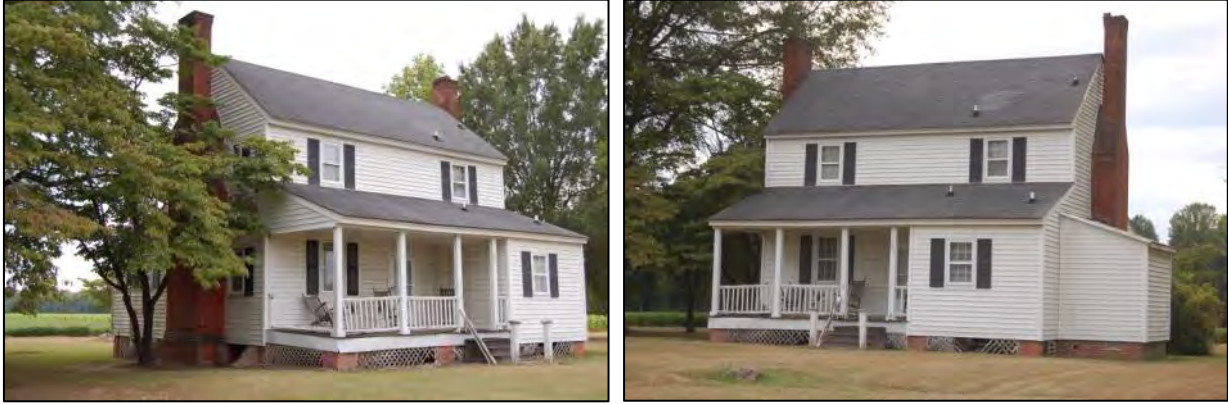
Since 1998, the house's porch, which was not original, has been altered through the replacement of its posts and the addition of a modern balustrade. Artificial siding hides its beaded weatherboards. The exterior looks little different than it did in the 1990s: it retains its original or early six-over-six sash, along with paved single and double-shouldered chimneys. The interior was not available for viewing, but is believed to be intact.

**Figure 17: Grady-Harper House: front elevation and double-shouldered chimney, 2017.**

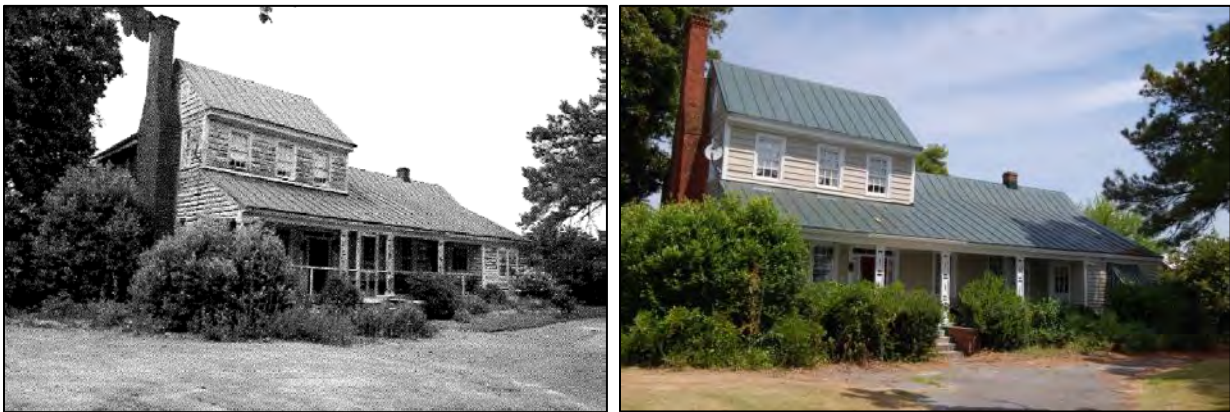
**Figure 18: Rountree-Askew-Moseley House: south front and west side elevations in 2010, at left, and 2017, at right.**

The approximately 60-year span of the three building periods of the Rountree-Askew-Moseley House (LR-0797) in the Mewborn's Crossroads community reflect the three popular styles of the first half of the nineteenth century, the Georgian, Federal, and Greek Revival (Figure 18 and Figure 19). The house likely began with two rooms and a shed around the turn of the eighteenth century. This section retains wide vertical-sheathed walls and one raised-six-panel door. Between about 1820 and 1840 the owners added a two-story block to the west, which retains such Federal-style features as flat-paneled wainscoting and six-panel doors, molded chair rails and surrounds, and a tripartite mantel. A two-story wing affixed to the north rear by 1860 retains Greek Revival-style post-and-lintel mantels. The residence was in good condition in 1998, but when recorded in 2010 was sorely in need of paint and maintenance. By 2016, however, it had been restored. Its exterior retains original or early nine-over-nine and nine-over-six sash, molded surrounds, Flemish bond chimney on the west, mid-nineteenth-century, open-work porch posts, and weatherboards. The interior was not available for viewing. The residence was determined NRHP-eligible in 1993.

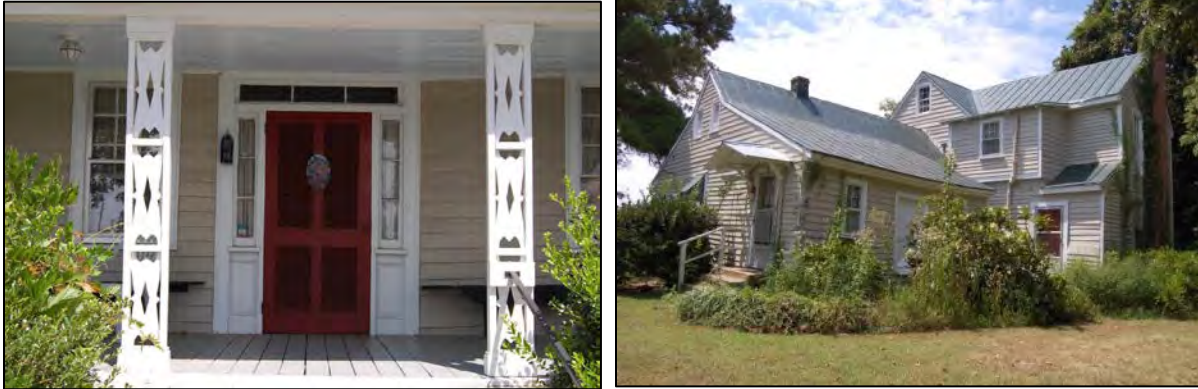
**Figure 19: Rountree-Askew-Moseley House: Trabeated entry at principal front block, at left; at right, rear elevation with ca. 1860 block to right, original block to left, and later added/enclosed shed rooms, 2017.**

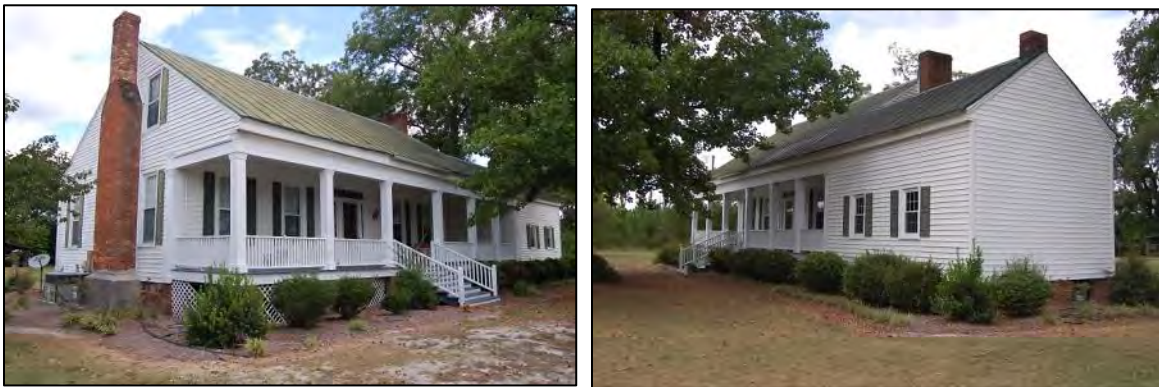
**Figure 20: Wiley Joel Rouse House: west side and south front elevations, at left; south front and east side elevations, at right, 2017.**

The Greek Revival finish of the Study-Listed Wiley Joel Rouse House (LR-1008) suggests it was built toward the end of its assigned 1825-1850 period of construction, perhaps in 1843 (Figure 20 and Figure 21). *Coastal Plain and Fancy* (Little et al. 1998:54) described it as follows:

By 1998 the Wiley Joel Rouse House had received synthetic siding. It retains this siding, but also its original nine-over-nine and nine-over-six sash, square-columned porch posts and corner pilasters, flush gable ends, and trabeated entrance. The only notable alteration since then is the covering over of the exposed chimney face at the east gable end of the one-story kitchen wing. In addition to its fine house, the property includes a large number of outbuildings. The house is included on the North Carolina SL.

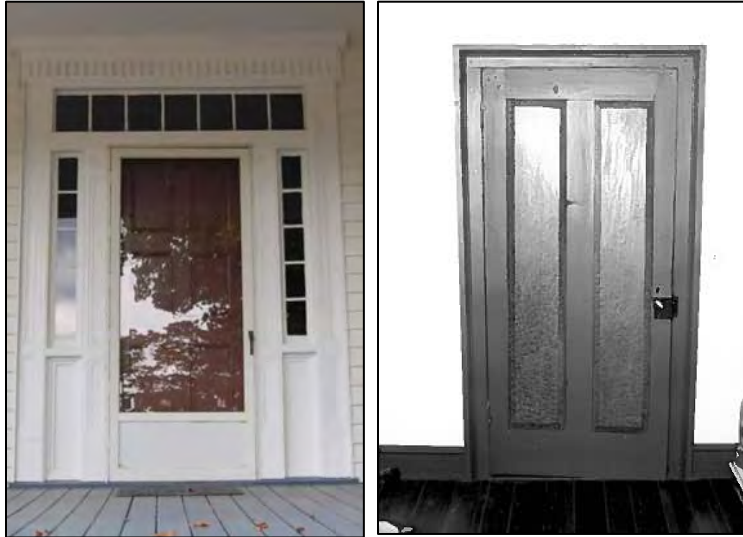
**Figure 21: Wiley Joel Rouse House: Federal six-panel door within Greek Revival trabeated surround at front entry, at left, 2017; and Greek Revival two-panel door, at right (photographer: Robbie Jones, 1994).**

Reflecting its period of construction, when the Federal style was being supplanted, the house features six-panel doors and the more fashionable two-panel doors of the Greek Revival style.

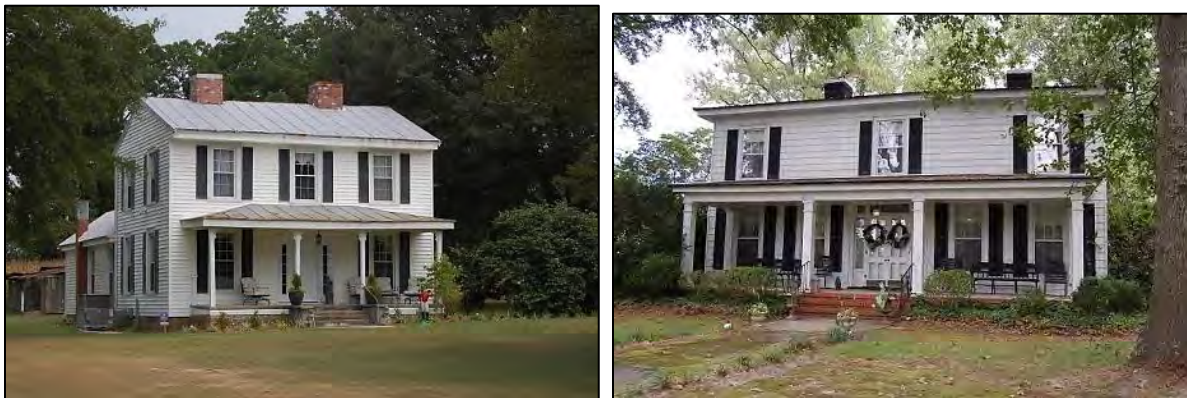
**Figure 23: Pridgen-Hardy House, at left, Cunningham-Patrick-Bryan House, at right, front elevations, 2017.**

The Pridgen-Hardy and Cunningham-Patrick-Bryan houses—both built for young men ca. 1853 and remodeled in the 1930s—are representative (Figure 23). The Pridgen-Hardy House retains its form and plan, gable-end roof, interior chimney stacks, flush-gable ends, nine-over-nine and some six-over-six sash, trabeated entry, and chamfered porch posts. Its second-story nine-over-six sash and one of its chimney stacks have been replaced. The larger five-bay-wide Cunningham-Patrick-Bryan House retains its form, plan, interior chimneys, and trabeated entry, too, along with a low-hipped roof, six-over-six sash, straightforward post-and-lintel mantels, and two-panel doors. Both are also artificially sided, as they were in 1998. The houses have not been individually recorded or assessed, but the Lenoir Collegiate Institute Rural Community is on the North Carolina SL.

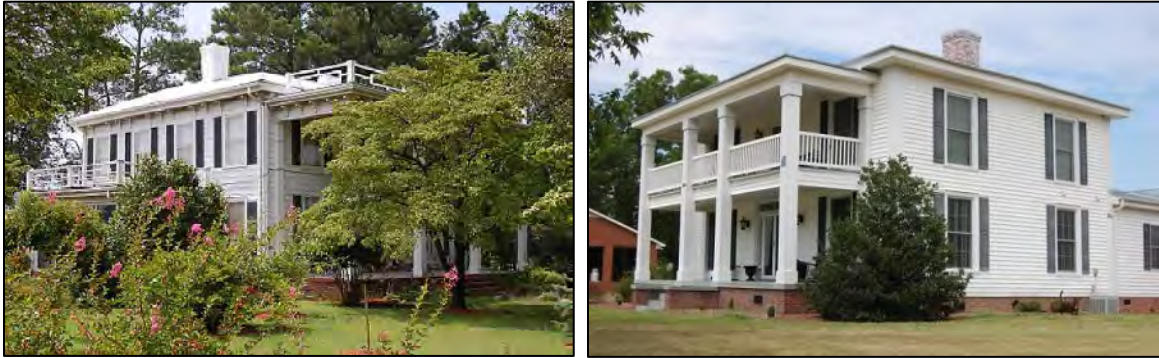
**Figure 24: Other less-intact Lenoir Collegiate Institute Rural Community dwellings: T.W. Dawson House (former dormitory), ca.1855, at left; Gibbons-Hardy House (former dormitory), ca. 1853, at right, 2017.**

Numerous buildings erected between 1853 and 1858 for the Lenoir Collegiate Institute (LR-0940) survive in the eponymous Institute community in northwest Lenoir County (Figure 22 through Figure 24). They include four double-pile, center-hall-plan, hipped and gable-roofed residences built in 1853 as dormitories, a ca. 1855 church, and other single-pile two-story houses. During the middle two quarters of the twentieth century new owners renovated and altered the houses, but they are an important group of buildings and individually represent the Greek Revival-style form and many of its common features.

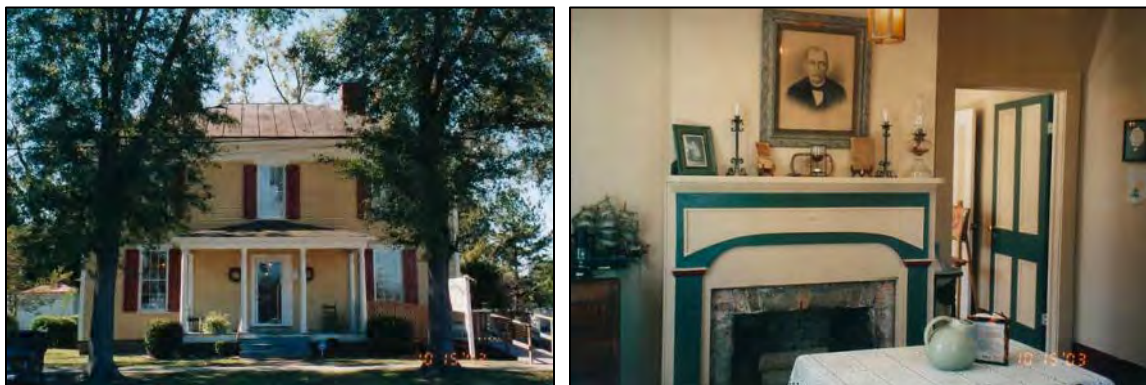
**Figure 25: Archbell House/(former) Baptist Parsonage; front elevation and post-and-lintel mantel with arched panel (source: Lenoir County Historical Association, 2003).**

Kinston's (former) Baptist Parsonage or the Archbell House (LR-0214) was listed in the NRHP in 1989 and remains an intact representative of a straightforward Lenoir County Greek Revival-style dwelling (Figure 25). Built for the parson of the town's First Baptist Church, it is a substantial but relatively plainly finished dwelling. It retains its two-story, double-pile, center-hall-plan form, which is topped by a hipped roof and interior chimney stacks. It further retains six-over-six sash set in simple surrounds, cornerboards topped by minimal capitals, and a wide plain friezeboard topped by a boxed cornice. The NRHP nomination describes the interior in part as follows (Black 1989a):

The interior of the house is as simply finished as is the exterior. Walls are plastered, although some plaster has been taken down and replaced with sheetrock. The original Greek Revival post-and-lintel mantels survive throughout the house; that in the southeast room has an arched opening and a narrow molding around an arched panel on the frieze. All original and restored openings have simple post-and-lintel surrounds except for one. . . . There are modern replacement four-panel doors throughout the house.

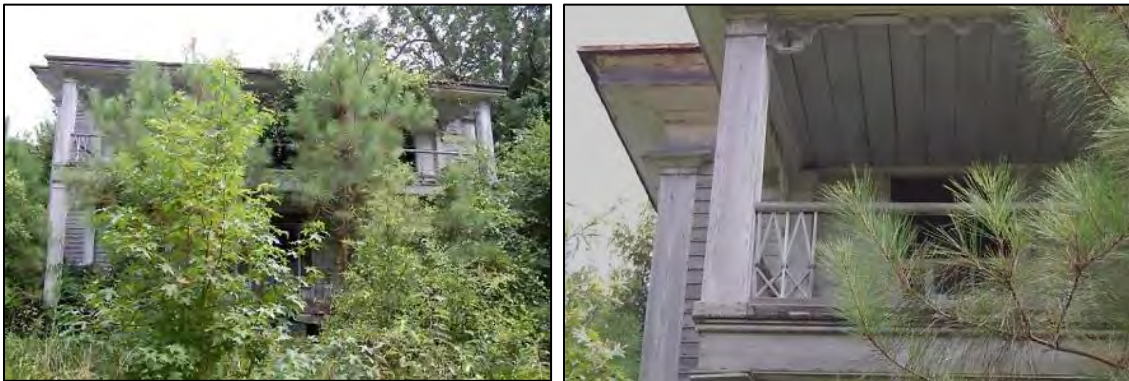
**Figure 26: Rouse-Edmondson-Wilson House: front elevation with two-tier porch and porch detail, 2017.**

The house is remarkably unaltered, in part because of its long vacancy and lack repair or modernization (Figure 26 and Figure 27). It is also much deteriorated. In addition to its piazza its exterior retains weatherboards, wide corner posts with prominent capitals, a wraparound rear porch with original square posts topped by capitals, and six-over-six sash. Some of this sash and the sidelights and transom of the front entry are boarded over, but visible from the interior. Inside the house retains almost all of its original finish, including two-panel doors, chair rails, and a stair with stick railings, rounded handrails, and square posts terminating in capitals. Since 2010 its eight post-and-lintel mantels with tall plain lintels have been removed, its only notable loss. In spite of its condition, it remains a grand example of the Greek Revival and Italianate styles in the county.

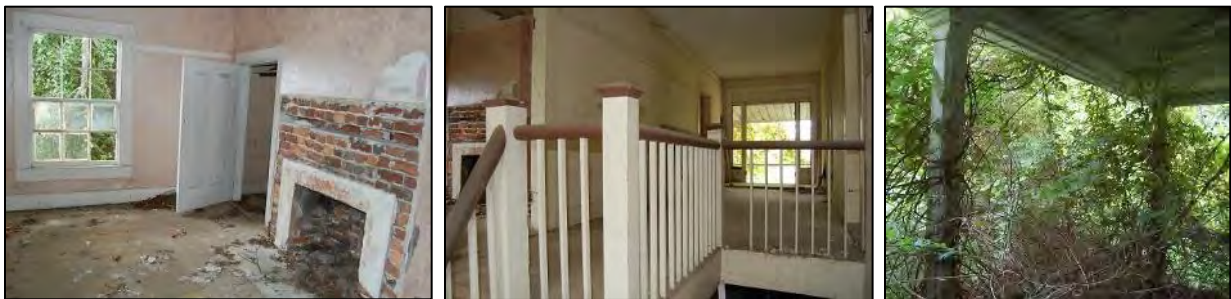
**Figure 27: Rouse-Edmondson-Wilson House: upstairs front bedroom, upstairs hall looking out to upper porch, and rear porch detail, 2017.**

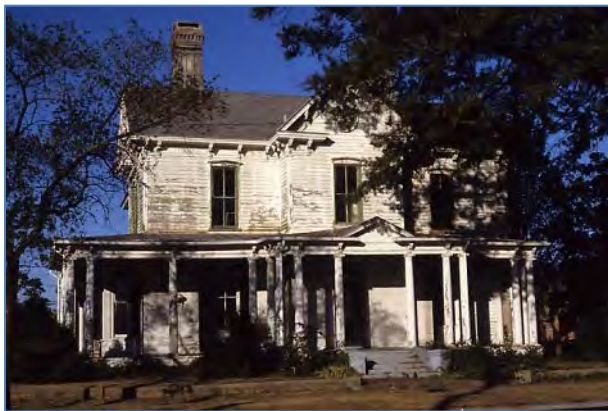
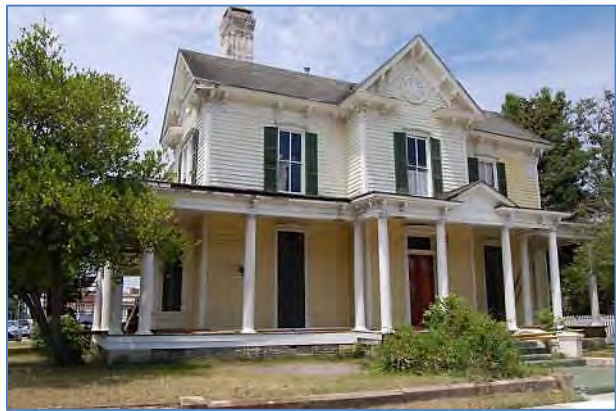
**Figure 28: B.W. Canady House: front elevation in 1984 prior to restoration (source: Preservation North Carolina and North Carolina State University), at left, and in 2017.**

Merchant, tobacco warehouse-owner, county commissioner, and Kinston mayor B.W. Canady erected a two-story, L-plan house (LR-0052) on North Queen Street in Kinston about 1883 (Figure 28 and Figure 29). Its stylish Italianate features include a paneled frieze, denticulated cornice, brackets with pendants, long narrow two-over-two sash, and tall heavily corbeled chimney stacks. Its interior retains Italianate-style mantels on its second floor and Colonial Revival-style mantels added by the family in the early twentieth century. The Doric columns of its wraparound porch also date from its Colonial Revival update. The house was listed in the NRHP in 1989 (Black 1989b; Little et al. 1998:93-94, 205).

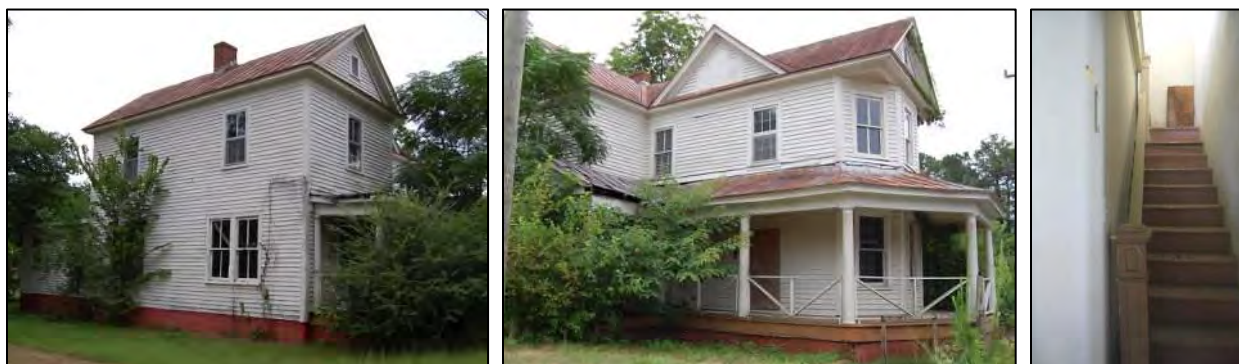
**Figure 30: Ezekiel K. Best House: east side elevation, at left, north front and west side elevations, at center, and stair, at right, 2017.**

African-American Ezekiel K. Best erected a two-story T-plan house (LR-1334) on Hicks Avenue in Kinston about 1911 (Little et al. 1998:11, 153, 215-216). Less ornate than many other contemporary houses in Kinston, it nonetheless features Queen Anne and Colonial Revival-style elements, including a full-height side bay, a wraparound porch supported by Tuscan columns, and triangular pediments at its multiple gables (Figure 30). Although its sash has been altered and some bays changed, it retains its weatherboard siding.

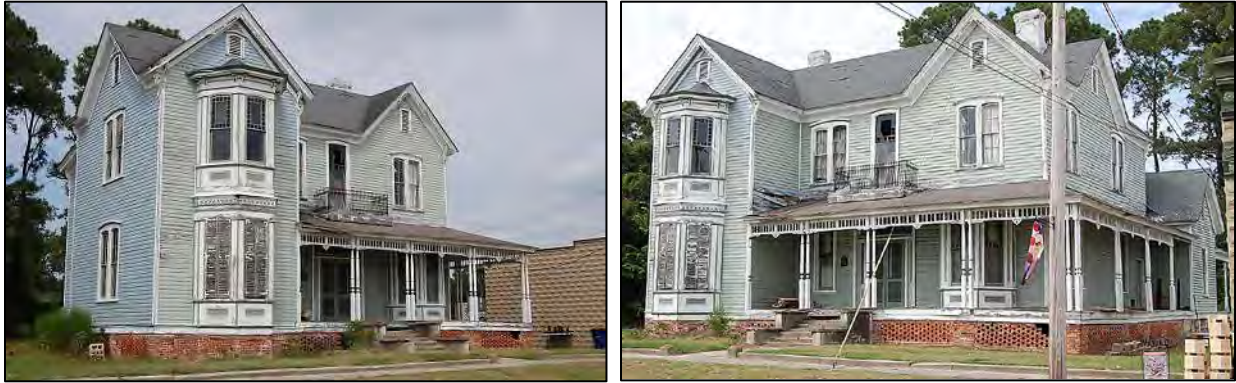
In LaGrange, Lenoir County's second town, George B.W. Hadley (LR-1100) built a two-story, multi-gabled, L-plan house on West Railroad Street about 1890 (Little et al. 1998:286, 295). Large and neatly finished, it features such Queen Anne-style elements as projecting bay windows, segmentally arched paired windows, and a wraparound porch with turned posts and an upper apron of spindles and jigsawed pendants (Figure 31 and Figure 32). The intact house retains these features along with its original German siding. Recently purchased, the residence is being restored.

**Figure 31: George B.W. Hadley House: west side and south front elevations, at left, and south front and east side elevations, at right, 2017.**

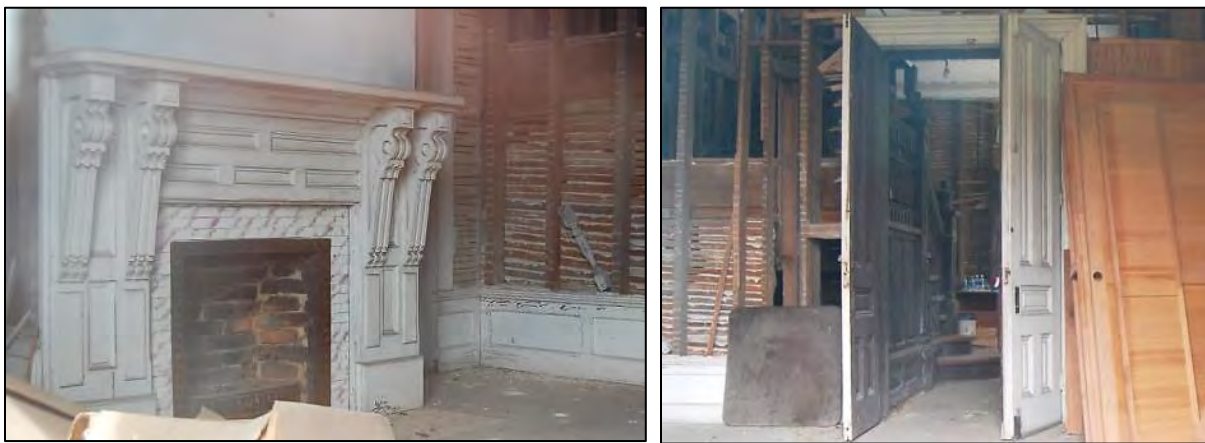
**Figure 32: George B.W. Hadley House: front parlor mantel, at left, and view through parlor of ornate stair, 2017.**

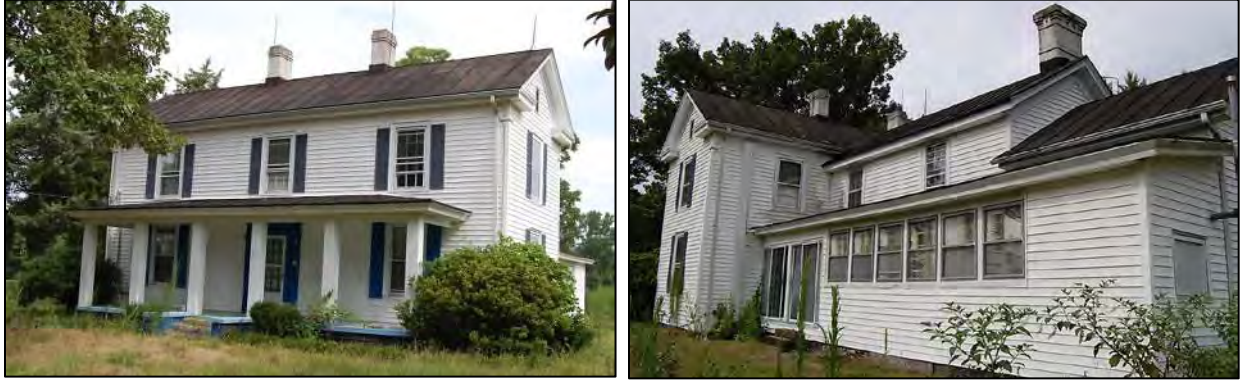
Large two-story dwellings, whether ornate or more modestly finished, were more commonly built in Kinston and LaGrange than in rural Lenoir County. Those built in the countryside were almost always more simply finished. The turn-of-the-century Tom Worthington House (LR-0721) near Grifton in northeastern Lenoir is two stories tall with a two-story ell that gives it a T-plan footprint (Little et al. 1998:351). Compared to its town contemporaries, it is modestly finished with cornice returns at its end gables, sidelights and transom at its centered entry, and three heavily corbeled interior chimney stacks (Figure 33). Six large square columns support its hipped-roof front porch. The house also retains six-over-six sash and at least one plain post-and-lintel mantel, viewed through a window, but is covered with artificial siding. Also porches to either side of its two-story ell have been enclosed and the kitchen ell to its rear is likely a later addition.

**Figure 33: Tom Worthington House: south front elevation, at left, and east side and north rear elevations, at right, 2017.**

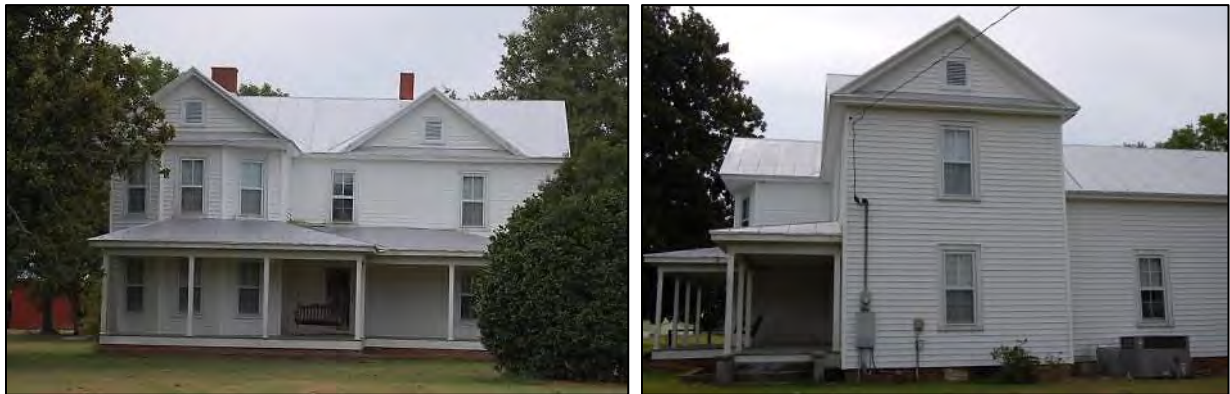
William Parker Gilbert erected a farmhouse (LR-0725) in the Hugo community around 1910 that matches the contemporary Kinston and LaGrange houses in size, but not in finish (Little et al. 1998:350). Two stories tall with a T-shaped footprint and one-story rear ell, it features a two-story front bay, pedimented gables, and a long porch supported by delicate columns (Figure 34). Its four-over-four windows are intact, but it is now faced with vinyl siding and its interior chimney stacks have been rebuilt without corbels. It may retain its original mantels, but that could not be confirmed. A number of outbuildings continue to stand to its rear. A wealthy man, Gilbert farmed and owned a large sawmill.

**Figure 34: William P. Gilbert House: north front elevation, at left, and west side elevation, at right, 2017.**

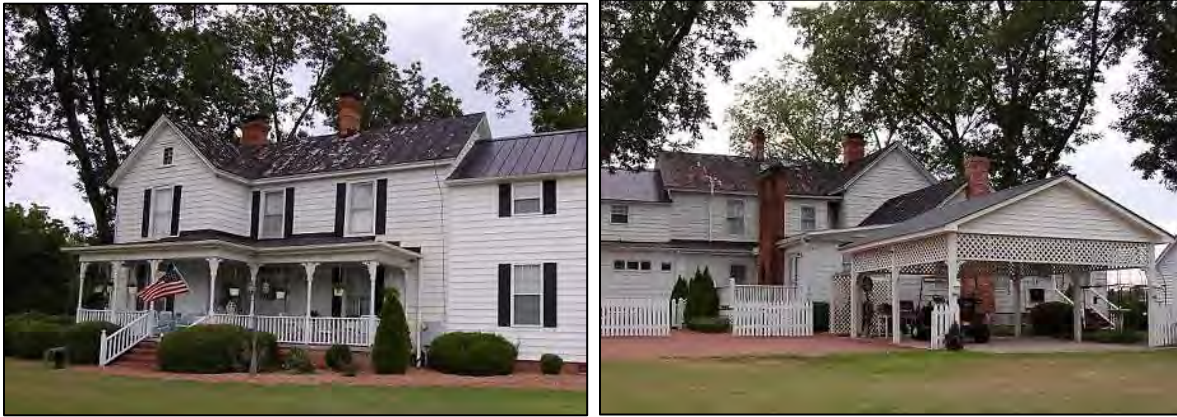
Prosperous farmer Joseph Williams erected his two-story, T-plan house (LR-1204) on his 1,150-acre farm in the mid-1910s in the Southwood community (Little et al. 1998:418). The large house is expanded further by one-story ells (Figure 35). Considering the extent of Williams' property holdings, his home is modestly finished. It retains a Victorian porch with turned posts and jigsaw brackets, along with heavily corbeled interior chimney stacks. It otherwise has little exterior detail work, although the addition of artificial siding and a large two-story wing (since 2010) may have removed its original finish.

**Figure 35: Joseph Williams House: north front elevation with tall post-2010 wing, and south rear elevation with later one-story ell and enclosed porches, 2017.**

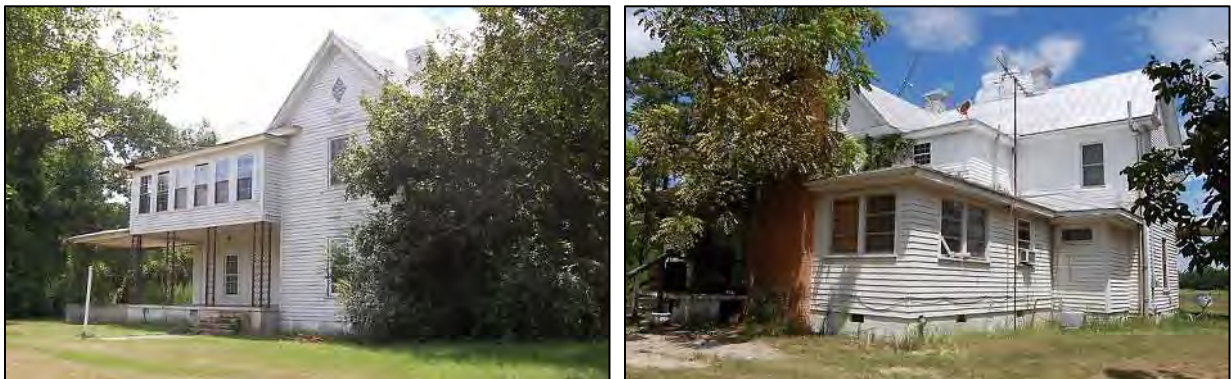
A largely intact, two-story, T-footprint house in rural Lenoir County is the former home of Herbert William Davis (1860-1926) (LR-1018), which dates from the late nineteenth century (Figure 36 and Figure 37). In the 1870s his father, John P. Davis, ran the Davis Mill, the predecessor of which stands a short distance west in the Strabane community (*Kinston Journal*, November 20, 1879). Local newspapers described Herbert William (or H. William) as a “well known farmer” (*Kinston Daily Free Press*, August 21, 1916). The original exterior features the house retains include a tripartite entry and door with round-headed panels, weatherboard siding, cornice returns, diamond-shaped ventilators, and corbeled brick chimney stacks. A second-story sunroom, placed atop the front porch, is original or an early addition. The house is vacant and its interior is obscured. Its windows are new snap-in sash, though, and its porch and porte cochere are supported by inventive, if non-historic, metal posts. Later-added ells and enclosed porches mark the rear elevation.

**Figure 36: H. William Davis House: north front and south rear elevations, 2017.**

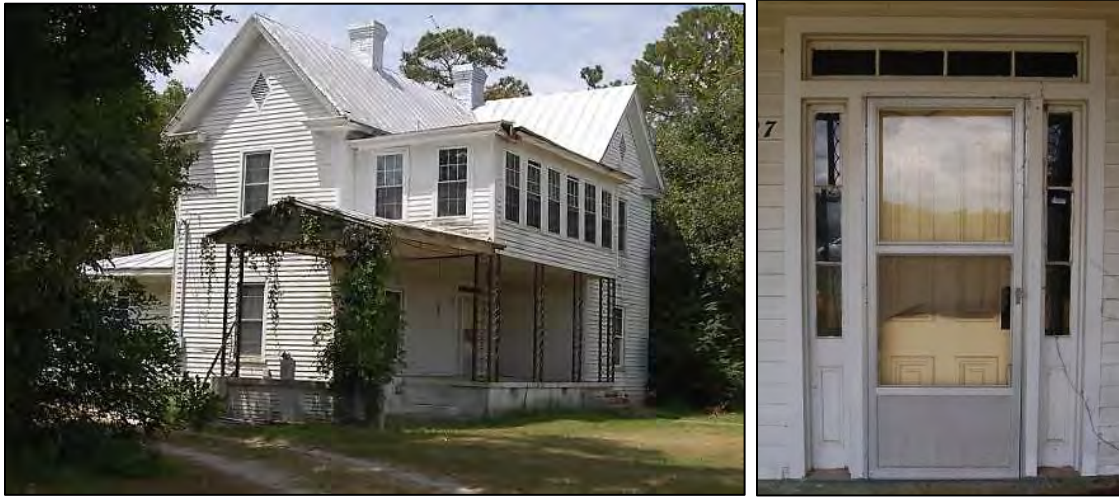
**Figure 37: H. William Davis House: east side and north front elevations, and front entry with sidelights, transom, and Italianate-style paneled door, 2017.**

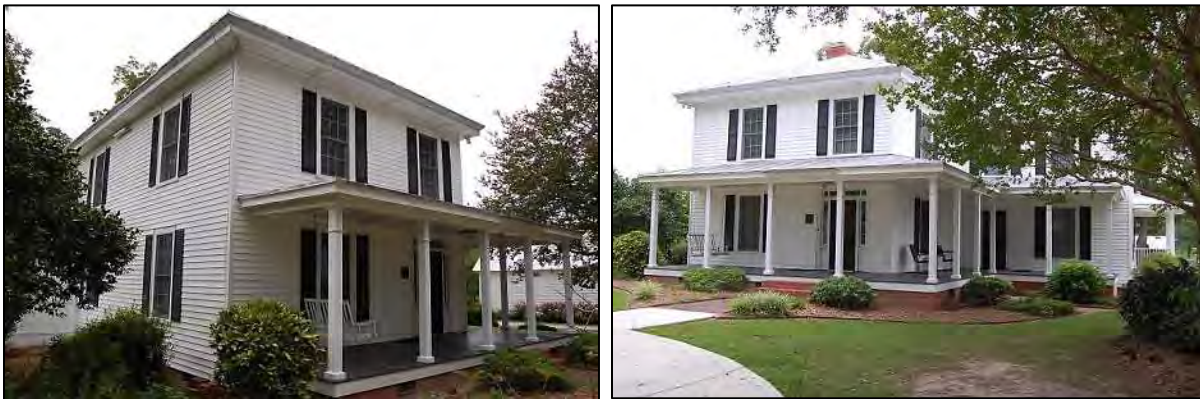
The Study-Listed Seth or Willie West House (LR-0740) at West Crossroads, built ca. 1876, is a nascent foursquare with two-story wing that in form connects it with the T- and L-footprint houses (Little et al. 1998:387). It retains its high-hipped seam-metal roof with interior chimney stack, trabeated entry, and wraparound porch supported by later-added slender columns (Figure 38). Its six-over-six sash has largely been replaced with snap-in sash, vinyl covers its weatherboards, and its porch columns are not original. Whether it retains its basic Victorian woodwork inside was not determined.

**Figure 38: Seth or Willie West House: west side and south front elevations, at left, and south front and east side elevations, at right, 2017.**

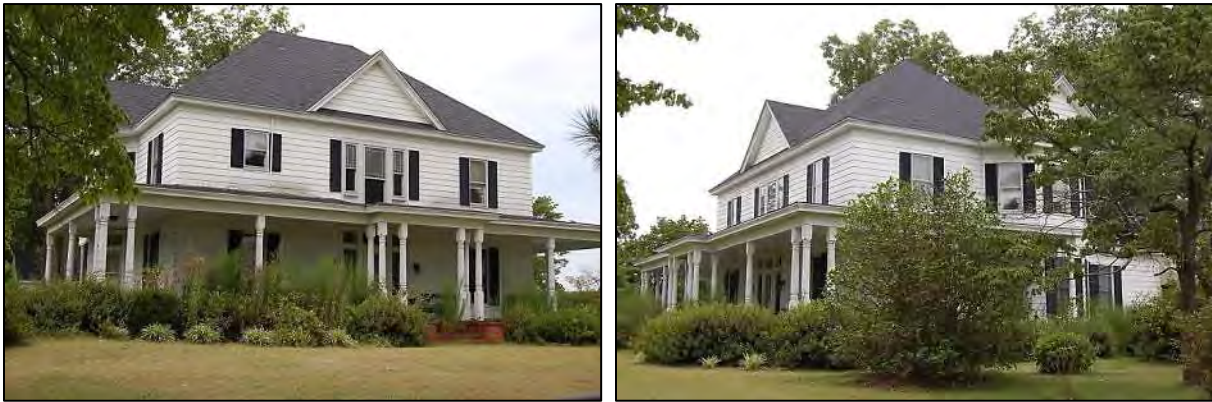
Prosperous farmer John Fields erected the Fields-Sugg House (LR-0945) just outside of LaGrange around 1906 (Figure 39). The dwelling combines elements of the Queen Anne style with the foursquare form. Its wraparound porch with turned columns, façade gable, and projecting two-story bays at both side elevations are picturesque Victorian elements applied to the boxy, two-story, double-pile, hipped-roof form of the foursquare. Its exterior retains its original porch, one-over-one-sash, and trabeated entry with a tripartite window arrangement above at the second story. Its siding is modern. Its interior was noted for holding “some of the best preserved and most sophisticated Victorian detailing in the county, featuring such elements as an open-string stairway with molded newel posts, pocket doors, columned overmantels with mirrors, molded window and door surrounds with decorative corner blocks, and an intricate hall screen” (Little et al. 1998:276). In 2001 the Fields-Sugg Farm was determined eligible for NRHP listing. The house currently stands vacant and it could be determined whether its interior remains intact.

**Figure 39: Field-Suggs House: east side and north front elevations, at left, and north front and west side elevations, at right, 2017.**
