North Carolina Department of Natural and Cultural Resources  
State Historic Preservation Office

MEMORANDUM

Subject: Historic Architecture Eligibility Evaluation Report, US 70 Kinston Bypass, R-2553,  
Lenoir County, ER 09-1307

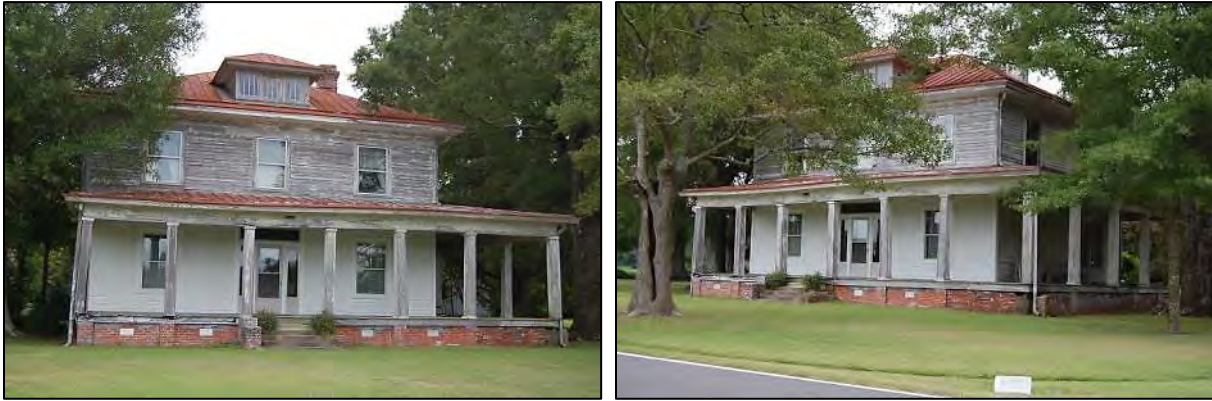
Charles A. Broadway, Sr., a prominent figure in the Graingers community, erected the eponymous Broadway House (LR-0802) about 1915 or 1916 (Brown 2016:22-36; Little et al. 1998:121; 362). An excellent and little-altered example of a foursquare in the Lenoir County—whether rural or city—it is a square, two-story, double-pile, frame building that is sided by weatherboards and topped by a low-hipped seam-metal roof with wide overhanging eaves (Figure 40). A hip-roofed dormer centered at the northwest front elevation, and two interior brick chimneys topped by corbelled stacks, rise from the roof. The front elevation is three bays wide with a centered front door flanked by a transom and sidelights filled with beveled glass. The large sash windows are eight-over-one. A wraparound hip-roofed porch supported by square columns extends across the front and southwest side elevations. The porch and body of the house stand on brick piers with brick infill. At the rear of the southwest side elevation are paired eight-over-one windows. Six of these windows wrap around the southwest side and southeast rear elevations at the second story, providing generous light and air for the upstairs corner room, as was popular early in the century. A hip-roofed three-quarters-width porch, which includes what appears to be an original enclosed room, crosses the rear elevation.

**Figure 40: Charles A. Broadway House: west front elevation, at left, and west and south side elevations, at right, 2017.**

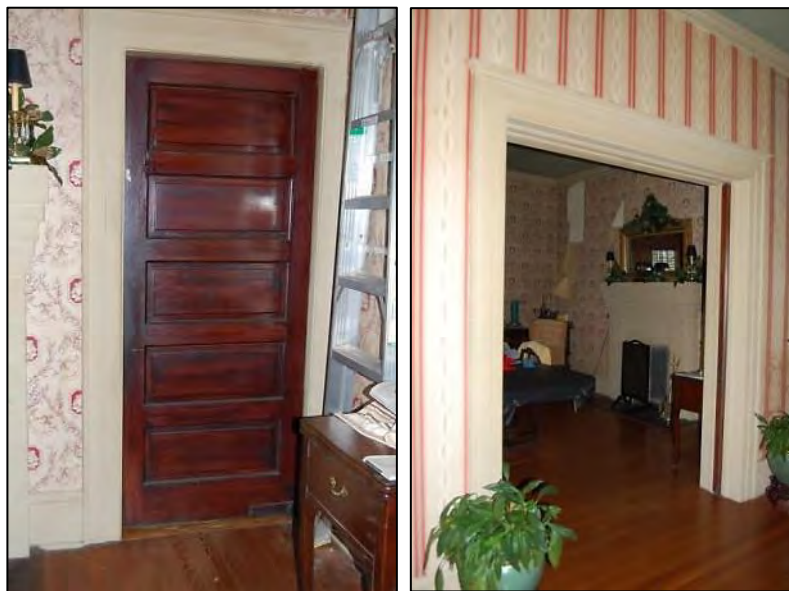
The house’s interior has two large rooms across its front and two rooms divided by a center hall behind (Figure 41). Its ceilings are 11-feet tall and its walls are plastered. The front rooms, which were available for viewing, include two brick mantels, large pocket doors, a five panel door,

original push-button light switches, and molded baseboards, cornices, and surrounds. Overall, both the interior and exterior of the house are remarkably intact. The Broadway House was determined eligible for NRHP listing in 2010/2016.

**Figure 41: Charles A. Broadway House: front parlors, 2016.**

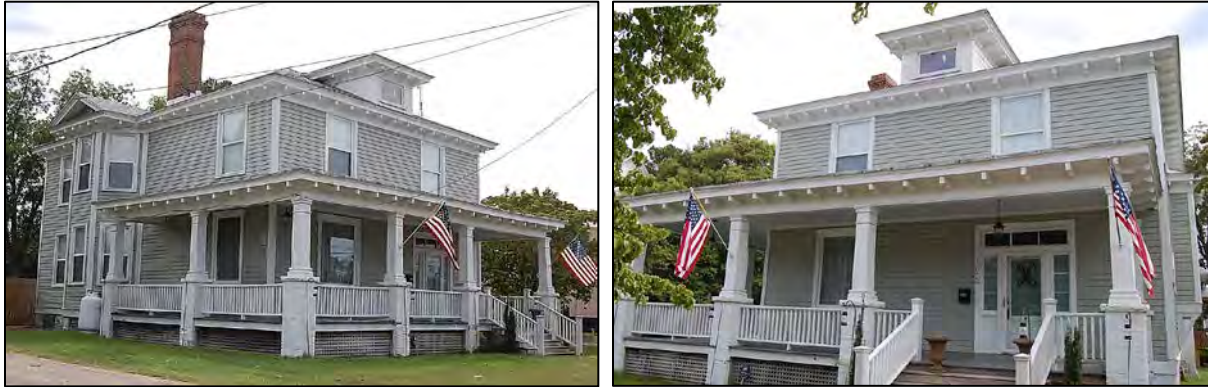
In 1915 James and Sudie Wooten built a large foursquare in LaGrange (LR-1085). Amplified by a two-story bay to one side, a smaller oriel to the other, and a long footprint, it shows the tenacity of Queen Anne-style elements in Lenoir, even in the face of the foursquare form and Craftsman-style decorative elements (Figure 42). The house's Craftsman features include prominently exposed rafter tails and a spacious wraparound porch with tapered columns raised high on brick piers. Its hip-roofed front dormer, sided by shingles, mirrors its principal hip roof. Other original features include most of its one-over-one sash, an entry with sidelights and transom, and a tall corbelled chimney stack. Since 1998, it has been sided with vinyl and some of its original two-over-two sash has been removed. Its interior was not viewed.

**Figure 42: James and Sudie Wooten House: east side and north front elevations, at left, and north front and west side elevations, at right, 2017.**

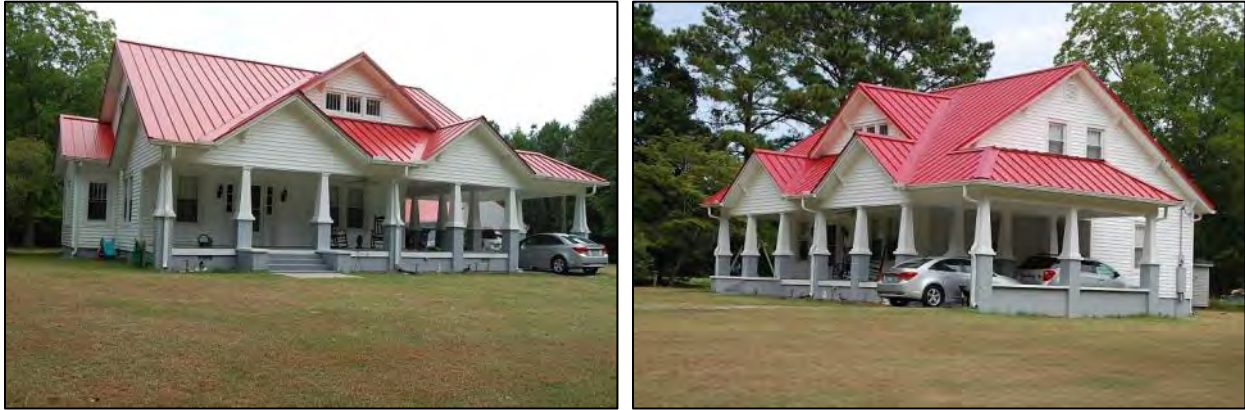
The Dr. Brantson Beeson and Naomi Holder House (LR-0924) also applies Craftsman elements—deep wraparound porch and porte cochere with tapered posts on brick piers, triangular kneebraces, four-over-one sash—to a one-and-a-half-story house with a complicated arrangement of roofs that recalls the Queen Anne (Figure 44). Their house was not only a late nod to the Victorian, but even a bit behind the times by Craftsman standards: they built it as a retirement home, near Institute, in 1936 (Little et al. 1998:319). Vinyl siding and a red metal roof are later alterations.

**Figure 44: Dr. Brantson Beeson and Naomi Holder House: north side and west front elevations, at left, and west front and south side elevations, at right, 2017.**

construction and its one-and-a-half-story dormered form, it appears to have lost much of its integrity. These houses include those discussed at Section 3, above, such as the Dr. Brantson Beeson and Naomi Holder House (Figure 44), the James Williams Brothers House (Figure 45), and the Felix Hardison House (Figure 46). The house is accordingly recommended as not significant under Criterion C for its architecture. The house and its outbuildings are also not recommended as eligible under Criterion C as a significant and distinguishable, multiple-component entity. Many of the former farms' outbuildings survive to the rear (north) of the house, though they have largely been sided with sheet metal. Within the past few years, however, many have been demolished—including an associated tenant house and outbuildings that stood on a farm lane to the north beyond the main outbuilding collection—and the house now stands vacant. Due to the house's alterations, and the loss of fabric or complete loss of many outbuildings, the resource does not retain the integrity necessary to be eligible for NRHP listing under Criterion C as a historic district.

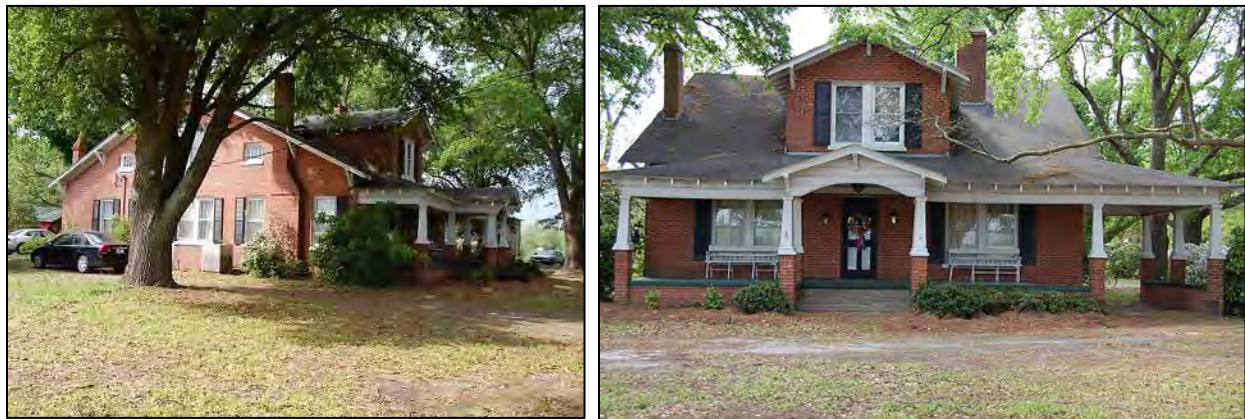
Although the use of Craftsman elements does not make a house a bungalow or even indicate that it was built in the early twentieth century, there are numerous houses in Lenoir that are clear representatives of the Craftsman-style bungalow. James William Brothers chose the Craftsman style full-blown for the dwelling he erected in 1928 just outside of Institute (LR-0921) (Figure 45). Built of brick it has long sweeping gabled roofs underpinned by triangular kneebraces, a gabled-dormer with exposed rafter ends and kneebraces, and a wraparound porch and porte cochere with exposed rafter ends and kneebraces, as well as tapered wooden posts on brick piers. (Since the below photographs were taken in 2010, the house's four-over-one sash has been replaced by one-over-one windows; otherwise it remains as pictured.)

**Figure 45: James William Brothers House: northeast side and northwest front elevations, at left, and northwest front elevation, at right, in 2010.**

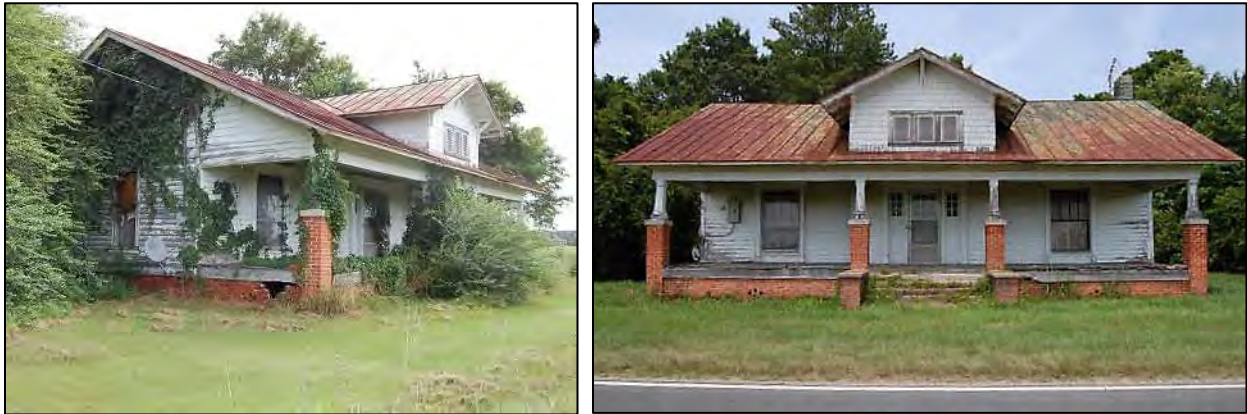
Other than deterioration caused by neglect and vacancy, the house looks like it did when built.

**Figure 46: Felix Hardison House: west side and south front elevation, at left, in 2017, and front elevation, at right, in 2010.**

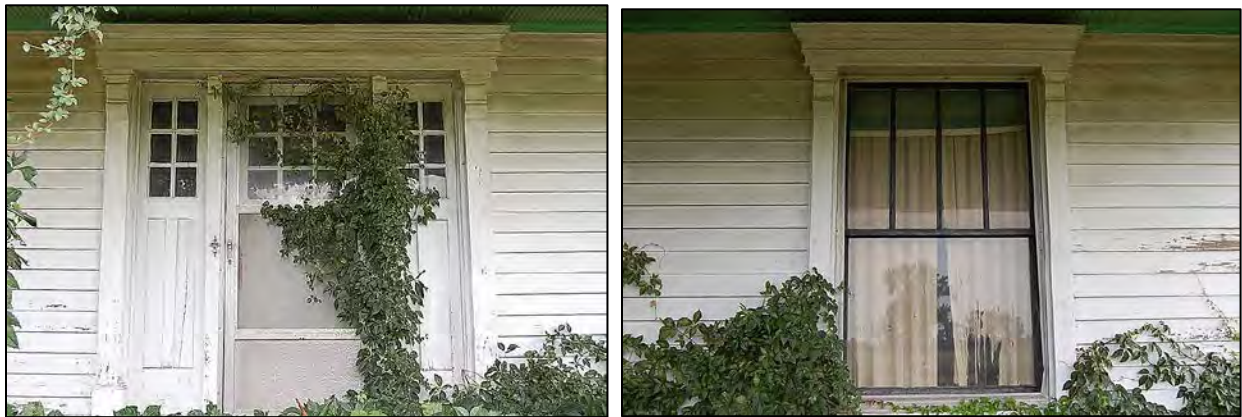
Felix Hardison (LR-0770) erected his bungalow in the Savannah community in the late 1910s (Little et al. 1998:330) (Figure 46 and Figure 47). More modestly scaled than the Brothers House and of wood rather than brick, it nonetheless utilizes the same Craftsman palette and even retains its four-over-one sash intact. According to *Coastal Plain and Fancy* (Little et al. 1998:330), the Hardison House was “one of the more ambitious of those built in rural areas of the county.” It continues:

**Figure 47: Felix Hardison House: front entry and window details, 2017.**

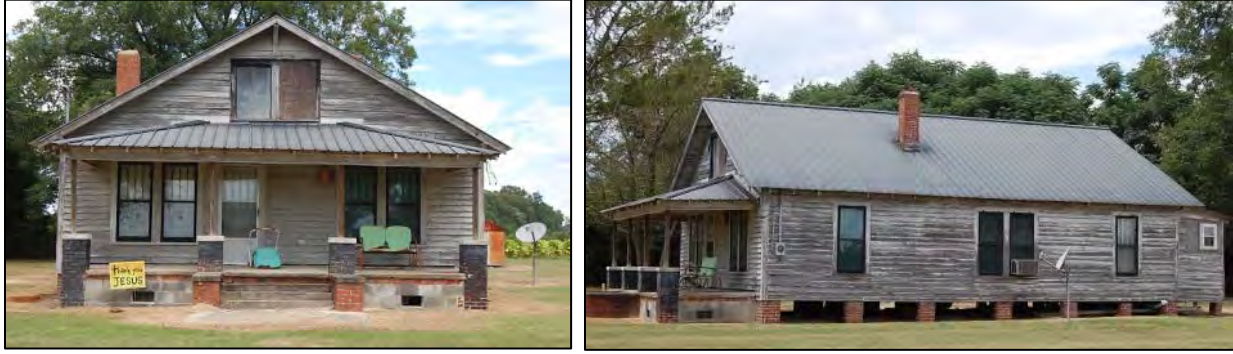
The decorative nature of the Craftsman, which could adapt to any residential form, is apparent at this house, which may have been erected by African-American farmer Owen Williams. According to the federal census, Williams lived in the same house in 1935 and 1940 in Moseley Township in which this gable-front house is located. (The house and associated farmland are currently owned by Williams' heirs.) A 1930s construction date conforms with its appearance (Figure 48). The one-story form of the frame house connects it with innumerable small dwellings built in Lenoir County and elsewhere in the nineteenth and twentieth centuries, although these were more commonly gable-end than front gabled. The front gable with triangular kneebraces connects it to the Craftsman, as do paired four-over-one sash, a full-façade porch, and tall brick piers supporting plain posts that may be a later replacement. In addition to its Craftsman elements, the house retains its original weatherboards and brick foundation piers.

**Figure 48: Owen Williams House: south front elevation, at left, and east side elevation, at right, 2017.**

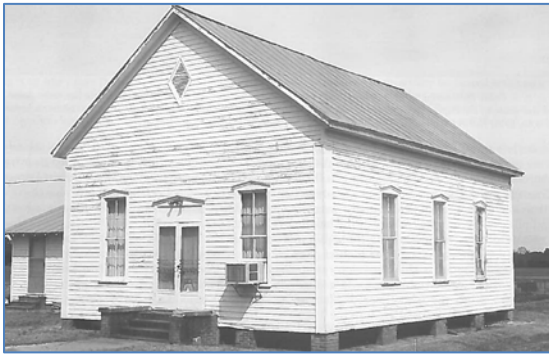
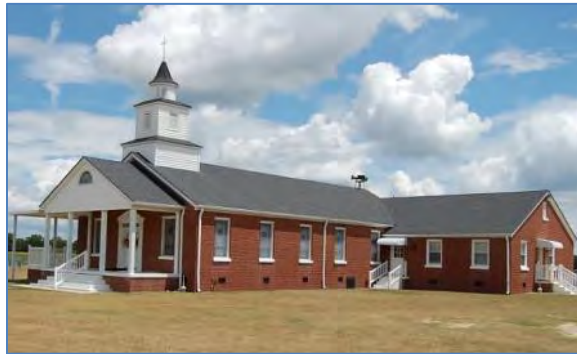
According to *Coastal Plain and Fancy* (Little et al. 1998:79), churches built in the county starting in the late 1800s were commonly frame, front gabled, and lacking steeples. Daly’s Chapel Free Will Baptist Church (LR-0998) in 1998 retained its original late nineteenth-century form, weatherboards, and four-over-four sash, which were embellished with corner pilasters and pedimented surrounds at the entry and windows (Figure 50). This church was demolished and replaced by 2010.

**Figure 50: Daly’s Chapel Free Will Baptist Church: in 1994, at left (photographer: Robbie Jones), and replacement church, at right, in 2017.**

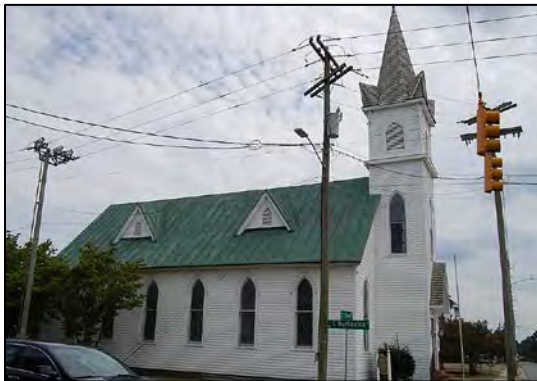
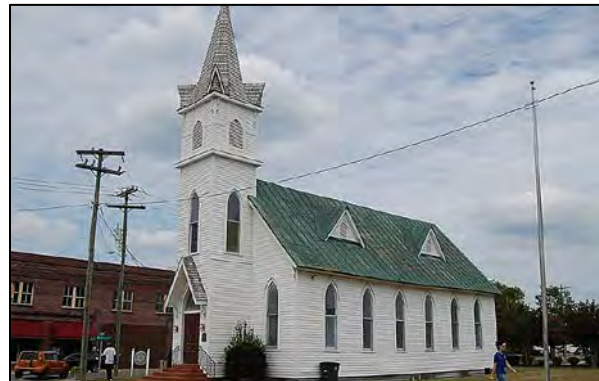
Two Gothic Revival-style town churches are at the upper end of the type of gable-front church found out in the county, the NRHP-listed former LaGrange Presbyterian Church (Rotary Club Building) (LR-0006), built in 1892 (Little and Sumner 1986), and the 1895 former LaGrange Free Will Baptist Church (LR-1134) (Figure 51 and Figure 52). Built of frame within two blocks of each other only three years apart, they are, according to *Coastal Plain and Fancy* (Little et al. 1998:301) “undoubtedly designed and built by the same carpenter.” Both are three bays wide and six bays deep, with pairs of dormers at either side elevation, narrow lancet windows, and prominent steeples. The refinement of their stained glass, molded surrounds, and original steeples and soaring spires separate them from their country contemporaries, though their basic forms are largely the same. They are little altered, although both have been vinyl sided.

**Figure 51: LaGrange Presbyterian Church: north side and west front elevations, at left, and west front and south side elevations, at right, 2017.**

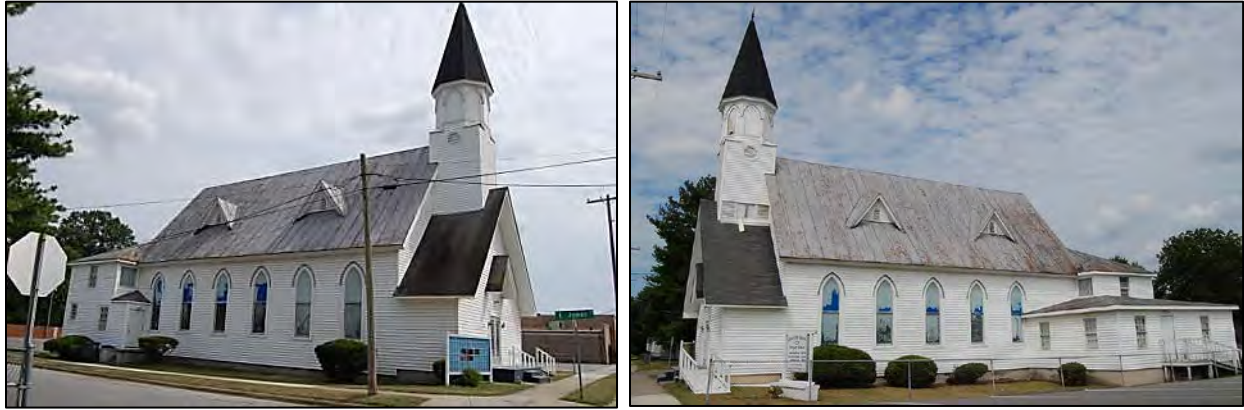
**Figure 52: LaGrange Free Will Baptist Church: north side and west front elevations, at left, and west front and south side elevations, at right, 2017.**

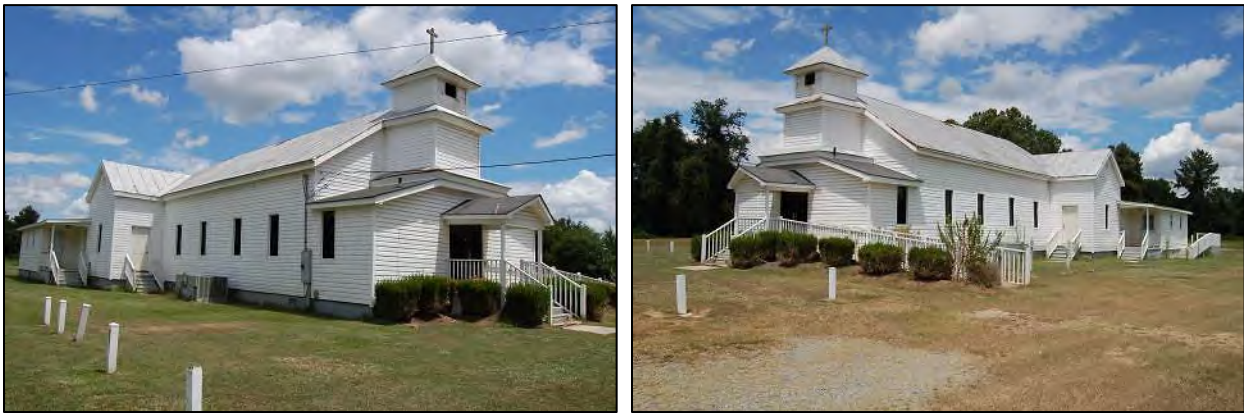
All of Lenoir County's rural churches that survive from the period are altered to a greater or lesser extent. The following seven are representative. An African-American congregation erected Rockford Chapel Free Will Baptist Church (LR-0993) near LaGrange about 1915 (Figure 53). The church is frame with a T-shaped footprint. Its windows have been replaced and its vestibule and stepped tower-like steeple may be later additions. It is covered with vinyl which, though not original, partly reflects its original weatherboarded appearance. (All of the surviving rural churches are believed to have been built with weatherboard cladding, but all are re-sided. Most of the later siding is brick veneer, which is often out of character.)

**Figure 53: Rockford Chapel: west side and south front elevations, at left, and south front and east side elevations, at right, 2017.**

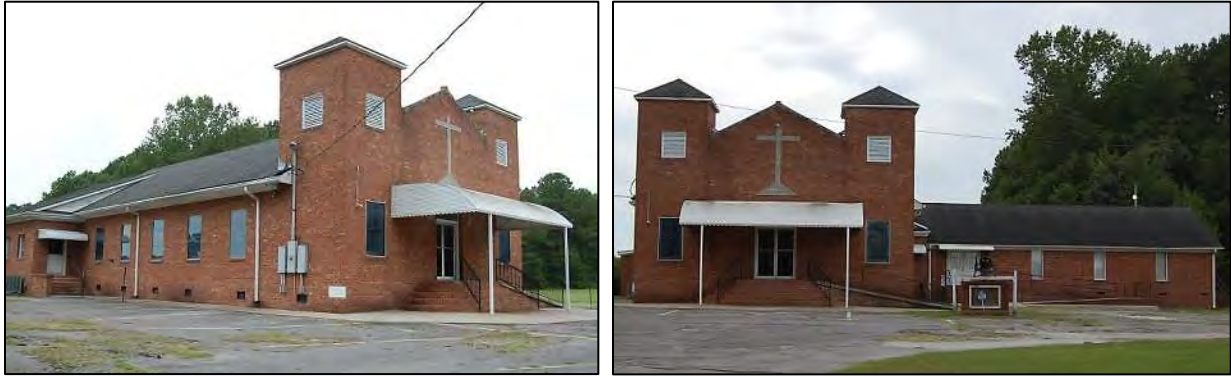
Another African-American congregation erected the Vine Swamp Church of Christ (LR-1205) in the vicinity of Elm Grove early in the twentieth century (Little et al. 1998:425) (Figure 54). Its church retains opalescent stained-glass windows and paired corner towers. In the 1950s the congregation added a cinderblock cross-wing at the rear and brick-veneered the building. A large wing extending to the building's northwest postdates 1988. Although the church was originally weatherboarded, its brick veneer conforms to some extent with its towered design. It recalls the appearance of such refined black churches, erected of brick with towers, as Kinston's Saint John's United African Free Will Baptist Church (ca. 1914) and LaGrange's Ebenezer Missionary Baptist Church (1920).

**Figure 54: Vine Swamp Church: southeast side and northeast front elevations, at left, and northeast front elevation and later wing, at right, 2017.**

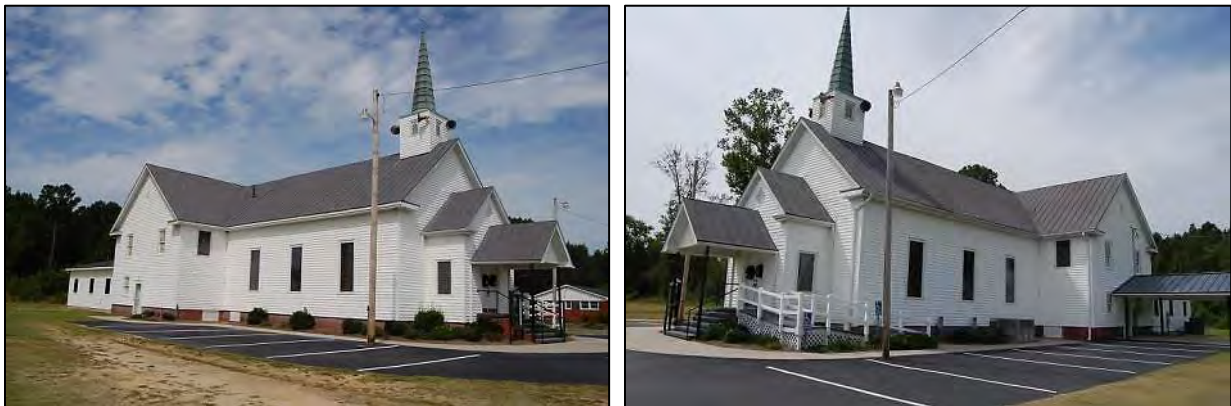
Airy Grove Christian Church (LR-0793) rose near Kinston around 1895. Its sanctuary is “typical of churches in the county—frame, front gable, one bay wide, and three bays deep” (Little et al. 1998:328). Its steeple is a later addition, as are its windows, and a large education wing was added across the rear prior to 1998. Although re-sided, it is clad with vinyl in imitation of its original weatherboards (Figure 55).

**Figure 55: Airy Grove Christian Church: southeast side and northeast front elevations, at left, and northeast front and northwest side elevations, at right, 2017.**

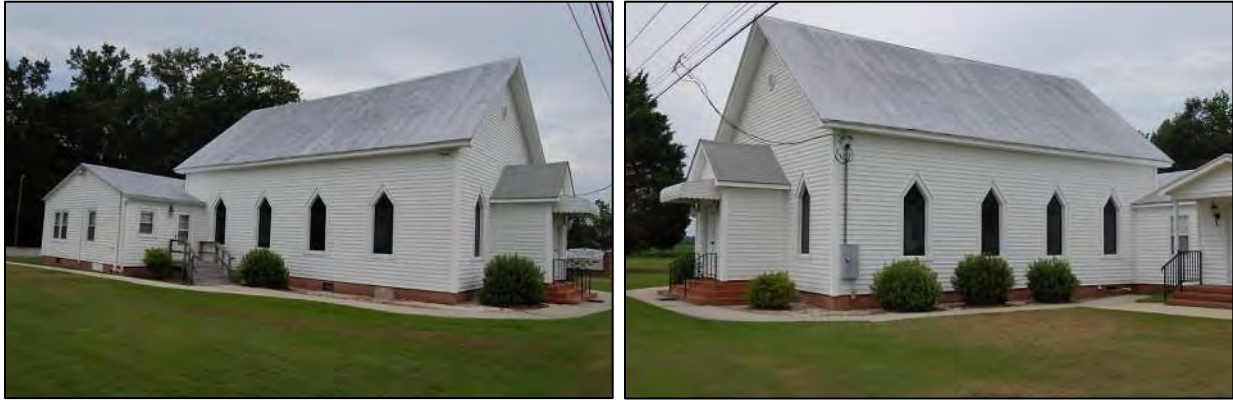
Bethel Christian Church (LR-0719) near Grifton dates from 1925. It is more intact than many contemporaries in the county. Although remodeled in 1956, it retains its gable-front T-plan design and pointed-arch windows. Further, a steeple was not added to it and its weatherboards are covered with vinyl rather than brick veneer (Little et al. 1998:354) (Figure 56).

**Figure 56: Bethel Christian Church: south side and east front elevations, at left, and east front and north side elevations, at right, 2017.**

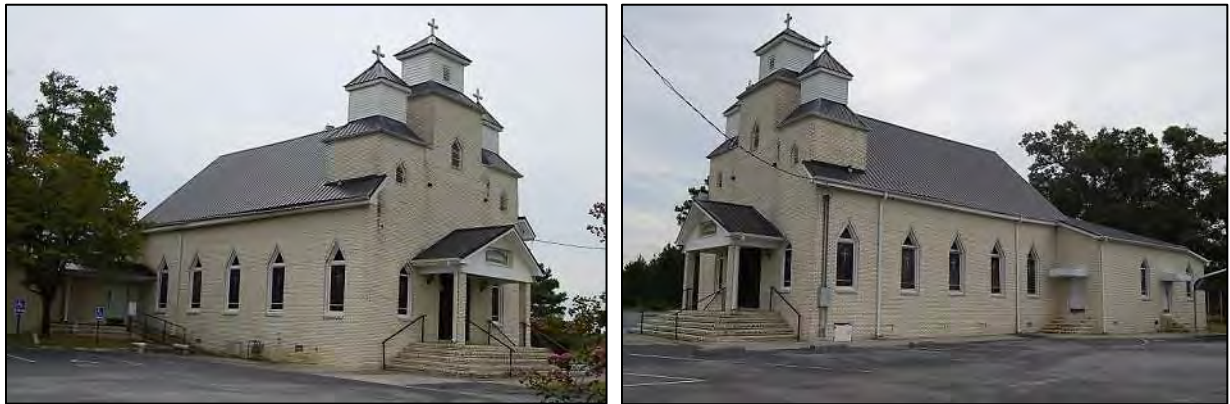
The grandest of the county's rural churches is the Sand Hill Free Will Baptist Church (LR-0730) near West Crossroads. It was built around 1888 with three front towers, reflecting the popularity of the towered form among Lenoir's African-American congregations (Figure 57). Its triangular-arched bays appear to be original, but its steeples do not. In 1972 the congregation brick-veneered the building and added a side wing (Little et al. 1998:83, 386).

**Figure 57: Sand Hill Free Will Baptist Church: north side and west front elevations, at left, and west front and south side elevations, at right, 2017.**

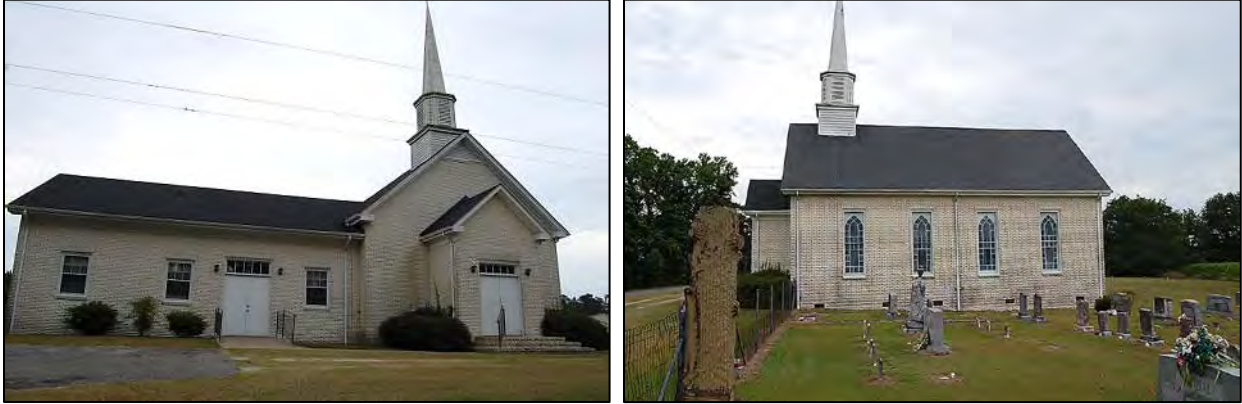
The church looks much like it did in the late 1970s (Figure 58).

**Figure 58: Bethany United Methodist Church: west front elevation with added classroom wing, at left, and south side elevation and cemetery, at right, 2017.**

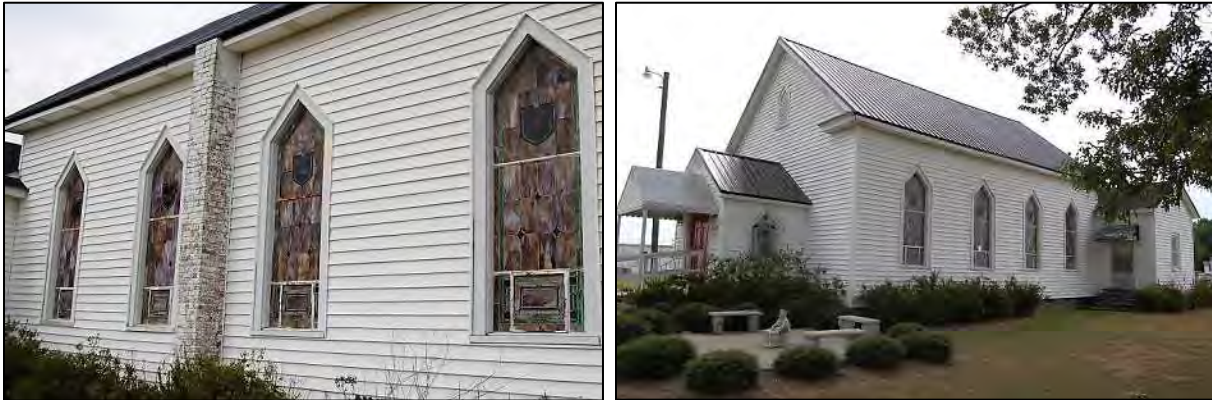
Edwards Chapel United Methodist Church (LR-0758), built in the Fountain Hill community in 1912, retains its original steeple-less gable-front form, cornice returns, and triangular-arched stained-glass windows, (Little et al. 1998:346). Its relatively minor changes include the addition of a small front vestibule and rear addition in the mid-twentieth century and the covering of its weatherboards with vinyl siding (Figure 59).

**Figure 59: Edwards Chapel United Methodist Church: east side elevation, at left, and north front and west side elevations, at right, 2017.**

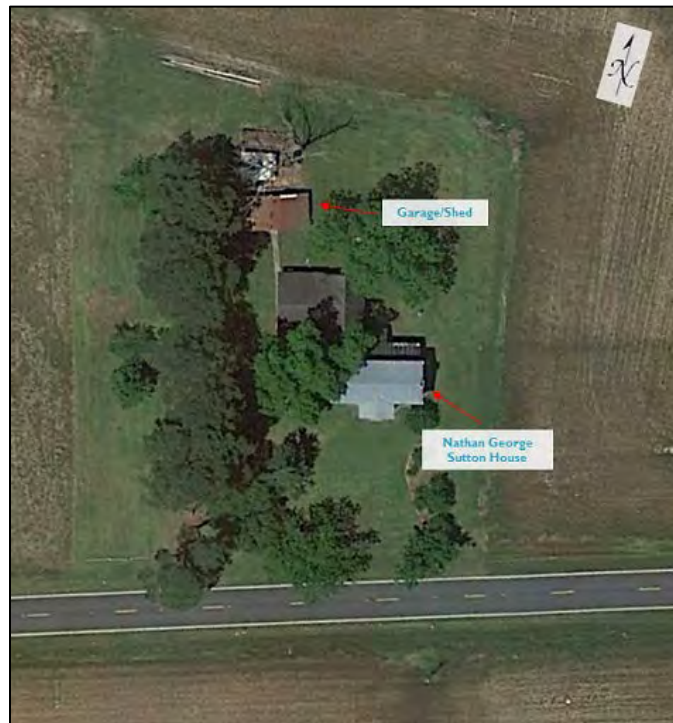
The Nathan George Sutton House sits at the northwest corner of a 137-acre rural parcel south of the US 70 corridor and LaGrange. Surrounded by farmland, the parcel contained multiple outbuildings when it was last surveyed in 2010. With the exception of a garage to its north, all of these resources have disappeared from the landscape (Figure 60).

**Figure 60: Site plan of Nathan George Sutton House with Mays Store Road at bottom (base image courtesy of Google Earth).**

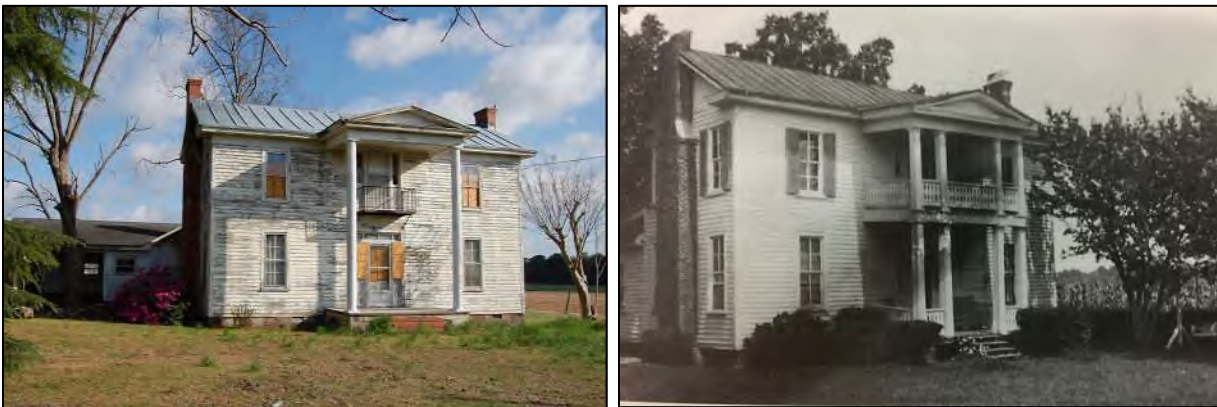
Likely built between 1870 and 1880, the frame Sutton House is one room deep, two stories tall, and three-bays wide. It originally stood on a brick-piered foundation that has since been filled in with concrete masonry blocks. The side-gabled house retains its original weatherboards,

cornerboards, cornice returns, and boxed eaves, but features a replacement standing-seam-metal roof. Typical of the I-house form in the state, two exterior-end brick chimneys are found on the building's east and west gable ends (Figure 61 through Figure 64).

**Figure 61: Nathan George Sutton House: at left, west side and south front elevations in 2017 and, at right, in the 1990s (source: *Coastal Plain and Fancy*).**

The Nathan George Sutton House retains its two-story, single-pile, center-hall-plan form, along with weatherboards, cornerboards, cornice returns, and boxed eaves. Its two-tier front porch, however, has been jarringly replaced by two modern full-height columns. A second major addition is the large modern ell and carport affixed to its northwest corner. The house's curving staircase is early and refined, but the first floor otherwise appears to be largely altered. Due to these alterations and additions, the house no longer retains its integrity and is recommended as not eligible for NRHP listing. When compared with the two-story houses discussed above at Section 3—both those from the antebellum period and the later nineteenth century—its loss of physical integrity is apparent and it is accordingly not recommended as NRHP eligible under Criterion C for its architecture. The house additionally lacks association with any notable historic event or figure. It therefore is recommended as not significant under Criteria A and B. It is not likely to yield important historical information on the basis of its appearance or construction. Accordingly it is not recommended as NRHP-eligible, as an architectural resource, under Criterion D.

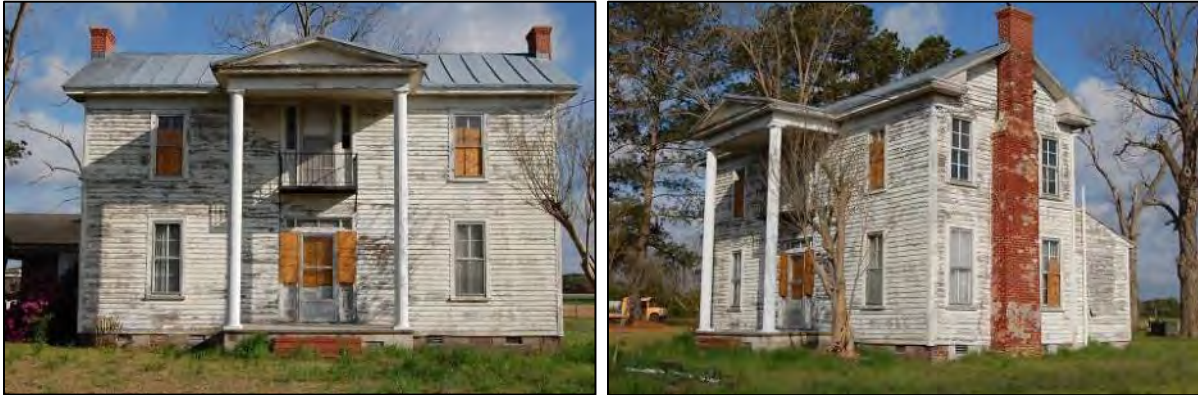
A two-story pedimented portico frames the central bay of the house's south front elevation. Two modern metal columns support the original pediment, which features a molded cornice, a deep set tympanum, and an unadorned frieze. The original two-story four-column porch survived at least into the mid-1990s, though it had been replaced by its 2010 re-recording. The house in the 1990s also retained its original trabeated front entry. The sidelights and door are currently boarded over, but match those still exposed at the bay centered. The current narrow, modern, second-story balcony is only a shadow of the one it supplanted, which had an ornate sawnwork balustrade. The same balustrade treatment framed the first-story porch as well. The house retains its original four-over-four double-hung windows, which are set in plain surrounds.

Figure 62: Nathan George Sutton House: at left, south front elevation; at right, south front and east side elevations.

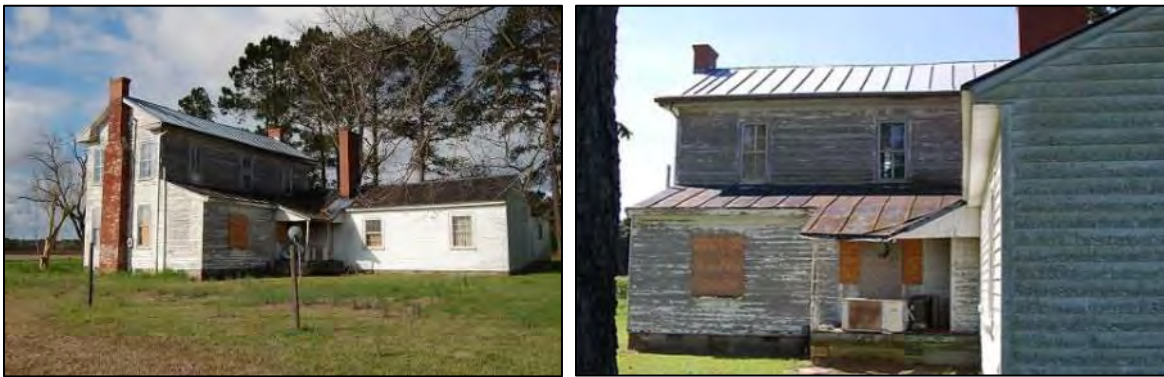
A long, one-story, shed-roofed room crosses two-thirds of the north rear elevation. A bay on its east side is weatherboarded over; another facing north is covered with plywood. The entry in the shed, which is centered at the rear elevation, is now boarded over. When viewed in 2010, its sidelight treatment matched that of the front elevation, indicating the shed is original. Further, it is supported by brick piers like those of the main block. A chunky tapered column that still edges its one-bay porch looks like it too may be an early or original feature. Next to the shed, also affixed to the house's rear, is a one-story gabled ell and that was likely the house's kitchen.

Figure 63: Nathan George Sutton House: at left, east side and north rear elevations; at right, north rear elevation.

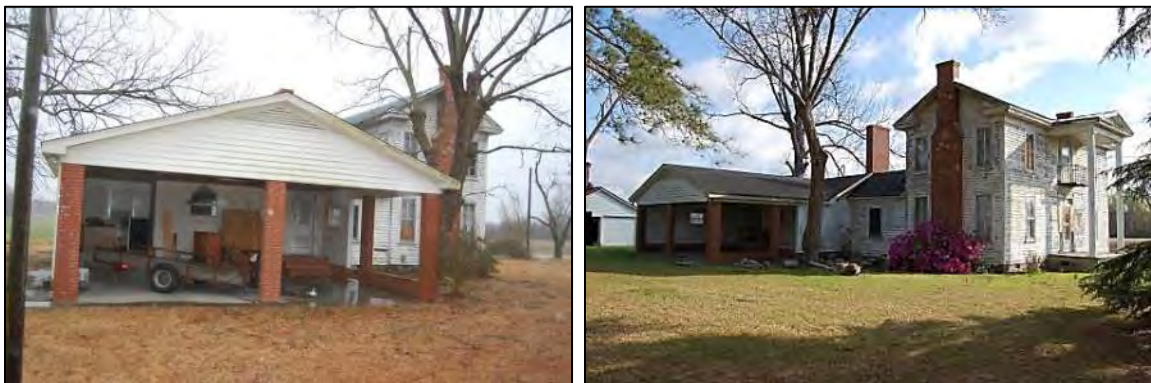
The substantial addition that extends from the house's northwest rear corner is decidedly later, apparently dating from around the turn of the twentieth century. It contains a long wing to the rear of the ell that is served by a tall massive brick chimney. Projecting from the west side of this wing is two-vehicle carport supported by brick columns. The footprint of the addition is almost equal in size to that of the house, although it only stands a single story tall.

Figure 64: Nathan George Sutton House: west side and south front elevations.

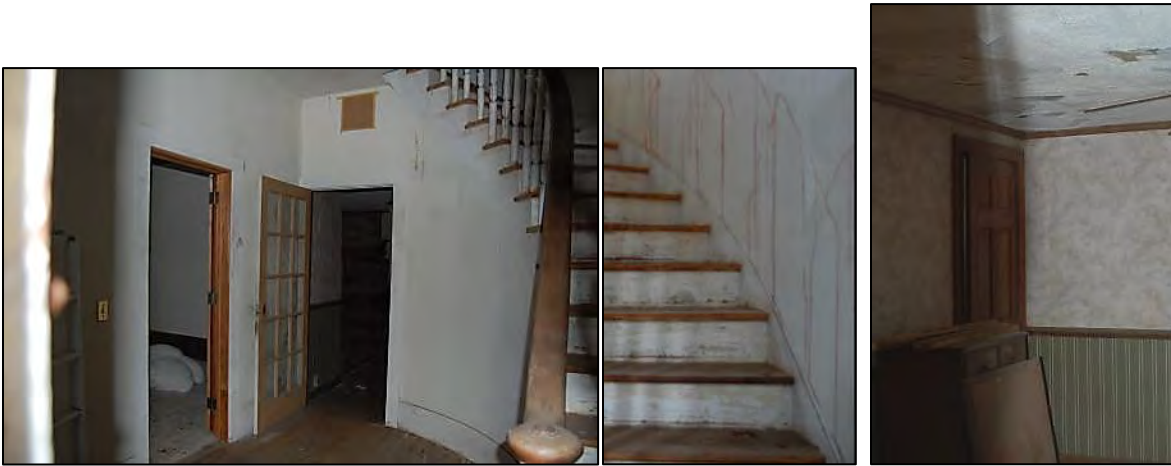
to the house. The elegant curved staircase, from its curvilinear wall to its walnut handrail and turned balusters, is a feature found more often in urban houses than even comfortably affluent country farmhouses.

**Figure 65: Nathan George Sutton House: at left, composite view of stair hall, 2010; at right, west parlor, 2017.**

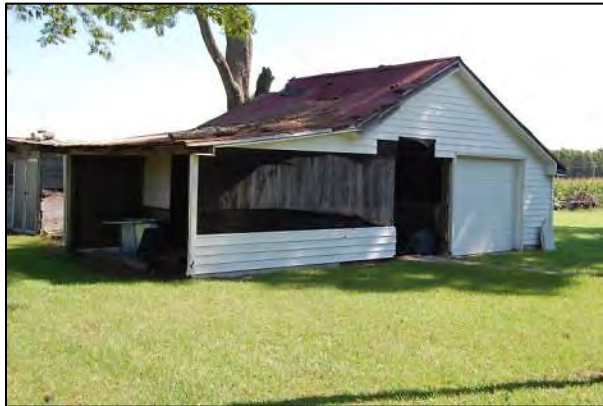
A side-gabled frame garage to the house's rear may date from the early or mid-twentieth century. Its vinyl siding and modern garage door, though, give it the appearance of a late twentieth century building (Figure 66).

**Figure 66: Nathan George Sutton House: view of garage/shed looking north.**

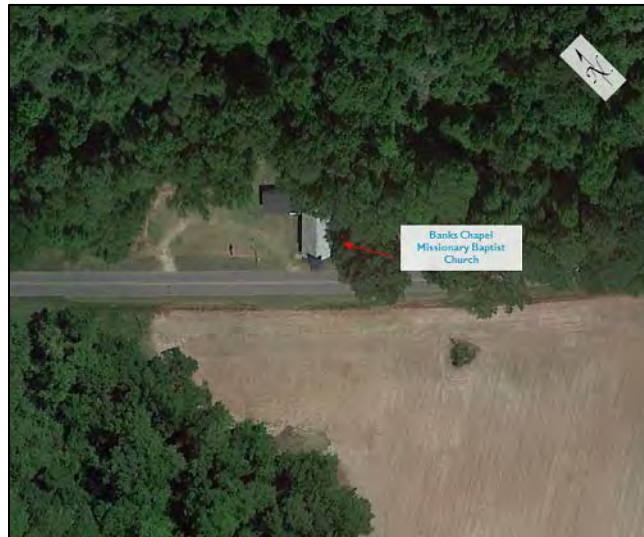
Located just over seven miles west of Kinston, north of the US 70 corridor, Banks Chapel Missionary Baptist Church is situated on a one-half-acre lot, close by the east side of Eason Road. The church stands in a small clearing and is surrounded on its north, east, and west sides by dense woods. It is the only resource on the parcel, which does not even include a parking lot (Figure 67).

**Figure 67: Site plan of Banks Chapel Missionary Chapel with Eason Road at center (base image courtesy of Google Earth).**

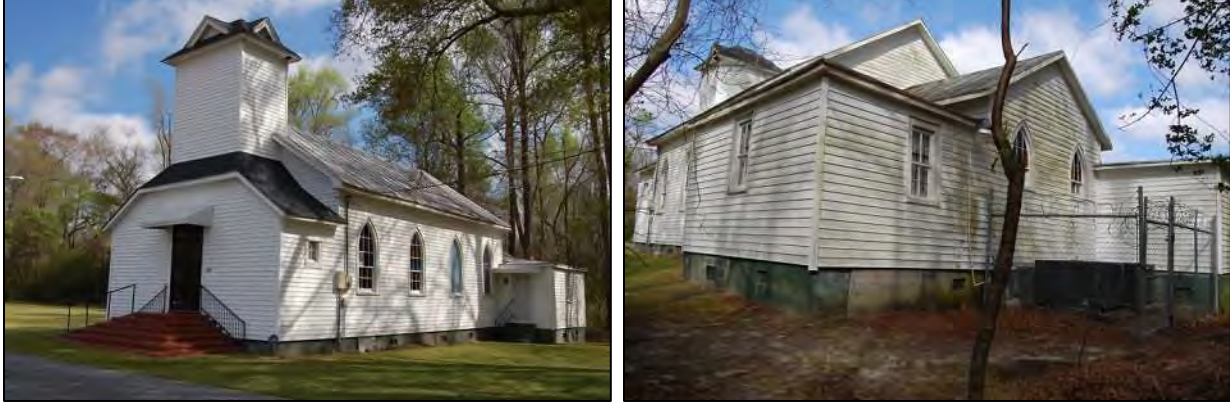
Dating from around the turn-of-the-twentieth-century, the frame church, clad in later-added vinyl siding, rests on a continuous concrete masonry block foundation and features a rambling T-shaped plan (Figure 68 and Figure 69). Its original front-gabled central block, constituting the building’s sanctuary, stands one bay wide and four deep. Topping the south front ridge of the church’s gabled roof is a simple wood frame steeple clad in vinyl siding that is a later addition. The church’s south-facing entrance is accessed through a vestibule that is also a later addition. Like the rest of the building, it is clad in later vinyl siding. Its centered double glass doors are modern. A brick stair framed with cast iron railings leads to the door.

Four original arched windows filled with multi-colored lights adorn both the east and west side elevations of the sanctuary. At sanctuary’s rear a small squat apse extended to the north includes

similar arched windows, which suggest that it is original to the church. Two later wings of unequal length project to either side of the apse. Separate from the worship space, they are likely utilized for church programming and other events. Despite multiple site visits, interior access to the building was unavailable.

**Figure 68: Banks Chapel: at left, south front and east side elevations; at right, east side and north rear elevations with original apse at center.**

Due to its alterations and additions, Banks Chapel Missionary Baptist Church no longer retains its integrity and is recommended as not eligible for NRHP listing. Its weatherboards are covered with vinyl and its front vestibule and the steeple atop it are additions. Also later added are the one-story wings that extend in three directions from its rear. Its integrity, as well as its design, is not equal to that of other similarly fashioned churches in Lenoir County, including LaGrange Presbyterian Church, LaGrange Free Will Baptist Church, and Sand Hill Free Will Baptist Church, discussed at Section 3, above. Therefore it is not recommended as NRHP eligible under Criterion C for its architecture. The church further lacks association with any notable historic event or figure and is accordingly recommended as not significant under Criteria A and B. It is not likely to yield important historical information on the basis of its construction or appearance. It is therefore not recommended as NRHP-eligible, as an architectural resource, under Criterion D.

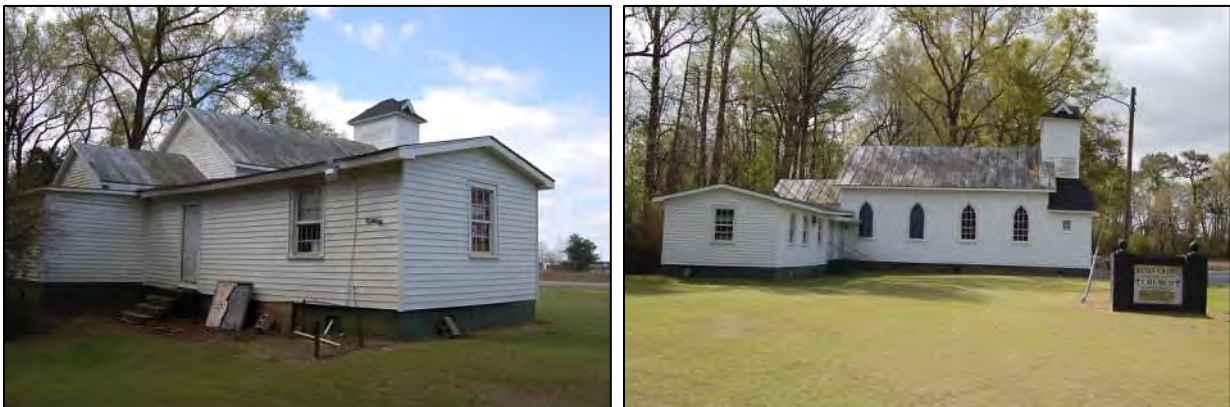
**Figure 69: Banks Chapel: at left, north rear and west side elevations; at right, west side elevation.**

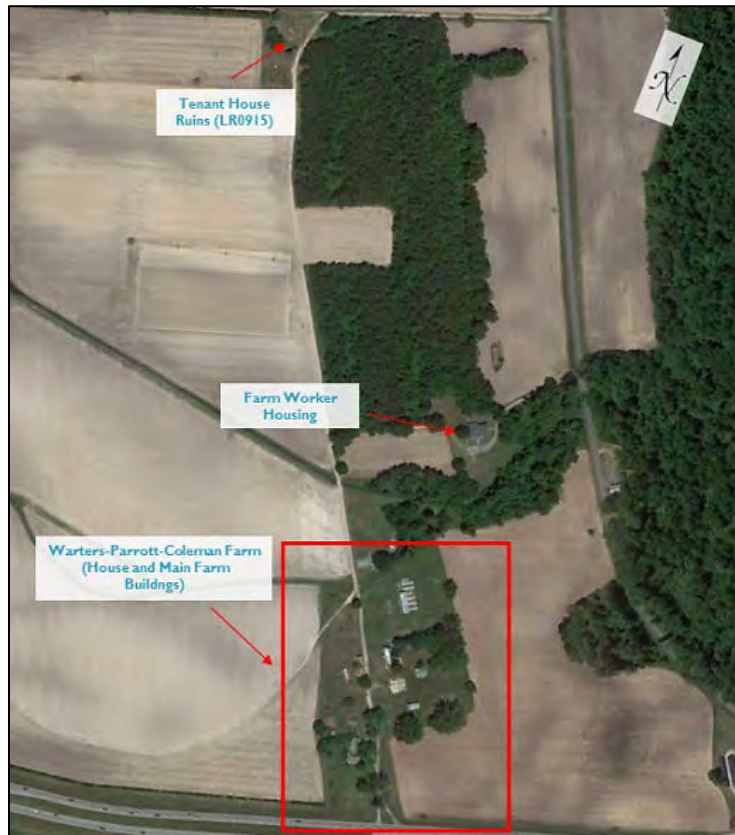
The Warters-Parrott-Coleman House is situated on a 308-acre parcel of agricultural land on the north side of US 70 between LaGrange and Kinston. The house and numerous accompanying secondary buildings—remnants of a twentieth-century tobacco farm—sit on an open green space at the southern side of the large parcel. The farm complex is surrounded on its northern, eastern, and western sides by actively farmed fields (Figure 70 and Figure 71).

**Figure 70: Site plan of Warters-Parrott-Coleman Farm (base image courtesy of Google Earth).**

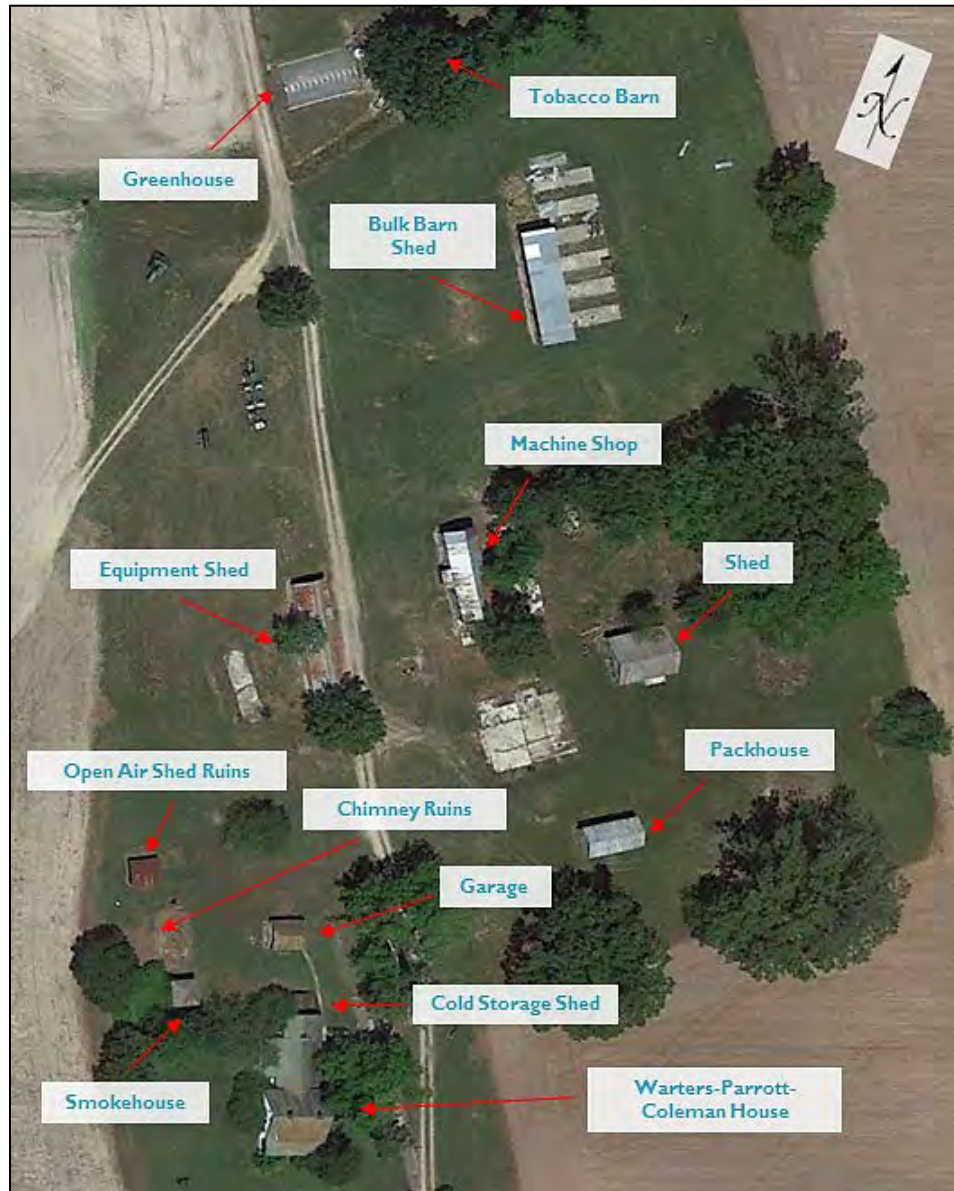
**Figure 71: Zoom view site plan of Warters-Parrott-Coleman Main Farm Buildings (base image courtesy of Google Earth).**

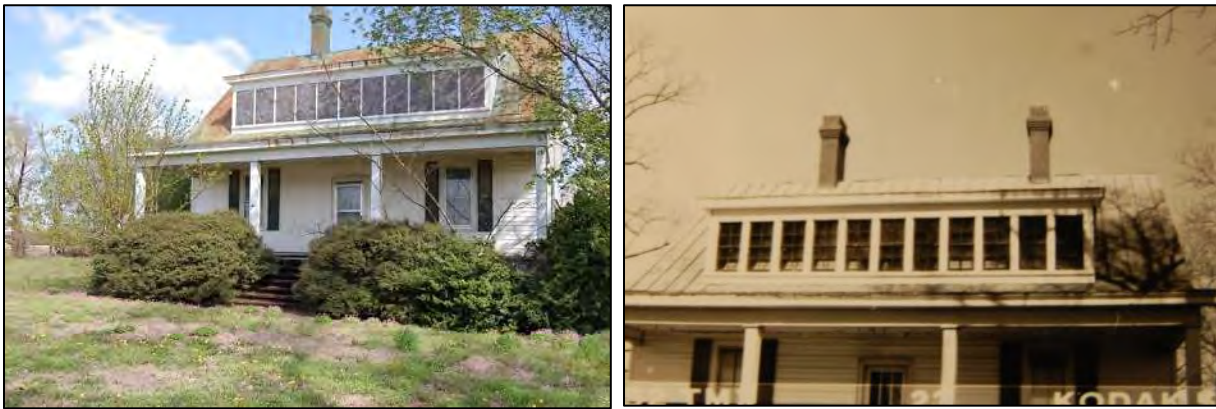
**Figure 72: Warters-Parrott-Coleman House: south front elevation with boarded-over shed dormer in 2017; and shed in 1994 with at least part of roof to its rear visible through windows (Robbie Jones).**
