North Carolina Department of Natural and Cultural Resources  
State Historic Preservation Office

MEMORANDUM

Subject: Historic Architecture Eligibility Evaluation Report, US 70 Kinston Bypass, R-2553,  
Lenoir County, ER 09-1307

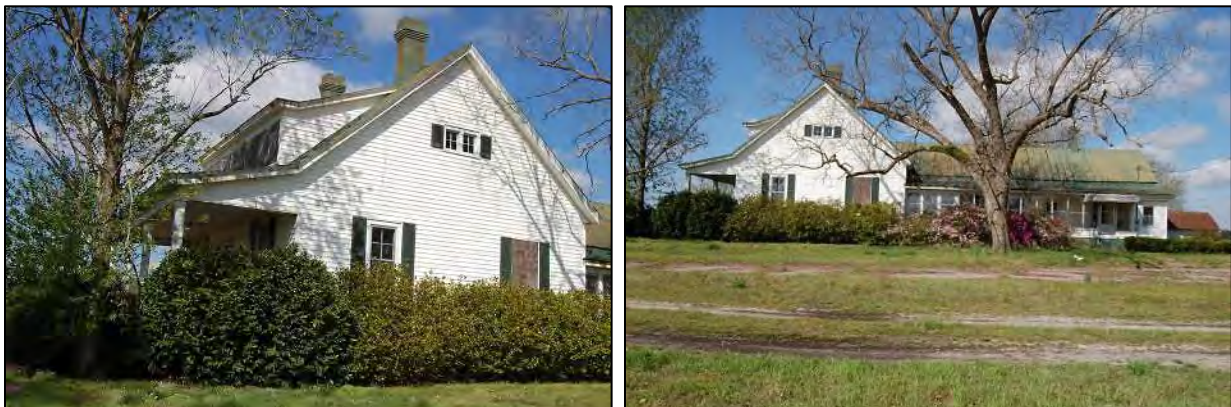
The frame Warters-Parrott-Coleman had two principal building phases. Its front block, which faces the road, appears to date from the late nineteenth century. The rear ell was likely built a decade or two earlier. The one-and-a half-story, two-pile, front block sits atop a continuous concrete-block foundation and is topped with a steeply pitched side-gabled roof. The roof is clad in standing-seam metal and features two centrally located interior ridgeline chimneys. An 11-bay shed roof dormer that featured four-over-four double-hung windows—now hidden behind plywood—sits atop the block’s south-facing front elevation. A prominent feature of the house, it is likely an early/mid-twentieth-century addition. Curiously, dormer never appears to have opened into the house; photographs taken before it was boarded over appear to picture the roof to

its rear. The house's original weatherboards are covered by vinyl siding. An early shed-roofed porch supported by four square wooden columns extends across the front elevation. In its shade is a central entry flanked on either side by original four-over-four double-hung windows. Two identical windows are found on both the east and west gable ends. In addition, two paired, fixed, four-light windows pierce the gable peaks at the side elevations (Figure 72 through Figure 75).

**Figure 73: Warters-Parrott-Coleman House: south front and east side elevations, at left; east side elevation, at right.**

While the house's principal front block retains its one-and-a-half-story, gable-end, double-pile form and long shed-roofed dormer, many alterations have been made to it. It is sided in vinyl, its porch posts are replacements, and some of its windows, including those of its dormer, have been enclosed. The rear ell, likely the house's original block, retains some original sash, but its east-facing porch has been enclosed and a later shed room extends from its west-facing elevation. It too is vinyl sided. Inside, the front block retains at least one original post-and-lintel mantel, but it has been sheetrocked and many of its doors have been replaced. The interior of the ell has also been modernized. When compared with the houses that most closely match its period of

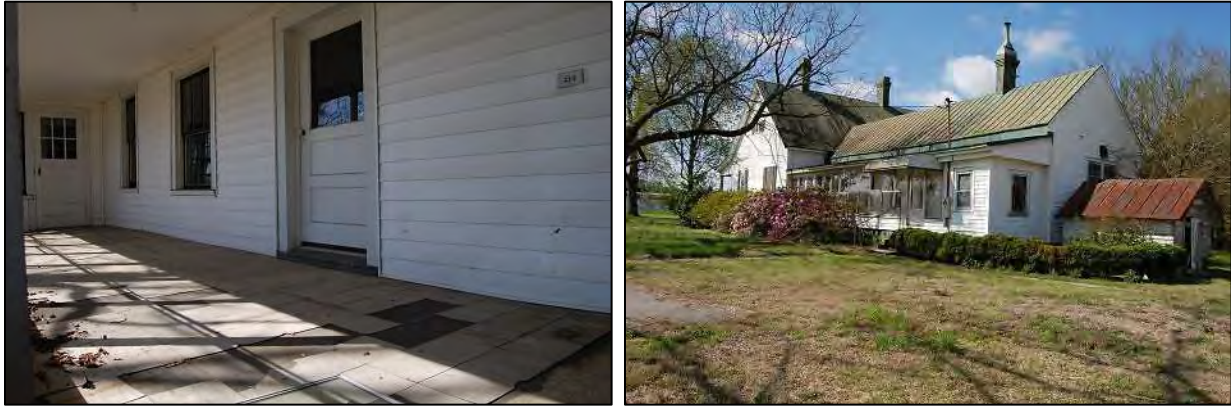
**Figure 74: Warters-Parrott-Coleman House:** at left, east side elevation of ell at sunporch; at right, east side and north rear elevations of ell.

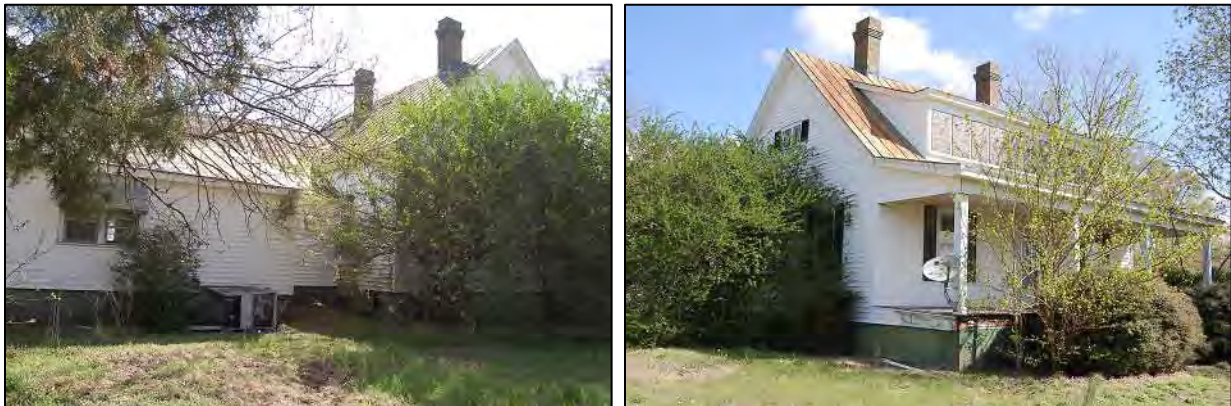
**Figure 75: Warters-Parrott-Coleman House:** at left, west side elevation with recess that may once have been an open breezeway; at right, west side and south front elevations.

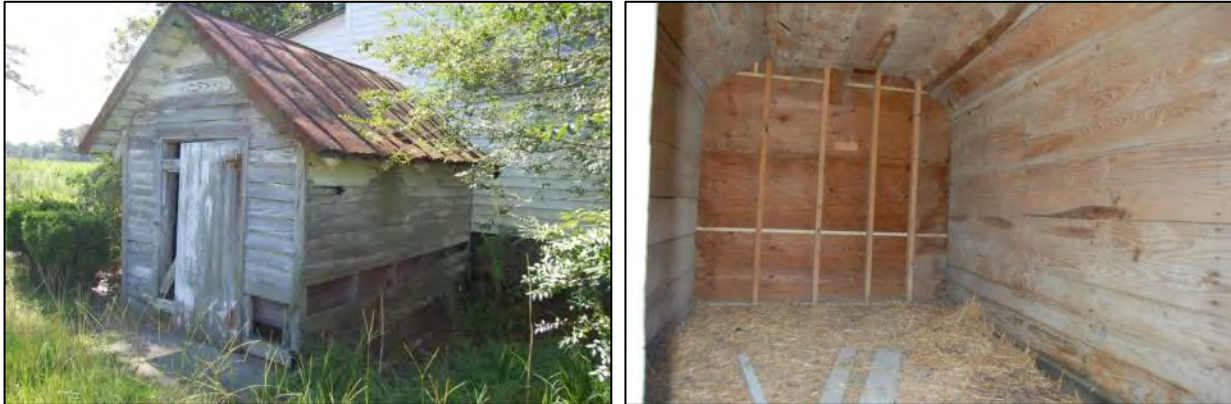
This early twentieth-century, front-gabled, frame shed is located immediately to the house's rear. It is clad in weatherboards, topped by seam-metal roof, and accessed by a wood-batten door at its north gable. The interior of the building is clad with vertical wood boards that extend over its ceiling. The space between the interior and exterior walls would have insulated items kept in the building, particularly if it was once filled straw or another material (Figure 77).

**Figure 77:** Left, view of northern elevation of shed, looking to south; right, view of interior of shed, looking south.

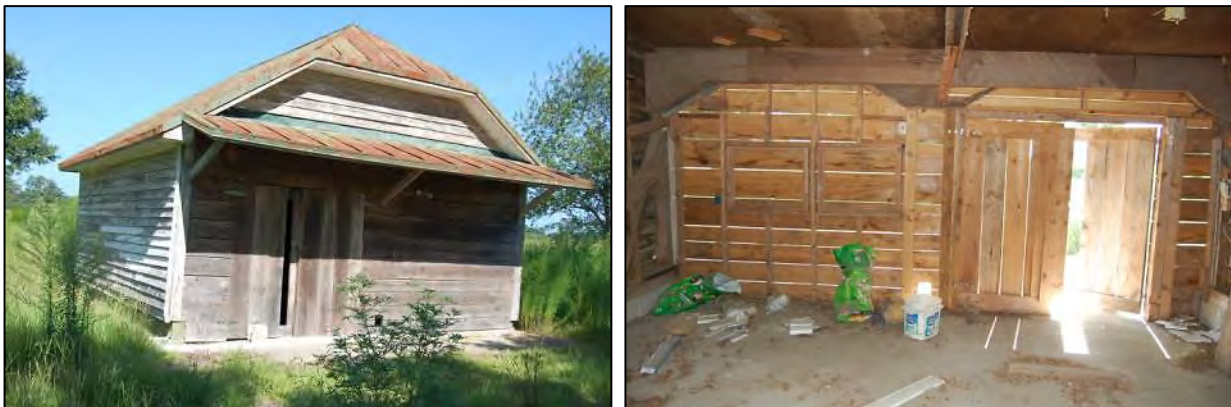
The clipped-gable frame building, which likely dates from the early twentieth century, is located near the rear of the house. This is not surprising, as it was erected as a garage. A shed-roofed shelter supported by three wooden brackets extends over the original two-bay garage openings, which have been covered. The building is clad in weatherboards (Figure 78).

**Figure 78:** South side and east front elevations of garage, at left, and interior view showing alterations, at right.

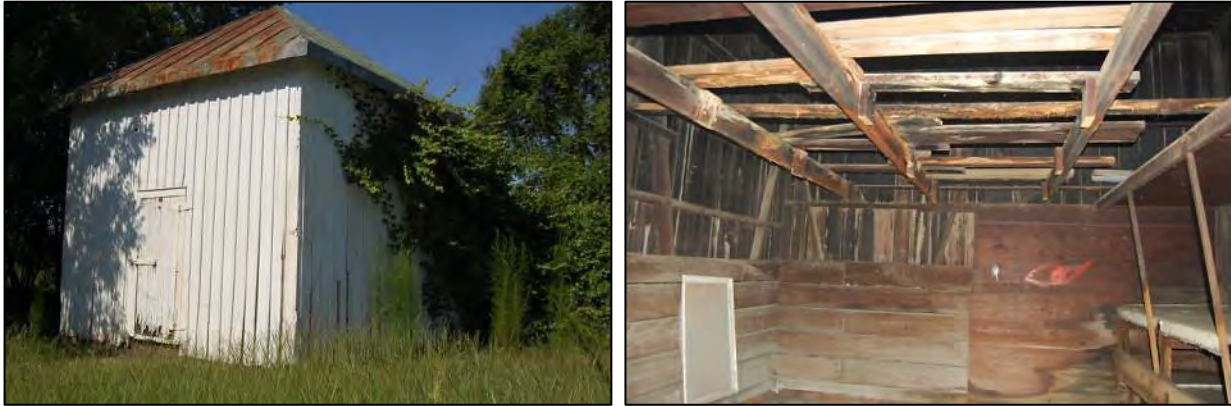
**Figure 79:** View looking northeast at smokehouse, at left, and smoke-stained interior, at right.

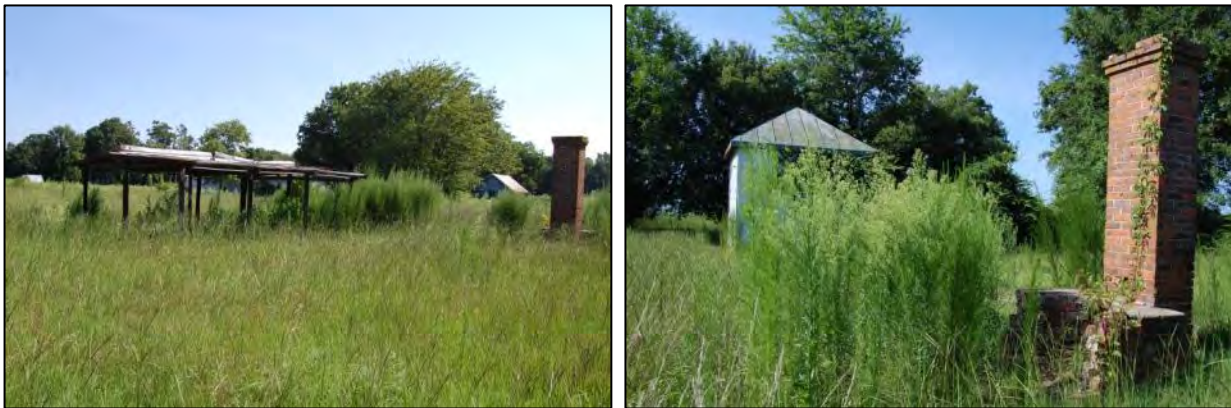
The remains of an open shed and chimney are located to the northwest of the house. Their original functions could not be determined (Figure 80).

**Figure 80:** Left, view of chimney and shed ruins, looking west; right, view of chimney ruin looking south.

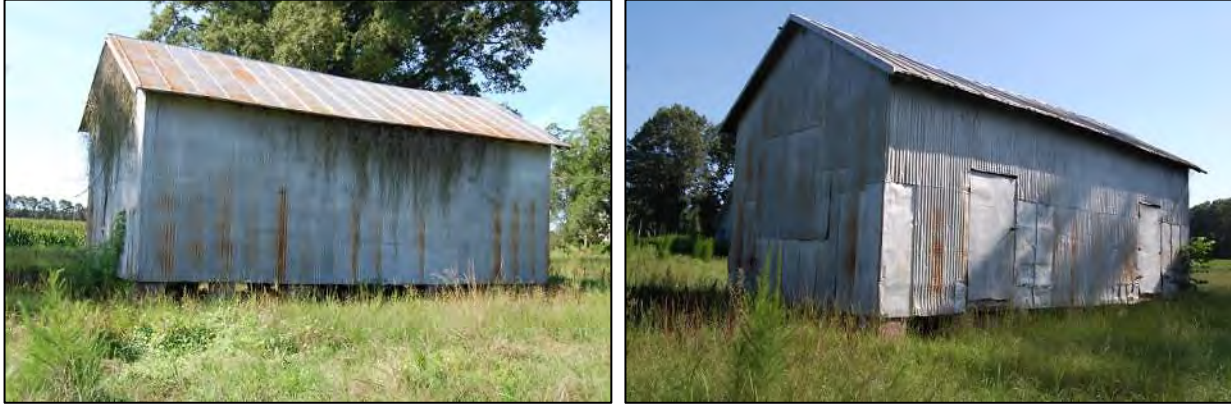
A frame early/mid-twentieth packhouse is one of a small number of tobacco-related outbuildings that still stand on the parcel. It is raised off the ground on brick piers and topped by a standing-seam, gabled roof. Its entire body, including its openings, is covered by a later addition of sheet metal. Unlike many other packhouses, it is long rather than tall (Figure 81).

**Figure 81:** At left, west elevation of packhouse, at right, south and east elevations.

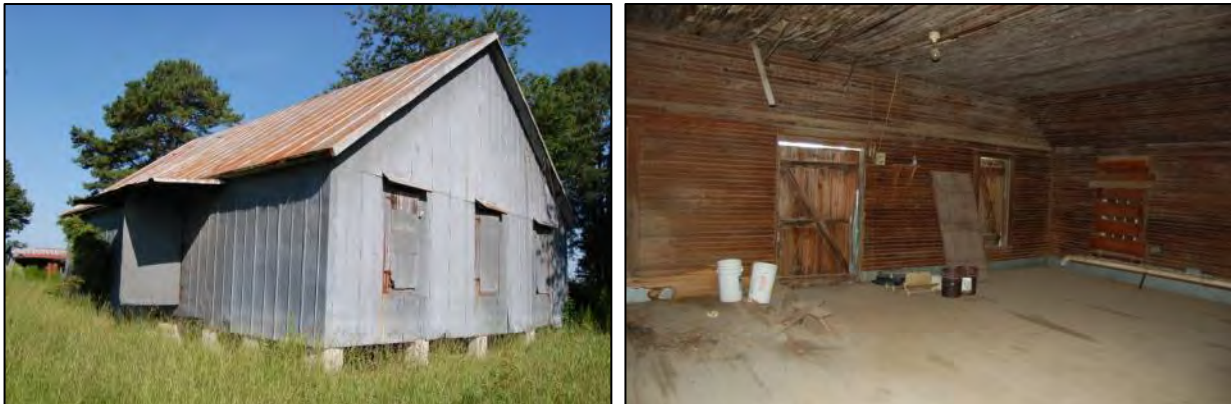
The original function of this early/mid-twentieth-century gabled outbuilding is unclear. It may have been a packhouse or a shed, but its interior is surprisingly finished with beaded wallboards. It is divided into two large rooms and does not appear to have been used as residence. It once had multiple windows and doors, all of which have been covered in sheet metal (Figure 82).

**Figure 82:** Left, view of northeast corner of Shed, looking southwest; right, view of interior of shed, looking south.

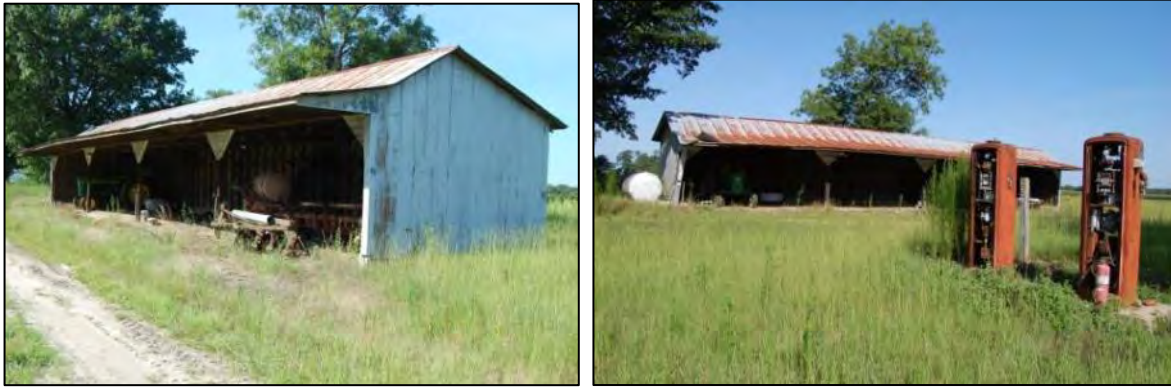
This late-twentieth-century pole building is enclosed on three sides by vertical wood siding, but open on one long elevation to facility the storage of large farm equipment. It is divided into four open bays by large wooden posts, which are covered by a metal gabled roof and overhang. Old gas pumps stand a short distance to its east (Figure 83).

**Figure 83:** At left, view looking southwest at equipment shed; at right, old gas pumps a short distance to its front.

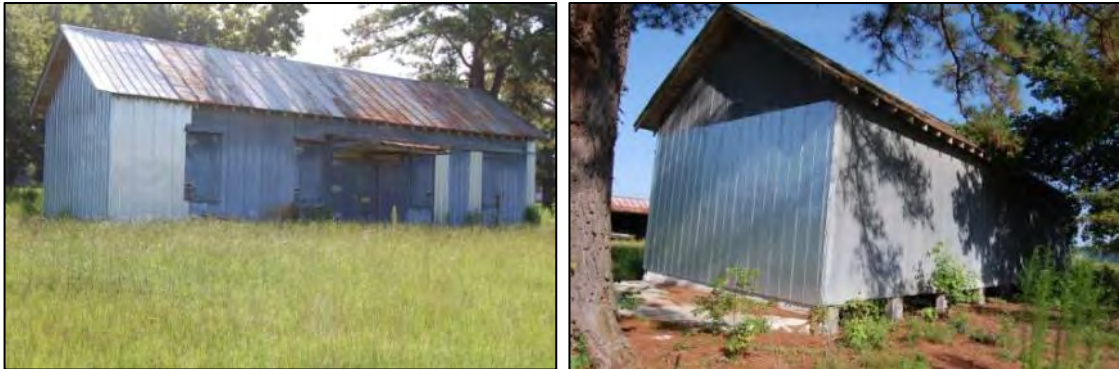
The mid-twentieth-century frame building likely served as a machine shop. Its gabled roof is topped by standing-seam metal with exposed rafter ends and its walls and former openings have been covered with vertical metal sheathing. Its varied openings suggest changing use over time (Figure 84).

**Figure 84:** At left, view looking northeast at machine shop; at right, view looking west.

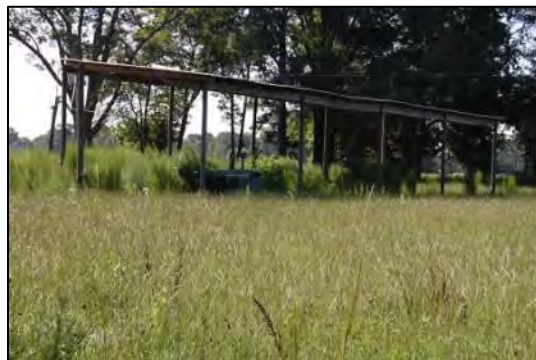
This partially intact shed once served a number of bulk barns. They have been removed but their concrete pads remain. It likely dates to the late twentieth century (Figure 85).

**Figure 85:** View of former bulk barn shed looking west.

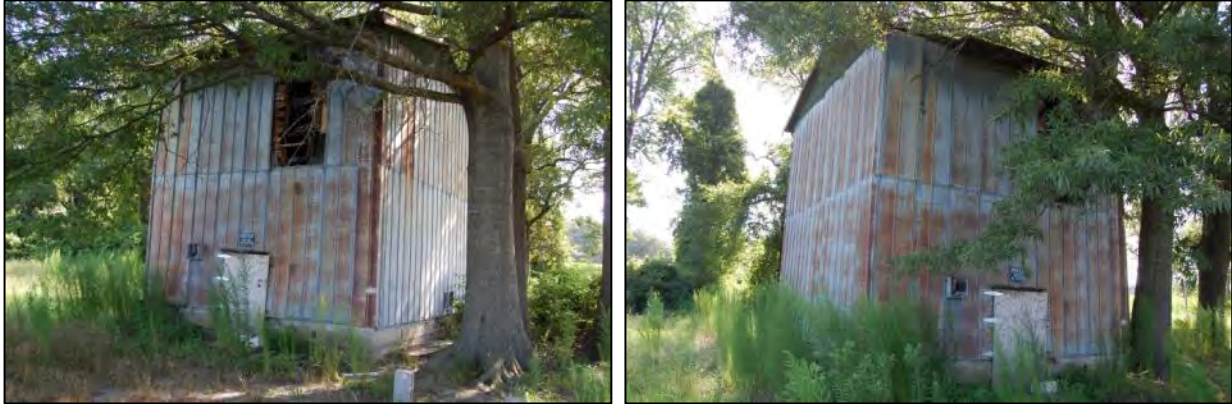
This early/mid-twentieth-century building is the only surviving tobacco barn on the parcel. Its frame was later covered with vertical metal sheathing. A gabled metal roof tops it (Figure 86).

**Figure 86:** At left, view looking northwest at tobacco barn; at right, view looking northeast.

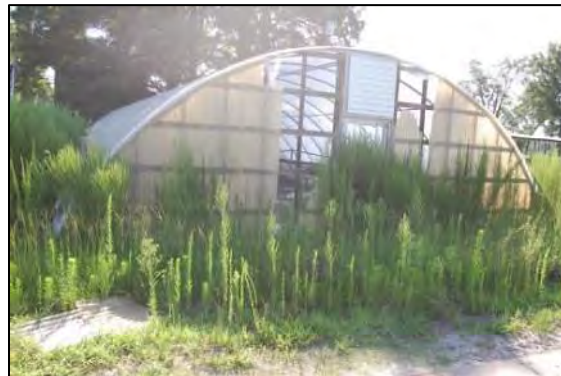
**Figure 87:** View west at greenhouse.

Opposite the barn stands this late twentieth-century, plastic-covered, cold-frame greenhouse (Figure 87).

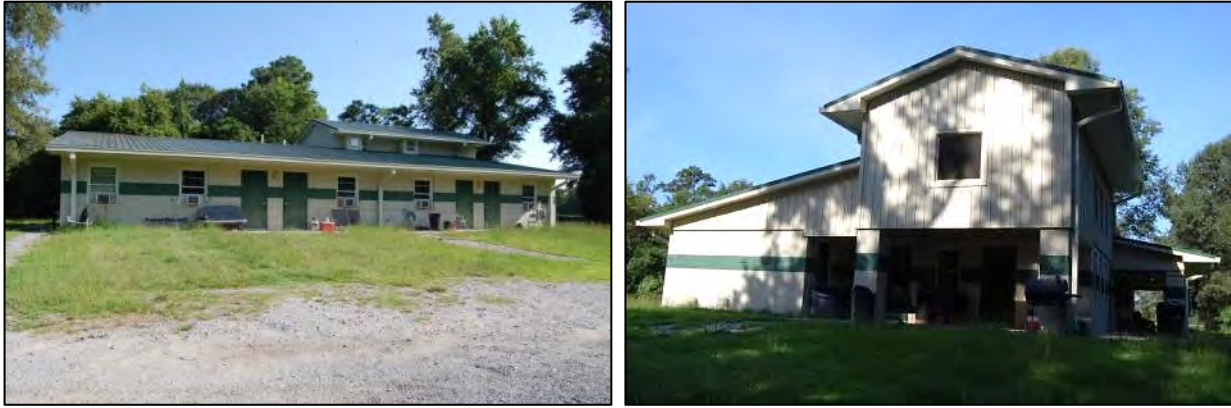
**Figure 88:** Left, view of southern elevation of Worker Housing Building; right, view of eastern elevation of building, looking west.

This one-story concrete-block building is located to the far northeast of the Warters-Parrott-Coleman House. This is not surprising, as it was built in late-twentieth or early-twenty-first-century to house farm workers. It appears to be organized much like a tiny motel unit, but with some common space at its taller section (Figure 88).

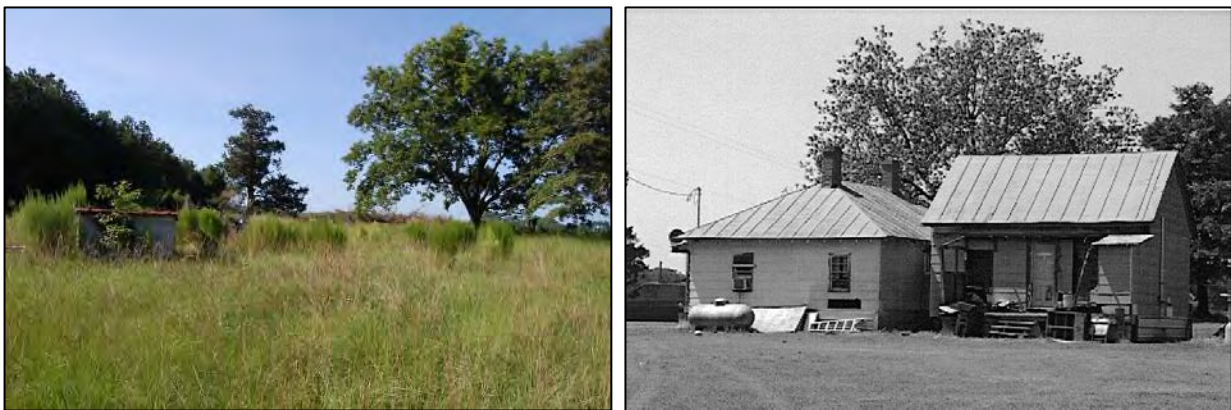
**Figure 89:** At left, view of ruins of former tenant house, looking east; at right, 1994 photograph of house (Robbie Jones).

Only ruins stand at the site of the former Warters-Parrott-Coleman tenant house. Likely built in the early twentieth century, it was located to the far northwest of the house (Figure 89).

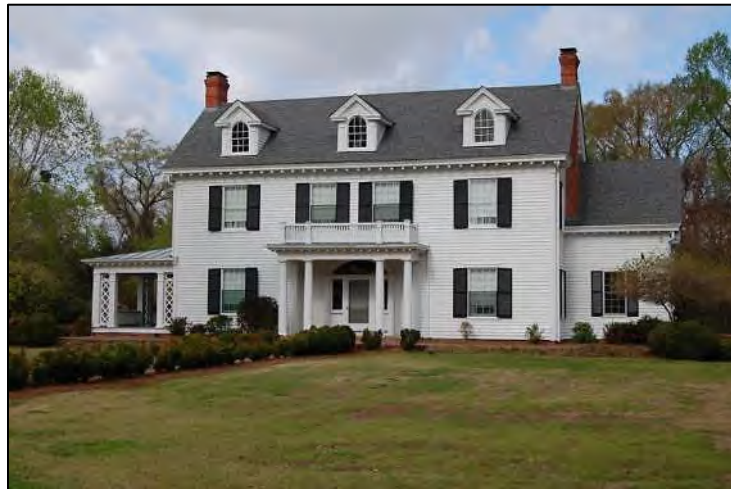
**Figure 91: James A. & Laura McDaniel House: east front elevation**

The James A. & Laura McDaniel House or Maxwood was determined eligible for NRHP listing following completion of a historic architecture eligibility evaluation report (Brown 1997). A portion of the report’s description states the following (Figure 91):

The James A. & Laura McDaniel House . . . is located west of Kennedy Home Road down a long pecan-lined lane that turns into a circle at the east front façade and continues around the house’s south side to three surviving domestic outbuildings at the rear. Rows of trees extend from Kennedy Home Road to the north and south of the lane, taking in, along the road, small fields, and closer to the house, a front lawn. Behind the house is a woodlot. . . . The McDaniel House is a large frame, weatherboarded dwelling two stories tall and two rooms deep, with a two-story rear ell that gives it a T-shaped plan. The front portico, which shades the central bay of the three-bay primary elevation, features Tuscan columns, modillion blocks, and a balustrade that fronts paired windows above the entry. The entry is adorned with an elliptical fanlight, dentil molding, and leaded-glass sidelights. . . . The interior of the house features an ornate classical finish.

Maxwood has not been altered since it was determined eligible for NRHP in 1998. It retains its integrity, is in excellent condition, and continues to merit NRHP listing.

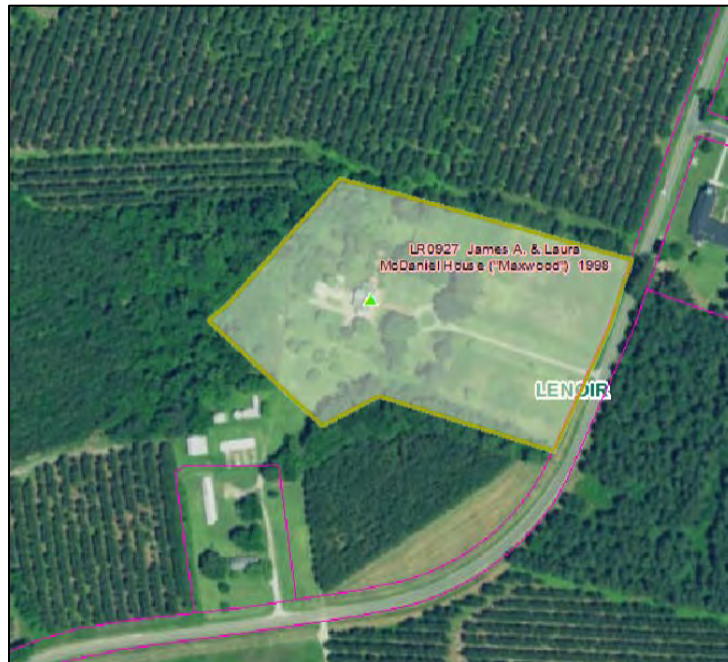
**Figure 92: NRHP-eligible boundary of James A. & Laura McDaniel House (source: <http://gis.ncdr.gov/hptoweb/>)**

Maxwood’s NRHP boundary, as recommended in the report, followed, at its east, the edge of right-of-way of Kennedy Home Road; at its north, a row of trees extending west from Kennedy

Home Road; at its west the edge of a partially cut woodlot; at its south a row of trees extending west from Kennedy Home Road; and at its southwest the edge of a side yard short of where this yard tails into a rectangular array of largely modern outbuildings (Figure 92). This boundary takes in: the front (east) grounds of the house, which include a pecan tree-lined entry drive, two small flanking fields, and grassy lawns; the side lawns, which at the north include boxwoods and shrubs and at the southeast include a grassy lawn, a few trees, and a small grape arbor; and, at the rear (west), it takes in three outbuildings immediately behind the house and a small area of open grounds behind the house and outbuildings at the edge of a woodlot. It encompasses an approximately eight-acre portion of the 325-acre property upon which the house stands and follows the existing NCDOT right-of-way.

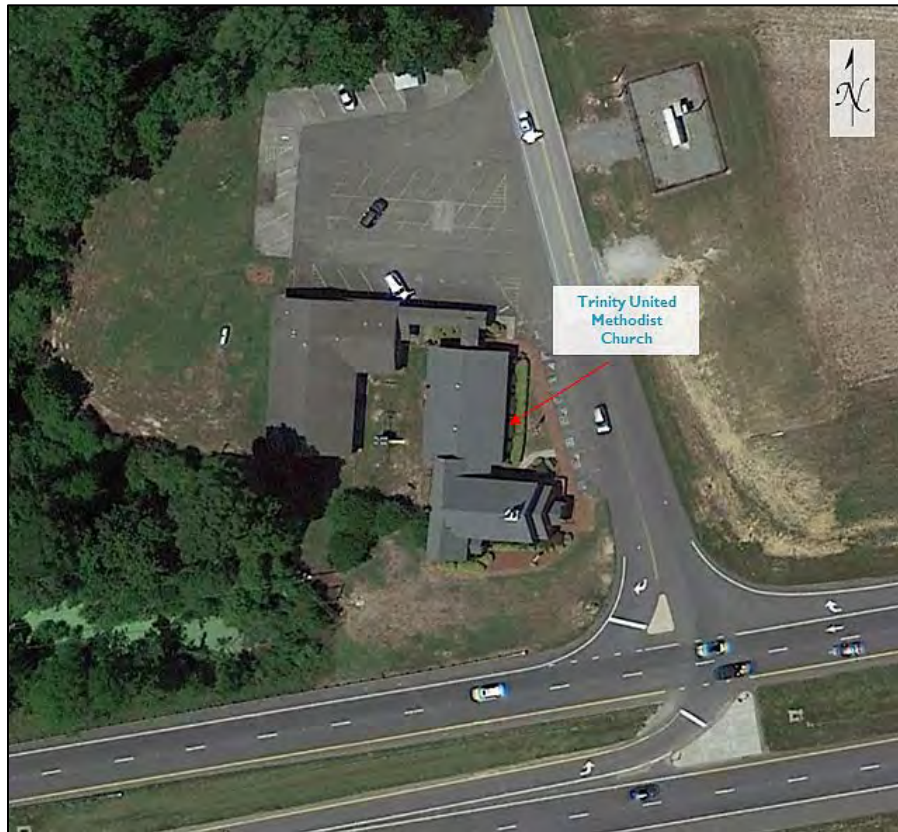
Figure 93: Site plan of Trinity United Methodist Church with US 70 at bottom (base image courtesy of Google Earth).

Trinity United Methodist Church is situated on a 1.33-acre parcel at the northwest corner of US 70 and Banks School Road between LaGrange and Kinston. A large parking lot is located to the north of the church and occupies about a third of the parcel. An open green space to the west rear of the church occupies another third of the parcel. The church occupies the remaining space. A brick sidewalk wraps around the perimeter of the building and connects the church to its various additions (Figure 93).

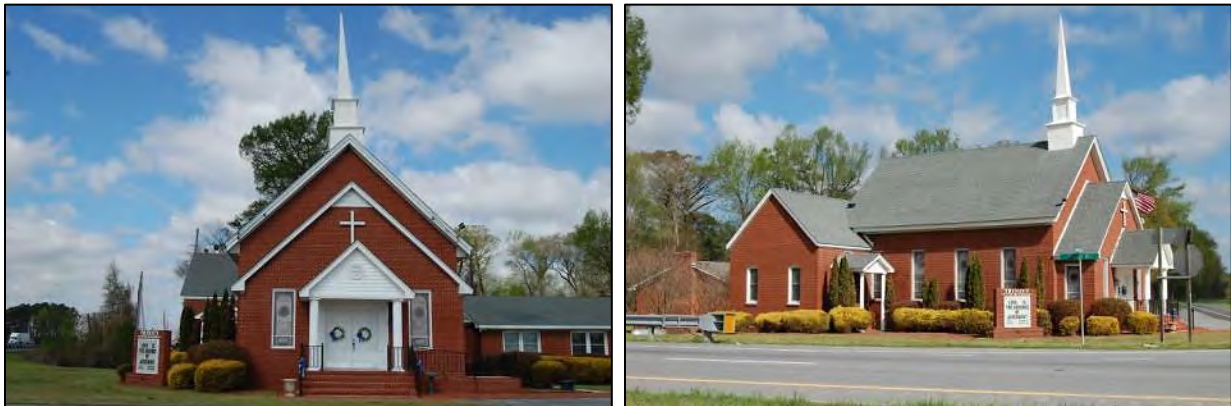
- **Trinity United Methodist Church** (LR 0702): We concur that due to the large additions, window replacement, brick veneer, and other alterations the church has lost historic integrity and is not eligible for listing in the NRHP under Criterion C. The church also does not meet Criterion A, B, D, or Criteria Consideration A. Please note that the Historic Property Survey Summary Form and database entry for the property indicate that the church is a contributing building in the Sandy Bottom Historic District. As this is not the case, please revise the form and database accordingly.

**Figure 94: Trinity United Methodist Church: at left, east front elevation; at right, south side and east front elevations.**

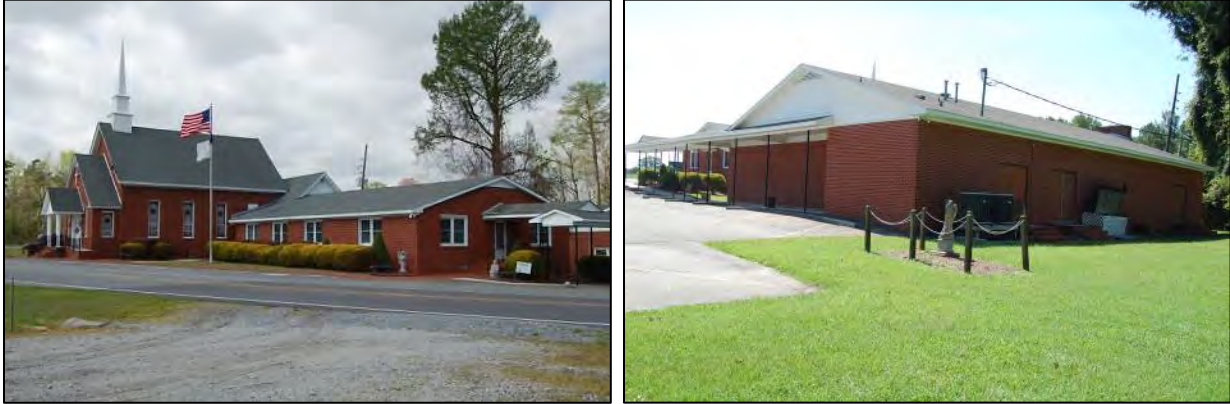
**Figure 95: Trinity United Methodist Church: at left, north side elevations of church and addition; at right, east side and north rear elevations of fellowship hall.**

Around 1940 a large, single-story, four-bay, side-gabled block was added to the north elevation of the sanctuary. The addition features paired one-over-one windows on all elevations and a centrally placed door on its north gable end. This replacement door is connected to an L-shaped, covered, paved walkway that leads to an L-shaped single-story fellowship hall that was built in 1979. All portions of the building, both original and additions are clad in brick veneer. In all likelihood, the sanctuary was originally weatherboarded (Figure 94 through Figure 96). Despite multiple site visits, interior building access was not available.

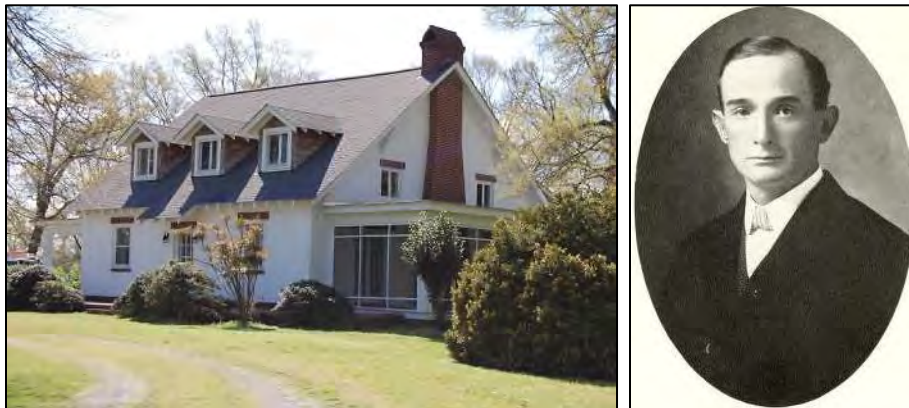
**Figure 97: Dr. James M. Parrott House: north front and west side elevations, at left, 2017; and Parrott, ca. 1914.**

The Dr. James M. Parrott House is a one-and-a-half-story dwelling that retains its original dormers, exposed rafter ends, and other modest Craftsman-style elements (Figure 97). It was built during the 1920s as a summer cottage for Dr. Parrott on his family’s farm in Falling Creek. According to *Coastal Plain and Fancy* (Little et al. 1998:369):

The Parrott House has changed little since it was determined eligible in 1998. It retains its integrity, is in excellent condition, and continues to remain NRHP-eligible.

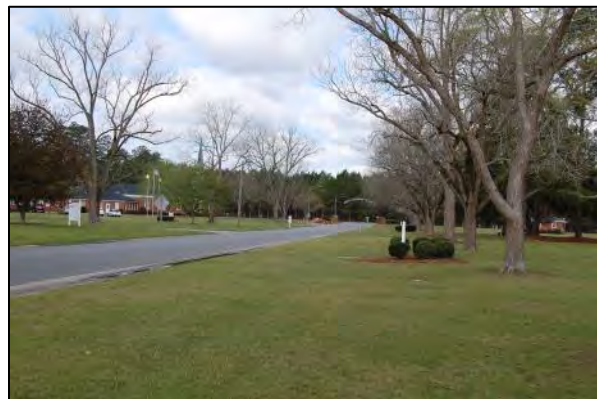
**Figure 99: Kennedy Memorial Home Historic District: entry and church from Kennedy Home Road, 2017.**

The opening paragraph of the description section of the Kennedy Memorial Home Historic District NRHP nomination summarized its appearance as follows (Little et al. 2009) (Figure 99):

Kennedy Memorial Home, an orphanage owned by the Baptist Children’s Homes of North Carolina, is a 1,240 acre tract of land in rural Lenoir County, North Carolina, on the south side of US Highway 70 five miles west of Kinston. . . . The orphanage buildings flank Cedar Dell Lane, a wide, straight avenue that extends east from Kennedy Home Road to its terminus at Cedar Dell, an antebellum plantation house that pre-dates the orphanage. Nineteen residential buildings, a church, and an educational building constructed from the 1920s to the early 2000s face the avenue or are arranged in a secondary row to the rear of the flanking buildings. To the rear of Cedar Dell stands a row of six agricultural buildings dating primarily from the mid-1900s. To the north of Cedar Dell Lane, behind the residential buildings, are a group of five food storage, processing, and maintenance buildings for the orphanage. Interspersed throughout the main campus are garages and sheds and recreational facilities—swimming pool, tennis courts, softball field, and picnic shelter.

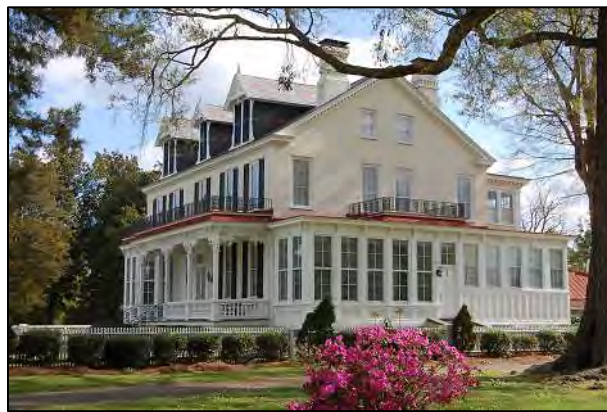
**Figure 101: Cedar Dell: west front and south side elevations, 2017.**

The NRHP nomination for Cedar Dell (Kennedy Memorial Home) summarized its appearance (Department of Archives and History 1971d) (Figure 101):

Cedar Dell was originally constructed around 1820 as a two-story brick dwelling with a side-hall plan. Late in the nineteenth century, the dwelling was enlarged and converted to a Victorian mansion. . . . The interior of Cedar Dell presents a center-hall plan two rooms deep. The southern rooms have some surviving Federal features, while those rooms on the north contain excellent Victorian interiors.

Cedar Dell looks like it did when nominated in 1971. It retains its integrity, is in excellent condition, and continues to merit NRHP listing.

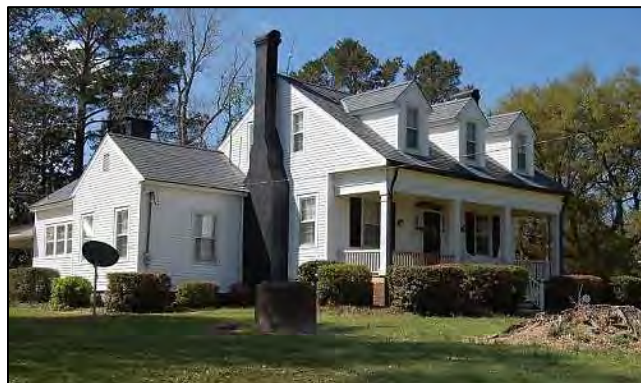
**Figure 102: Henry Loftin Herring Farm: east side and north front elevations of house, 2017.**

The Henry Loftin Herring Farm was determined eligible for NRHP listing on the basis of a historic architecture eligibility evaluation report, which described it in part as follows (Brown 1997) (Figure 102):

The Henry Loftin Herring House is one-and-a-half stories tall, three bays wide, and two rooms deep. Built of frame, it is clad in vinyl siding and topped by slate shingles. The original portion of the house may have been a story-and-loft coastal cottage with an engaged front (north) porch, gable-end roof, exterior-end double-shouldered chimneys, hall/parlor-plan principal rooms, and rear (south) shed room. In addition to its form, the house's original or early surviving decorative features include the chimneys, the east of which bears an inscription of 1822; the front entryway, which includes an elliptical fanlight and sidelights set in wood panels; a solid brick common-bond foundation, a rare feature among the county's early buildings; and two Federal-style mantels. Much of the remaining exterior finish of the house dates from the 1928 Colonial Revival-style renovations, which included side and rear additions. . . . Inside, the house retains one grand Federal feature, an ornately carved three-part mantel, in the living room, which is served by the dated east chimney. A second more simply finished Federal-style mantel is located in the west upstairs bedroom.

The Henry L. Herring Farm has not notably changed since it was determined NRHP-eligible in 1998. It retains its integrity, is in good condition, and continues to merit NRHP listing.

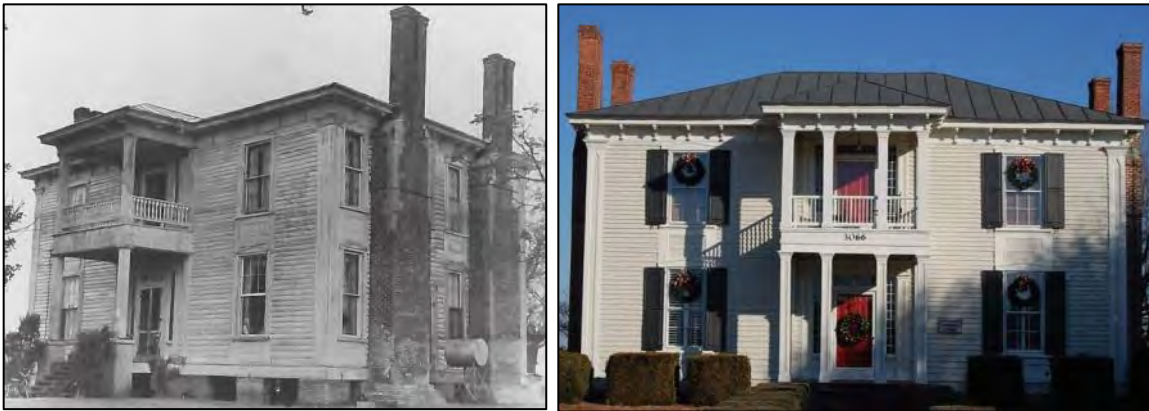
**Figure 104: Dempsey Wood House: south front and east side elevations in 1969, at left (photographer: Jim Shell) and 2009, at right.**

The owners of the Wood House added vinyl siding to it within the past eight years (Figure 104 and Figure 105). This resulted in removing or covering the weatherboards, full-height corner plasters and capitals, and panels that underpinned the window bays. Further, the brackets at the eaves were replaced in-kind and the porch, altered by 2009, was altered again. However, the house retains its tripartite surrounds, weatherboards, pilasters, and brackets at the first and second stories of its front elevation; paired chimneys at its side elevations; and proportions and form. In addition, its interior is at least partially intact (Figure 104 and Figure 105). The house is therefore believed to retain sufficient integrity to merit continued NRHP listing.

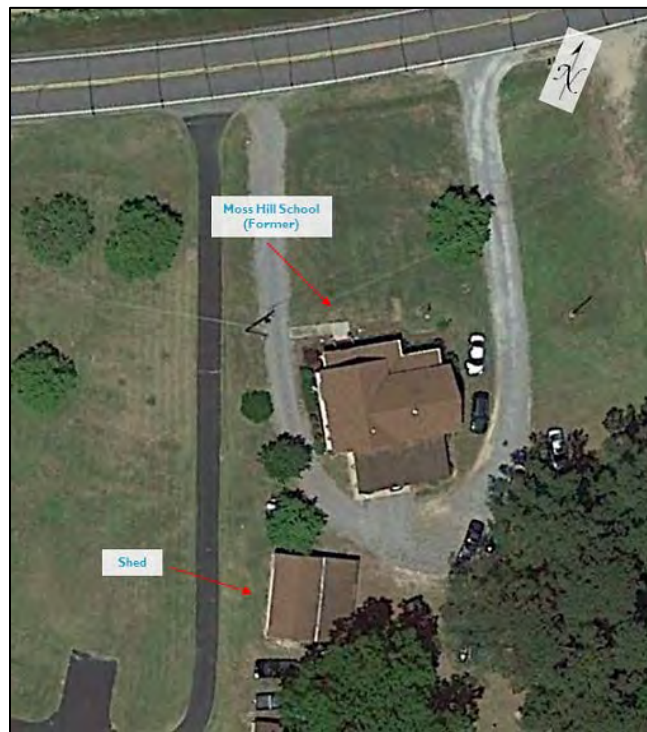
**Figure 107: Site plan of former Moss Hill School with NC 55 at top (base image courtesy of Google Earth).**

Situated along the south side of NC-55, approximately two miles east of its original location, the former Moss Hill School—long used as a residence—sits on a one-acre parcel near the crossroads community of Sandy Bottom. A U-shaped drive connects on both sides to NC-55 and circles around the back (southern) side of the house. A small late twentieth-century shed is located a short distance southwest of the house (Figure 107).

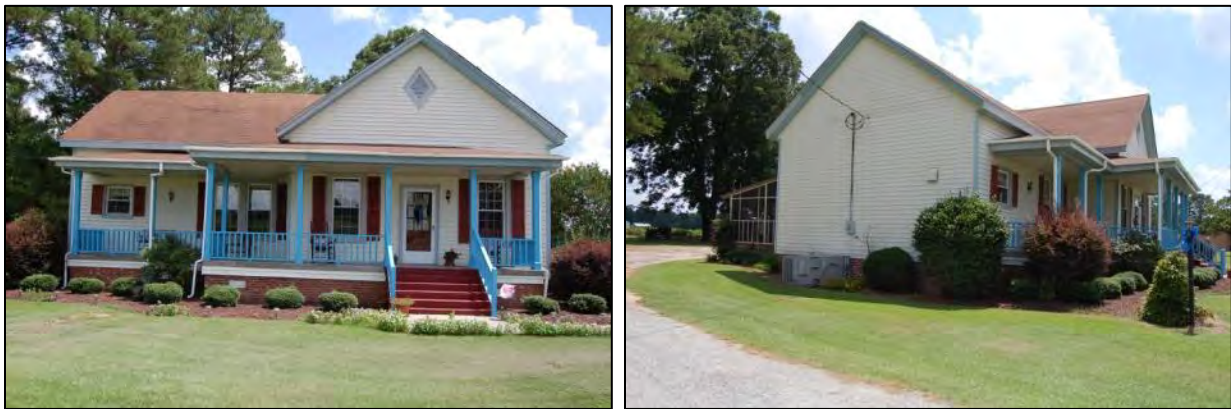
- **Moss Hill School** (former) (LR 1146): We concur that due to the relocation of the building, later additions, changes in fenestration, window replacement, application of vinyl siding, and changes to the floor plan the school has lost historic integrity and is not eligible for listing in the NRHP under Criterion C. The school also does not meet Criterion A, B, D or Criteria Consideration B.

**Figure 108: Former Moss Hill School: at left, north front elevation; at right, east side elevation.**

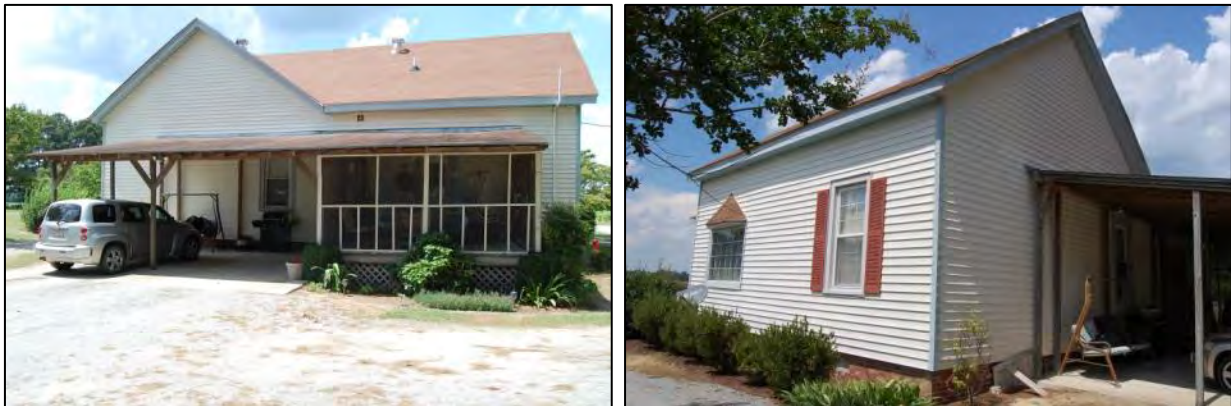
**Figure 109: Former Moss Hill School: at left, south rear elevation; at right, east side and south rear elevations.**

Despite undergoing two moves during the course of its life, the former Moss Hill School retains its original one-story gable-and-wing form. During the mid-/late twentieth century, a six-bay wraparound porch was added to the former school’s north front elevation. The porch sits on a continuous brick foundation and is supported by simple square columns connected with a rail

and square pickets. A four-bay shed-roofed carport/sunporch was added to the building's south rear after its second move in the 1980s. The roofs of both porches, in addition to the building's original cross gables, are clad in later-added asphalt shingles (Figure 108 and Figure 109).

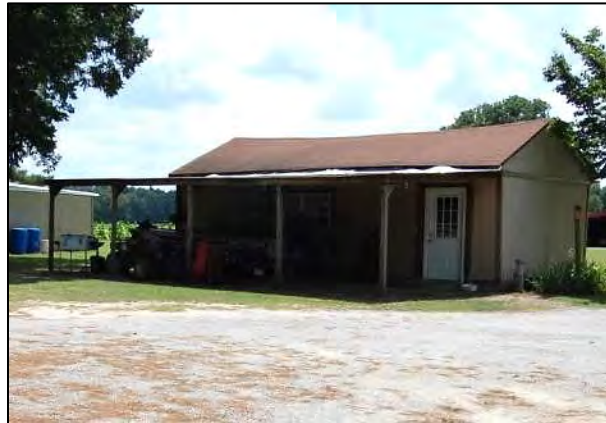
Figure 110: View of eastern elevation of shed, looking southwest.

The frame side-gabled shed behind the former school is clad in horizontal composite siding and topped with asphalt shingles. It dates from the late twentieth century (Figure 110).

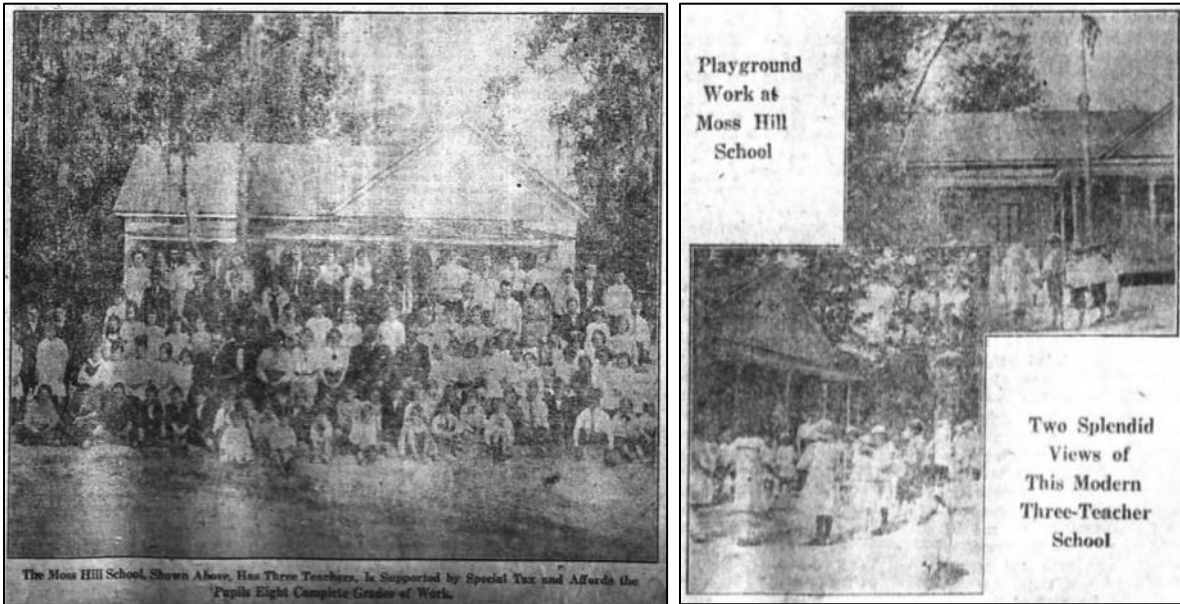
**Figure 111: Photographs from the July 18, 1916 *Kinston Free Press* depicting the Moss Hill School and its students and faculty during commencement and on the playground.**

The first Moss Hill School is said to have been incorporated in 1868, but closed just a few years later. Under the tutelage of “Miss Kate” Davis the school was resurrected in 1878 under the name of the Davis School. Classes were held in a log building on the property of A.W. Whitefield. The school’s name was changed to Moss Hill Academy in 1880. On January 2, 1889 the school building burned when the roof caught fire. Fortunately school was not in session and no injuries were sustained (The Daily Free Press 1889). The present building was constructed as a replacement shortly thereafter by J.C. Davis (The Lenoir County Historical Association 1981, 289) (Figure 111).

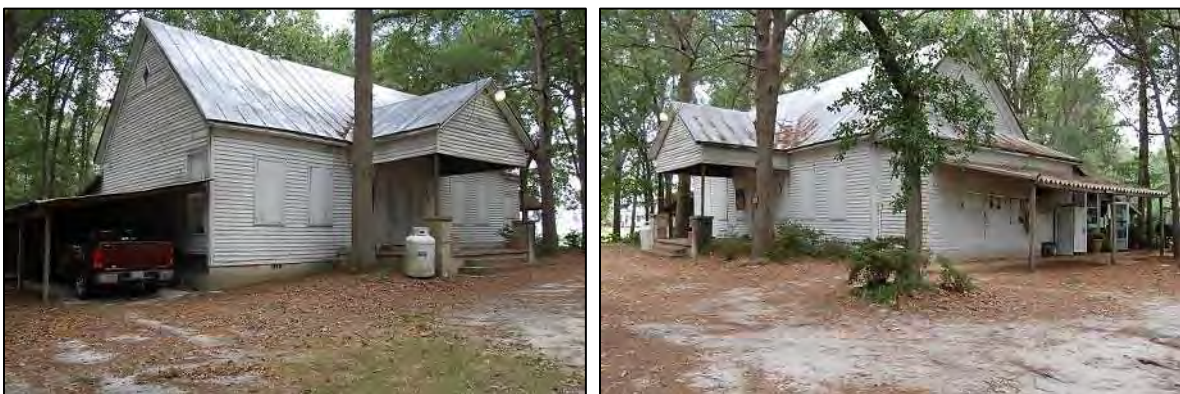
Lenoir County retains a surprising number of relatively intact early schools. Holy Innocents Episcopal Church erected its Parish School (LR-1016) near the rural community of Strabane in 1903-1904 (Little et al. 1998:111, 392). A one-story, gabled, frame building, it retains its weatherboards, cornice returns, surrounds, and at least one door. Its original entry was in a gable, not along one of its long elevations. Additions have been affixed to it—a portico to the south, an open shed to the west, a small enclosed shed room and open shed to the east, and a shed room across the current north rear. Overall, though, the building is surprisingly intact (Figure 112).

**Figure 112: Holy Innocents Parish School: west gabled and south front elevations, at left, and south front and east gabled elevations, at right, 2017.**

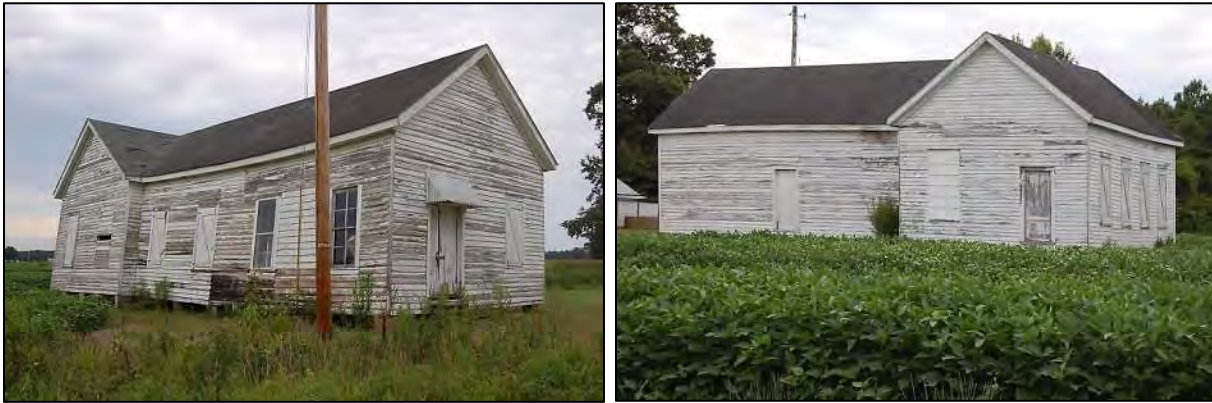
The former Tyndall School (LR-1181) was erected east of Deep Run between about 1890 and 1915 and closed in 1925 as part of the school consolidation movement (Little et al. 1998:404). The frame building retains its original gable-front block and four-bay-wide, gable-end, rear cross

wing. It also continues to be sided in weatherboards and lit at least in part by four-over-four sash windows. Restored in 1996, it too remains unusually intact (Figure 113).

**Figure 113: Tyndall School: at left, looking northeast with front block at right; at right, looking northwest with rear block at right.**

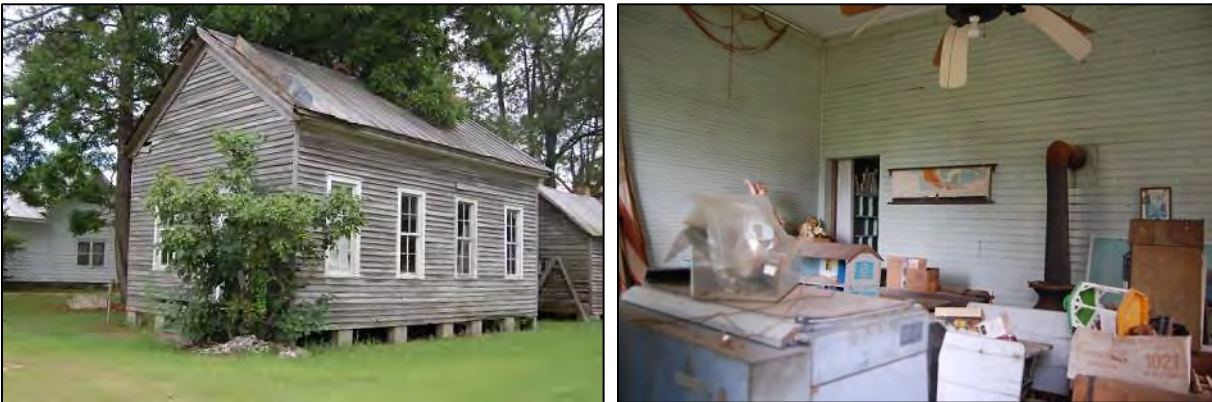
The (former) Lynwood School (LR-1207) near Elm Crossroads dates from ca. 1914, prior to the consolidation movement of the 1920s that led to its closing. It served as a residence until it was moved to its present location and restored in 1979 (Little et al. 1998: 425). It likely originally stood about three or four miles to the north. Not only does the school retain weatherboards and four-over-sash, but inside beaded boards still side its walls and central partition (Figure 114).

**Figure 114: Lynwood School: view looking south with entry obscured by fig tree at center of image; view through front door at interior.**

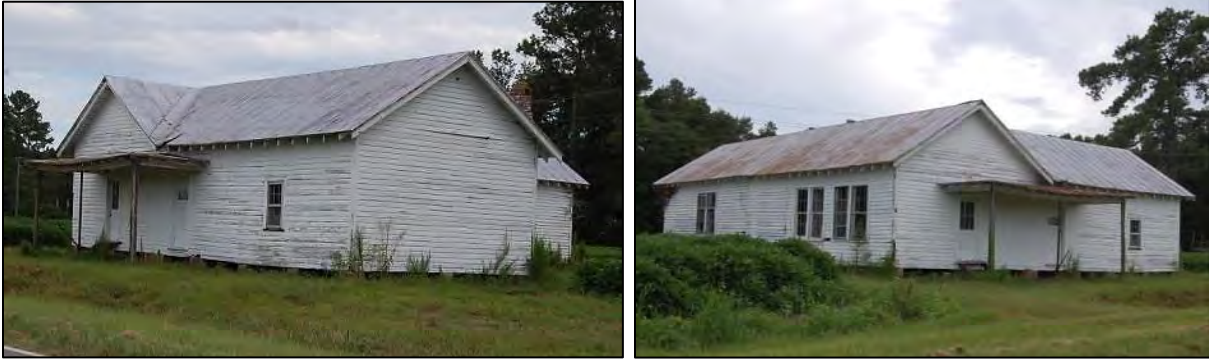
The African-American children of the southern corner of Lenoir County began attending the Vine Swamp School (LR-1210) about 1917. Unlike its white counterparts from the early twentieth century, the school remained active into the 1950s, when the county's black schools were finally consolidated (Little et al. 1998:424). It retains its one-story gabled form, German siding, and six-over-six sash (Figure 115).

**Figure 115: Vine Swamp School: view looking southeast, at left, and southwest, at right, 2017.**
