North Carolina Department of Natural and Cultural Resources  
State Historic Preservation Office

MEMORANDUM

Subject: Historic Architecture Eligibility Evaluation Report, US 70 Kinston Bypass, R-2553,  
Lenoir County, ER 09-1307

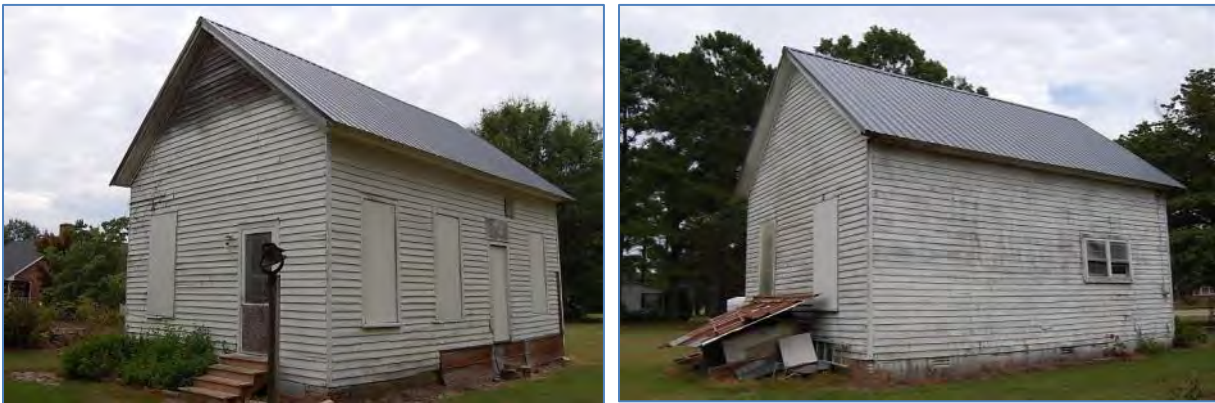
The former Taylor School (LR-1227), built in the Pleasant Hill community between 1900 and 1910, is largely intact as well (Little et al. 1998:434). A wing that was added to its side after it was converted into a residence was removed between its 1994 and 2000 recordation. It remains a small, gabled, frame building sided with weatherboards (Figure 116).

**Figure 116: Taylor School: gable-end east and south elevations, at left; gabled west and north elevations, at right, 2017.**

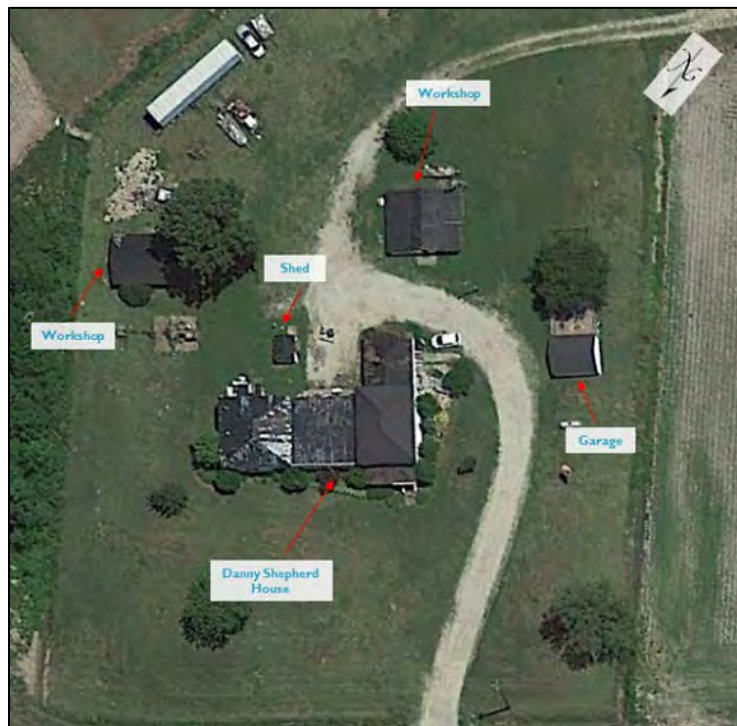
The Danny Shepherd House sits on the south side of NC 55 just west of the community of Sandy Bottom (Figure 117). It is situated on an open 2.35 acre parcel, surrounded by fields on all sides, and includes five resources: the Danny Shepherd House, a workshop and shed to the south of the house; a garage to the west; and a second workshop to the east of the house. All of the buildings appear to date to the early/mid-twentieth-century.

**Figure 117: Site plan of Danny Shepherd House with NC 55 just off of bottom of image (base image courtesy of Google Earth).**

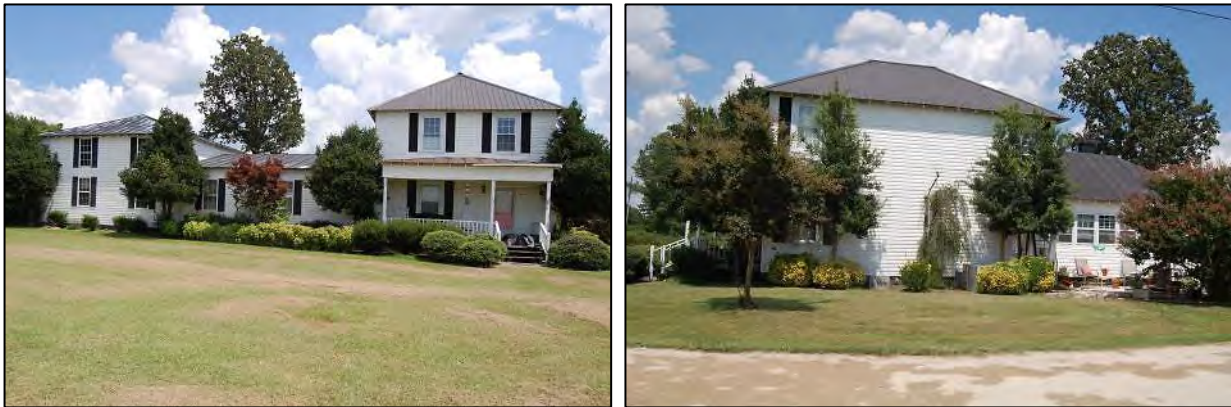
Originally constructed as a frame, two-story foursquare with a rear kitchen ell, the Danny Shepherd House acquired two major additions during the mid-twentieth-century: a second two-story foursquare block located to its east, and a one story two-bay garage that connects the two foursquares. All sections of the house are clad in vinyl siding (Figure 118 through Figure 120).

An original, one-story, two-bay porch supported by plain chamfered columns and featuring an unadorned rail with square pickets frames the front (northern) elevation of the original foursquare. Both the porch and block are topped with standing-seam-metal hipped-roofs and display exposed rafter tails in the Craftsman style. A brick chimney protrudes from the eastern roof slope. Snap-in six-over-six muntins fill the block's replacement one-over-one windows and other alterations have been made to its fenestration. The building's primary entrance is located on its northern elevation and appears to retain its original fixed-light two-panel door. The one-story kitchen ell attached to southwest corner of the block originally featured a porch on its western side, which was later closed in (Robbie Jones, 1994).

**Figure 118:** At left, north front elevation of house with taller original block at right; at right, west side elevation of original block.

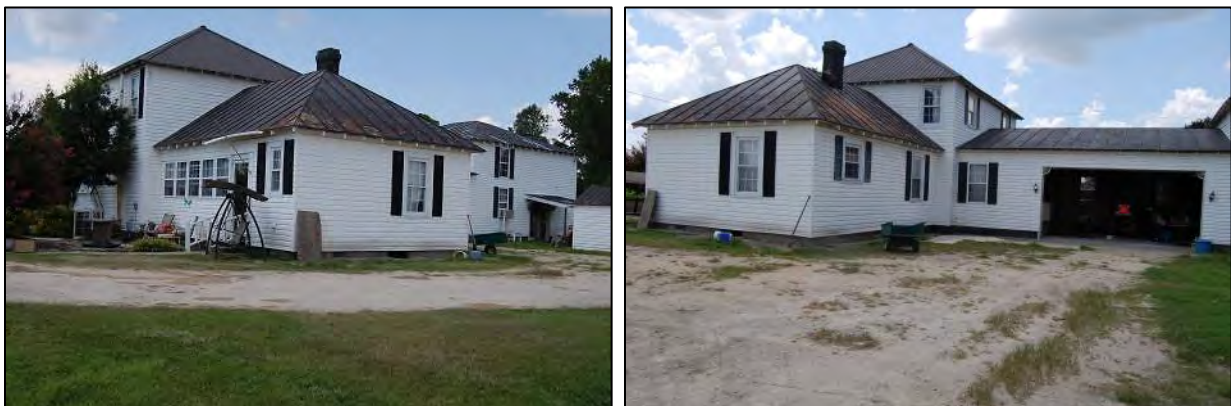
**Figure 119:** At left, west side and south rear elevations of main block and kitchen ell; at right, south rear elevation of main block and garage hyphen

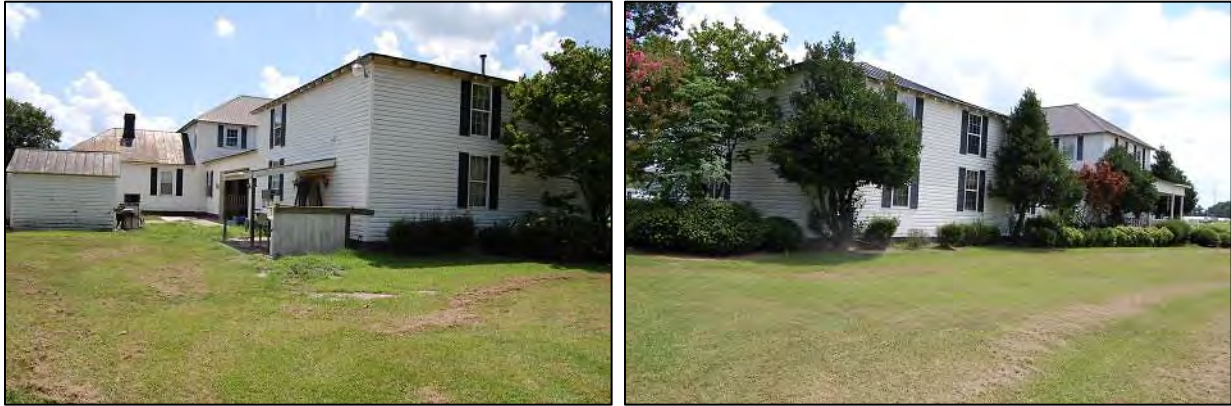
Like the original block, the eastern two-story foursquare addition is capped by a hipped standing-seam metal roof and displays exposed rafter tails. It also has replacement snap-in windows and an altered fenestration pattern on its western, southern, and eastern sides. A rear shed-roofed porch extends from the building's southern elevation and covers two modern single-light fiberglass doors. The hyphen garage features two modern windows on its front (northern) elevation, and one on its southern elevation, in addition to a large modern garage door. Despite multiple site visits, interior access to the building was not available.

**Figure 120:** At left, south rear and east side elevations of later block; at right, north front elevations of foursquare blocks.

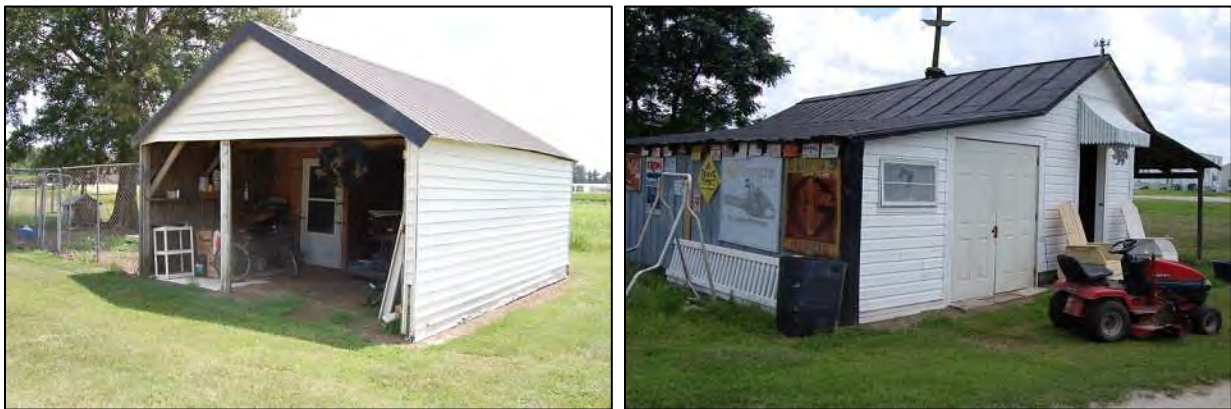
Located south of the house, the single-pile, mid-twentieth-century, front-gabled garage is clad in vinyl siding and capped with a seam-metal roof. It features a deep overhang on its north elevation supported in part by an off-center wooden post (Figure 121, at left).

This mid-twentieth-century side-gabled workshop is clad in vinyl. It has a shed-roofed addition clad in metal sheathing on one side and a lean-to supported by wooden posts and topped with a standing-seam metal roof on the other (Figure 121, at right). Modern doors and windows pierce its elevations.

**Figure 121:** At left, view of garage looking south; at right, view of workshop looking west.

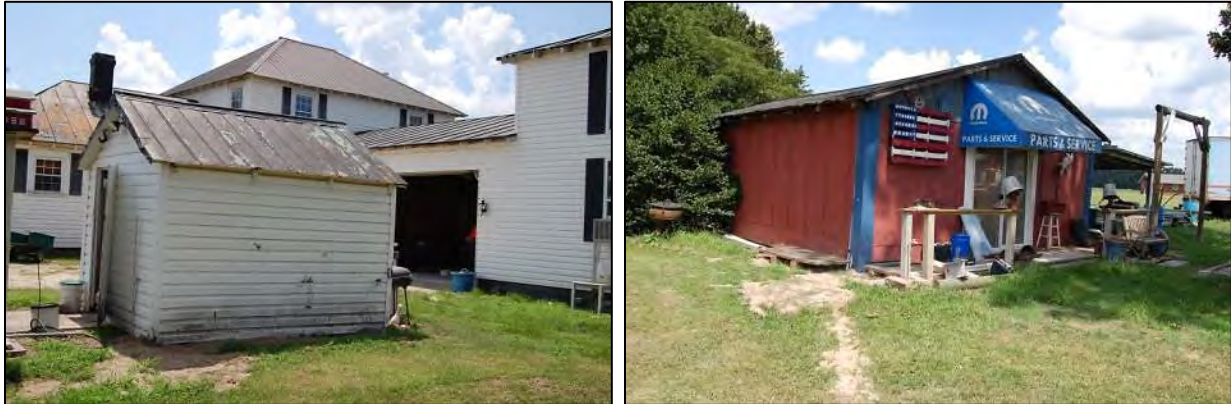
The early/mid-20th century frame gable-end shed is clad in vinyl siding and topped by a standing-seam-metal roof underpinned by exposed rafter tails. An off-centered door is located on the building's southern elevation (Figure 122, at left).

Constructed during the early/mid-twentieth-century, this side-gabled frame workshop is clad in metal sheathing. Its roof is topped with standing-seam metal and underpinned by exposed rafter tails (Figure 122, at right). Centrally placed modern sliding doors are located on the building's eastern gable end. A lean-to supported by plain wooden posts extends from the building's western side.

**Figure 122: View looking east at shed with house to rear, at left; view looking south at workshop, at right**

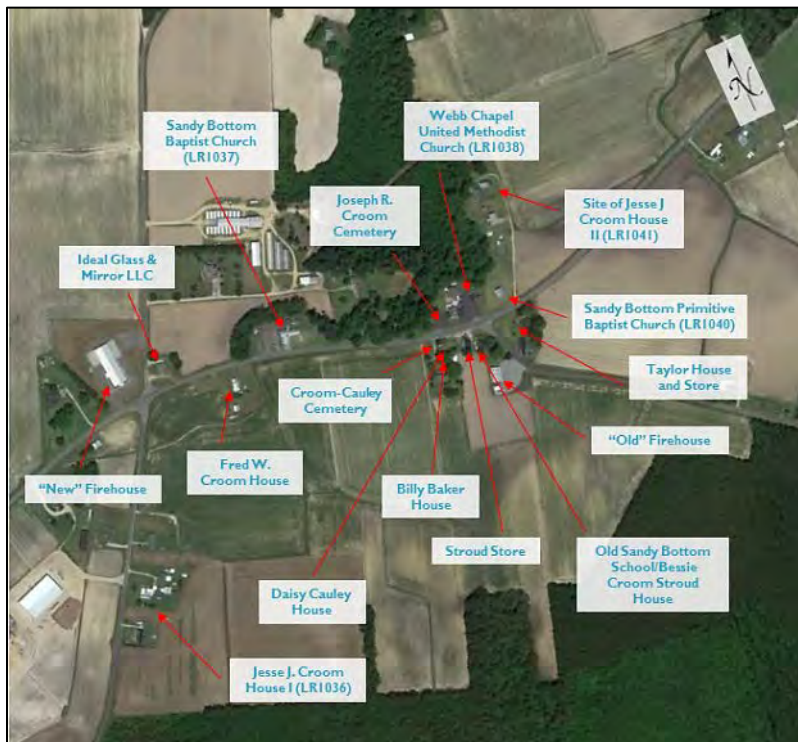
The Sandy Bottom Historic District encompasses the historic community of Sandy Bottom. Characterized by large open fields and small residential and church lots scattered with mature trees, the historic district extends along both side US 70 within the community. Its earliest buildings are located at the crossroads of US 70, Rouse Adams Lane, and Green Haynes Road. New residential development and an agricultural processing and distribution facility edge its eastern, southern, and western edges. Woods stand south of the district. Figure 123 immediately below locates the major resources within and just outside of the proposed district boundary. Figure 124 and Figure 125 include the locations—by single-letter notation—of every resource included within the district, whether that resource contributes or not, and the proposed district boundary. The resources are identified by name and single-letter notation in the text that follows.

**Figure 123: Overall site plan of Sandy Bottom Historic District with major resources within and outside of proposed NRHP boundaries labeled (base image courtesy of Google Earth).**

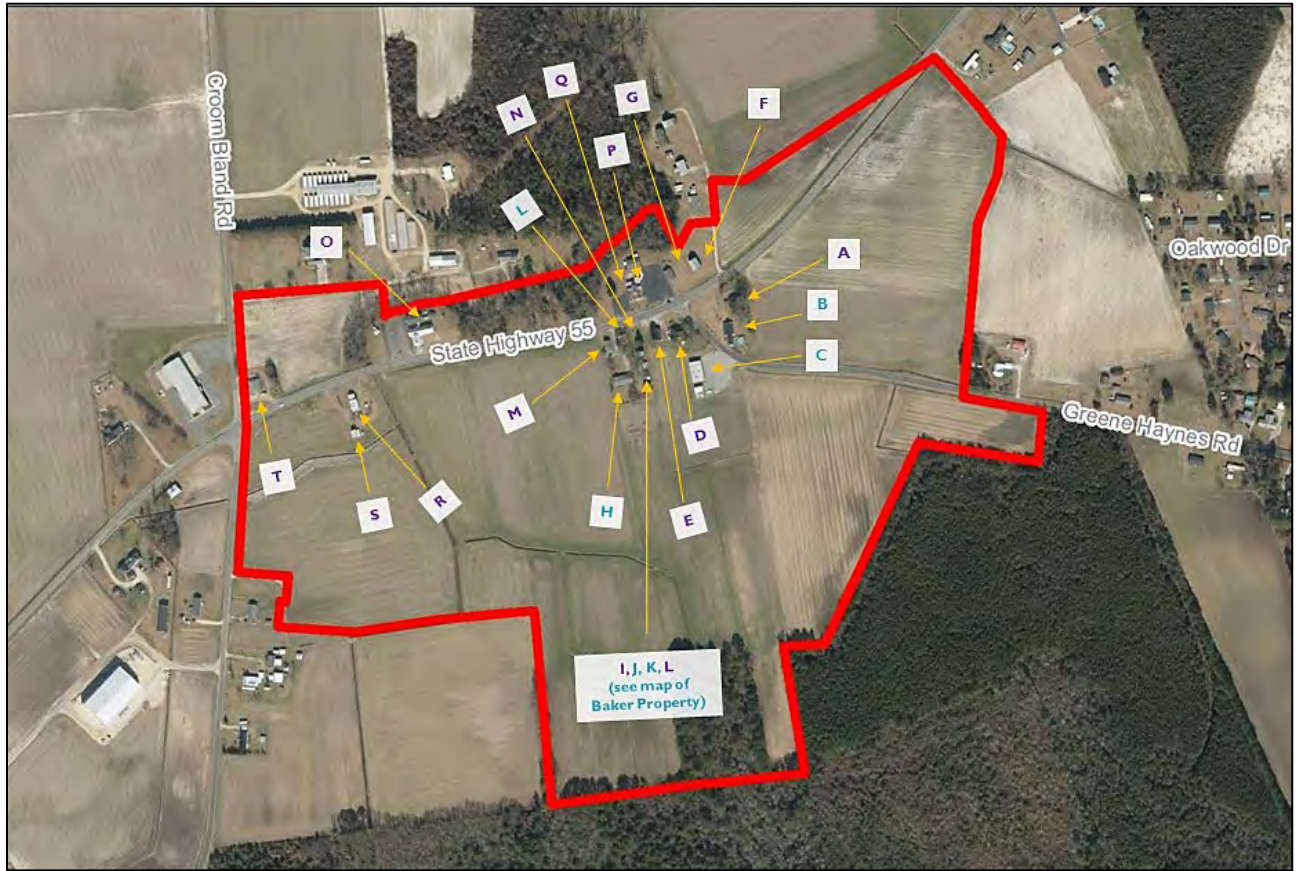
Figure 124: Sandy Bottom Historic District locator map with resources labeled with letters; purple letters indicate contributing resources and blue ones those that are non-contributing (base image courtesy of Google Earth).

The community is comprised of 20 resources: four houses, four outbuildings, three stores, three churches, and three cemeteries, along with a former machine shop, firehouse, and school. As discussed below, 16 of them are recommended as contributing resources and four as non-contributing resources.

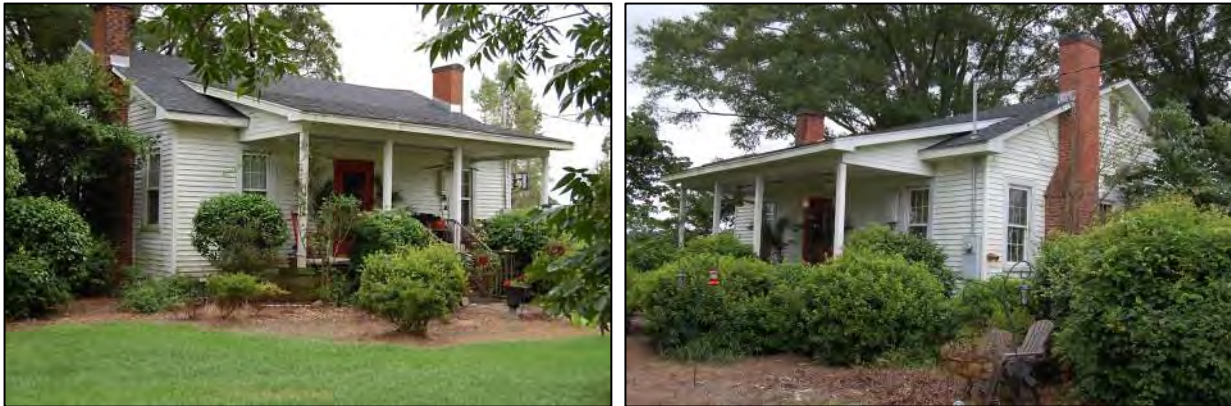
The Taylor House sits on an open lot at the eastern edge of the Sandy Bottom Historic District. The house is bounded on its northern side by NC 55, by Green Haynes Road to its west, and by fields to its east and south. The house shares the lot with the old Taylor Store, which is located to the southwest. It is a single-story, three-bay, double-pile dwelling erected in the late nineteenth/early twentieth-century that is topped by a side-gabled roof. A later double-pile shed-roofed addition extends to the house's south rear. Vinyl siding covers the entire house. A shed-roofed porch supported by simple wooden posts frames the north front elevation, which is marked by windows with snap-in muntins that suggest they hold early nine-over-nine sash. (None of the house's "nine-over-nine" windows are what they appear to be.) The porch rests on a continuous brick foundation as does the rest of the house. Two exterior-end, half-shouldered, brick chimney stacks are off-set on either gable end of the house. The house retains sufficient integrity to contribute to the historic district (Figure 126).

**Figure 126: Taylor House: at left, east side and south front elevations; at right, south front and west side elevations.**

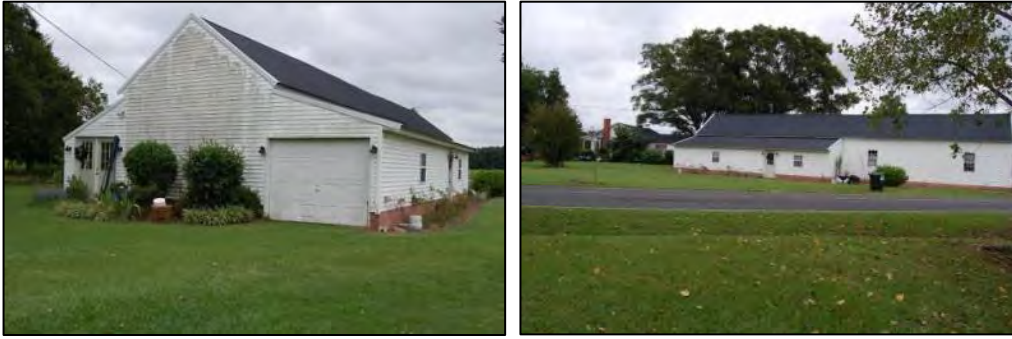
The former Taylor Store is situated to the southwest of the Taylor House and is oriented toward the north, sitting further from the road than the house. It dates from the late nineteenth or early twentieth century. Although converted into a packhouse and then a garage during the latter part of the twentieth century, the building's original basic store form remains. The single-story, front-gabled building is linear in plan with two shed-roof additions on its eastern and western sides. The original mass of the building was additionally extended to the south, doubling its size. The building rests on a continuous brick foundation and is entirely clad in replacement vinyl siding, and the store's original openings have been covered. The store is so altered that it does not retain sufficient integrity to contribute to the historic district (Figure 127).

**Figure 127: Former Taylor Store: at left, view looking south; at right, view looking northeast with Taylor House in distance.**

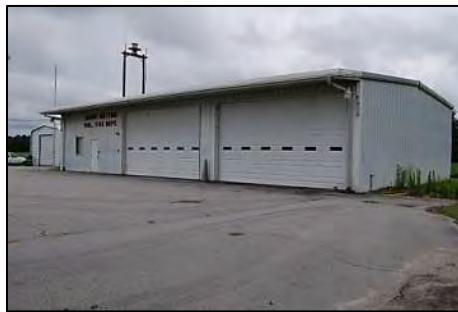
This single-story, four-bay, side-gabled firehouse was built in the late 1970s for the Sandy Bottom Volunteer Fire Company. It is clad in vertical metal sheathing and fronted by a large parking lot. Its east front elevation is dominated by two wide garage doors. A new firehouse was built on the west side of Sandy Bottom in 2009, displacing this building. The former firehouse is outside of the district's period of significance and therefore does not contribute to it (Figure 128).

**Figure 128: Former Sandy Bottom Firehouse: east elevation.**

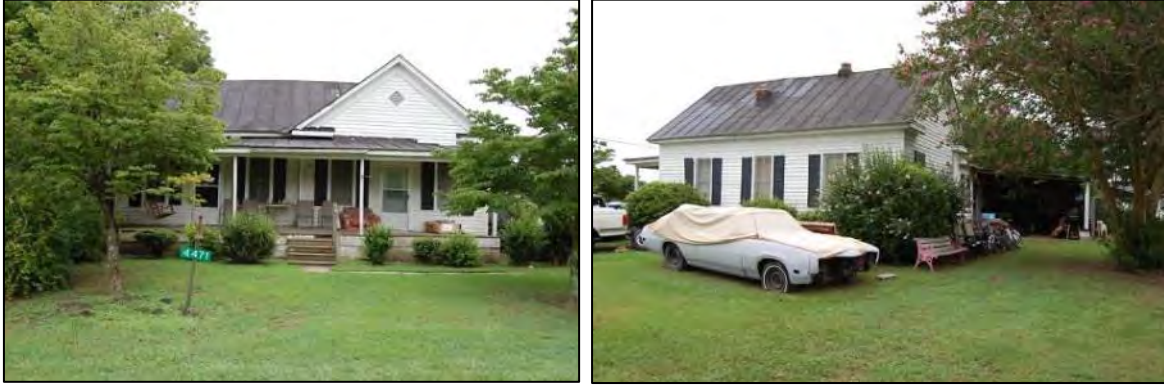
The former Sandy Bottom School/Bessie Croom Stroud House sits directly west of the Sandy Bottom crossroads. Originally constructed as a school at the turn of the twentieth century, the building was converted into a house around 1917. Despite this conversion, it retains its original one-story gable-and-wing plan, a traditional plan for country schools of the time. The gables retain their cornice returns and diamond-slat ventilators. The building sits atop a continuous concrete-block foundation and is clad in weatherboards. A three-bay porch, likely added during the building's conversion to a residence, frames its north front elevation. It is supported by three plain wood columns. Two interior brick chimney stacks penetrate the standing-seam-metal roof. Primary entry to the house is through the centrally located door on its northern façade. It is flanked on either side by four-over-four double-hung windows that appear to be original. Three additional original windows light the western elevation. A rear, single-story, mid-/late-twentieth-century addition sided with vinyl extends south from the house's southeast corner. The former school/house retains sufficient integrity to contribute to the historic district (Figure 129).

**Figure 129: Former Sandy Bottom School: at left, north front elevation; at right, west side and south rear elevations.**

In 1901 the Sandy Bottom School was built at the Sandy Bottom Crossroads, across the street from Webb Chapel. This is clearly noted on the 1910 Rural Delivery Map. On July 18, 1916, the *Kinston Daily Free Press* published a special educational edition that included the following short history of the school:

In 1900 this building was replaced by a larger and more comfortable one, which was ceiled, painted, well seated, and lighted. In 1905 a primary department was added and furnished with patent desks. Two teachers were employed. A pump was driven, which gave a more healthful water supply. The furnishings were supplemented by new black-boards, a globe, teachers' chairs and tables and pictures...The census for the year [1916] was 67, 63 of whom were enrolled. The attendance was especially good.

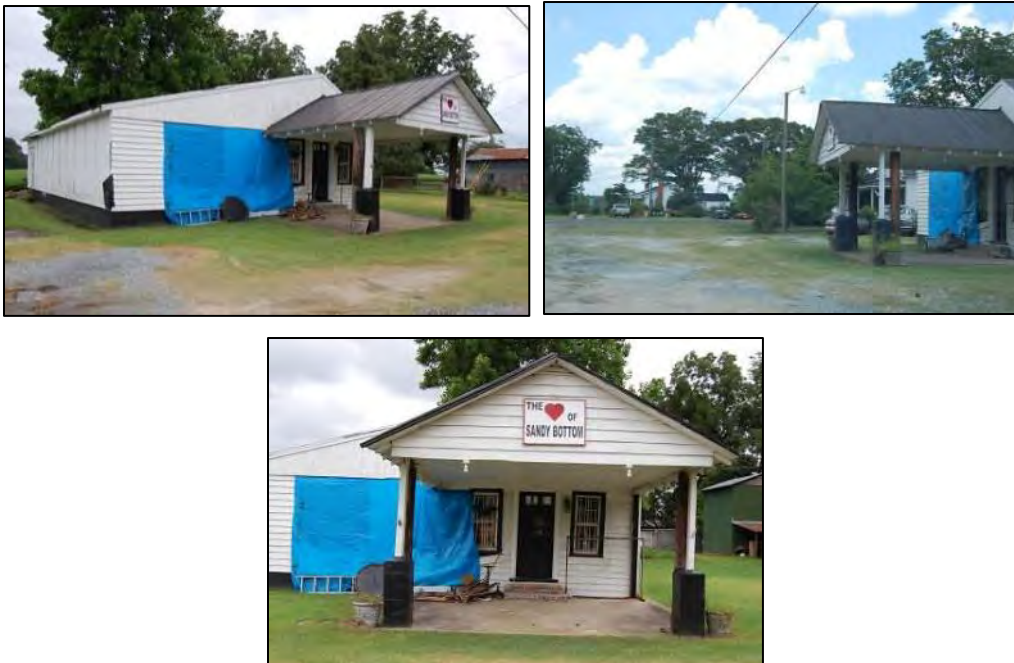
The early twentieth-century Bessie Croom Stroud Store is located to the west of the former Sandy Bottom School/Bessie Croom Stroud House near the Sandy Bottom Crossroads. Front gable of the single-story building faces the street. It is clad in weatherboards and rests on a continuous concrete-block foundation. The roof is clad in standing-seam-metal and displays exposed rafter tails. Projecting from the building's front is a canopy underpinned by exposed rafter ends that once shielded gas pumps. It is supported by wooden posts on brick piers. In its shade is the store's entry, which is flanked by a window to either side. A vinyl- and vertical-wood-sided, shed-roofed extends to the store's east. It appears to be a later addition. The store retains sufficient integrity to contribute to the historic district (Figure 130).

**Figure 130: Bessie Croom Stroud Store: top left, west side and north front elevations; top right, north front and east side elevations with former school/Stroud House visible behind canopy and Taylor House in distance; bottom, store front with canopy.**

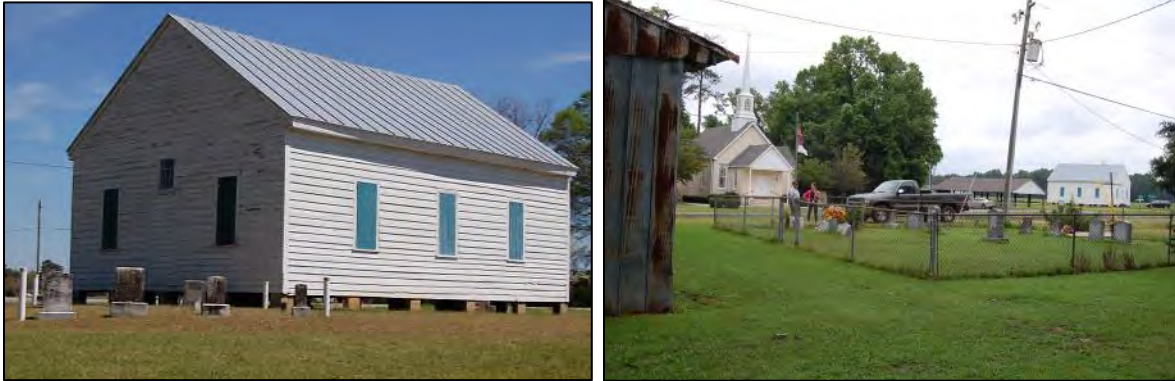
The Sandy Bottom Primitive Baptist Church is an intact meeting house erected in the 1850s. It is described as a separate entry, above, as is the adjacent Williams Family Cemetery. Both resources retain sufficient integrity to contribute to the historic district (Figure 131).

**Figure 131: Croom Meeting House and Williams Family Cemetery: at left, gabled north and east elevations of meeting house with cemetery in foreground; at right, from left to right, edge of shop building, Webb Chapel, Croom-Cauley Cemetery, and Meeting House.**

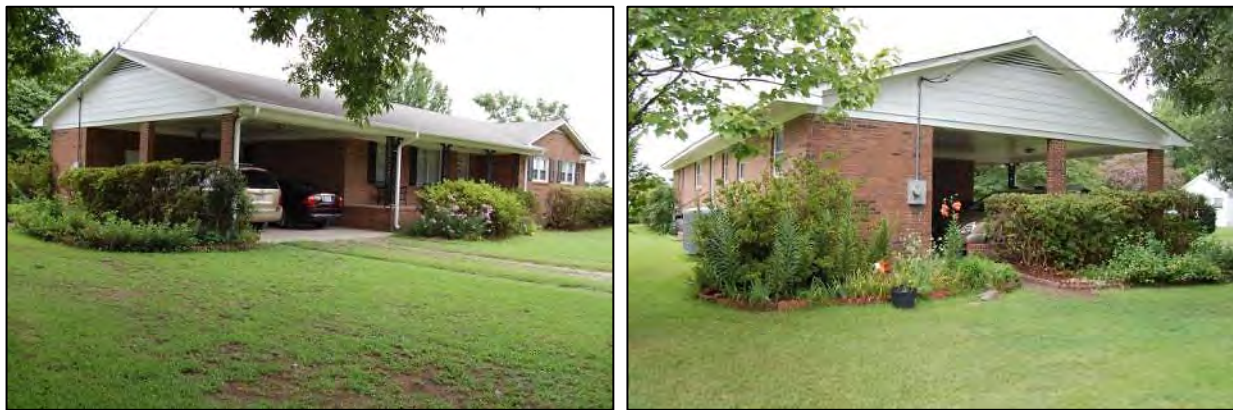
Built in the 1970s, the Billy Baker House sits on a long rectangular parcel to the west of the Sandy Bottom Crossroads. The cross-gabled brick ranch house is five bays wide with an attached double-bay carport. Paired windows are found along the building's northern front elevation, which is shaded by a recessed porch supported by cast-iron columns. Multiple outbuildings-most predating the house- are located to the north of the house including: a packhouse, chicken coop, frame shed and metal workshop. The Daisy Croom Cauley and the Cauley-Croom Cemetery also sits at the front (north) end of the two acre parcel along NC-55. The house is outside of the historic district's period of significance and therefore does not contribute to it (Figure 132).

**Figure 132: Billy Baker House: at left, east side and north front elevations; at right, south rear and east side elevations.**

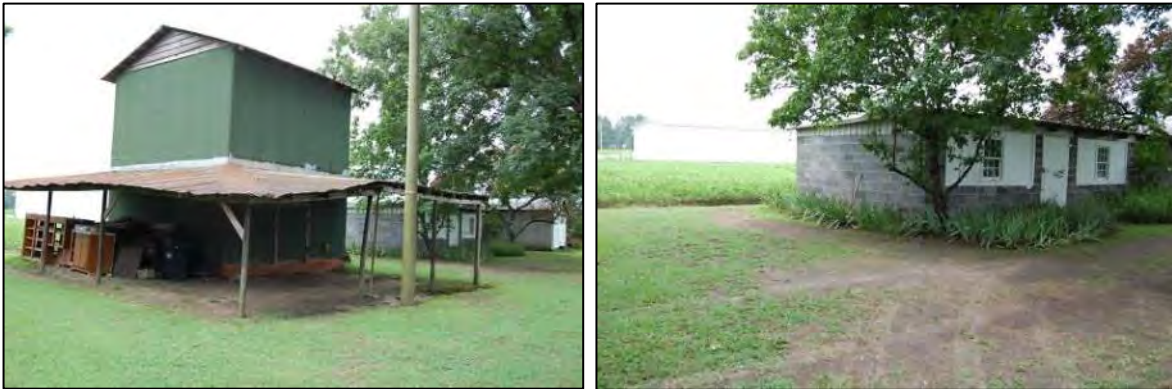
This frame packhouse has a gabled roof and is clad with later-added asphalt sheathing and a standing-seam metal roof. Its original weatherboard cladding is still visible at its gables. A lean-to addition topped in standing-seam-metal and supported by wooden posts extends from the building's northern and eastern elevations. The packhouse, which dates to the early/mid-twentieth century, predates the Billy Baker House, which stands just to its east. The packhouse retains sufficient integrity to contribute to the historic district (Figure 133, at left).

**Figure 133: Views looking southeast at packhouse, at left, and chicken coop (with former firehouse in distance), at right.**

This late twentieth-century building was erected by Billy Baker as a chicken coop. It is constructed of concrete-block. A centrally placed door flanked by a window to either side is located on its west-facing front elevation. Its flat roof is formed of standing-seam metal. The chicken coop is outside of the historic district's period of significance and therefore does not contribute to it (Figure 133, at right).

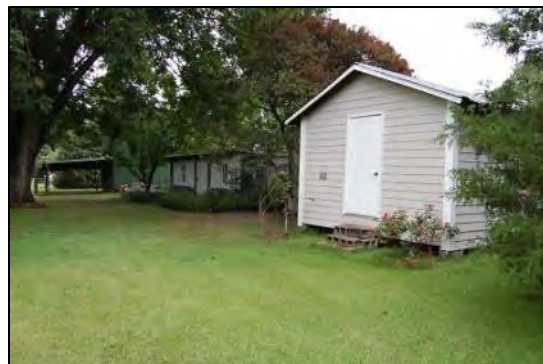
This is located to the northeast of the Billy Baker House and rests on concrete masonry piers. The building is clad in replacement vinyl siding and features a centrally located door on its west gable end. It appears to date from the late twentieth century is therefore outside of the historic district's period of significance and does not contribute to it (Figure 134).

**Figure 134: View looking northeast at shed with packhouse at far left and chicken coop at center.**

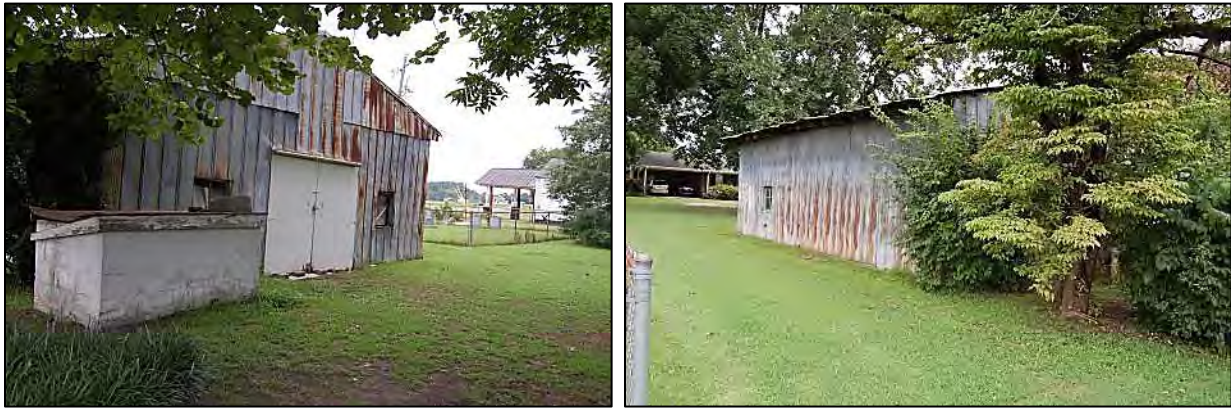
According to Billy Baker, this frame building was erected in the mid-twentieth century as a machine shop, which added to the commercial activity in what was then a bustling crossroads community of houses, churches, and stores. The shop stands in front of Baker's house along NC 55. To its east are the Croom-Cauley cemetery and Bessie Croom Stroud Store. The shop has a straightforward design. It is a gable-front rectangular building fully clad in sheet metal (Figure 135).

**Figure 135: Shop: to left, south rear elevation with cemetery and Stroud Store beyond; to right, east side and north front (in trees) elevations, with Billy Baker House to rear.**

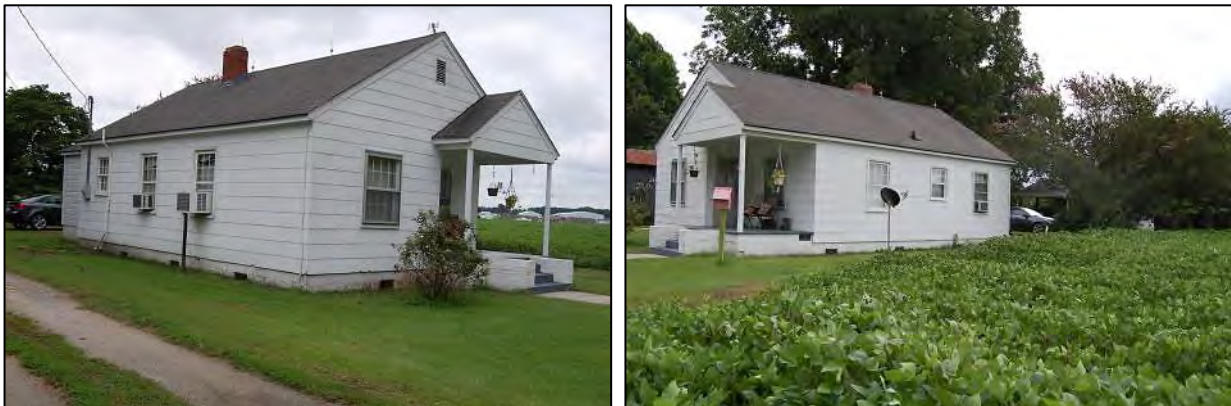
The single-story front-gabled Daisy Croom Cauley House is located at the northwest corner of the Billy Baker parcel, on land originally owned by Cauley. It appears to date from the mid-twentieth century. The house stands on a continuous concrete-block foundation and is clad in asbestos siding. A pedimented recessed front porch comprises the eastern bay of the north elevation and is supported by two simple wood posts. A small, later-added, gabled ell extends from the house's south rear elevation. The house retains sufficient integrity to contribute to the historic district (Figure 136).

**Figure 136: Daisy Croom Cauley House: at left, east side and north front elevations; at right, west side elevation with tobacco field in foreground and Billy Baker House to right rear.**

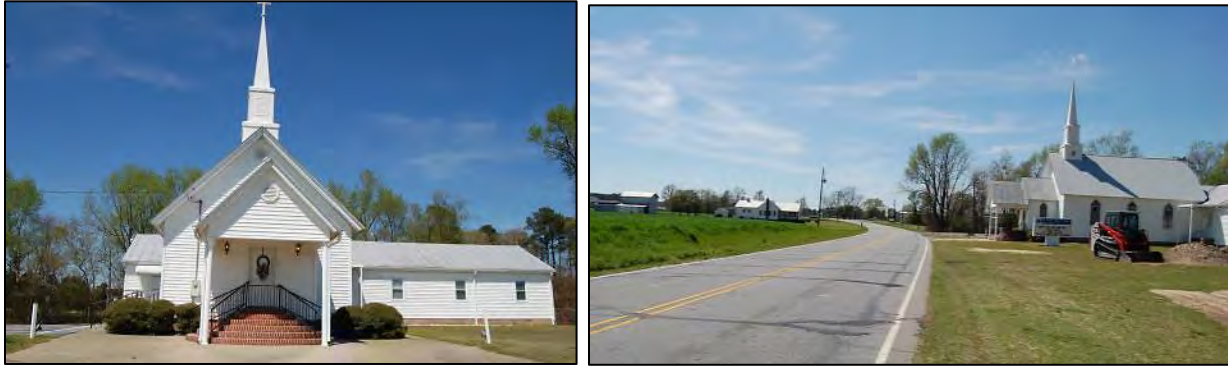
The Sandy Bottom Baptist Church, which was built in stages during the twentieth century, is described as a separate entry, above. It retains sufficient integrity to contribute to the historic district (Figure 139).

**Figure 139: Sandy Bottom Baptist Church: at left, south front elevation; at right, east side elevation of church with and Fred Croom House on opposite side of NC 55 in distance.**

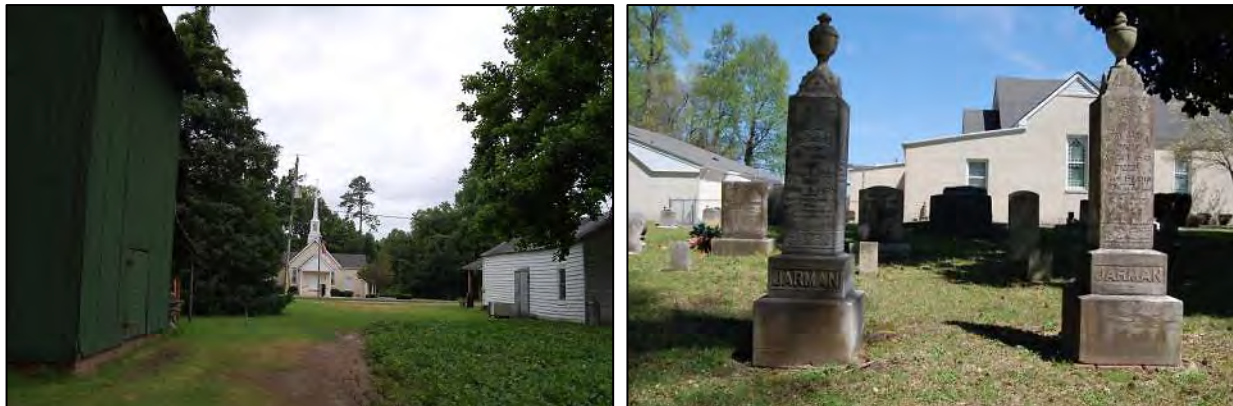
Webb Chapel is an intact church erected additively during the twentieth century. It is described as a separate entry, below, as is the adjacent Joseph R. Croom Cemetery. Both resources retain sufficient integrity to contribute to the historic district (Figure 140).

**Figure 140: Webb Chapel: at left, view of south front elevation from across NC 55, with packhouse on Baker property at left and Stroud Store at right; cemetery markers and west side elevation of church, at right.**

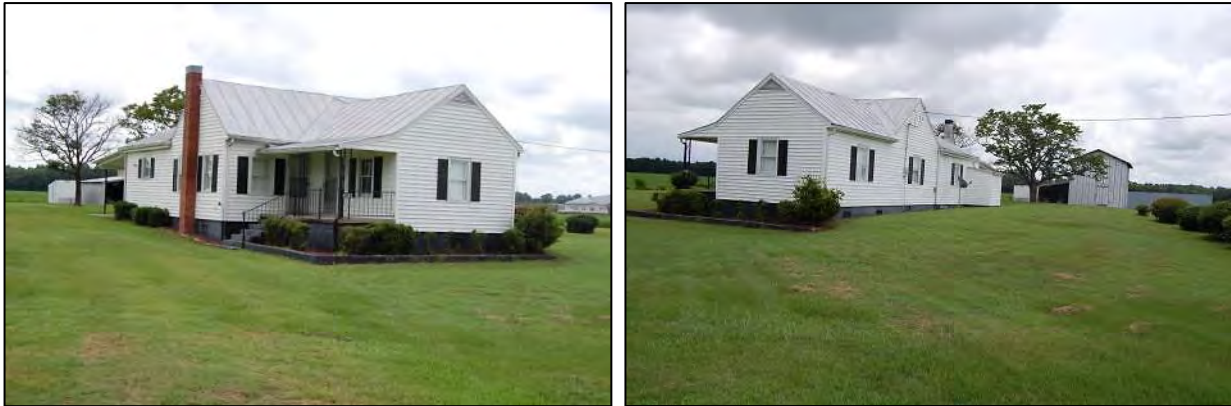
The frame, early twentieth-century, single-story, cross-gabled Fred W. Croom House is located near the western edge of the Sandy Bottom Historic district and bounded on its east, west, and south sides by actively farmed fields. The original house was L-shaped in plan, with a central rectangular mass and a front (north) projecting wing. A single-story gabled ell affixed to its south

rear may be original to the house or is an early addition. The entire house is clad in vinyl siding; it was likely originally weatherboarded. An exterior-end brick chimney stack climbs the house's east gable end and an interior brick stack projects from the ridgeline of the ell. The multi-gabled roof is clad in standing-seam metal. Two doorways are located in the angle of the front corner porch, which is finished with modern metal supports. The house's three-over-one double-hung windows appear to be original. A rear lean-to carport addition extends from the southern elevation of the ell is a later addition. The house retains sufficient integrity to contribute to the historic district (Figure 141).

**Figure 141: Fred Croom House: at left, east side and north front elevation; at right, north front and south side elevations with packhouse at right distance.**

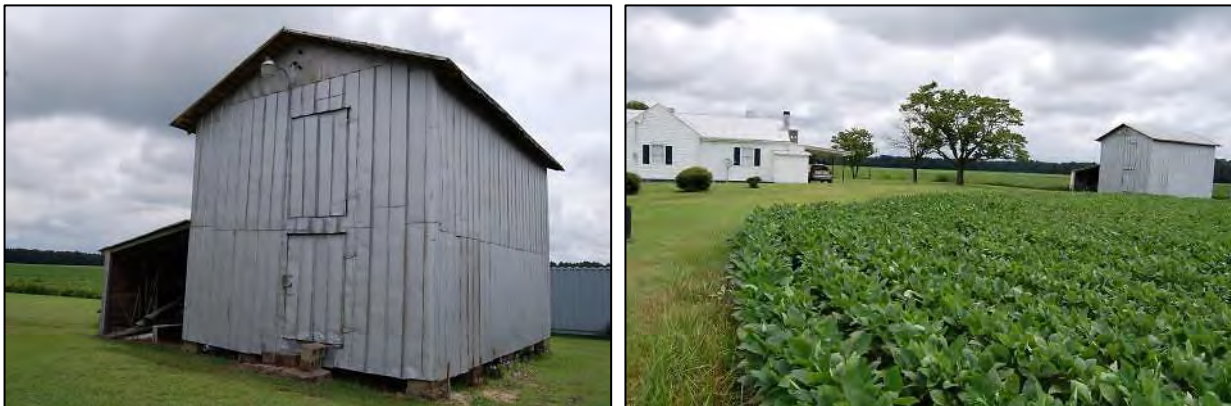
This early/mid-twentieth century packhouse, located behind (south of) the Fred Croom House, is built of frame construction and sided with sheet metal. In typical fashion, its front gable holds two doors, one above the other. A lean-to extends to its east side. The packhouse retains sufficient integrity to contribute to the historic district (Figure 142).

**Figure 142: Packhouse: at left, north front and west side elevations; at right, looking east across tobacco fields within the historic district at house to left and packhouse to right.**

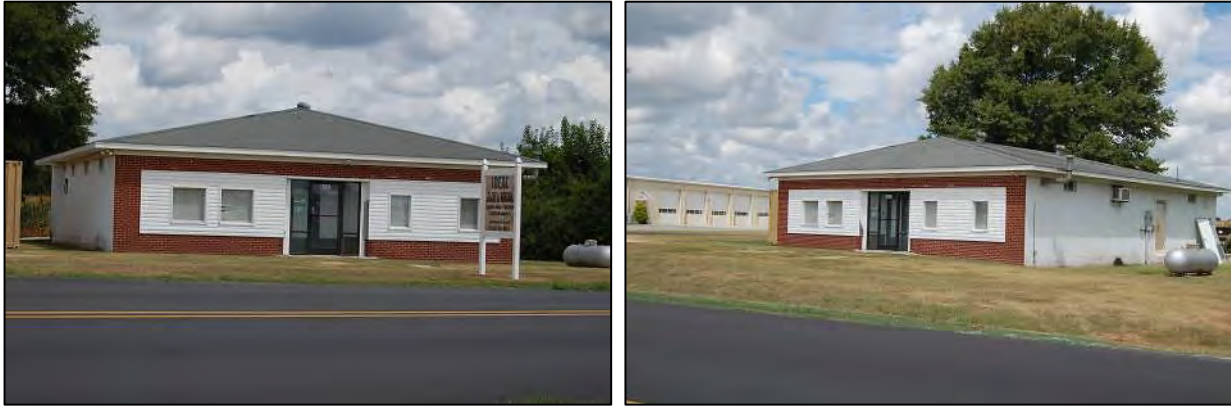
Located on the north side of NC 55, at the northwest edge of the historic district's boundary, is the Ideal Glass & Mirror building, which built as a store—the district's third—in the 1950s. The hipped-roofed concrete-block building is square in form and topped by a hipped roof. Its north

rear and side elevations retain their unadorned concrete-block walls. The original store front at the south front elevation has been altered by the addition of brick-veneer, modern glass doors, and a vinyl-sided insert with modern windows. The building is no longer a store, but continues to operate as a business. This building, three sides of which remain intact, is believed to retain sufficient integrity to contribute to the historic district (Figure 143).

**Figure 143: Ideal Glass: at left, west side and south front elevations; at right, south front and east side elevations with modern fire house outside of historic district at left distance.**

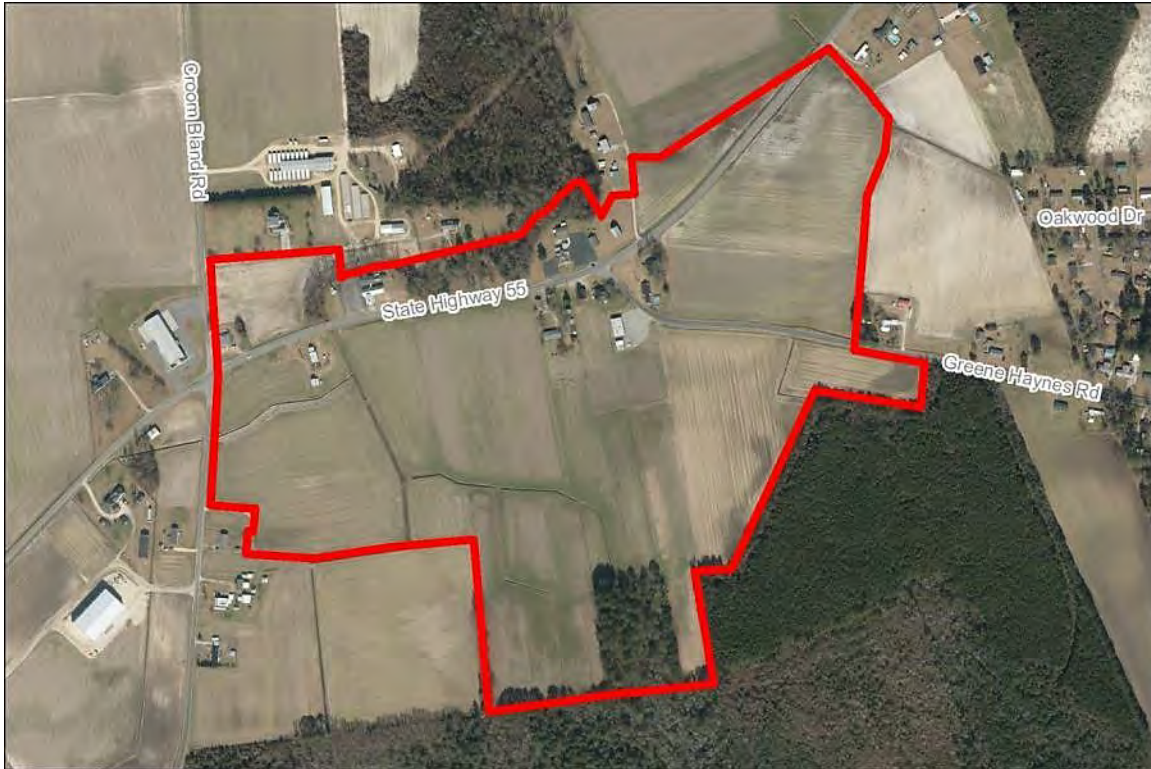
The proposed NRHP boundary (Figure 157) is drawn to include a large number of contributing resources and exclude resources on the periphery of the district that would be noncontributing (Figure 153 through Figure 156), while also including an appropriate and historic setting for the district. The proposed boundary follows the existing NCDOT right-of-way.

Figure 157: Map of proposed Sandy Bottom Historic District NRHP boundary, outlined in red.

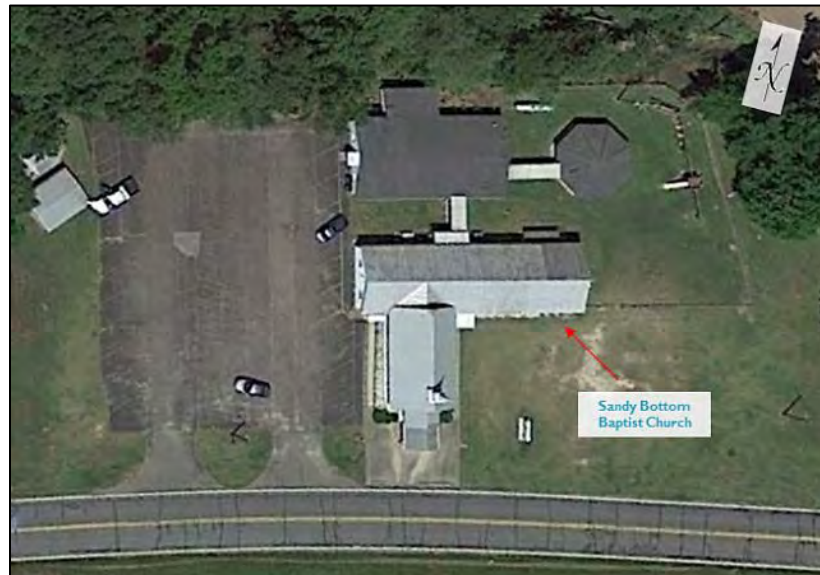
The Sandy Bottom Baptist Church sits near the western edge of the Sandy Bottom community on a 1.25-acre parcel. The church is situated toward the front of an open lot, which is bounded on its southern side by NC 55 and trees on its northern, eastern, and western sides. A large concrete parking lot located on the west side of the church occupies almost half of the parcel (Figure 158).

**Figure 158: Site Plan of Sandy Bottom Baptist Church with NC 55 at bottom (base image courtesy of Google Earth).**

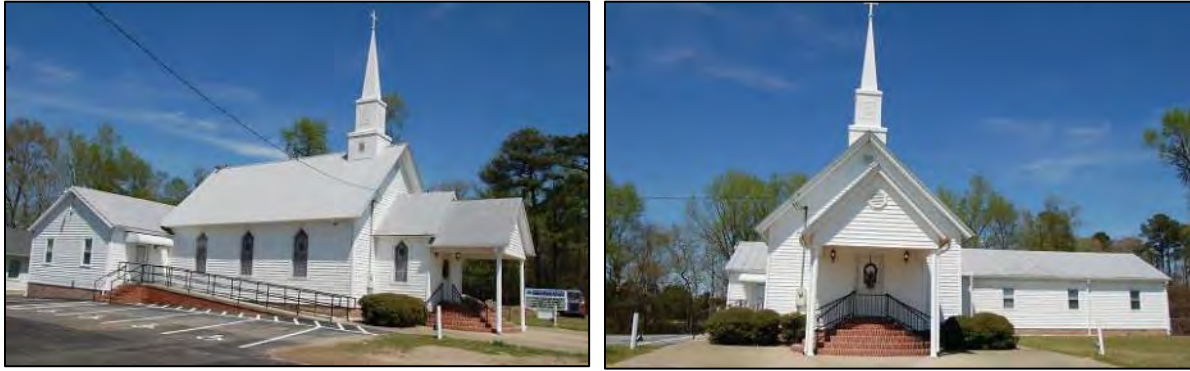
Local history states that the original mass of the church—the single-bay front-gabled sanctuary—was constructed around 1907. Both east and west side elevations are marked by three lancet windows. While the fenestration pattern is likely original, new stained-glass windows were installed in 1998. During the early/mid-twentieth century, a front-gabled narthex was added to the church's south front elevation. The building is primarily accessed through the centrally located replacement door in this narthex. The narthex additionally features lancet windows in the same style of the sanctuary on its side elevations. A pedimented front portico supported by composite Tuscan columns and a brick stairway were added sometime during the mid-twentieth century. The steeple likely dates from this time as well (Figure 159 and Figure 160).

**Figure 159: Sandy Bottom Baptist Church: at left, west side and south front elevation; at right, south front elevation.**

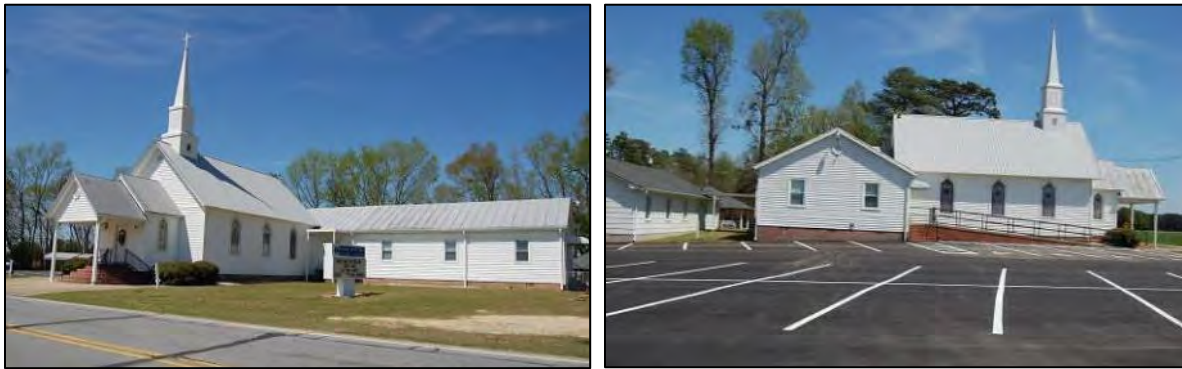
During the 1950s a one-story two-pile addition was added to the north rear of the church—and subsequently extended during the decade—giving the building an overall L-shape. The side-

gabled addition is clad in vinyl siding and, like the church, rests on a continuous brick foundation. A rear single-story fellowship hall was built in 1976. Resting on a concrete-block foundation and clad in vinyl, the hall is accessed from the church by a covered walkway. A round barbecue pavilion connected to the fellowship hall by a covered walkway was also built during in the late 1970s. Despite multiple site visits, access to the building was unavailable.

**Figure 160: Sandy Bottom Baptist Church: at left, south front and east side elevations with 1950s addition extending to side; at right, west side elevation with fellowship hall and round barbecue pavilion at far left.**

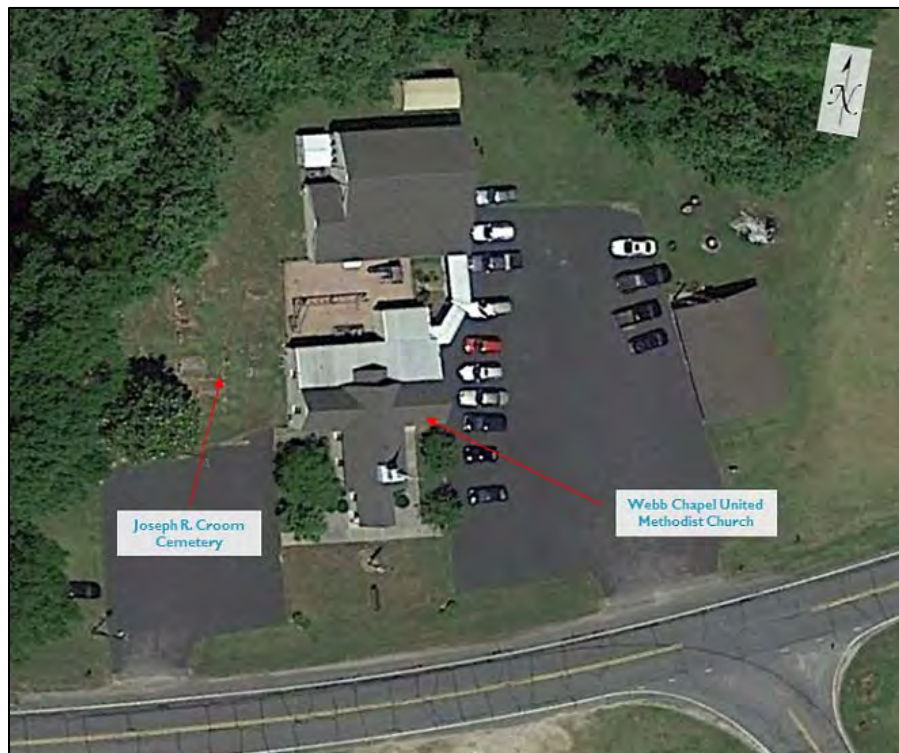
Webb Chapel United Methodist Church is located on a two-acre parcel at the crossroads of the Sandy Bottom Community, on the north side of US 55 (Figure 161). It is recommended as a contributing resource to the proposed Sandy Bottom Historic District, addressed separately above.

**Figure 161: Site plan of Webb Chapel United Methodist Church (base image courtesy of Google Earth).**
