North Carolina Department of Natural and Cultural Resources  
State Historic Preservation Office

MEMORANDUM

Subject: Historic Architecture Eligibility Evaluation Report, US 70 Kinston Bypass, R-2553,  
Lenoir County, ER 09-1307

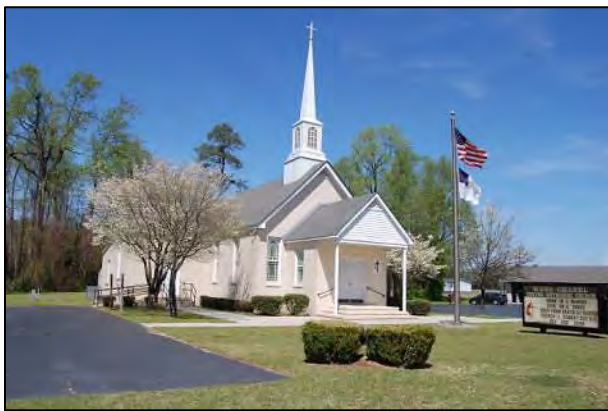
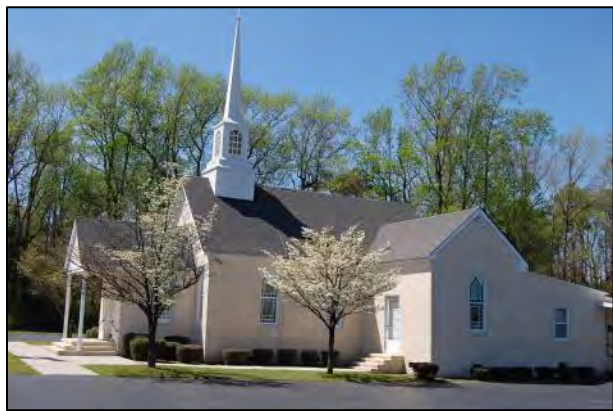
Church history suggests that the original one-room sanctuary was built in the early 1900s. Now clad in brick veneer, the original single-bay, four-pile-deep, front-gabled building would have been clad in weatherboards. It also initially lacked a steeple. The sanctuary retains its original lancet stained-glass windows. However, the window openings have been enlarged and the glass modified to fit into them. During the early twentieth century, east and west transepts were added

to the building creating a T-shaped plan. Instead of covering the original windows in these locations, they were shifted to the gable ends of both transepts. Two original secondary horizontal wood-paneled doors are found at each transept. A second addition of a front vestibule and pedimented portico extended the building to south front in the early/mid-twentieth century. The portico houses the church's centrally placed front doors, which are not original. A single-story, four-bay, shed-roofed was added to the church's rear in the mid-twentieth century (Figure 162 through Figure 164). Despite multiple site visits, interior access to the building was not available.

**Figure 162: Webb Chapel United Methodist Church: at left, west side and south front elevations; at right, south front and east side elevations**

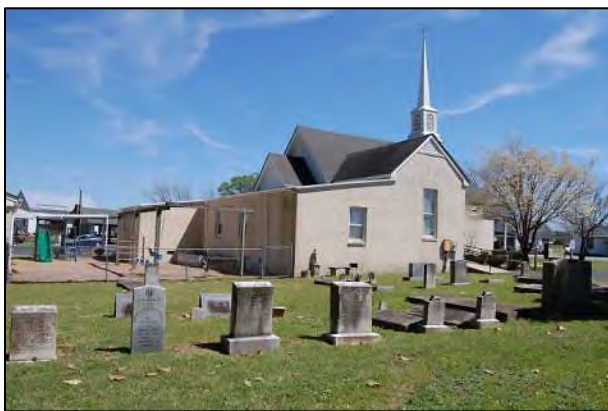
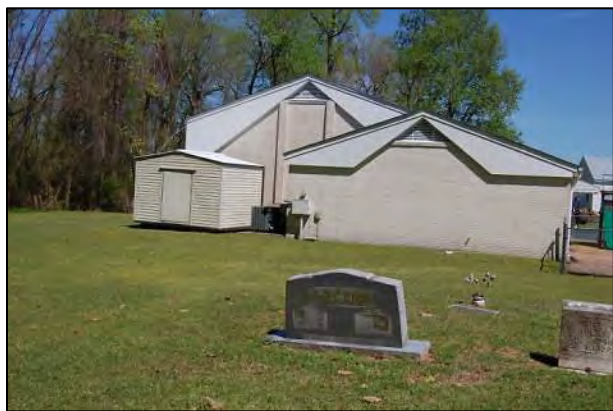
A large, late-twentieth century, side-gabled, masonry fellowship hall sits to the rear (north) of the main block. It is connected by an exterior paved walkway. The church parcel also contains the Joseph. R. Croom Cemetery and a large parking lot to its west. The cemetery contains about 75 interments underneath plainly finished markers.

**Figure 163: Webb Chapel United Methodist Church: at left, north rear and west side elevations of church with cemetery in foreground, at right, view of western elevation of church Fellowship Hall, looking east.**

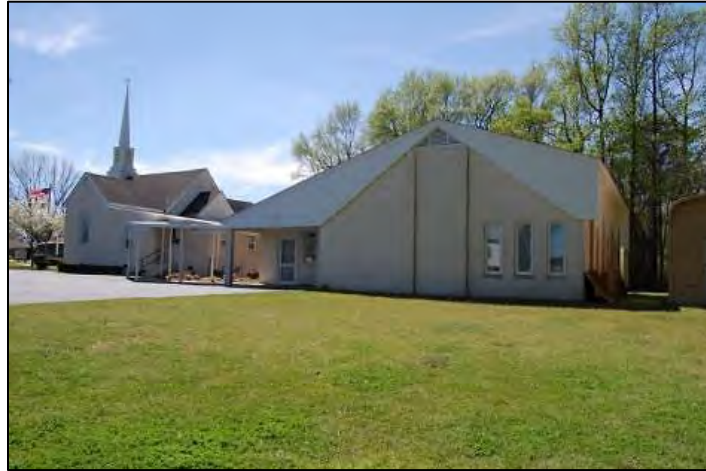
**Figure 164: Webb Chapel United Methodist Church: west side elevations of church at left and fellowship hall, at right.**

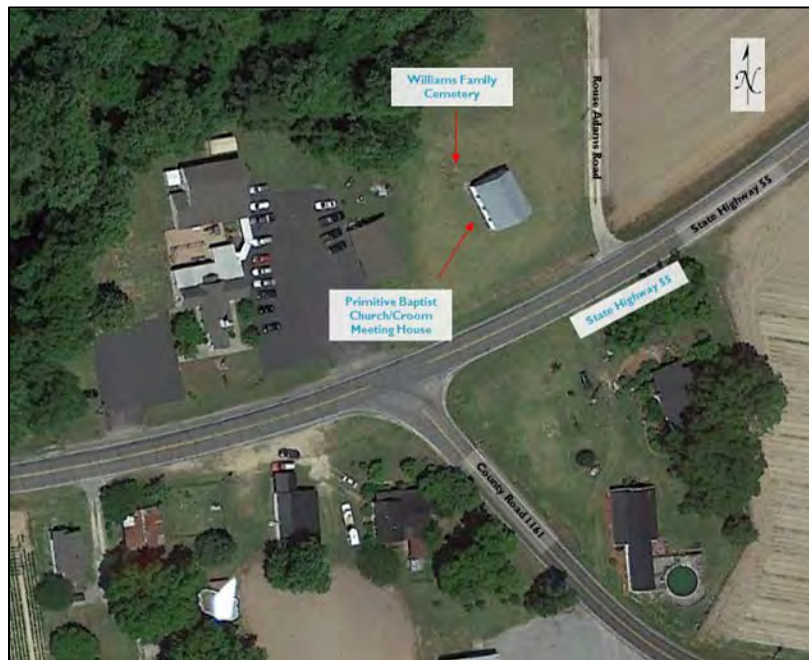
The Sandy Bottom Primitive Baptist Church or Croom Meeting House sits at the Sandy Bottom Crossroads on the north side of NC 55 (Figure 165). The building occupies an open one-and-a-half-acre parcel. A tiny cemetery stands off its northwest corner.

**Figure 165: Site plan of Sandy Bottom Primitive Baptist Church (base image courtesy of Google Earth).**

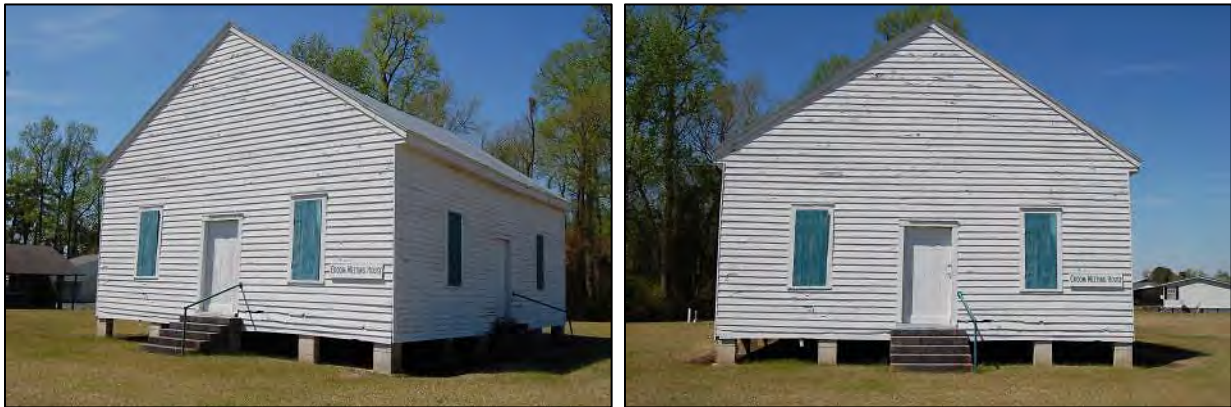
and is simple in its form and ornament. Its alterations are few. Its gabled roof is clad in standing-seam metal, which replaced original wood shingles. At its rear gable, a former door bay has been weatherboarded over. The building rests on concrete-block piers as a result of being shifted a very short distance on its site to the north in the 1970s as part of the NC 55 widening project. Other than these changes, the church looks much like it did when it opened in the 1850s.

The meetinghouse is a frame rectangular building with no portico, additions, or steeple (Figure 166 through Figure 168). It holds only a single room. It is covered with weatherboards and flanked by cornerboards. Boxed eaves mark its east and west side elevations. The church is oriented with its gables facing north and south. On the south is a centered wood batten door flanked by two windows hidden by shutters. The surrounds here and on the other elevations are plain. The long east elevation is similarly finished with a center wooden door flanked by shuttered window. Three shuttered windows extend along the west side elevation. The north gabled elevation originally looked like the south one. Its door has been closed off by weatherboards and a window above is either original or dates from the sealing of the door. According to tradition, the rear door was the slave entrance, which was closed off following the Civil War, not after the church's construction.

**Figure 166: Croom Meeting House: at left, east side and south gabled elevations; at right, south gabled elevation.**

The Croom Meeting House is the least altered antebellum church in Lenoir County and retains a high degree of integrity. Its original features include its gable-front form and weatherboard cladding, patterns of bays and nine-over-nine sash, wooden doors, floorboards, and even its pulpit and pews. A remarkable survival, it is recommended as NRHP eligible for its architecture under Criterion C as an excellent example of an antebellum meetinghouse and also under Criterion A, as an early intact meetinghouse/church in the areas of social history and religion. Although the family cemetery on its property is not clearly associated with it, it is believed to contribute to its integrity. The period of significance is believed to extend from the 1850s, when the building was erected, to 1964, when it was sold and finally ceased functioning as a church. The building is recommended not eligible for NRHP listing under Criteria B or D as it is not associated with any significant historic figure, nor does it boast the potential to yield any substantive information in the field of architectural history.

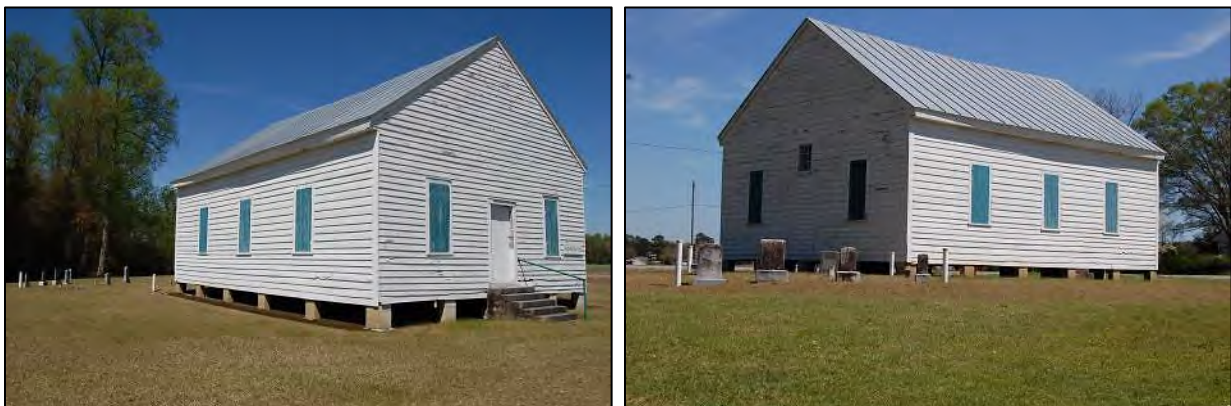
**Figure 167: Croom Meeting House: at left, west side and south gabled elevations; at right, north gabled and west side elevations.**

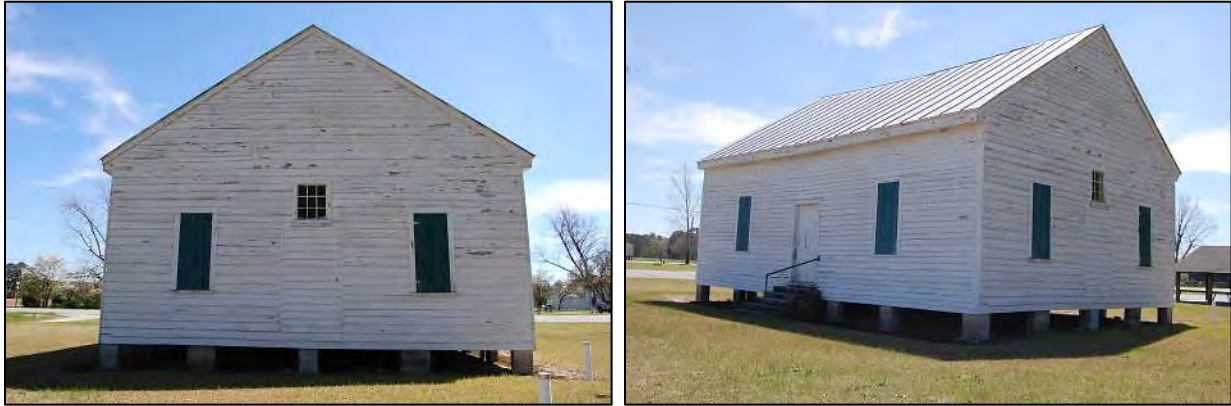
**Figure 168: Croom Meeting House: at left, south gabled elevation; at right, east side and south gabled elevations.**

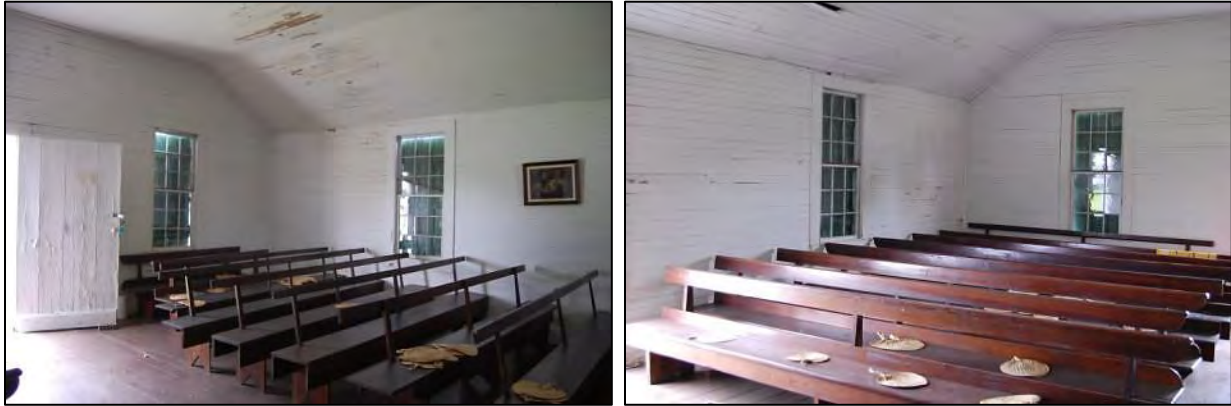
The church's interior is as simple in its design as its exterior (Figure 169 through Figure 171). Its single room is sheathed on all sides and at its ceiling with beaded tongue-and-groove boarding that likely dates from the late nineteenth or early twentieth century. From inside the original nine-over-nine double-hung windows can be seen to remain in place. A large, square, hand-planed pulpit that appears to be contemporary with the building is centered on the north gable end wall. Ghost-marks in the room's center mark its original location; it was likely moved following the closure of the north gable door. Original wide-plank pine floors span the building from north to south. Original pine pews, plainly articulated, are placed in a cruciform pattern, two lines running north to south with a central aisle in between, and a line on the eastern and western sides of the pulpit. The roof framing is visible through a hatch. John Wood of the North Carolina HPO, who visited the site when it was surveyed, indicated that a tie-beam appeared to be pit-sawn, but that the rafters were replaced. (According to former congregants, the building has withstood a number of severe storms, one of which may have necessitated the rebuilding of the roof.)

**Figure 170: Croom Meeting House: at left, view of interior of church looking southwest; at right, view of interior of church looking southeast.**

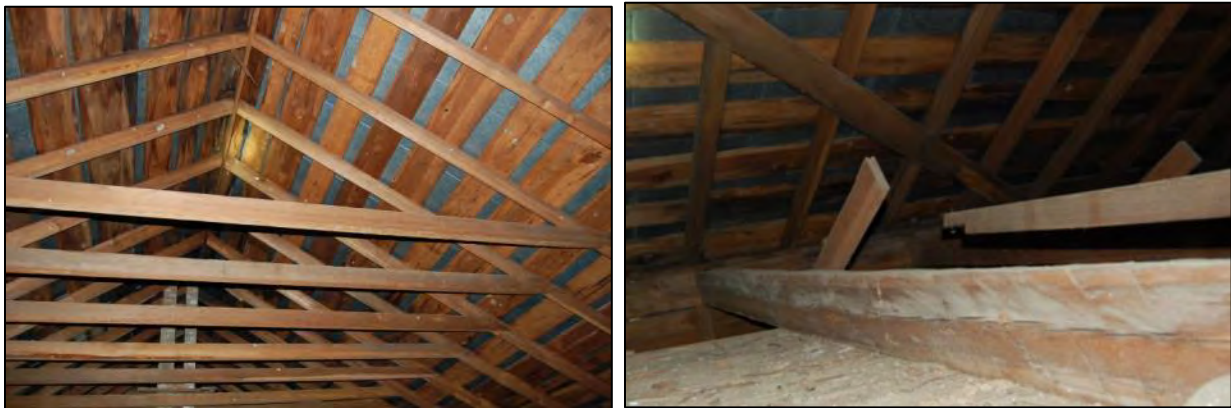
**Figure 171: Croom Meeting House: at left, view of replacement roof trusses; at right, original roof tie beam that appears to be pit-sawn.**

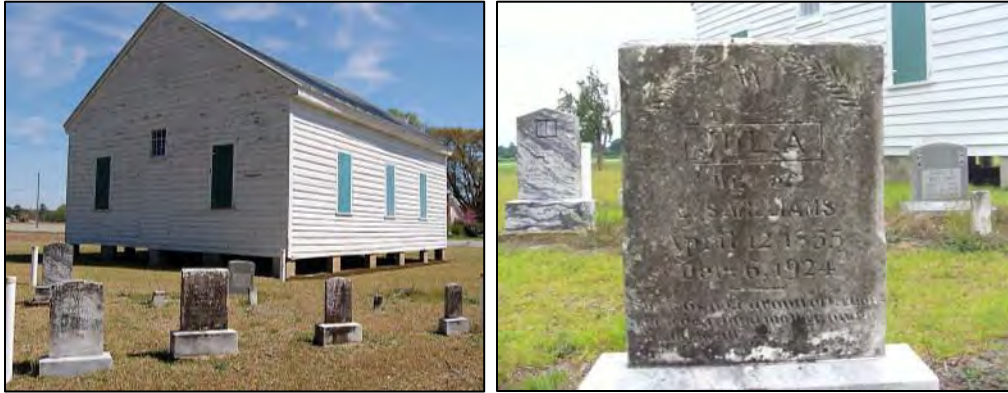
Curiously, the tiny Williams Family Cemetery just off of the church's northwest corner is not directly associated with it (Figure 172). Not marked by a wall or fence, it contains seven markers identifying the graves of Joseph Williams (1852-1929) and his wife, Julia Williams (1855-1924); their children, Roy Williams (1896-1916) and Julia Williams (1890-1892); and David S. Williams (1885-1953), Jessie David Williams (1924-1924), and Henry G. Williams (1881-1935) (<http://lenoir.lostsoulsgenealogy.com/cems/williamscem.htm>). The markers are straightforward stone headstones

Figure 172: Williams Family Cemetery standing just northwest of Croom Meeting House

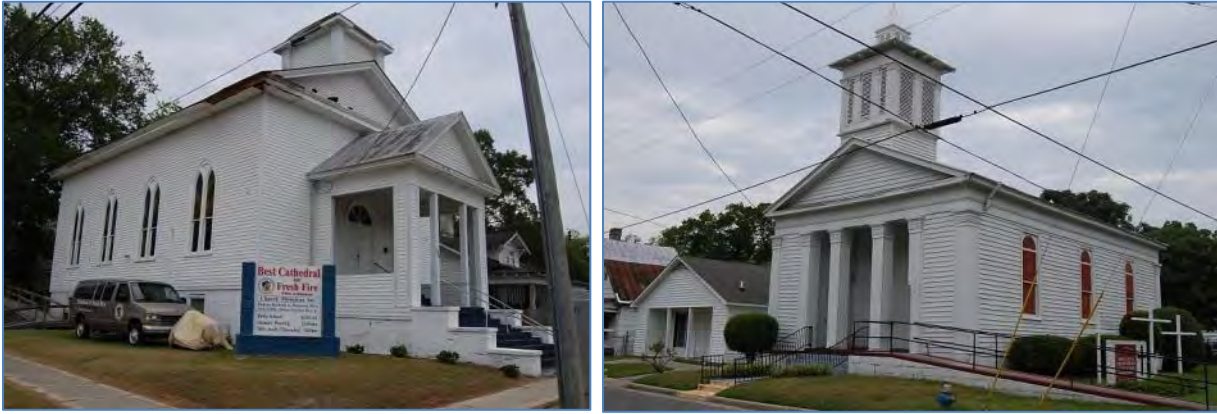
Six antebellum churches are known to survive in Lenoir County. Two of the more intact ones are in Kinston. The congregants of the Caswell Street Methodist Church (LR-0323) began construction of their church in 1860, but completion awaited the end of the war (Little et al. 1998:64, 203). Its basic Greek Revival-style, gable-front, triangular-pedimented form is intact, but it has otherwise been altered over the years (Figure 173, at left). Its entrance portico is an addition, as are its Gothic Revival-style windows, which replaced its original sash. Its bell tower and octagonal spire are gone. Only a belfry with altered, outsized, corner pilasters survives. Once weatherboarded, the church is now covered with vinyl siding. More intact is the NRHP-listed First Baptist Church of Kinston or White Rock Presbyterian Church (LR-0462), erected ca. 1858 (Little et al. 1998:64, 217; Black 1989c). Its textbook, Greek Revival-style, *distyle in antis* portico retains its two central fluted columns and flanking smooth pilasters (Figure 173, at right). The original louvered belfry is still in place, although its steeple is gone. Weatherboards yet cover the building and a wide plain friezeboard continues to ring it.

**Figure 173: Caswell Street Methodist Church, north side and west front elevations, at left; White Rock Presbyterian Church, south front and east side elevation, at right, 2017**

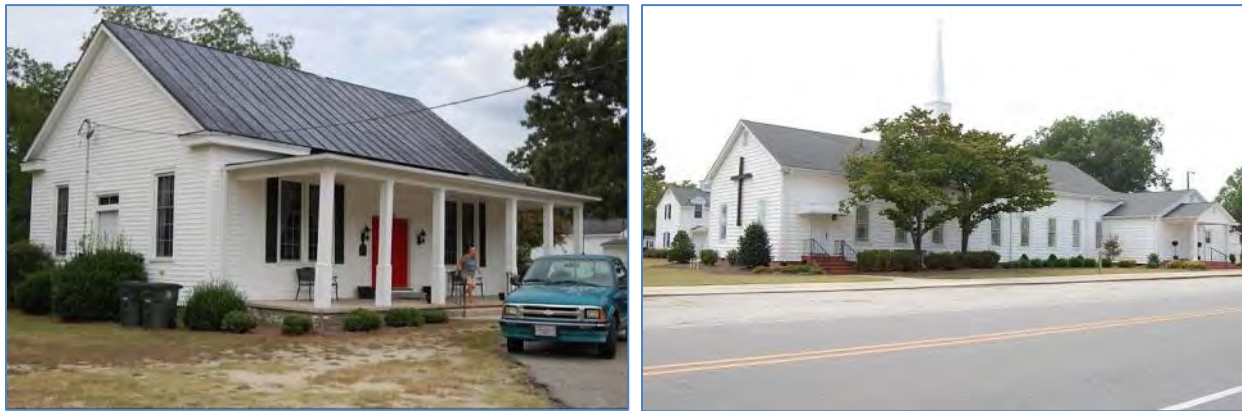
Three other antebellum churches with far less integrity survive in Lenoir. The ca. 1857 former Bear Creek Primitive Baptist Church (LR-1160) in LaGrange, now the home of the LaGrange Garden Club, has been moved several times (Little et al. 1998:304). Its modest form is intact and its original entry is apparent at its west gable end (Figure 174, at left). Otherwise, it is sided with vinyl, its windows have been replaced, a porch has been added, and most of its original fabric is gone. The original small antebellum sanctuary of the Wheat Swamp Christian Church (LR-0902) reportedly still stands (Little et al. 1998:42, 319). Subsumed within the sprawling complex of the church, it is no longer discernable (Figure 174, at right).

**Figure 174: Bear Creek Primitive Baptist Church, east gable and long north elevations, at left; view looking west at Wheat Swamp Christian Church, at right, 2017**

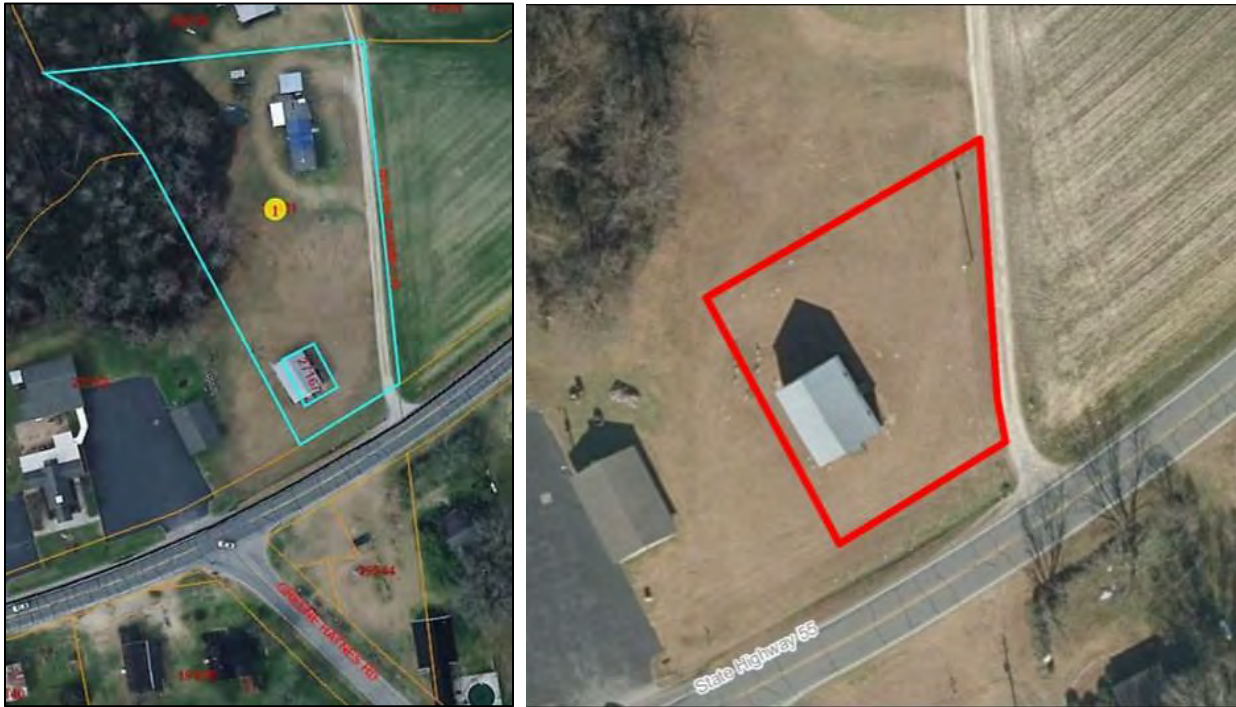
The one-and-a-half-acre parcel that the Croom Meeting House occupies is inappropriate in its entirety as an NRHP-eligible boundary, as it includes a modern house and outbuildings on its northern half. The recommended boundary occupies about 0.4 acres on the parcel's south. This boundary extends on the east to the west side of Rouse Adams Lane, not across it; on the north to just below the entry drive to the modern house on the parcel; on the west to the property line; and on the south to the edge of NCDOT right-of-way on the north side of NC 55. This provides an appropriate setting for the church, includes the cemetery, and excludes the modern house and roadways. It includes the entire fractional parcel (#27167) upon which the church stands and the south portion of the larger lot that surrounds it (#27845). It should be noted that the parcel lines shown on the tax map are apparently shifted slightly to the east of the actual lines. The description of the proposed boundary is intended to clarify its precise location (Figure 176). The boundary is intended to follow the existing NCDOT right-of-way.

**Figure 176: Image of tax map, at left, with parcels outlined in blue (note irregularity of line placement); proposed Croom Meeting House boundaries at right, outlined in red.**

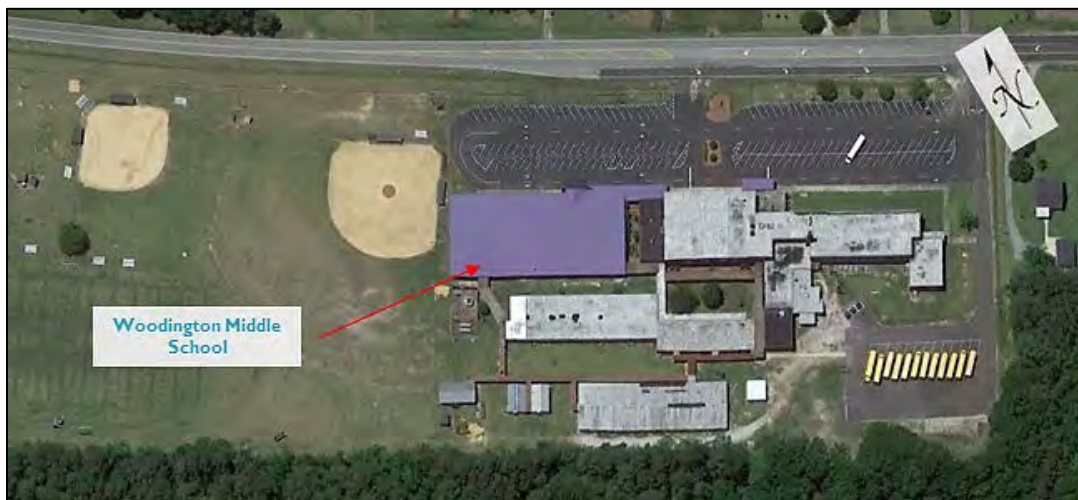
Situated on the south side of NC 258 in the Woodington crossroads community, the Woodington Middle School evolved over the course of the mid- and late twentieth century (Figure 177).

**Figure 177: Site plan of Woodington Middle School (base image courtesy of Google Earth).**

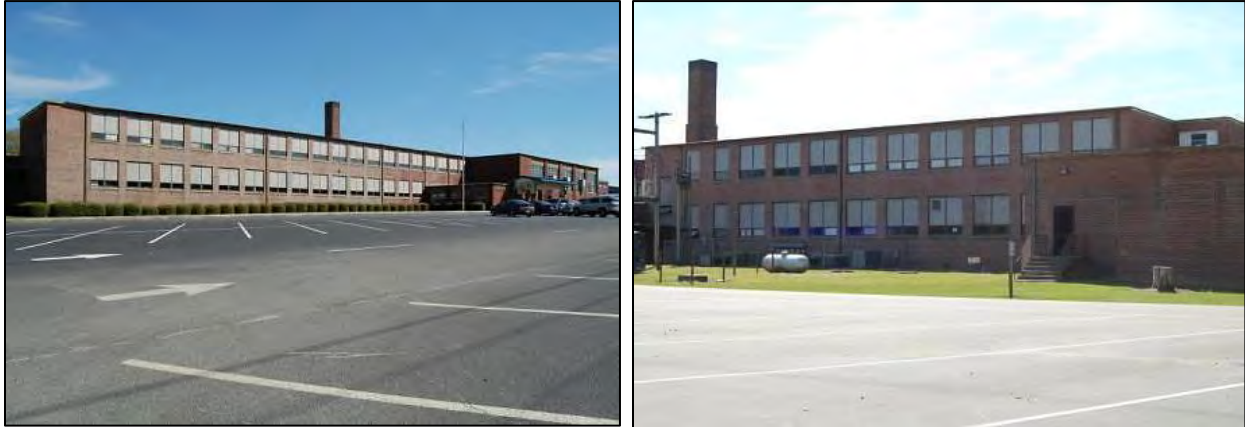
The oldest wing of the masonry school is found at its east ( Figure 178 through Figure 180). Featuring a flat roof and clad in brick veneer, the 20-bay, linear, two-story, original block was constructed in 1952. Openings for 18 sets of paired plate-glass windows adorn the north front elevation of the building. The original windows have been replaced with newer, smaller, more energy efficient windows; the gaps left by these small insertions have been filled with modern materials. Attached to the east side elevation of the block is an original, single-story, flat-roofed wing. The projecting flat roof shielding its walkway hints at the International style. The windows have been filled or replaced, however, obscuring its original appearance.

**Figure 178: Woodington Middle School: at left, north front elevation of original block; at right, south rear elevation of block.**

Woodington Middle School retains its original 1952 block, but that block's appearance has been much altered by the replacement and partial closure of all of its classroom windows. The slightly later gymnasium to the southwest remains largely intact, but is flanked by an expansive modern wing added in 1998. Woodington is not equal in integrity or design to the Moss Hill or Contentnea schools and is recommended as not NRHP-eligible under Criteria C. Further, Woodington lacks association with any notable historic event. Although it is a school, it did not play any significant role in the history of education in Lenoir County. It is therefore recommended as not eligible under Criterion A. It further lacks association with any notable historic figure and is recommended as not significant under Criterion B. As the former school is not likely to yield important historical information on the basis of its appearance or construction, it is not recommended as eligible, as an architectural resource, under Criterion D.

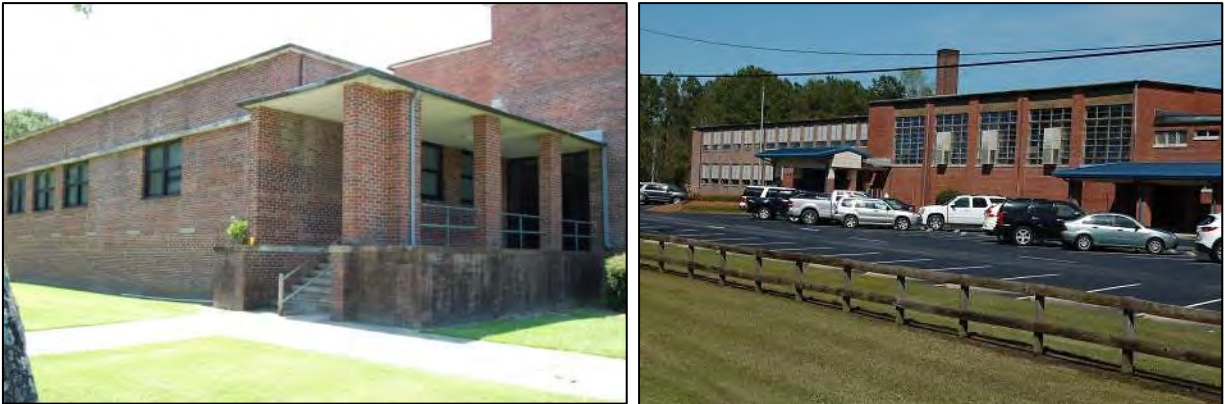
**Figure 179: Woodington Middle School: at left, easternmost portion of original block; at right, north front elevations of gymnasium and original block.**

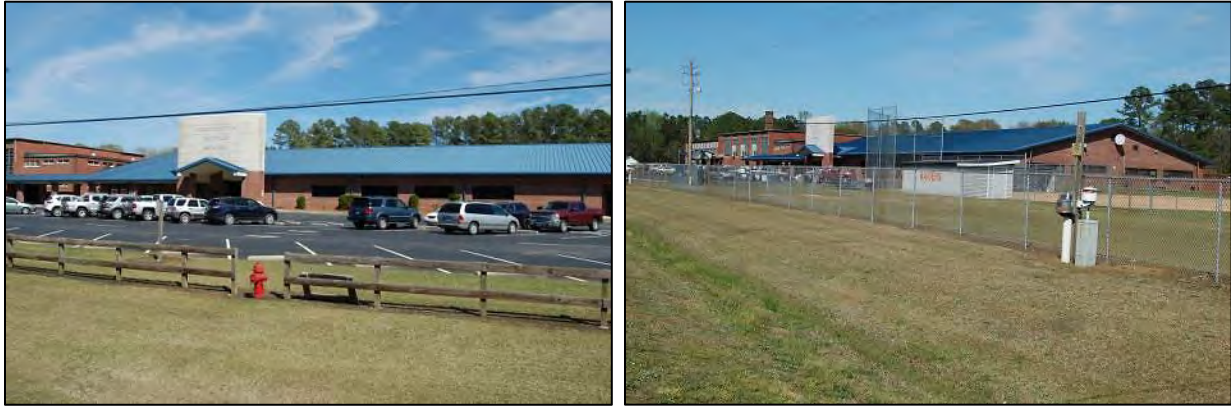
has a low-sloped side-gabled roof and a wide overhanging front portico. A large pedimented entry with a concrete sign extended above is placed centrally on the block's primary north elevation. A brick blue metal roof covers the block. All sections of the school are marked inside by plain concrete-block corridors.

The south rear elevation of the school is finished, and altered, much like the front. Multiple single-story extensions, however, suggest later additions; their placement does not reveal a plain pattern of development. Overflow classroom trailers are set further to the school's rear. Athletic fields occupy the west end of its long parcel. Interior access to the building was not available.

**Figure 180: Woodington Middle School: at left, north front elevation of modern 1998 addition; at right, north front and west side elevations of modern block with playing fields to right.**

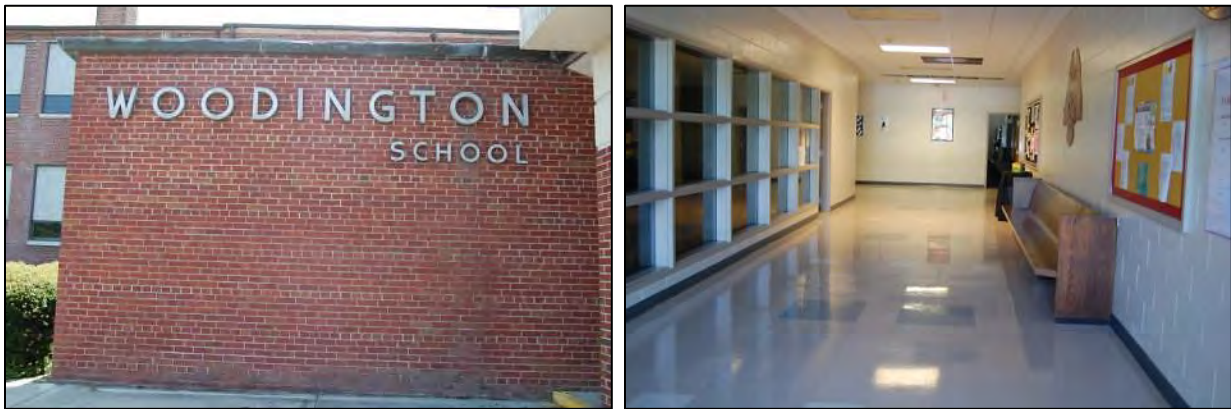
**Figure 181: Woodington Middle School: at left, detail view of school name sign found on original section of building; at right, interior view of hallway.**

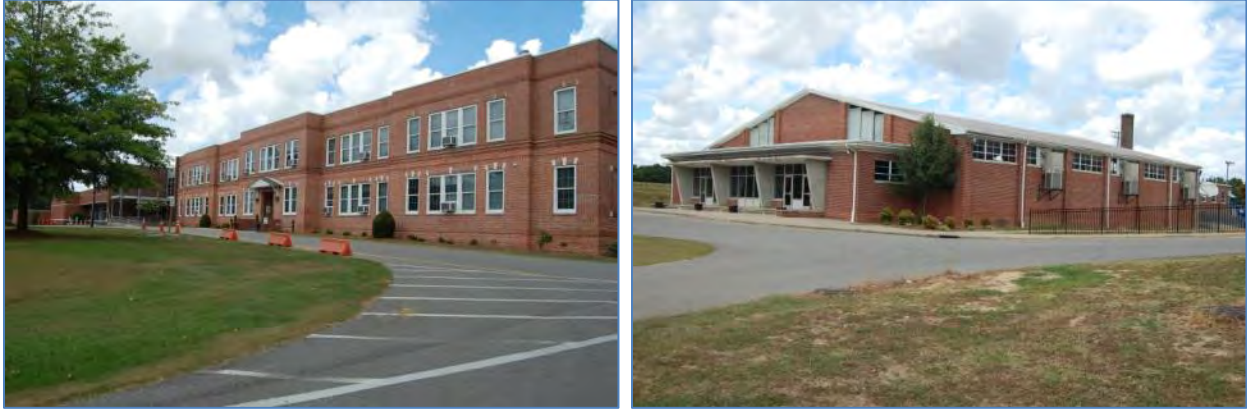
Two large, post-consolidation, brick schools with a high degree of integrity survive in rural Lenoir County. The Study-Listed Moss Hill Elementary School (LR-1012) remains largely intact in the Strabane community. It retains its original 1917 block, designed in a restrained Colonial Revival-style, by prominent Wilmington architect Leslie Boney (Figure 182). Attached to the west side of this block is a 2010 addition that supplanted a 1950 classroom wing. A modernist 1955 gymnasium still stands west of the school (Little et al. 1998:112, 394).

**Figure 182: Moss Hill Elementary School: at left, original 1917 block with 2010 addition to its left; at right, 1955 gymnasium, 2017.**

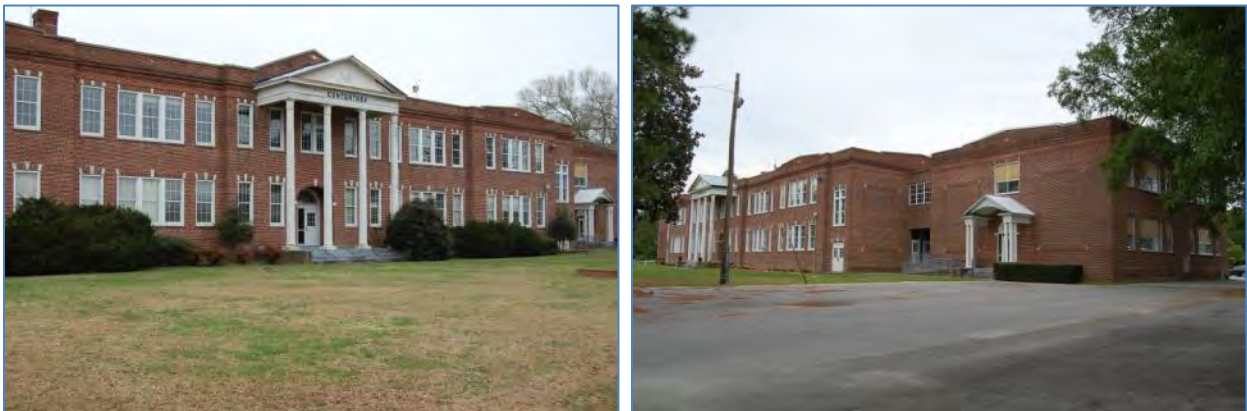
The Neoclassical Revival-style Contentnea School (LR-0800), also designed by Leslie Boney, was erected in Graingers in 1923-1924 (Little et al. 1998:363). A wing was added to the south of the original block in 1929 and a second matching wing added to the north in 1950 (Figure 183). Additional classrooms and a gymnasium rose to the rear in 1956-1957. The school was designated NRHP-eligible in 2010 and its boundaries revised to include its teacherage on the south in 2016 (Brown 2016).

**Figure 183: At left, Contentnea School: west front elevation of original block; at right, front elevation with 1929 south wing to right, 2017.**

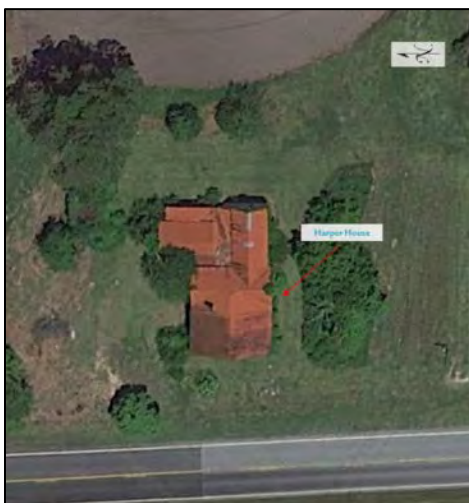
Located a little over seven miles south of Kinston, the Harper House is bounded on its western side by US 258 and agricultural land to its northern, southern, and eastern sides. Although surrounded by fields, the house's close proximity to the divided-highway has detracted from its once rural setting (Figure 184). The house lacks maintenance and is rapidly deteriorating.

**Figure 184: Site plan of Harper House with NC 258 at bottom (base image courtesy of Google Earth).**

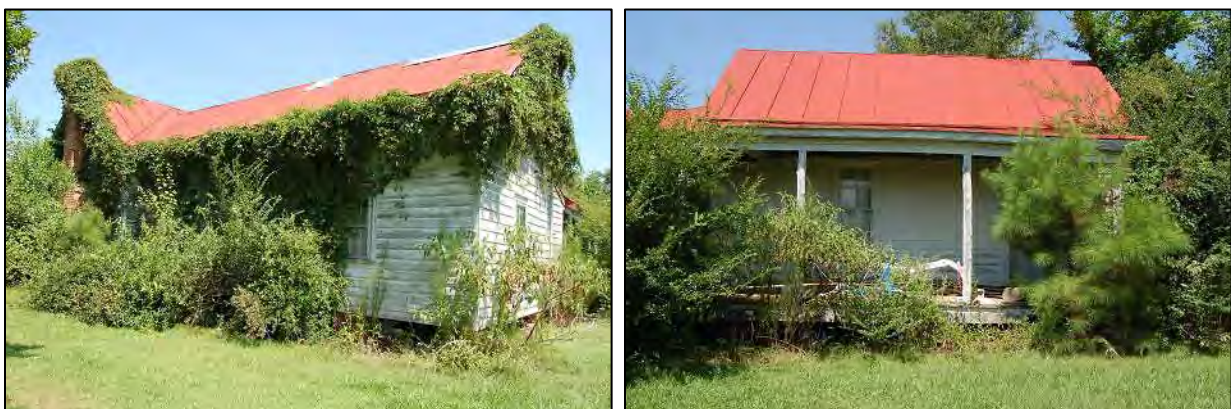
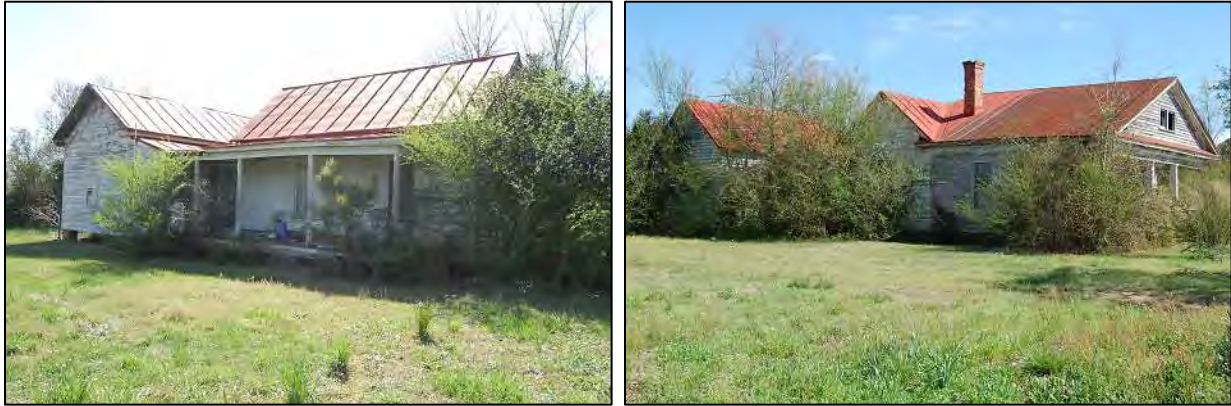
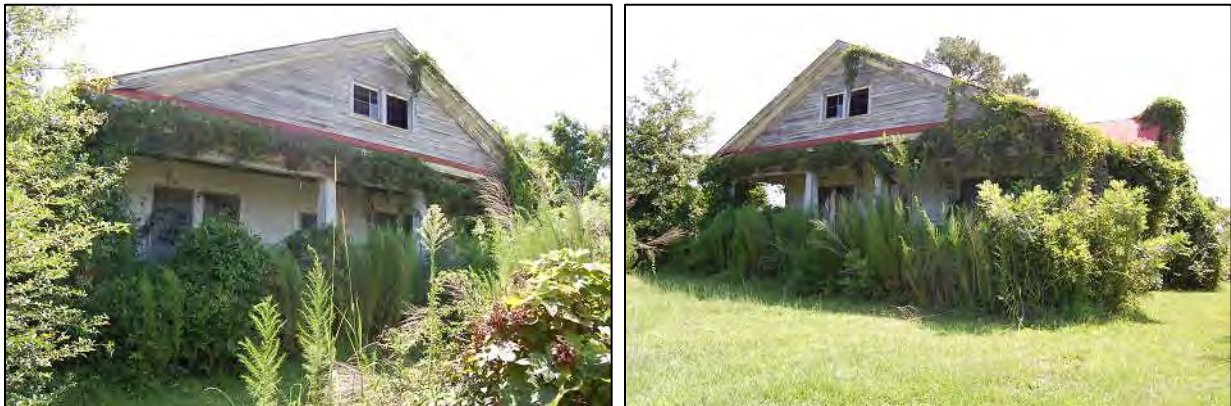
The original ca. 1902 block of the Harper House is L-shaped and stands at its east rear. It was originally a single-story, single-pile, frame building that stood alone on brick piers. It retains its original weatherboard siding, standing-seam gabled roof, and some six-over-six windows. To the house's north side, within the legs of its L-shaped body, is a one-story, single-pile, gable-end, frame block that was likely originally a freestanding kitchen. At its east-facing elevation, the kitchen retains a six-over-six window and an early doorway. A porch across its east elevation was likely added or altered to connect the early house and kitchen. Likely in the teens or twenties, a block was added to the west of the original house and kitchen. Fronting on the road, it became the principal face of the house. Likely at this time, the three separate portions of the house were connected as one (Figure 185 through Figure 188).

The 1928 block is built of frame and weatherboarded. Its three-bay-wide, south-facing, front elevation is extended by a deep, engaged, full-façade porch. In typical Craftsman-style fashion, the porch is supported by tapered posts on brick piers, which are connected by a wooden rail and square pickets. The pediment displays a large molded cornice, an unadorned entablature, and a set of paired windows in the center of its tympanum. Plain cornerboards adorn the eastern and western corners of the house. The symmetrically placed front bays are set in plain surrounds. Paired six-over-one double-hung windows—another Craftsman feature—flank the central entry. An interior brick chimney rises from the block's roof. A second exterior-end chimney stands on the south gable-end of the original house.

**Figure 186:** Harper House: south-facing elevation of original block, at left; at right, east-facing elevation of kitchen block, at right.

**Figure 187: Harper House: to left, east-facing elevations of original block at left and kitchen at right; to right, north side elevations of kitchen at left and Craftsman block at right.**

**Figure 188: Harper House: west front elevation of Craftsman block, at left, and west front and south side elevations, at right**

The Harper House is recommended as not eligible for NRHP listing. It has no known connection with historic events or notable persons and is therefore not eligible under Criteria A or B. Its much-altered and additive plan is also not notable and is not NRHP-eligible under Criterion C. The house started out as a one-story, gabled, L-shaped dwelling with a detached kitchen. At some point the kitchen was shifted up between the legs of the L and attached to the house. This was contemporaneous with the addition of the Craftsman-style front-gabled block facing the road. These changes resulted in alterations to the house's form and finish. It is not nearly as intact as other small gabled houses in the county, such as the West Crossroads Tenant, Clyde Daughety, Hine-Warters-Adkinson, and T.J. Herring Tenant houses. Further, its later gable-front block is not as notable an example of the Craftsman style as such dwellings as the Felix Hardison, James William Brothers, and Owen Williams houses. Due to its loss of integrity, the house lacks the potential to yield any significant architectural information in the future and therefore does not merit eligibility, as an architectural resource, under Criterion D.

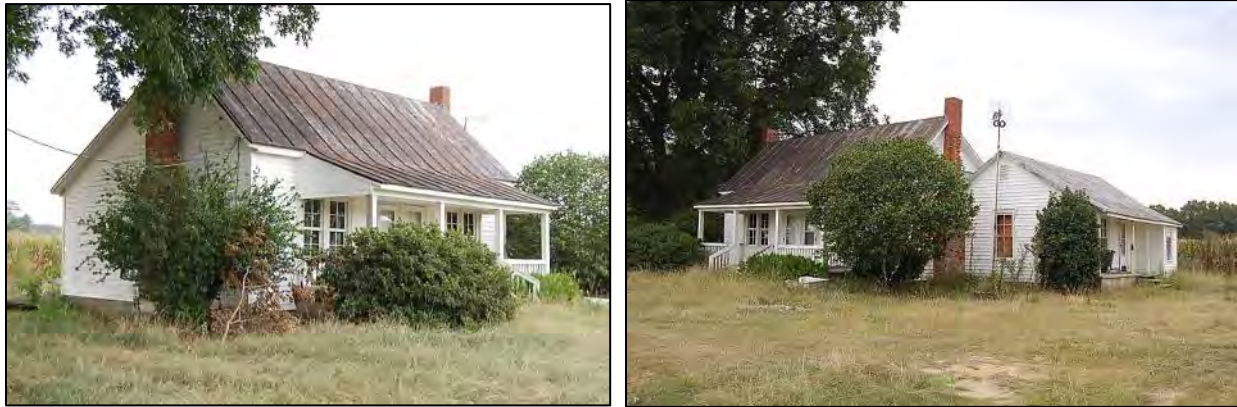
The late nineteenth-century Horace Barwick House (LR-1054) in the Deep Run community is also a modest house that retains its one-story gable-end form (Figure 191). Its kitchen/dining room ell remains in place, attached to its northeast rear corner (Little et al. 1998:399).

**Figure 191: Horace Barwick House: west side and south front elevations, at left, and east side elevation with kitchen wing in foreground, at right, 2017**

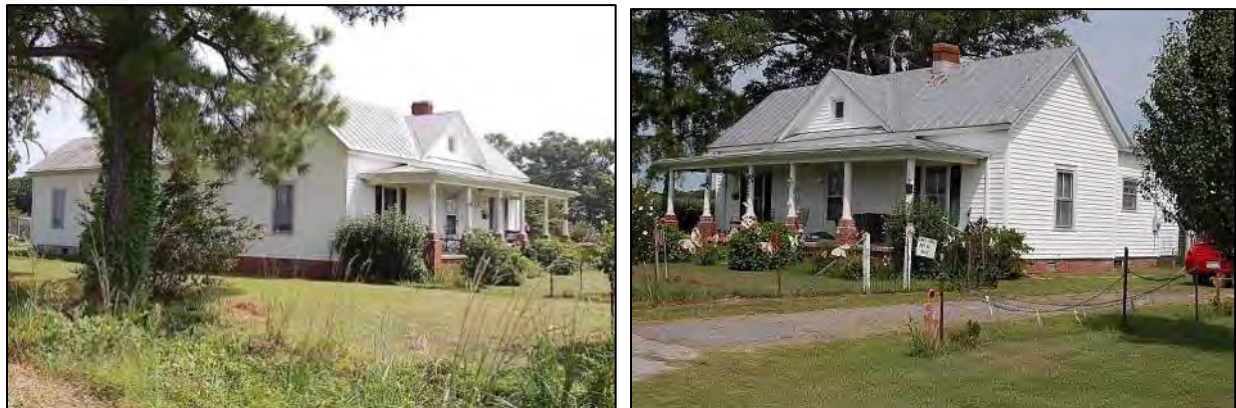
The Clyde Daughety House (LR-0829) near Wootens Crossroads is yet another typical and intact small holder or tenant house dating from around the turn of the century. Weatherboards, two-over-two windows, and a gable-end roof with façade gable continue to mark it (Figure 192). Its kitchen ell has been fully integrated into its rear elevation, likely through the enclosure of its original breezeway.

**Figure 192: Clyde Daughety House: west side and front elevations, at left; front and east side elevations, at right, 2017.**

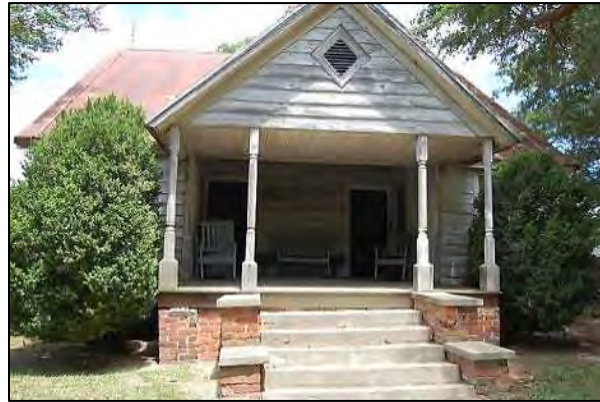
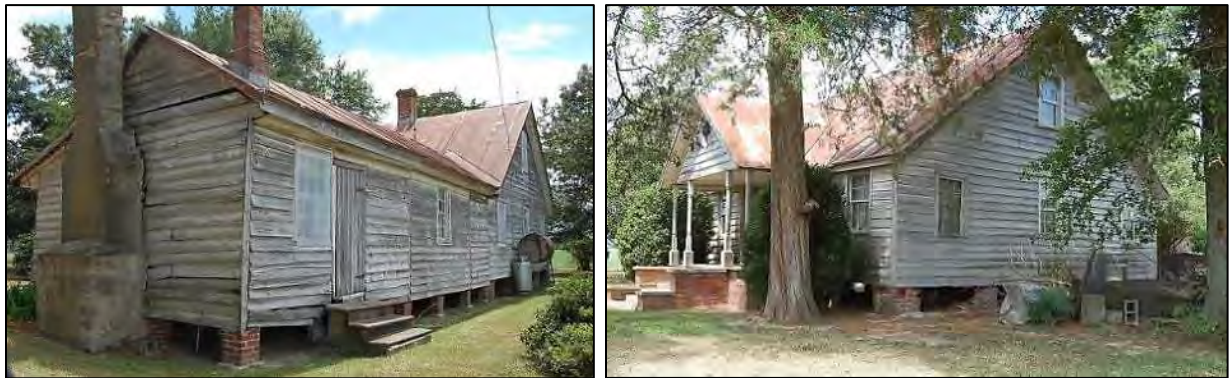
The house's exterior retains the recessed entry and front porch, weatherboards, brick foundation piers, six-over-six sash, and board-and-batten doors. The location of the breezeway that once separated the front block from the rear kitchen is evident, although it appears to have been enclosed early on. The interior was not available for inspection.

**Figure 193: Hines-Warters-Adkinson House: south front elevation with intact recessed entry and ca. 1900 turned columns and porch.**

**Figure 194: Hines-Warters-Adkinson House: at left, north rear and west side elevations with location of former breezeway to kitchen visible at central window bay; at right, south front and east side elevations, 2017.**

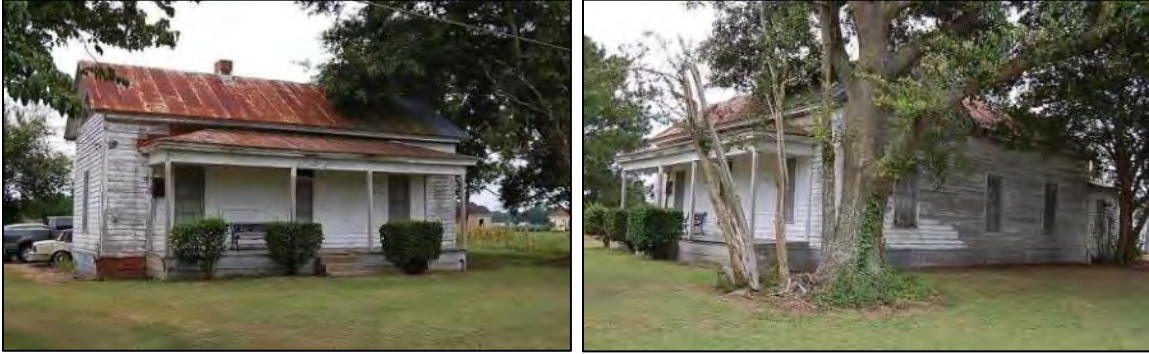
Thomas Jason “T.J.” Herring (1878-1949), who lived on the William Isler Herring Farm (LR-0860), may have built the one-story, gable-end, frame tenant house that continues to stand on his former holding (Figure 195). Located at 1531 NC 55 northeast of Kinston, it stands about a mile west of his home. Its original surviving features include weatherboard cladding, six-over-six windows, a transom, a wide plain friezeboard, and an attached one-story ell.

**Figure 195: T.J. Herring Tenant House: east side and north front elevations, at left; north front and west side elevations, at right, 2017.**

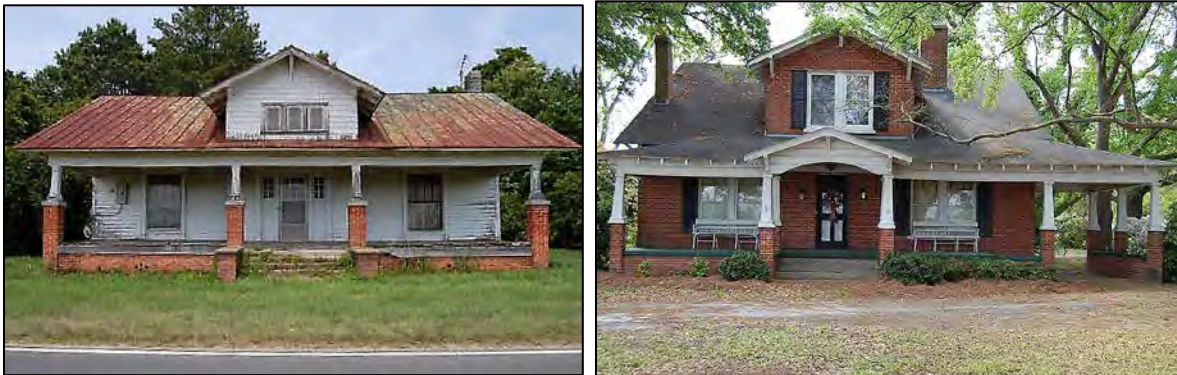
The later-added front block of the Harper House relates decoratively to such Craftsman-style dwellings as the one-and-a-half-story Felix Hardison House (LR-0770) and James William Brothers House (LR-0921) (Figure 196). This is most notable at its Craftsman-style porch. Both stylistically and formally, the Harper House is particularly closely related to the gable-front Owen Williams House at 5270 Bear Creek Road southwest of Jenny Lind. The Williams House has a gable-front façade with a full façade porch of posts on brick piers, triangular kneebraces, and four-over-one sash. Little altered, it retains its weatherboard cladding as well (Figure 197).

**Figure 196: Felix Hardison House, at left, south front elevation, and James William Brothers House, northwest front elevation, at right.**

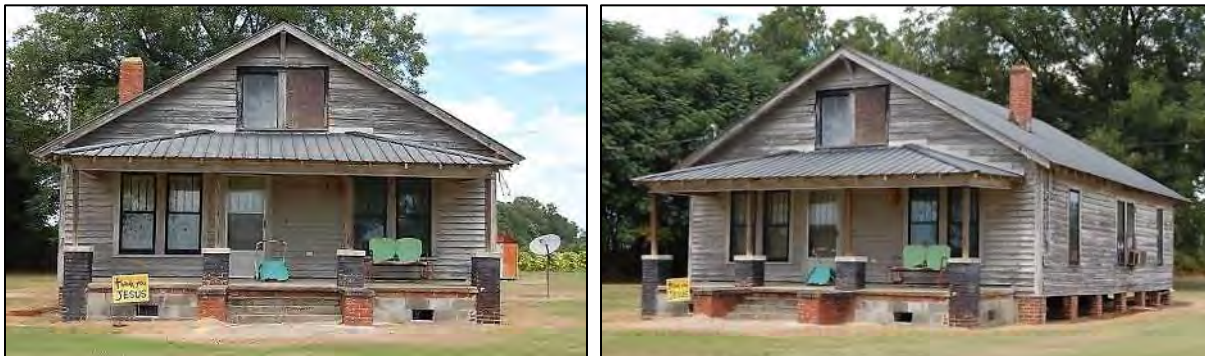
**Figure 197: Owen Williams House: south front elevation, at left, and front and east side elevations, at right, 2017.**

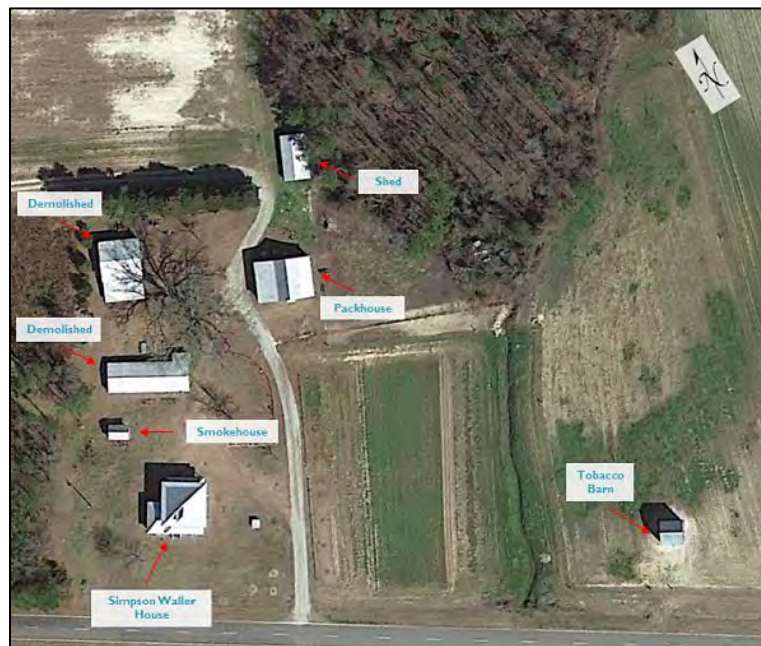
Four outbuildings, remnants of a larger twentieth-century farm complex, remain standing. A frame smokehouse is located north of the house and a metal-clad packhouse and an equipment shed stand farther north. To the northeast beyond the garden is a metal-clad tobacco barn. At the time of the July 2017 site visit, the foundation was being set for a new building to the north of the house, replacing two recently demolished twentieth-century agricultural buildings that are pictured on site map (Figure 198 and Figure 199).

**Figure 198: Site plan of Simpson Waller House with Strouds Corner Road at bottom (base image courtesy of Google Earth).**

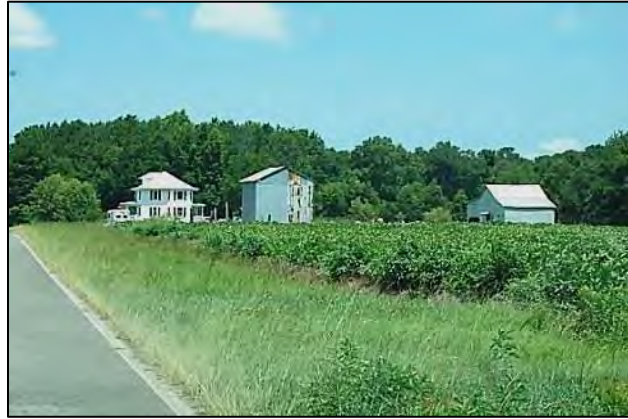
**Figure 199: View looking northeast with house at left, tobacco barn at center, and packhouse at right.**
