North Carolina Department of Natural and Cultural Resources  
State Historic Preservation Office

MEMORANDUM

Subject: Historic Architecture Eligibility Evaluation Report, US 70 Kinston Bypass, R-2553,  
Lenoir County, ER 09-1307

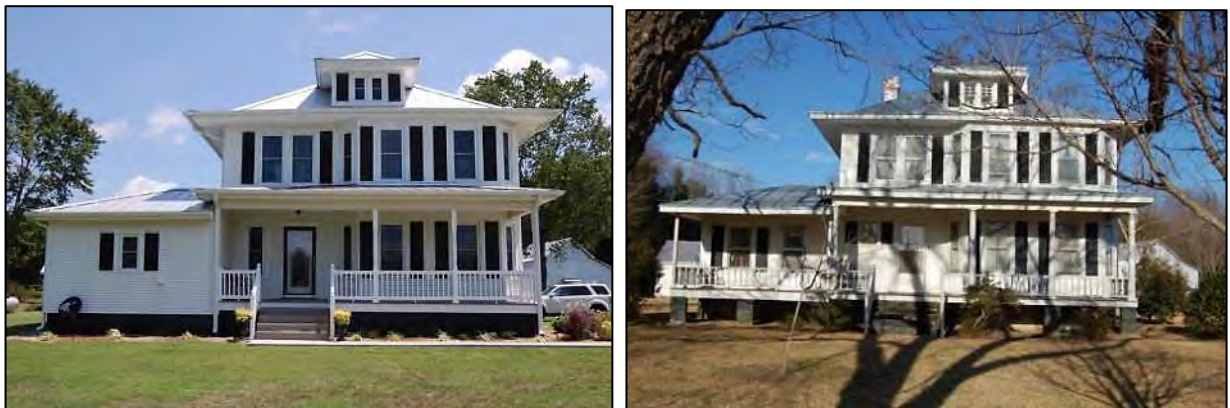
- **Simpson Waller House** (LR 1213): Placed on the HPO Study List in 1994. We concur that due to the enclosure of the porch, replacement of porch elements, application of vinyl siding, replacement of windows, removal of the chimney stacks, interior alterations, and the loss of some outbuildings the house has lost historic integrity and is not eligible for listing in the NRHP under Criterion C. The house also does not meet Criterion A, B, or D.

**Figure 200: Simpson Waller House: at left, south front elevation in 2017 and, at right, in 2010 with chimneys, porches, and weatherboards in place.**

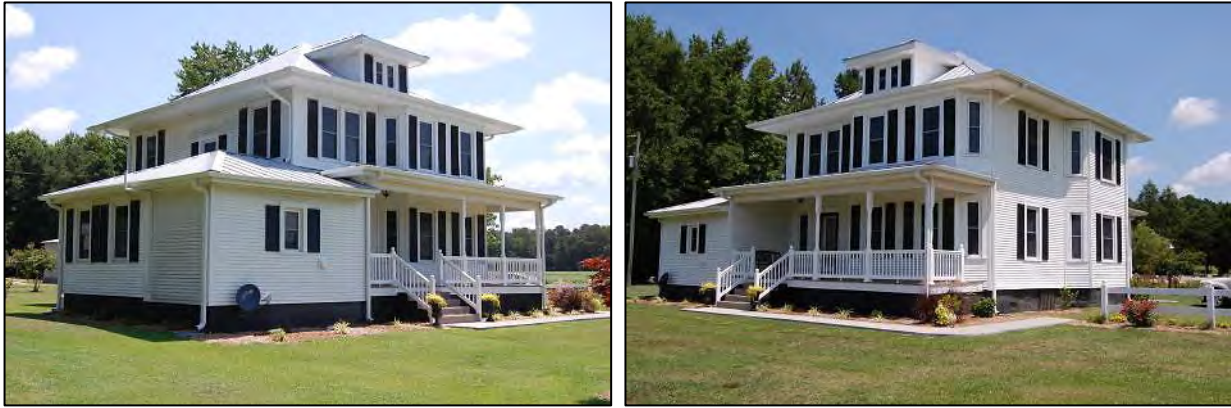
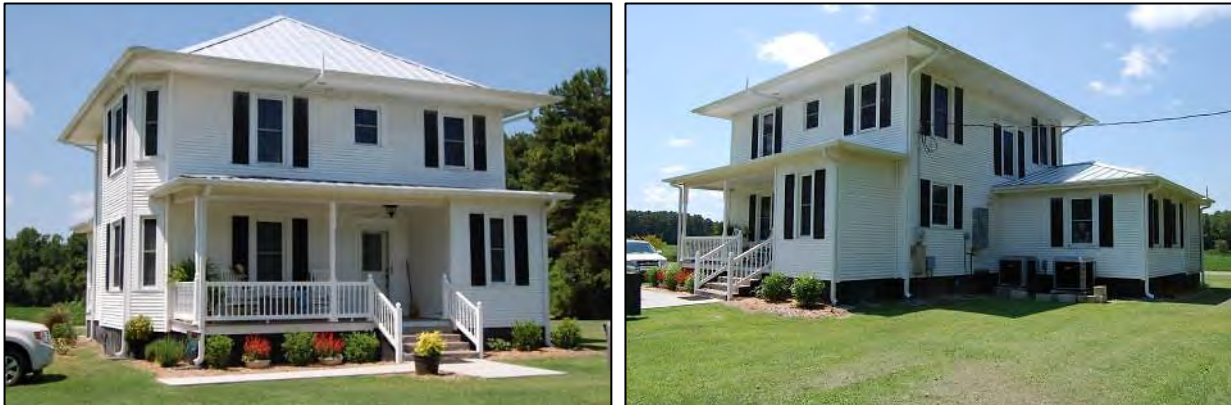
A pre-fabricated Charleston Style Aladdin Home, the two-story frame Simpson Waller house was described by its manufacturer, the Aladdin Company, as a “modern square-type.” The central mass of the house is three bays wide and features a side-hall entry plan. The building sits on a continuous concrete-block foundation and is topped by a hipped roof. A three-bay porch spans the front (southern) elevation of the house. A small one-story addition dating from the 1930s extends from the house’s western side. Originally constructed with a front porch connecting to the porch of the main house, the addition was enclosed between 2010 and 2017 (Figure 200 through Figure 202).

With the exception of the addition, the house has retained its overall footprint since its construction in 1918. However, it has undergone significant exterior alterations, most of which have taken place since the building’s last survey in 2010. During the 1970s, the house’s original weatherboard siding was replaced with vinyl. Between 2010 and 2017 the roof was replaced with rolled tin and the two interior brick chimneys were removed.

The three-bay porch spanning the front elevation has been completely replaced since 2010. The original porch had wooden Tuscan columns with a low rail and square pickets; the replacement porch has turned columns and balusters and a new rail. The porch on the north rear elevation has

Both the front and back doors to the house have been replaced and a new pre-fabricated door surrounds with a keystone detail have been added. The original Aladdin doorbell has apparently been removed. The window to the right west of the front door has been enlarged, as has the window to the west of the rear door. All of the windows have been replaced since 2010, including the two dormer windows located on the façade. The windows have been given new surrounds, though they retain their earlier fixed replacement shutters. While the building's interior was inaccessible, an interview with the current homeowner revealed that he has entirely rebuilt the interior, replacing plaster walls with wallboard, installing new doors, and removing the original mantels. Interior access to the house was not available.

**Figure 201: Simpson Waller House: west side and south front elevations, at left, and south front and east side elevations, at right.**

**Figure 202: Simpson Waller House: east side and north rear elevations, at left, and north rear and west side elevations, at right.**

The Simpson Waller House does not boast association with any significant historical events or persons and is recommended as not NRHP-eligibility under Criteria A or B. The house has lost its physical integrity effectively, retaining only its original foursquare form and framing members. Its weatherboards have been covered with vinyl, its roof by rolled tin, and its interior chimney stacks removed. Its front porch has been altered and partially enclosed and its sash and exterior doors replaced. The current homeowner stated that he has completely rebuilt the interior. This effort included removing the mantels, replacing the doors, adding sheetrock walls, and shifting partitions. Such Lenoir County foursquares as the Charles A. Broadway House, Field-Suggs House, and the James and Sudie Wooten House, which are pictured and discussed at the Section 3 architectural context, above, retain far higher degrees of integrity and better represent the form and its common finishes. The Simpson Waller House is therefore recommended not NRHP-eligible under Criterion C. It is not likely to yield important historical information on the basis of its construction or appearance, particularly due to its substantial alteration. It is therefore not recommended as NRHP-eligible, as an architectural resource, under Criterion D.

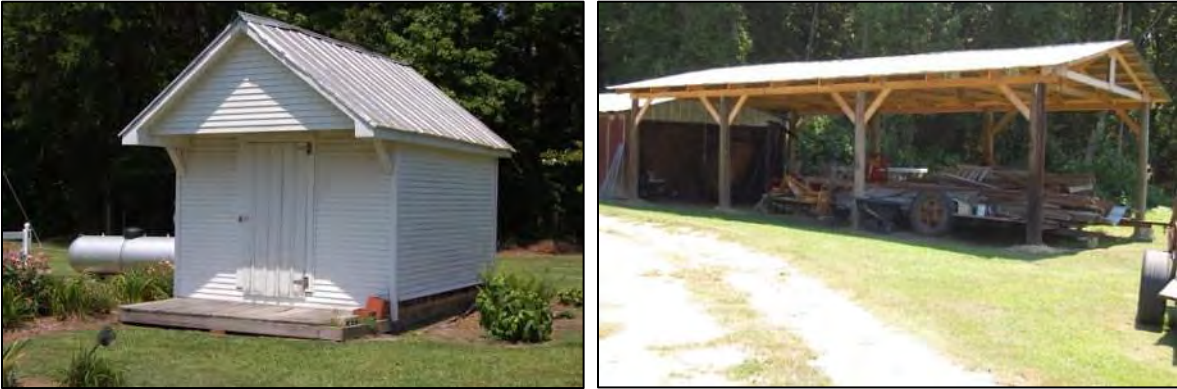
The frame smokehouse dates to the early twentieth century (Figure 203, at left). Originally clad in weatherboards, it is now vinyl sided and topped by a modern, standing-seam, gabled roof. Two triangular kneebraces support an extension of the roof on the east elevation that shades a wooden board-and-batten door. The smokehouse rests on a continuous concrete-block foundation.

**Figure 203: Looking southwest at smokehouse, at left, and northeast at machine shed/open equipment shed.**

The shed is comprised of two parts: an early/mid-twentieth-century machine shed clad in metal siding and an abutting open equipment shed that was not standing when the recent aerial of the site map was shot (Figure 203, at right).

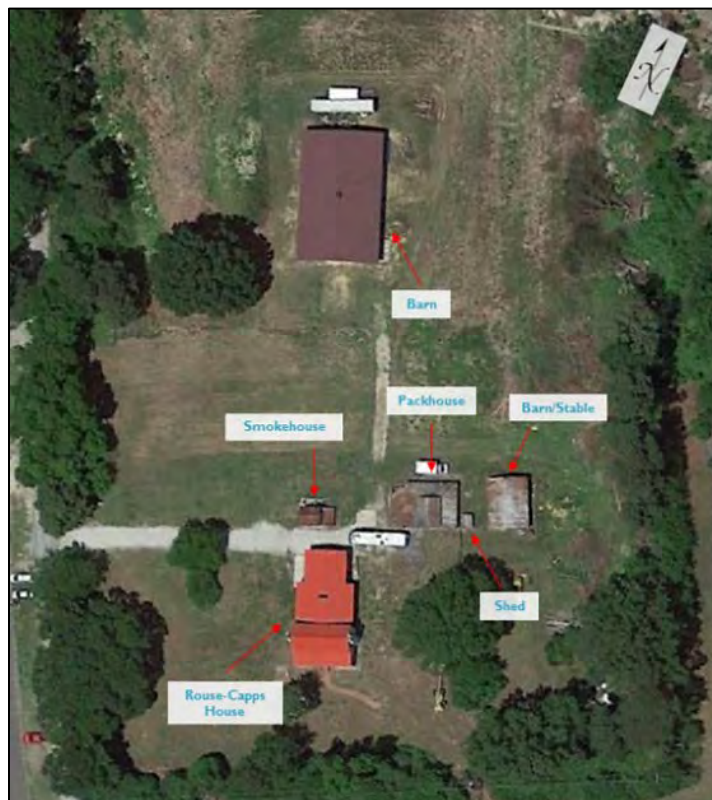
The Rouse-Capps House sits on a 6.4-acre parcel just one mile west of downtown Kinston. Despite fronting West Vernon Avenue on its southern side, the house retains a partially secluded setting as its parcel is edged by perimeter of mature oak trees on three sides. The house is accessed by a side drive, which approaches from the southwest. Five resources, in addition to the Rouse-Capps House, are found on the parcel. One of these, a large modern barn, stands well to the north. The other four are lined up in a row just behind the house’s north rear: a smokehouse that likely dates to the mid-nineteenth century; an early twentieth-century packhouse; a tiny early twentieth-century shed or chicken house; and a small early/mid-twentieth-century barn/stable (Figure 206).

**Figure 206: Site plan of Rouse-Capps House with West Vernon Road just off of bottom (base image courtesy of Google Earth).**

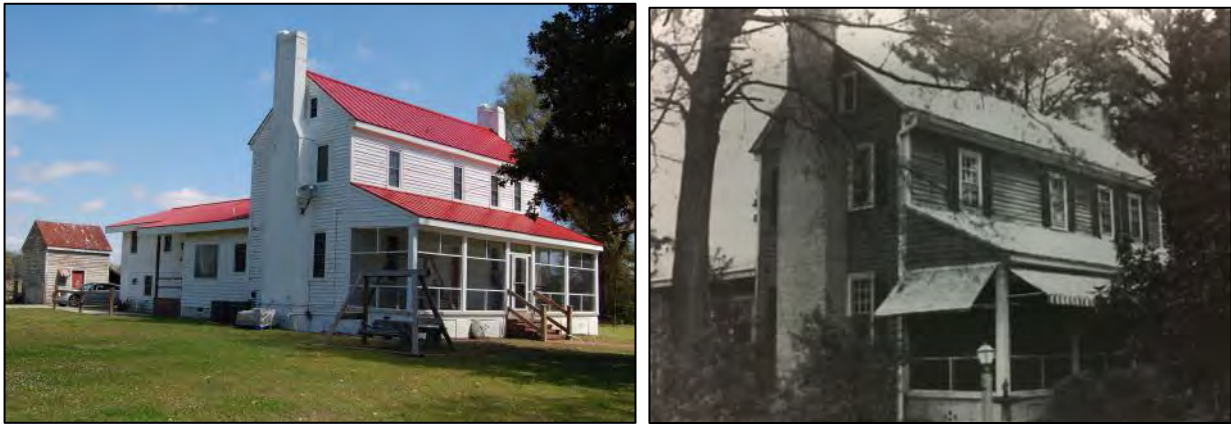
- **Rouse-Capps House** (LR 0923): We concur that due to a large modern rear addition and the replacement of windows the house has lost historic integrity and is not eligible for listing in the NRHP under Criterion C. The house also does not meet Criterion A, B, or D.

**Figure 207: Rouse-Capps House: at left, west side and south front elevations in 2017 and, at right, in the mid-1990s (*Coastal Plain and Fancy*).**

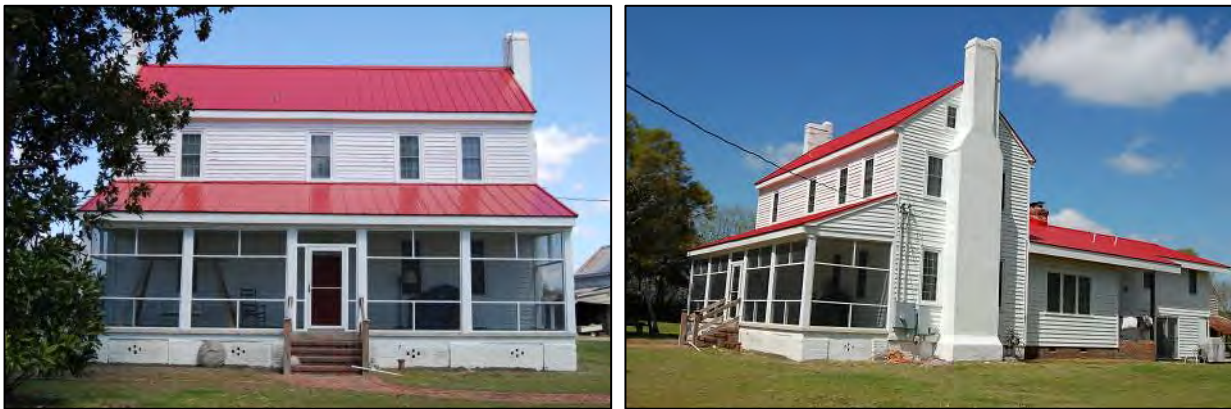
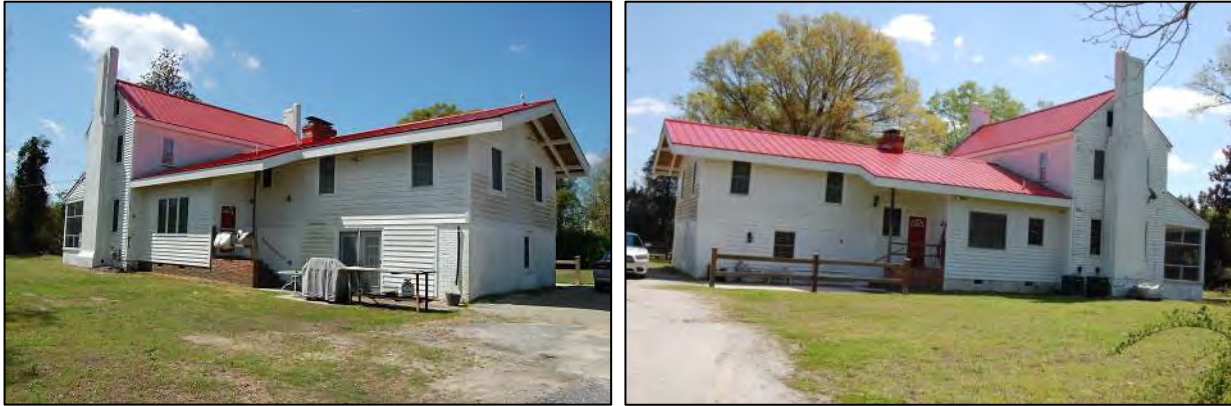
This two-story, single-pile, gable-end, antebellum house is believed to be built with a center-hall plan, despite its asymmetrical four-bay fenestration (Little et al. 1998:367). Constructed of heavy timber frame, the house remains clad in early weatherboards and retains both of its Flemish bond, exterior-end, shouldered chimneys. The narrow secondary stack set back along the side of each chimney is an unusual feature that likely holds a flue. The plain surrounds framing the house's bays are original, as are its front and rear boxed cornices. The original nine-over-nine sash, however, has been replaced by modern windows with snap-in muntins that attempt to duplicate the initial fenestration. These modern windows, and many other elements of the house, were added following a significant fire in 1969 (Figure 207 through Figure 210).

The fire destroyed the back portions of the house. In the 1970s the current modern two-story ell at the north rear was added. A large addition, its footprint nearly equals the size of the house. The addition is served by multiple and varied fenestration and doors. A large brick chimney rises from its ridgeline. Both the house and ell are covered by a modern metal roof, painted bright red, that widely overhangs the addition's eaves. Roof lines visible in aerial images suggest that the addition was added in phases, but replacement vinyl siding masks this.

**Figure 208: Rouse-Capps House: at left, south front elevation; at right, south front and east side elevations.**

**Figure 209: Rouse-Capps House: at left, east side and north rear elevations; at right, north rear and west side elevations.**

The Rouse-Capps House is recommended as not eligible for NRHP listing. It has no known connection with historic events or notable persons and is therefore not eligible under Criteria A or B. The Rouse-Capps House is additionally believed to retain insufficient integrity to support NRHP listing under Criterion C. Its single-pile, two-story, gable-end form is intact, as are some original features that include weatherboards, surrounds, cornerboards, boxed cornices, and exterior end chimneys. However, the windows have been replaced with one-over-one sash with vinyl snap-muntins, the full-façade front porch dates from the late twentieth century, and a two-

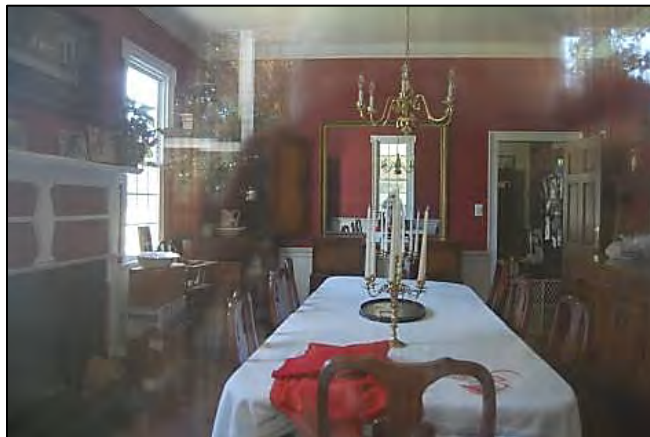
Interior access to the house was unavailable during repeated visits. (The owner of record, James Hood Capps, died in 2016, and his son, James Hood Capps, Jr., lives in Atlantic Beach.) However, views through windows revealed that the restored mantels still survive in the downstairs' parlors, along with other features that were restored in the 1970s (Figure 211).

**Figure 21 I: Rouse-Capps House: west parlor.**

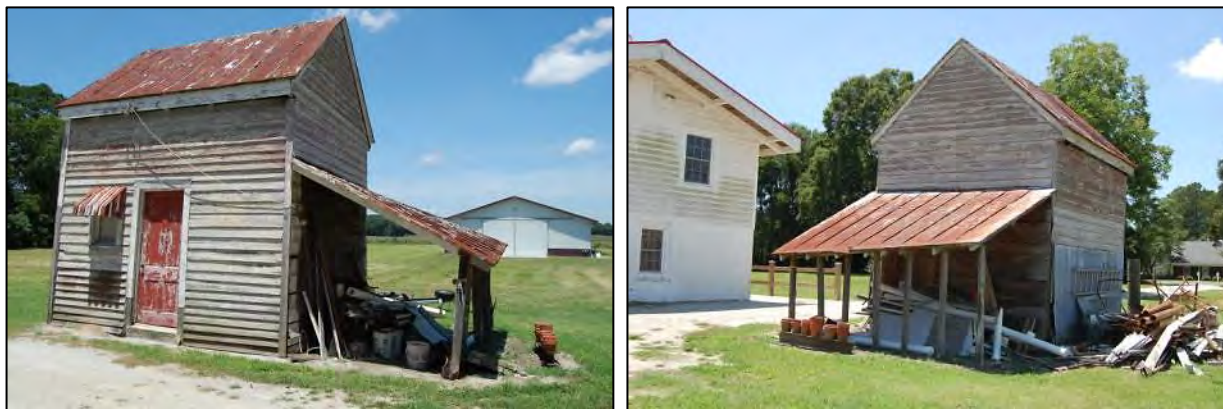
The frame building located directly behind (north) of the Rouse-Capps House is likely an antebellum smokehouse erected along with the house. It has flush-gable ends, boxed rafters, and weatherboard cladding edged with cornerboards. A centrally placed door with a simple wooden surround is located on the building's southern elevation, with a small window topped with a metal awning to its west. Its western elevation features a centrally located window that has been boarded up. A shed roof lean-to supported by square wooden posts extends from the building's eastern side. Both gable and shed roofs are clad in standing-seam metal (Figure 212).

**Figure 212: At left, view of south front elevation of smokehouse with modern barn in distance; at right, view of east side elevation of smokehouse with house ell at left.**

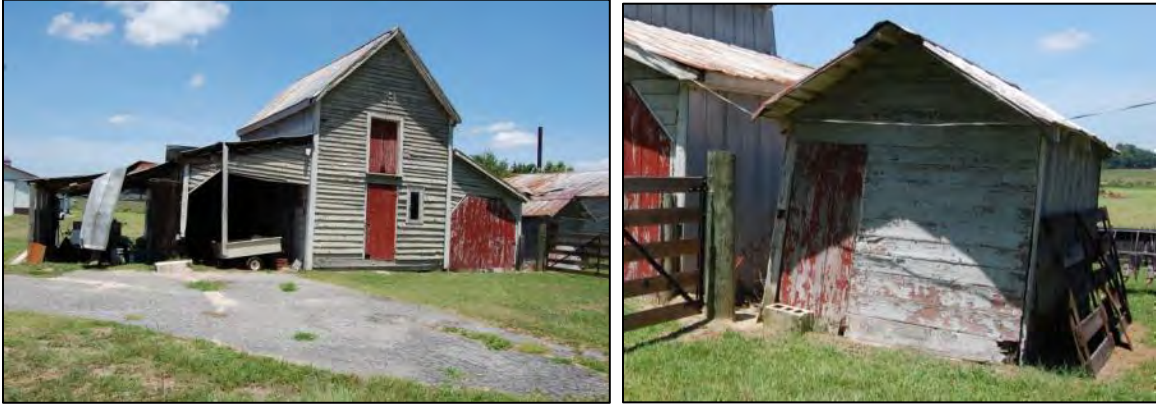
The early twentieth-century frame packhouse is clad in weatherboard siding and sits to the northwest of the house. Its primary south-facing elevation retains two central doors, one set above the other. A small window has been added to their side. Frame shed roof addition extend along the east and west side elevations and wrap around the north rear gable. An additional open shed extends from the northwest corner (Figure 213, at left).

**Figure 213.** At left, view looking northeast at packhouse; at right, view looking northwest at adjacent shed

Located between the packhouse and barn/stable is this early twentieth-century shed that Robbie Jones identified as a chicken house in 1994. A small frame building, it has horizontal wooden siding on its south front elevation, which is also served by a door and the extended overhang of the gabled roof. Metal sheathing covers the rest of the building. Rafter tails are exposed at its eaves (Figure 213, at right).

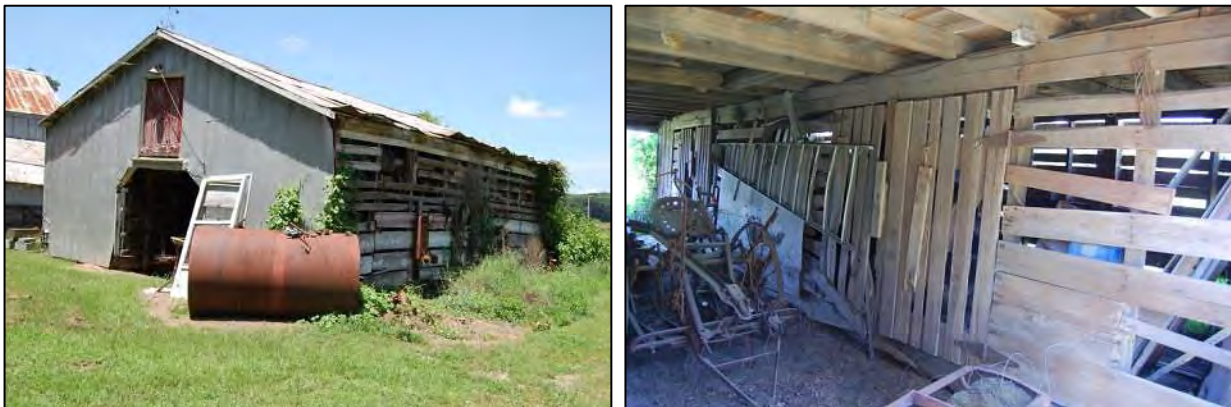
The early/mid-twentieth century, front-gabled, frame barn/stable is located to the northeast of the Rouse-Capps House at the end of the line of nearby outbuildings. The building features a central aisle with cribs on either side, suggesting an original use of crop storage as well as providing stabling space. A board-and-batten door sits above the central door, providing access to the second-story loft. The building is clad on its northern and southern elevations by horizontal metal sheathing, and by weatherboard siding on its eastern and western elevations (Figure 214).

**Figure 214:** At left, gabled south and long east side elevations of barn/stable; at right, interior.

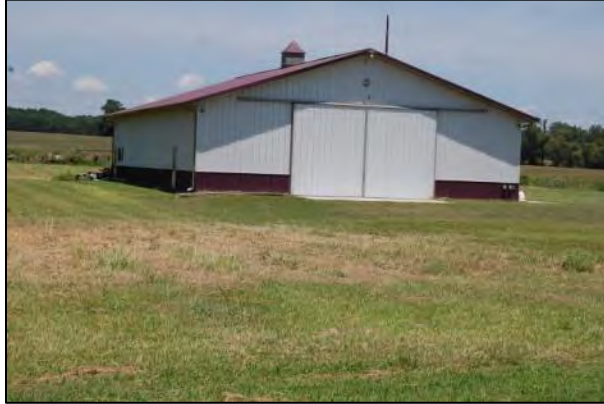
The large central bay barn is located to the north of the Rouse-Capps House is a modern metal-sheathed building erected in the early twenty-first century (Figure 215).

**Figure 215: View of long west and gabled south elevations of modern barn.**

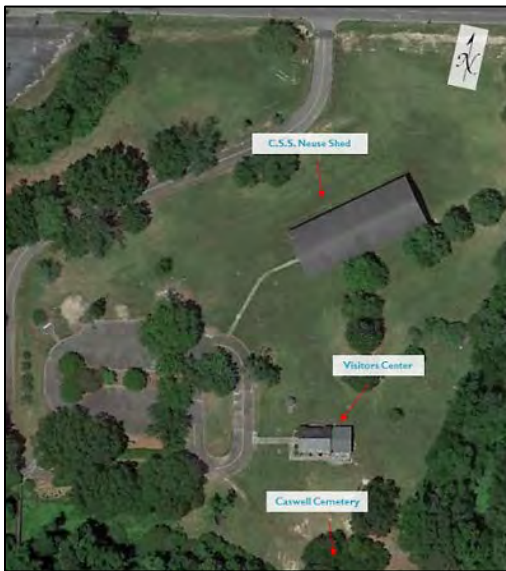
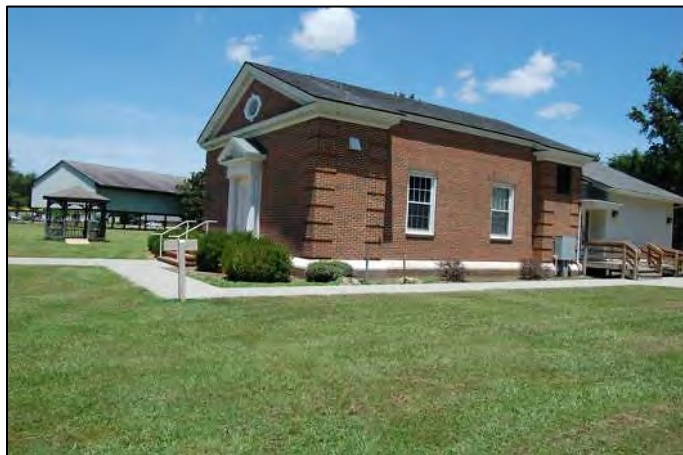
The C.S.S. Neuse/Governor Richard Caswell Memorial Visitors Center (Caswell Memorial Site) is located just to the west of downtown Kinston on West Vernon Avenue/US 258. With the exception of its southern side, the 25 acre parcel is surrounded by twentieth-century commercial and residential development. A perimeter of mature trees separates the site from this development. The Caswell Memorial Site is within on an open green lot scattered with mature trees that is accessible by a long concrete drive. The site contains three resources: the C.S.S. Neuse Shed, located at the northern end of the property; the Governor Richard Caswell Memorial Visitors Center, located to the south of the Neuse Shed; and the Caswell Cemetery, located to the south of the Visitors Center (Figure 216).

**Figure 216: At left, site plan of C.S.S. Neuse/Governor Richard Caswell Memorial Visitors Center with US 258 at top (base image courtesy of Google Earth); at right, view of visitors center with former Neuse shed at left distance.**

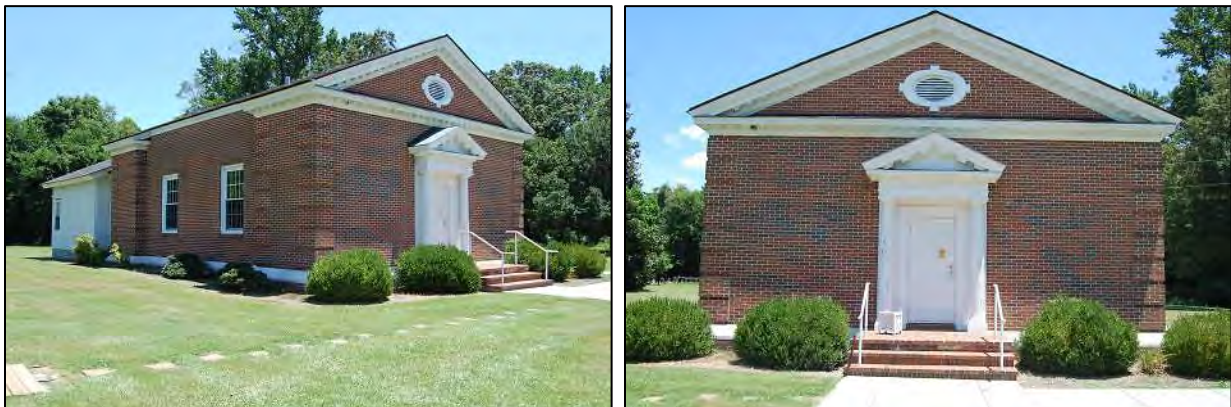
- **C.S.S Neuse/ Governor Richard Caswell Memorial Visitors Center** (LR 0076): We concur that a modern rear addition and the replacement of windows has impacted the visitor's center's historic integrity. When compared with other institutional buildings the visitors center does not appear to be architecturally significant and is not eligible for listing in the NRHP under Criterion C. The visitors center also does not meet Criterion A, B, or D. As the building was constructed as a museum/visitor's center and not a monument it is not eligible under Criteria Consideration F. The **Caswell Cemetery** does not meet Criterion A, B, C, or D or Criteria Consideration D. Until proven otherwise, the cemetery does not appear to contain the graves of persons of transcendent importance. It is not of great age, does not exhibit distinctive design features, and is not associated with important historic events. Please note that the C.S.S Neuse Shed is noted in the report as being constructed in both the 1960s and 1970s. Please revise to reflect correct date of construction.

**Figure 217: Visitor's Center: north side and west front elevations, at left; west front elevation, at right**

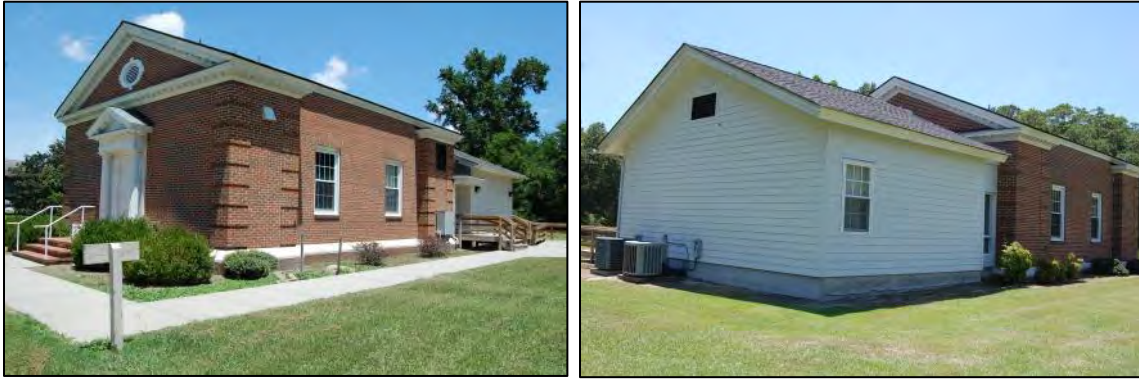
The single-story, four-pile, front-gabled Visitors Center was built in 1964 and rests on a continuous brick foundation. Rectangular in plan, it is comprised of two blocks: an original, double-pile, brick-clad block, and a rear, double-pile, vinyl-sided, frame late twentieth-century addition (Figure 217 through Figure 219).

The original Colonial Revival-style block is symmetrical in overall design and features large gable-end pediments trimmed with a molded cornice and dentils. A decorative circular vent is located in the center of tympanum of both the eastern and western ends. The cornice wraps all four corners of the building and continues along the northern and southern side elevations before terminating. It rests on massive pilasters edged with pairs of brick quoins. A concrete watercourse runs along the bottom of the block. A centrally placed pedimented front entry is found on the building's primary (western) elevation. The original six-paneled wooden door is topped with a heavy pediment with a large molded cornice and dentils. A traditional entablature sits beneath the pediment and features a large molded cornice with dentils underneath, a frieze with large brackets, and an unadorned fascia. The entablature is supported on either side by fluted columns sitting on square plinths. Brick stairs framed by metal handrails lead to the door. Two symmetrically spaced, eight-over-eight, replacement windows with brick sills and brick lintels with keystones are found on the building's northern and southern sides. With the exception of its windows, the building appears to retain its original materials.

**Figure 218: Visitor's Center: west front and south side elevations, at left; east rear and north side elevations, at right.**

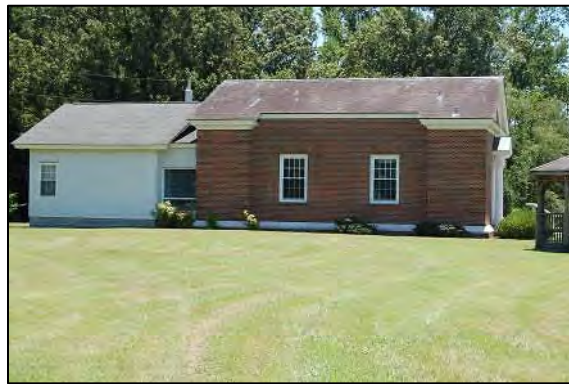
**Figure 219: Visitor's Center: north side elevation.**

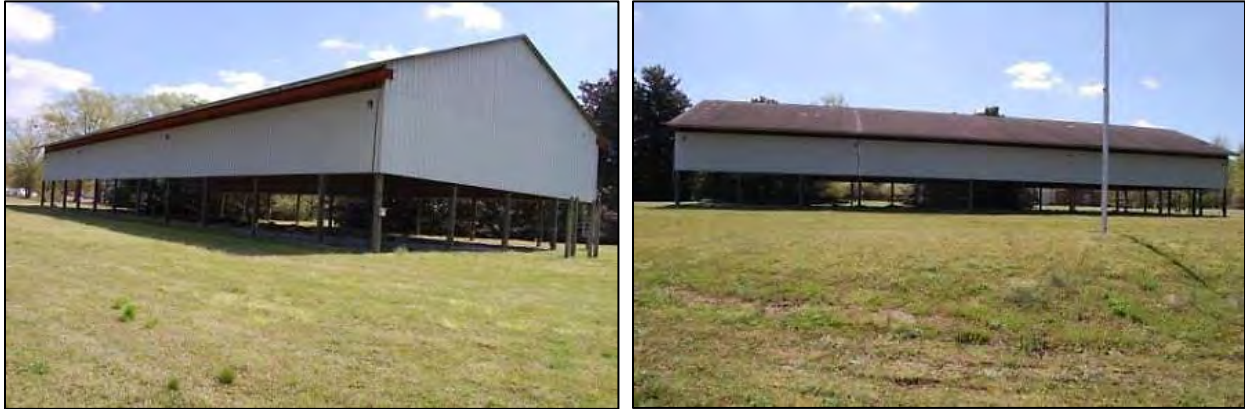
Built in the 1960s, the C.S.S. Neuse shed stands empty, just a short distance north of the Caswell Visitors Center. Of post-in-ground construction, the open-air shed is eleven piles deep and four bays wide. The side-gabled building is topped with asphalt shingles and clad with metal sheathing halfway down all four of its elevations. A sidewalk frames the interior perimeter of the shed and surrounds a scattering of concrete piers on which the C.S.S. Neuse once sat. Prefabricated wooden trusses are visible on the building's interior and numerous lights hang overhead (Figure 220 and Figure 222 ).

Figure 221: View looking southeast at C.S.S. Neuse shed, at left, and south, at right.

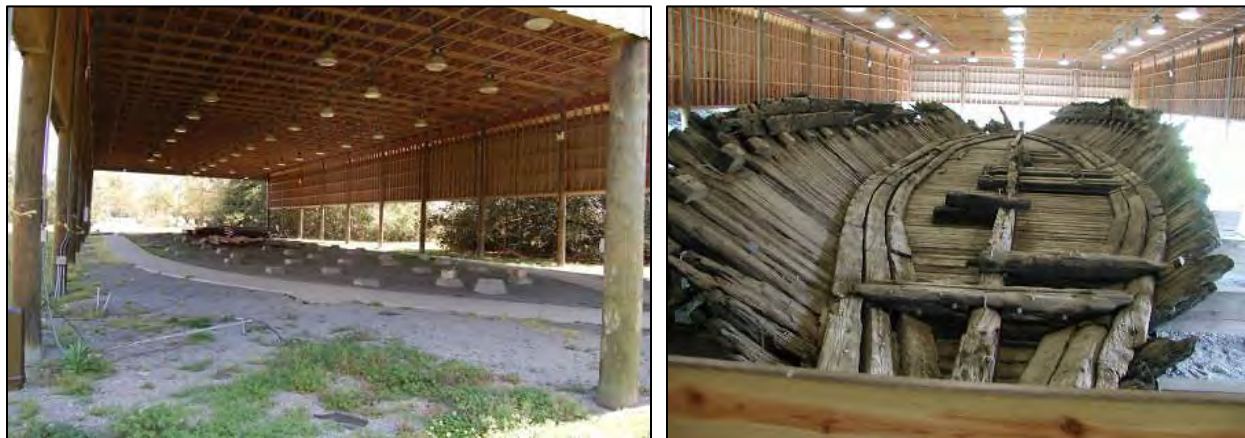
Figure 222: View looking north at interior of C.S.S. Neuse shed, at left; 2003 photograph of C.S.S. Neuse in shed, at right (courtesy of C.S.S. Neuse State Historic Site).

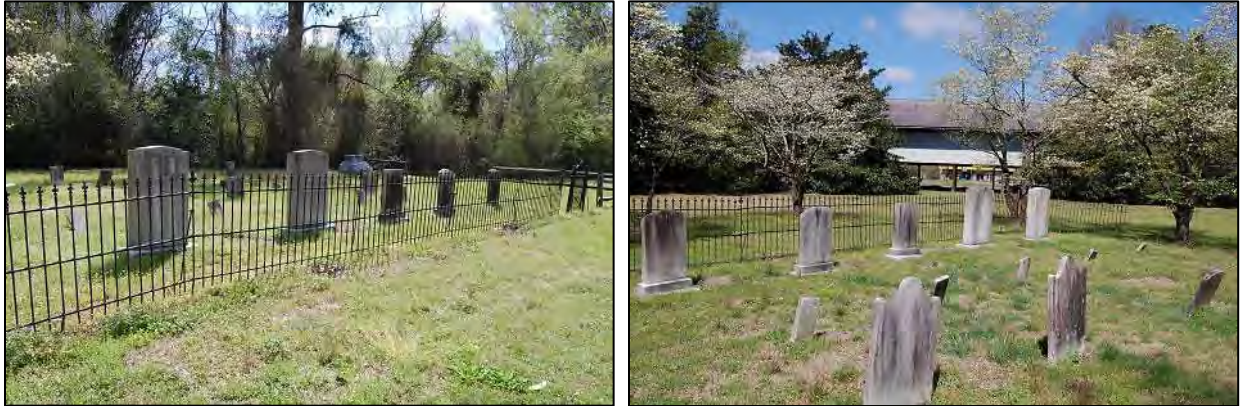
Located to the south of the Visitors Center, the Caswell Family Cemetery contains 21 documented sets of remains including, perhaps, the remains of North Carolina Governor Richard Caswell. Caswell's alleged grave is marked with the square base of an earlier monument to the governor. The cemetery is rectangular in shape and surrounded by a cast-iron fence which is in disrepair. Granite and limestone headstones of moderate design are situated in neat rows running east to west. Most headstones are above ground and simple in their design, featuring plain rounded or square tops. A few stones feature curved Baroque tops (Figure 223 and Figure 224) .

**Figure 223: Caswell Cemetery: view looking southeast, at left, and northwest with shed in background, at right**

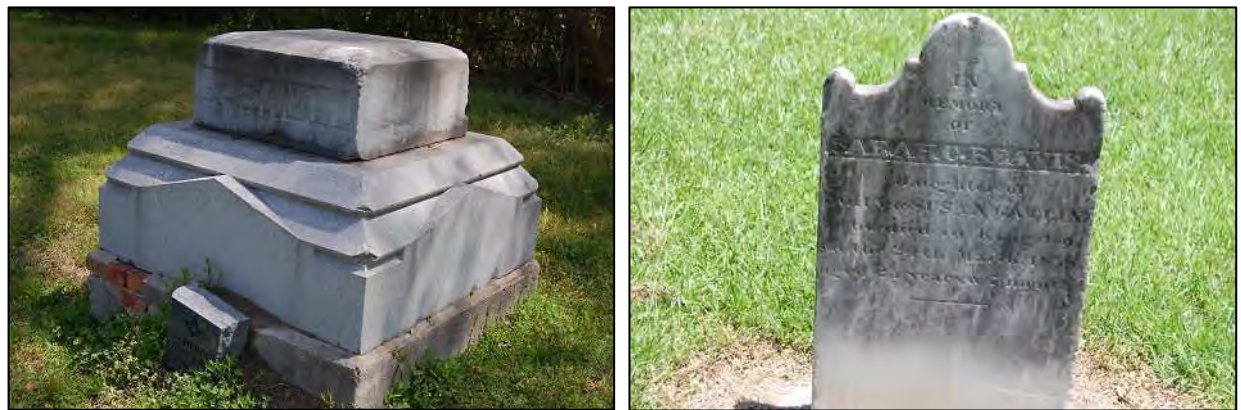
**Figure 224: Caswell Cemetery: Governor Caswell marker, at left, and relatively ornate 1838 headstone of Sarah C. Reavis, at right.**

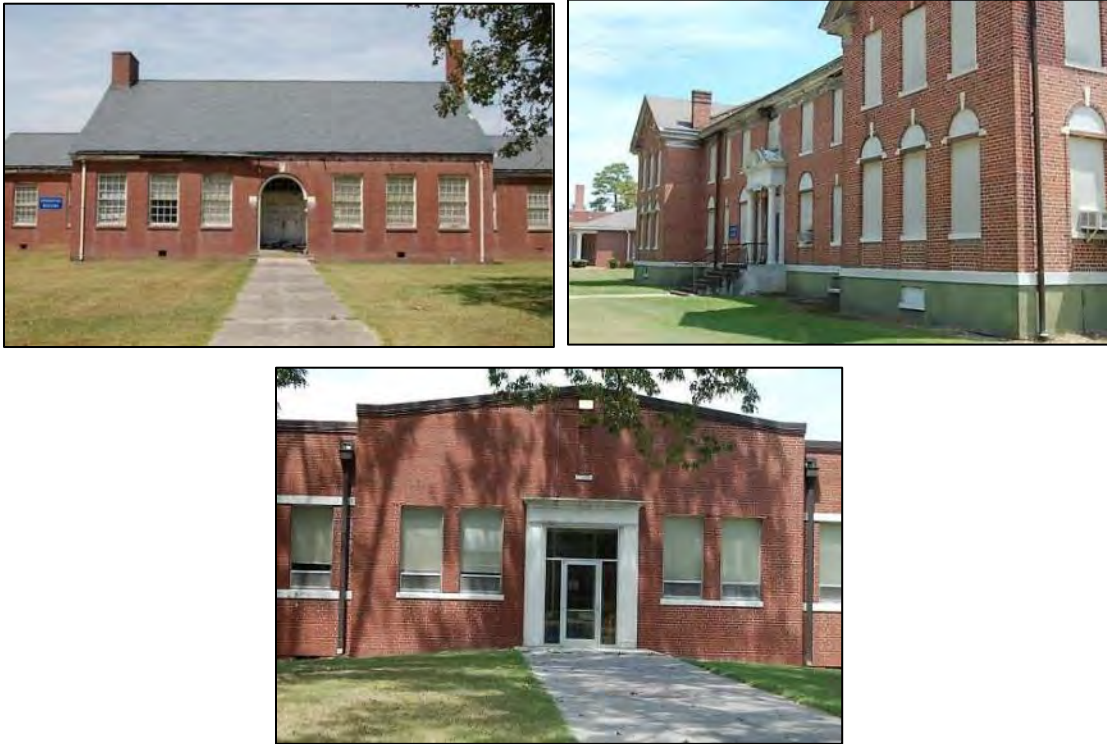
Lenoir County is graced by two large collections of institutional resources erected by the state in the early and mid-twentieth century—the Dobbs Farm School or North Carolina Industrial Colony for Women (LR-0884) (determined NRHP-eligible in 2008) and the Caswell Center (LR-0066)—both of which are located near Kinston. They are dominated by red-brick Colonial Revival-style buildings. These buildings were erected throughout their long histories, but most date from the 1950s and 1960s (Little et al. 1998:114, 265, 342-343) (Figure 225 and Figure 226).

**Figure 225: 1930s and post-WWII Colonial Revival-style buildings at Dobbs Farm School, 2017.**

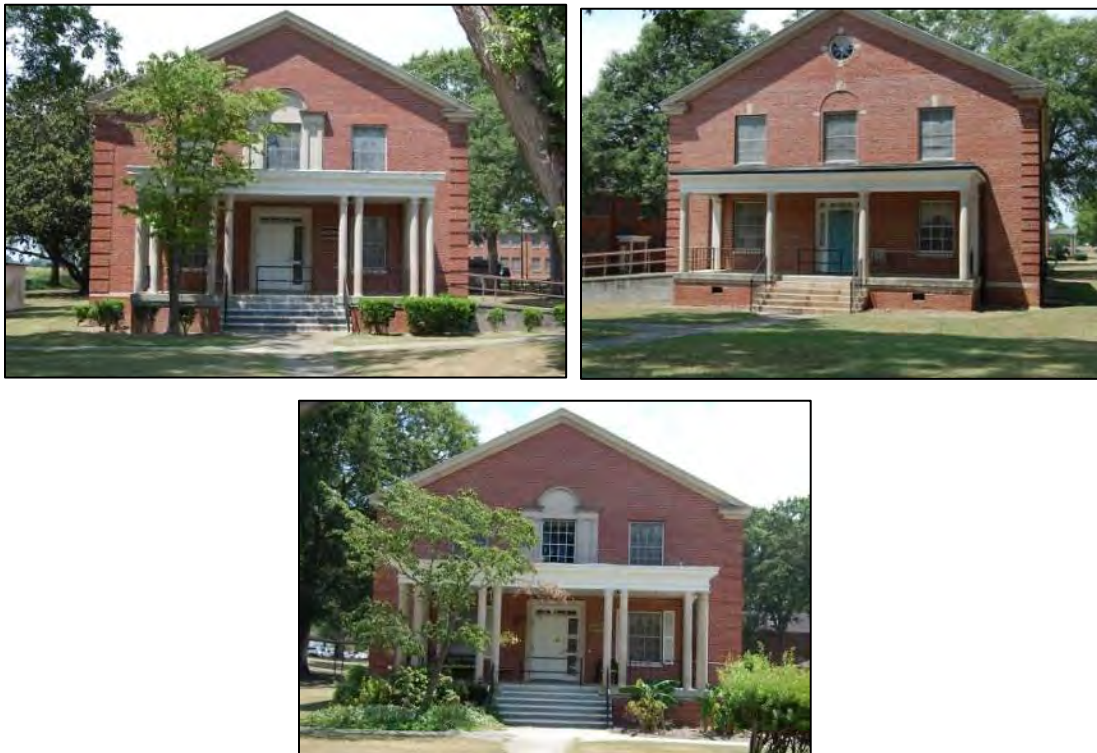
**Figure 226: Post-WWII Colonial Revival-style buildings at Caswell Center, 2017.**

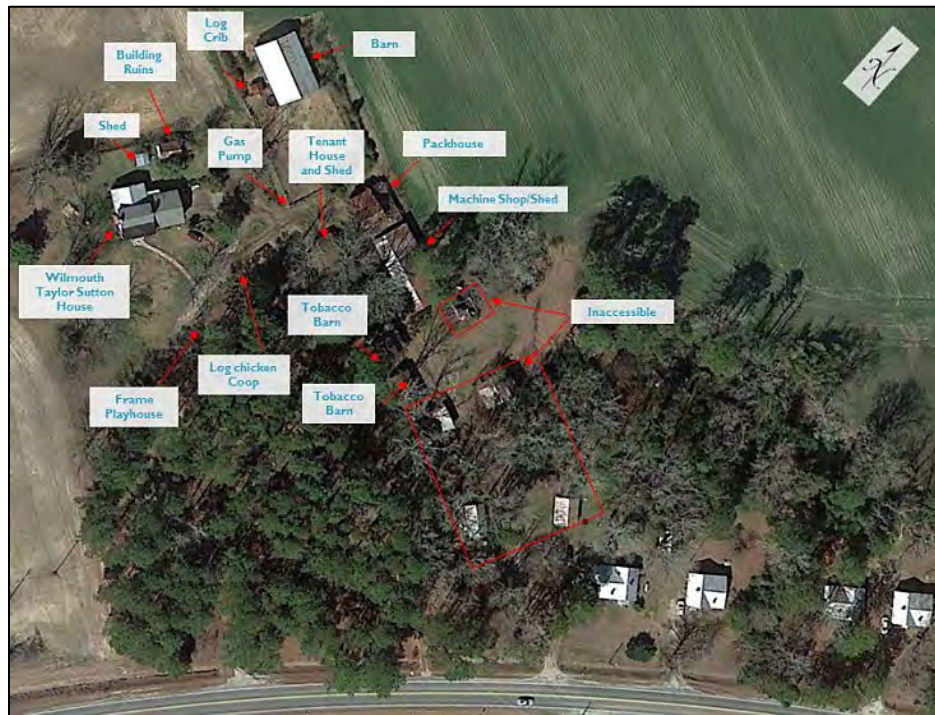
The Wilmouth Taylor Sutton House sits on a 65-acre parcel of land on the north side of US 258, approximately two miles southwest of Kinston. Situated on the northeastern edge of the parcel, the house is accompanied by a number of additional resources—the remnants of an early/mid-twentieth-century farm complex. The house is believed to have lost all integrity and the outbuildings are not believed to constitute a historic collection of resources without an associated intact dwelling.

**Figure 228: Site plan of Wilmouth Taylor Sutton House (base image courtesy of Google Earth).**

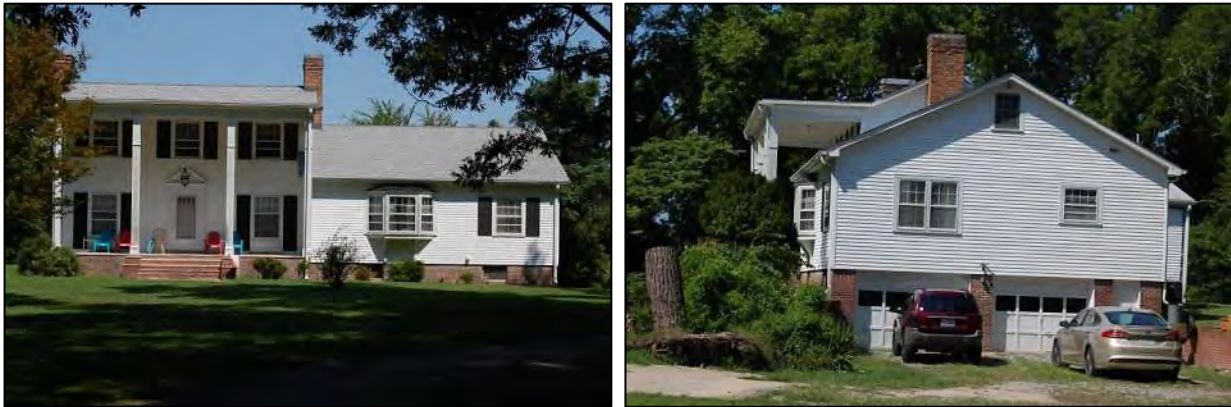
The Wilmouth Taylor Sutton House is believed to have been constructed in part in the late nineteenth century as a traditional I-house (Figure 229 and Figure 230). Significant changes during the twentieth century, however, have made its original core almost recognizable. The

original two-story, three-bay, single-pile building has been covered in vinyl siding and doubled in size by two mid-/late twentieth-century additions: a rear (northwestern), single-story, three-bay ell, and a two bay, double-pile, eastern wing that includes a basement-level garage. The house's flat-roofed, two-story, three-bay portico, supported by imitation columns, was added to the front elevation during the late twentieth century. The portico frames an ornate added Neoclassical Revival-style entryway complete with a broken pediment and engaged pilasters. The only recognizable early features of the dwelling are two exterior-end, shouldered, brick chimneys at either gable end. The northeastern chimney, though, has been almost entirely engulfed by the twentieth-century wing.

While the house may retain its original front-elevation fenestration pattern, the window openings have been noticeably enlarged and filled with replacement vinyl sash. Both the ell and the wing feature various styles of vinyl windows haphazardly located. These include an oriel window on the southeast front elevation of the wing. Ultimately, the house appears to be, and effectively is, a late twentieth-century creation. Despite multiple site visits, interior access to the house was unavailable.

**Figure 229: Wilmoth Taylor Sutton House: at left, southeast front elevation; at right, northeast side elevation.**

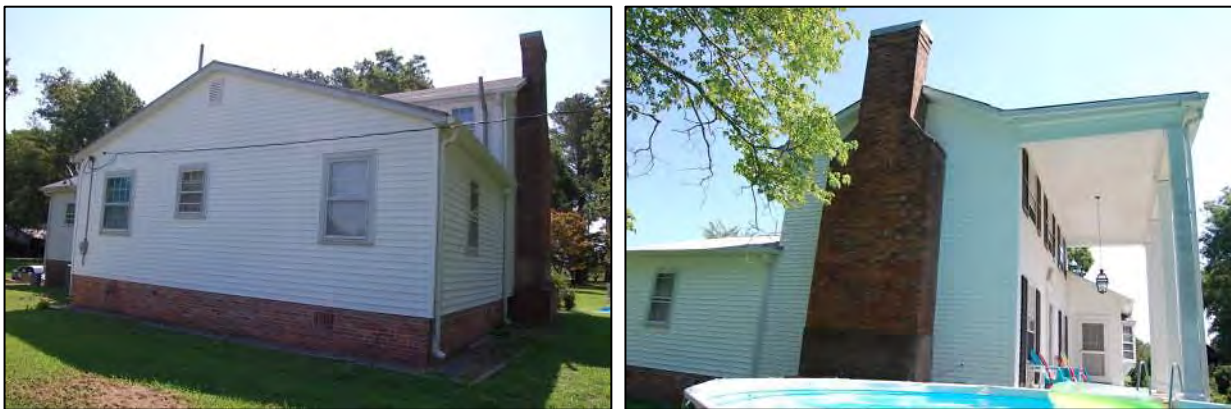
**Figure 230: Wilmoth Taylor Sutton House: at left, northwest rear elevation; at right, southwest side elevation with early chimney visible.**

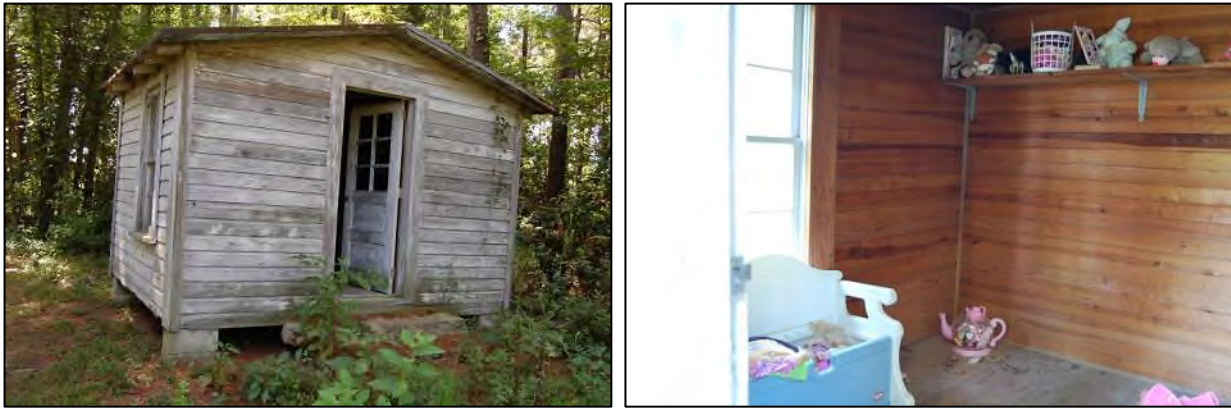
This early/mid-twentieth-century front-gabled building is located to the southeast of the Sutton House. The building is of frame construction, stands on concrete masonry block piers, and is clad in weatherboard siding and finished with cornerboards. It has exposed rafter tails, two four-over-four windows at its side elevations, and a single entry in its front gable. The interior has wood floors and wood siding that appear to have been refinished. Its original function is unknown; it is currently used as a playhouse (Figure 231).

**Figure 231: West front elevation of playhouse, at left; interior, at right.**

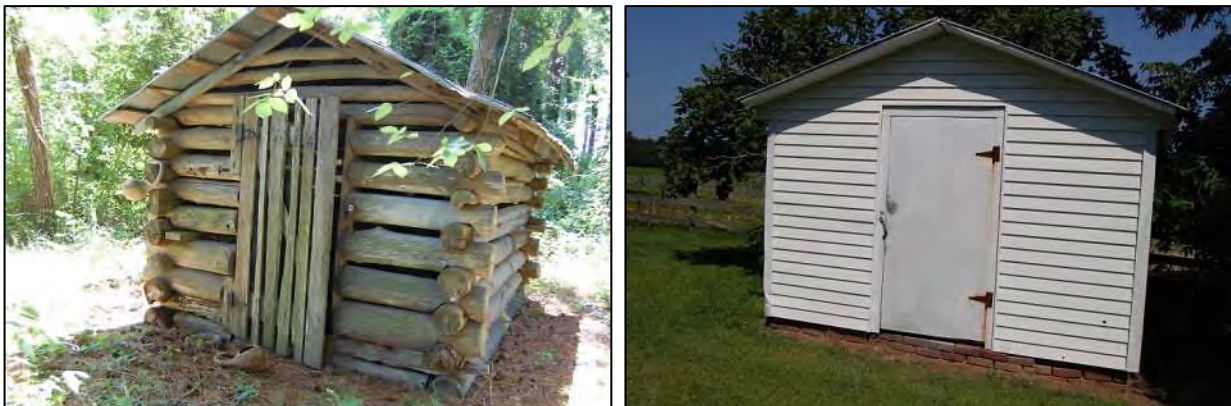
This early/mid-twentieth-century building is built of saddle-notched logs. It has a centrally placed wood batten door in one of its gables. It was most recently utilized as a chicken coop (Figure 232, at left).

**Figure 232: West front elevation of Log Chicken House, looking east, at left; south front elevation of shed, at right.**

This early/mid-twentieth century building is built of frame on a continuous brick foundation. A metal door is centrally placed in its southeastern gable end. It is clad in vinyl siding and topped with a standing-seam metal roof (Figure 232, at right).

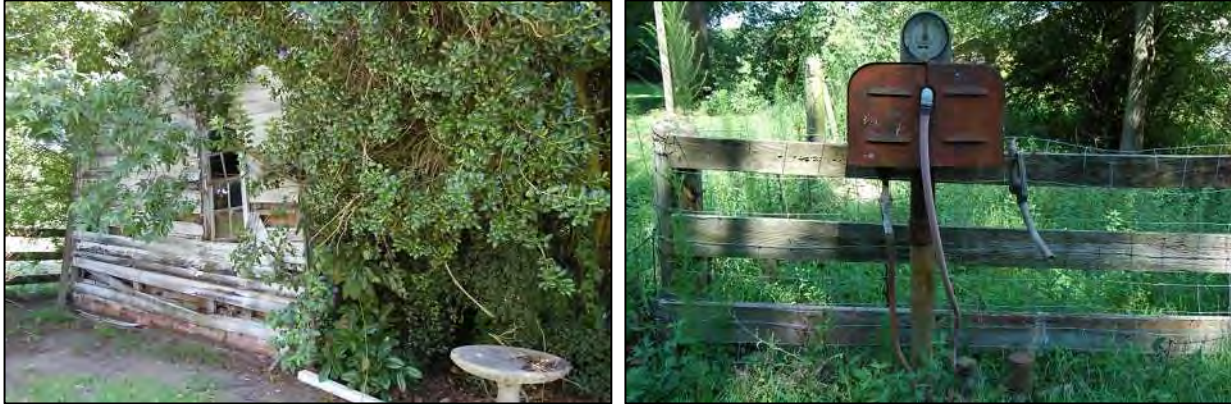
The remnants of an early/mid-twentieth century shed are located north of the white vinyl shed (Figure 233, at left).

**Figure 233: View of building ruins, looking north; at left; gas pump, at right.**

This former gas pump is located near the middle of the farm complex (Figure 233, at right).

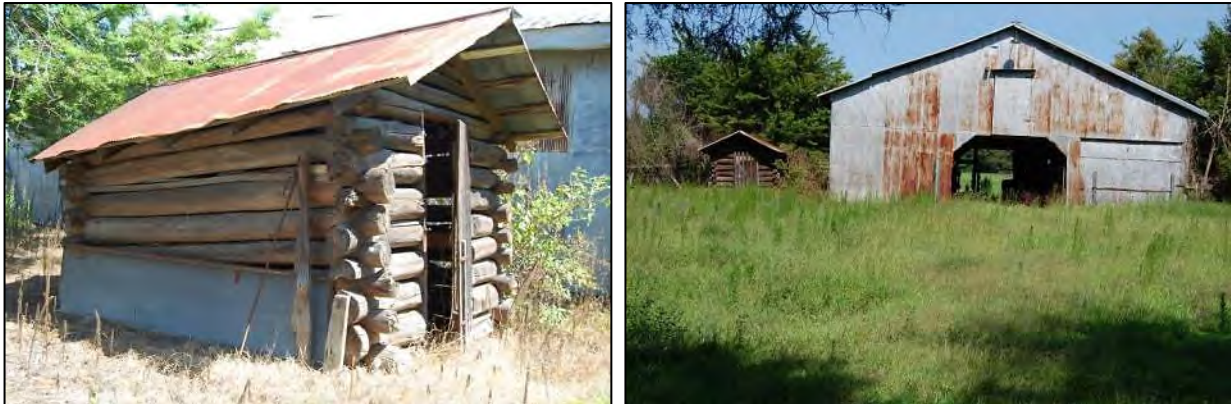
The roof of this early/mid-twentieth-century saddle-notched log building is clad in metal sheathing. A centrally located door opens at its east gable (Figure 234, at left).

**Figure 234: At left, south side and east front elevations of log crib; at right, east-facing gabled elevation of barn.**

This early/mid-twentieth-century front-gabled frame features a center aisle with cribs on either side. A large door next to the aisle suggests it was converted for tractor or other equipment storage at some point. The building could not be closely approached (Figure 234, at right).

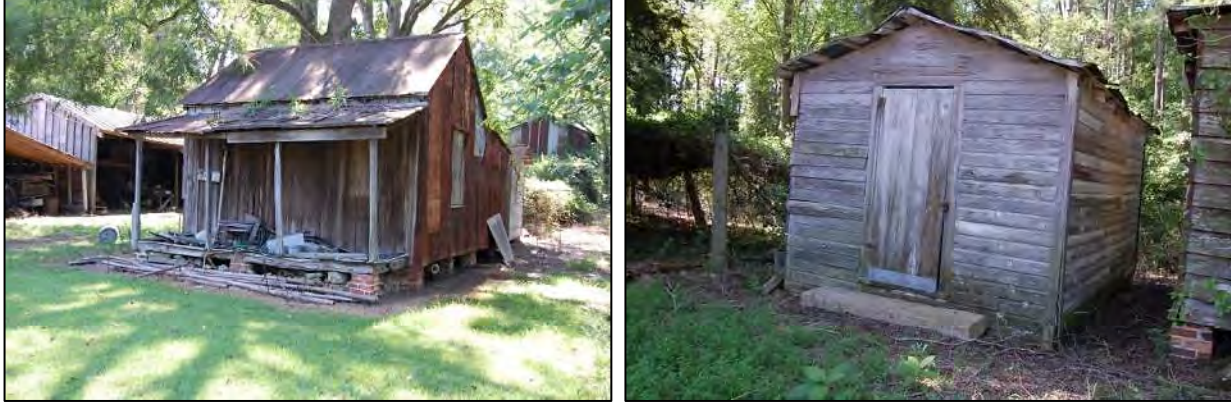
This early/mid-twentieth-century, side-gabled, frame building appears to have once been used as a dwelling. Resting on brick piers, it is clad in vertical wood and metal siding. A three-bay porch

supported by chamfered wood posts frames the southern side of the building. A door is centrally placed in the western gable end and an enclosed shed roof addition extends from the building's western side. Due to its small size, it was likely converted from its original unknown use (Figure 235, at left).

**Figure 235: At left, south front and east side elevations of tenant house; at right, south front and east side elevations of shed.**

Built in the early/mid-twentieth-century along with the other outbuildings, this front-gabled frame shed is clad in weatherboards and topped with a standing-seam metal roof. A wood-batten opens from its west gable (Figure 235, at right).
