North Carolina Department of Natural and Cultural Resources  
State Historic Preservation Office

MEMORANDUM

Subject: Historic Architecture Eligibility Evaluation Report, US 70 Kinston Bypass, R-2553,  
Lenoir County, ER 09-1307

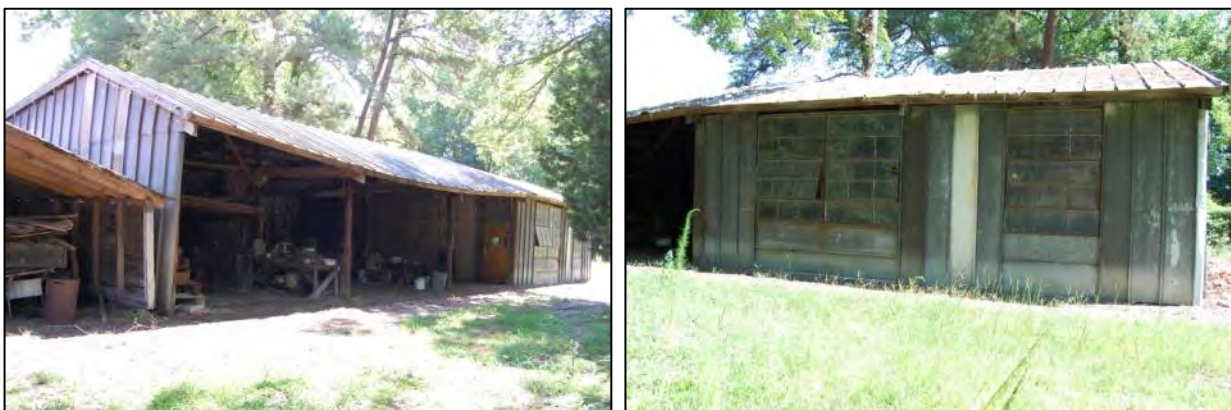
The machine shop/shed is a side-gabled frame building clad in metal sheathing, with a large central door on its southeastern side. The three easternmost bays of the building are open, divided by two plain wooden posts. The westernmost bays are comprised of six-over-six-over-three hinged windows. The building was built in the early/mid-twentieth-century (Figure 236).

**Figure 236: Views of southwestern elevations of machine shop/shed.**

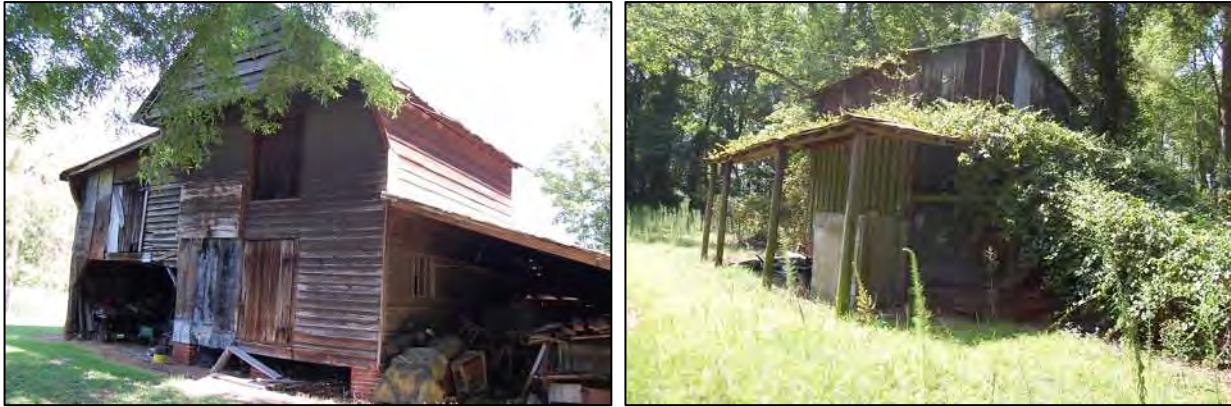
The packhouse house utilizes a typical. It is built of frame set on brick piers and clad in weatherboards, with two centrally placed doors on its south gabled elevation, one on the first floor, and one on the second. A wooden appendage, resembling a hay hood, extends out over the

doors on the building's southern elevation. Two shed roof additions extend from the building's east and west side elevations. The packhouse was built in the early/mid-twentieth-century (Figure 237, at left).

**Figure 237:** At left, south front and east side elevation of packhouse;; at right, view looking south of tobacco barn.

This frame tobacco barn dates from the early/mid-twentieth-century. It is clad in metal sheathing and topped by a gabled standing-seam metal roof. A wraparound lean-to supported by wooden posts extends from two of its elevations (Figure 237, at right).

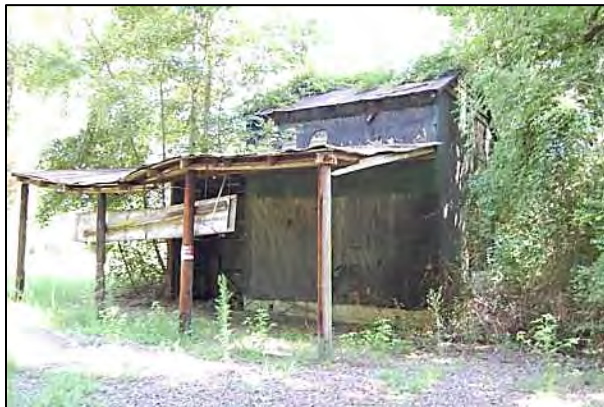
This frame tobacco barn looks like its companion. It is clad in metal sheathing and topped by a gabled standing-seam metal roof. A wraparound lean-to supported by wooden posts extends from two of its elevations. It dates from the early/mid-twentieth-century (Figure 238).

**Figure 238:** View of tobacco barn looking south.

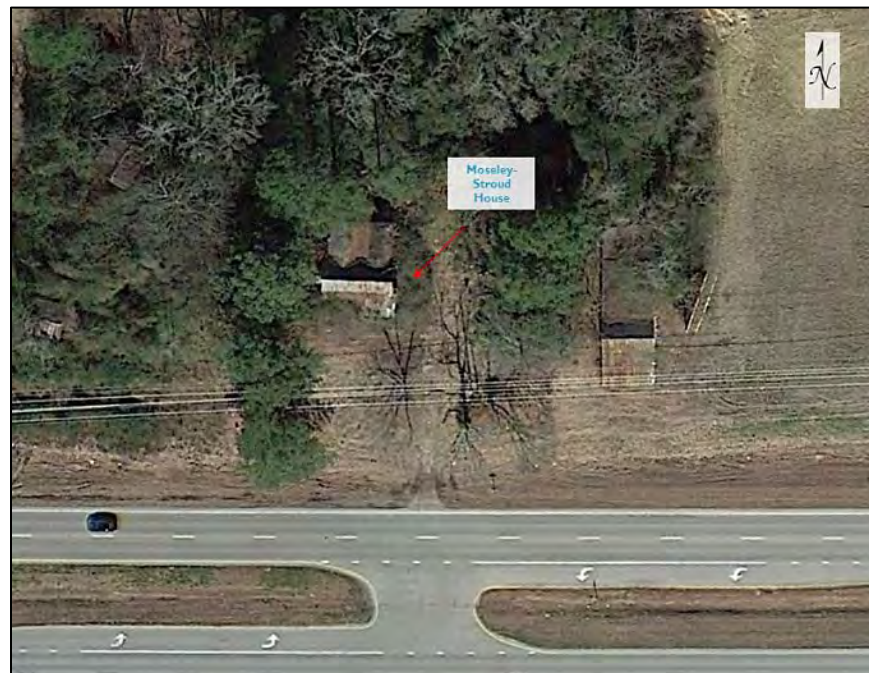
The narrow, rectangular, one-story frame house—built throughout the eighteenth, nineteenth, and twentieth centuries—is ubiquitous in Lenoir County (Figure 240). These houses are generally end-gabled, although in the twentieth century many were built with gables turned toward the front. The Moseley-Stroud House is an early example of the form that is thought to have once had an unusual three-room plan.

**Figure 240: Site plan of Moseley-Stroud House on north side of US 70 (base image courtesy of Google Earth).**

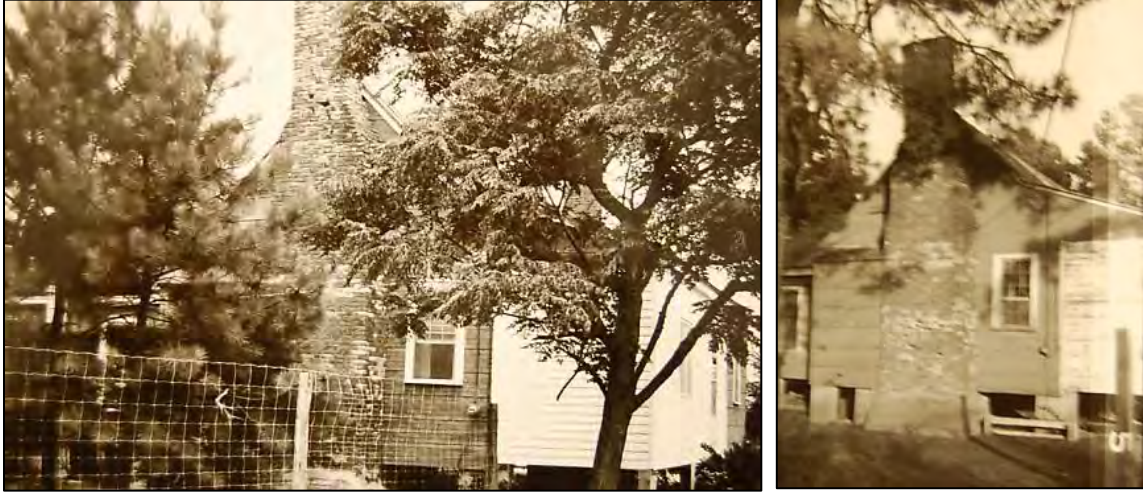
Figure 242: Moseley-Stroud House: west side elevation at left, 1968 (source: North Carolina Division of Cultural Resources), and at right, 1993 (Robbie Jones).

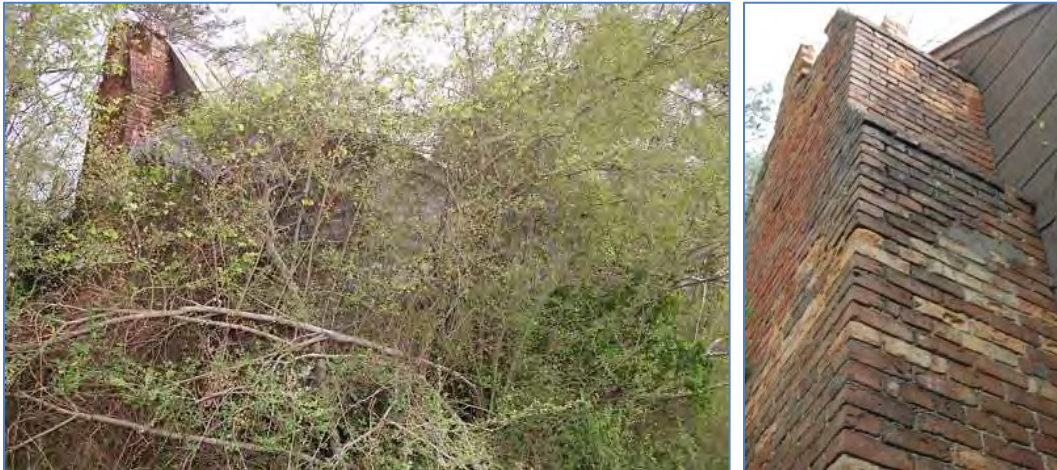
Since 1993, when Robbie Jones recorded the house, it has deteriorated significantly. It has become inaccessible due to extensive overgrowth and the danger of collapse. The western gable-end chimney has begun to fall and the building's exterior cladding is coming detached. All of the windows and doors are replacement. Views through the open windows revealed the retention of no original interior details. All of the doors and trim in the front (southern) two rooms of the building date to the mid-twentieth century. A modern kitchen and wall covering were also visible through windows on the opposite end of the house. However, due to the impossibility of safely entering the former dwelling, the loss or survival of its interior features could not be confirmed.

Figure 243: Moseley-Stroud House: west side elevation and chimney detail, 2017.

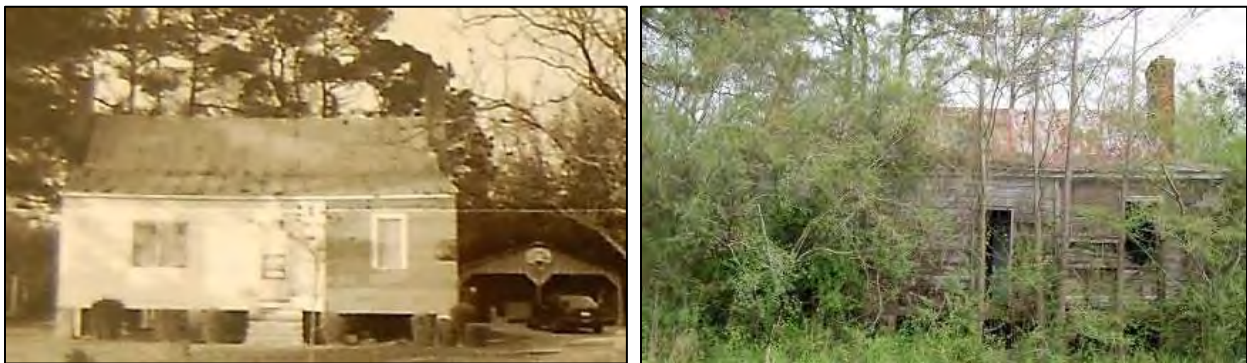
Figure 244: Moseley-Stroud House: south front elevation at left, 1993 (Robbie Jones), and at right, 2017; note that garage is no longer extant.

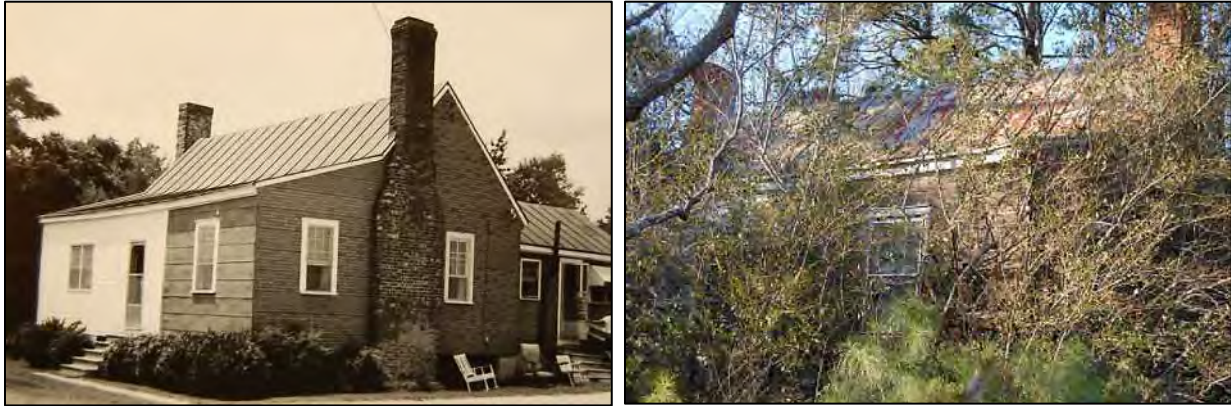
**Figure 245: Moseley-Stroud House: south front and east side elevations at left, ca. 1968 (source: North Carolina Division of Cultural Resources), and, at right, 2017.**

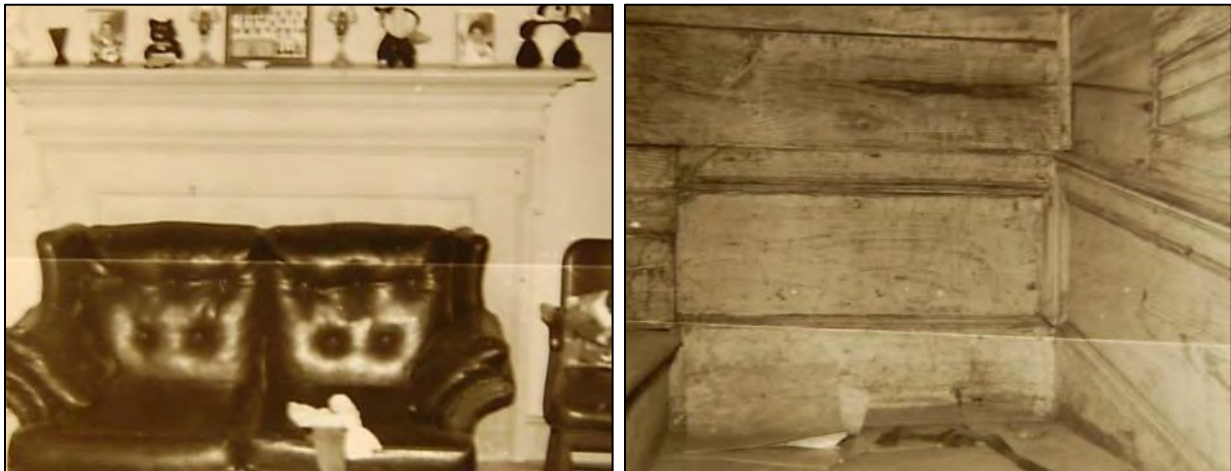
**Figure 246: Moseley-Stroud House: late eighteenth/early nineteenth-century mantel in west room, at left, and wainscoting in stair hall, at right, 1993 (Robbie Jones).**

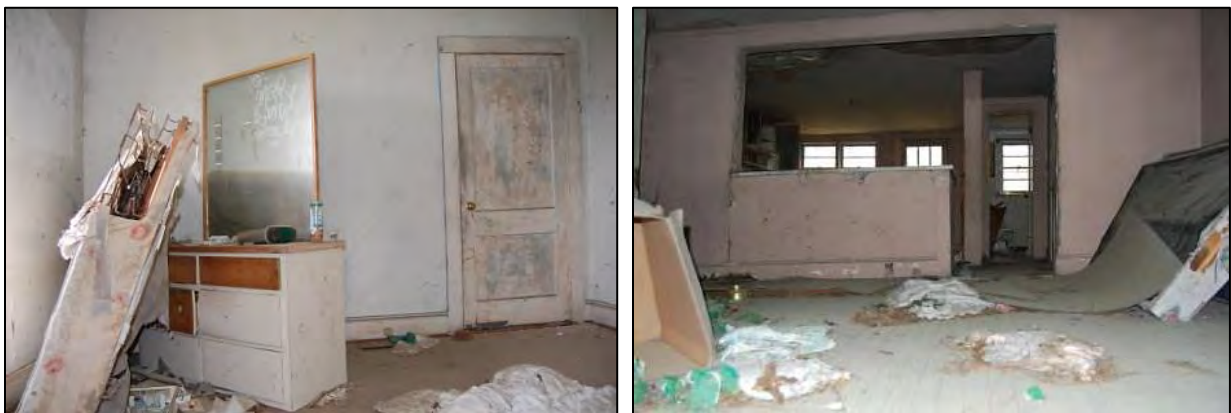
**Figure 247: Moseley-Stroud House: mid-twentieth-century finish photographed through windows of east front pent room, at left, and ell, at right, 2017.**

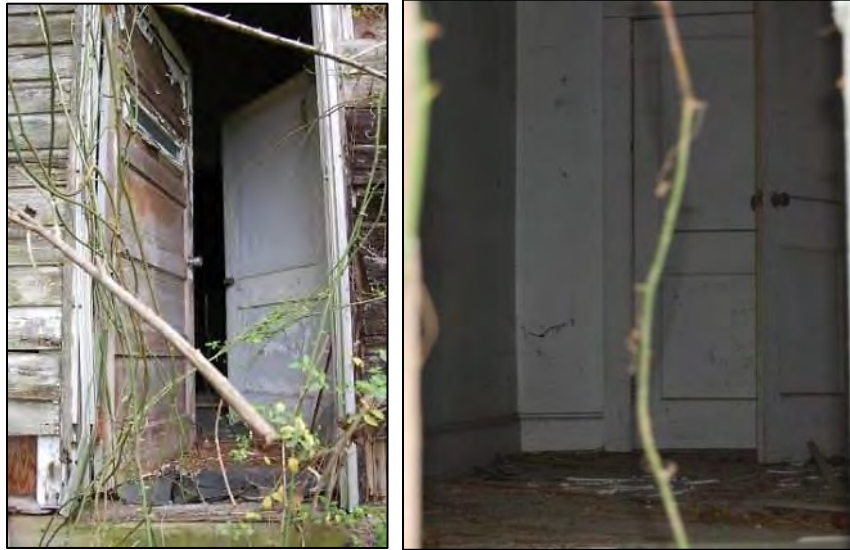
**Figure 248: Moseley-Stroud House: mid-twentieth-century doors and finish of front entry at left, and center hallway photographed through entry, at right, 2017.**

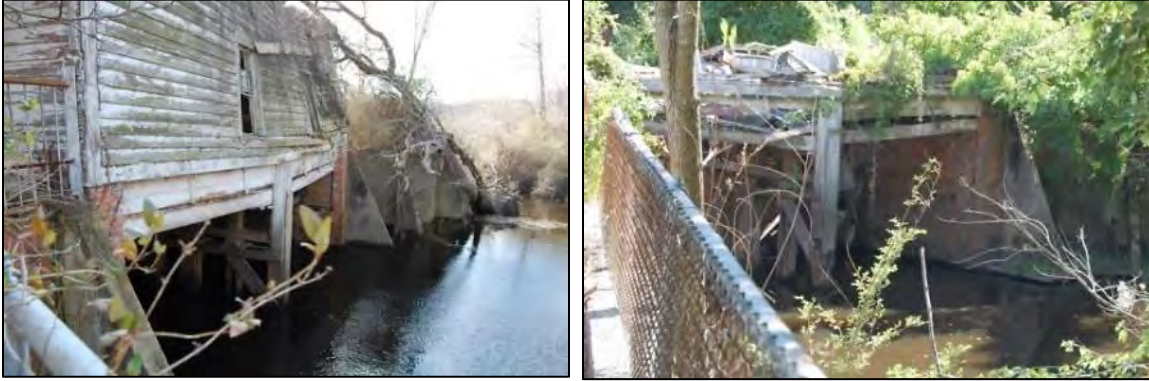
Significant deterioration has occurred at the Kelly’s Millpond Site since the last survey of the property in 2010. As can be observed from the images below, the mill has fallen into complete ruin. A few associated resources including two frame sheds and a small concrete-block building still stand in part on the site (Figure 252 through Figure 254).

Figure 252: At left, view of north elevation of Kelly's Mill, 2010; at right, same view, 2017.

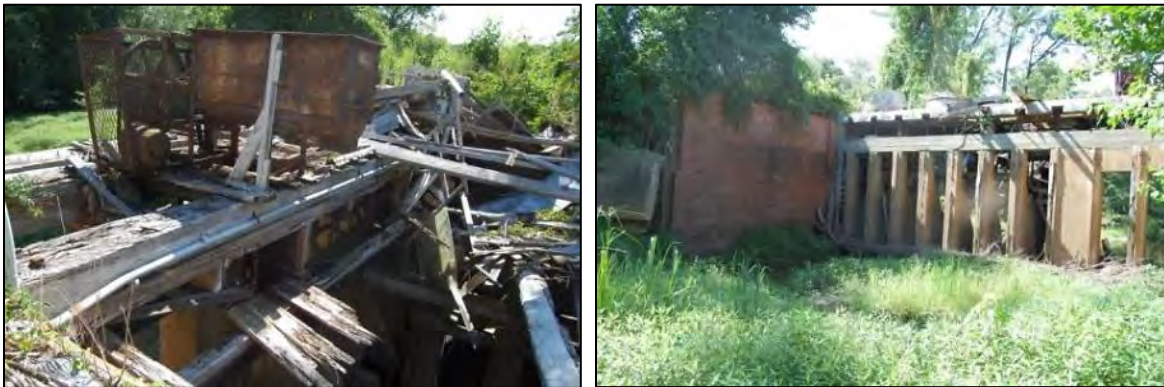
Figure 253: At left, mill ruins ca. 2017 (looking south); at right, ruins of mill substructure (looking north up former mill race).

Some sub-ground-level features of the former mill at the millpond site remain, but the building is effectively gone. Two grist mills, neither still in operation, survive relatively intact in the county. The Alfonzo Walters Mill (LR-0964) was built on an earlier millpond in the LaGrange vicinity in 1917-1919 (Little et al. 1998:116-117, 274). It is comparable in size to the former Kelly's Millpond Mill (Figure 255). The much larger Davis Mill (LR-1017) in the Strabane community dates from 1947 (Figure 256). Issler Davis erected the first mill on its site, as well as the millpond, around 1850 (Little et al. 1998:392). On the basis of the loss of virtually all integrity, and the presence of two much more intact mills in the county, the mill that stood at Kelly's Millpond Site is recommended as not individually eligible for NRHP listing as a historic architectural resource under NRHP Criterion C. It has insufficient integrity to support individual significance under Criterion A for connection with any historic events, and is not known to be associated with any notable person. It is therefore recommended not eligible under Criteria A or B as an individual architectural resource. It is not likely to yield important historical information on the basis of its appearance or construction and is therefore not recommended as individually NRHP-eligible, *as an architectural resource*, under Criterion D.

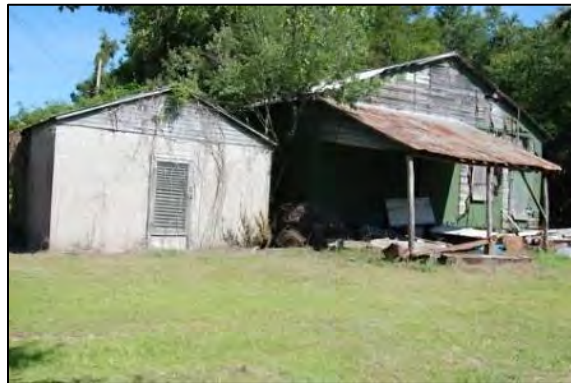
Figure 254: Frame shed adjacent to concrete block building (looking east), 2017.

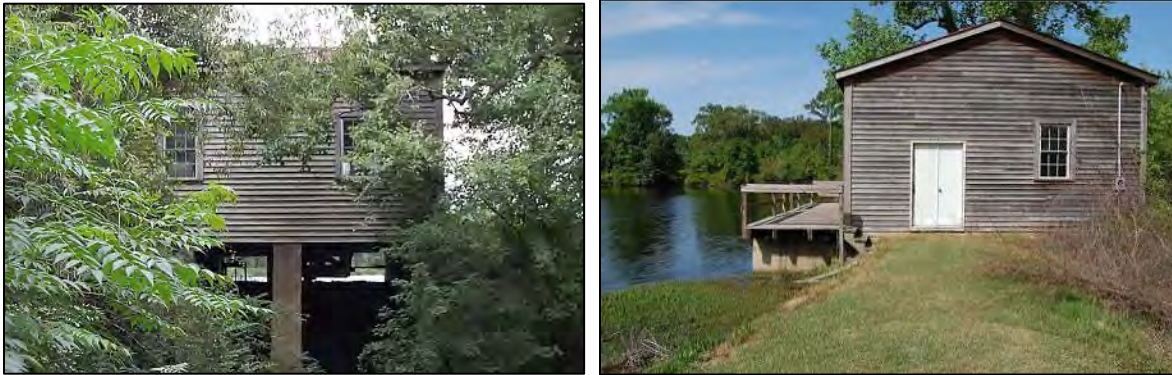
Figure 255: Alfonzo Walters Mill: north elevation in 2017, at left, and east elevation in 2010, at right.

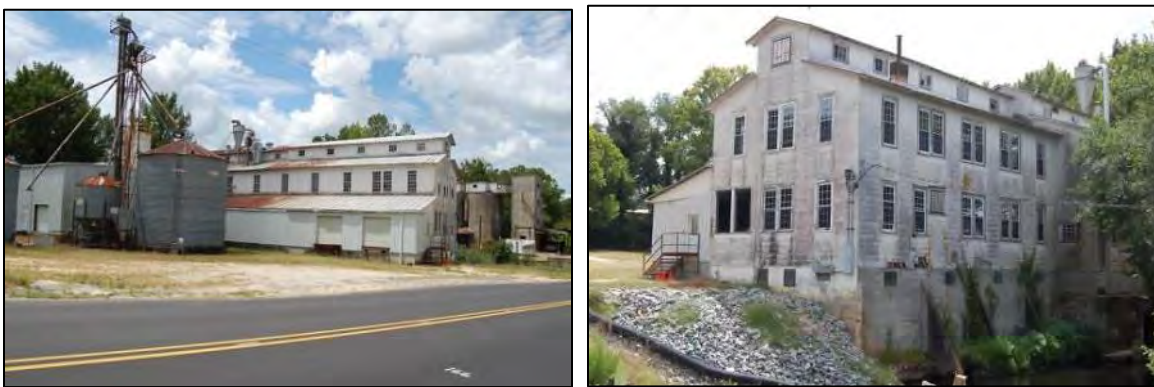
Figure 256: Davis Mill: looking southwest at mill complex, at left, and south and west elevations of mill, at right, 2017.

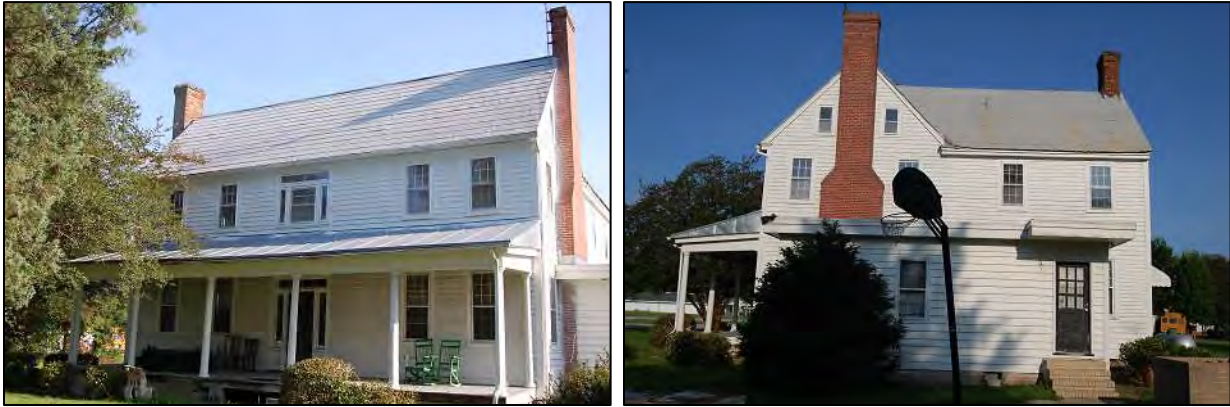
The heavy timber-frame, two-story, antebellum Cobb-King-Humphrey House is L-shaped in plan featuring a five-bay-wide, two-pile-deep front block with an original rear ell extending off its northeast corner (Figure 260). This original portion of the house is clad in weatherboards and edged by wooden cornerboards. The house sits atop a continuous concrete-block foundation that

likely replaced an early stone or brick foundation. The gables have flush cornices with returns and unadorned entablatures partially hidden by modern gutters. The roof's original wood shingles have been replaced with decorative tin shingles (King-Humphrey 1994).

**Figure 260:** Left, south front elevation of Cobb-King-Humphrey House; right, east side elevation of house.

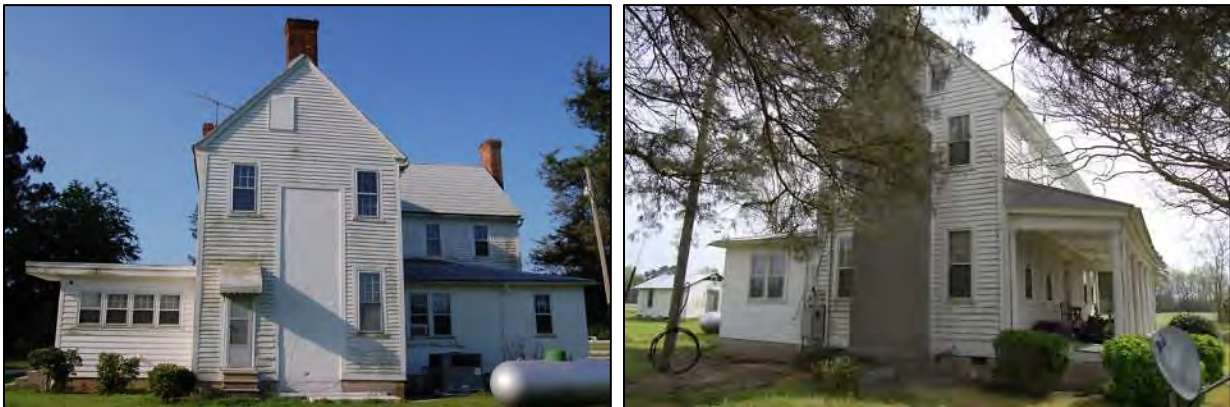
Brick shouldered exterior-end chimneys are found on both the eastern and western gable ends of the front block of the house. The eastern chimney is a replacement, but the western one, which is stuccoed and stands free of the building, is original. A third brick chimney is found on the at the gable end of the ell. It is an interior exposed-face chimney, an uncommon design feature in Lenoir County (Figure 261).

**Figure 261:** Left, north rear elevation of Cobb-King-Humphrey House; right, west side and south front elevations of house.

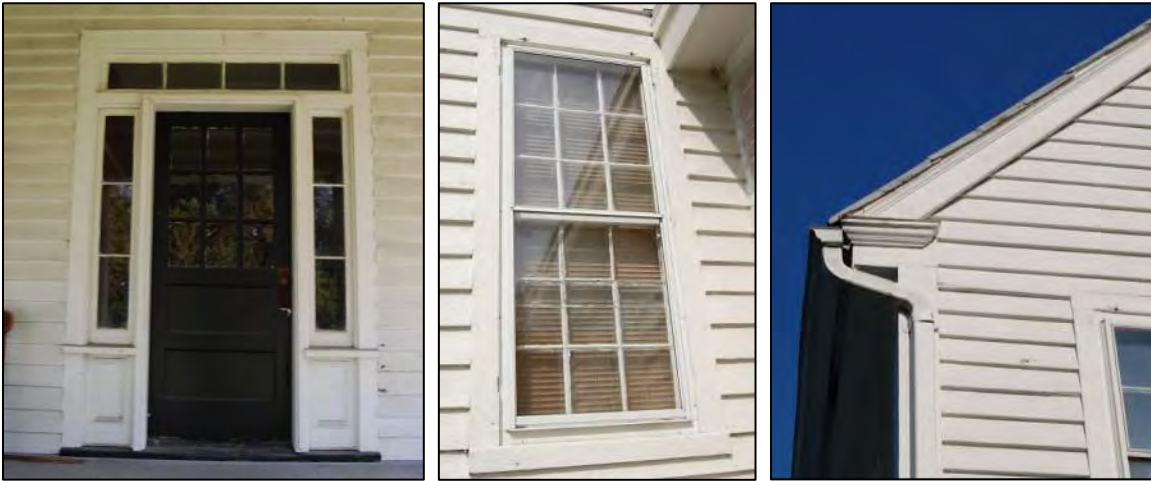
**Figure 262: Left: detail of front door sidelights and transom; center: detail of original nine-over-nine light windows; right: detail of boxed cornice.**

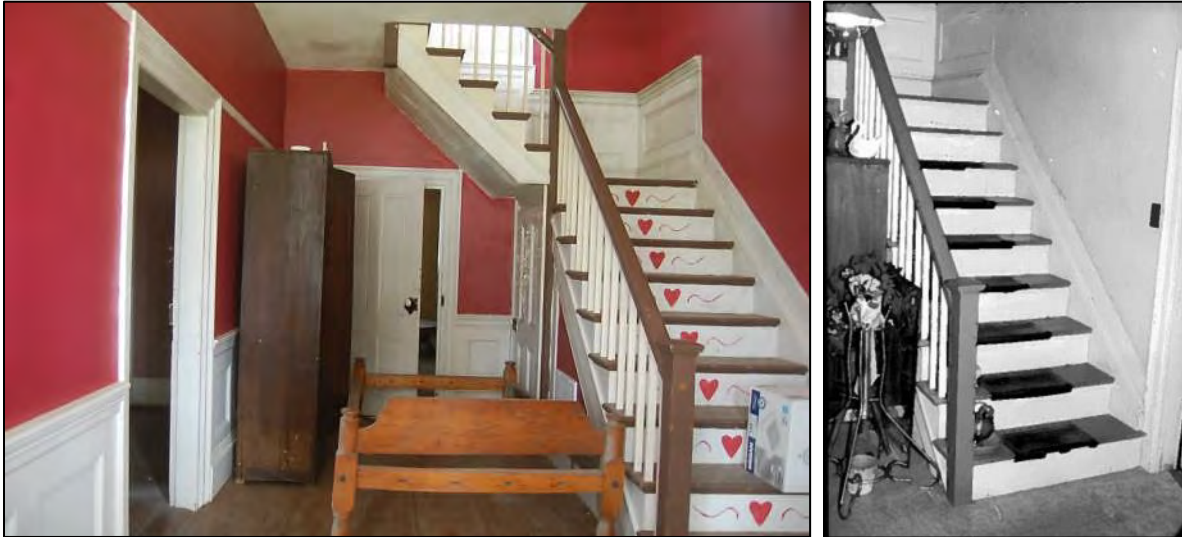
Interior access to the house was unavailable at the time of survey. However, views through the windows of the house revealed paneled wainscoting, four-paneled doors, and an original stair (Figure 263). Photographs taken in 1994 by Robbie Jones reveal handsome Federal features, including mantels with reeded pilasters that are likely still in place.

**Figure 263:** Left, interior image of front hall looking through sidelight window on front elevation; right, interior image of front hall in 1994 (photo credit: Robbie Jones).

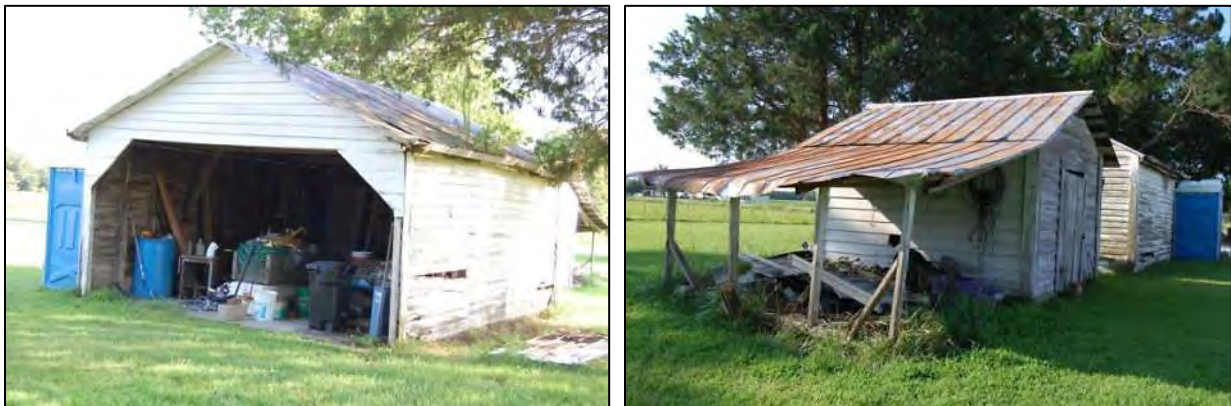
Located to the east of the Cobb-King-Humphrey House, and facing south, the front-gabled frame garage dates to the early twentieth century (Figure 264, at left). It was likely built by Richard King shortly after he purchased the house in 1914. The building is clad in weatherboard siding and capped with a standing seam metal roof. The large opening on the building's southern side suggests the building was constructed to hold two cars; however, the door(s) no longer remain.

**Figure 264:** View looking north at garage, at left; looking south at shed (with garage to rear), at right.

Situated directly behind (to the north) of the garage, this small side-gabled frame shed is rectangular in plan and features a wooden batten door framed by a simple wooden surround on its western side (Figure 264, at right). It is clad with large weatherboards and features a standing-seam metal roof. A lean-to attached to the building's northern side is supported by four square wooden posts. The shed likely dates to the King period of ownership.

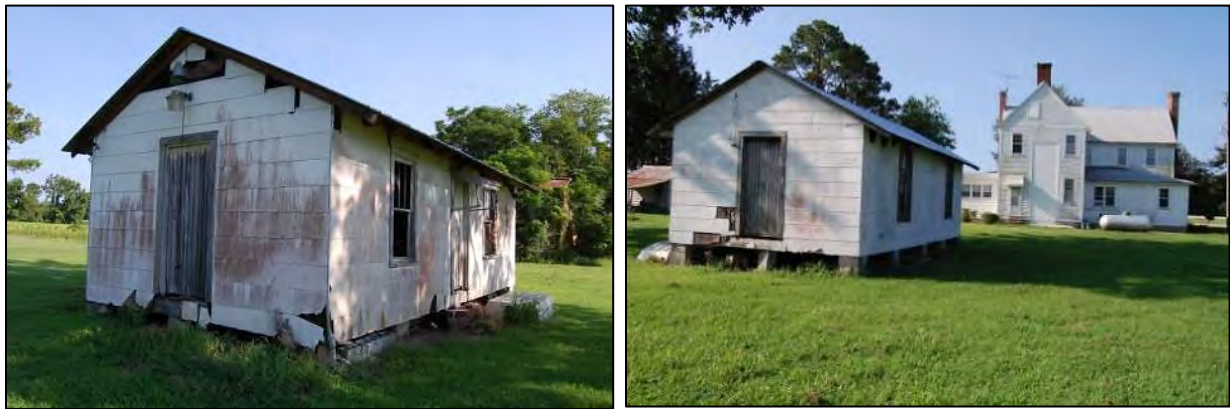
This three-bay, single-pile, frame building sits atop concrete block piers and is located a short distance to the north rear of the Cobb-King-Humphrey House. It was utilized as storage house during the latter part of the twentieth century according to Mary King-Humphrey (Figure 265). A centrally placed door is located on the eastern elevation and is flanked on either side by nine-over-nine double-hung windows, which were likely salvaged from another building. Windows identical in style and placement are found on the opposite (western) elevation. The door is simply composed of wooden battens. Two additional doors of the same style are located on the northern and southern gable ends. The side-gabled roof is clad in standing-seam metal and displays exposed rafter tails, suggesting a 1920s/1930s date of construction. The building is clad in the same asbestos panel siding as the northwestern addition to the Humphrey House, with which it may be contemporary.

**Figure 265:** Left, view looking north of the storage house; right, contextual view looking south of Storage House in relation to main house.

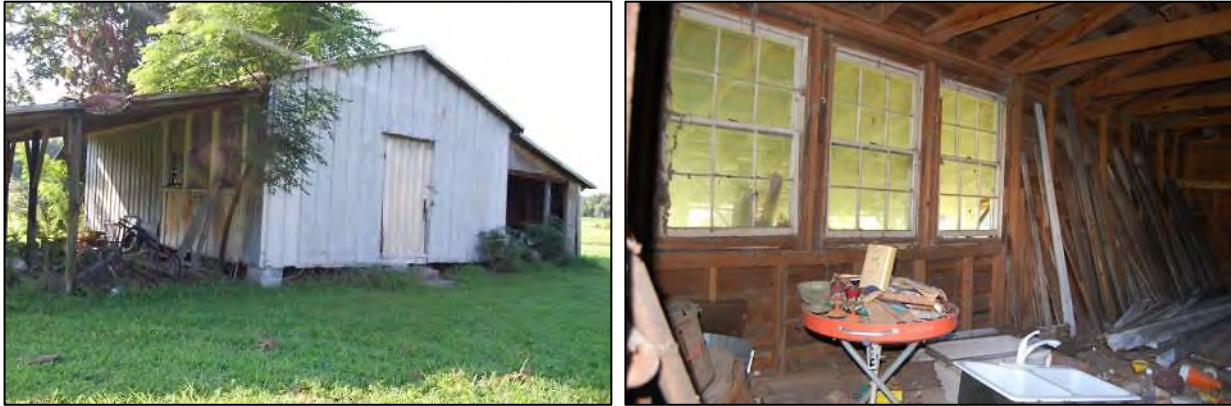
This side-gabled frame structure clad in standing seam metal and sitting on concrete block piers features a band of three windows on its eastern elevation, suggesting its use as a striphouse during the farm's tobacco production years (Figure 266). It appears to date from the early twentieth century. Located to the northeast of the main house, its eastern orientation provided maximum sunlight during the work day, a necessary element for stripping tobacco. The windows are six-over-six double-hung sash. A metal door is found on the building's western gable end and a wooden screened door on the eastern gable end. Shed roof lean-tos were added to the north, west, and eastern sides of the building sometime during the mid-20th century. The metal siding is also a later addition.

**Figure 266:** Left, view of western elevation of striphouse; (looking east); right, interior view of striphouse windows.

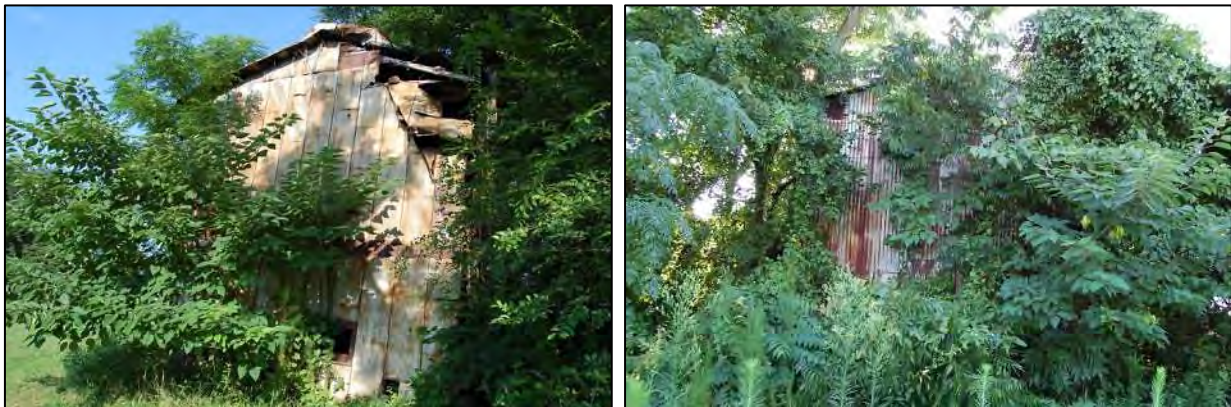
Situated in a row running north of the storage between two fields are four early twentieth-century tobacco barns standing in various states of decline (Figure 267 and Figure 268). The buildings are similar in design: side gabled in orientation and of frame construction. All four are clad in metal and asphalt sheathing and feature standing-seam metal roofs. A brick foundation was evident at the less-overgrown northernmost barn. In addition, a small wooden batten door was accessible on the building's eastern side. A view of the building's interior revealed the wooden poles and framework used to hang tobacco in the drying process.

**Figure 267:** Left, view of the first/southernmost tobacco barn (looking northeast); right, view of the second tobacco barn (looking northeast).

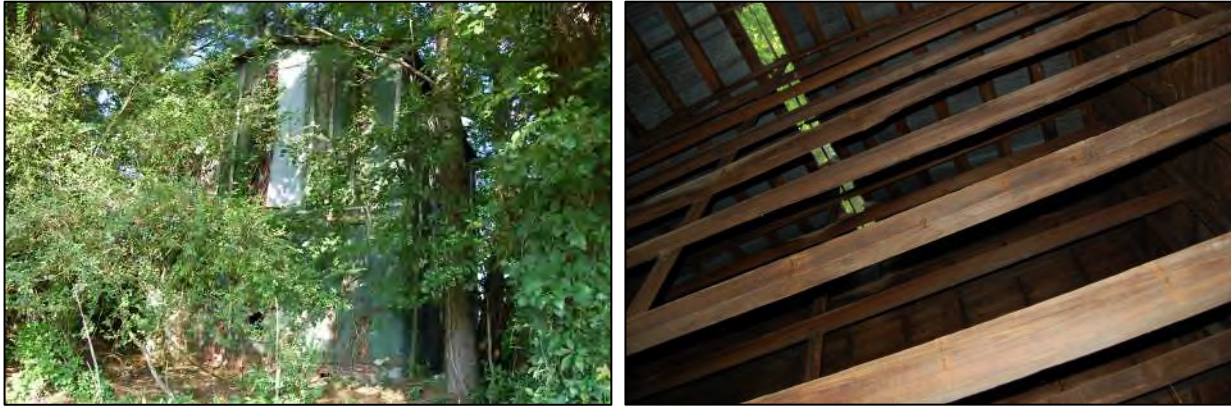
**Figure 268:** Left, view of the third tobacco barn (looking northeast); right, poles in fourth/northernmost packhouse.

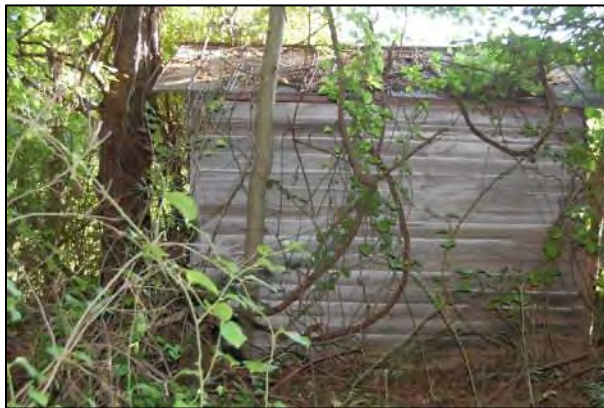
Located north of the four tobacco barns, this small frame shed is clad in weatherboard siding and features a standing seam metal roof (Figure 269). It appears to be contemporary with the barns.

**Figure 269:** View of shed's southern elevation.

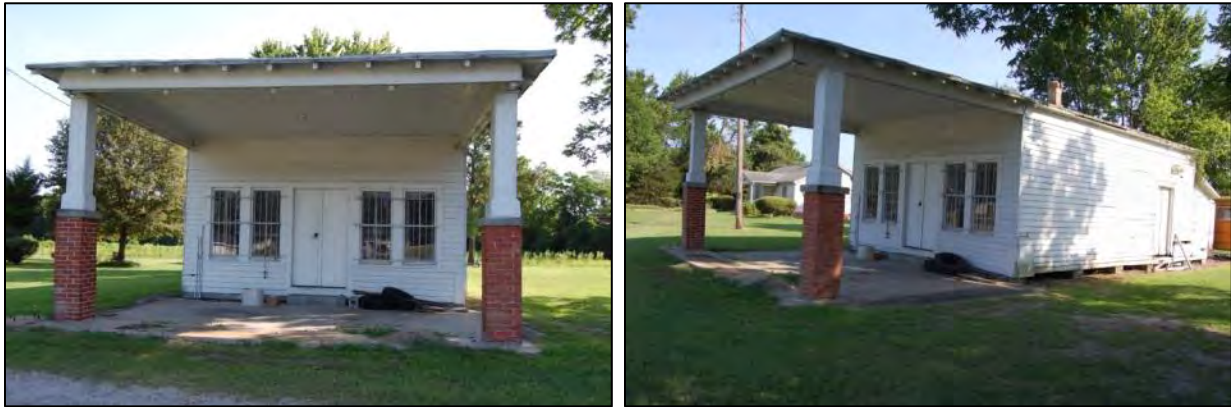
The ca. 1920s King Store is located directly west of the Cobb-King-Humphrey House, just off of and fronting on US 70 (Figure 270 and Figure 271). A typical early twentieth-century store, it is three bays wide and two piles deep with a rear shed-roof addition. Of frame construction, it rests upon a concrete-block foundation and is clad in weatherboards. Standing-seam metal covers its low-sloped gabled roof. Two double-hung two-over-two windows frame either side of the centrally placed door on southern façade facing the road. The original front doors have been replaced with more modern unadorned wooden doors. A secondary wood-batten door is located on the eastern elevation at the building's northeast corner. A single interior brick chimney stack sits on the building's ridge line.

A large overhang that would have shielded no-longer-extant gas pumps project's from the store's front. Two Craftsman-style columns of tapered posts on brick piers support it and rafter tails are exposed at its gabled roof. The building's rear shed addition sits on concrete masonry piers, is clad in weatherboard, and features simple wood-batten doors on its eastern and western sides.

**Figure 270:** Left, view of the front (southern) elevation of the King Store, looking to north; right, view of the southeast corner of the King Store, looking to the northwest.

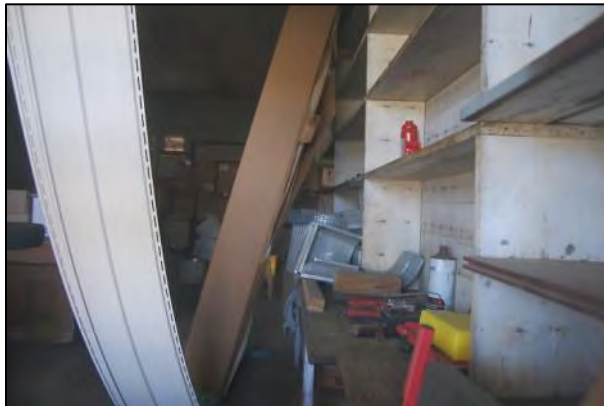
The building's interior was inaccessible. It is now used for storage. Views through the windows, though, revealed the retention of the store's original shelving.

**Figure 271:** View of interior of the King Store, looking through eastern window on the building's front (southern) side.

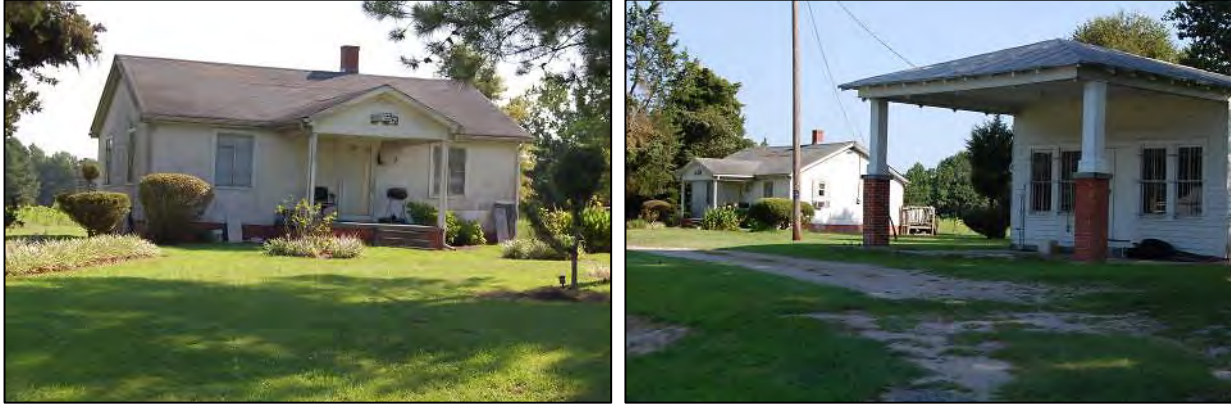
Built in the early/mid-twentieth century, this small house stands just northwest of the King Store, a bit more distant from the road (Figure 272). The one-story frame building rests atop a continuous brick foundation, is clad in asbestos tile siding, and features a side-gabled roof clad in asphalt shingles. An interior brick chimney rises from the building's ridgeline. A centrally located horizontal-panel wooden door is found on the building's primary (southern) elevation flanked by casement windows framed by unadorned wooden trim. The primary elevation is framed by a centrally located pedimented front porch supported by two plain, square, wooden columns. The porch sits on a raised brick foundation with three concrete stairs on its southern side.

**Figure 272: Left, view of south front elevation of house; contextual view of store in relation to the house, looking to the northwest.**

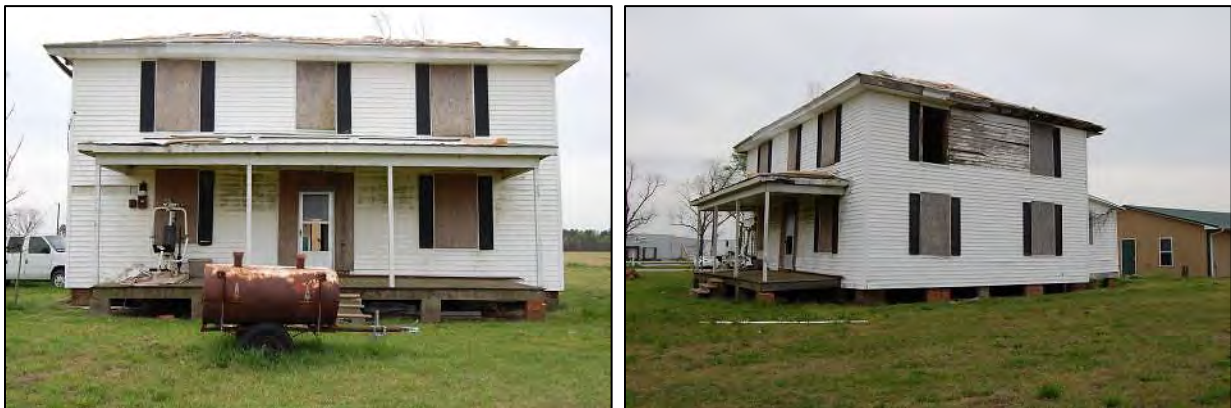
three-bay, hipped-roof, front porch supported by later-added square posts. Its west rear elevation is shaded by a shed-roofed porch with enclosed rooms at either end that are original features. The house is in extremely poor condition and altered by the removal of its two interior chimney stacks and the boarding over of its front entry and all of its sash. Some of its original six-over-six double-hung windows, however, remain in place behind their sheets of plywood. A mid-1990s photograph in *Coastal Plain and Fancy* (Little et al. 1998:415) depicts the house occupied and apparently in good condition. By 2010 it has long been vacant and was quite deteriorated. It is now much more deteriorated (Figure 278 and Figure 279).

**Figure 278: Robert Bond Vause House: west front elevation, at left, and west front and south side elevations, at right.**

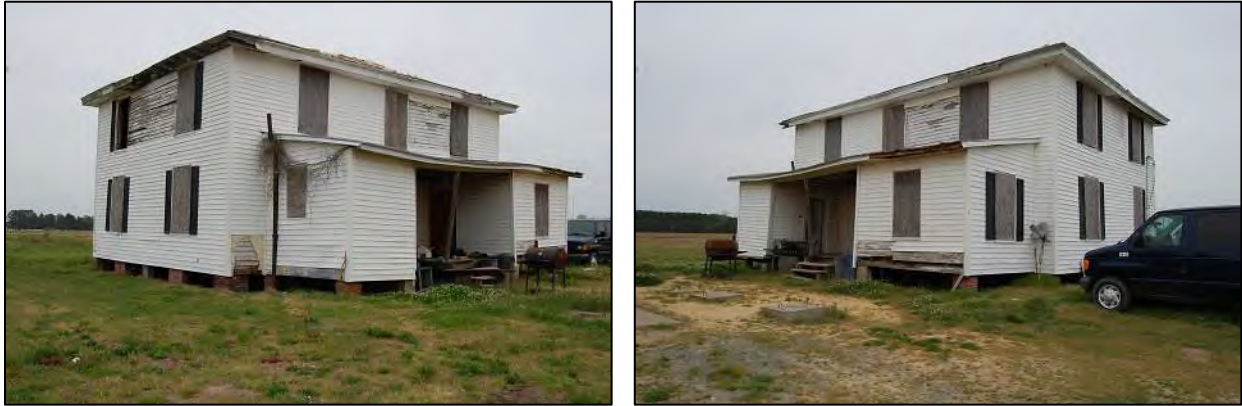
**Figure 279: Robert Bond Vause House: south side and east rear elevations, at left; east rear and north side elevations, at right.**

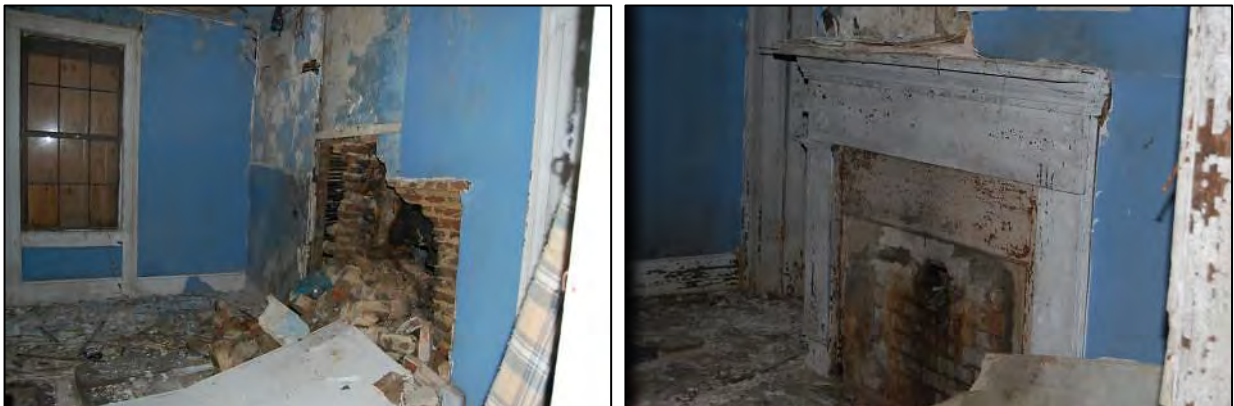
The building's first-story interior retains many straightforward, original, Greek Revival-style elements, including window surrounds with panels beneath, simple baseboards, post-and-lintel mantels, plaster walls, and a stair with a boxy newel post and stick balusters (Figure 280). The second story could not be viewed due to the questionable condition of the stair. A comparison of the current state of the interior with an image taken in 2010 illustrates the continued and accelerated decline of the house (Figure 281).

**Figure 280: Robert Bond Vause House: first-floor rooms.**

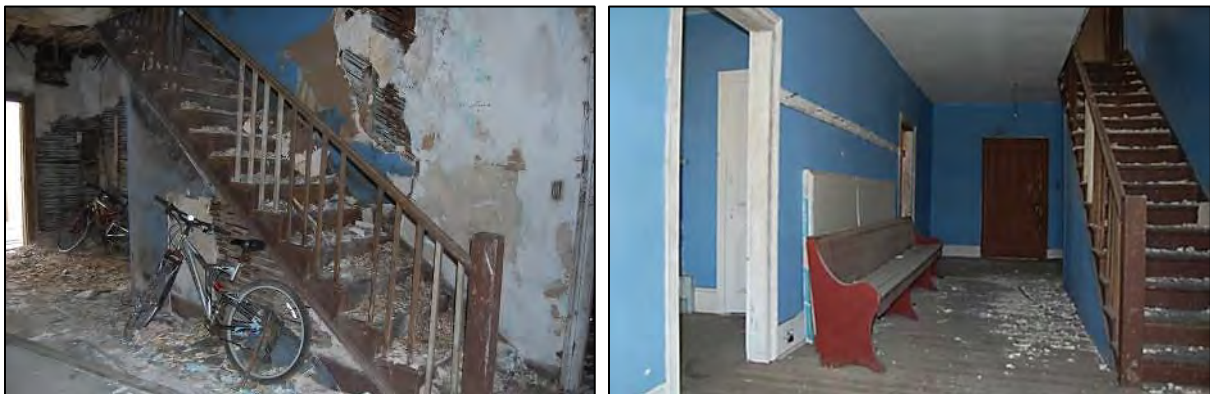
**Figure 281: Robert Bond Vause House: first-floor stair hall at present, at left, and in 2010, at right,**

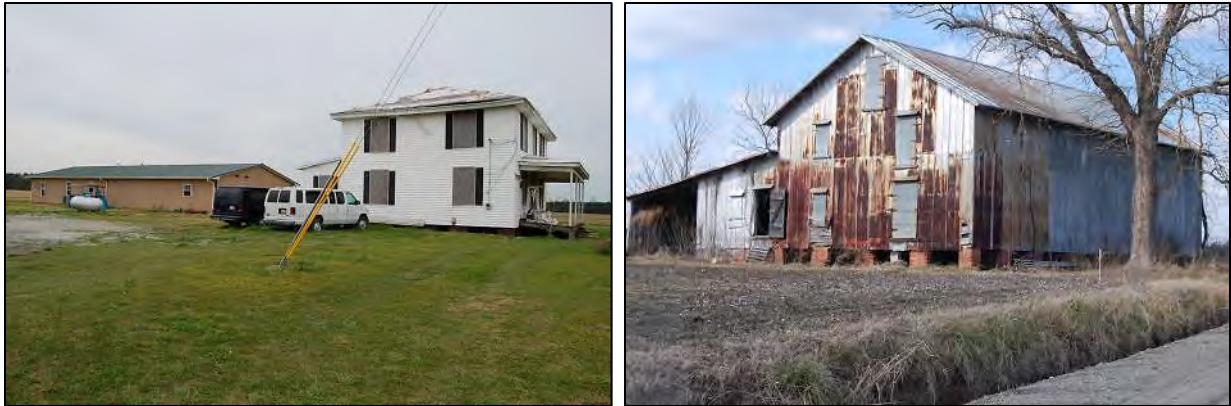
Located to the east rear of the house is a new, one-story, metal-clad building utilized for farm worker housing (Figure 282, at left). Other outbuildings that previously stood near the house, which included a gable-roofed brick smokehouse and a large packhouse, no longer stand (Figure 282, at right).

**Figure 282: Robert Bond Vause House: at left, view looking southeast of house and modern farm worker housing; at right, 2010 image of large packhouse that no longer stands.**

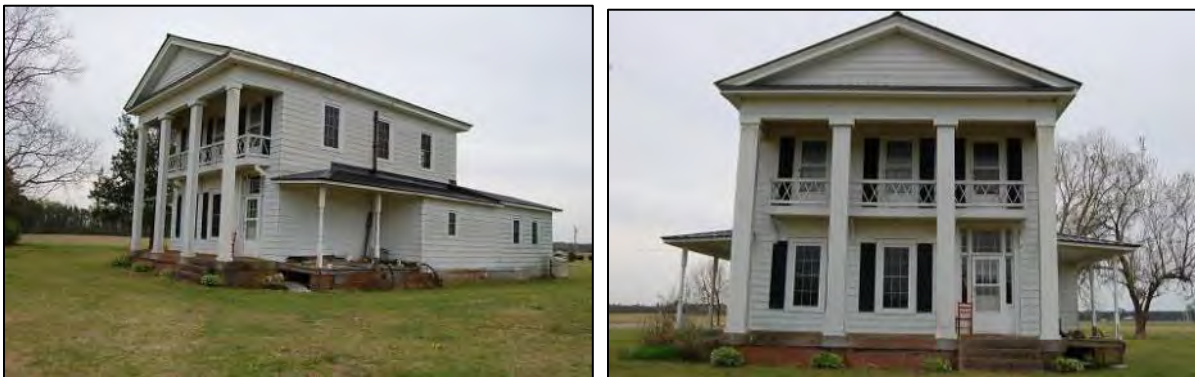
The principal block of the antebellum Wooten-Whaley House is two stories tall, two rooms deep, and topped by a gable-front rather than gable-side roof. Its entry is located on the right-hand (northeast) side of its three-bay-wide, east-facing, front elevation, reflecting its side-hall plan. The house is built of frame, but its original weatherboards are covered with aluminum siding. Its most notable feature—a grand two-story portico supported by four full-height columns and crowned by a triangular pediment—is also aluminum covered. (Whether the original columns remain in place could not be determined.) The portico sits on a concrete slab that rests on a continuous brick foundation (Figure 285 through Figure 288).

**Figure 285: Wooten-Whaley House: north front and east side elevations, at left, and north front elevation, at right.**

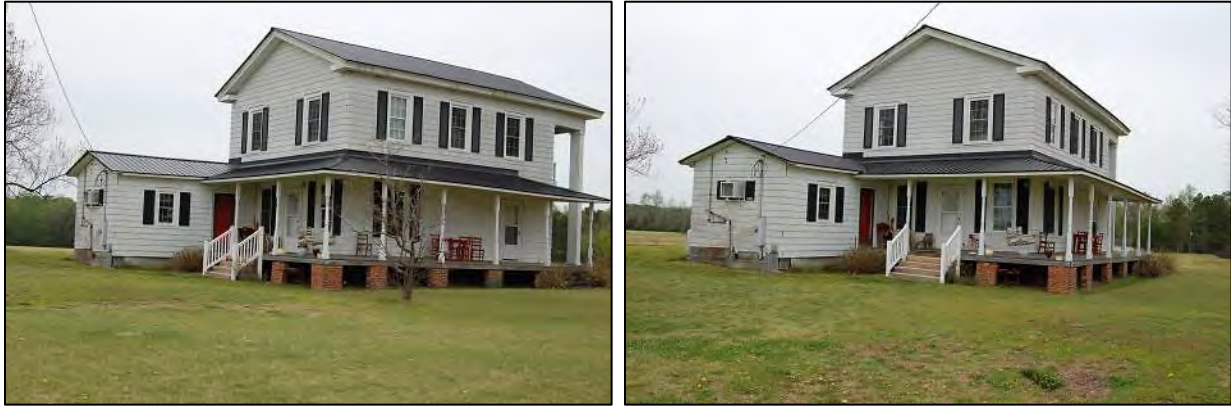
Figure 286: Wooten-Whaley House: west rear and south side elevations.
