North Carolina Department of Natural and Cultural Resources  
State Historic Preservation Office

MEMORANDUM

Subject: Historic Architecture Eligibility Evaluation Report, US 70 Kinston Bypass, R-2553,  
Lenoir County, ER 09-1307

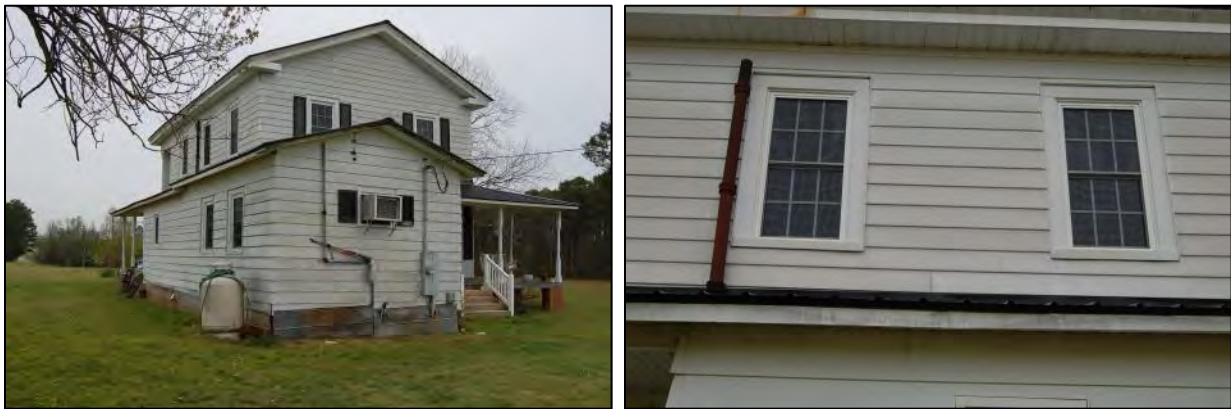
The principal block of the antebellum Wooten-Whaley House is two stories tall, two rooms deep, and topped by a gable-front rather than gable-side roof. Its entry is located on the right-hand (northeast) side of its three-bay-wide, east-facing, front elevation, reflecting its side-hall plan. The house is built of frame, but its original weatherboards are covered with aluminum siding. Its most notable feature—a grand two-story portico supported by four full-height columns and crowned by a triangular pediment—is also aluminum covered. (Whether the original columns remain in place could not be determined.) The portico sits on a concrete slab that rests on a continuous brick foundation (Figure 285 through Figure 288).

Figure 287: Wooten-Whaley House: west rear and north side elevations, at left; second story of north side elevation, at right.

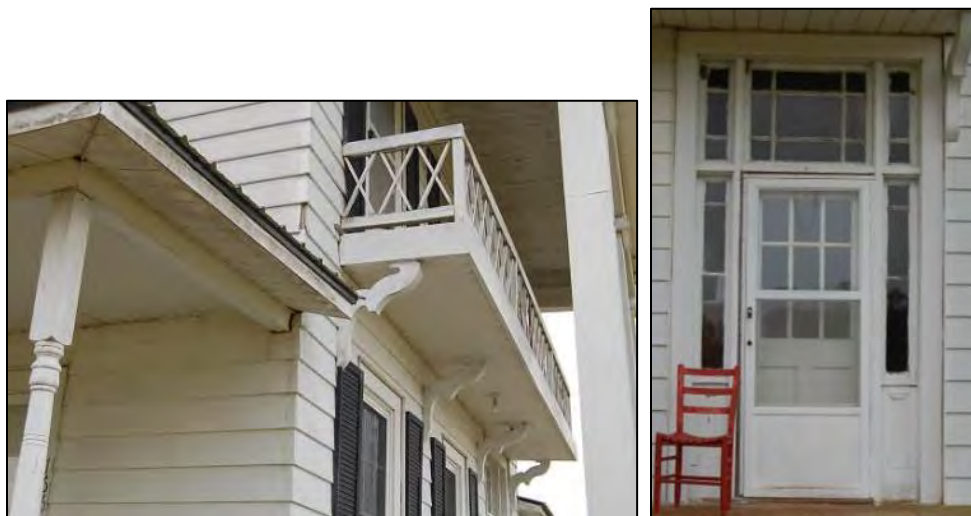
A second-story balcony set within the shadow of the portico may retain a few original features—four heavy curved brackets that support it and a balustrade of X-shape members that may be intended to suggest a sheaf-of-wheat design. Photographs of the interior from 1994 depict a similar pattern at the stair that is more three dimensionally worked. Three replacement doors open onto the balcony.

Figure 288: Wooten-Whaley House: details of columns, second-story porch, and entry.

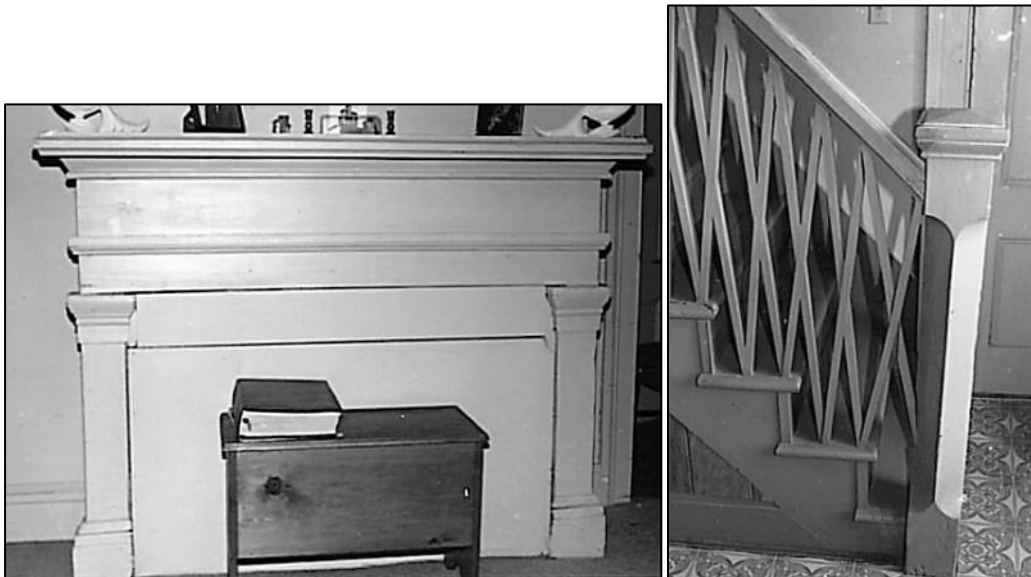
An abstracted sheaf-of-wheat balustrade encloses the balcony and is repeated on the interior side-hall stair. Other important interior elements include a square newel post with exaggerated chamfering on the corners, four-panel doors, and simple Greek Revival mantels with bold proportions in the standard post-and-lintel design.

**Figure 289: One of four identical post-and-lintel mantels and vigorously modeled stair in 1994 (Robbie Jones)**

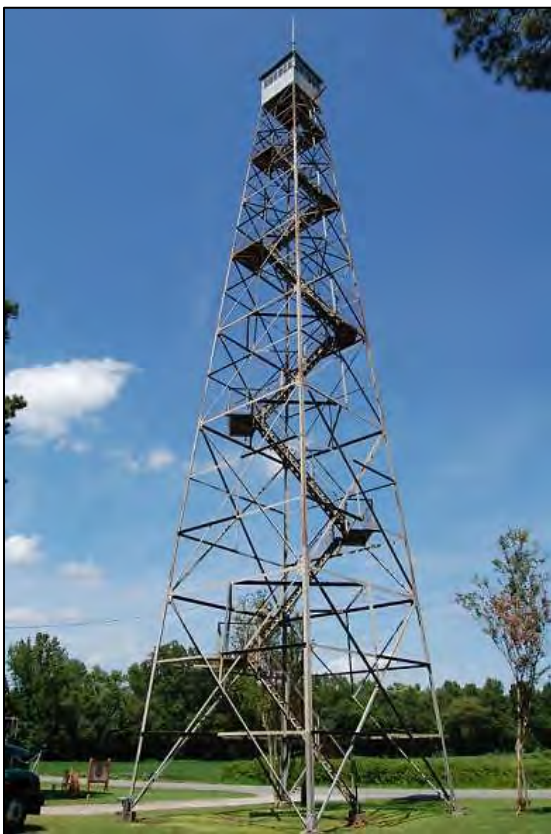
Kelly's Pond Lookout Tower is a 99'-9"-tall observation-only lookout tower built on an Aermotor Company model MC-39 tower plan (Figure 293 through Figure 296). Its open battered design employs an "X"-brace support system constructed of riveted, galvanized-steel, angle members produced by the Carnegie Steel company.

**Figure 293:** At left, looking northeast at Kelly's Pond Lookout Tower; at right, USDA Forest Service, Region 9, standard plan for 99'9" steel lookout tower with 7' x 7' cab, revised October 8, 1934 (HABS No. M0-1913).

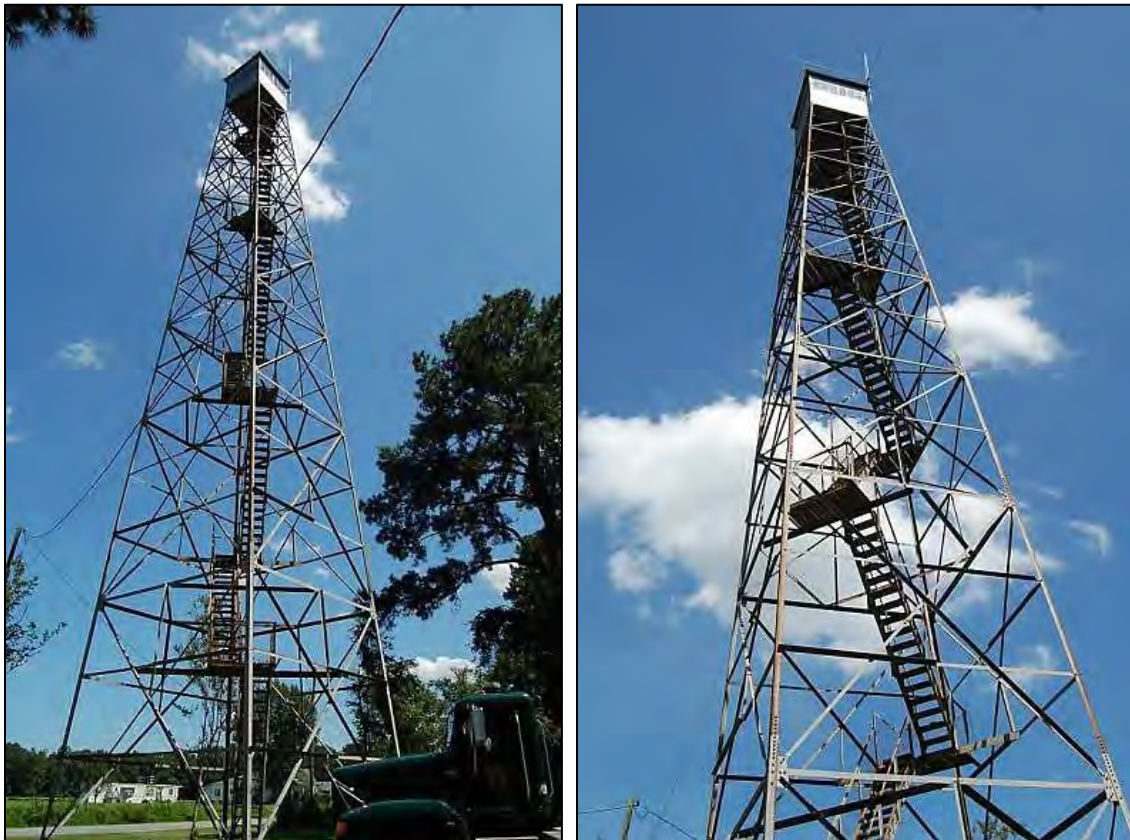
**Figure 295: Kelly's Pond Lookout Tower: looking southeast, at left, and south, at right.**

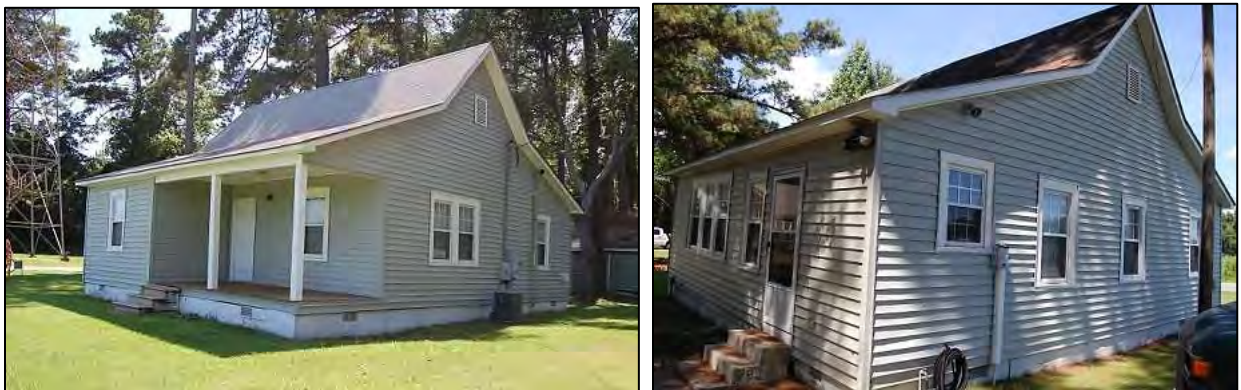
The house in which a tower lookout lived, at least during fire season, was referred to as the towerman's or lookoutman's house, even though the lookout might be a woman (Figure 297 and Figure 298) (Van Dolsen 1999). This house was erected by the Civilian Conservation Corps (CCC) in 1937 along with the tower. The gable-end frame house is one-story tall. Its three-bay front elevation includes an engaged shed room and two-bay, engaged, recessed porch. Engaged shed rooms cross its rear elevation. The side elevations hold windows, but no chimneys, and no stack rises from the asphalt-shingled roof. The exterior has been altered through the addition of vinyl siding, one-over-one sash windows with six-over-six snap-in muntins, and replaced porch posts. The interior, however, remains intact. A 1940 list of state lookout towers generously describes it as a "5-room" towerman's house: it is only about 33' wide x 39' deep, including its engaged front porch and rear shed rooms (Board of Conservation and Development 1940:48). The rooms are small, including a tiny one within the shed, and they are interconnected, as the house lacks a hall. They retain beaded-board walls and ceilings, plain surrounds, and some original five-panel doors. The tower's original Osborne Fire Finder device is also located in the house. The building is now used as offices by the North Carolina Forest Service.

**Figure 297: Kelly's Pond Lookout Tower: at left, east front and north side elevations of house with tower and workshop to either side; at right, west rear and south side elevations of house.**

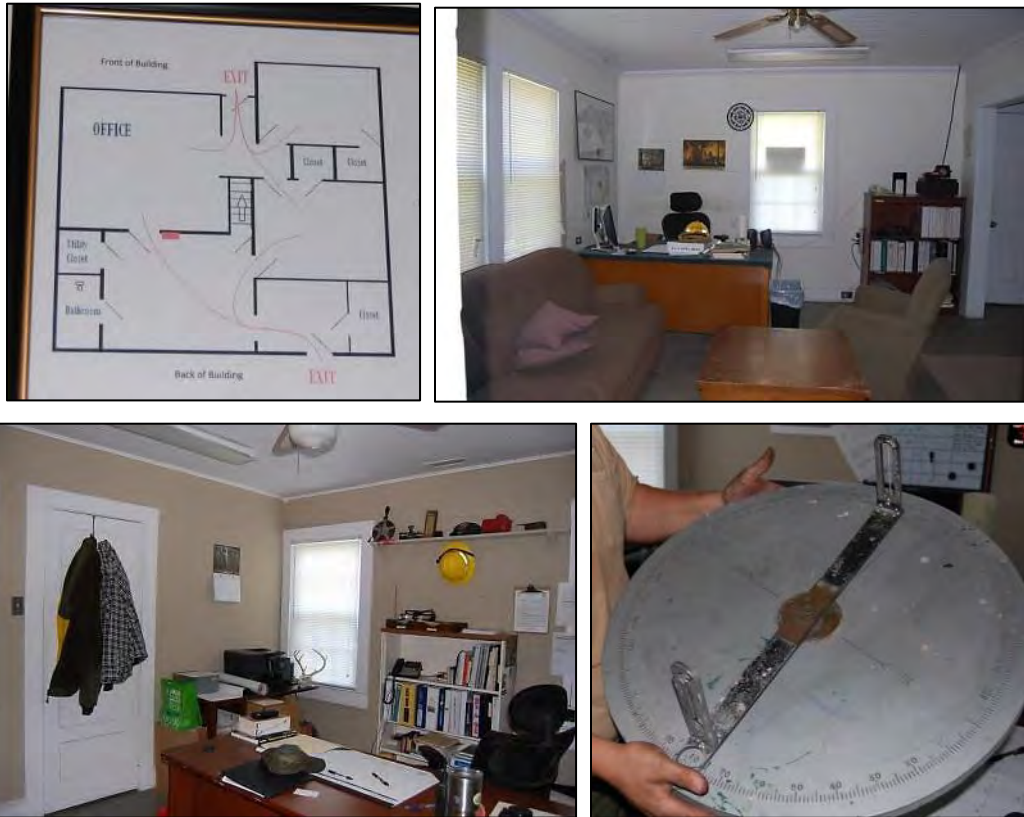
**Figure 298: Kelly's Pond Lookout Tower: modern floorplan, intact interior of house, and original Osborne Fire-Finder.**

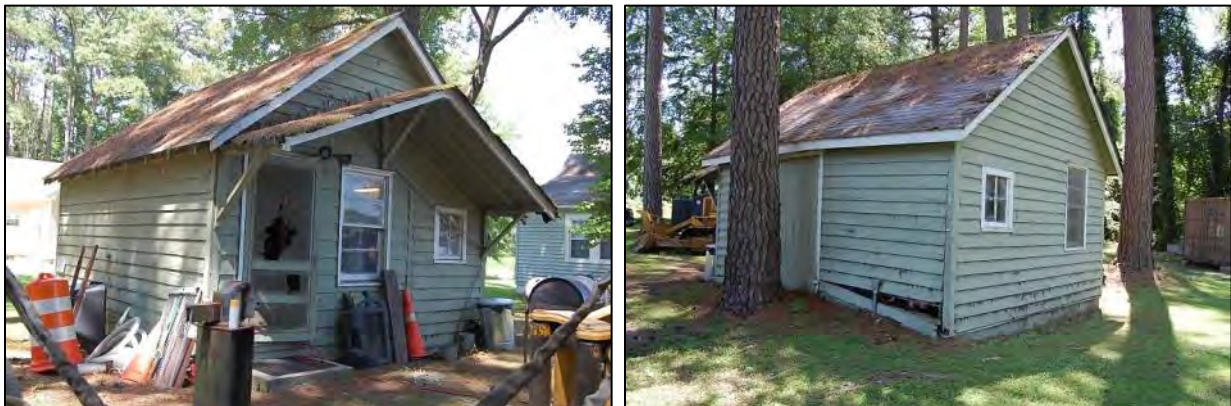
The building that is currently used by the North Carolina Forest Service as a workshop was likely erected in 1937, along with the tower and house, for the same purpose (Figure 299 and Figure 300). One-story-tall and of frame, it retains its original weatherboards, gable-front roof underpinned by exposed rafter ends, and full-façade porch roof supported by oversized triangular kneebraces. Two of the workshop's windows have been changed, although two four-light windows appear to be original. Its interior has been reworked over the years.

**Figure 299: Kelly's Pond Lookout Tower: west side and south front elevations of workshop, at left, and east side and north rear elevations, at right.**

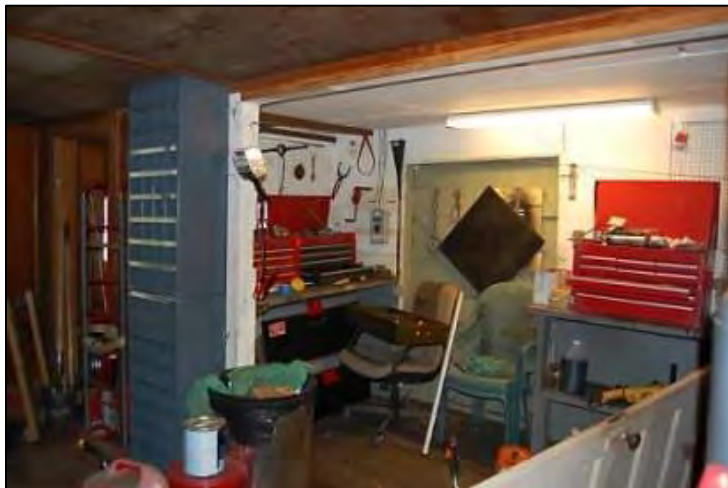
Figure 300: Kelly's Pond Lookout Tower: workshop interior.

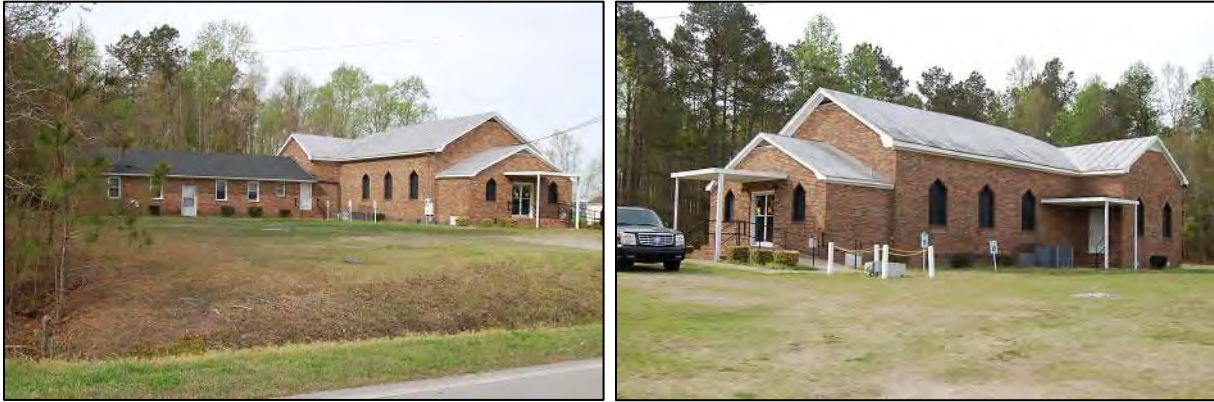
The main block of the current frame church—composed of the vestibule, sanctuary, and apse laid out in a T-plan—was erected in 1949 to replace a building that burned in 1937 (Figure 303 through Figure 305). In 1979 it was extended to the west by a side-gabled, seven-bay, brick-veneered wing. At that time the main block was also brick veneered. The entire building rests on a continuous brick foundation. The roof of the main block is standing-seam metal and features gable-vents and flared cornice ends. Asphalt shingles cover the west wing's roof.

Fixed, single-light, arched windows serve the vestibule and side elevations of the sanctuary and rear apse. Their tinted glass postdates 1987. Three such windows once lit the rear of the building, but were bricked in as part of the church's re-cladding. Their ghosts are still clearly visible.

**Figure 303: Beautiful Valley Church: East side and north front elevations, at left; north front and west side elevations, at right.**

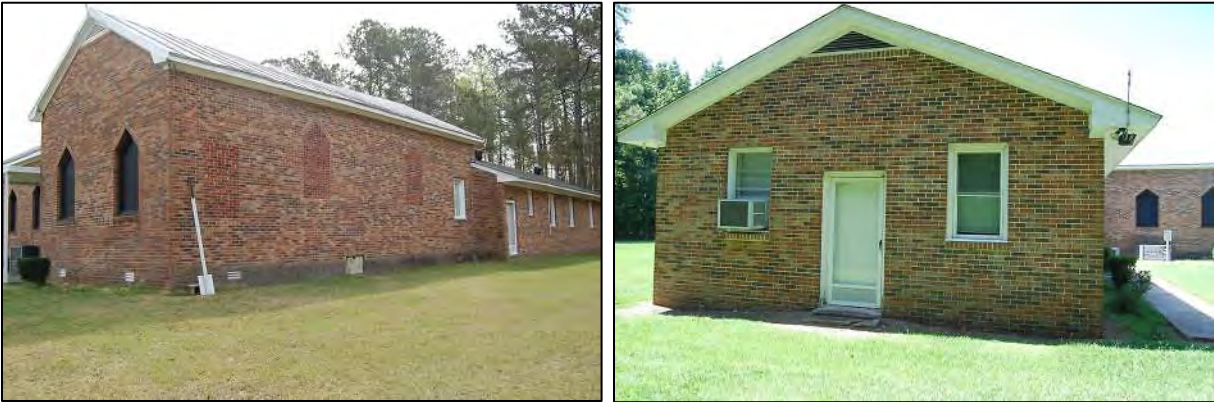
**Figure 304: Beautiful Valley Church: West side and south rear elevations, at left; east side elevation, at right.**

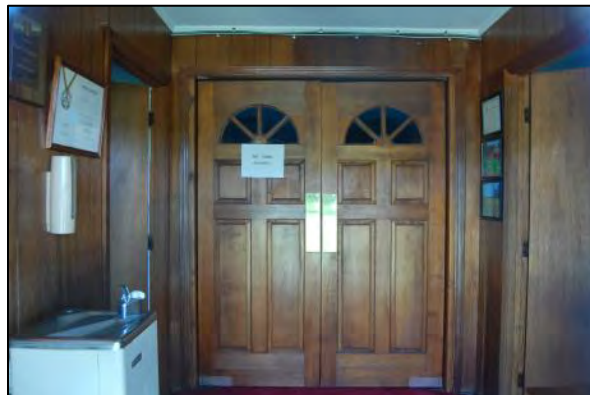
The congregation now enters the church through modern double glass doors shielded by a flat metal-roofed metal porch supported by two thin metal posts. The entry and porch date from 1987 or later. The vestibule is finished with wooden doors and paneling. This appears to date from 1987 or later as well. Despite multiple site visits, interior access to the building was not available.

**Figure 305: Beautiful Valley Church: interior of vestibule.**

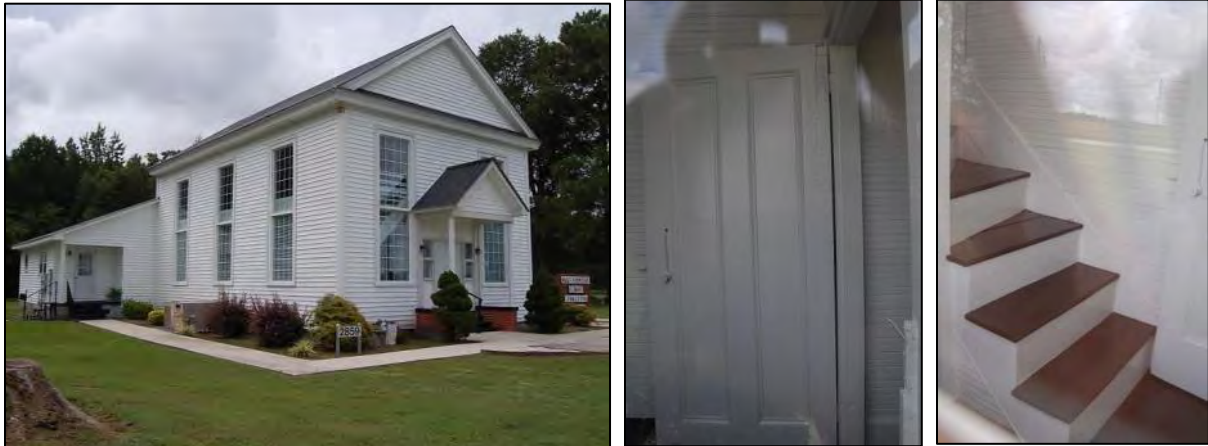
gable tops the church's gable-front façade and tall windows rise at its side elevations that serve the main floor of the sanctuary and the gallery above. The building has modern windows with snap-in muntins and is sided with vinyl that more closely references its original weatherboard siding than would brick veneer. Its vestibule retains an original two-panel door, an early winder stair, and beaded-board siding. A large addition extends across the rear (Figure 307).

**Figure 307: Cypress Creek Methodist Church: northeast side and northwest front elevations, at left, and early door and stair in vestibule, at center and right, 2017.**

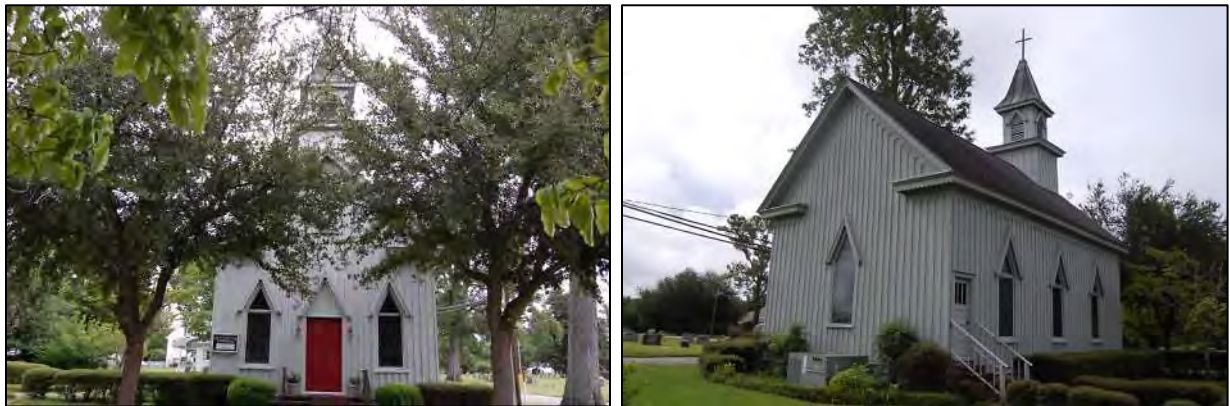
Grace Episcopal Church (JN-0003) is listed in the NRHP individually and as part of the Trenton Historic District (JN-0005) (Department of Archives and History 1971b; Division of Archives and History 1974). Its cornerstone was laid in 1885 and it was dedicated in 1892. Although modestly sized and of frame, the building has an ornately finished Gothic Revival-style exterior that includes board-and-batten sidings terminating in an arcade at the eaves, triangular-headed openings accented by molded hoods, scalloped bargeboards, and an attenuated steeple. The building is remarkably intact (Figure 308).

**Figure 308: Grace Episcopal Church: south front elevation, at left, and north rear and west side elevations, at right, 2017.**

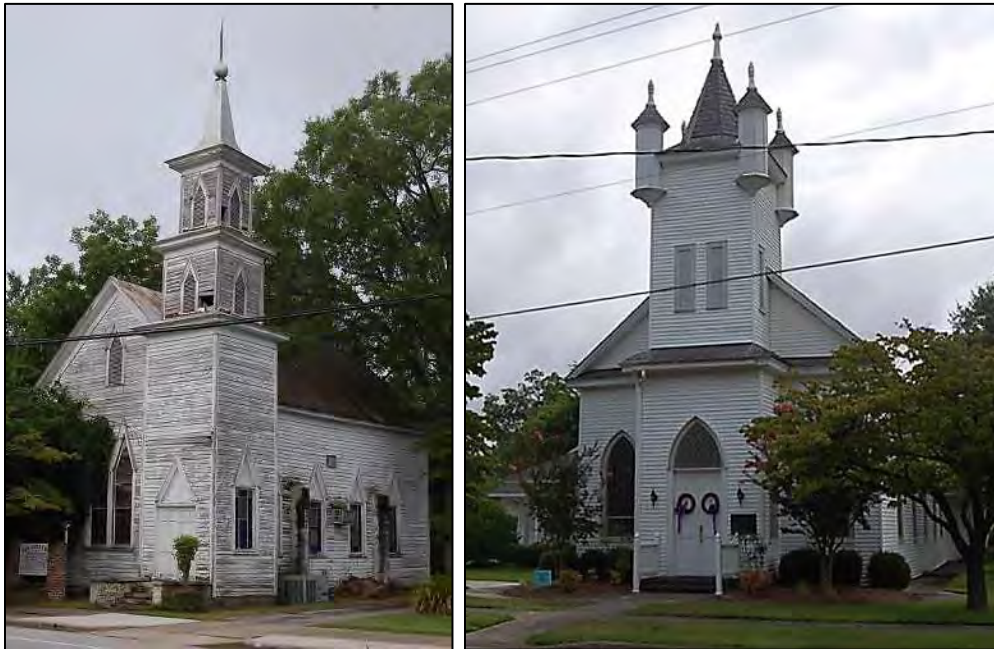
Another notable and contemporary Gothic Revival-style church in the town is the Trenton Pentecostal Holiness Church (Ministries of Christ Baptist Church) (, at left). It is little changed, but for deterioration, since it was included within the Trenton Historic District (Division of Archives and History 1974). The nomination described it as “a gable roof building with acutely-

pointed triangular-arched openings with heavy hoodmolds. These recur, filled with louvers, on the three-stage corner tower, which is capped by a slim spire and weathervane.”

In 1887 the congregation of the Trenton Methodist Church (JN-0037) purchased the lot upon which its Gothic Revival-style church was soon raised. The tall, frame, gable-front building is Gothic Revival with large pointed-arch windows filled with leaded glass and a tower described as “eccentric” in the Trenton Historic District NRHP nomination (, at right). It rises in two stages crowned by a polygonal spire supplemented with four smaller, overhanging, corner towers or bartizans with similar spires (Division of Archives and History 1974; [www.trentonunitedmethodistchurch.org/history.html](http://www.trentonunitedmethodistchurch.org/history.html)).

**Figure 309: East front and north side elevations of Trenton Pentecostal Holiness Church, at left, and south side and west front elevations of Trenton Methodist Church, at right, 2017.**

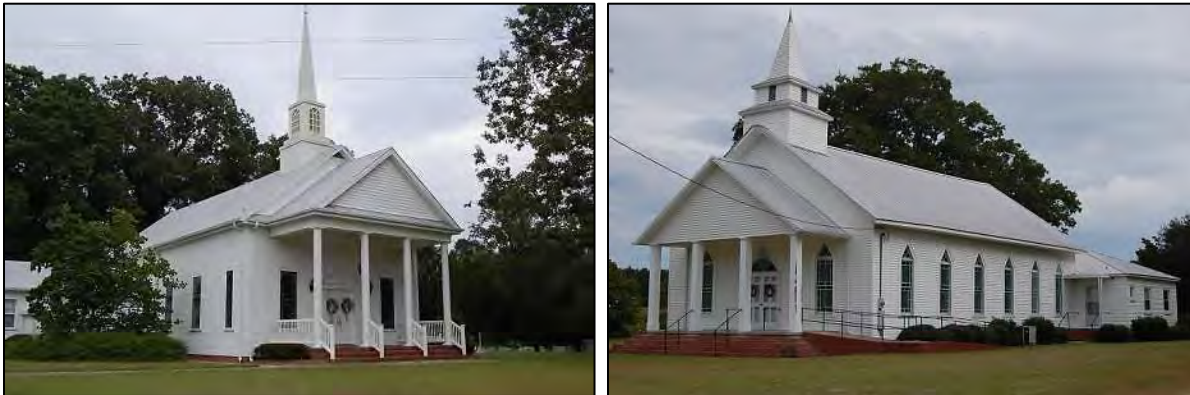
The large Pleasant Hill Christian Church (JN-0155) at the Pleasant Hill crossroads, built ca. 1905, retains its gable-front form and stained-glass windows (, at left). Its vinyl siding reflects its original weatherboard cladding. Additions appear to include the columned portico, classically enflamed entrance, and steeple. A large later-added wing extends to the west of the rear elevation. The similarly fashioned Friendship Original Free Will Baptist Church (JN-0251) was built north of Trenton ca. 1930 (Figure 310, at right). Vinyl covers its weatherboards and outlines its triangular-arched stained-glass windows. A rear cross-wing may be a later addition, along with the front portico and steeple.

**Figure 310:** At left, west side and south front elevations of Pleasant Hill Christian Church; at right, south front and east side elevation of Friendship Original Free Will Baptist Church.

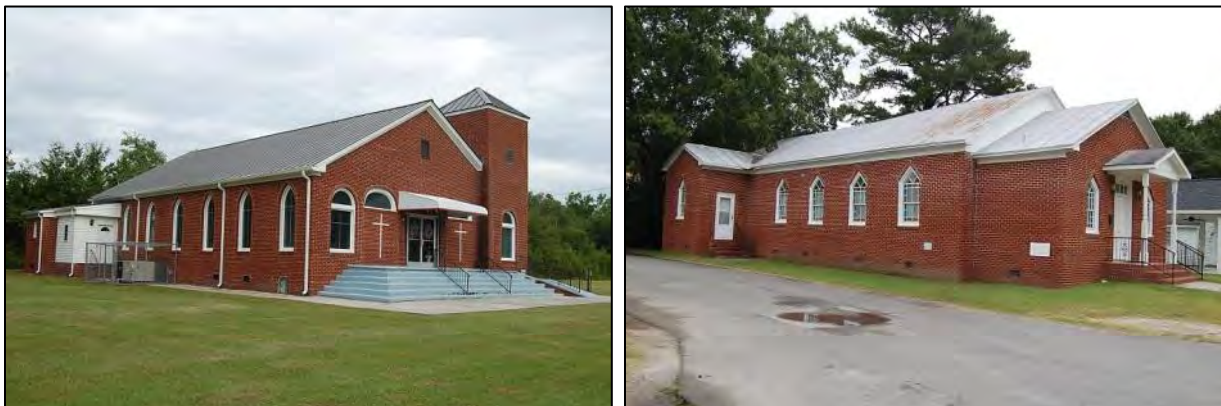
The congregation of Holly Branch Free Will Baptist Church (JN-0085) on Wyse Fork Road, two miles south of Beautiful Valley was formed in 1855, but laid the cornerstone for its current church in 1955 (Figure 311, at left). The African-American church looks similar to Beautiful Valley. Its brick veneer is likely a later addition, as suggested by changes to the bays of the front elevation. Its windows have also been altered. Its corner tower, however—a common feature at African-American churches in nearby Lenoir County—is original. Hill’s Chapel Missionary Baptist Church (JN-0470) just outside of the Trenton Historic District dates from 1920 (Figure 311, at right). Its Gothic Revival-style arched windows appear to be original or early, but its brick veneer dates from 1963, when the church was “rebuilt” according to a plaque. It was further “remodeled” after a flood in 1999 according to the same plaque. The African-American congregation never added a steeple or tower to their home.

**Figure 311:** At left, south side and east front elevations of Holly Branch Free Will Baptist Church; at right, west side and south front elevations of Hill’s Chapel Missionary Baptist Church.

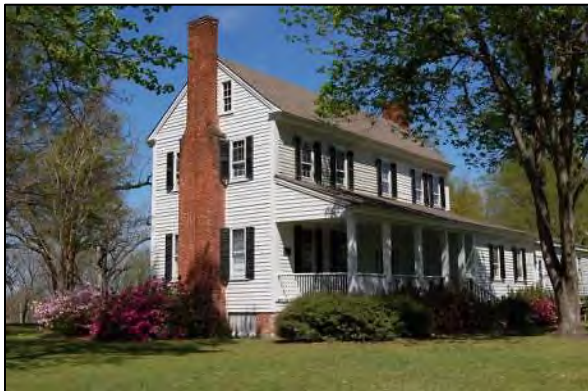
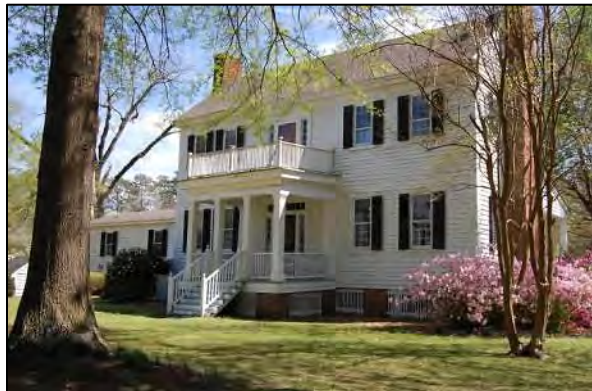
The Jesse Jackson House NRHP nomination (Department of Archives and History 1971c) described it in part as follows (Figure 312):

The house is a two-story frame structure with a common bond brick foundation and a gable roof. The west (front) façade is five bays wide with a central entrance in each story. The entrance on the first floor contains a Greek Revival door with two long vertical flat panels surmounted by an eight-light transom which carries over the sidelights. . . . Protecting the main entrance is a one-story porch featuring a diminutive entablature supported by wooden pillars. The flat roof is enclosed by a plain square balustrade. . . . The interior is center passage in plan. A stair with plain balusters square in section and molded handrail rises on the left side of the hall in two flights to the second floor and then in two flights to the attic. The walls in all rooms are of plaster above a high baseboard. There is a wide flat panel beneath each window, which is enclosed by an extension of the heavy window casing. The mantles are all of the same basic design. A pair of square pilasters supports an entablature with two paneled end blocks and a horizontal fret below a simple molded cornice shelf.

**Figure 312: Jesse Jackson House: west side and south road-facing elevation, at left, and west side and north river-facing elevation, at right, 2017.**

The Jesse Jackson House has changed little since it was listed in the NRHP in 1971. It retains its integrity, is in very good condition, and continues to merit NRHP listing.

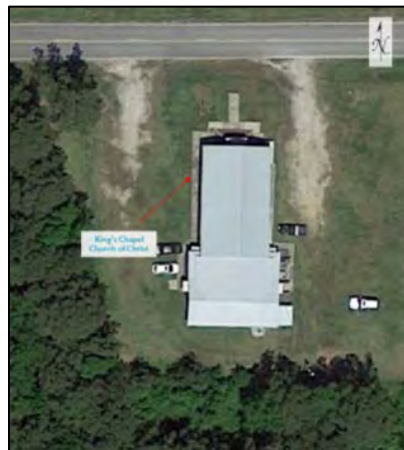
King's Chapel Church of Christ is situated on a one-acre rural parcel about five-and-a-half miles southeast of Kinston. Surrounded by farmland and woods, the parcel fronts Elijah Loftin Road and contains no additional features or resources (Figure 314).

**Figure 314: Site plan of King's Chapel Church of Christ with Elijah Loftin Road at bottom (base image courtesy of Google Earth).**

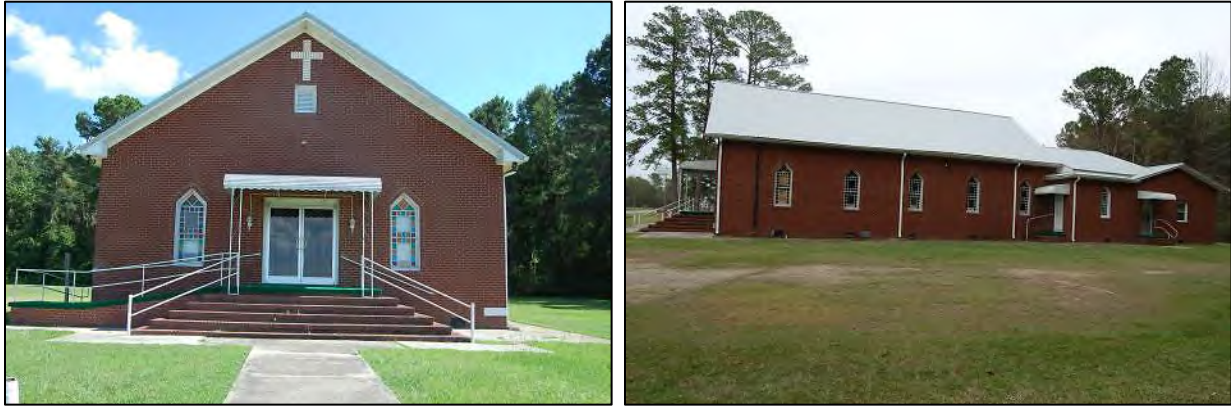
The church is one story tall and faces north to the road. A modest building, it has a gable-front form and lacks a steeple, perhaps reflecting (as Robbie Jones noted when he surveyed it in 1994) an early meetinghouse form. Basic form aside, the mid-twentieth-century building retains few original features other than its pointed-arch bays that are filled with colored-glass windows. Its double-door front entry is modern, as are the decorative metal columns and metal awning that protect it. Aluminum has replaced or covered its original surrounds and the entire church is covered with an added veneer of brick (Figure 315 through Figure 317).

Figure 315: King's Chapel Church: at left, north front elevation; at right, west side elevation.

King’s Chapel Church of Christ does not have sufficient integrity to be eligible for NRHP listing. It retains its gable-front form and stained-glass pointed-arch windows, but has been much altered. Its weatherboards have been supplanted by brick veneer, twin glass doors have replaced its front entry, and a brick-veneered concrete-block addition projects from its rear elevation. Its integrity is not equal to that of other similarly fashioned churches in Lenoir County, including Sand Hill Free Will Baptist, Church LaGrange Presbyterian Church, and LaGrange Free Will Baptist Church, discussed at Section 3, above. Therefore the church is not recommended as NRHP eligible under Criterion C for its architecture. The church further lacks association with any notable historic event or figure and is accordingly recommended as not significant under Criteria A and B. It is not likely to yield important historical information on the basis of its construction or appearance and is recommended as not NRHP-eligible under Criterion D.

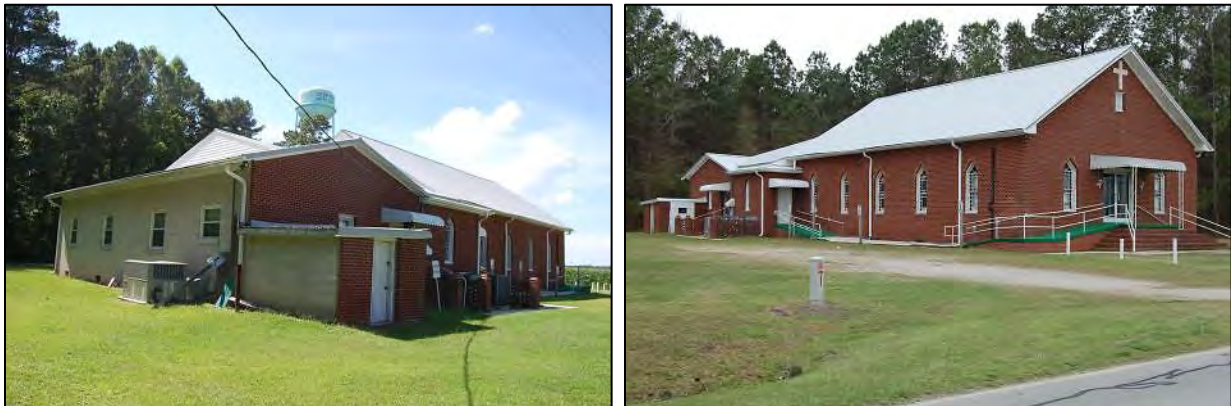
A one-story, concrete-block and brick-veneer addition extends from the building's north rear elevation. It likely dates from the 1960s when the original body of the building was veneered. The vestibule, viewed through the window, also appears to date from the same time. Despite multiple site visits, interior access to the building was unavailable.

Figure 316: King's Chapel Church: at left, south rear and east side elevations; at right, east side and north front elevations

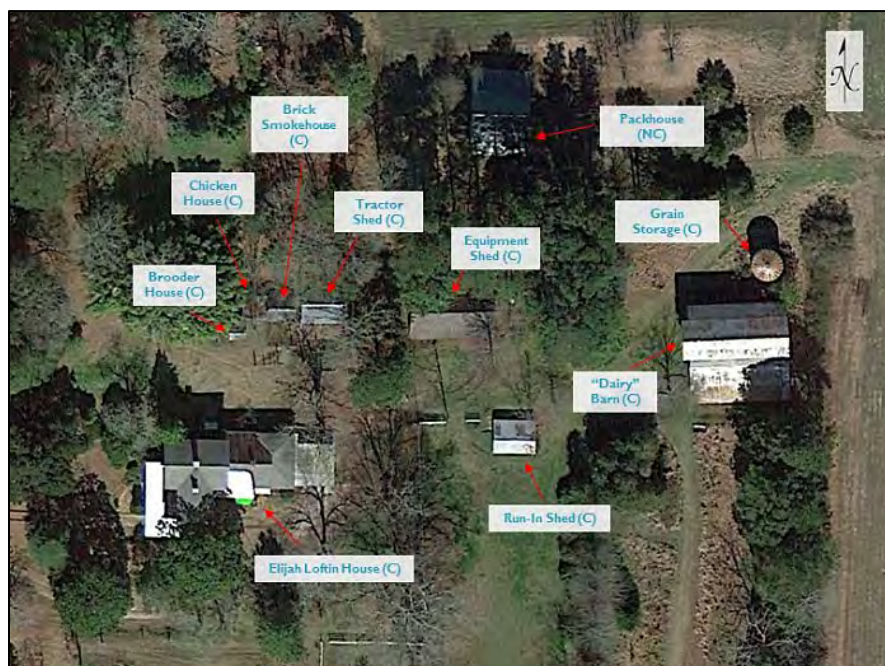
The Elijah Loftin House sits at the end of a dirt lane off of Highway 58, about five miles southeast of Kinston. Once part of a large farm of 1,500 acres, the house now occupies 81 acres, most of which remain as fields. Beyond the parcel is additional agricultural land. A small number of acres located toward the front (western) edge of the property are populated with a scattering of mature trees. Amidst this wooded area is a small clearing in which sits the Loftin House and the remainder of its associated farm complex. The eastern side of the property remains as fields, which are actively farmed (Figure 318 and Figure 319).

Multiple early/mid-twentieth-century outbuildings survive, suggesting a once thriving farm operation. To the north of the Loftin house is a row of small outbuildings including a brooder house, chicken house, brick smokehouse, tractor shed, and equipment shed. To the east is a horse run-in shed, a dairy barn, and a grain storage building. Northeast, now located on a separate parcel, is a packhouse that once belonged to the farmstead.

Figure 318: Site plan of the Elijah Loftin House (base image courtesy of Google Earth).

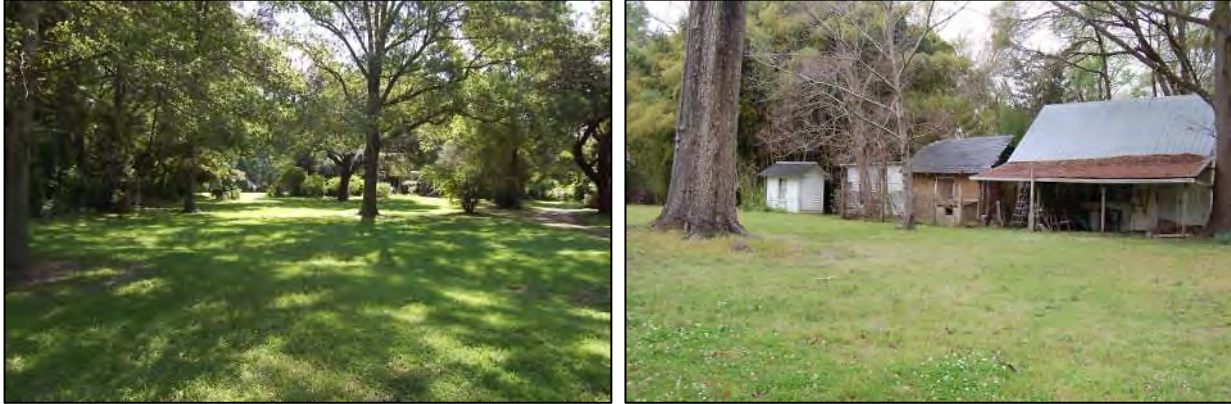
**Figure 319:** Left, contextual view of Elijah Loftin House, in distance, looking north from drive near road; right, view of outbuildings set parallel to the north of the house.

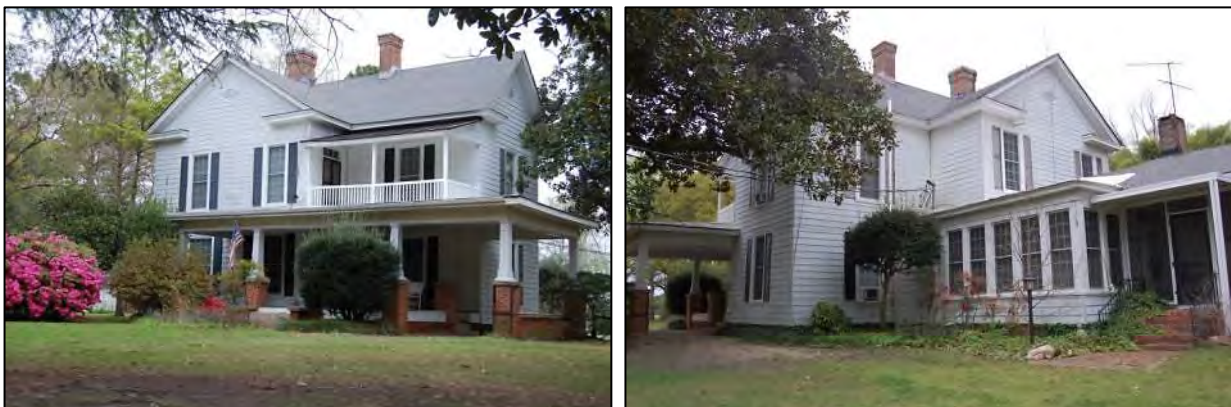
- **Elijah Loftin House (LR 1195):** Placed on the HPO Study List in 1994. The building retains a high degree of historic integrity and appears to be eligible under Criterion C as a notable intact example of a large late nineteenth/early-twentieth-century, T/L-plan farm house that represents a continued evolution of design. The house retains an unusually large number of contemporary outbuildings related to domestic activities and the production of food. We concur with the recommended determination and boundary.

**Figure 320:** Elijah Loftin House: west front and south side elevations, at left; south side and east rear elevations, at right.

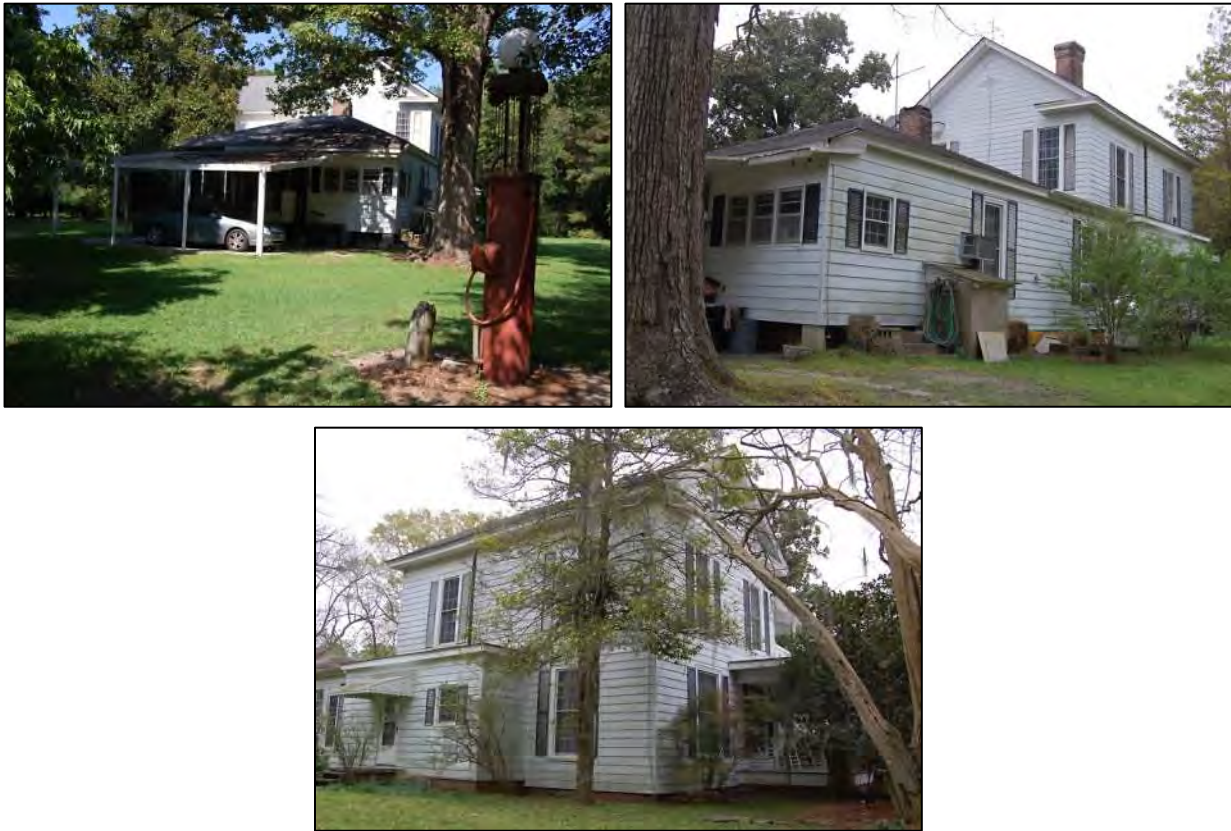
The frame two-story Elijah Loftin House is laid out in T-shaped plan, with a central block two piles deep and two bays wide running east to west, and a rear two-story ell projecting to the front (south) standing one pile deep and one bay wide. Family tradition suggests that this Victorian house was built around portions of an early antebellum house; however, evidence of this is not visible from exterior architectural details. The ca. 1870s T-shape portion of the house is clad in replacement aluminum siding (the 1994 survey by Robbie Jones reported weatherboards), rests on a continuous brick foundation, and is oriented toward the east. The cross-gabled roof is topped with asphalt shingles and features an unadorned entablature and cornice surrounds. The roof is topped with two corbelled, interior, central-ridgeline chimneys (Figure 320 and Figure 321).

A few one-story ells extend from the body of the house. The earliest of these appears to be an east rear, gable-end, single-pile kitchen extending off of the building's northeast corner. It is served by the house's third brick ridgeline chimney and was likely built during the late-nineteenth/early-twentieth century. During the early/mid-twentieth century, a one-story, double-pile, hipped-roof block supported by a concrete masonry pier foundation was added to the north side of the kitchen ell, effectively doubling its size. The southeastern portion of this addition was built as a screened-in-porch. A second small addition was also made to the northern side of the building's main mass during this period—a narrow rectangular bump-out likely built as a bathroom. During the mid-twentieth century, a sun porch and carport were added to the east end of the kitchen ell. Like the main body of the house, the additions are aluminum sided.

**Figure 321: Elijah Loftin House: top left, east rear elevation of house; top right, east rear and north side elevations; bottom center, north side and west front elevations.**

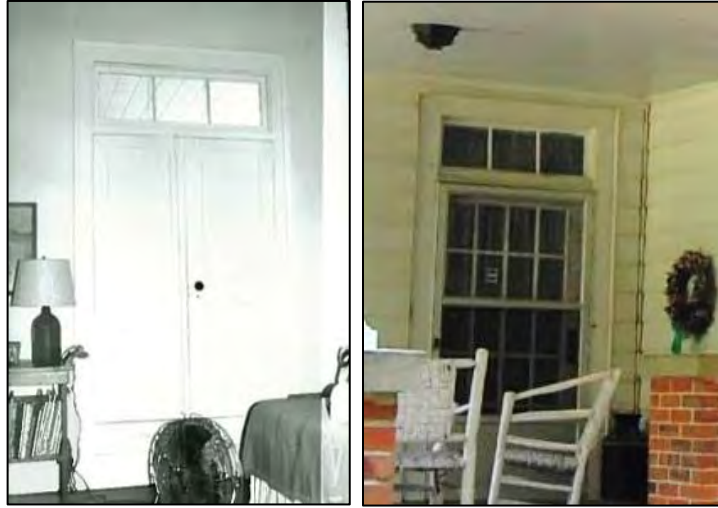
The building's primary entrance is a centrally located, multi-light door on its west elevation shaded by the Craftsman porch. It is topped with a three-light transom (Figure 322). A wooden split two-panel also set an identical transom opens onto the second-story porch above. Additional doors open from other elevations, including one on the south with a wheelchair lift. The house also features a number of different windows, including many with nine-over-nine sash. This sash, and perhaps the two-panel door, were likely salvaged from the earlier house on the site, which burned.

**Figure 322: Left, view of interior of second story door in 1994 (photographer: Robbie Jones); right, view of exterior of first floor door, 2017.**

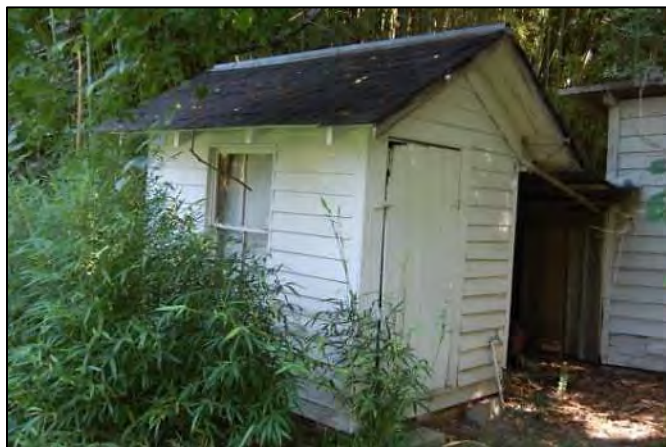
Located just north of the Loftin House, this small, frame, weatherboard building sits atop stone piers (Figure 323). The early twentieth-century building features a gable roof clad with asphalt shingles and exposed rafter tails. A two-over-two double-hung window is found on its south side and a plain wood-batten door at its east gable end.

**Figure 323: View of southern elevation of brooder house, looking northwest.**

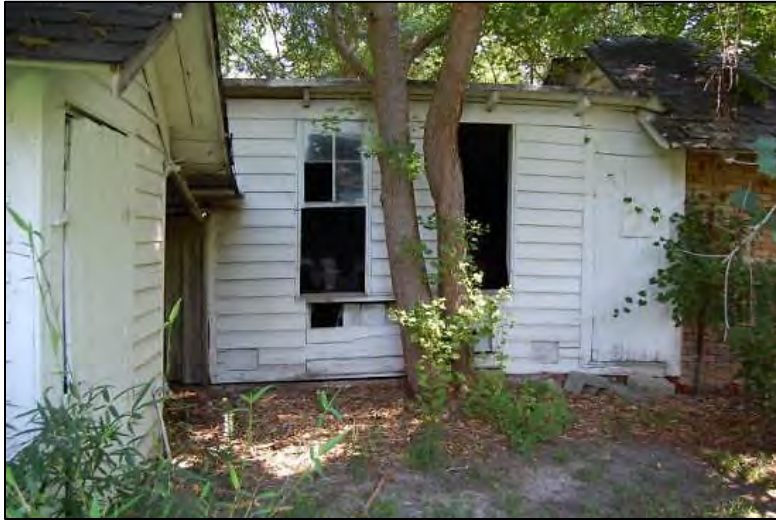
This frame weatherboard-sided building is rectangular in plan and located directly north of the Loftin House (Figure 324). It is connected on its southwest corner to the brooder house. The outbuilding features remnants of two four-over-four double-hung windows and a simple wood-batten door on its southern elevation. A flat roof clad in standing seam metal and displaying exposed rafter tails caps the early twentieth-century building.

**Figure 324: South elevation of chicken house with brooder house at left.**

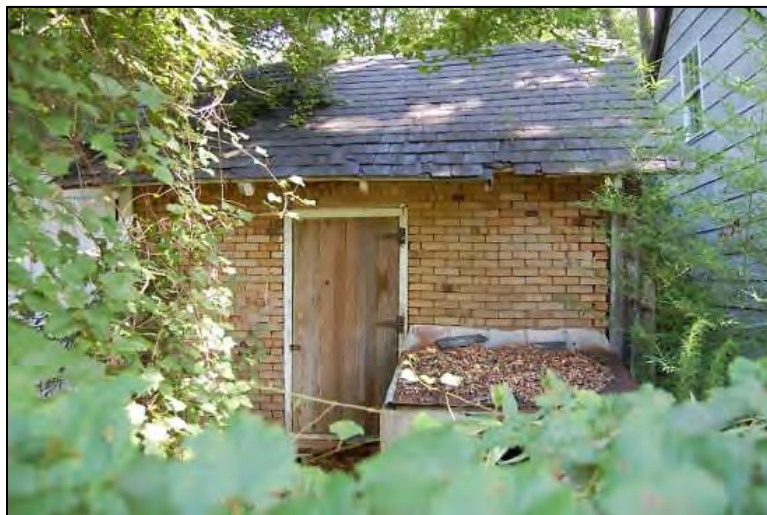
Situated in the line of outbuildings to the north of the Loftin House, between the chicken house and the tractor shed, the side-gabled brick smokehouse is topped with slate shingles and displays exposed rafter tails (Figure 325). Dating to the early twentieth century, it features a wood-batten door on its southern side that is trimmed with a simple wooden surround. Much of the mortar between the building's brick courses on its northern side has fallen away.

**Figure 325: View of the southern elevation of the brick smokehouse.**

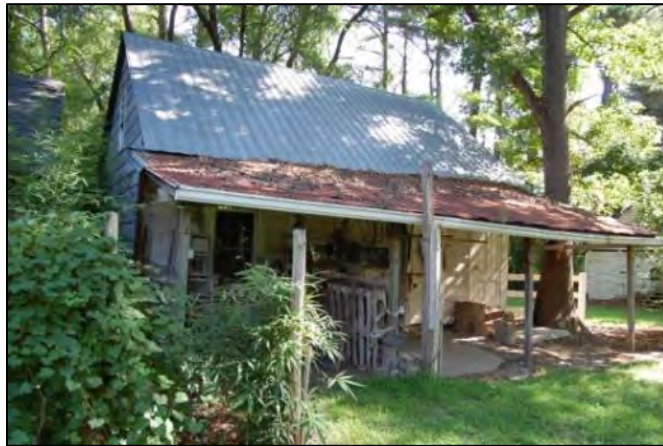
Like its neighboring outbuildings, the frame tractor shed dates to the early/mid-twentieth century (Figure 326). Side-gabled and horizontal-board-sided, the shed features a lean-to on its primary (northern) elevation supported by four roughly cut wood posts. Three four-paneled doors and a six-paneled garage door mark the building's southern elevation. All doors are trimmed with plain wooden surrounds. Standing-seam metal tops the gable roof, with corrugated metal siding the lean-to. Small, double-hung, six-over-six windows are visible at the peaks of the building's gable ends. A rear lean-to addition supported by plain wood posts and clad in corrugated metal edges the building's southern side.

**Figure 326: Southern elevation of tractor shed.**

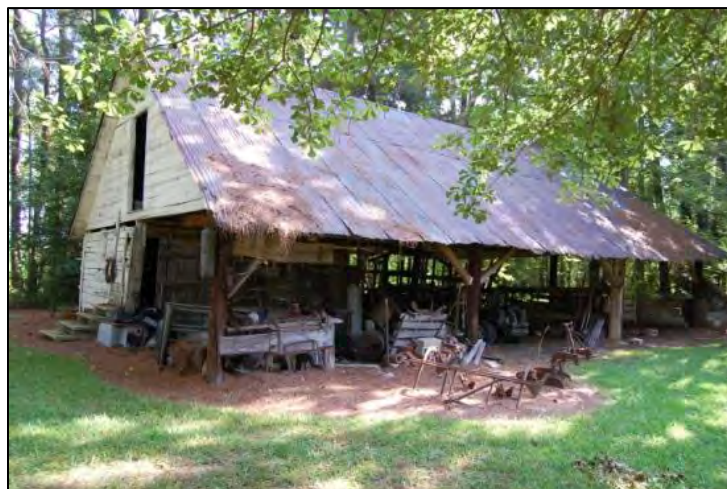
The last in the line of outbuildings running parallel to the north side of the Loftin House, the frame equipment shed is three bays wide and two piles deep (Figure 327). With the exception of the building's northwest corner, which is encased on the exterior by weatherboards, the shed is open allowing for large equipment storage. The building features a steep side-gabled roof topped with corrugated metal and includes a second-floor loft space enclosed with weatherboards. A rough-cut doorway is located in the western gable end of the loft.

**Figure 327: Southern elevation of equipment shed.**

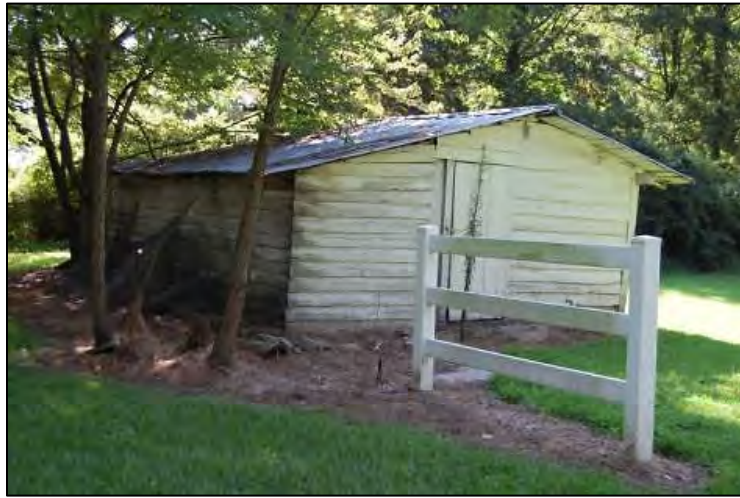
Originally constructed as a brooding house, the frame building located directly to the east of the Loftin house was converted into a horse run-in sometime during the mid/late-twentieth century (Figure 328). Covered by weatherboards on its north and west sides, the building is open on its east and south sides revealing two bays. Its low-pitched side-gabled roof is topped with a standing seam metal and features rafter tails. A rough-cut wood-batten door is located on its western elevation.

**Figure 328: View of southern elevation of Run-In Shed, looking north.**
