North Carolina Department of Natural and Cultural Resources  
State Historic Preservation Office

MEMORANDUM

Subject: Historic Architecture Eligibility Evaluation Report, US 70 Kinston Bypass, R-2553,  
Lenoir County, ER 09-1307

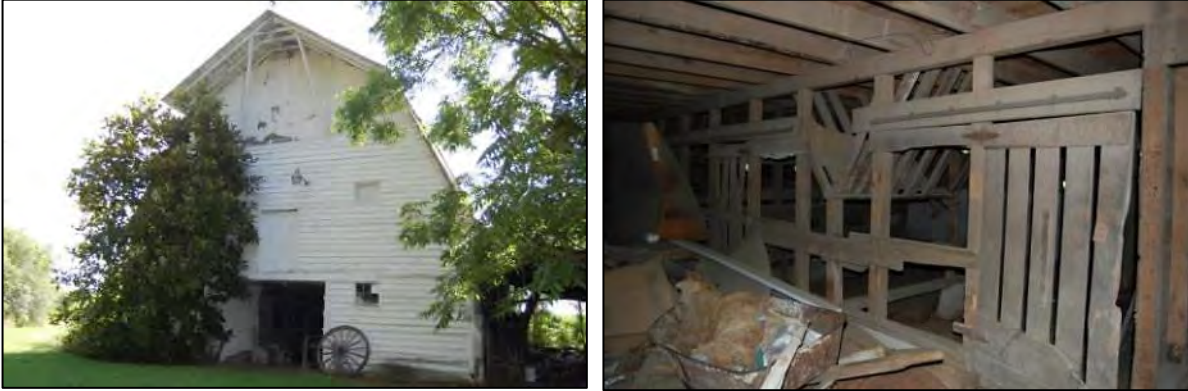
Located at the eastern edge of the Loftin farm complex, this gambrel roof dairy barn was constructed around 1946 according to Robbie Jones' recordation (Figure 329). The frame barn sits on a concrete foundation and boasts the typical dairy barn's features: a gambrel roof, hay hood, and center aisle with a row of stalls on either side. It is weatherboarded and topped by a standing-seam metal roof. A recent interview with a Loftin family descendant revealed that the second floor of the barn was utilized as a tobacco packhouse, and the third floor was used to house chickens during the mid/late-20th century. Evidence of the barn's use as a packhouse is evident through the door that was cut into the second floor of the building, above the central entrance. Chicken wire is still visible spanning the width of the third-floor gable-end door on the barn's western side. Four fixed six-light windows can additionally be found on the western side, two on the second floor, and two on the first. A mid/late-twentieth century lean-to is found on the building's southern side. Spanning the length of the barn, the lean-to is supported by rough-cut wooden posts and topped with a metal roof.

**Figure 329: West front elevation of dairy barn and interior stalls retaining feed bins.**

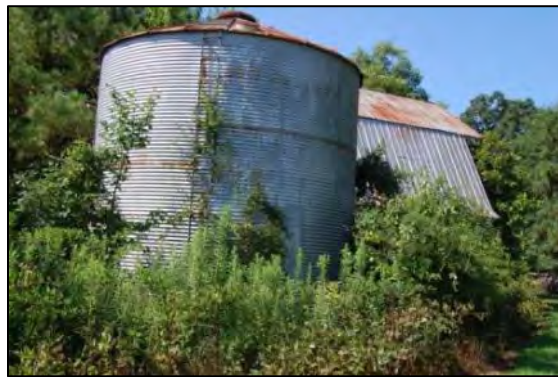
The circular metal grain storage structure is situated a few yards to the north of the barn's northeast corner (Figure 330). Dating to the mid-twentieth century, the circular structure stands on a concrete slab and is made entirely of metal.

**Figure 330: View of grain storage structure, looking southwest.**

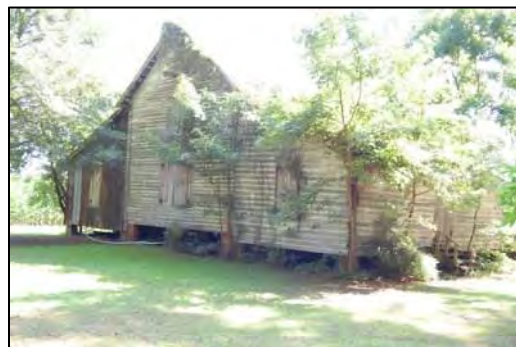
This frame weatherboarded packhouse sits on a parcel adjacent to the Elijah Loftin House parcel and was once part of the larger Loftin farm (Figure 331). No longer associated with the house, which includes no other buildings built for tobacco cultivation, it is excluded from the proposed NRHP boundary.

**Figure 331: View looking northeast at packhouse.**

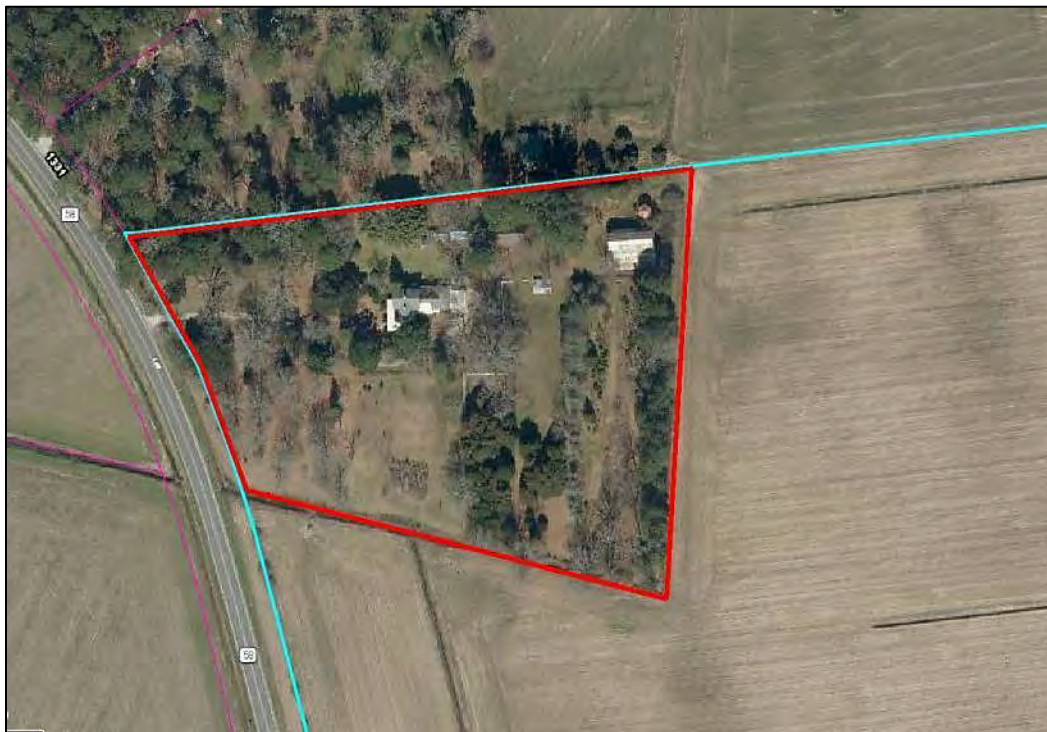
The parcel currently associated with the Elijah Loftin House encompasses about 243 acres extending to the east of NC 58 on both sides of Elijah Loftin Road (Figure 333). Almost all of the property to NC 58's north, with the exception of the land around the house and its outbuildings, is cleared and under cultivation. The land to the south is planted in pine. As the house is no longer a farmhouse, and its surviving outbuildings were related to domestic activities and the production of food (rather than tobacco or cotton), these boundaries are believed to extend far beyond those necessary to provide the resource with an appropriate setting and boundary. The boundary is therefore recommended as the land that immediately frames the house and outbuildings, which is composed of tended grounds shaded by trees. This approximately 7.5-acre tract is bounded on the north by the parcel line, on the east by a row of trees beyond which are fields, to the south by the northern edge of a drainage ditch that edges a field, and to the west by the parcel line (Figure 334). The parcel line at the west terminates at the eastern edge of the NCDOT right-of-way along NC 58.

Figure 334: Proposed NRHP boundary of Elijah Loftin House, outlined in red, occupying northwest corner of overall parcel

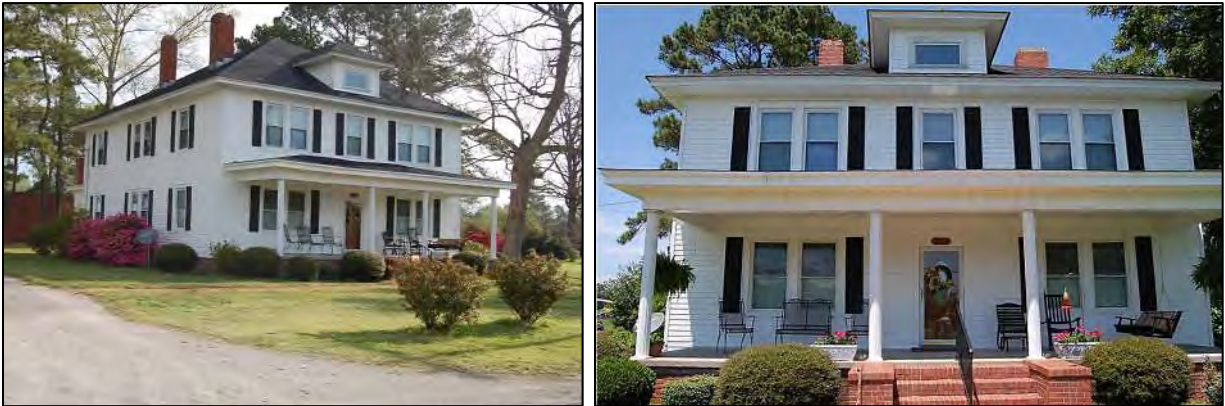
The three-bay, double-pile, hip-roofed, frame teacherage is clad in modern vinyl siding, rests on a continuous brick foundation, and stands two-stories tall with an attic (Figure 336 through

Figure 338). A one-story single-pile ell featuring a low-pitched roof extending from the north rear of the building is also vinyl clad. Four evenly spaced interior brick chimney stacks protrude from the house's hipped-roof. An original three-bay hipped-roof front porch with replacement columns frames the first floor of the south elevation. It is accessed by an original brick stair. The porch's central bay frames the building's primary entrance. The entry door is a modern replacement and all of the house's windows have been replaced with modern, one-over-one, double-hung sash in recent years. A small, original, hipped-roof bay that holds a secondary entry at its rear extends from the building's eastern side.

**Figure 336: Dover Teacherage: west side and south front elevations, at left; south front elevation, at right**

Considering its many changes and the number of intact teacherages in the eastern portion of the state, it is believed that the Dover Teacherage does have sufficient integrity to support NRHP listing. While the building retains its foursquare form, its porch columns and all of its windows have been replaced and its original weatherboards covered with vinyl siding. Its interior retains its stairway and some finish, but it has been much altered by its current owner, who modernized it and removed and shifted at least one partition wall. Therefore it is not recommended as NRHP

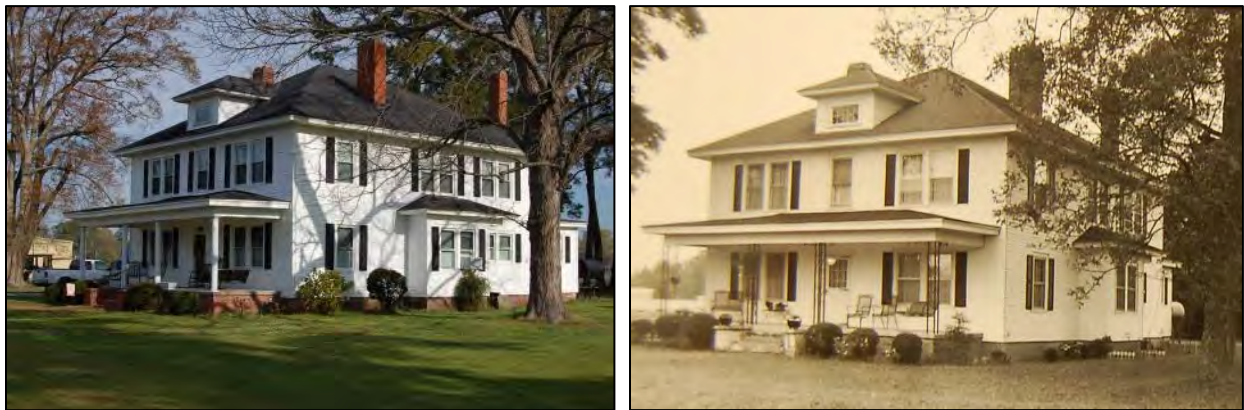
**Figure 337: Dover Teacherage: south front and east side elevations in 2017, at left, and in early view, at right (photo courtesy of North Carolina HPO).**

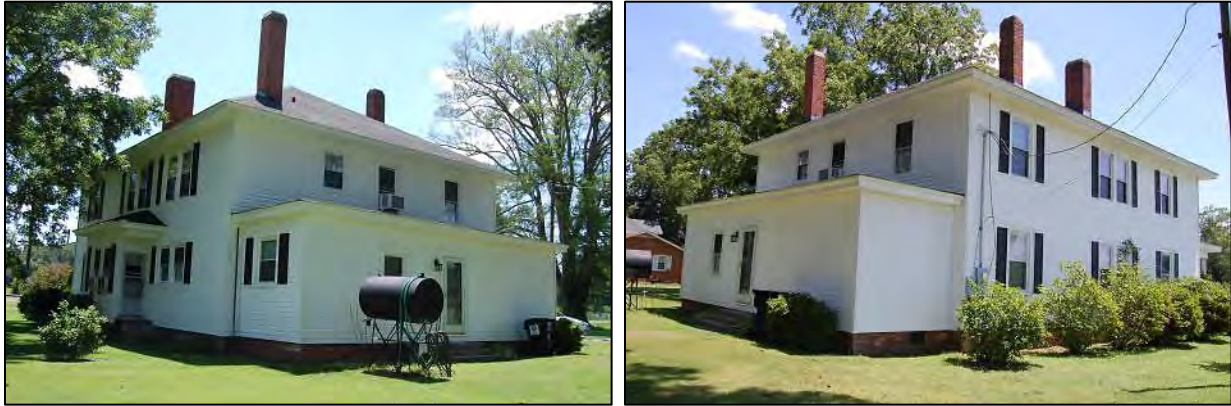
**Figure 338: Dover Teacherage: east side and north rear elevations, at left; north rear and west side elevations, at right.**

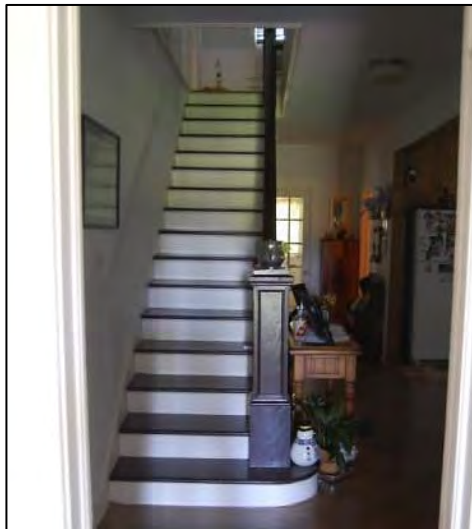
Limited access to the interior revealed a reconfiguration of the building's first floor. A center partition wall, running north to south, has been removed to open up the entire eastern side of the house to create a large eat-in kitchen. The original kitchen, which once occupied the northwestern corner of the teacherage, has been converted into a dining room, and the original western front parlor, once the dining room, is now a living room. The original staircase and newel post remain in place (Figure 339).

**Figure 339: View of original staircase from entry looking toward rear of teacherage; note partition wall removed at right as part of modern kitchen expansion.**

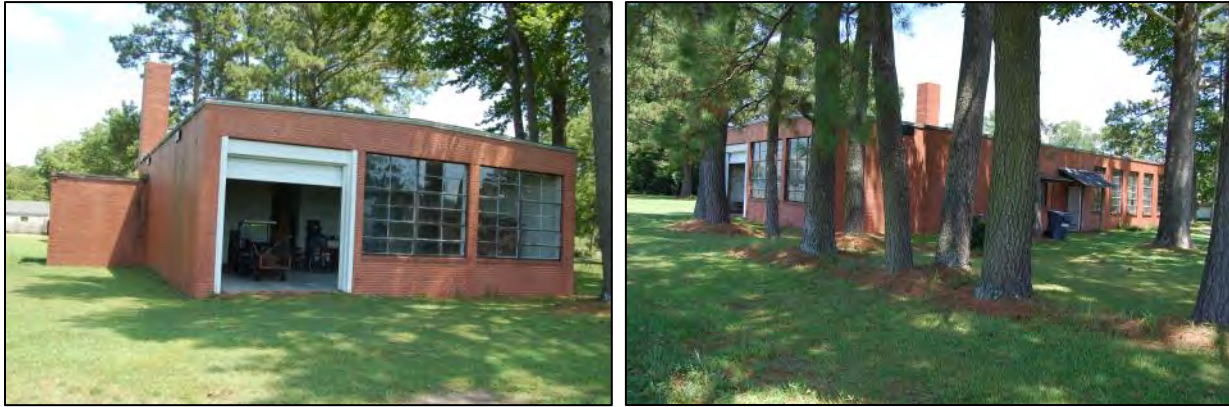
This single-story, three-bay building was used in the mid-twentieth century as a vocational agricultural building for students of the Dover School, which stood apart from the building to the west. It is of masonry construction and features a flat roof clad in metal sheathing (Figure 340). An interior brick chimney extends from the northern side of the building, abutting a small one-room brick addition. Two large industrial windows, each featuring 24 fixed lights in metal panes, are found on the primary (eastern) elevation. A single-bay replacement garage door also marks this elevation. The building's southern elevation features two additional four-paneled wood

**Figure 340: north and east elevations of Vocational Agricultural Building, at left; east and south elevations, at right.**

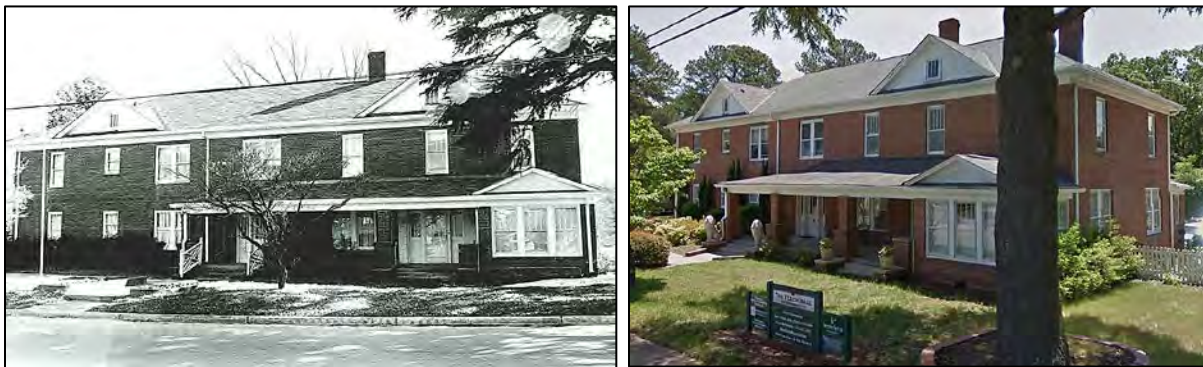
The Fuquay Springs Teacherage was erected around 1925 and expanded by a large addition in 1947 (Young 2005). It is a long, two-story, brick, Craftsman-style building that was NRHP-listed under Criterion A for its association with the history of local public education (Figure 341).

**Figure 341: Fuquay Springs Teacherage: north front elevation in 2005 when NRHP-listed (photographer: Diane Young) and in 2016 Google image**

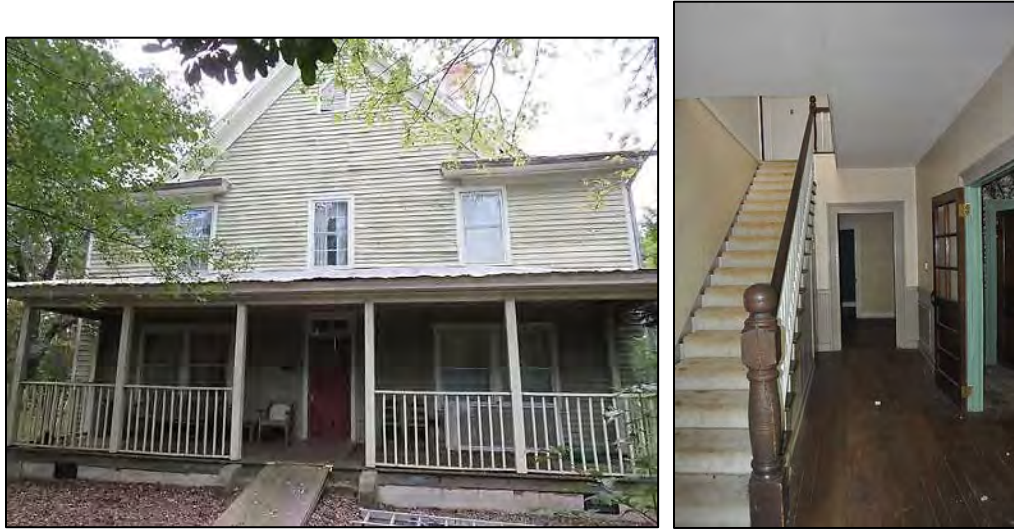
The ca. 1906 Leesville School Teacherage retains its gable-end form, wide front gable, cornice returns, interior chimney stacks, full-façade front porch, and at least some of its original six-over-six windows and turn-of-the-century interior finish (<https://www.presnc.org/properties/leesville-school-teacherage/>) (Figure 342). It continues to stand amidst heavy modern development in Raleigh's northwest corner.

**Figure 342: Leesville School Teacherage: east front elevation, at left, and interior, at right, in 2016 (source: Preservation North Carolina)**

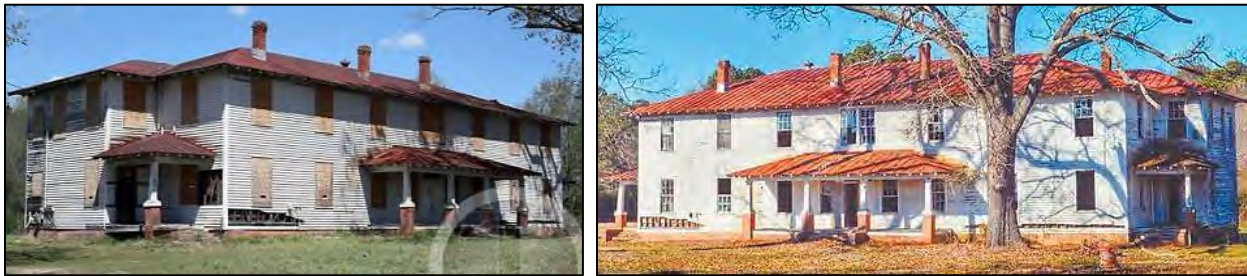
The early twentieth-century Red Oak Farm Life High School Dormitory-Teacherage (NS-0424) in Nash County is a sprawling, two-story, frame building the surviving original features of which include weatherboarding, interior chimney stacks, exposed rafter ends, and Craftsman-style porches (Figure 343). It was placed on the North Carolina SLSL in 2016 and in 2017 acquired by the newly-formed Red Oak Area Historic Preservation Society.

**Figure 343: Red Oak Farm Life Dormitory-Teacherage: southeast front elevation (left image: Rocky Mount Telegram, April 10, 2017; right image: Nashville Graphic, April 6, 2017).**

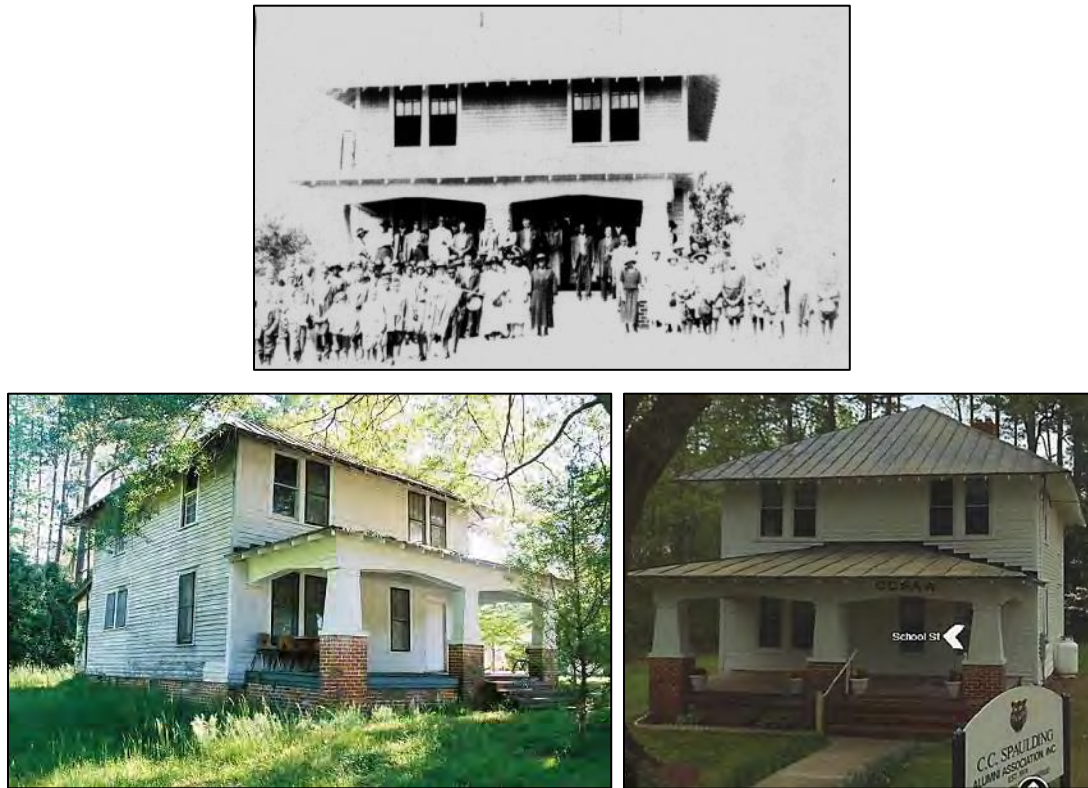
With the assistance of the Rosenwald Fund, the Spring Hope Colored High School Teacherage was built in 1926 just outside of the town of Spring Hope, also in Nash County (Figure 344). It went up contemporaneously with the high school across the street. Maintained by the C.C. Spaulding Alumni Association since 1974, the school is an extremely intact foursquare with an impressive Craftsman-style porch, weatherboarding, exposed rafter ends, and a little-altered interior (<http://ccspauldingalumniassocinc.com/>). Its Rosenwald Fund association amplifies its architectural and educational significance. The survival of the school it was built to serve (at least as of August 2017) further bolsters its integrity of setting, feeling, and association.

**Figure 344: Spring Hope Colored High School Teacherage: at top, south front elevation in 1920s (source: Julius Rosenwald Fund Archives, Fisk University); at bottom left, west side and south front elevations in 2007; and at bottom right, south front and east side elevations in 2016 (Bing image).**

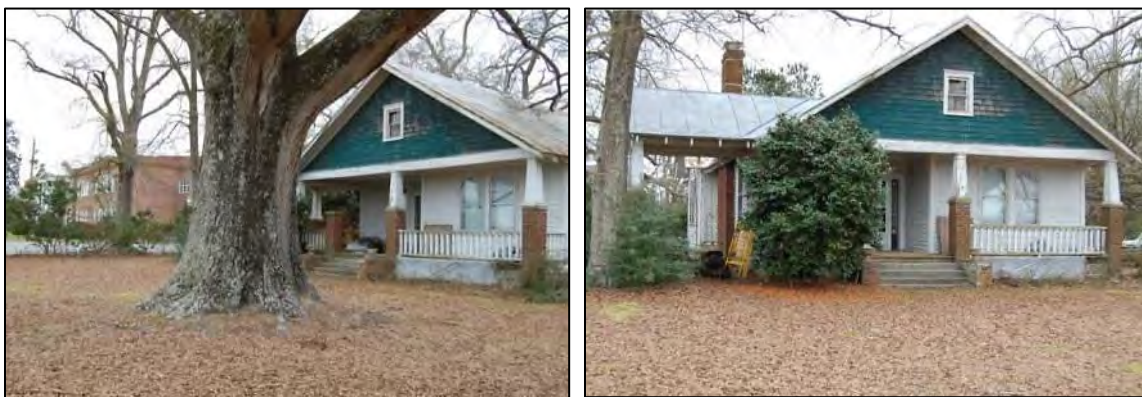
Closer to the Dover Teacherage—only about eight miles to the northwest—the Contentnea School Teacherage and its adjacent school continue to stand in Graingers in Lenoir County (Figure 345). The intact ca. 1925 frame bungalow retains its weatherboard and shingled siding and its Craftsman-style finish, including exposed rafter ends and a porch of tapered posts on brick piers that extends out to form a porte cochere. The teacherage’s integrity of setting, feeling, and association is boosted by the presence of the school

**Figure 345: Contentnea School Teacherage: west front elevations of teacherage and Contentnea School, at left, and north side and west elevations of teacherage, at right, 2017**

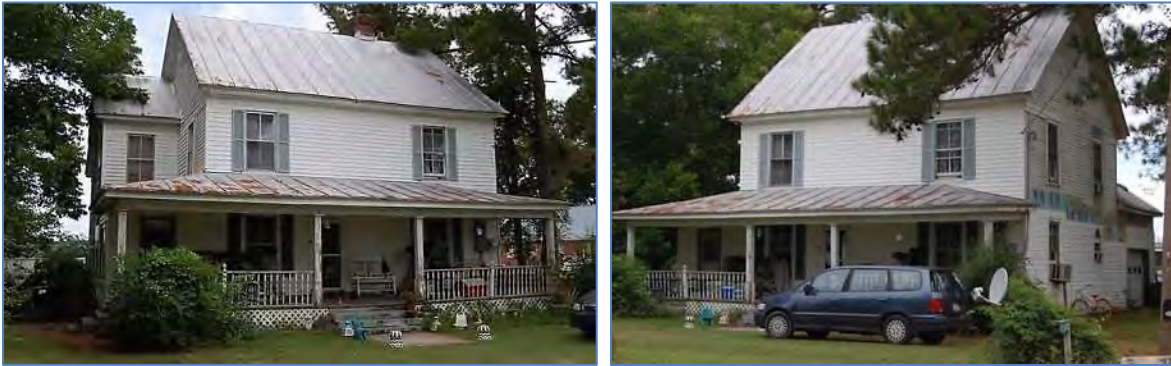
About 15 miles south of Dover stands the Comfort School Teacherage in Jones County. Its residents taught at the Study-Listed 1930s Comfort School (JN-0184) that continues to stand to the southwest across NC 41. The teacherage's form, cornice returns, and two-over-two sash windows suggest that it was a turn-of-the-century house converted into a teacherage. Changes to the building include sections of vinyl siding, some altered sash, and the affixing of a garage wing to the rear (Figure 346).

**Figure 346: Comfort School Teacherage: west side and south front elevations, at left, and south front and east side elevations, at right**

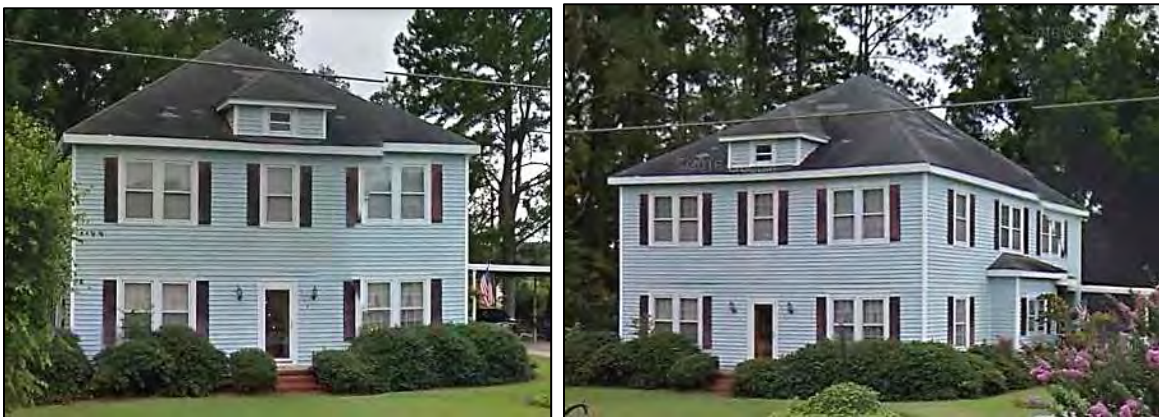
Following the completion of fieldwork, it was determined that another teacherage stands in Craven County, the Jasper Teacherage (CV-1019) in the small community northwest of New Bern that lent it its name. It is located about 15 miles due east of Dover. According to NC HPO files, the former teacherage was built about 1935 with WPA funding. Online photographs suggest that it has lost its porch and has been re-sided, and that it looks very much like the contemporary Dover Teacherage.

**Figure 347: Jasper Teacherage: south side and east front elevations, at left; east front and north side elevations, at right (Google images)**

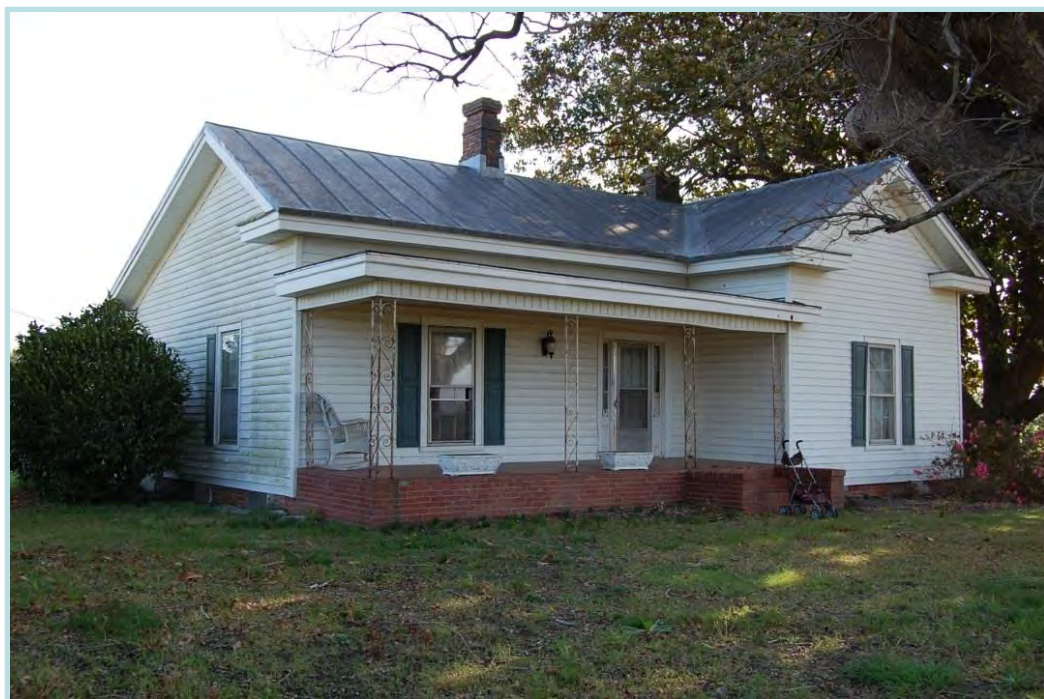
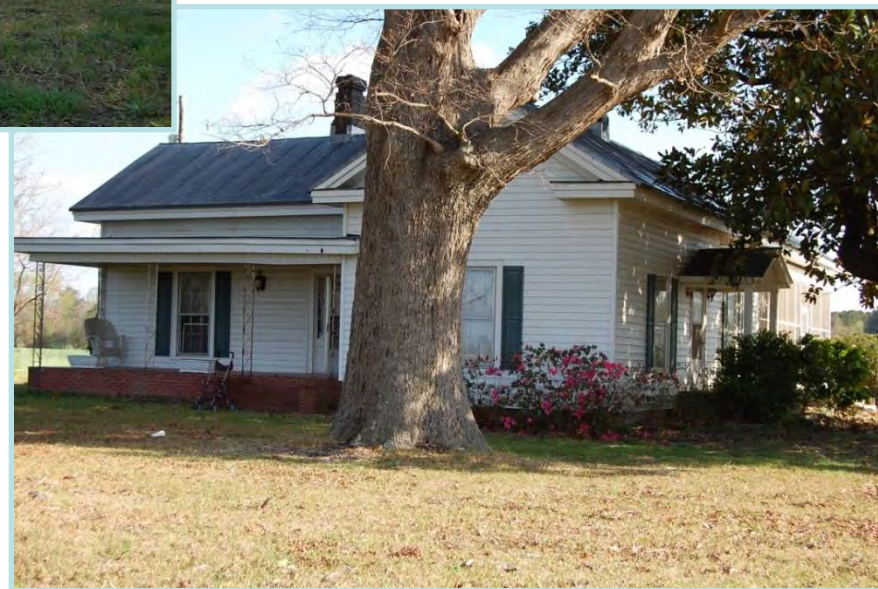
**#1 - RAY HARDEE FARM (LR-0977) – turn-of-the-century farmhouse; believed to lack significance and integrity**

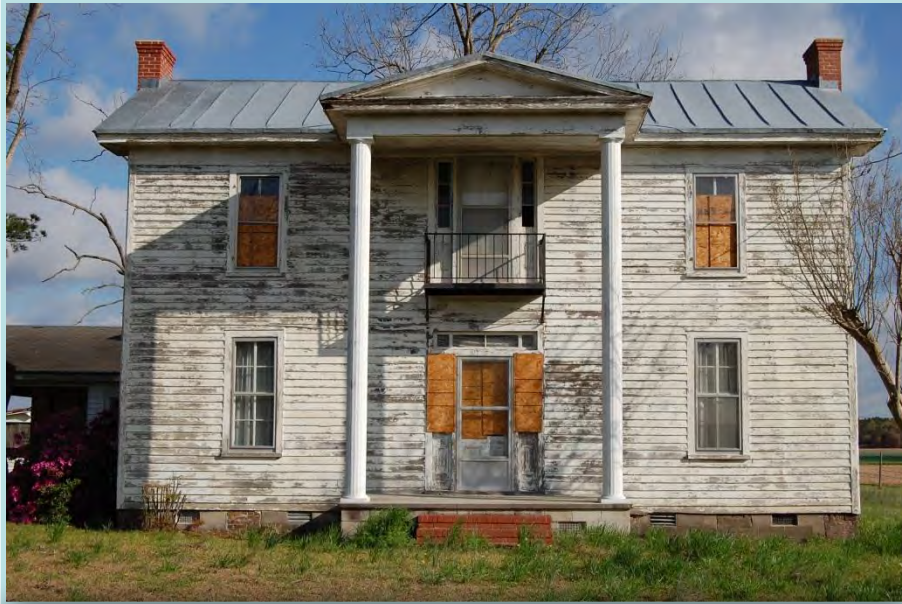
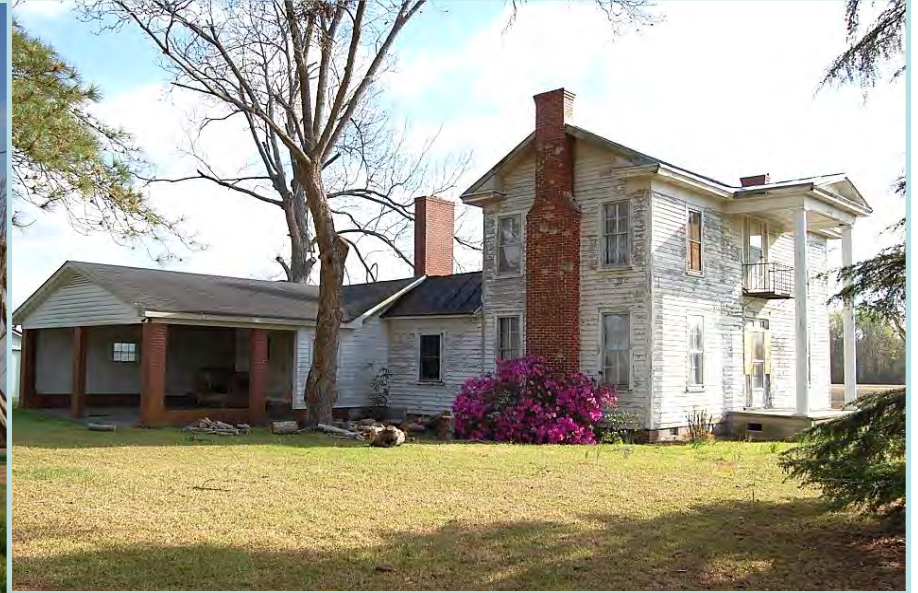
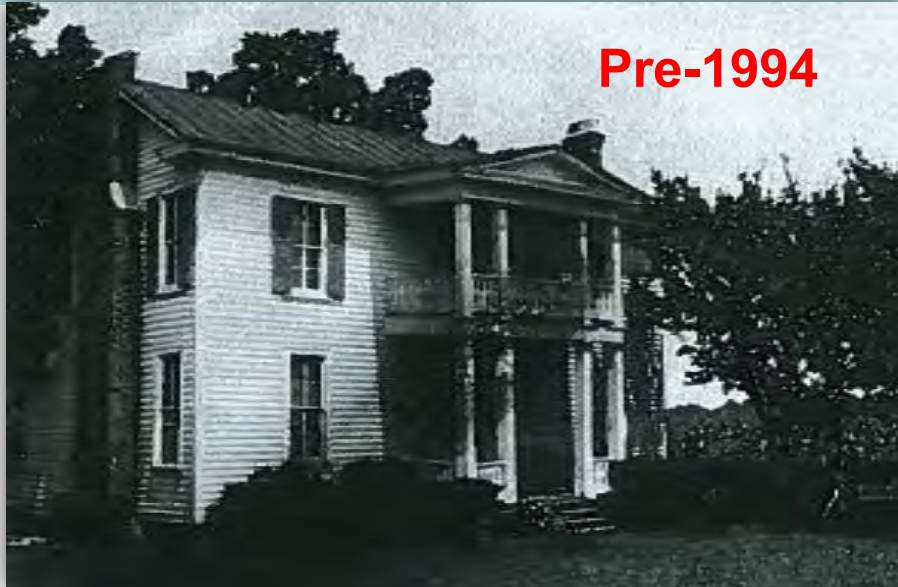
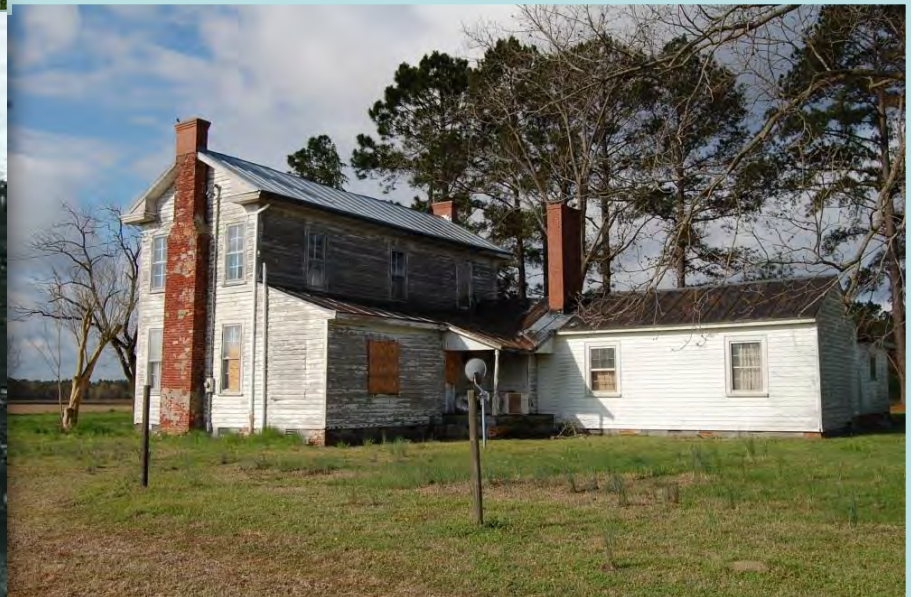
**#2 - NATHAN GEORGE SUTTON HOUSE (LR-0956) – ca.1850-75,  
Greek Revival-style house; believed to lack integrity**

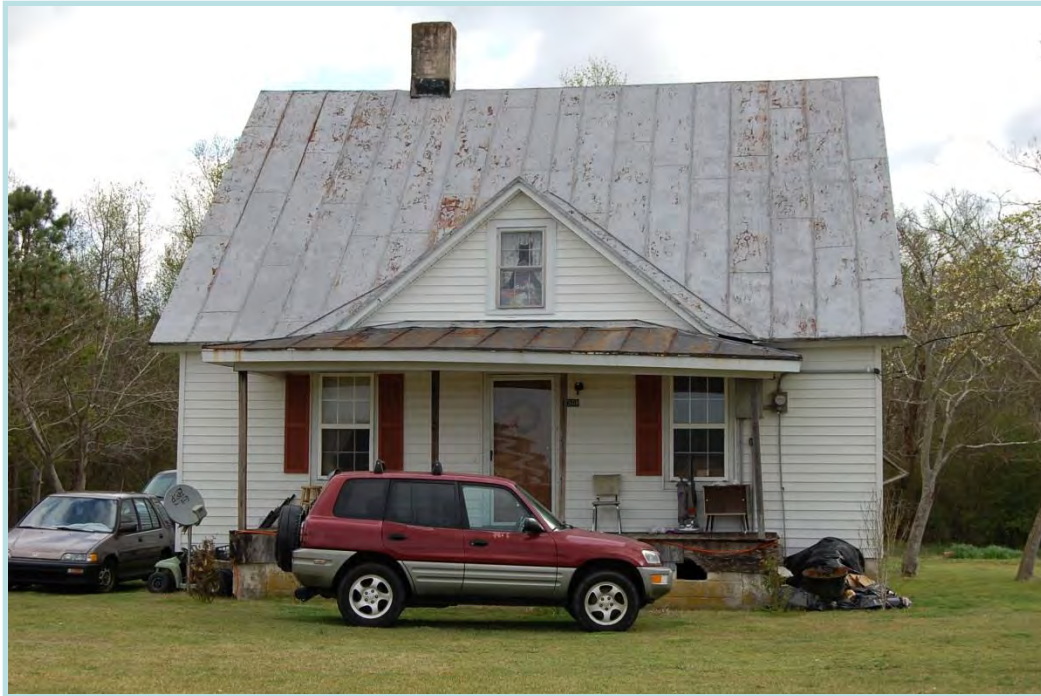
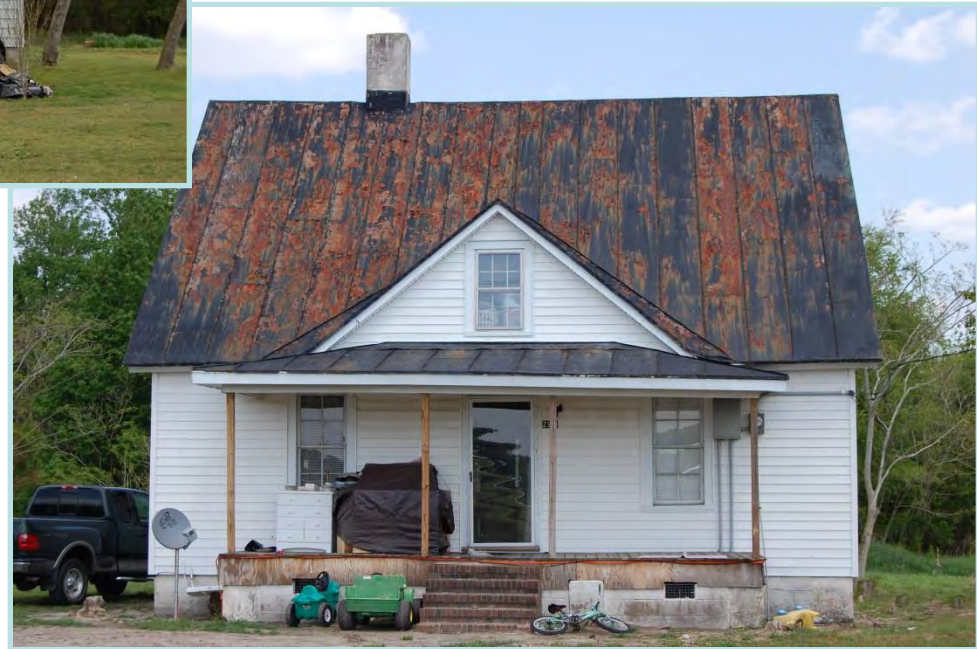
**#3 - HOUSE (LR-0947) – turn-of-the-century farmhouse; believed to lack significance and integrity**

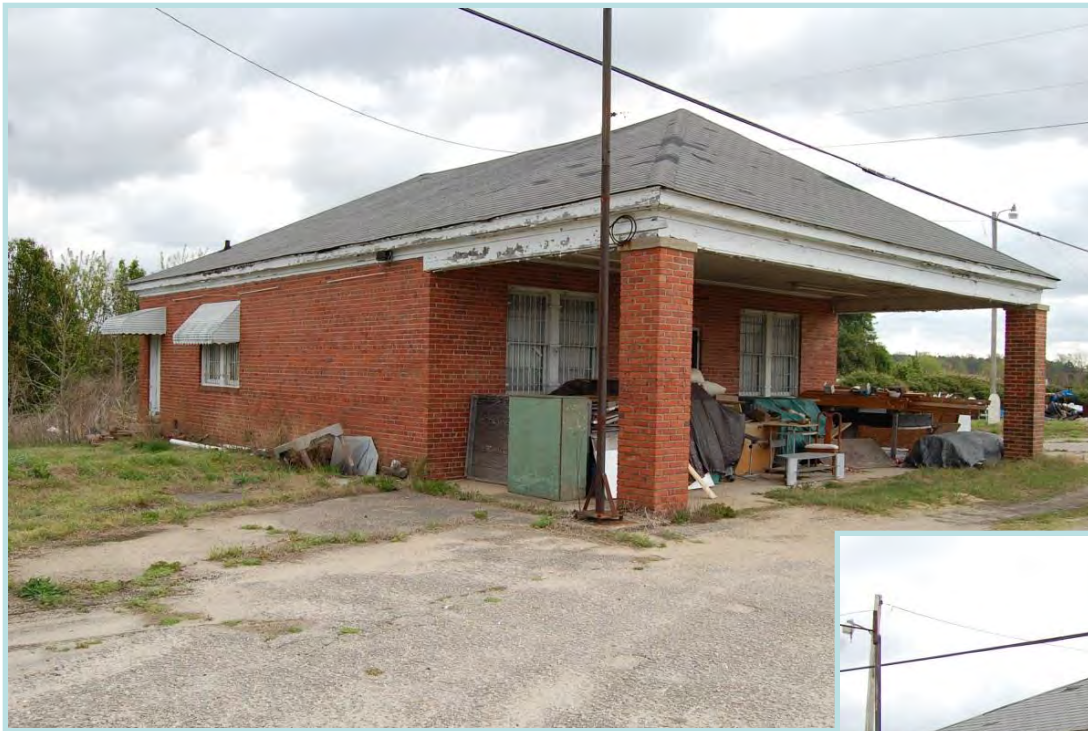
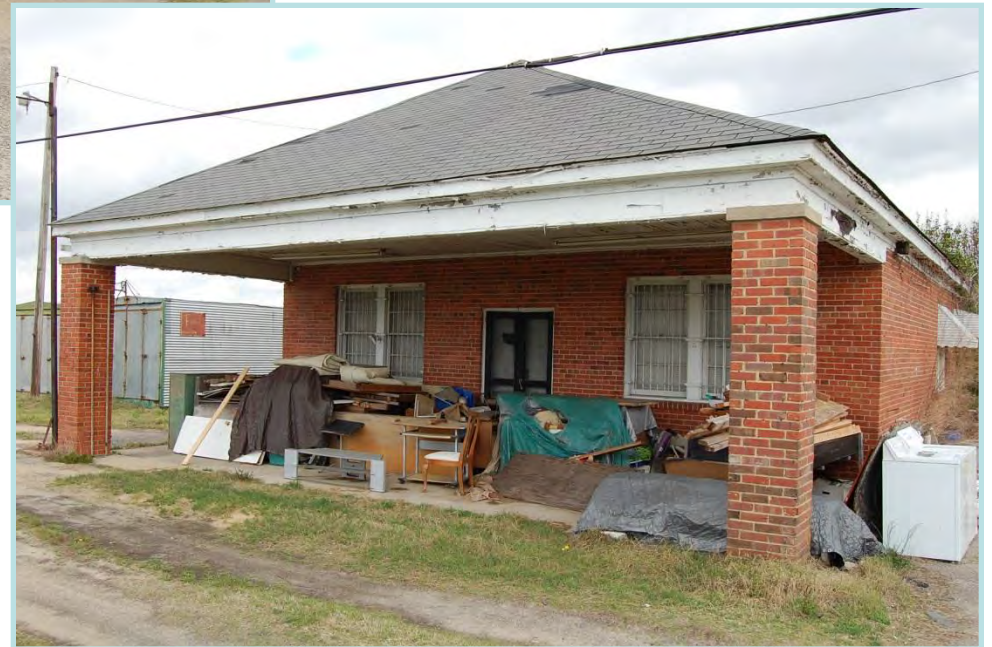
**#4 - (FORMER) BEAMAN GROCERY/SERVICE STATION (LR-0948)**  
– 1948 commercial building; believed to lack significance

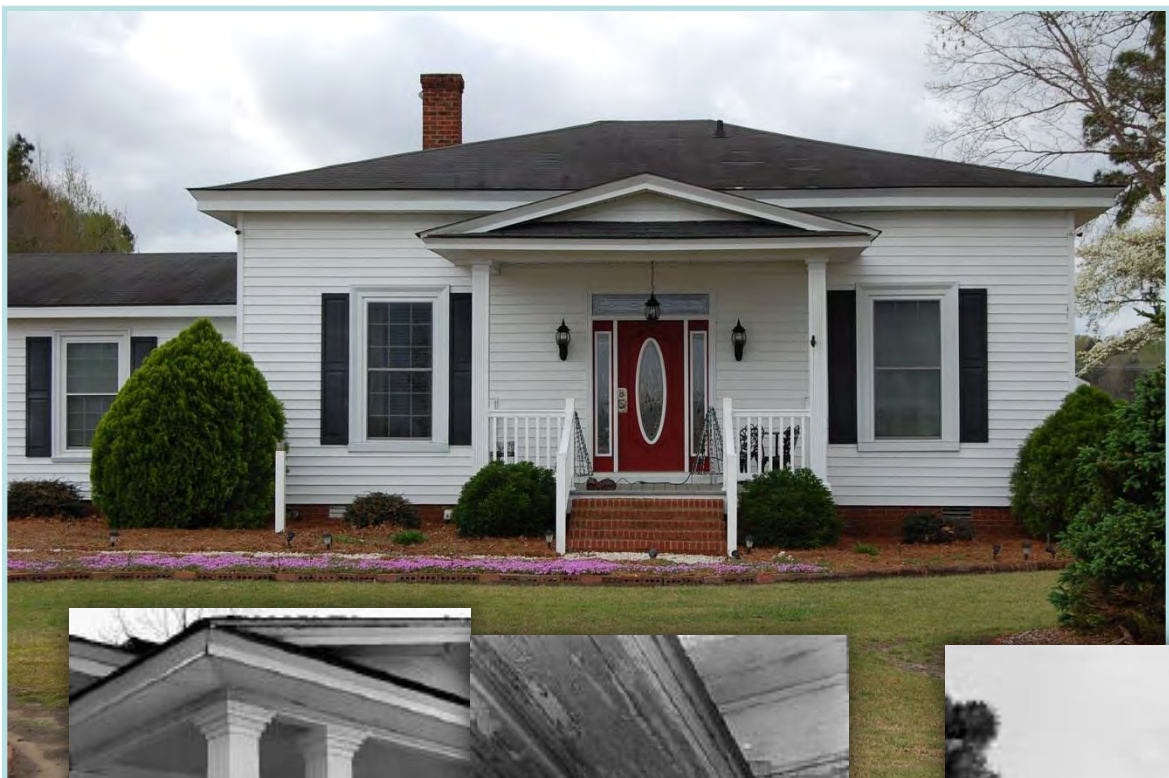
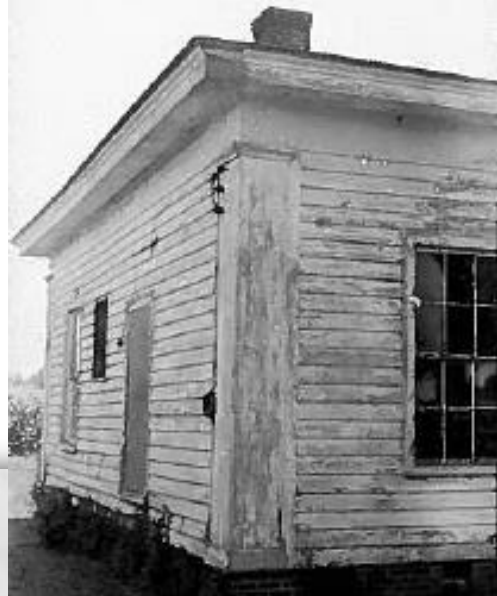
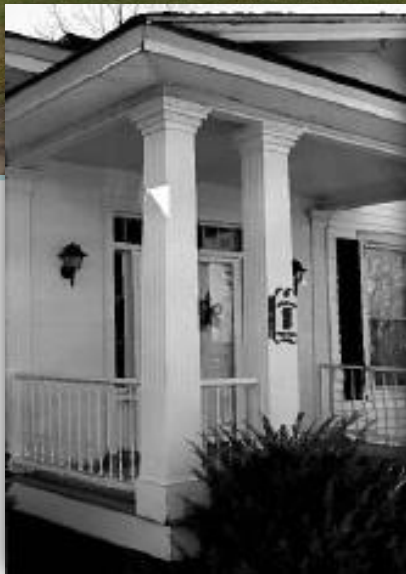
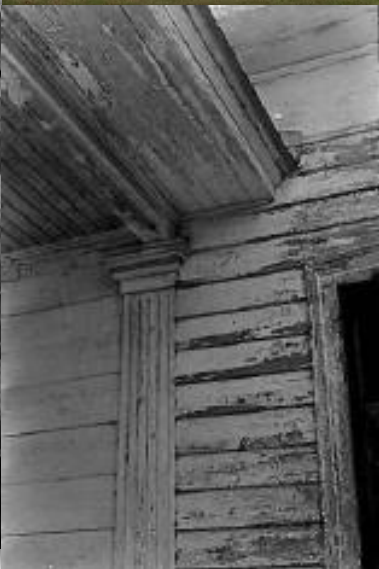
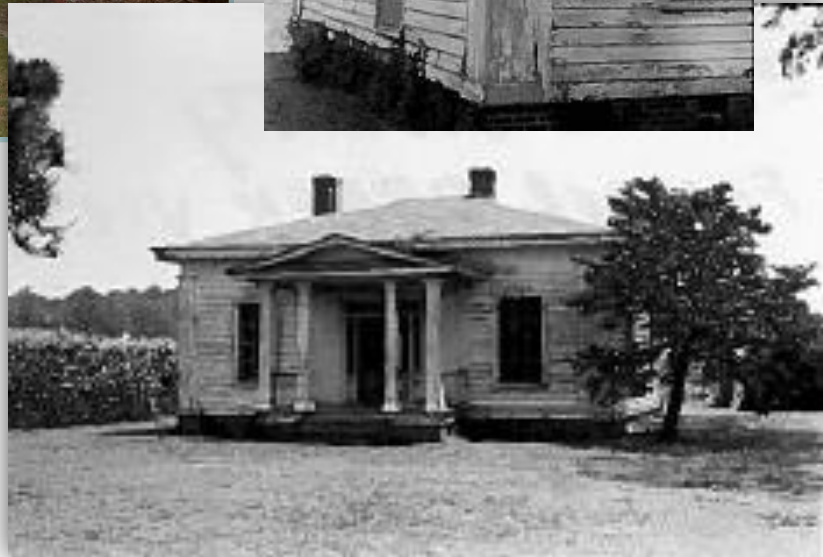
**#5 - SUTTON-TURNAGE HOUSE (LR-0962) – ca.1860 Greek Revival-style house; believed to lack integrity**

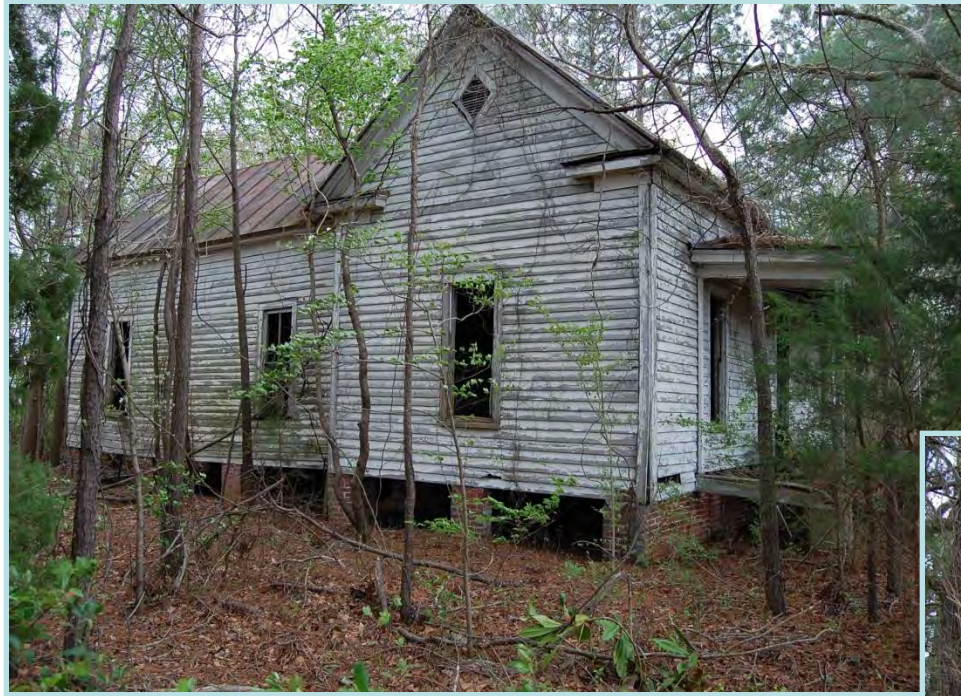
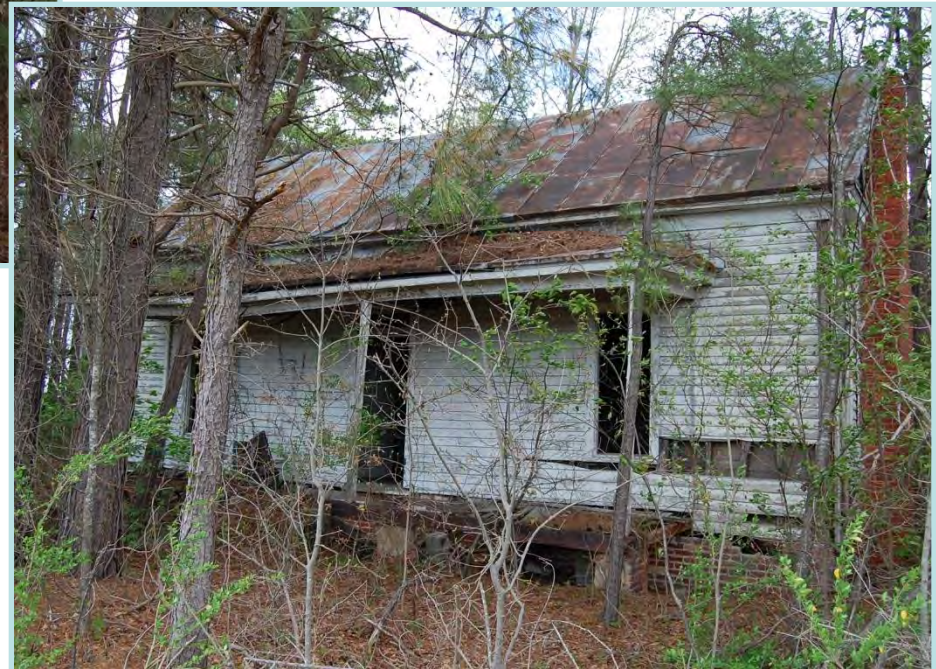
**#6 - HOUSE (LR-0958) – turn-of-the-century farmhouse; believed to lack significance and integrity**

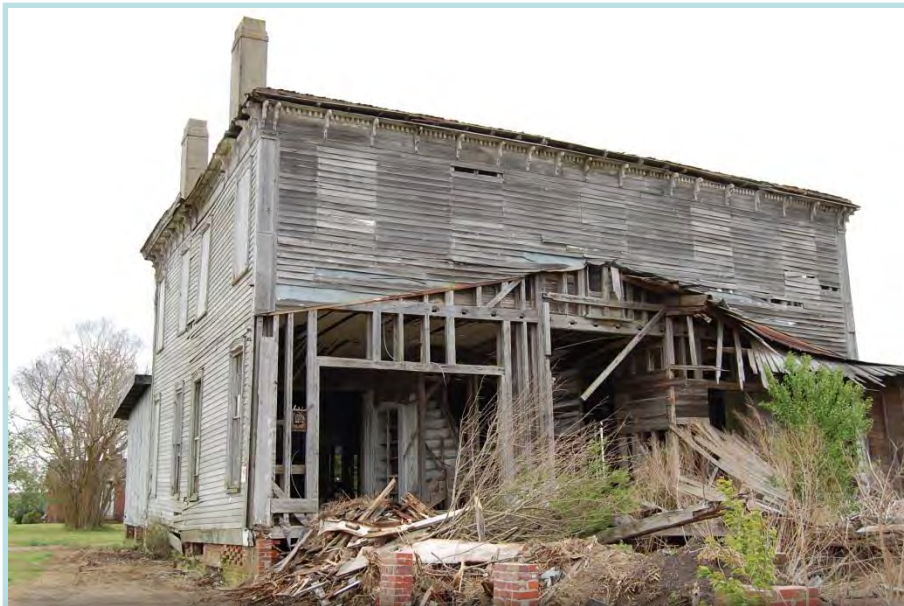
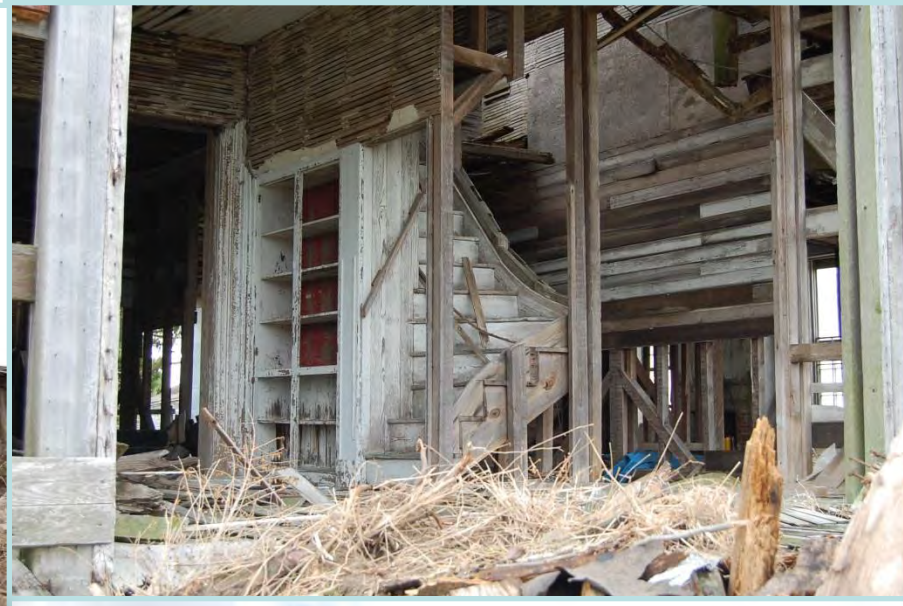
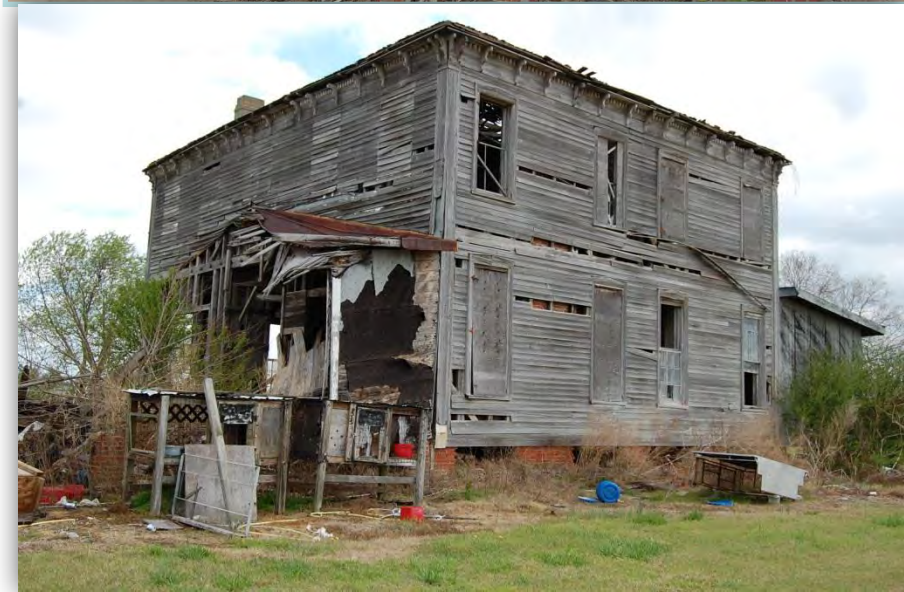
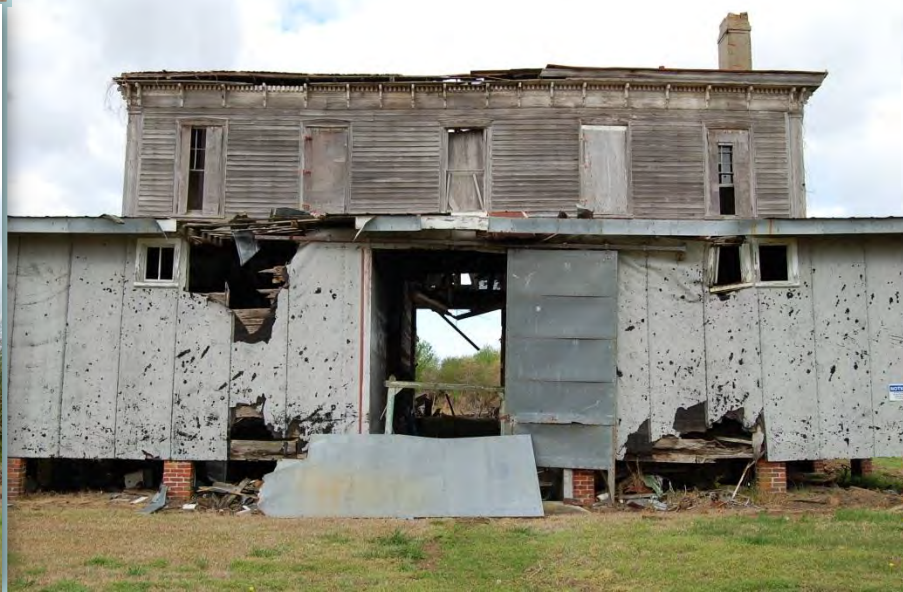
**#7 - BRIGHT KENNEDY HOUSE (LR-0957) – ca.1850, Greek Revival/Italianate-style house; believed to lack integrity**
