North Carolina Department of Natural and Cultural Resources  
State Historic Preservation Office

MEMORANDUM

Subject: Historic Architecture Eligibility Evaluation Report, US 70 Kinston Bypass, R-2553,  
Lenoir County, ER 09-1307

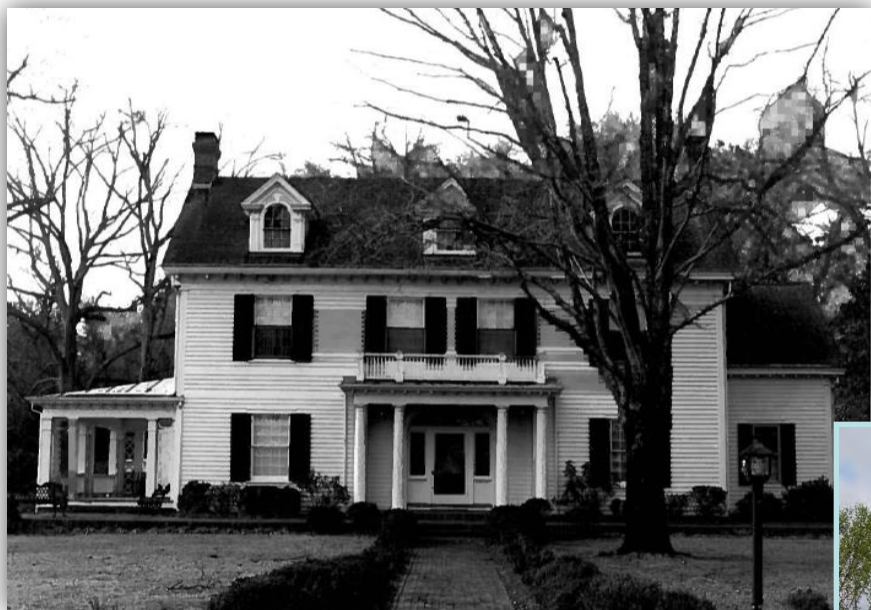
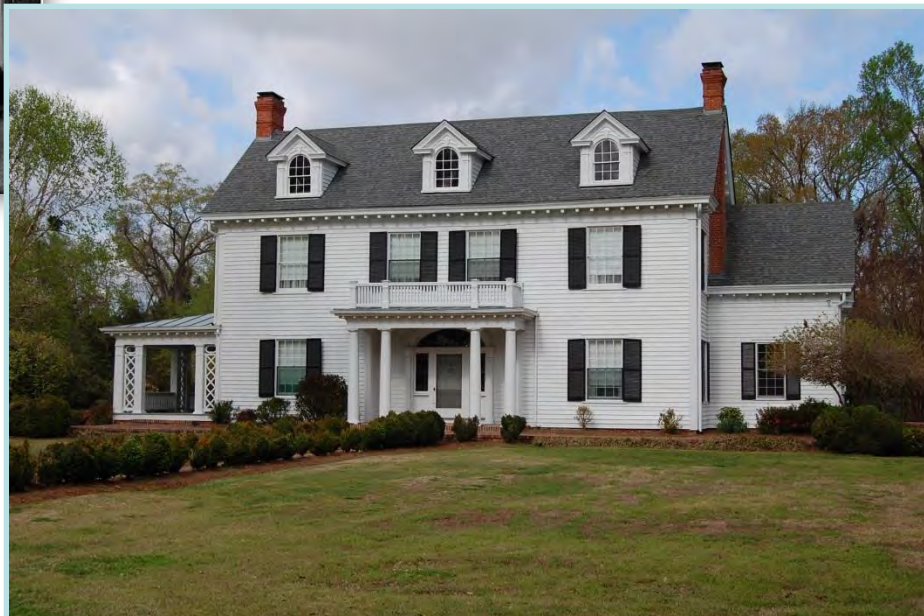
**#8 - JAMES ALEXANDER & LAURA McDANIEL HOUSE “MAXWOOD”  
(LR-0927) – refined Colonial Revival-style house built 1914-16;  
1998 DOE; believed to remain NR-eligible**

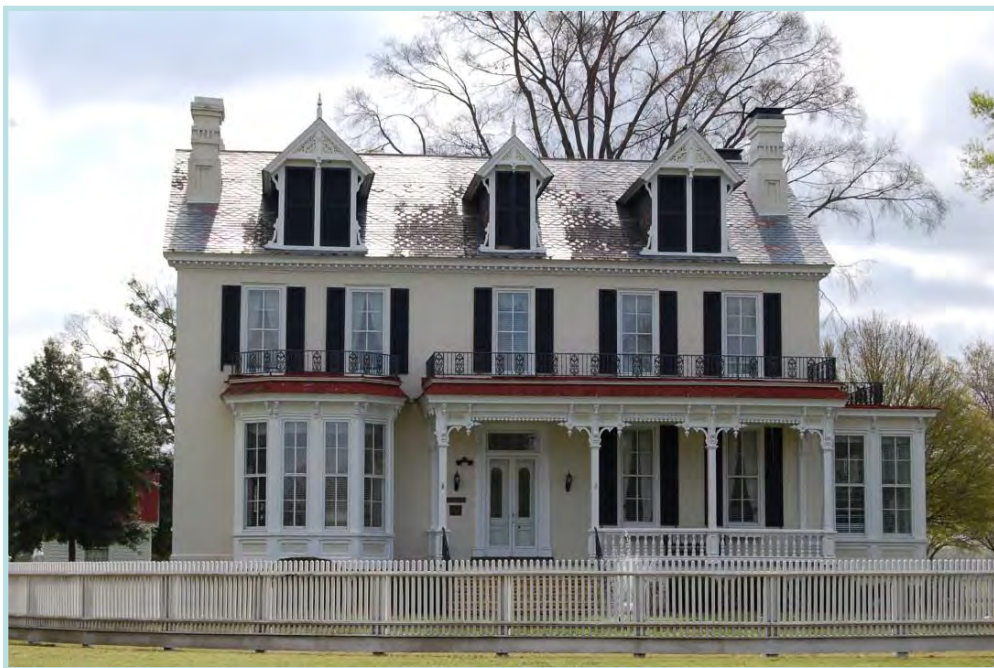
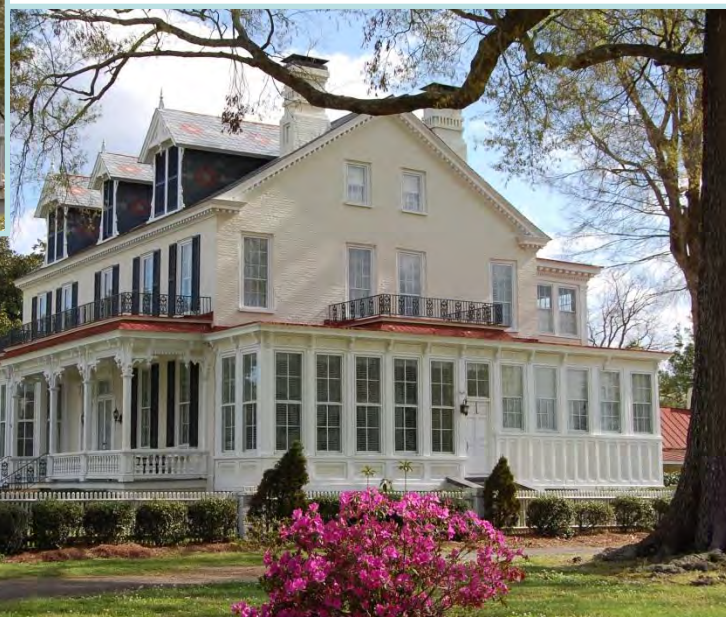
**#9 - CEDAR DELL (LR-0001) – ca.1810-20, Federal-style plantation seat remodeled with Victorian finish in 1880; NR-listed in 1971; believed to merit continued NR listing**

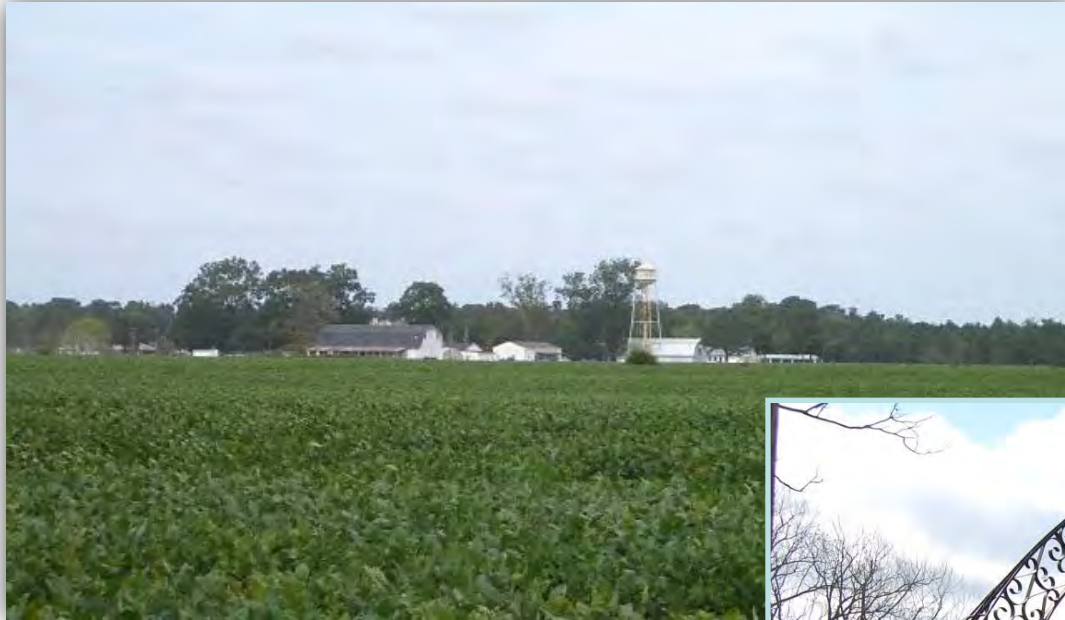
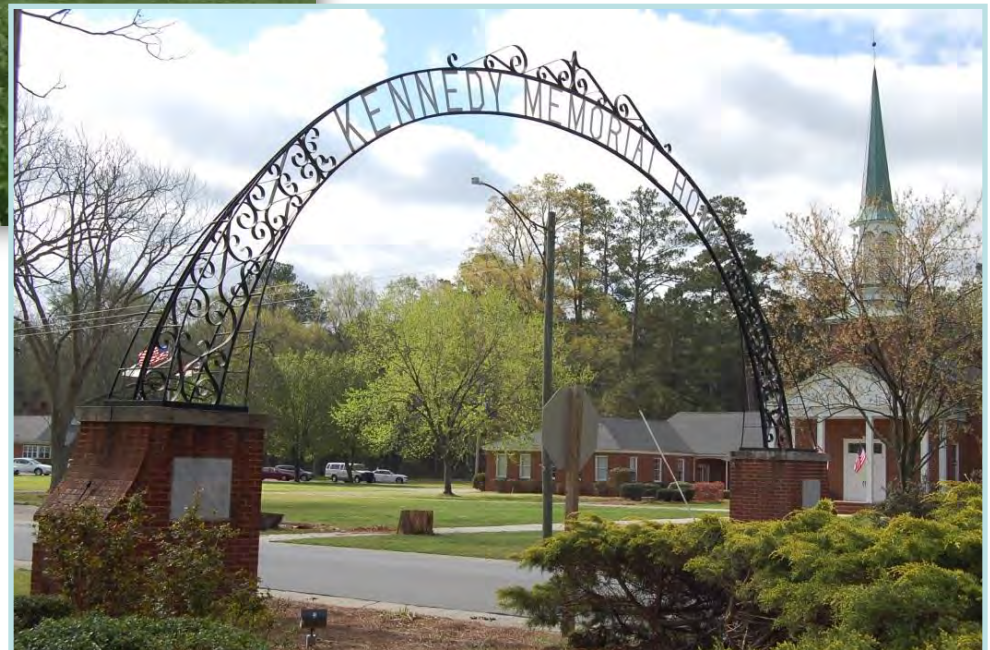
**#10 - KENNEDY MEMORIAL HOME HISTORIC DISTRICT (LR-1189) – Baptist orphanage begun in 1914 (includes earlier Cedar Dell); 1,240 acre property NR-listed in 2009; believed to merit continued NR listing**

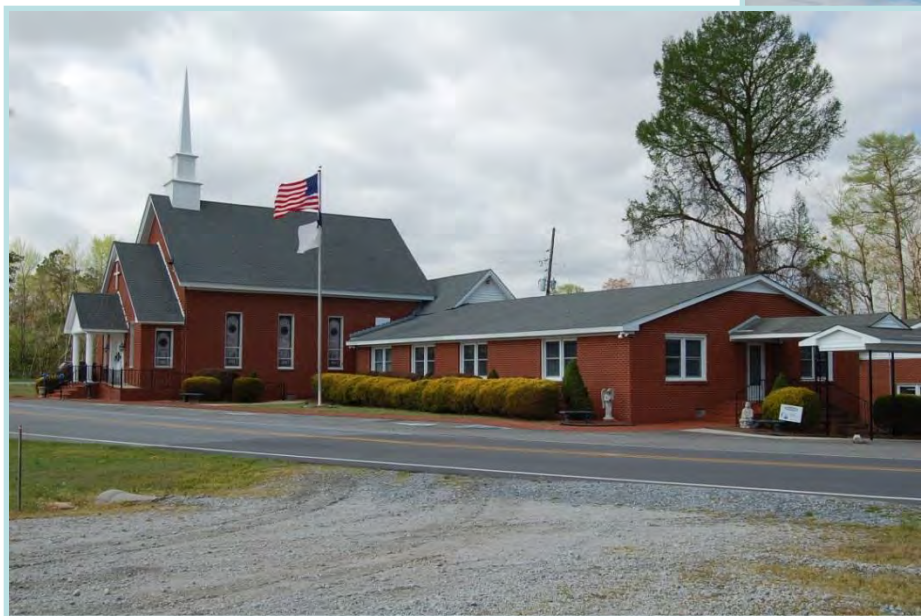
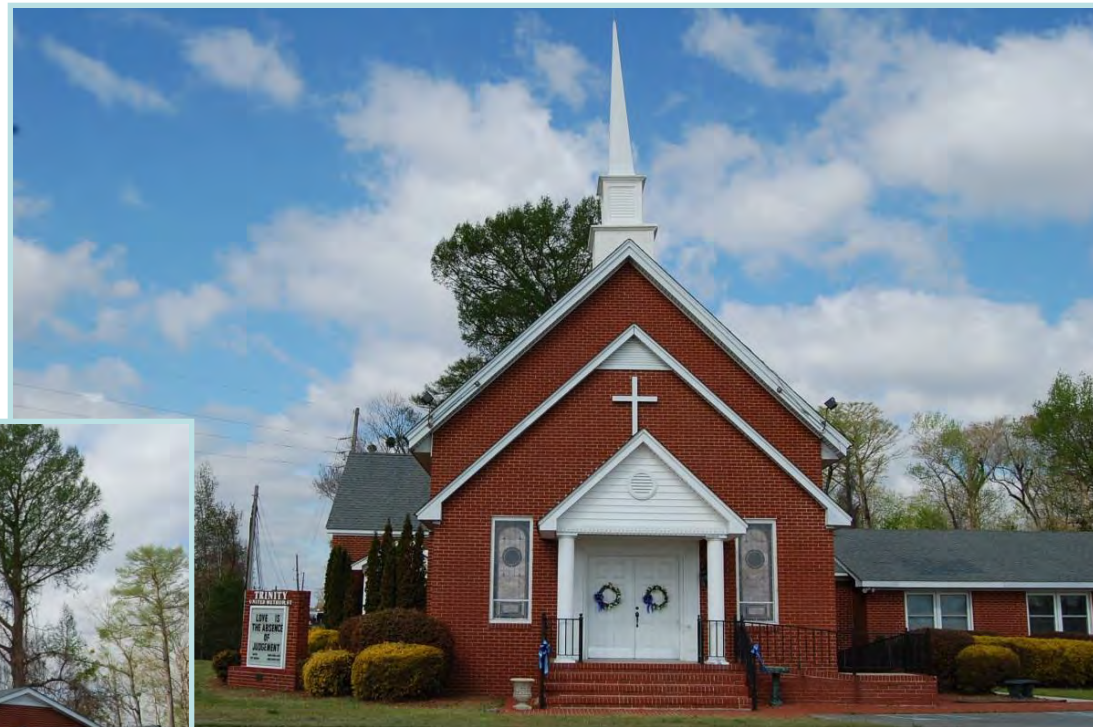
**#11 - TRINITY METHODIST CHURCH (LR-0702) – Ca.1887, 1900, 1948-49, 1972, 1979 church; believed to lack significance and integrity**

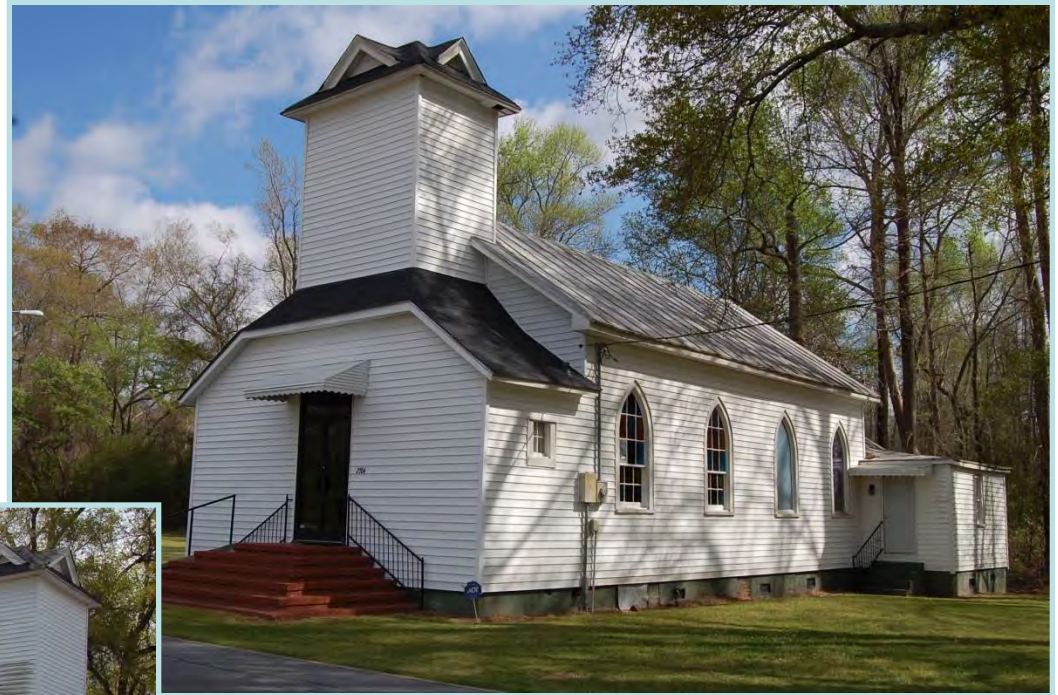
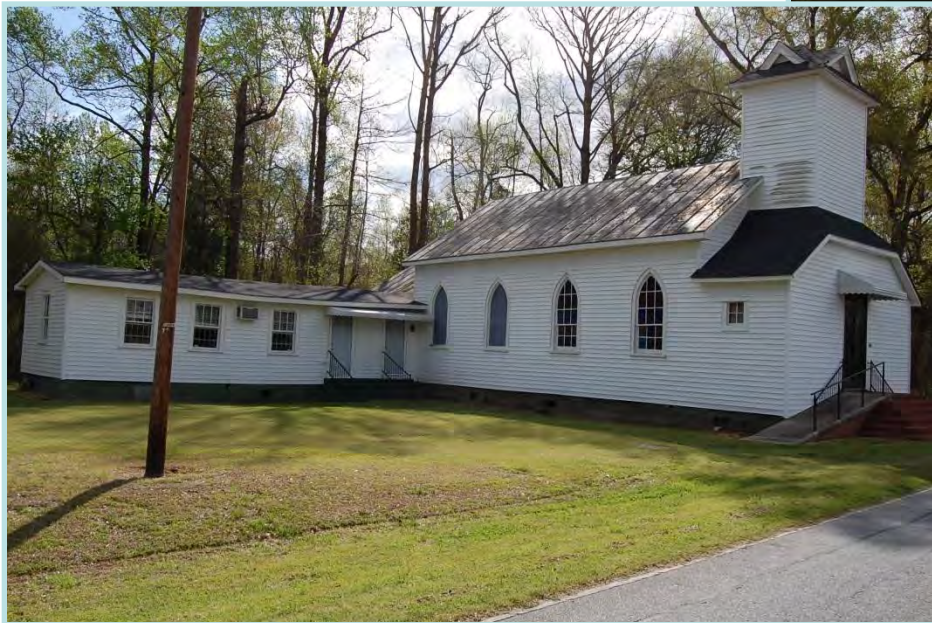
**#12 - BANKS CHAPEL MISSIONARY BAPTIST CHURCH (LR-0914) –  
Ca.1900 rural church; believed to lack significance and integrity**

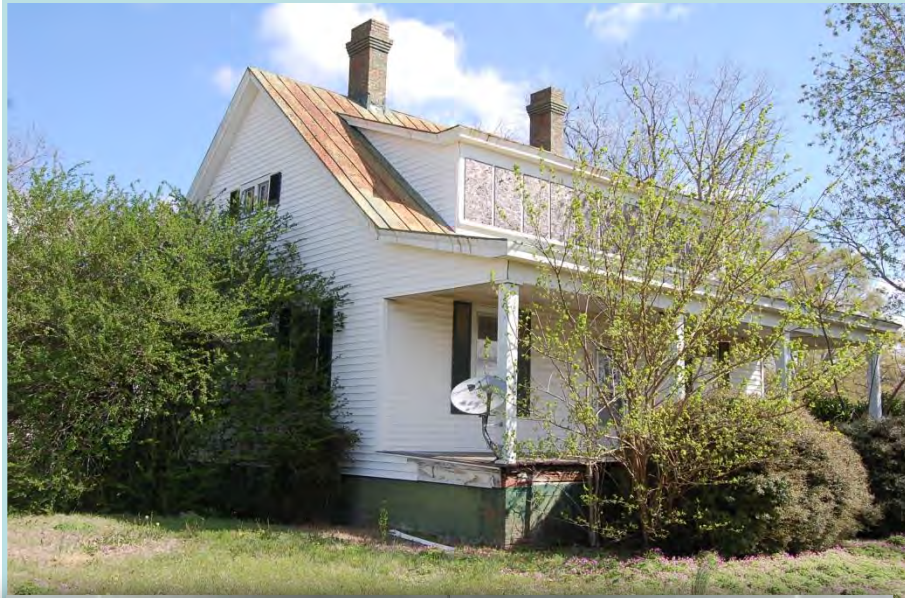
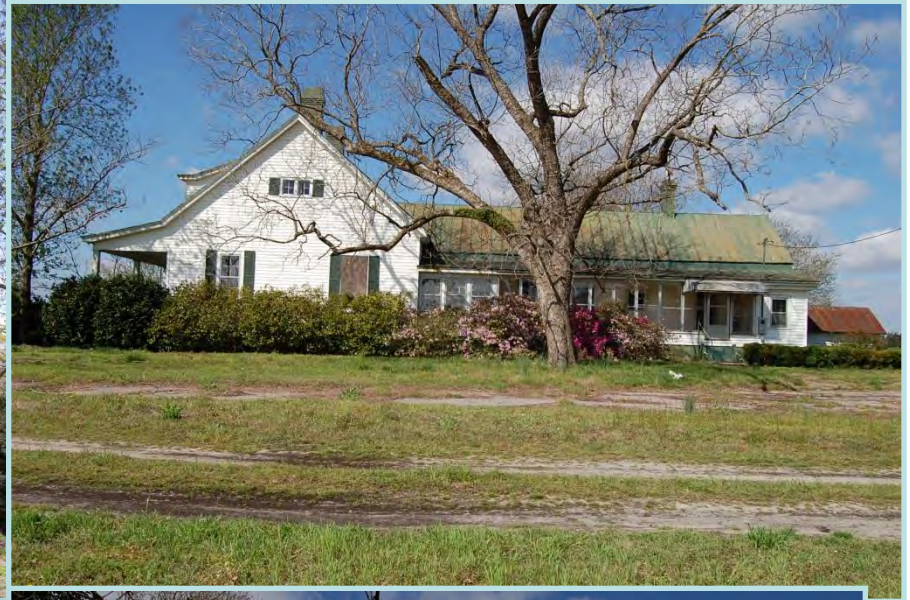
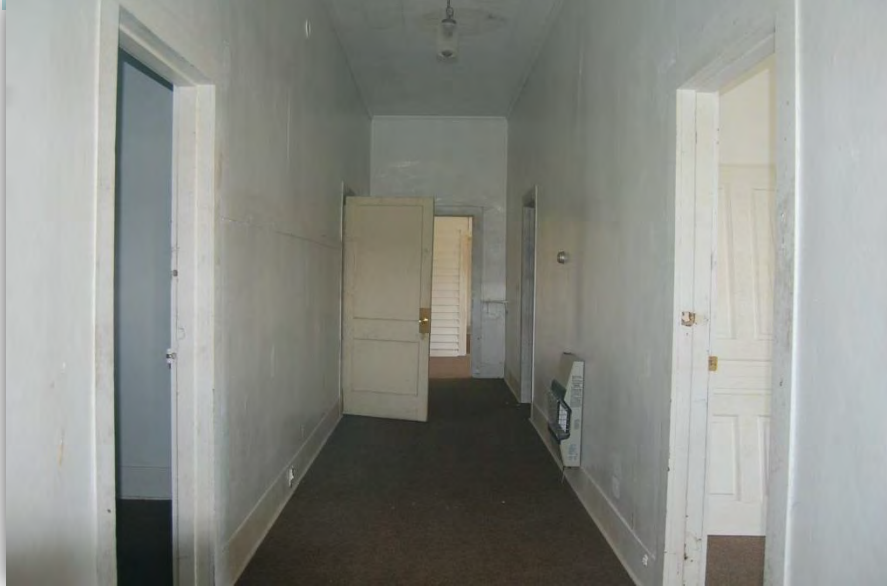
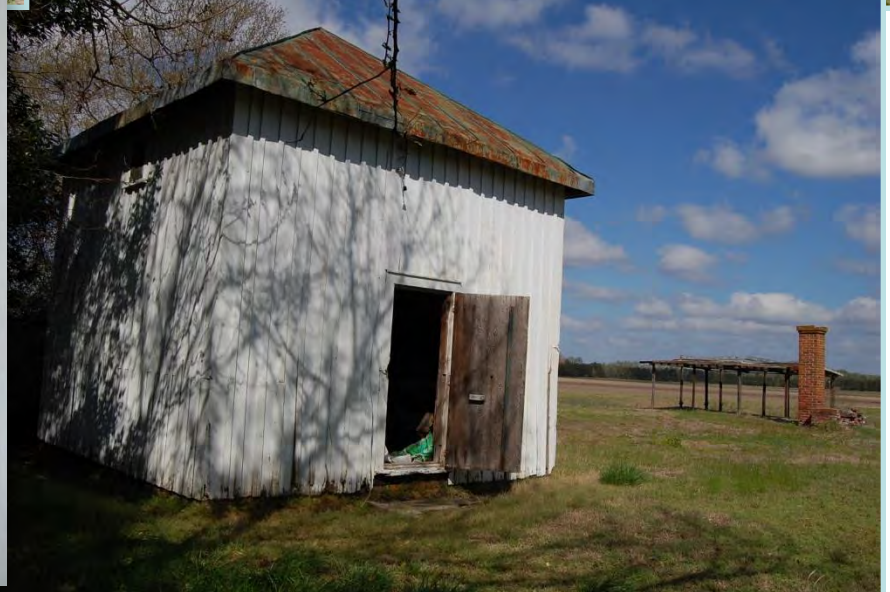
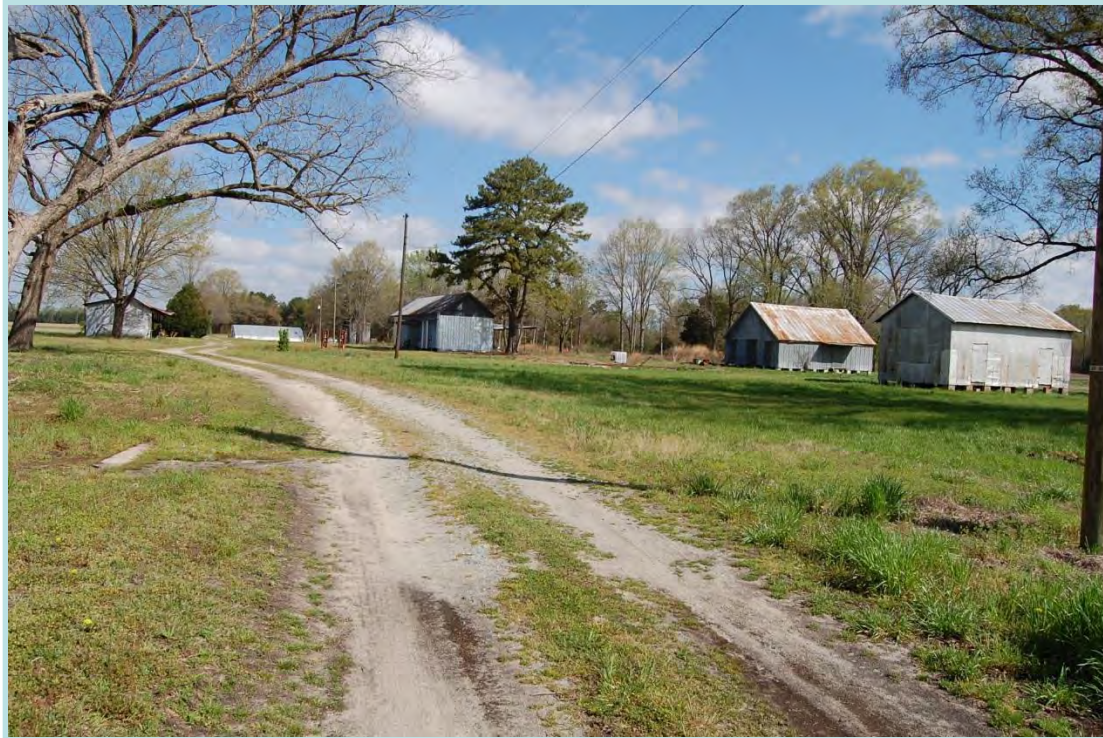
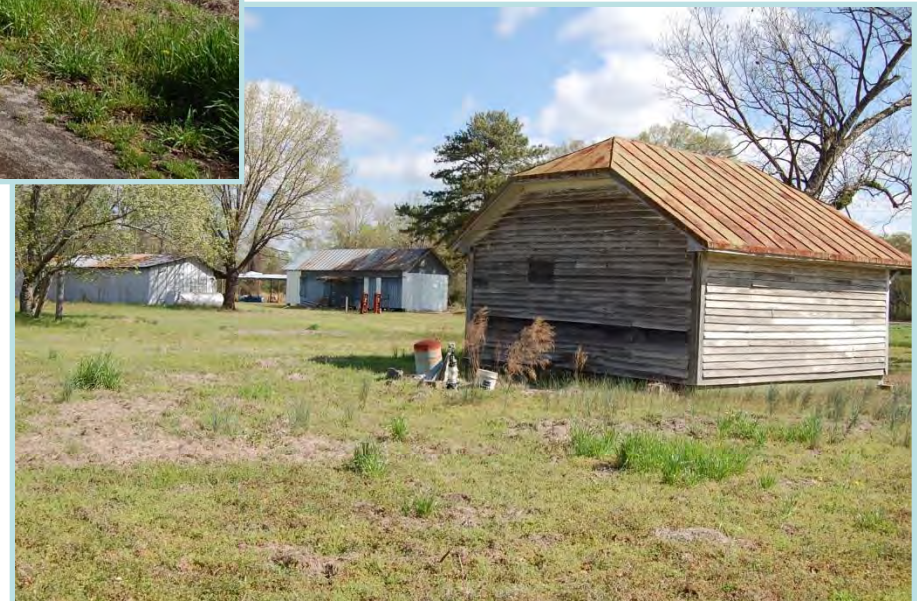
**#13 - WARTERS-PARROTT-COLEMAN FARM (LR-0967) – late 19<sup>th</sup>-c house w/ earlier ell and numerous outbuildings; believed to lack integrity**

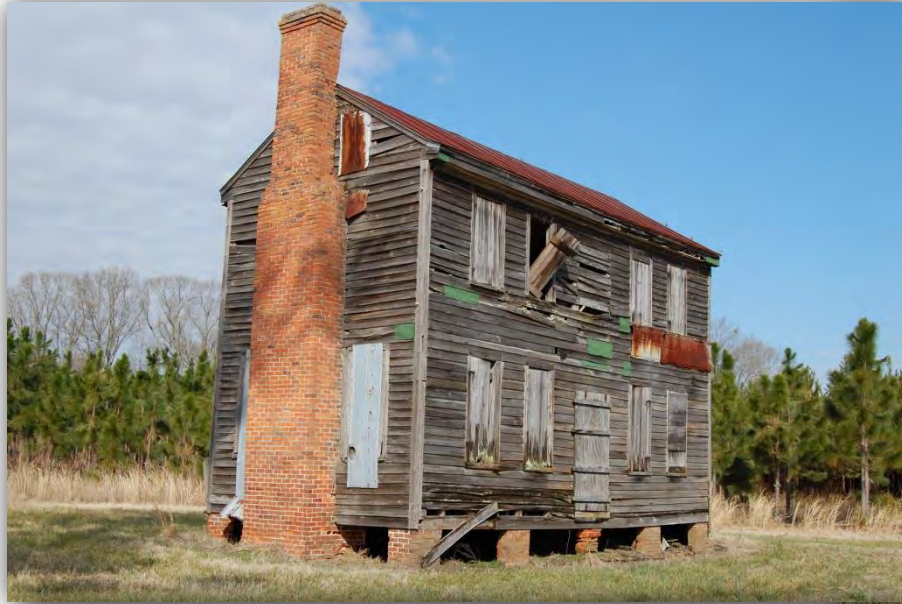
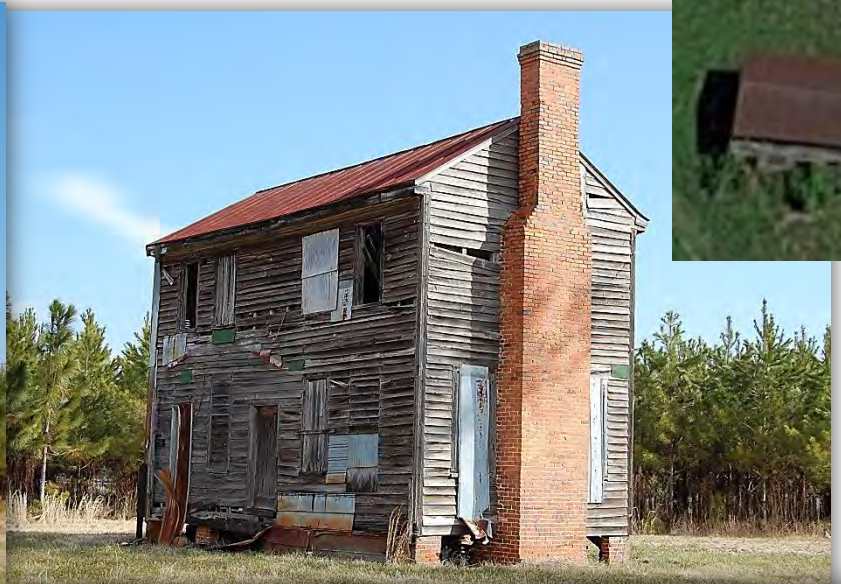
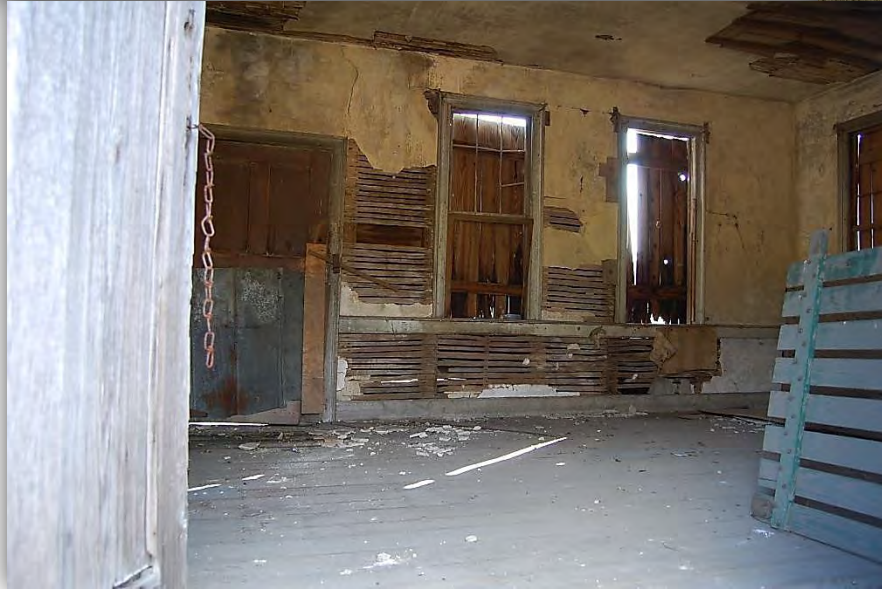
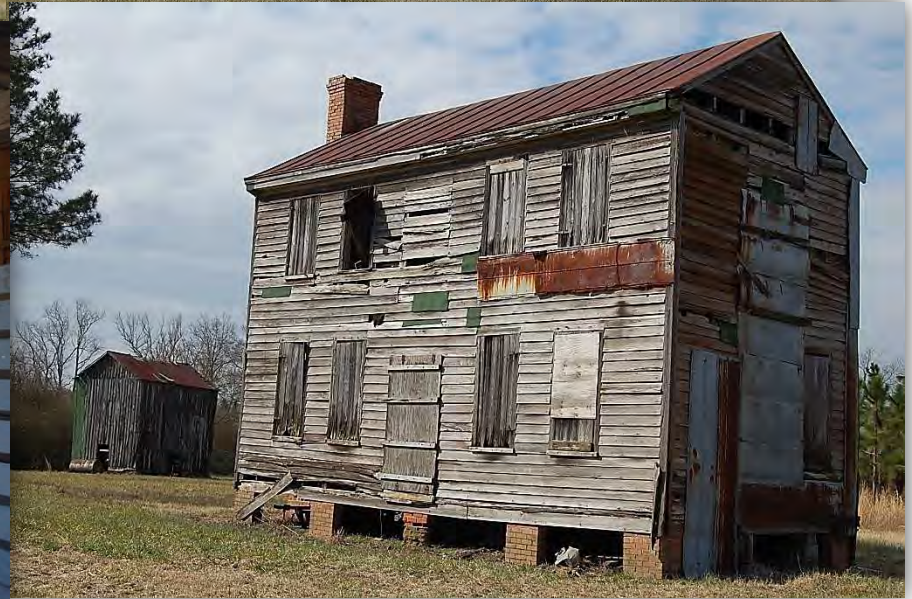
**#14 - JAMES WARTERS HOUSE (LR-0926) – ca.1840s hall-parlor-plan I-house; believed to lack integrity [2010 photographs; ca.2017 aerial]**

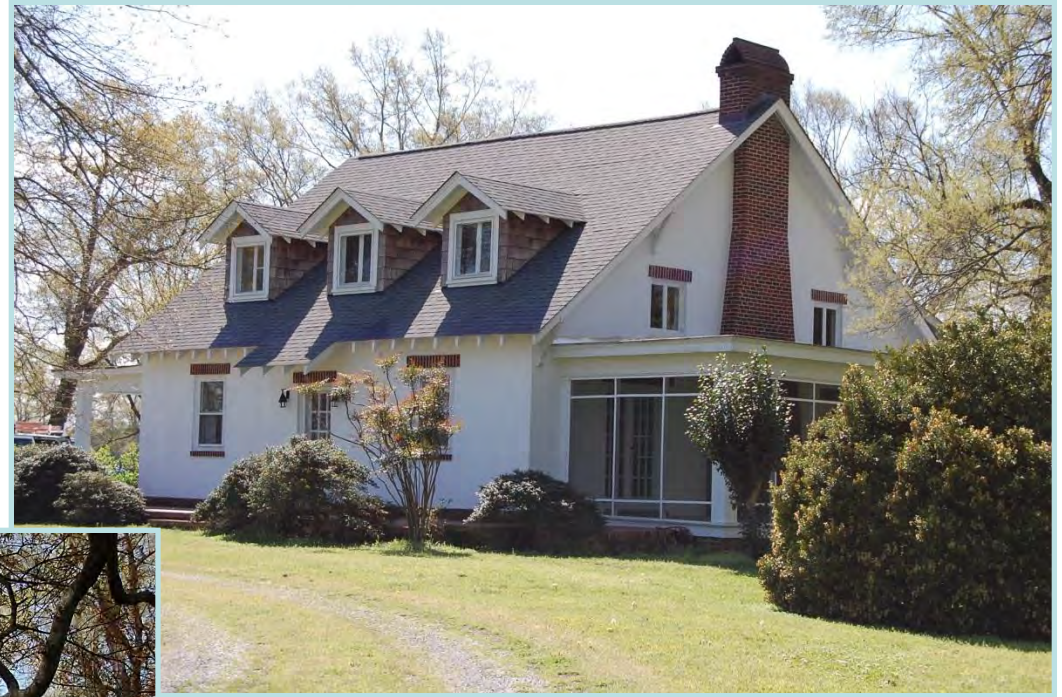
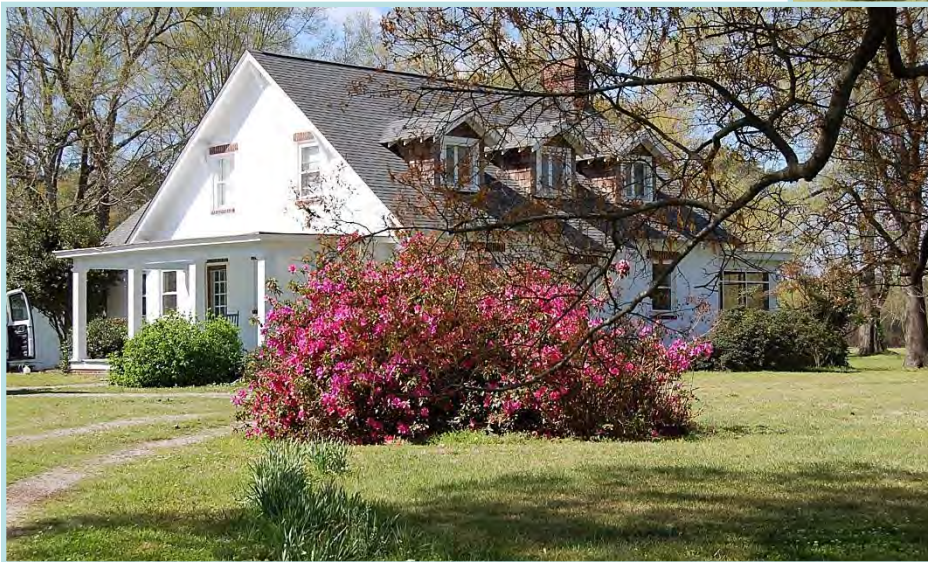
**#15 - DR. JAMES M. PARROTT HOUSE (LR-0703) – 1920s**  
**Craftsman-style house of prominent physician Parrott; 1998 DOE;**  
**believed to remain NR-eligible**

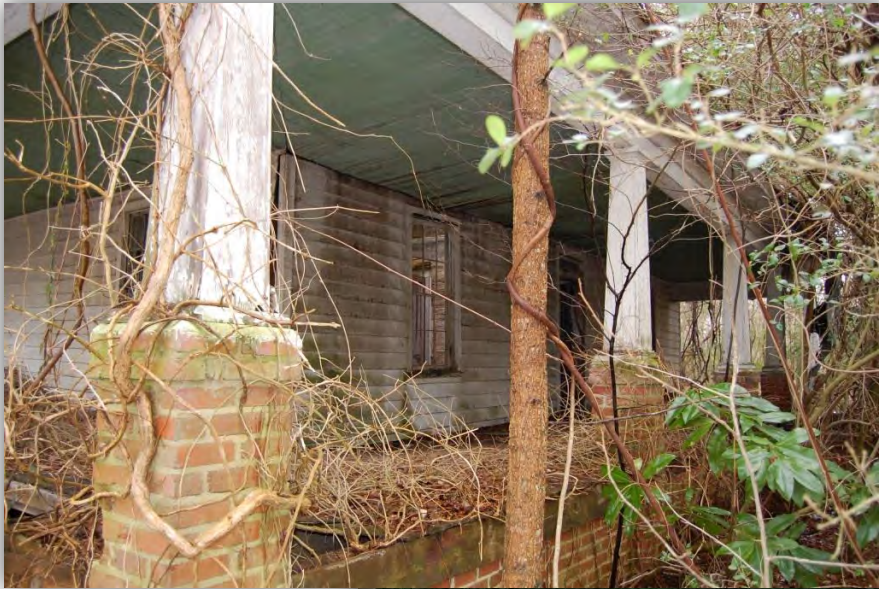
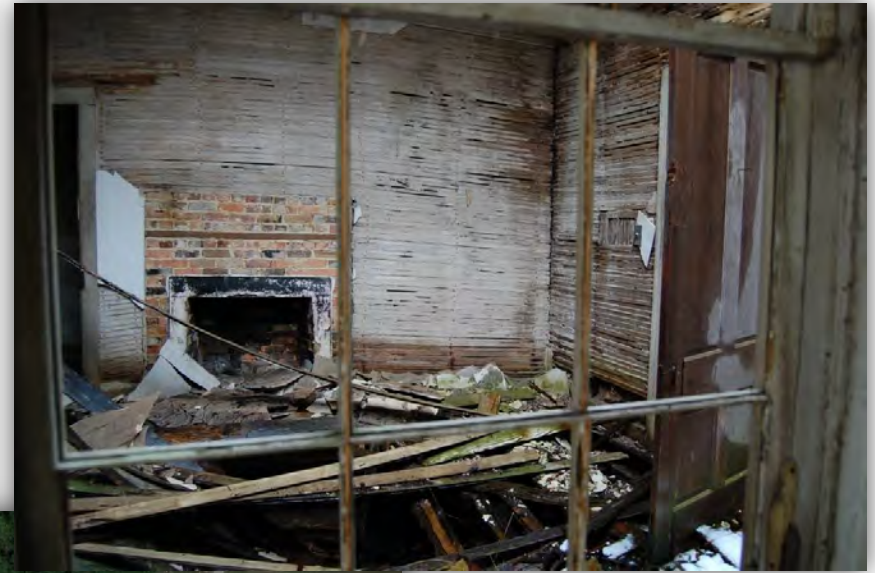
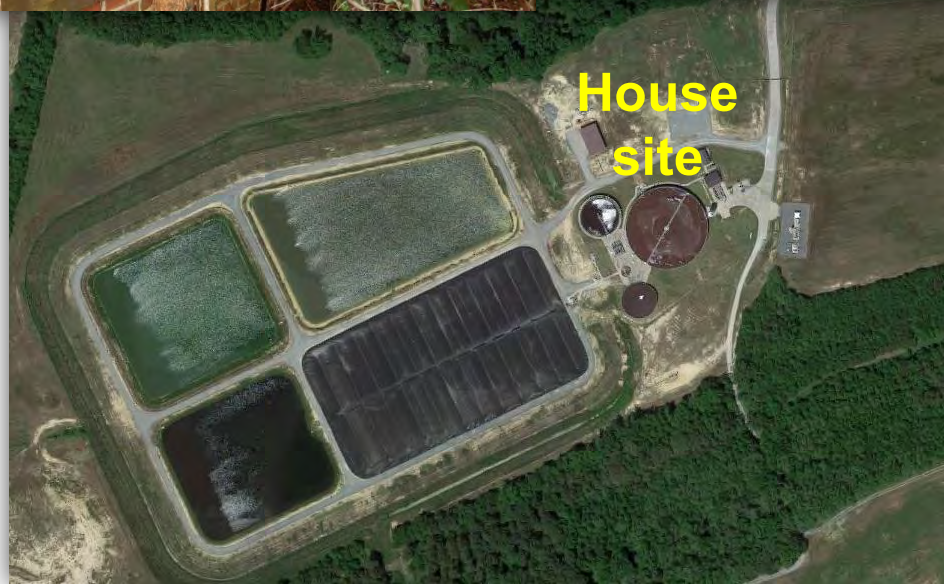
**#16 - PRUITT HOUSE (LR-0896) – late 19<sup>th</sup>-c house demolished for sewer treatment plant after 2010 [2010 photographs; ca.2017 aerial]**

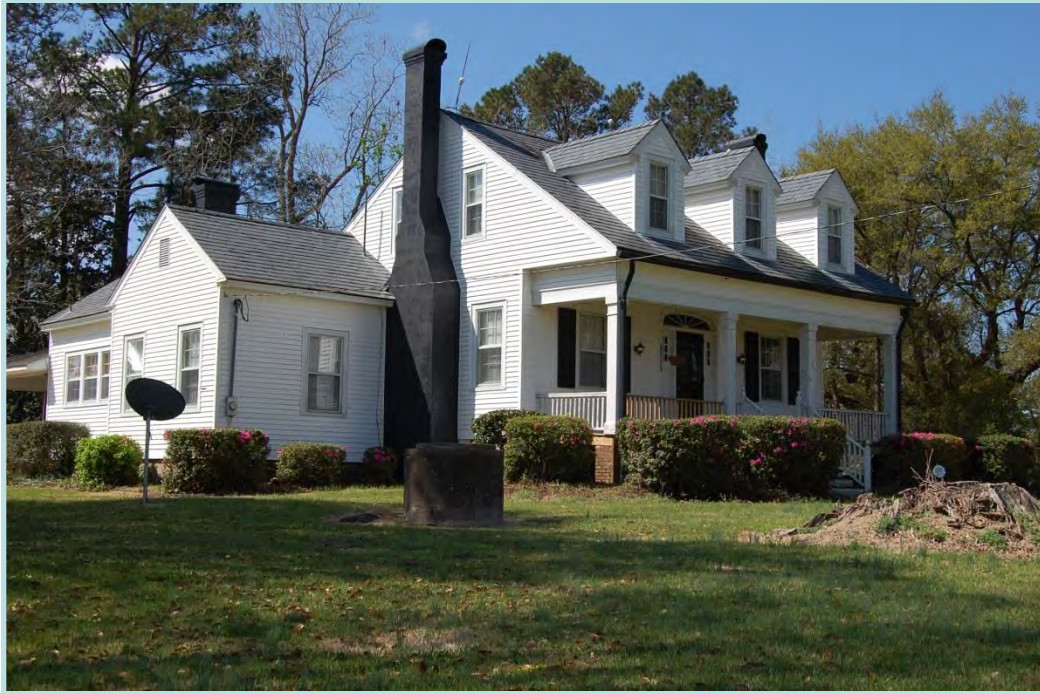
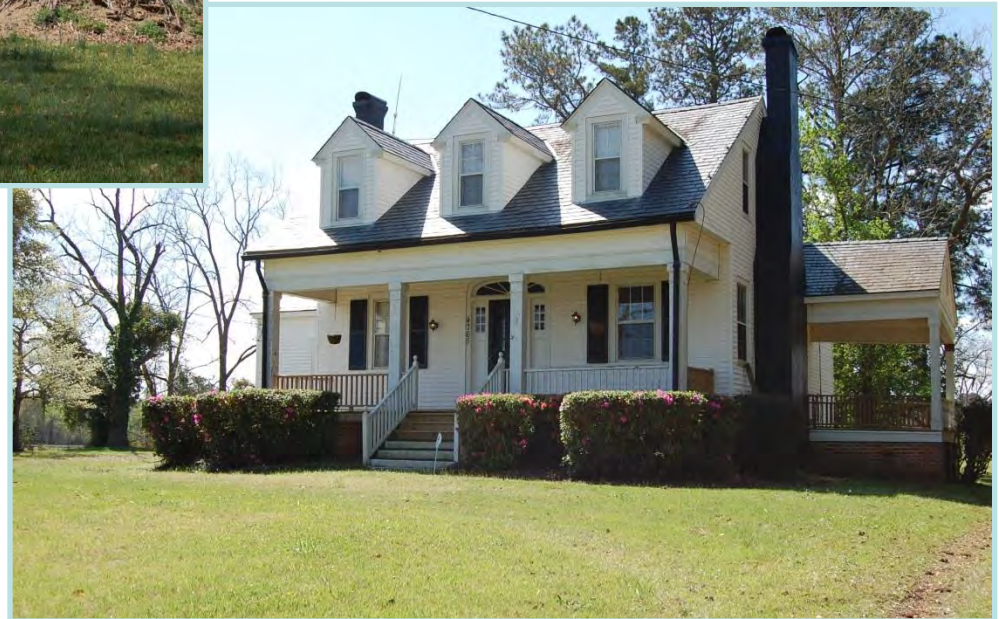
**#17 - HENRY LOFTIN HERRING FARM (LR-0700) – ca.1812  
Federal-style coastal cottage remodeled in Colonial Revival-style  
ca.1928; 1998 DOE; believed to remain NR-eligible**

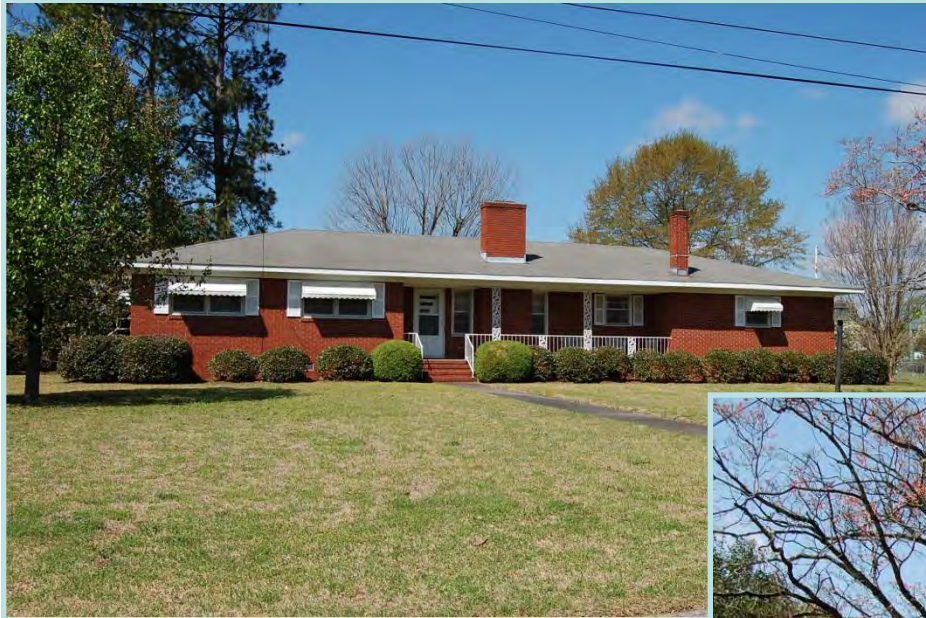
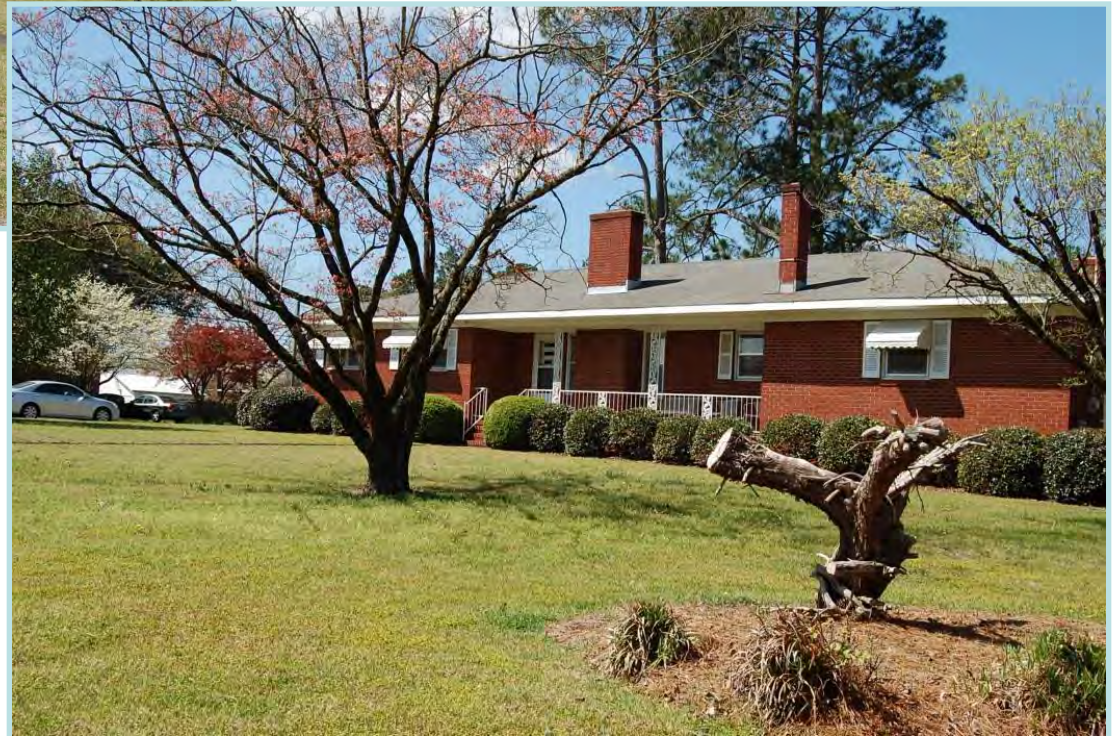
**#18 - HOUSE (LR-1530) –1950s ranch house; reviewed and considered not eligible for NR in 2008**

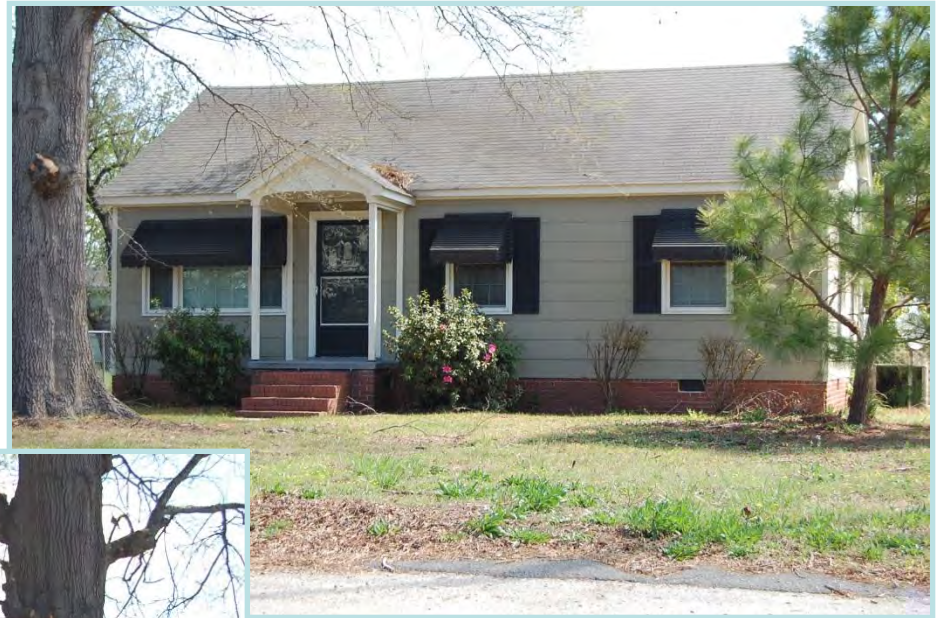
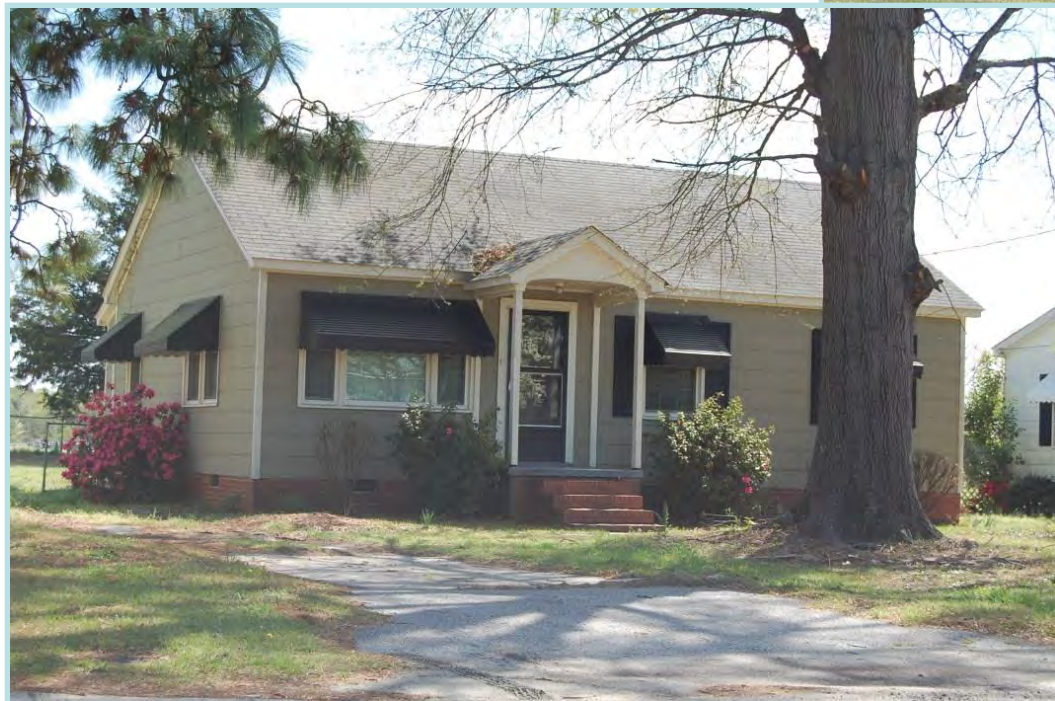
**#19 - HOUSE (LR-1528) – 1950s frame house; reviewed and considered not eligible for NR in 2008**

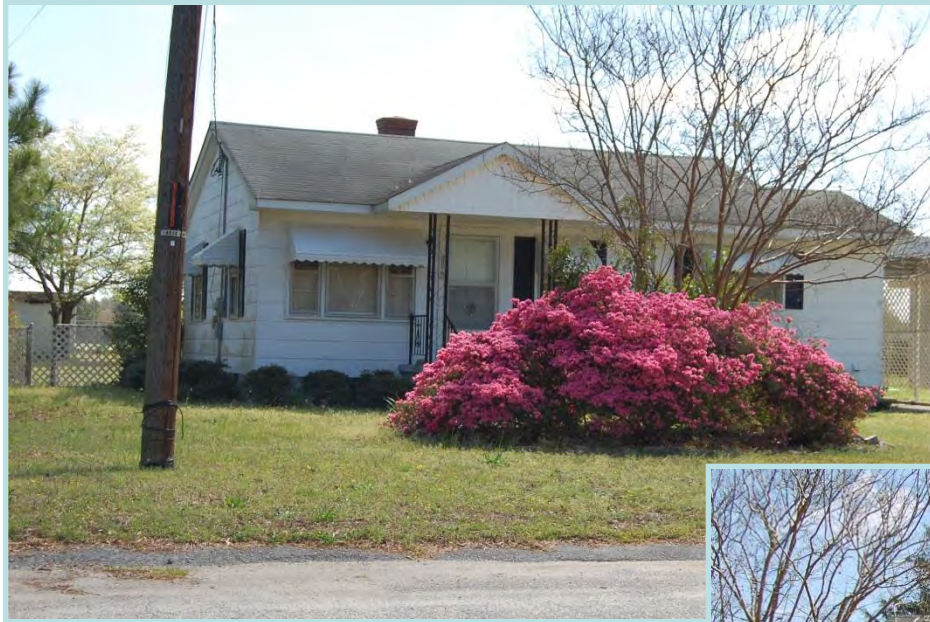
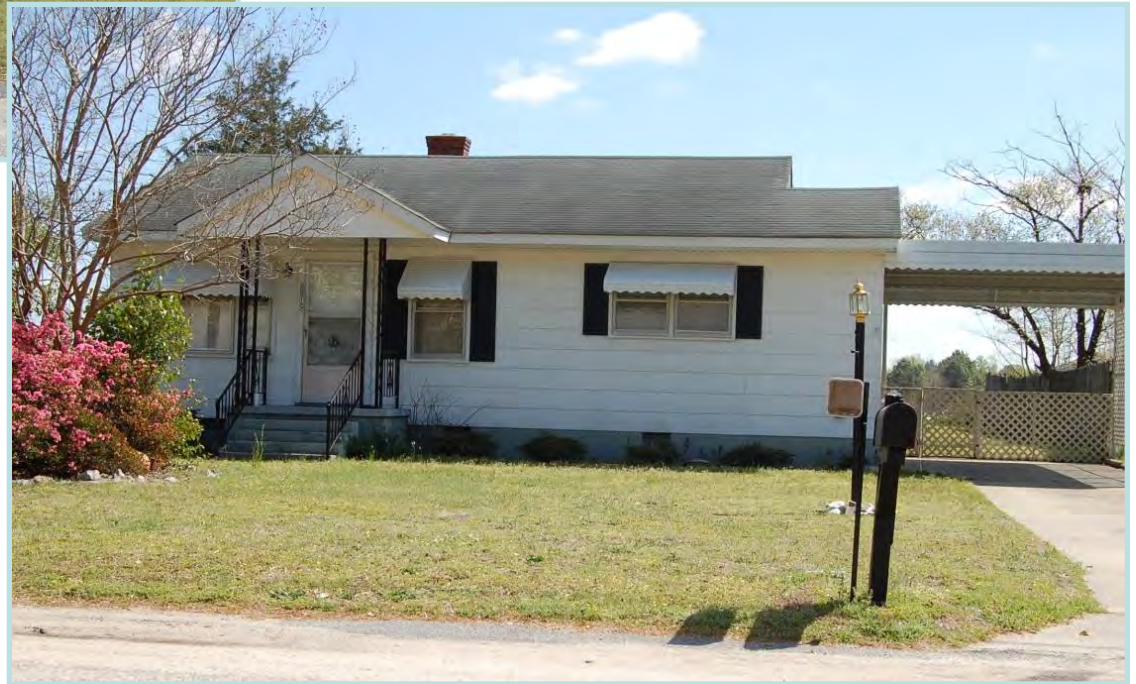
**#20 - HOUSE (LR-1527) –1950s frame house; reviewed and considered not eligible for NR in 2008**

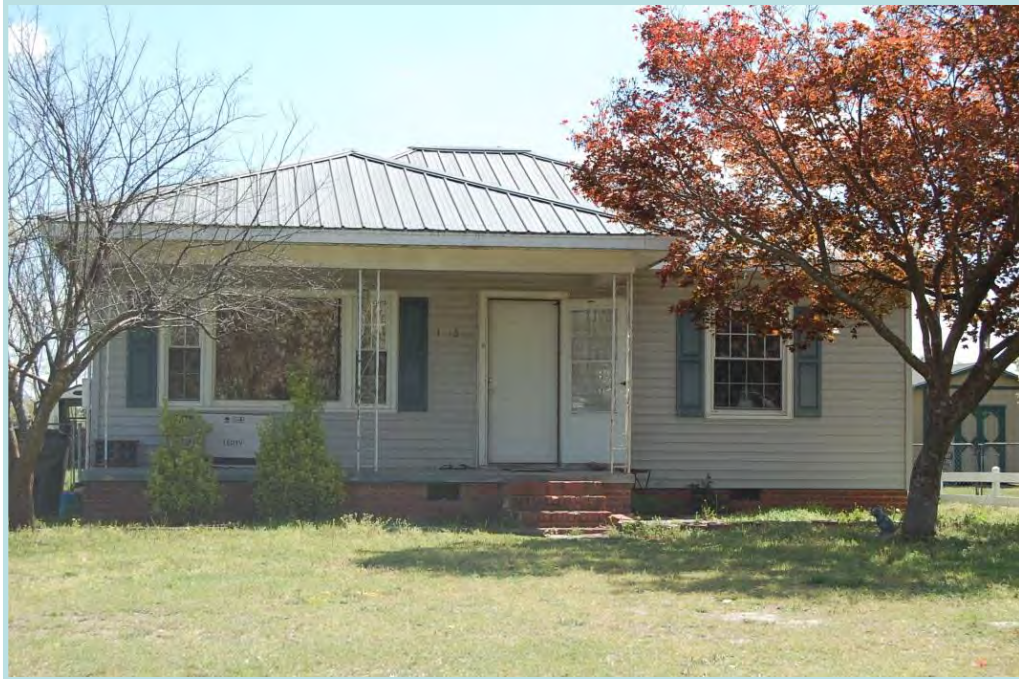
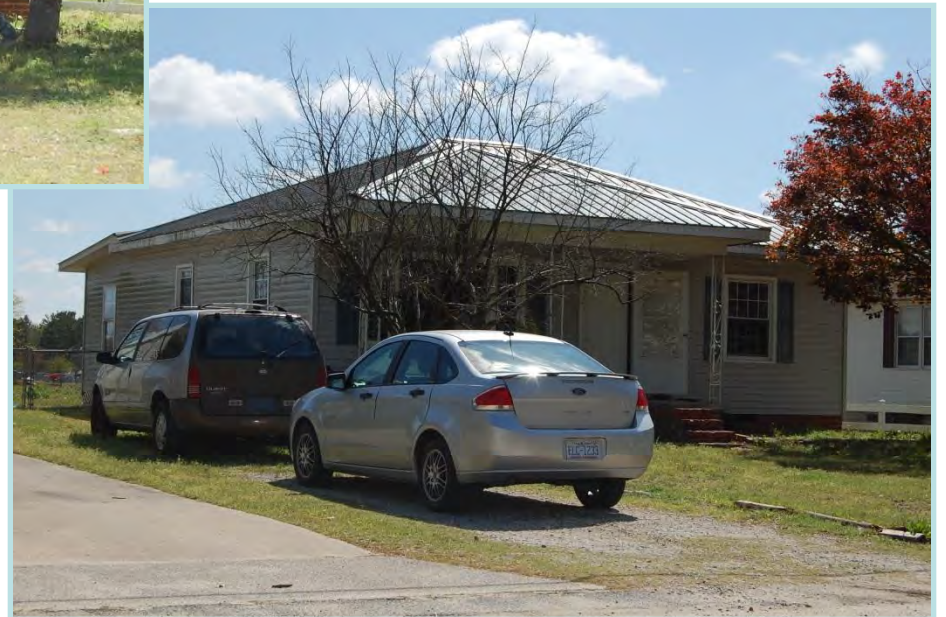
**#21 - HOUSE (LR-1526) – 1950s frame house; reviewed and considered not eligible for NR in 2008**

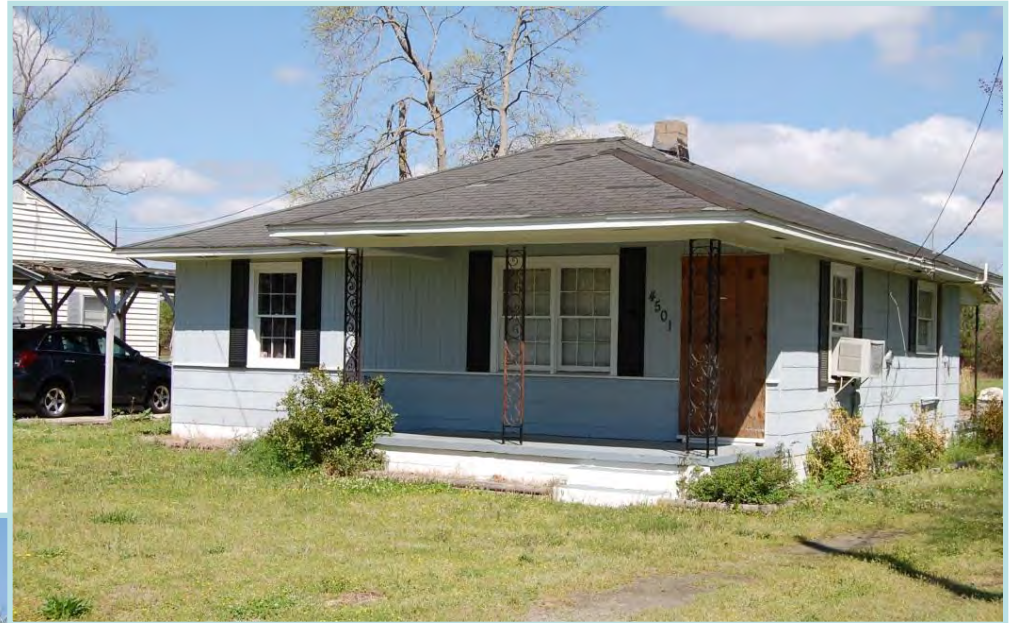
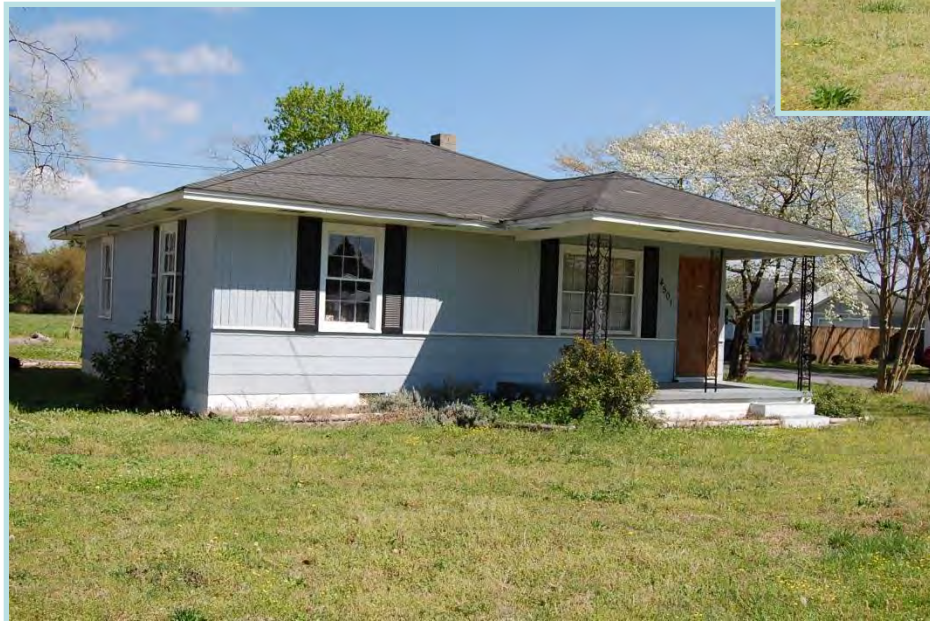
**#22 - HOUSE (LR-1529) – 1950s frame house; reviewed and considered not eligible for NR in 2008**
