North Carolina Department of Natural and Cultural Resources  
State Historic Preservation Office

MEMORANDUM

Subject: Historic Architecture Eligibility Evaluation Report, US 70 Kinston Bypass, R-2553,  
Lenoir County, ER 09-1307

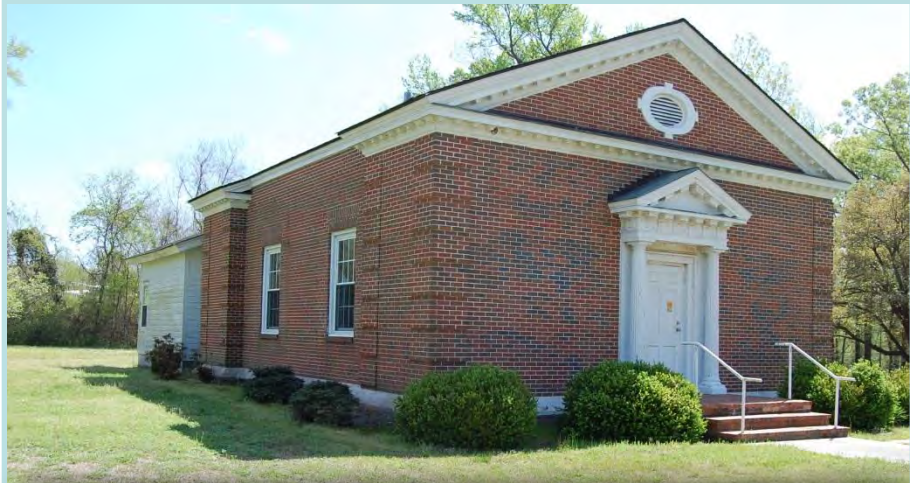
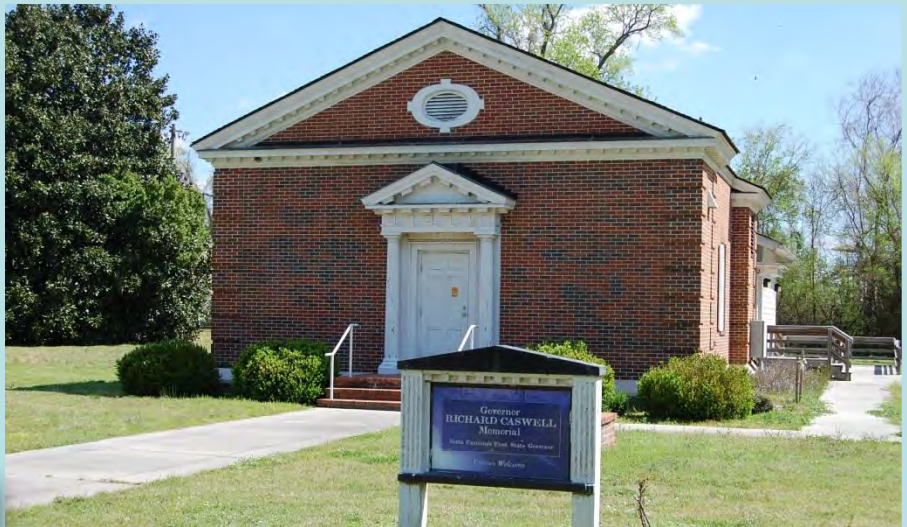
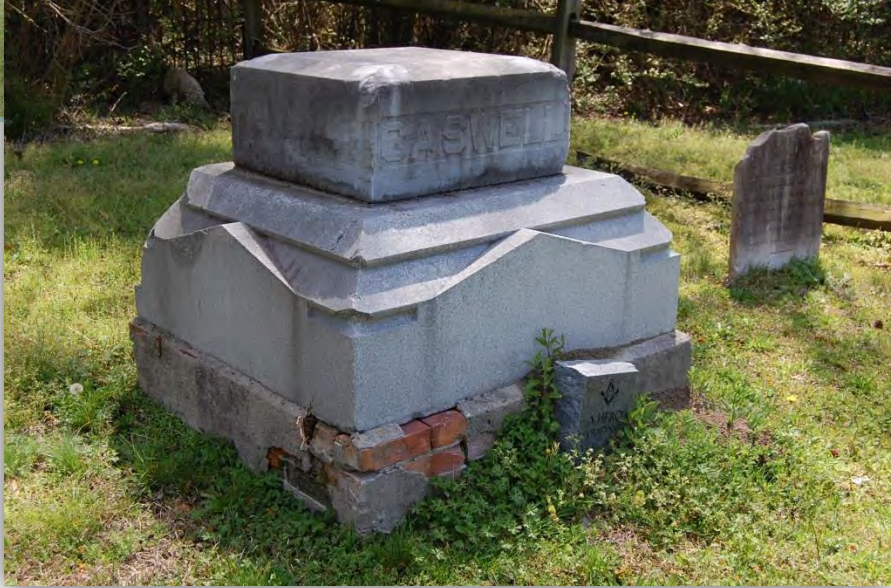
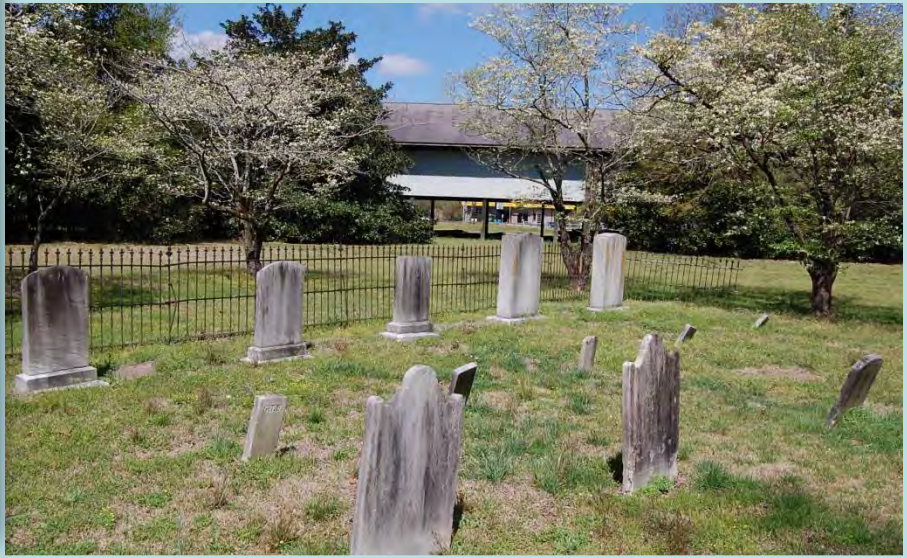
**#23 - GOV. RICHARD CASWELL MEMORIAL VISITORS CENTER (LR-0076)**  
1966 Colonial Revival-style visitors center; late 18<sup>th</sup>-c to 1950 cemetery —  
may include Caswell's grave, marked by part of memorial moved from  
Kinston in 1908; believed to lack significance under NR Exceptions D & F

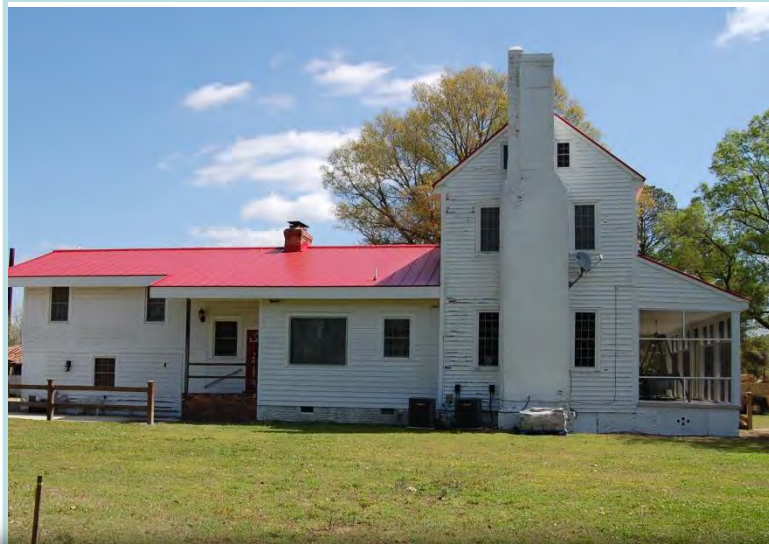
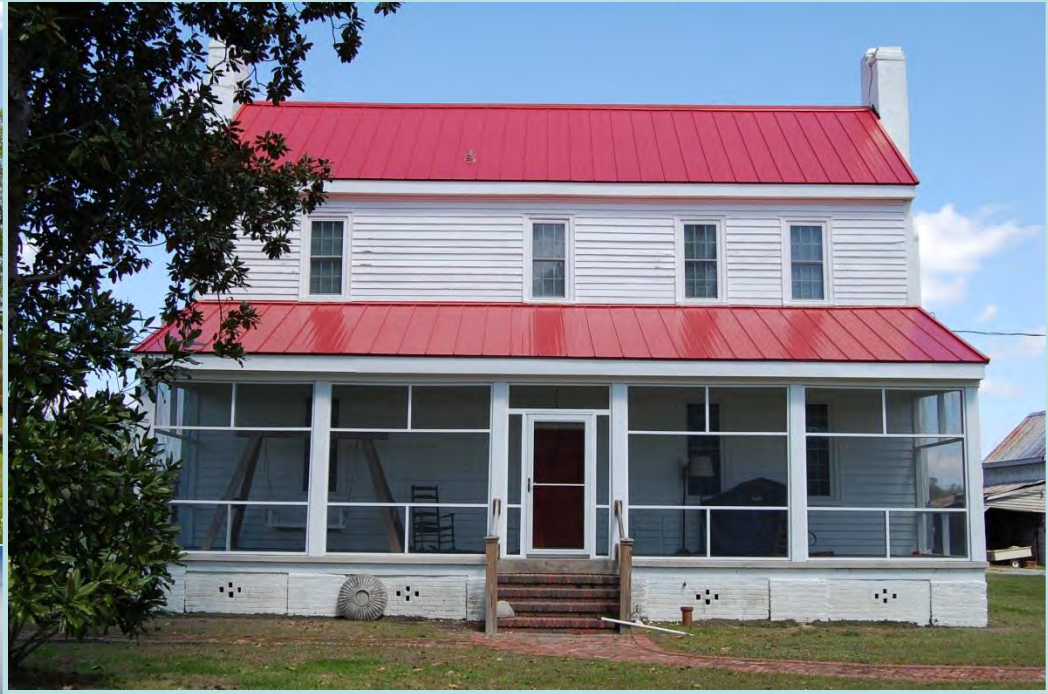
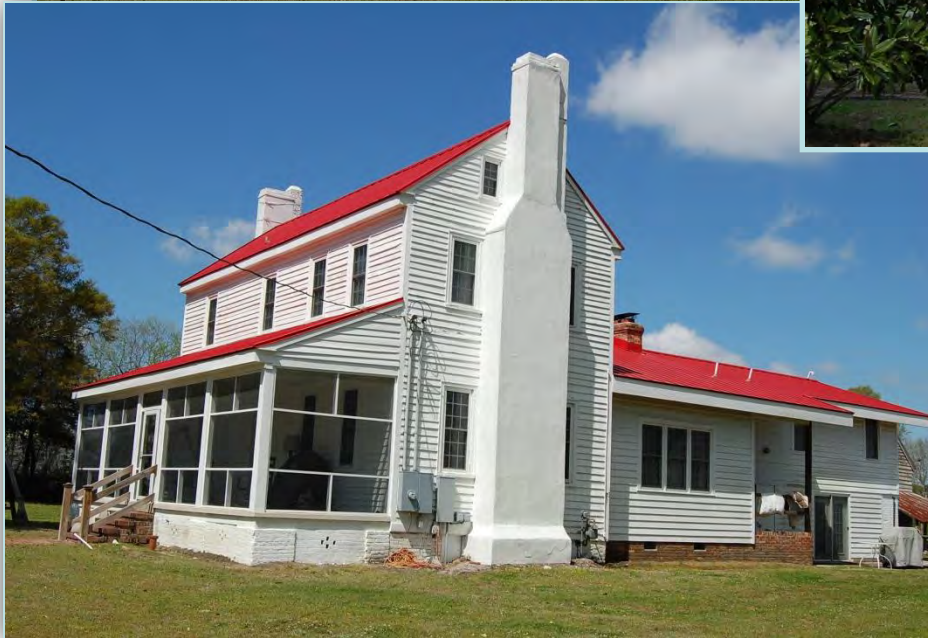
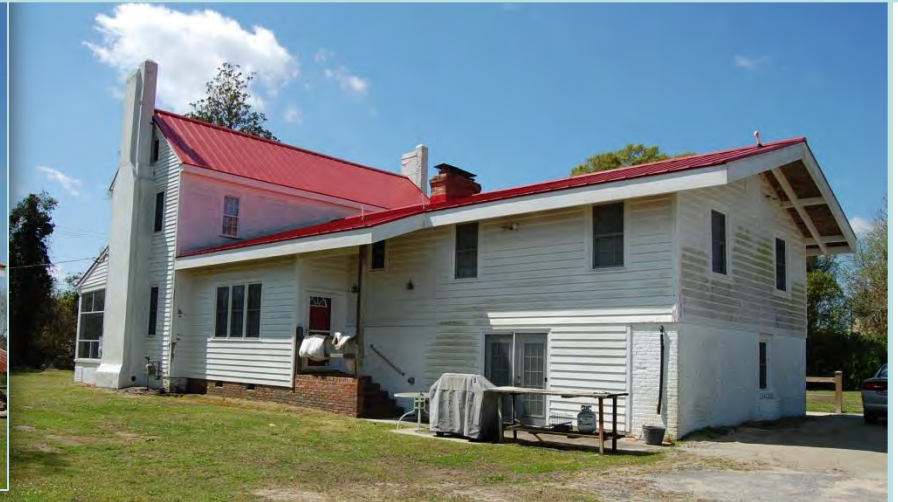
**#24 - ROUSE-CAPPS HOUSE (LR-0923) – ca.1850 Federal/Greek Revival-style house; believed to lack integrity**

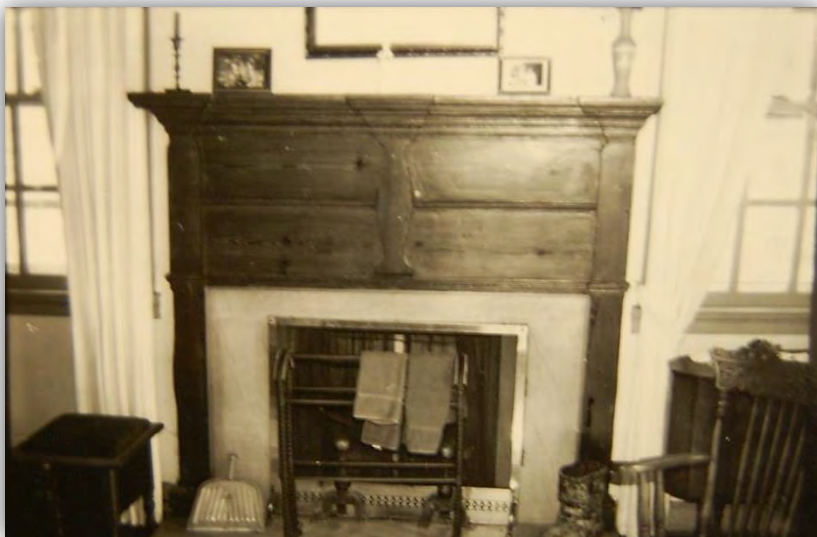
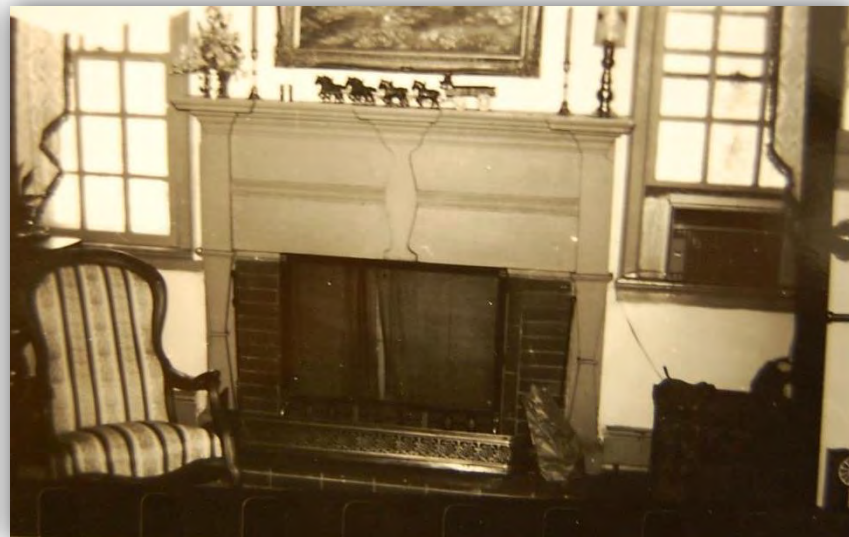
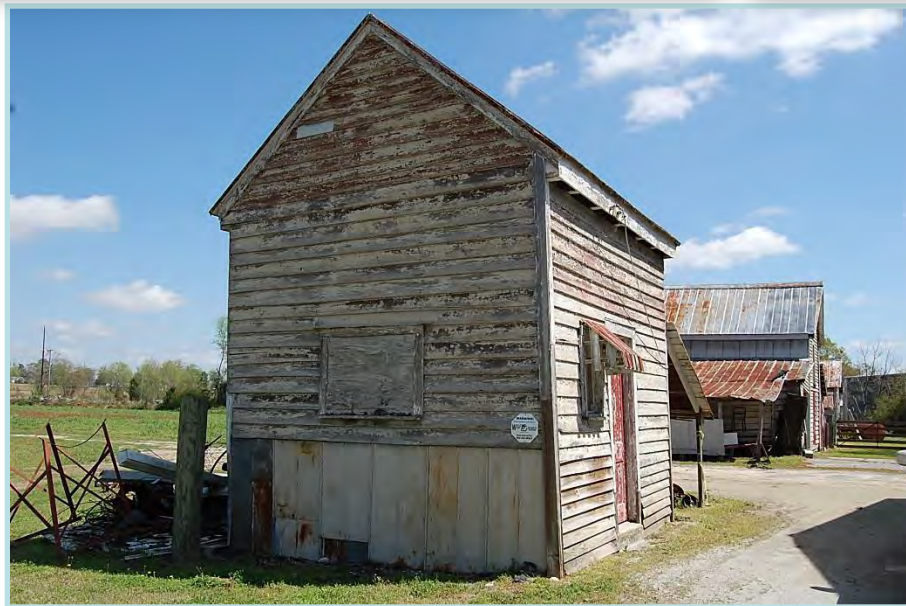
## #24 - ROUSE-CAPPS HOUSE (LR-0923)

**Interiors - 1994**

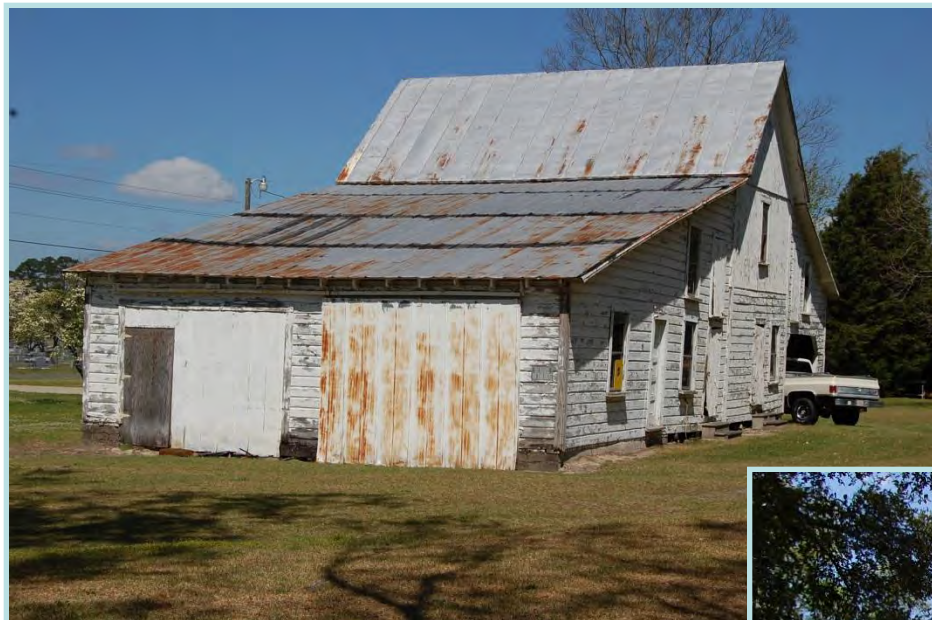
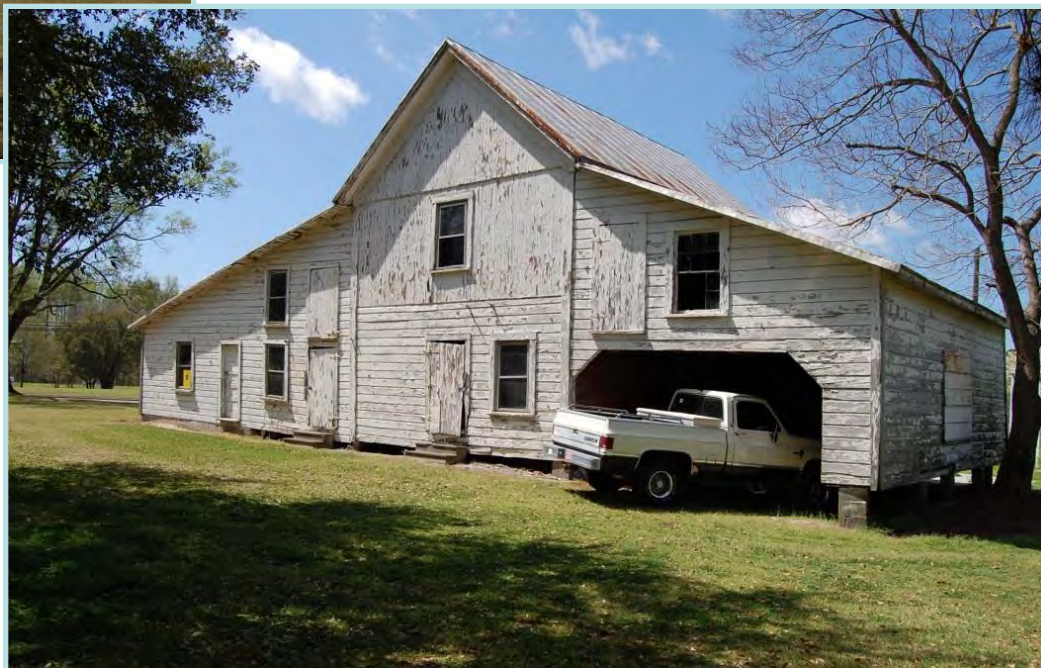
**#25 - BARN (LR-1507) – Early/mid-20<sup>th</sup>-c frame barn with packhouse at center and shed wings; reviewed and considered not eligible for NR in 2008**

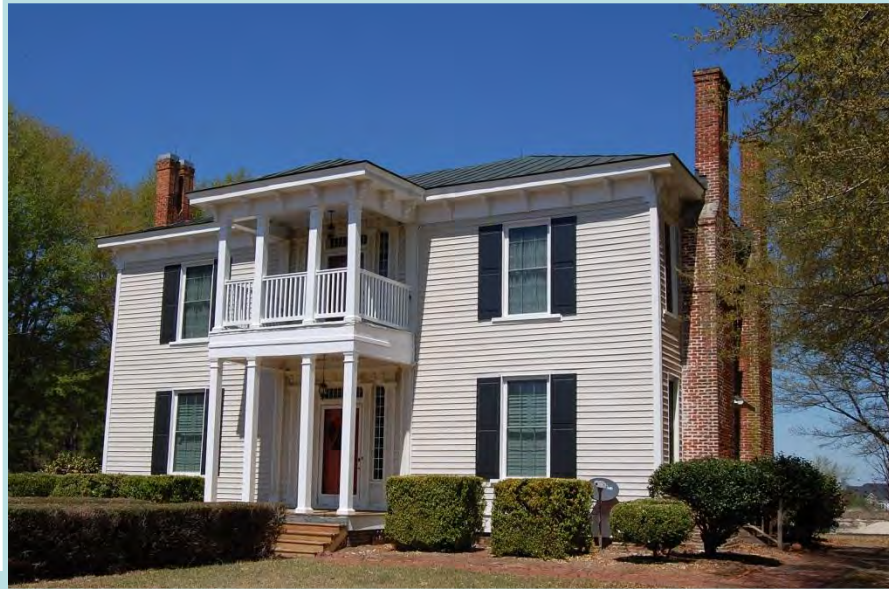
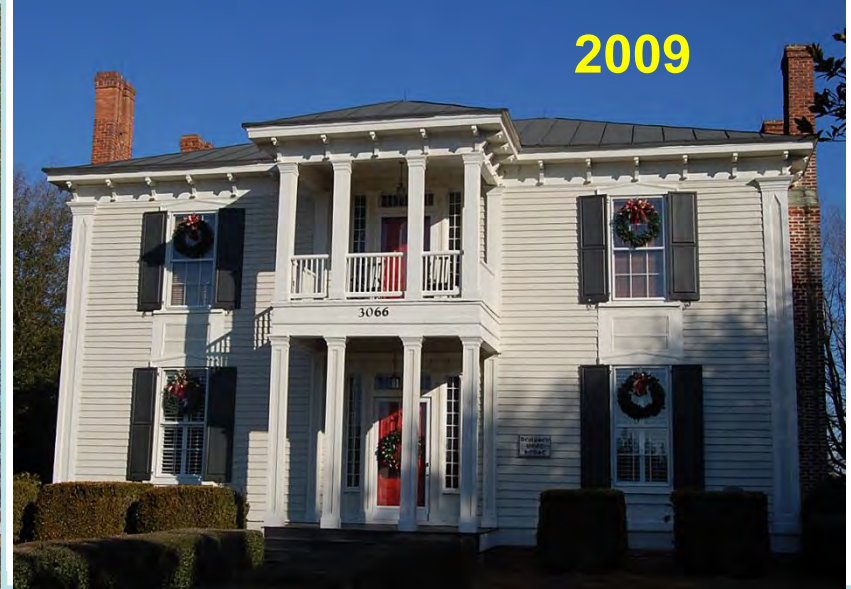
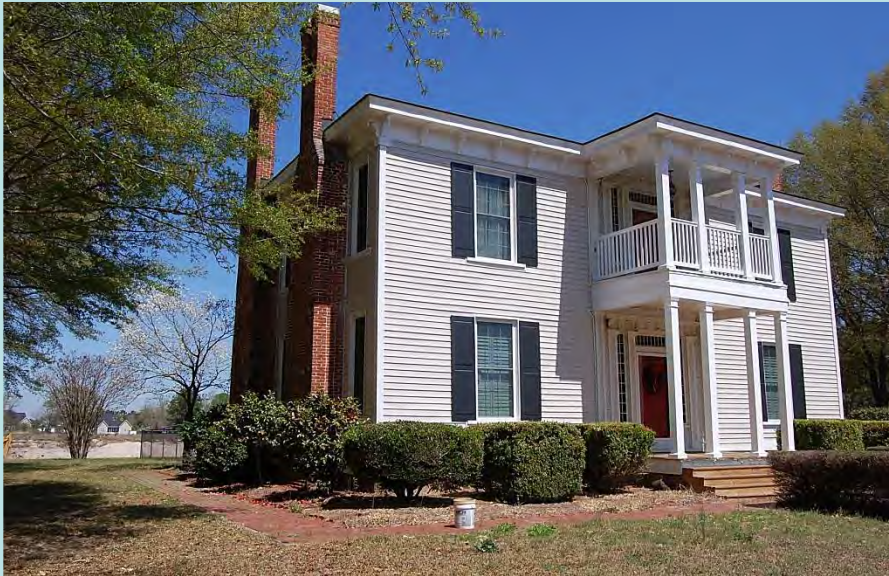
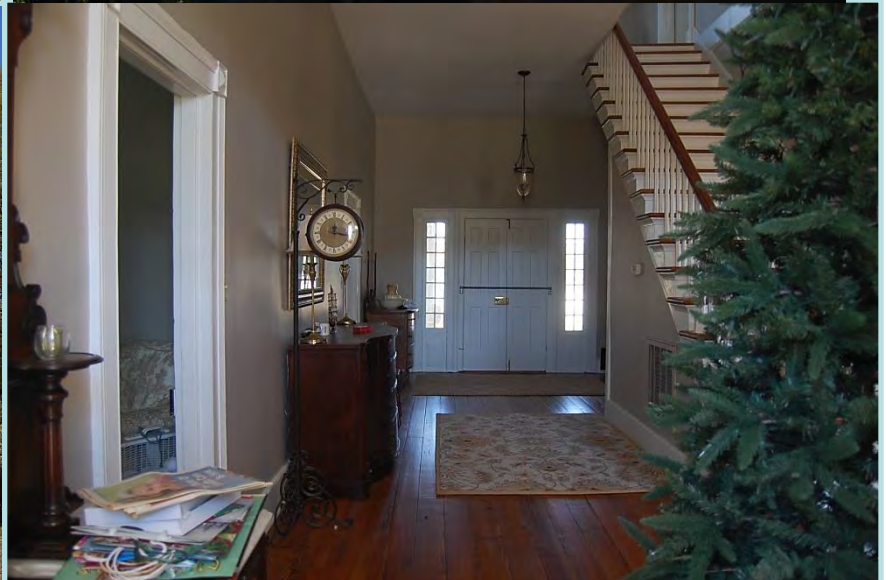
**#26 - DEMPSEY WOOD HOUSE (JAMES WOOD HOUSE) (LR-0008) – 1850s Italianate/Greek Revival-style house; NR-listed in 1971; believed to retain sufficient integrity to merit continued NR listing**

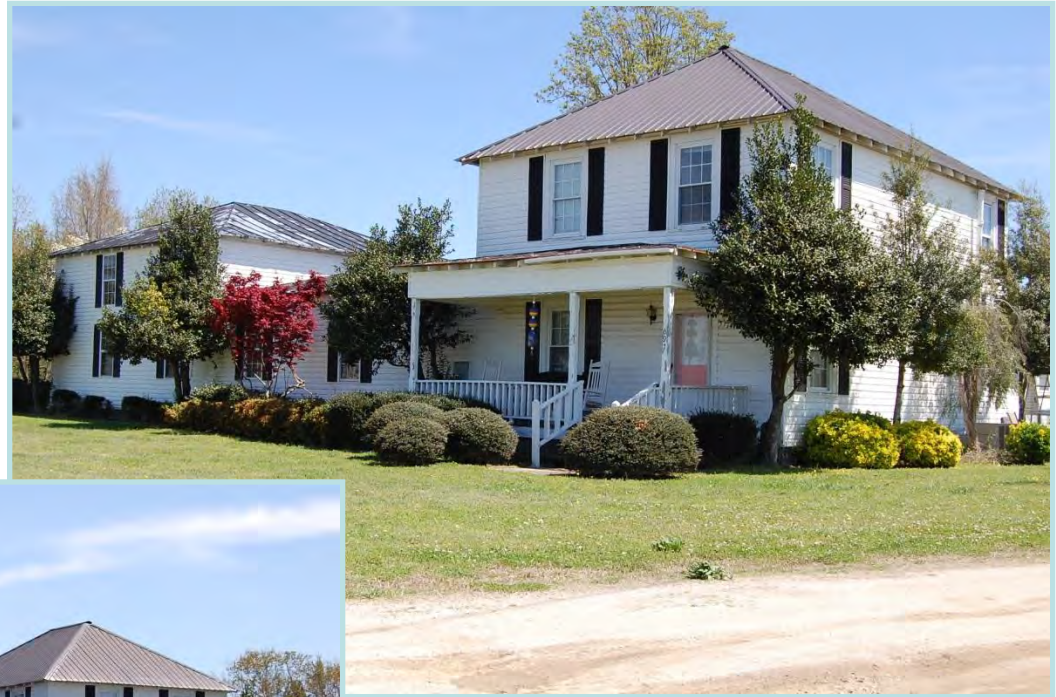
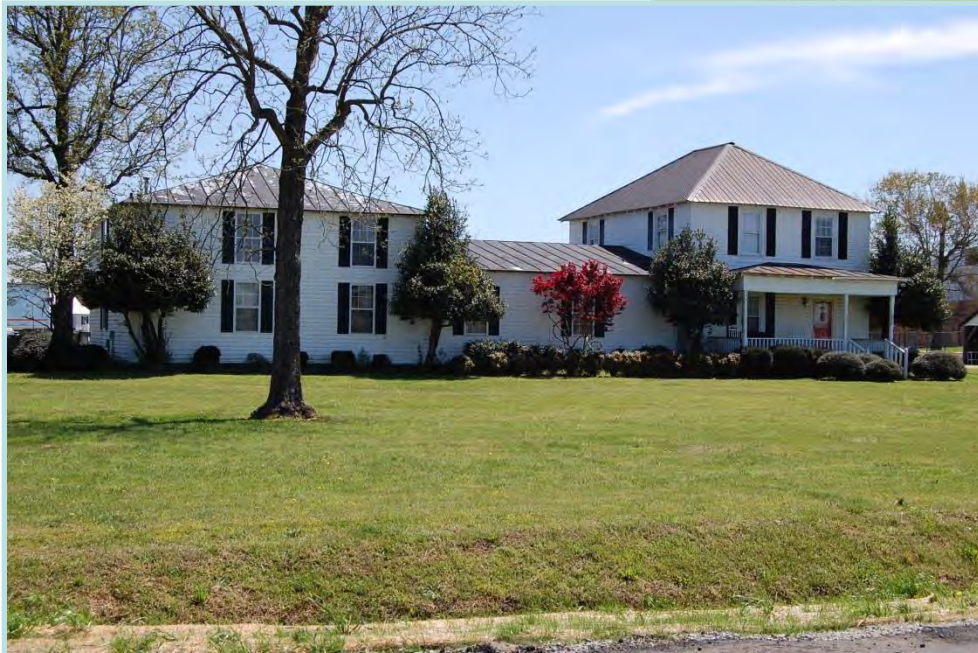
**#27 - DANNY SHEPHERD HOUSE (LR-1035) – early 20<sup>th</sup>-c  
foursquare with later added hyphen and foursquare wing;  
believed to lack significance and integrity**

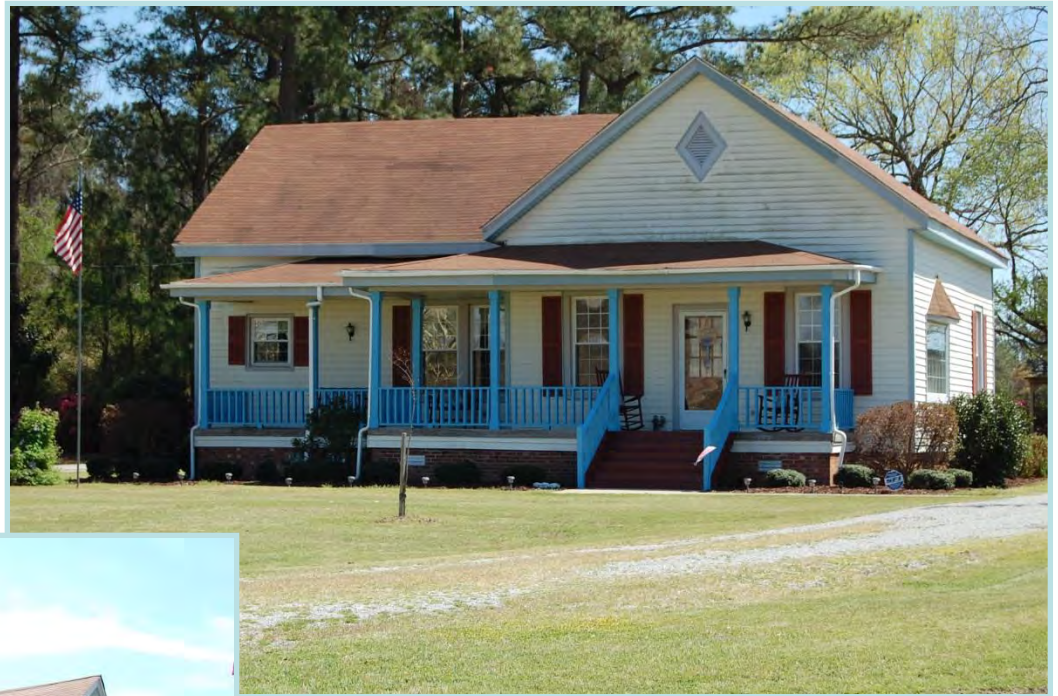
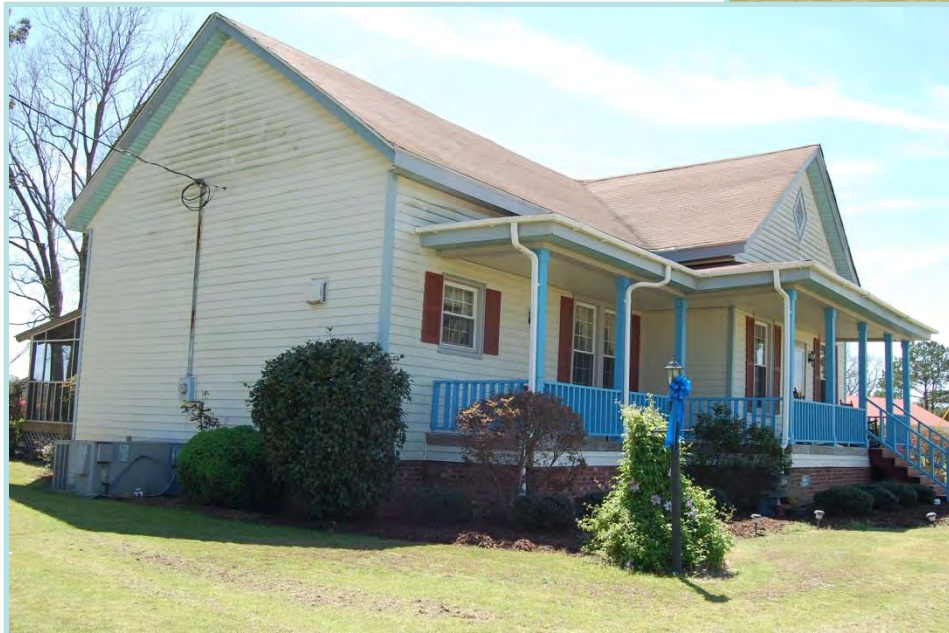
**#28 - (FORMER) MOSS HILL SCHOOL (LR-1046) – ca.1890 former school; believed to lack integrity**

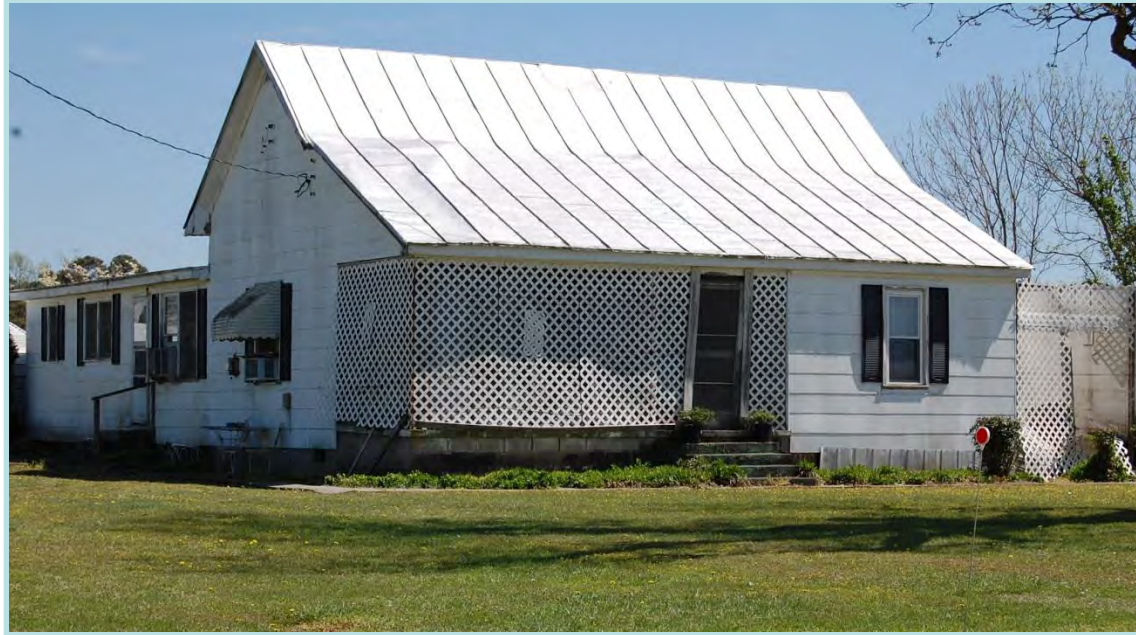
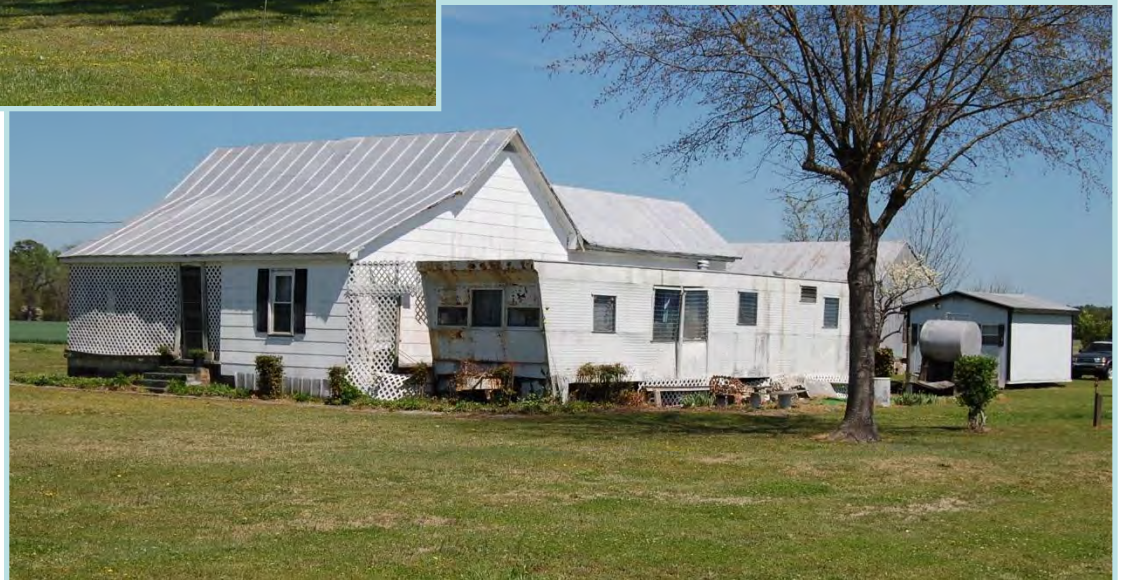
**#29 - JESSE JACKSON CROOM HOUSE (LR-1036) – 1890s frame house; believed to lack significance and integrity**

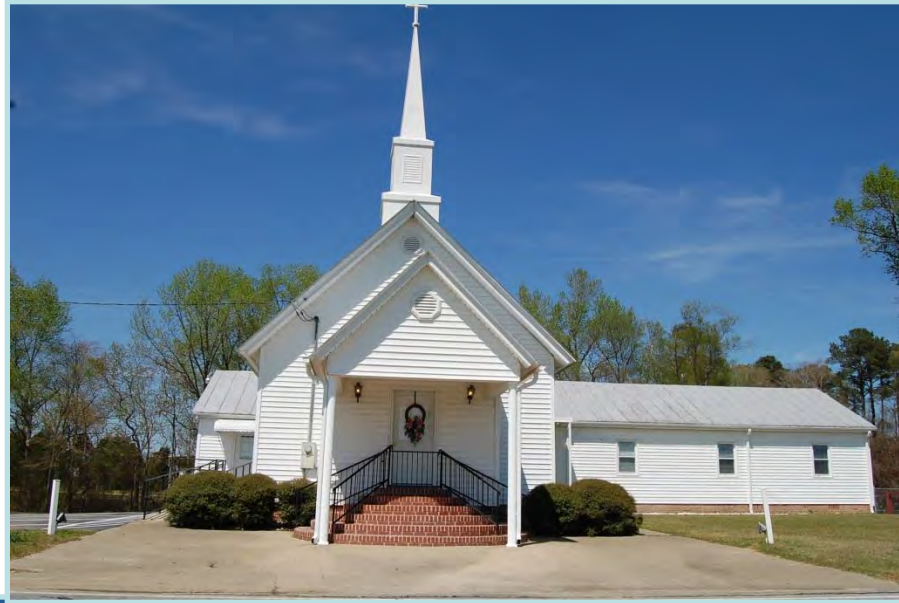
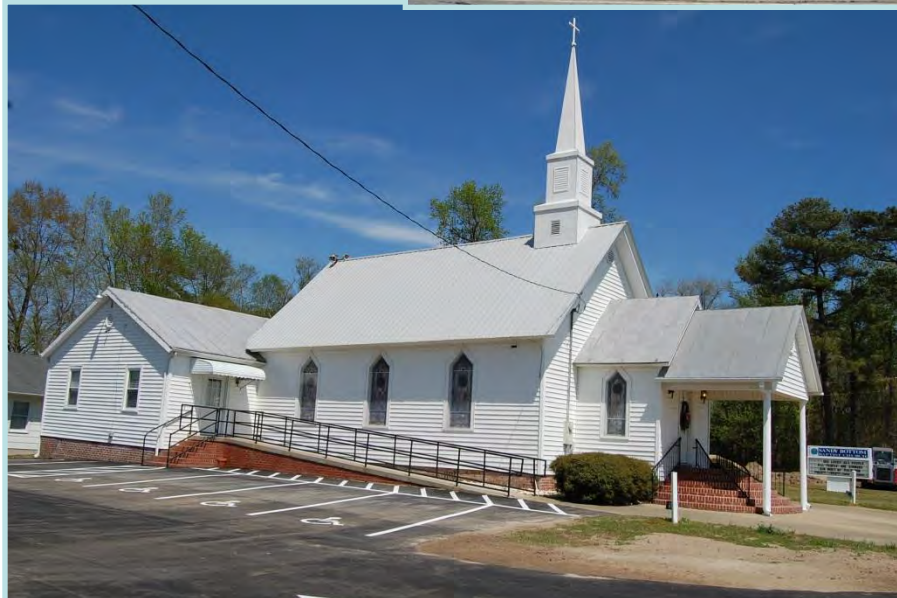
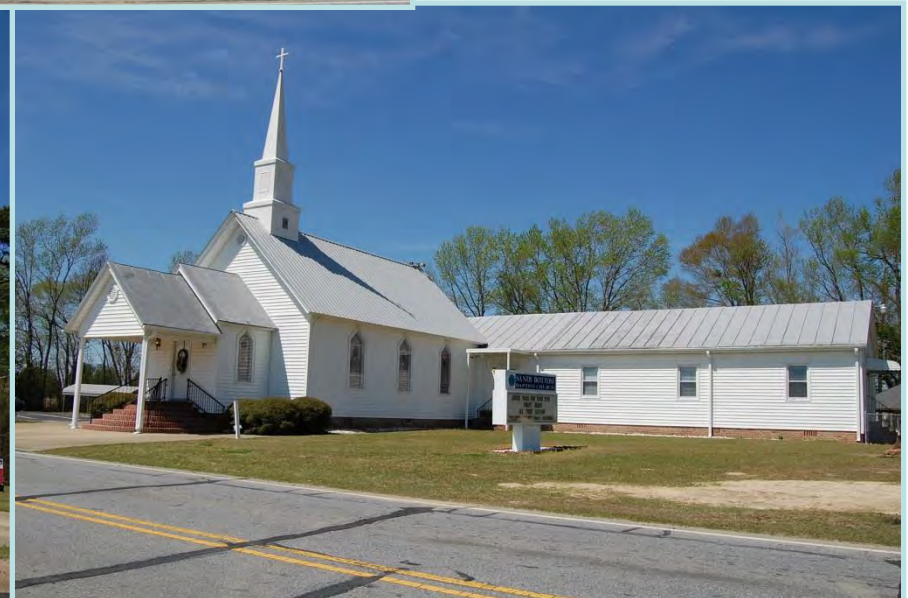
**#30 - SANDY HILL BAPTIST CHURCH (LR-1037) – turn-of-the-century church w/ mid-20<sup>th</sup>-c additions; believed to lack integrity**

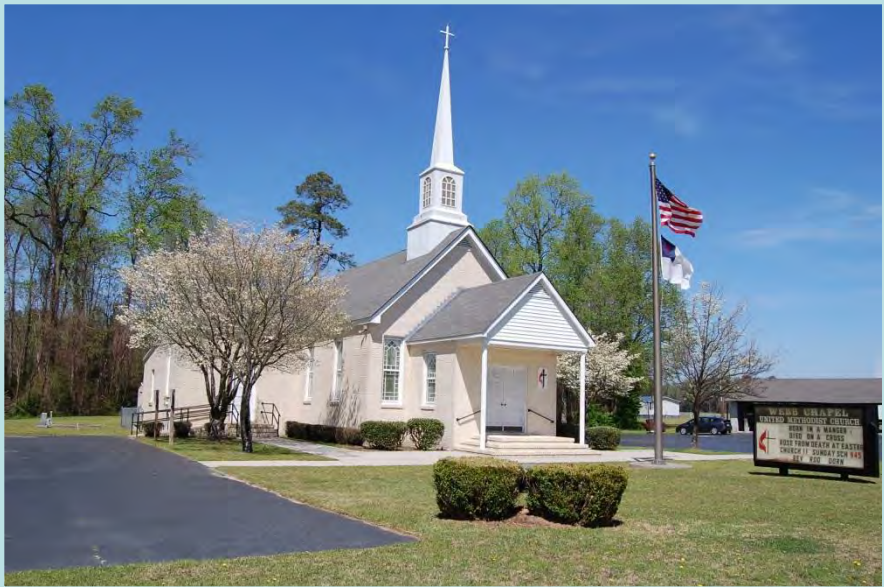
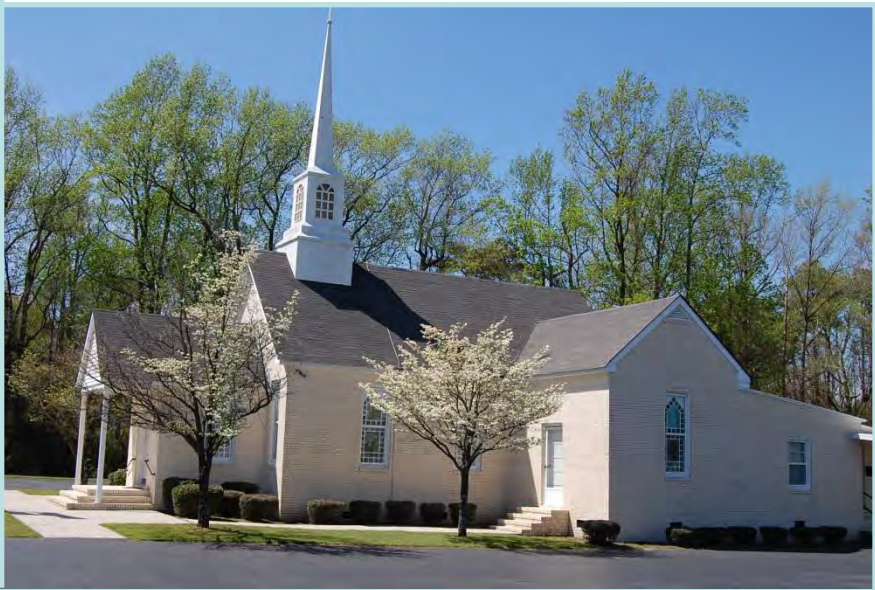
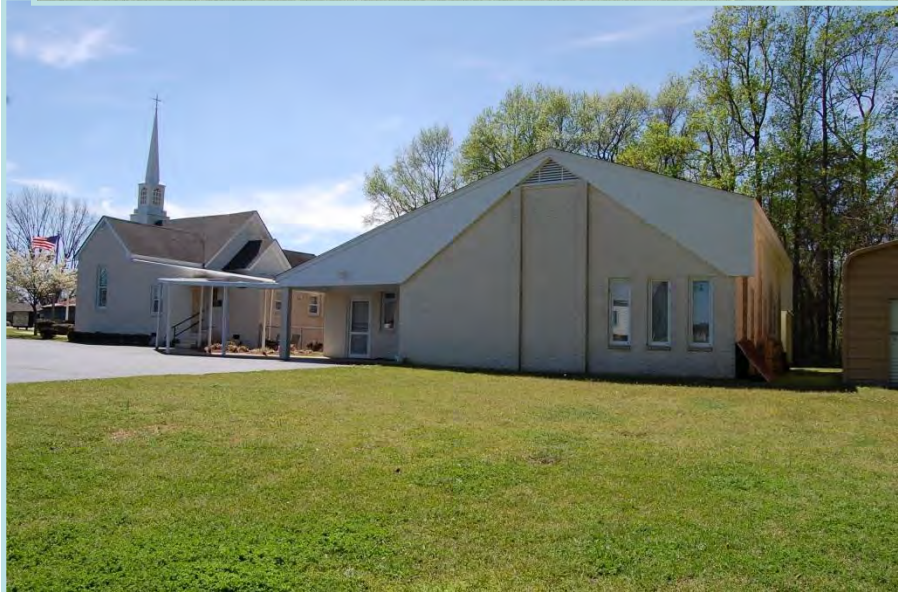
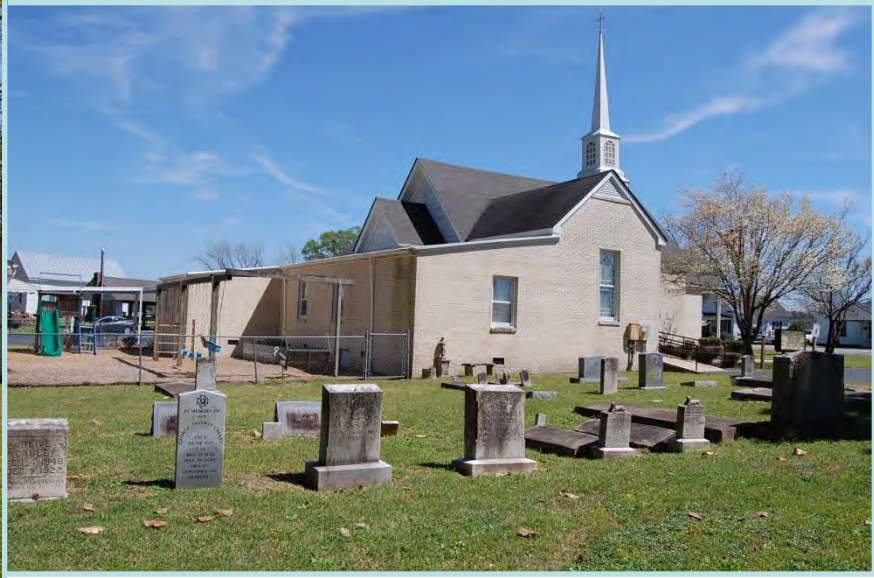
**#31 - WEBB CHAPEL UNITED METHODIST CHURCH (LR-1037) – early 20<sup>th</sup>-c church w/ later additions and brick-veneer; believed to lack integrity**

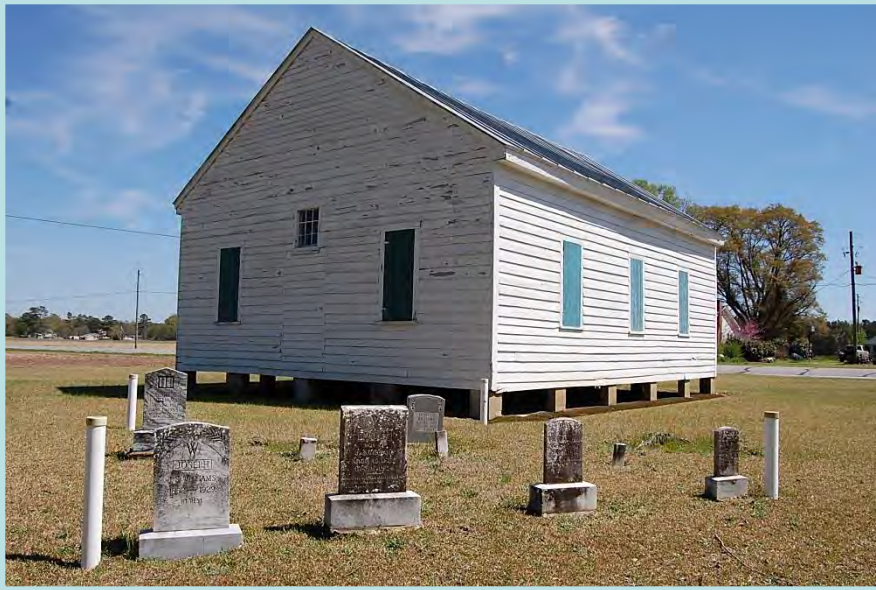
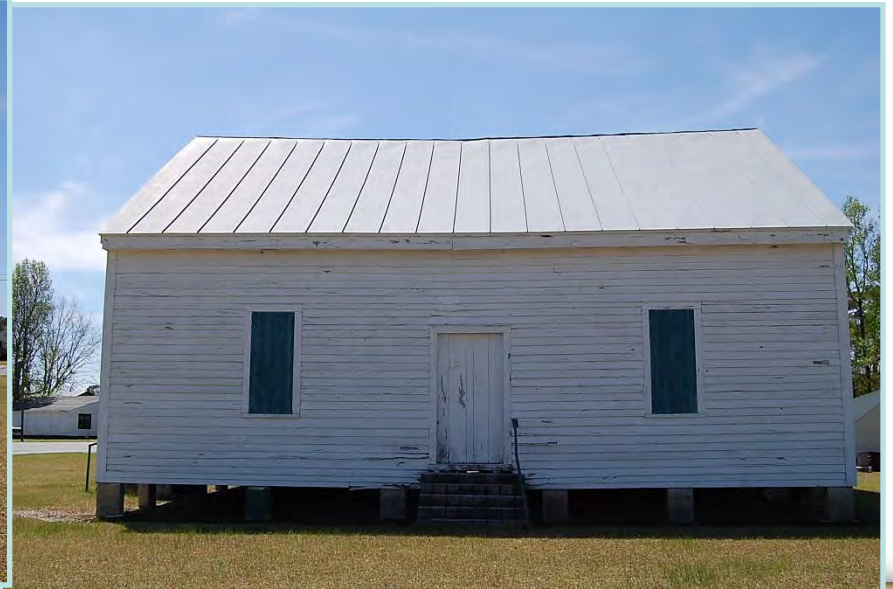
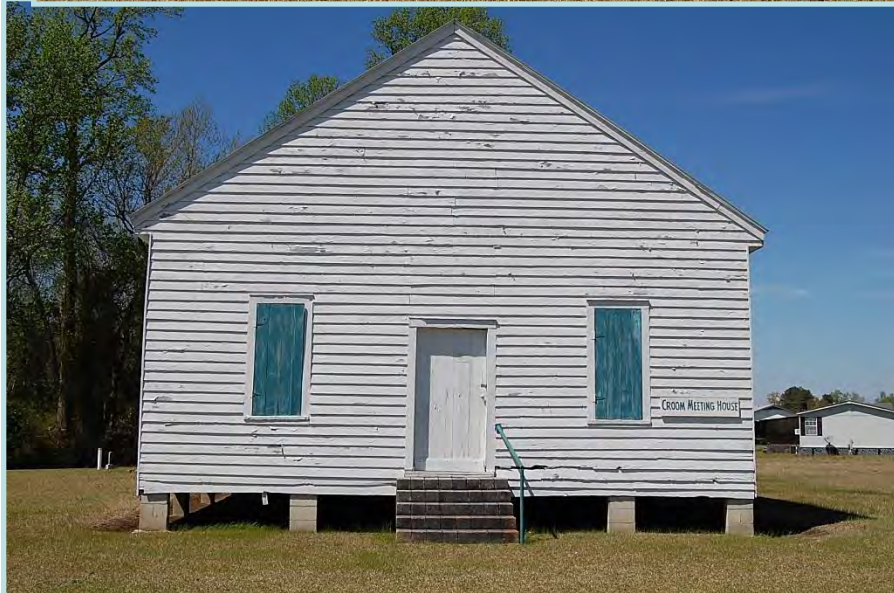
**#32 - CROOM MEETING HOUSE (LR-1040) – Primitive Baptist meeting house erected in 1st half of 19th c; placed on NR Study List in 1994, requires further assessment**

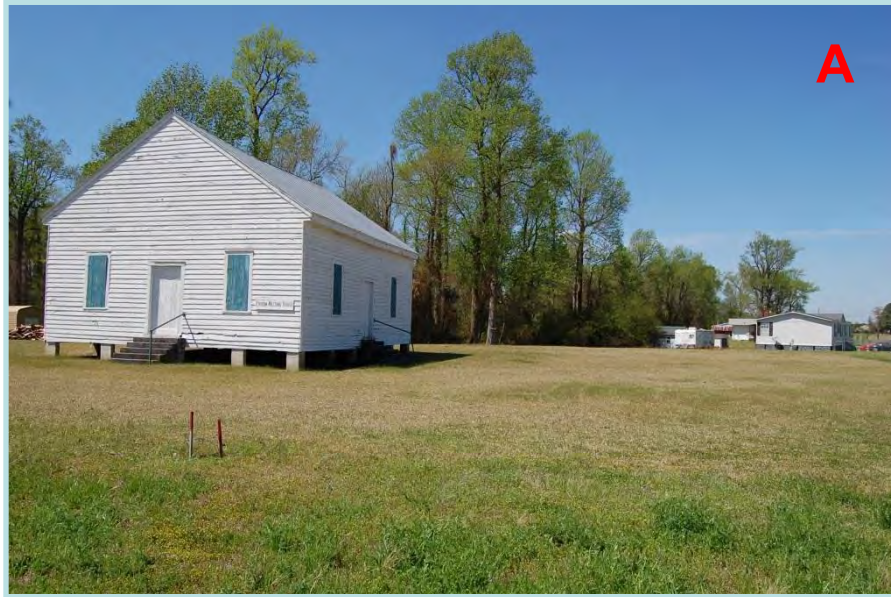
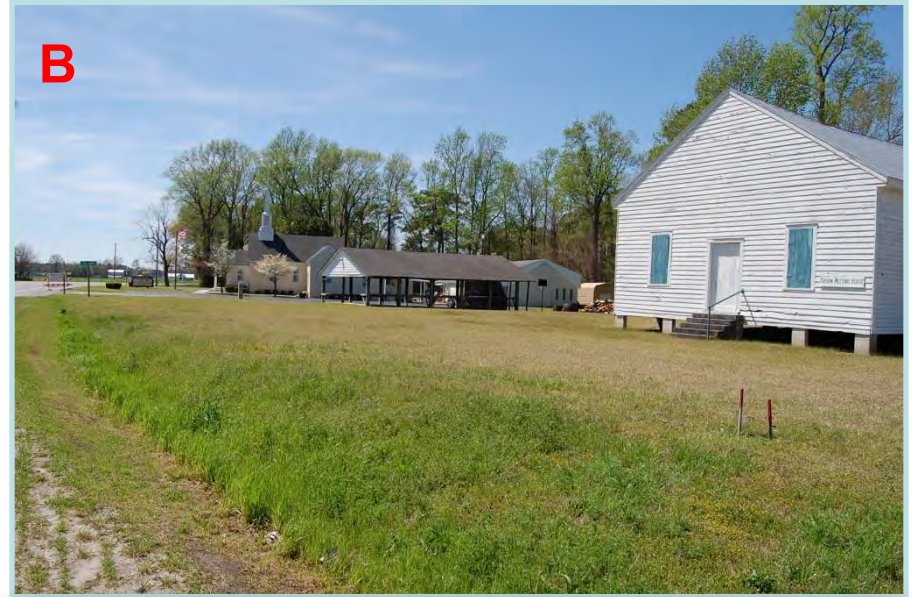
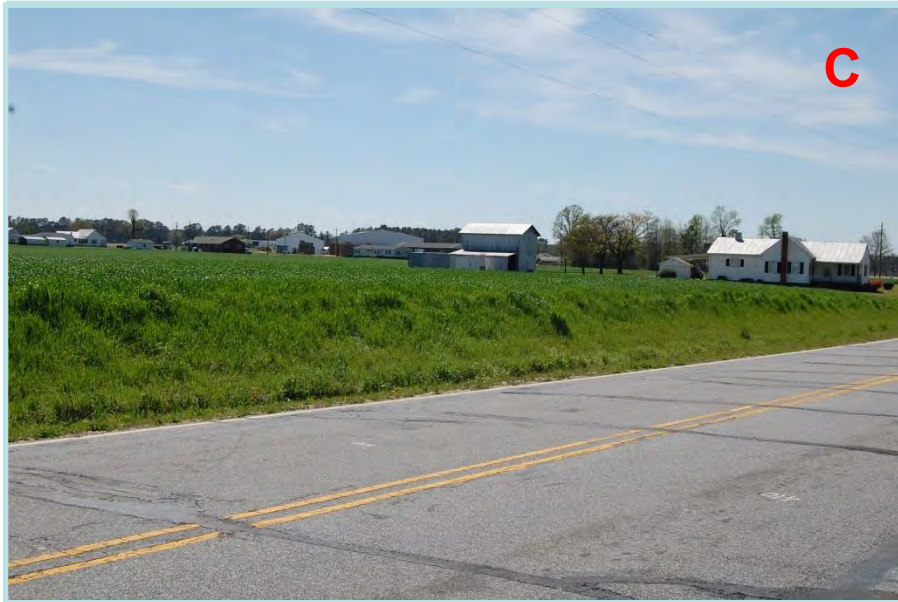
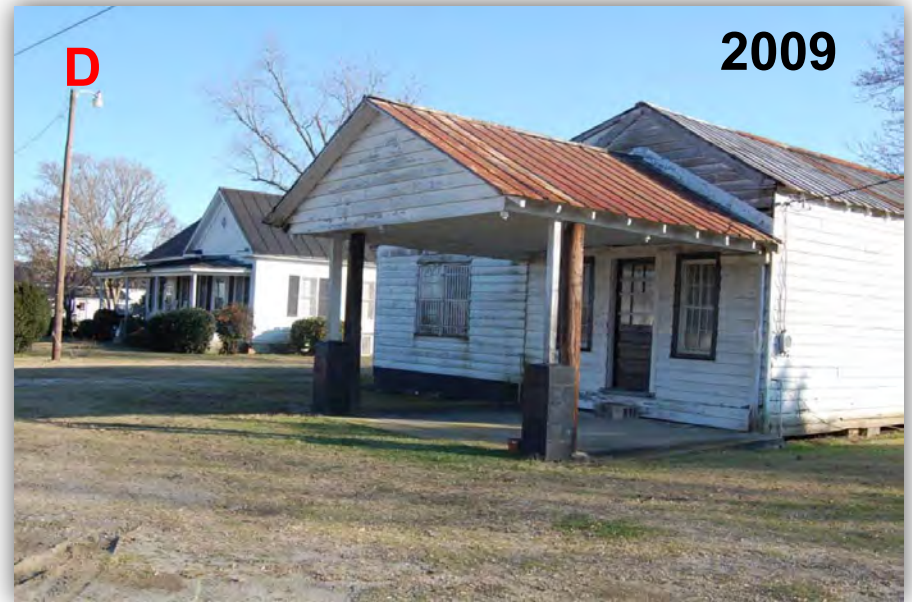
# #33 - SANDY BOTTOM COMMUNITY (LR-1039) – 1890s to 1940s and later rural community; believed to lack integrity

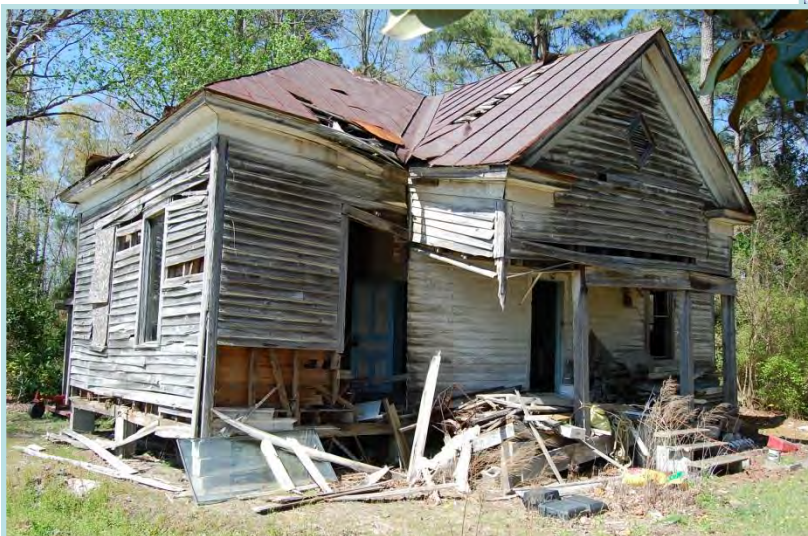
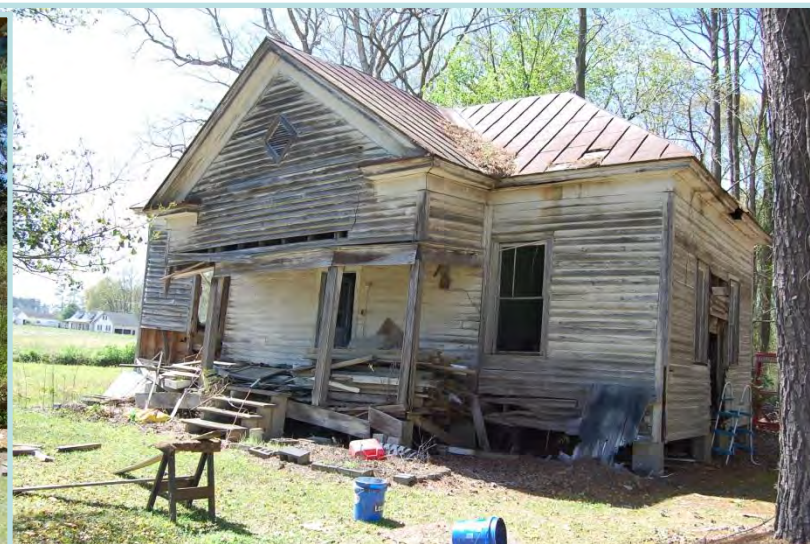
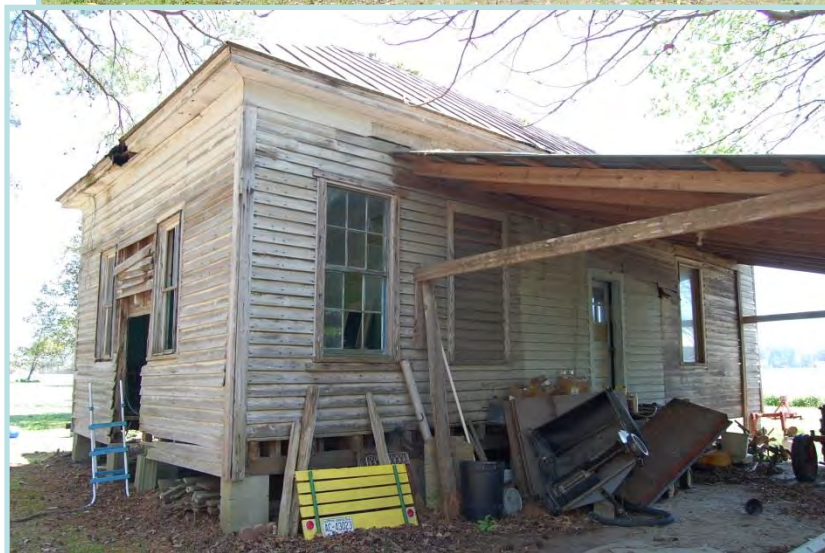
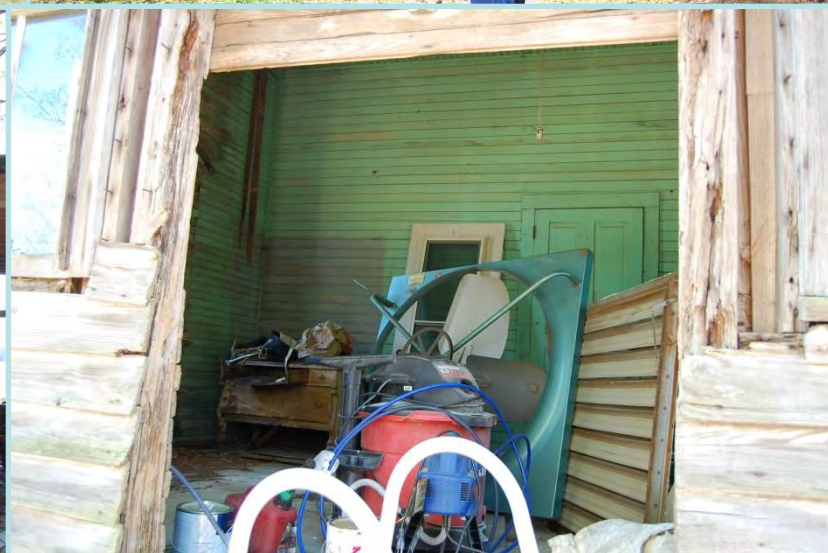
**#34 - (FORMER) PINEY GROVE SCHOOL (LR-1049) – early 20<sup>th</sup>-c frame building moved ½ mile to current site ca.1965; believed to lack integrity**
