North Carolina Department of Natural and Cultural Resources  
State Historic Preservation Office

MEMORANDUM

Subject: Historic Architecture Eligibility Evaluation Report, US 70 Kinston Bypass, R-2553,  
Lenoir County, ER 09-1307

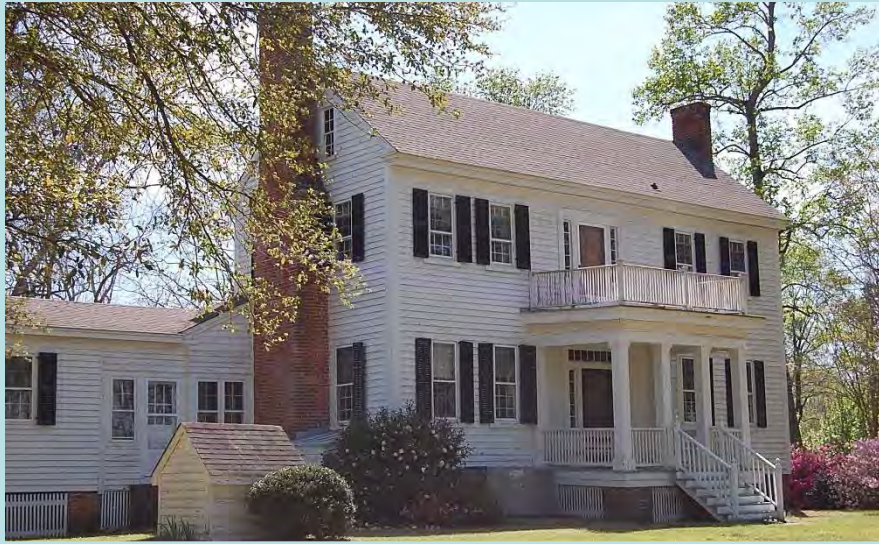
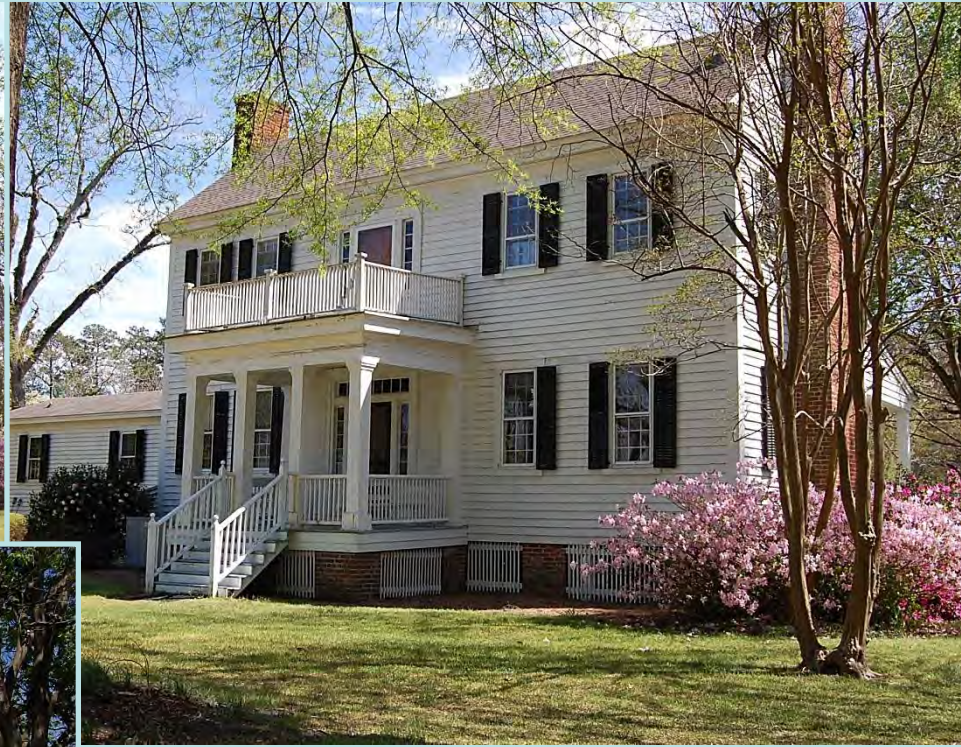
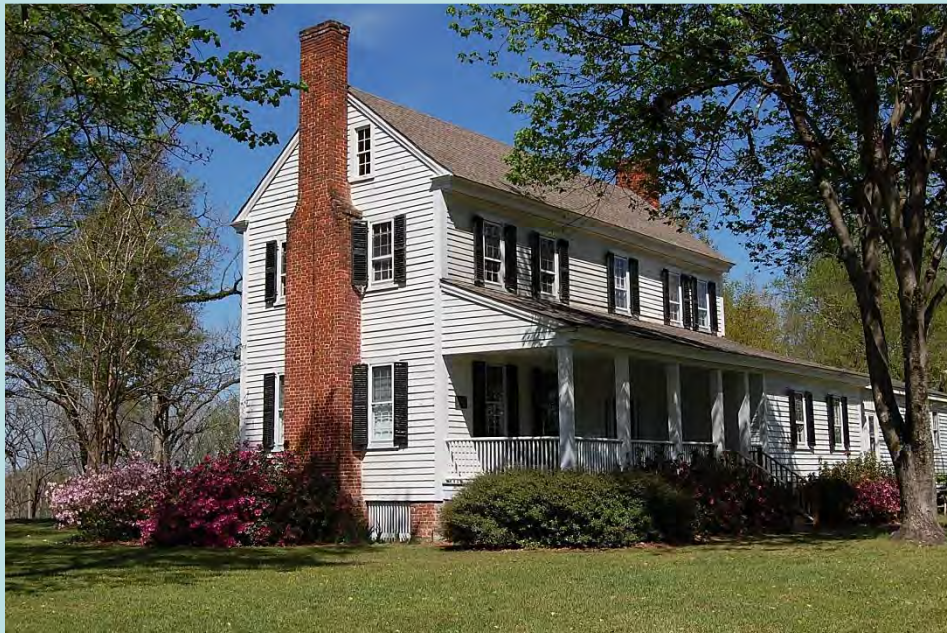
**#35 - JESSE JACKSON HOUSE (LR-0005) – Greek Revival-style plantation seat built 1840s; NR-listed in 1971; believed to merit continued NR listing**

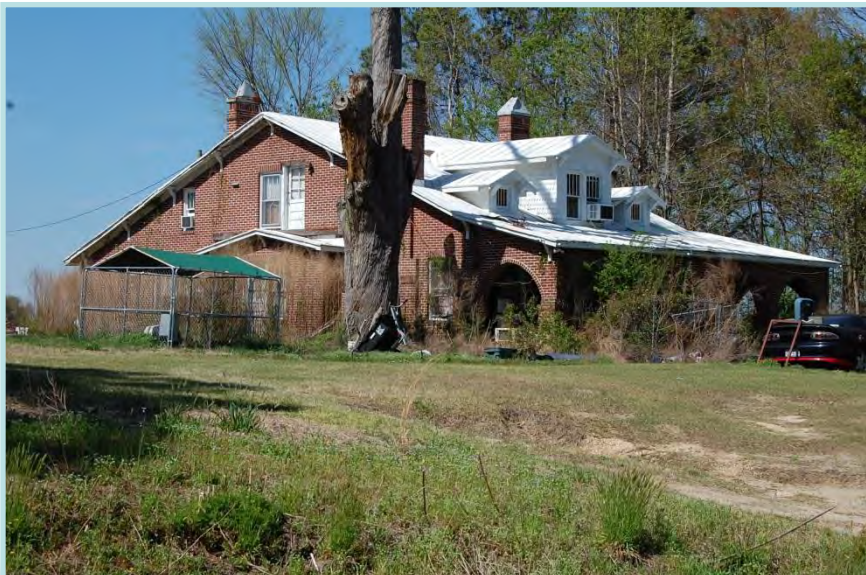
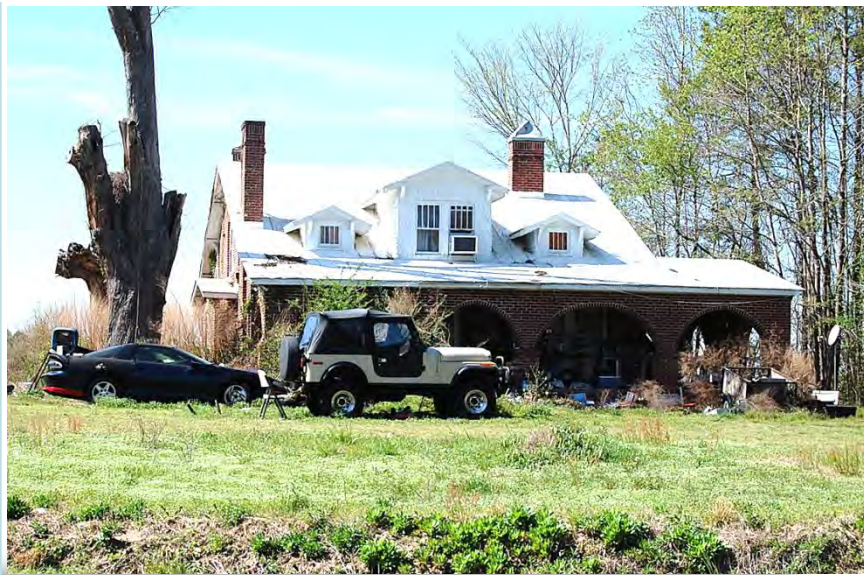
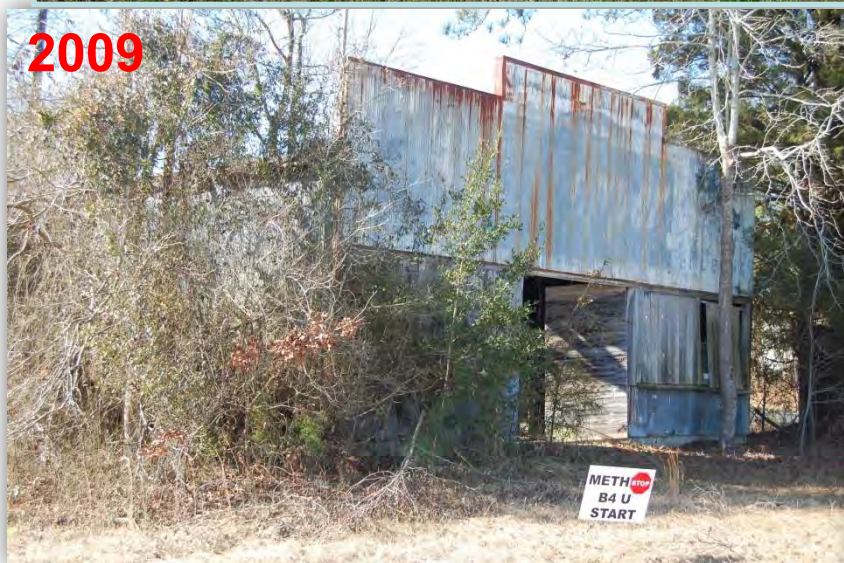
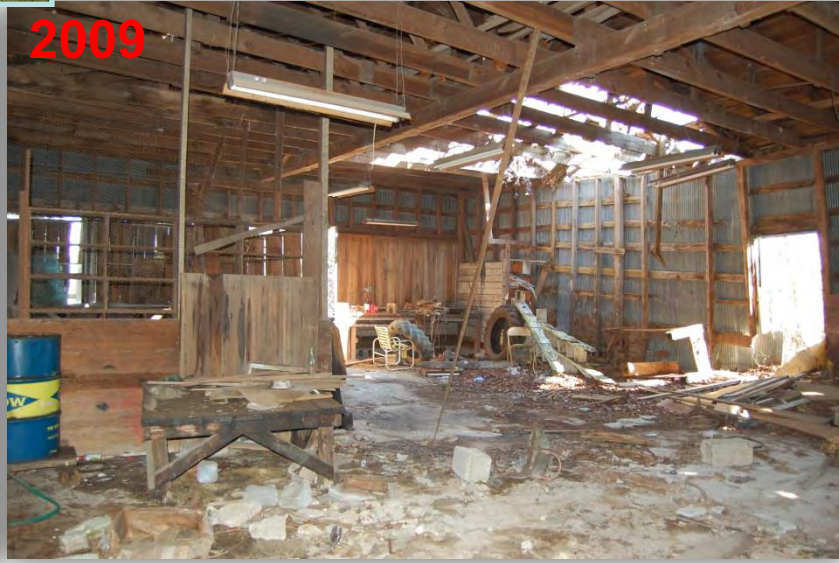
**#36 - MILLAR WALLER HOUSE II AND STORE/SAWMILL (LR-0593) –  
1920s brick bungalow and former store/sawmill; believed to lack  
significance and integrity**

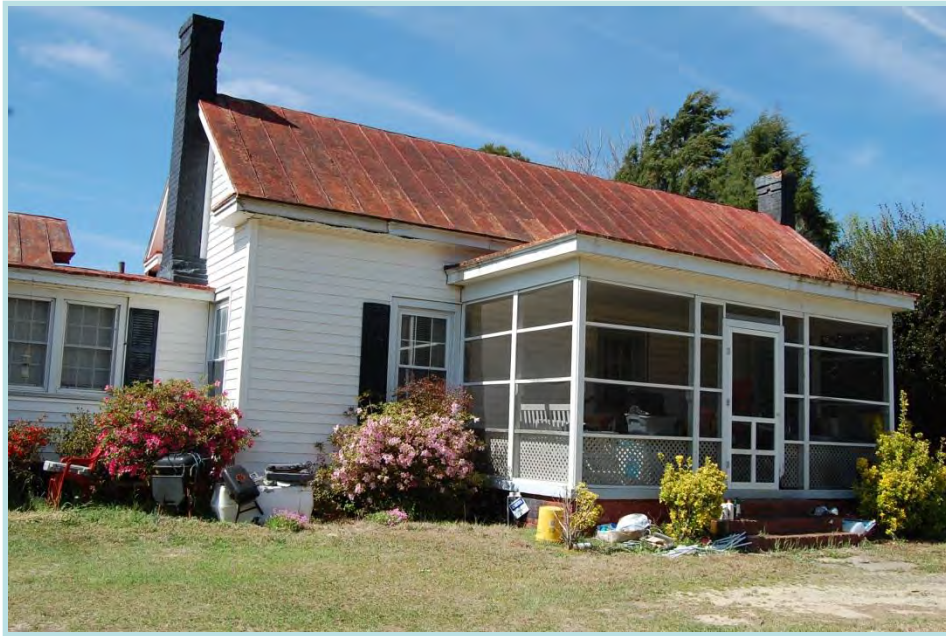
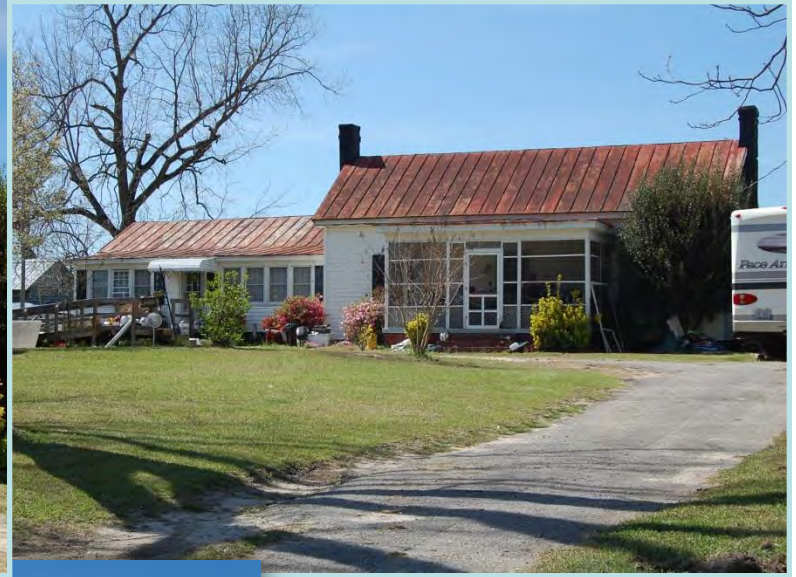
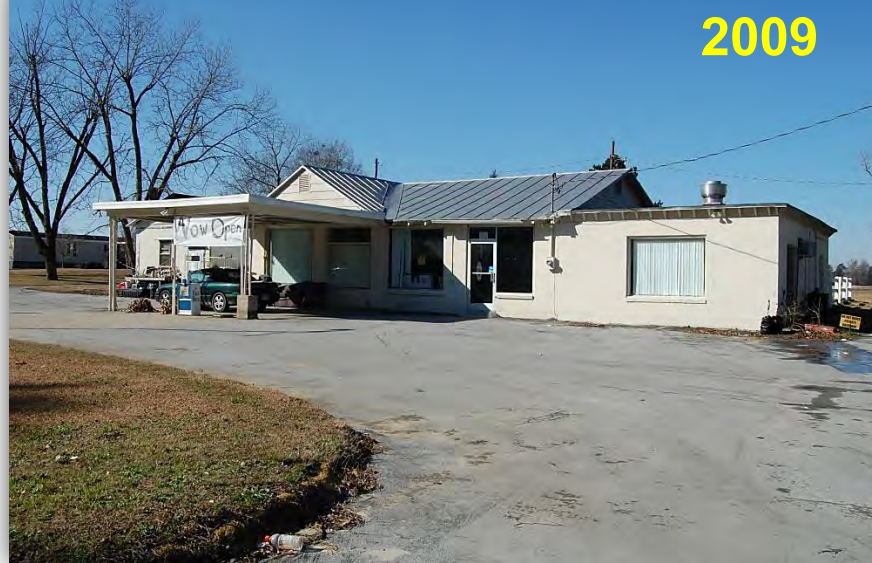
**#37 - MILLAR WALLER HOUSE I (LR-0588) – ca.1890 house and 1940s store; believed to lack significance and integrity**

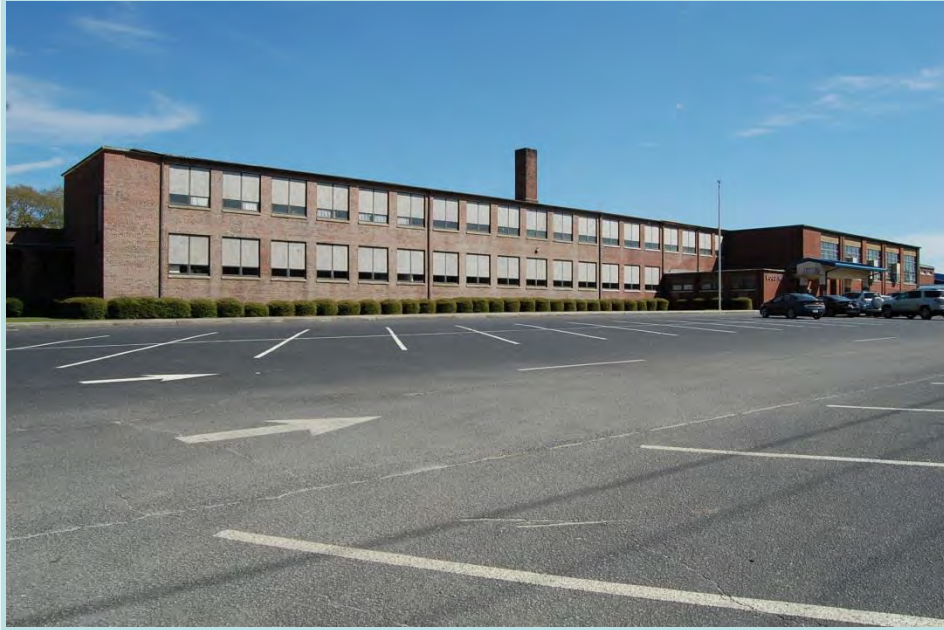
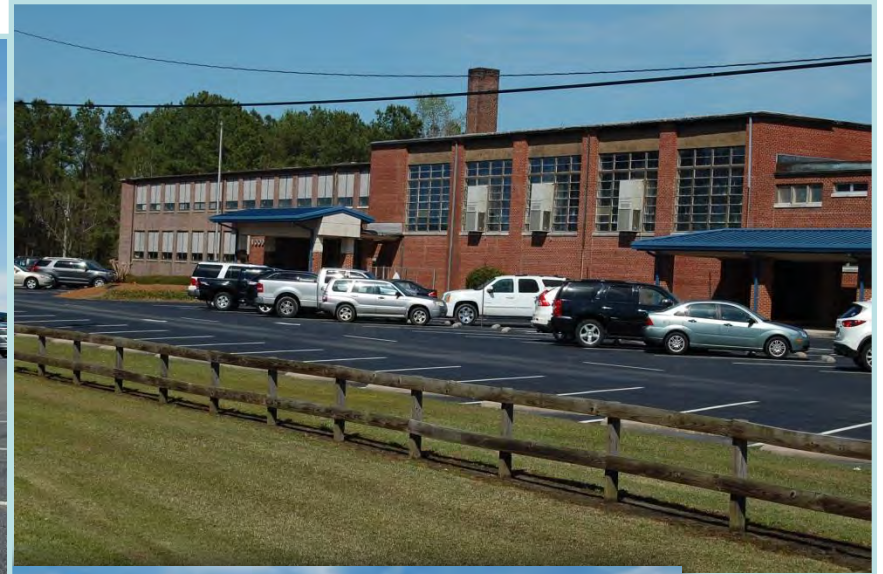
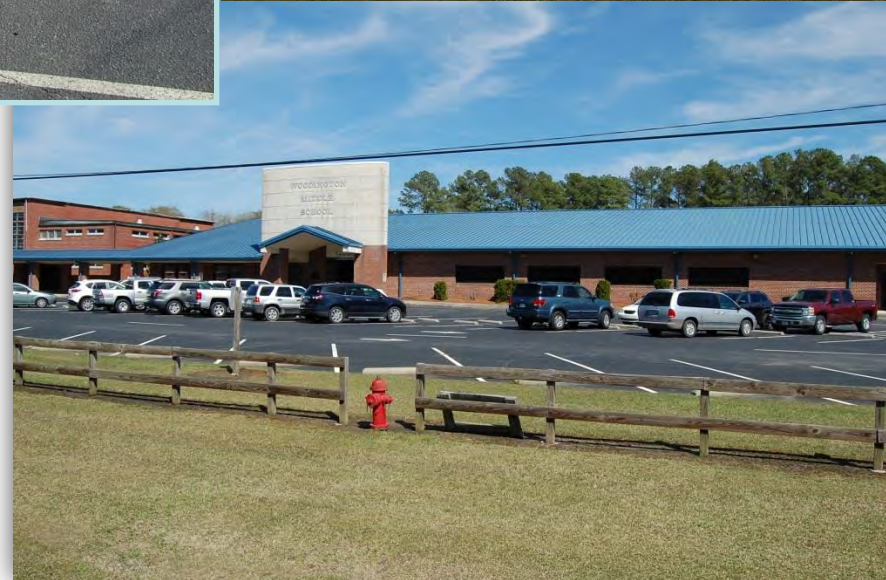
**#38 - WOODINGTON MIDDLE SCHOOL (LR-1544) – 2-story block built late 1940s/early 1950s; central gymnasium likely added later in 1950s; 1-story block ca.1999-2009; believed to lack integrity**

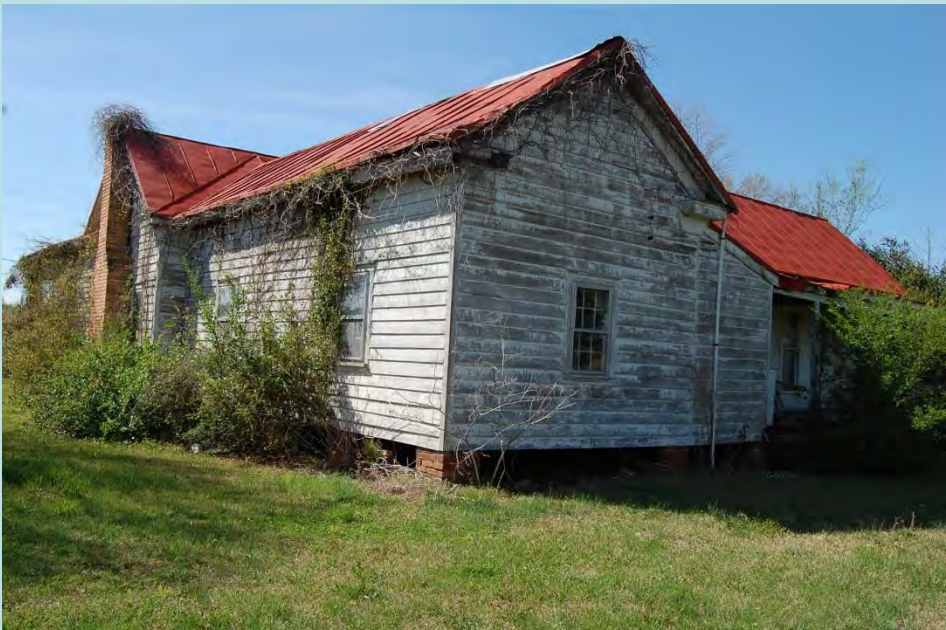
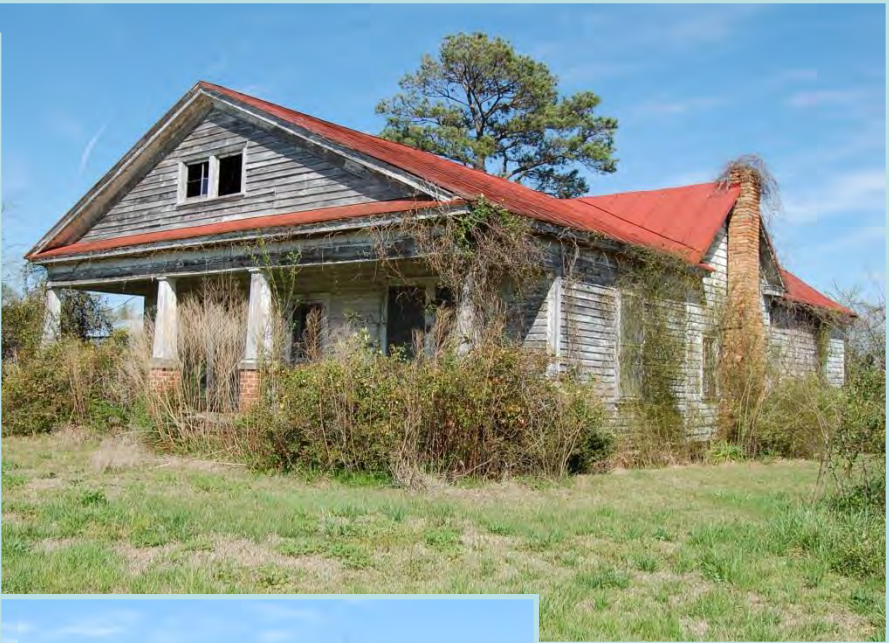
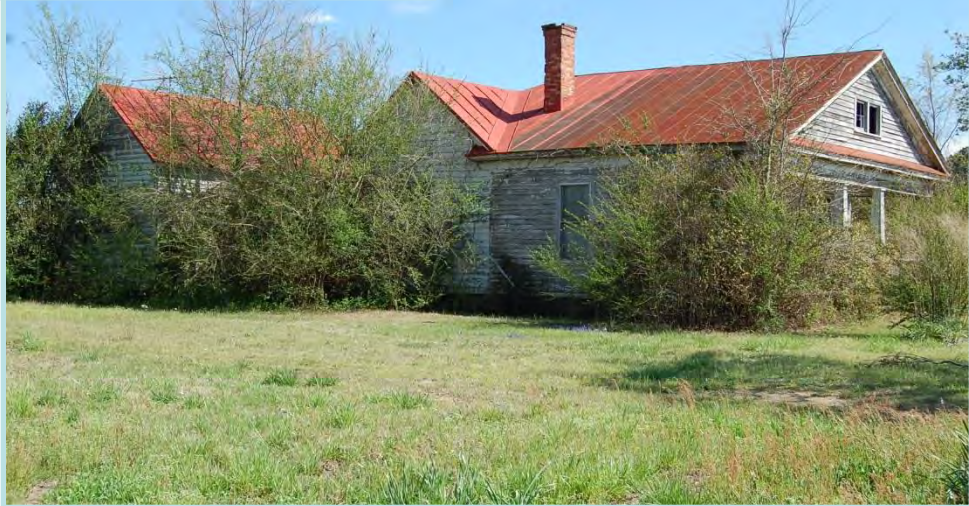
**#39 - HOUSE (LR-1545) – rear gable-and-wing block late 19<sup>th</sup>-c; front block w/ Craftsman porch added 1920s; believed to lack integrity**

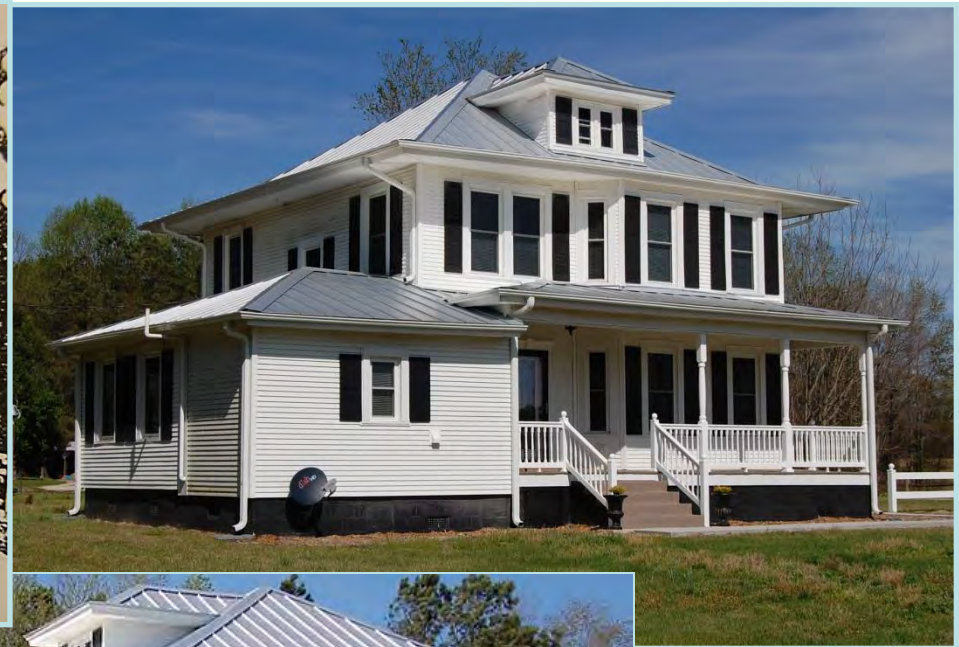
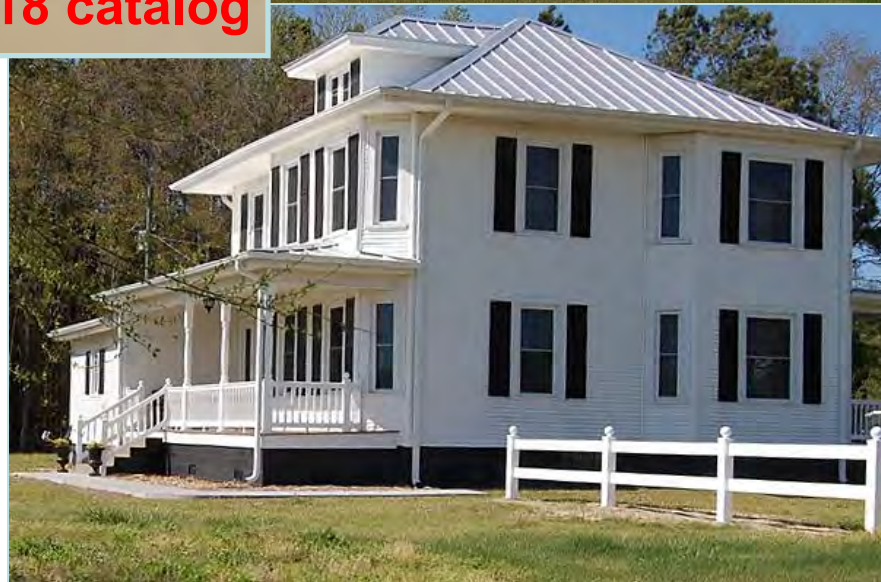
**#40 - SIMPSON WALLER HOUSE (LR-1213) – 1918 Aladdin Homes prefabricated house; placed on NR Study List in 1994, requires further assessment**

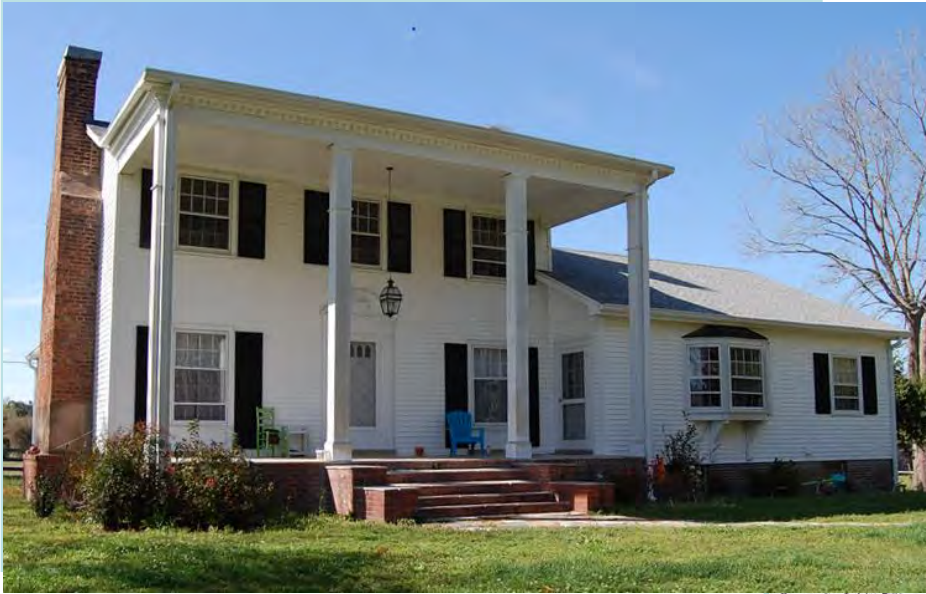
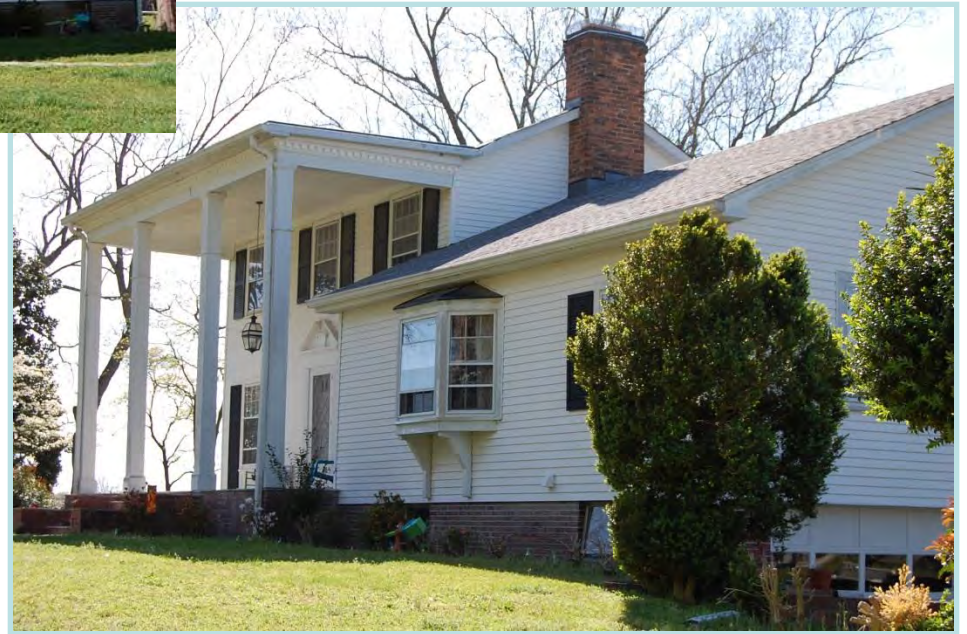
**#41 - SUTTON HOUSE (LR-1548) – 1960s house that according to owner encompasses part of a mid-19<sup>th</sup>-c Sutton-family house; believed to lack significance and integrity**

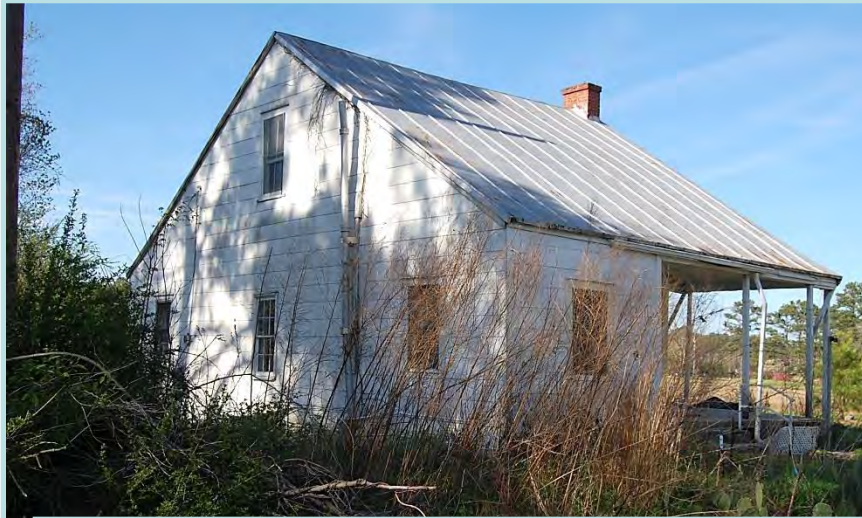
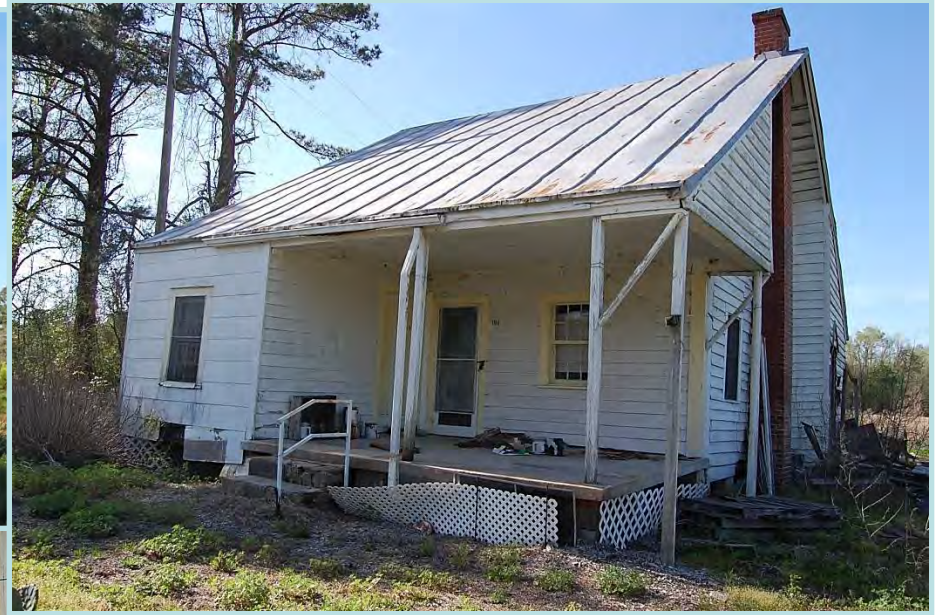
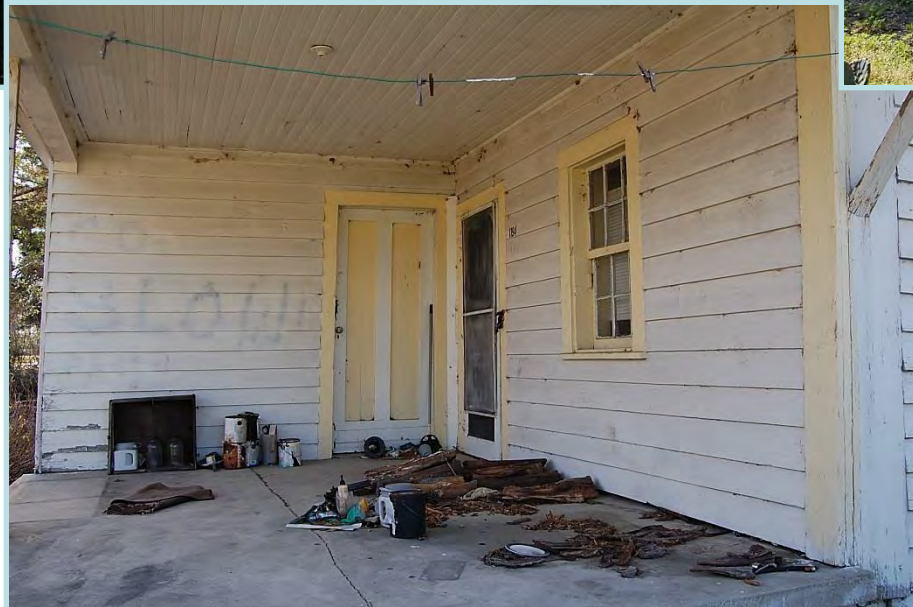
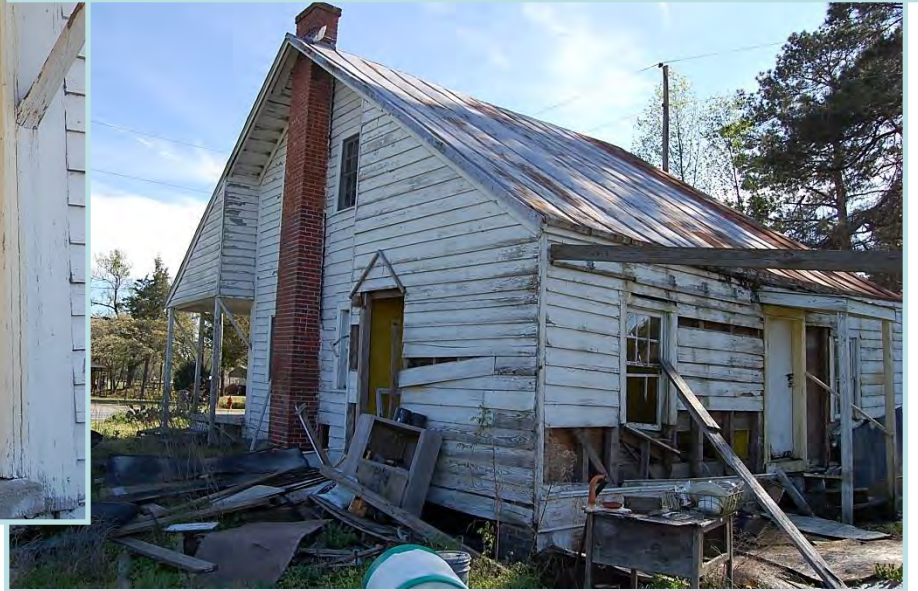
**#42 - HUNTER-HARPER LOG HOUSE (LR-1218) – mid-19<sup>th</sup> c log house with frame shed addition at rear; believed to lack integrity**

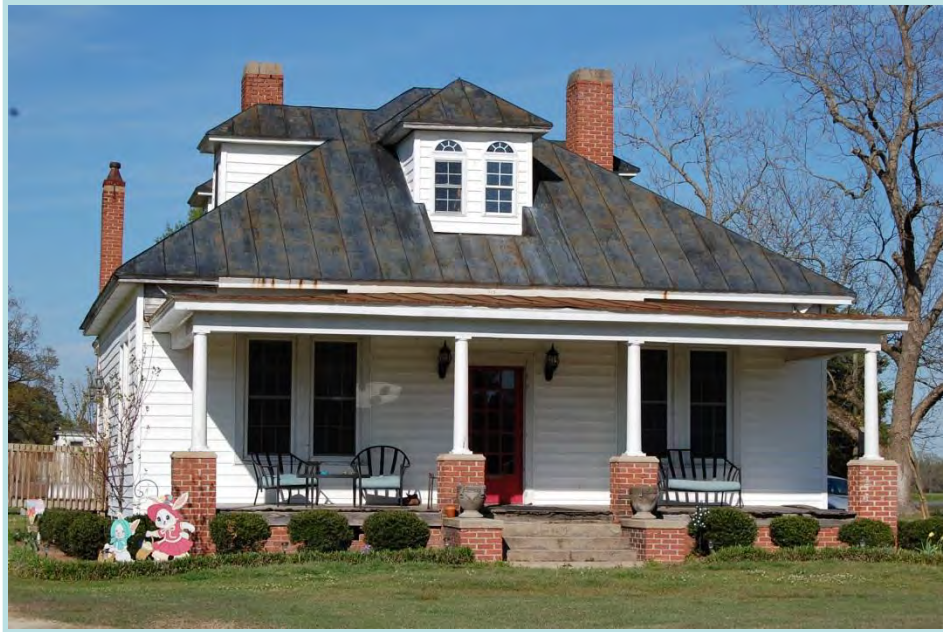
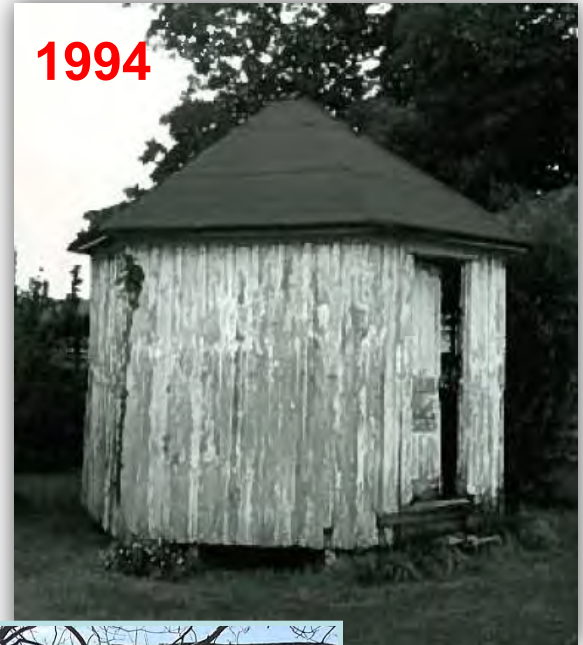
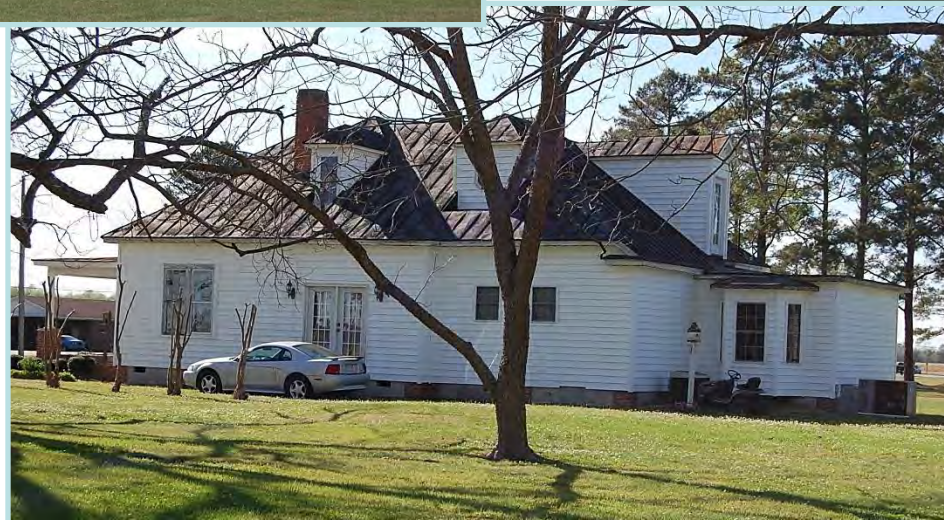
**#43 - ELLIOT S. RUSSELL HOUSE (LR-1193) – ca.1927 frame house;  
unique-to-county, ca.1906 apiary moved to site no longer extant ;  
believed to lack significance and integrity**

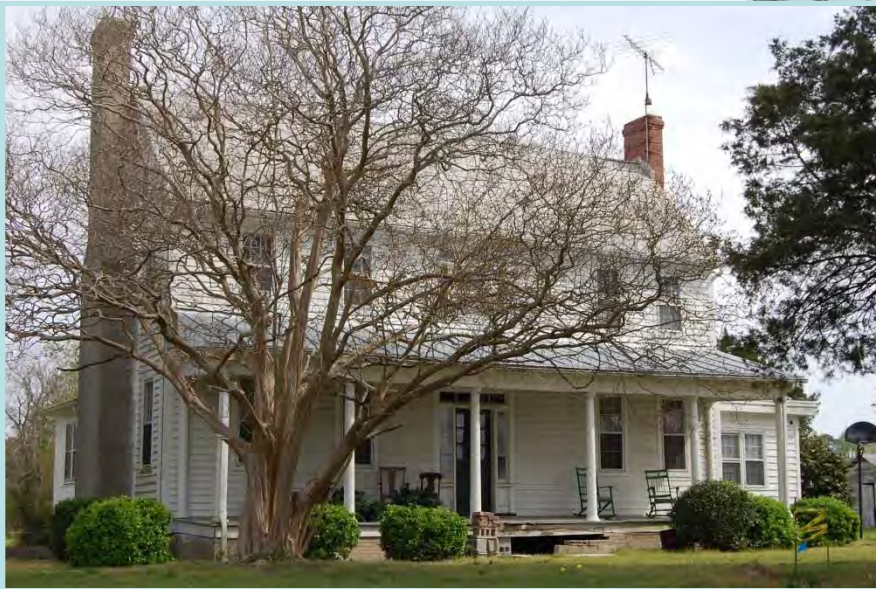
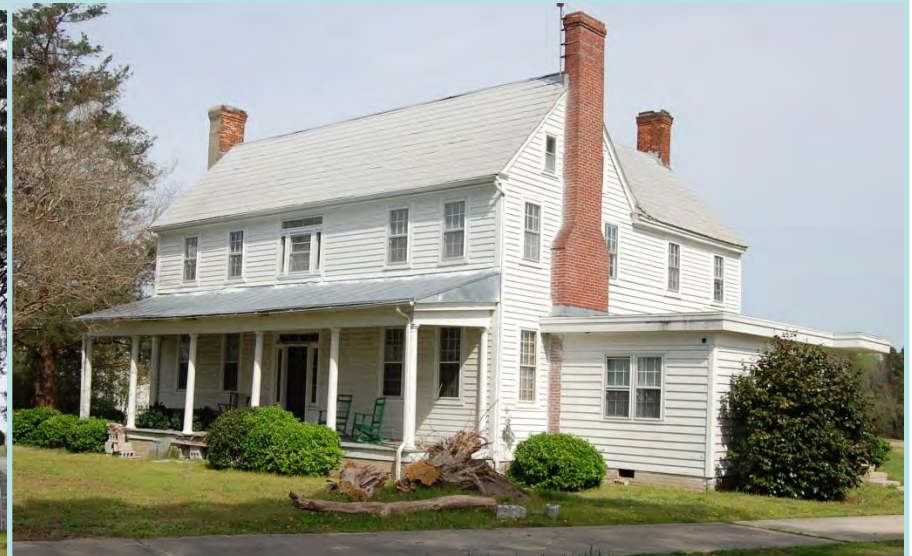
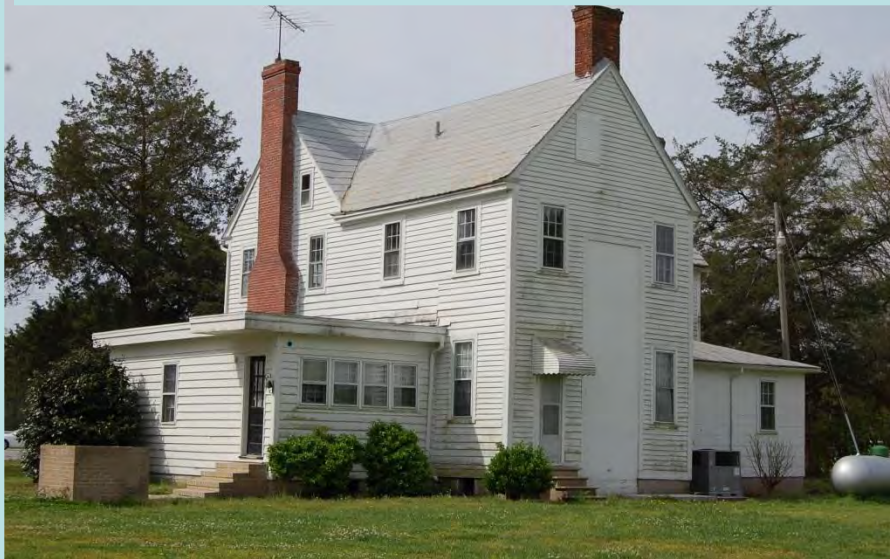
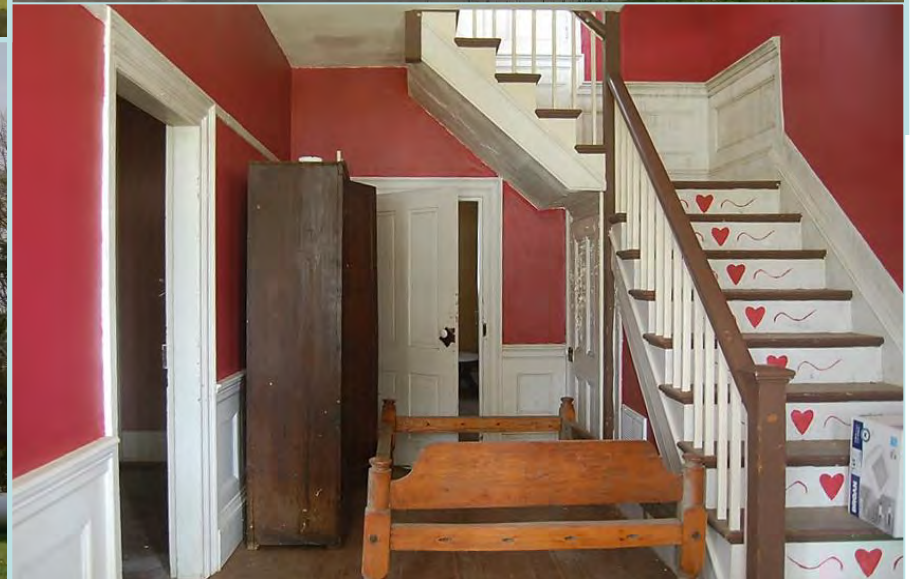
**#44 - COBB-KING-HUMPHREY HOUSE (LR-1197) – contributes to Wyse Fork Battlefield (JN-0306) as part of archaeological site 31LR234; NR Study List in 1994, requires further assessment independent of Wyse Fork**

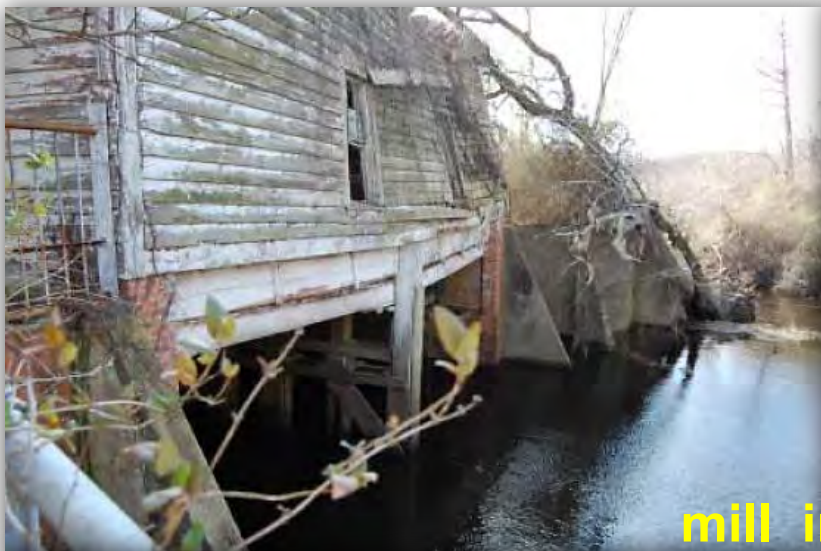
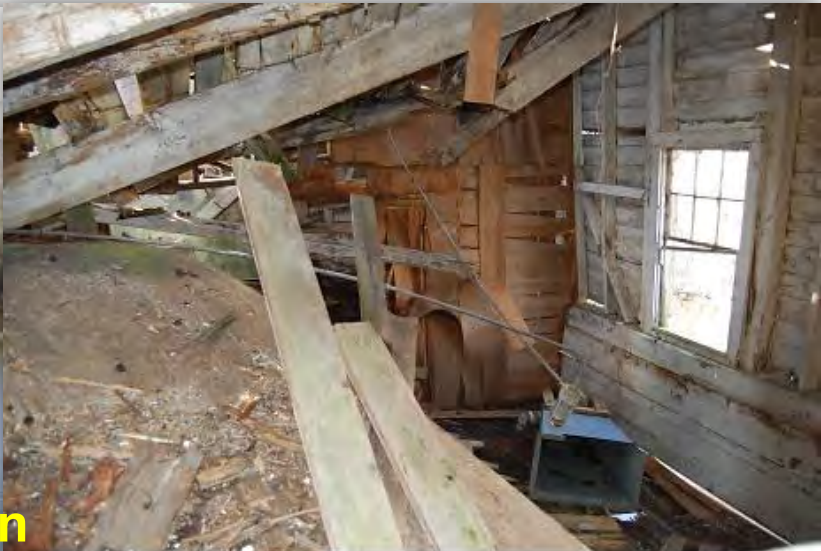
**#45 - KELLY'S MILLPOND SITE (LR-1203) – mill active on site late 18<sup>th</sup> c to 1970s; major portions since collapsed/removed; contributes to Wyse Fork Battlefield (JN-0306) as part of archaeological site 31LR235; 1998 DOE**

mill in 2010

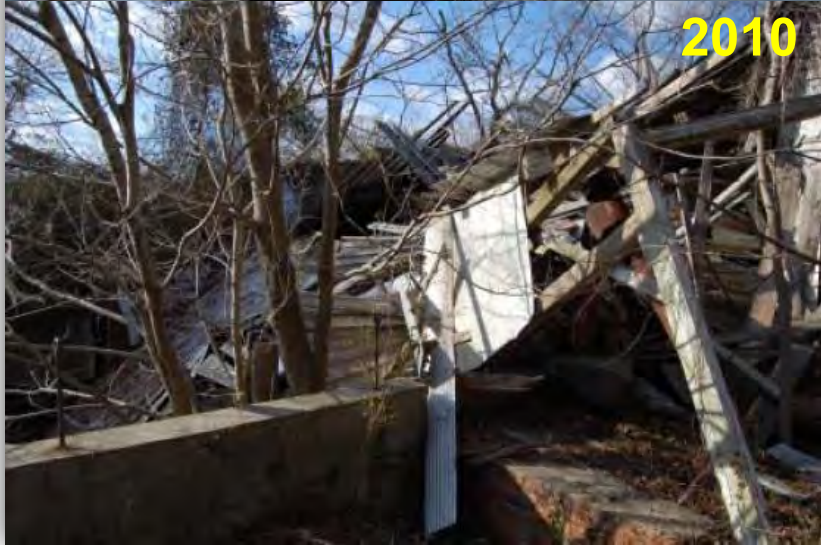
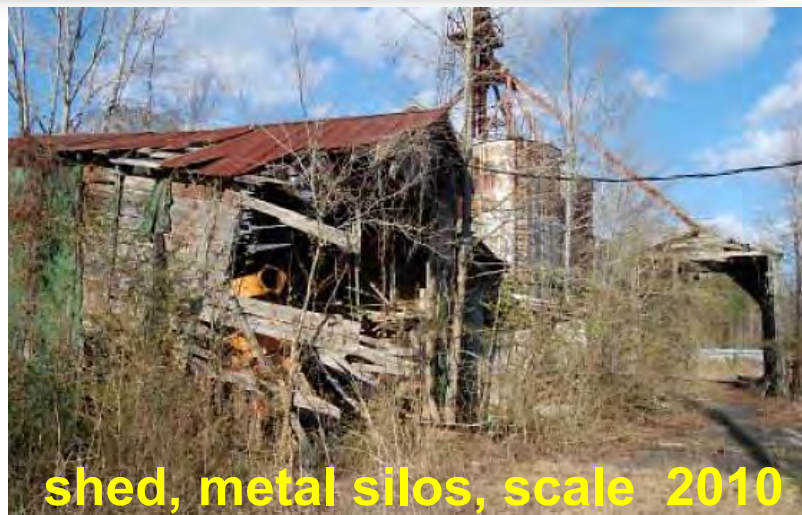
shed, metal silos, scale 2010

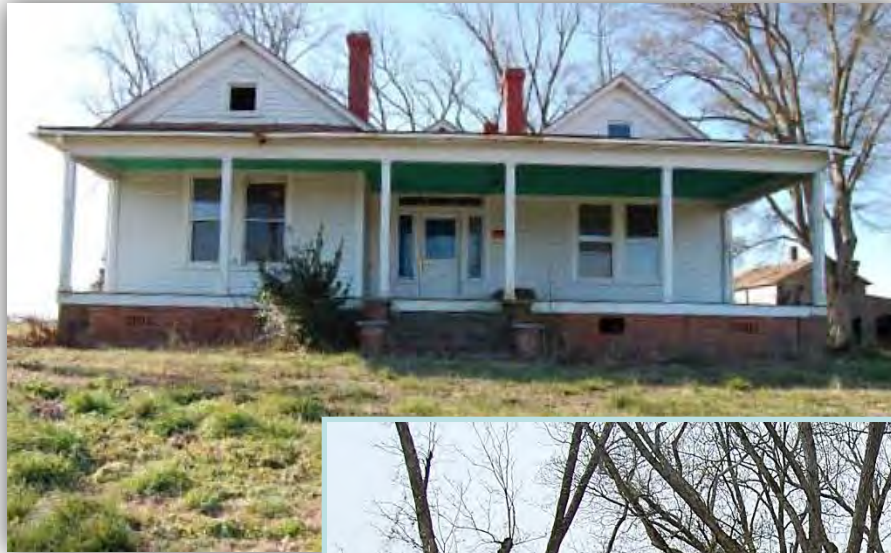
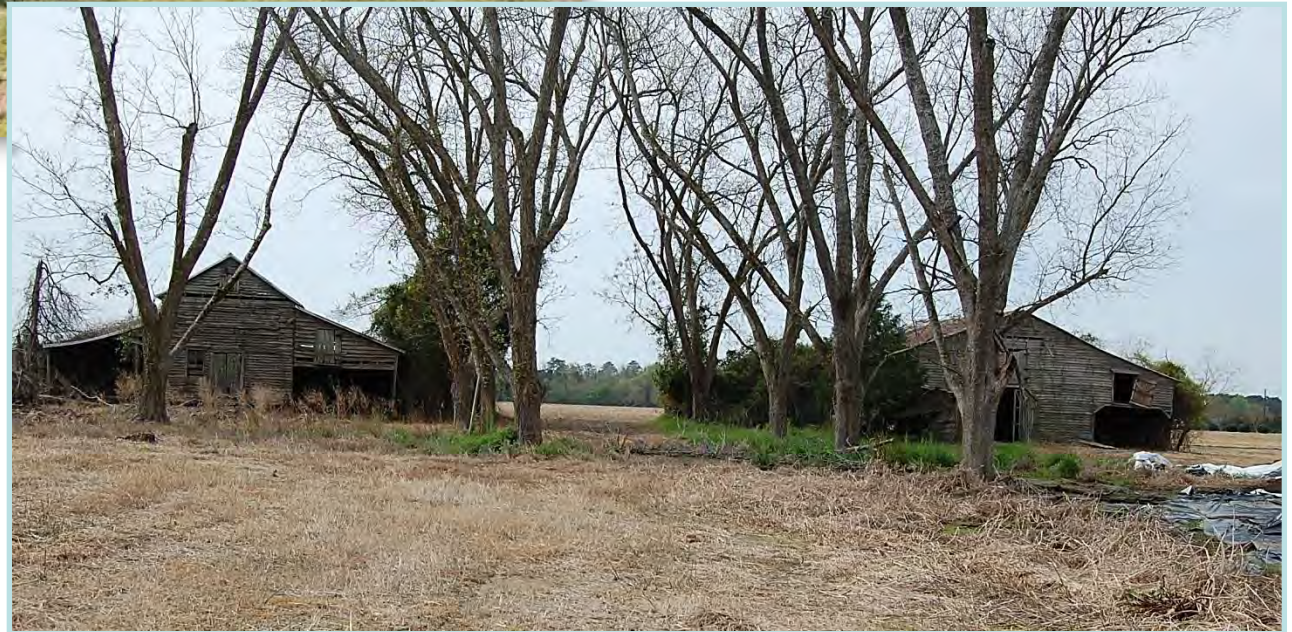
**#46 - THOMAS WALTER STROUD HOUSE AND FARM (MILLER STROUD HOUSE) (LR-1202) – ca.1921, 1929-30 house demolished post-2010; only two outbuildings remain; believed to lack significance and integrity**

**2010**

**2017**

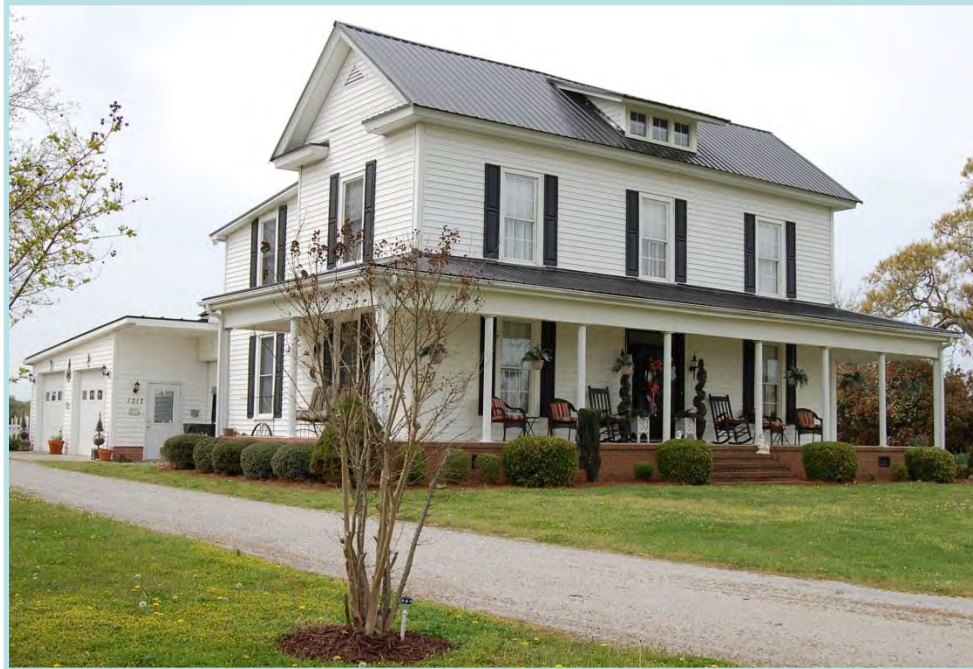
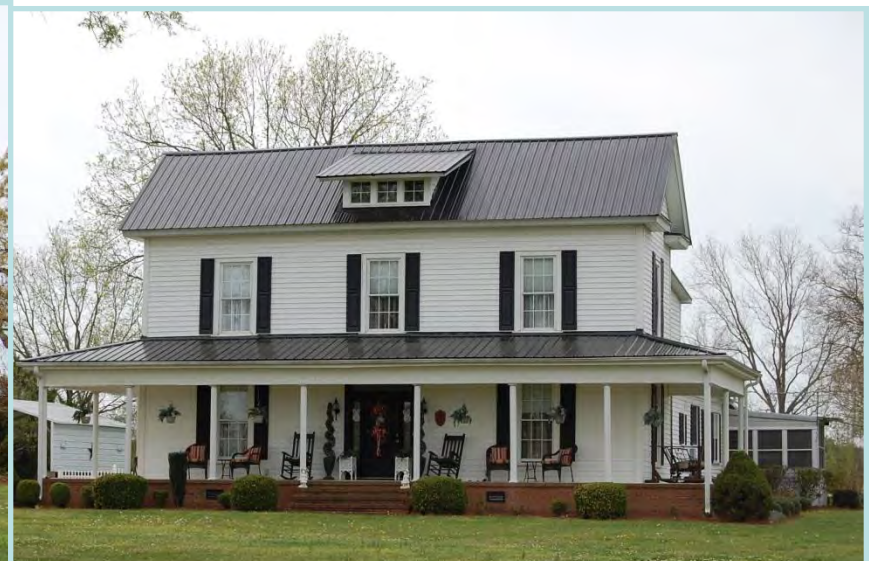
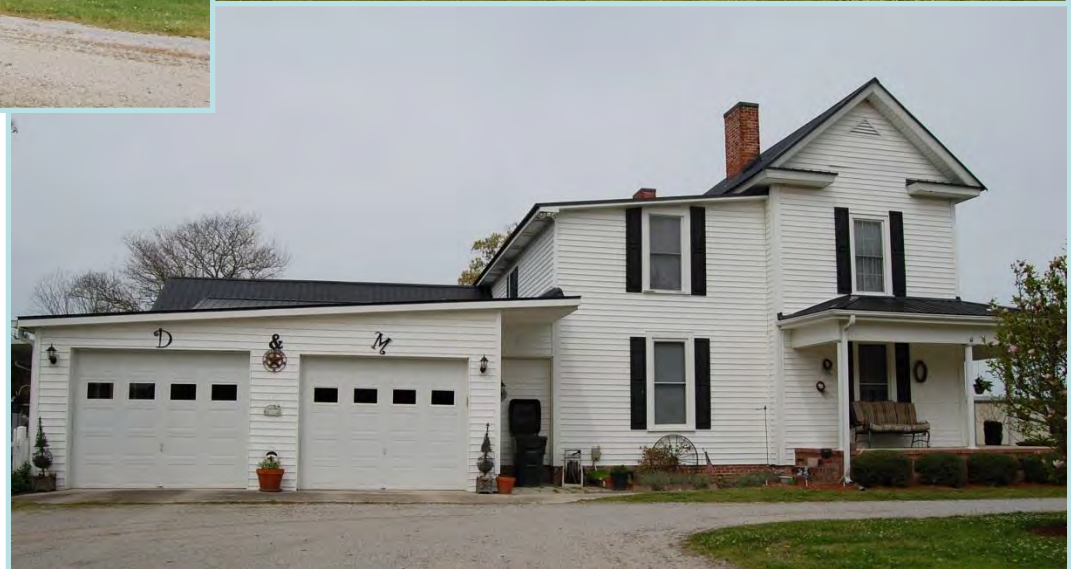
**#47 - HOWARD-WILLIAMS HOUSE (LR-1067) – ca.1890 frame I-house;  
believed to lack significance and integrity**
