North Carolina Department of Natural and Cultural Resources  
State Historic Preservation Office

MEMORANDUM

Subject: Historic Architecture Eligibility Evaluation Report, US 70 Kinston Bypass, R-2553,  
Lenoir County, ER 09-1307

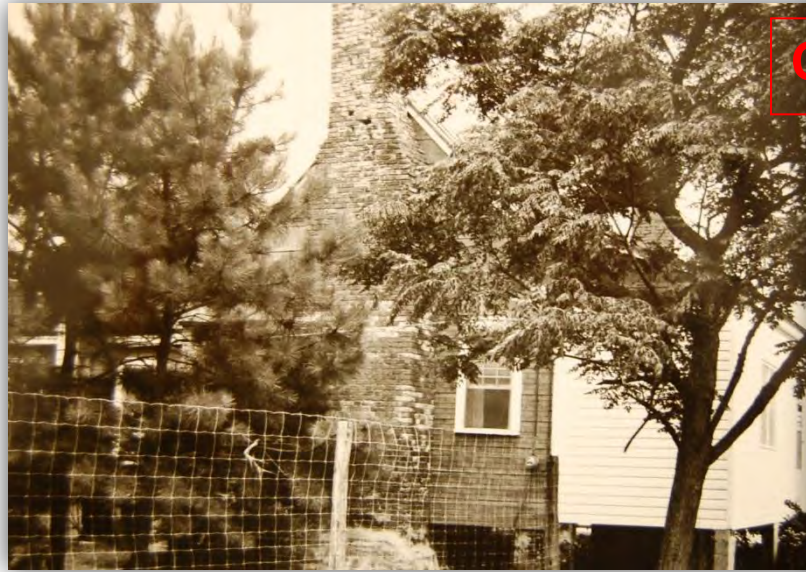
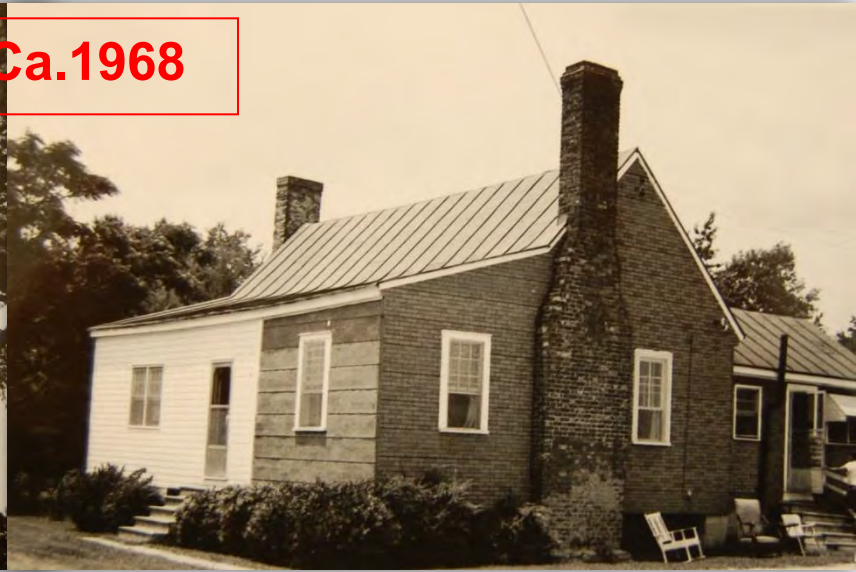
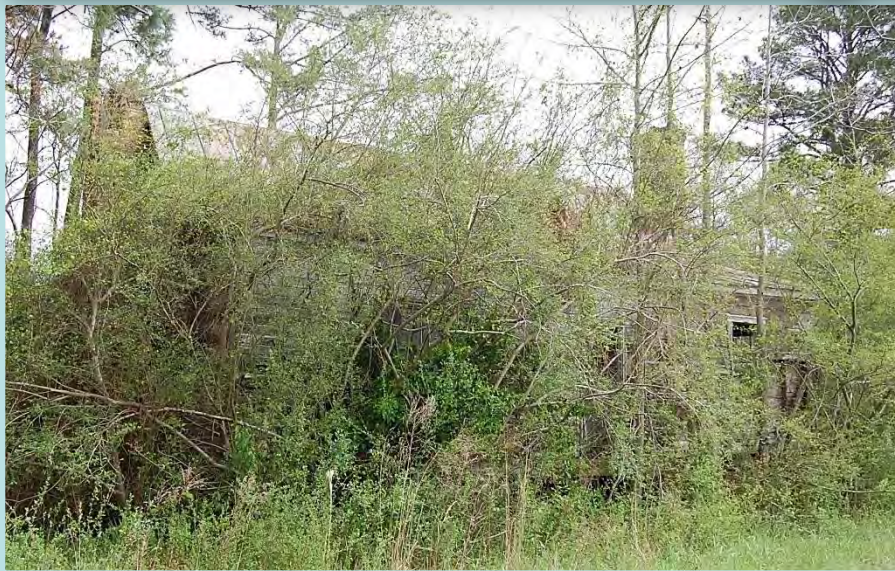
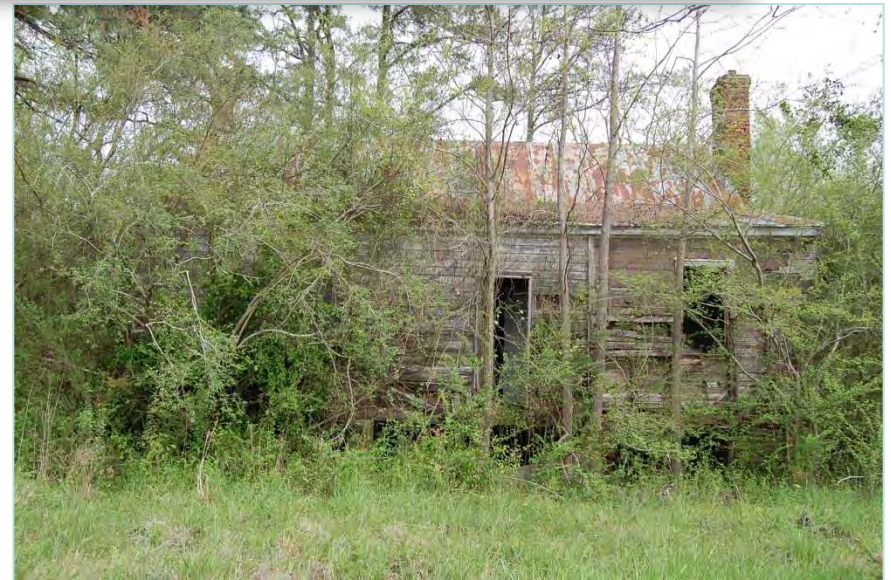
**#48 - MOSELEY-STROUD HOUSE (GRAHAM PLACE) (LR-0857) – late 18<sup>th</sup>/early 19<sup>th</sup>-c, 1-story-and-loft, 3-room Quaker-plan house; placed on NR Study List in 1994, requires further assessment**

Ca.1968

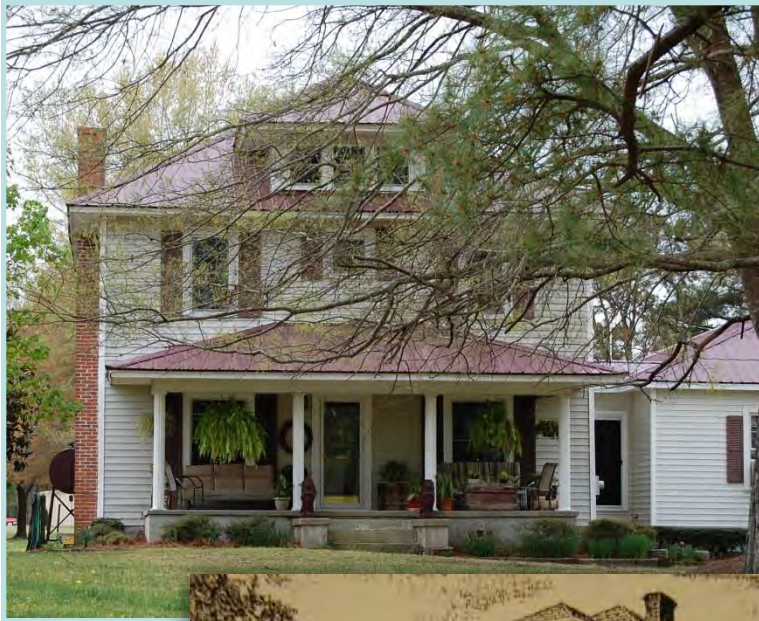
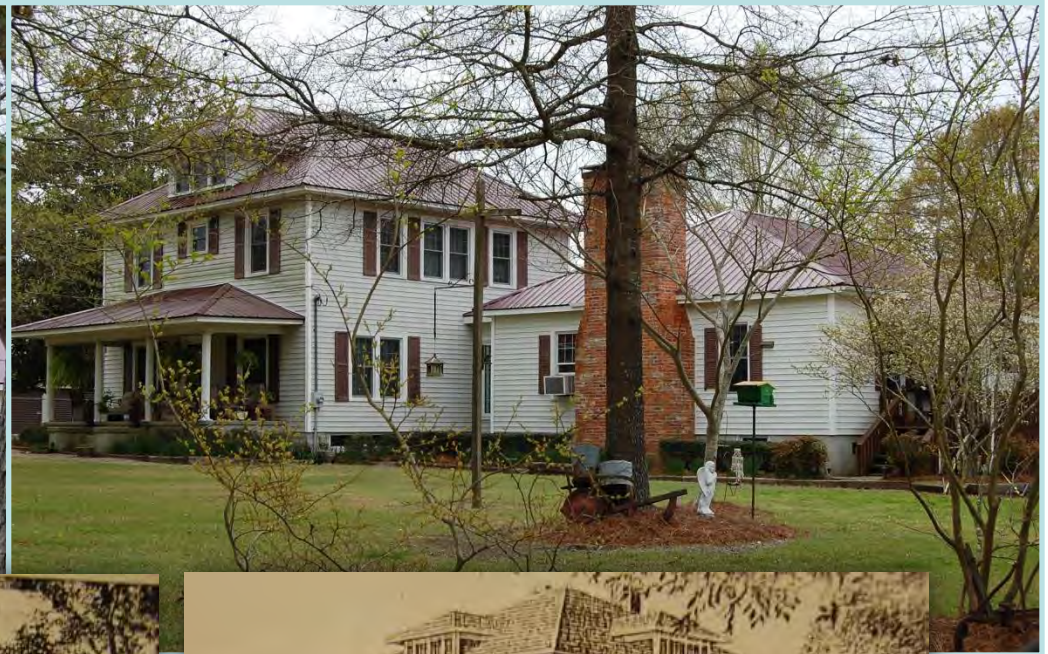
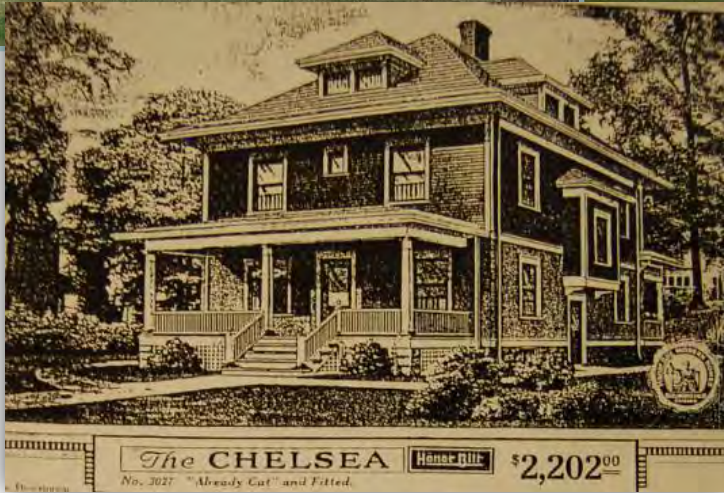
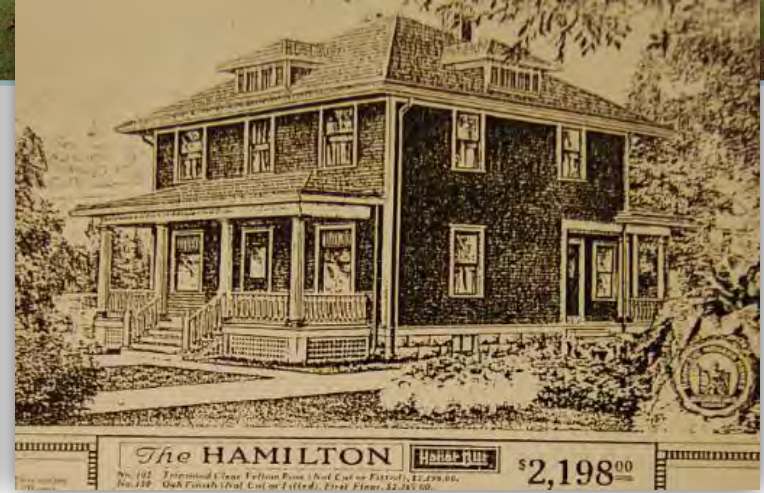
**#49 - BROWN-GATES HOUSE (JASPER GATES HOUSE) (LR-1201) – ca.1918 house ordered from Sears; believed to lack integrity**

**1918 catalog images**

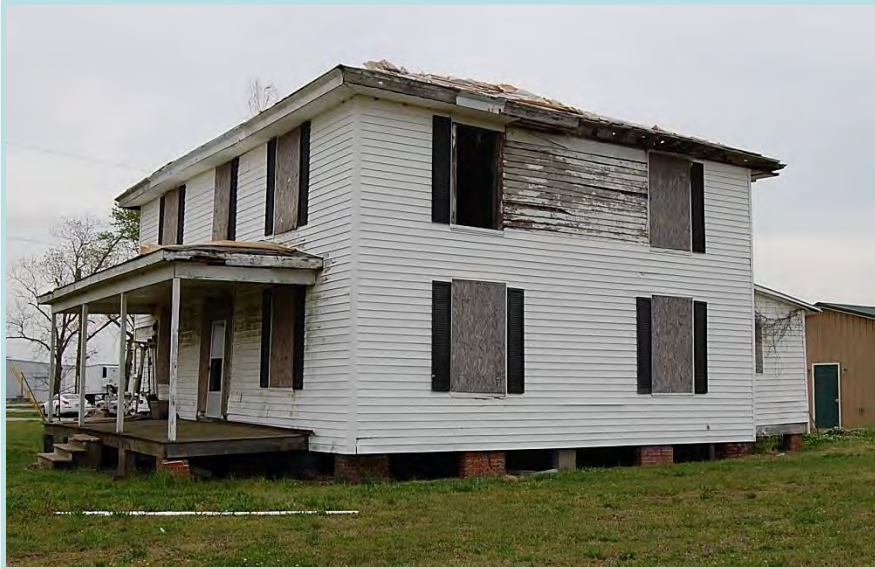
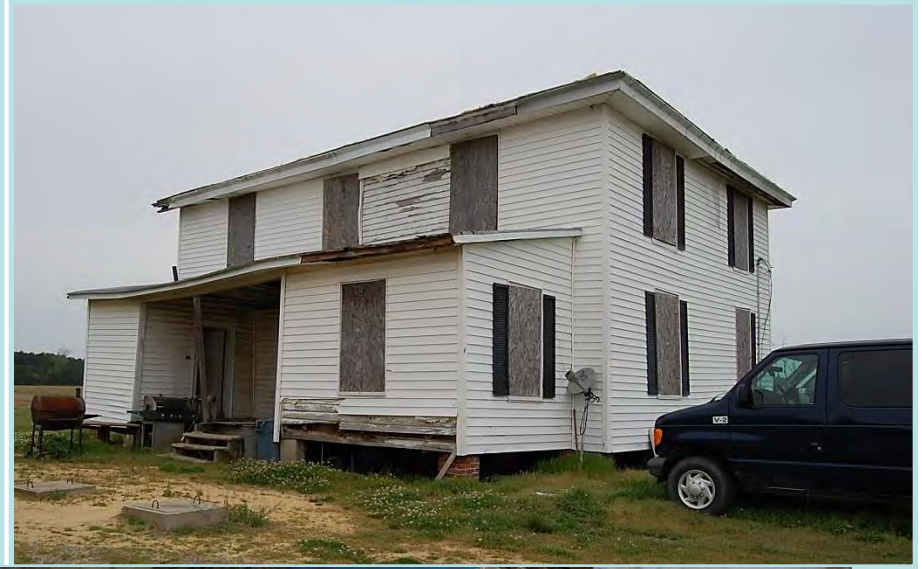
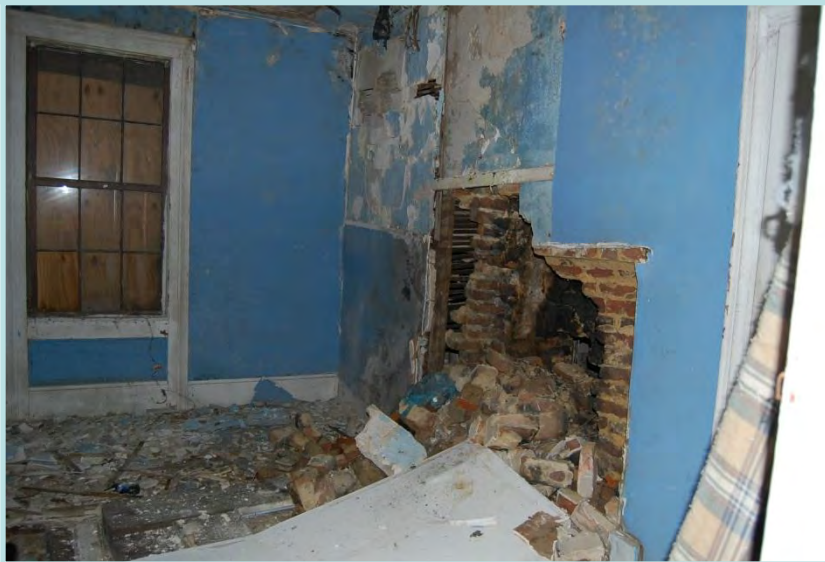
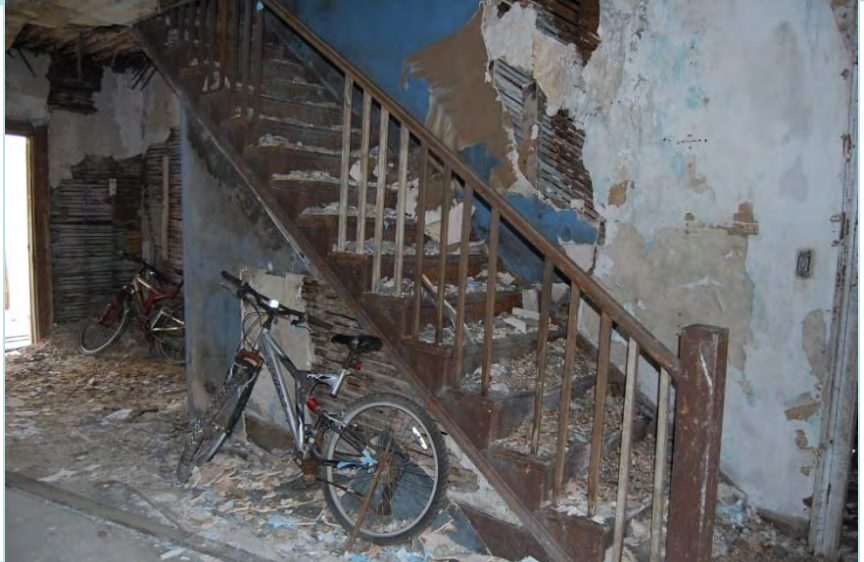
**#50 - ROBERT BOND VAUSE HOUSE (LR-1186) – 1850s Greek Revival-style house; included as a contributing resource to Wyse Fork Battlefield (JN-0306); believed to have lost historic architectural integrity**

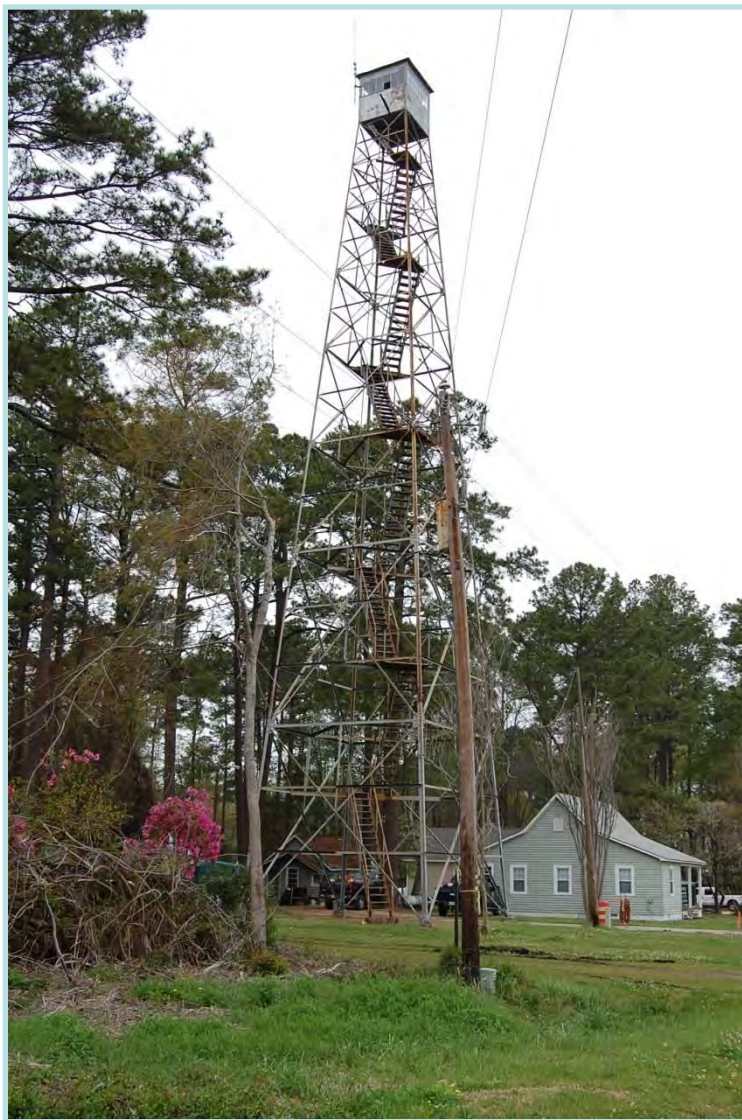
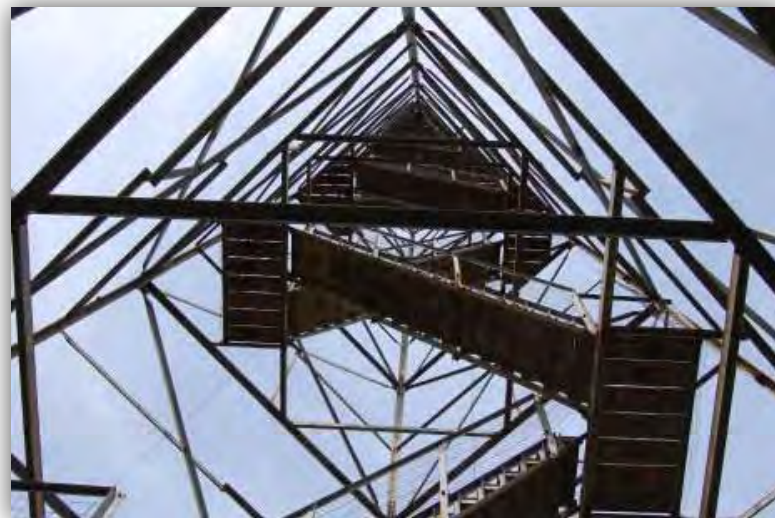
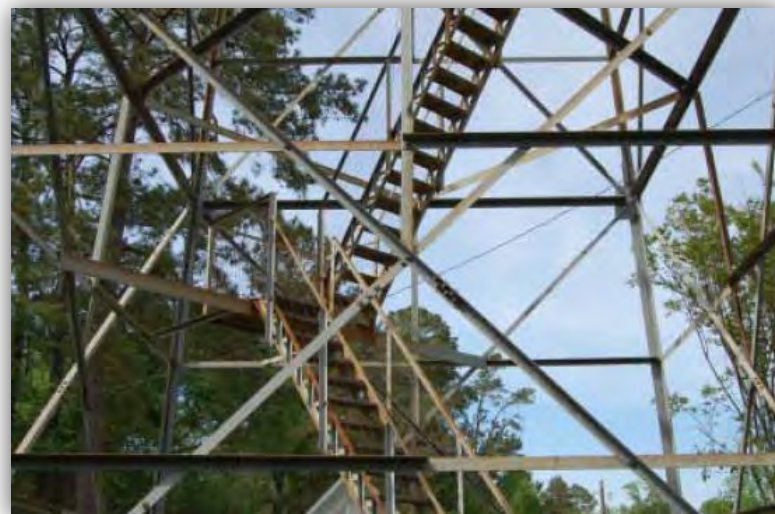
**#51 - KELLY'S POND FIRE LOOKOUT TOWER (LR-1550) – 99'9" steel tower erected 1937; believed to retain significance and integrity**

**detail images 2010**

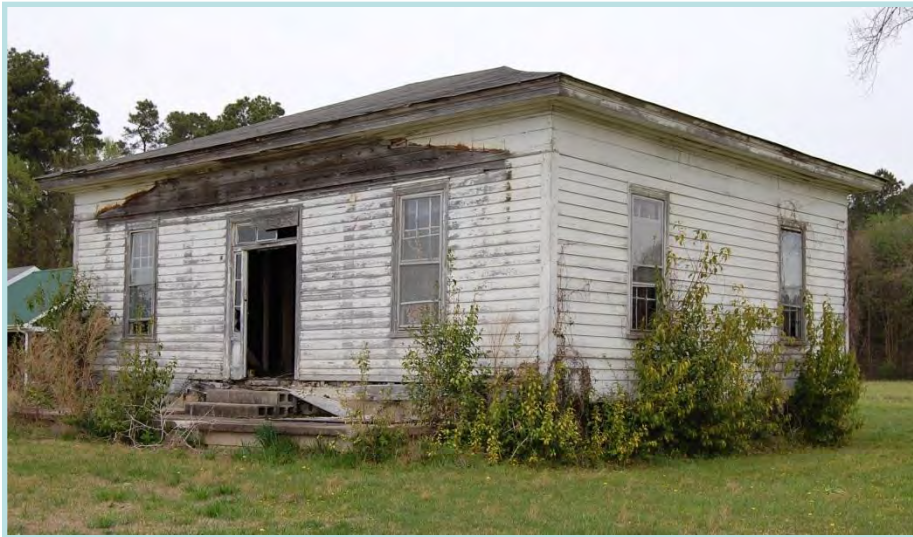
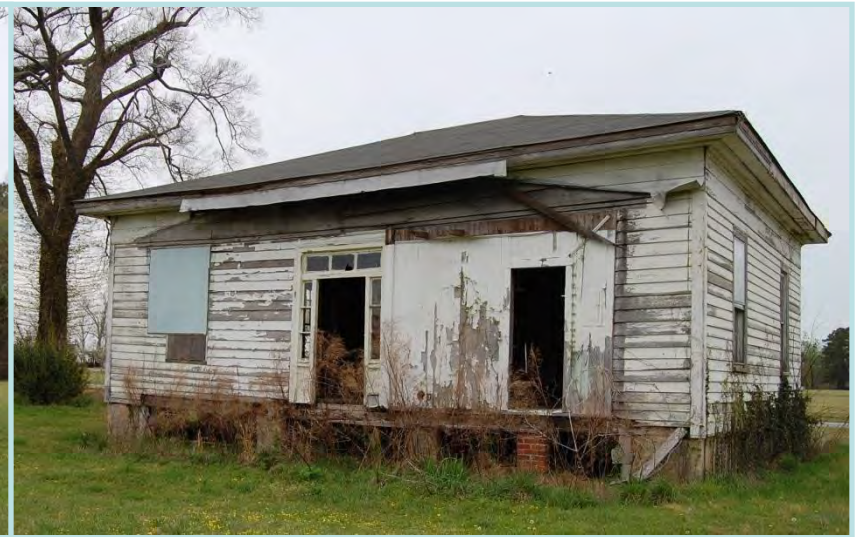
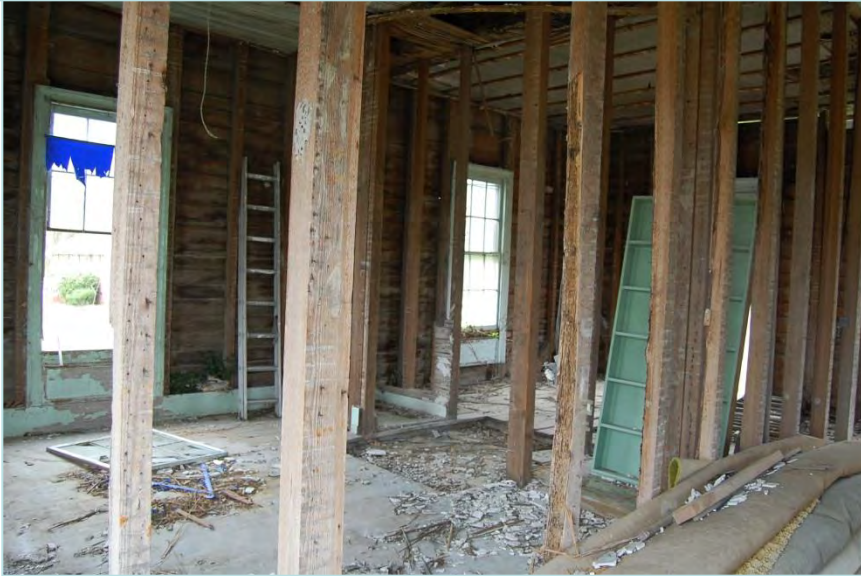
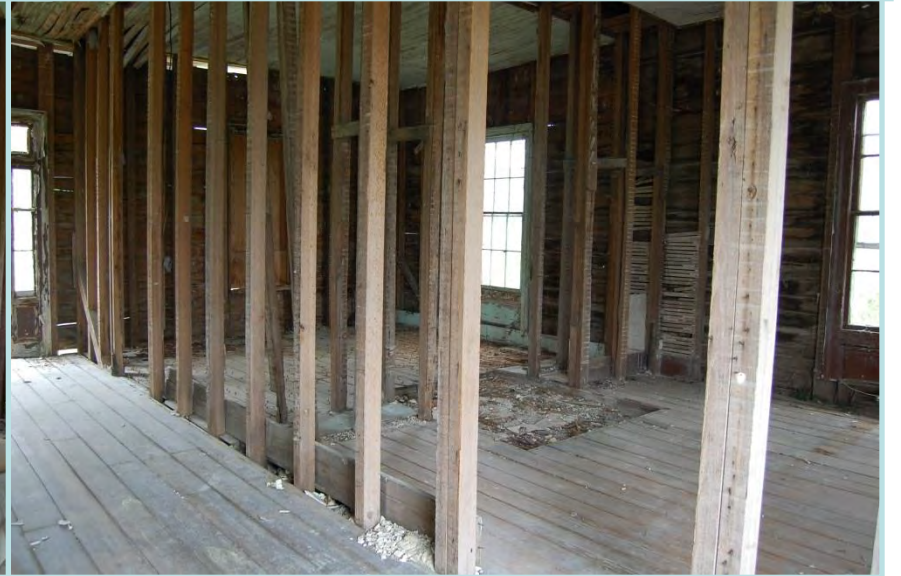
**#52 - HOUSE (LR-1188) – mid-19<sup>th</sup>-c house with interior stripped down to studs; believed to have lost integrity**

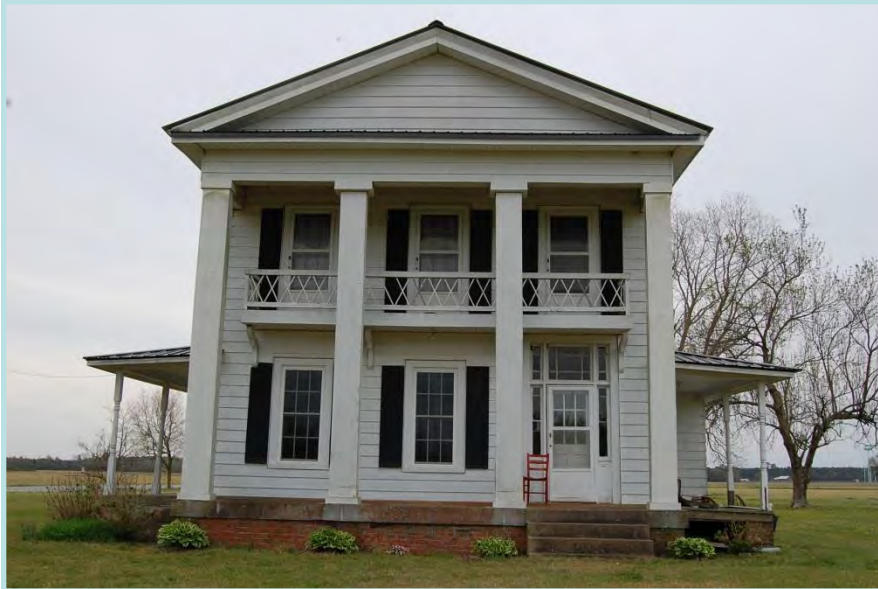
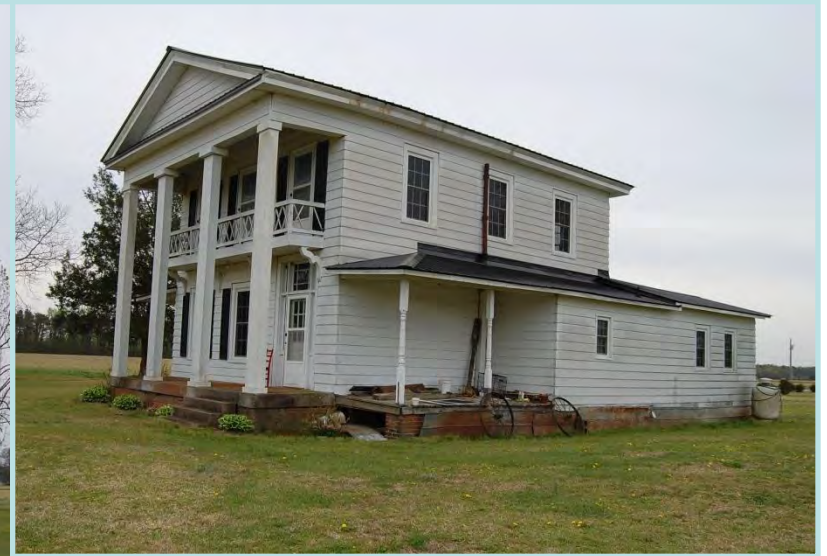
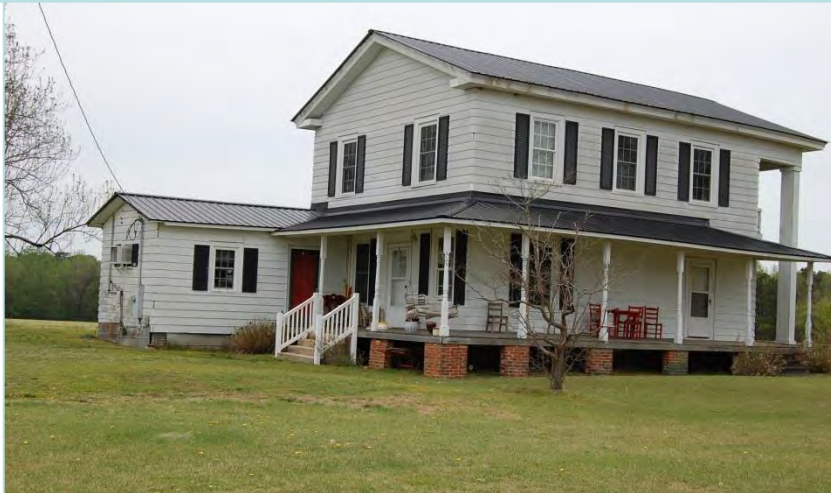
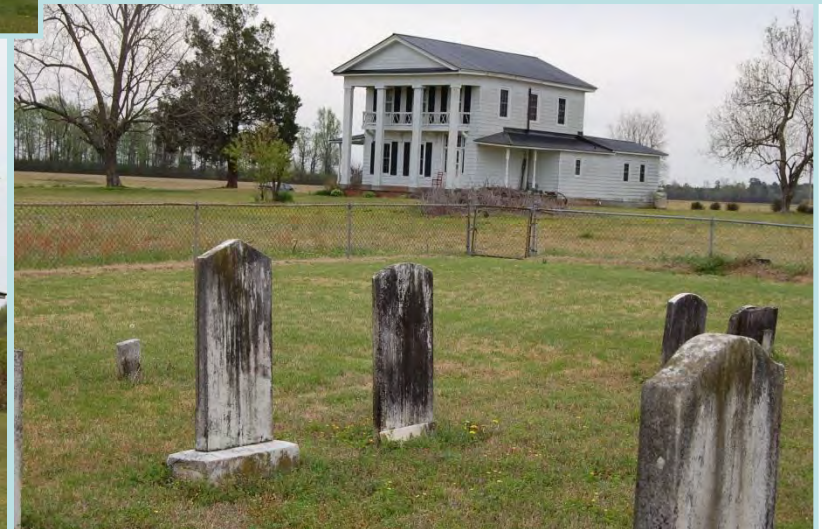
**#53 - WOOTEN-WHALEY HOUSE (JOHN COUNCIL WOOTEN) HOUSE (LR-1185) – ca.1859, Greek Revival-style, temple-front house; included as a contributing resource to Wyse Fork Battlefield (JN-0306); NR Study Listed 1994, requires further assessment independent of Wyse Fork**

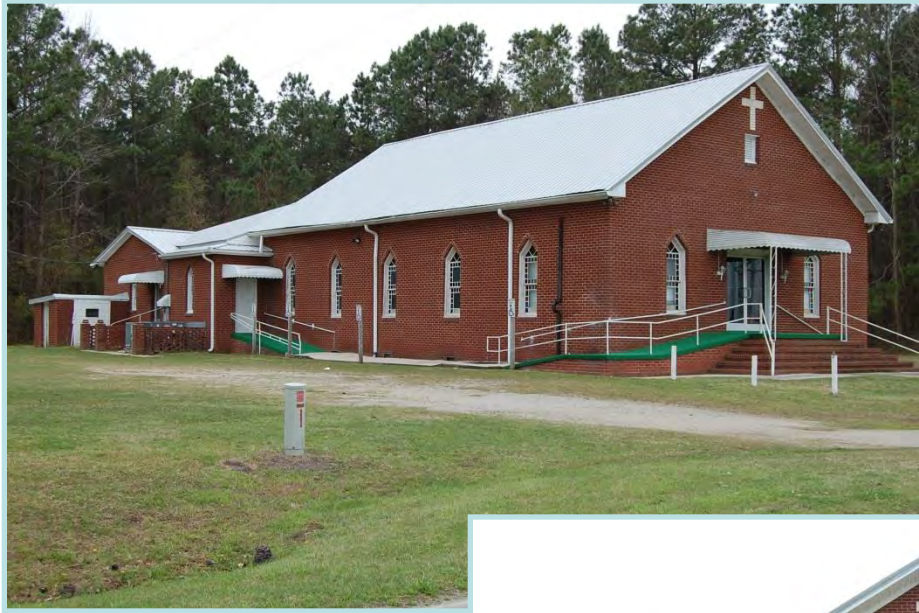
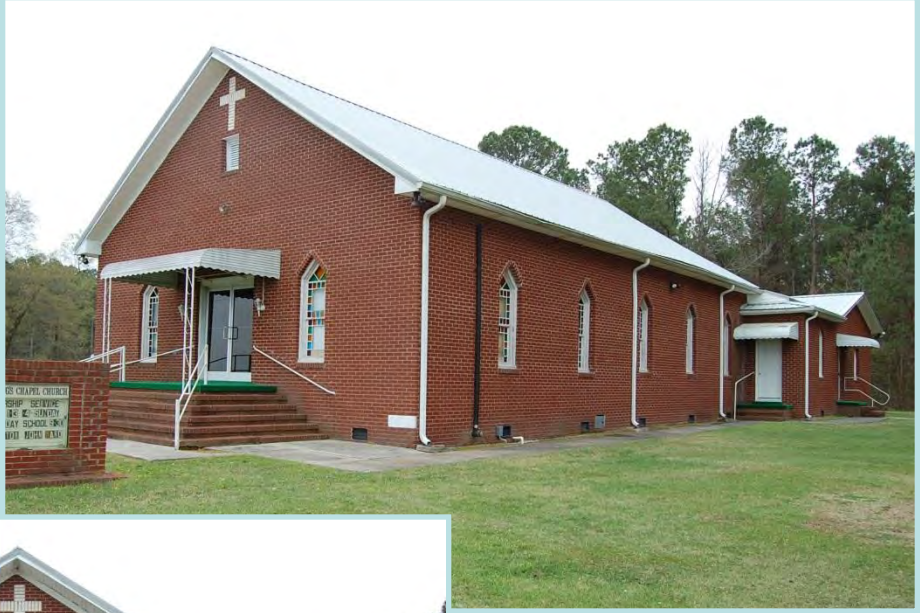
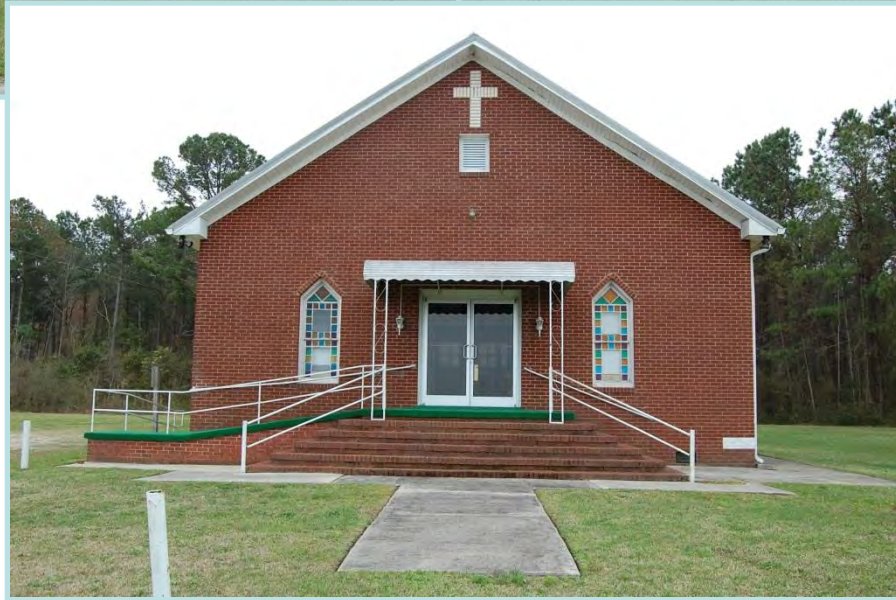
**#54 - KING'S CHAPEL CHURCH OF CHRIST (DISCIPLES OF CHRIST)  
(LR-1094) – African-American gable-front church remodeled to current  
appearance in 1962; believed to lack integrity**

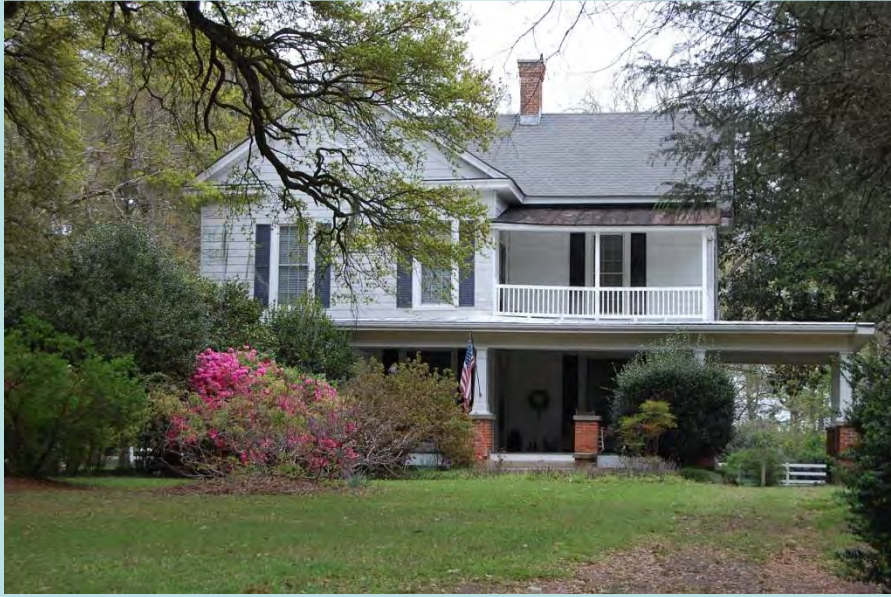
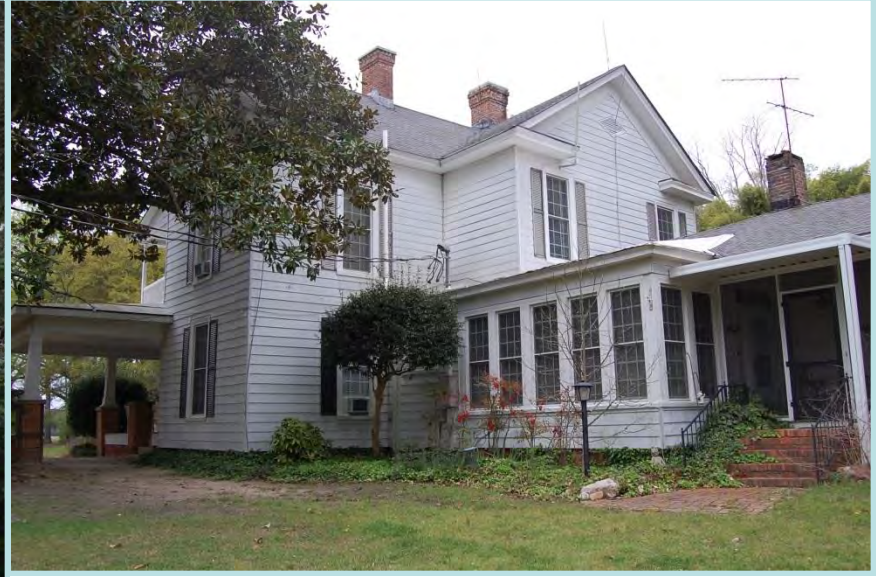
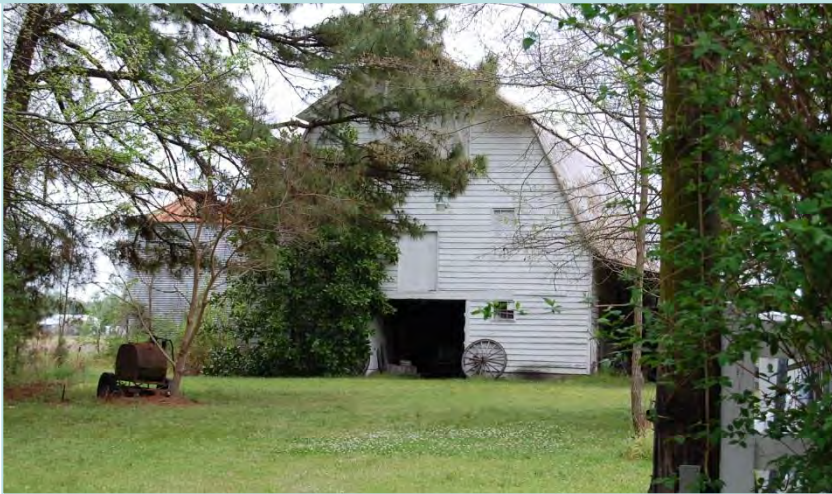
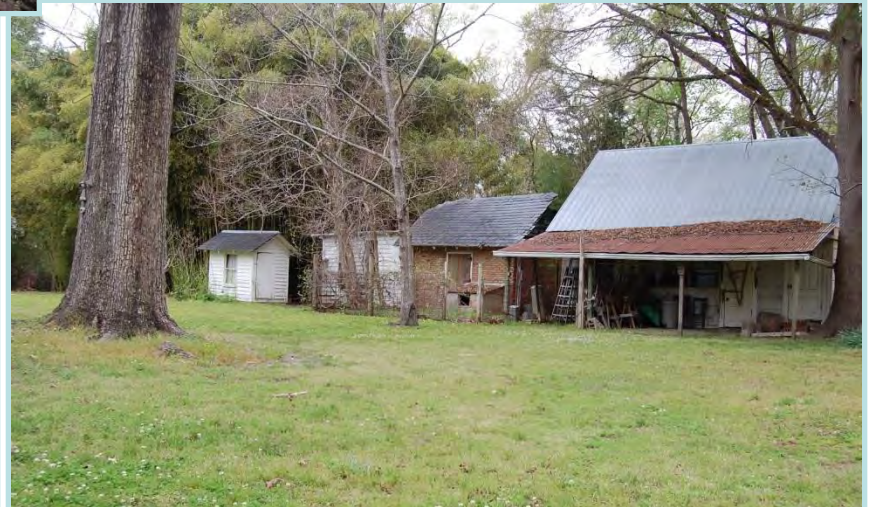
**#55 - ELIJAH LOFTIN HOUSE (LR-1195) – ca.1880 house with large collection of early to mid-20<sup>th</sup>-c outbuildings; placed on NR Study List in 1994, requires further assessment**

The Elijah Loftin House has no known connection with significant historic events or notable persons and is therefore recommended not eligible under Criteria A or B. It is, however, recommended as NRHP eligible under Criterion C as a notable representative of a large, late nineteenth/early twentieth-century, T/L-plan farmhouse that represents a continued evolution of design. From its late nineteenth-century construction, it retains its T-shaped form, corbeled chimney stacks, cornice returns, and sash salvaged from its predecessor. (Alternatively, part of the house may date from the mid-nineteenth century). From its early twentieth-century update, it retains a number of windows and doors and a Craftsman-style porch and porch cochere. In form it is similar to the residences discussed above at Section 3—the B.W. Canady, Ezekiel K. Best, George B.W. Hadley, Tom Worthington, Joseph Williams, and H. William Davis houses. The later addition of its Craftsman-style porch reflects early twentieth-century updates to residences, such as the Emory-Russell House (also discussed at Section 3) and the Harper House, assessed in a separate entry, below. In addition to its surviving physical features, the house retains an unusually large number of contemporary outbuildings related to domestic activities and the production of food. This gives it strong integrity of location, setting, feeling, and association. Overall, the house, its outbuildings, and site retain a high degree of integrity. It is recommended as eligible at the local level of significance. The period of significance of the house, along with its numerous outbuildings, is recommended as extending from ca. 1878 to 1955, when George Loftin died. The house is not likely to yield important historical information on the basis of its appearance or construction. Accordingly it is not recommended as NRHP-eligible, as an architectural resource, under Criterion D.

ELIJAH LOFTIN HOUSE		
Element of Integrity	Level of Integrity	Assessment
Location	High	Remains on site where it was built.
Design	Medium	Retains many original and early features, including T-plan form, corbeled chimneys, cornice returns, and Craftsman porch and porte cochere. It is artificially sided and some sash and doors have been replaced and additions added.
Setting	High	Retains numerous outbuildings and, more broadly, cultivated fields and tree plantations frame it in all directions.
Materials	Medium	Retains many original and early features, including T-plan form, corbeled chimneys, cornice returns, and Craftsman porch and porte cochere. It is artificially sided and some sash and doors have been replaced and additions added.
Workmanship	Medium	Retains many original and early features, including T-plan form, corbeled chimneys, cornice returns, and Craftsman porch and porte cochere. It is artificially sided and some sash and doors have been replaced and additions added.

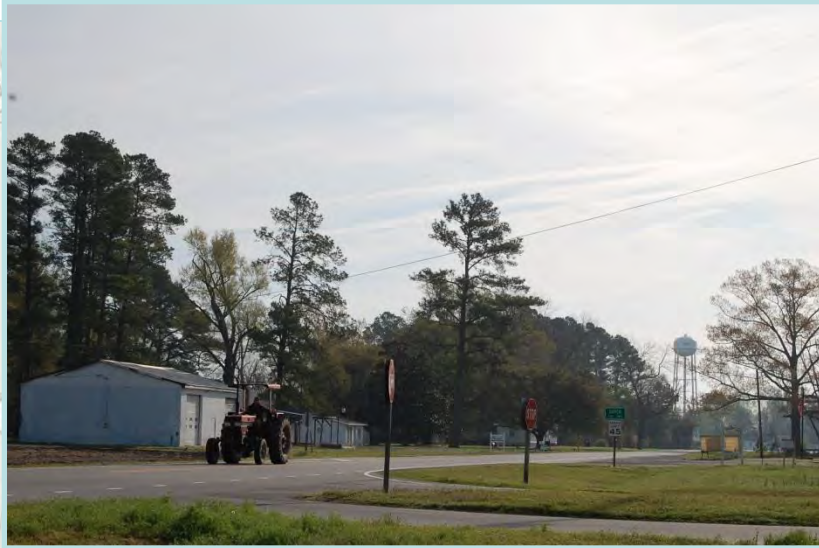
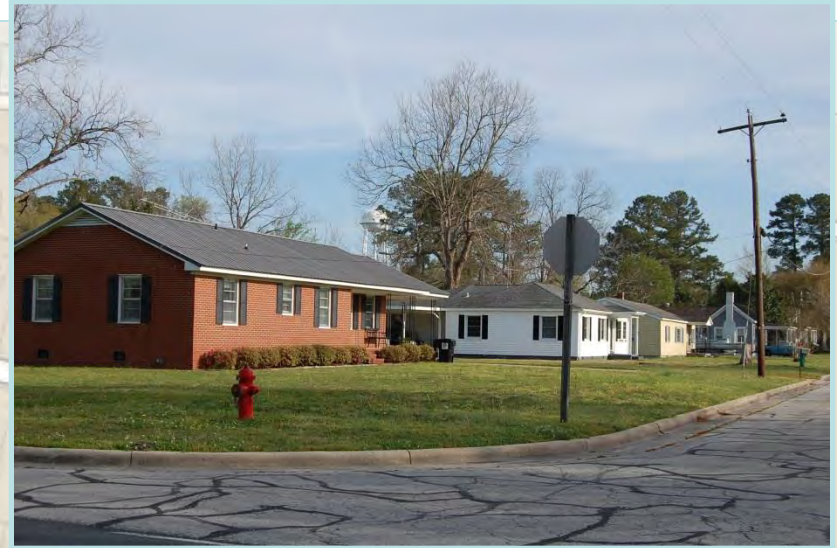
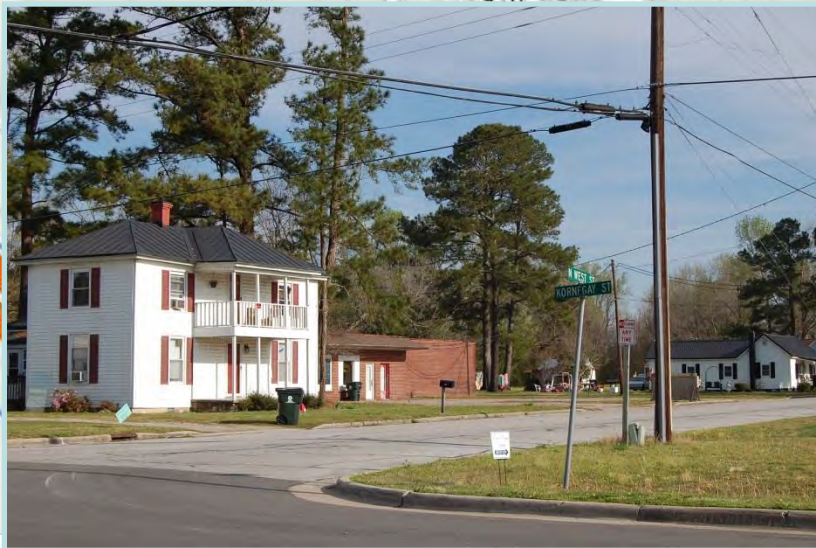
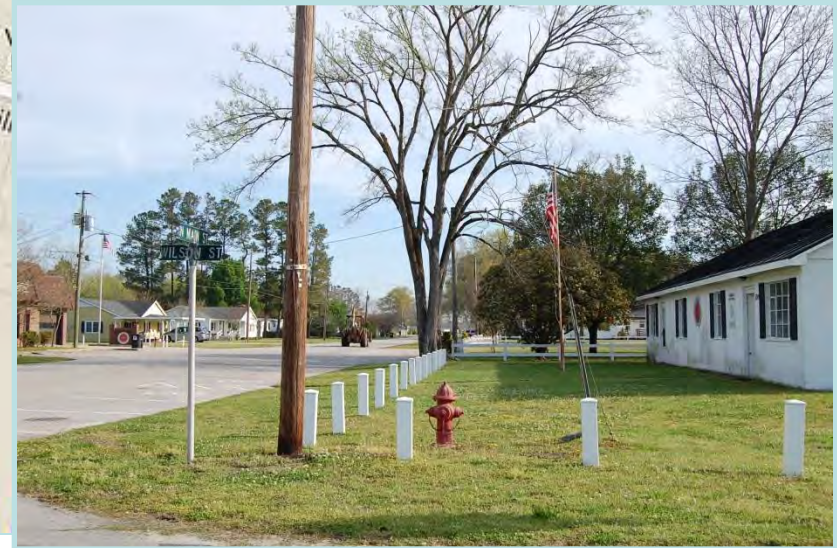
**#56 - DOVER (CV-2263) – turn-of-the-century community; reviewed and considered not eligible for NR in 2013**

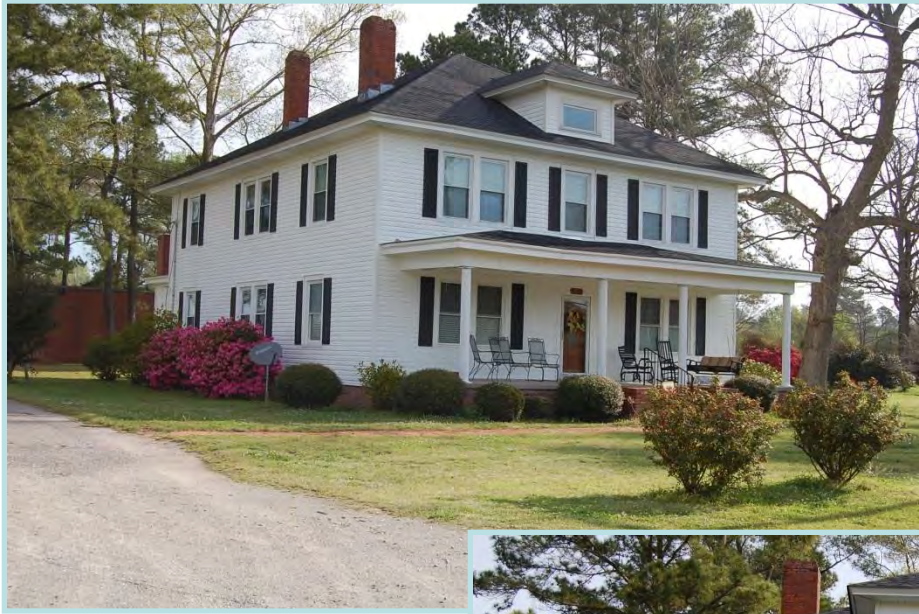
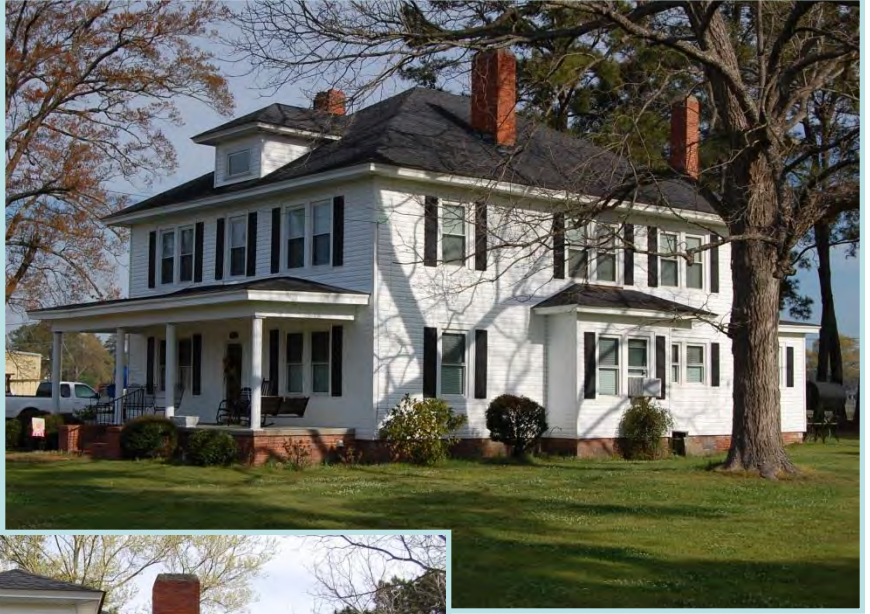
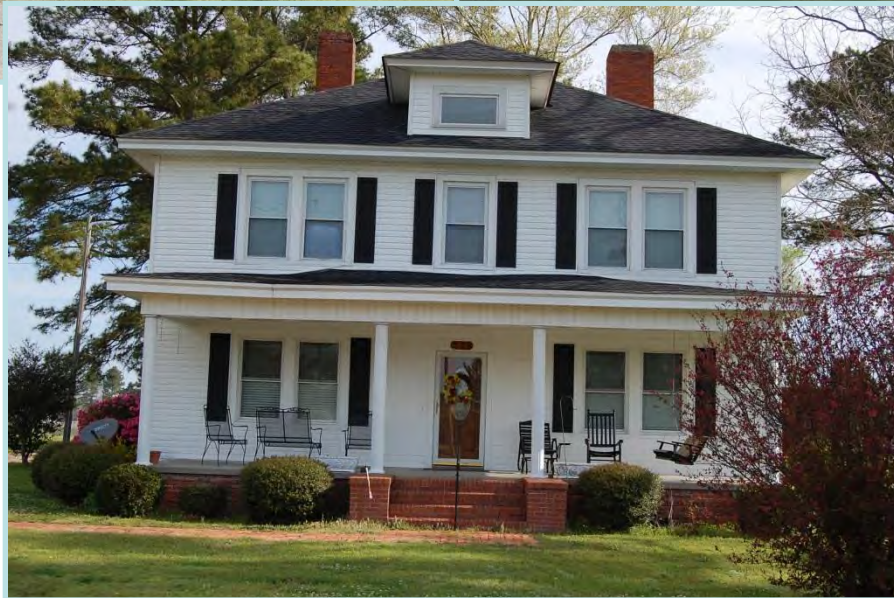
**#57 - DOVER TEACHERAGE (CV-1410) – Built by WPA in 1937 with four apartments for Dover School teachers; believed to lack integrity**

The three-bay, double-pile, hip-roofed, frame teacherage is clad in modern vinyl siding, rests on a continuous brick foundation, and stands two-stories tall with an attic (Figure 336 through

Figure 338). A one-story single-pile ell featuring a low-pitched roof extending from the north rear of the building is also vinyl clad. Four evenly spaced interior brick chimney stacks protrude from the house's hipped-roof. An original three-bay hipped-roof front porch with replacement columns frames the first floor of the south elevation. It is accessed by an original brick stair. The porch's central bay frames the building's primary entrance. The entry door is a modern replacement and all of the house's windows have been replaced with modern, one-over-one, double-hung sash in recent years. A small, original, hipped-roof bay that holds a secondary entry at its rear extends from the building's eastern side.

Considering its many changes and the number of intact teacherages in the eastern portion of the state, it is believed that the Dover Teacherage does have sufficient integrity to support NRHP listing. While the building retains its foursquare form, its porch columns and all of its windows have been replaced and its original weatherboards covered with vinyl siding. Its interior retains its stairway and some finish, but it has been much altered by its current owner, who modernized it and removed and shifted at least one partition wall. Therefore it is not recommended as NRHP

eligible under Criterion C for its architecture. The former teacherage further lacks association with any notable historic event or figure and is accordingly recommended as not significant under Criteria A and B. It is not likely to yield important historical information on the basis of its construction or appearance. It is therefore not recommended as NRHP-eligible, as an architectural resource, under Criterion D.

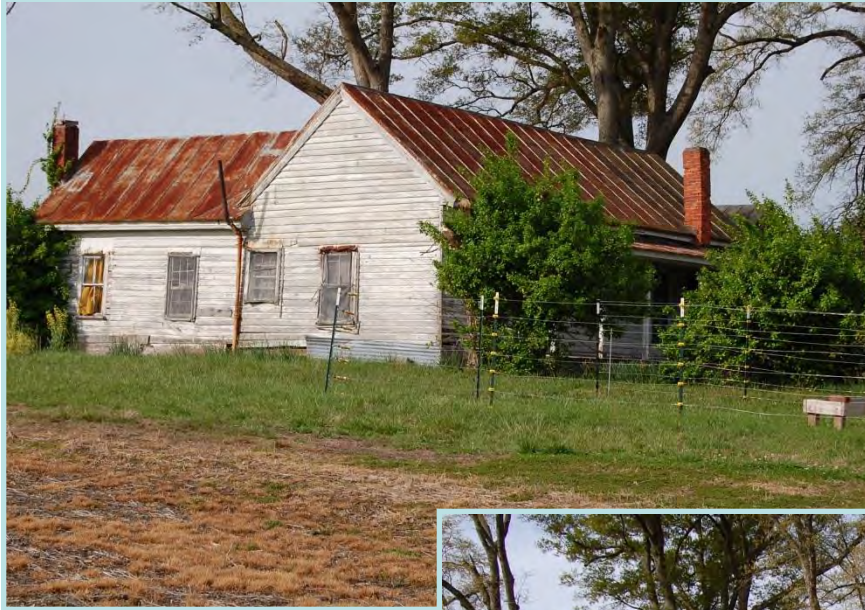
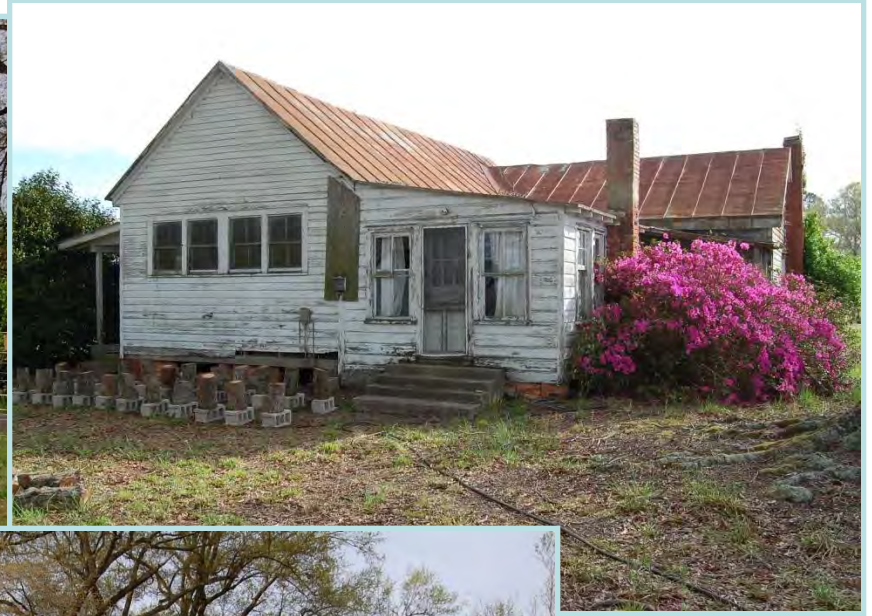
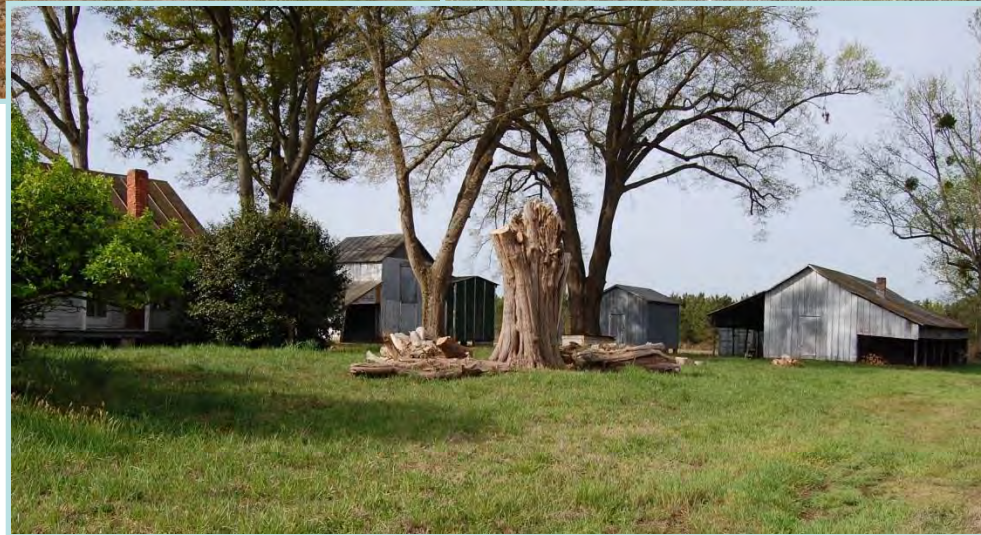
**#58 - WEST HOUSE (JN-0083) – Turn-of-the-century house with a few outbuildings; reviewed and considered not eligible for NR in 2013**
