North Carolina Department of Natural and Cultural Resources  
State Historic Preservation Office

MEMORANDUM

Subject: Historic Architecture Eligibility Evaluation Report, US 70 Kinston Bypass, R-2553,  
Lenoir County, ER 09-1307

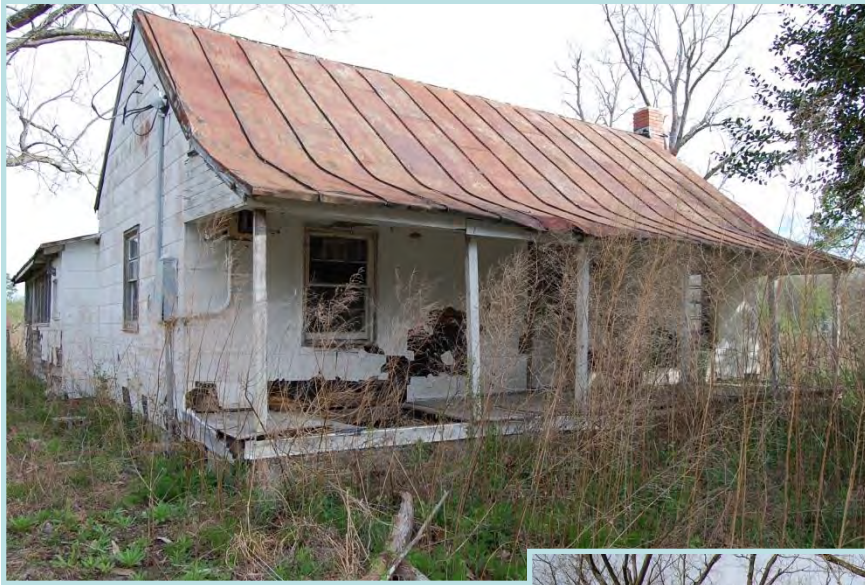
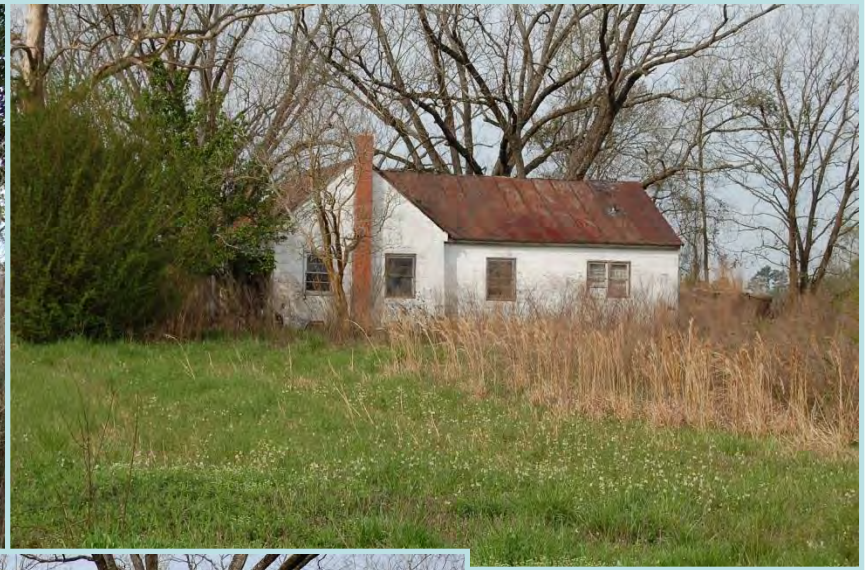
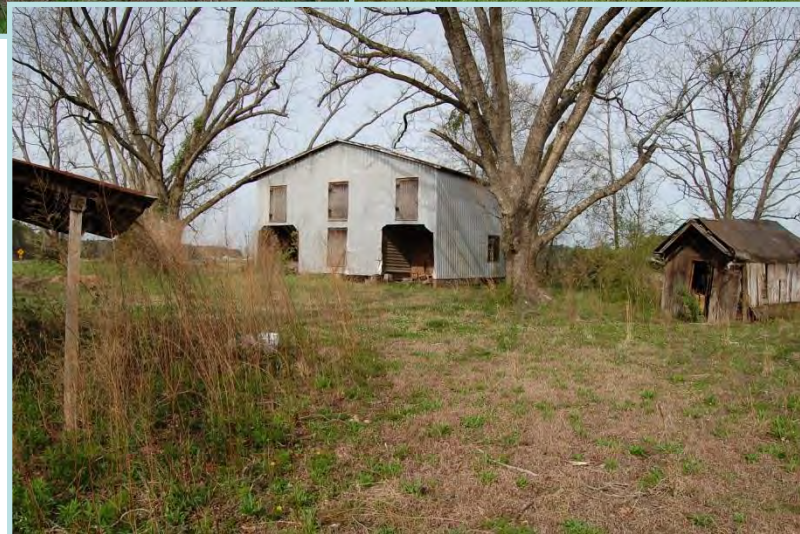
**#59 - ROY E. WEST HOUSE (JN-0055) – Turn-of-the-century house with packhouse/barn and smokehouse to rear; reviewed and considered not eligible for NR in 2013**

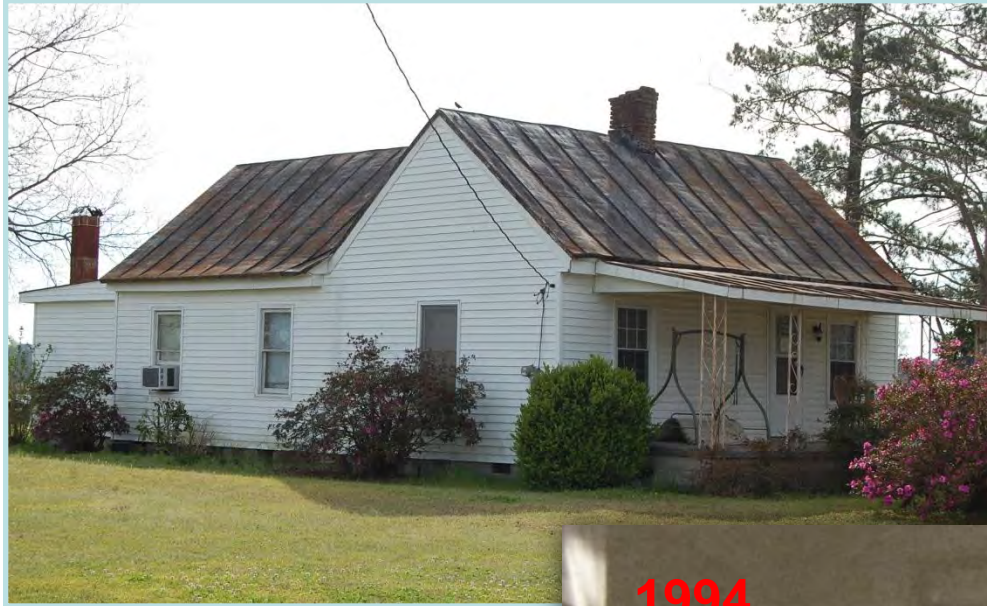
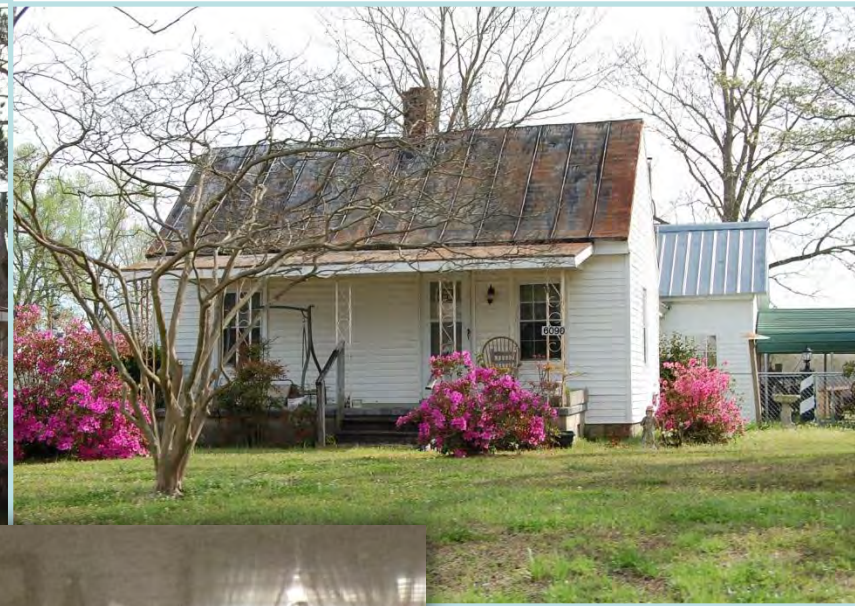
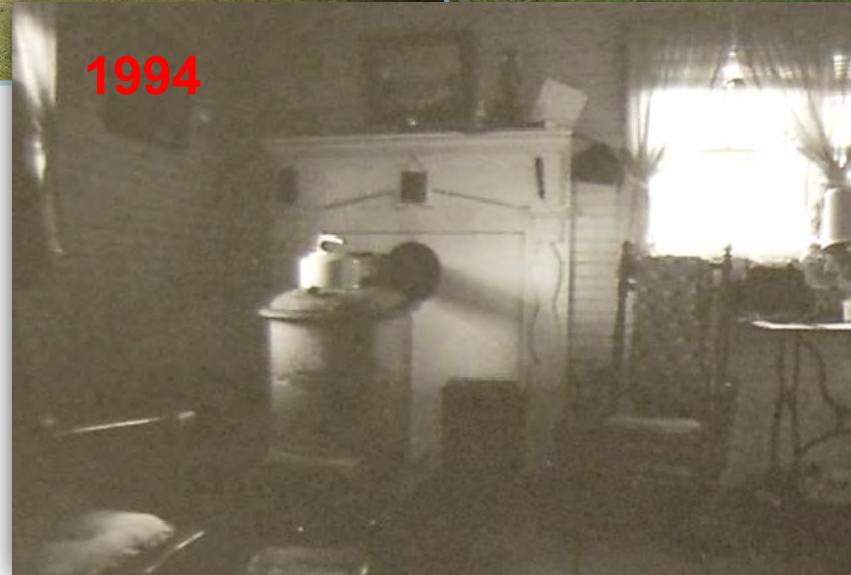
**#60 - LUTHER SIMMONS HOUSE (JN-0084) – ca.1865-1880 frame house;  
believed to lack integrity**

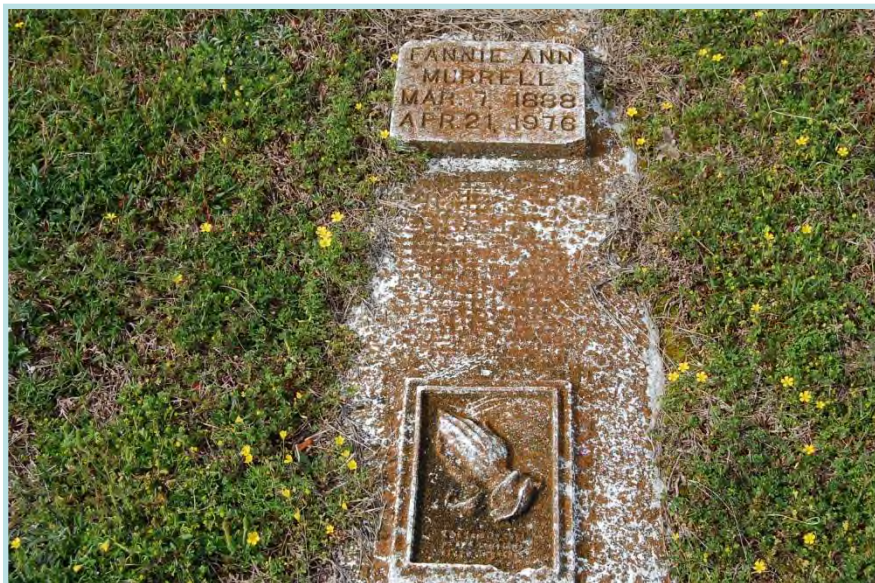
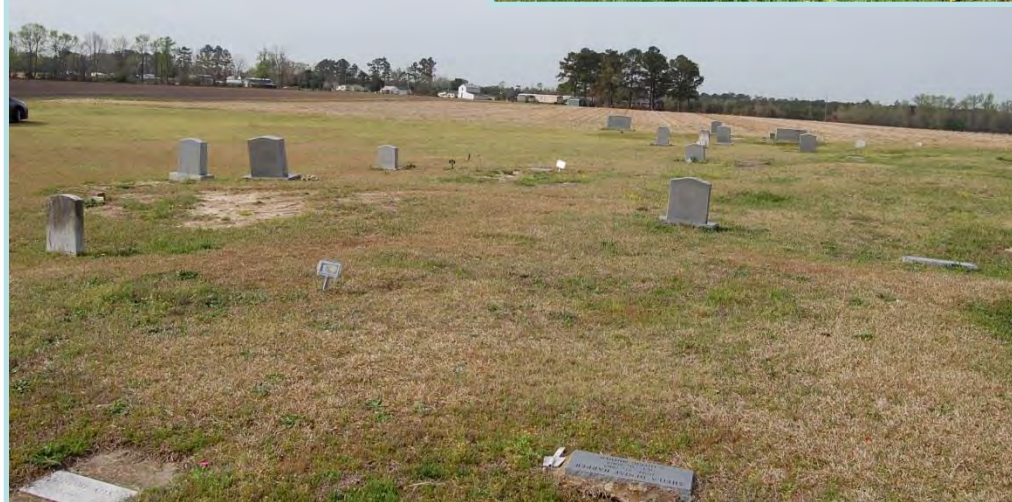
**#61 - BEASLEY CEMETERY (JN-0087) – three-section, 20<sup>th</sup>-c cemetery;  
reviewed and considered not eligible for NR in 2013**

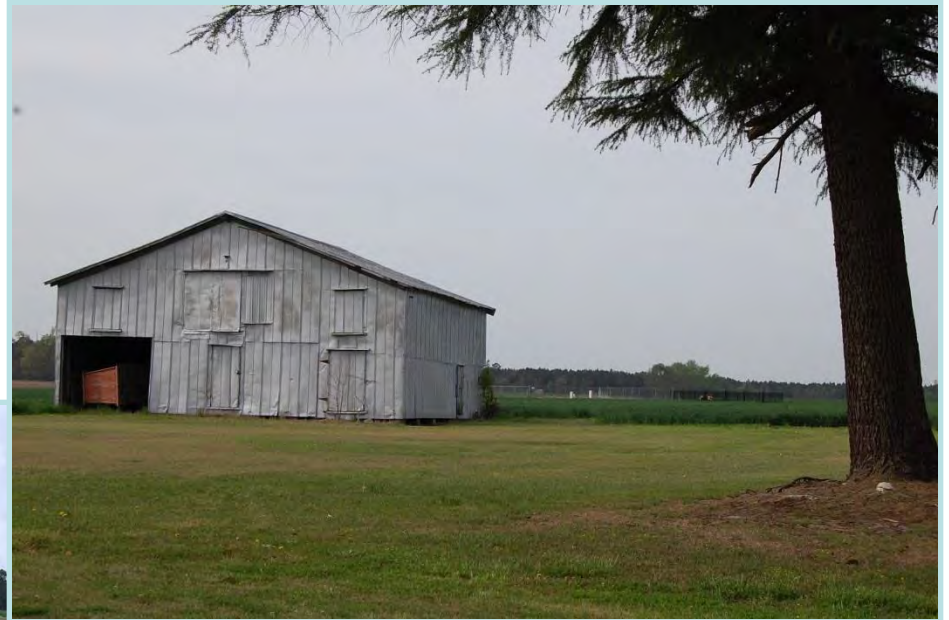
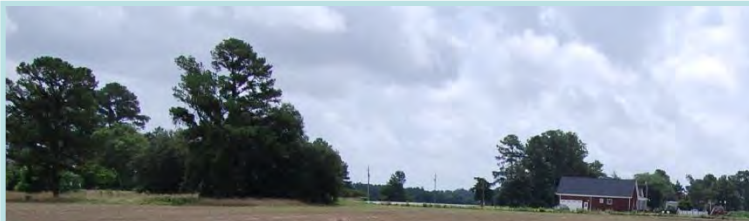
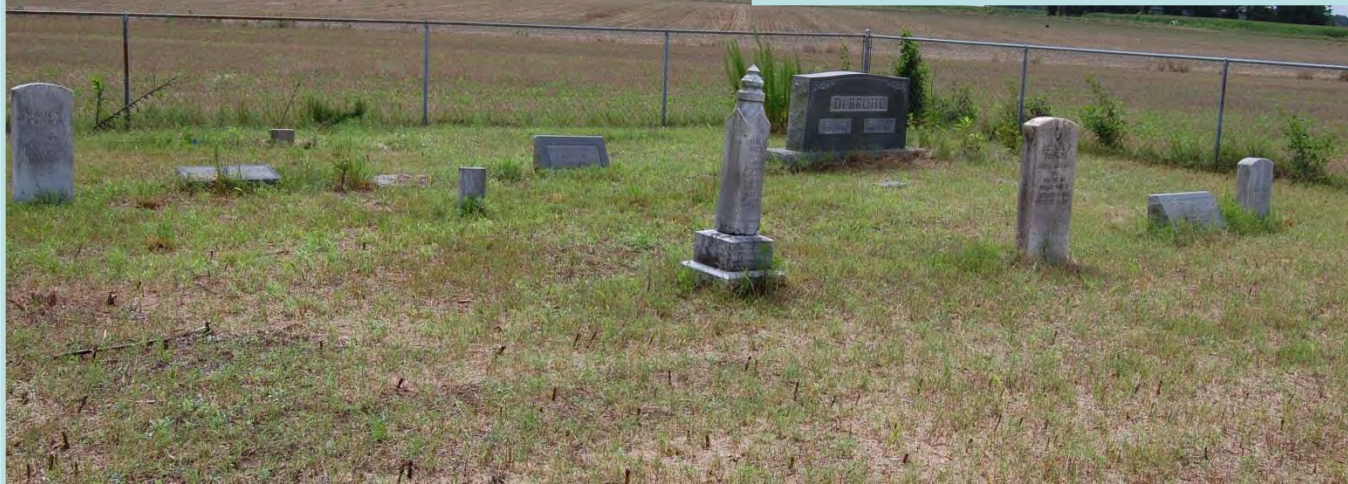
**#62 - JOEL ALEXANDER DeBRUHL HOUSE (JN-0071) – former early 20<sup>th</sup>-c house, demolished pre-2013; packhouse/barn and 20<sup>th</sup>-c cemetery remain; reviewed and considered not eligible for NR in 2013**

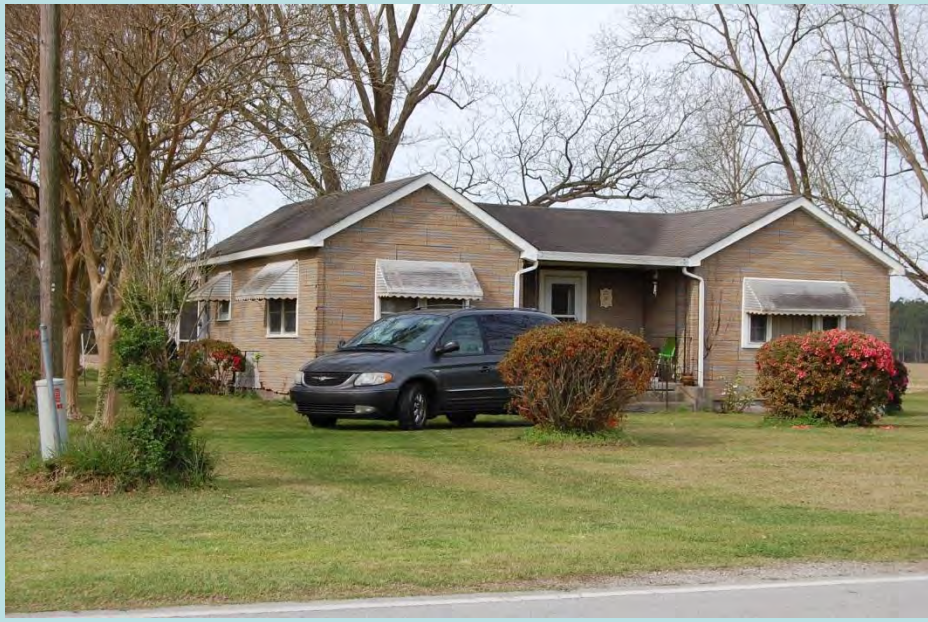
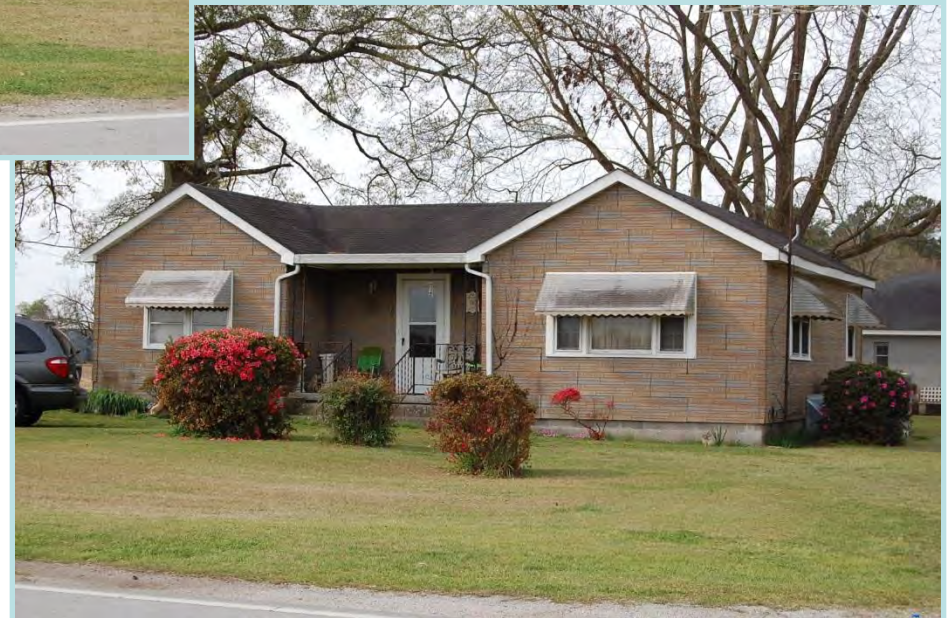
**#63 - M. HILL HOUSE (JN-0103) – 1949 and 1956 frame house; believed to lack significance and integrity**

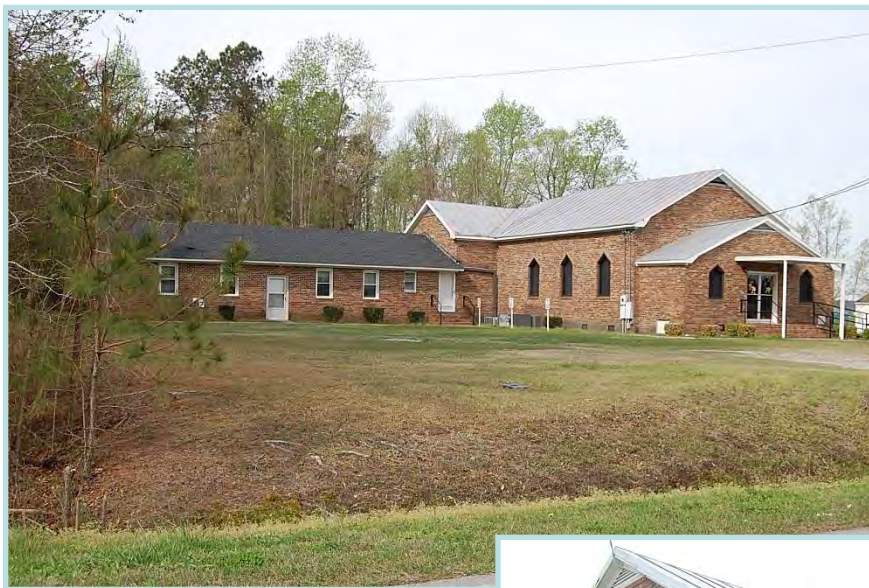
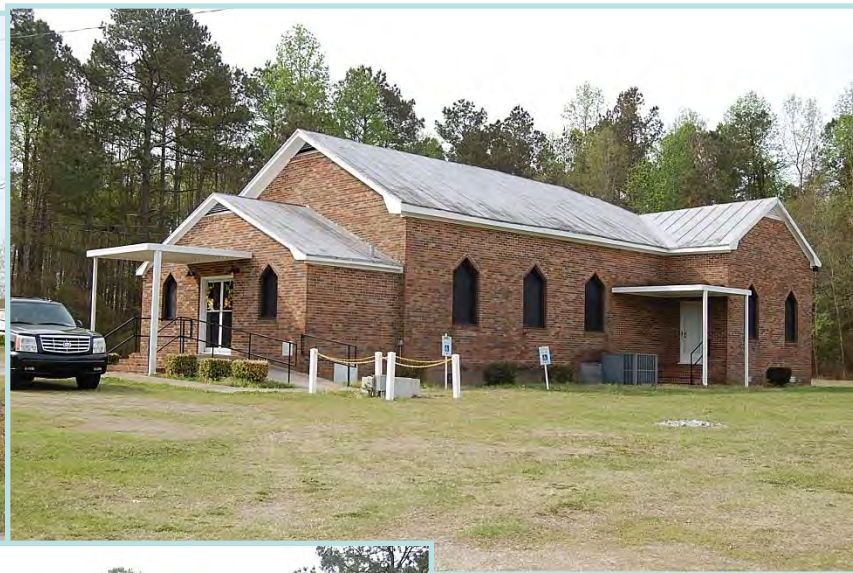
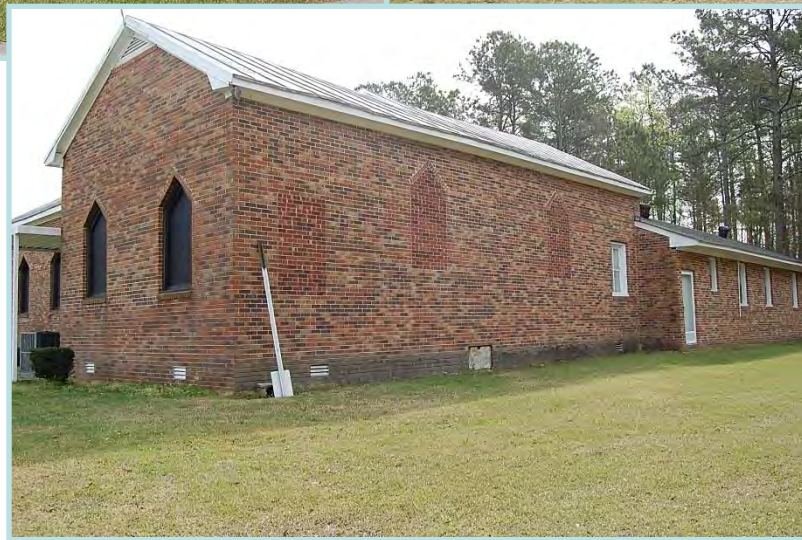
**#64 - BEAUTIFUL VALLEY FREE WILL BAPTIST CHURCH (JN-0102) – ca.1937, 1979, 1987 African-American church; believed to lack integrity**

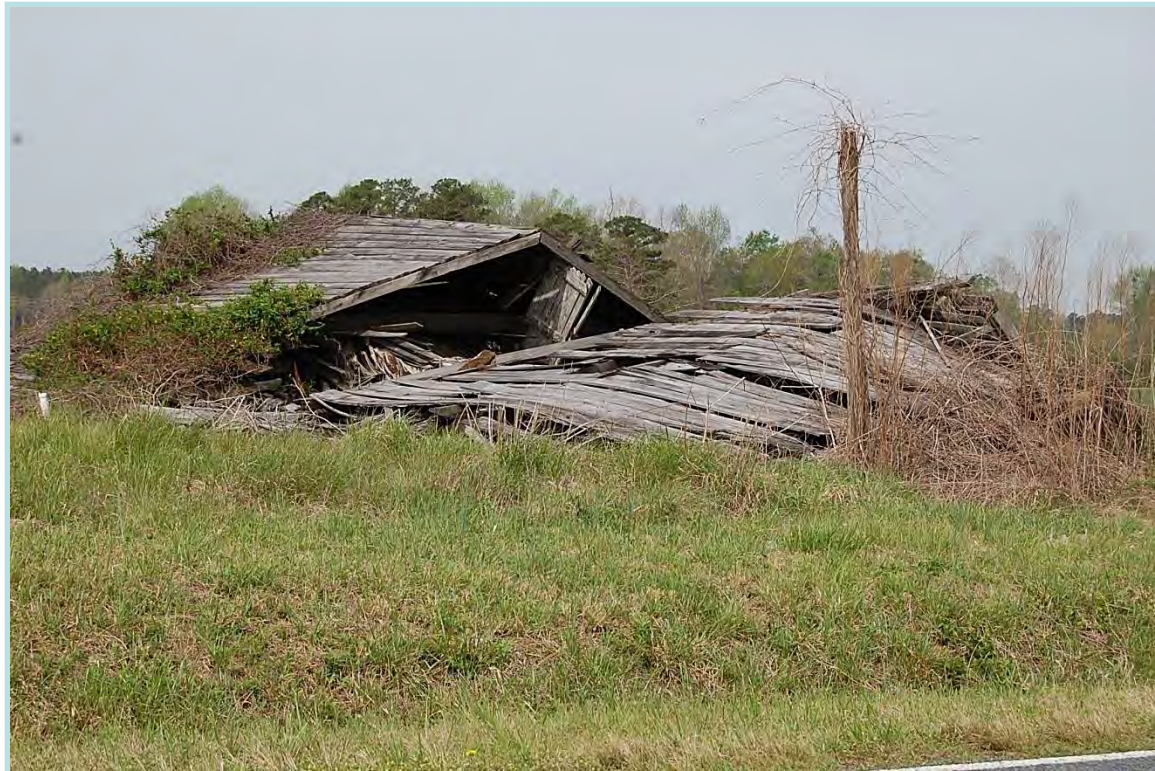
**#65 - CLAY HILL HOUSE (JN-0097) – frame house collapsed prior to 2013; reviewed and considered not eligible for NR in 2013**

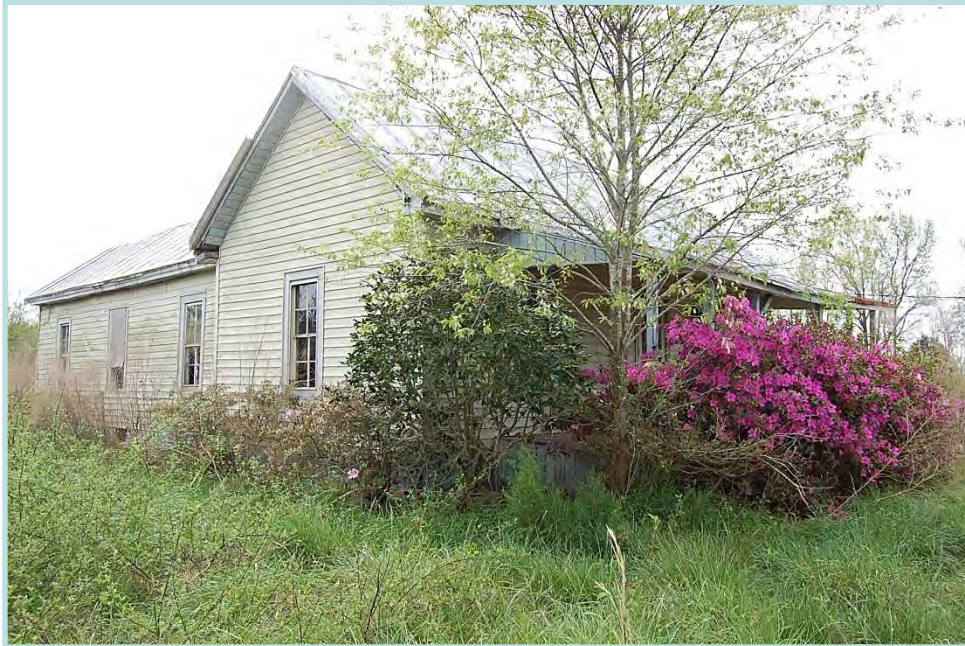
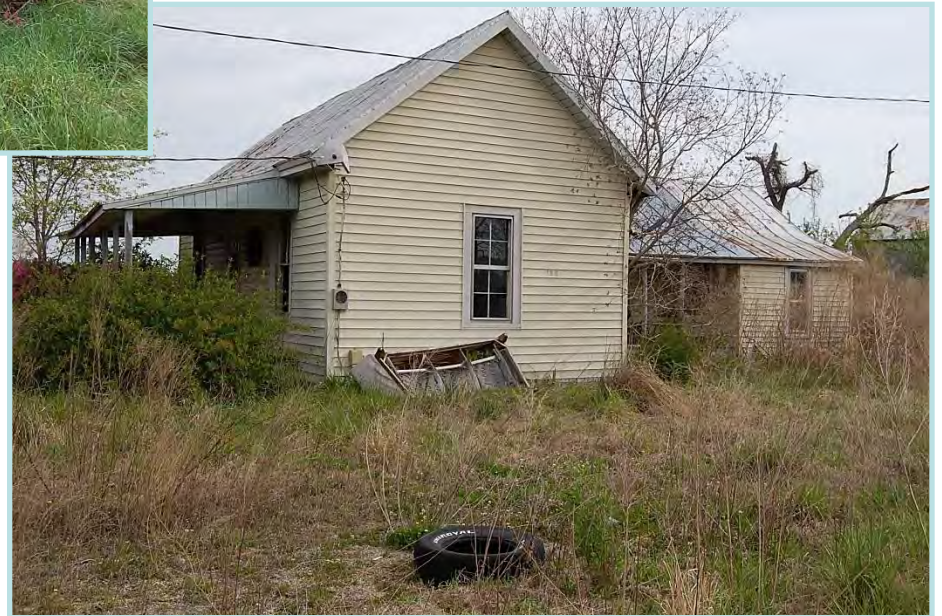
**#66 - FERRELL-HOOD HOUSE (LR-0098) – turn-of-the-century tenant house; believed to lack significance and integrity**

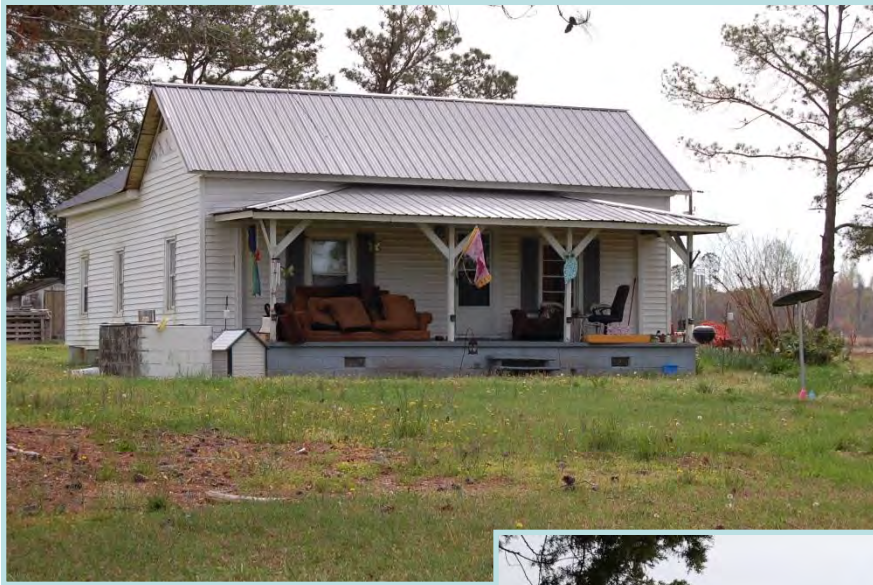
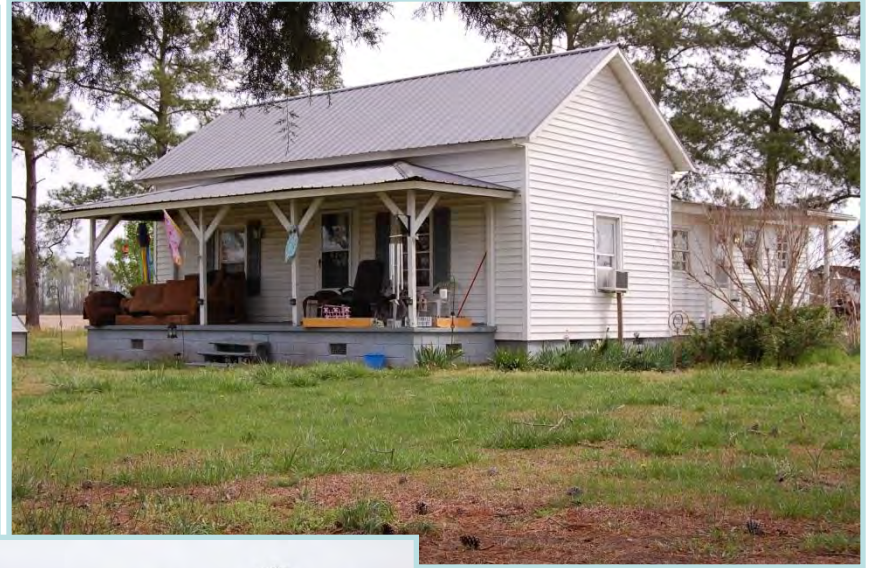
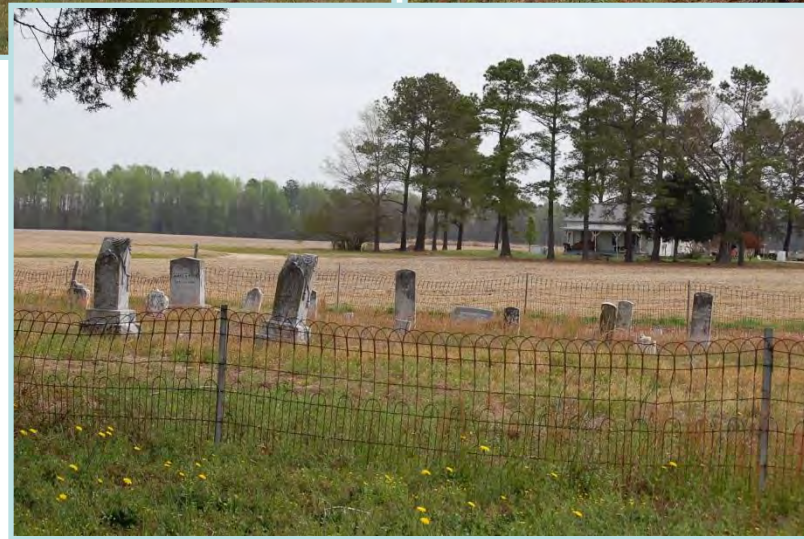
**#67 - FERRELL HOUSE (JN-0099) – turn-of-the-century house with small family cemeteries to rear and to front along Caswell Station Road; believed to lack significance and integrity**

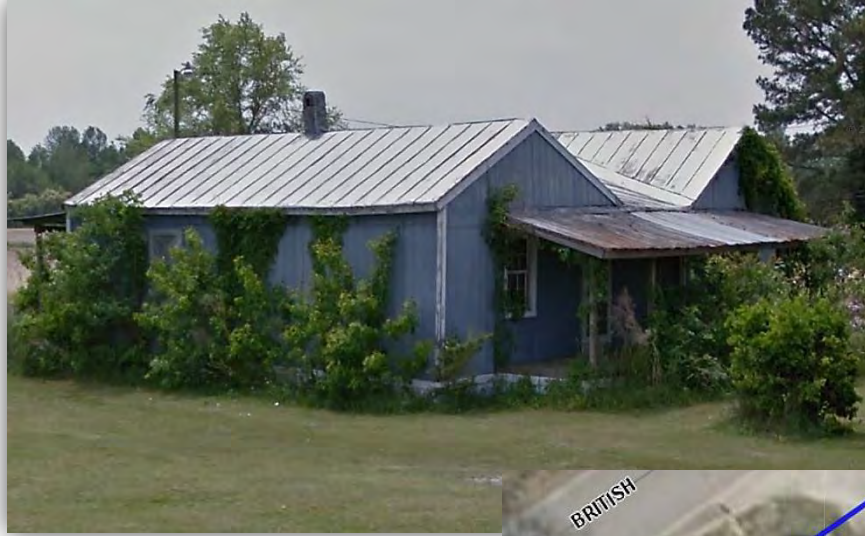
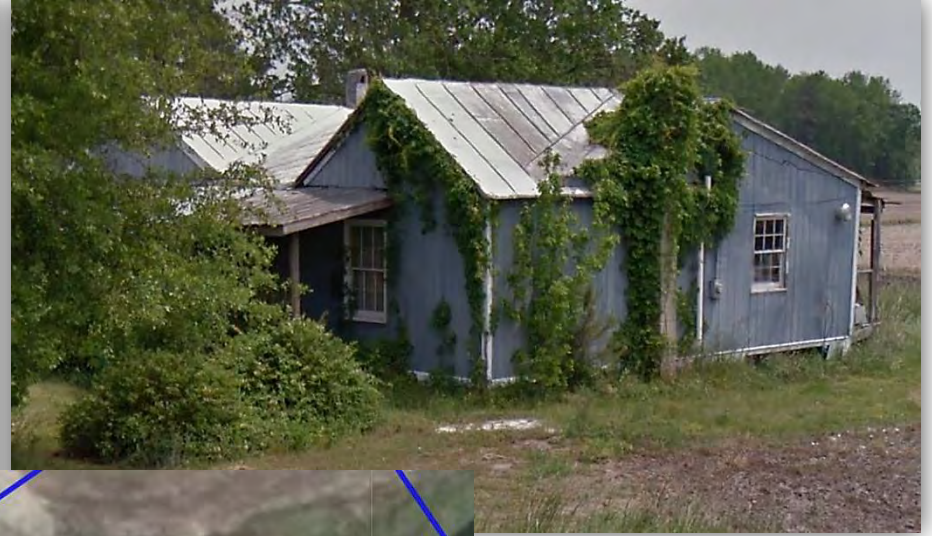
**#68 - PHILLIPS HOUSE (JN-0101) – early 20<sup>th</sup>-c house; believed to lack significance and integrity [modern Google and Jones County orthogonal tax map images]**

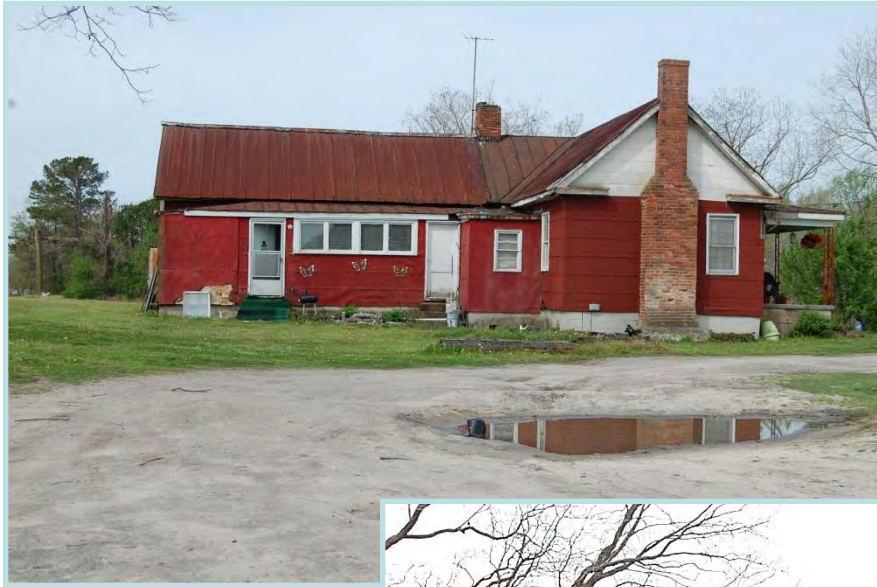
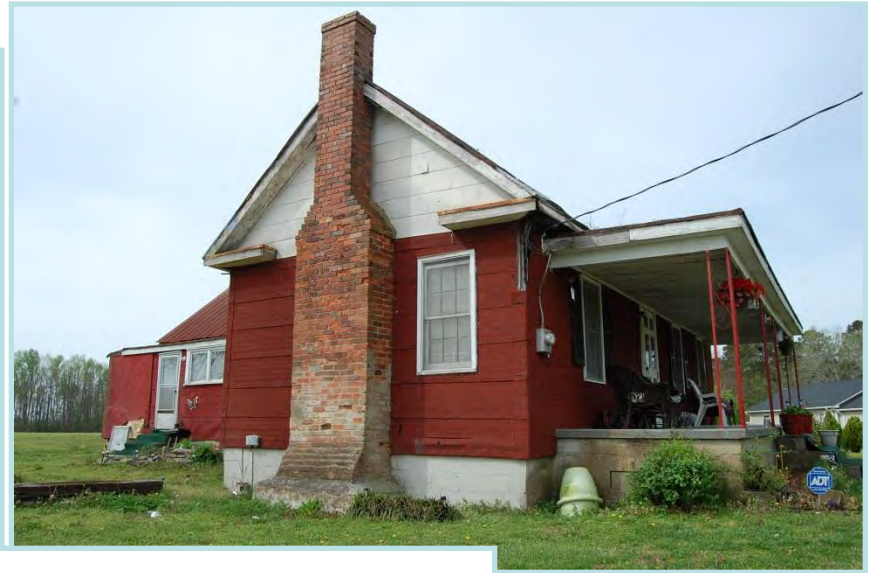
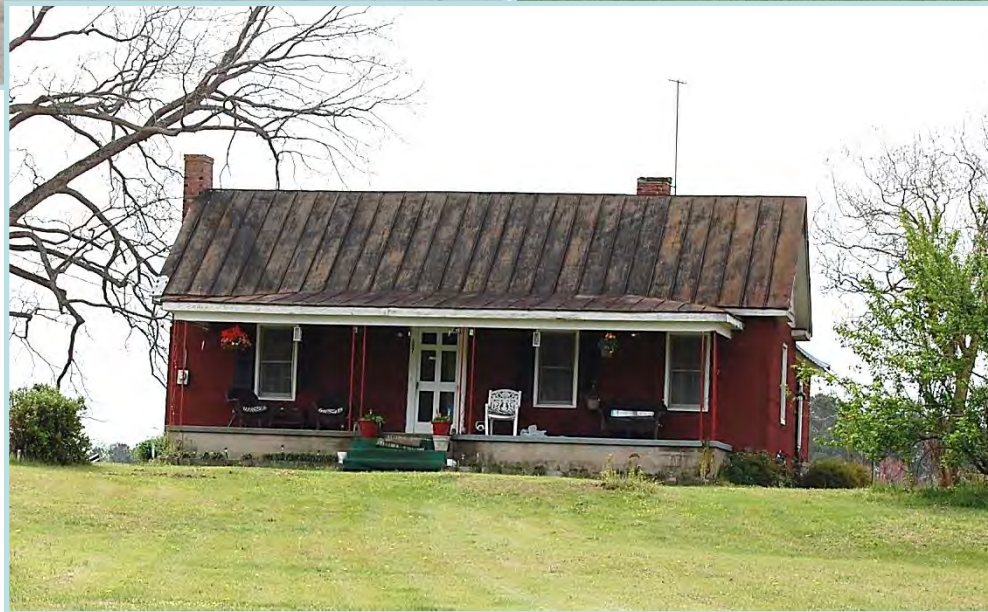
**#69 - LEE-JOHNSON HOUSE (JN-0104) – turn-of-the-century house;  
believed to lack significance and integrity**

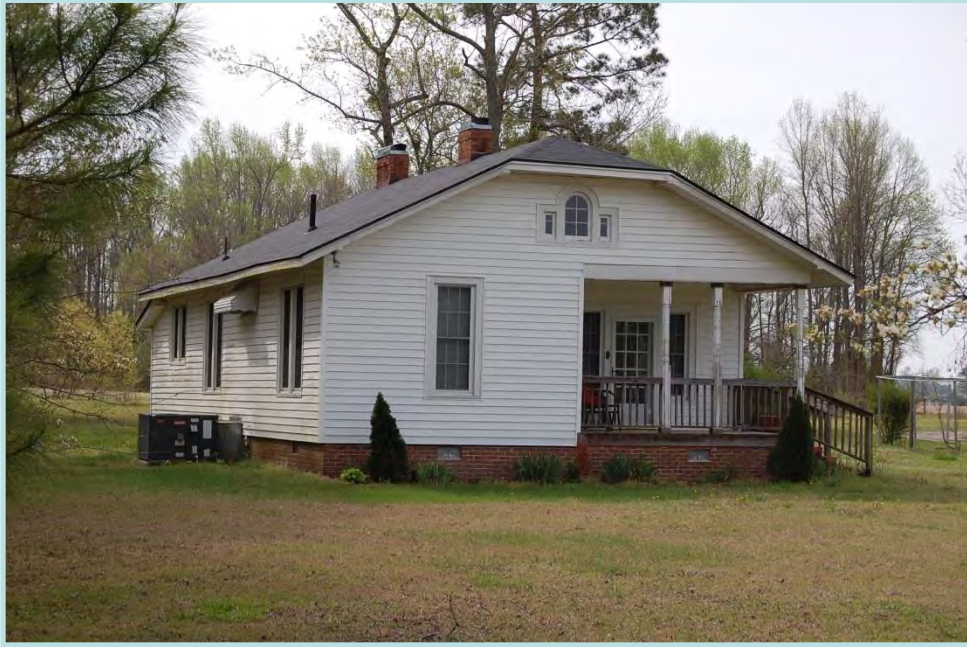
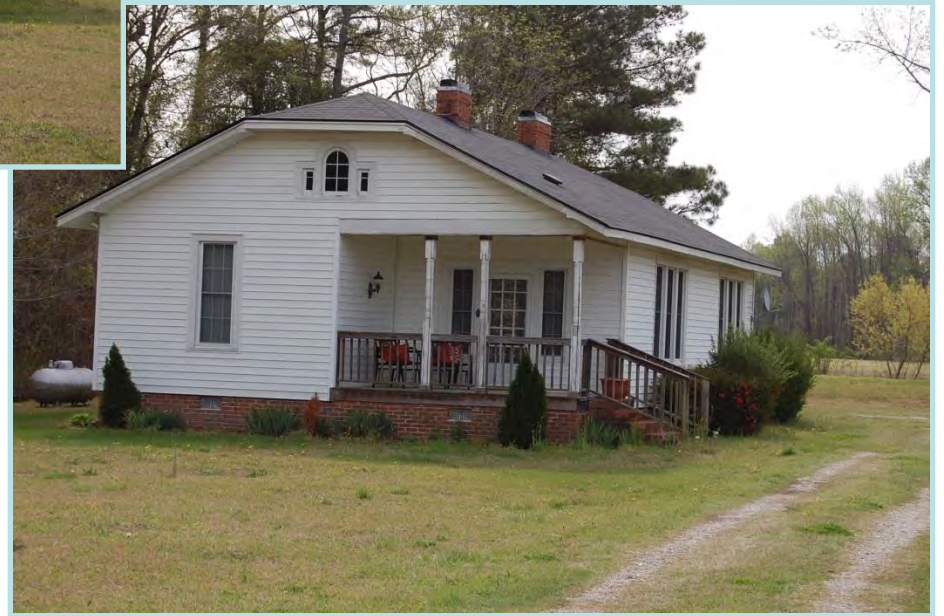
**#70 - GRADY HOUSE (LR-0100) – built between 1905 and 1925 in Kinston and moved to site; believed to lack significance and integrity**

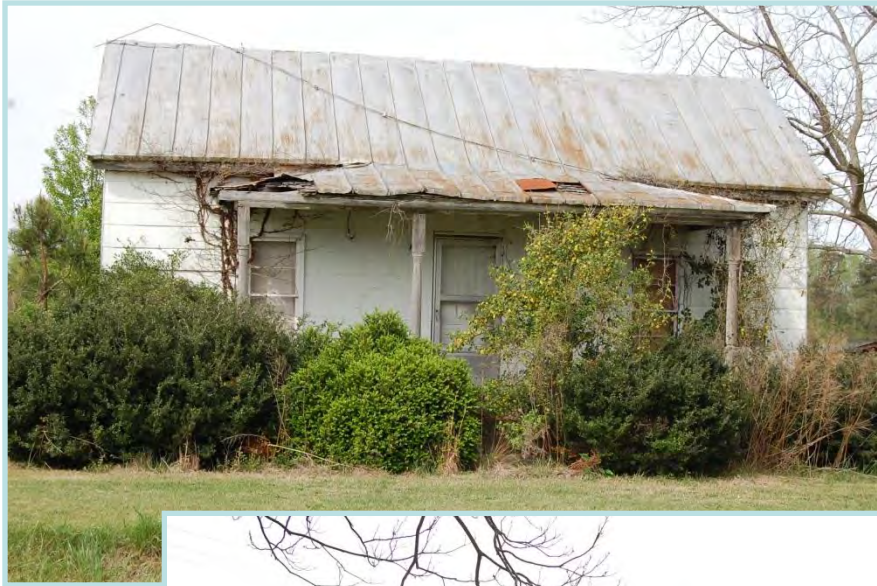
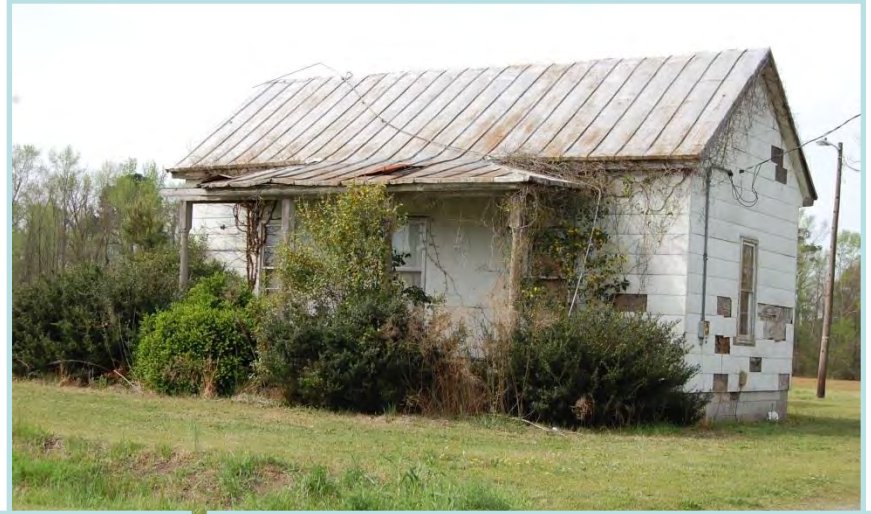
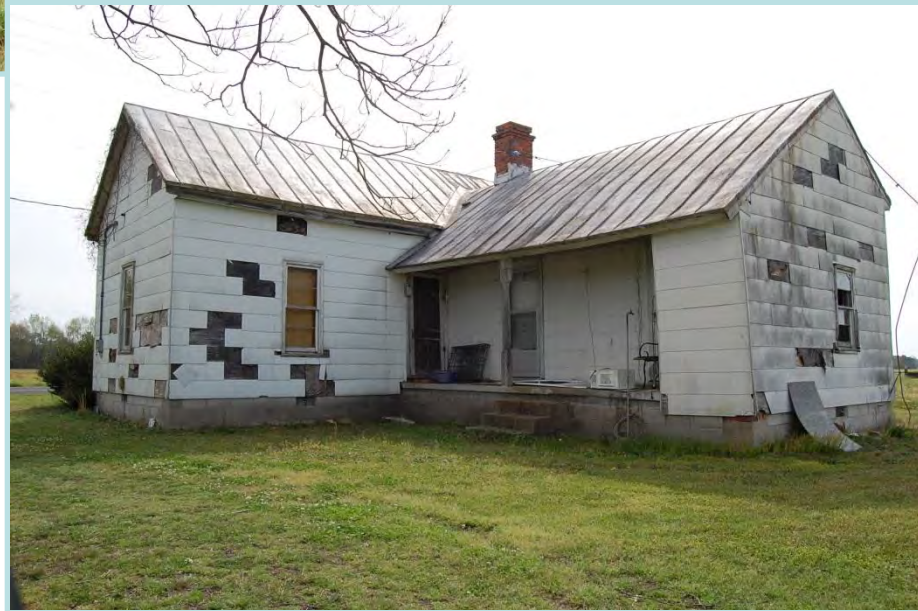
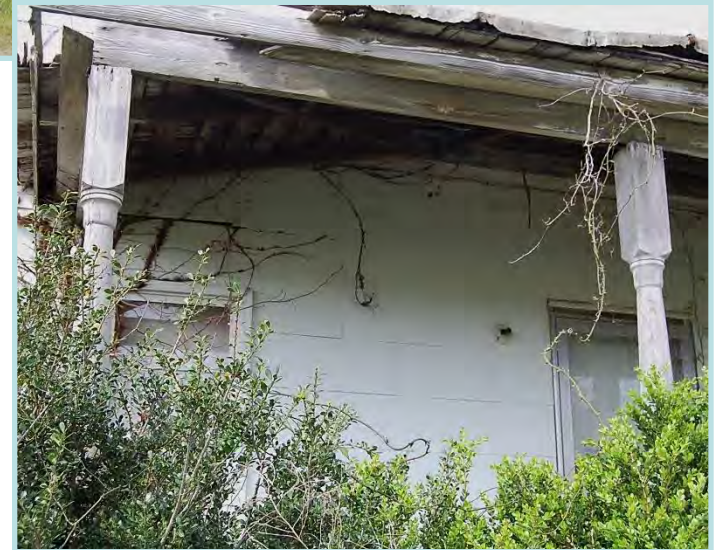
**#71 - BRYANT HOUSE (JN-0108) – turn-of-the-century frame house;  
believed to lack significance and integrity**

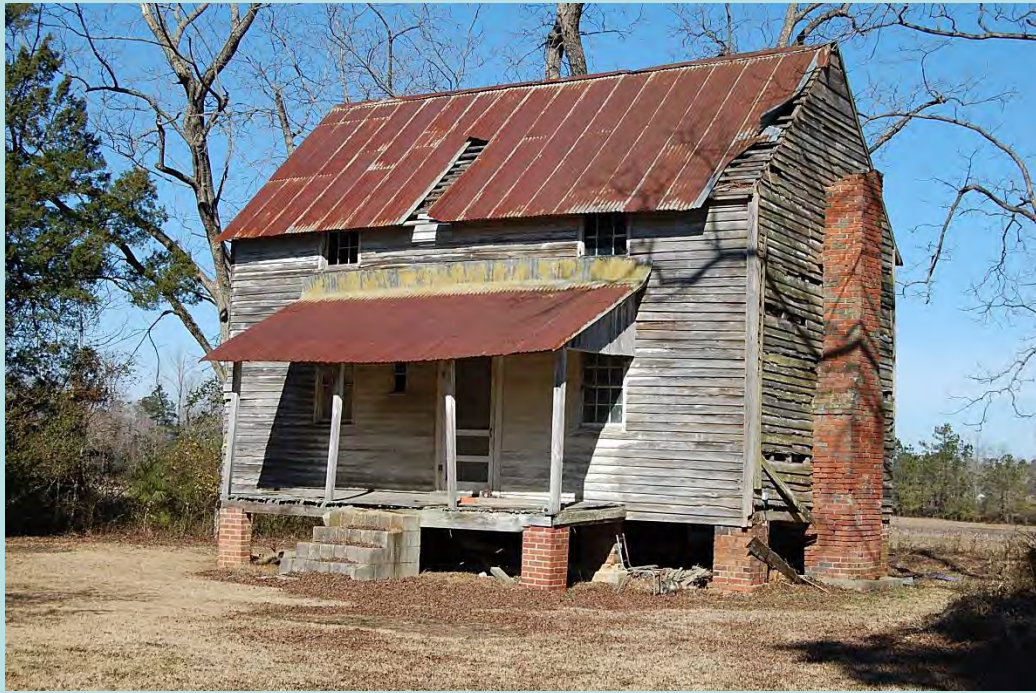
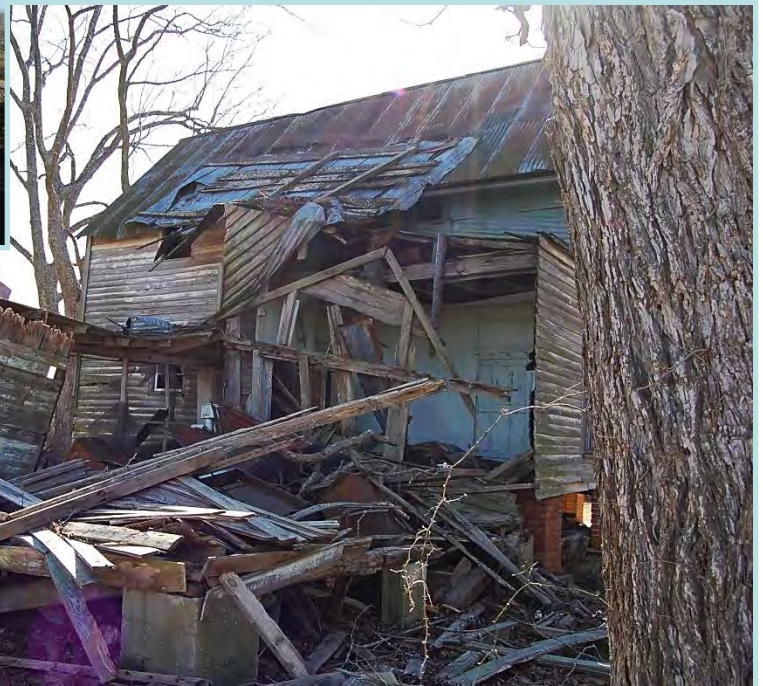
**#72 – ALONZO DAUGHETY HOUSE (LR-1220) – built by African-American farmer late 19<sup>th</sup>/ early 20<sup>th</sup> c; could not be seen—collapsed beneath trees and overgrowth or gone; believed to lack integrity [2010 photographs]**
