**North Carolina Department of Cultural Resources
State Historic Preservation Office**

MEMORANDUM

SUBJECT: Architectural Survey for Improvements to US 158, from East of NC 34 at Belcross to NC 168, R-2574, Currituck and Camden Counties, ER 11-1152

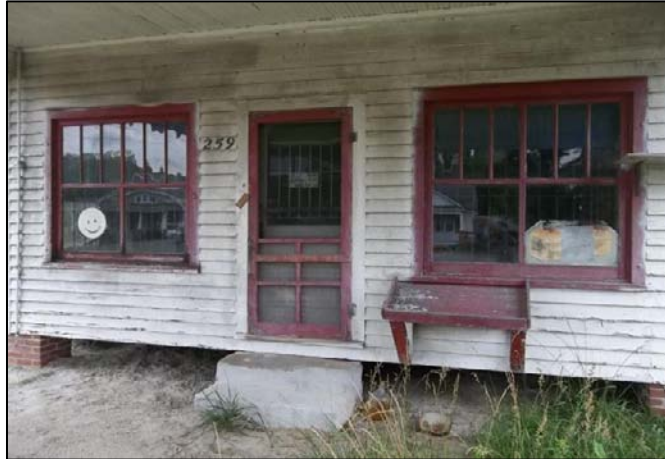
Photo 1: Detail of the Primary (Northwest) Elevation, Creekmore Store/Gas Station.

Based on the extant historic fabric from this time period, the building continues to display a high level of historic integrity in its location, workmanship, feeling and association, and a relatively moderate level in its setting, design, and materials (Photo 1). Architecturally, it continues to be a good example of a house-with-canopy style gas station, representative of a growing trend of providing consumer services for automobile drivers in the second quarter of the twentieth century. Therefore, it is recommended that this resource remains eligible for the NRHP under Criteria A and C and under Criterion Consideration B as a moved property.

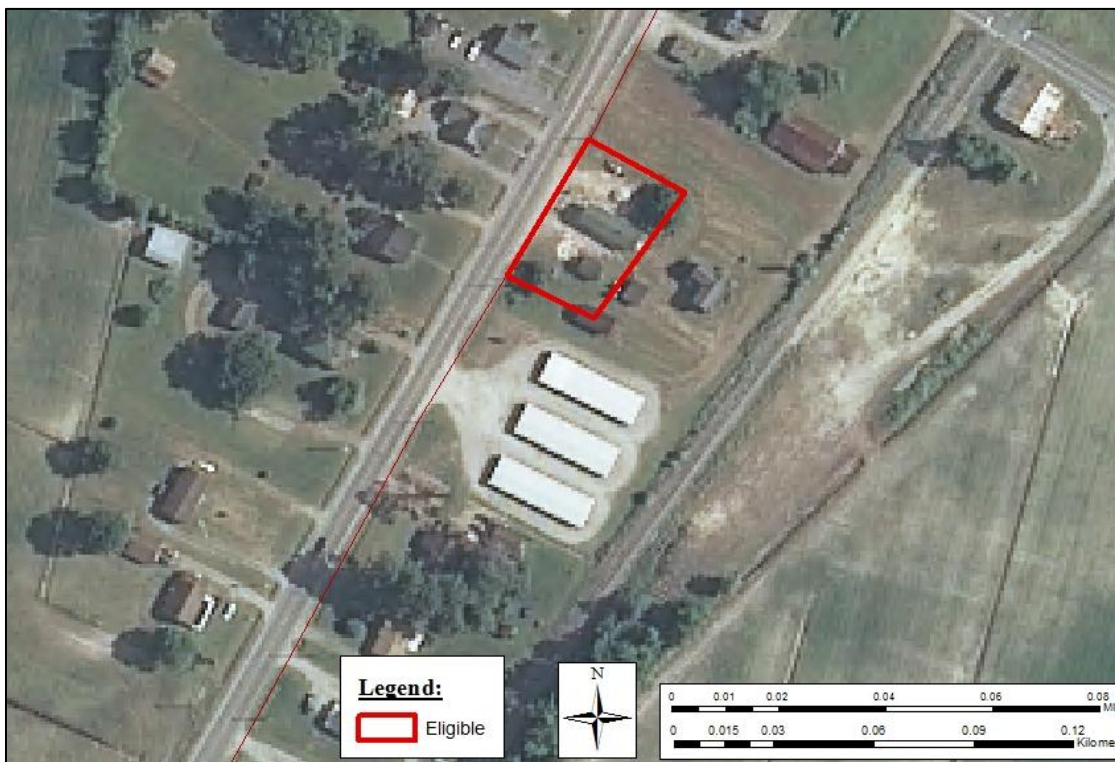
Figure 6: NRHP Boundaries for Location of the Creekmore Store/Gas Station After its Relocation (Camden County Geographic Information System/GIS 2012).

The NRHP boundaries established for the Creekmore Store/Gas Station during previous investigations conform to the existing tax parcel (Figure 6). These boundaries extend roughly from the NCDOT right of way adjacent to U.S. Highway 158 to the north, bounded by a modern commercial property to the west, extending back towards the Creekmore House and the railroad to the south and by the railroad and the Harris property to the east.

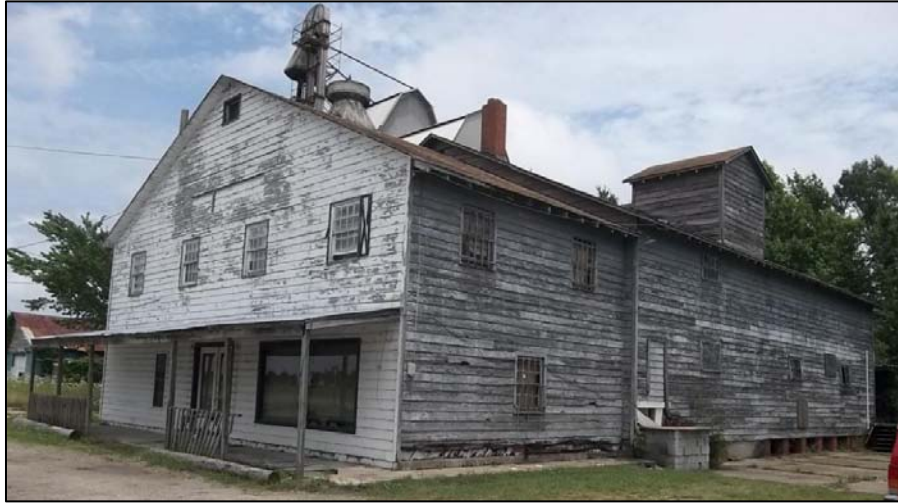
Photo 2: View of Warehouse One, Looking East.

Warehouse One – Labeled as building number four in the 1949 plat, this warehouse is currently the largest in the complex. The three-bay, two-story warehouse, constructed in 1936, rests on a brick pier foundation with portions in-filled with continuous concrete block (Photo 2). It has a frame structural system sheathed in diagonally placed boards that are further clad in simple-drop weatherboard. The warehouse features a front-gabled roof clad in asphalt shingles. The roofline is broken into two segments that visually distinguish the original portion of the building from a smaller two-story addition at the northwest end. The original section of the warehouse is rectilinear in form and contains a single, interior, brick chimney located near the northwest corner. A small, gabled structure, designed to support a grain leg (the conveyer that moved material into the appropriate storage area), rises from the west elevation of the building and is also clad in simple-drop weatherboard. The east and

The original section of the warehouse extends southeast towards the Chesapeake and Albemarle Railroad and features a covered loading dock at the first floor of the rear, or southeast, elevation. The loading dock is framed and covered by a one-story hipped roof with a wood plank floor that rests on a mix of concrete and brick piers (Photo 3). A large sliding door covers an open bay at the rear of the building. This opening is also seen in the framing that enclosed the loading dock. A smaller, single-leaf entry also marks the rear elevation. How much evidence remains of the railroad spur that lined the loading docks is unknown, but the line has been abandoned. An abundance of vegetation at the time of survey prevented further inspection of the southeast side of the parcel.

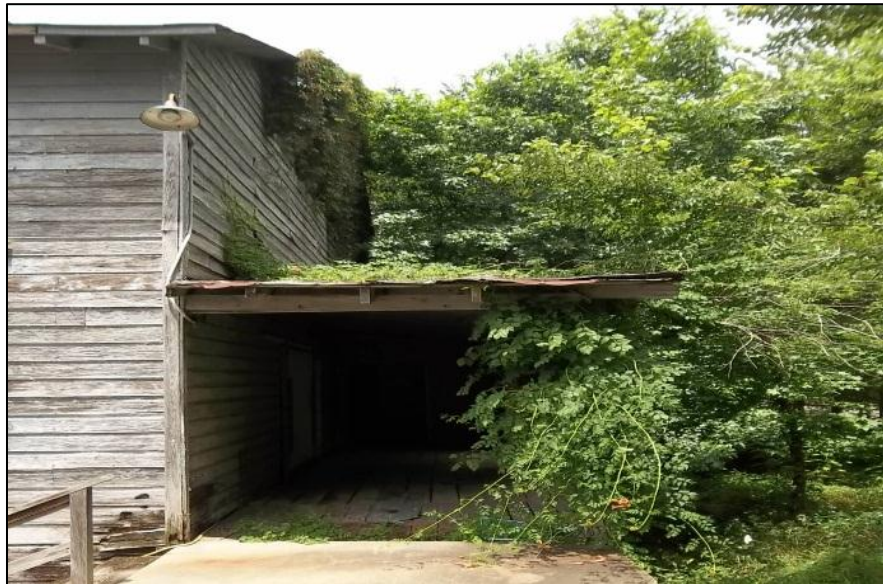
Photo 3: View of Loading Dock Looking Northeast, Warehouse One.

west elevations of the original warehouse are dotted by eight-light, wood-frame, awning windows, some of which have been covered by plywood.

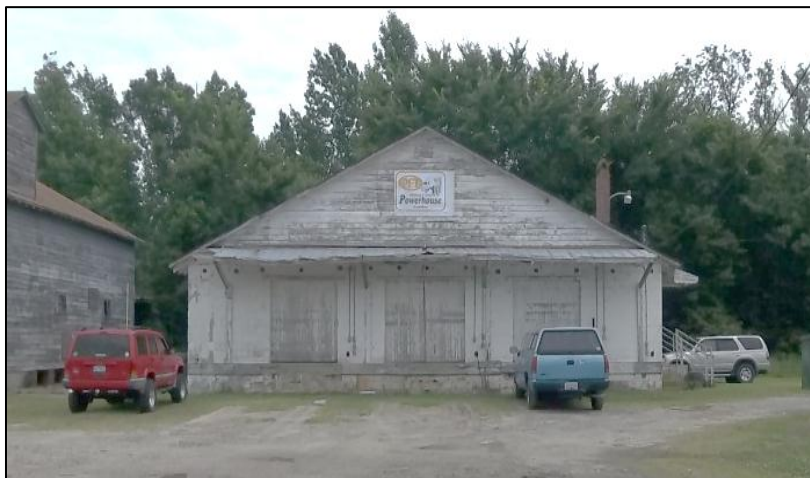
Photo 4: Northwest Elevation, Warehouse Two.

Warehouse Two – Labeled as building number two in the 1949 plat, this warehouse was also constructed in 1940 (Camden County Geographic Information System/WebGIS 2012). It is a one-story, three-bay, concrete-block storage building that rest on a continuous foundation (Photo 4). A frame truss system supports the front-gabled roof that is sheathed in asphalt shingles. Overhanging eaves and exposed rafters line the east and west elevations. The gable ends of the building are clad in weatherboard. One interior brick flue is centrally located on the west elevation.

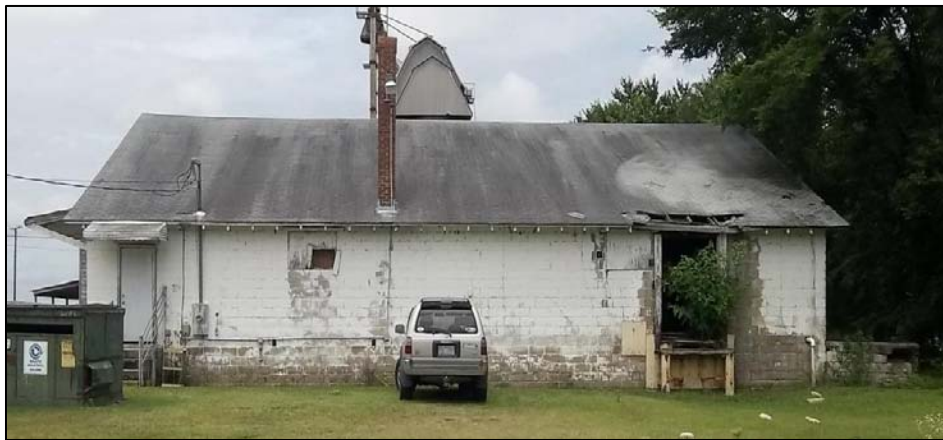
Photo 5: Southwest Elevation, Warehouse Two.

The façade is marked by three garage-bay openings, historically covered by sliding doors that are now filled with wood siding. A full-length pent roof extends across the façade and is sheathed in v-crimped sheet metal. A single-leaf, solid metal door is located below an aluminum awning at the northwest corner of the building. It is reached by a set of poured concrete stairs that allow access from two different directions and is topped by a metal pipe railing. Another pedestrian entry appears to have been located at southwest corner of the building, but is now open to the elements. The building is largely void of windows, but a small opening is visible near the northwestern end of both the east and west sides (Photo 5). At the rear or southeast elevation of warehouse two are three garage bay openings filled with overhead aluminum garage doors. Extending across the southeast elevation of the building is a linear, open loading dock that connects the covered loading dock at warehouse one. The loading dock has a concrete-block foundation and is capped with poured concrete (Photo 6).

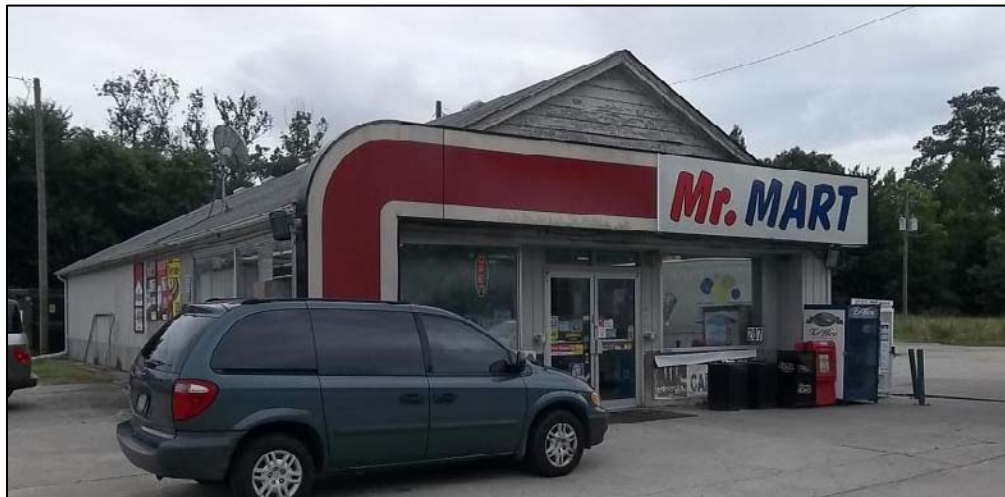
Photo 7: North Oblique, Office and Store/Mr. Mart Convenience Store.

Office and Store (presently Mr. Mart Convenience Store) – Labeled as building number one, “office and store” in Sawyer’s 1949 plat, this one-story, three-bay commercial building was constructed in 1946 (Bell 2012) (Photo 7). The foundation is not visible and is covered by T-111 siding along with much of the building’s structural system. At the façade, the gabled end is clad in what appears to be original weatherboard. The store is covered by a front-gabled roof that is sheathed in asphalt shingles. No chimneys were present at the time of survey.

The primary (northwest) façade features two fixed, metal-framed display windows that flank a metal-and-glass, double-door entryway—features commonly found in modern convenience stores. Part of the facade is obscured by a large electric sign made of metal and plastic that lines the north end of the façade and turns to run across it, creating something of an awning over the entrance. This showcases the store’s current name, “Mr. Mart.” Paired metal-framed display windows also fill the northwestern end of the store on both the east and west elevations (Photo 8). The rear (southeast) elevation features a small one-story, gabled addition to the building that is also clad in T-111 siding.

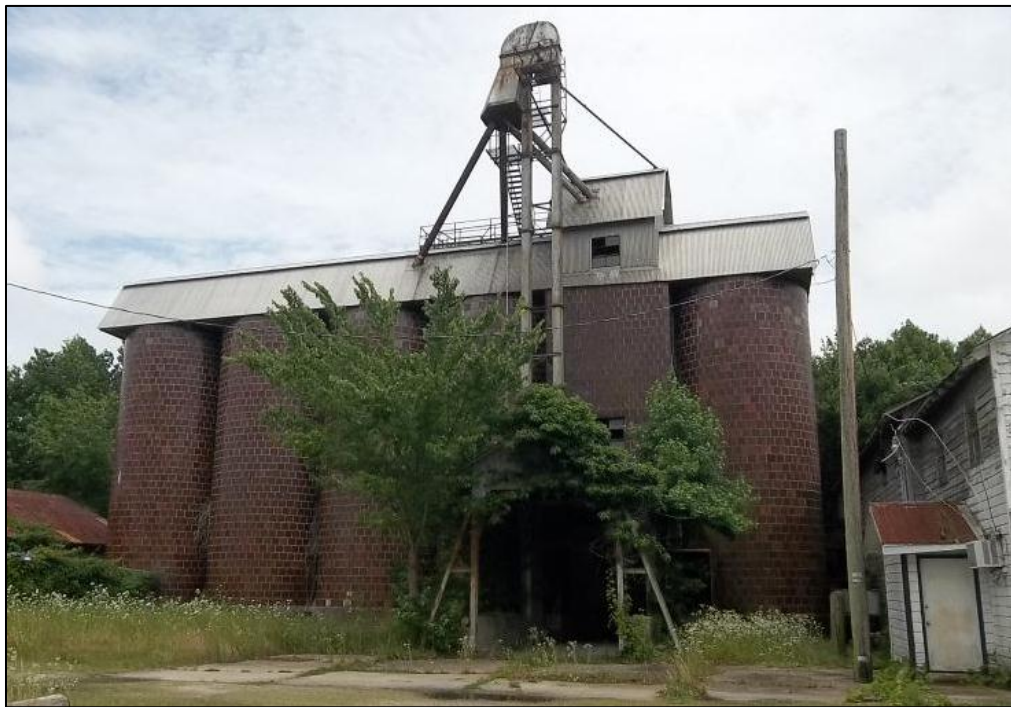
Photo 9: Northwest Elevation, Grain Elevator, Silos, and Loading Dock.

Grain Elevator and Silos – Erected in the latter-half of the 1940s, the most visible feature of the property is a series of five silos connected to a grain elevator which are all united by a metal gambrel roof (Photo 9). This structure was labeled as number five on Sawyer’s 1949 plat. The silos and grain elevator are constructed of glazed hollow-tile blocks. The exoskeleton of the grain elevator differs from the silos as it is square in shape and topped by a side-gabled structure that is clad in corrugated metal. The roof and truss system shelters the augers, chambers, and mechanical equipment used to move grain and seed between the silos. Extending northwest from the grain elevator is a front-gabled loading dock. This steel-framed structure is supported by a concrete-slab foundation and low cinder-block walls, and its roof is sheathed in standing-seam metal. This structure was used to shelter the trucks delivering and receiving grain and seed (Photo 10). A one-story, cinder-block addition covered by a shed roof connects the southernmost silo to the northeast corner of warehouse one. An abundance of vegetation prevented closer inspection of this section of the building. However, on the 1949 plat, this area is labeled “drier” and was the area where newly harvested corn was dried before being shelled.

the resource. The most visible feature of the property, the grain elevator and silos, retain a high level of historic integrity and are in good condition as hollow-tile-block structures are concerned. This type of construction was often "...too costly for widespread adoption. Also, the blocks were somewhat brittle and an accidental sudden impact would often cause the blocks to crack" (Noble 1984:747). Use of concrete, wood, or metal in the construction of feed mills and silos is more commonly seen across the country.

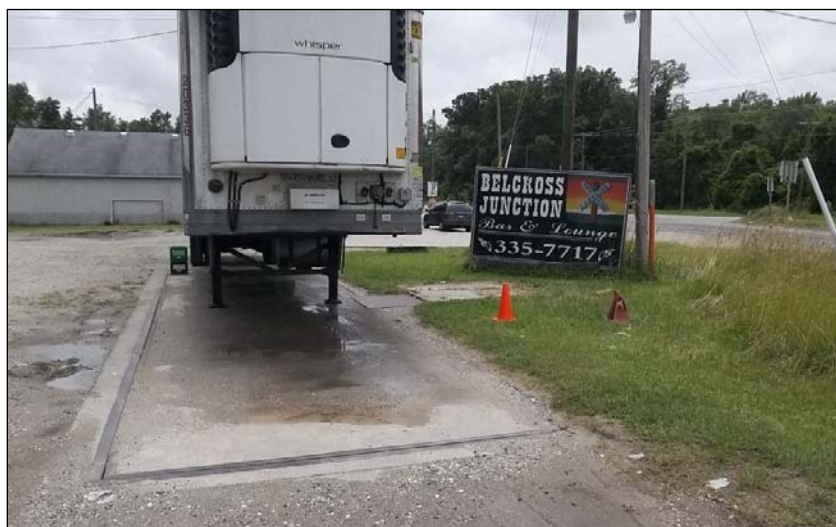
Photo 11: View of Truck Scales, Looking Southwest.

Truck Scales – The truck platform scales, marked on Sawyer’s 1949 plat by the number eight, is a metal framed poured-concrete platform that is level with the ground (Photo 11). Below the platform, a system of scales weighed the trucks delivering material to the mill. It is unknown if these scales are still present below the concrete platform or in use. The 1949 plat of the property shows a small box next to the scales platform, likely a shelter for the scales’ attendant. Today, no additional structures or above-ground elements remain next to the platform.

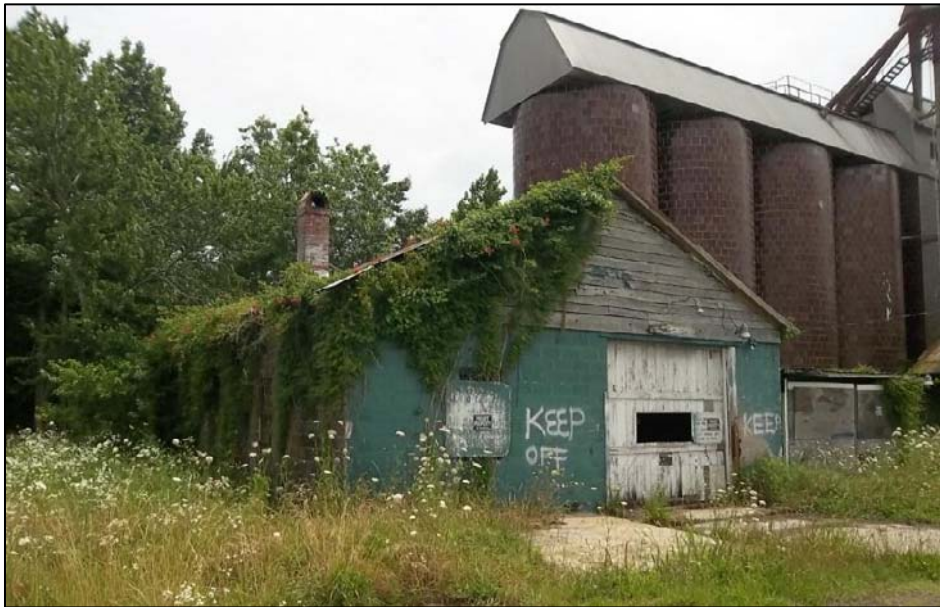
Photo 12: View of Warehouse Three/Garage, Looking South.

Warehouse Three/Garage – Located at the northeastern end of the complex, this building was labeled as a warehouse in the 1949 plat and identified by the number six; however, it appears to have been converted to a garage in recent decades. It is a one-story, two-bay, cinder-block building that dates around 1940 (Photo 12). The front-gabled roof of the warehouse is sheathed in standing-seam metal and the gable ends of the building are clad in weatherboard, similar to the construction methods and materials seen in the second warehouse. One interior brick chimney is located near the north corner of the northeast elevation. The façade, or northwest elevation, is marked by a large garage bay and a single window opening that has been covered with plywood. This building was largely covered by vegetation at the time of survey.

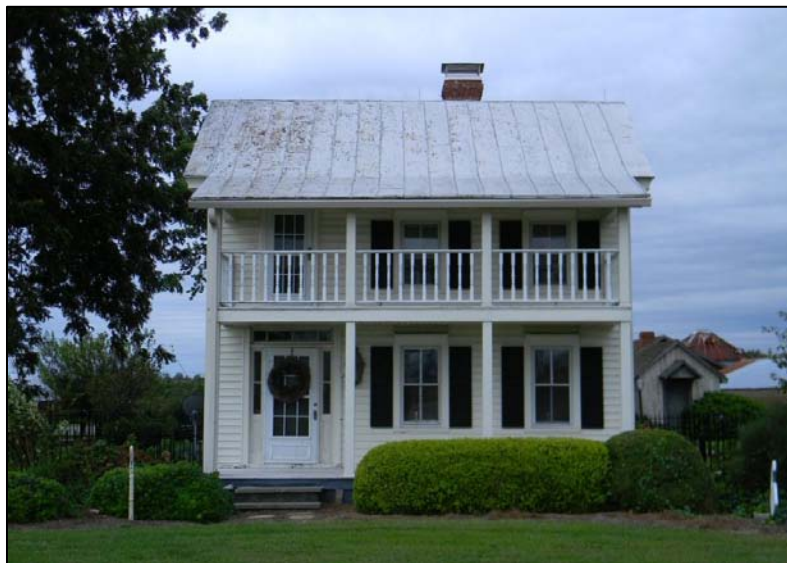
Photo 13: Primary (Northeast) Elevation, Cooper House.

The Cooper House is a two-story, three-bay, double-piled, frame residence built during the third-quarter of the nineteenth century, which features a side-hall plan—unusual in rural locations including this part of Currituck County (Photo 13). Side-hall plans are more commonly found in urban areas such as Halifax (Halifax County), Hertford (Perquimans County), and Elizabeth City (Pasquaotank/Camden Counties). A majority of the nineteenth-century houses around this part of Currituck County have a central-hall plan, such as the Culong House (CK0006) and the Boswood/Mathias House (CK0423).

The building is set on its original brick pier foundation, of which approximately 1 foot is visible above ground. The brick piers have been infilled with continuous cinderblocks. The wood frame was originally clad in weatherboard, which is currently covered in vinyl siding. The Cooper House is covered by a moderately pitched, side-gabled roof that is sheathed in standing-seam metal. The eaves are lined with an unadorned box cornice and frieze, including gable-end returns, which are also covered in vinyl. The soffit, approximately 8 inches deep, is also covered by vinyl.

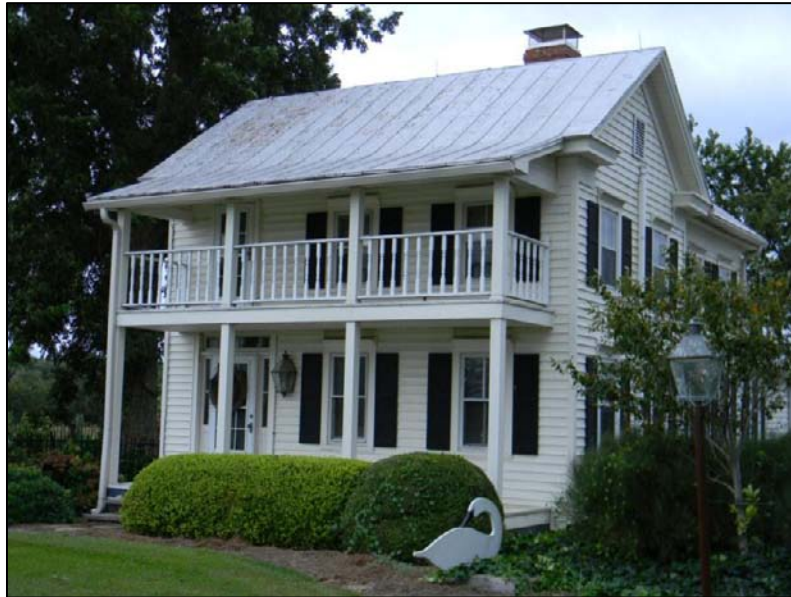
Photo 14: Detail of the Porch Located on the Northeast Elevation, Cooper House.

A two-story, three-bay, shed-roof porch extends across the northeast elevation (Photo 14). The construction date of the porch is unknown and it could be a later addition. Access to the porch to further investigate the door and second level was denied. The porch is raised on a brick pier foundation with cinderblock infill and roofed with standing-seam metal. The roof and second story floor are supported by slender square columns. The second story is lined with a railing that is composed of turned balusters.

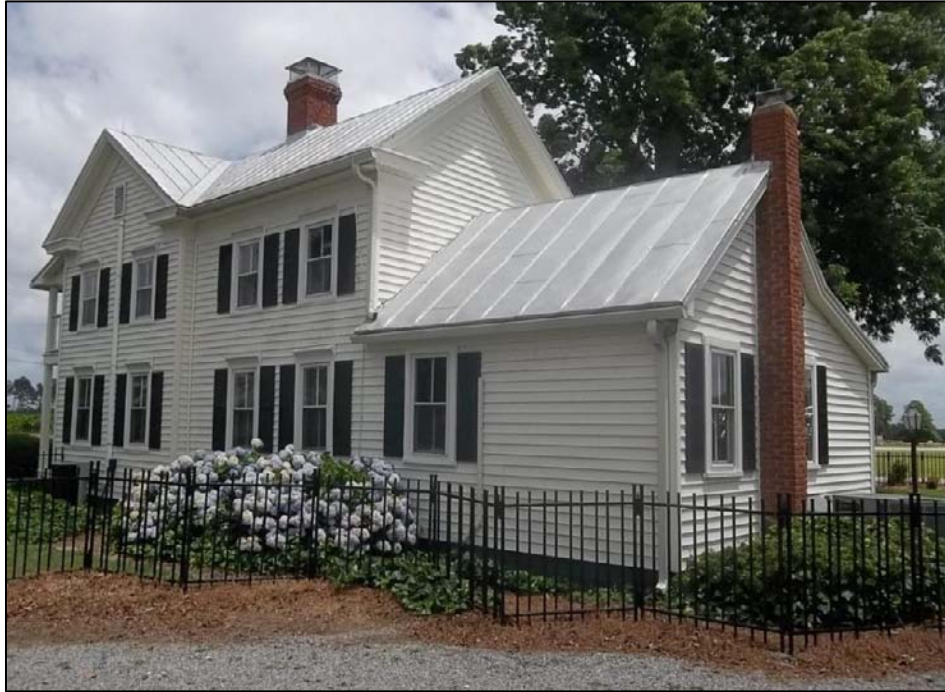
Photo 15: Rear Ell and Kitchen Addition, West Oblique, Cooper House.

A rear ell extends off the southwest elevation. It is similar to the main core of the house in its foundation, siding, and roof style. The only original chimney is a central-interior, corbeled cap, brick chimney where the ell meets the main portion of the house. Many of the stylistic features found on the ell are also present in the main house, such as window size and shape, and hood placement. These elements, as well as the double-flue chimney on the interior (discussed on page 5), suggest that the ell is either original to the house or was added shortly after the main section of the house was built.

A one-story kitchen addition is located on the rear (southwest) elevation of the house and, according to the current owner, was likely added during the mid-twentieth century (Photo 15) (Morris 2012). It is set on a raised, cinderblock foundation and clad in vinyl siding. The addition is covered by a gabled roof that is sheathed in standing-seam metal. An exterior-end, brick chimney is situated on the southwest elevation. Window openings include two-over-two and six-over-six, wood-framed, double-hung sash windows covered by exterior storm windows. On the southeast side of the addition is a one-story porch that is now enclosed (Photo 16). It is clad in vinyl siding and covered by a shed roof. A row of three wood-frame, two-over-two, double-hung sash windows are adjacent to the enclosed porch entry on the southeast elevation. A wooden deck on raised piers extends across this porch entry.

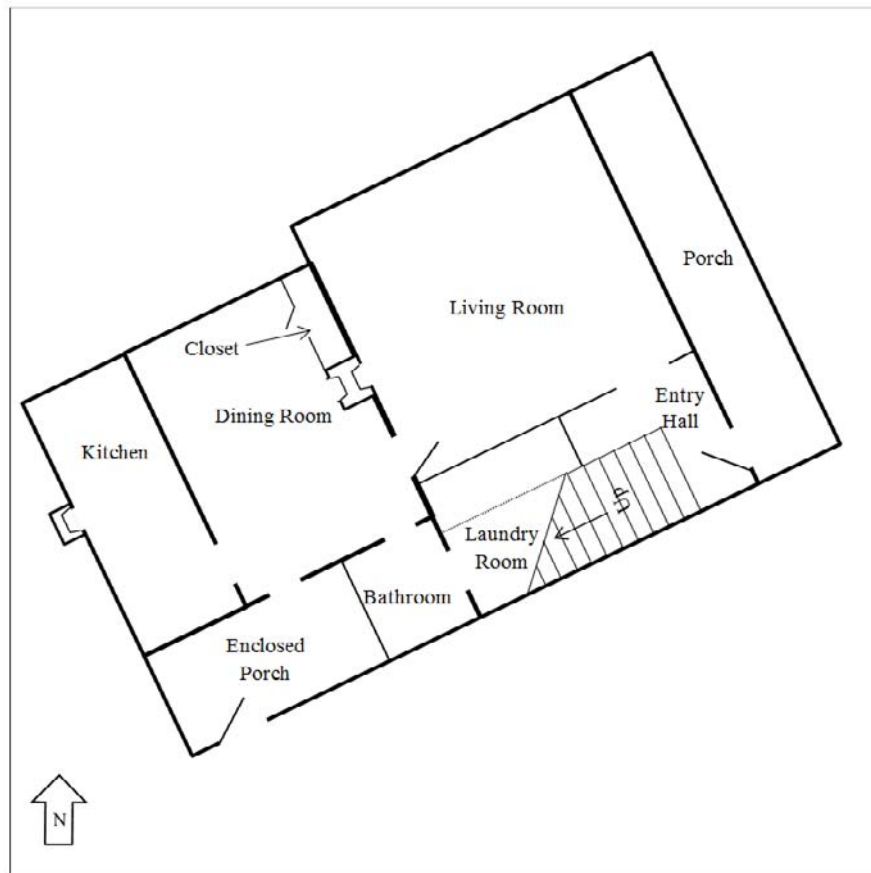
Figure 11: First Floor Plan of the Cooper House, Not Drawn to Scale.

The current survey revealed that much of the interior remains intact. Upon entering the house by way of the primary entrance, the first area accessed is the side hall which features a staircase (Figure 11). The open-string stairway features wooden risers and treads and an unadorned carriage. The stairs are lined with a balustrade that is composed of paired, turned posts that terminates in a robust newel post (Photo 17). Adjacent to the entry hall is the current living room. The hall and living room have the original heart pine floors; the ceilings and the walls are plastered. Because of the location of the fireplace within the house, there are two openings: one in the living room and one in the adjoining dining room that is located in the rear ell. The fireplace in the living room has a wooden surround with a round-edge mantelshelf. A bull's eye is centered on the vertical side panels and also the horizontal panel just below the mantelshelf.

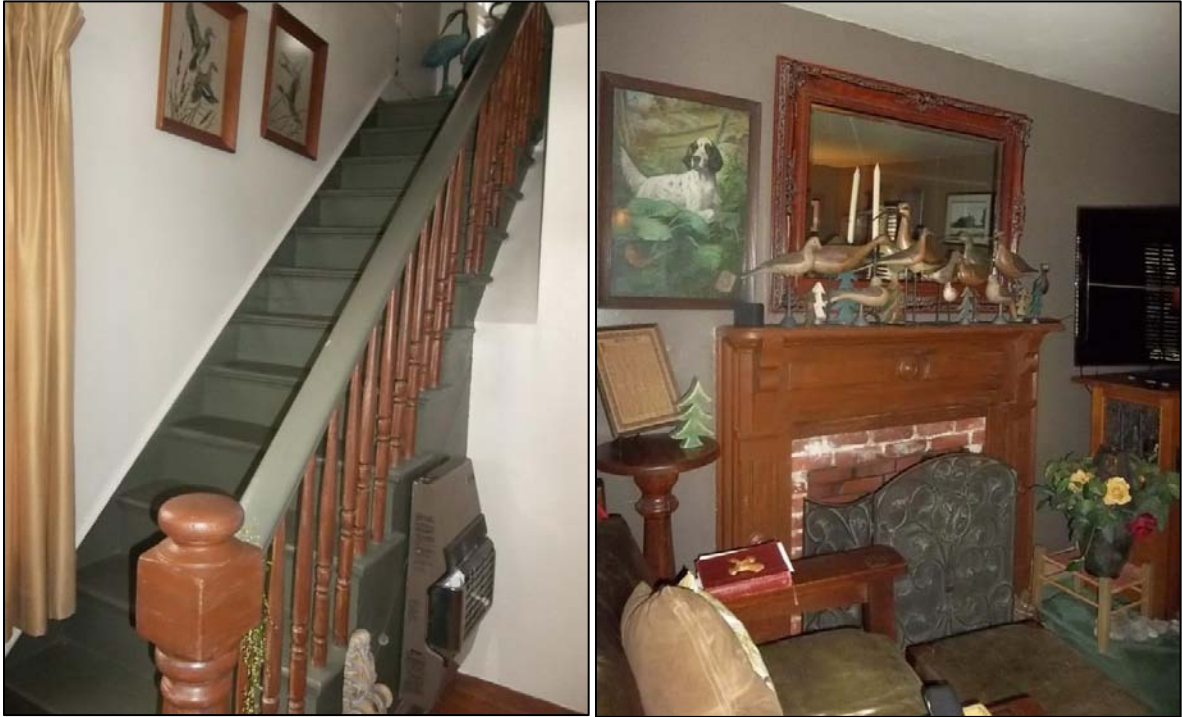
Photo 17: Entry Hall Staircase (Left) and Living Room and Fireplace (Right).

The doorway that leads from the living room into the dining room is a four-paneled door with original hardware set within an unadorned molded wood frame. Above the door is a single-light transom (Photo 18). The original plaster in the dining room, as well as the original floor and ceiling materials, have been replaced. The floor is covered in a cork material, and the walls have been replastered. The ceiling was recently clad in wooden boards. The mantel, which is likely original, features fluted pilasters and brackets that support the mantelshelf.

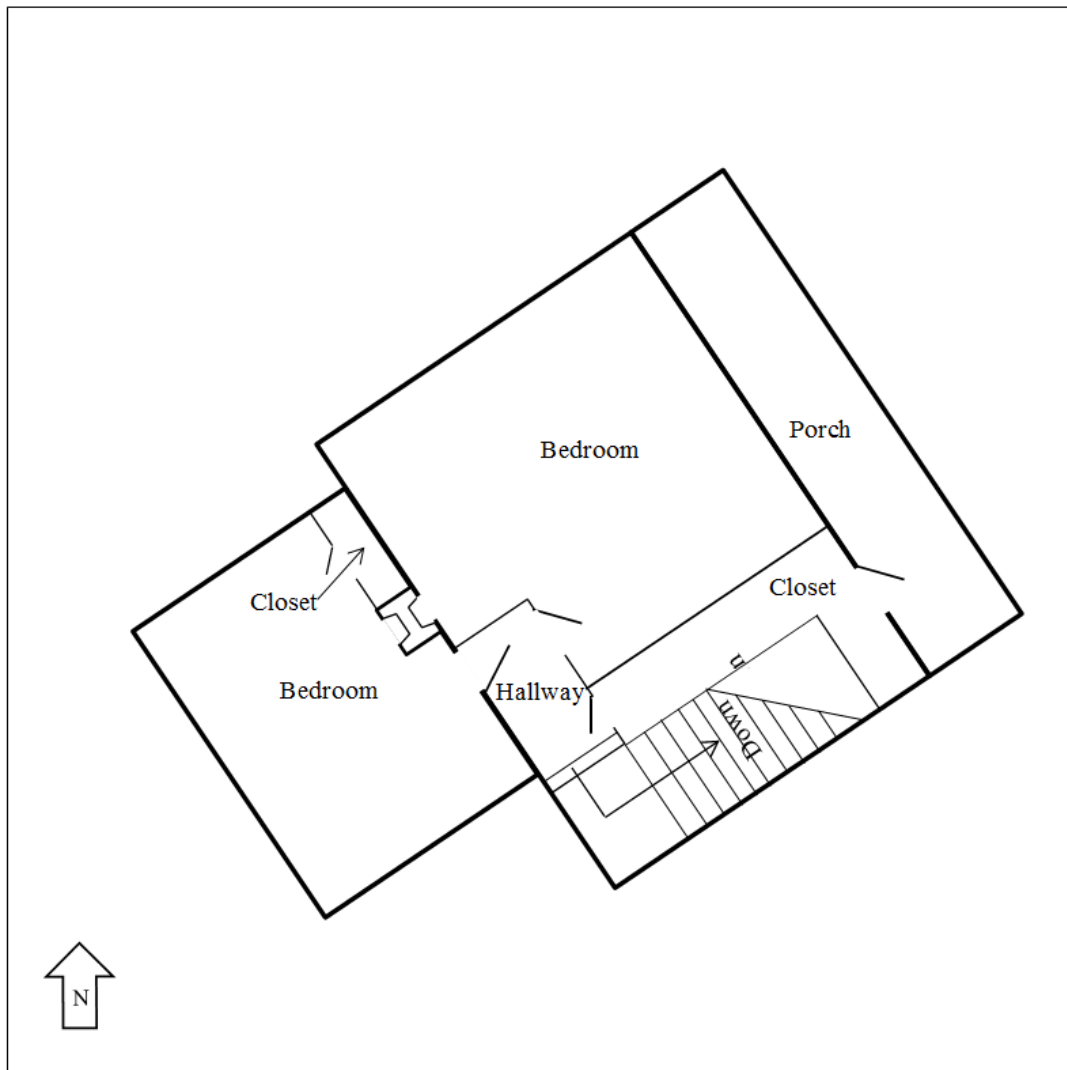
Figure 12: Second Floor Plan of the Cooper House, Not Drawn to Scale.

On the second story there are two bedrooms: one above the living room and one above the dining rooms, and a hallway that connects all the rooms. The second level features the original wood flooring, baseboards, and window and door frames (Figure 12). The area above the first story side hall was likely partitioned off from the bedroom to be used as a closet or a breezeway to the porch doorway. Currently it is used as a closet. Other than a glimpse into the space, the current owner denied access to this space. An entry to the attic crawl space is located on the ceiling in the second floor hallway (Photo 19).

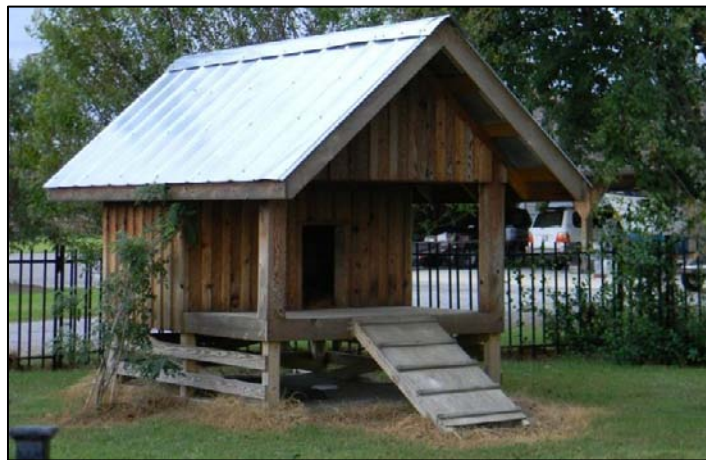
Photo 20: Southeast Oblique of the Dog House.

There are four outbuildings associated with this resource. A large frame doghouse, built during the 1990s or 2000s, is situated south of the Cooper House within the boundaries of the metal fence (Photo 20). It is raised on wooden piers and clad in board-and-batten siding.

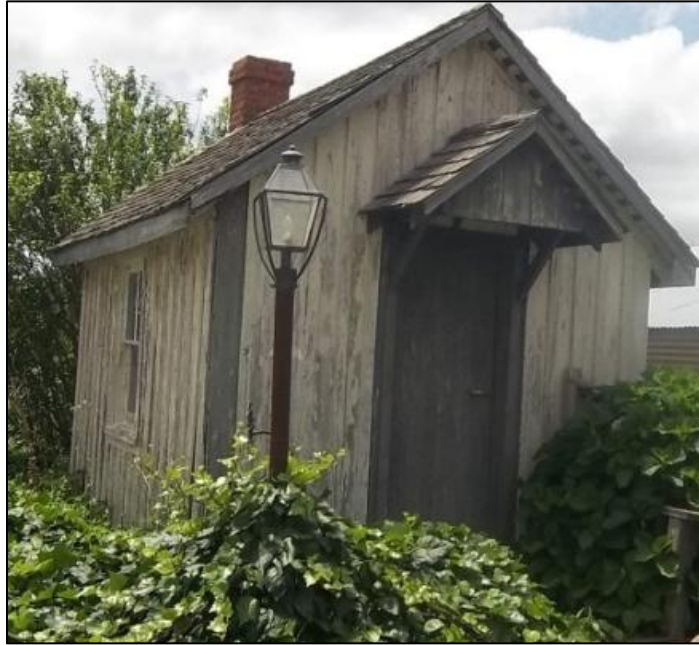
Photo 21: Southeast Oblique of the Tenant House.

A one-story, one-bay frame outbuilding is located west of the primary resource. According to an interview with the current owner, it was used as a tenant house as late as the 1940s (Morris 2012). This resource is clad in board-and-batten siding and covered by a front-gabled roof that is sheathed in asphalt shingles (Photo 21). An exterior-end chimney with a corbeled cap is located on the west elevation. Although originally made of brick, the bottom of the chimney has been replaced with cinderblocks. The building is accessed by a wood door set within a wood frame on the east elevation. The entry is covered by a front-gable pent roof that is supported by slender brackets. A wood-framed, two-over-two, double-hung sash window is located on the north and south elevations. Though used as a dwelling during

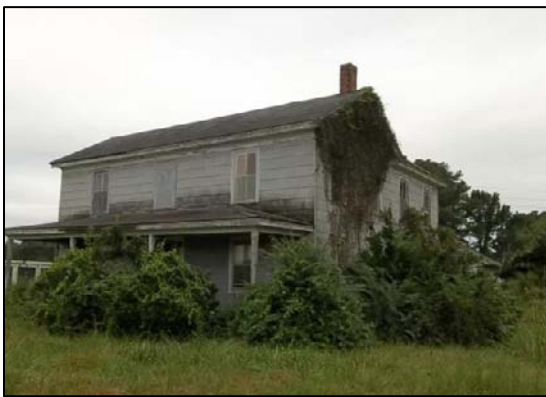
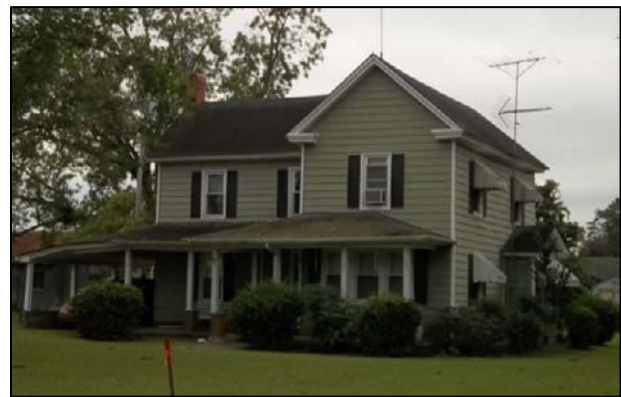
Photo 25: The Creekmore House (Left) and the Doris Harris House (Right).

There are five residential buildings within the evaluated Village of Belcross District: the Effie Creekmore House (CM0074), Creekmore House (CM0075), Krainiack House (CM0076), Pestar Building (CM0077), and the Doris Harris House (CM0079). Two of the earliest dwellings are the Creekmore House and the Doris Harris House. The Creekmore house was built circa 1900 immediately northwest of the railroad. The two-story, three-bay dwelling has a central-hall plan and is representative of a common type and form found throughout Camden and Currituck Counties. The Doris Harris House is a two-story house with a projecting front gable on the northwest elevation. Both houses are characteristic of rural architectural patterns of the late-nineteenth and early-twentieth centuries.

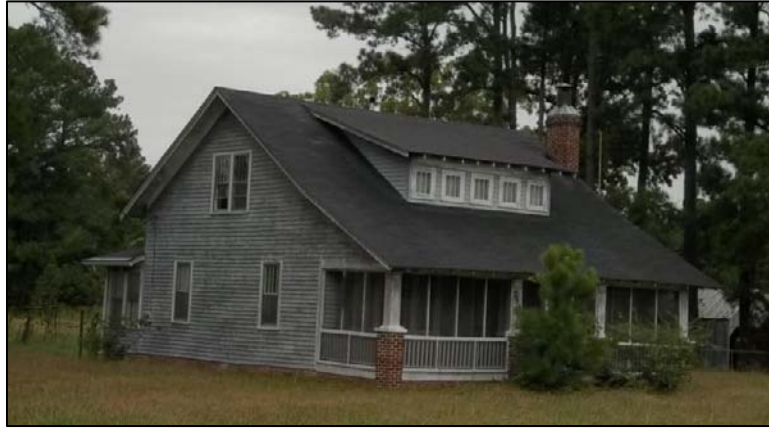
The remaining three dwellings—the Effie Creekmore House, the Pestar Building, and the Krainiack House—are small bungalows built between 1920 and 1940 (Camden County Geographic Information System/WebGIS 2012). Each building was constructed as a one-and-a-half story, single-family dwelling with a frame structural system. The buildings feature typical Craftsman elements such as paired windows and large porches with tapered, square posts set upon brick bases.

Photo 26: The Effie Creekmore House, Looking Northwest. This is one of three examples of bungalow dwelling in the Village of Belcross.

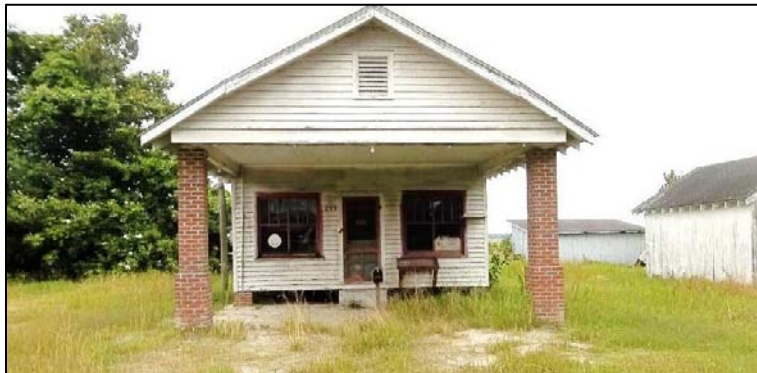
Photo 30: Northeast Elevation, Creekmore Store/Gas Station.

In the 1920s and early 1930s, the automobile era ushered in a new period of growth for Belcross. Bruce and Effie Creekmore constructed the Creekmore Store/Gas Station along what was then the main road heading west towards Camden County Courthouse (Photo 30). The store/gas station, constructed in 1931, is an excellent example of a house-with-canopy style gas station that was popular during this era (Griffith 1994). Many of these new gas automobile-oriented buildings were constructed to attract business from the rising number of drivers touring new and improved roads across the state.

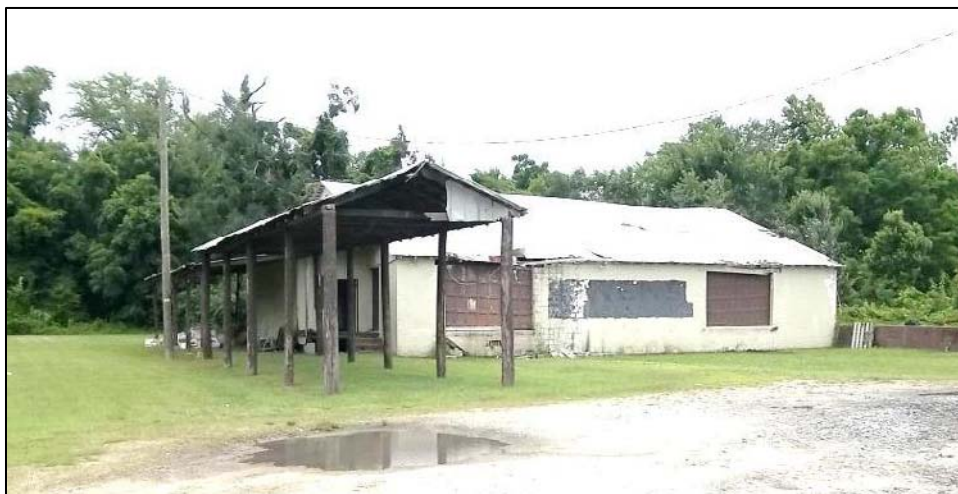
Photo 32: View of the Potato Grading Shed, Looking Northeast.

In the 1930s and 1940s Belcross, like many towns across America, experienced stagnated growth because of the Depression. In the late 1930s Belcross became the site of a migrant labor camp. Workers, mainly from the Deep South, came to pick, process, and ship potatoes (Library of Congress [LOC] 1940). The farmland around Belcross was dotted with tenant houses like those surveyed, such as Sawyer's Tenant Houses (CM0094). All four of these buildings are no longer extant. The Creekmore family constructed a larger general store that catered to locals, travelers and migrant workers (Photo 31). The general store in the photograph below is no longer extant; however, the two houses in the background remain. The Potato Grading Shed also reflects this period of Belcross's history (Photo 32).

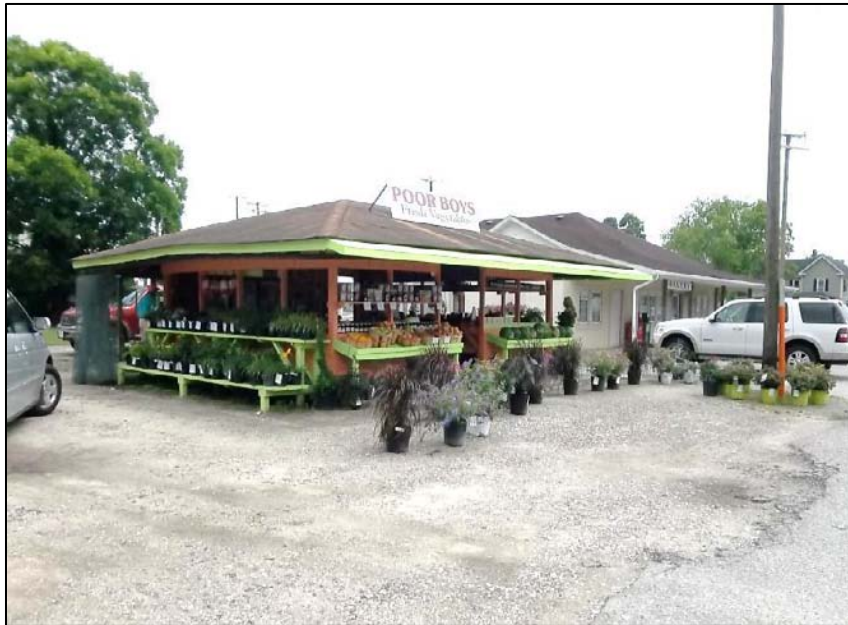
Photo 33: Northeast Oblique, “Poor Boys Fresh Vegetables” Farmstand.

Additional buildings constructed in Belcross during the 1940s and 1950s included a post office, some commercial buildings, and a second gas station. This gas station was owned by the Harris Family and now houses the Belcross Bakery. Doris and Adolphus Harris owned the gas station and opened a small farmstand, now called, “Poor Boys Fresh Vegetables” (Photo 33) (Harris 2012). The gas station opened in 1949 and the farm stand was constructed in 1953. Both of these buildings still stand, although the gas station has been modified to adapt to its new use as a bakery (Photo 34).

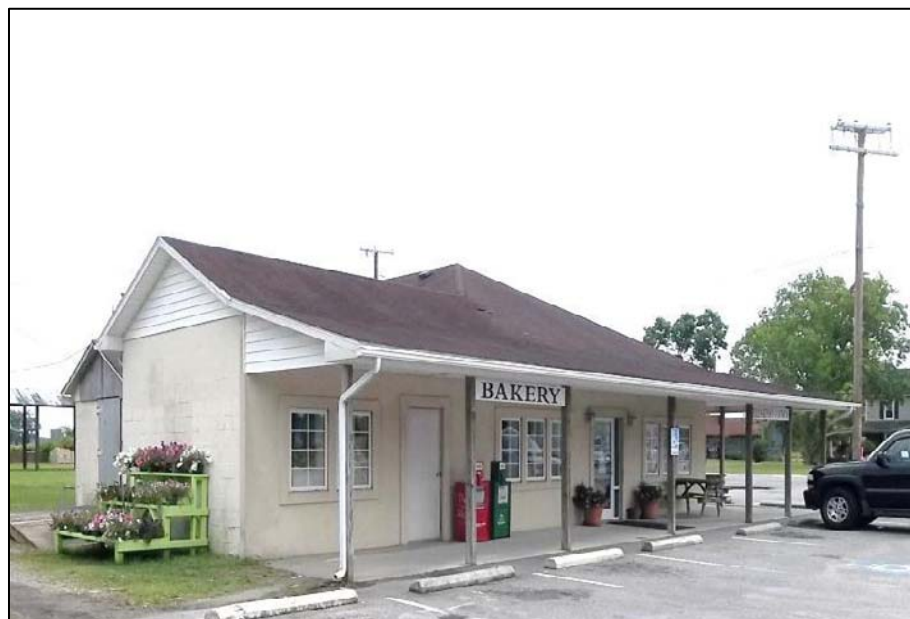
Photo 34: Northeast Oblique, Former Gas Station, Now Belcross Bakery.

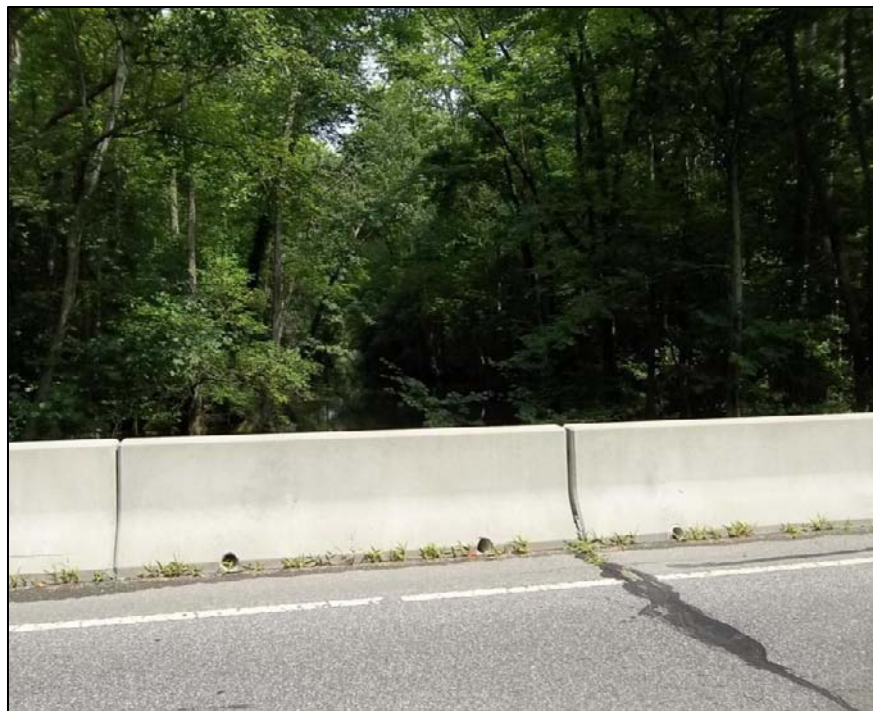
Photo 35: View of the Run Swamp Canal From U.S. Highway 158, Looking Northwest.

The Run Swamp Canal is a narrow waterway located on the Camden/Currituck County line. The Canal begins northwest of the small community of Gregory and continues 3.75 miles southeast, crossing under State Route 34 and U.S. Highway 158 (Shortcut Road) before draining into Indiantown Creek (Figure 17 and Figure 18; Photo 35). The canal is man-made with many smaller ditches from adjacent farmland draining into it. Closer to the project APE, the canal is buffered by wooded swampland. There are no walls or locks visible along the Run Sawn Canal within the APE. Furthermore, dense vegetation suggests that it currently functions as a drainage corridor rather than transportation channel (Photo 36).

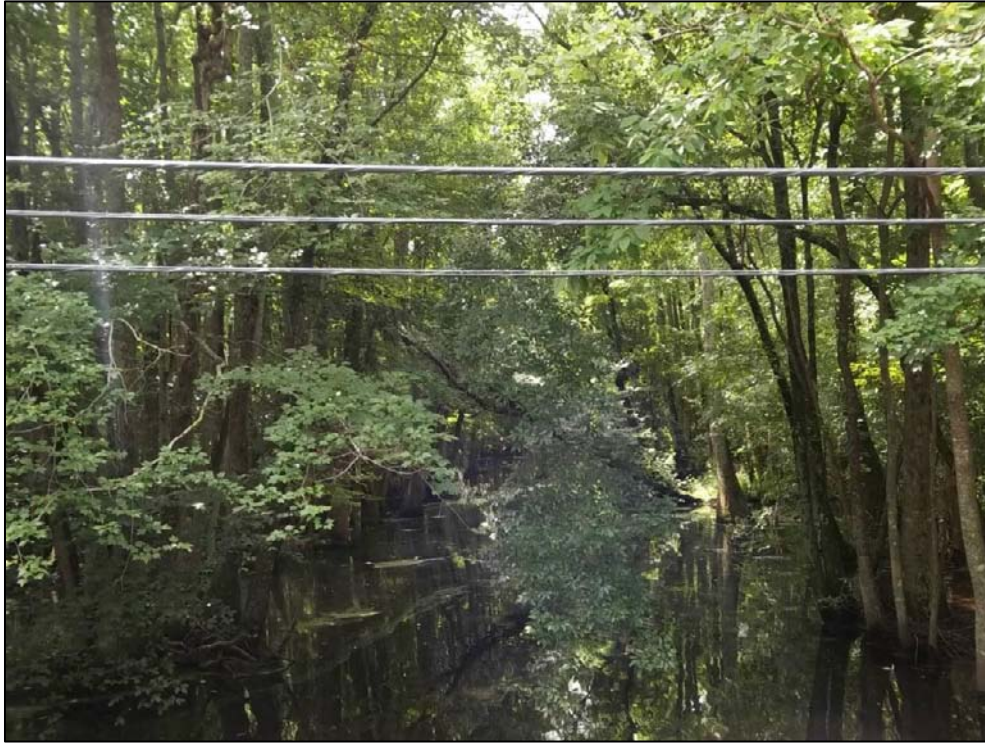
Photo 36: View of Run Swamp Canal, Taken from U.S. Highway 158 (Shortcut Road),
Looking North.

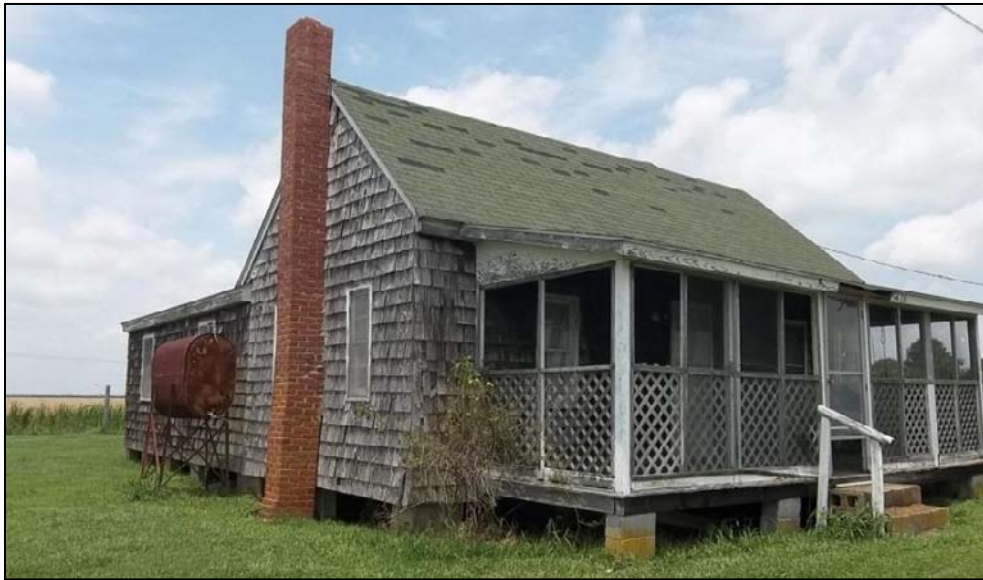
The Don Roberts House at 1476 Shortcut Road is a one-story, three-bay building. This single-family dwelling was constructed around 1933 (CCITS/GIS 2012). The building is set on concrete-block piers and frame structural system is clad in wood shingles nailed over the original weatherboard siding (Photo 37). The house is covered by a moderately pitched, side-gabled roof that is sheathed in asphalt shingles. Below the eaves on the south and north elevations is an unadorned, wooden, box cornice. An exterior-end brick chimney is centrally located on the west elevation (Photo 38).

Photo 37: South (Main) and West Elevations, Don Roberts House.

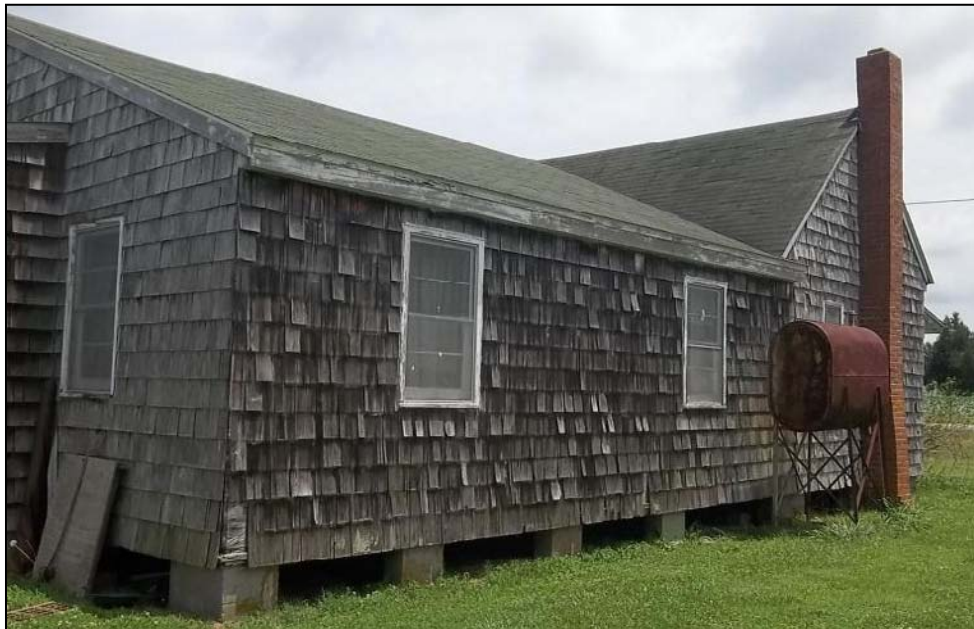
Photo 38: View of the West Elevation, Looking East, Don Roberts House.

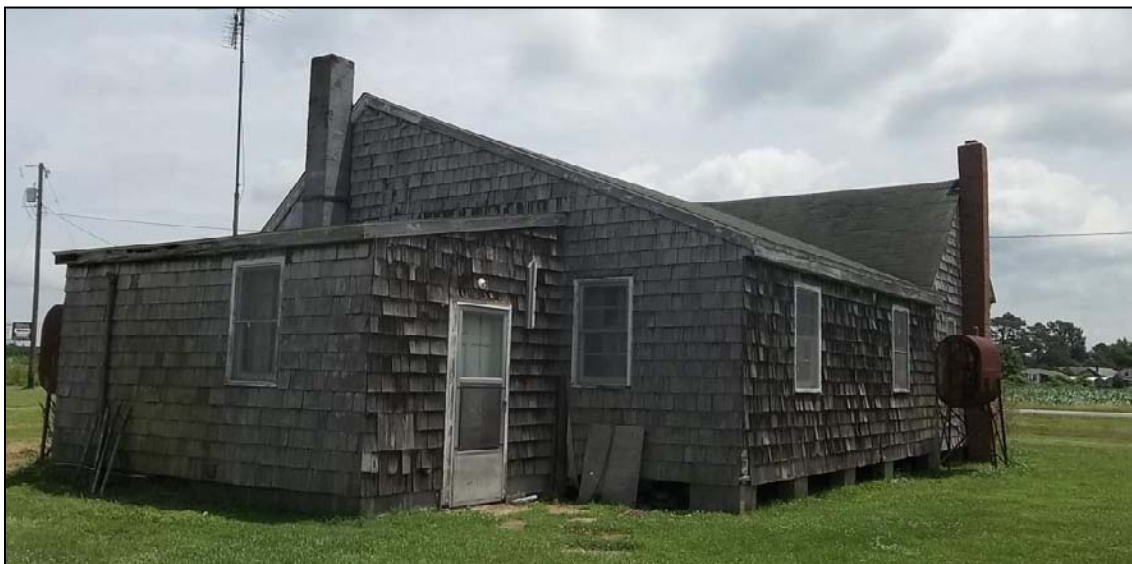
An asymmetrical one-story rear ell projects from the north elevation, creating a T-plan (Photo 39). It rests on cinderblock piers parged with concrete and is clad in wood shingles. It is covered by a gable roof that is sheathed in asphalt shingles. An exterior-end, cinderblock chimney is located on the north elevation. This ell features two-over-two (horizontal muntins), double-hung sash windows set within wooden frames.

A one-story addition extends off the north elevation of the rear ell (Photo 39). It is set on a continuous foundation made of cinderblock with a frame structural system, like the main core of the house, and is clad in wood shingles. It is covered by a shed roof that is sheathed in asphalt shingles. The addition is accessed by a paneled, wood door with a metal storm door on the west elevation. Other fenestrations include four-over-four, double-hung sash windows set within a wooden frame.

Photo 39: North (Rear) and West Elevation, Don Roberts House.
