**North Carolina Department of Cultural Resources
State Historic Preservation Office**

MEMORANDUM

SUBJECT: Architectural Survey for Improvements to US 158, from East of NC 34 at Belcross to NC 168, R-2574, Currituck and Camden Counties, ER 11-1152

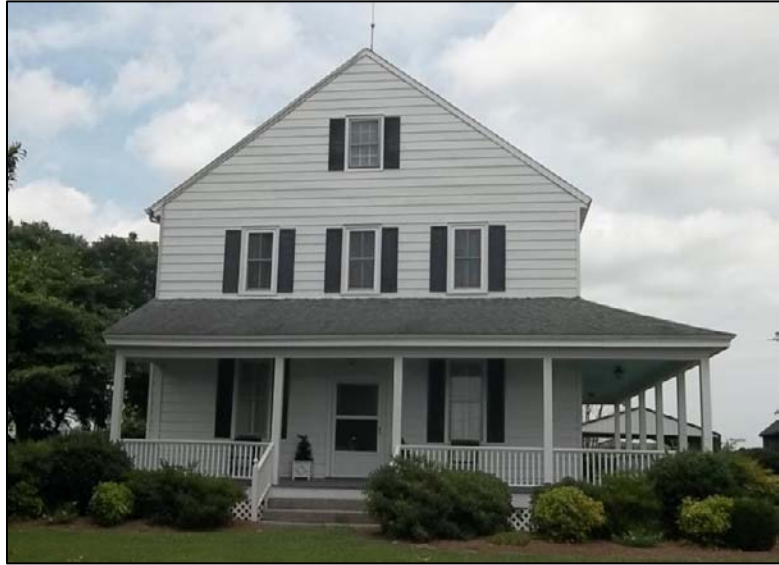
The John Humphries House is a two-and-a-half story, three-bay building (Photo 40). This single-family dwelling was constructed around 1820 in the Federal style. The building is set on a continuous brick foundation that is laid in an American bond. According to the current owner, the building originally sat on brick piers but the building was later lowered and the current foundation was laid (Roberts 2012) The frame structural system is clad in aluminum siding. The house is covered by a moderately pitched, front-gabled roof that is sheathed in asphalt shingles. An interior-end, brick chimney laid in a stretcher bond pierces the roof near the southeast corner.

Photo 40: West Elevation of the John Humphries House.

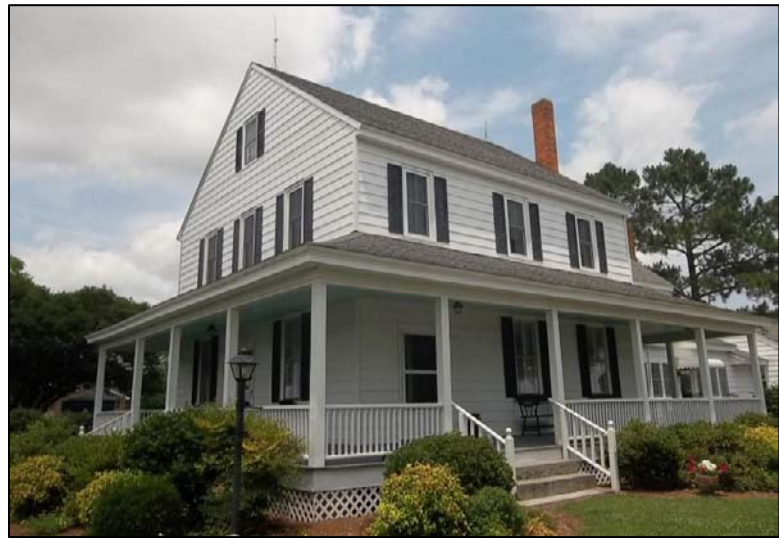
A one-story porch wraps around the west, south, and east elevations (Photo 41). It is raised on brick piers that are covered by wood lattice work. The porch is covered by a hipped roof sheathed in asphalt shingles and supported by square posts clad in aluminum. The porch is accessed by poured concrete steps and the edge is lined with an unadorned balustrade.

Photo 41: Southwest Oblique of the John Humphries House.

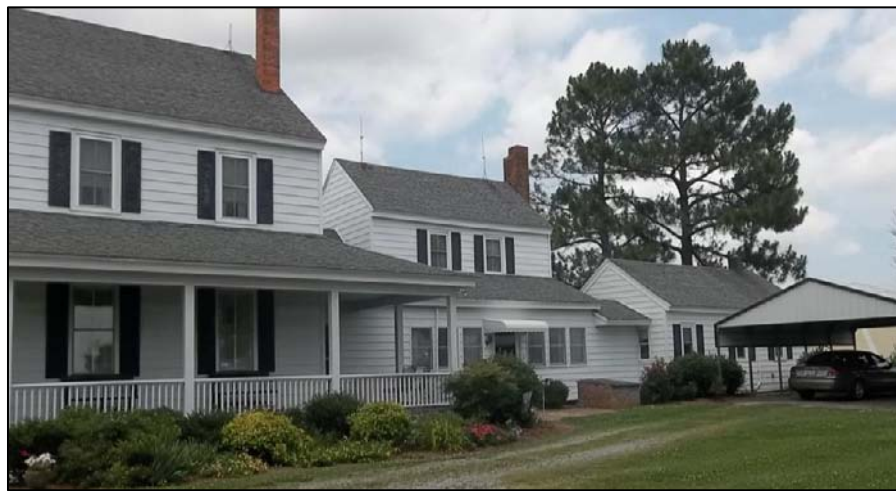
Attached to the east side of the house is a two-story kitchen. Originally constructed as a separate building, the kitchen was connected to the main dwelling by a one-story hyphen during the early-twentieth century (Photo 42 and Photo 43) (Ancestry.com 2012; Roberts 2012). The kitchen is set on a brick foundation and clad in aluminum siding. The building is covered by a moderately pitched, side-gabled roof that is sheathed in asphalt shingles. An exterior-end, double-flue, brick chimney is located on the east elevation. This chimney also features a double-shoulder stack. A one-story, shed-roof addition extends off the south elevation of the kitchen. This was constructed in the early-twentieth century as a porch and later enclosed to act as a foyer for this part of the house. Currently the kitchen is accessed by a storm door on the addition. Window openings on this kitchen are composed of wood-

A one-story building is attached to the east elevation of the kitchen and enclosed porch (Photo 42). Like the remainder of the house, it is clad in aluminum siding and covered by a gabled roof. The size of this addition and chimney suggest it was likely added during the third-quarter of the twentieth century. This section of the house has one-over-one, vinyl replacement windows.

Photo 42: South Elevation of the John Humphries House.

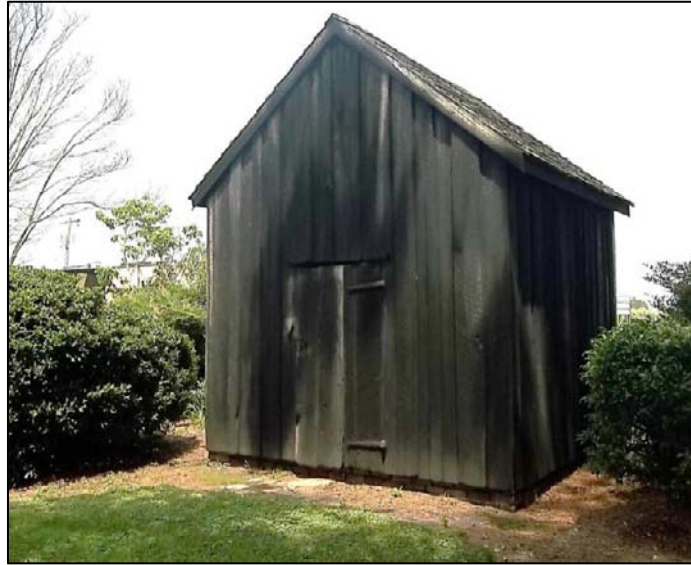
A one-story, one-bay smokehouse that dates to the 1820s is situated southeast of the house (Photo 44). The building rests on a foundation of continuous brick and the frame structural system is clad in circular-sawn, board-and-batten siding. It is covered by a front-gable roof that is sheathed in cedar shingles. The entrance, a wooden plank door, is centered on the west elevation and attached using two metal hinges. Immediately south of the attached kitchen is a well that was likely constructed around same time as the house. The above-ground portion of this structure is square and constructed with hand-made bricks. Currently it is covered by a piece of pressed board (Photo 45).

Photo 44: Smokehouse, Southwest Oblique.

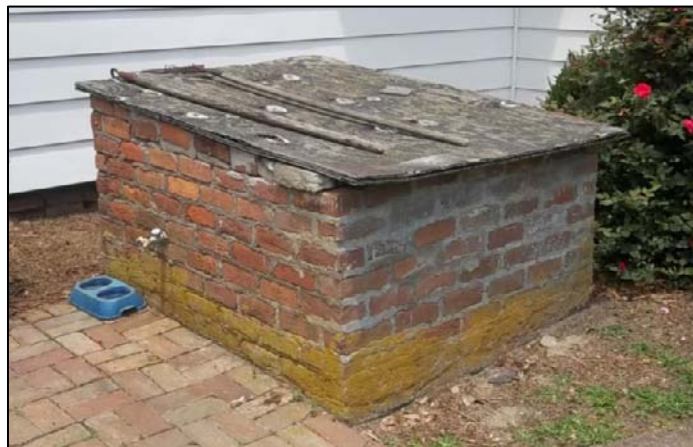
Photo 45: Brick Well, Southwest Oblique.

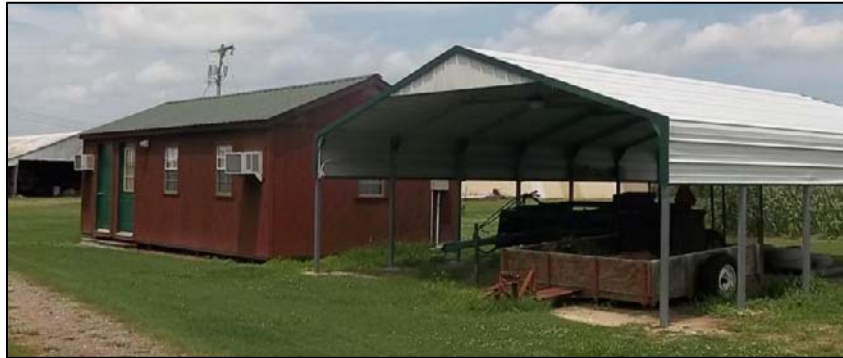
A late-twentieth century work shed is located east of the John Humphries House. It is raised on piers and the structural system is clad in T-111 siding (Photo 46). The building is covered by a moderately pitched, side-gable roof that is sheathed in v-crimp metal. There are two

There are three outbuilding associated with the John Humphries House that date to the fourth quarter of the twentieth century. There are two aluminum carports: one is located south of the house and once is east of it (Photo 46 and Photo 47). Each is covered by a front-gable roof sheathed in standing-seam metal, which is supported by metal posts. A wood-frame farm market stand is located south of the John Humphries House. The open-air structure is covered by a gable roof.

Photo 46: Work Shed (Left) and First Carport (Right), Southwest Oblique.

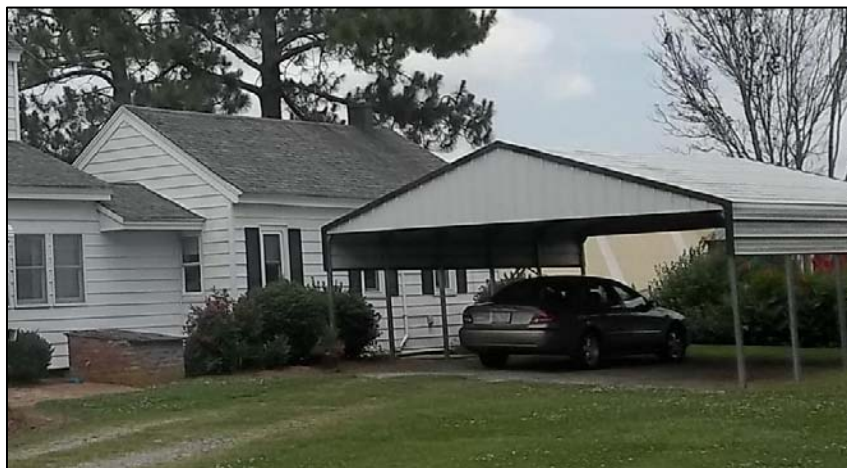
Photo 47: Second Carport, Southwest Oblique.

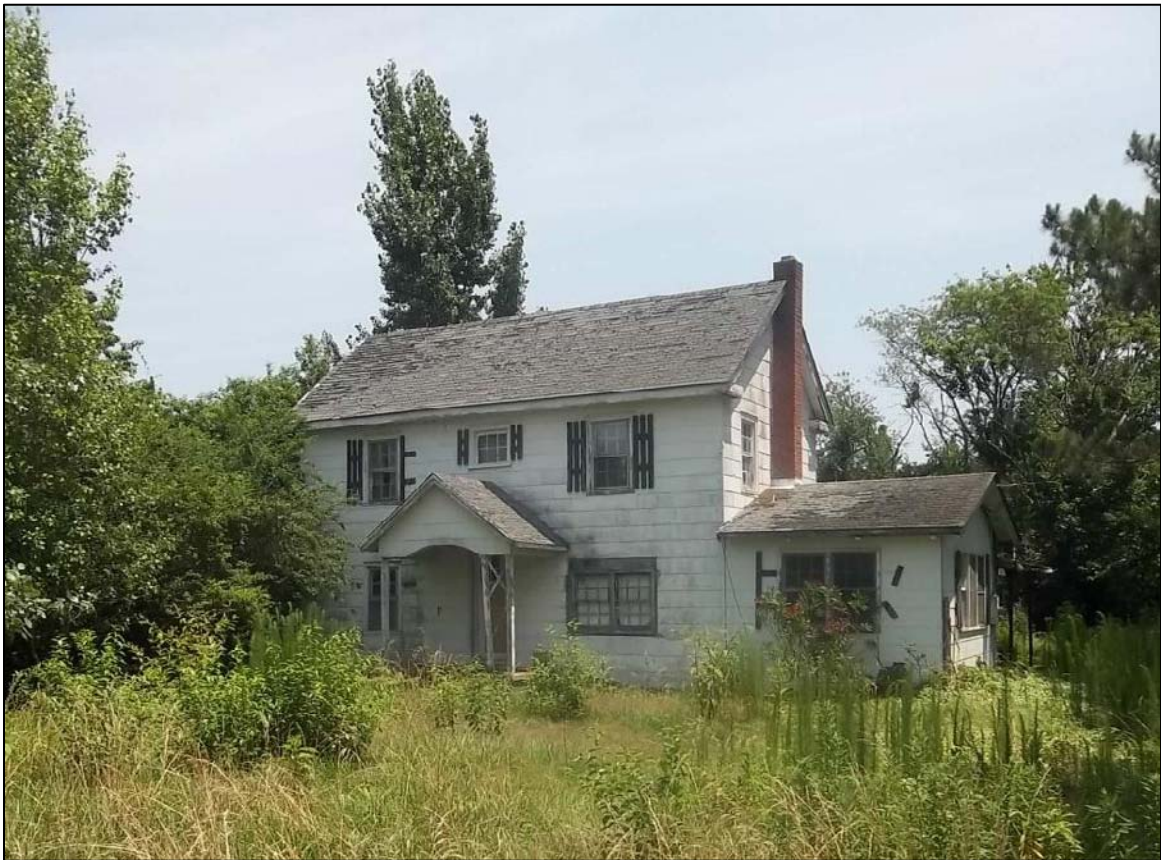
The Lindsey House is a two-story, three-bay house with Colonial Revival attributes. There is conflicting information regarding the date of construction; local tax records indicate the house was built in 1900, while other research has determined the house was built in 1830. From the research done as part of this survey, the form and plan of the house, as well as its features, such as the size of the chimney and windows, suggest that it was built around 1900. Surrounding early-twentieth century dwellings such as the Forbes House (CK0414) and the Jones House (CK0329) share many of characteristics exhibited by the Lindsey House (Photo 50). The Lindsey House foundation was not visible, but its frame structural system is clad in asbestos shingles. The dwelling has a central-hall plan which is common throughout Currituck County. The resource is covered by a side-gable roof that is sheathed in asphalt shingles. Each gable end features overhanging eaves and cornice returns. An exterior-end, brick chimney is located on the south elevation.

Photo 50: Southwest Oblique, Lindsey House.

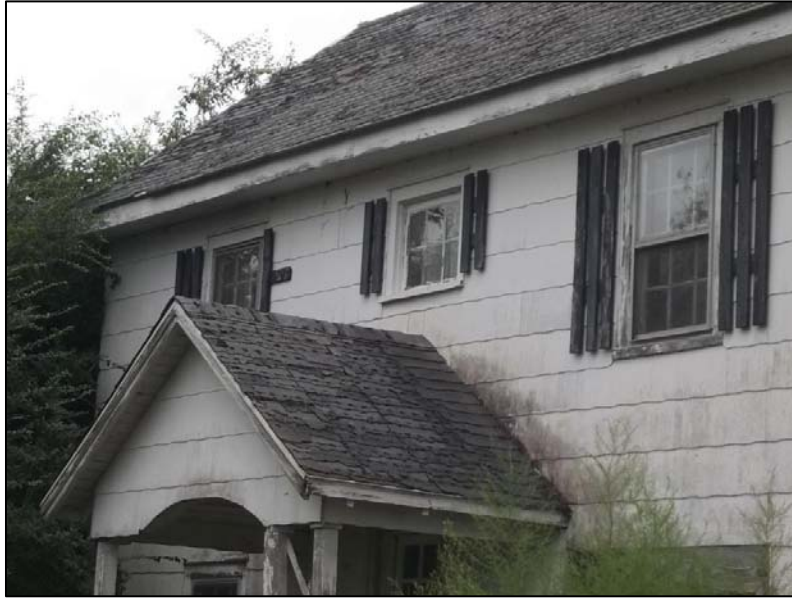
The primary entrance, a paneled, wood door, is centered on the façade or west elevation. Other fenestrations include single and paired, six-over-six, double-hung sash windows set within wood frames. Some windows are flanked by decorative wooden shutters. A small, six-light fixed sash is centered on the second story of the west elevation (Photo 51). A poured-concrete foundation supports the one-story, one-bay porch that is centrally located on the west elevation. The porch is covered by a front-gabled roof supported by wood posts.

Photo 51: West Elevation, Second Story.

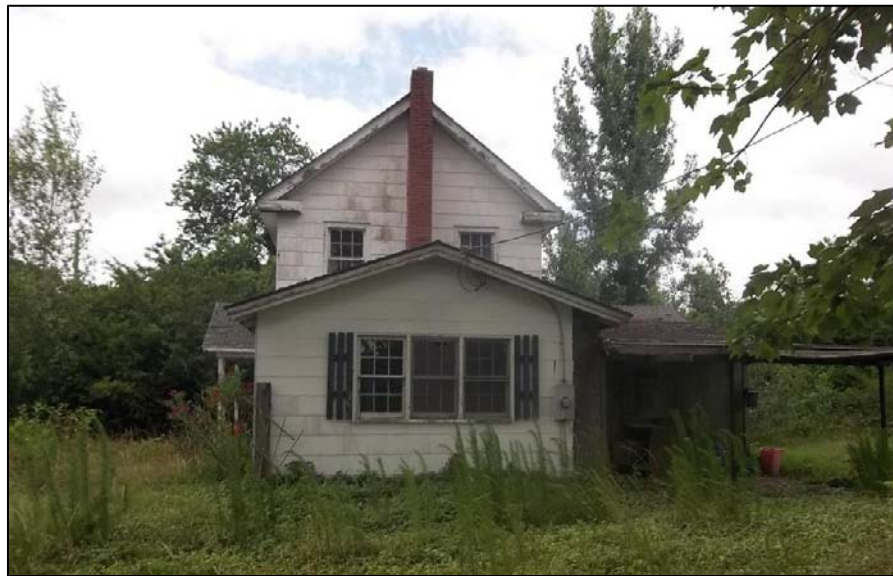
A one-story addition extends from the south elevation. It is clad in asbestos siding and is covered by a low-pitched, gable roof (Photo 52). The addition was originally constructed as a screened side porch and was enclosed during the third-quarter of the twentieth century (Photo 53). The addition features six-over-six, double-hung sash windows.

Photo 52: South Elevation.

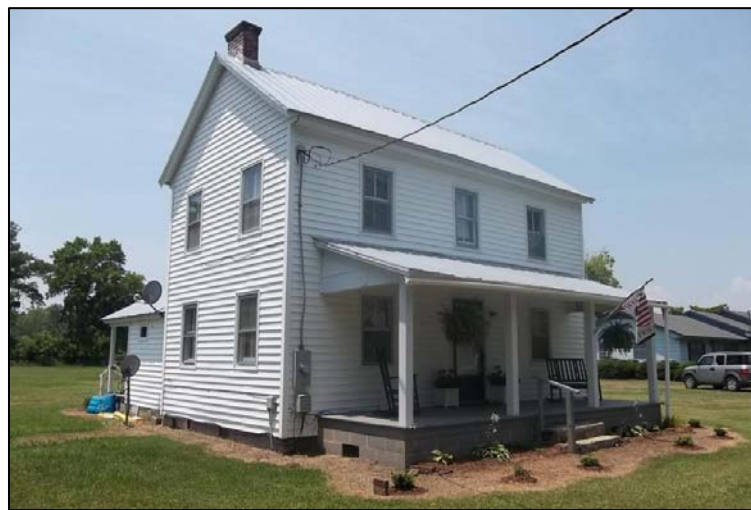
The Forbes House is a two-story, three-bay, center-hall plan likely built around the turn of the twentieth century for Pattie Wilkins Forbes (Photo 54) (CCITS/GIS 2012). Within the last decade, the house was moved 88 feet west and placed on a cinderblock foundation (Bess 2012). The house was originally located adjacent to the highway. It is likely that this house was once clad in weatherboard but has since been covered in asbestos siding and is now clad in vinyl siding.

Photo 54: Southeast Oblique of the Forbes House.

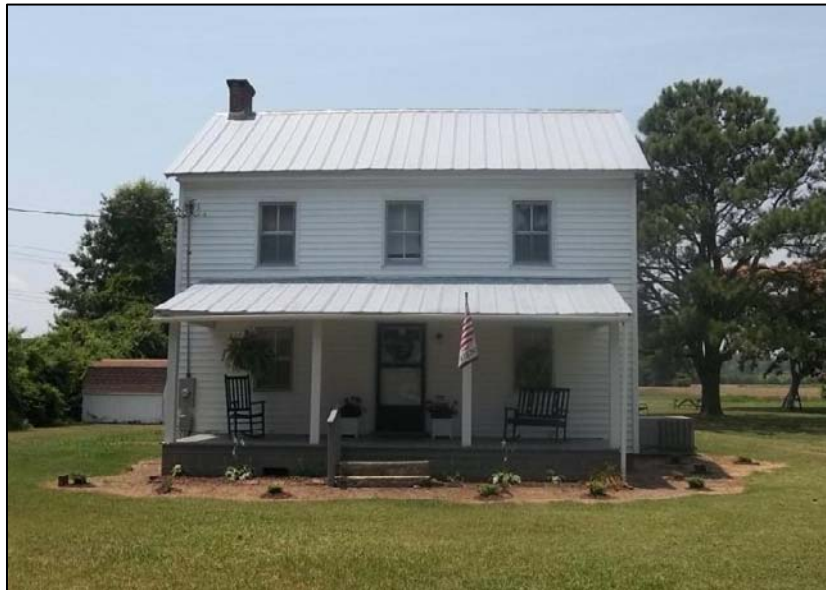
Photo 55: East Elevation of the Forbes House.

A one-story, three-bay porch is located on the east elevation (Photo 55). It is set on a newly replaced cinderblock foundation and is accessed by an old set of pre-cast concrete steps—likely original to the resource and moved when the house was relocated—with a wooden hand rail on the south side. The porch has a wood floor and is covered by a shed roof that is sheathed in standing-seam metal and supported by square, wood posts. The porch appears to have been built when the house was moved.

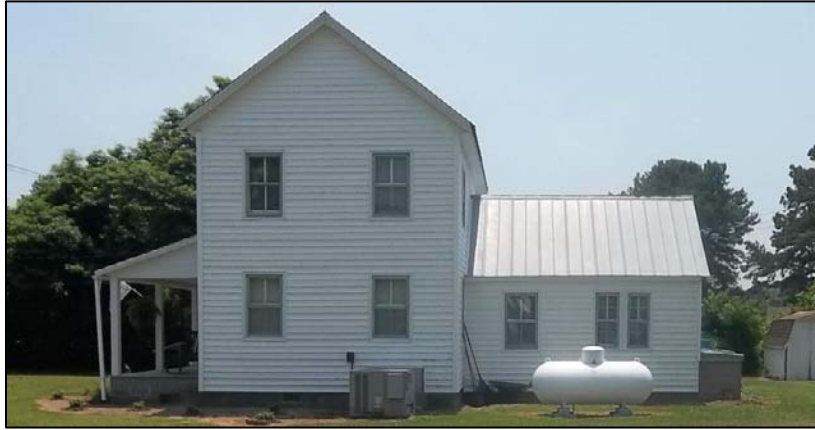
Photo 56: North Elevation of the Forbes House.

Extending off the west elevation is a one-story rear ell (Photo 56). It is likely this was built after the initial construction of the house; however, the work done as part of the current survey did not yield enough information to determine exactly when this ell was added. Like the original core of the house, the addition is set on a raised, cinderblock foundation and the structural system is clad in vinyl. The ell is covered by a gable roof that is sheathed in standing-seam metal. What was once a full-length porch on the south elevation has now been partially enclosed. Currently there is just a one-story, one-bay porch at the southwest corner of the ell. A cinderblock cistern is located on the west elevation of the ell (Photo 57).

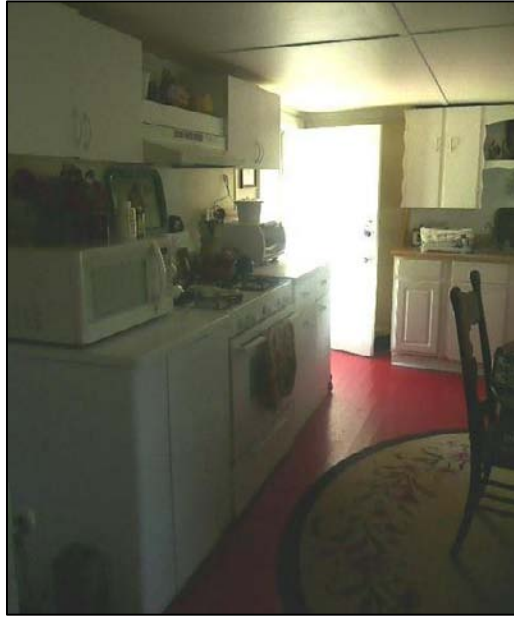
Photo 59: View of Kitchen in the Forbes House, Looking Southwest.

Most of the interior alterations have been made to the rear ell. Currently used as the kitchen, the floor is made of wood boards and the walls are clad in plaster (Photo 59). The ceilings are covered in wood boards. The walls of the kitchen are lined with cabinetry and appliances; it is probable that none are original to this part of the house. During the third quarter of the twentieth century part of the side porch was enclosed and converted into a bathroom.

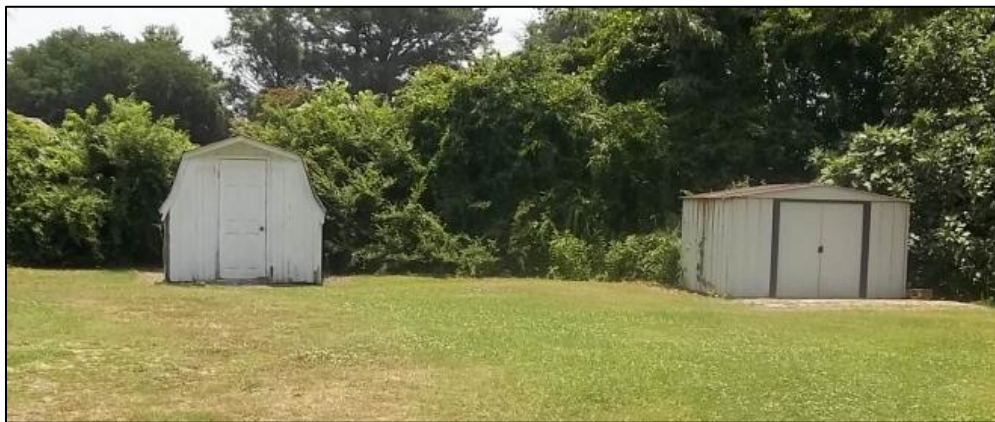
Photo 61: Two Sheds Associated with the Forbes House.

There are two outbuildings associated with the Forbes House (Photo 61). Each is situated southwest of the primary resource. The first is a one-story, one-bay shed that dates to the last-quarter of the twentieth century. It is clad in metal and is covered by a gambrel roof. This outbuilding is accessed by a wood, six-panel door on the north elevation. The other secondary resource was likely built in the late-twentieth century. It is clad in metal siding and covered by a low-pitched, front-gabled roof that is sheathed in metal. The entrance to this shed is a set of double doors on the north elevation.

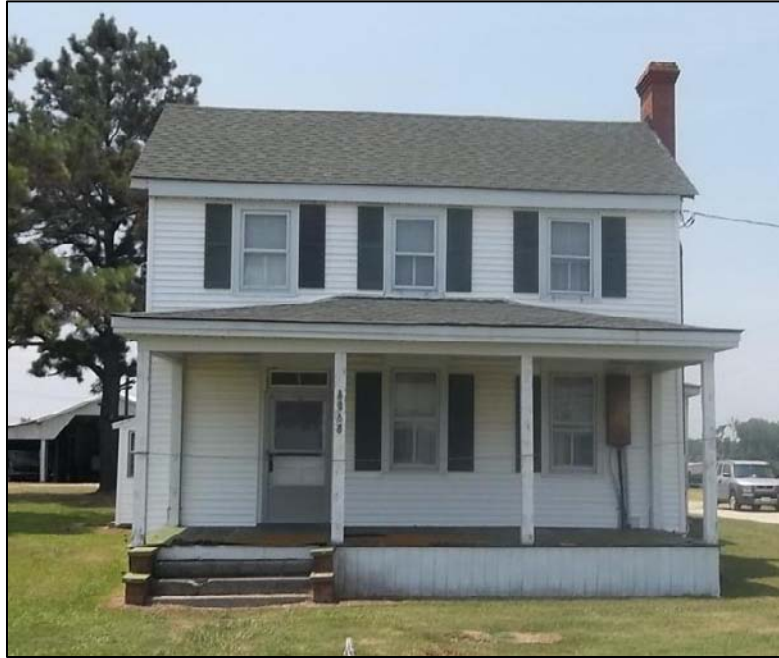
Photo 63: Primary (East) Elevation of the Jones House.

The resource is a two-story, three-bay building (Photo 63). This single-family farmhouse was constructed around the turn of the twentieth century (CCITS/GIS 2012). The building has a side-hall plan, which varies from the more commonly found central-hall plan in northern Currituck County. The dwelling is raised on brick piers composed of a mixture of header and stretcher rows with cinderblock infill. The frame structural system, originally clad in wood weatherboard siding, has been covered with vinyl siding either during the third or last quarter of the twentieth century.

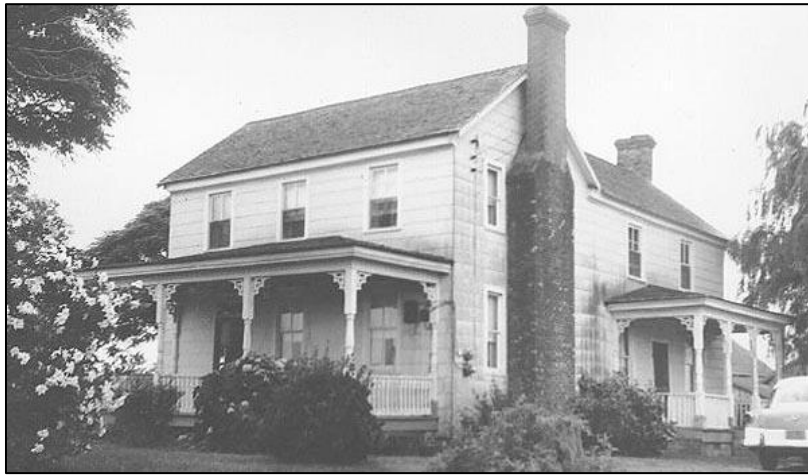
Photo 64: Circa 1960 Photograph of the Jones House (NCGenWeb 2012b).

The building is covered by a moderately pitched, side-gabled roof that is sheathed in asphalt shingles. The wooden eaves of the roof extend approximately 8 inches from the plane of the wall below. An exterior-end brick chimney is located on the north elevation. It has a poured concrete base and the bottom two-thirds of the chimney—likely original to the building—is laid in a five-to-one common bond. The top one-third of the chimney appears to be a replacement; the difference in brick color and texture is currently visible and may also be observed in a 1960s photograph of the house (Photo 64). The replacement section of the chimney is laid in a stretcher bond and features a corbeled cap.

On the east elevation is a one-story, three-bay porch. It is raised on brick piers and accessed by a set of poured concrete steps flanked by a low, stepped brick wall on each side. It is covered by a moderately pitched, hipped roof that is sheathed in asphalt shingles and supported by square wood posts. The 1960s photograph of the house shows that the porch once featured the balustrade, turned posts, and spindle work detailing that was common during the late-nineteenth and early-twentieth centuries.

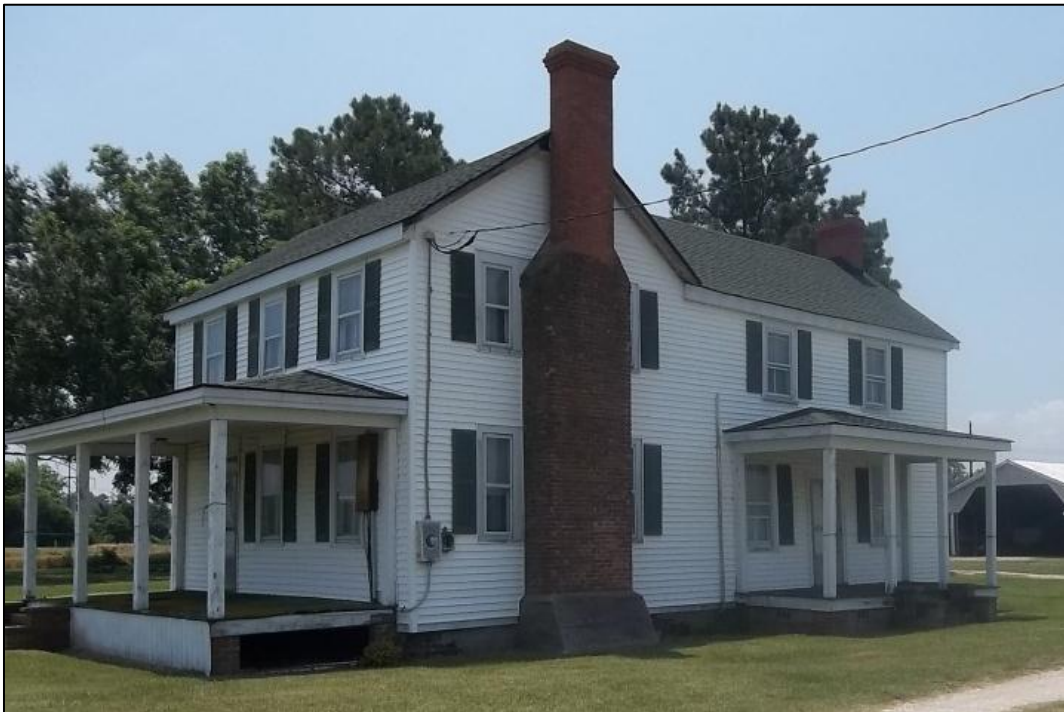
Photo 65: Northeast Oblique of the Jones House.

A rear ell extends from the west elevation of the original core of the house. The similar foundation suggests that it was built either at the same time as the rest of the house or shortly thereafter (Photo 65). Like the core section, the ell is raised on brick piers that have now been in-filled with cinderblocks. The structural system is clad in vinyl siding and is covered by a gable roof. An interior-end, brick chimney with a corbeled cap is located on the north elevation. The ell is accessed by a wood, four-panel door with an exterior storm door. Other fenestrations include two-over-two (vertical muntins), double-hung sash windows. Although all of the windows are two-over-two, the size and shape differ; those on the main core are narrow, especially on the north elevation. A one-story, two-bay porch is located on the north elevation. It is set on a brick pier foundation with cinderblock infill and accessed by a centered set of poured concrete steps. The porch is covered by a hipped roof that is supported by square, wood posts.

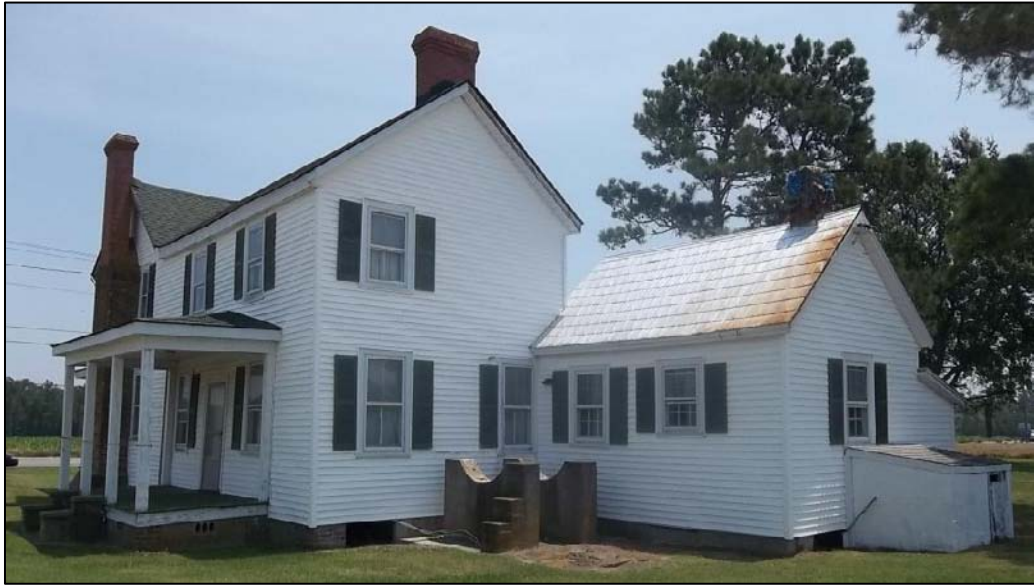
Photo 66: Northwest Oblique of the Rear Ell and the Kitchen.

A one-story building is now attached to the house by the rear ell (Photo 66 and Photo 67). The odd placement and closeness of this building in comparison with the main building, as well as the replaced foundation, make it probable that the building was moved to be physically connected to the house. It is possible that this was originally a separate kitchen;

its size and chimney suggest that the building originally had a domestic function. This building is set on a cinderblock foundation and clad in vinyl siding. It is covered by a steeply pitched gable roof that is sheathed in pressed-tin shingles. A brick, interior-end chimney is situated near the west elevation. Fenestrations include six-over-six, double-hung sash windows flanked by louvered shutters. A linear, one-story addition connects the kitchen to the rear (south) of the house. Like the rest of the building, this latest addition is clad in vinyl siding and was likely added during the late-twentieth century. It is covered by a shed roof sheathed in standing-seam metal. Two secondary metal doors are located on the south elevation. There are seven one-over-one, double-hung sash windows on this addition.

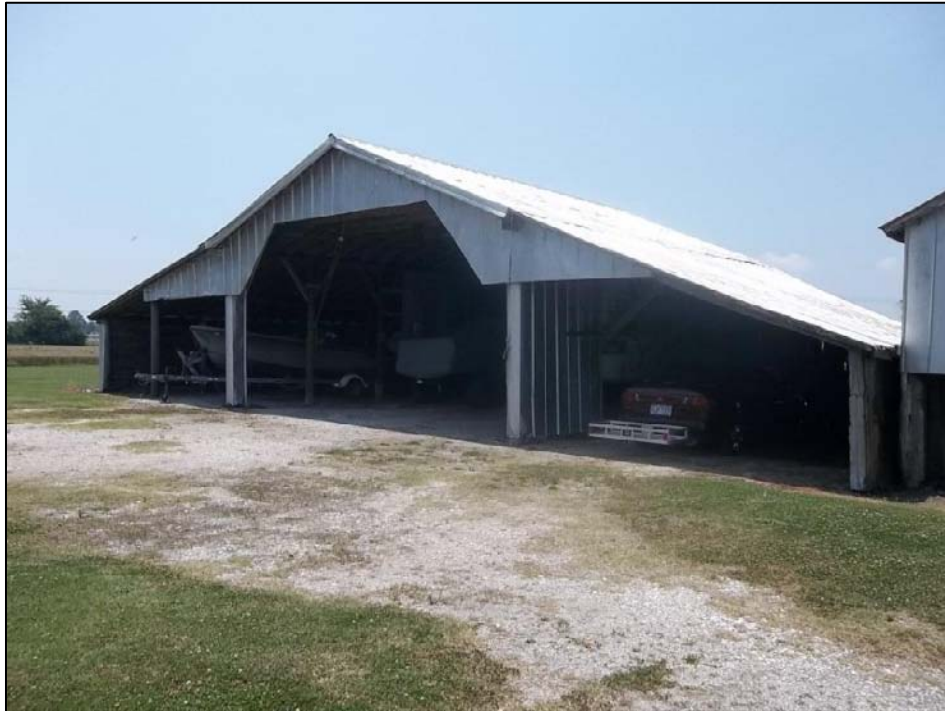
Photo 68: East Elevation of the Garage.

There are four outbuildings associated with the Jones House. A one-story, three-bay garage that dates to the third-quarter of the twentieth century is located west of the primary resource (Photo 68). The building's pole-type construction is clad in vertical sheets of metal. The garage is covered by a low-pitched front-gable roof that is sheathed in standing-seam metal. Three large openings mark the west elevation. Three large openings mark the west elevation.

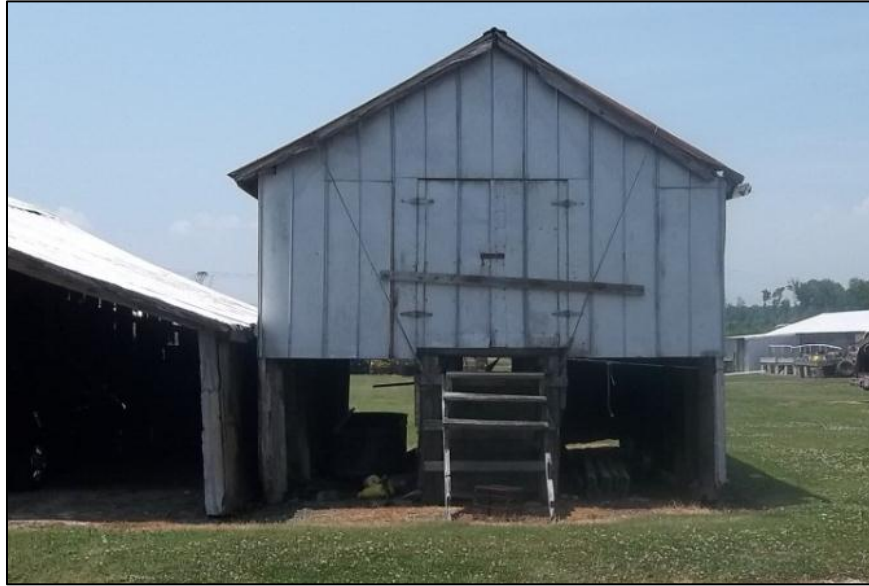
Photo 69: West Elevation of the Agricultural Outbuilding.

A one-story, one-bay, agricultural outbuilding is situated west of the Jones House and just north of the garage (Photo 69). It is raised on round, wood piers and the frame structural system is clad in standing-seam metal. This agricultural building is covered by a moderately pitched, front-gabled roof that is sheathed in standing-seam metal. The rafters are exposed on the north and south elevations. This building is accessed by a set of wood steps that lead to a metal, double door on the east elevation. It is possible that this building was used for the storage of sweet potatoes or other crops grown on the Jones Farm and therefore built around the same time as the house.

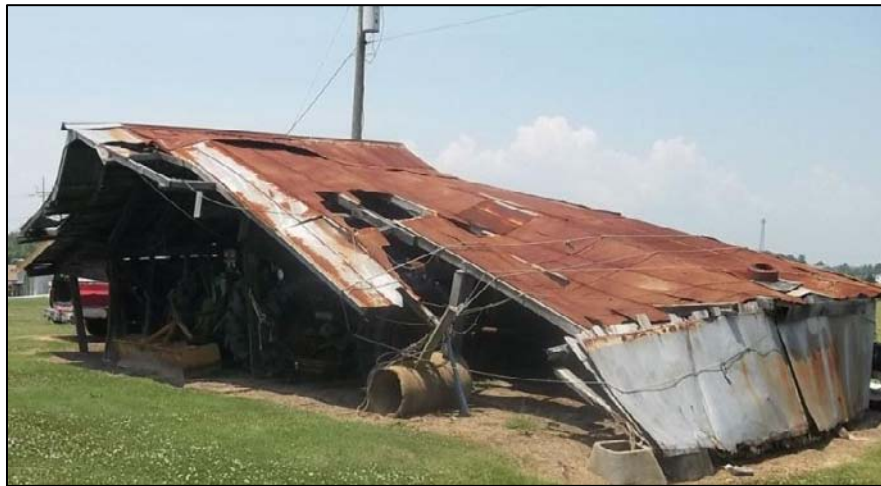
Photo 70: Southeast Oblique of the Dilapidated Outbuilding.

A mid-twentieth century dilapidated outbuilding, possibly an equipment shed, is located west of the primary resource. The frame structural system is clad in sheets of metal and covered by a front-gabled roof with a shed-roof addition on the east side (Photo 70). The building has started to collapse as a result of deterioration over time.

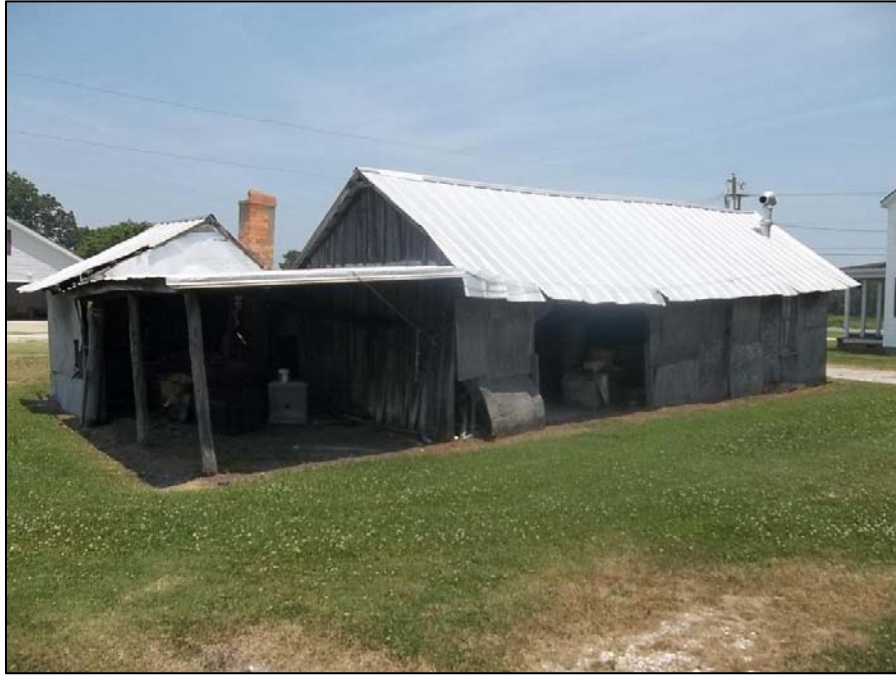
Photo 71: Southwest of the Shed/Workshop.

A shed/workshop building, which likely dates to the same period of construction as the house, is located west of the primary resource. It is composed of what was, at one point, two separate buildings, which are connected and function as one building (Photo 71). The first main part is a one-story, front-gabled equipment shed/workshop that is clad in board-and-batten siding and particle board. The roof is sheathed in standing-seam metal. This part of the building features a four-over-four, double-hung sash window and an open-air entry with clipped corners on the south elevation. A metal vent pierces the roof. The second section of this outbuilding is a one-story building that is currently clad in sheets of metal. It is covered by a gable roof sheathed in standing-seam metal. A brick chimney—originally an exterior-end chimney—is located on the east elevation. Today, these two buildings are connected through a series of shed-roof additions.

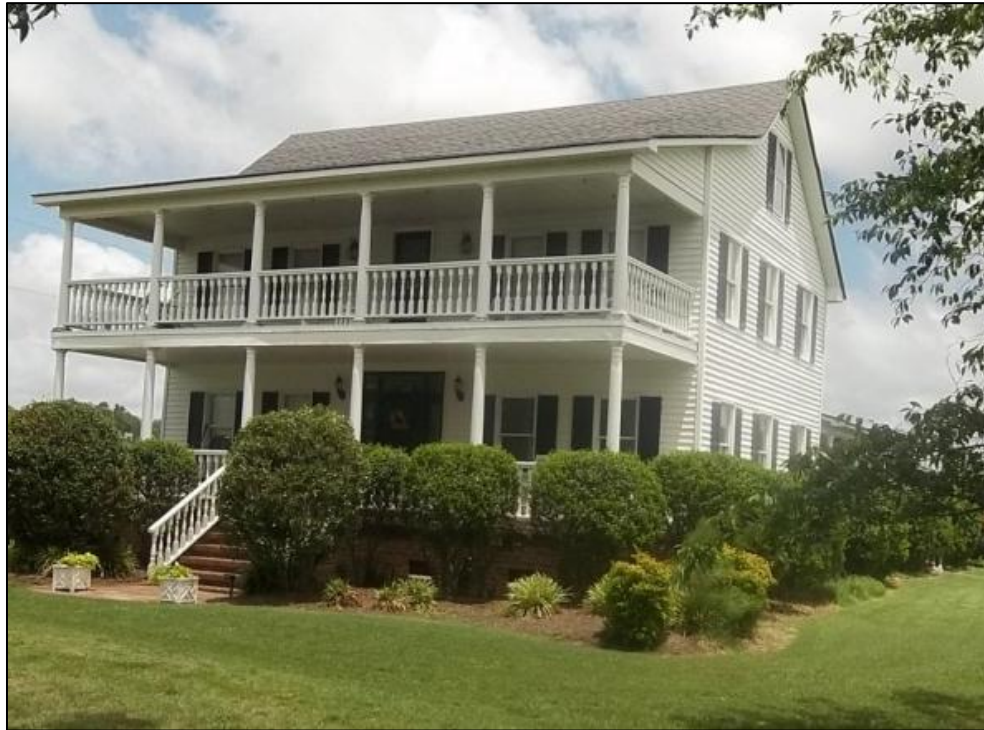
Photo 73: Southwest Oblique of the Boswood/Mathias House.

This resource is a two-story, five-bay building likely built around the mid-nineteenth century under the ownership of Willoughby and Cordelia Boswood (CCDB; Morris 2011) (Photo 73). The dwelling originally sat adjacent to the road but was moved eastward during the fourth quarter of the twentieth century. When the building was moved it received a new brick foundation laid in a stretcher-bond configuration and the frame structural system was clad in vinyl siding. Based on many of the older houses in the area, it is probable that the house was originally clad in wood weatherboard siding. A 1960 photo of the house shows that it was then clad in what appears to be asbestos siding, which was also a secondary treatment.

The building is covered by a moderately pitched, side-gabled roof that is sheathed in asphalt shingles. The eaves of the roof are shallow and project approximately 6 inches from the plane of the wall below. The house once featured two interior, brick chimneys with a corbeled cap; however, during the late-twentieth-century remodel of the house, these were removed (Palmer 2012).

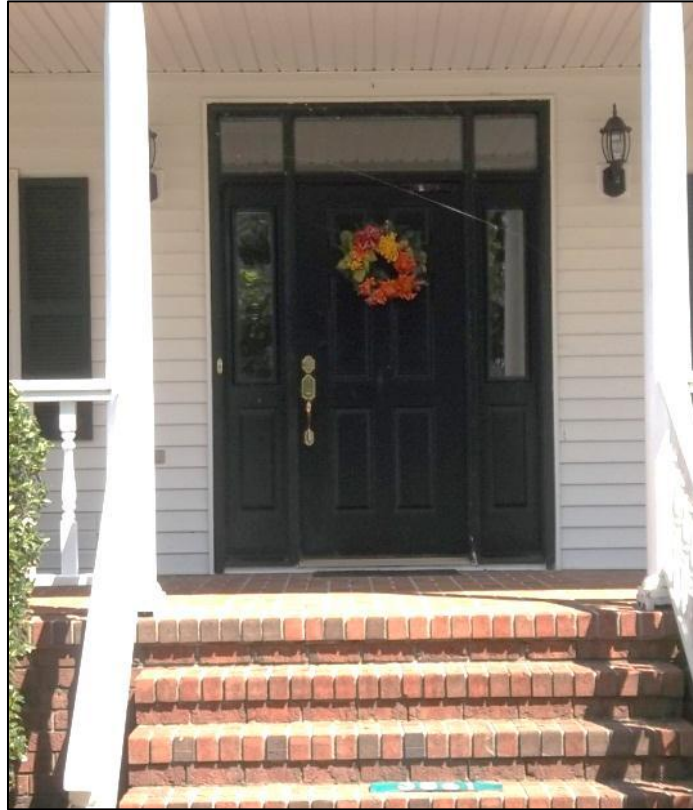
Photo 74: Primary Entrance Detail on the West Elevation.

The primary entrance to the house is centered on the west elevation. It is a replacement, six-panel, wooden door set below a three-light transom. The door is flanked by two sidelights and panels (Photo 74). Other fenestrations include replacement one-over-one, double-hung sash vinyl windows. All windows are flanked by louvered shutters. During the 1960s the house had wood-frame, two-over-two, double-hung sash windows that were likely removed during the recent renovation.

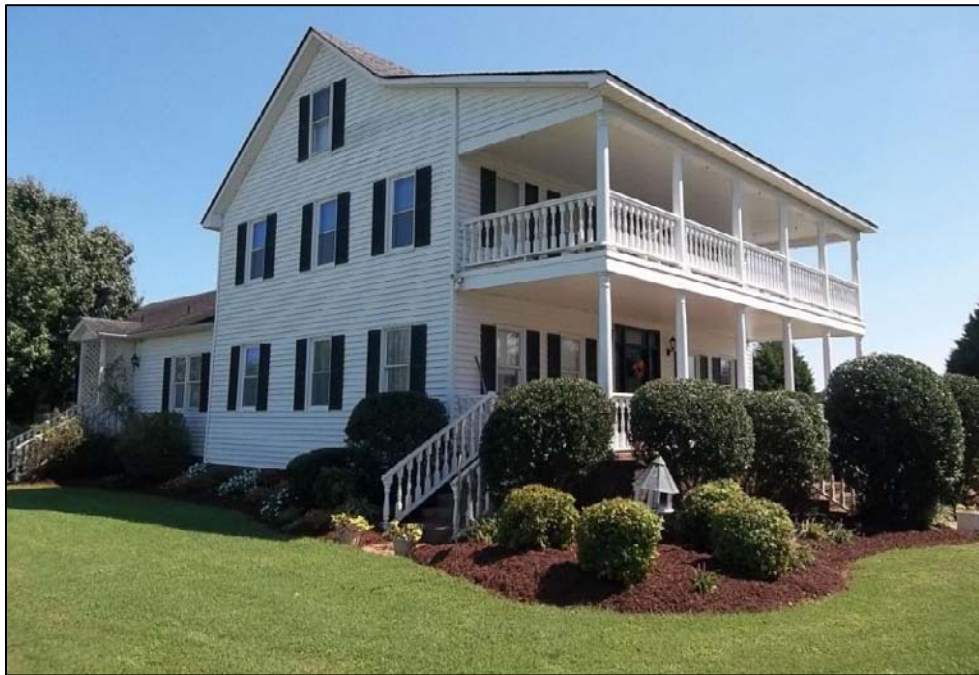
Photo 75: Detail of the Porch on the West Elevation.

Throughout much of the twentieth century the house featured a one-story, five-bay, screened porch with a hipped roof located on the primary elevation (Photo 75). During the extensive renovation that porch was removed and replaced with the current two-story, five-bay porch. This replacement is set on a brick foundation that is laid in a stretcher-bond configuration. It is accessed by a set of brick steps on the west side. The porch is covered by a shed roof that is supported by slender, round columns. Each level is lined with a balustrade that is composed of turned balusters.

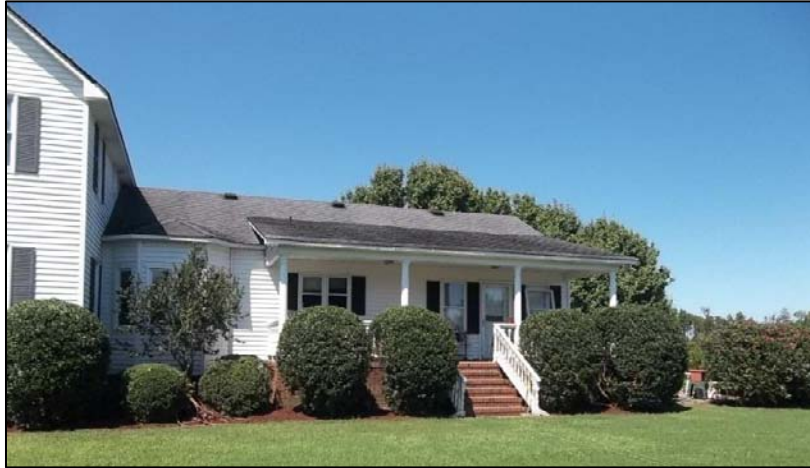
Photo 76: South Elevation of the One-Story Addition.

A one-story addition—likely constructed during the first half of the twentieth century—is located on the east elevation. Like the original core of the house, this addition is set on a brick, stretcher-bond foundation and clad in vinyl siding. It is covered by a gable roof that is sheathed in asphalt shingles (Photo 76). A secondary entrance is situated on the south elevation under a one-story porch. Another entrance is located on the north elevation of the rear addition. A one-story, one-bay brick porch covered by a front-gable roof on the south elevation.

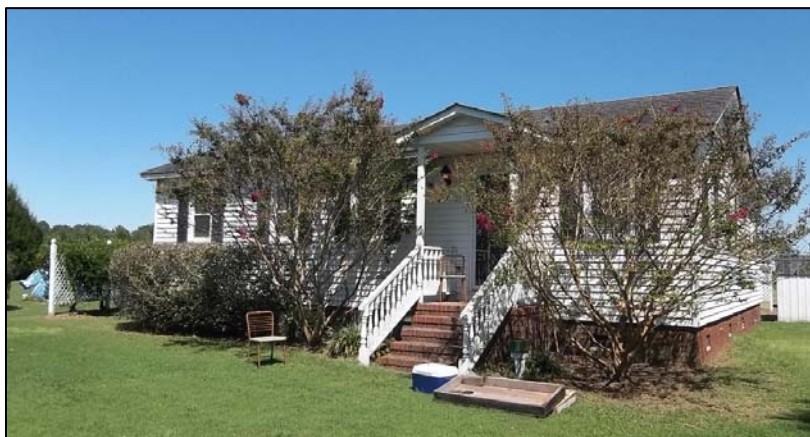
Photo 77: Southwest Oblique of the Secondary Residence.

According to the first-hand, written account of G. Dodson Mathias, son of C. Adrian and Hilda Boswood Mathias, there used to be several domestic and agricultural outbuildings associated with the building (Morris 2011). Today, there is only one secondary residence on the property. The current owner stated that this outbuilding was the old kitchen for the Boswood/Mathias house; however, access to the interior was denied and there is no archival or exterior evidence to suggest that it was kitchen (Palmer 2012). Currently, this one-story, five-bay building is used as a secondary residence (Photo 77). It is set on a brick foundation and the structural system is clad in vinyl siding. It is covered by a side-gabled roof that is sheathed in asphalt shingles. The primary entrance is located on the west elevation. Over the door is a one-story, one-bay porch that is covered by a front-gabled roof and supported by square, wood posts with a brick foundation. A one-bay garage extends off the north elevation of the secondary residence.

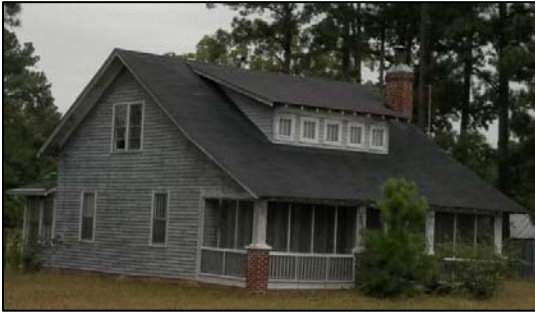
The Effie Creekmore House at 258 E. U.S. Highway 158 is a one-and-a-half story, three-bay house. The single-family dwelling was constructed around 1930 with bungalow elements. The frame structural system is clad in weatherboard siding and covered by a side-gable roof. The resource remains in fair condition, but does not exhibit high artistic value as the work of a master, nor is it an outstanding example of this particular architectural style or form. Modest modifications over time have somewhat diminished its historic integrity of design, materials, workmanship, feeling and association. It was determined to be not eligible for individual listing on the NRHP under Criteria A–C. This resource is not likely to yield any new information pertaining to the history of building design or technology. For a property to be eligible under Criterion D, it must meet two requirements: 1) the property must have, or have had, information to contribute to our understanding of human history or prehistory, and 2) the information must be considered significant. Therefore, this resource was determined to be not eligible under Criterion D.

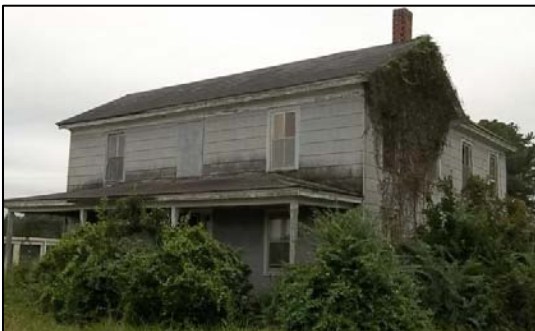
The Creekmore House is a two-story, three-bay building with a central-hall plan. The single-family dwelling was constructed around 1900 and is one of the earliest remaining residential buildings in the Village of Belcross. The frame structural system is clad in asbestos siding and covered by side-gable roof. The resource remains in fair to poor condition. It has been vacant for several decades. Moderate modification, as well as the years of neglect, has resulted in a diminished historic integrity of materials, design, feeling, association, and workmanship. In addition, it does not exhibit high artistic value as the work of a master, nor is it an outstanding example of this particular architectural style or form. It was determined to be not eligible for individual listing on the NRHP under Criteria A–C. This resource is not likely to yield any new information pertaining to the history of building design or technology. For a property to be eligible under Criterion D, it must meet two requirements: 1) the property must have, or have had, information to contribute to our understanding of human history or prehistory, and 2) the information must be considered significant. Therefore, this resource was determined to be not eligible under Criterion D.

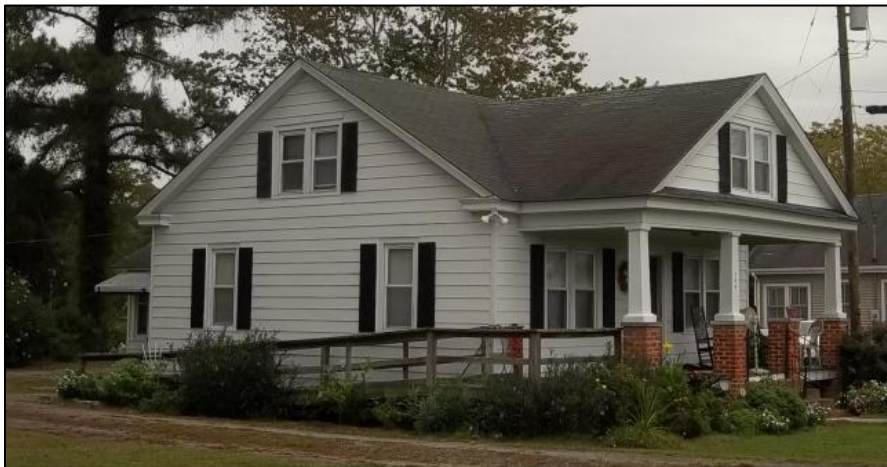
The Krainiack House at 260 E. U.S. Highway 158 is a one-and-a-half story, three-bay house. The single-family dwelling was constructed around 1946 with bungalow elements. The building's frame structural system is clad in aluminum siding and is covered by a side-gable roof. The resource is in fair condition. Moderate modifications over time have resulted in a diminished historic integrity of materials, design, feeling, association, and workmanship. In addition, it does not exhibit high artistic value as the work of a master, nor is it an outstanding example of this particular architectural style or form. It was determined to be not eligible for individual listing on the NRHP under Criteria A–C. This resource is not likely to yield any new information pertaining to the history of building design or technology. For a property to be eligible under Criterion D, it must meet two requirements: 1) the property must have, or have had, information to contribute to our understanding of human history or prehistory, and 2) the information

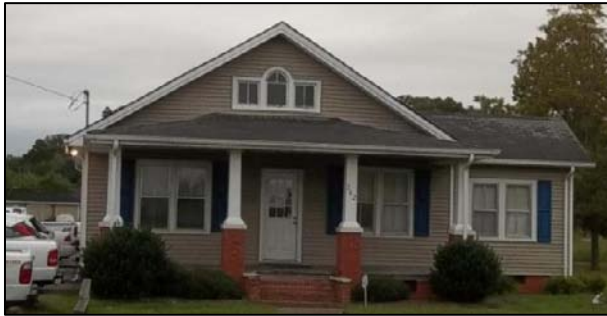
The Pestar House at 262 E. U.S. Highway 158 is a one-and-a-half story, three-bay building. The single-family dwelling was constructed around 1940 with Craftsman elements. The frame structural system is clad in weatherboard siding and the building is covered by side-gable roof. The resource is in good condition. Moderate modifications over time have resulted in a diminished historic integrity of materials, design, feeling, association, and workmanship. In addition, it does not exhibit high artistic value as the work of a master, nor is it an outstanding example of this particular architectural style or form. It was determined to be not eligible for individual listing on the NRHP under Criteria A–C. This resource is not likely to yield any new information pertaining to the history of building design or technology. For a property to be eligible under Criterion D, it must meet two requirements: 1) the property must have, or have had, information to contribute to our understanding of human history or prehistory, and 2) the information must be considered significant. Therefore, this resource was determined to be not eligible under Criterion D.

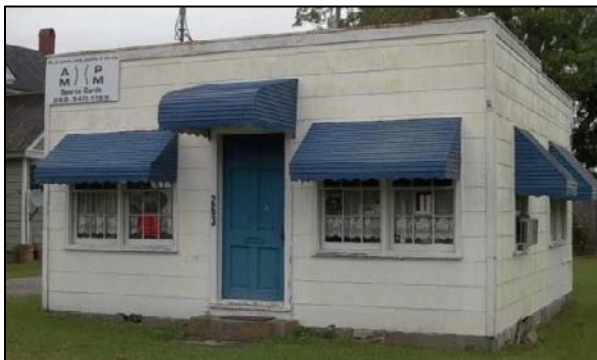
The APMM Sportscard/Old Post Office at 263 E. U.S. Highway 158 is a one-story, three-bay commercial building. This resource was built around 1940 to function as the Post Office for Belcross. This building has a cinderblock structural system that is covered in asbestos shingles. The resource is in fair condition. Moderate modifications over time have resulted in a diminished historic integrity of materials, design, feeling, association, and workmanship. In addition, it does not exhibit high artistic value as the work of a master, nor is it an outstanding example of this particular architectural style or form. It was determined to be not eligible for individual listing on the NRHP under Criteria A–C. This resource is not likely to yield any new information pertaining to the history of building design or technology. For a property to be eligible under Criterion D, it must meet two requirements: 1) the property must have, or have had, information to contribute to our understanding of human history or prehistory, and 2) the information must be considered significant. Therefore, this resource was determined to be not eligible under Criterion D.
