**North Carolina Department of Cultural Resources
State Historic Preservation Office**

MEMORANDUM

SUBJECT: Architectural Survey for Improvements to US 158, from East of NC 34 at Belcross to NC 168, R-2574, Currituck and Camden Counties, ER 11-1152

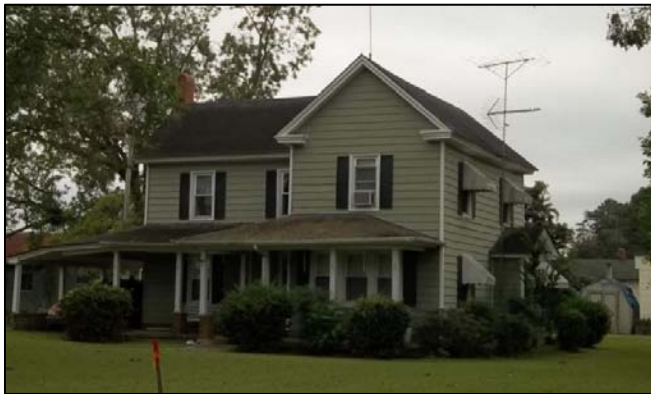
The Doris Harris House at 265 E. U.S. Highway 158 is a two-story, three-bay building. The single-family dwelling was built around 1910 with an irregular plan. The building has a frame structural system clad in aluminum siding and is covered by a gabled roof. This resource is in good condition. Moderate modifications over time have resulted in a diminished historic integrity of materials, design, feeling, association, and workmanship. In addition, it does not exhibit high artistic value as the work of a master, nor is it an outstanding example of this particular architectural style or form. It was determined to be not eligible for individual listing on the NRHP under Criteria A–C. This resource is not likely to yield any new information pertaining to the history of building design or technology. For a property to be eligible under Criterion D, it must meet two requirements: 1) the property must have, or have had, information to contribute to our understanding of human history or prehistory, and 2) the information must be considered significant. Therefore, this resource was determined to be not eligible under Criterion D.

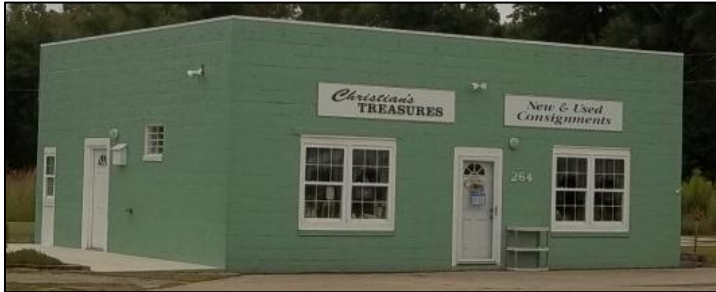
Christian's Treasures at 264 E. U.S. Highway 158 is a one-story, three-bay commercial building. This resource was built around 1940. This cinderblock building is covered by a shed roof. The resource is in fair condition. Moderate modifications over time have resulted in a diminished historic integrity of materials, design, feeling, association, and workmanship. In addition, it does not exhibit high artistic value as the work of a master, nor is it an outstanding example of this particular architectural style or form. It was determined to be not eligible for individual listing on the NRHP under Criteria A–C. This resource is not likely to yield any new information pertaining to the history of building design or technology. For a property to be eligible under Criterion D, it must meet two requirements: 1) the property must have, or have had, information to contribute to our understanding of human history or prehistory, and 2) the information must be considered significant. Therefore, this resource was determined to be not eligible under Criterion D.

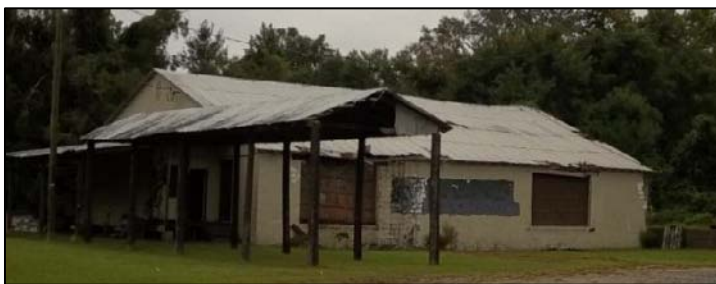
The Warehouse at 104 Belcross Road is a one-story building constructed around 1950 as a potato grading shed. The resource is in fair to poor condition. Modifications over time and neglect as a result of vacancy have resulted in a diminished historic integrity of materials, design, feeling, association, and workmanship. In addition, it does not exhibit high artistic value as the work of a master, nor is it an outstanding example of this particular architectural style or form. It was determined to be not eligible for individual listing on the NRHP under Criteria A–C. This resource is not likely to yield any new information pertaining to the history of building design or technology. For a property to be eligible under Criterion D, it must meet two requirements: 1) the property must have,

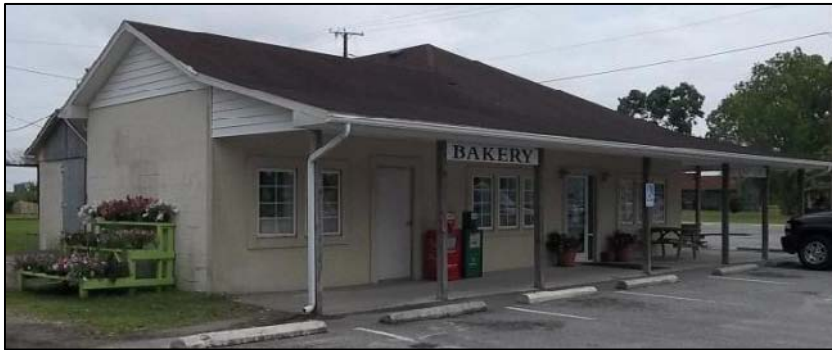
Belcross Bakery at 269A E. U.S. Highway 158 is a one-story commercial building constructed around 1940. The building has a cinderblock structural system that is covered by a hipped roof. The resource is in fair condition. Modifications over time and neglect as a result of vacancy have resulted in a diminished historic integrity of materials, design, feeling, association, and workmanship. In addition, it does not exhibit high artistic value as the work of a master, nor is it an outstanding example of this particular architectural style or form. It was determined to be not eligible for individual listing on the NRHP under Criteria A–C. This resource is not likely to yield any new information pertaining to the history of building design or technology. For a property to be eligible under Criterion D, it must meet two requirements: 1) the property must have, or have had, information to contribute to our understanding of human history or prehistory, and 2) the information must be considered significant. Therefore, this resource was determined to be not eligible under Criterion D.

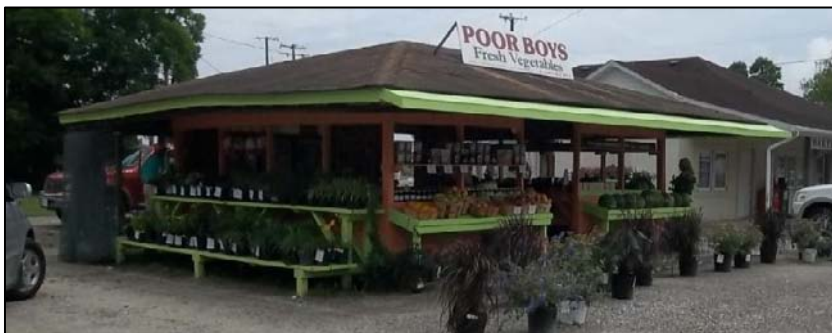
Poor Boys Fresh Vegetables at 269B E. U.S. Highway 158 is a one-story, open-air market constructed around 1953. The resource is in good condition. The building does not exhibit high artistic value as the work of a master, nor is it an outstanding example of this particular architectural style or form. It was determined to be not eligible for individual listing on the NRHP under Criteria A–C. This resource is not likely to yield any new information pertaining to the history of building design or technology. For a property to be eligible under Criterion D, it must meet two requirements: 1) the property must have, or have had, information to contribute to our understanding of human history or prehistory, and 2) the information must be considered significant. Therefore, this resource was determined to be not eligible under Criterion D.

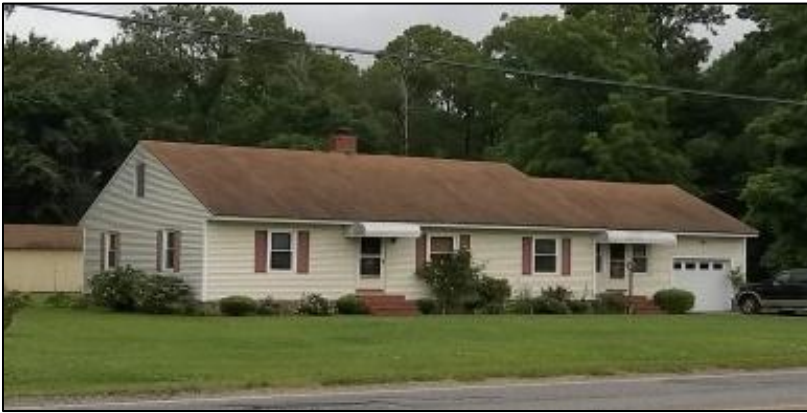
The resource at 274 E. U.S. Highway 158 is a 1960, one-story, six-bay, Ranch style single-family dwelling. The frame structural system is clad in vinyl siding and covered by a side-gable roof. The resource remains in fair condition, but does not exhibit high artistic value as the work of a master, nor is it an outstanding example of this particular architectural style. Moderate modifications over time have diminished its historic integrity of design, materials, workmanship, feeling and association. It was determined to be not eligible for individual listing on the NRHP under Criteria A–C.

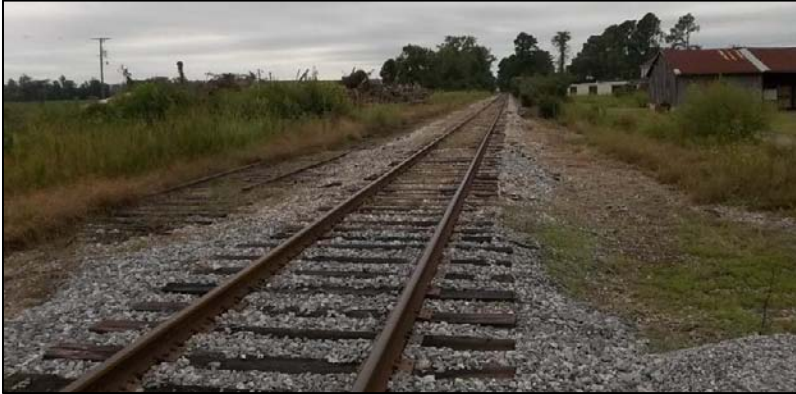
The Chesapeake & Albemarle Railroad, historically the Norfolk Southern, is a single track railroad built between Norfolk, Virginia and Edenton North Carolina. The resource is still used today and remains in good condition, but does not exhibit high artistic value as the work of a master, nor is it an outstanding example of this particular architectural style. Moderate modifications over time have diminished its historic integrity of design, materials, workmanship, feeling and association. It was determined to be not eligible for individual listing on the NRHP under Criteria A–C.

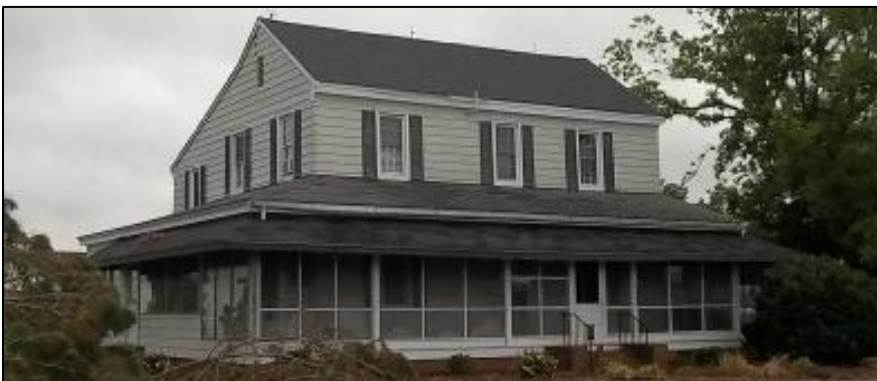
The resource at 124 Whitehurst Lane is a two-story, three-bay, single-family residence. The frame structural system is clad in vinyl siding and the building is covered by a side-gable roof. While the house remains in fair condition, it does not exhibit high artistic value as the work of a master, nor is it an outstanding example of this particular architectural style. Substantial modifications have diminished its historic integrity of design, materials, workmanship, feeling and association. It was determined to be not eligible for individual listing on the NRHP under Criteria A–C. This resource is not likely to yield any new information pertaining to the history of building design or technology. For a property to be eligible under Criterion D, it must meet two requirements: 1) the property must have, or have had, information to contribute to our understanding of human history or prehistory, and 2) the information must be considered significant. Therefore, this resource was determined to be not eligible under Criterion D.

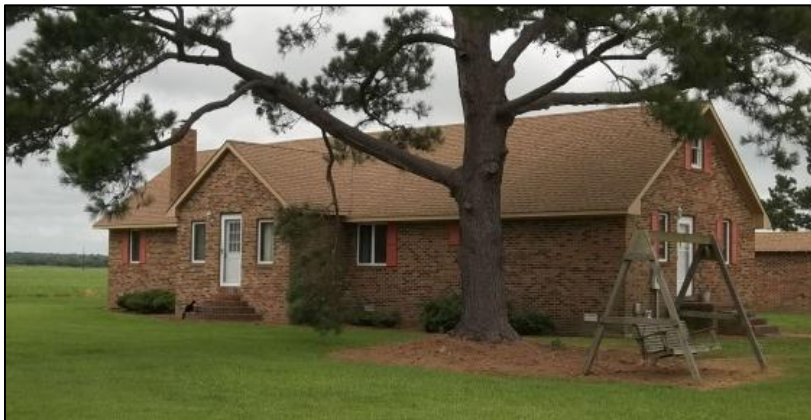
The two resources at 420/424 E. U.S. Highway 158 are two, one-story, side-gable Ranch houses, clad in brick veneer. Both dwelling were constructed circa 1950 and were moved to their current location. Both houses are in fair condition; however, they lack integrity of location and they do not exhibit high artistic value as the work of a master, nor are they an outstanding example of the Ranch Style. They were determined to be not eligible for individual listing on the NRHP under Criteria A–C or Criterion Consideration B for moved property. These resources do not likely to yield any new information pertaining to the history of building design or technology. For a property to be eligible under Criterion D, it must meet two requirements: 1) the property must have, or have had, information to contribute to our understanding of human history or prehistory, and 2) the information must be considered significant. Therefore, these resources are determined to be not eligible under Criterion D.

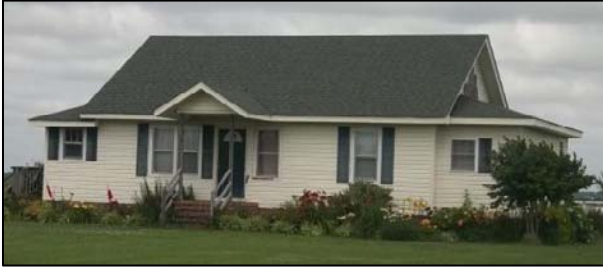
17. CM0089: Bray House
440 E. U.S. Highway 158
PIN: 028946005105160000

440 E. U.S. Highway 158, constructed in 1940s is a three-bay, one-story Minimal Traditional house. Although it remains in fair condition, this is not known to be an outstanding example of this particular type of architecture, nor is it directly associated with an important event or individual. It was determined to be not eligible for the NRHP under Criteria A–C as an individual resource. This resource is not likely to yield any new information pertaining to the history of building design or technology. For a property to be eligible under Criterion D, it must meet two requirements: 1) the property must have, or have had, information to contribute to our understanding of human history or prehistory, and 2) the information must be considered significant. Therefore, this resource was determined to be not eligible under Criterion D.

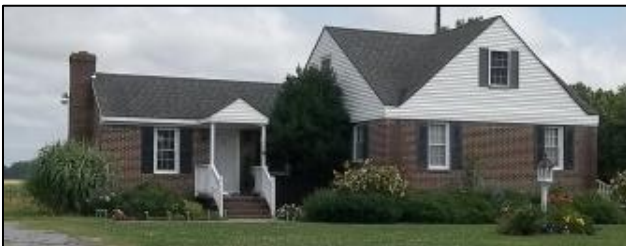
18. CM0090: Linda Day Bray House
448 E. U.S. Highway 158
PIN: 028946005263310000

The resource at 448 E. U.S. Highway 158 was constructed in 1864; however, it was completely renovated in the 1960s. Today it is a one-and-a-half story house redesigned in the Minimal Traditional style. This resource is in fair condition; however, this is not known to be an outstanding example of this particular type of architecture, nor is it directly associated with an important event or individual. It was determined to be not eligible for the NRHP under Criteria A–C as an individual resource. This resource is not likely to yield any new information pertaining to the history of building design or technology. For a property to be eligible under Criterion D, it must meet two requirements: 1) the property must have, or have had, information to contribute to our understanding of human history or prehistory, and 2) the information must be considered significant. Therefore, this resource was determined to be not eligible under Criterion D.

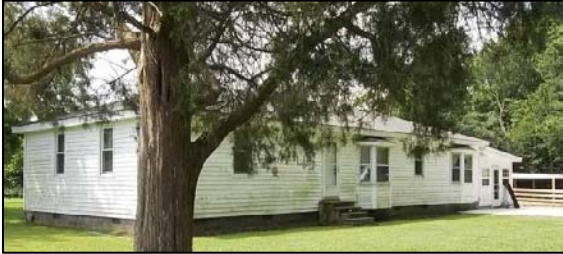
20. CK0359: Sanderlin Property
1851 Shortcut Road
PIN: 8946-93-4755

The house at 1851 Shortcut Road is a one-story Ranch dwelling, clad in vinyl siding. This resource is in fair condition; however, this is not known to be an outstanding example of this particular type of architecture, nor is it directly associated with an important event or individual. It was determined to be not eligible for the NRHP under Criteria A–C as an individual resource. This resource is not likely to yield any new information pertaining to the history of building design or technology. For a property to be eligible under Criterion D, it must meet two requirements: 1) the property must have, or have had, information to contribute to our understanding of human history or prehistory, and 2) the information must be considered significant. Therefore, this resource was determined to be not eligible under Criterion D.

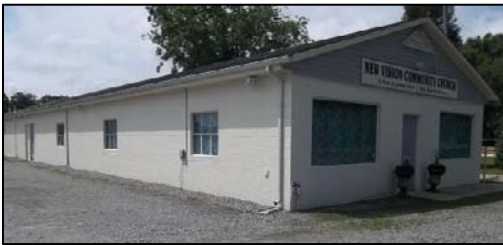
21. CK0360: New Vision Community Church
1847 Shortcut Road
PIN: 8946-93-5961

The resource at 1847 Shortcut Road is a circa-1950, small vernacular industrial building converted into a church. The resource is in fair condition; however, the complex does not exhibit high artistic value as the work of a master, nor is it an outstanding example of this particular architectural style. Moderate modifications to the building over time have diminished its historic integrity of design, materials, workmanship, feeling and association. It was determined to be not eligible for individual listing on the NRHP under Criteria A–C. This resource is not likely to yield any new information pertaining to the history of building design or technology. For a property to be eligible under Criterion D, it must meet two requirements: 1) the property must have, or have had, information to contribute to our understanding of human history or prehistory, and 2) the information must be considered significant. Therefore, this resource was determined to be not eligible under Criterion D.

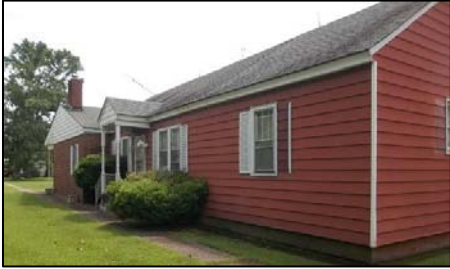
22. CK0361: Nellie Heath House
1839 Shortcut Road
PIN: 8946-94-7092

The Nellie Heath House, 1839 Shortcut Road, constructed circa 1950, is a one-story, five-bay, Minimal Traditional house. The dwelling is clad in vinyl siding and covered by a gable roof. Although it remains in fair condition, this is not known to be an outstanding example of this particular type of architecture, nor is it directly associated with an important event or individual. It was determined to be not eligible for the NRHP under Criteria A–C as an individual resource. This resource is not likely to yield any new information pertaining to the history of building design or technology. For a property to be eligible under Criterion D, it must meet two requirements: 1) the property must have, or have had, information to contribute to our understanding of human history or prehistory, and 2) the information must be considered significant. Therefore, this resource was determined to be not eligible under Criterion D.

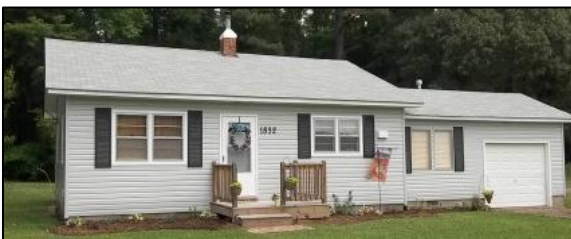
23. CK0362: Messina House
1832 Shortcut Road
PIN: 8946-94-7311

The Messina House at 1832 Shortcut Road is a one-story, three-bay mid-twentieth century dwelling. The building is covered in vinyl siding and covered by a side-gable roof. The resource is not known to be an outstanding example of this particular type of architecture, nor is it directly associated with an important event or individual. It was determined to be not eligible for the NRHP under Criteria A–C as an individual resource. This resource is not likely to yield any new information pertaining to the history of building design or technology. For a property to be eligible under Criterion D, it must meet two requirements: 1) the property must have, or have had, information to contribute to our understanding of human history or prehistory, and 2) the information must be considered significant. Therefore, this resource was determined to be not eligible under Criterion D.

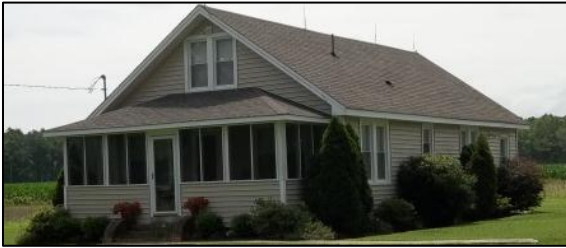
24. CK0363: Leary/Corbett House
1827 Shortcut Road
PIN: 8946-94-9125

The resource at 1827 Shortcut Road is a circa-1940, one-and-a-half story, two-bay bungalow form, single-family dwelling. This building is clad in vinyl siding and covered by a front-gable roof. Though it is in fair condition, this resource does not exhibit high artistic value as the work of a master, nor is it an outstanding example of a particular architectural style. Modifications over time have significantly diminished its historic integrity. It was determined to be not eligible for individual listing on the NRHP under Criteria A–C. This resource is not likely to yield any new information pertaining to the history of building design or technology. For a property to be eligible under Criterion D, it must meet two requirements: 1) the property must have, or have had, information to contribute to our understanding of human history or prehistory, and 2) the information must be considered significant. Therefore, this resource was determined to be not eligible under Criterion D.

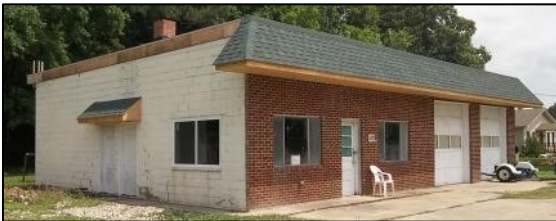
25. CK0364: Gas Station/Service Garage
1825 Shortcut Road
PIN: 8946-94-8338

The resource at 1825 Shortcut Road is a one-story, three-bay service garage constructed in 1965. The building has a cinderblock structural system. Though it is in fair condition, this resource does not exhibit high artistic value as the work of a master, nor is it an outstanding example of a particular architectural style. Modifications over time have significantly diminished its historic integrity. It was determined to be not eligible for individual listing on the NRHP under Criteria A–C. This resource is not likely to yield any new information pertaining to the history of building design or technology. For a property to be eligible under Criterion D, it must meet two requirements: 1) the property must have, or have had, information to contribute to our understanding of human history or prehistory, and 2) the information must be considered significant. Therefore, this resource was determined to be not eligible under Criterion D.

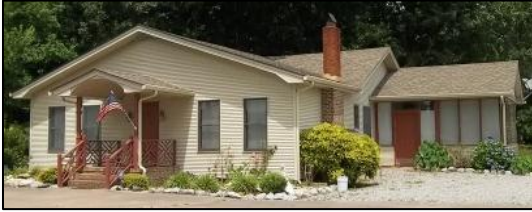
26. CK0365: Bait Barn and House
1818 Shortcut Road
PIN: 8956-04-1605

The resources at 1818 Shortcut Road include one single-family dwelling, constructed in 1960, a modern commercial building, and several modern storage buildings. The resource is in fair condition but does not exhibit high artistic value as the work of a master, nor is it an outstanding example of a particular architectural style. Modifications over time have diminished its historic integrity. It was determined to be not eligible for individual listing on the NRHP under Criteria A–C. This resource is not likely to yield any new information pertaining to the history of building design or technology. For a property to be eligible under Criterion D, it must meet two requirements: 1) the property must have, or have had, information to contribute to our understanding of human history or prehistory, and 2) the information must be considered significant. Therefore, this resource was determined to be not eligible under Criterion D.

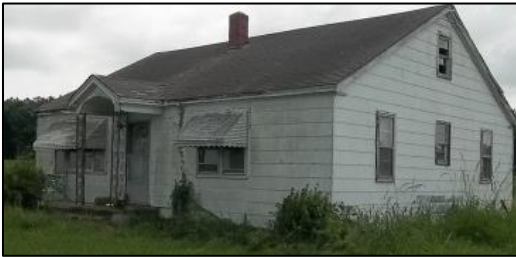
27. CK0366: Ashby/Wilson House
1793 Shortcut Road
PIN: 8956-03-3997

The resource at 1793 Shortcut Road is a one-story single-family dwelling constructed in the Minimal Traditional style. The frame structural system is clad in asbestos siding and covered by a side-gable roof. The house is in poor condition and does not exhibit high artistic value as the work of a master, nor is it an outstanding example of any particular architectural style. Substantial modifications to each of the buildings over time have diminished the historic integrity of this property. It was determined to be not eligible for individual listing on the NRHP under Criteria A–C. This resource is not likely to yield any new information pertaining to the history of building design or technology. For a property to be eligible under Criterion D, it must meet two requirements: 1) the property must have, or have had, information to contribute to our understanding of human history or prehistory, and 2) the information must be considered significant. Therefore, this resource was determined to be not eligible under Criterion D.

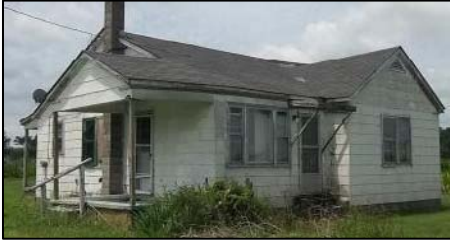
28. CK0367: Eunice Watkins/Wilson House
486 N. Gregory Road
PIN: 8956-15-0282

The resource at 486 N. Gregory Road is a one-story single-family dwelling constructed in the Minimal Traditional style. The frame structural system is clad in asbestos siding and covered by a side-gable roof. The dwelling is in poor condition and does not exhibit high artistic value as the work of a master, nor is it an outstanding example of any particular architectural style. Substantial modifications to each of the buildings over time have diminished the historic integrity of this property. It was determined to be not eligible for individual listing on the NRHP under Criteria A–C. This resource is not likely to yield any new information pertaining to the history of building design or technology. For a property to be eligible under Criterion D, it must meet two requirements: 1) the property must have, or have had, information to contribute to our understanding of human history or prehistory, and 2) the information must be considered significant. Therefore, this resource was determined to be not eligible under Criterion D.

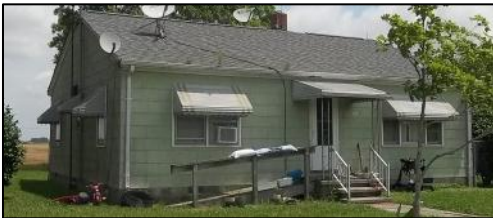
29. CK0368: William Gregory House
491 N. Gregory Road
PIN: 8956-15-4453

The resource at 491 N. Gregory Road is a one-story single-family dwelling Ranch style single-family dwelling. The frame structural system is clad in asbestos siding and covered by a side-gable roof. The dwelling is in fair condition and it does not exhibit high artistic value as the work of a master, nor is it an outstanding example of any particular architectural style. It was determined to be not eligible for individual listing on the NRHP under Criteria A–C. This resource is not likely to yield any new information pertaining to the history of building design or technology. For a property to be eligible under Criterion D, it must meet two requirements: 1) the property must have, or have had, information to contribute to our understanding of human history or prehistory, and 2) the information must be considered significant. Therefore, this resource was determined to be not eligible under Criterion D.

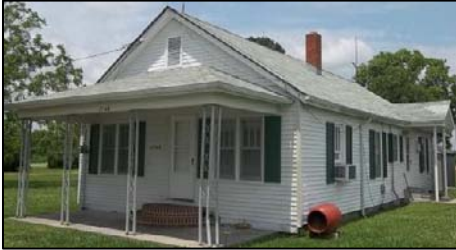
30. CK0369: Forbes Property
1746 Shortcut Road
PIN: 8956-15-5389

The resource at 1746 Shortcut Road is a one-story, single-family dwelling constructed in the bungalow form. The house is clad in vinyl siding and covered by a front-gable roof. The dwelling is in fair condition; however, it does not exhibit high artistic value as the work of a master, nor is it an outstanding example of any particular architectural style. Substantial modifications to the building over time have diminished the historic integrity of this property. It was determined to be not eligible for individual listing on the NRHP under Criteria A–C. This resource is not likely to yield any new information pertaining to the history of building design or technology. For a property to be eligible under Criterion D, it must meet two requirements: 1) the property must have, or have had, information to contribute to our understanding of human history or prehistory, and 2) the information must be considered significant. Therefore, this resource was determined to be not eligible under Criterion D.

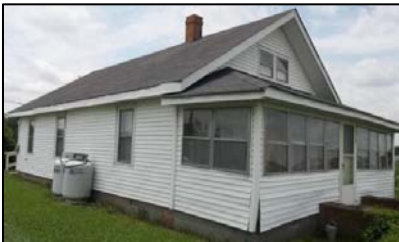
31. CK0370: Barnard House
124 S. Gregory Road
PIN: 8956-14-8276

The resource at 124 S. Gregory is a one-and-a-half story, two-bay bungalow form dwelling clad in vinyl siding. The resource is not known to be an outstanding example of a particular type of architecture, nor is it directly associated with an important event or individual; it was determined to be not eligible for the NRHP under Criteria A–C as an individual resource. This resource is not likely to yield any new information pertaining to the history of building design or technology. For a property to be eligible under Criterion D, it must meet two requirements: 1) the property must have, or have had, information to contribute to our understanding of human history or prehistory, and 2) the information must be considered significant. Therefore, this resource was determined to be not eligible under Criterion D.

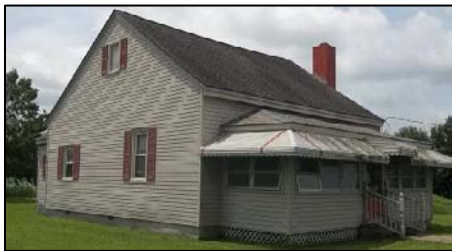
33. CK0372: Gregory Dayton/Garrington House
196 S. Gregory Road
PIN: 8956-34-7223

The resource at 196 S. Gregory Road is a one-story, two-bay, bungalow form dwelling. The house was constructed as a vernacular farmhouse in 1871, and in the 1920s or 1930s was renovated in the more popular bungalow form. Although the resource is in fair condition, it does not exhibit high artistic value as the work of a master, nor is it an outstanding example of a particular architectural style. Substantial modifications to the façade have significantly diminished its historic integrity. It was determined to be not eligible for individual listing on the NRHP under Criteria A–C. This resource is not likely to yield any new information pertaining to the history of building design or technology. For a property to be eligible under Criterion D, it must meet two requirements: 1) the property must have, or have had, information to contribute to our understanding of human history or prehistory, and 2) the information must be considered significant. Therefore, this resource was determined to be not eligible under Criterion D.

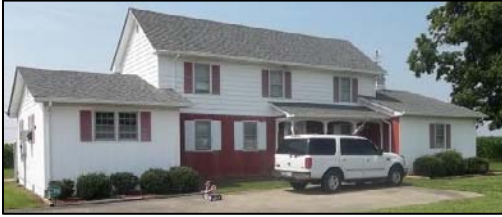
34. CK0373: Skiba/Lindsey House
1630 Shortcut Road
PIN: 8956-38-5172

The resource at 1630 Shortcut Road is a two-story, five-bay, single-family dwelling with Colonial Revival style detail. According to tax records, the house was constructed in 1850, but the resource has undergone considerable renovations, most likely in the mid-twentieth century. The resource is in fair condition, but does not exhibit high artistic value as the work of a master, nor is it an outstanding example of a particular architectural style. Modifications to the façade have significantly diminished its historic integrity. It was determined to be not eligible for individual listing on the NRHP under Criteria A–C. This resource is not likely to yield any new information pertaining to the history of building design or technology. For a property to be eligible under Criterion D, it must meet two requirements: 1) the property must have, or have had, information to contribute to our understanding of human history or prehistory, and 2) the information must be considered significant. Therefore, this resource was determined to be not eligible under Criterion D.

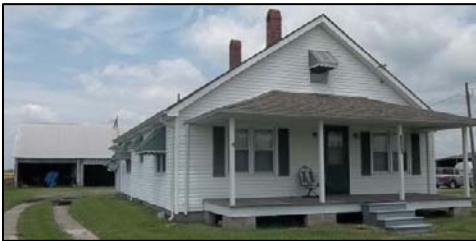
35. CK0374: Cecil Barnes/White House
1574 Shortcut Road
PIN: 8956-47-9571

The resource at 1574 Shortcut Road is a one-and-a-half story, two-bay bungalow, clad in vinyl siding. The house is clad in vinyl siding and covered by a front-gable roof. The resource is in fair condition, but does not exhibit high artistic value as the work of a master, nor is it an outstanding example of a particular architectural style. It was determined to be not eligible for individual listing on the NRHP under Criteria A–C. This resource is not likely to yield any new information pertaining to the history of building design or technology. For a property to be eligible under Criterion D, it must meet two requirements: 1) the property must have, or have had, information to contribute to our understanding of human history or prehistory, and 2) the information must be considered significant. Therefore, this resource was determined to be not eligible under Criterion D.

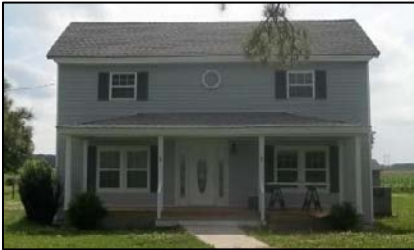
38. CK0376: Annie Roberts House
118 S. Indiantown Road
PIN: 8956-78-7533

The resource at 118 S. Indiantown Road is a two-story, three-bay I-house. The single-family dwelling was constructed circa 1900; however, the house has just recently undergone a complete renovation. The resource is in good condition, but does not exhibit high artistic value as the work of a master, nor is it an outstanding example of a particular architectural style. Modifications to the façade have significantly diminished its historic integrity. It was determined to be not eligible for individual listing on the NRHP under Criteria A–C. This resource is not likely to yield any new information pertaining to the history of building design or technology. For a property to be eligible under Criterion D, it must meet two requirements: 1) the property must have, or have had, information to contribute to our understanding of human history or prehistory, and 2) the information must be considered significant. Therefore, this resource was determined to be not eligible under Criterion D.

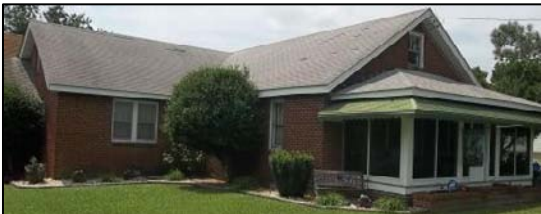
39. CK0377: Don Roberts House #2
134 S. Indiantown Road
PIN: 8956-78-8046

The resource at 134 S. Indiantown Road is a one-and-a-half story, three-bay, brick bungalow form dwelling. The structural system is clad in a brick, stretcher-bond veneer covered in a cross-gable roof. It is in good condition; however, it does not exhibit high artistic value as the work of a master, nor is it an outstanding example of a particular architectural style. It was determined to be not eligible for individual listing on the NRHP under Criteria A–C. This resource is not likely to yield any new information pertaining to the history of building design or technology. For a property to be eligible under Criterion D, it must meet two requirements: 1) the property must have, or have had, information to contribute to our understanding of human history or prehistory, and 2) the information must be considered significant. Therefore, this resource was determined to be not eligible under Criterion D.

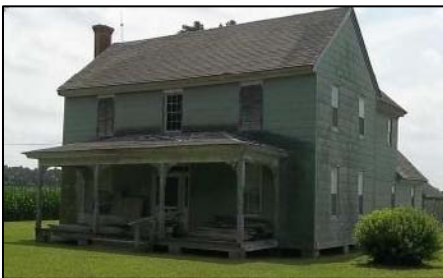
41. CK0271: A. Thomas Roberts House
164 S. Indiantown Road
PIN: 8956-67-8374

The resource at 164 S. Indiantown Road, constructed in 1910, is a two-story, four-bay, I-house. It is in fair condition and does not exhibit high artistic value as the work of a master, nor is it an outstanding example of a particular architectural style. Moderate modifications have diminished its historic integrity. It was determined to be not eligible for individual listing on the NRHP under Criteria A–C. This resource is not likely to yield any new information pertaining to the history of building design or technology. For a property to be eligible under Criterion D, it must meet two requirements: 1) the property must have, or have had, information to contribute to our understanding of human history or prehistory, and 2) the information must be considered significant. Therefore, this resource was determined to be not eligible under Criterion D.

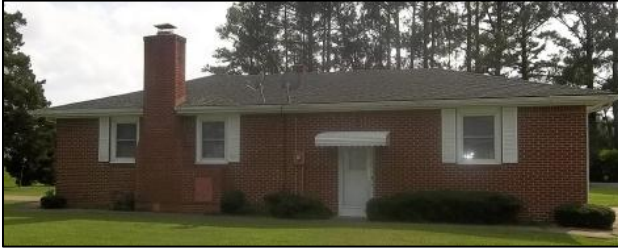
42. CK0379: James R. Sanderlin House
1302 Shortcut Road
PIN: 8967-11-0160

The resource at 1302 Shortcut Road is a one-story, four-bay brick Ranch style single-family dwelling. The building is clad in a brick, stretcher-bond veneer and covered by a hipped roof. The house remains in good condition; however, does not exhibit high artistic value as the work of a master, nor is it an outstanding example of the Ranch style. It was determined to be not eligible for individual listing on the NRHP under Criteria A–C. This resource is not likely to yield any new information pertaining to the history of building design or technology. For a property to be eligible under Criterion D, it must meet two requirements: 1) the property must have, or have had, information to contribute to our understanding of human history or prehistory, and 2) the information must be considered significant. Therefore, this resource was determined to be not eligible under Criterion D.

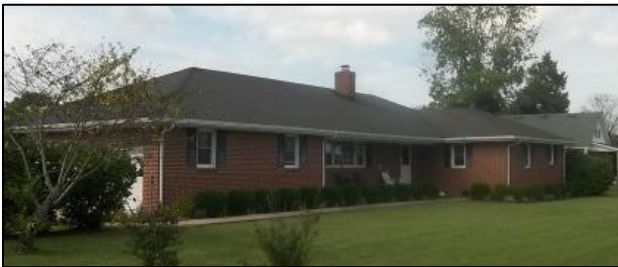
The resource at 1296 Shortcut Road, is a circa-1964, one-story, six-bay Ranch style single-family dwelling. The building is clad in a brick, stretcher-bond veneer and covered by a hipped roof. The resource is in good condition, but does not exhibit high artistic value as the work of a master, nor is it an outstanding example of a particular architectural style. It was determined to be not eligible for individual listing on the NRHP under Criteria A–C. This resource is not likely to yield any new information pertaining to the history of building design or technology. For a property to be eligible under Criterion D, it must meet two requirements: 1) the property must have, or have had, information to contribute to our understanding of human history or prehistory, and 2) the information must be considered significant. Therefore, this resource was determined to be not eligible under Criterion D.

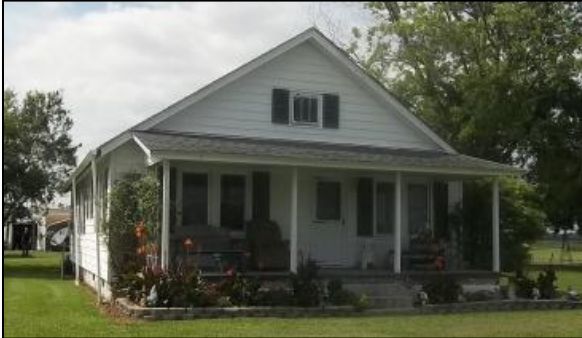
The resource at 115 Sanderlin Road is a circa-1940, one-and-a-half story, three-bay bungalow type, single-family dwelling. The structural system is clad in aluminum siding and covered by a front-gable roof. The house is in fair condition; however, it was determined to be not eligible for individual listing on the NRHP under Criteria A–C. This resource is not likely to yield any new information pertaining to the history of building design or technology. For a property to be eligible under Criterion D, it must meet two requirements: 1) the property must have, or have had, information to contribute to our understanding of human history or prehistory, and 2) the information must be considered significant. Therefore, this resource was determined to be not eligible under Criterion D.

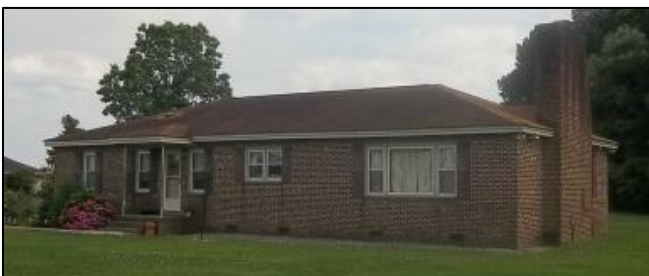
The resource at 121 Sanderlin Road is a one-story, four-bay brick Ranch style single-family dwelling. The building is clad in a brick, stretcher-bond veneer and covered by a hipped roof. It is presently in fair condition, but is not considered to be an outstanding example of Ranch Style architecture. It was determined to be not eligible for individual listing on the NRHP under Criteria A–C. This resource is not likely to yield any new information pertaining to the history of building design or technology. For a property to be eligible under Criterion D, it must meet two requirements: 1) the property must have, or have had, information to contribute to our understanding of human history or prehistory, and 2) the information must be considered significant. Therefore, this resource was determined to be not eligible under Criterion D.

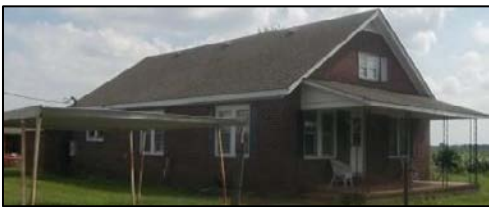
47. CK0384: George Sanderlin House
102 Four Forks Road
PIN: 8967-11-7022

The resource at 102 Four Forks Road is a one-and-a-half story, three-bay, brick, single-family dwelling with a front gable roof built in 1942. The building is clad in a brick, stretcher-bond veneer and covered by a front-gable roof. The resource is in fair condition, but does not exhibit high artistic value as the work of a master, nor is it an outstanding example of a particular architectural style. Modifications to the building over time have significantly diminished its historic integrity. It was determined to be not eligible for individual listing on the NRHP under Criteria A–C. This resource is not likely to yield any new information pertaining to the history of building design or technology. For a property to be eligible under Criterion D, it must meet two requirements: 1) the property must have, or have had, information to contribute to our understanding of human history or prehistory, and 2) the information must be considered significant. Therefore, this resource was determined to be not eligible under Criterion D.

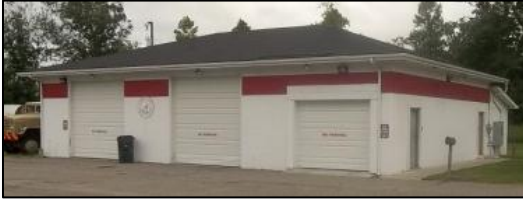
48. CK0385: Crawford Township VFD
620 Shortcut Road
PIN: 8977-73-5737

Built in 1961, the resource at 620 Shortcut Road is a one-story, three-bay, commercial building with a low-pitched hipped roof, sheathed in asphalt shingles. The front façade features three large garage bays. The resource is in fair condition, but does not exhibit high artistic value as the work of a master, nor is it an outstanding example of a particular architectural style. Modifications such as replacement windows and rear additions have diminished its historic integrity. It was determined to be not eligible for individual listing on the NRHP under Criteria A–C. This resource is not likely to yield any new information pertaining to the history of building design or technology. For a property to be eligible under Criterion D, it must meet two requirements: 1) the property must have, or have had, information to contribute to our understanding of human history or prehistory, and 2) the information must be considered significant. Therefore, this resource was determined to be not eligible under Criterion D.

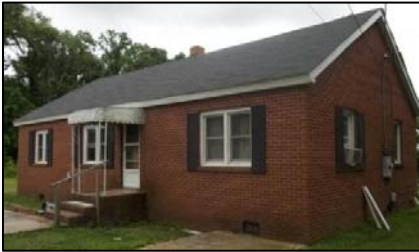
50. CK0387: Spence Property 1
409 (A) Shortcut Road
PIN: 8987-23-7119

The resource at 409 (A) Shortcut Road is a 1950, one-story, four-bay, brick single-family dwelling with a side-gable roof. The resource is in fair condition, but does not exhibit high artistic value as the work of a master, nor is it an outstanding example of a particular architectural style. Modifications to the building over time have significantly diminished its historic integrity. It was determined to be not eligible for individual listing on the NRHP under Criteria A–C. This resource is not likely to yield any new information pertaining to the history of building design or technology. For a property to be eligible under Criterion D, it must meet two requirements: 1) the property must have, or have had, information to contribute to our understanding of human history or prehistory, and 2) the information must be considered significant. Therefore, this resource was determined to be not eligible under Criterion D.

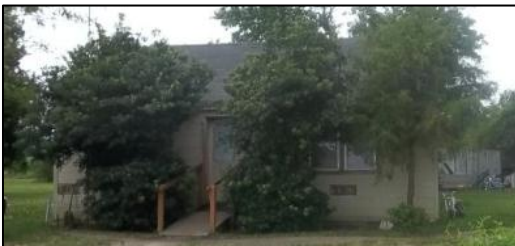
51. CK0388: Spence Property 2
409 (B) Shortcut Road
PIN: 8987-23-7119

The second resource at 409 Shortcut Road is a 1950, one-story, three-bay, single-family dwelling with a side-gable roof. The resource is in poor condition and does not exhibit high artistic value as the work of a master, nor is it an outstanding example of a particular architectural style. Modifications to the building over time have significantly diminished its historic integrity. It was determined to be not eligible for individual listing on the NRHP under Criteria A–C. This resource is not likely to yield any new information pertaining to the history of building design or technology. For a property to be eligible under Criterion D, it must meet two requirements: 1) the property must have, or have had, information to contribute to our understanding of human history or prehistory, and 2) the information must be considered significant. Therefore, this resource was determined to be not eligible under Criterion D.

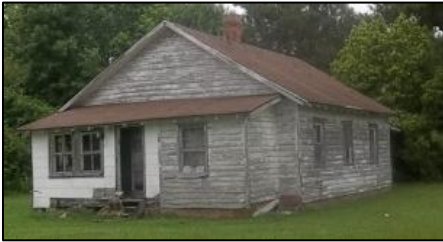
52. CK0389: Hunt House
393 Shortcut Road
PIN: 8987-23-9196

The resource at 393 Shortcut Road is a 1930, one-story, three-bay, single-family dwelling with a front-gable roof. The house is clad in original weatherboard. The resource is in poor condition and does not exhibit high artistic value as the work of a master, nor is it an outstanding example of a particular architectural style. Modifications to the building over time have significantly diminished its historic integrity. It was determined to be not eligible for individual listing on the NRHP under Criteria A–C. This resource is not likely to yield any new information pertaining to the history of building design or technology. For a property to be eligible under Criterion D, it must meet two requirements: 1) the property must have, or have had, information to contribute to our understanding of human history or prehistory, and 2) the information must be considered significant. Therefore, this resource was determined to be not eligible under Criterion D.

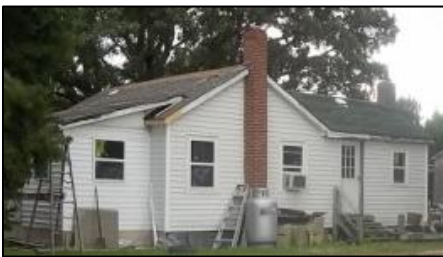
53. CK0390: Simmons House
390 Shortcut Road
PIN: 8987-23-9196

Built in 1933, the resource at 390 Shortcut Road is a one-story, three-bay, bungalow form dwelling with a side-gable roof. The house is clad in vinyl siding. The resource is in poor condition and does not exhibit high artistic value as the work of a master, nor is it an outstanding example of a particular architectural style. Modifications to the building over time have significantly diminished its historic integrity. It was determined to be not eligible for individual listing on the NRHP under Criteria A–C. This resource is not likely to yield any new information pertaining to the history of building design or technology. For a property to be eligible under Criterion D, it must meet two requirements: 1) the property must have, or have had, information to contribute to our understanding of human history or prehistory, and 2) the information must be considered significant. Therefore, this resource was determined to be not eligible under Criterion D.

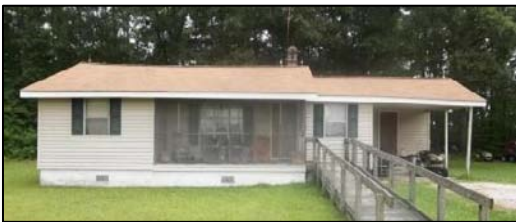
57. CK0394: Cave House
250 Barco Road
PIN: 8987-53-4310

Built in 1964, the resource at 250 Barco Road is a one-story, four-bay, Ranch style house with a low-pitched, side-gable roof. The dwelling is clad in vinyl siding and the front porch has been screened. The resource is in fair condition and does not exhibit high artistic value as the work of a master, nor is it an outstanding example of a particular architectural style. Modifications to the building over time have significantly diminished its historic integrity. It was determined to be not eligible for individual listing on the NRHP under Criteria A–C. This resource is not likely to yield any new information pertaining to the history of building design or technology. For a property to be eligible under Criterion D, it must meet two requirements: 1) the property must have, or have had, information to contribute to our understanding of human history or prehistory, and 2) the information must be considered significant. Therefore, this resource was determined to be not eligible under Criterion D.

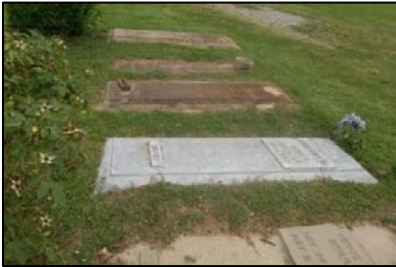
58. CK0395: Williams Family Cemetery
218 Barco Road
PIN: N/A

This cemetery on Barco Road is a small family graveyard associated with the Barnard-Williams family. The resource is in fair condition, with the earliest burial occurring in 1960. The resource does not exhibit high artistic value as the work of a master, nor is it an outstanding example of a particular architectural style. It was determined to be not eligible for individual listing on the NRHP under Criteria A–C. This resource is not likely to yield any new information pertaining to the history of building design or technology. For a property to be eligible under Criterion D, it must meet two requirements: 1) the property must have, or have had, information to contribute to our understanding of human history or prehistory, and 2) the information must be considered significant. Therefore, this resource was determined to be not eligible under Criterion D.

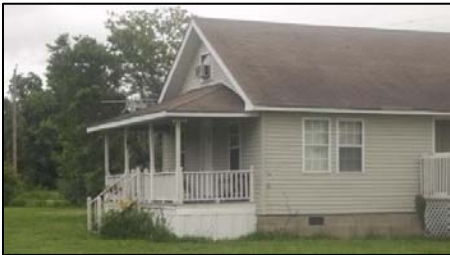
59. CK0396: Poyner/Stahel House
258 Shortcut Road
PIN: 8987-63-3263

The resource at 258 Shortcut Road is a circa-1940, one-and-a-half story, three-bay bungalow type dwelling with a steeply pitched front-gable roof. The house is clad in vinyl siding. The resource is in fair condition and does not exhibit high artistic value as the work of a master, nor is it an outstanding example of a particular architectural style. Modifications to the building over time have significantly diminished its historic integrity. It was determined to be not eligible for individual listing on the NRHP under Criteria A–C. This resource is not likely to yield any new information pertaining to the history of building design or technology. For a property to be eligible under Criterion D, it must meet two requirements: 1) the property must have, or have had, information to contribute to our understanding of human history or prehistory, and 2) the information must be considered significant. Therefore, this resource was determined to be not eligible under Criterion D.

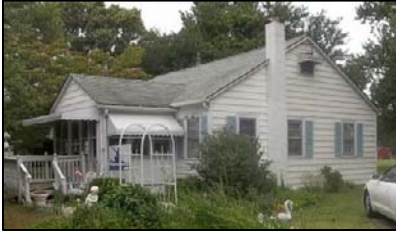
60. CK0397: Davis/Gibbs House
230 Shortcut Road
PIN: 8987-73-0237

The resource at 230 Shortcut Road is a one-story, three-bay Minimal Traditional style house side-gabled roof built in 1947. The dwelling has a side-gabled roof and is clad in vinyl siding. The resource is in fair condition and does not exhibit high artistic value as the work of a master, nor is it an outstanding example of a particular architectural style. Modifications to the building over time have significantly diminished its historic integrity. It was determined to be not eligible for individual listing on the NRHP under Criteria A–C. This resource is not likely to yield any new information pertaining to the history of building design or technology. For a property to be eligible under Criterion D, it must meet two requirements: 1) the property must have, or have had, information to contribute to our understanding of human history or prehistory, and 2) the information must be considered significant. Therefore, this resource was determined to be not eligible under Criterion D.

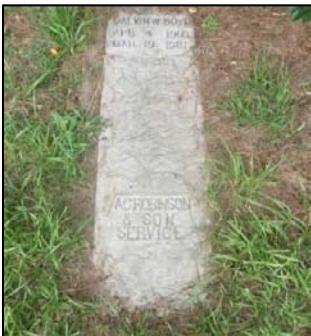
61. CK0398: McCleave/Warden Cemetery
220 Shortcut Road
PIN: 8987-73-2202

This resource at 220 Shortcut Road is a small family cemetery associated with the McCleave and Warden families. The resource is in fair condition, with the earliest burial occurring in 1960. The resource does not exhibit high artistic value as the work of a master, nor is it an outstanding example of a particular architectural style. It was determined to be not eligible for individual listing on the NRHP under Criteria A–C. This resource is not likely to yield any new information pertaining to the history of building design or technology. For a property to be eligible under Criterion D, it must meet two requirements: 1) the property must have, or have had, information to contribute to our understanding of human history or prehistory, and 2) the information must be

considered significant. Therefore, this resource was determined to be not eligible under Criterion D.

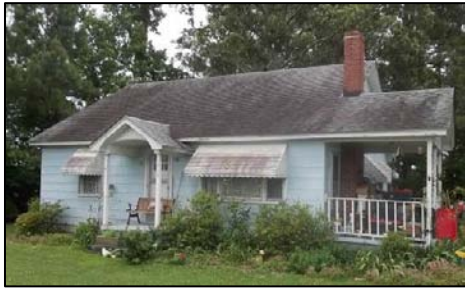
62. CK0399: Davenport House
205 Shortcut Road
PIN: 8987-72-6872

The resource at 205 Shortcut Road is a 1952, one-story, three-bay Minimal Traditional style house, with a side-gable roof. The dwelling is clad in aluminum siding. The resource is in fair condition; however, it does not exhibit high artistic value as the work of a master, nor is it an outstanding example of a particular architectural style. It was determined to be not eligible for individual listing on the NRHP under Criteria A–C. This resource is not likely to yield any new information pertaining to the history of building design or technology. For a property to be eligible under Criterion D, it must meet two requirements: 1) the property must have, or have had, information to contribute to our understanding of human history or prehistory, and 2) the information must be considered significant. Therefore, this resource was determined to be not eligible under Criterion D.

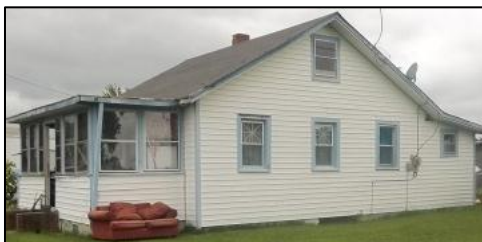
63. CK0400: Poyner House
196 Shortcut Road
PIN: 8987-73-8101

Built in 1952, the resource at 196 Shortcut Road is a one-story, three-bay Minimal Traditional style house, with a side-gable roof. The dwelling is clad in aluminum siding. The resource is in fair condition; however, it does not exhibit high artistic value as the work of a master, nor is it an outstanding example of a particular architectural style. Modifications to the building over time have significantly diminished its historic integrity. It was determined to be not eligible for individual listing on the NRHP under Criteria A–C. This resource is not likely to yield any new information pertaining to the history of building design or technology. For a property to be eligible under Criterion D, it must meet two requirements: 1) the property must have, or have had, information to

contribute to our understanding of human history or prehistory, and 2) the information must be considered significant. Therefore, this resource was determined to be not eligible under Criterion D.

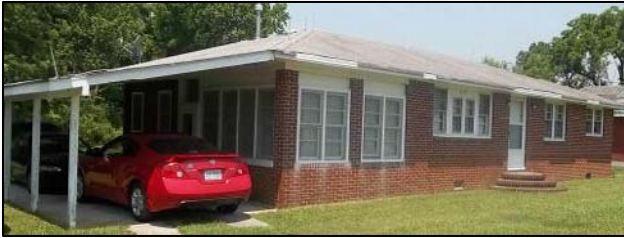
64. CK0401: Cooper/Ansell House
4206 Caratoke Highway
PIN: 8996-18-5010

The resource at 4206 Caratoke Highway is a circa-1960, one-story, six-bay Ranch style house, with a hipped roof. The dwelling is clad in a brick veneer. The resource is in fair condition; however, it does not exhibit high artistic value as the work of a master, nor is it an outstanding example of a particular architectural style. It was determined to be not eligible for individual listing on the NRHP under Criteria A–C. This resource is not likely to yield any new information pertaining to the history of building design or technology. For a property to be eligible under Criterion D, it must meet two requirements: 1) the property must have, or have had, information to contribute to our understanding of human history or prehistory, and 2) the information must be considered significant. Therefore, this resource was determined to be not eligible under Criterion D.

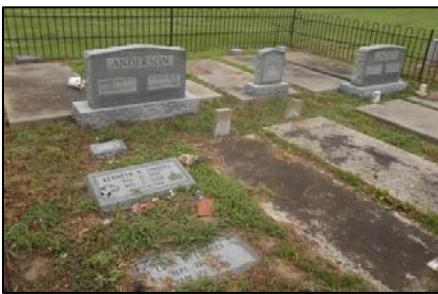
65. CK0402: Lindsey Cemetery
4203 Caratoke Highway
PIN: N/A

The Lindsey Cemetery is a small family graveyard associated with the Lindsey Family. The resource is in fair condition, with the earliest burial occurring in 1927. The resource does not exhibit high artistic value as the work of a master, nor is it an outstanding example of a particular architectural style. It was determined to be not eligible for individual listing on the NRHP under Criteria A–C. It has not been evaluated under Criterion D.

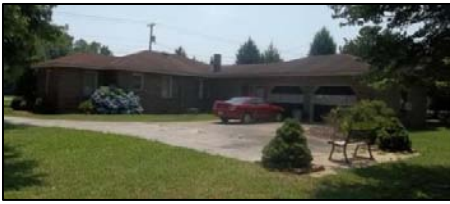
66. CK0403: Poyner/Ansell House

The resource at 4174 Caratoke Highway is a 1954, one-story, six-bay Ranch style house, with a hipped roof. The dwelling is clad in a brick veneer. The resource is in fair condition; however, it does not exhibit high artistic value as the work of a master, nor is it an outstanding example of a particular architectural style. Modifications to the building over time have significantly diminished its historic integrity. It was determined to be not eligible for individual listing on the NRHP under Criteria A–C. This resource is not likely to yield any new information pertaining to the history of building design or technology. For a property to be eligible under Criterion D, it must meet two requirements: 1) the property must have, or have had, information to contribute to our understanding of human history or prehistory, and 2) the information must be considered significant. Therefore, this resource was determined to be not eligible under Criterion D.

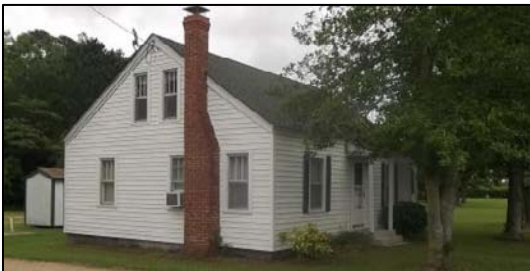
67. CK0404: Lindsey House
4171 Caratoke Highway
PIN: 8996-18-6975

Built in 1942, the resource at 4171 Caratoke Highway is a one-story, three-bay single-family dwelling built in the Minimal Traditional style. The house has a side gable roof and is clad in vinyl siding. The resource is in fair condition; however, it does not exhibit high artistic value as the work of a master, nor is it an outstanding example of a particular architectural style. Modifications to the building over time have significantly diminished its historic integrity. It was determined to be not eligible for individual listing on the NRHP under Criteria A–C. This resource is not likely to yield any new information pertaining to the history of building design or technology. For a property to be eligible under Criterion D, it must meet two requirements: 1) the property must have, or have had, information to contribute to our understanding of human history or prehistory, and 2) the information must be considered significant. Therefore, this resource was determined to be not eligible under Criterion D.

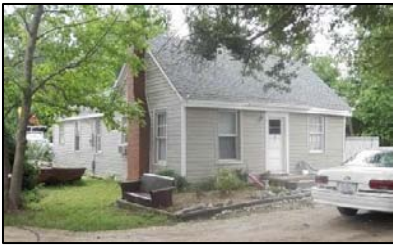
68. CK0405: Swinson/Swain House

The resource at 111 Sam Wilkins Lane is a one-story, three-bay single-family dwelling built in the Minimal Traditional style built in 1911. The house has a side gable roof and is clad in vinyl siding. The resource is in fair condition; however, it does not exhibit high artistic value as the work of a master, nor is it an outstanding example of a particular architectural style. Modifications to the building over time have significantly diminished its historic integrity. It was determined to be not eligible for individual listing on the NRHP under Criteria A–C. This resource is not likely to yield any new information pertaining to the history of building design or technology. For a property to be eligible under Criterion D, it must meet two requirements: 1) the property must have, or have had, information to contribute to our understanding of human history or prehistory, and 2) the information must be considered significant. Therefore, this resource was determined to be not eligible under Criterion D.
