**North Carolina Department of Cultural Resources
State Historic Preservation Office**

MEMORANDUM

SUBJECT: Architectural Survey for Improvements to US 158, from East of NC 34 at Belcross to NC 168, R-2574, Currituck and Camden Counties, ER 11-1152

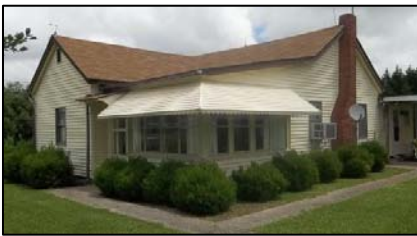
69. CK0406: Garrenton House
4157 Caratoke Highway
PIN: 8996-19-9394

The resource at 4157 Caratoke Highway is a circa-1940, one-story, three-bay single-family dwelling built in the Minimal Traditional style. The house has a cross-gable roof and is clad in vinyl siding. The resource is in good condition; however, it does not exhibit high artistic value as the work of a master, nor is it an outstanding example of a particular architectural style. Modifications to the building over time have significantly diminished its historic integrity. It was determined to be not eligible for individual listing on the NRHP under Criteria A–C. This resource is not likely to yield any new information pertaining to the history of building design or technology. For a property to be eligible under Criterion D, it must meet two requirements: 1) the property must have, or have had, information to contribute to our understanding of human history or prehistory, and 2) the information must be considered significant. Therefore, this resource was determined to be not eligible under Criterion D.

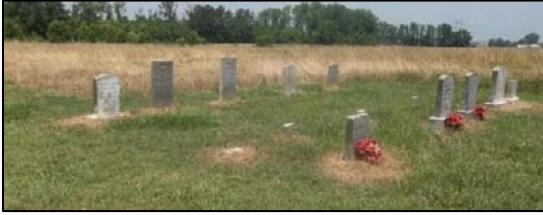
70. CK0407: Dunton/Forbes/Scarborough Cemetery
South of 4156 Caratoke Highway
PIN: 8996-19-4139

This cemetery is a small family graveyard associated with the Dunston, Forbes, and Scarborough families. The resource is in fair condition, with the earliest burial occurring in 1925. The resource does not exhibit high artistic value as the work of a master, nor is it an outstanding example of a particular architectural style. Modifications over time have diminished its historic integrity. It was determined to be not eligible for individual listing on the NRHP under Criteria A–C. This resource is not likely to yield any new information pertaining to the history of building design or technology. For a property to be eligible under Criterion D, it must meet two requirements: 1) the property must have, or have had, information to contribute to our understanding of human history or prehistory, and 2) the information must be considered significant. Therefore, this resource was determined to be not eligible under Criterion D.

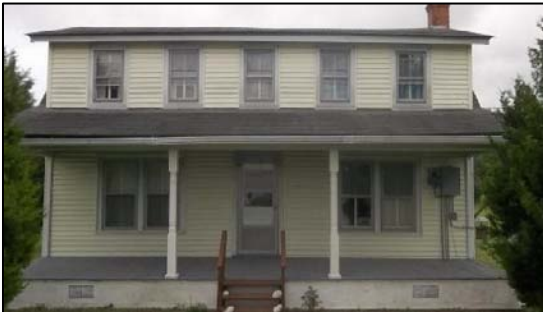
Built in 1927, the resource at 4141 Caratoke Highway is a two-story, three-bay, single-family dwelling. The resource is in fair condition; however, it does not exhibit high artistic value as the work of a master, nor is it an outstanding example of a particular architectural style. It was determined to be not eligible for individual listing on the NRHP under Criteria A–C. This resource is not likely to yield any new information pertaining to the history of building design or technology. For a property to be eligible under Criterion D, it must meet two requirements: 1) the property must have, or have had, information to contribute to our understanding of human history or prehistory, and 2) the information must be considered significant. Therefore, this resource was determined to be not eligible under Criterion D.

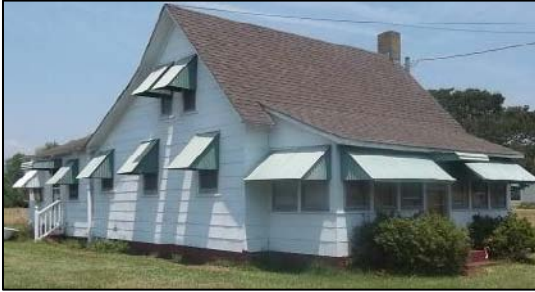
72. CK0409: Harrison/Walker House
4150 Caratoke Highway
PIN: 8996-29-0731

The resource at 4150 Caratoke Highway is a one-story, three-bay, single-family dwelling built in 1927. The resource does not exhibit high artistic value as the work of a master, nor is it an outstanding example of a particular architectural style. Modifications to the building over time have significantly diminished its historic integrity. It was determined to be not eligible for individual listing on the NRHP under Criteria A–C. This resource is not likely to yield any new information pertaining to the history of building design or technology. For a property to be eligible under Criterion D, it must meet two requirements: 1) the property must have, or have had, information to contribute to our understanding of human history or prehistory, and 2) the information must be considered significant. Therefore, this resource was determined to be not eligible under Criterion D.

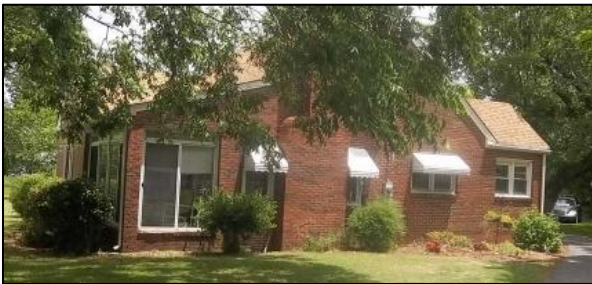
Built in 1952, the resource at 4131 Caratoke Highway is a one-story, three-bay, single-family dwelling constructed in the Minimal Traditional style. The resource is in fair condition; however, it does not exhibit high artistic value as the work of a master, nor is it an outstanding example of a particular architectural style. Modifications to the building over time have significantly diminished its historic integrity. It was determined to be not eligible for individual listing on the NRHP under Criteria A–C. This resource is not likely to yield any new information pertaining to the history of building design or technology. For a property to be eligible under Criterion D, it must meet two requirements: 1) the property must have, or have had, information to contribute to our understanding of human history or prehistory, and 2) the information must be considered significant. Therefore, this resource was determined to be not eligible under Criterion D.

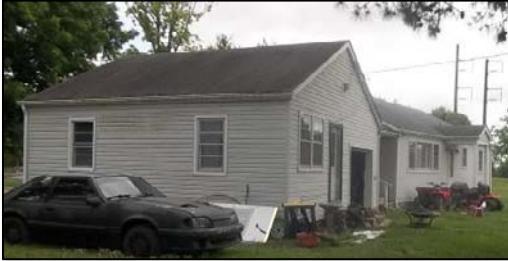
74. CK0411: Williams/Kight House
4117 Caratoke Highway
PIN: 8997-10-9301

The resource at 4117 Caratoke Highway is a one-story, four-bay Ranch style dwelling constructed in 1957. The dwelling has a side-gable roof and is clad in vinyl siding. The resource is in fair condition; however, it does not exhibit high artistic value as the work of a master, nor is it an outstanding example of a particular architectural style. Modifications to the building over time have significantly diminished its historic integrity. It was determined to be not eligible for individual listing on the NRHP under Criteria A–C. This resource is not likely to yield any new information pertaining to the history of building design or technology. For a property to be eligible under Criterion D, it must meet two requirements: 1) the property must have, or have had, information to contribute to our understanding of human history or prehistory, and 2) the information must be considered significant. Therefore, this resource was determined to be not eligible under Criterion D.

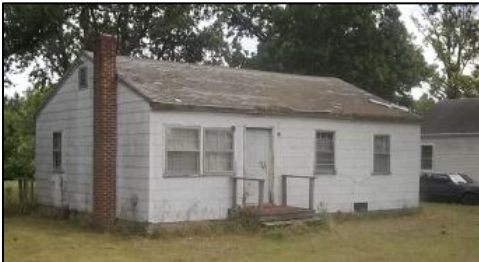
75. CK0412: Long/Kight House
4113 Caratoke Highway
PIN: 8997-10-8461

Built in 1953, the resource at 4113 Caratoke Highway is a one-story, three-bay single-family dwelling, with a side-gable roof and clad in asbestos shingles. The resource is in fair condition; however, it does not exhibit high artistic value as the work of a master, nor is it an outstanding example of a particular architectural style. It was determined to be not eligible for individual listing on the NRHP under Criteria A–C. This resource is not likely to yield any new information pertaining to the history of building design or technology. For a property to be eligible under Criterion D, it must meet two requirements: 1) the property must have, or have had, information to contribute to our understanding of human history or prehistory, and 2) the information must be considered significant. Therefore, this resource was determined to be not eligible under Criterion D.

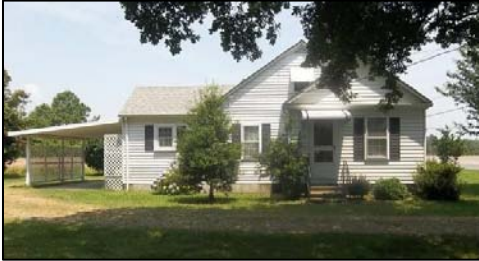
77. CK0413: O'Neal House
4108 Caratoke Highway
PIN: 8997-10-8414

The resource at 4108 Caratoke Highway is a circa-1950, one-and-a-half story, three-bay single-family dwelling, with a front-gable roof and clad in vinyl siding. The resource is in fair condition; however, it does not exhibit high artistic value as the work of a master, nor is it an outstanding example of a particular architectural style. Modifications to the building over time have significantly diminished its historic integrity. It was determined to be not eligible for individual listing on the NRHP under Criteria A–C. This resource is not likely to yield any new information pertaining to the history of building design or technology. For a property to be eligible under Criterion D, it must meet two requirements: 1) the property must have, or have had, information to contribute to our understanding of human history or prehistory, and 2) the information must be considered significant. Therefore, this resource was determined to be not eligible under Criterion D.

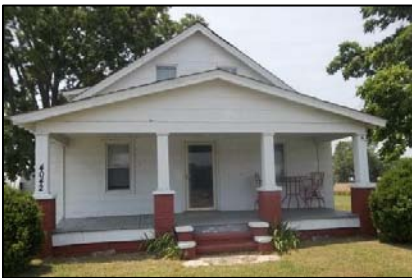
80. CK0415: Nathan O'Neal House
4042 Caratoke Highway
PIN: 8997-01-8810

The resource at 4042 Caratoke Highway is a circa-1940, one-and-a-half story, three-bay, bungalow with a front-gable roof and clad in asbestos shingles. The resource is in fair condition; however, it does not exhibit high artistic value as the work of a master, nor is it an outstanding example of a particular architectural style. It was determined to be not eligible for individual listing on the NRHP under Criteria A–C. This resource is not likely to yield any new information pertaining to the history of building design or technology. For a property to be eligible under Criterion D, it must meet two requirements: 1) the property must have, or have had, information to contribute to our understanding of human history or prehistory, and 2) the information must be considered significant. Therefore, this resource was determined to be not eligible under Criterion D.

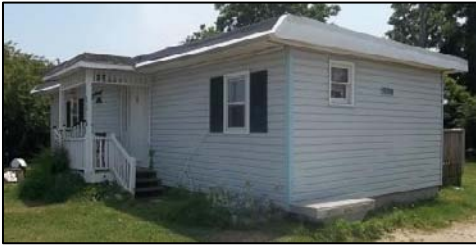
83. CK0418: Payton/Poyner House
4016 Caratoke Highway
PIN: 8997-02-5117

The resource at 4016 Caratoke Highway is a one-story, three-bay Modern style house built in 1955. The dwelling has a hipped roof. The resource is in poor condition; however, it does not exhibit high artistic value as the work of a master, nor is it an outstanding example of a particular architectural style. Modifications to the building over time have significantly diminished its historic integrity. It was determined to be not eligible for individual listing on the NRHP under Criteria A–C. This resource is not likely to yield any new information pertaining to the history of building design or technology. For a property to be eligible under Criterion D, it must meet two requirements: 1) the property must have, or have had, information to contribute to our understanding of human history or prehistory, and 2) the information must be considered significant. Therefore, this resource was determined to be not eligible under Criterion D.

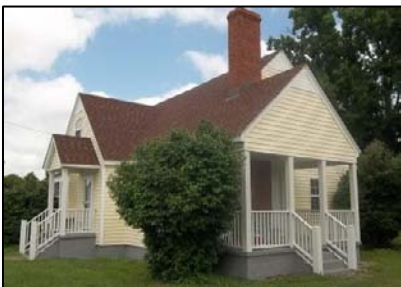
84. CK0419: White/Dozier House
3953 Caratoke Highway
PIN: 8997-03-0322

Constructed in 1946, the resource at 3953 Caratoke Highway is a one-and-a-half story, three-bay, Minimal Traditional style house. The resource is in good condition; however, it does not exhibit high artistic value as the work of a master, nor is it an outstanding example of a particular architectural style. Modifications to the building over time have significantly diminished its historic integrity. It was determined to be not eligible for individual listing on the NRHP under Criteria A–C. This resource is not likely to yield any new information pertaining to the history of building design or technology. For a property to be eligible under Criterion D, it must meet two requirements: 1) the property must have, or have had, information to contribute to our understanding of human history or prehistory, and 2) the information must be considered significant. Therefore, this resource was determined to be not eligible under Criterion D.

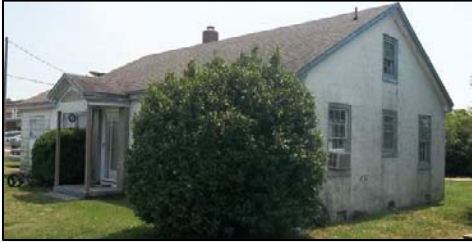
85. CK0420: Crozier/ Dozier House
3942 Caratoke Highway
PIN: 8987-93-5227

The resource at 3942 Caratoke Highway is a one-story, three-bay, Minimal Traditional style house built in 1957. The dwelling has a side-gable roof and is clad in a stucco veneer. The resource is in poor condition and it does not exhibit high artistic value as the work of a master, nor is it an outstanding example of a particular architectural style. Modifications to the building over time have significantly diminished its historic integrity. It was determined to be not eligible for individual listing on the NRHP under Criteria A–C. This resource is not likely to yield any new information pertaining to the history of building design or technology. For a property to be eligible under Criterion D, it must meet two requirements: 1) the property must have, or have had, information to contribute to our understanding of human history or prehistory, and 2) the information must be considered significant. Therefore, this resource was determined to be not eligible under Criterion D.

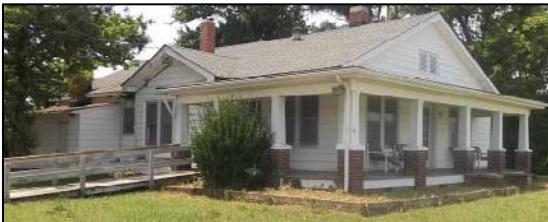
86. CK0330: Brumsey House
3906 Caratoke Highway
PIN: 8987-94-1131

The resource at 3906 Caratoke Highway is a circa-1935, one-story, three-bay, Craftsman style house. The dwelling has a cross-gable roof and is clad in vinyl siding. The resource has had many modifications, vinyl siding, new windows and new additions in the recent past. The resource does not exhibit high artistic value as the work of a master, nor is it an outstanding example of a particular architectural style. Modifications to the building over time have significantly diminished its historic integrity. It was determined to be not eligible for individual listing on the NRHP under Criteria A–C. This resource is not likely to yield any new information pertaining to the history of building design or technology. For a property to be eligible under Criterion D, it must meet two requirements: 1) the property must have, or have had, information to contribute to our understanding of human history or prehistory, and 2) the information must be considered significant. Therefore, this resource was determined to be not eligible under Criterion D.

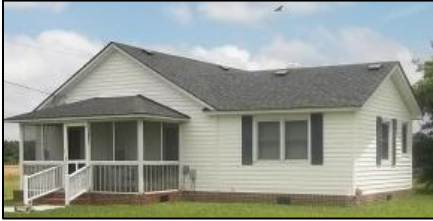
87. CK0421: Sheilds House
3883 Caratoke Highway
PIN: 8987-94-2877

Built in 1936, the resource at 3883 Caratoke Highway is a one-story, three-bay house with Craftsman elements. The house has a cross-gable roof and is clad in vinyl siding. The resource is in good condition; however, it does not exhibit high artistic value as the work of a master, nor is it an outstanding example of a particular architectural style. Modifications to the building over time have significantly diminished its historic integrity. It was determined to be not eligible for individual listing on the NRHP under Criteria A–C. This resource is not likely to yield any new information pertaining to the history of building design or technology. For a property to be eligible under Criterion D, it must meet two requirements: 1) the property must have, or have had, information to contribute to our understanding of human history or prehistory, and 2) the information must be considered significant. Therefore, this resource was determined to be not eligible under Criterion D.

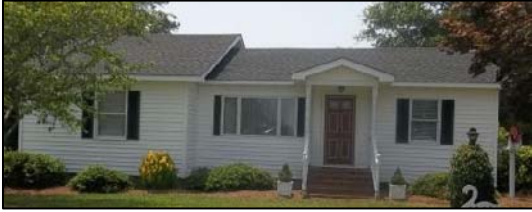
90. CK0424: Sawyer House
3858 Caratoke Highway
PIN: 8987-85-6201

The resource at 3858 Caratoke Highway is a one-story, three-bay, Ranch style dwelling built in 1956. The house has a side-gable roof and is clad in vinyl siding. The resource has had many modifications in the recent past. The resource is in good condition; however, it does not exhibit high artistic value as the work of a master, nor is it an outstanding example of a particular architectural style. Modifications to the building over time have significantly diminished its historic integrity. It was determined to be not eligible for individual listing on the NRHP under Criteria A–C. This resource is not likely to yield any new information pertaining to the history of building design or technology. For a property to be eligible under Criterion D, it must meet two requirements: 1) the property must have, or have had, information to contribute to our understanding of human history or prehistory, and 2) the information must be considered significant. Therefore, this resource was determined to be not eligible under Criterion D.

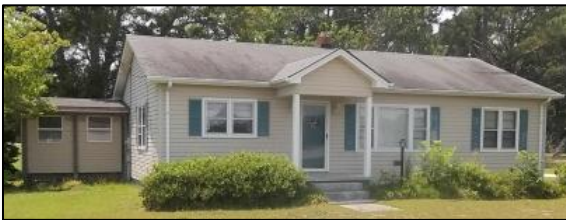
91. CK0425: Todd/Johnson House
3850 Caratoke Highway
PIN: 8987-85-5309

Built in 1959, the resource at 3850 Caratoke Highway is a one-story, four-bay, Ranch style house. The dwelling has a side-gable roof and is clad in vinyl siding. The resource has had many modifications, vinyl siding, new windows and new additions in the recent past. The resource is in good condition; however, it does not exhibit high artistic value as the work of a master, nor is it an outstanding example of a particular architectural style. Modifications to the building over time have significantly diminished its historic integrity. It was determined to be not eligible for individual listing on the NRHP under Criteria A–C. This resource is not likely to yield any new information pertaining to the history of building design or technology. For a property to be eligible under Criterion D, it must meet two requirements: 1) the property must have, or have had, information to contribute to our understanding of human history or prehistory, and 2) the information must be considered significant. Therefore, this resource was determined to be not eligible under Criterion D.

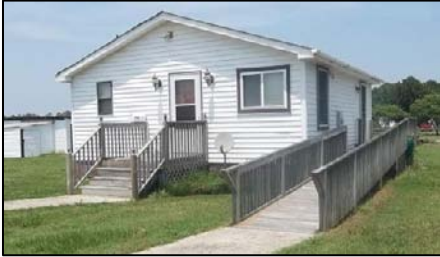
92. CK0426: Barnes/Barnard House
3823 Caratoke Highway
PIN: 8987-86-4189

The resource at 3823 Caratoke Highway is a one-story, three-bay, mobile home constructed in 1963. The resource has a side-front gable roof and is clad in a vinyl siding. The resource is in fair condition; however, it does not exhibit high artistic value as the work of a master, nor is it an outstanding example of a particular architectural style. Modifications to the building over time have significantly diminished its historic integrity. It was determined to be not eligible for individual listing on the NRHP under Criteria A–C. This resource is not likely to yield any new information pertaining to the history of building design or technology. For a property to be eligible under Criterion D, it must meet two requirements: 1) the property must have, or have had, information to contribute to our understanding of human history or prehistory, and 2) the information must be considered significant. Therefore, this resource was determined to be not eligible under Criterion D.

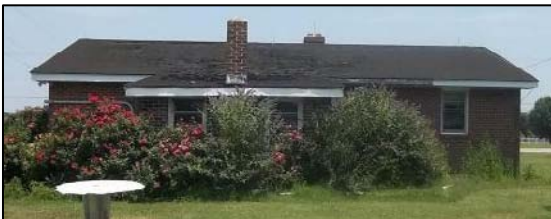
93. CK0427: Griffith/Barnard House
3814 Caratoke Highway
PIN: 8987-75-5427

Built in 1963, the resource at 3814 Caratoke Highway is a one-story, four-bay, Ranch style house, with a side-gable roof. The house is clad in a brick veneer. The resource is in good fair; however, it does not exhibit high artistic value as the work of a master, nor is it an outstanding example of a particular architectural style. Modifications to the building over time have significantly diminished its historic integrity. It was determined to be not eligible for individual listing on the NRHP under Criteria A–C. This resource is not likely to yield any new information pertaining to the history of building design or technology. For a property to be eligible under Criterion D, it must meet two requirements: 1) the property must have, or have had, information to contribute to our understanding of human history or prehistory, and 2) the information must be considered significant. Therefore, this resource was determined to be not eligible under Criterion D.

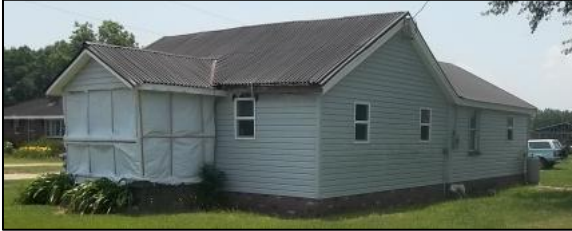
94. CK0428: Griffith House
3810 Caratoke Highway
PIN: 8987-76-9054

The resource at 3810 Caratoke Highway is a circa-1940, one-story, three-bay house with Craftsman elements. It has a side-gable roof clad in asphalt. The resource is in fair condition; however, it does not exhibit high artistic value as the work of a master, nor is it an outstanding example of a particular architectural style. Modifications to the building over time have significantly diminished its historic integrity. It was determined to be not eligible for individual listing on the NRHP under Criteria A–C. This resource is not likely to yield any new information pertaining to the history of building design or technology. For a property to be eligible under Criterion D, it must meet two requirements: 1) the property must have, or have had, information to contribute to our understanding of human history or prehistory, and 2) the information must be considered significant. Therefore, this resource was determined to be not eligible under Criterion D.

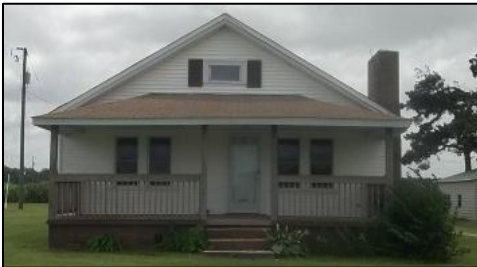
96. CK0429: Ginger Morris House
3752 Caratoke Highway
PIN: 8987-77-2405

The resource at 3752 Caratoke Highway is a one-and-a-half story, three-bay house built in 1946. It has a front-gable roof, and the resource is clad entirely in vinyl siding. The resource is in fair condition; however, it does not exhibit high artistic value as the work of a master, nor is it an outstanding example of a particular architectural style. Modifications to the building over time have significantly diminished its historic integrity. It was determined to be not eligible for individual listing on the NRHP under Criteria A–C. This resource is not likely to yield any new information pertaining to the history of building design or technology. For a property to be eligible under Criterion D, it must meet two requirements: 1) the property must have, or have had, information to contribute to our understanding of human history or prehistory, and 2) the information must be considered significant. Therefore, this resource was determined to be not eligible under Criterion D.
