North Carolina Department of Cultural Resources
State Historic Preservation Office

MEMORANDUM

SUBJECT: Historic Structures Survey Report, Widening of John Street/Old Monroe Road (SR 1009)
From Trade Street to Wesley Chapel/Stout Road, U-4714, Mecklenburg & Union Counties,
ER 13-0879

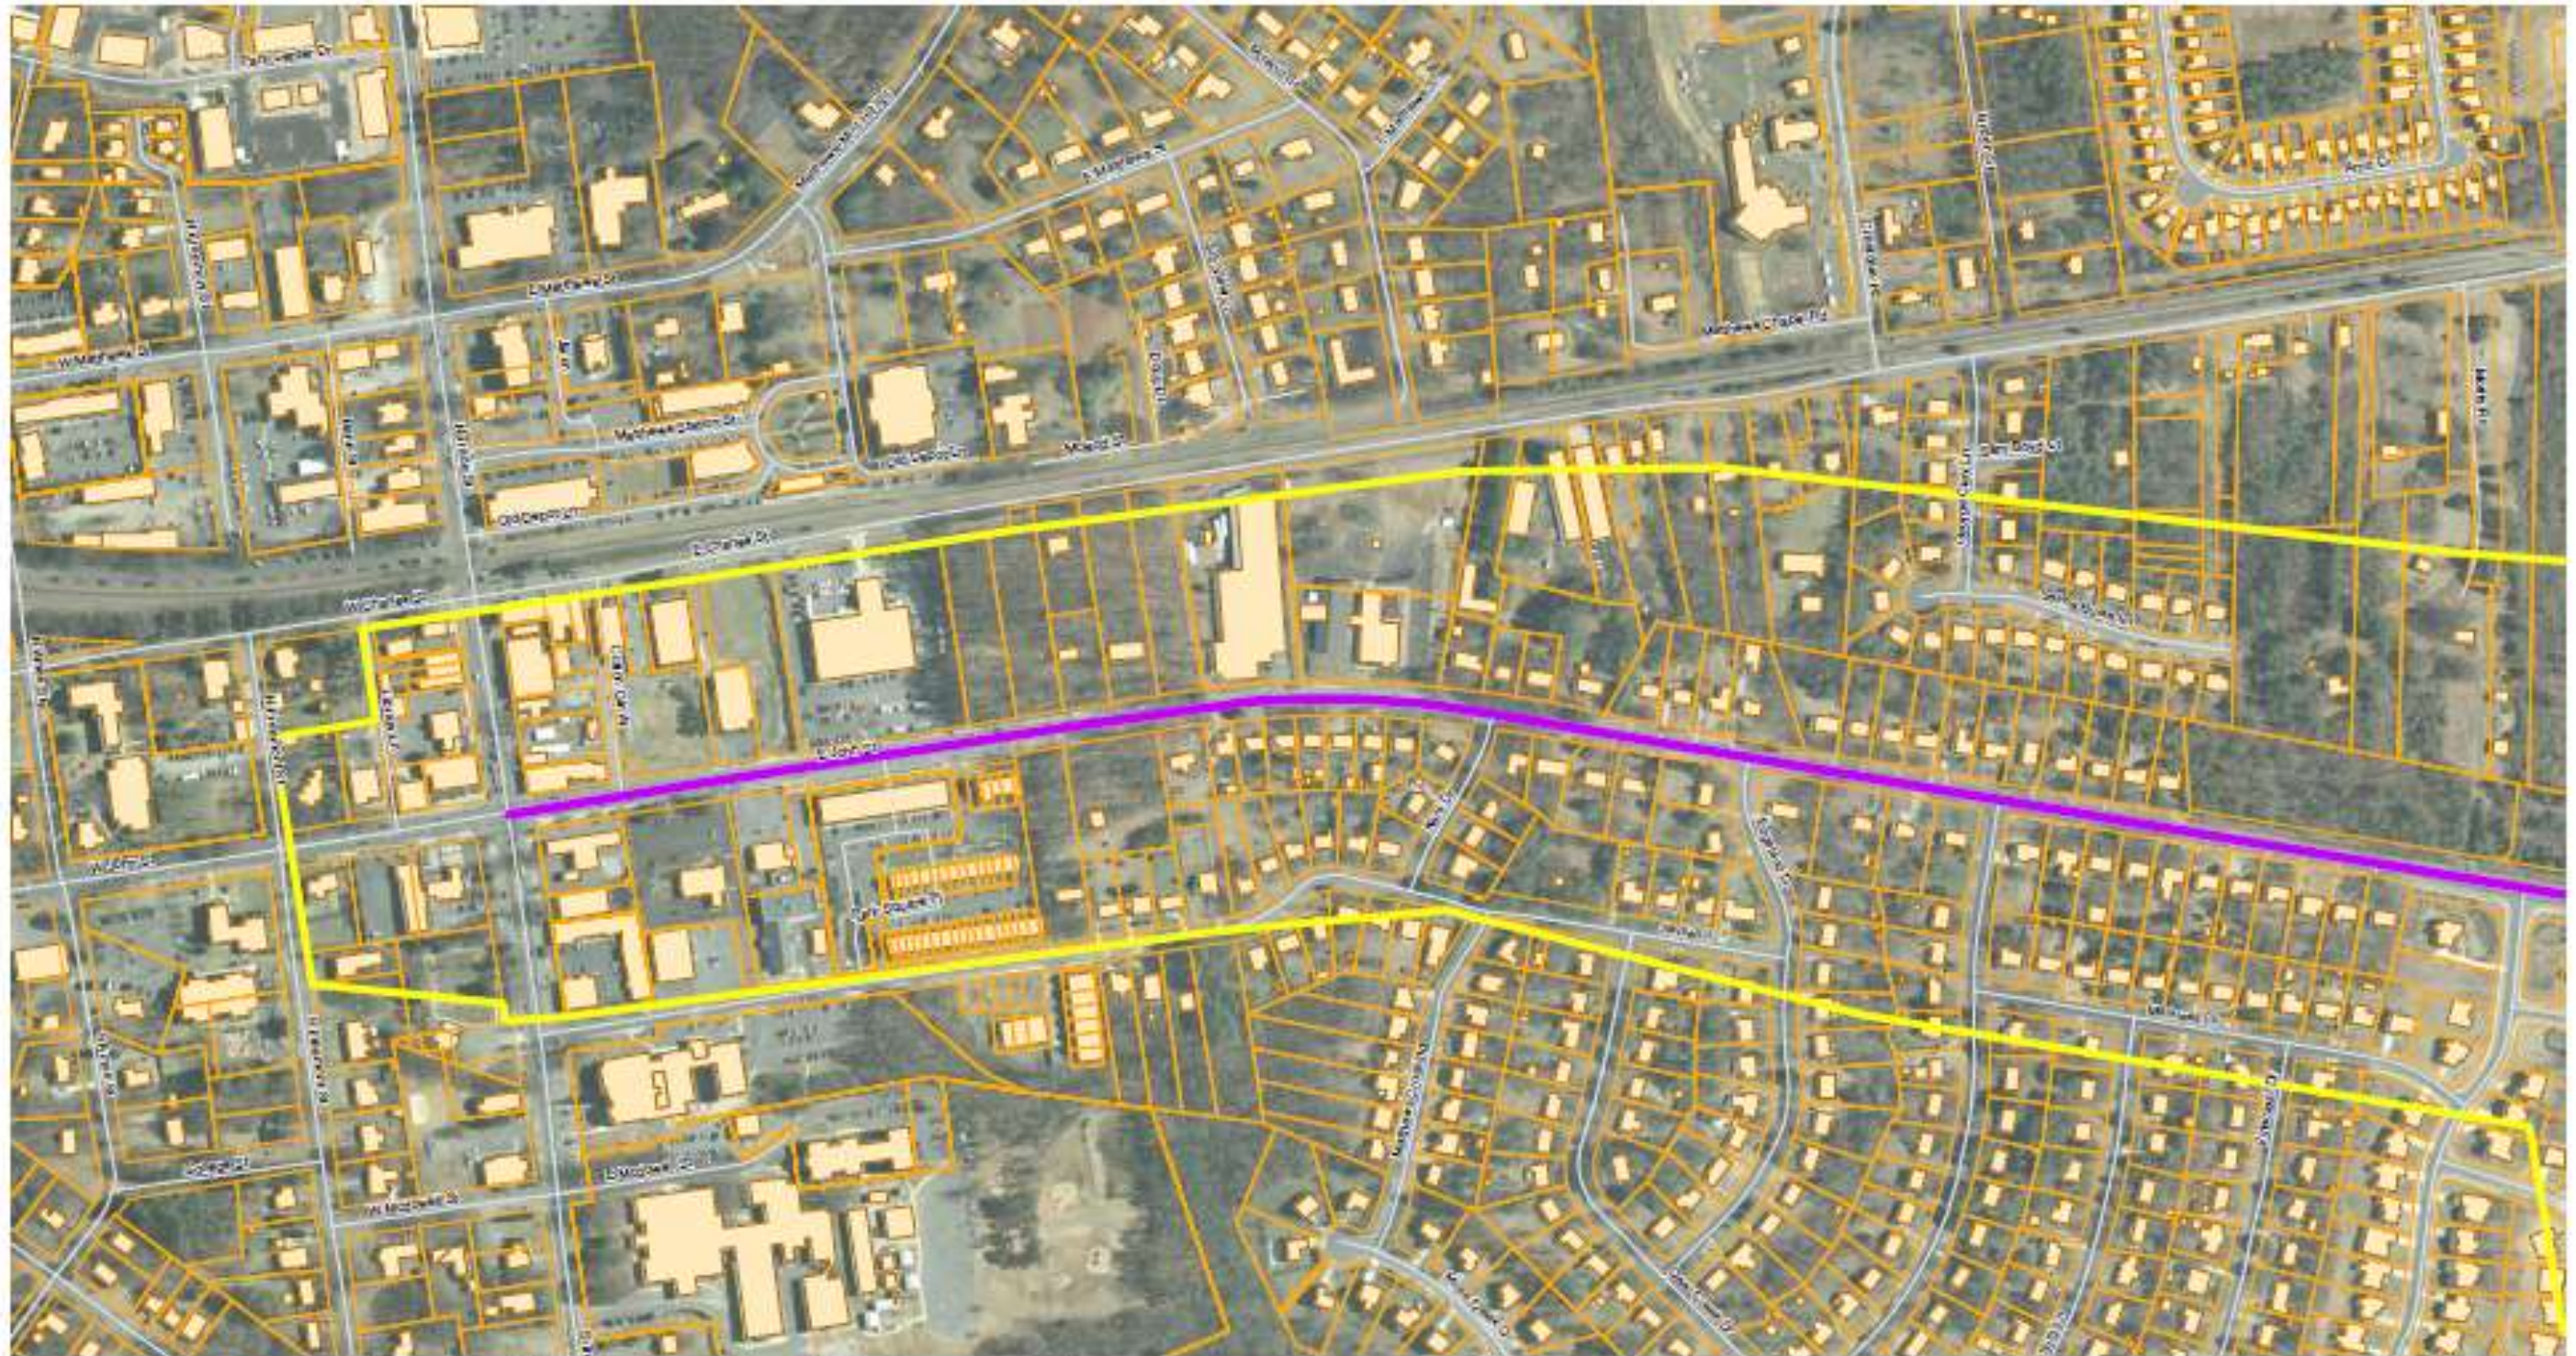
<p>Figure 2a Area of Potential Effects (APE) Map Widening of John Street (SR 1010)/ Old Monroe Road (SR 1009) TIP No. U-4714 Mecklenburg and Union Counties, North Carolina</p>	<ul style="list-style-type: none"> U-4714 Project Area of Potential Effects (APE) Road Parcel Structure <p style="text-align: right;">Map 1 of 9</p>	<p><i>Note: Map depicts the APE. Refer to detail maps in Appendix B for specific locations of surveyed properties.</i></p> <p><i>Data courtesy of Mecklenburg and Rowan counties, NCGIA, and NCDOT.</i></p>	<p style="text-align: center;">Index Map</p>
--	-------------------------------------------------------------------------------------------------------------------------------------------------------------------------------------------------------------------------------------------------------------------------------------------------------------	--------------------------------------------------------------------------------------------------------------------------------------------------------------------------------------------------------------	-------------------------------------------------------------------------------------------------------------------------------------------------------------------------------------------------------------	----------------------------------------------

This survey was conducted with the following goals: 1) to determine the APE; 2) to identify all resources at least fifty years of age within the APE; and 3) to evaluate these resources according to the National Register of Historic Places criteria. The APE boundary is shown in **Figures 2a-2i**. Detailed APE maps showing the locations of the surveyed properties are found in **Appendix B**.

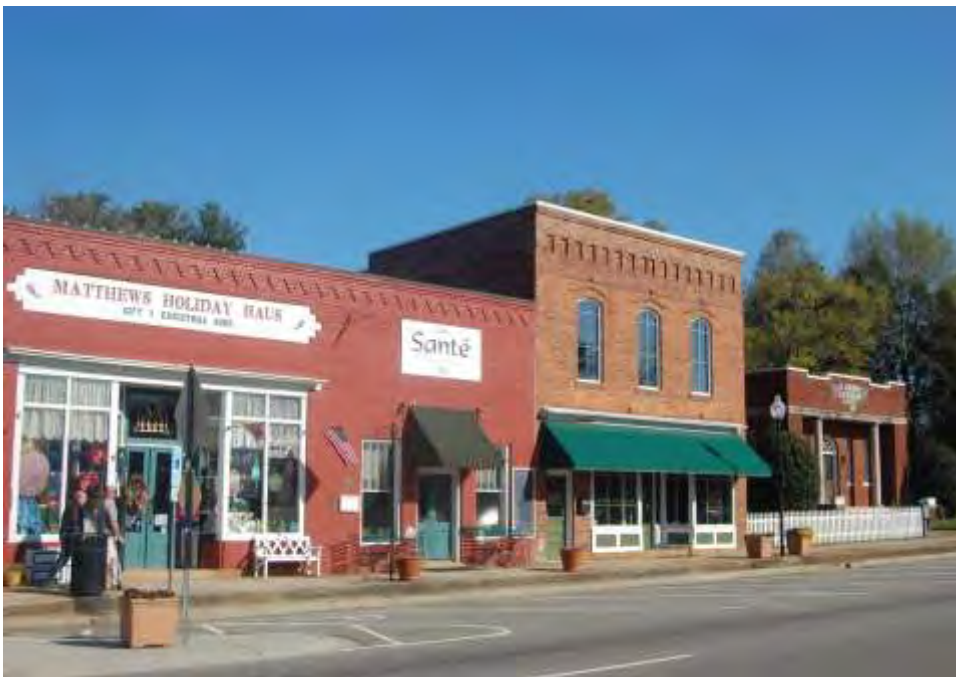
Plate 1. Matthews Commercial Historic District, Funderburk Brothers Dry Goods Store (Left), E. J. Funderburk General Merchandise Store (Center), Commercial Building at 189 North Trade Street (Center Right), and 1939 Post Office (Right), Looking Northwest.

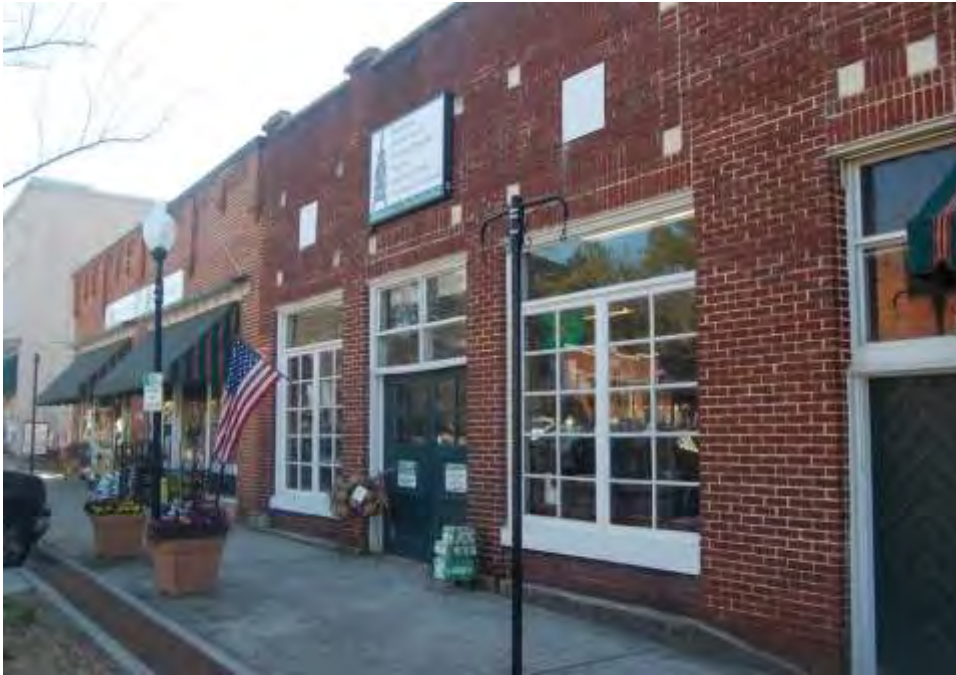
Plate 2. Matthews Commercial Historic District, Heath and Reid General Store (Far Left) and Renfrow Hardware Store, Looking Northeast.

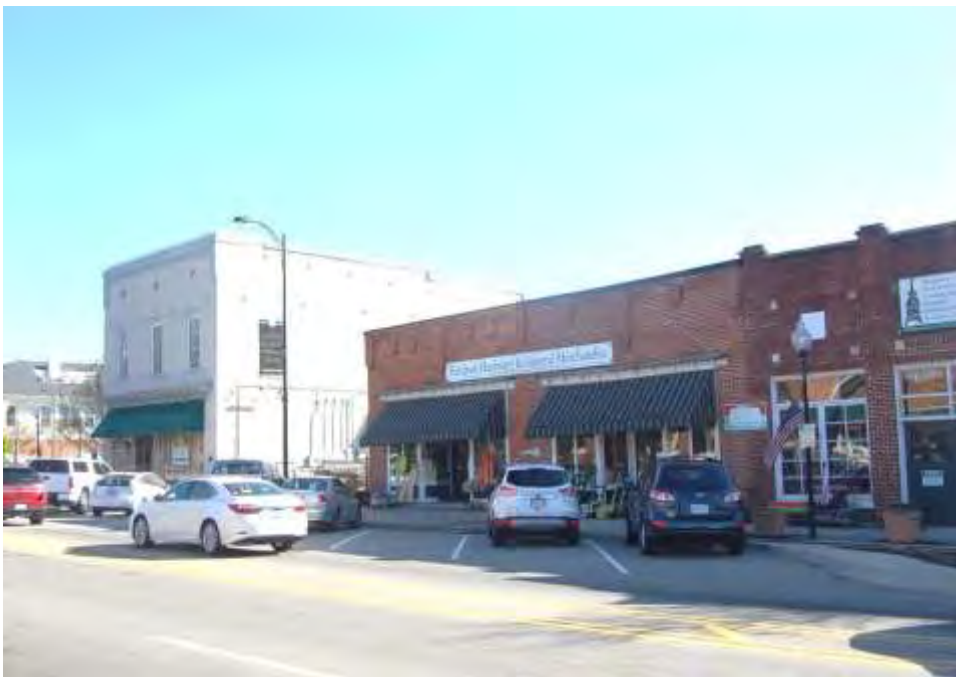
Plate 3. Matthews Commercial Historic District, Heath and Reid General Store (Left) and Renfrow Hardware Store, Looking Northeast.

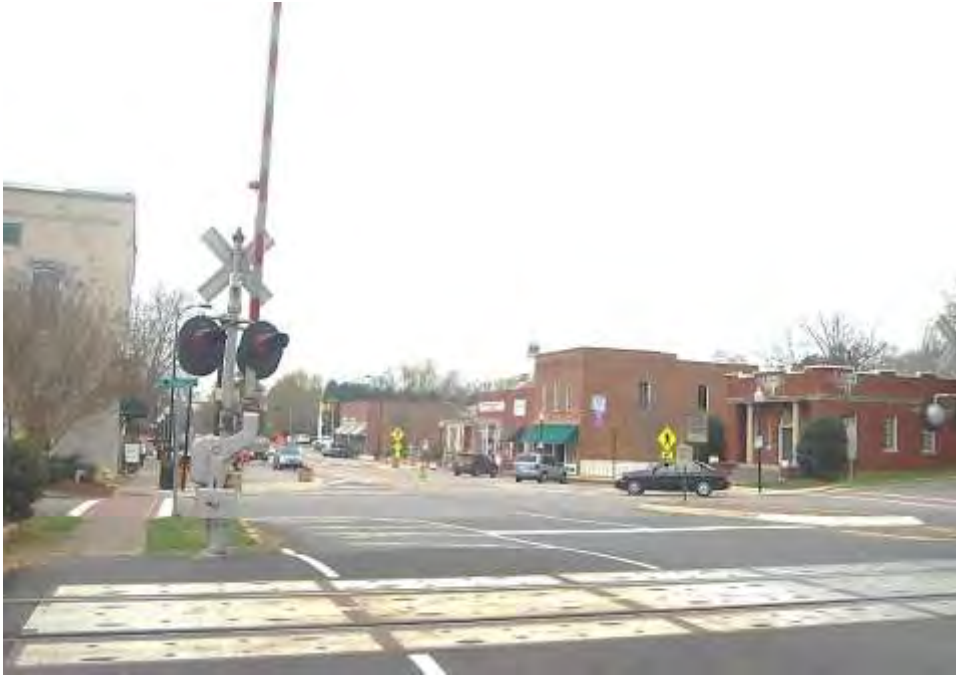
Plate 4. Matthews Commercial Historic District, West Side of North Trade Street, 1939 Post Office (Far Right), Looking Southwest.

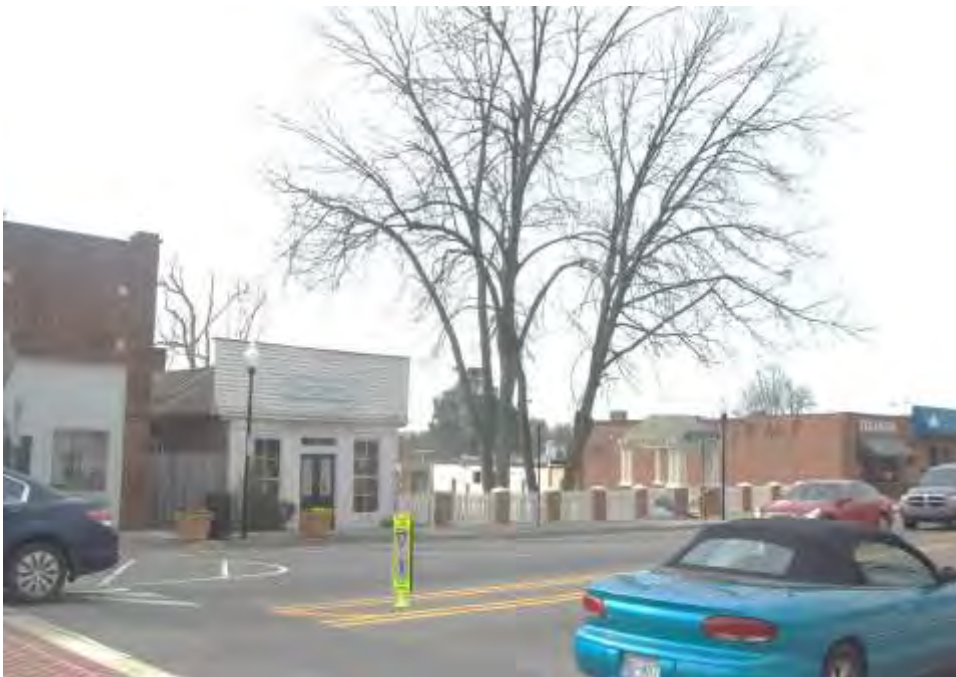
Plate 5. Matthews Commercial Historic District, 1892 Post Office and Proposed Expansion Area, Site of Cotton Gin Auxiliary Buildings Behind Fence and 1957 Commercial Building, Looking Southeast from North Trade Street.

- The addition of the fence, stairs, and modern gazebo at the sidewalk edge has significantly altered the appearance of the property to the southeast.
- It is not clear if other gin-related buildings used to stand on the property in the now vacant area.

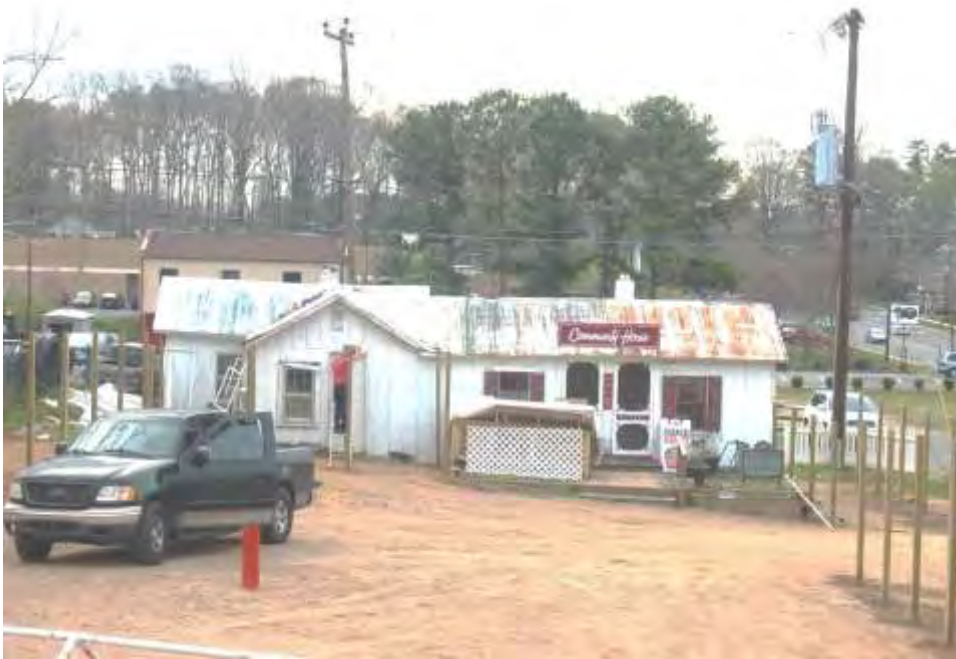
Plate 6. Matthews Commercial Historic District, Proposed Expansion, Cotton Gin Auxiliary Buildings, Looking East from North Trade Street.

The boundary excluded two frame auxiliary buildings (mid-1920s) that were originally part of a cotton gin complex spanning both the east and west sides of the aptly named Cotton Gin Alley. (The gin was destroyed during Hurricane Hugo.) The alley parallels Trade Street one block to the east, and the two cotton gin buildings sit at the back of the lot next to the 1892 post office. The property, which extends from Trade to Cotton Gin Alley, is now used as the town farmers market. The cotton gin buildings appear to have been left out of the district because the nomination focused primarily on the masonry storefronts on Trade and Charles streets.

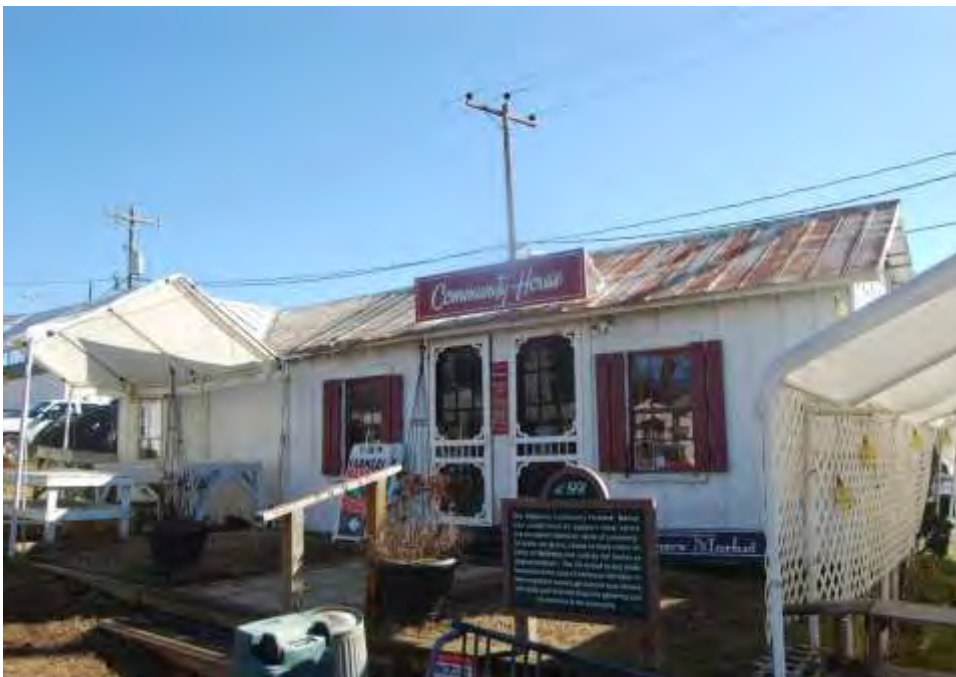
Plate 7. Matthews Commercial Historic District, Proposed Expansion, Cotton Gin Auxiliary Buildings, Looking Northeast.

- No information is offered about what the auxiliary buildings were used for, and no case has been made for their importance.
- A case has not been made for the individual contribution of the 1957 store building to Matthews' downtown area and expanding the historic district's period of significance to include it would require such a claim. There has to be important history and/or architecture to add a very small number of buildings to a district.

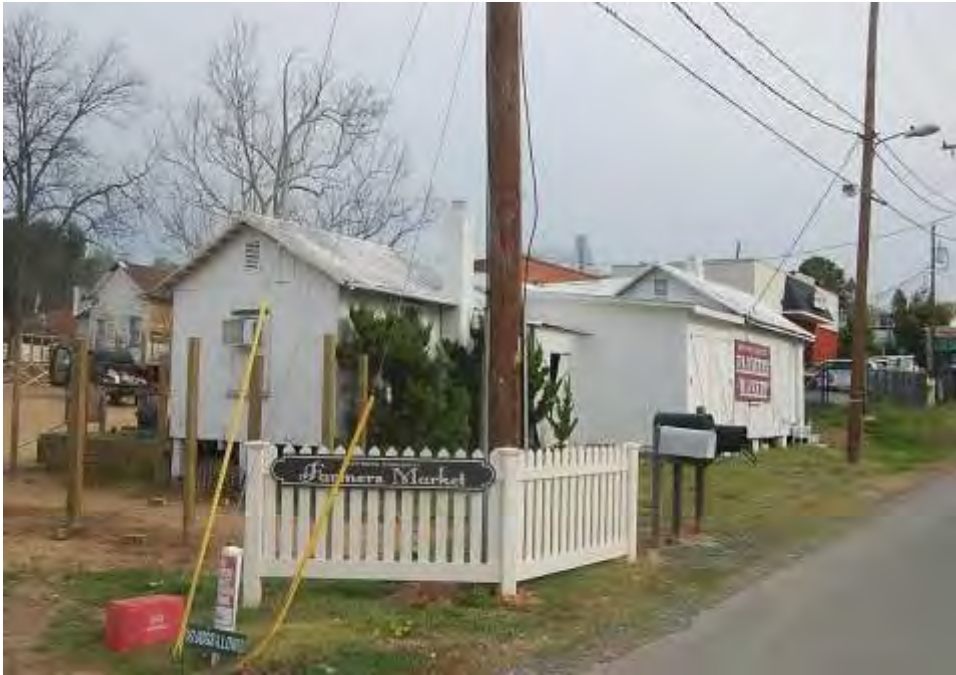
Plate 8. Matthews Commercial Historic District, Proposed Expansion, Cotton Gin Auxiliary Buildings, Rear (East) Elevation, Looking Northwest.

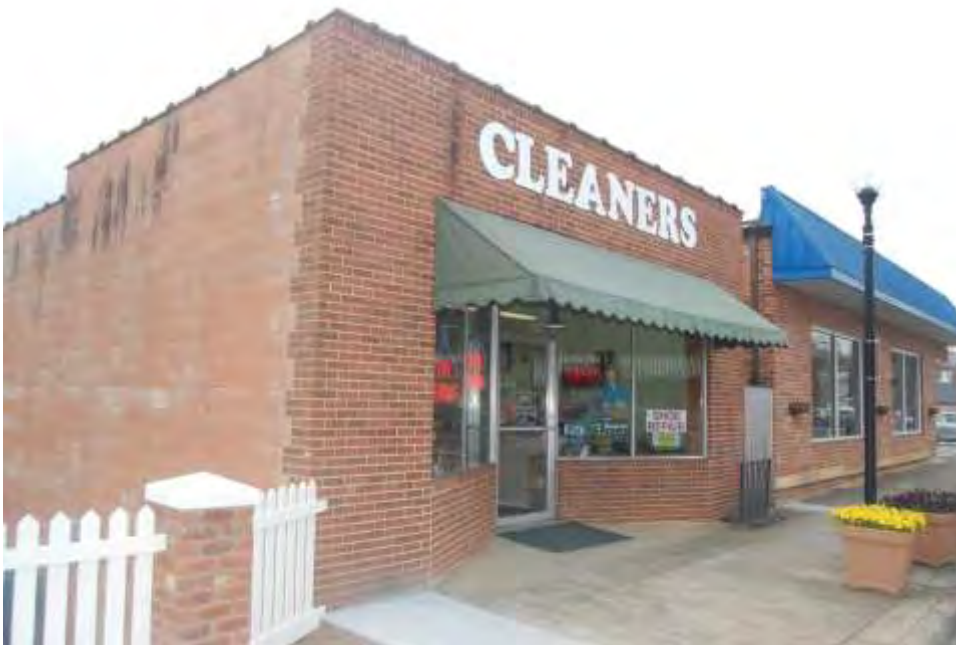
Plate 9. Matthews Commercial Historic District, Proposed Expansion, 1957 Commercial Building at 106 North Trade Street and Modern Building at Corner, Looking Southeast.

The one-story, brick commercial building (1957) next door was also omitted from the historic district because the building postdated the period of significance. The commercial building has a flat parapet lined with terra cotta coping and an angled, recessed entrance with metal-sash display windows and door. The cotton gin buildings have gable roofs, corrugated-metal or board-and-batten siding, and six-over-six light, double-hung, wood-sash windows. The cotton gin buildings and the brick store share the same tax parcel and are recommended for inclusion in an expanded historic district. The corner building is modern, having been erected after the earlier building on the site was lost in a mid-1960s fire (Kratt 2014).

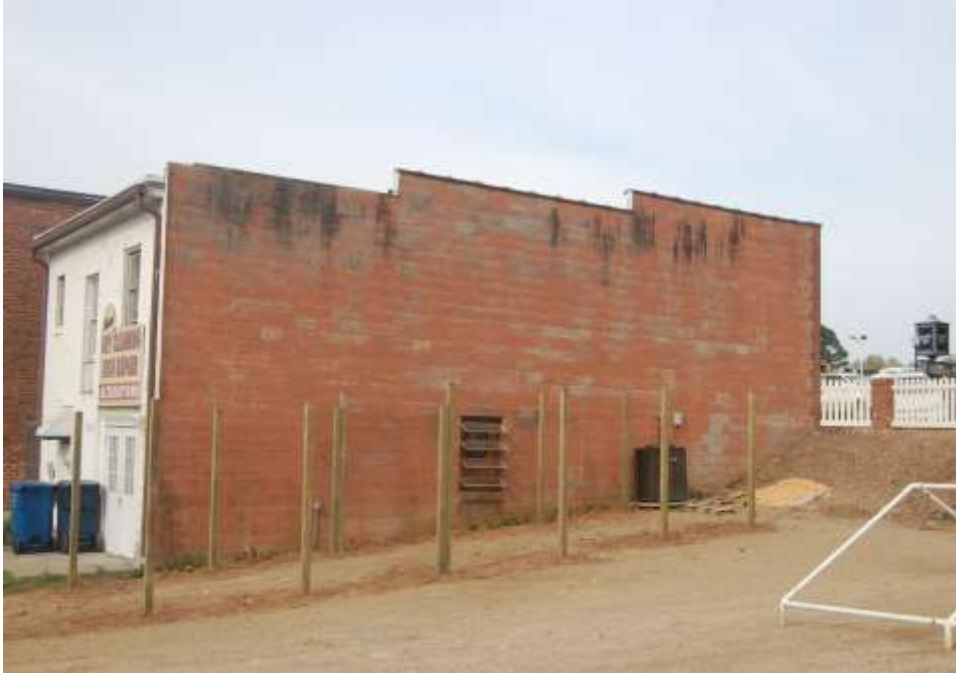
Plate 10. Matthews Commercial Historic District, Proposed Expansion, 1957
Commercial Building at 106 North Trade Street, Side (North) Elevation, Looking Southwest.

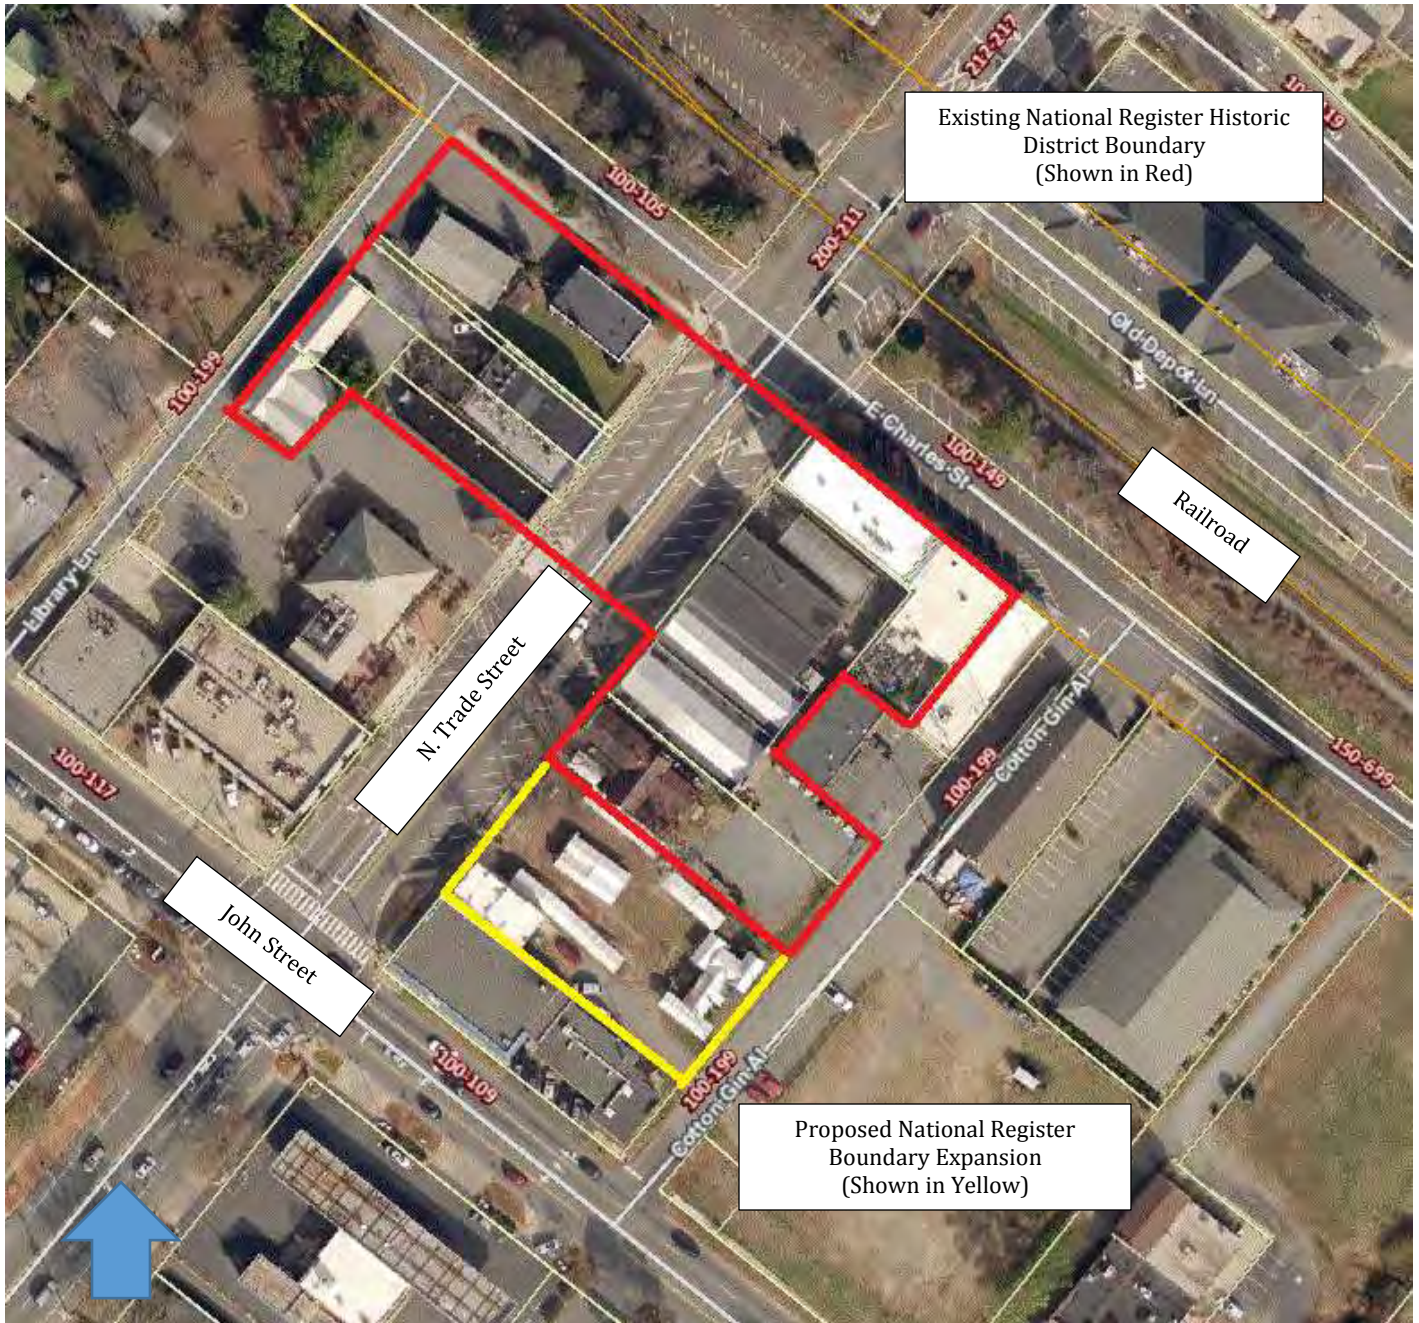
Figure 4
Matthews Commercial Historic District
Proposed National Register Boundary Expansion

The proposed National Register boundary amendment to the Matthews Commercial Historic District encompasses three commercial buildings which sit on one tax parcel (PIN 21501304) of roughly 0.40 acres. The area of expansion abuts the south side of the existing historic district. The three properties would contribute to the commercial and architectural significance of the historic district within an amended period of significance. The expanded boundary would add no noncontributing resources to the district. Depicted in **Figure 4**, the recommended boundary amendment would conform to the tax parcel on which the store and cotton gin buildings sit.

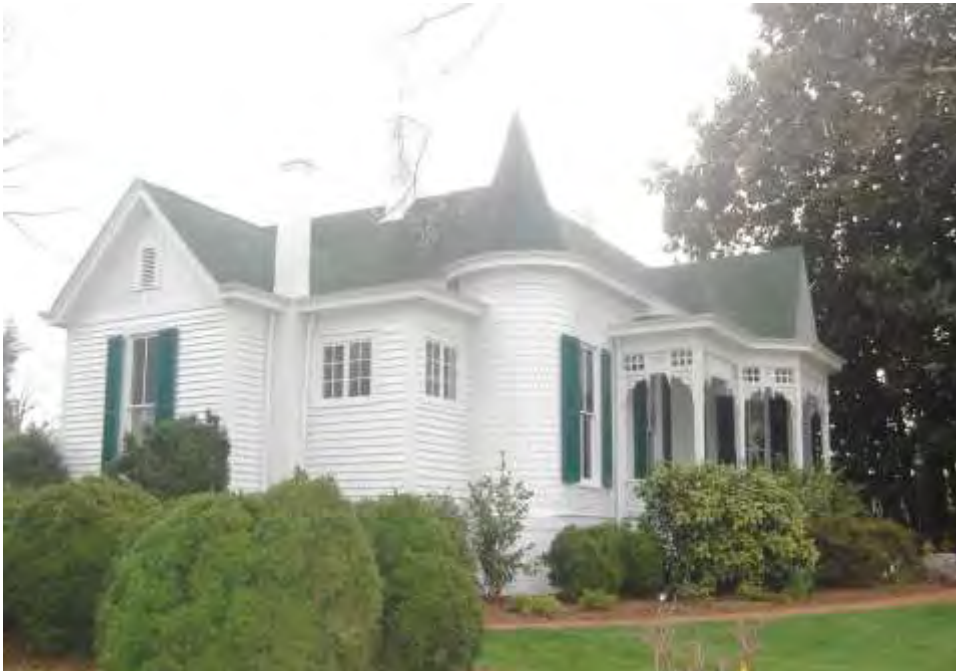
Plate 12. Reid House, Front (South) and Side (West) Elevations, Looking Northeast.

The 1890 Reid House is a remarkably intact and elaborate expression of the Queen Anne style in the town of Matthews. The house is located one block west of the town's historic commercial core and faces southwest towards West John Street. The spacious house lot measures approximately 134 feet by 200 feet. To the rear of this lot stands a frame storage building (circa 1925), which may have been built as servant's quarters, and a 1975 gazebo. Now vinyl sided, the storage building has a side-gable roof and two batten doors in the south elevation. The entrances are sheltered by bracketed, front-gable canopies. The two garage bays in the west elevation have canted corners and double-leaf, batten doors with upper lights. The modern gazebo is octagonal in plan with a turned-post balustrade, a pagoda-style roof, and picturesque detailing.

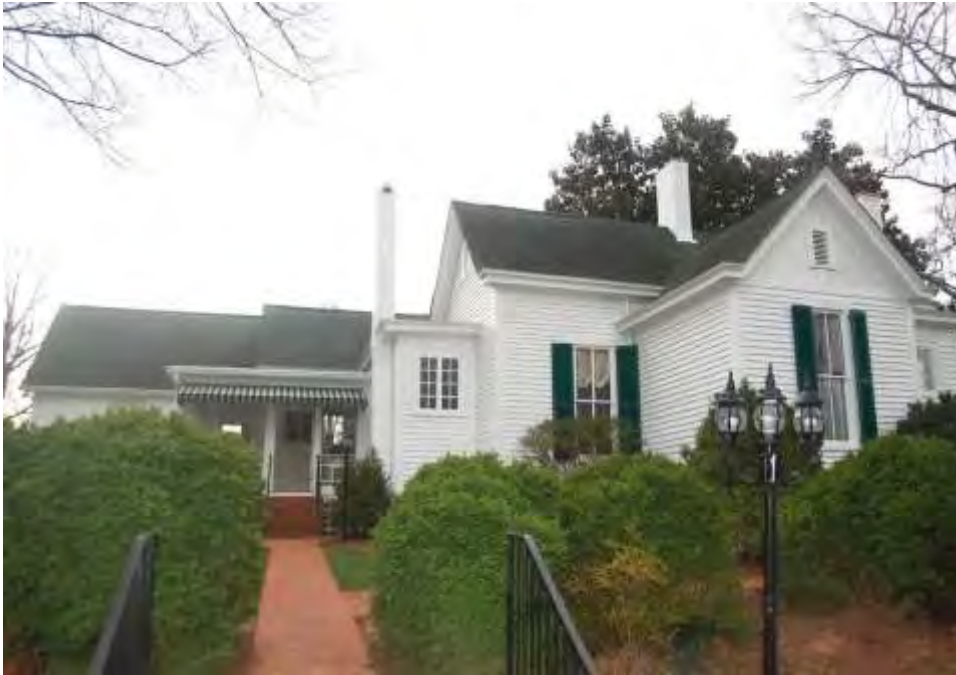
Plate 13. Reid House, Side (West) Elevation and Kitchen Wing, Looking East.

Additions to the house include the one-bay bathroom appendage between the corner tower and the projecting wing on the side (west) elevation, a gable-roofed kitchen wing, a modern sunroom on the kitchen's west elevation. The kitchen wing is said to have been the original well house which was relocated and converted to the kitchen in the early twentieth century (Little and Huffman 1987).

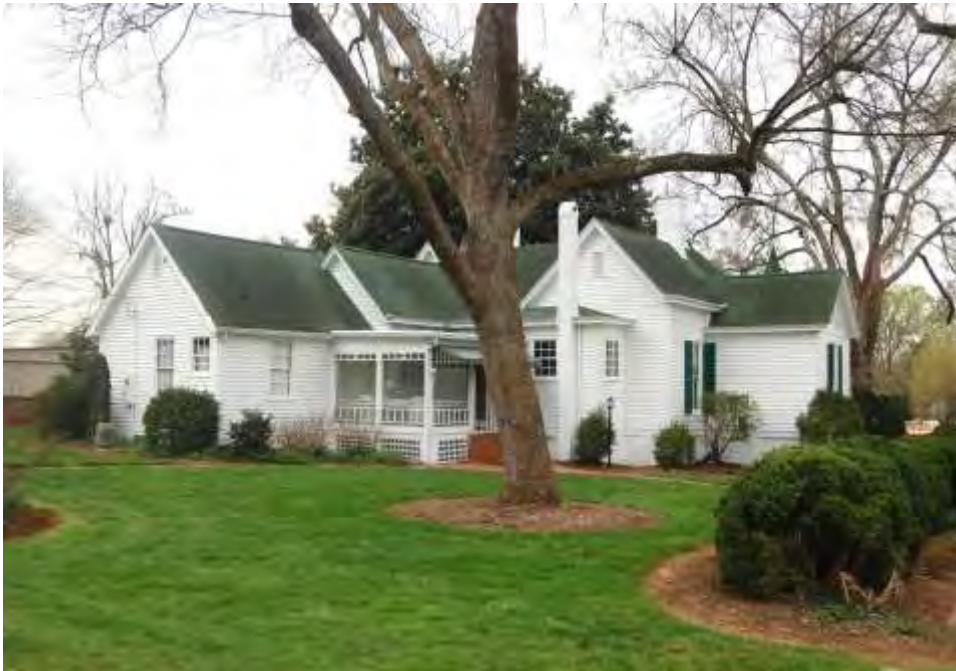
Plate 14. Reid House, Rear (North) Elevation, Kitchen Wing, and Back Yard, Looking Southeast.

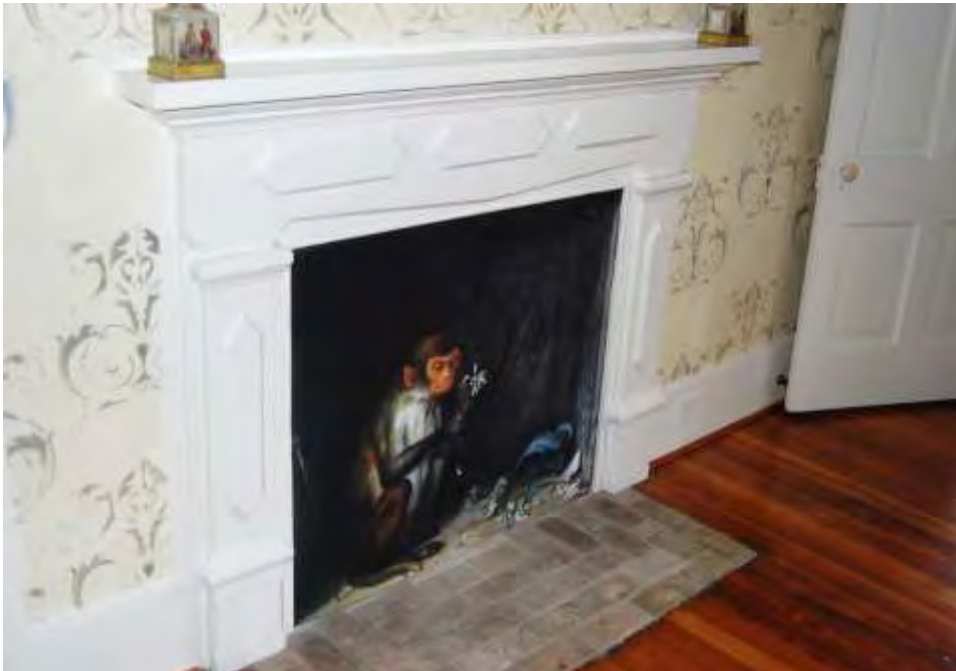
Plate 16. Reid House, Interior, Dining Room Mantel.

The interior has a center-hall plan with rooms of irregular size and configuration on either side. The center hall, which is divided into a front hall and a rear hall, is decorated with a beaded-board wainscot. The house retains most of its original four-panel doors with fluted-band surrounds although the entrance to the east front room (parlor) has been enlarged. The mantels in the principal rooms survive and display similar designs with paneled pilasters, paneled friezes, and molded mantel shelves. The mantel in the tower room is distinguished by the lozenge-shaped raised panels and the scalloped molding along the frieze.

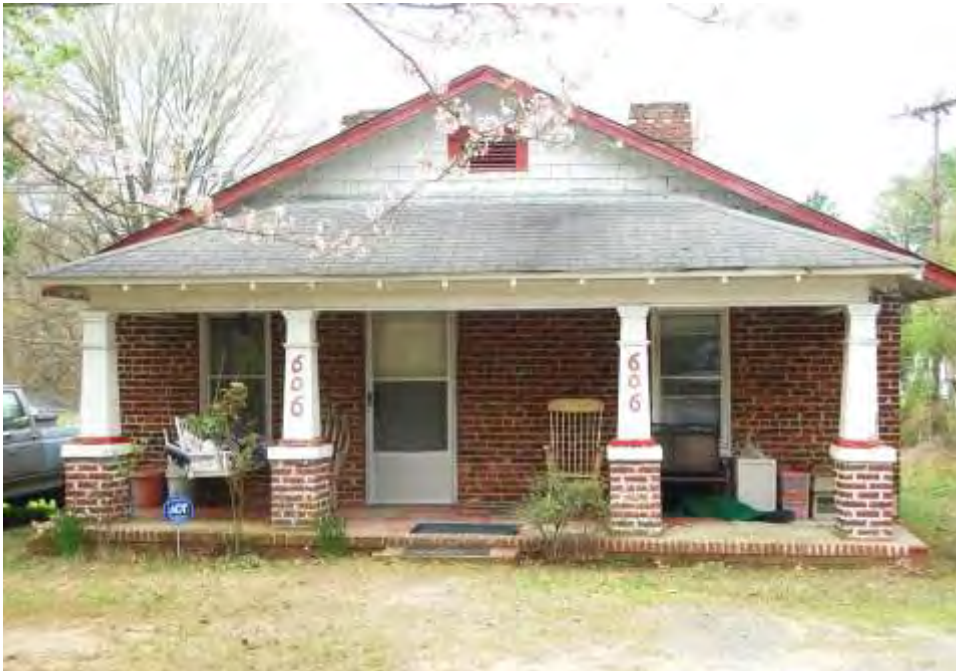
Plate 20. Rowland-Clay House, Façade (North Elevation), Looking South.

The Rowland-Clay House has hallmarks of the bungalow style with front-gable form, deep eaves, exposed rafters, and battered porch piers. Wood shingles cover the front gable which has a small, square, fluted vent. Two interior, brick chimneys pierce the roof. Each chimney stack features caps of smooth brick courses ornamented with a course of alternating, blond-brick and red-brick headers. The brick exterior is laid in American bond with rough mortar. The hip-roofed porch has is supported by battered piers resting on brick pedestals. The concrete porch floor was probably installed in the 1950s. The three-bay façade has a slightly off center entrance with a replacement wood door. The one-over-one light, double-hung, wood sash windows appear to be original. The roof at the rear of the house extends to cover a one-bay, frame addition. This appendage is now aluminum sided and has an inset back porch supported by slender, square posts on the east bay. The addition has a concrete-block foundation. The principal investigators did not gain access to the interior of the house. However, the current owner and occupant states that is little changed with simple brick mantels, hardwood floors, and plaster walls and ceilings all remaining intact.

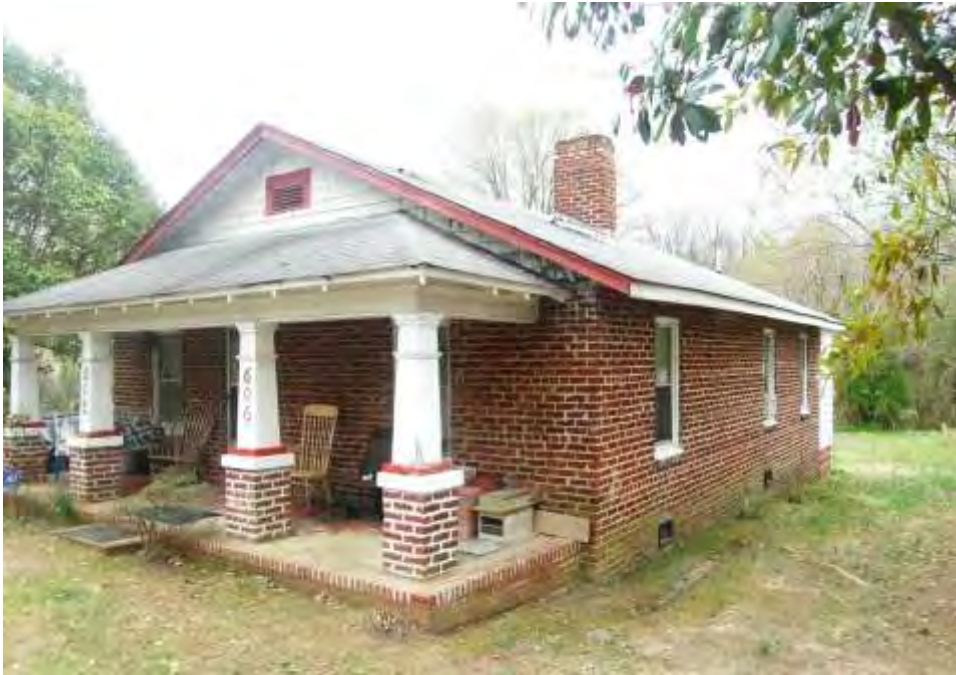
Plate 21. Rowland-Clay House, Façade and Side (West) Elevation, Looking Southeast.

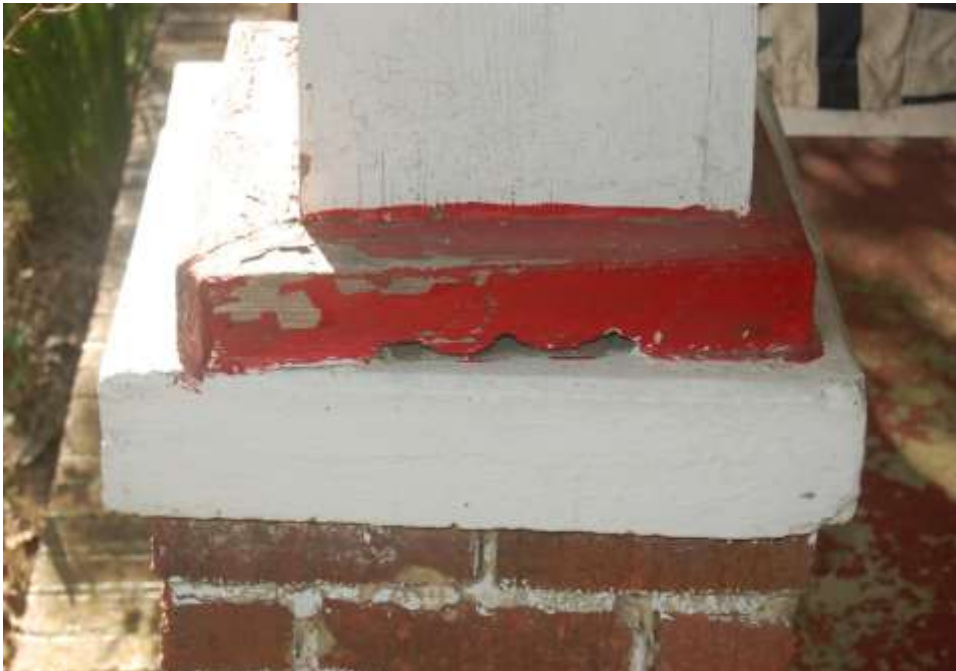
Plate 22. Rowland-Clay House, Porch Post Detail.

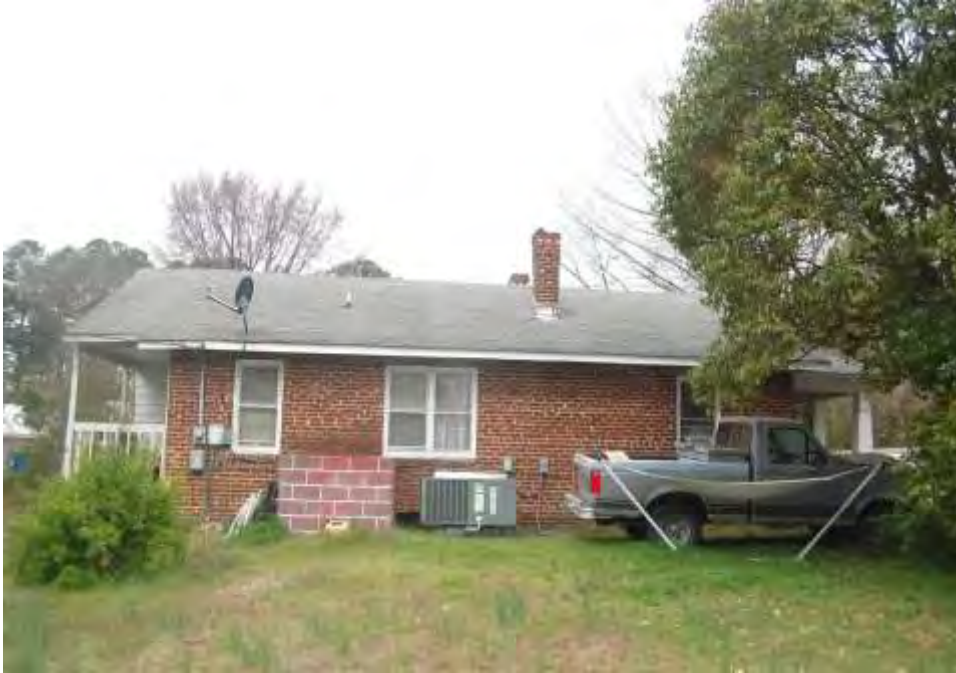
Plate 23. Rowland-Clay House, Side (East) Elevation, Looking West.

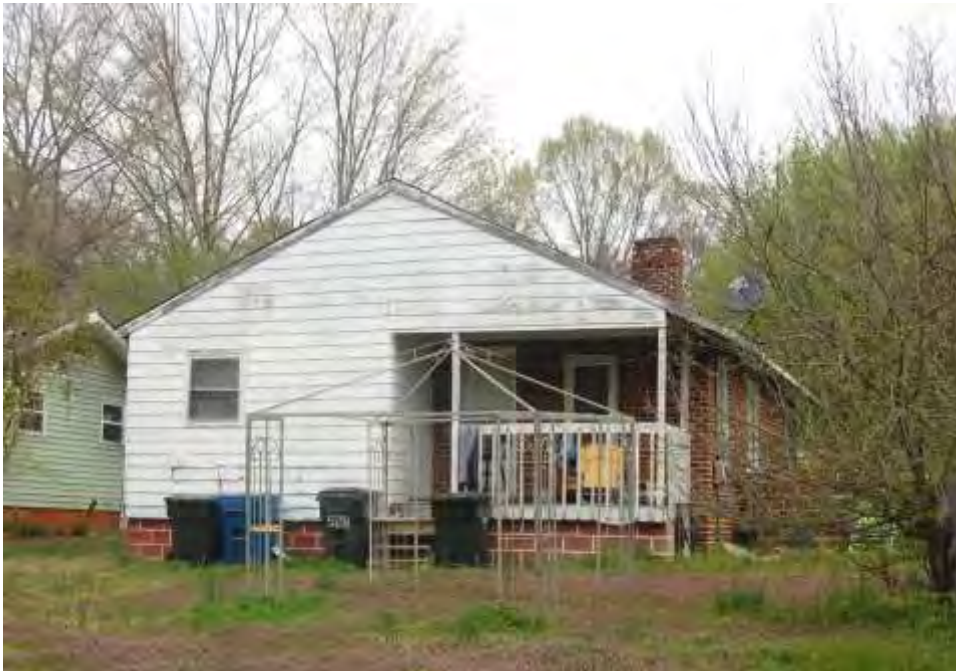
Plate 24. Rowland-Clay House, Rear (South) Elevation, Looking North.

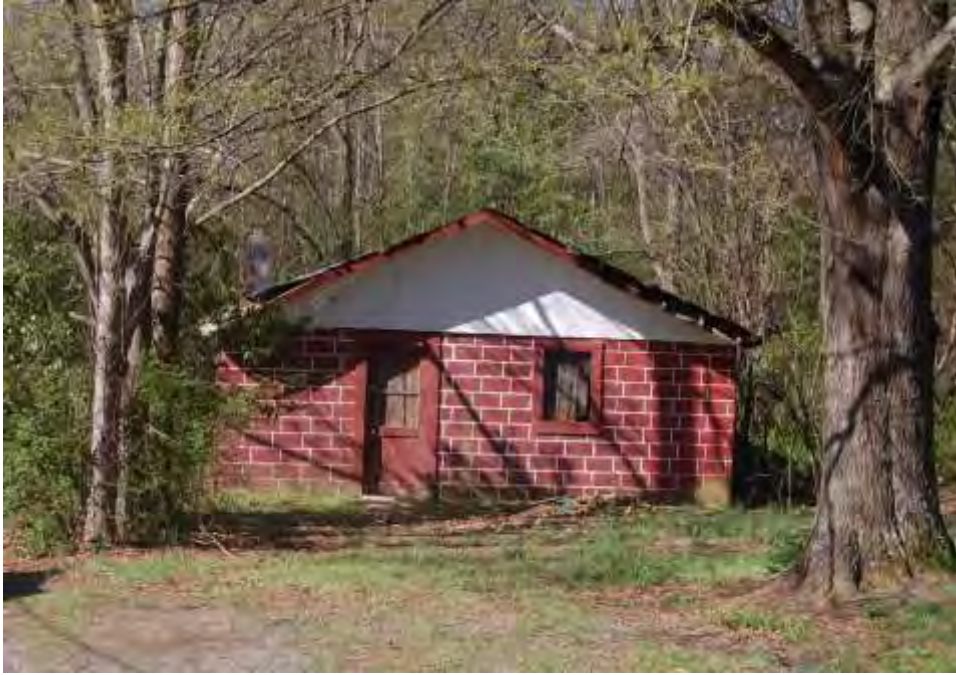
Plate 25. Rowland-Clay House, Workshop Behind House, Looking South.

In addition to the house, the property includes a one-story, front-gable workshop/storage building constructed of concrete block. Now vacant and in disrepair, this building is located behind the house along the eastern border of the tax parcel. The lot also includes a kitchen garden.

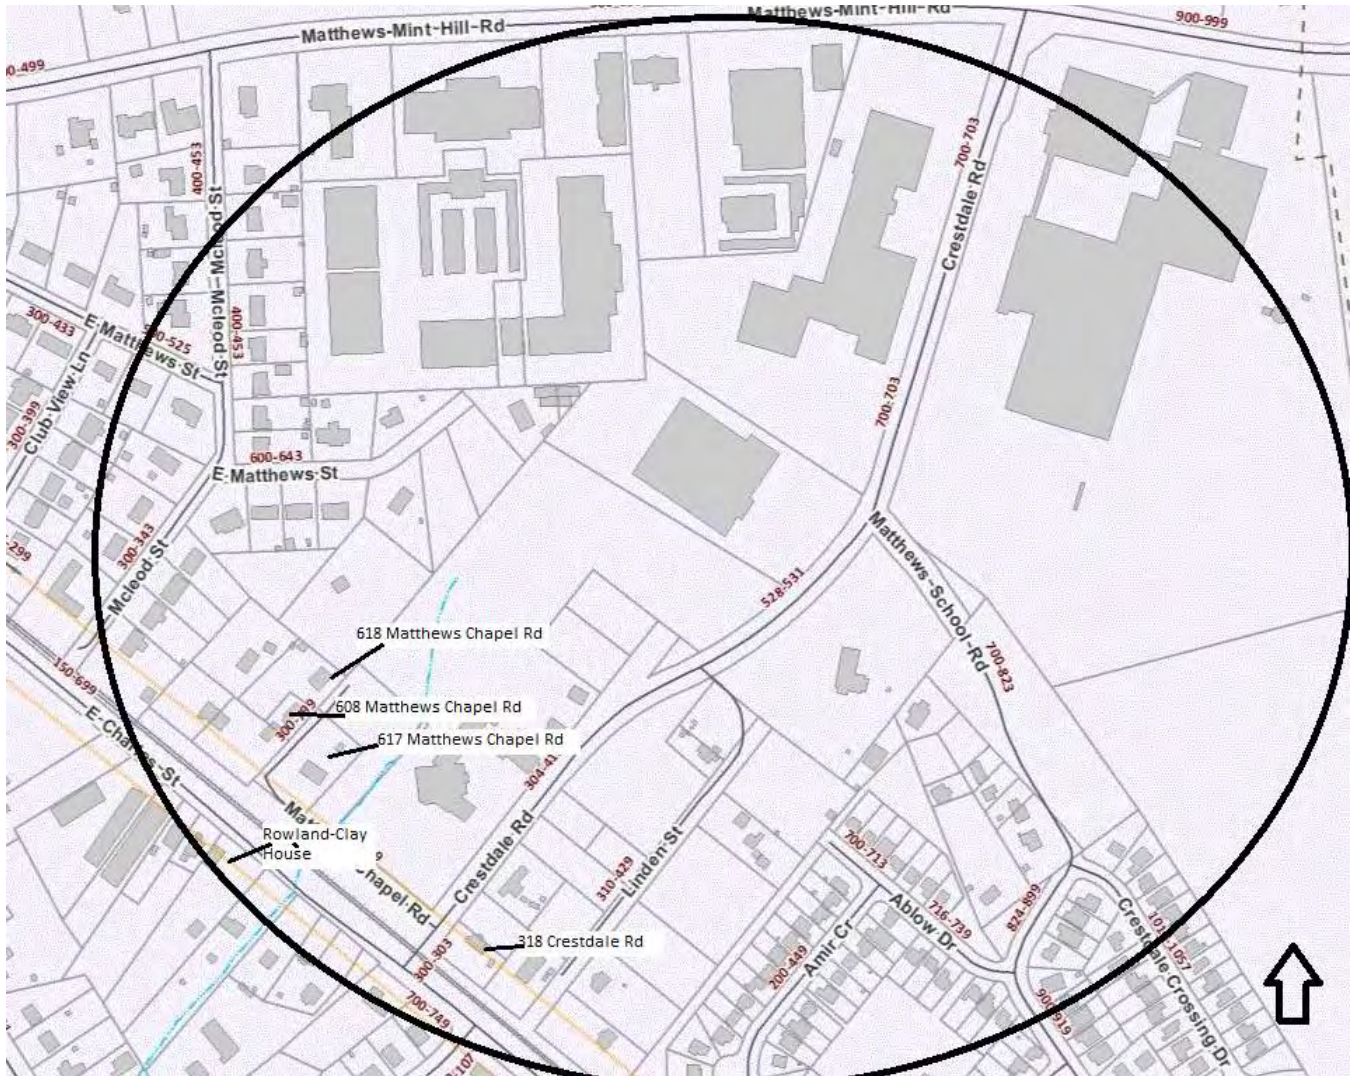
Figure 6
Location Map
Crestdale (Tank Town) Community
Showing Locations of Houses Remaining from Early Twentieth Century

A 2002 architectural inventory of African American resources in Mecklenburg County recorded only four Tank Town houses built in the early twentieth century that remain basically intact, including the Rowland-Clay House. All of these houses still stand. By contrast to the Rowland-Clay bungalow, the others are simpler one-story, frame dwellings with greater alterations, including replacement sidings, porch posts, windows, chimneys, and foundations. Three are clustered along Matthews Chapel Road and may have been moved to the sites (see **Plates 26-32**) (Gray and Stathakis 2002: 8-9; Jeffers and Morrill 2007).
