North Carolina Department of Cultural Resources
State Historic Preservation Office

MEMORANDUM

SUBJECT: Historic Structures Survey Report, Widening of John Street/Old Monroe Road (SR 1009)
From Trade Street to Wesley Chapel/Stout Road, U-4714, Mecklenburg & Union Counties,
ER 13-0879

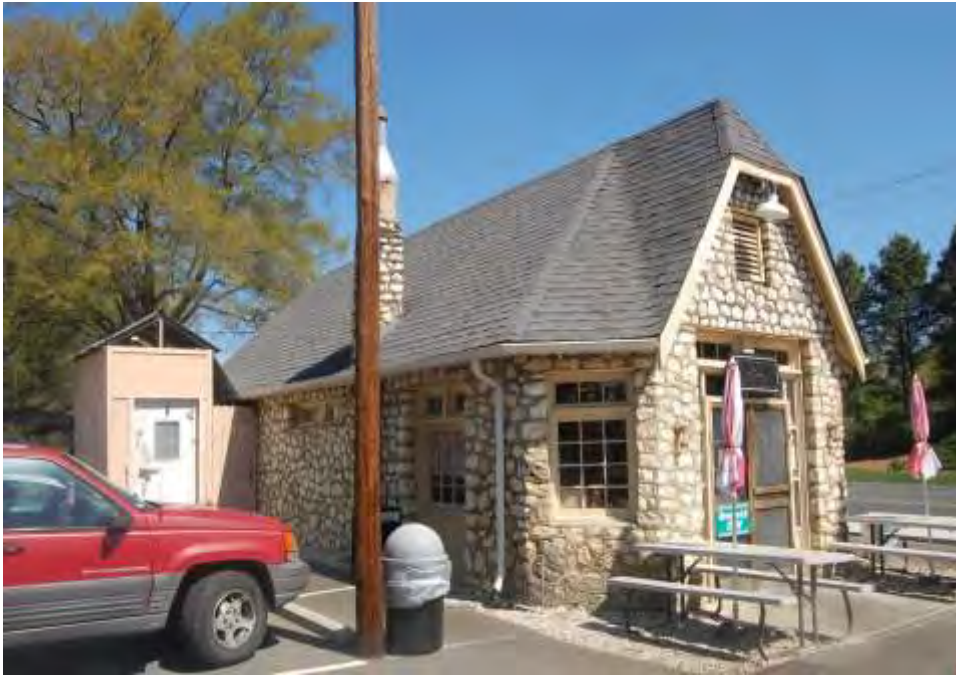
Constructed circa 1935, the well-preserved Banks H. Funderburk Store occupies a small triangular site on the west side of Old Monroe Road. The store is distinctive for its consciously rustic flint stone veneer, its narrow form capped by a steeply-pitched jerkinhead roof over the main entrance, and flanking cutaway bays. The eaves of the roof have exposed rafters along the side elevations. The multiple-light, wood-sash windows are original and vary in size and shape. They are slightly recessed and set in simply molded wood surrounds. The main entrance consists of double-leaf wood doors with glazed upper sections, sidelights, and a multiple-light transom. The store's large windows have multiple-light transoms, and the windows on the side elevations also have vertical-board aprons. The side (west) elevation has a flint stone chimney flue. A modern frame enclosure that contains a barbeque cooker is located at the rear of the south side. The rear (north) elevation has a centered, four-over-four light, double-hung, wood-sash window. Although the store operated as a gas station as well as general store, no evidence of the gas pumps remains (Pickens 1990: 266).

Plate 33. Banks H. Funderburk Store, Entrance and Side (West) Elevation, Looking Northwest.

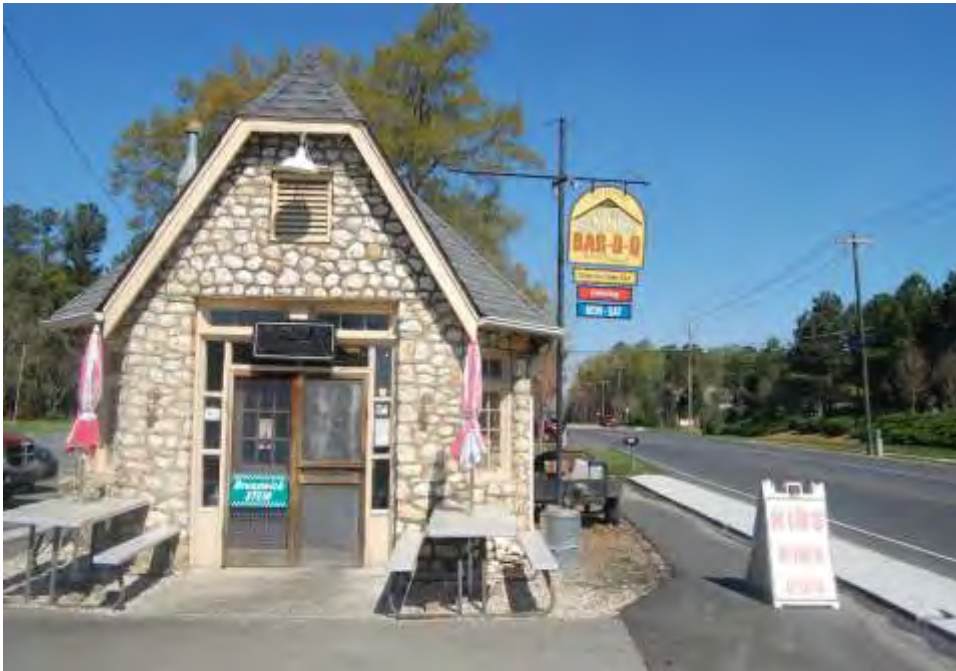
Plate 34. Banks H. Funderburk Store, Entrance, Looking Northwest.

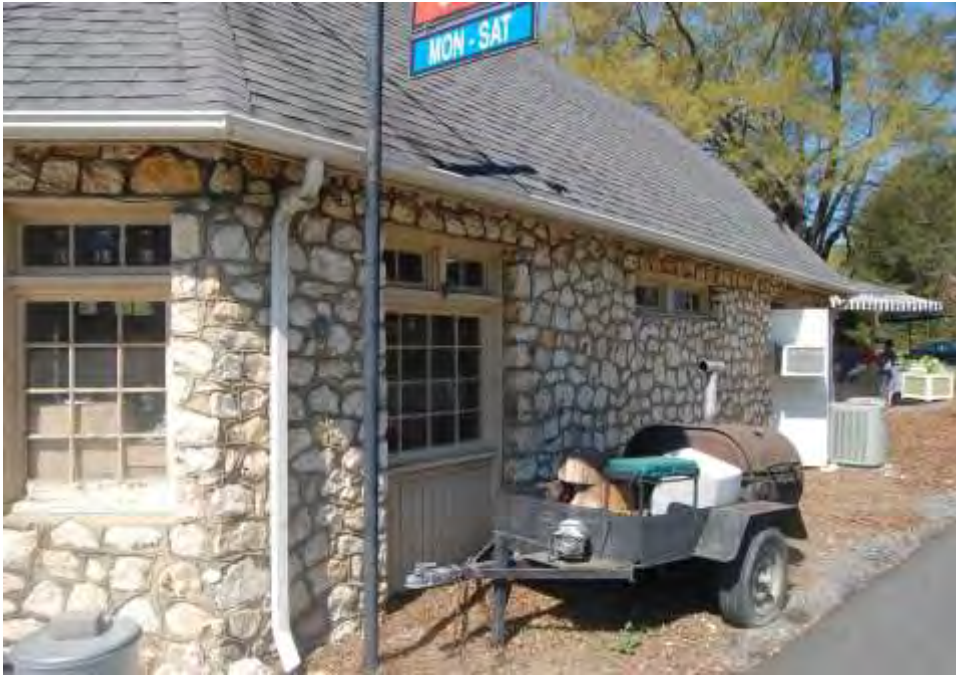
Plate 35. Banks H. Funderburk Store, Side (East) Elevation, Looking Northwest.

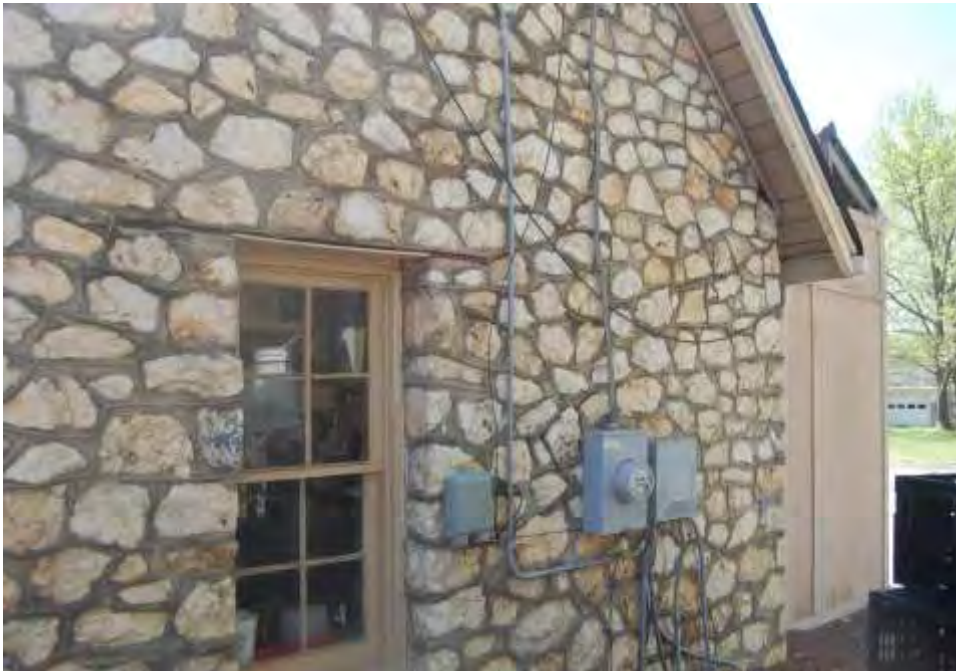
Plate 36. Banks H. Funderburk Store, Rear (North) Elevation, Looking Southeast.

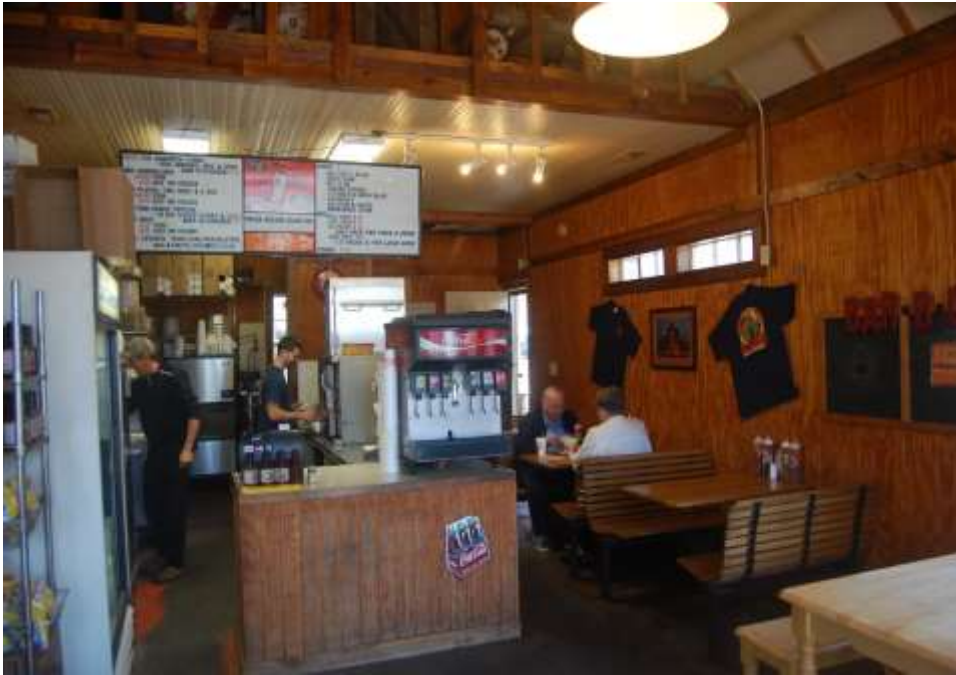
Plate 37. Banks H. Funderburk Store, Interior.

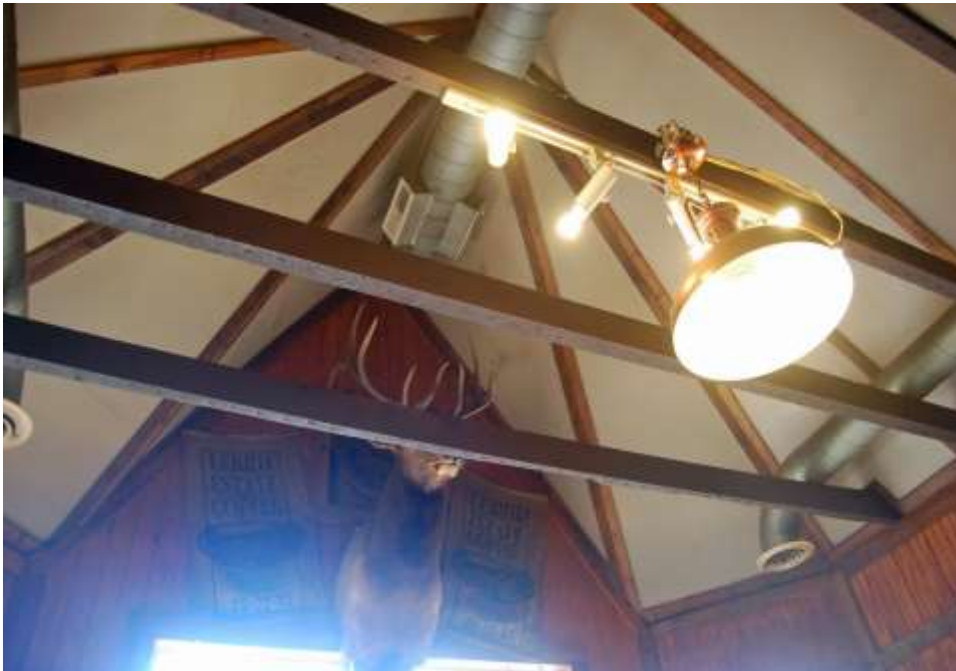
Plate 38. Banks H. Funderburk Store, Interior, Ceiling Detail.

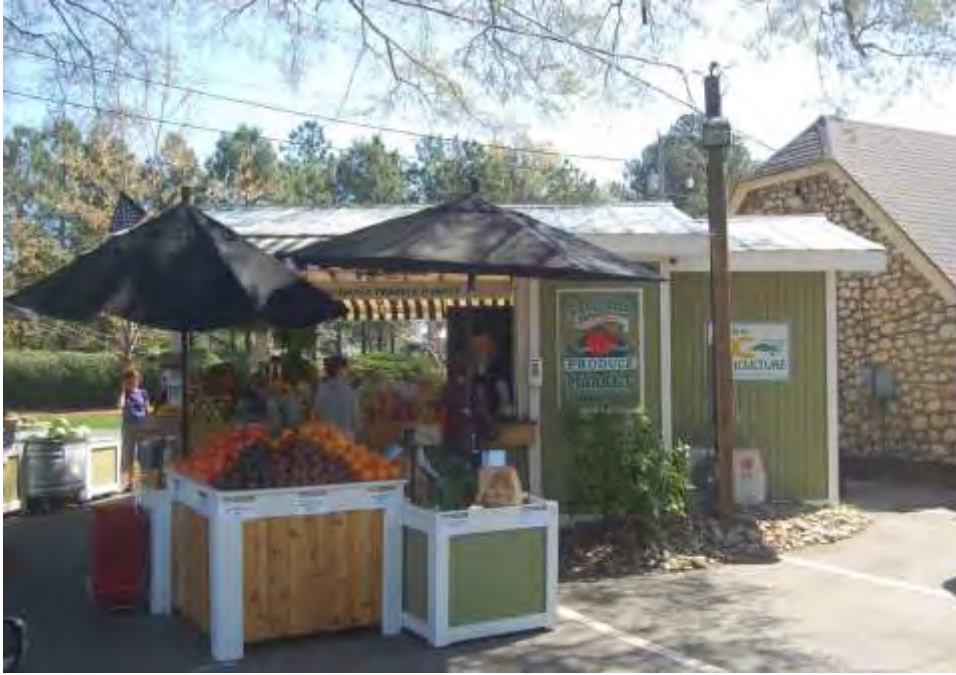
The simple interior has been updated recently for use as a restaurant. There is one main room with modern wood partitions and wood-paneled walls that houses the open kitchen and the seating area. The exposed ceiling rafters and concrete flooring are original. A temporary, prefabricated farm stand is located on the lot, just west of the store. This seasonal structure will be removed in the fall.

Plate 39. Banks H. Funderburk Store, Seasonal Farm Stand, Looking East.

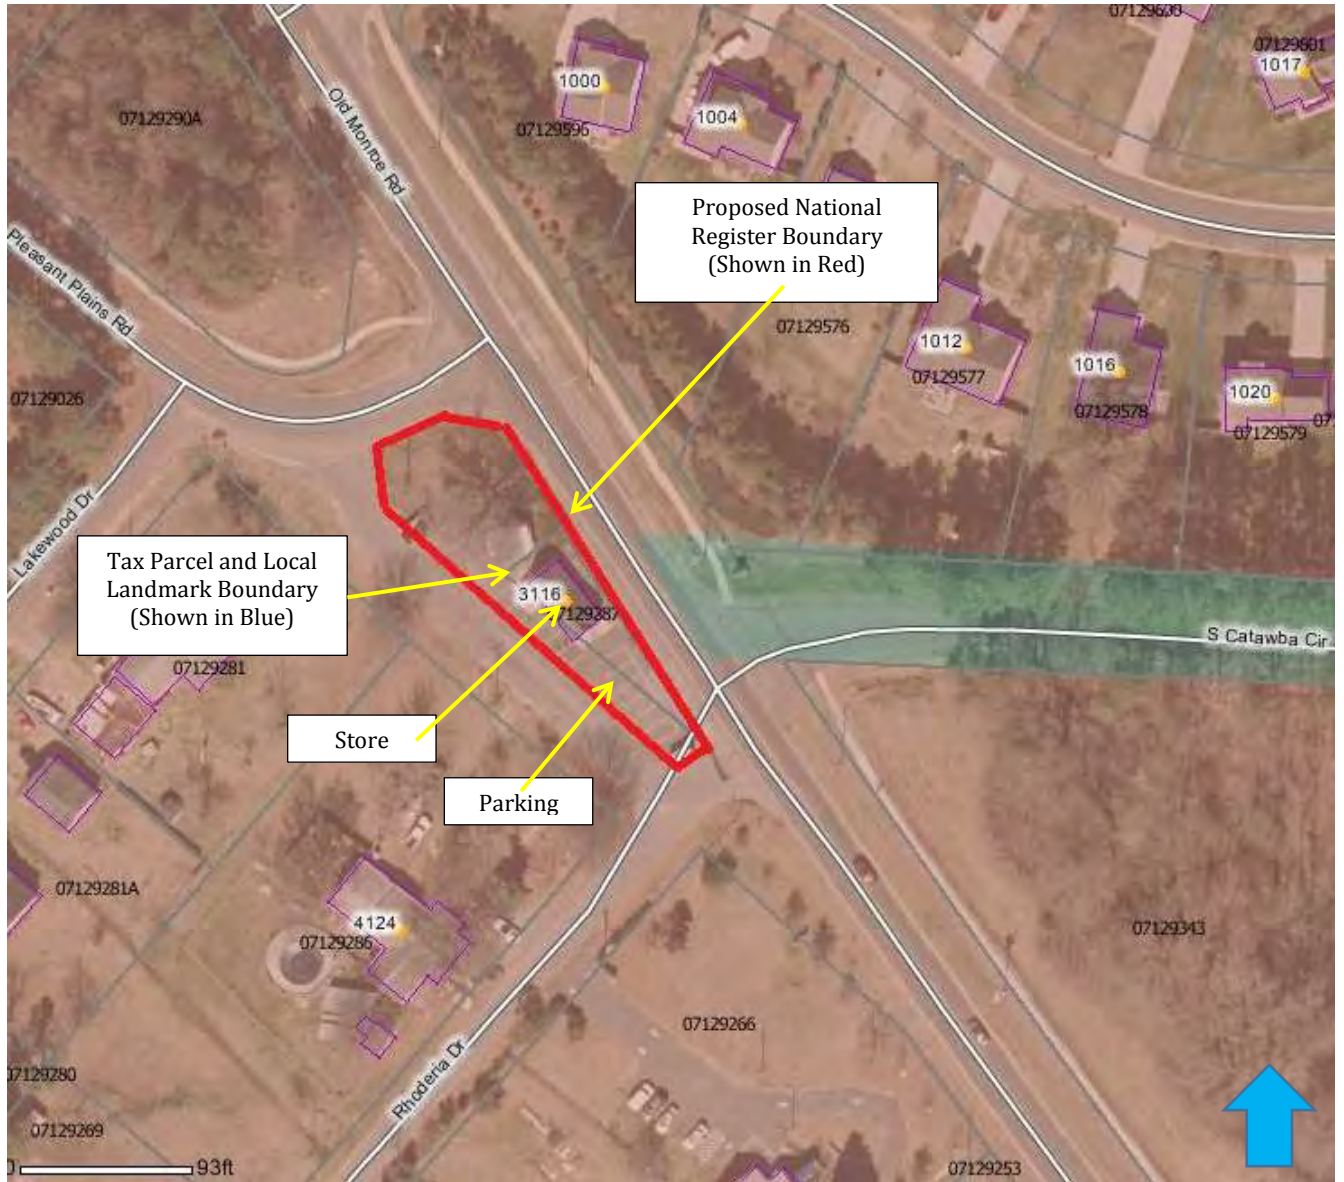
**Banks H. Funderburk Store
Proposed National Register Boundary and Local Landmark Boundary**

Shown on **Figure 8**, the proposed National Register boundary is clearly defined by the roadside wedge of land (roughly one acre) bordered by Old Monroe Road (east), the store's driveway (west), Pleasant Plains Road (north), and Rhoderia Drive (south). The recommended boundary encompasses the store as well as areas historically used for customer parking. The proposed boundary includes more land than is contained within the current tax parcel (PIN 07129287). The tax parcel of approximately 0.6 acres excludes much of the triangular-shaped site and cuts through the southwest corner of the building. The local landmark boundary appears to conform to the tax parcel.

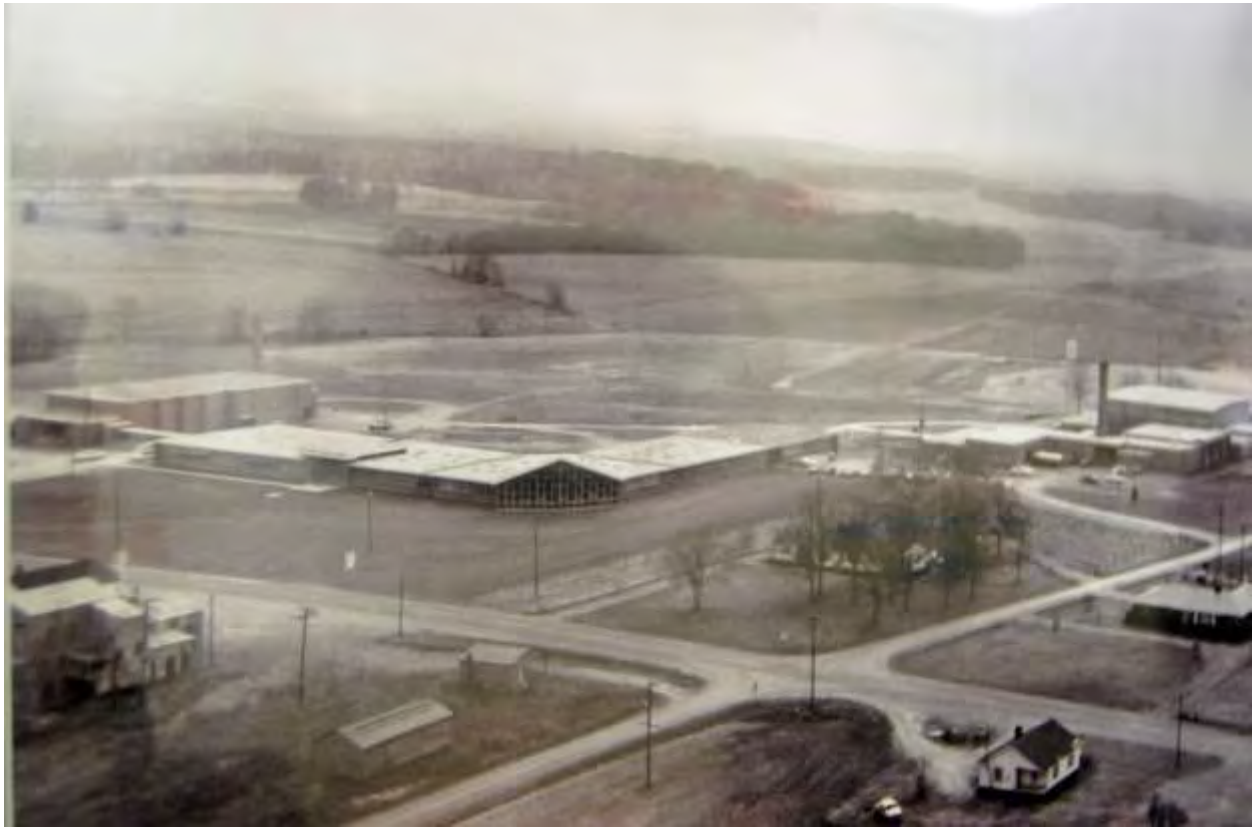
Plate 40. Sun Valley High School, Circa 1963 Aerial Photograph, Looking South. Source: Sun Valley High School.

The campus south of the main buildings remains athletic fields with a football stadium and baseball field. These facilities do not appear to have been completed by the time a circa 1963 aerial photograph of the campus was made but were probably largely constructed during the 1960s (Hughes 2014).

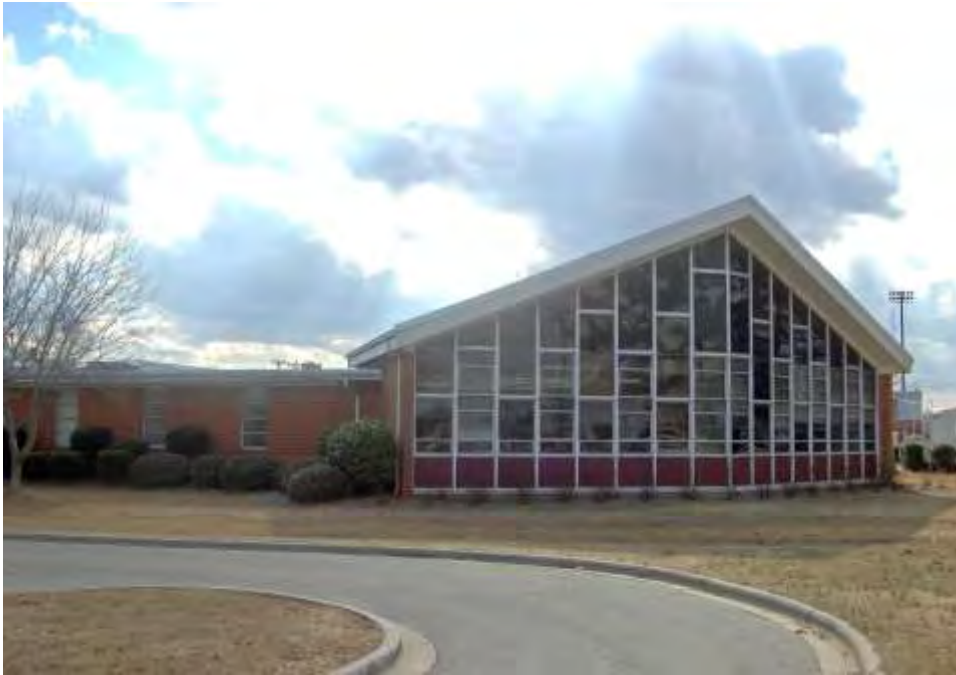
Plate 42. Sun Valley High School, Library, Looking South.

The main entrance to the school opens into a broad foyer that connects to the two classroom corridors and is flanked by the school offices. The interior has slate flooring in the main hall, linoleum tile flooring in the adjoining corridors, and exposed brick and concrete-block walls lined with metal lockers along the classroom hallways. The original wood classroom doors with glazed upper sections are intact. Exposed pipes and ductwork run beneath the dropped, acoustic-tile ceilings in the hallways. The original library is now divided into two rooms—classroom and teacher lounge—by a modern concrete-block wall. A dropped, acoustic-tile ceiling has been installed in the classroom section of the former library.

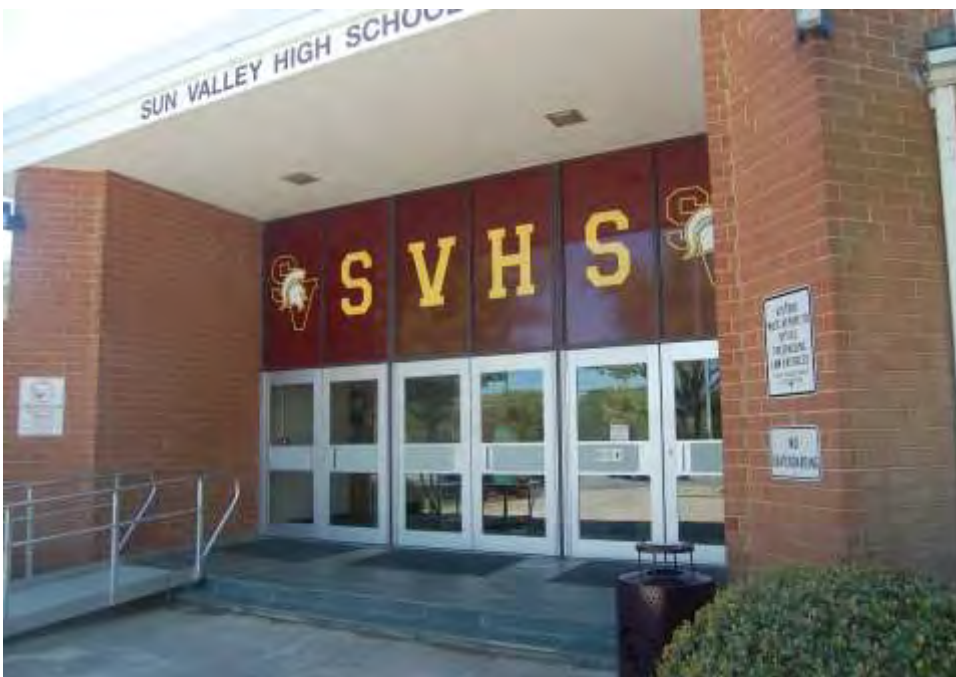
The school's main entry is located at the center of the original east classroom wing facing Old Monroe Road. The flat-roofed entrance projects slightly from the façade and consists of an expansive, full-height glazed doorway with metal-framed, glass doors flanked by wide, brick piers. These doors are modern replacements of metal-framed doors of similar design. The entry originally had a large, glazed transom that is now covered.

Plate 43. Sun Valley High School, Main Entrance, North Elevation, Looking South.

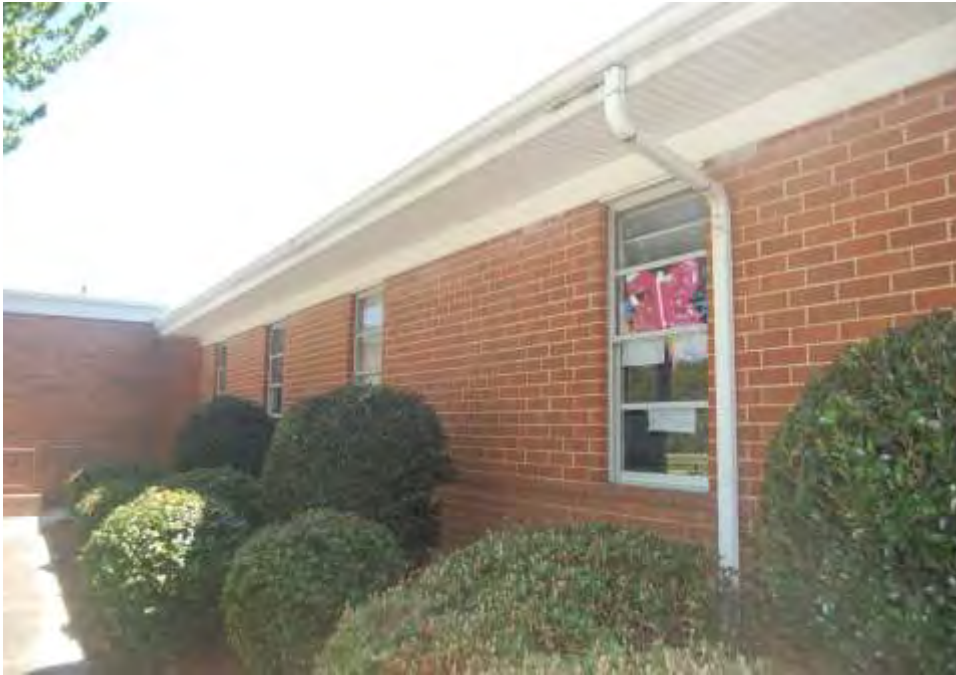
Plate 44. Sun Valley High School, East Classroom Wing, North Elevation, Modern Brick Infill, Looking Southeast.

For purposes of compliance with Section 106 of the National Historic Preservation Act (NHPA), Sun Valley High School is recommended **not eligible** for National Register eligibility under any criterion because of a loss of architectural integrity.

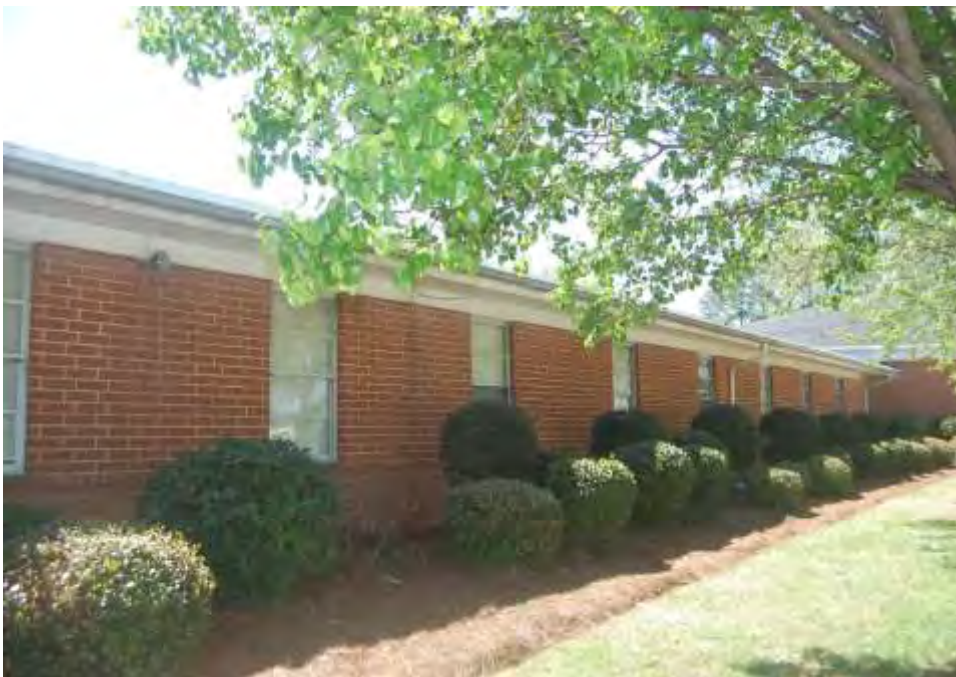
Plate 45. Sun Valley High School, East Classroom Wing, North Elevation, Modern Brick Infill, Looking Southwest.

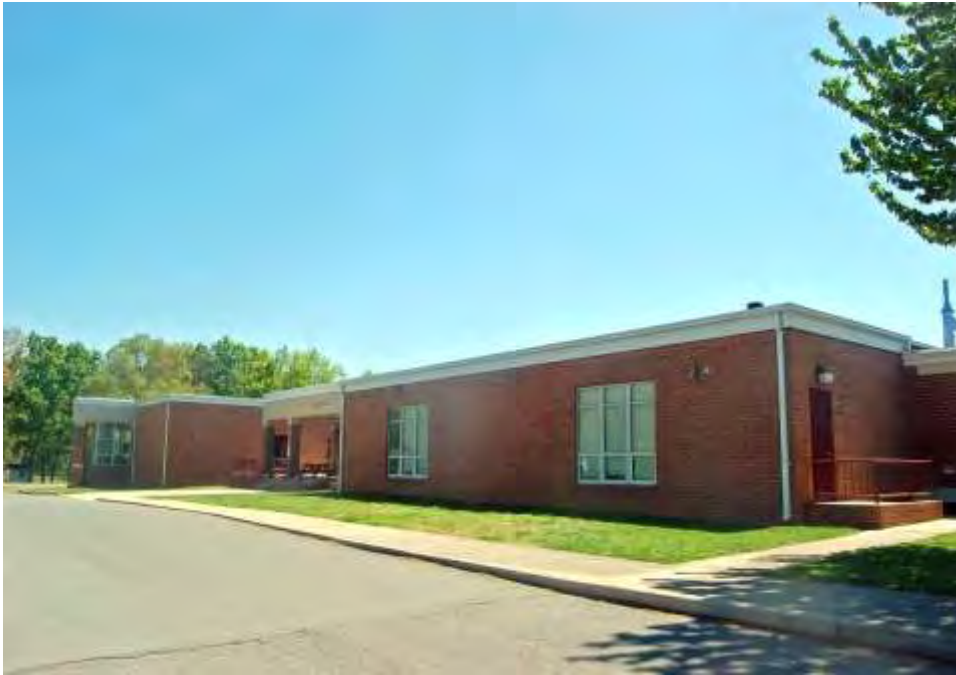
Plate 46. Sun Valley High School, East Side of North Elevation, 1993 Classroom Addition and 1993 Auditorium Additions, Looking Southeast.

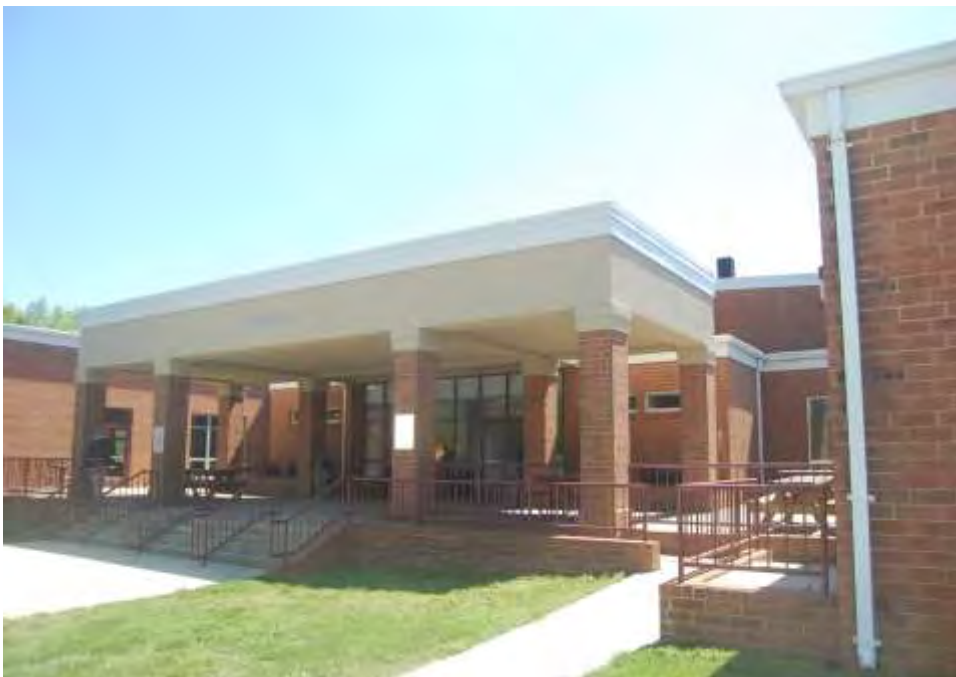
Plate 47. Sun Valley High School, East Side of North Elevation, 1993 Auditorium Addition, Looking South.

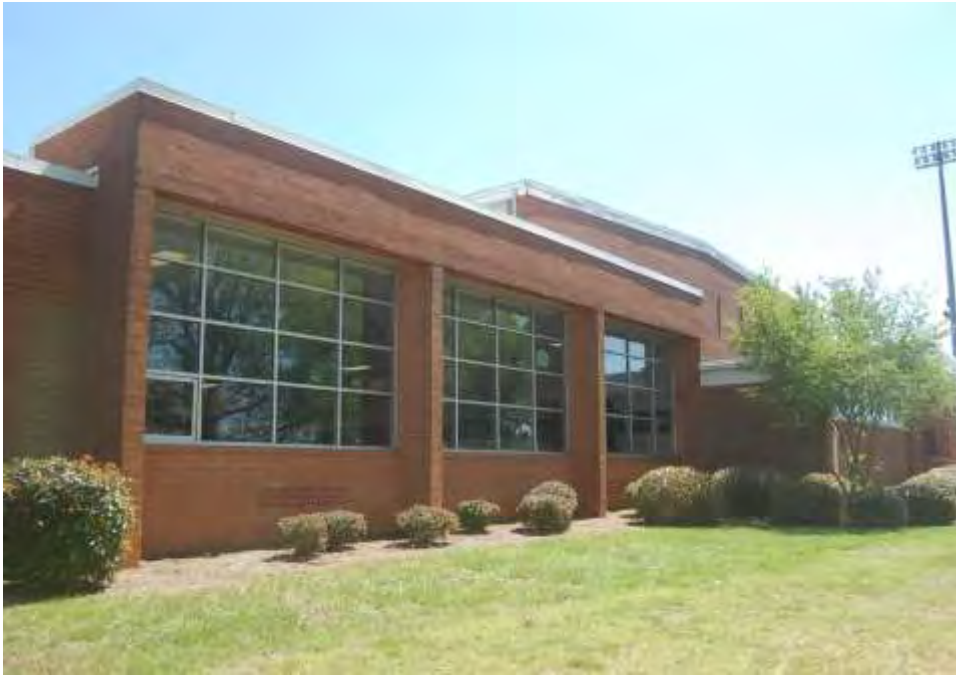
Plate 50. Sun Valley High School, 1960 Cafeteria, Replacement Windows, Looking Southeast.

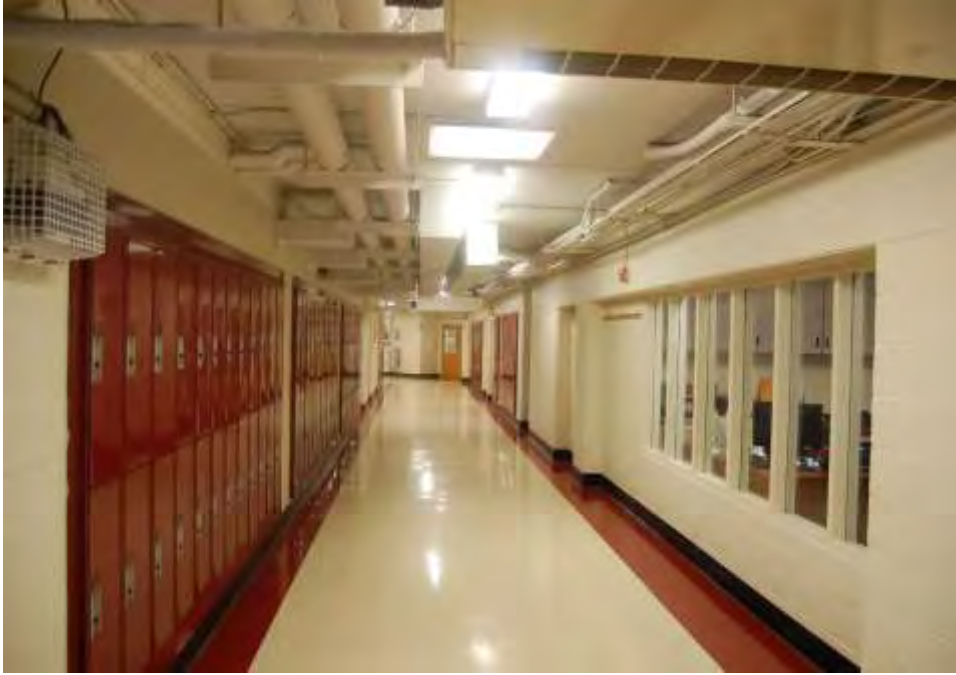
Plate 54. Sun Valley High School, Interior, 1960 Classroom Corridor.

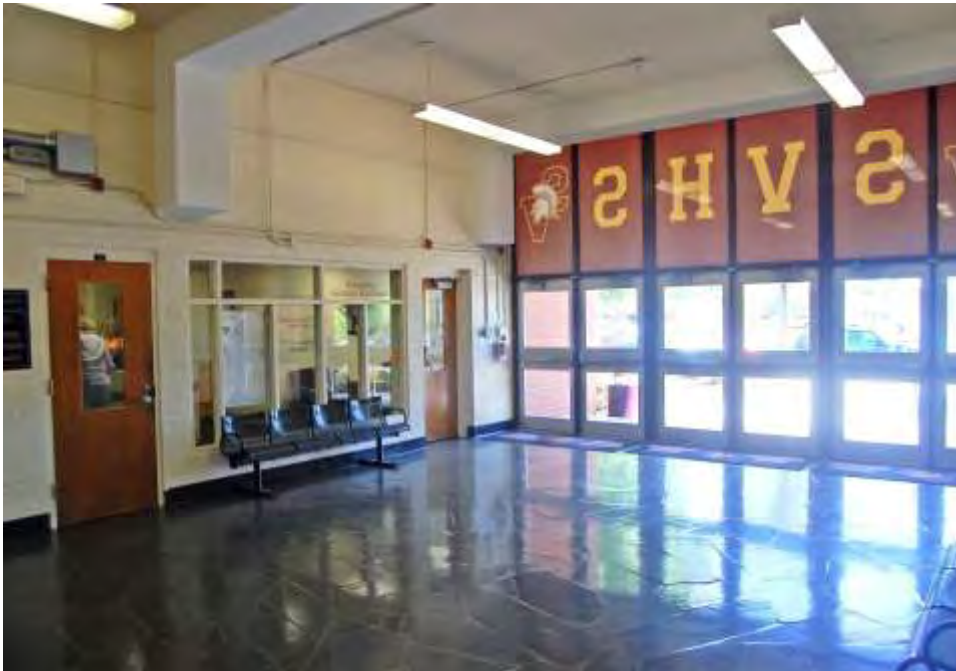
Plate 55. Sun Valley High School, Interior, Entrance Foyer.

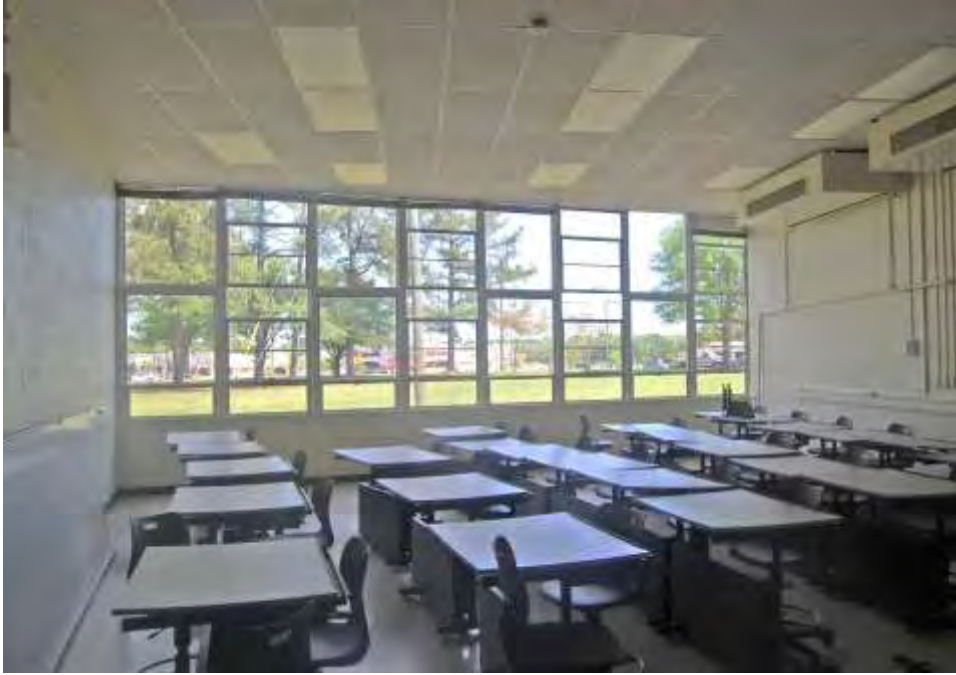
Plate 56. Sun Valley High School, Interior, Former Library.

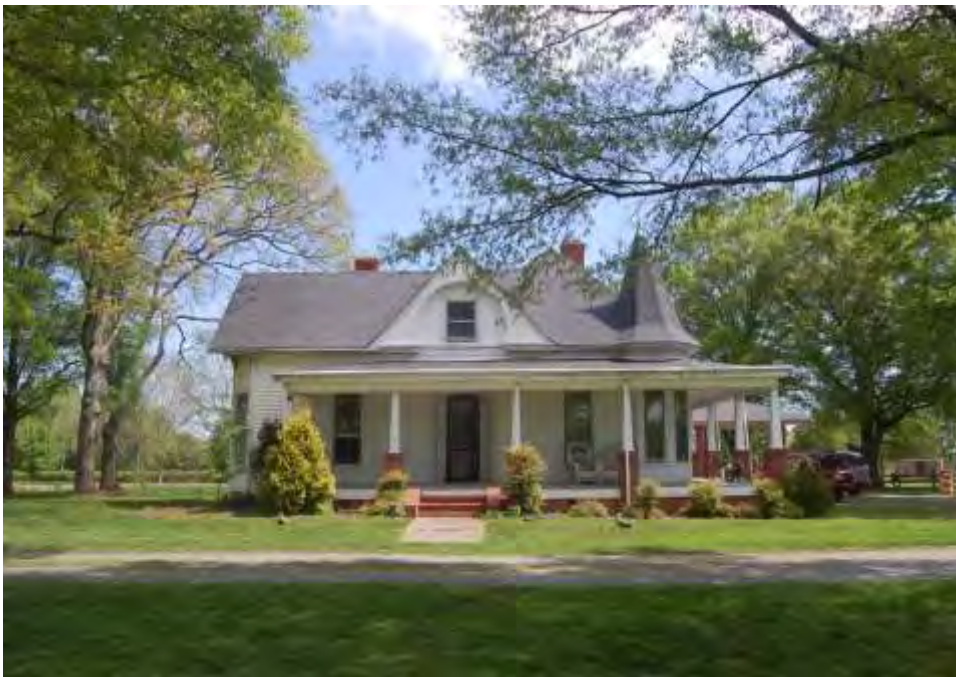
The bungalow-inspired porch piers (now vinyl sided) and brick pedestals were added in the 1930s. The one-over-one light, double-hung, wood-sash windows were also probably installed at about that time. Around 1960, a three-part window replaced the original window on the west elevation, and modern windows were installed in the rear kitchen ell. A brick rear addition and carport were also constructed circa 1960 (Killough 2014; Pickens 1990: 265).

Plate 57. Heywood-Killough House, House and Setting, Looking North.

The **Heywood - Killough House (UN0178) does not meet National Register criteria.** The application of synthetic siding, a modern rear addition, new windows, the replacement of the original porch with a Craftsman style porch, and extensive interior remodeling has significantly altered the appearance of this Queen Anne style house.

The Heywood-Killough House no longer retains all seven aspects of integrity needed for National Register eligibility. Occupying its original site surrounded by farmland and at least two outbuildings that date to the early twentieth century, the house retains its integrity of location, setting, feeling, and association. However, the house has lost its integrity of design, workmanship, and materials. On the exterior, vinyl siding covers the majority of the house and its decorative gables, and the original windows have been replaced. A brick addition was constructed circa 1960 across the rear, and a brick carport was also built on the east side at the same time. The two brick chimney stacks are modern, and the original picturesque porch posts were replaced in the 1930s when the one-over-one windows were probably installed.

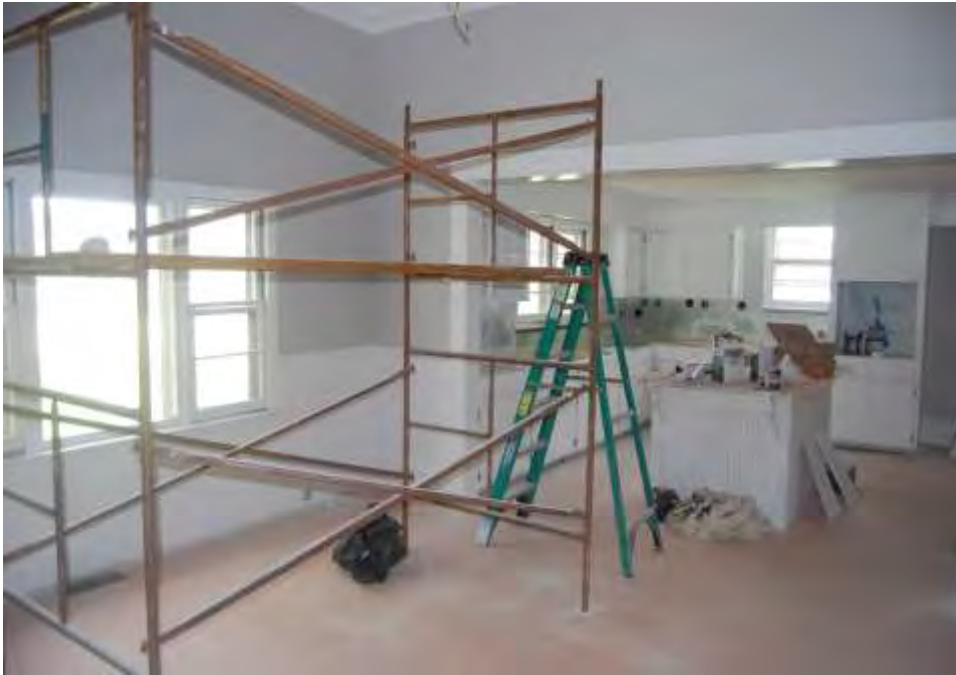
Plate 65. Heywood-Killough House, Interior, Dining Room and Modernized Kitchen Ell.

The interior is undergoing a complete remodeling. The center hall has been closed off to allow for a staircase and bathroom. The dining room and kitchen ell are now one large room, and three of the four original mantels are now gone. A large opening has replaced the door that originally led to the dining room from the living room. Of the original four-room house, only the parlor remains intact.

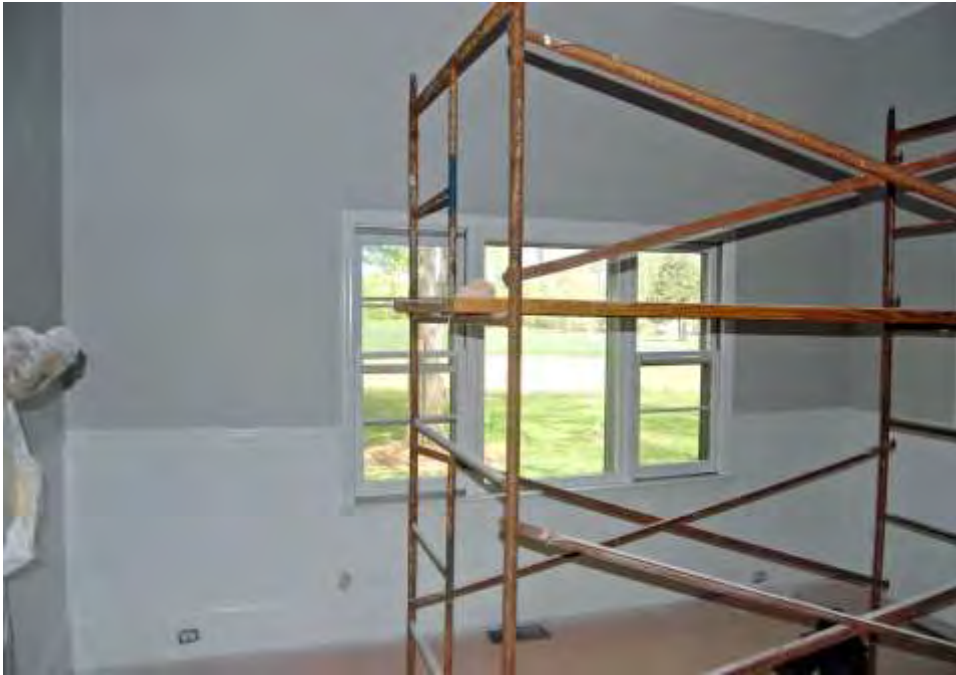
Plate 67. Heywood-Killough House, Interior, Dining Room, Added Circa 1960 Window.

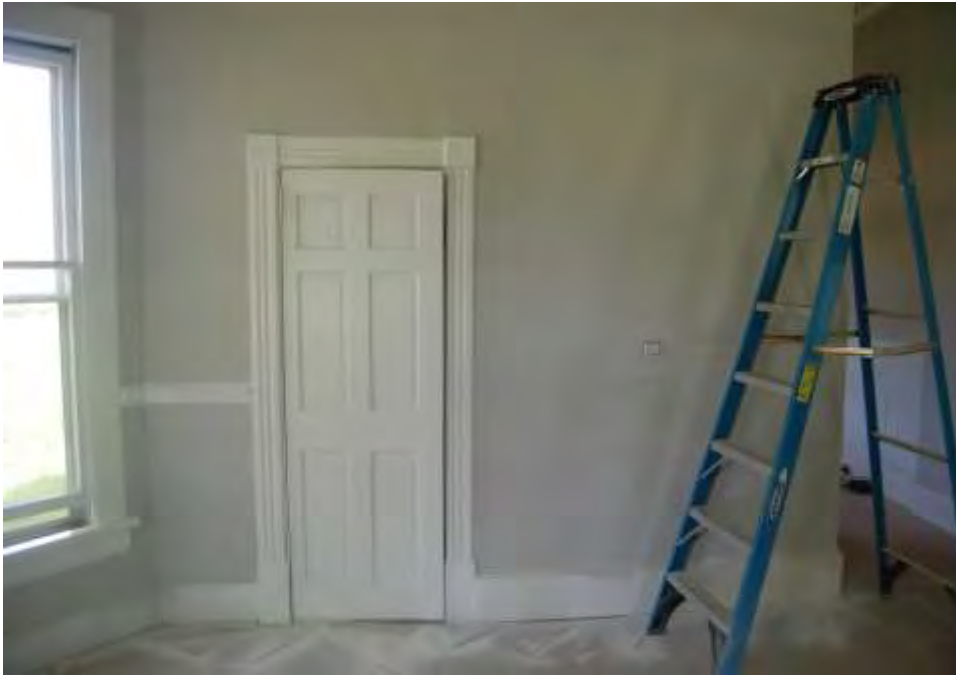
Plate 69. Heywood-Killough House, Interior, Living Room, Mantel Originally Located Right of Closet Door, Now Removed and Wall Sheetrocked.

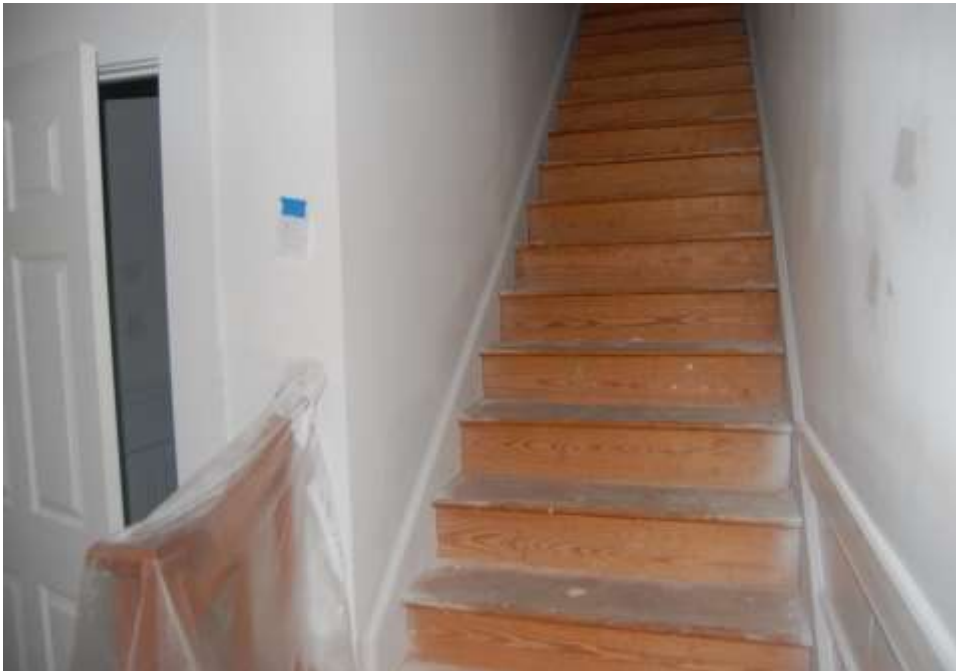
Plate 72. Heywood-Killough House, Interior, New Staircase Installed at the Rear of Original Center Hall.

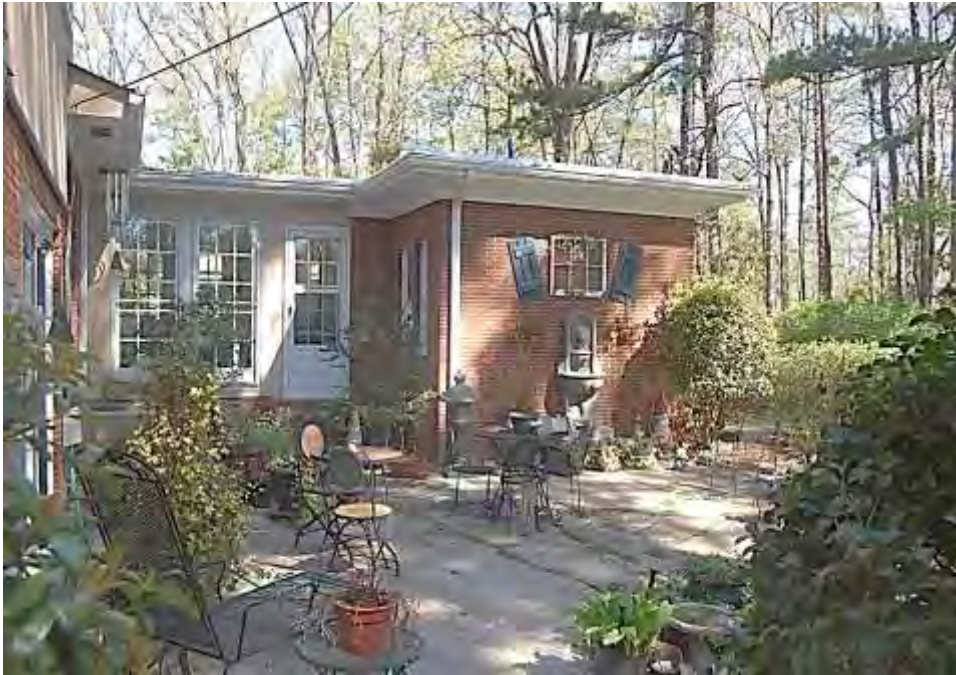
Plate 82. Banks and Carolyn Funderburk House, Enclosed Breezeway and Garage, Looking Northwest.

Finally, the Funderburk house is unusual in its degree of preservation. The only changes that have occurred on the exterior are the in-kind replacement of the sliding glass doors and the enclosure of the breezeway. With its extensive windows, the breezeway retains its generally open appearance as well as its form. The interior of the house is also well preserved with no changes to the floor plan. Columns have been added to the living room steps, and a wood railing has replaced a wrought iron railing in the breakfast room, but otherwise original moldings, doors, hardwood floors, kitchen and bathroom cabinets, bathroom tilework, and pine-paneled walls all survive intact. Furthermore, there have been few changes to the wooded landscape that forms the setting for the house.

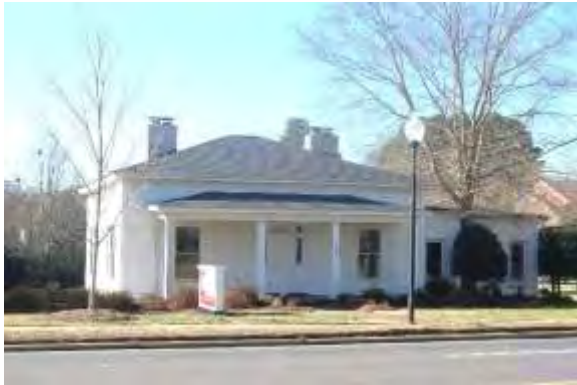
No. 2 Bain-Reid House (MK1173)
(PIN 22702423), 135 West John Street,
Matthews, Mecklenburg County

Built circa 1880, this one-story, double-pile, hip-roofed dwelling has been heavily remodeled. Now an office, the frame building has vinyl siding, replacement porch posts, replacement windows, and a remodeled interior. No original mantels remain. This altered house is not recommended for intensive-level investigation because of its loss of integrity.

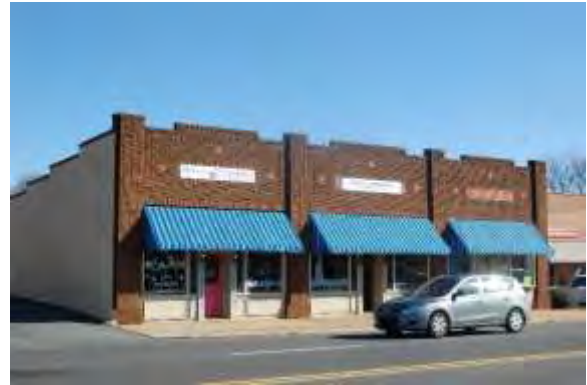
No. 4 Commercial Building
(PIN 19326203), 116 West John Street,
Matthews, Mecklenburg County

Erected in the late 1920s, this one-story, red-brick commercial building has been extensively remodeled. The existing façade, oriented to North John Street, consists of brick storefront bays and wood shopfronts that are all modern installations. The interiors have been modernized. This altered building is not recommended for intensive-level investigation because of its loss of integrity.

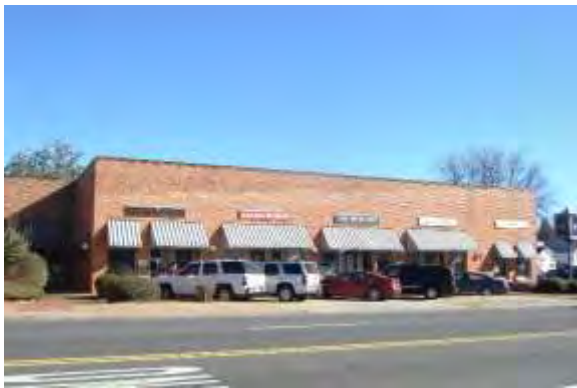
No. 5 Commercial Building
(PIN 19326204), 100 West John Street,
Matthews, Mecklenburg County

As with the commercial building at 116 West John Street (No. 4), this one-story, brick building (circa 1930) has been extensively remodeled for use as retail shops. The series of shopfronts on the east and south elevations are modern installations. The interiors also have been modernized. This altered building is not recommended for intensive-level investigation.
