SUBJECT: Installation of Sidewalks on the East Side of Main Street from 5<sup>th</sup> Street to Shopping Center at NC 89/US 311, Walnut Cove, PA 13-04-0011, Forsyth County, ER 13-2920

**NATIONAL REGISTER ELIGIBILITY EVALUATION FOR  
INSTALLATION OF SIDEWALKS ON THE EAST SIDE OF MAIN STREET  
FROM 5TH STREET TO SHOPPING CENTER AT NC 89/ US 311 INTERSECTION,  
WALNUT COVE, STOKES COUNTY**

**PA NO. 13-04-0011**

**Marvin A. Brown  
Principal Investigator**

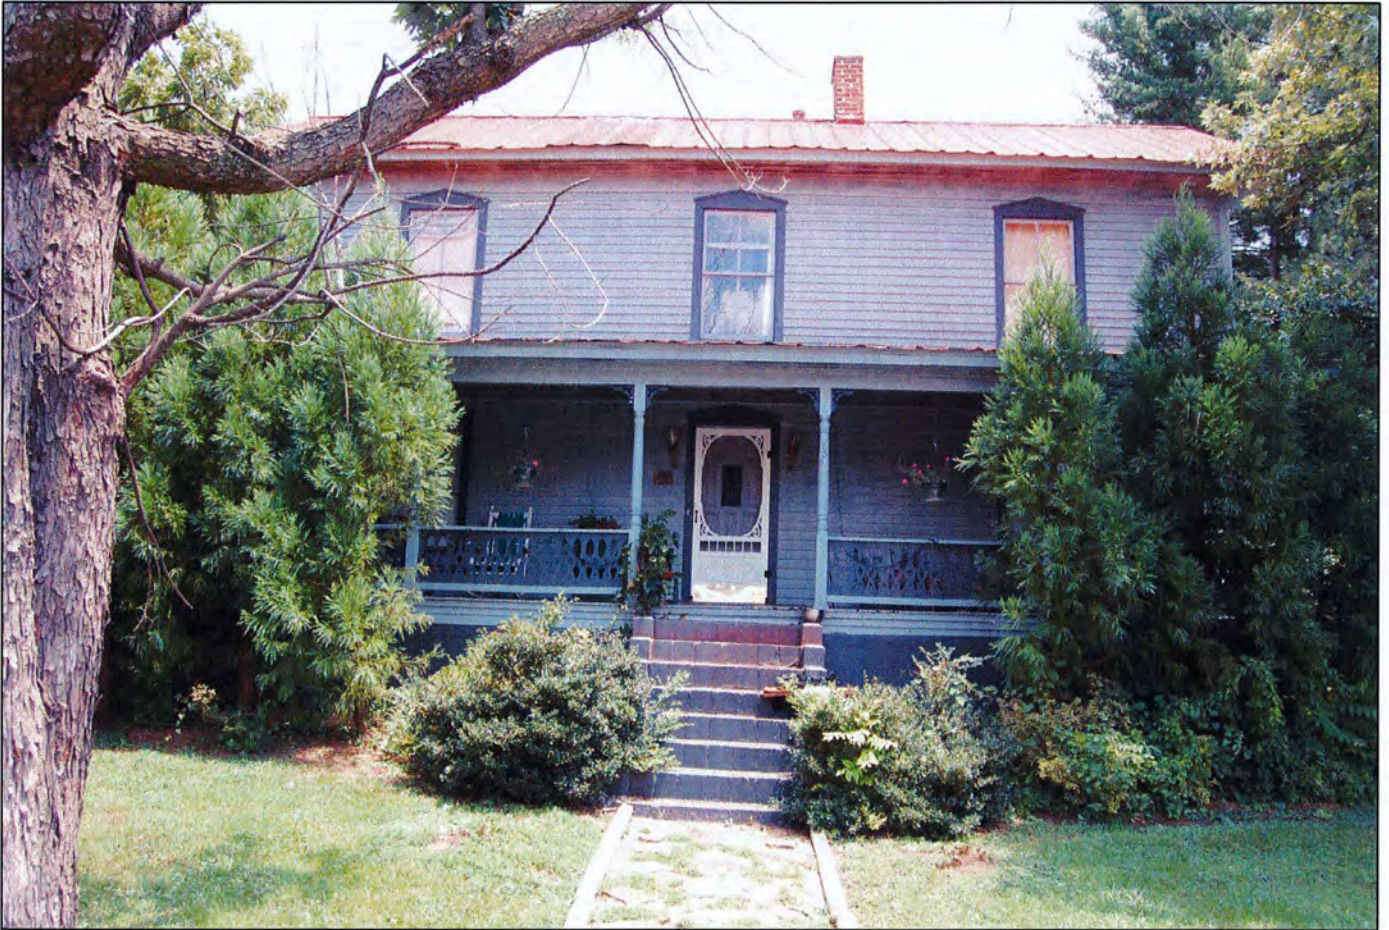
Figure 2. Rierson House: front elevation

The front block of the Samuel Wilson Rierson House is two stories tall and one room deep. It is built of frame clad in weatherboards that appear to be original. A stuccoed masonry foundation underpins the block. Its gable-end roof is covered by standing-seam metal and broken at its ridge by one off-center brick chimney stack. Narrow plain cornerboards and wider plain friezeboards enframe the rectangular structure (**Figure 2** to **Figure 7**).

Three symmetrically placed bays cross the front (west) elevation of the block. The first story is marked by a centered door with a window bay to either side. Three windows pierce the elevation's second story. All six bays are set in unusually long surrounds. At the first story these extend from just short of the porch floor up to the porch ceiling. Above they stretch from the porch roof up to and just onto the friezeboard. Triangular lintels top the surrounds, which are otherwise plainly finished. The front and screen door have been

replaced, but the window bays continue to hold long, two-over-two, double-hung sash. The pediments, extended bays, and long lights are basic reflections of the Italianate style popular during the Victorian period.

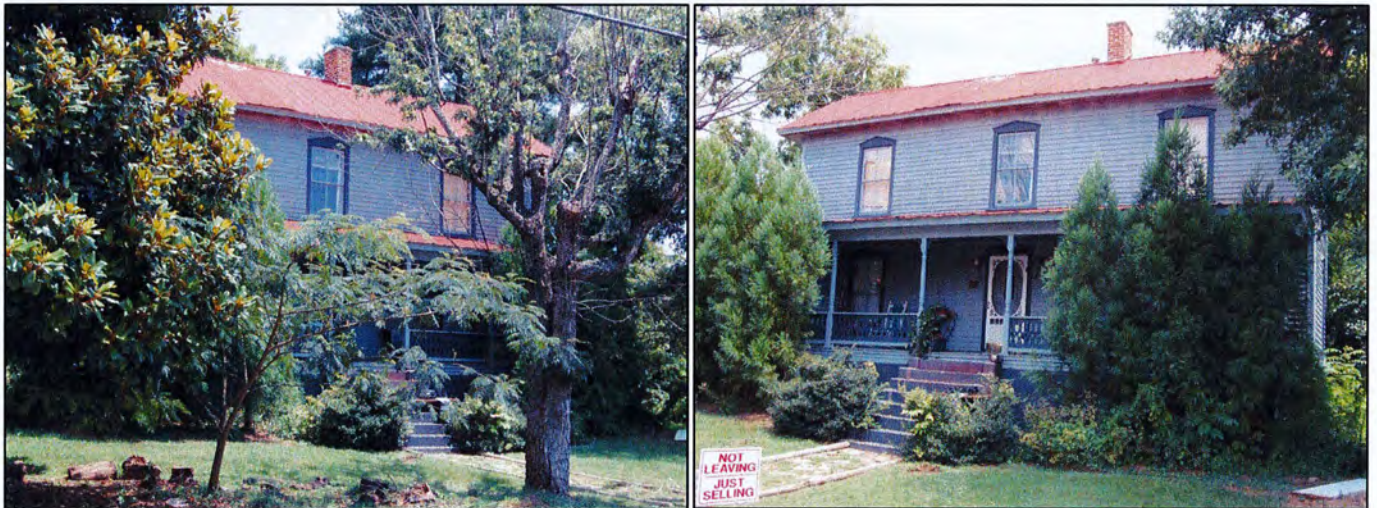
Figure 4. Rierson House: west front and north side elevations at left; west front and south side elevations at right

The north and south side elevations are identical. Each has two centered windows—one at the first story, the other above—with long two-over-two sash set in triangular-topped surrounds that mirror those of the front elevation. The wide overhangs of the gables, framed by moldings and underpinned by fascia boards, form distinct triangles. They terminate at boxed cornice returns. The rear (east) elevation has no openings. The regular pattern of the weatherboards suggests that this was always the case.

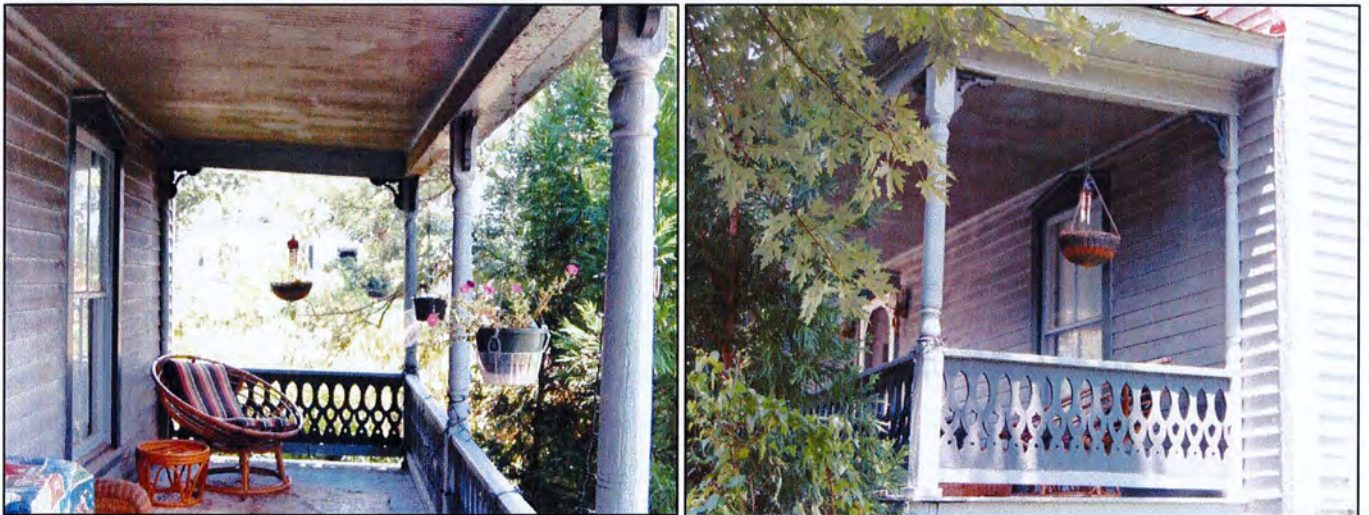
Figure 5. Rierson House: porch details

The intact porch stretched across the front elevation's first story also reflects popular late nineteenth-century design. Its posts are turned and edged at their tops by pierced jigsaw brackets. Jigsaws also produced the pierced and scalloped baluster boards which, set side to side, edge the porch with a lively openwork design.

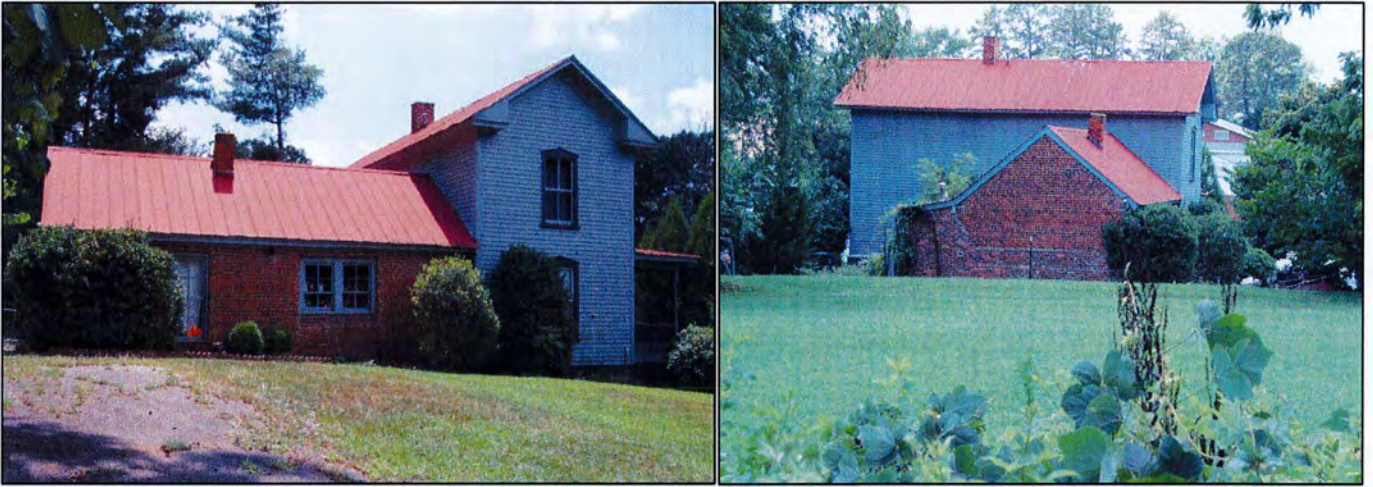
**Figure 6.** Rierson House—north side elevation at left; east rear elevation from rear of backyard and lot at right

Set perpendicular to the rear elevation of the front block is a one-story ell that gives the house an L-shaped footprint. It is built of brick, but the history of the property (discussed below) suggests that it is contemporary with the principal frame block. It is laid in five-over-one common bond and topped by a standing-seam metal roof penetrated near its center by a brick stack. At its long north elevation, a two-over-two window in a plain unpedimented surround appears to be original. A second opening has been partially filled and holds two later-added windows. There are no openings at the ell's east-facing gable end, but its lower section has had some bricks replaced and has been repointed since the house was recorded in 1983.

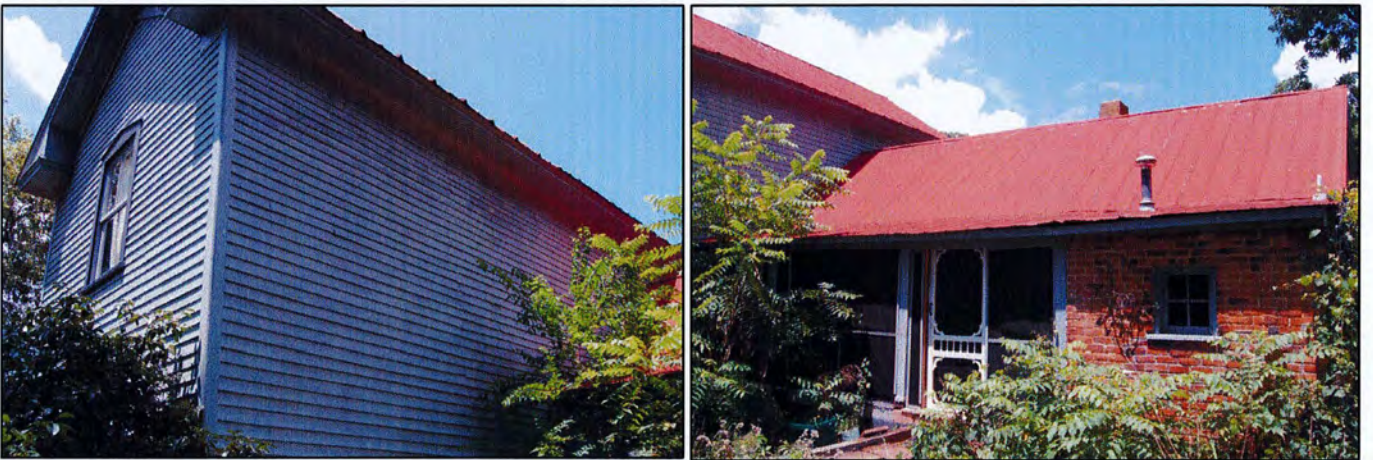
**Figure 7.** Rierson House—south side and east rear elevations

The ell's roof extends out at its long south elevation over a screened-in porch and a side room lit by a window that is likely not original. The porch holds two original or early four-panel doors that enter the ell. The size of the ell, the placement of the two doors, and its brick construction suggest that it was built to hold a dining room and a kitchen. Phillips made the same supposition in 1983.

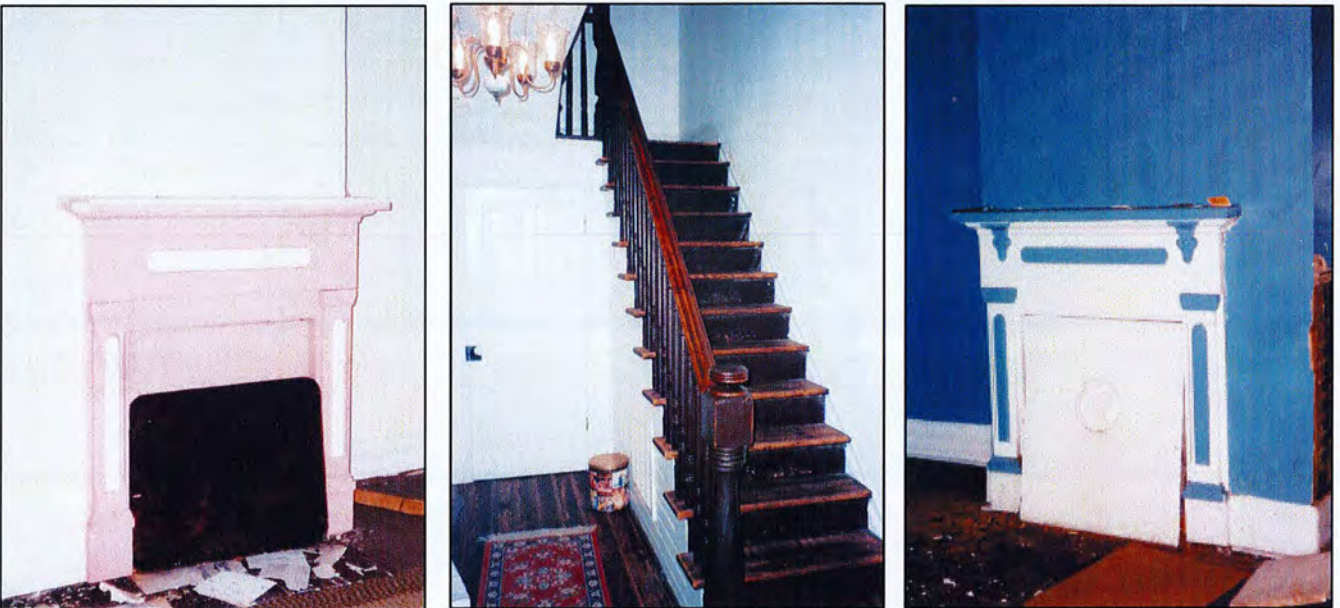
- Any and all wooden floors
- Five original wooden mantels
- The original staircase, including newel, handrail balusters, risers and treads.

Photographs of some of these interior features, taken in the 1990s, are included below (**Figure 8**).

**Figure 8.** Rierson House—two mantels and stairway in 1990s (source: Preservation North Carolina)

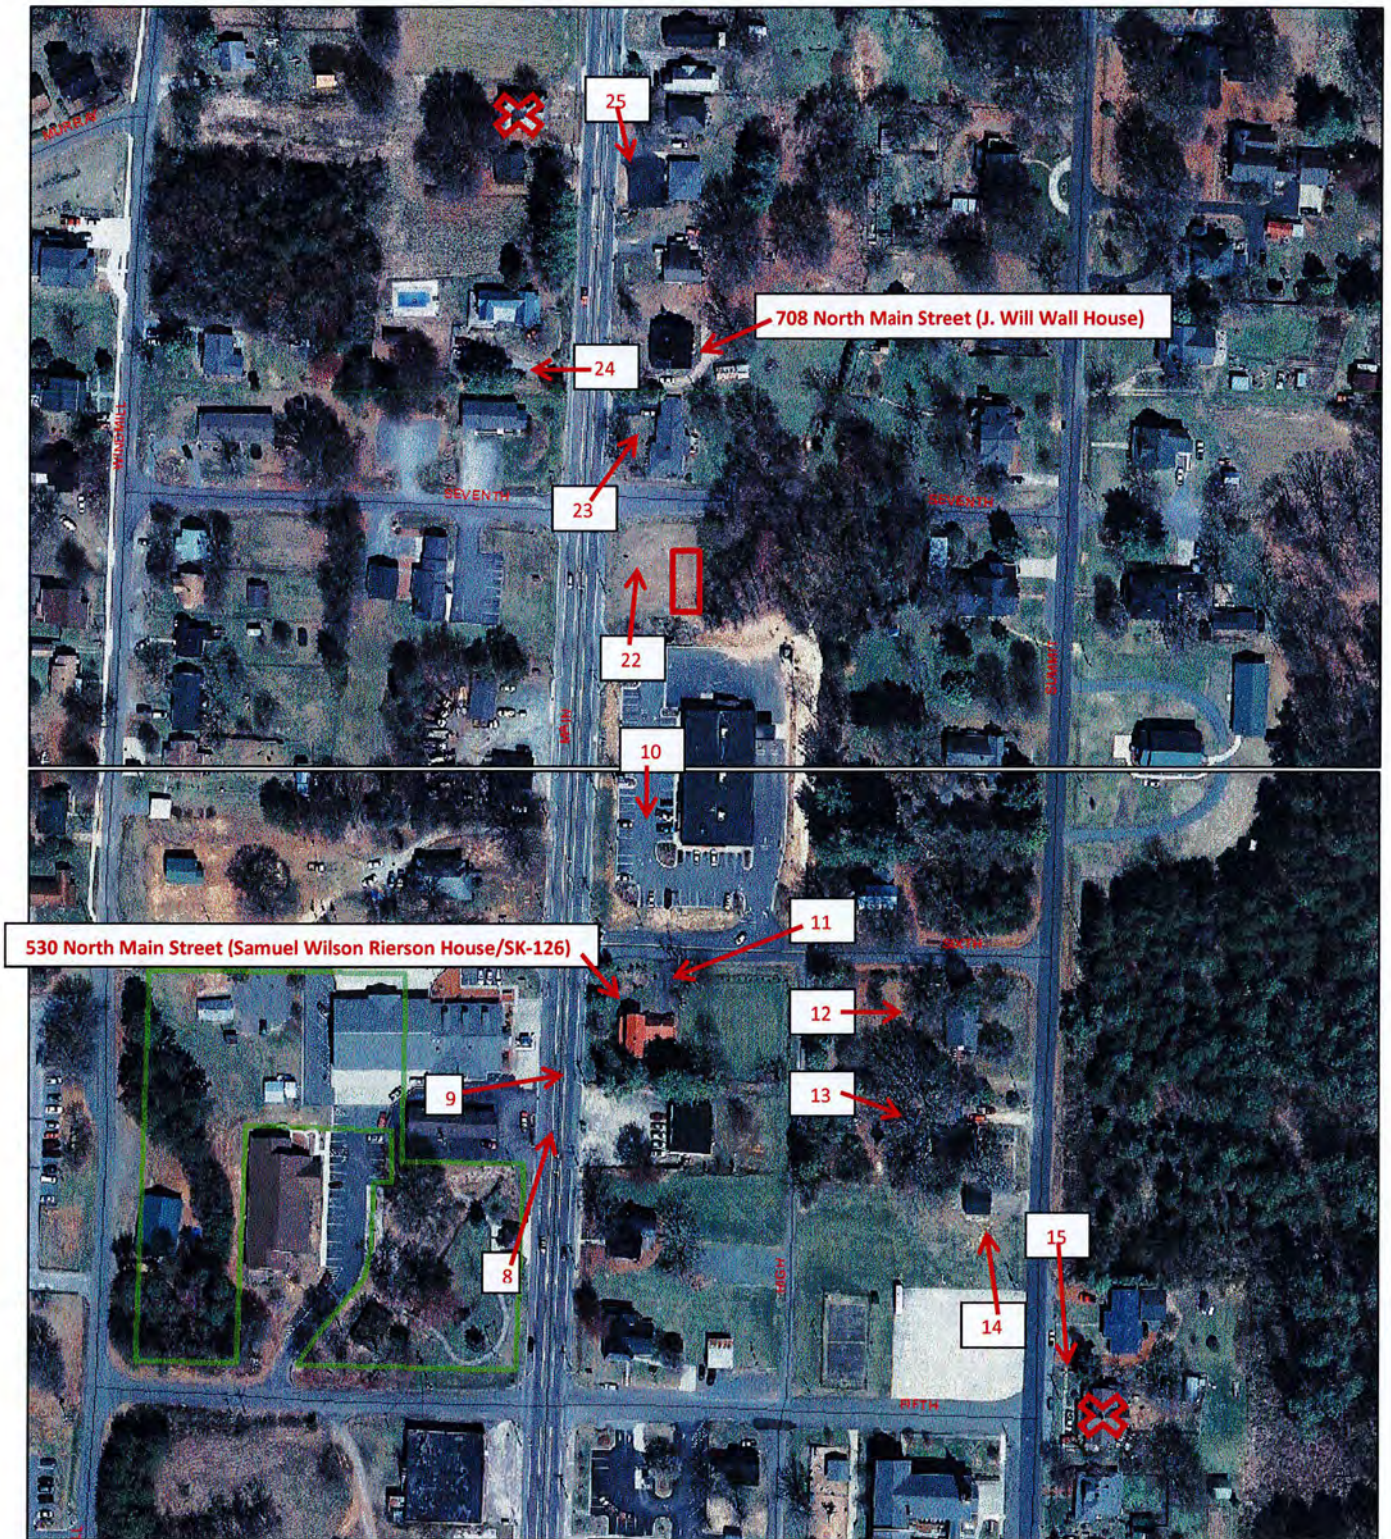
**Figure 10.** Map depicting locations of 530 North Main Street, 708 North Main Street, and the spots from which the contextual photographs for the two resources were taken (source of base image: Stokes County tax maps)

While the house is believed to be individually eligible for National Register listing under Criterion C for its architecture, it is not believed to be further eligible for listing under that Criterion as part of any historic district. As indicated by the following maps (**Figure 9** and **Figure 10**) and photographs, it is ringed by modern resources that cut it off from inclusion in any potential historic district. This includes any district that would incorporate part of North Main Street (**Figure 11** through **Figure 14**) and also the Summit Street Historic District (**Figure 15** through **Figure 18**), which is on the state Study List of resources potentially eligible for National Register listing. The northern end of that resource has seen the loss of its two northernmost resources—the P. Hanes Linville House (SK-112), replaced by a modern house, and the Dr. Rueben G. Tuttle House and Office (SK-111), now a vacant lot—on the east side of Summit Street north of 6th Street. On the west side of Summit north of its intersection with 6th is a large paved parking lot, a garage, and two mid-twentieth-century houses out of character with this historic district that were not included within its recommended boundaries. The same reasons that kept the Rierson House outside of the boundaries of the historic district when it was placed on the Study List in 1988 continue to keep it from meriting inclusion within that resource.

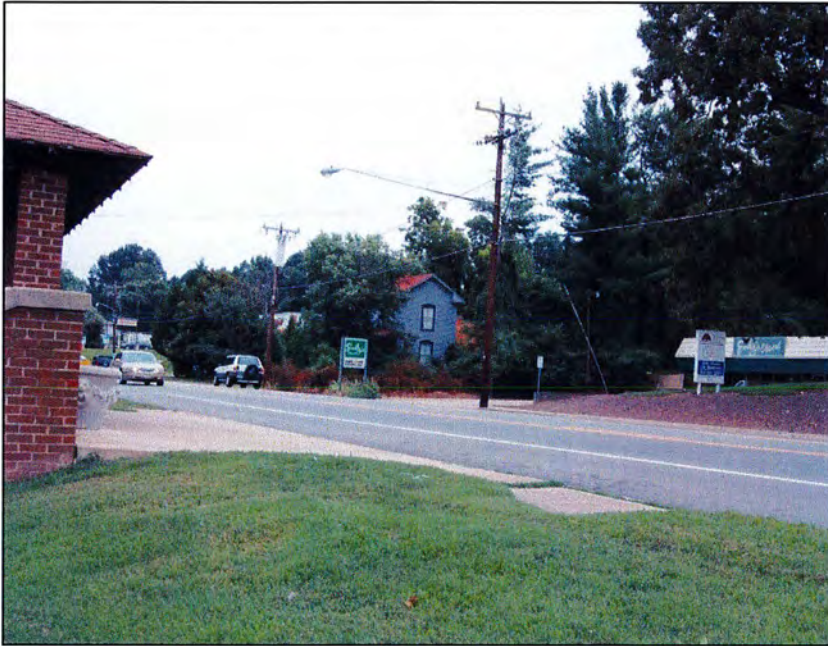
**Figure 11.** Looking northeast up Main Street at late twentieth-century thrift store at right, Rierson House at center, CVS drugstore at left distance, modern Dr. Jack Fowler park at far left foreground

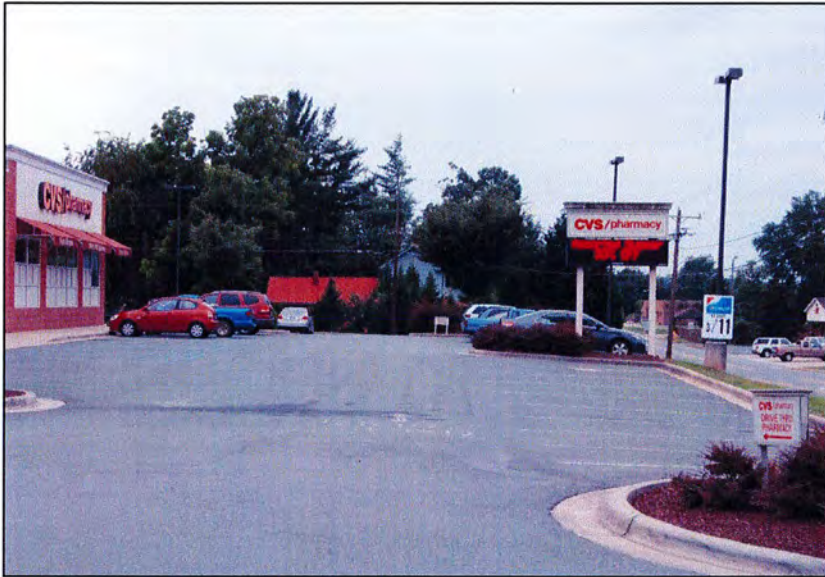
**Figure 13.** Looking south with early twenty-first-century CVS drugstore at left, Rierson House at center across 6th Street, and Main Street and ABC store at far right

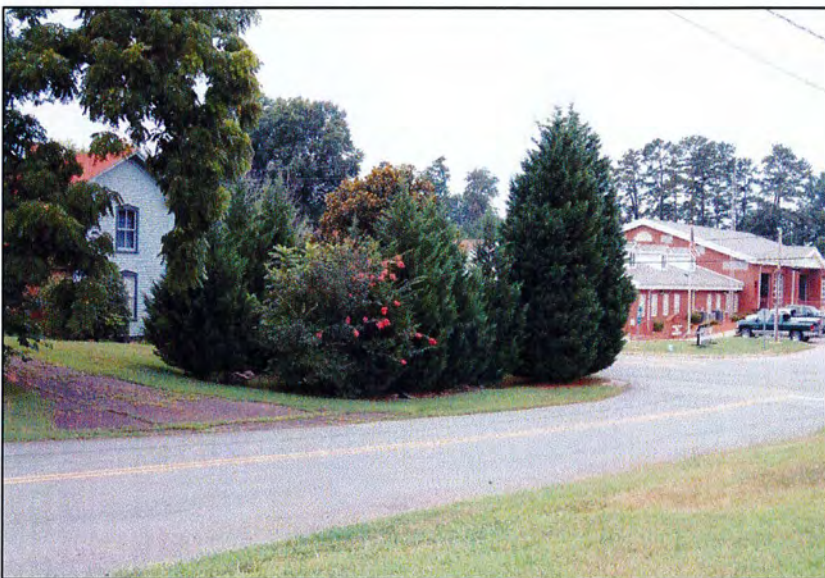
**Figure 14.** Looking southwest down 6th Street with Rierson House at left and early twenty-first-century fire department building at right across Main Street

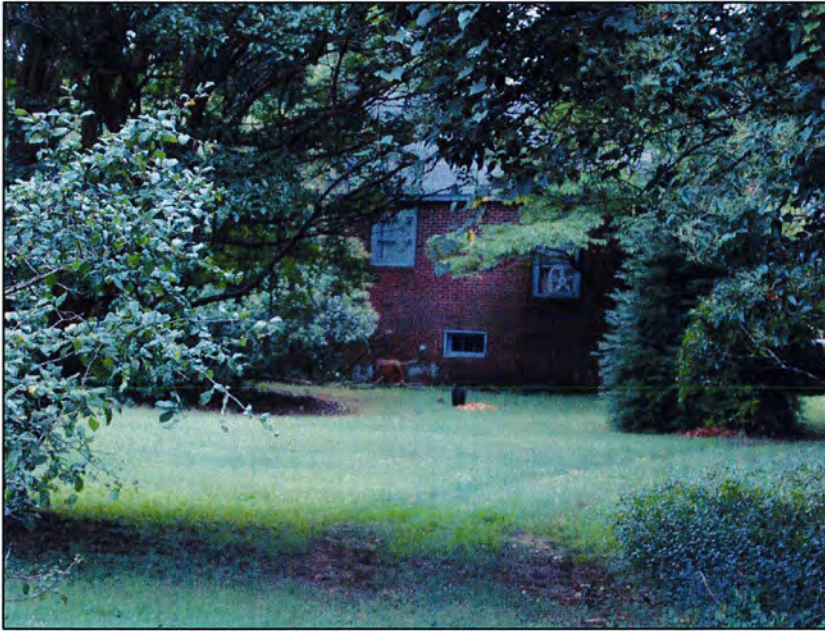
**Figure 15.** Looking east from High Street (alley) running along rear of Rierson House lot toward back elevation of 517 Summit Street (north of Summit Street Historic District)

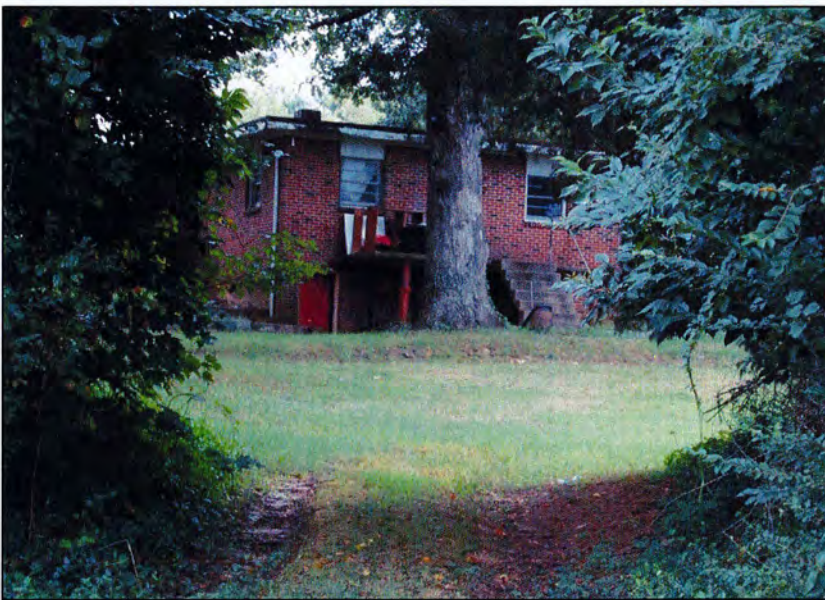
**Figure 16.** Looking east from High Street (alley) running along rear of Rierson House lot toward back elevation of 511 Summit Street (north of Summit Street Historic District)

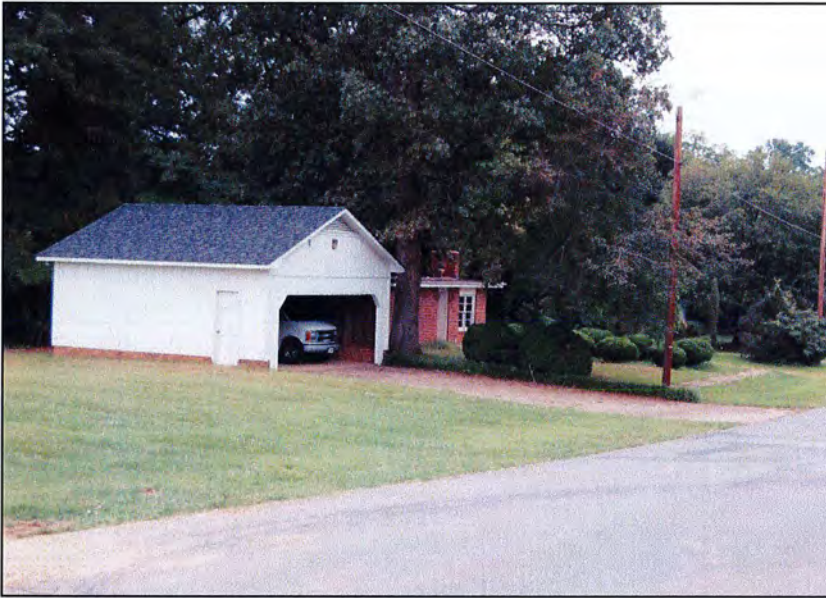
**Figure 17.** Looking northwest from junction of Summit Street and 6th Street toward garage and front elevation of 511 Summit Street at northern edge of Summit Street Historic District

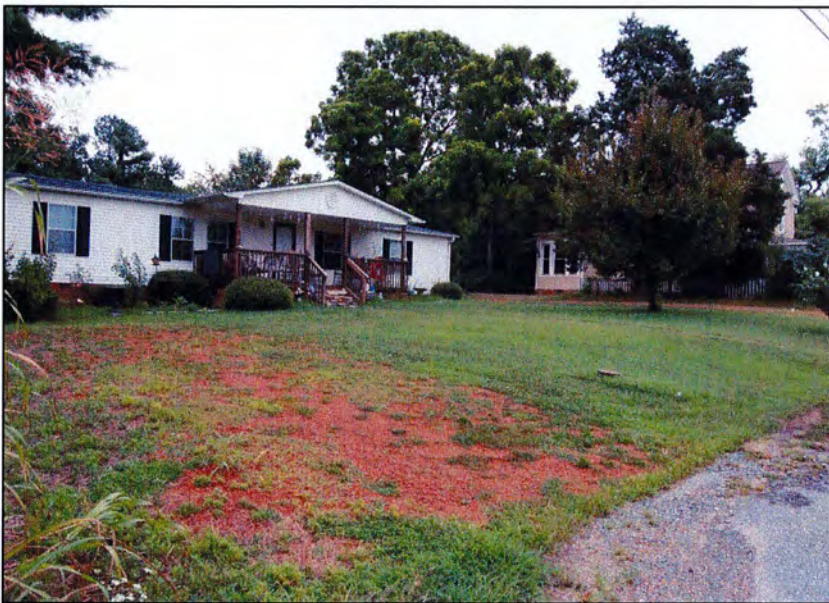
**Figure 18.** Looking southeast from junction of Summit Street and 6th Street toward manufactured house on site of P. Hanes Linville House (SK-112) at left and J. Luther Mitchell House (SK-110) at right at northern edge of Summit Street Historic District; note that Dr. Rueben G. Tuttle House and Office (SK-111), which stood between the two houses, was demolished after 1983

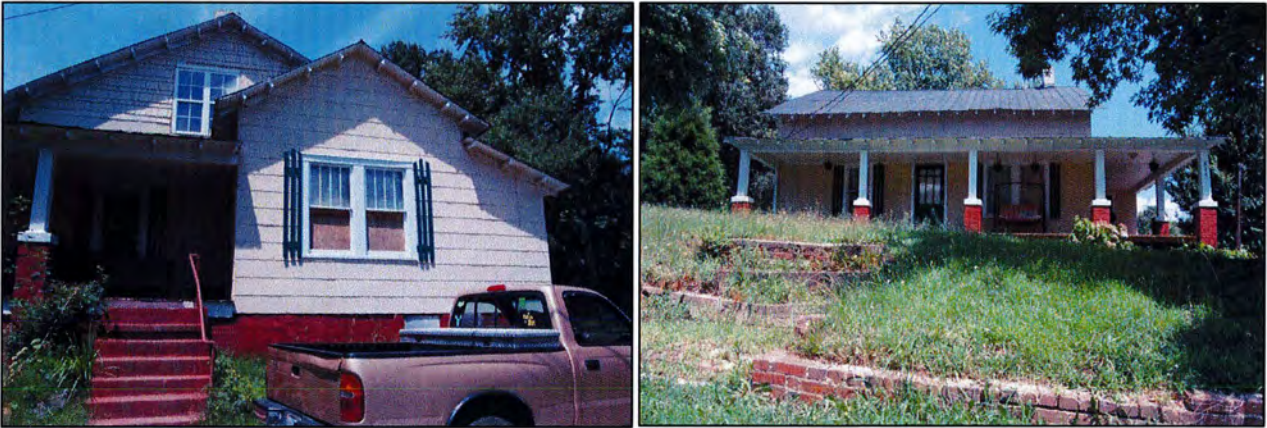
original four-over-one window in the shadow of the wraparound porch. The paired four-over-sash window unit in the shingled gable peak above is out of character with the other windows, but may be original. A projecting room at the south side elevation, to the rear of the porch, also has a paired window unit with four-over-one sash. It can be entered through a door opening directly onto the porch. A shed-roofed ell crossing the rear (east) elevation once included an open porch at its north end. A paired four-over-one window unit near its center indicates that it was also partially enclosed, however.

**Figure 23.** Wall House: south side elevation at left; west front elevation and retaining wall and stairs at right

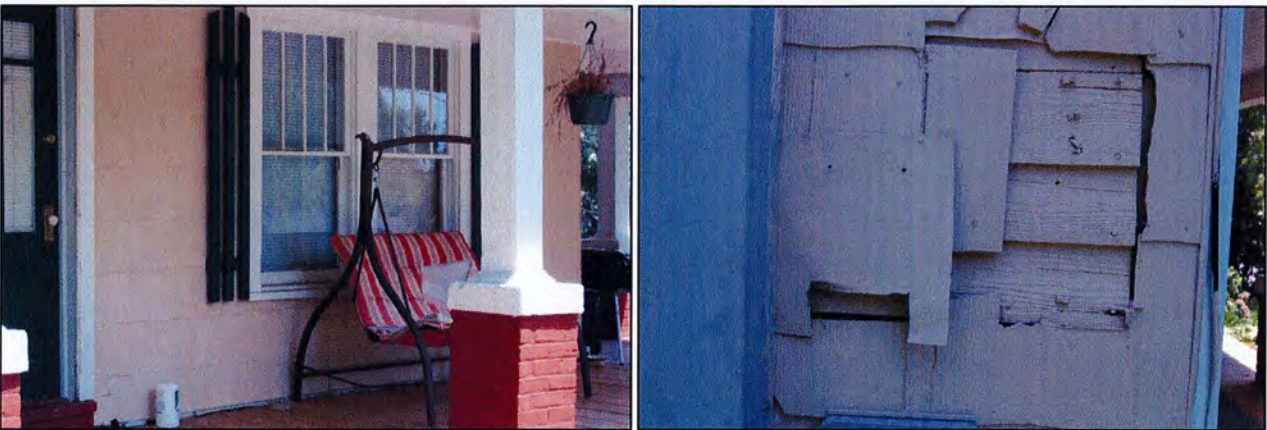
We also concur that the **J. Will Wall House at 708 North Main Street** is not eligible for listing in the National Register. The 1920s house does not appear architecturally important, and the application of asbestos siding has significantly altered the house.

**Figure 24.** Wall House: west front elevation with Craftsman-style porch, sash, and front door at left; north side elevation with original German siding exposed beneath asbestos shingles at right

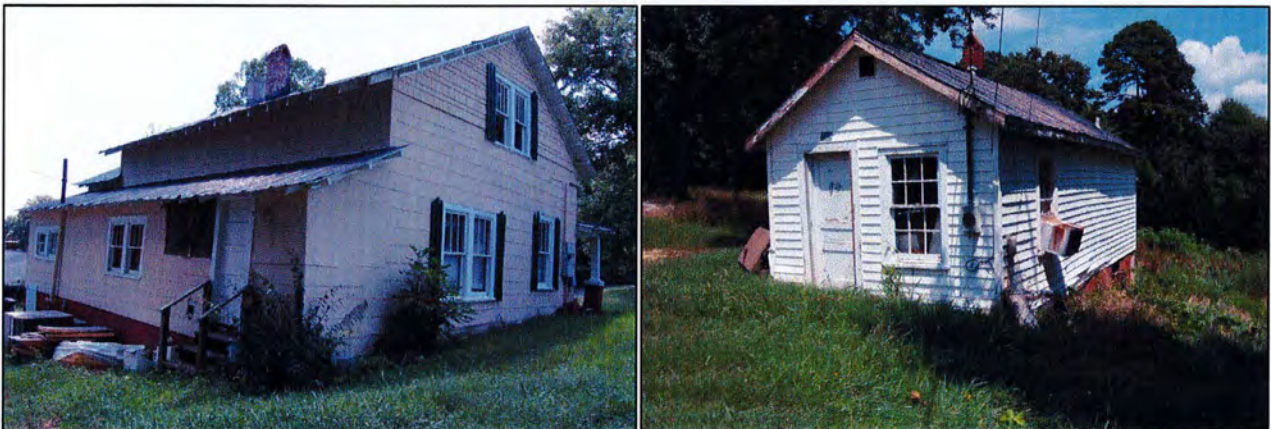
One outbuilding stands to the rear of the house (**Figure 25**, at right). It is a one-story, gable front, two-room building built of frame clad in vinyl. A door and six-over-six sash window fill its front (west) elevation. Its south side elevation has one long window, its north side elevation a small window and a door that enters the rear room. A brick flue stack rises from the center of its standing-seam metal roof. The placement of the openings and the flue suggest that the building may have been erected as a summer kitchen. The number "709" is marked over and upon the front door. This is the address of the house immediately across Main Street from the house. This building, which appears to date from earlier in the twentieth century than the house, may have been moved from there or elsewhere in the town.

**Figure 25.** Wall House: north side and east rear elevations at left; west front and south side elevations of outbuilding immediately to rear of house at right

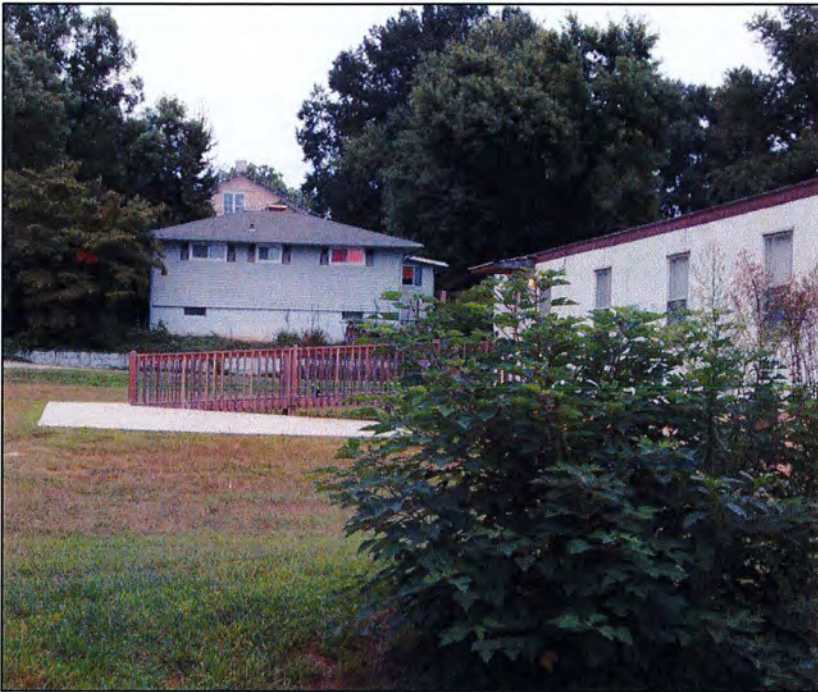
**Figure 26.** Looking north from edge of CVS parking lot toward early twenty-first-century car dealership building at right, late twentieth-century house at left, and J. Will Wall House at left distance; Main Street out of sight just to left

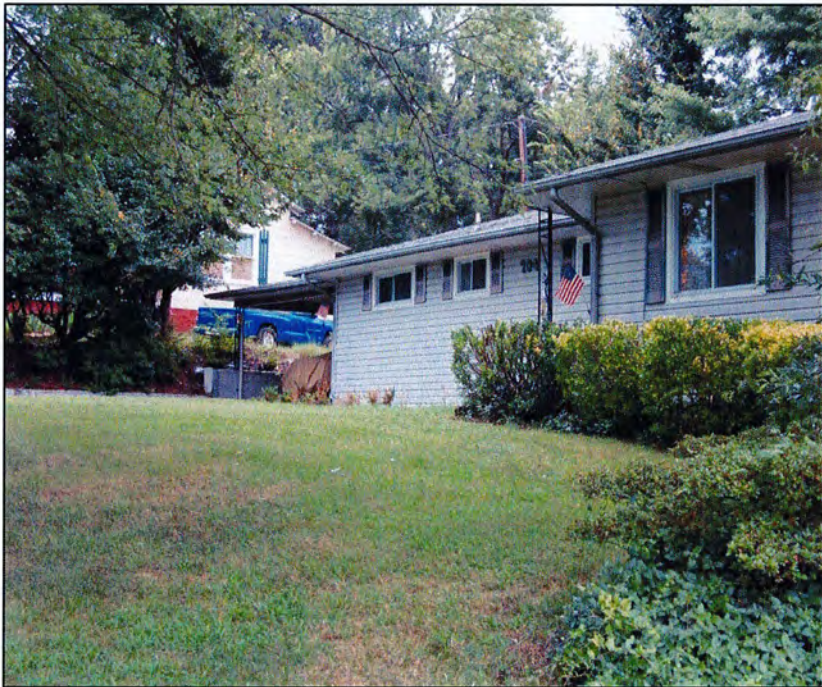
**Figure 27** Looking northeast from junction of Main and 7th at late twentieth-century house at right and J. Will Wall House at left

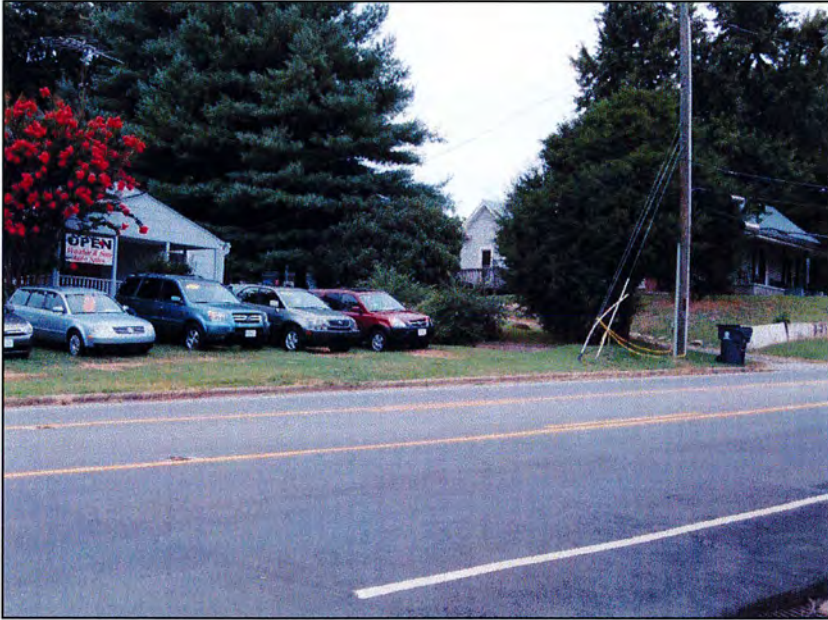
**Figure 28.** Looking northwest across Main Street from J. Will Wall House at late twentieth-century car dealership building at left and early twentieth-century house at right

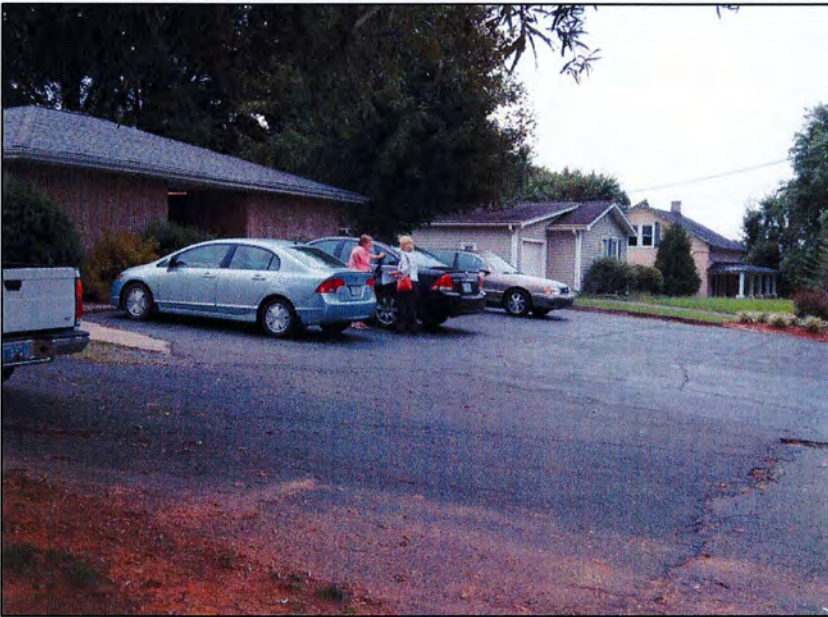
**Figure 29.** Looking southeast with Main Street just to right at early twenty-first-century financial offices at left, late twentieth-century house at center, and J. Will Wall House at right)
