Re: Replace Bridge 31 on SR 1464 (Shawtown Road) over Big Pine Creek, PA 13-09-0005,
Alleghany County, ER 14-0180

HISTORIC ARCHITECTURAL ANALYSIS OF THE
R.L. HENDRIX HOUSE (AL 198)
ALLEGHANY COUNTY, NORTH CAROLINA

Replace Bridge No. 31 on SR 1464 (Shawtown Road) Over Big Pine Creek
Alleghany County, North Carolina

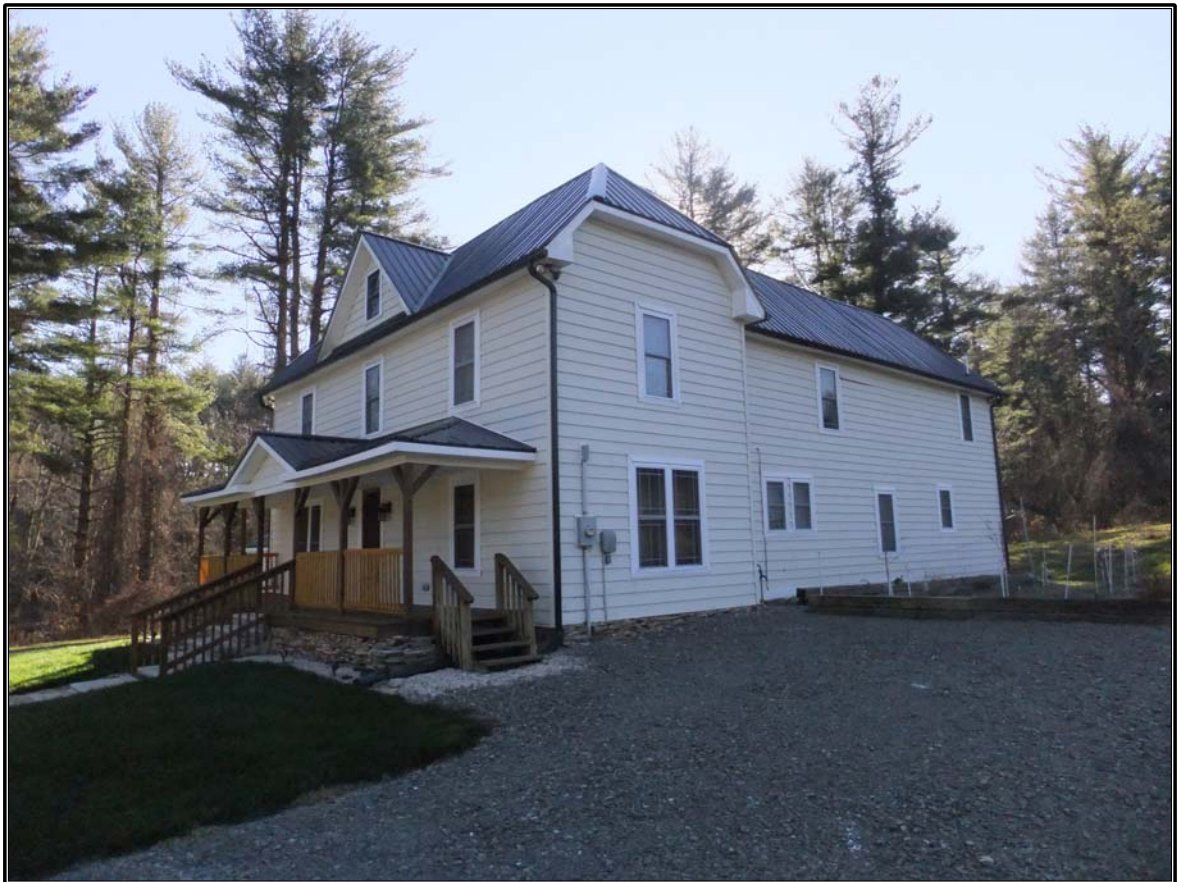
House, overview: The house, which totals 3,136 square feet of living space, is comprised of two distinct sections: the original, three-bay, clipped gable central passage I-house portion constructed circa 1895, and a large, two-story rear addition. The addition is formed by the circa 1920 western portion and an enclosed porch of an unknown vintage on the east; the entire house was renovated in 2007 to support its operation as a bed and breakfast (Figure 6) (Sizemore 1980; Blue Ridge Bed and Breakfast 2013).

Figure 6. R.L. Hendrix House (AL 198): Southeasterly view of the residence.

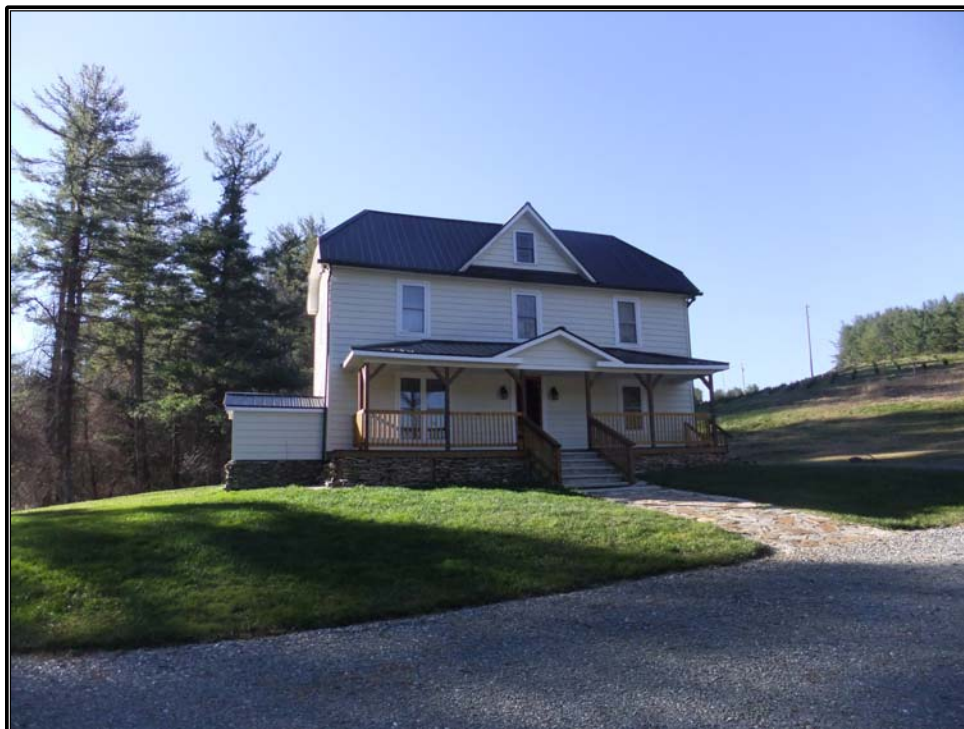
House, exterior: The original portion of the house is of the "triple A" form (a central front gable that breaks the roofline) with clipped gable ends (Figure 7). An interior brick chimney with a corbelled cap projects from the ridge of the rear addition. Exterior chimneys formerly on the east and rear elevations of the addition have been removed.

Figure 7. R.L. Hendrix House (AL 198): Southerly view of the residence.

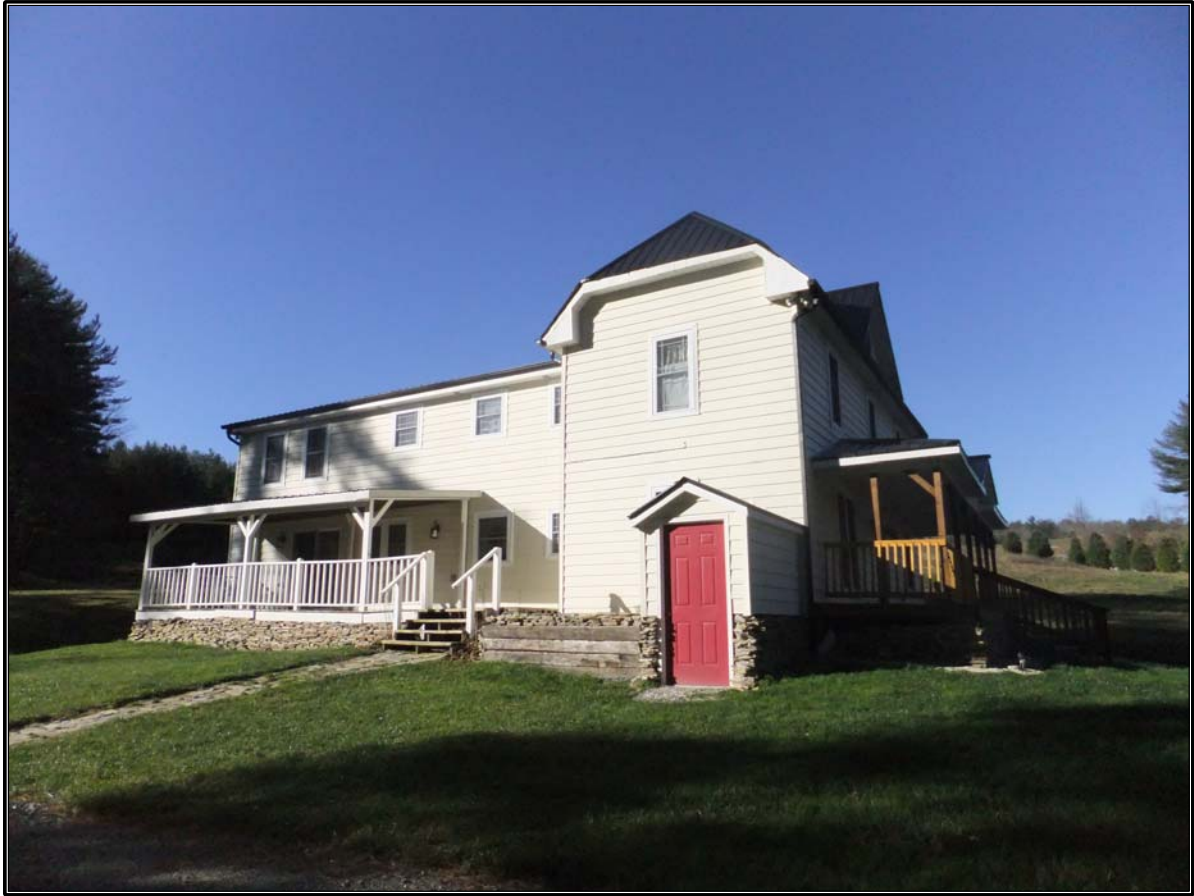
The east elevation (Figure 8) features a secondary entry centered within a small, one-story, front-gabled shelter. The single-leaf, modern replacement door provides exterior access to the basement. A single window punctuates the first and second floor. The west elevation (see Figure 6) features a paired window opening on the first floor and a single opening on the second floor.

Figure 8. R.L. Hendrix House (AL 198): Southwesterly view of east elevation and rear additions.

Running perpendicular to the original mass, the large rear addition (see Figure 8) more than doubles the house's footprint. Like the primary mass, it is clad in vinyl siding and continues one-over-one, double-hung vinyl sash windows with snap-in grids simulating a Craftsman-inspired geometry. The east elevation of the addition features a secondary entry, comprised of vinyl French doors set behind a sliding screen; the entry opens onto a full-length wood porch constructed of contemporary materials. The entry and a paired window unit to the north are sheltered beneath a two-bay shed roof supported by wood posts; a wood railing runs along the perimeter. A single window is positioned to the north beyond the porch roof. Five singly-placed windows of varying sizes front the second floor. The west elevation features one paired and two singly placed window units on the first floor and two irregularly placed window units on the second floor.

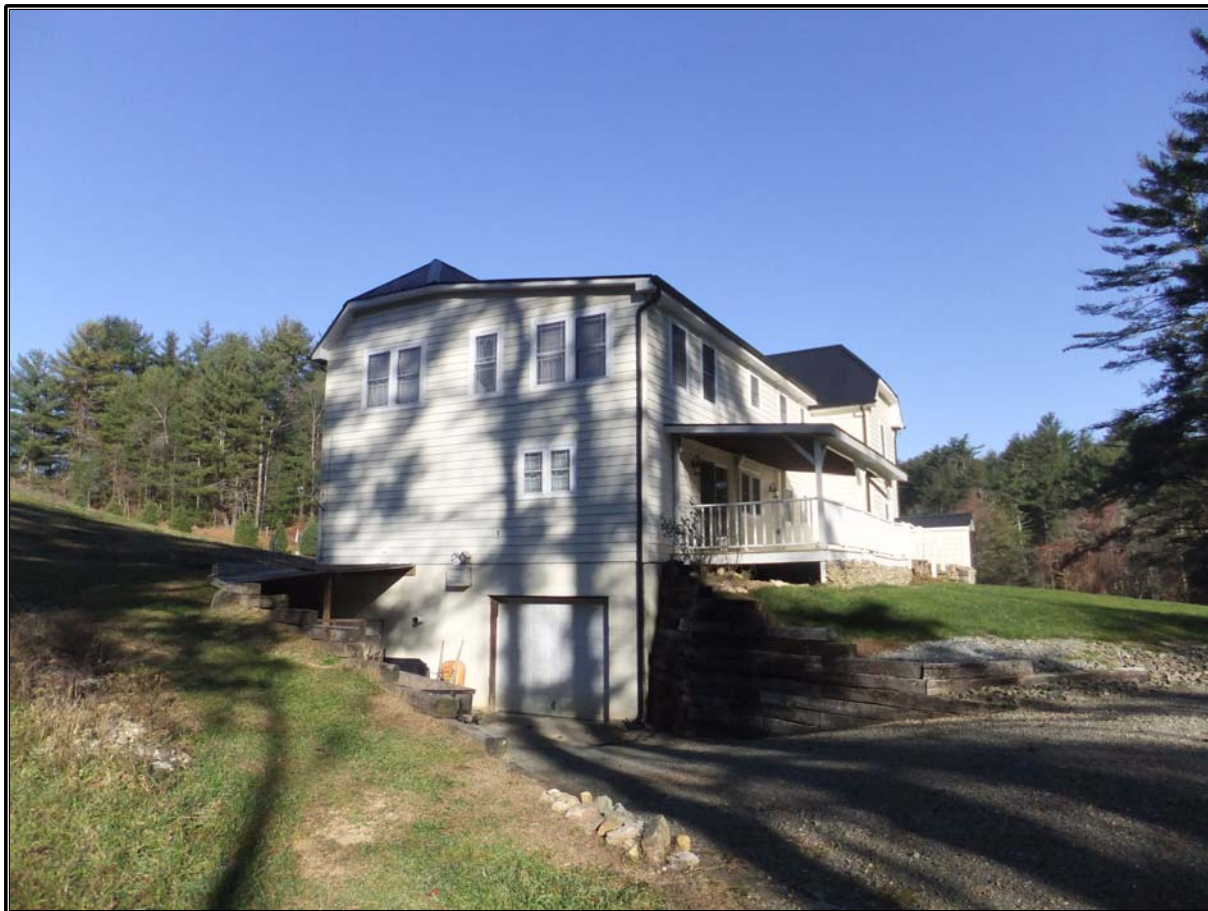
The rear addition is exposed below grade. Here, a vinyl sectional overhead garage door is located at the eastern corner, opening onto the gravel driveway (Figure 9). A small paired unit occupies the first floor of the rear elevation and two paired units flank a single unit on the second floor. A wood lean-to is attached to the rear elevation, west of the garage. Wood posts support the ribbed-metal roof.

Figure 9. R.L. Hendrix House (AL 198): Northwesterly view of rear elevation.

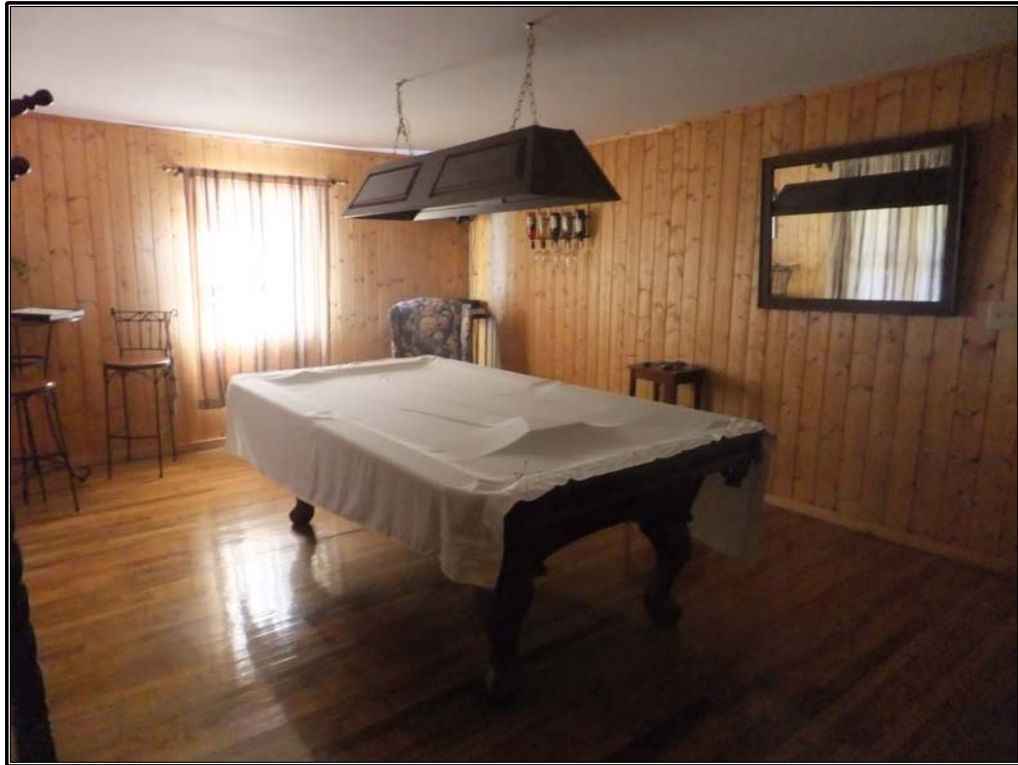
The floor consists of hardwood planks, and the walls are sheathed in wood paneling in the eastern room, the “Pool Parlor;” only the lower half is sheathed with paneling in the western room, the bar area (Figures 11–12). All other walls and the ceiling are drywall. A fireplace featuring a corbelled brick surround and molded wood mantel is centered on the south wall of the western room.

Figure 11. R.L. Hendrix House (AL 198): "Pool Parlor."

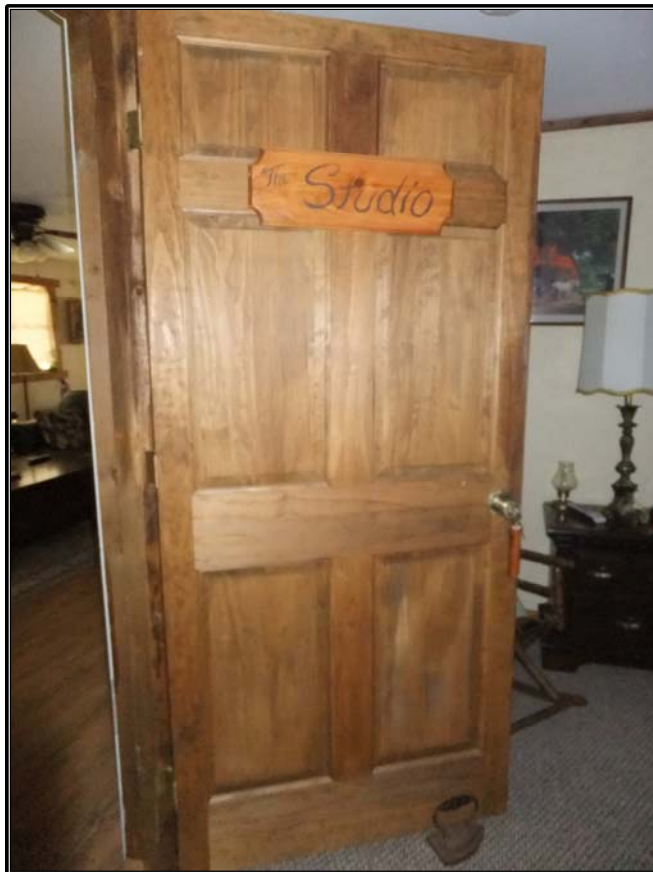
Figure 16. R.L. Hendrix House (AL 198): Typical wood paneled door.

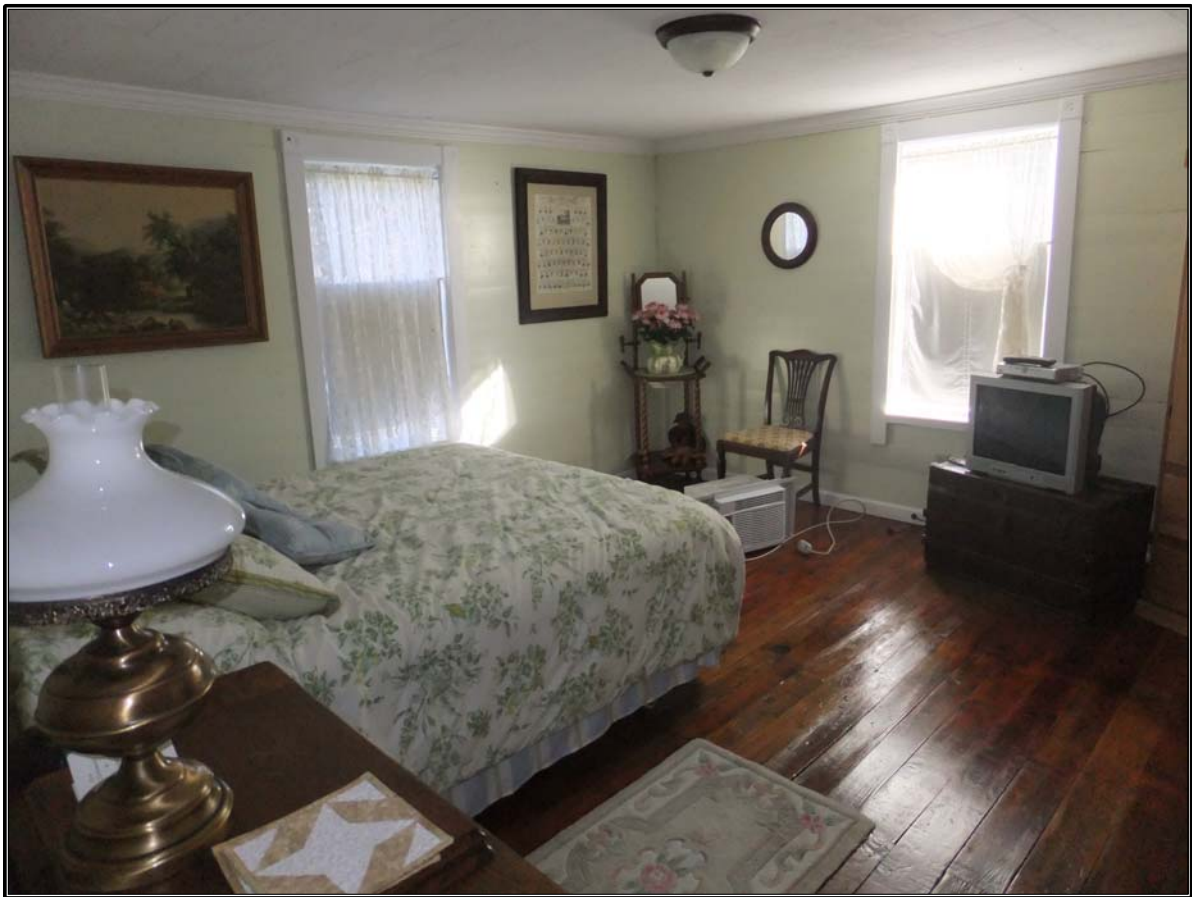
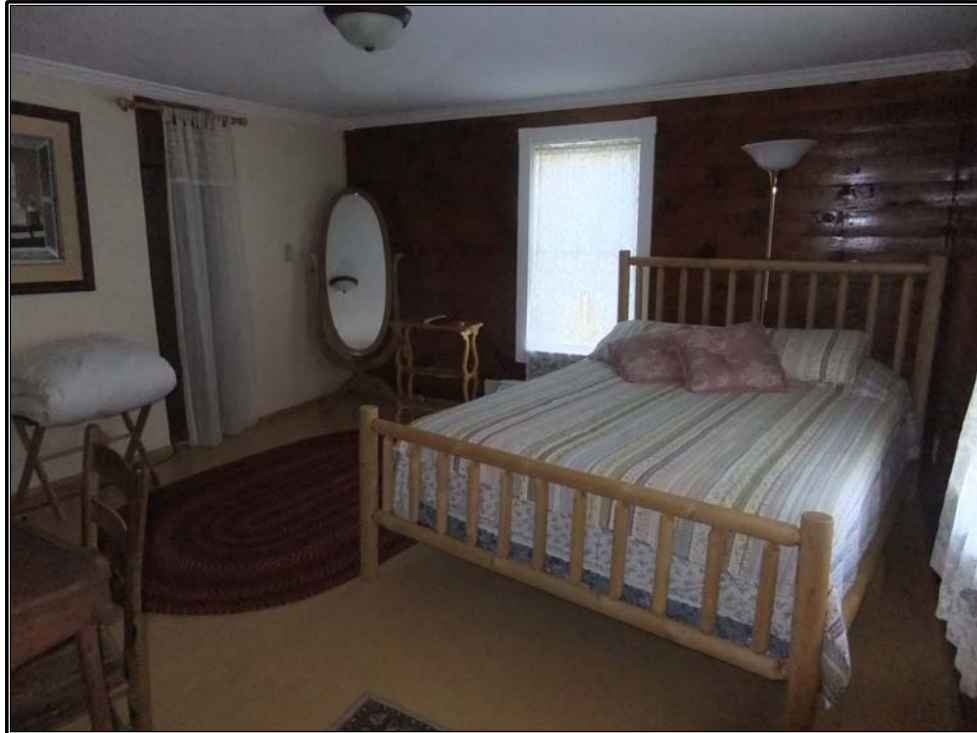
House, interior, second floor: The second floor of the original portion of the house is divided into two bedrooms. The bedrooms retain their wide, wood plank flooring, and the western bedroom retains two of its plaster walls. The eastern bedroom and the outer walls of both bedrooms are covered with horizontal wood paneling. Entries feature wood paneled doors. Finishes include wood baseboards, crown molding and window surrounds with carved corner blocks (Figures 17–18).

Figure 17. R.L. Hendrix House (AL 198): “Homestead” bedroom.

Figure 18. R.L. Hendrix House (AL 198): "Pioneer" bedroom.

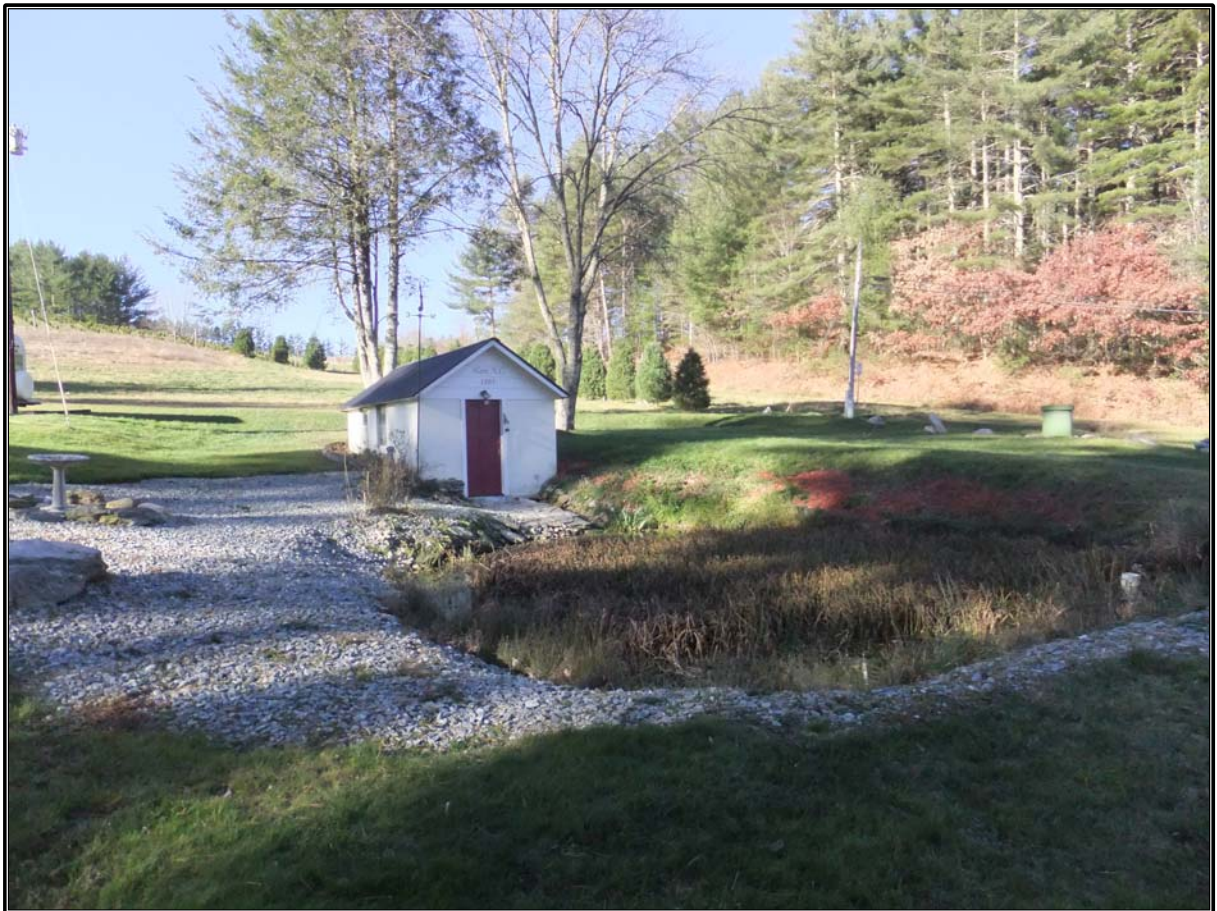
Springhouse: The springhouse, located approximately 100 feet north of the house is a one-story, front-gabled concrete block structure (Figure 26). The building is situated beneath a v-crimp metal roof, with the rear portion of the structure constructed into the hillside so that it is below grade. The area beneath the gables are clad with aluminum siding. “Hare N.C. 1895” is painted onto the center of the siding on the northeast elevation; a wood paneled door is centered below. The door opens onto a flagstone walkway that leads to the filled-in duck pond. A fixed sash vinyl window with snap-in grids simulating Craftsman detailing identical to that on the house is located at the center of the rear elevation (Figure 27).

Figure 26. R.L. Hendrix House (AL 198): Southwesterly view of springhouse.

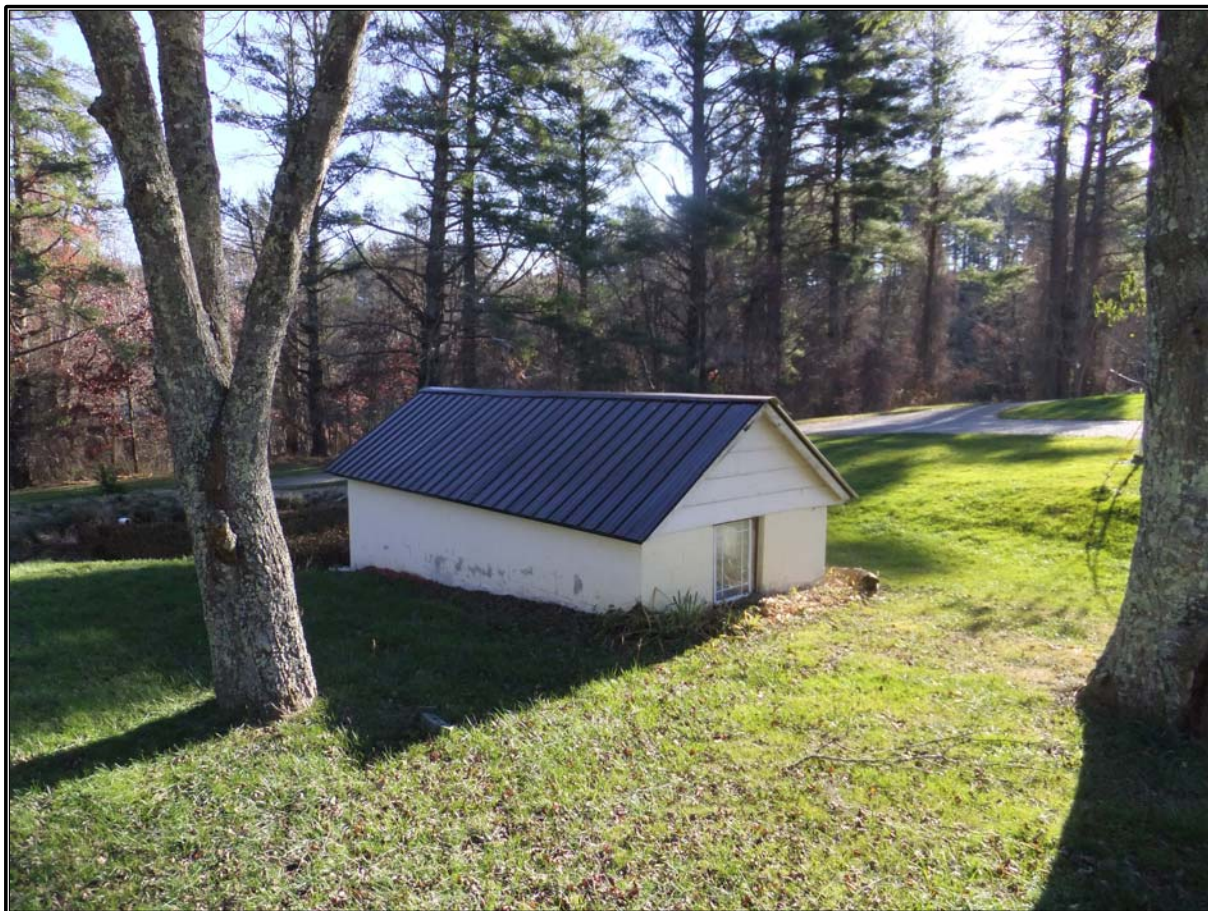
Figure 27. R.L. Hendrix House (AL 198): Rear of springhouse.

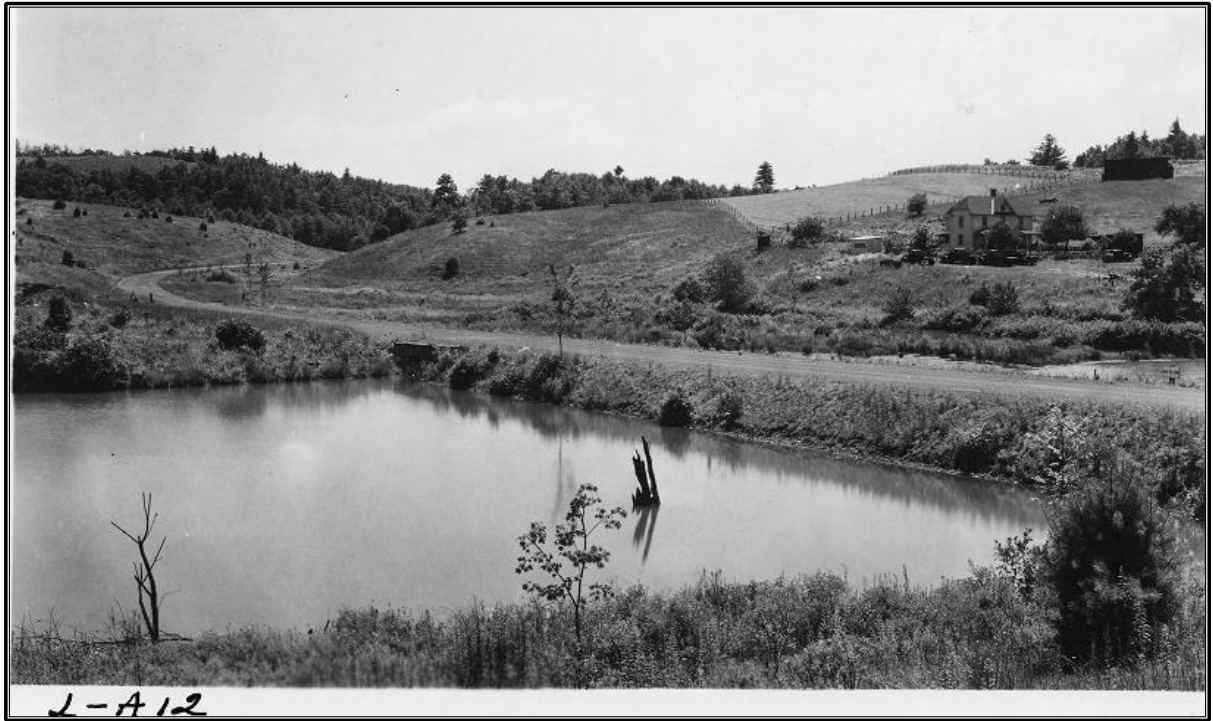
Figure 29. Circa 1935 photograph of Hare Mill Pond and the R.L. Hendrix House (AL 198) (North Carolina State Archives: Driving Through Time).

The 1930s brought changes to the Ransom Hendrix’s property as the Blue Ridge Parkway, splitting Hare Mill Pond, was constructed immediately adjacent to Hendrix’s landholding. The house itself and a portion of Hendrix’s land was captured in a circa 1935 series of photographs depicting Hare Mill Pond at the time of the Blue Ridge Parkway’s construction (Figures 30–31). Clearly visible in at least one photograph, the house, at this time, was comprised of the primary “triple A” mass and a long, narrow addition extending off the western end of the rear (south) elevation. A shed-roof porch is set within the ell formed by the addition and the primary mass. The full-width façade porch is present at this time; however, its details are indiscernible in the photograph. The house is encompassed by a post-and-rail fence that forms a small house yard amidst the larger agrarian parcel. At least three outbuildings are visible, as are five vehicles, a sign of Hendrix’s wealth amassed through his commercial and agricultural interests. With the construction of the Blue Ridge Parkway came other opportunities for investment in the area. To this, in 1938, R.L. Hendrix and wife granted right-of-way to Caldwell Mutual Corporation on his then 223.75-acre parcel for the construction of an electrical transmission corridor (ACCO DB 48:297).

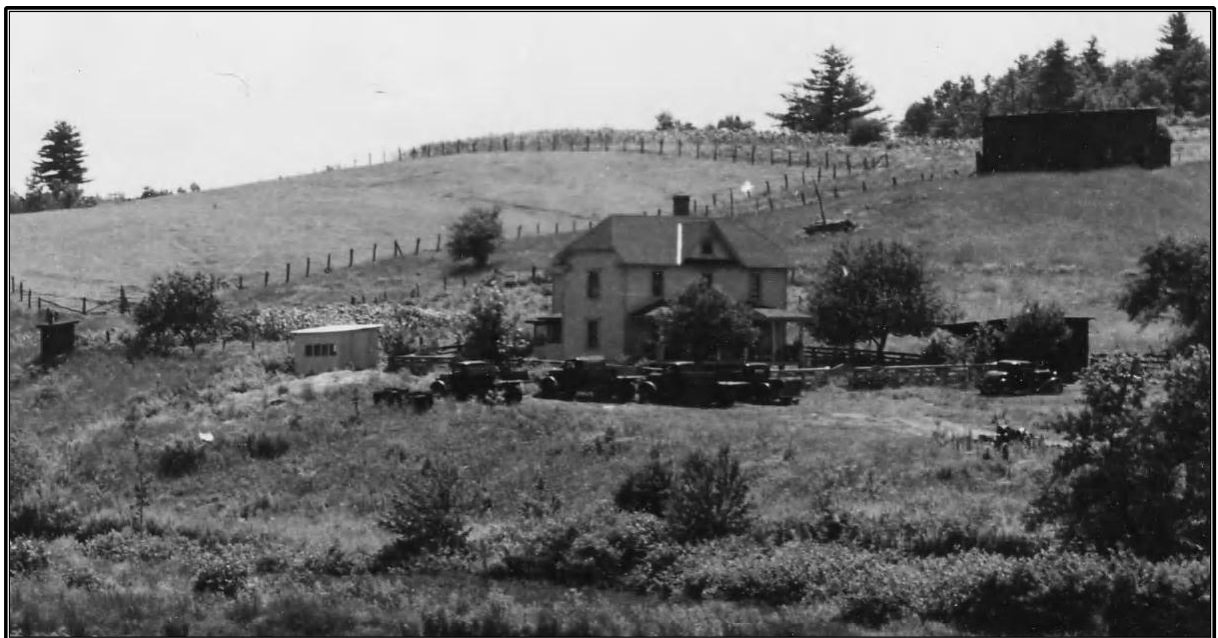
Figure 30. Close-up of circa 1935 photograph of Hare Mill Pond and the R.L. Hendrix House (AL 198) (North Carolina State Archives: Driving Through Time).
